Utah Geological Survey Technical Report

Project: Update on conditions through 2008 at the Springhill landslide, North Salt Lake, Utah			
By: F.X. Ashland and A.H. Elliott	Date: March 23, 2009		County: Davis
USGS Quadrangles: Salt Lake City North (1254)	Section/Township/Range: Sec. 12, T. 1 N., R. 1 W., Salt Lake Base Line and Meridian		
Requested by: NA	Dates reports received at UGS: NA		
		Job number: 09-01

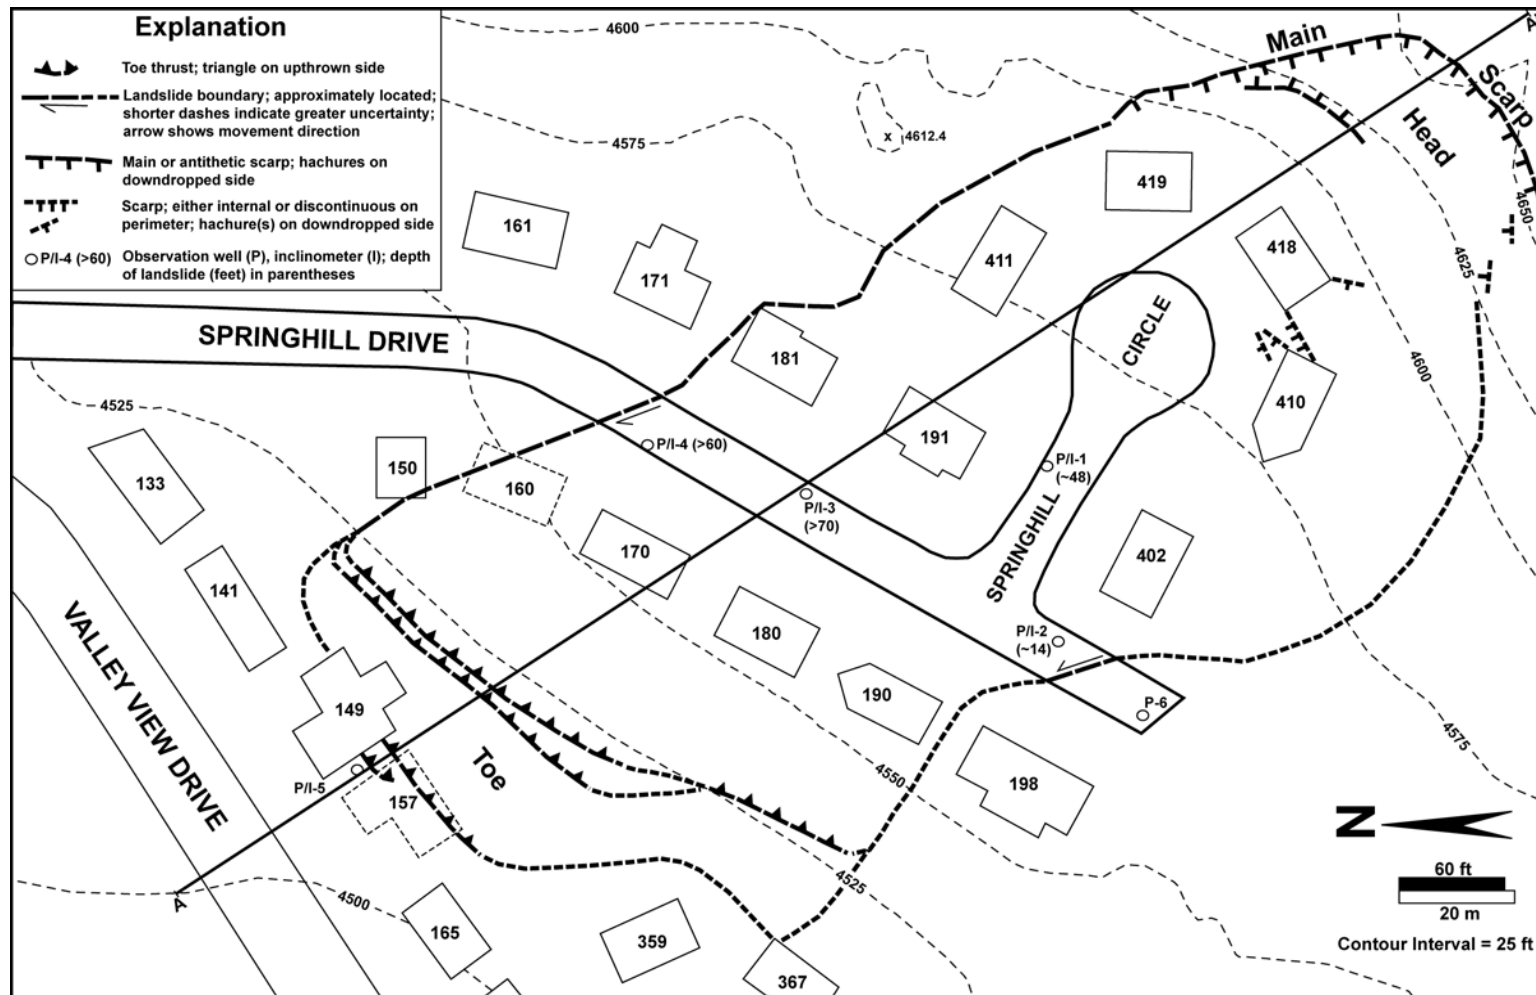
Figure 2. Map of the Springhill landslide. Base map modified from Terracon (1998). A trace of the Wasatch fault zone (not shown on map, see figure 5 for approximate location) is inferred to cross the landslide in the backyards of the lots immediately southeast of Valley View Drive. Geologic cross section A-A' is shown on figure 5. Dashed lines indicate houses that have been demolished.

The landslide (figures 2 and 5) is about 720 feet (220 m) long and reaches a maximum width of about 290 feet (90 m) where it crosses Springhill Drive. The local relief is about 150 feet (46 m) and the average slope is about 21 percent. The landslide is about 48 feet (15 m) deep beneath Springhill Circle (at inclinometer I-1) (figure 6) and probably deeper than 70 feet (21 m) near Springhill Drive (at inclinometer I-3). At inclinometer I-2, near the southern boundary, the landslide is only between about 10 and 14 feet (3-4 m) deep (Terracon, 2000). At inclinometer I-5, near the toe of the landslide, the depth of the landslide may be between about 6 and 18 feet (2-6 m) (Terracon, 2000, 2005). The inclinometer plot for I-5 suggests that perhaps three separate slide surfaces intercept the casing within that depth range. These slide surfaces may be developing below ground downslope of the mapped toe and have not yet intercepted the ground surface. The landslide is moving slowly toward the northwest (toward Valley View Drive).

The northern boundary of the landslide is presently well defined by scarps, linear troughs, road cracks and pavement distress, and deflections of linear elements such as fences. The southern boundary of the landslide is less well defined because it crosses a wetland area south of Springhill Circle, but a set of recurrent road cracks indicates its location in the southern part of Springhill Drive. Since 2006, scarps have formed in the head of the landslide, southeast of Springhill Circle. These scarps locally reached a maximum height of about 3 feet (1 m) by December 2008 (figure 7).

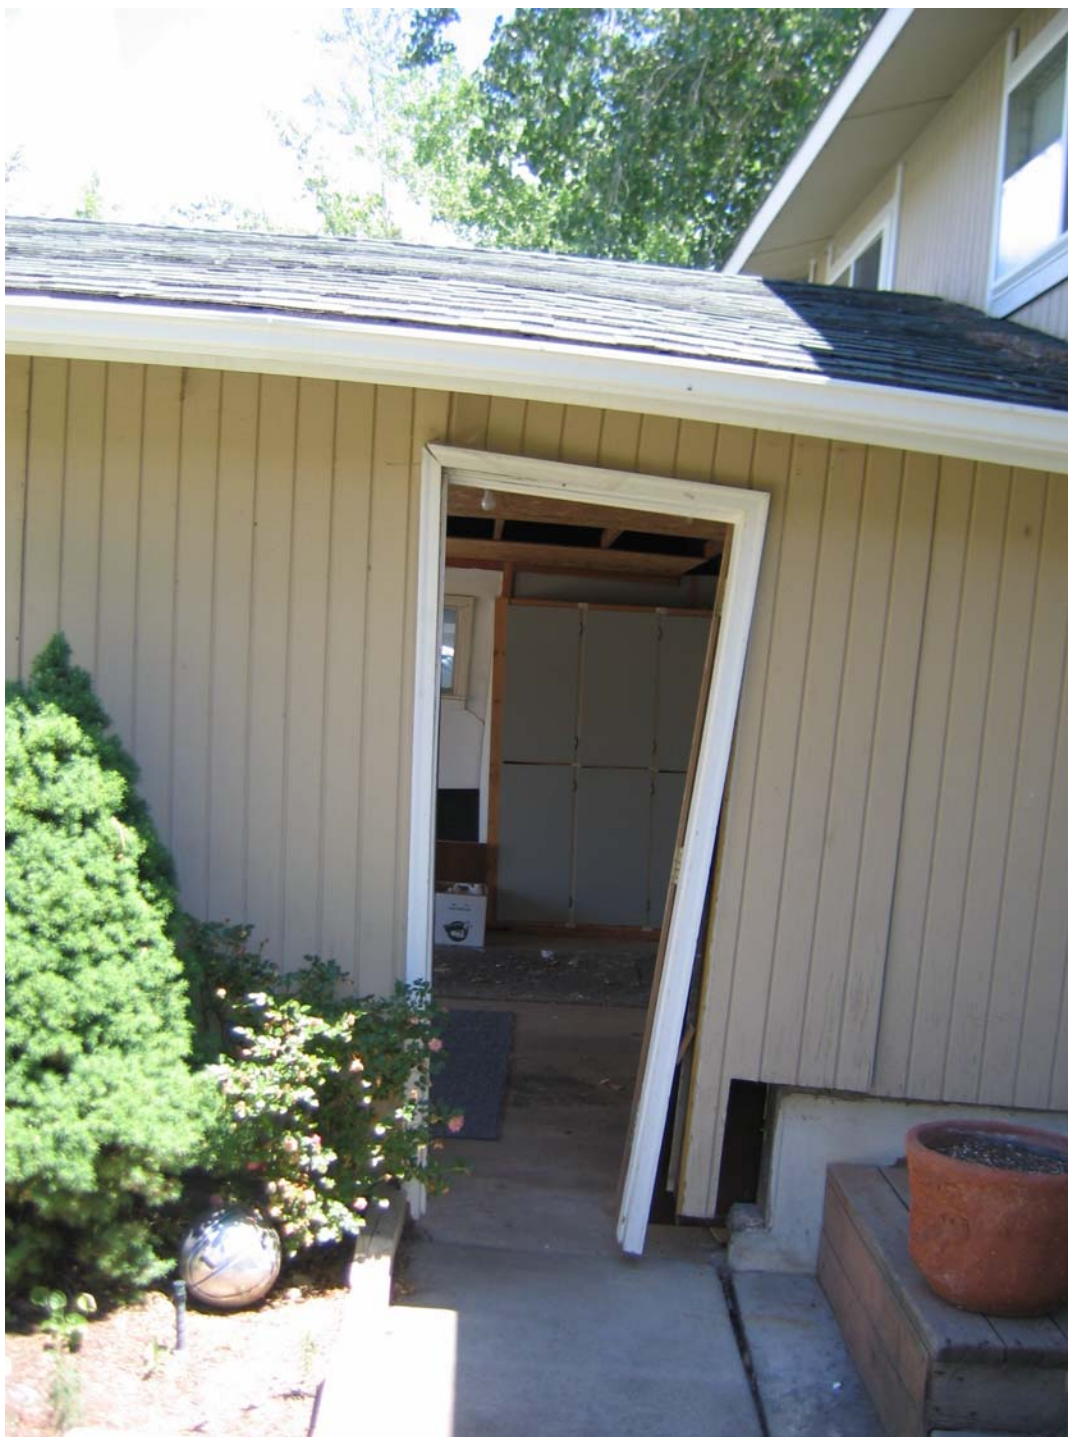
Figure 3. Damage to garage attached to a house at 157 South Valley View Drive. House was subsequently demolished. Photograph taken in June 2006.

In the late 1990s, residents in the Springhill area of North Salt Lake began noticing building and pavement cracking and other distress related to relatively minor movement of the landslide. By 1998, a house at 160 Springhill Drive that straddled the northeastern boundary of the landslide was severely damaged and condemned (Giraud, 1999; Ashland, 2003). Relatively severe distress also occurred to several houses along Valley View Drive (formerly 350 E) and Springhill Circle. Little movement or damage occurred during a dry period between 1999 and 2004, but the rate of movement accelerated during the 2005 wet year. Since 2005, the amount of movement each year has increased, except in 2007 (a dry year), resulting in an increased amount of damage and distress, particularly to houses in the upper and lower parts of the landslide (figure 3) and to Springhill Drive (figure 4).

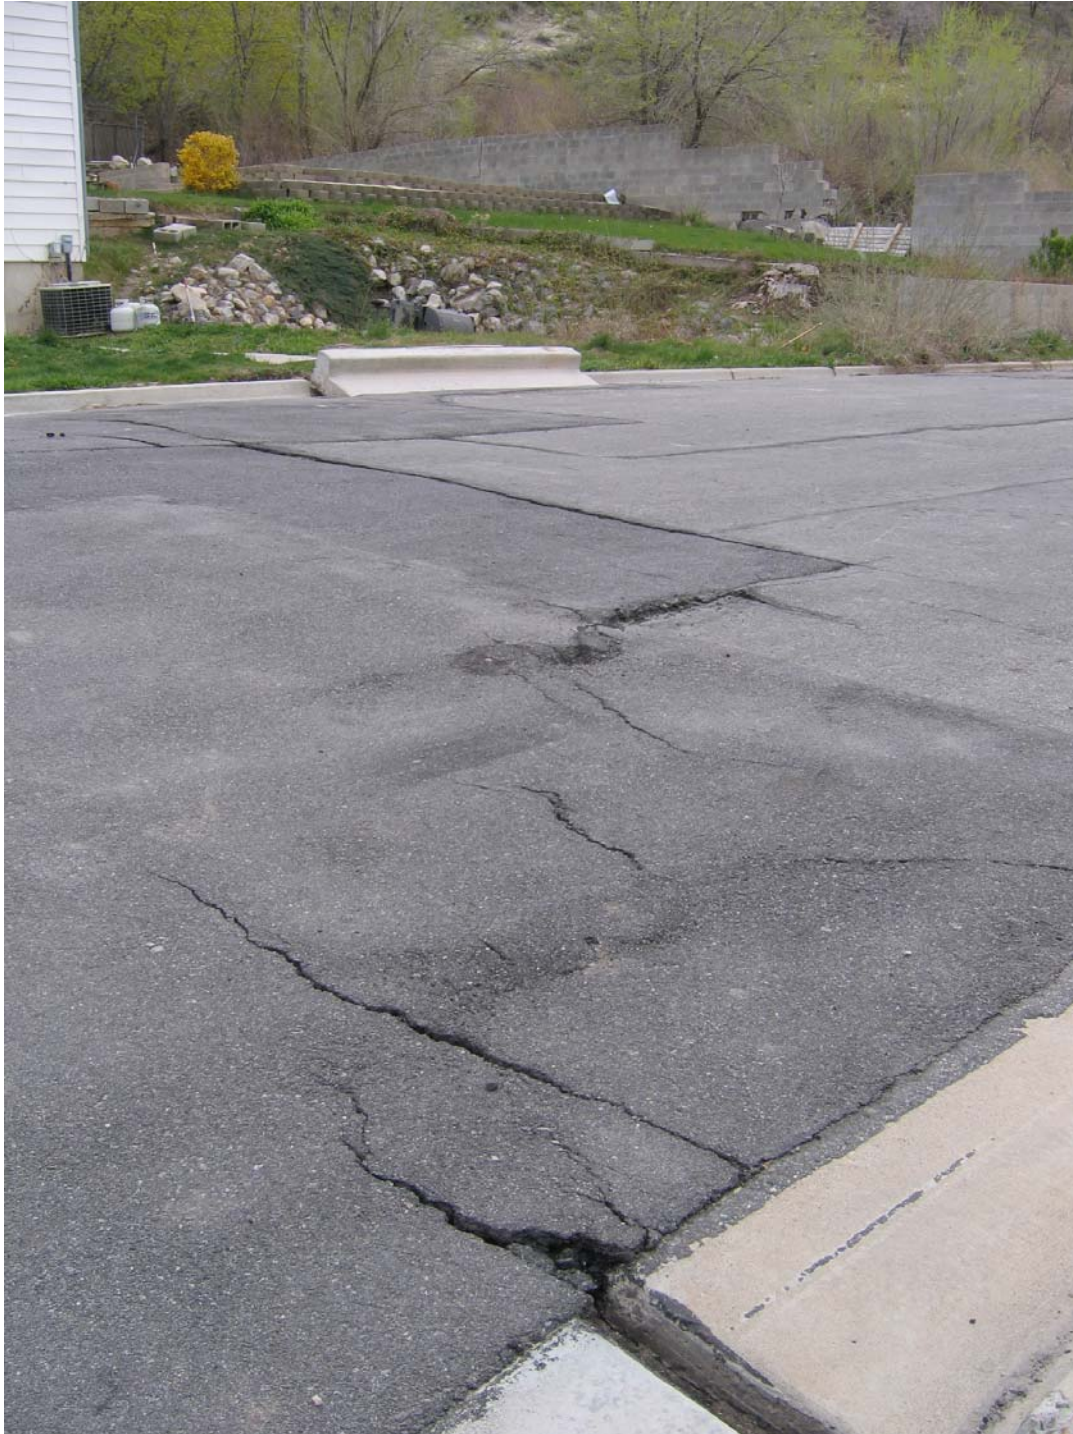
Figure 4. Road damage to south end of Springhill Drive along south-flank shear zone. View is upslope and to the southeast. Tilted and displaced curb and gutter visible on opposite side of road. Ground on left side of photograph is moving downslope (toward bottom-left edge of photograph). Photograph taken in May 2008.

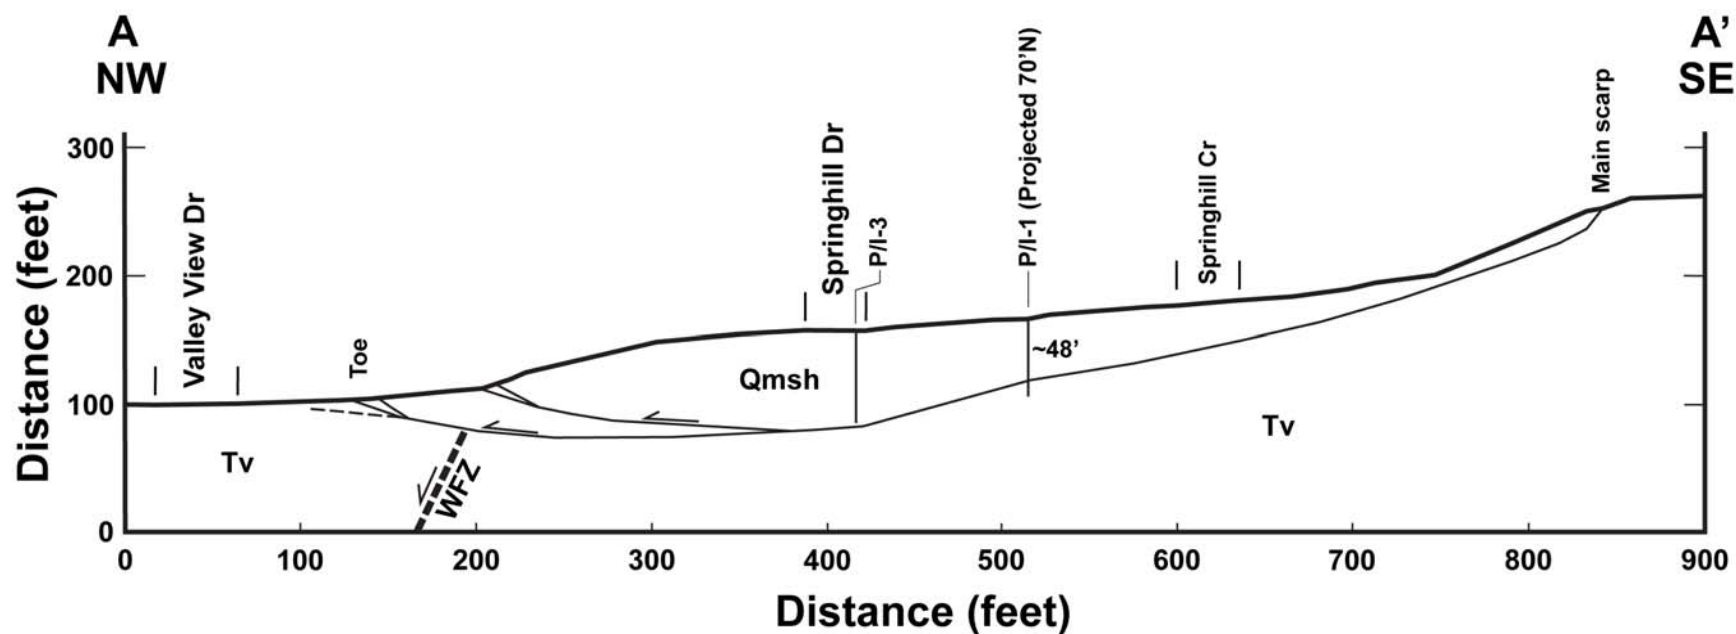
Figure 5. Geologic cross section of Springhill landslide based on depths from inclinometers and slope-stability analysis. Landslide (Qmsh) overlies weathered Tertiary volcanic rocks (Tv). Basal slide-plane splays intersect the ground surface at four locations (see figure 2). Approximate location of trace of Wasatch fault zone (WFZ) shown beneath toe of landslide. Inclinometer I-5 near northwestern edge of toe not shown for clarity because of its location immediately downslope of frontal toe thrust. See figure 2 for section line location.

The toe of the landslide is characterized by several step-like features between Valley View Drive and the steep slope at the back of the lots along the southeast side of the road. UGS mapping suggests that the main basal slide plane, which is about 48 feet (15 m) deep at inclinometer I-1, splays and intersects the ground surface in at least four locations, each coinciding with one of the steps (figure 5). Each of the slide-plane intersections is referred to as a toe thrust, and collectively they form a toe thrust system. As landslide movement occurs upslope, a portion of the total movement is distributed among each splay. Due to the relatively small differential movement amounts at each toe thrust, the ground bends or flexes. Eventually, with sufficient cumulative movement of the landslide, differential movement at each toe thrust will cause the ground on the upslope side of the thrust to override the ground surface directly downslope.

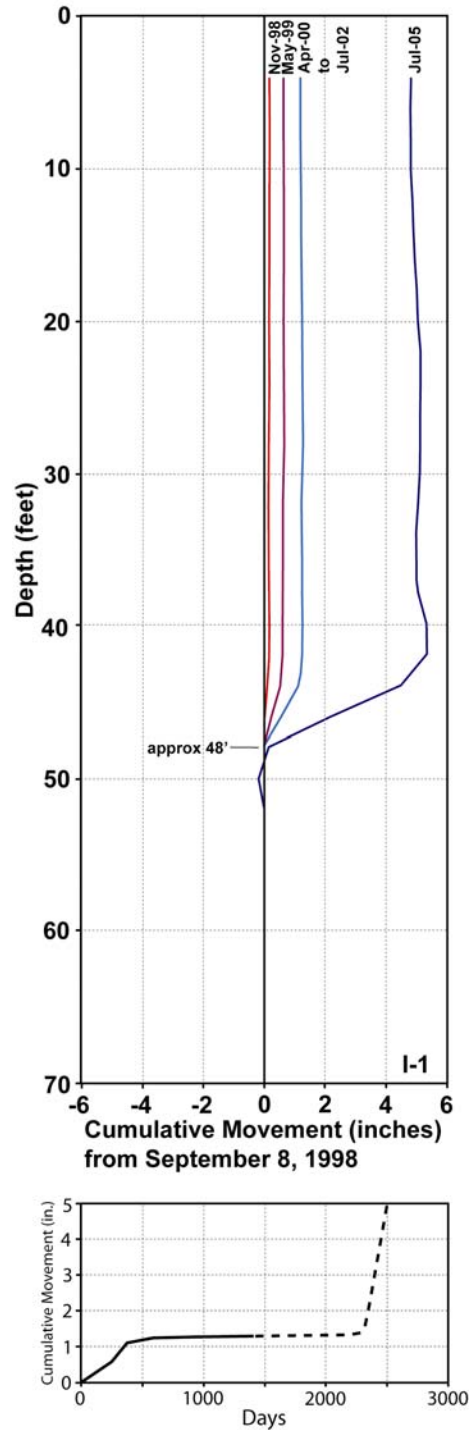
Figure 6. Plots for inclinometer I-1 in Springhill Circle. Upper plot shows cumulative movement versus depth between September 1998 and July 2005. Landslide depth is about 48 feet (15 m.) Lower plot shows cumulative movement versus time. Dashed part of curve is inferred based on surface observations between July 2002 and July 2005. Plots modified from Terracon (2005).

Measurements from inclinometer I-1 showed that the landslide persistently moved between September 1998 and April 2000 (figure 6). However, the data also indicated that the rate of movement dramatically slowed between late 1999 and early 2000, coincident with the onset of a prolonged dry period from 1999 through 2003. Two subsequent measurements in 2001 and 2002 showed only very minor movement, confirming that the rate of movement had slowed by the year 2000. A final measurement in July 2005 indicated a dramatic increase in both the amount and rate of movement (Terracon, 2005). Between September 1998 and July 2002, only about an inch (2.5 cm) of movement had occurred at inclinometer I-1. However, by July 2005, nearly 4 additional inches (10 cm) of movement had occurred, indicating a dramatic increase in the rate of movement with the return of wet conditions in 2005.

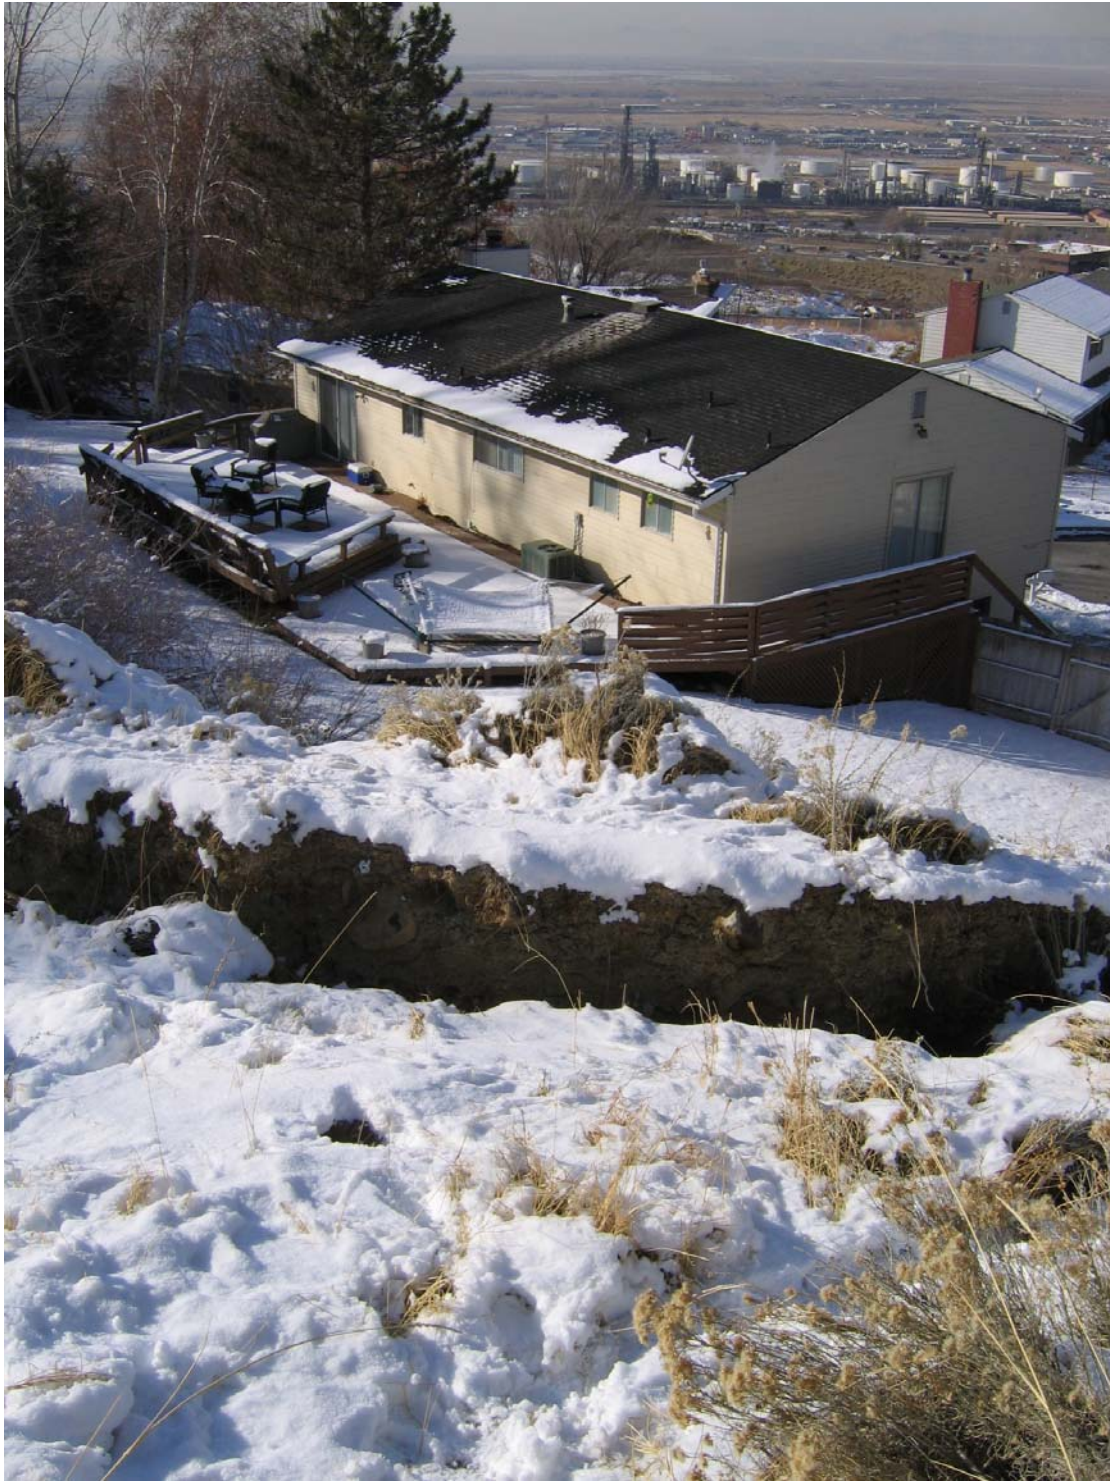
Figure 7. View downslope and to the west of lowermost antithetic (uphill-facing) scarp in the main scarp zone. Photograph taken in December 2008.

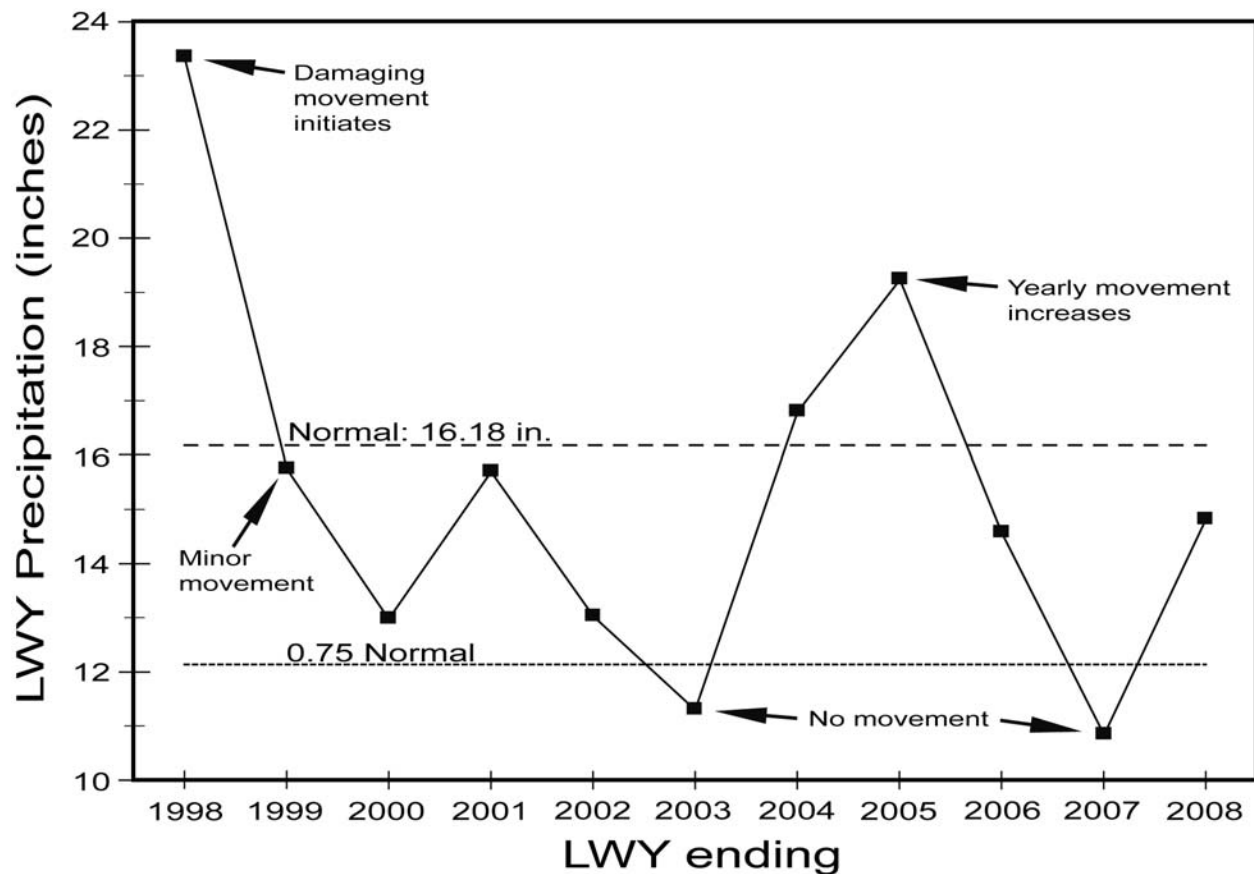
Figure 8. Salt Lake City precipitation for landslide water years (LWY) ending between 1998 and 2008 annotated with movement history of the Springhill landslide. Damaging movement initiated in 1998 during the second-wettest LWY on record dating back to 1875 in Salt Lake City. Minor movement of landslide occurred during drier-than-normal period between 1999 and 2002. By 2003, movement may have suspended during exceptional dry conditions (LWY precipitation was less than 75 percent of normal). Damaging movement started again in 2005 during the second-wettest LWY in the measurement period. Beginning in 2005, annual movement amounts reached 4 inches (10 cm) or more. Despite drier-than-normal conditions in the following years, movement continued and annual movement amounts increased, except in exceptionally dry 2007. Annual movement amounts reached as high as 9 inches (23 cm) by 2008. LWY precipitation data compiled from provisional data in monthly National Weather Service climatological reports. Normal precipitation for Salt Lake City from Ashland (2003).

The Springhill landslide has been persistently moving since the late 1990s, but movement may have suspended during dry years such as in 2003 and 2007. Figure 8 shows the general movement history in relation to precipitation during the landslide water years (LWY; Ashland, 2003) between 1997-98 and 2007-08. Damaging movement occurred or initiated in two wet years of 1998 and 2005. Since January 2008, the landslide has been continuously moving at a very slow rate. The total movement of the landslide since September 1998, likely exceeds 18 inches (46 cm).

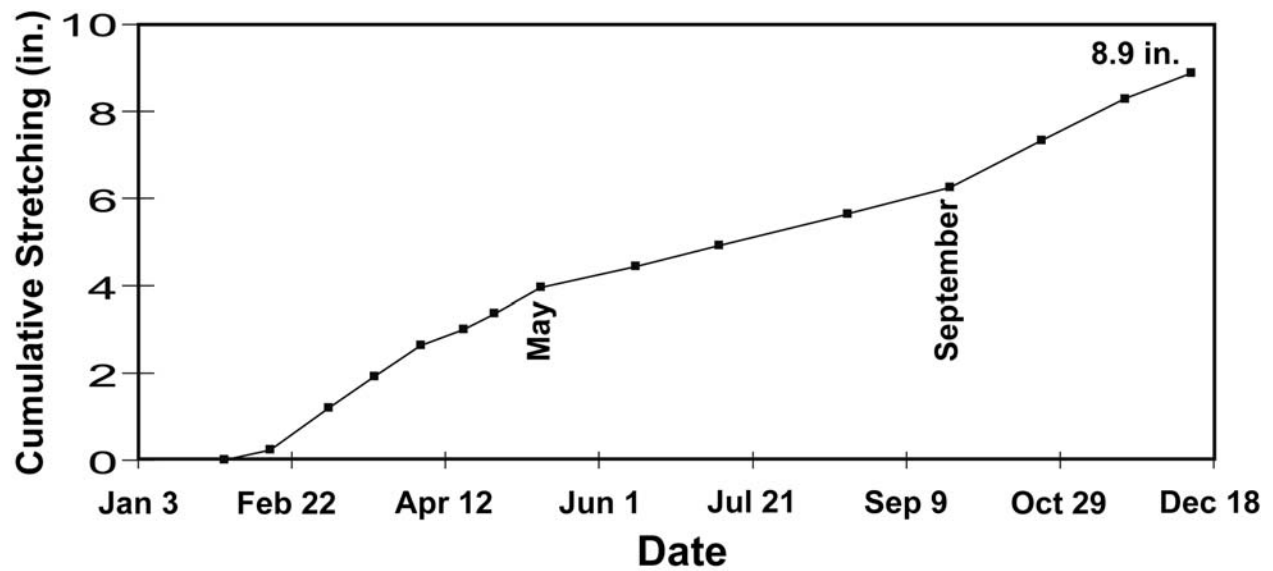
Figure 9. Cumulative stretching across main scarp zone in 2008. Total stretching was about 8.9 inches (23 cm). Changes in the rate of movement occurred in May and September, separated by periods during which movement occurred at a nearly constant rate. A gradual increase in the rate of movement also occurred in early February. Ground deformation measurements were taken between January 31 and December 11.

Measurements of ground deformation across the main scarp zone and toe in 2008 indicated continuous movement throughout the year (figures 9 and 10). The rate of deformation (movement) across the main scarp zone (figure 9) increased by around late February coincident with the snowmelt and was relatively constant through early May. By around mid-May, the rate of movement slowed, but movement continued at a nearly constant rate through at least late summer. An increase in the rate of movement occurred in September 2008. By December, about 8.9 inches (23 cm) of stretching had occurred in 2008.

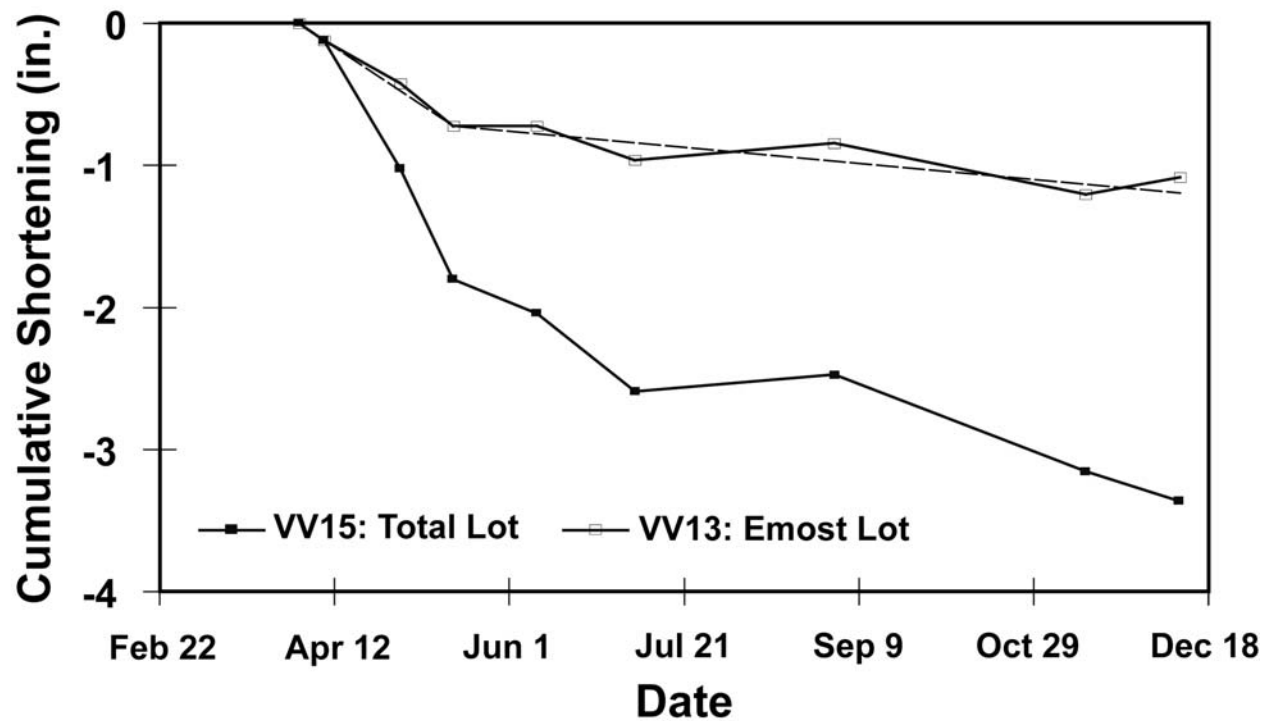
Figure 10. Cumulative shortening across the toe thrust system at lot 157 Valley View Drive between April and December 2008. Upper curve shows cumulative shortening across southeasternmost two toe thrusts (figure 2). Lower curve shows cumulative shortening across entire toe thrust system, which was about 3.4 inches (9 cm) over the eight-month measurement period between April 2 and December 10. A decrease in the rate of movement occurred in May, similar to that observed in the upper part of the landslide, likely in response to declining ground-water levels in the dry period between March and July 2008. Dashed line shows probable deformation curve removing measurement error.

Monitoring at the toe of the landslide showed how upslope movement was distributed among the step-like toe thrusts southeast of Valley View Drive (figure 10). Most of the movement occurred on the westernmost toe thrust directly southeast of inclinometer I-5, but each of the other toe thrusts was also active, accommodating some of the upslope movement. Between April and June 2008, about 2 inches (5 cm) of shortening occurred across the toe thrust system due to movement upslope. Based on measurements through December 2008, an estimated 3.4 inches (9 cm) of shortening occurred over the entire system in an eight-month period.

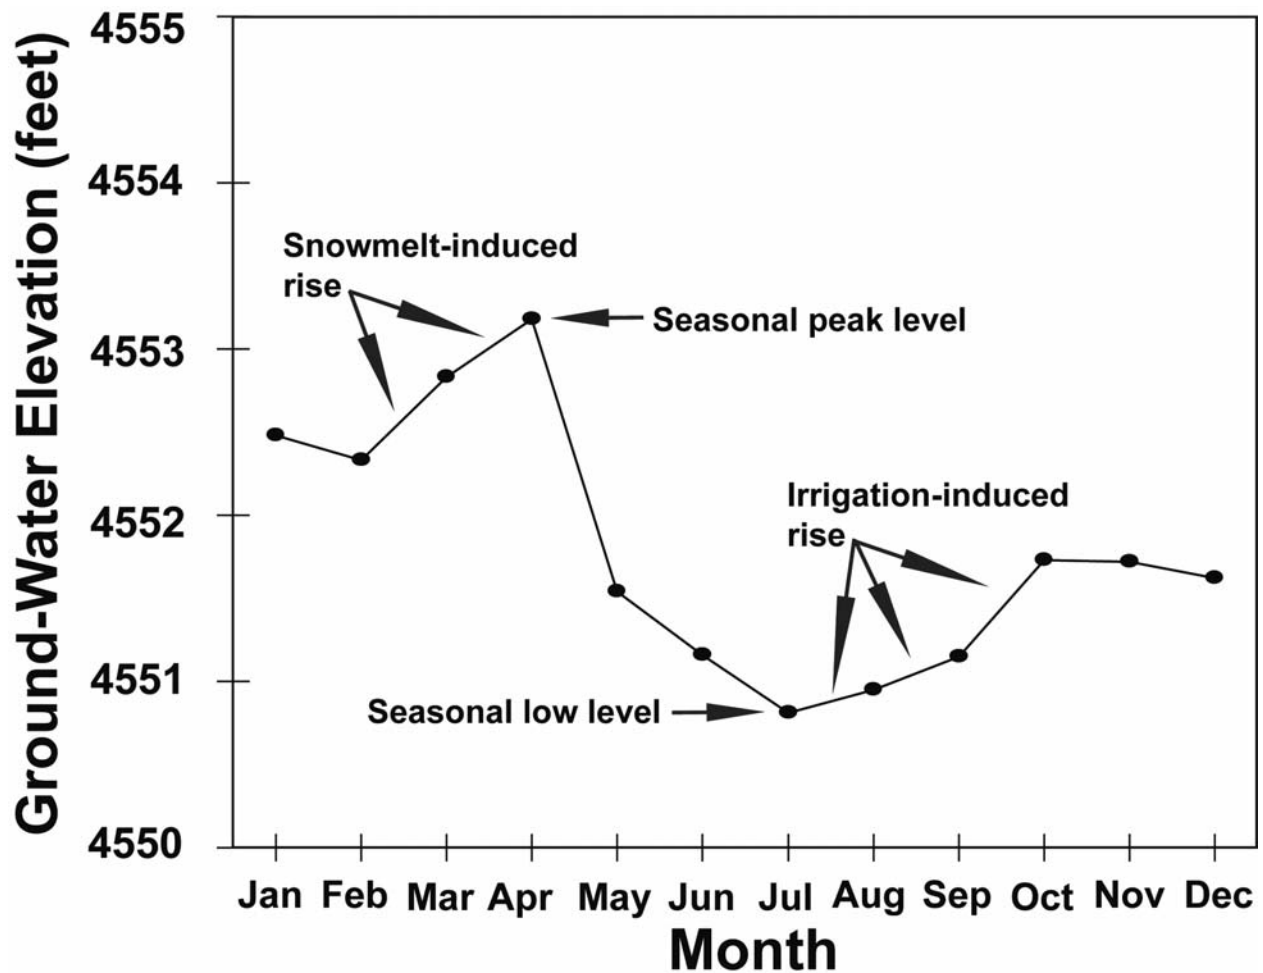
Figure 11. Seasonal fluctuation in ground-water level in observation well P-4 in 2006. Rise in ground-water level between February and April to seasonal peak level is due mostly to infiltration of snowmelt. Seasonal low ground-water level occurs in response to dry hot weather and evapotranspiration. The rise in ground-water level between July and October is likely due to local landscape irrigation. Subsequently, the ground-water level declines in the fall and early winter. The rate of landslide movement typically increases with rising ground-water levels in the early part of the year and decreases as ground-water levels decline from the seasonal peak levels.

Ground-water levels in each observation well fluctuate seasonally (throughout the year) and generally are at their highest level during or shortly following the snowmelt (in the first half of the year) or later in the year (possibly as a result of local landscape irrigation) (figure 11). Between 1999 and 2004, the seasonal peak ground-water levels in the four wells in Springhill Drive typically occurred in the first six months of the year (figure 12), suggesting the ground-water levels rise in response to snowmelt and spring precipitation (generally the wettest months of the year are March through May). In the dry years between 2001 and 2004, the seasonal peak ground-water level in observation well P-1 in Springhill Circle occurred in either August or September, possibly in response to summertime landscape irrigation. Notably, lawns surround the observation well in every direction. The peak ground-water level in two of the Springhill Drive wells, P-3 and P-4, occurred three times, collectively, in the last two months of the year, possibly due to landscape irrigation in the summer or extreme (record) monthly precipitation in the fall.

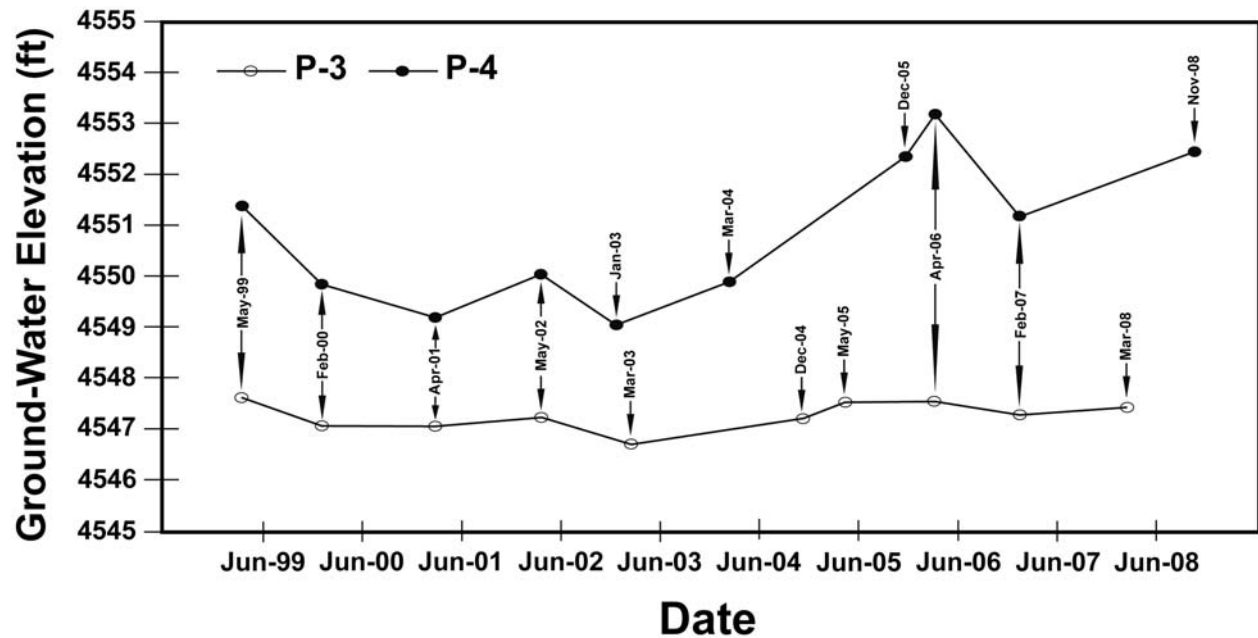
Figure 12. Fluctuations in seasonal peak ground-water levels (SPGWL) in observation wells P-3 and P-4 between 1999 and 2008. The SPGWL coincides with the lowest stability of the landslide during the year, and thus is a basis for assessing the relative stability of the landslide. High SPGWLs since 2005, most evident in P-4, coincide with increased annual movement amounts, except in 2007.

The possible impact on ground-water levels from extreme monthly precipitation is illustrated by the ground-water fluctuations preceding the late-in-the-year seasonal peak ground-water level in observation well P-3 in 2004. The seasonal peak ground-water level in observation well P-3 in December 2004 was preceded by extreme monthly precipitation in October during which 6.0 inches (15 cm) of precipitation fell in nearby Bountiful. The monthly total in October was 267 percent of the normal monthly precipitation and equivalent to 22 percent of the annual precipitation (versus 8 percent for normal October precipitation). Between October and December 2004, the ground-water level in the observation well rose nearly 5 inches (13 cm) (roughly 80 percent of the total seasonal fluctuation in 2004 of 6 inches [15 cm]). Interestingly, the rise in ground-water level subsequent to extreme October precipitation reversed a gradual decline in ground-water level over the summer and early fall from a previous peak level associated with snowmelt.

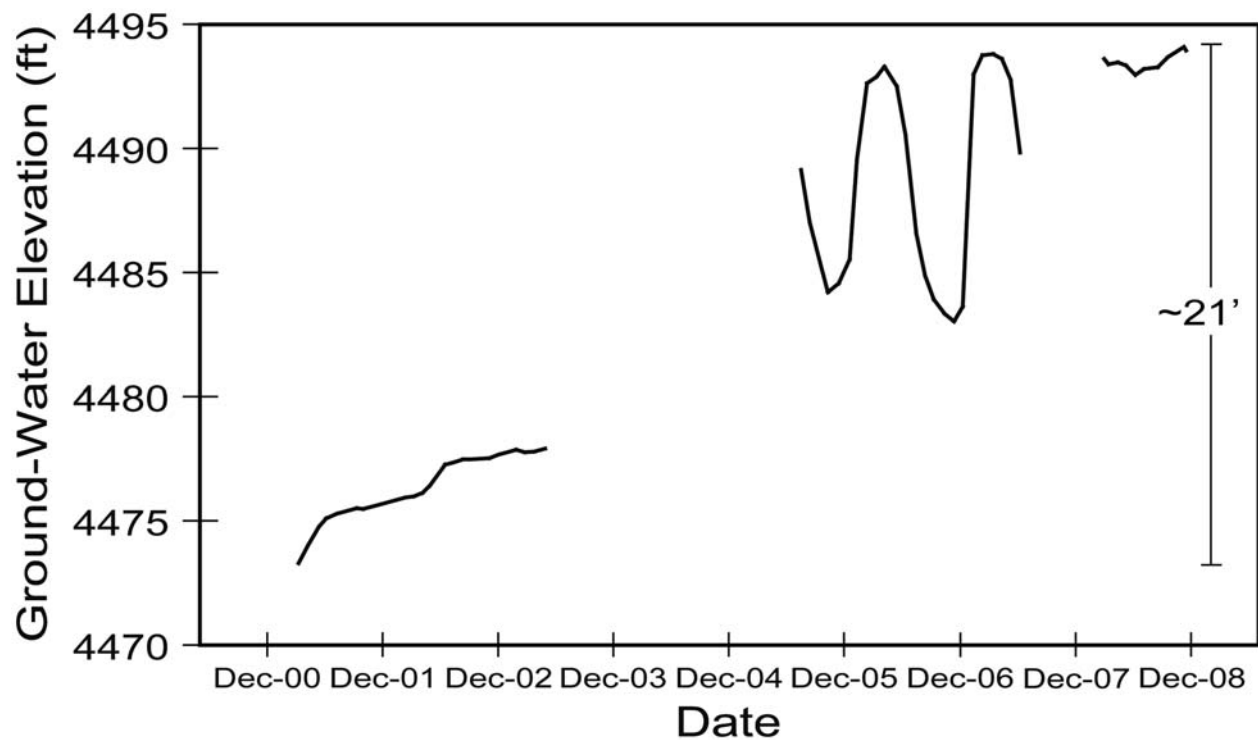
Figure 13. Rise in ground-water level in observation well P-5 near toe of the landslide since 2001. Observation well was dry when initially installed in 1998 until March 2001. Between March 2001 and April 2006 the ground-water level rose nearly 20 feet (6 m). Ground-water levels between 2005 and early 2007 fluctuated seasonally, with the peak levels following snowmelt. By November 2008, the ground-water level had risen to its highest level, rising a total of 21 feet (6.4 m) since 2001. Gaps indicate periods when observation well was not accessible.

Beginning in 2001, the ground-water level in observation well P-5, near the toe of the landslide, began to rise (figure 13). By 2005, seasonal fluctuations in ground-water level were observed with the highest level occurring in the early part of the year likely the result of the infiltration of snowmelt. The ground-water level rose at least 20 feet (6 m) by April 2006, a significant rise for which the cause remains unknown, and in 2008 was sustained within a foot of this peak level throughout the year. By November 2008, the ground-water level had risen to its highest level, rising a total of 21 feet (6.4 m) since 2001. The rising ground-water level in observation well P-5 is a concern if it also indicates a similar rise in ground-water levels in the toe of the landslide because such a rise results in a reduction in the frictional forces acting to resist downslope movement. The sustained high seasonal peak ground-water level near (and possibly in) the toe of the landslide since at least 2006 may be the primary cause of the increase in annual movement, and the sustained high ground-water level near the toe in 2008 may explain the continuous movement throughout the year.

Persistent movement of the Springhill landslide is likely in the future, except perhaps in the driest of years. Future movement amounts may exceed those since 2005 (4-9 inches [10-23 cm] per year). A 20-foot (6-m) rise in the ground-water levels near the toe of the landslide between 2001

and 2006 may be the cause of the increase in annual movement. If future annual movement amounts continue to exceed 6 inches (15 cm) per year, damage to houses, roads, and buried utilities will become more severe and recurrent, and new damage may occur to structures on parts of the landslide where damage was previously minor or tolerable.
