PHOTO ESSAY of FOUR UTAH EARTHQUAKES

1921 - 1962

by Sandra N. Eldredge and Edith H. O'Brien

Public Information Series 72
Utah Geological Survey
a division of
Utah Department of Natural Resources

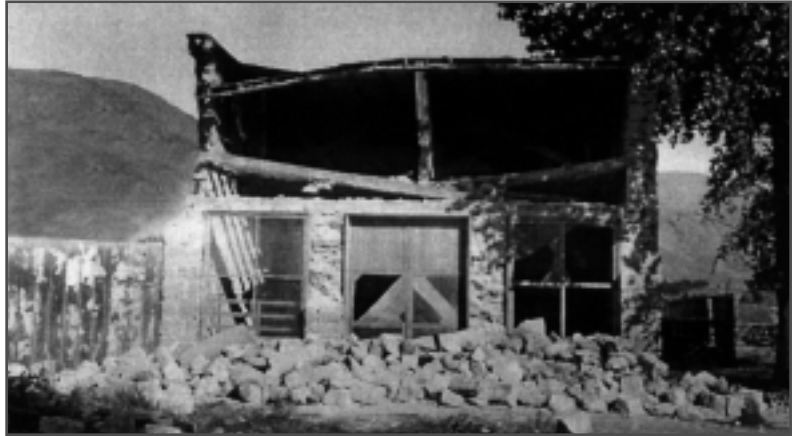
Left: Virtually all of the buildings in Elsinore were damaged. This photo shows typical damage incurred to Elsinore houses that were made of brick.

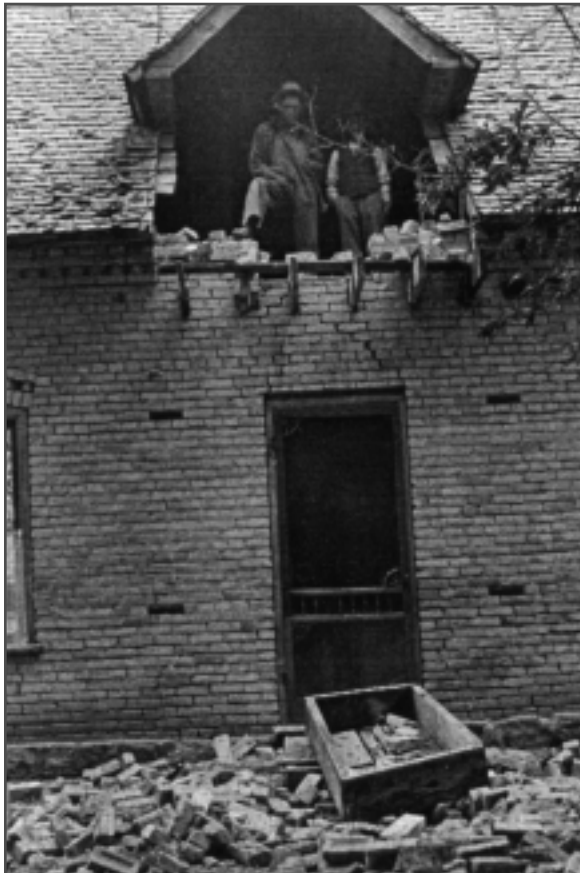
Bottom: The earthquake damaged Elsinore's new two-story brick schoolhouse. The four-to five-foot-high fire wall was shattered and tons of brick, cement, and mortar were thrown to the ground along three sides of the building. Fortunately, the earthquake occurred when children were not on the playgrounds next to the walls.

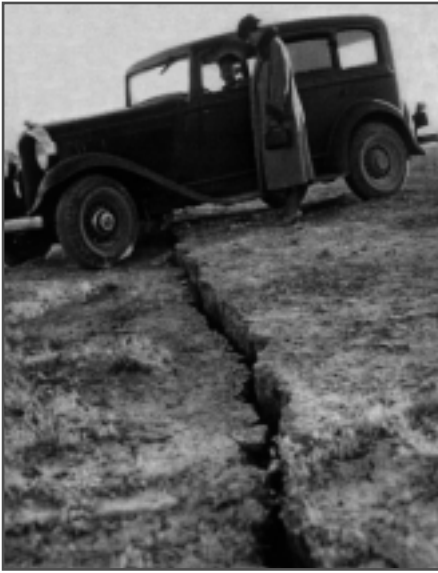
Surface fault rupture happens when movement along a fault is great enough to reach and rupture the ground surface (requires about magnitude 6.5 or greater). A fault scarp (steep break in slope) is created. At Hansel Valley, several short fault scarps were created having scarp heights up to 19 inches. Upper left photo shows a car straddling a one-foot-high fault scarp.

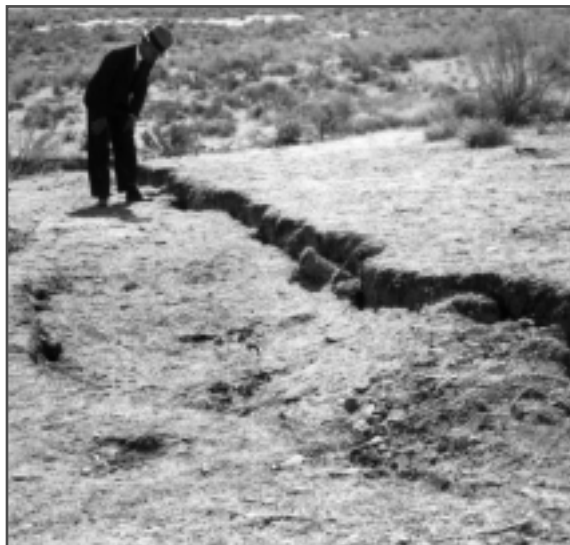
This scarp was measured to be 10 inches high.

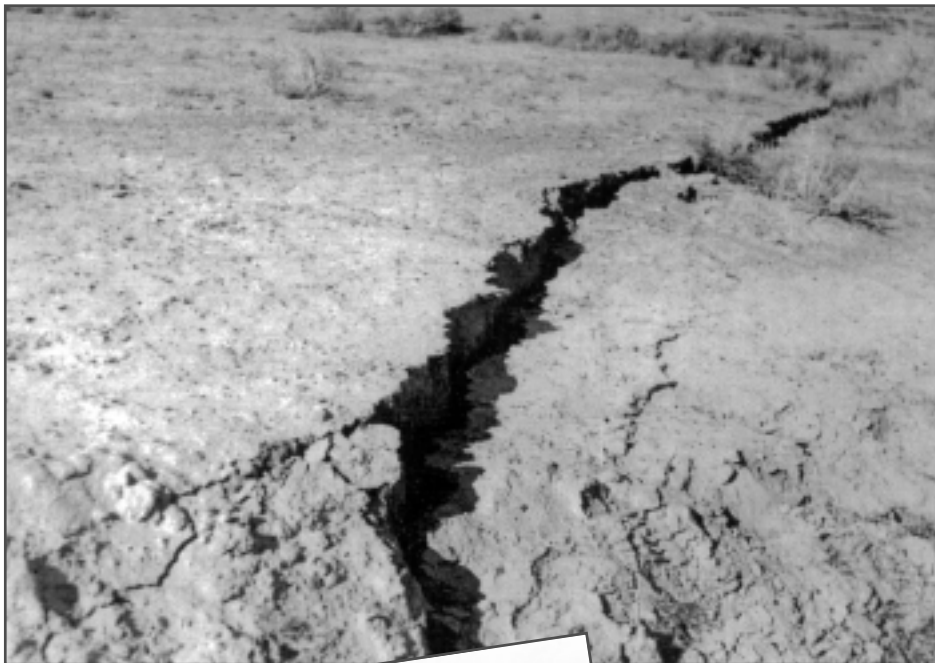
Fault scarp height varied over short distances.

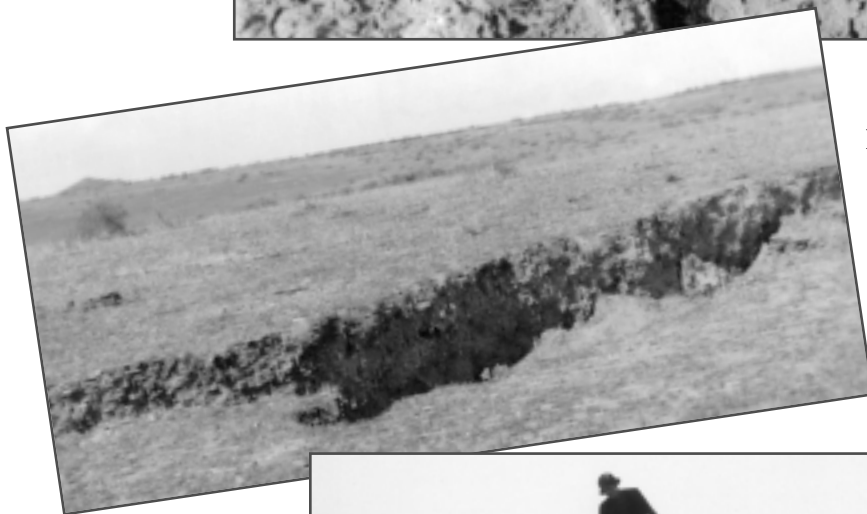
Water issued from a fault scarp on the salt flats northeast of Kosmo.

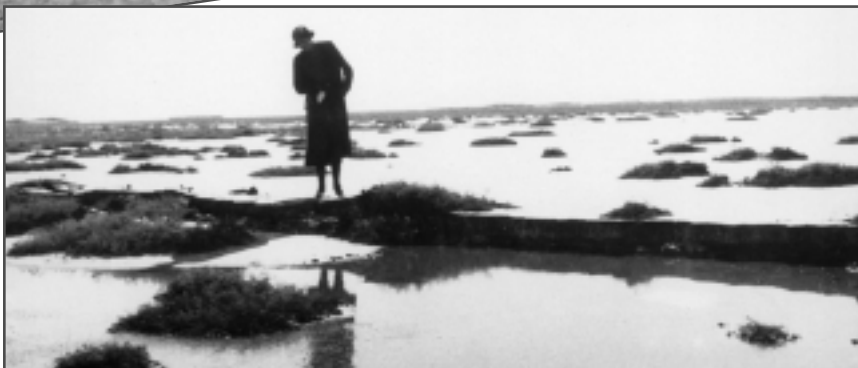
Top: Many new springs appeared; those near Monument Rock in Hansel Valley created wet and boggy ground over a large area.

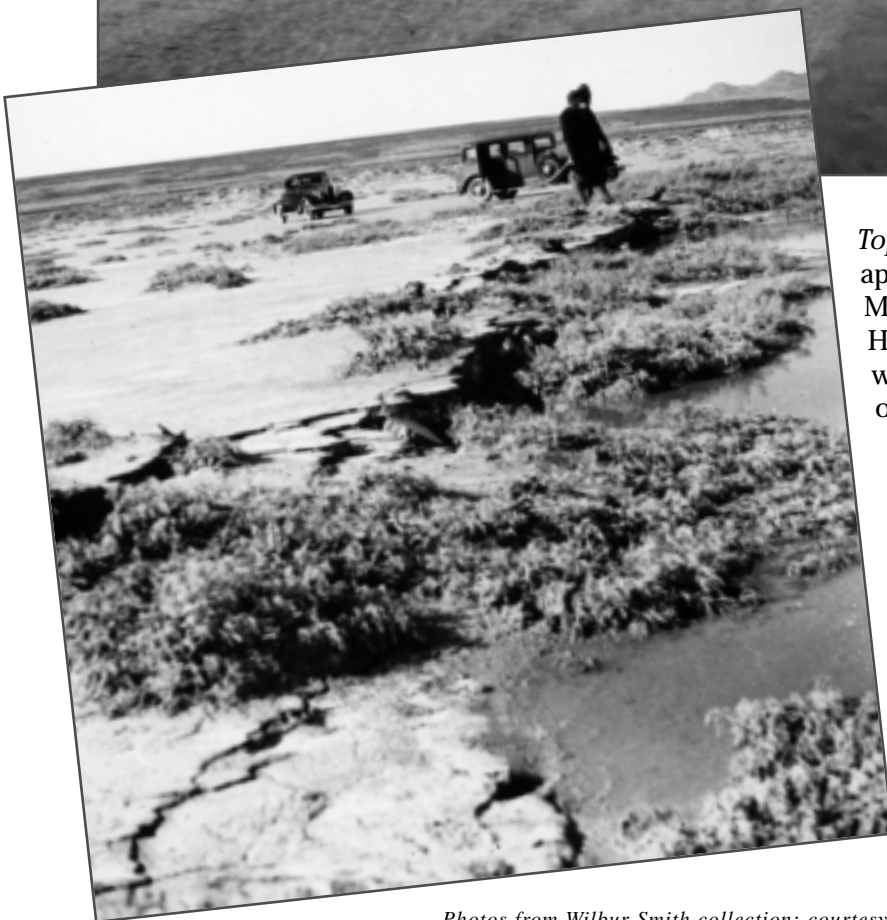
Left: Along this fault scarp, springs were rejuvenated.

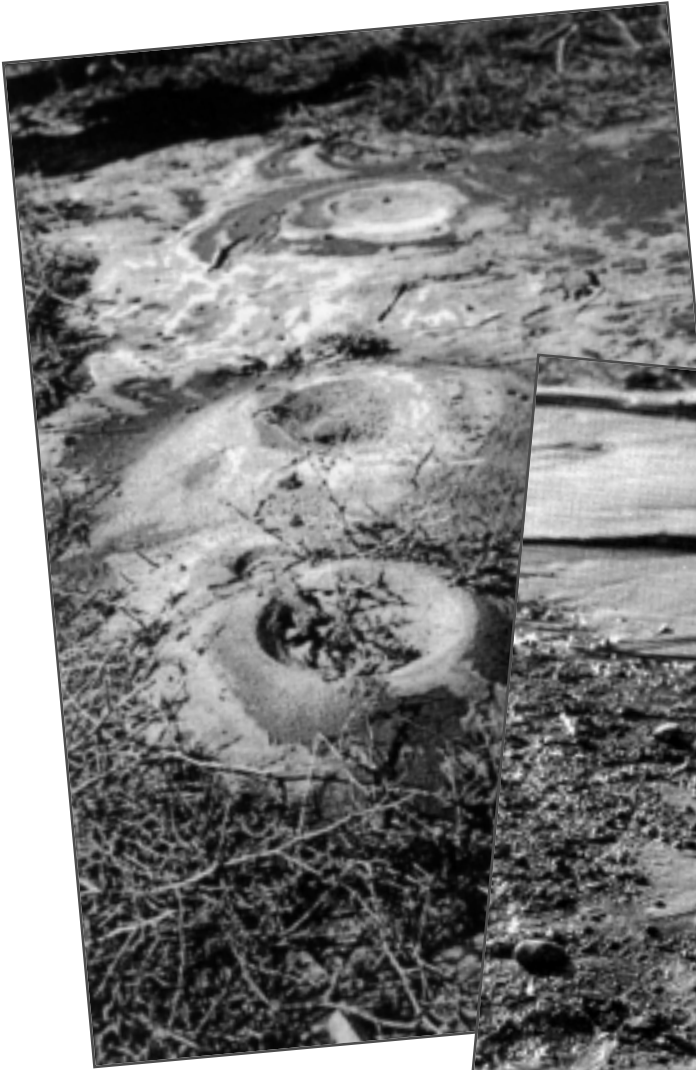
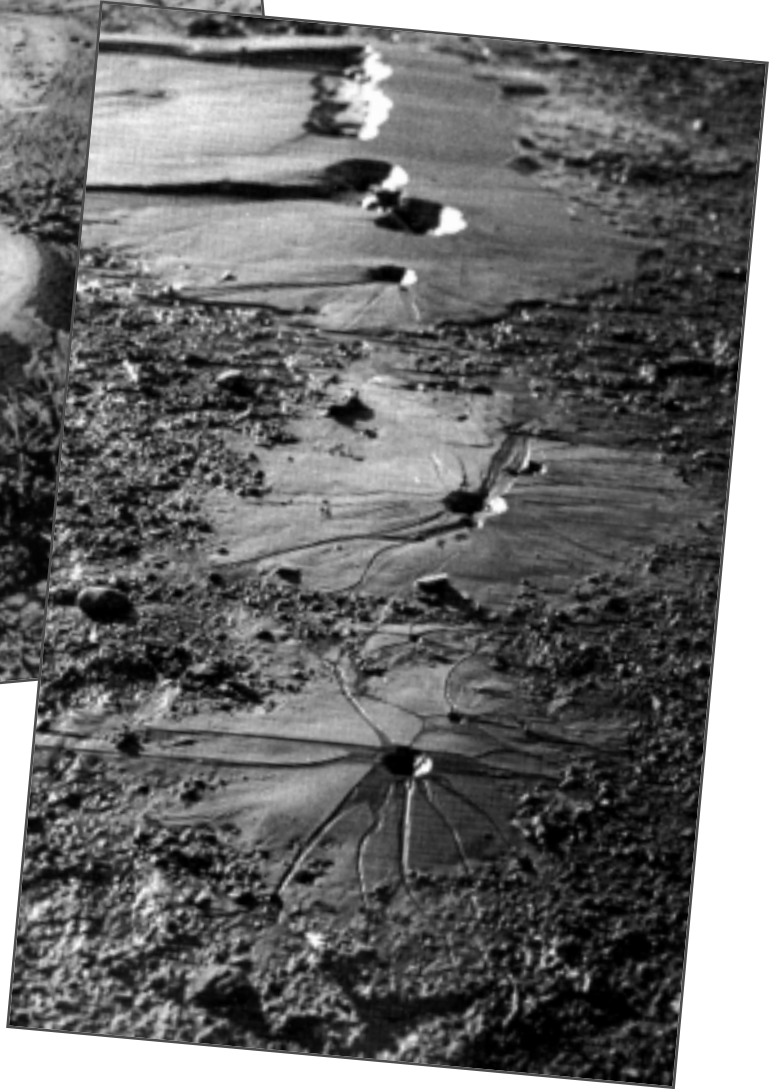
Approximately 50 sand blows formed in areas that liquefied. Ground shaking liquefied the buried water-soaked sands and silts, and water was forced to the surface along cracks in the overlying soil. The water flow brought up sand that was deposited in "cones."

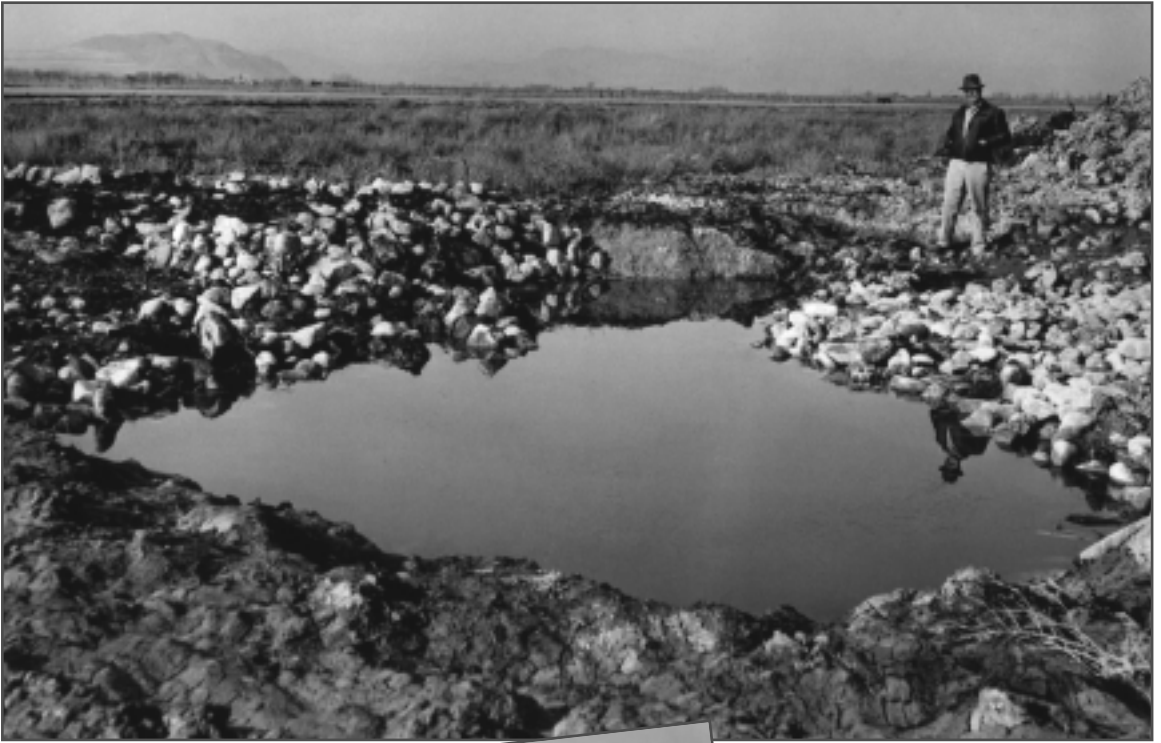
Ground shaking rejuvenated several springs. This spring appeared on the Logan-Cache Airport property.

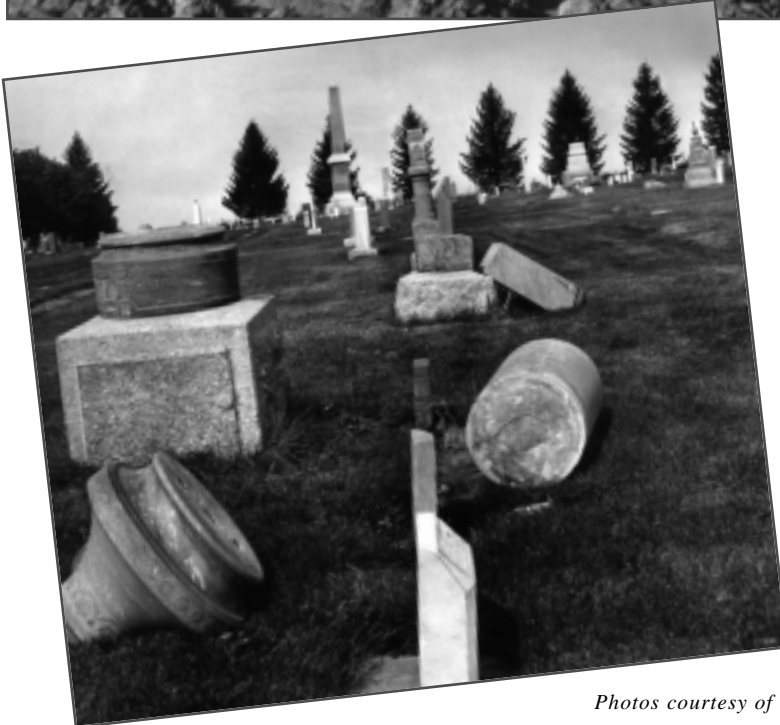
Many headstones in the Richmond cemetery toppled or were twisted during the ground shaking.

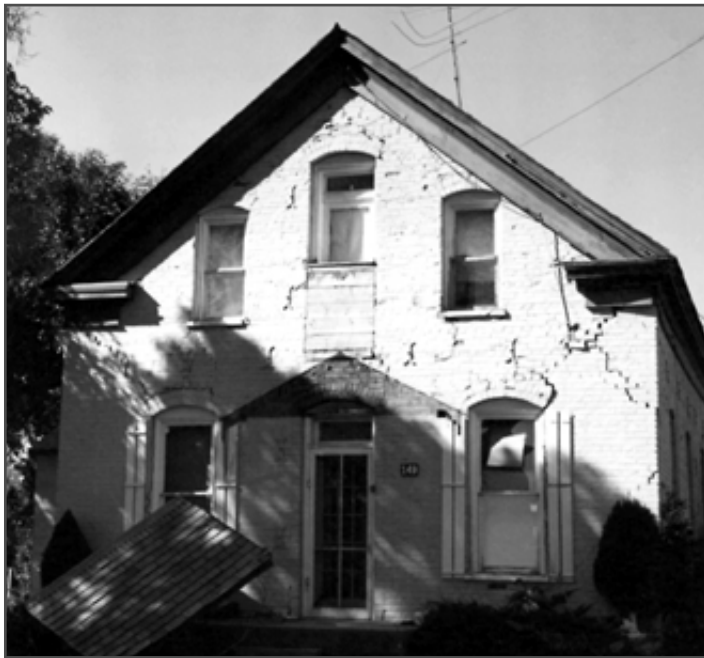
Building materials and construction are important factors in earthquake resistance. Unreinforced brick buildings in Richmond suffered moderate to severe damage.

Cracked walls and fallen porch contributed to the decision to tear down this home.

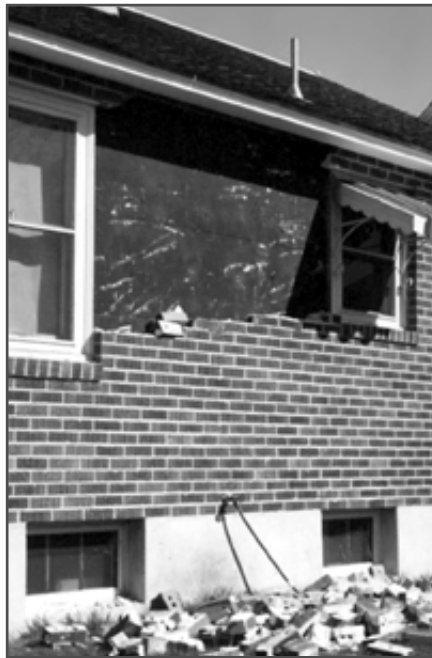
The brick veneer fell off part of this house.

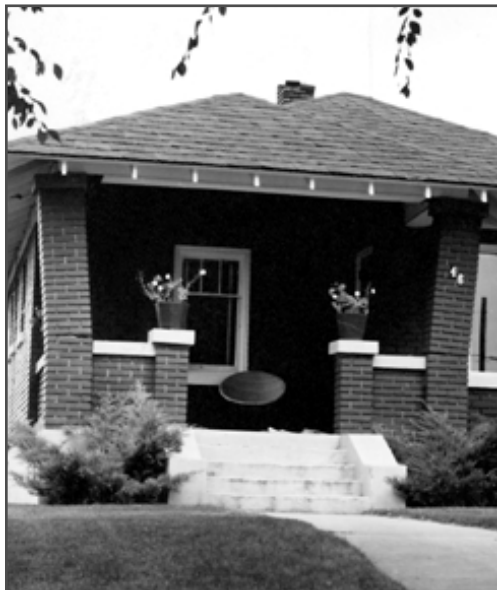
These brick porch columns were cracked and tilted.

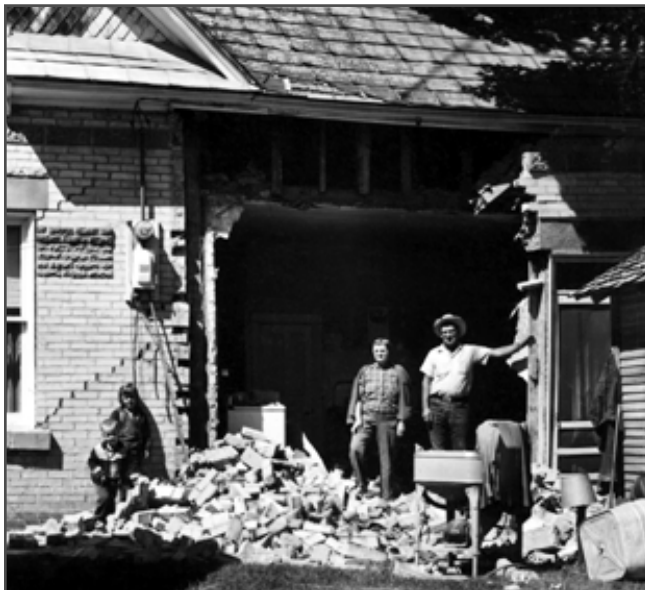
One wall of this brick home collapsed.

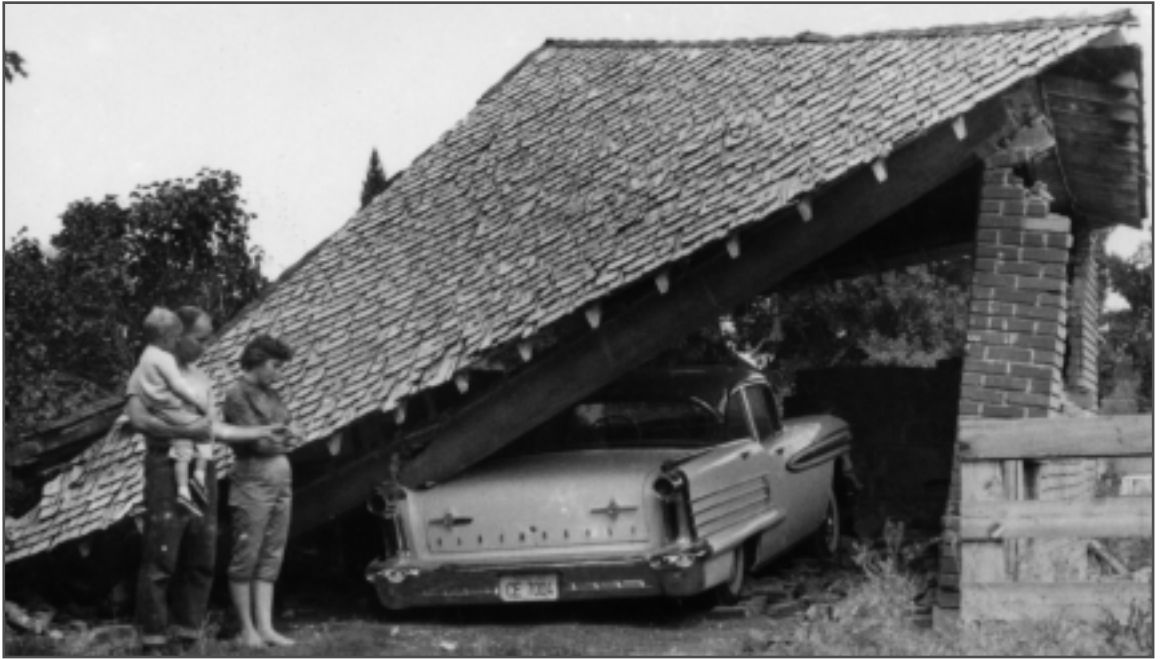
This brick garage collapsed onto a car in Richmond.

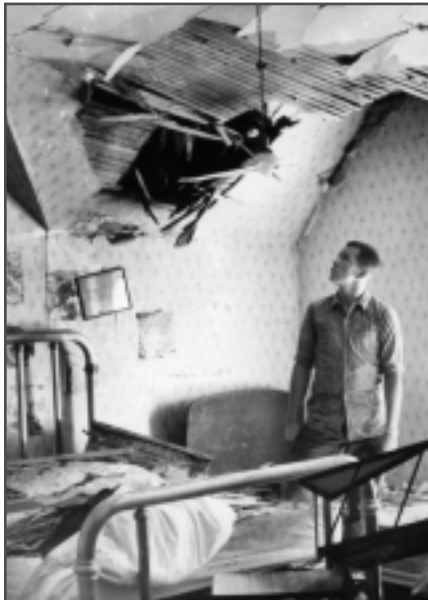
Left: A chimney fell through the roof and landed on this man's bed just as he was getting up. Notice the plaster and wood damage.

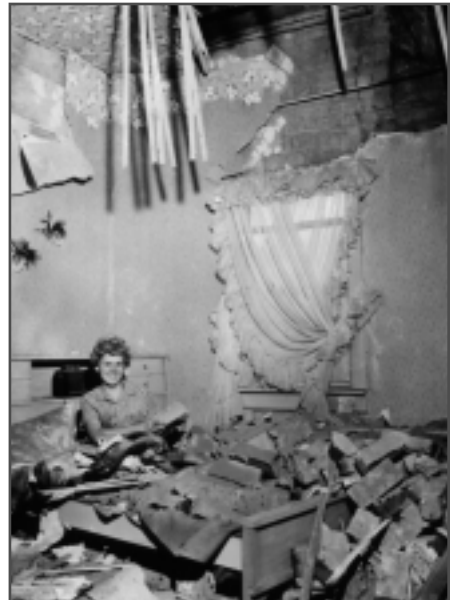
Right: Brick and plaster fell on this bed. The woman, who was in bed at the time, fortunately escaped with only a bruise.

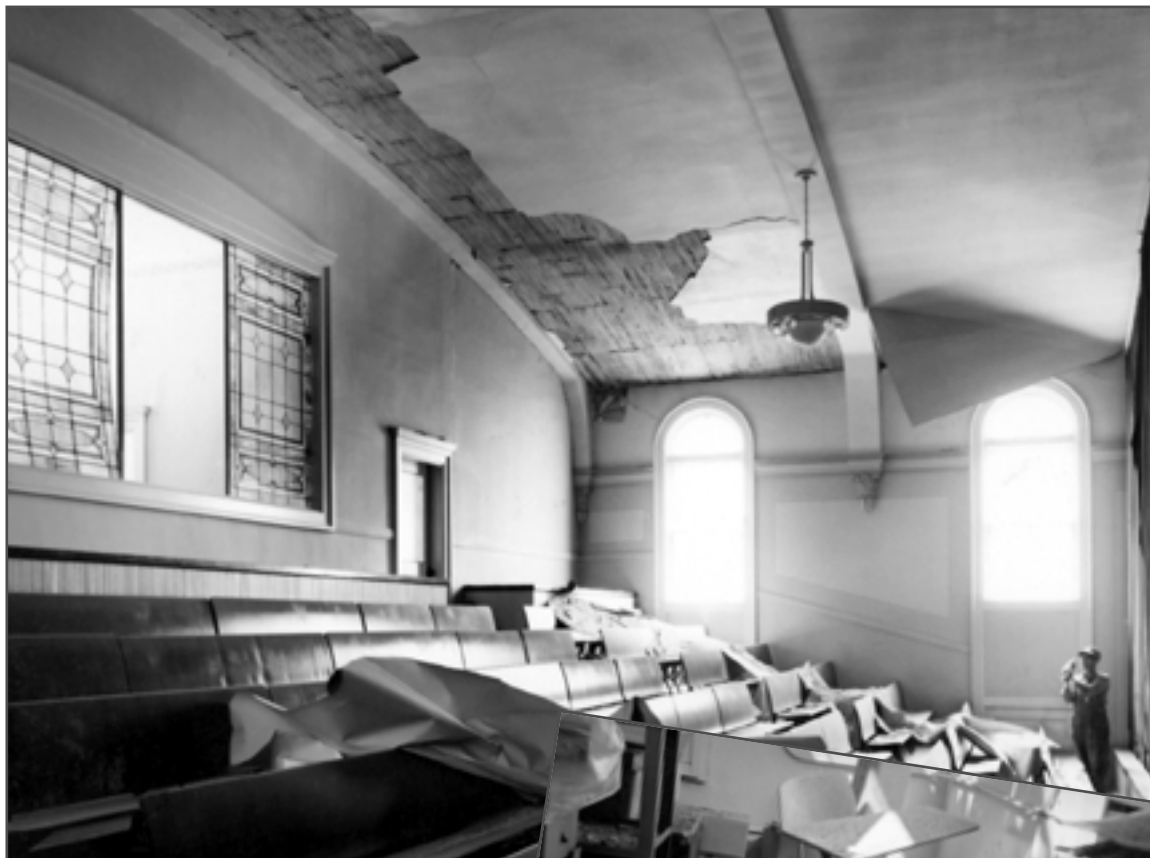
Plaster was knocked from the ceiling onto the seats in the Benson Stake Tabernacle in Richmond. Structural damage from the earthquake caused this building to be torn down.

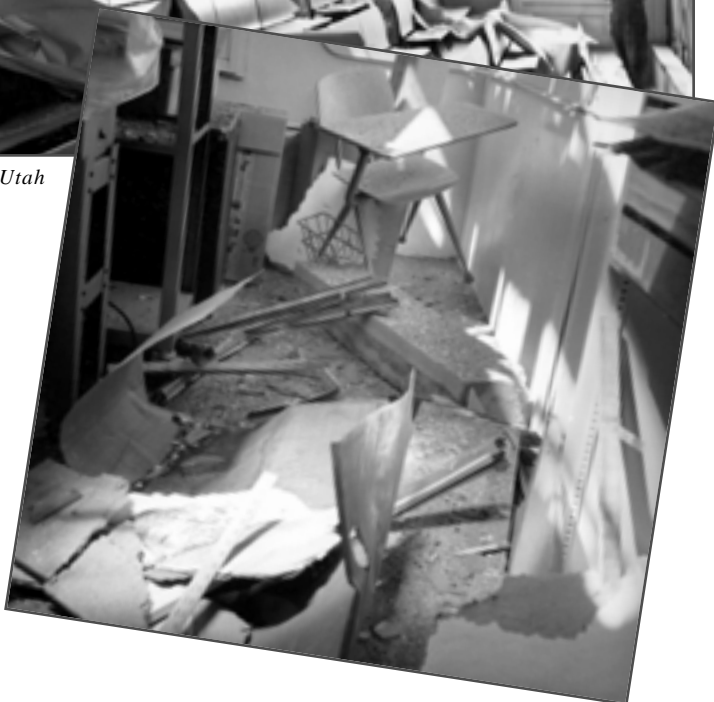
Bricks and plaster rained onto these desks in North Cache High School in Richmond during the earthquake. Luckily the quake hit at 6:35 a.m. before school opened.

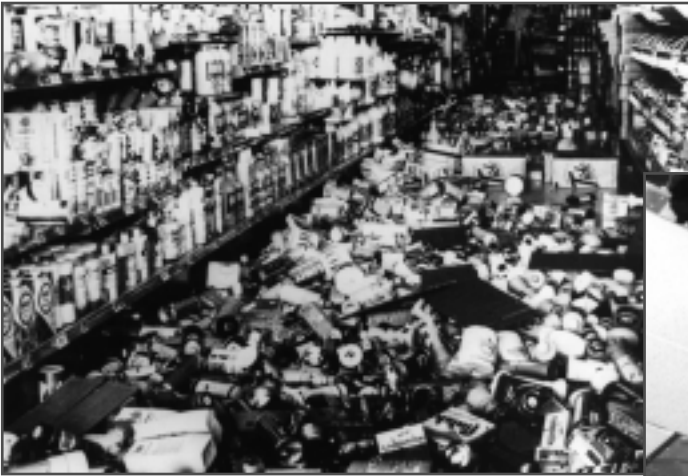
Left: Grocery stores in Cache Valley required several hours of clean-up after the earthquake.

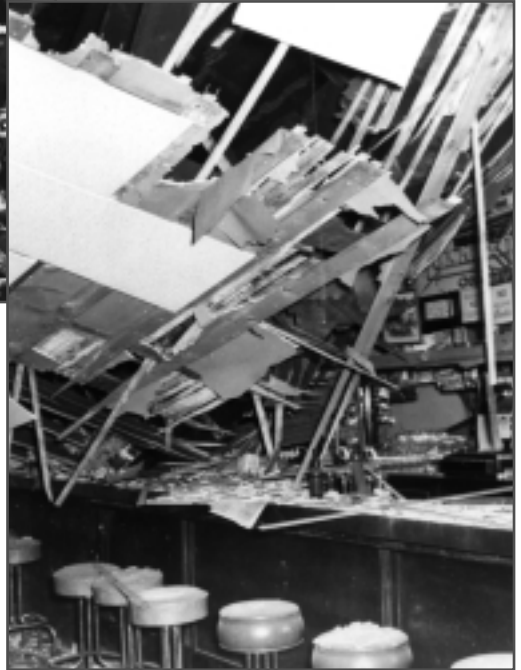
Right: The walls spread apart inside the Model Billiards building in Logan, allowing the roof to fall.

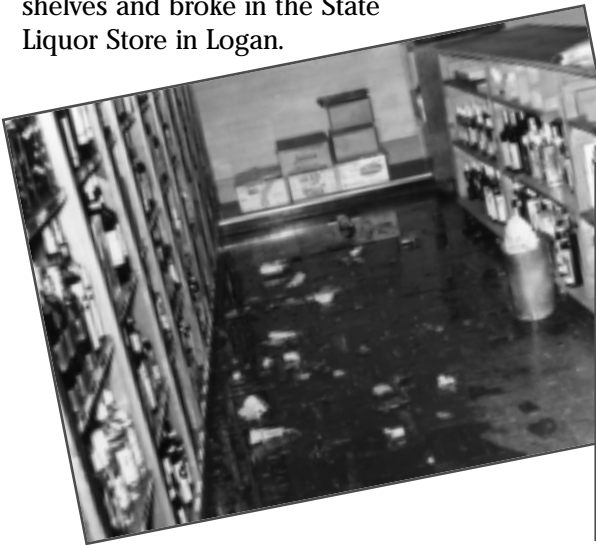
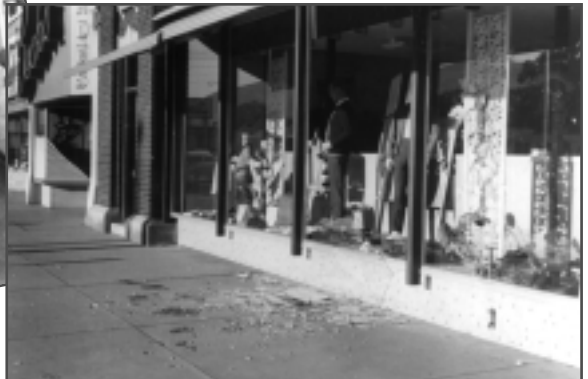
Many large plate glass windows were broken throughout Cache Valley, including the Keith O'Brien store in downtown Logan.

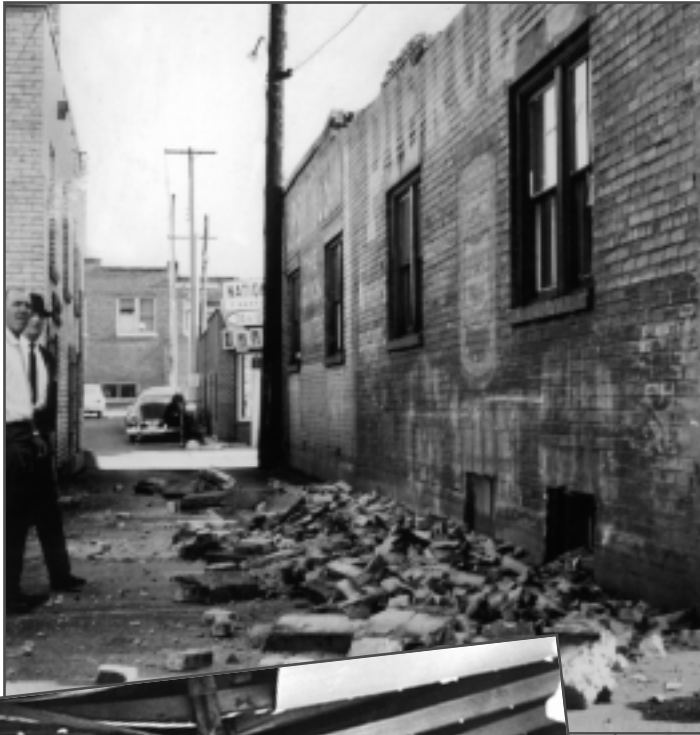
Left: An alley in Logan was littered with bricks that fell from a 40-foot-long wall of the Smith Printing Company building.

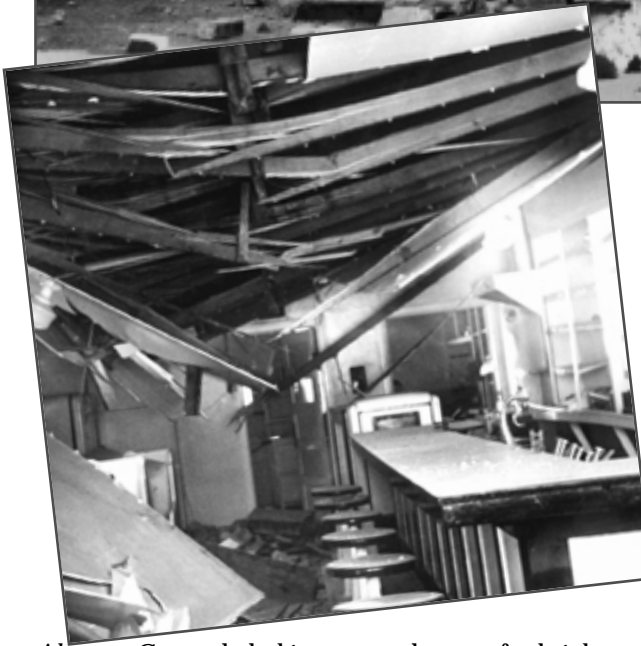
Below: Arrows show the path of bricks that tumbled from the parapet of the Lewiston Drugstore onto the roof of the City Café.

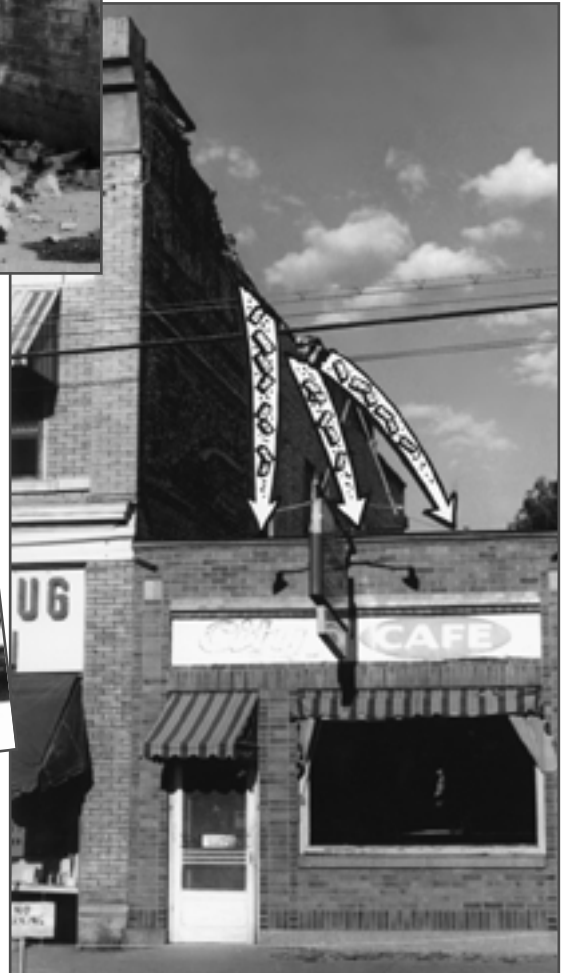
Above: Ground shaking caused part of a brick parapet of an adjacent building to fall through the roof of the City Café in Lewiston. Luckily, the café was not open at the time.

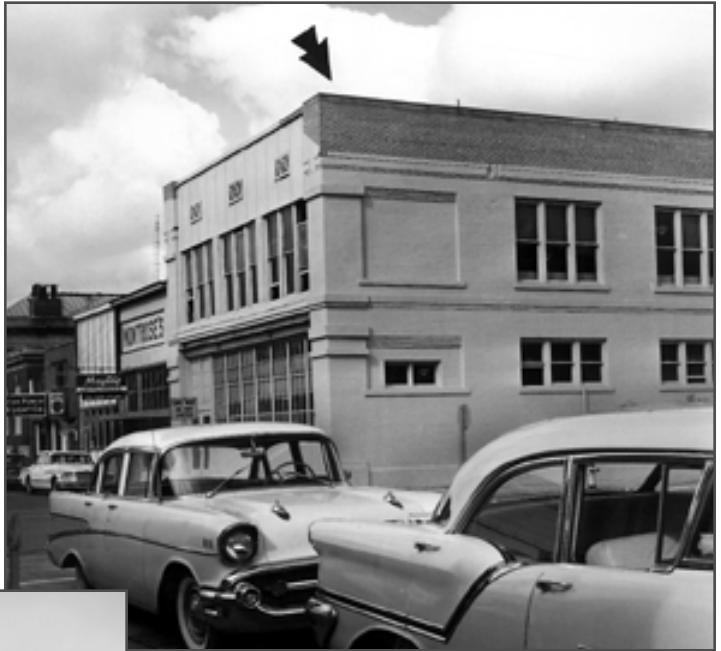
Right: Logan Junior High School was severely damaged by the earthquake, but was repaired and allowed to reopen within two weeks. The arrow shows where a reinforced concrete bond beam was cast around the walls at the roof line, and steel tie rods were installed. Structural engineers reported that this work would make the school more safe than it was before the earthquake. This photo shows the brick replacing the original loosened parapet wall.

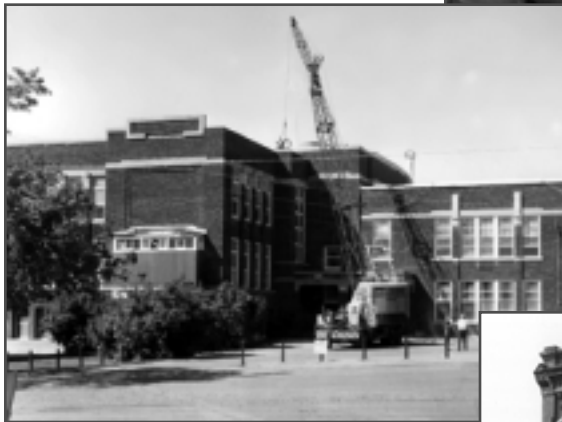
Left: At North Cache High School in Richmond, cranes were used to remove the 600-pound capstones that were loosened during the earthquake.

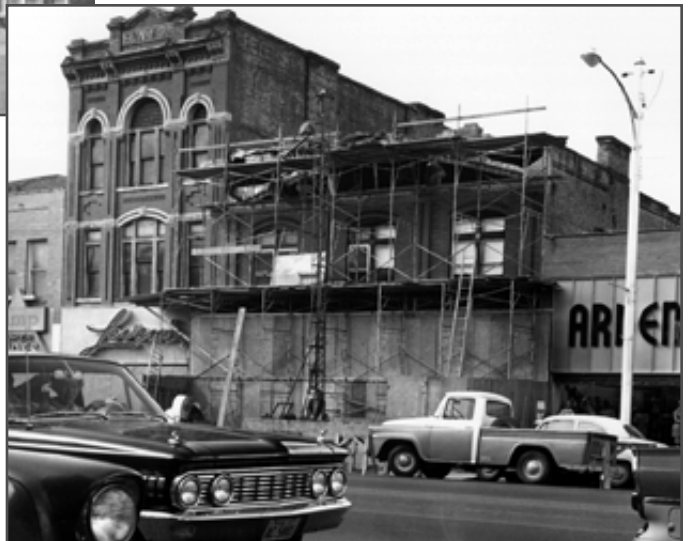
Right: Three weeks after the earthquake, scaffolding is moved along Main Street in Logan as workers repair buildings.

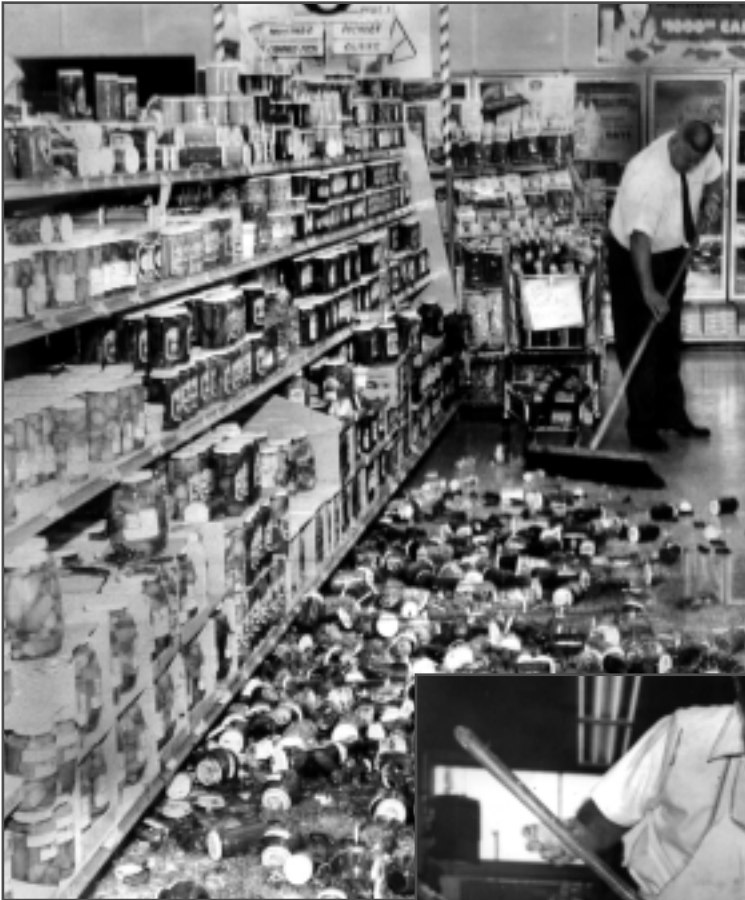
Merchandise in grocery stores
fell from the shelves into the
aisles.

Cleanup at Grand American
Market, 3400 South State
Street, Salt Lake City.

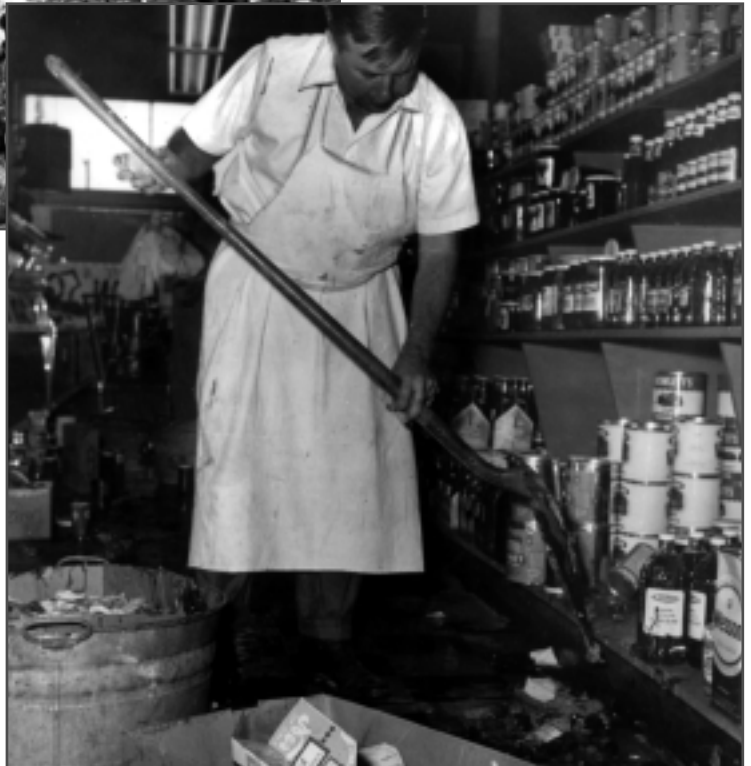
Cleanup at Colosimos' Standard
Market, Magna.

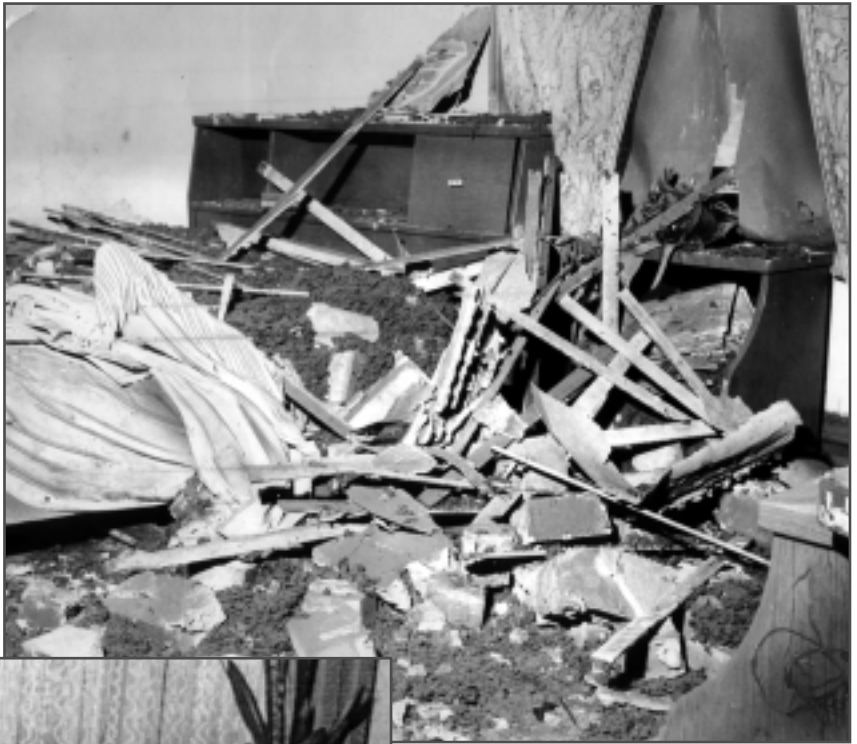
Some older homes in Salt Lake City suffered severe damage. A ceiling and part of an inner wall fell in and covered this bed with bricks and other debris at 17 North 500 West.

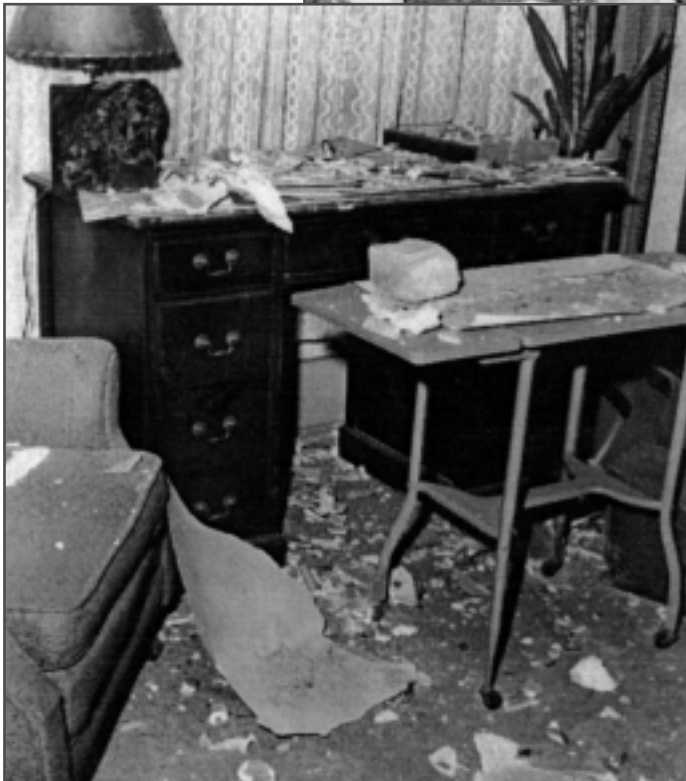
Part of the inner brick wall fell through the ceiling of this home in Salt Lake City.

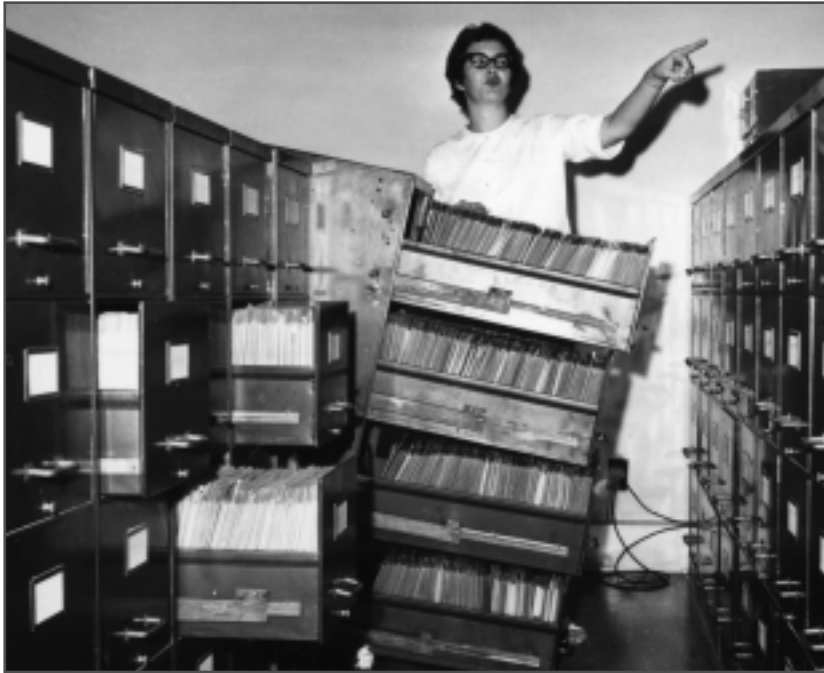
Filing cabinets were thrown open and tipped in the Beneficial Life Insurance Company offices at 47 W. South Temple, Salt Lake City.
