# THE 2005 SAGE VISTA LANE LANDSLIDE

## Cedar Hills, Utah County, Utah

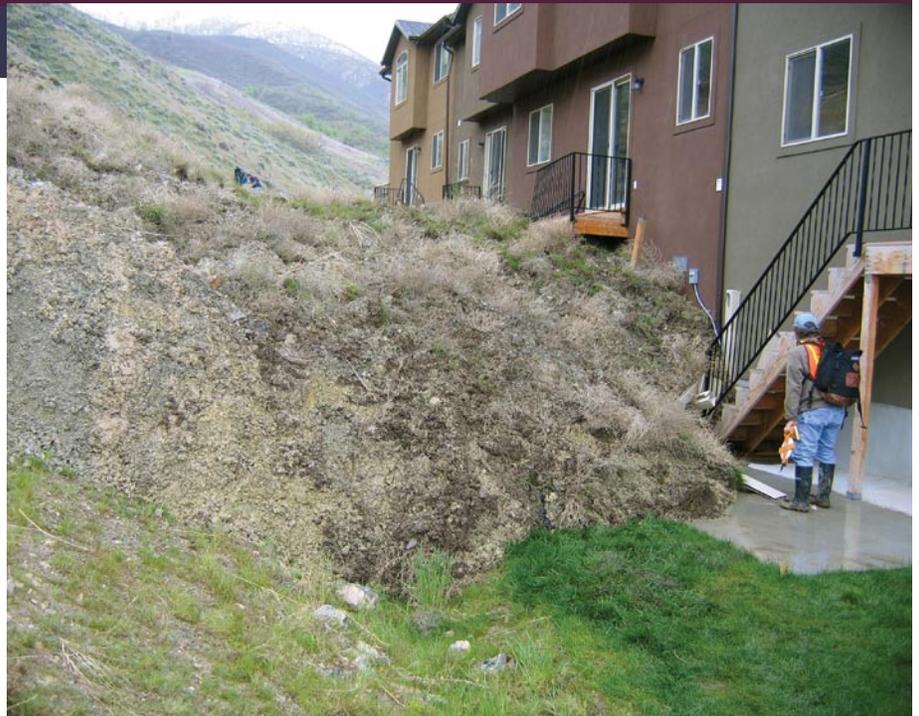
Homeowners in Cedar Hills first detected movement of the Sage Vista Lane landslide on April 28, 2005, and by the next day the landslide had moved against the lower back wall of a townhouse unit. In response, residents of the townhouses evacuated and the family in a duplex across the street moved out temporarily as a safety precaution. By mid-May, the landslide not only damaged and crushed vinyl fencing, air conditioners, and decks, but also caused enough structural damage to the townhouses that they were later condemned. Losses caused by the landslide were likely around \$1 million.

*Top: View of the landslide toe against the townhouses. Landslide movement damaged the townhouses, leading to their eventual demolition. Bottom: Location of the 2005 Sage Vista Lane landslide.*

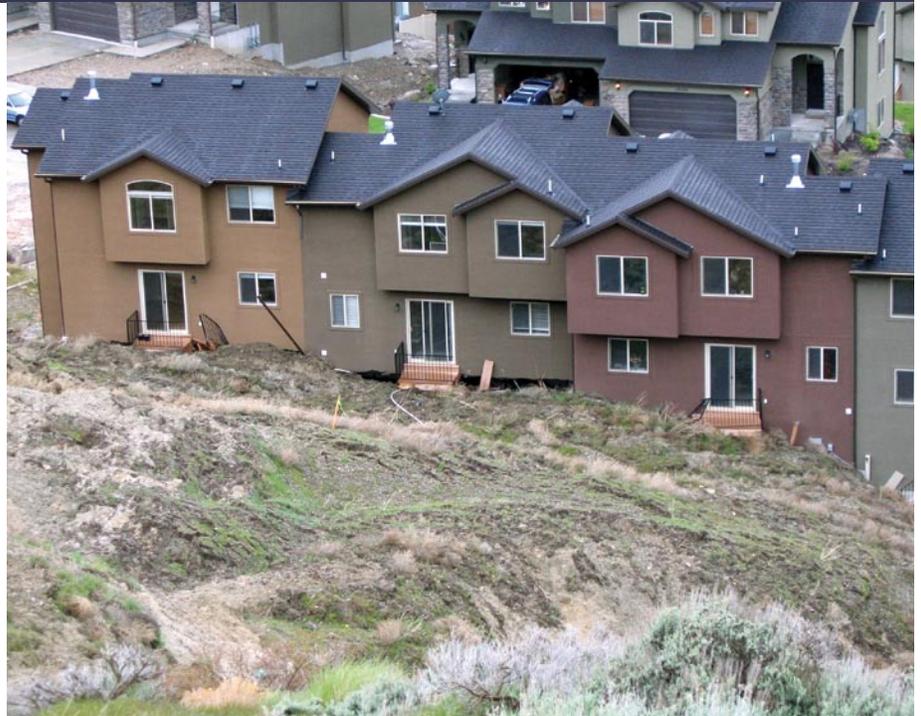
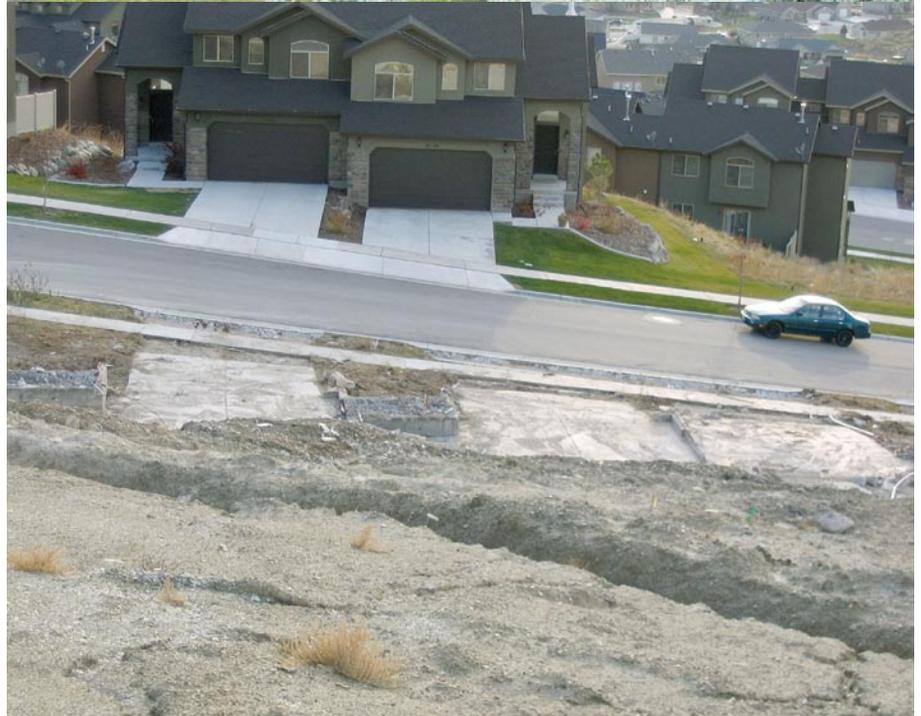
*Photo on the top shows a view down the steep slope of the landslide on May 12, 2005. Photo on the bottom was taken on November 15, 2006, following demolition of the townhouses.*

In October 2006, the city of Cedar Hills demolished the townhouses. The foundation was left in place as a resisting force to help prevent further landslide movement and additional damage to the subdivision.
