# THE 2005-06 CREEKSIDE DRIVE AREA LANDSLIDES

## Mountain Green, Morgan County, Utah

by Ashley Elliott

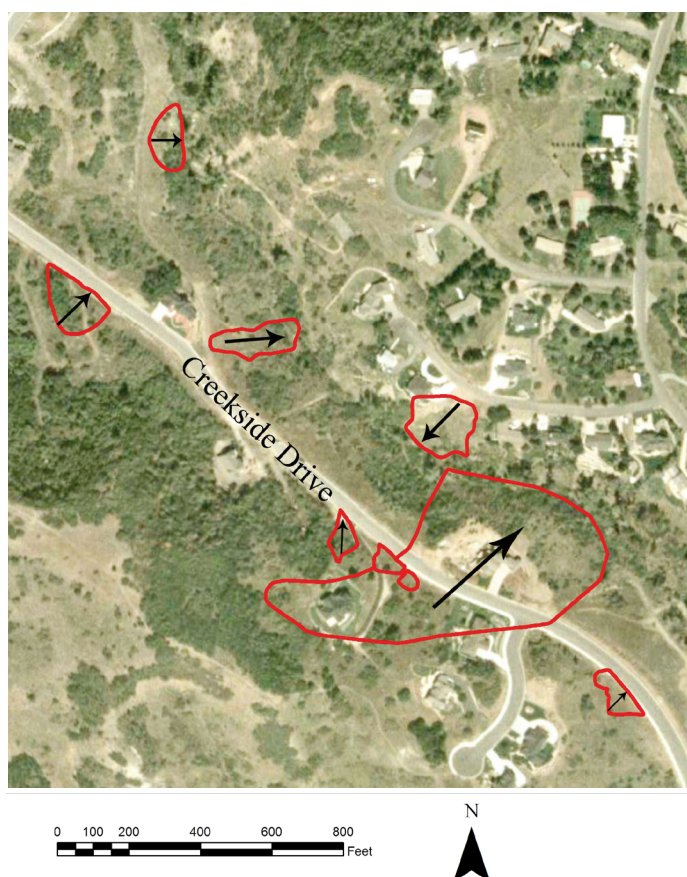
*The 2005-06 landslides in the Creekside Drive area. Black arrows indicate direction of movement.*

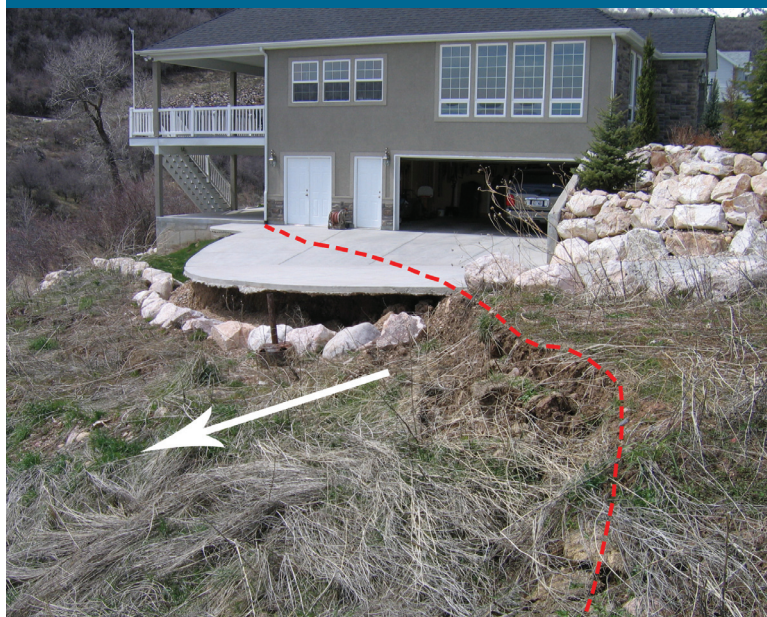
*The red line defines the upper edge of a Creekside Drive area landslide (located on Cascade Drive) that partly underlies a driveway slab. White arrow indicates direction of movement. Landslide movement left the slab unsupported.*

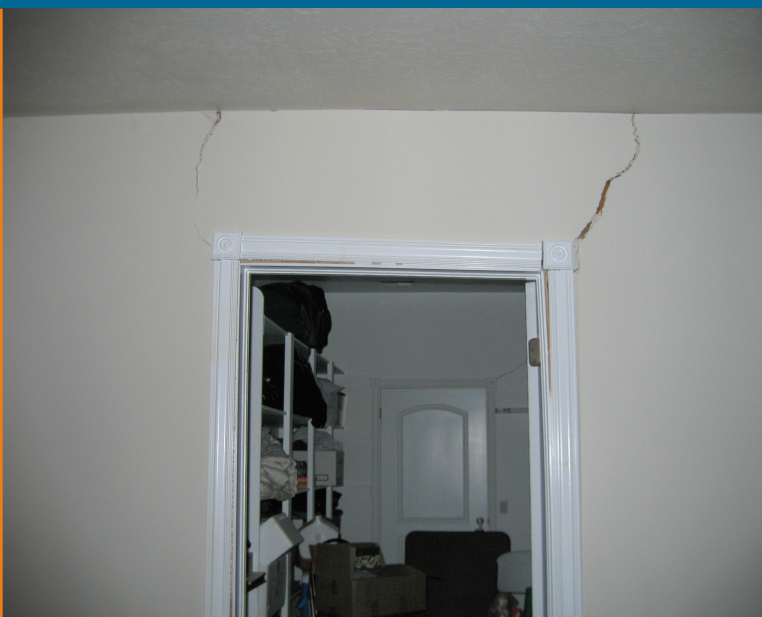
*Landslide movement caused severe structural damage to this house (located on Creekside Drive), including cracks in the walls and foundation. The nature and extent of damage led the owner to abandon the house in April 2006.*
