ESTIMATION OF POTENTIAL DEBRIS-FLOW VOLUMES FOR CENTERVILLE CANYON, DAVIS COUNTY, UTAH

by Richard E. Giraud and Jessica J. Castleton

REPORT OF INVESTIGATION 267
UTAH GEOLOGICAL SURVEY
a division of
UTAH DEPARTMENT OF NATURAL RESOURCES
2009

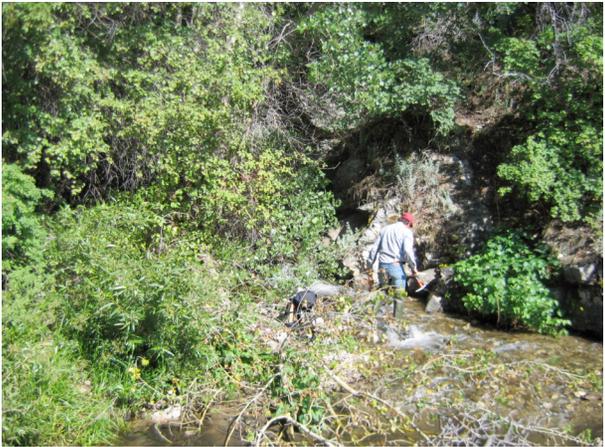
Channel Reach 1
Bulked Volume 7700 yd³

View upchannel

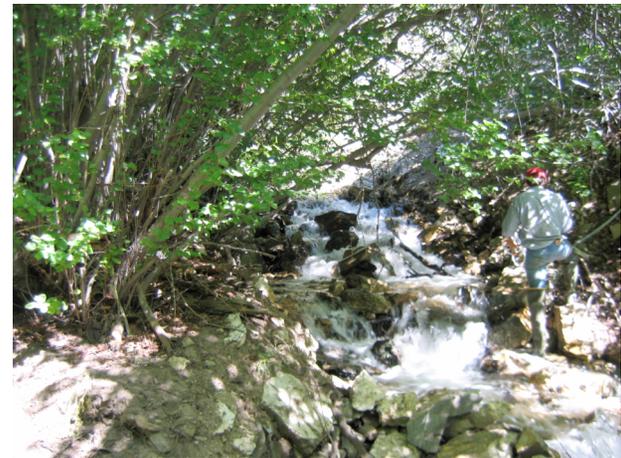
Channel Reach 2
Bulked Volume 3161 yd³

View upchannel

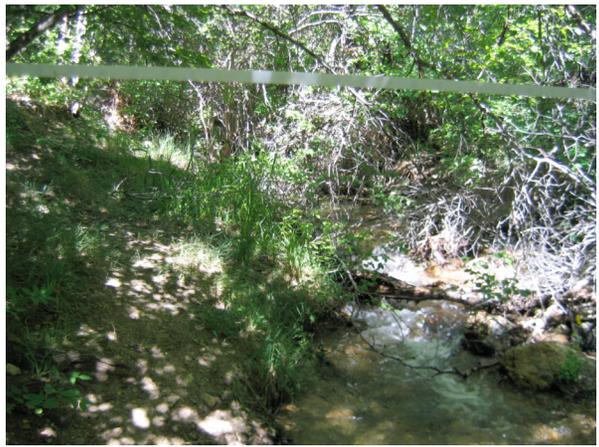
Channel Reach 4
Bulked Volume 29,496 yd³

View upchannel

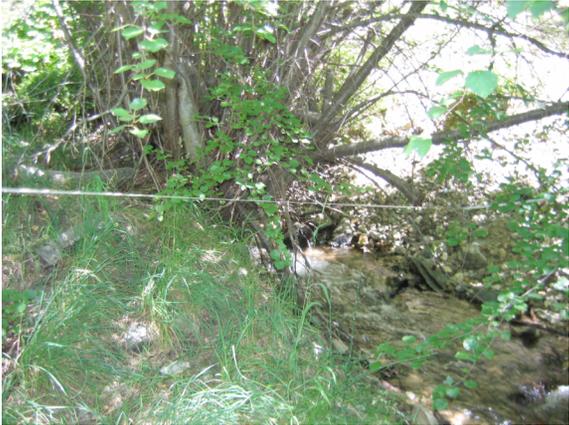
Channel Reach 4
Bulked Volume 29,496 yd³

View upchannel

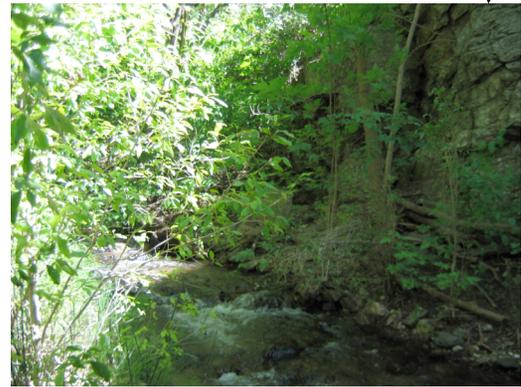
Channel Reach 5
Bulked Volume 25,852 yd³

View upchannel

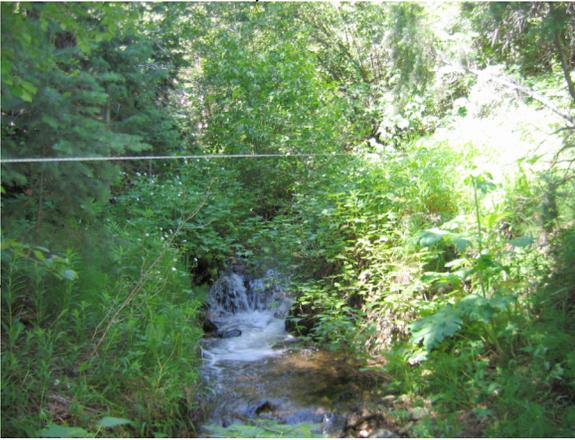
Channel Reach 6
Bulked Volume 21,623 yd³

View upchannel

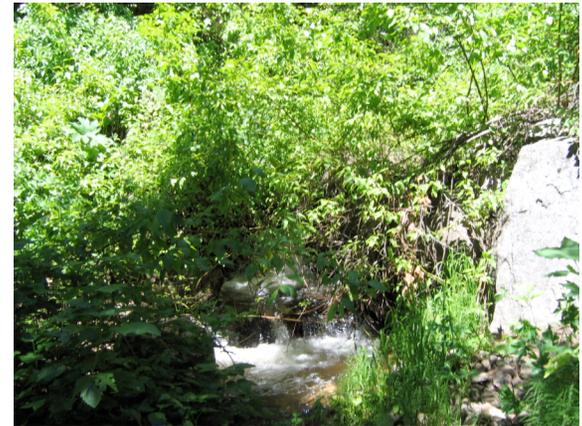
Channel Reach 8
Bulked Volume 5023 yd³

View upchannel

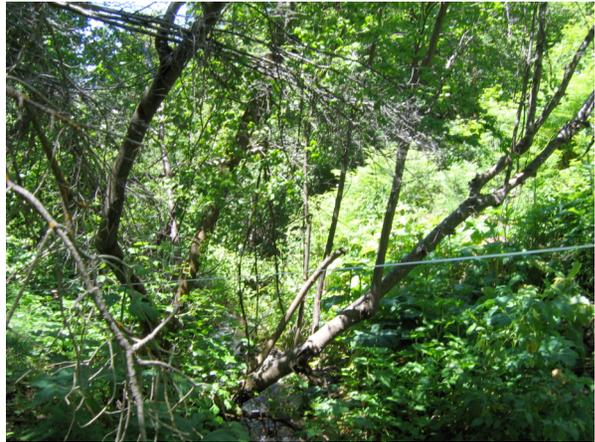
Channel Reach 11
Bulked Volume 16,716 yd³

View upchannel

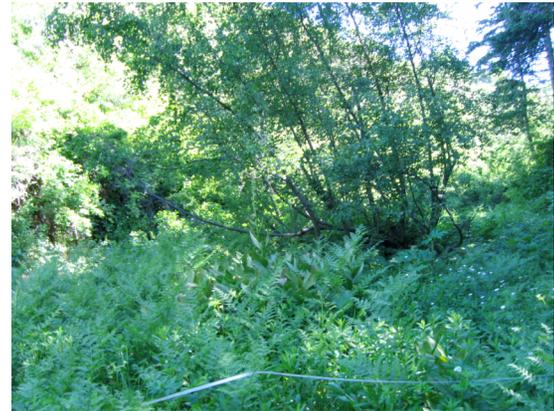
Channel Reach 13
Bulked Volume 32,208 yd³

View upchannel

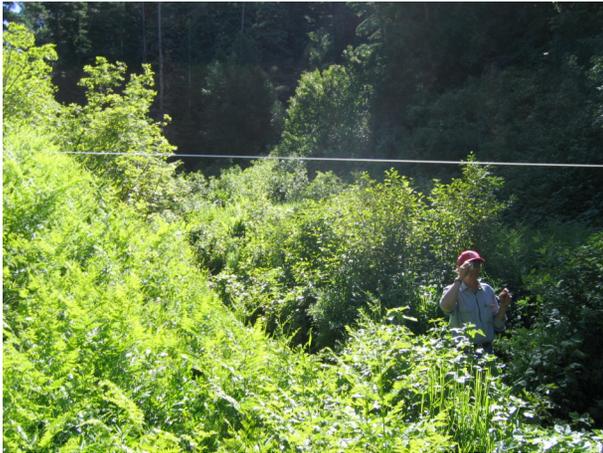
Channel Reach 13
Bulked Volume 32,208 yd³

View upchannel

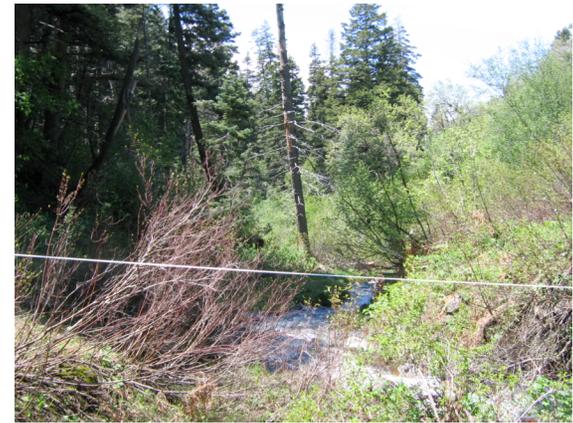
Channel Reach 13
Bulked Volume 32,208 yd³

View upchannel

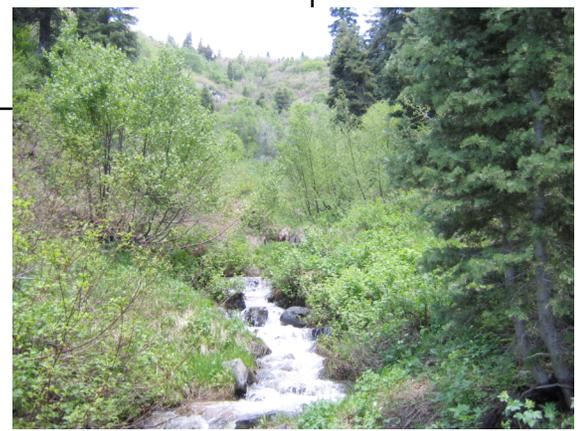
Channel Reach 14
Bulked Volume 12,037 yd³

View upchannel

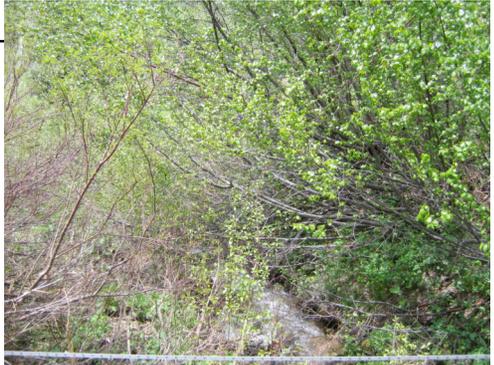
Channel Reach 14
Bulked Volume 12,037 yd³

View downchannel

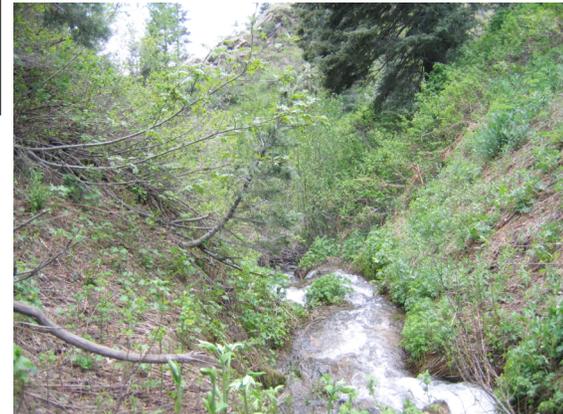
Channel Reach 15
Bulked Volume 2678 yd³

View upchannel

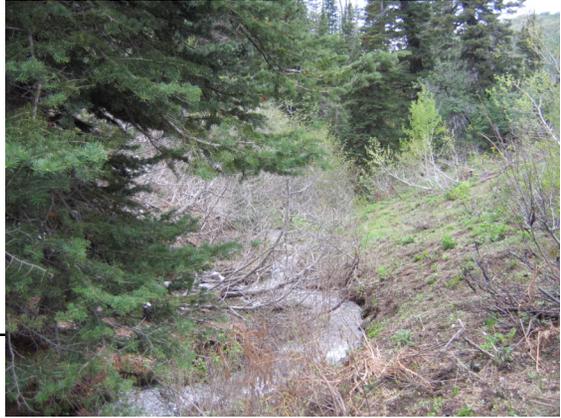
Channel Reach 16
Bulked Volume 2171 yd³

View upchannel

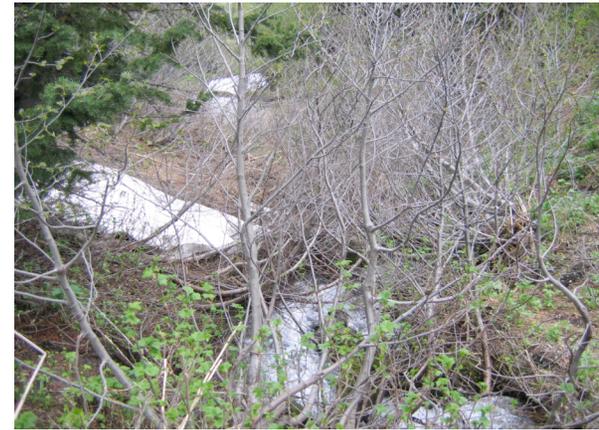
View upchannel

Channel Reach 17
Bulked Volume 581 yd³
