CHARACTERISTICS, CAUSES, AND IMPLICATIONS OF THE 1998 WASATCH FRONT LANDSLIDES, UTAH

by
Francis X. Ashland

SPECIAL STUDY 105
Utah Geological Survey
a division of
Utah Department of Natural Resources

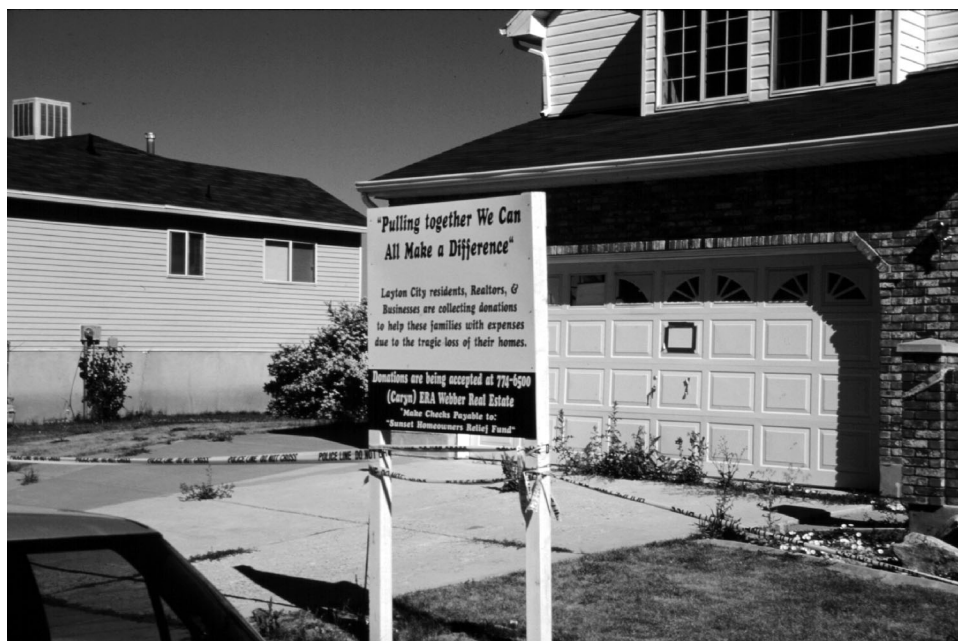
Figure 2. Condemned house at the Sunset Drive landslide in Layton prior to demolition. House to left was abandoned in 1999.

Direct and indirect losses in the Wasatch Front area resulting from 1998 landslides exceeded \$1 million. As of March 1999, the estimated losses at the Sunset Drive landslide in Layton (figure 2) were \$456,000 including the loss of two houses, one destroyed and demolished in 1998, another severely damaged and abandoned by early 1999. In North Salt Lake, an imperceptibly slow-moving landslide caused such severe damage to a house that it was subsequently condemned (figure 3). At least three other houses were also severely damaged and further damage is possible if landslide movement does not suspend. Damaging landslide movement also occurred in many other Wasatch Front communities including Salt Lake City and Provo where expensive attempts to prevent further movement or reduce property damage were made. Most of the landslide damage in 1998 occurred to residential property, but landsliding also damaged roads, a canal, and utility and culinary water lifelines. Most of the losses due to landsliding at residential properties were incurred directly by the homeowners because such losses are typically not covered by homeowner's insurance. However, some of the costs associated with damaging land-

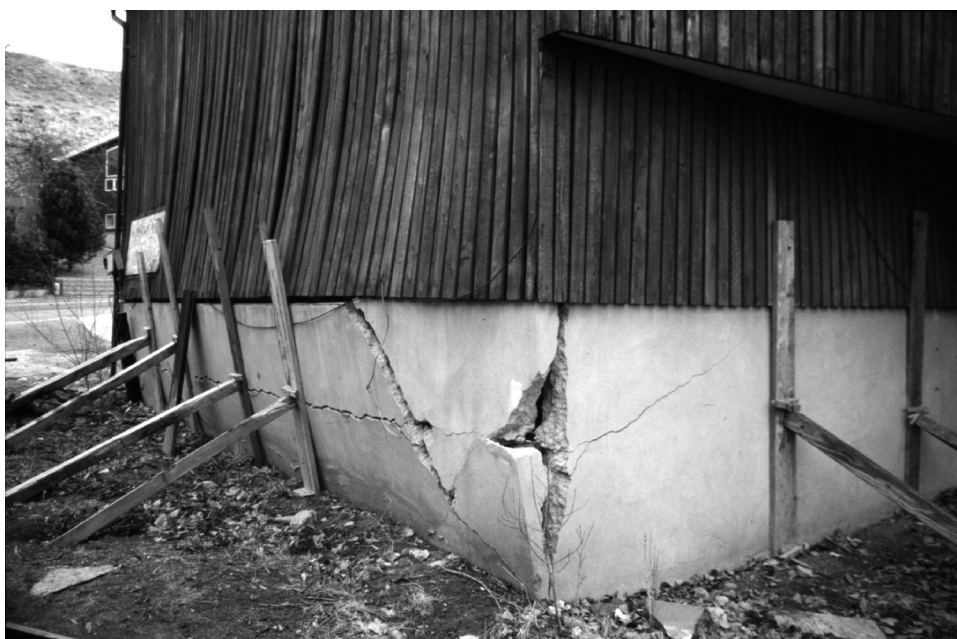
Figure 3. Condemned house at the Springhill landslide in North Sale Lake prior to demolition. View of northwest corner of house showing severe foundation damage.

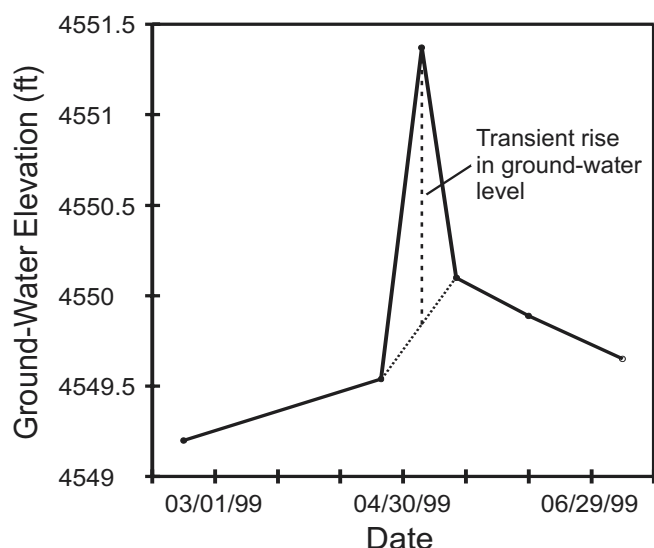
Figure 4. Transient ground-water-level rise associated with a four-day rainstorm in May 1999. Ground-water-level data from well P-4 (see figure 19 for borehole B-4 location) at Springhill landslide, North Salt Lake.

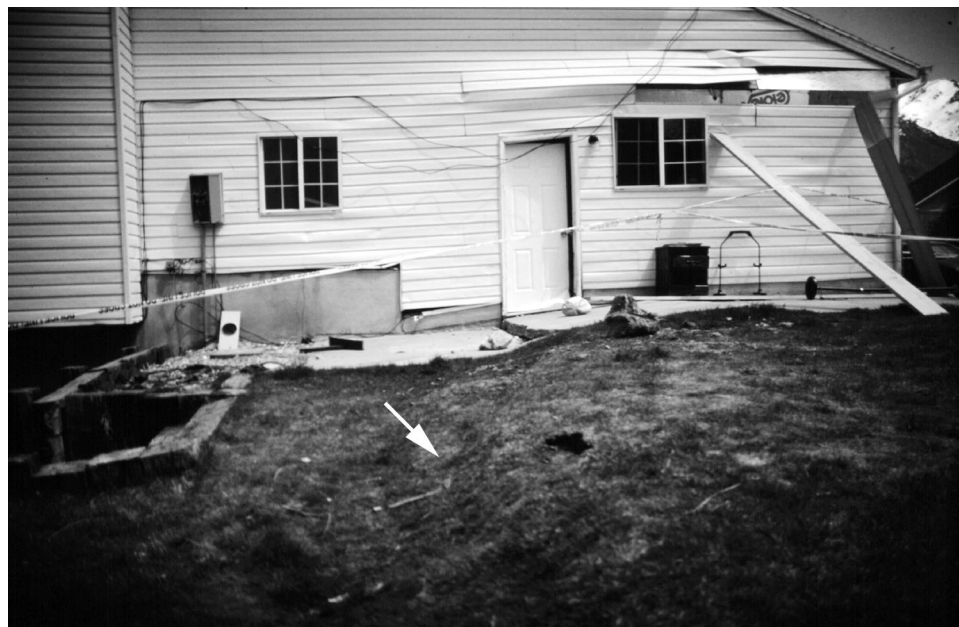
Figure 5. Damage to house on lot 105 at the Sunset Drive landslide in Layton. View of west side of house showing severe damage. Main scarp of the landslide is visible in foreground (arrow).

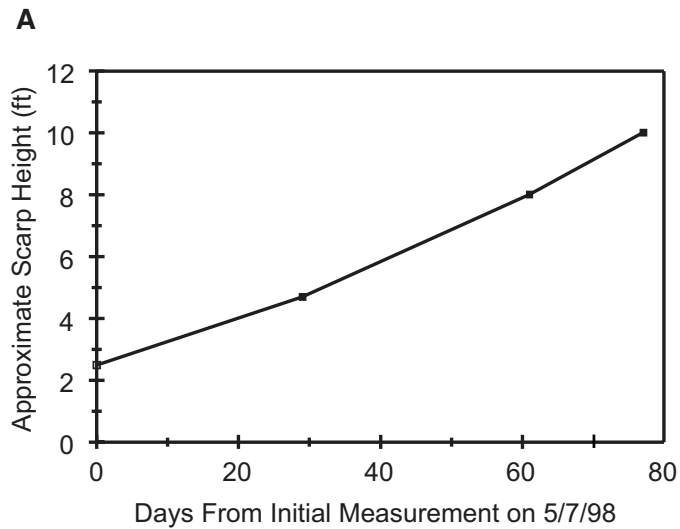
Figure 9 . Cumulative offset along the main scarp of the CBCC landslide. (A) Plot showing approximate cumulative offset between May 7, 1998, and July 23, 1998. (B) View toward the north of the main scarp on May 7, 1998, and (C) June 5, 1998.

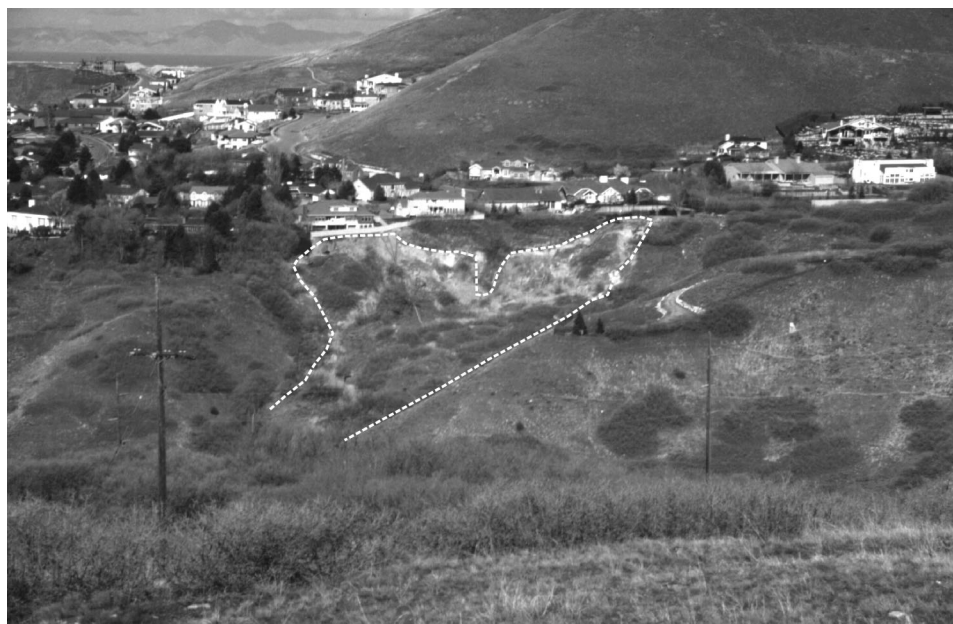
Figure 10. Oblique view of the CBCC landslide. View is toward the northwest. Dashed line shows approximate boundary. Toe of landslide is concealed by vegetation in foreground.

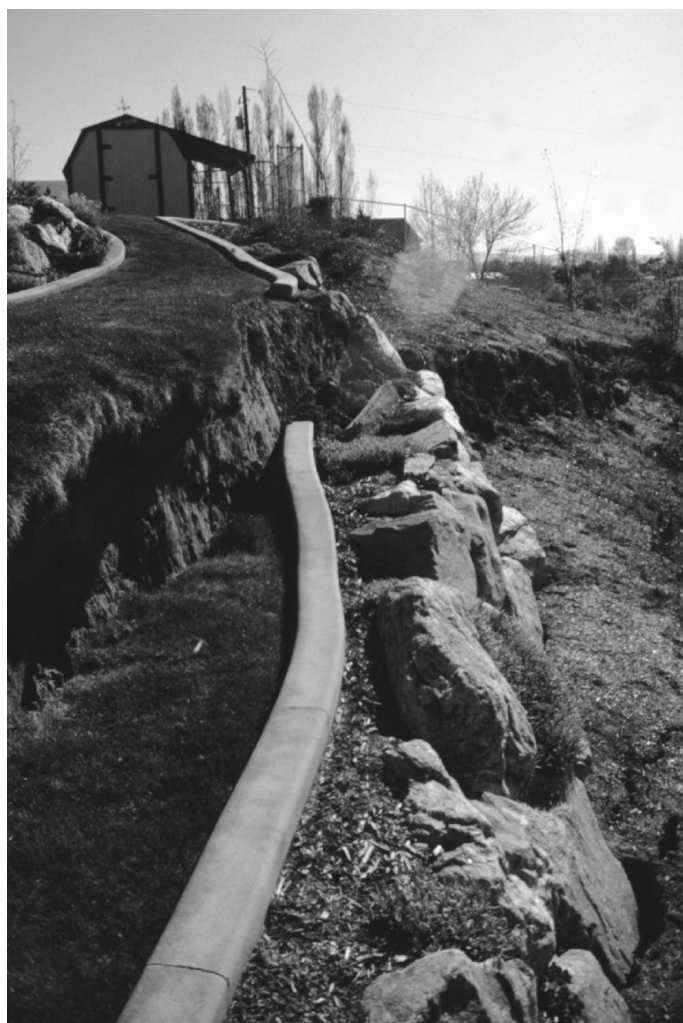
Figure 12. Head of the South Fork Kays Creek landslide in Layton. View is toward the west showing damage to landscaping. Main scarp of the landslide is visible in center of photo.

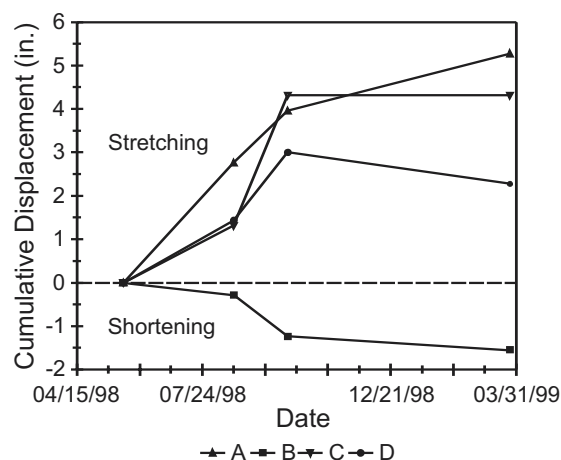
Figure 13. Cumulative displacement across the main scarp of South Fork Kays Creek landslide between May 22, 1998 and March 26, 1999. Data based on survey stakes and tape measurements. Survey stake series A is on west side of landslide and series D is on east side. Plot indicates movement had likely suspended by October 1998 except at A. Data courtesy of Richard Giraud, Utah Geological Survey.

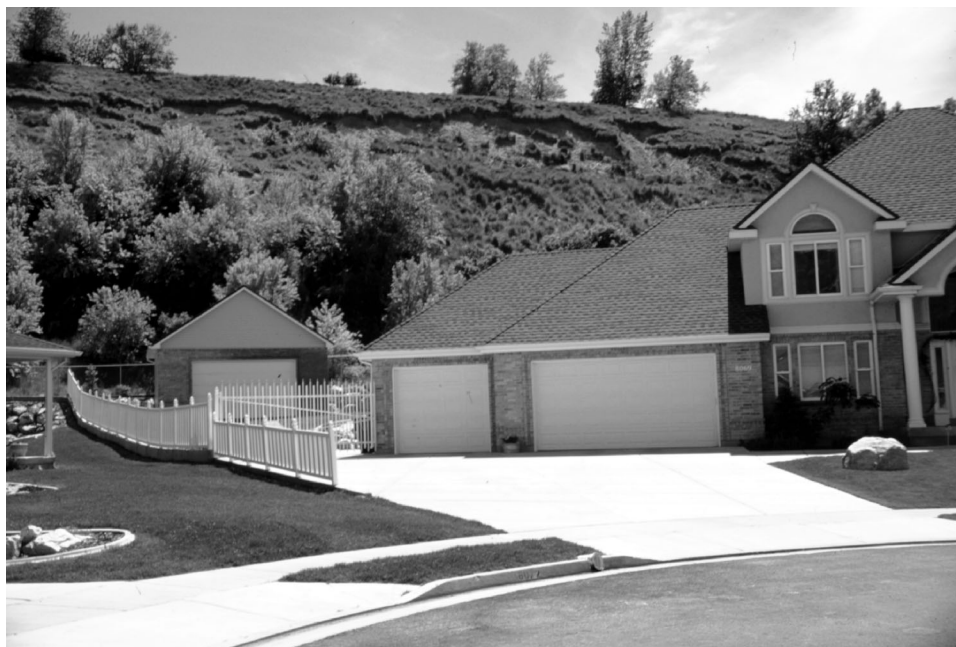
Figure 15. Shallow earth-slide complex at the Cedar Bench Subdivision landslide. View is toward the southwest.

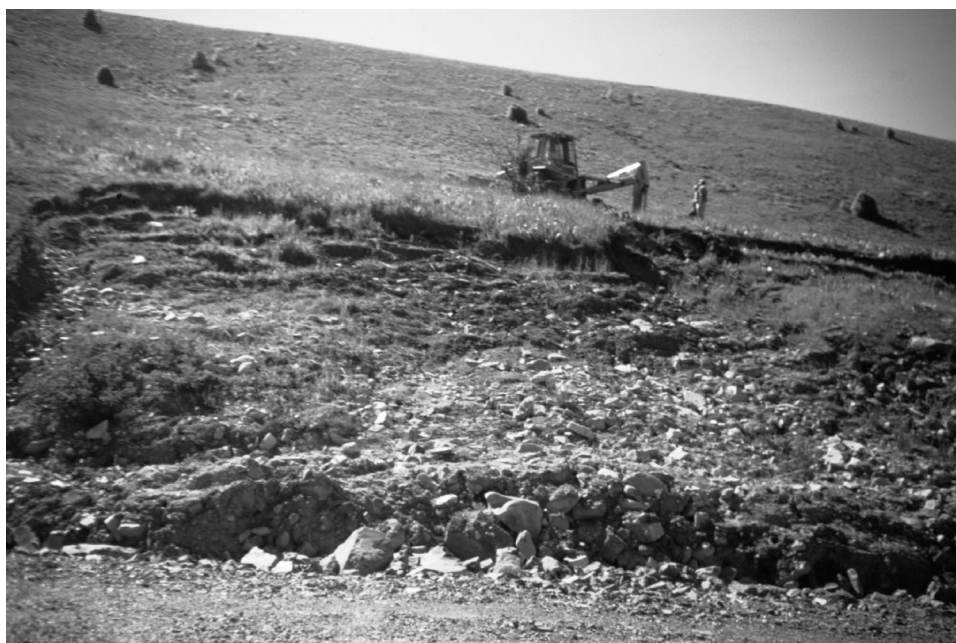
Figure 18. Shallow landslide at Green Hill Country Estates in Weber County. View is toward the southwest.

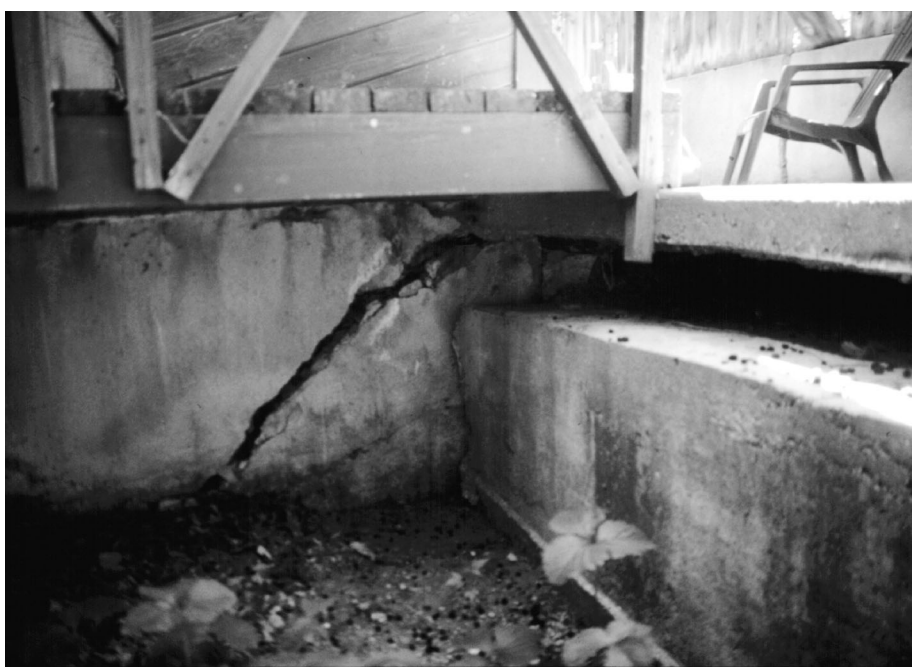
Figure 20. Foundation damage to a house at the Springhill landslide. View of southwest corner of house.

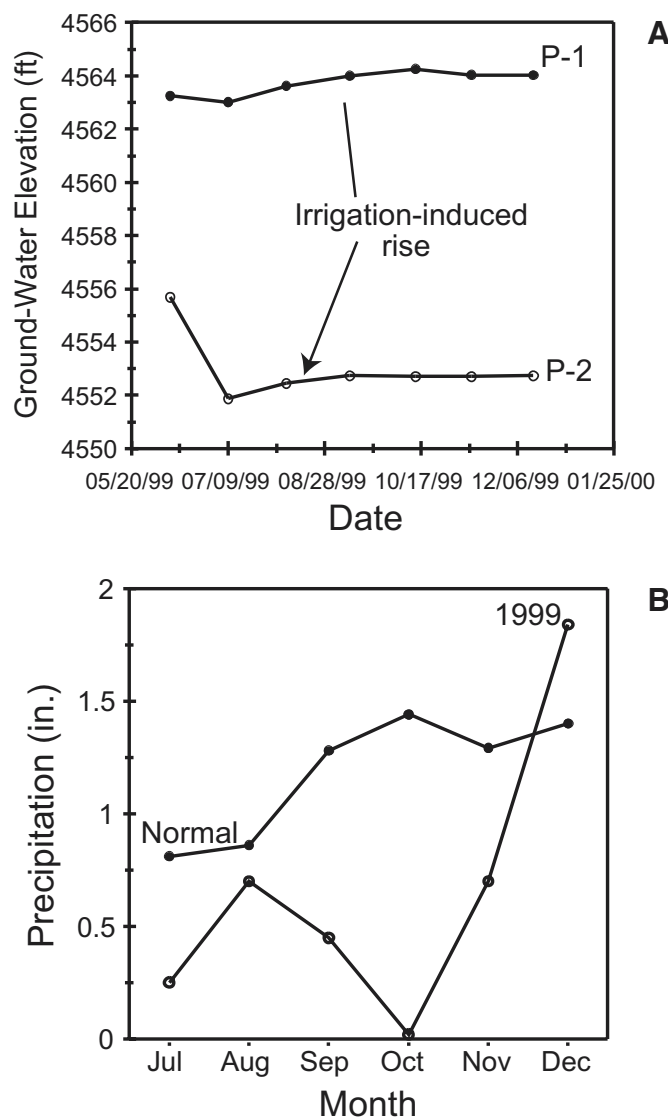
Figure 22. Irrigation-induced rise in ground-water levels at the Springhill landslide. During the late summer and early fall of 1999, ground-water levels rose in wells P-1 and P-2 at the Springhill landslide in North Salt Lake (A) despite below-normal precipitation during the same period (B). Precipitation data from Salt Lake City International Airport. Irrigation-induced rise reverses natural decline in ground-water levels in early summer.

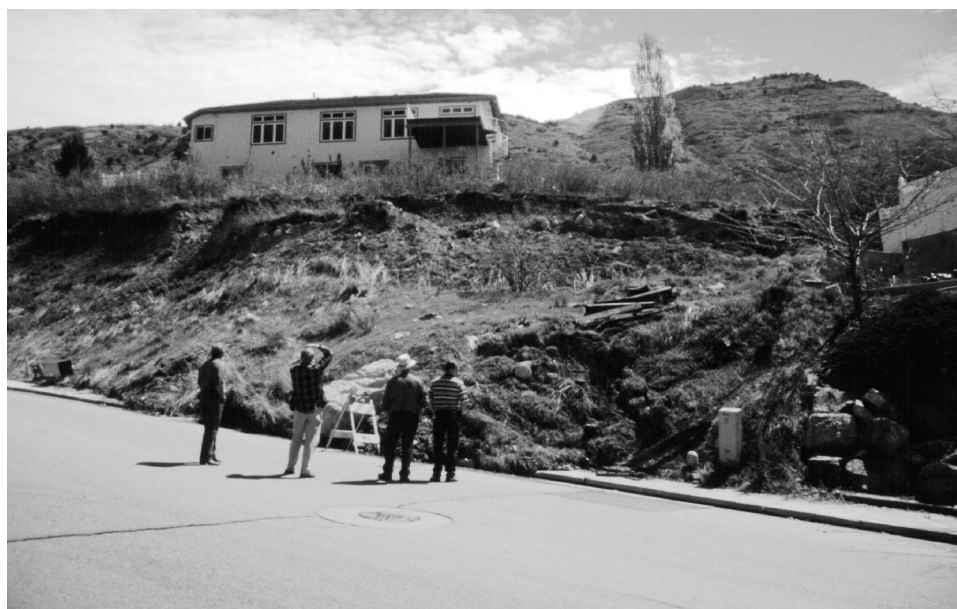
Figure 23. Landslide near the intersection of Windsor Drive and Foothill Drive in the lower part of the Sherwood Hills landslide complex, Provo. View is toward the east.

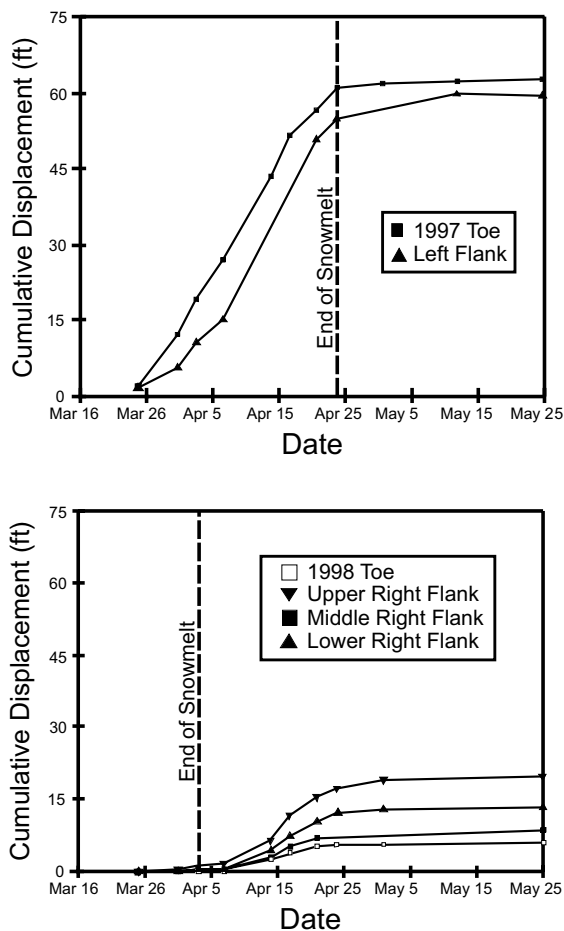
Figure 26. Cumulative displacement of the lower part of the Shurtz Lake landslide in 1998. The majority of the movement occurred in the vicinity of the 1997 toe. Displacements based on tape measurements of survey stakes across various landslide deformation features. Later end of snowmelt date in upper plot is due to higher elevation of 1997 toe and adjacent stations compared to other stations (lower plot). Data from Ashland and Horns (1998). Modified from Ashland and others (1999).

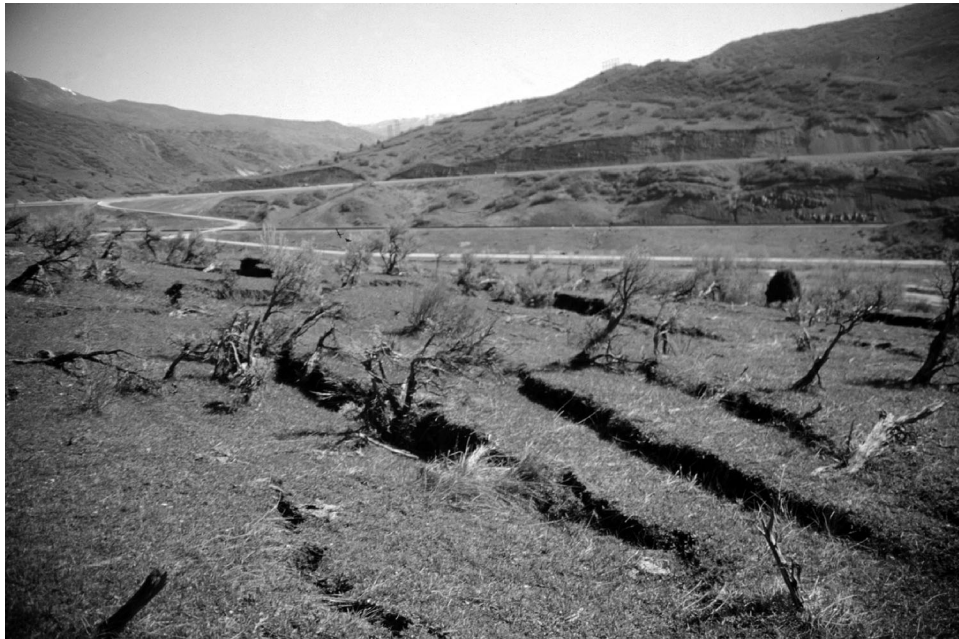
Figure 27. Upslope-facing minor scarps in the lower part of the Shurtz Lake landslide. Scarps intercept overland flow, increasing infiltration and ground-water levels. View is toward the northwest.

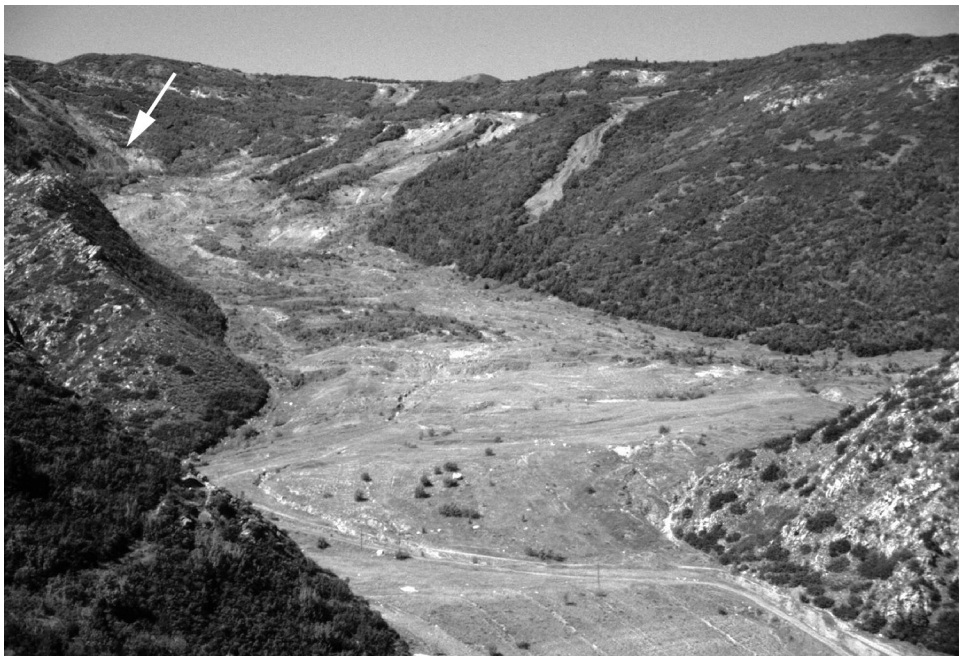
Figure 28. View toward the southwest of the Thistle landslide in Utah County. Most of the landslide above the 1983 blockage reactivated in 1998. Arrow points to new main scarp which formed in 1998.

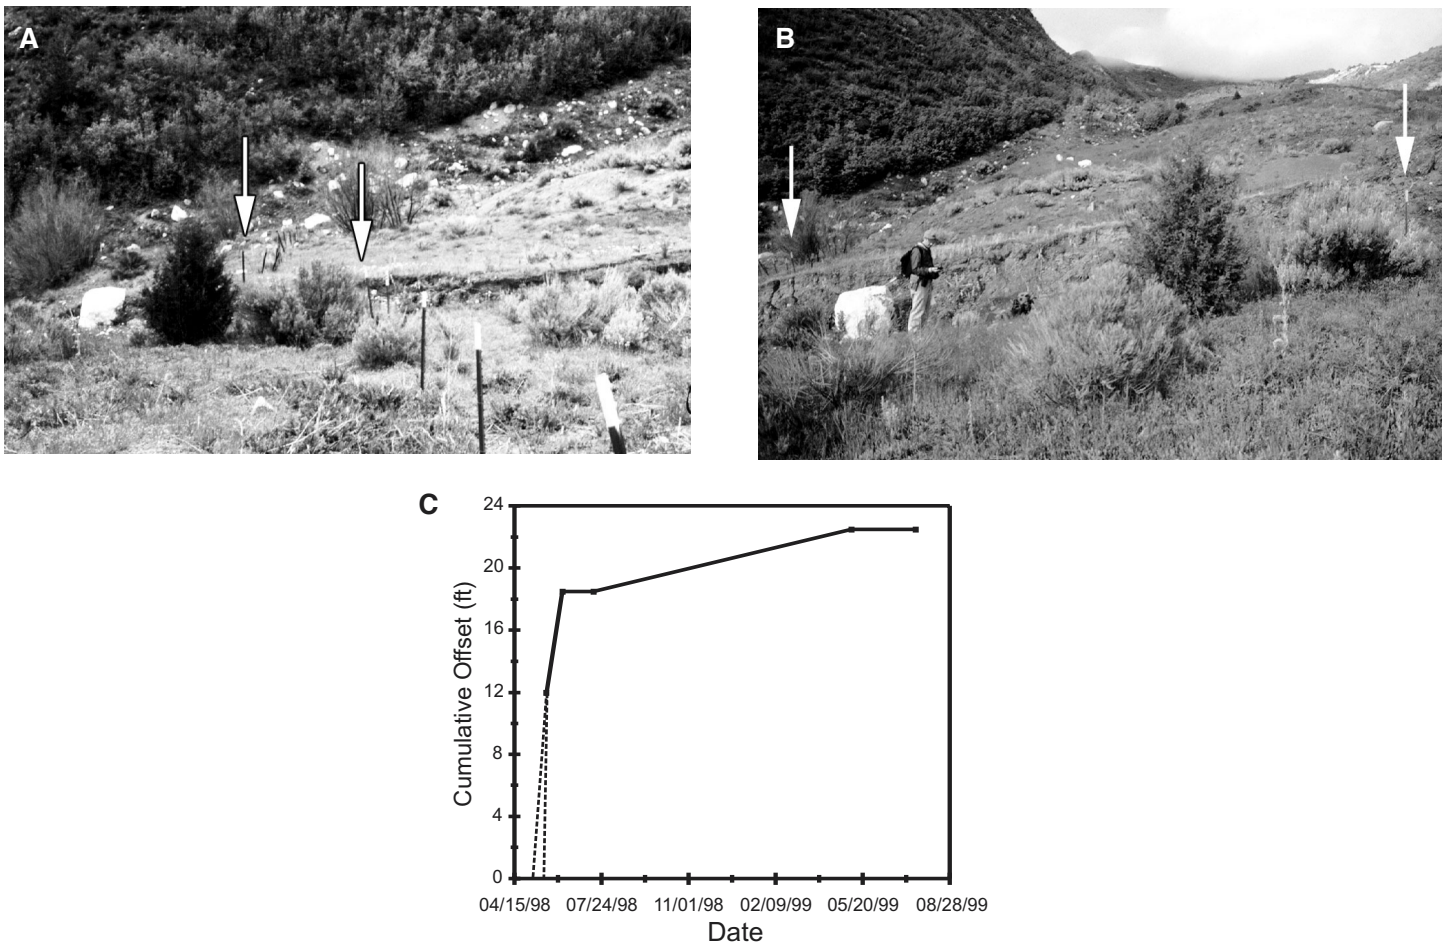
Figure 29. Cumulative offset of a fence by a left-lateral shear in the right toe area of the Thistle landslide. Photographs show offset of fence on May 22, 1998 (A), and June 9, 1998 (B). Plot (C) shows cumulative offset of fence along shear between May 22, 1998 and July 20, 1999. Dashed lines show probable offset prior to May 22, 1998. Onset of movement constrained by field observations to have occurred between May 5 and May 20, 1998.

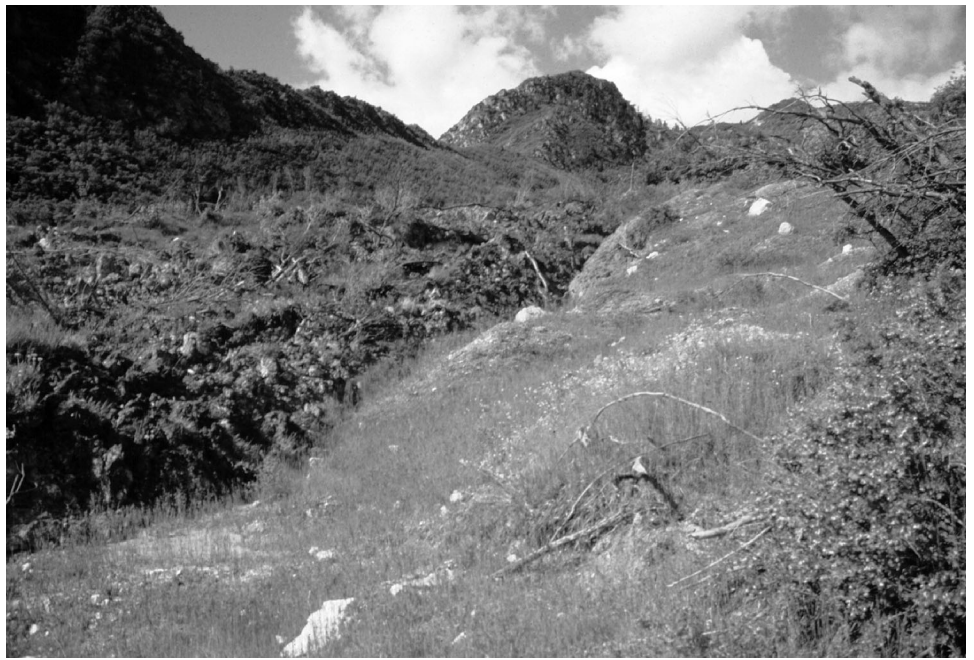
Figure 30. Earth flow in the upper right side of the Thistle landslide. View is toward the southwest.

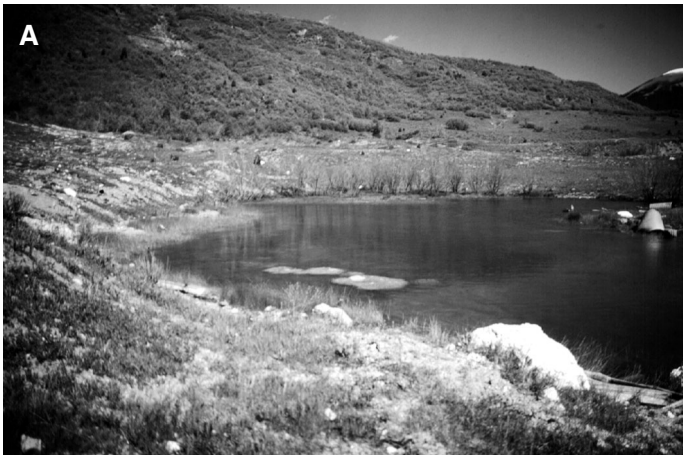
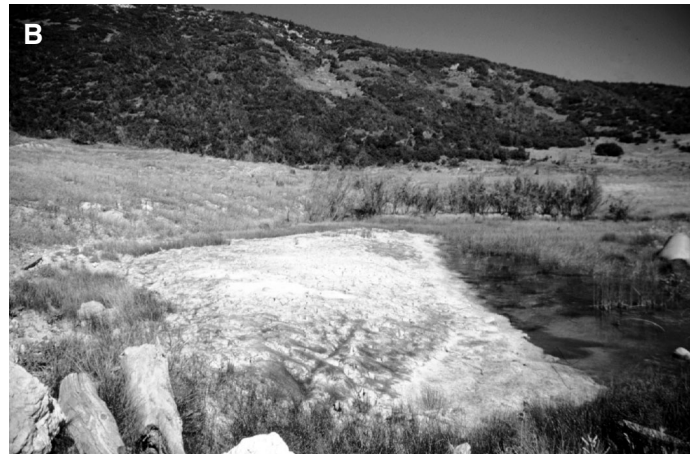
Figure 31. Uplift and tilting of the upslope (left) shore of a small pond on the Thistle landslide. Photographs show pond on May 20, 1998 (A), and July 15, 1998 (B). View is toward the west.
