ROCK-FALL HAZARD

STATE ROUTE 9 CORRIDOR GEOLOGIC-HAZARD STUDY AREA.

WASHINGTON COUNTY, UTAH

Utah Geological Survey Special Study 148

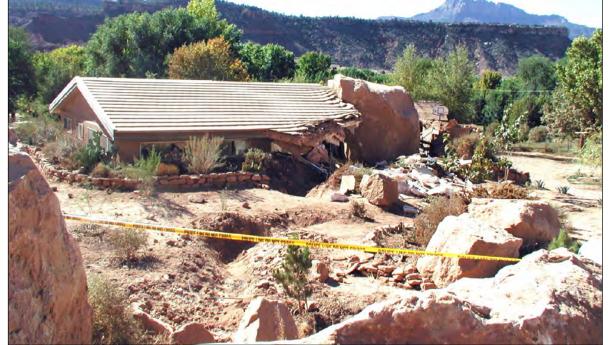
Figure 1. Rockville home at 200 North Center Street damaged by a rock-fall boulder on October 18, 2001.

Homes, other buildings, and vehicles have been struck and severely damaged from rock falls in the State Route 9 Corridor Geologic-Hazard Study Area (SR-9 study area) (figure 1; Lund, 2002; Knudsen, 2011; 2012). Rock fall is a natural mass-wasting process that involves the dislodging and downslope movement of individual rocks and rock masses (Cruden and Varnes, 1996). Rock falls pose a threat because falling or rolling boulders can damage property and cause injury or even loss of life. The probability of a damaging/life threatening rock fall is greatly increased where permanent facilities are located in rock-fall-hazard zones (figure 2). Rock-fall hazards exist where a source of rock is present above slopes steep enough to allow rapid downslope movement of dislodged rocks by falling, rolling, and bouncing.

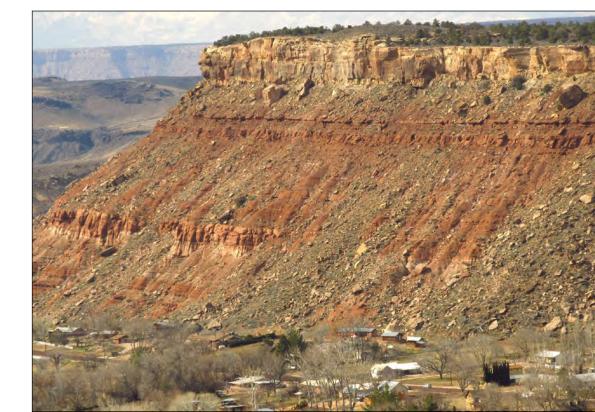
Figure 2. Permanent development in rock-fall hazard zones below Rockville Bench in Rockville. Rockville Bench is typical of many exposures in the study area where softer bedrock units crop out on slopes below more resistant cliff-forming formations. Photo date: February 2011.

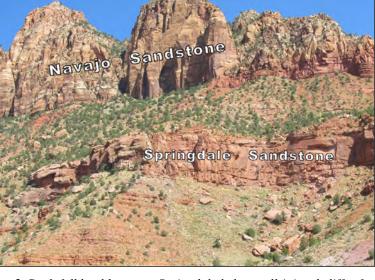
Figure 3. Rock-fall boulders near Springdale below well-jointed cliffs of

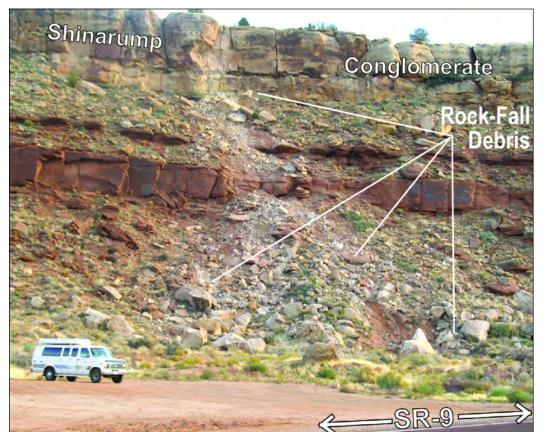
Figure 4. Rock-fall debris from a November 2010 rock fall in Rockville covers a relatively small area near the base of Rockville Bench.

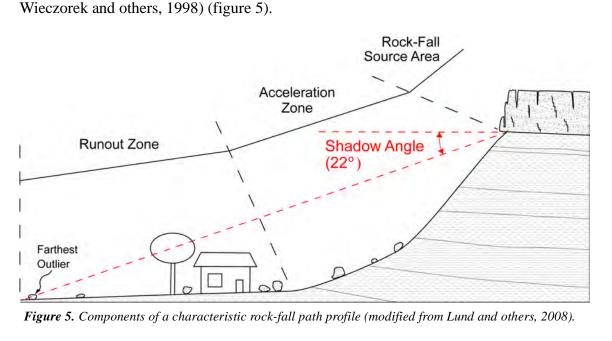
We established the boundaries of areas subject to rock-fall hazard in the study area by measuring a shadow angle (Evans and Hungr, 1993; Wieczorek and others, 1998), which is the angle formed between a horizontal line and a line extending from the base of the rock source to the outer limit of the runout zone (figure 5). Shadow angles vary based on rock type, boulder shape, slope steepness, slope roughness, and rock source height. We measured shadow angles for dozens of representative rock-fall boulders in the SR-9 study area. Our investigation showed that a shadow angle of 22° is generally applicable in the study area, and defines a hazard zone sufficiently wide to include the limits of rock-fall debris that accumulates at the base of cliffs and steep slopes.

This map shows areas in the SR-9 study area that are susceptible to rock fall. Determining the severity of rock-fall hazard requires evaluating the characteristics of three hazard components: (1) a rock source, in general defined by bedrock geologic units that exhibit relatively consistent patterns of rock-fall susceptibility throughout the study area, although talus/cliff-retreat deposits may also create a local source of rock falls, (2) an acceleration zone, where the rock-fall debris gains momentum as it travels downslope; this zone often includes a talus slope, which becomes less apparent with decreasing relative hazard and is typically absent where the hazard is low, and finally (3) a runout zone, which includes gentler slopes where boulders roll or bounce before coming to rest beyond the base of the acceleration zone (Evans and Hungr, 1993;

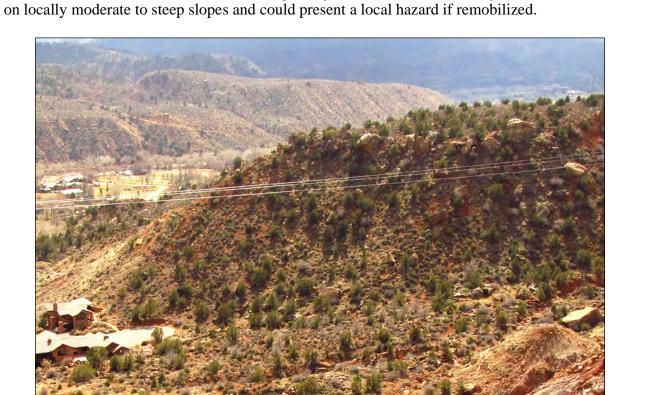
Figure 6. Isolated, large boulders of Navajo Sandstone considered to be cliff-retreat deposits litter slopes above homes in Springdale. Photo date: February 2011.

colluvial, and alluvial pediment-mantle deposits that contain large (some house-sized) boulders of chiefly Navajo Sandstone that are up to 1.5 miles from the nearest Navajo outcrop (figure 6). These boulders are likely talus/cliff-retreat deposits (some could be fin-collapse or large rockavalanche deposits) left isolated by canyon widening, and are not representative of the current rock-fall hazard sourced from distant Navajo canyon walls. However, many of these boulders lie

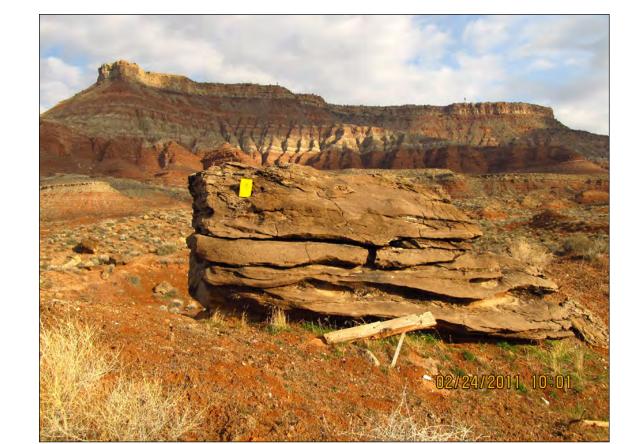
Figure 7. Isolated boulder of Shinarump Conglomerate that is too far from its source area (Shinarumpcapped Hurricane Mesa in distance) to have been deposited in recent times.

We also observed numerous large boulders of Shinarump Conglomerate littering abandoned alluvial terraces and other surfaces below Rockville Bench and Wire, Grafton, Gooseberry, and Hurricane Mesas that are up to 1 mile away from the nearest Shinarump outcrop (figure 7). Knudsen (2011, 2012) documented large (up to 30 feet in long dimension), isolated boulders of Shinarump Conglomerate near the center of Rockville with shadow angles of less than 15°. He concluded that the boulders are likely cliff-retreat deposits and that they do not represent the extent of current rock-fall hazard. Biek and others (2012) reported additional isolated Shinarump boulders on an abandoned terrace 0.5 mile west of Rockville, and they concluded that the boulders fell onto the terrace at a time when the distant Shinarump-capped mesa to the northeast (Rockville Bench) was much closer to the terrace than it is today. While such cliff-retreat boulders are not representative of the current rock-fall hazard sourced from adjacent Shinarump-capped mesas, some near the eroded edges of elevated abandoned terraces could present a local hazard if
