INTRODUCTION

HAZARD CLASSIFICATION

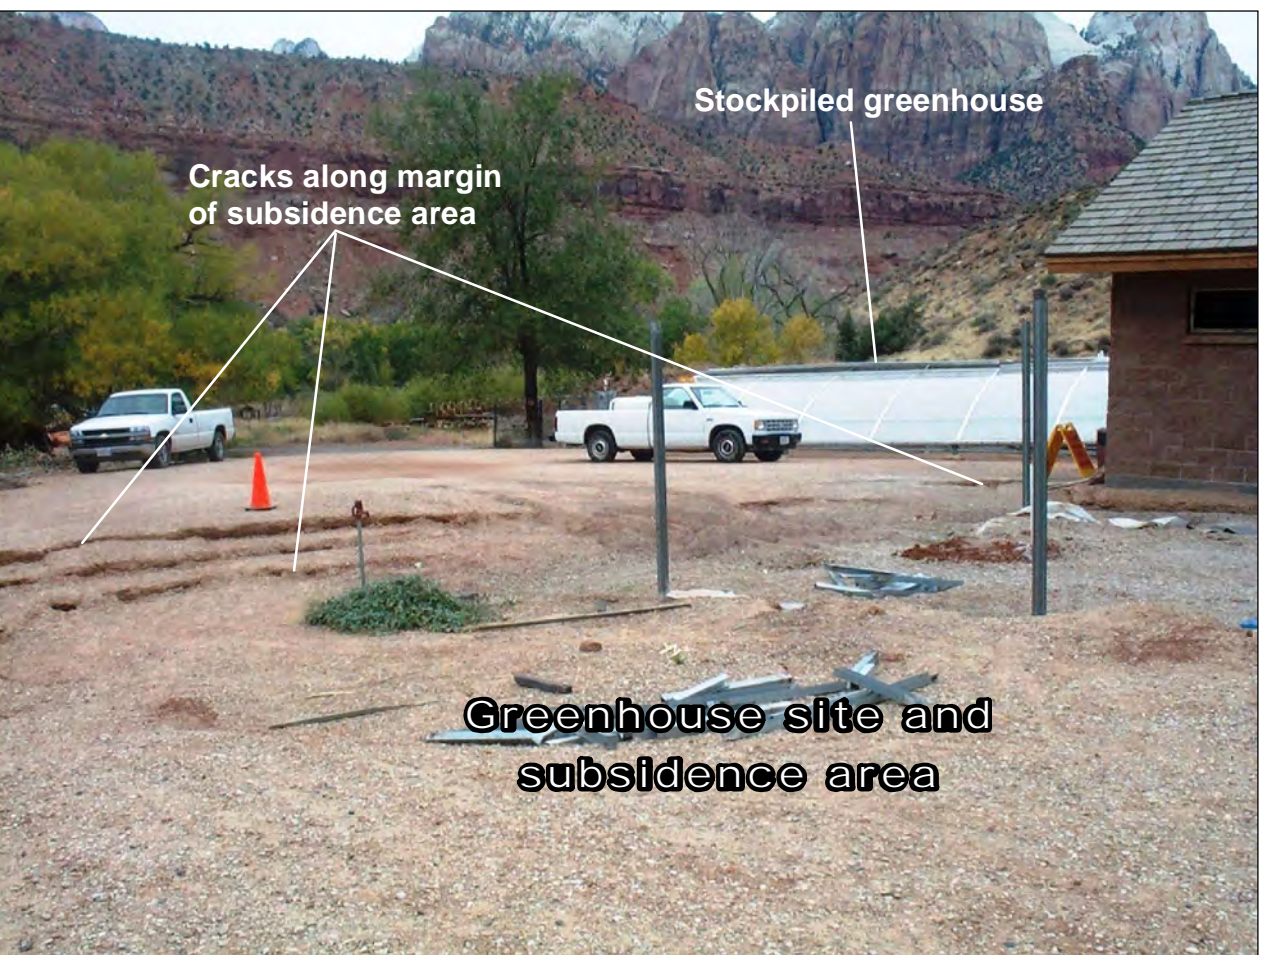
Figure 2. Site of the Zion National Park greenhouse (stockpiled behind truck near photo center) damaged by collapsible soils. Circa 2001 photo; courtesy of the National Park Service.

Naturally occurring deep percolation of water into collapsible deposits is uncommon after deposition due to the arid conditions in which the deposits typically form, and the steep gradient of many alluvial-fan and colluvial surfaces. Therefore, soil collapse is usually triggered by human activity such as irrigation, urbanization, and/or wastewater disposal. Kaliser (1978) reported serious damage (estimated \$3 million) to public and private structures in Cedar City, Utah, from collapsible soils. Rollins and others (1994) documented more than \$20 million in required remedial measures to a cement plant near Leamington, Utah, and Smith and Deal (1988) reported damage to a large flood-control structure near Monroe, Utah. In 2001, collapsible soils damaged the Zion National Park greenhouse soon after it was constructed (figure 2), as soils below and around the building were wetted by excess irrigation water. Park employees reported that a wastewater treatment plant that had once been located nearby also had a history of damage from ground subsidence.

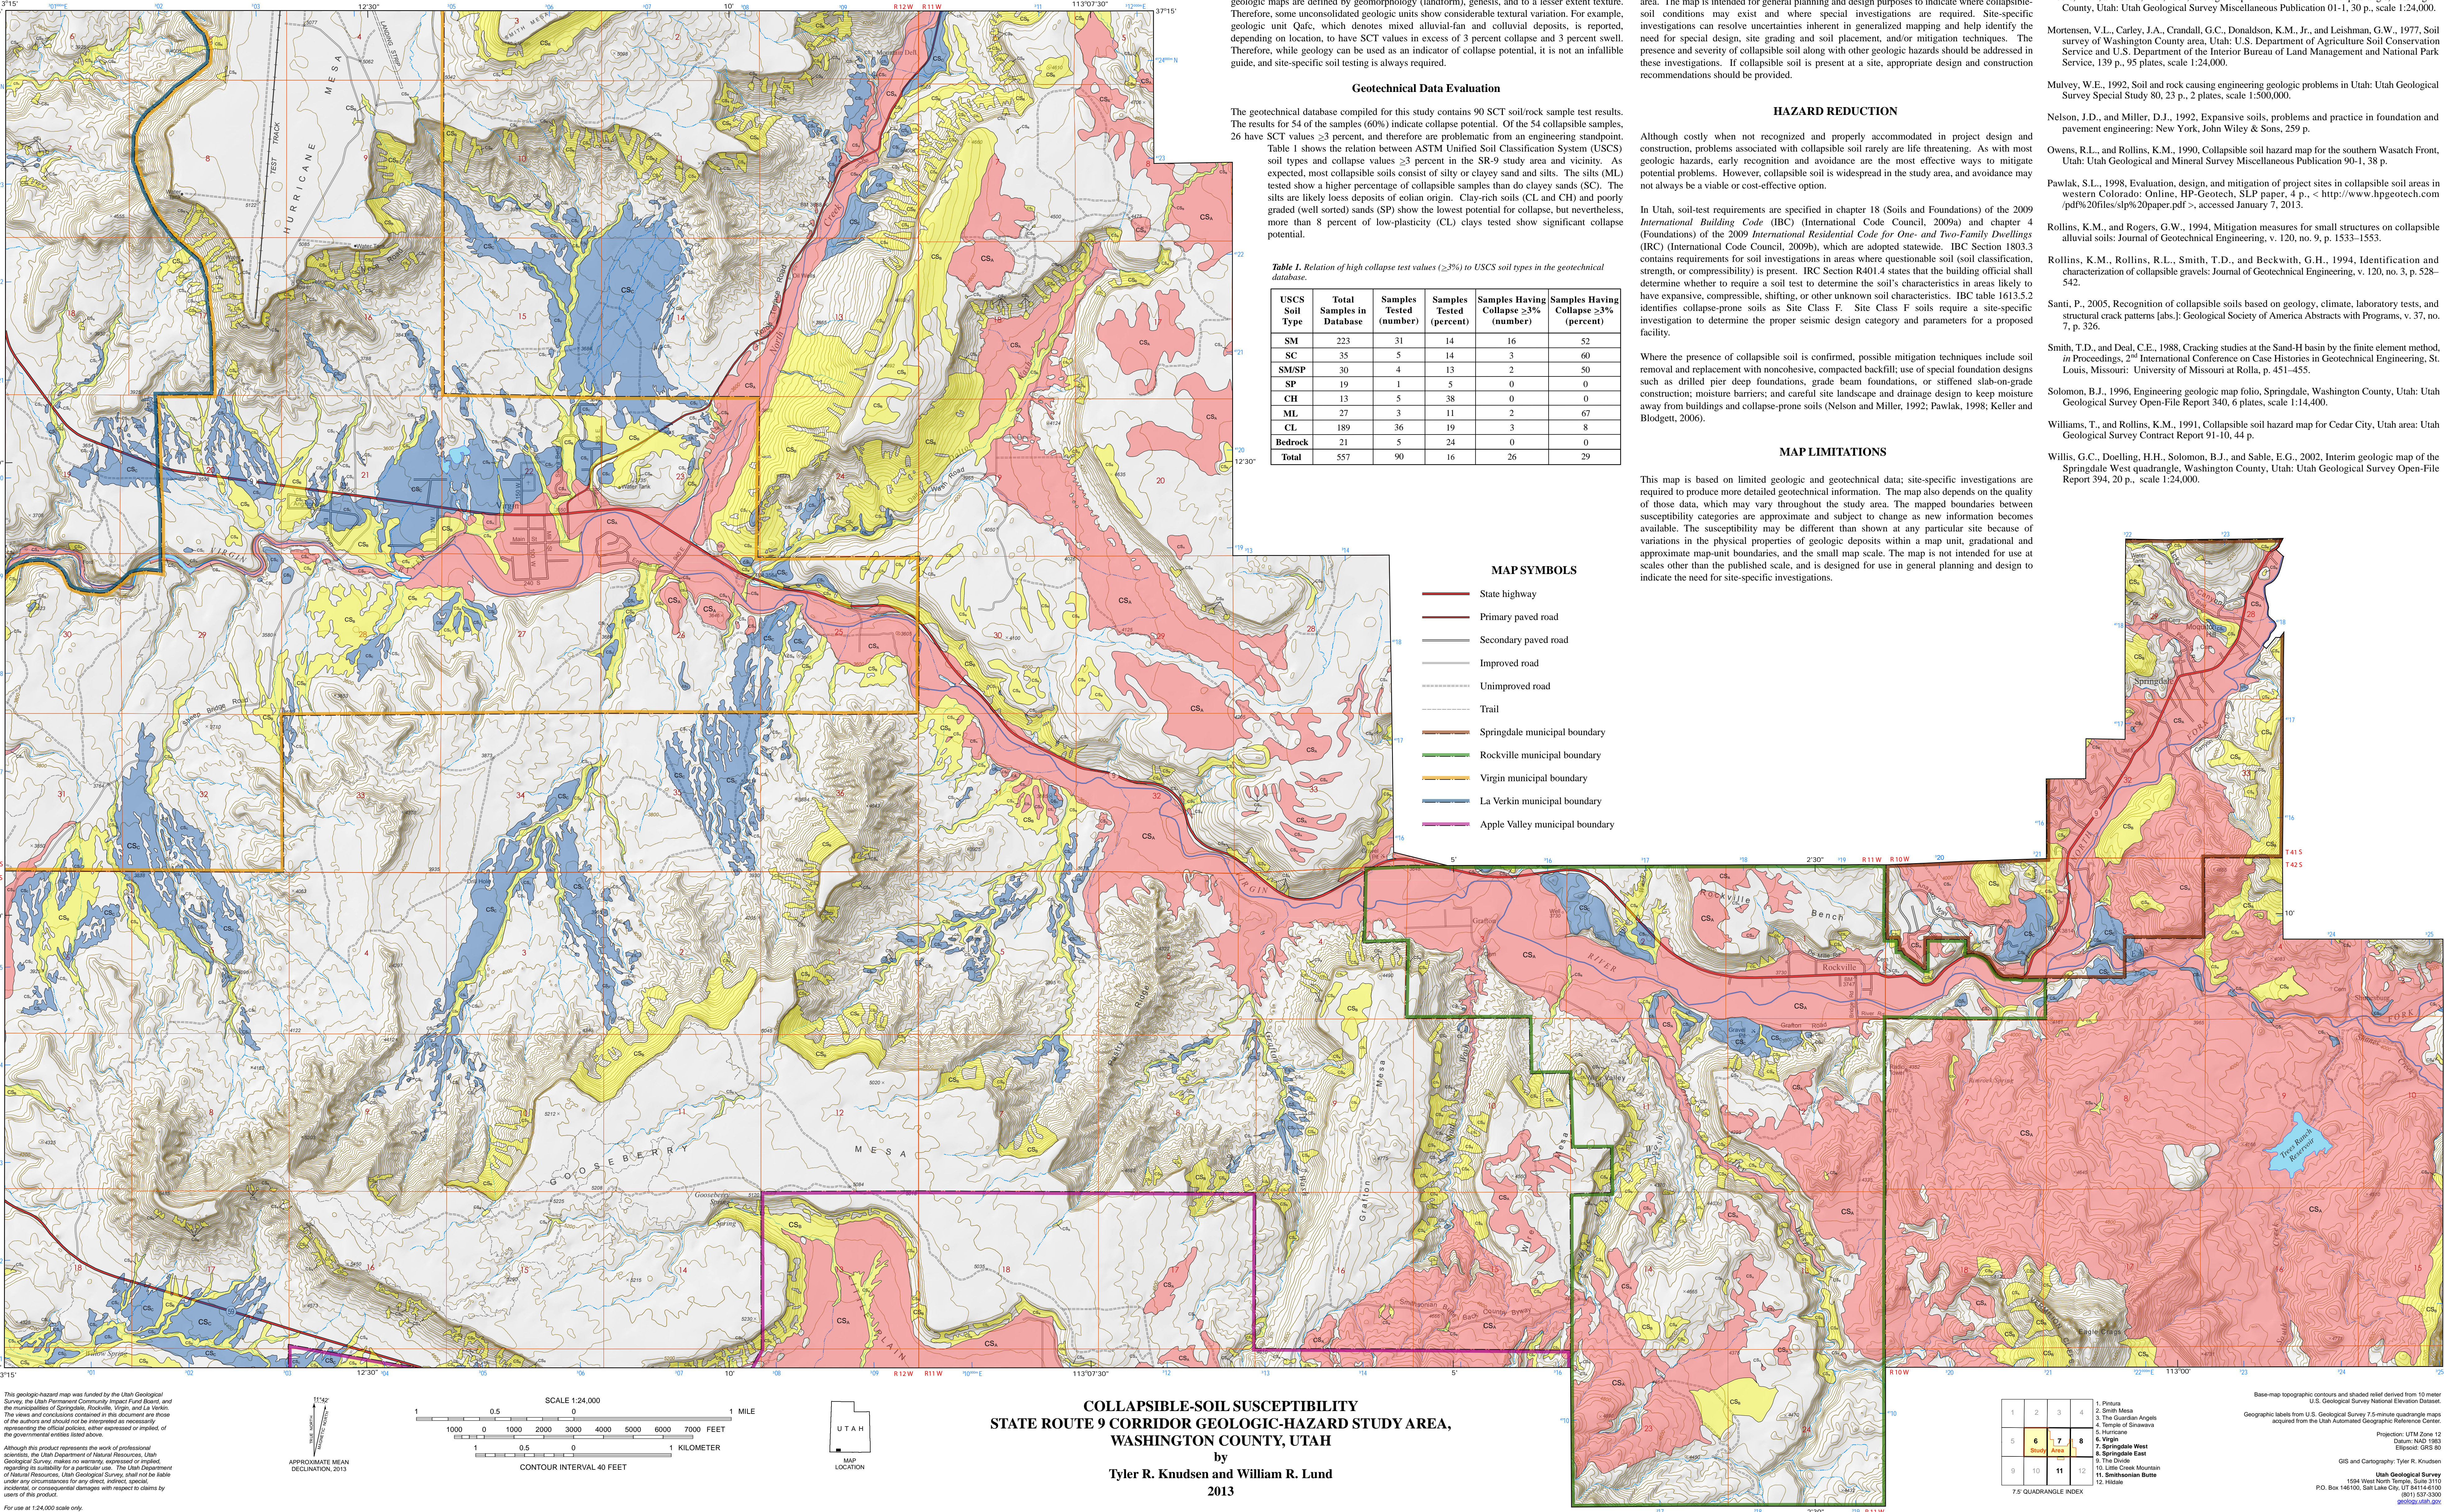
This map shows the location of known and suspected collapsible-soil conditions in the SR-9 study area. The map is intended for general planning and design purposes to indicate where collapsible-soil conditions may exist and where special investigations are required. Site-specific investigations can resolve uncertainties inherent in generalized mapping and help identify the need for special design, site grading and soil placement, and/or mitigation techniques. The presence and severity of collapsible soil along with other geologic hazards should be addressed in these investigations. If collapsible soil is present at a site, appropriate design and construction recommendations should be provided.

We grouped unconsolidated geologic units that may be prone to collapse into three susceptibility categories (table 2). The categories are based on available geotechnical data, and if the deposit genesis or texture is permissive of collapse. Due to the lack of geotechnical data over much of the study area, the classification system presented here employs a relative susceptibility ranking as opposed to a hazard-severity ranking. The soils in all three categories could exhibit ≥ 3 percent collapse, and therefore be regarded as having significant collapse potential. The collapsible-soil susceptibility categories are described in the Explanation section.

This map is based on limited geologic and geotechnical data; site-specific investigations are required to produce more detailed geotechnical information. The map also depends on the quality of those data, which may vary throughout the study area. The mapped boundaries between susceptibility categories are approximate and subject to change as new information becomes available. The susceptibility may be different than shown at any particular site because of variations in the physical properties of geologic deposits within a map unit, gradational and approximate map-unit boundaries, and the small map scale. The map is not intended for use at scales other than the published scale, and is designed for use in general planning and design to indicate the need for site-specific investigations.
