INTRODUCTION

The "Bedford Stone" is a very successful building material. The Sanpete limestone has not proven to be as permanent as desired. The purpose of this monograph is to examine the reasons for the poor quality

The Deterioration Processes of Oolitic Limestone

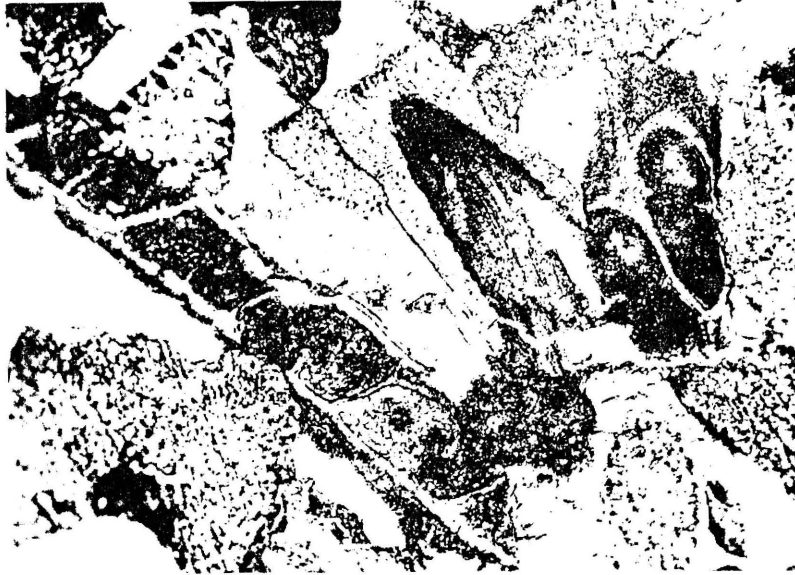
"In thin section the rock appears to be composed almost entirely of two generations of calcite. (See Figure 1.) The primary calcite is largely of organic origin and consists of the calcareous shells or skeletons of several forms of microscopic organisms. This primary calcite makes up 65 percent of the total volume of the rock as indicated by Delesse-Resiwal measurements with the integrating stage. The shells range in size from 0.3 mm. to 1.2 mm. in longest dimension. They are made of rather fine-grained calcite and are loosely packed together with no primary interstitial material between the shells. However, they are cemented together by rather large plates of secondary calcite which only partially fill the interstitial voids. Secondary calcite comprises 20 percent of the volume of the rock as indicated by integrating stage measurements. The grains are up to 1.0 mm. across. Open spaces not filled with secondary calcite account for 15 percent of the total volume. The void spaces probably are interconnected. The residue left after dissolving the calcium carbonate consists of quartz grains from 0.01 mm. to 0.1 mm. across. Most grains less than 0.05 mm. in size are anhedral doubly-terminated crystals. The residue also contains a small amount of light colored, finely divided, isotropic material which could not be identified."

Figure 1. Bedford, Indiana oolitic limestone. X70.

Photomicrographs of the Bedford limestone and Sanpete limestone are given in Figures 1 and 2, respectively. These figures support the petrographic description given above.

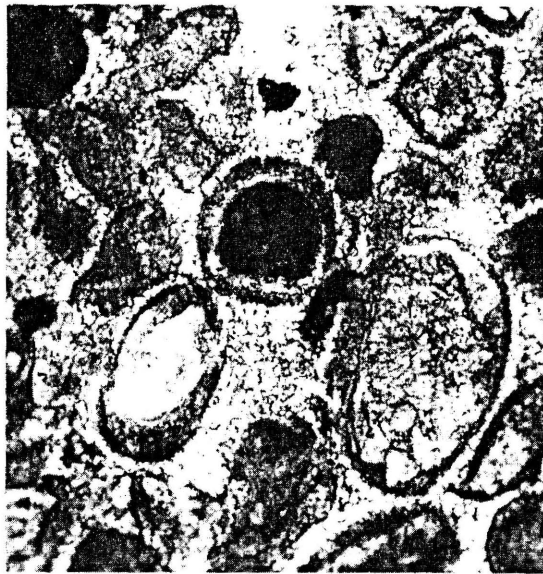
"Microscopic examination of this rock in thin section, Figure 2, reveals that it is composed of concentric bonded oölitites rather loosely cemented together. The oölitites are dense and very fine-grained with successive shells of varying color. They are predominantly calcite but with mixtures of a light yellowish mineral tentatively identified as a

clay mineral in some of the shells. A few of the calcites have detrital quartz grains as nuclei. The oölites range in diameter from 0.1 mm. to 1.0 mm. with the most common size about 0.5 mm. The interstitial material cementing the oölites together is a clear calcite with an average grain size of 0.01 mm. and an unidentified mineral occurring as clear, nearly square plates of smaller size.

"The cementing materials are very poorly consolidated, showing considerable void space. The porosity of the stone is about 23 percent. Considerable residue is left when the calcite is dissolved in dilute hydrochloric acid. This consists of the yellow clay mineral and the unidentified mineral occurring as noted above and as irregular microcrystalline aggregates. Also present are a few grains of quartz and an occasional diatom."

Figure 2. Sanpete, Utah oolitic limestone. X70.

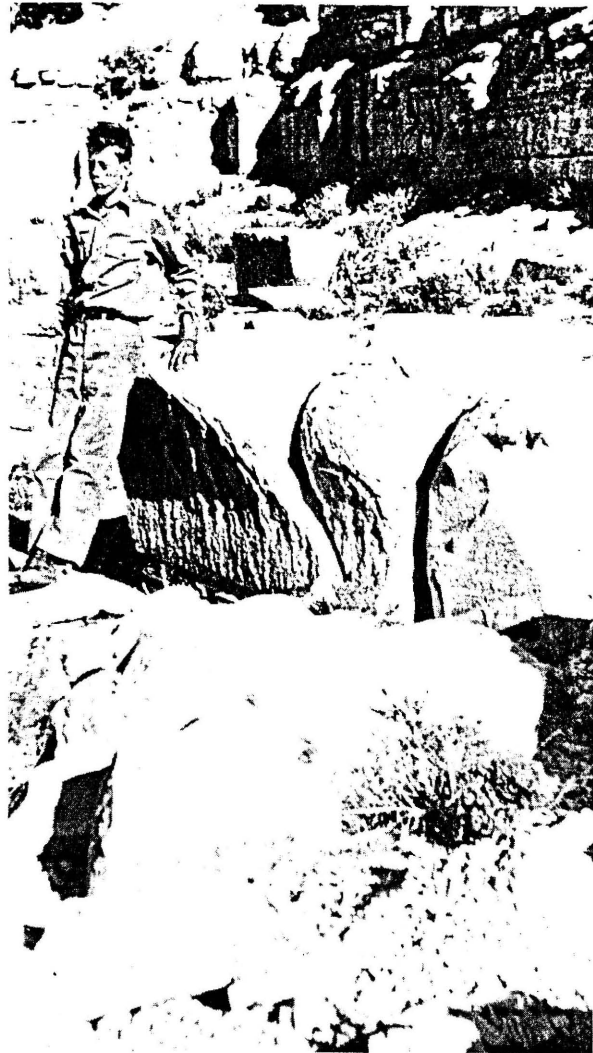
The effect of freeze-thaw cycles is well illustrated in Figure 3 which was taken at one of the quarries near Ephraim, Utah. Some comparatively recently quarried stones are shown. These blocks originally had sharp corners since they were broken out of the bed in near rectangular blocks. The camera is looking from the southwest toward the northeast. The southwest oriented corners of these stones are all rounded. This is caused by a night and day freeze-thaw cycling during the wet wintertime. This cycling process has a heaving action which spalls-off the sharp corners and leaves the stone rounded. The corners of these blocks facing away from the sun are still sharp and show little of this sort of deterioration.

Figure 3. The effect of freeze-thaw cycling on Sanpete oolitic limestone. (Note the rounded corners on the sunny side of the quarried blocks.)

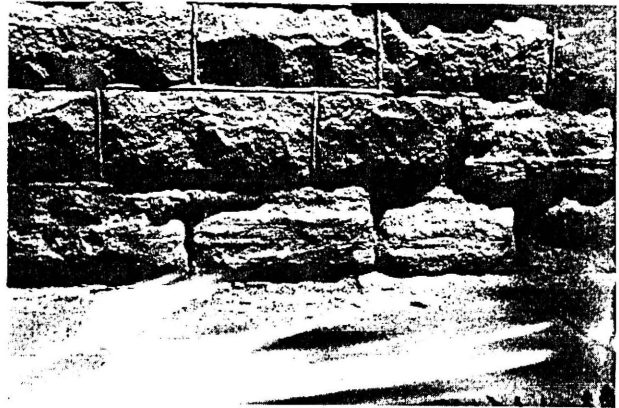
Deterioration by ground water attack is shown in Figure 4. Ground water always contains dissolved salts. Solutions of these diffuse into the porous stone, the water evaporates leaving the salts which act by various processes to weaken the bonding between the oölite grains, then the material crumbles away. This kind of attack is very noticeable where the Sanpete limestone is used for grave markers in cemeteries, and wherever the stone is used for ground level courses in buildings.

Figure 4. Lower courses of Sanpete stone, next to the ground, show severe deterioration while upper courses of stone are still well preserved.

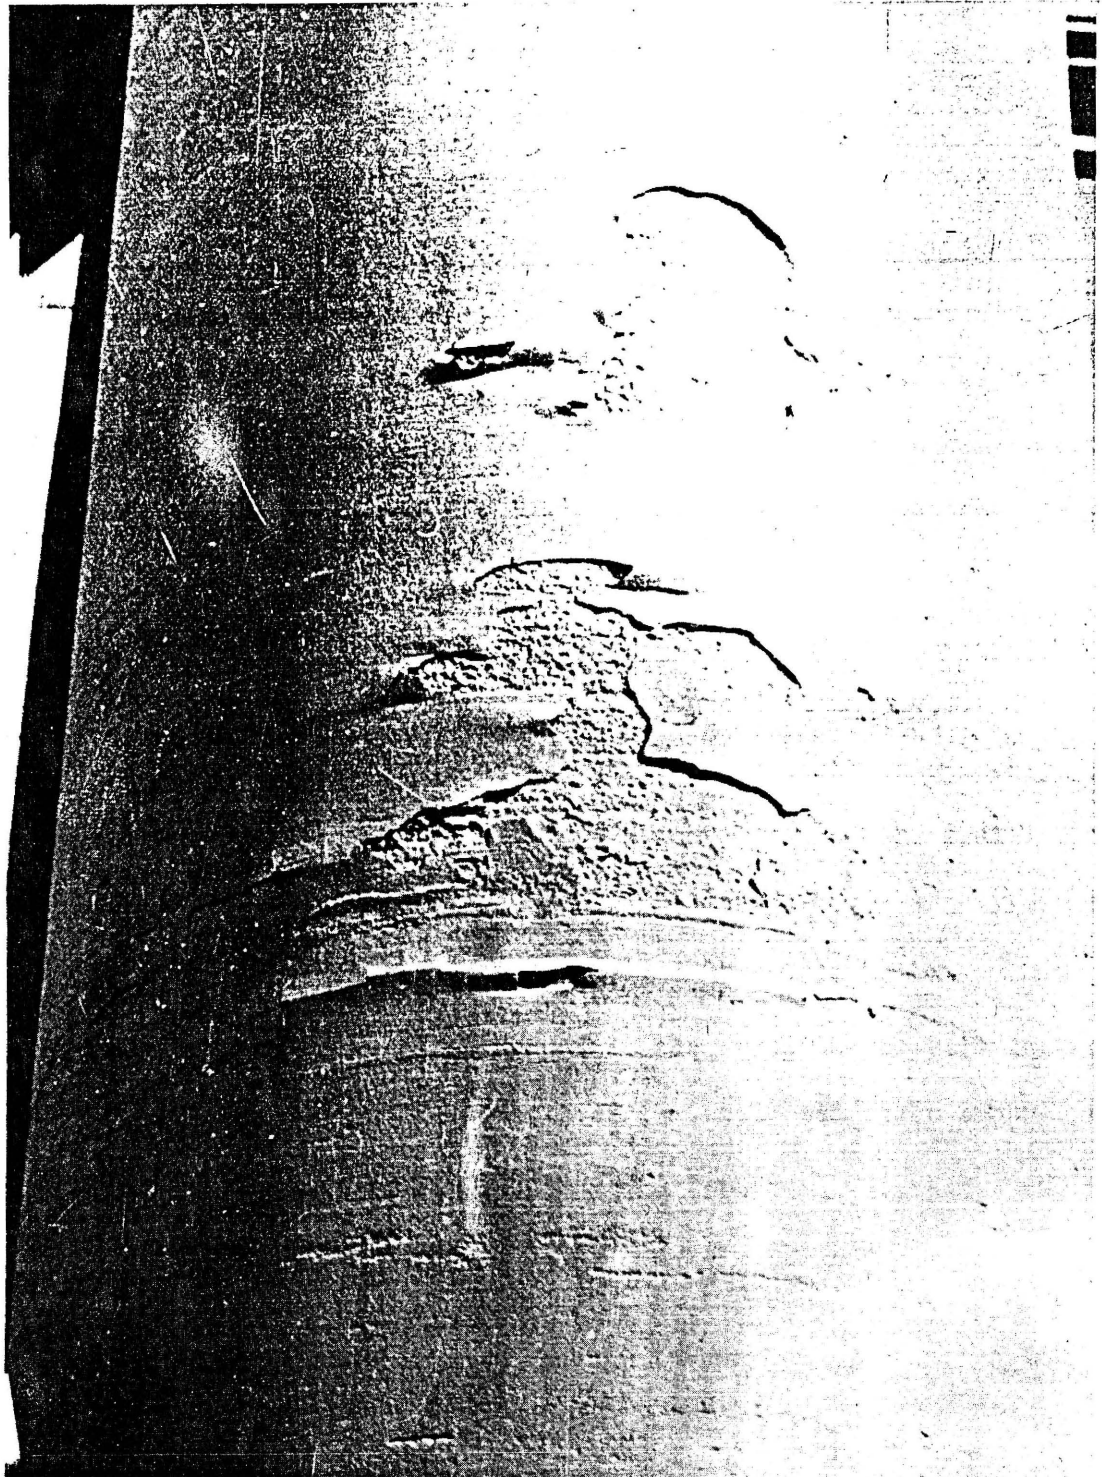
The effect of industrial gases in the deterioration of the Sanpete limestone is dramatically shown in Figure 5. This unsightly type of deterioration is shown wherever the stone is used in an industrial or urban atmosphere. The intricately carved facade of the Hearst Castle at San Simeon, California, which is made from Sanpete limestone, shows none of this kind of deterioration. The castle is on a hilltop overlooking the ocean and far away from a large population center so that the air contains none of the acid-type contaminants associated with large centers of population. Furthermore, the castle is located in an area where freezing is a rare event so that in this location the stones are not subject to freeze-thaw deterioration.

Figure 5. Large circular column of Sanpete oolitic limestone on west facade of the Park Building, University of Utah, showing the deterioration due to very small quantities of sulfur dioxide in the atmosphere.

arise from oxidation processes such as: (a) the combustion of gasoline; (b) the burning of solid, liquid and gaseous fuels, most of which contain at least a minimal amount of sulfur or sulfur compounds. The combustion of these materials leads to the production of small quantities of gaseous sulfur dioxide, SO_2 , which is a general atmospheric pollutant in all industrial areas and also in urban areas located in the colder climates where fuels are used for space heating. A long time analysis of the concentrations of SO_2 in the Salt Lake City atmosphere has been made by Dr. M. D. Thomas of the Department of Agricultural Research, American Smelting and Refining Company. According to a private communication from Dr. Thomas, these measurements show a continuous variation of 0.01 to 0.50 parts per million of SO_2 in the Salt Lake City area atmosphere. This may seem small; nevertheless, it is very significant in the effects which it produced on an alkaline rock such as the Sanpete stone. The spalling of the Sanpete limestone shown in Figure 5 is believed to be largely due to the trace amounts of SO_2 in the ambient atmosphere.

The conclusion to be reached is that the type of deterioration of Sanpete limestone illustrated in Figure 5 is due principally to the formation of gypsum from the limestone in interaction with atmospheric sulfur dioxide, oxygen, and water vapor.

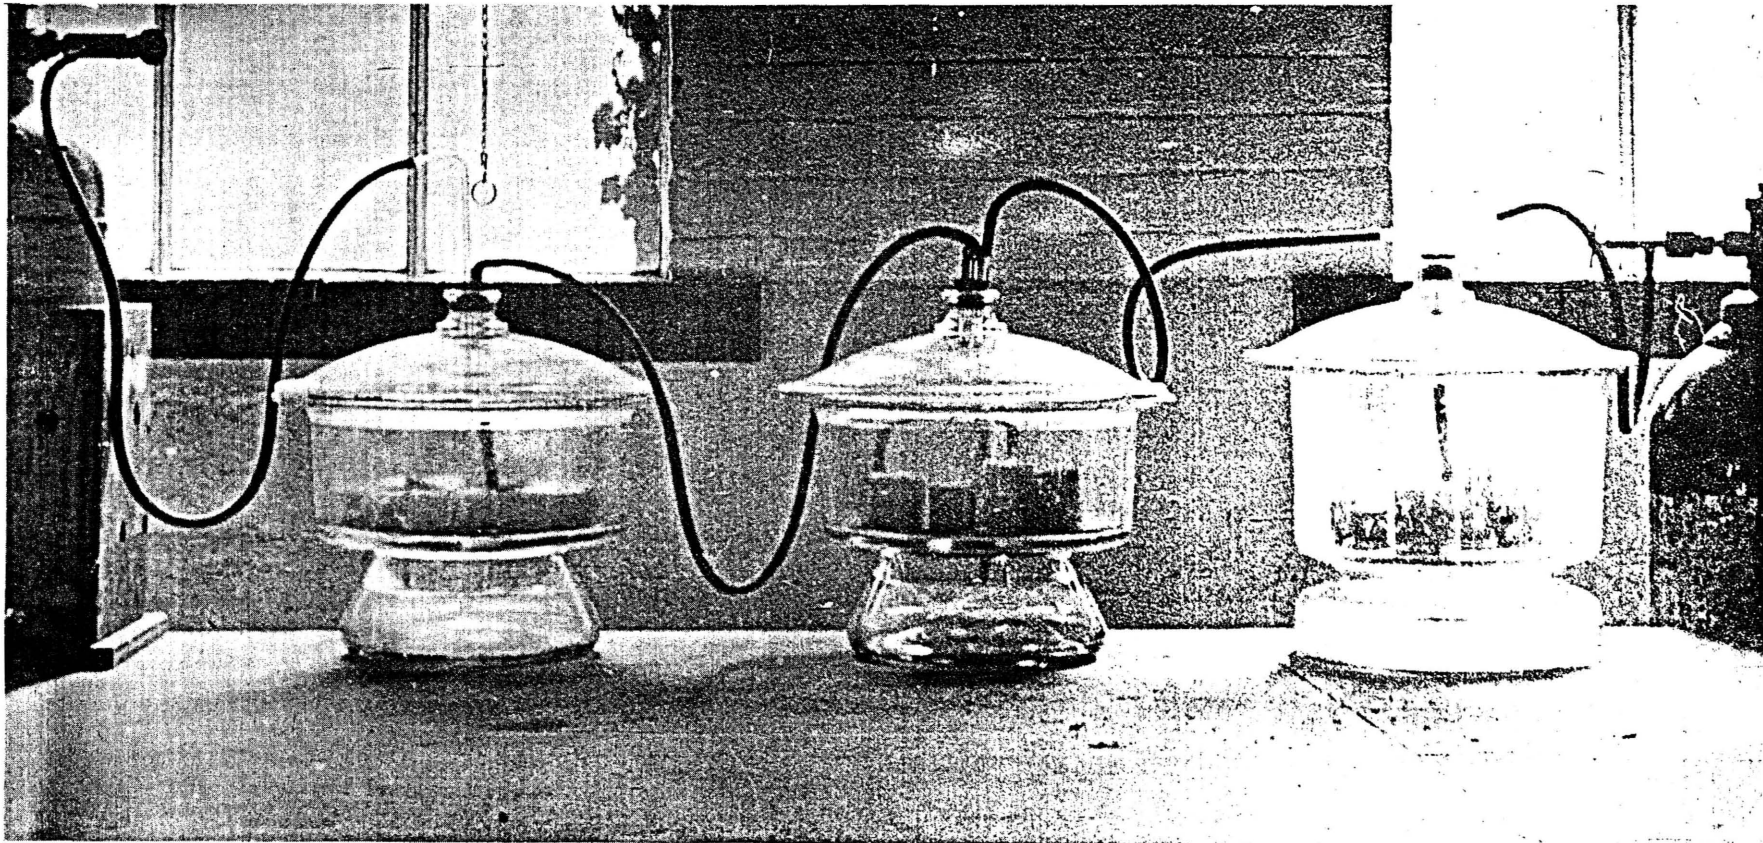
treated samples, were placed on racks in large closed glass dessicator jars above water, Figure 6. Sulfur dioxide from a tank was bled into and out of the chamber at a very slow rate. The atmosphere surrounding the stone samples, therefore, consisted of sulfur dioxide and saturated water vapor at atmospheric pressure. In some cases oxygen was also introduced into the chamber so that oxidation of the SO_2 might take place. The samples were maintained at room temperature throughout the experiment. The course of disintegration of the samples with time could readily be observed through the glass walls of the jar.

Figure 6. Limestone samples in closed dessicators being treated with SO_2 gas saturated with water vapor.

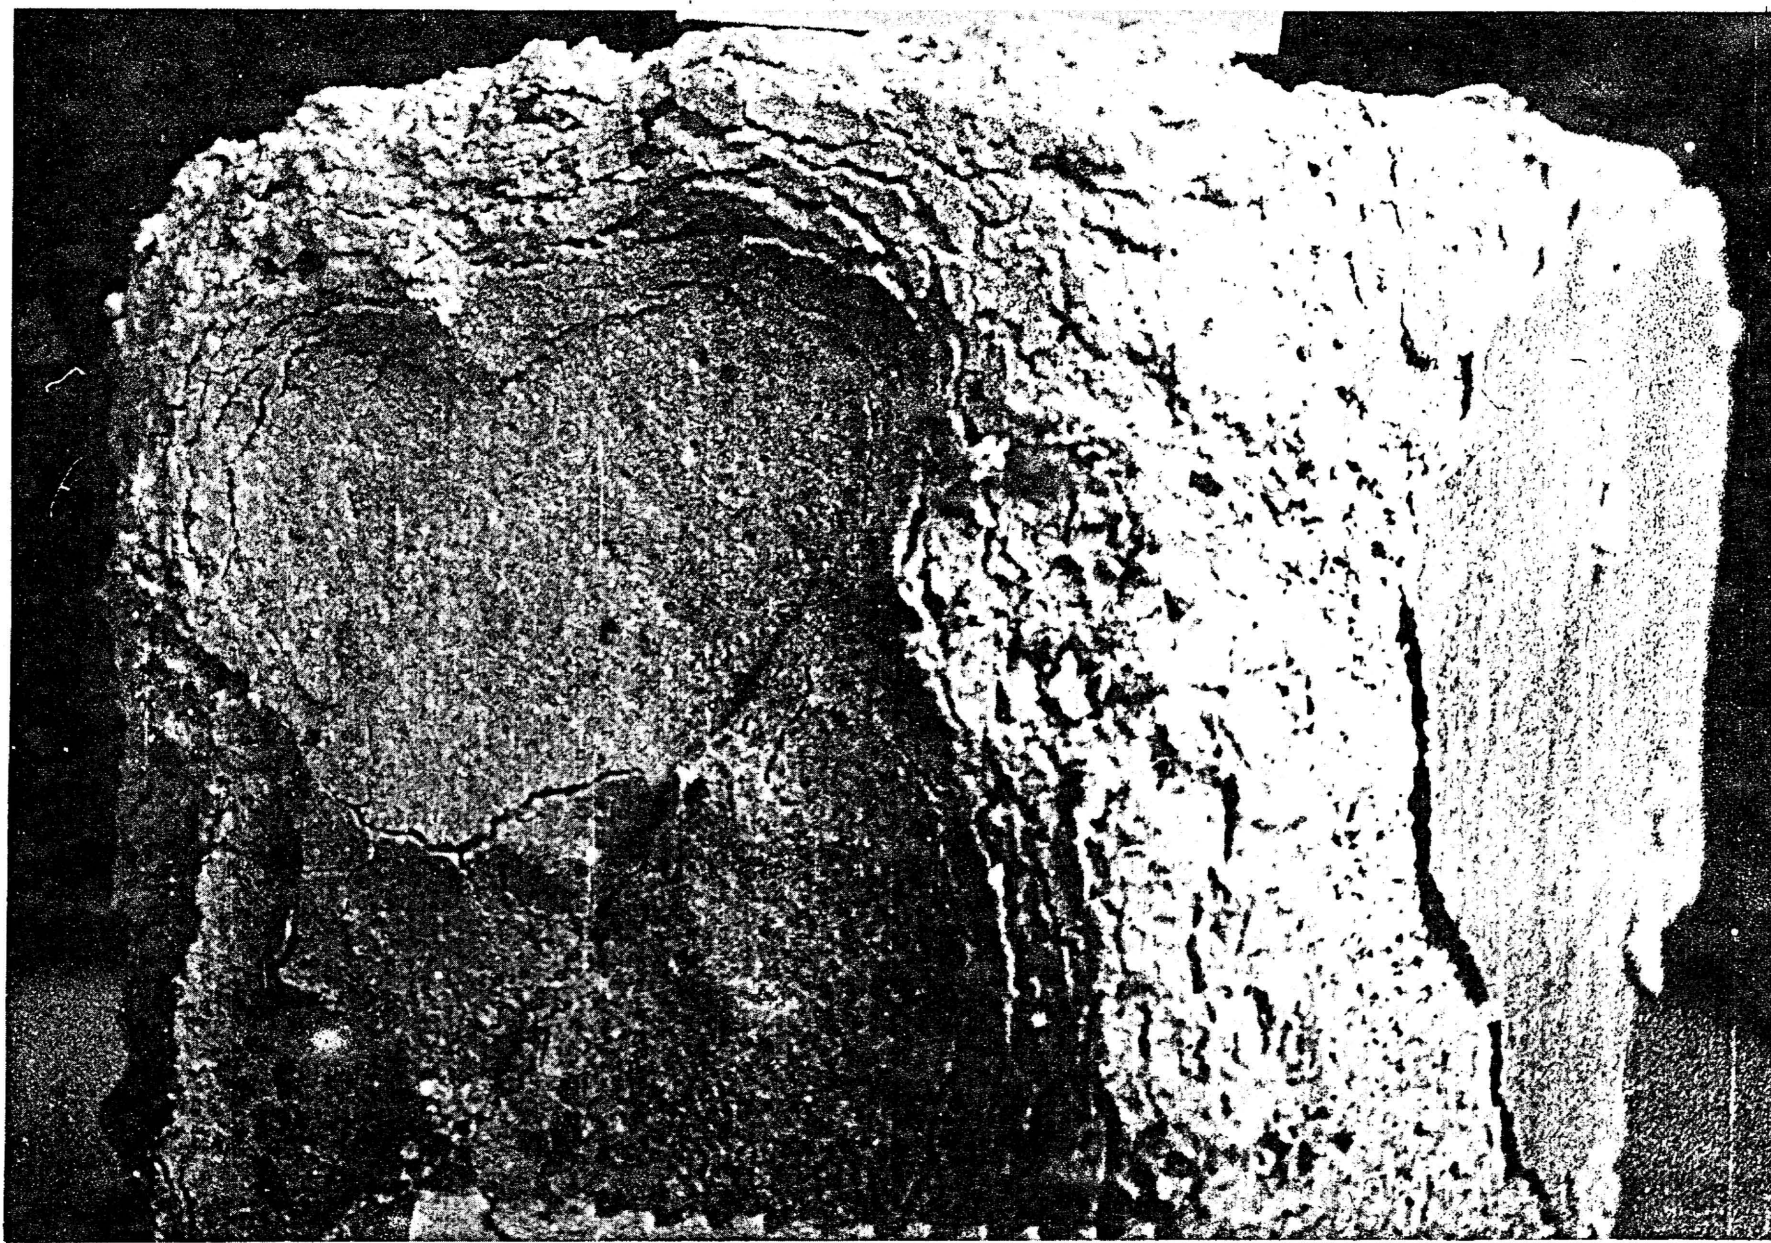
A parallel investigation of Sanpete limestone and Bedford limestone was made in this study. One can select the Sanpete stone out of the quarry for quality, the highest quality material being the most dense. Figure 7 shows a block of intermediate quality Sanpete stone after 21 days exposure to the moist SO₂ atmosphere. Figure 8 shows the best Sanpete stone after 36 days exposure to the same atmosphere. The exfoliation is much less in the higher quality stone than that of lesser quality, but in both cases the deterioration extends very deeply into the stone. In contrast is the deterioration of the Bedford stone, which is shown in Figures 9 and 10. Figure 9 shows the surface and corners of the block after 42 days exposure to the moist SO₂ atmosphere. No exfoliation is evident. Figure 10 shows a freshly sawed cross section through the same block pictured in Figure 9. The moist SO₂ atmosphere has attacked the surface of the stone, but the altered layer is still firmly adhered to the mother stone and the effect on the stone is only superficial; a sort of patina layer has been formed which is intact and the stone is still fully serviceable as a building material.

Figure 7. Untreated sample of intermediate quality Sanpete stone after 21 days in moist SO₂ atmosphere.

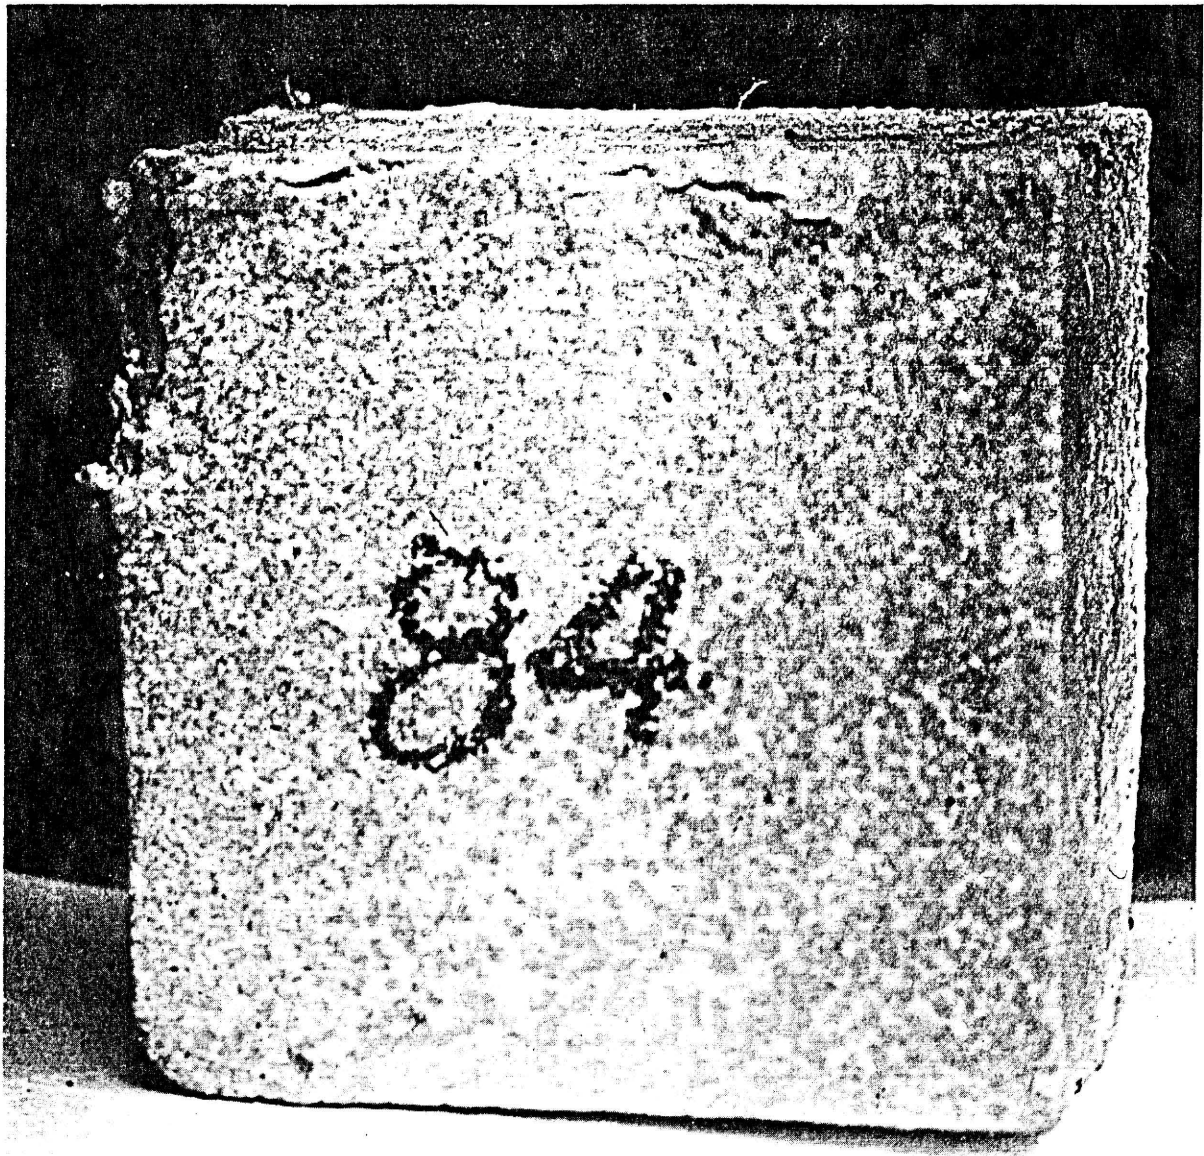
Figure 8. Untreated sample of best quality Sanpete stone after 36 days of treatment in the moist SO₂ atmosphere.

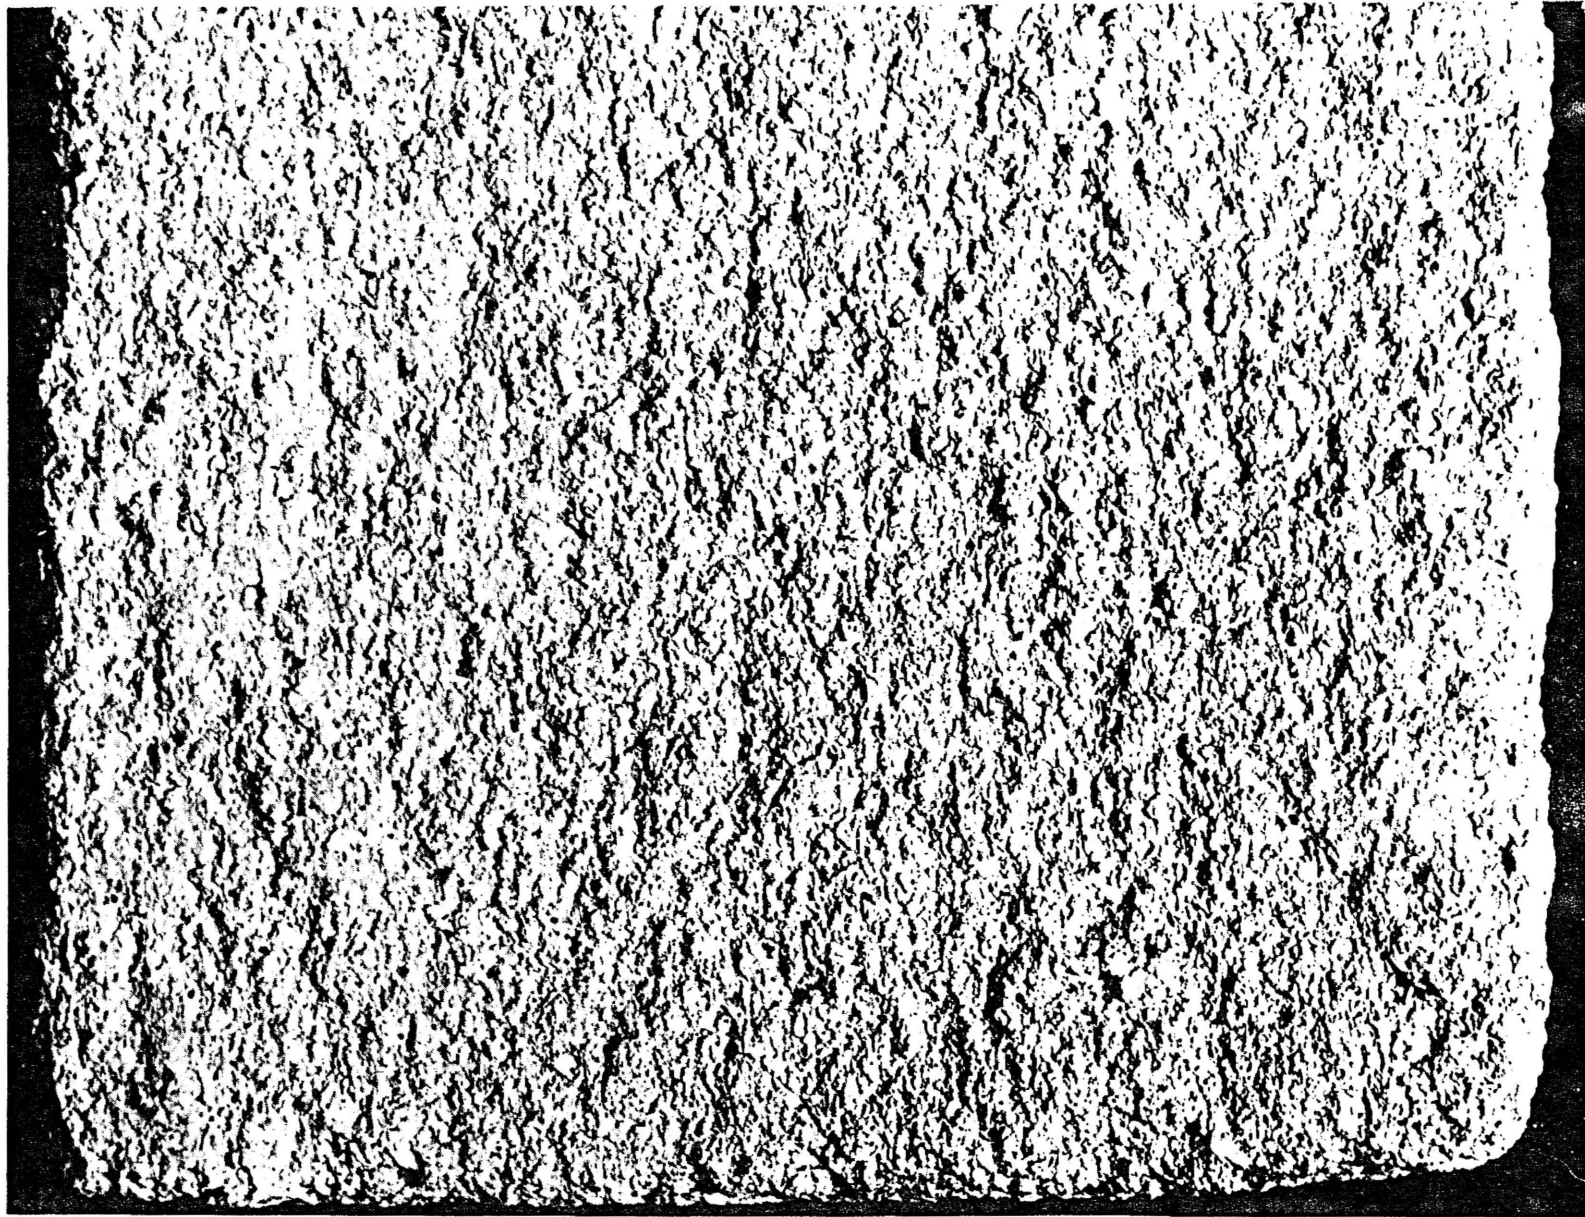
Figure 9. Indiana limestone after 42 days exposure to moist SO₂ atmosphere.

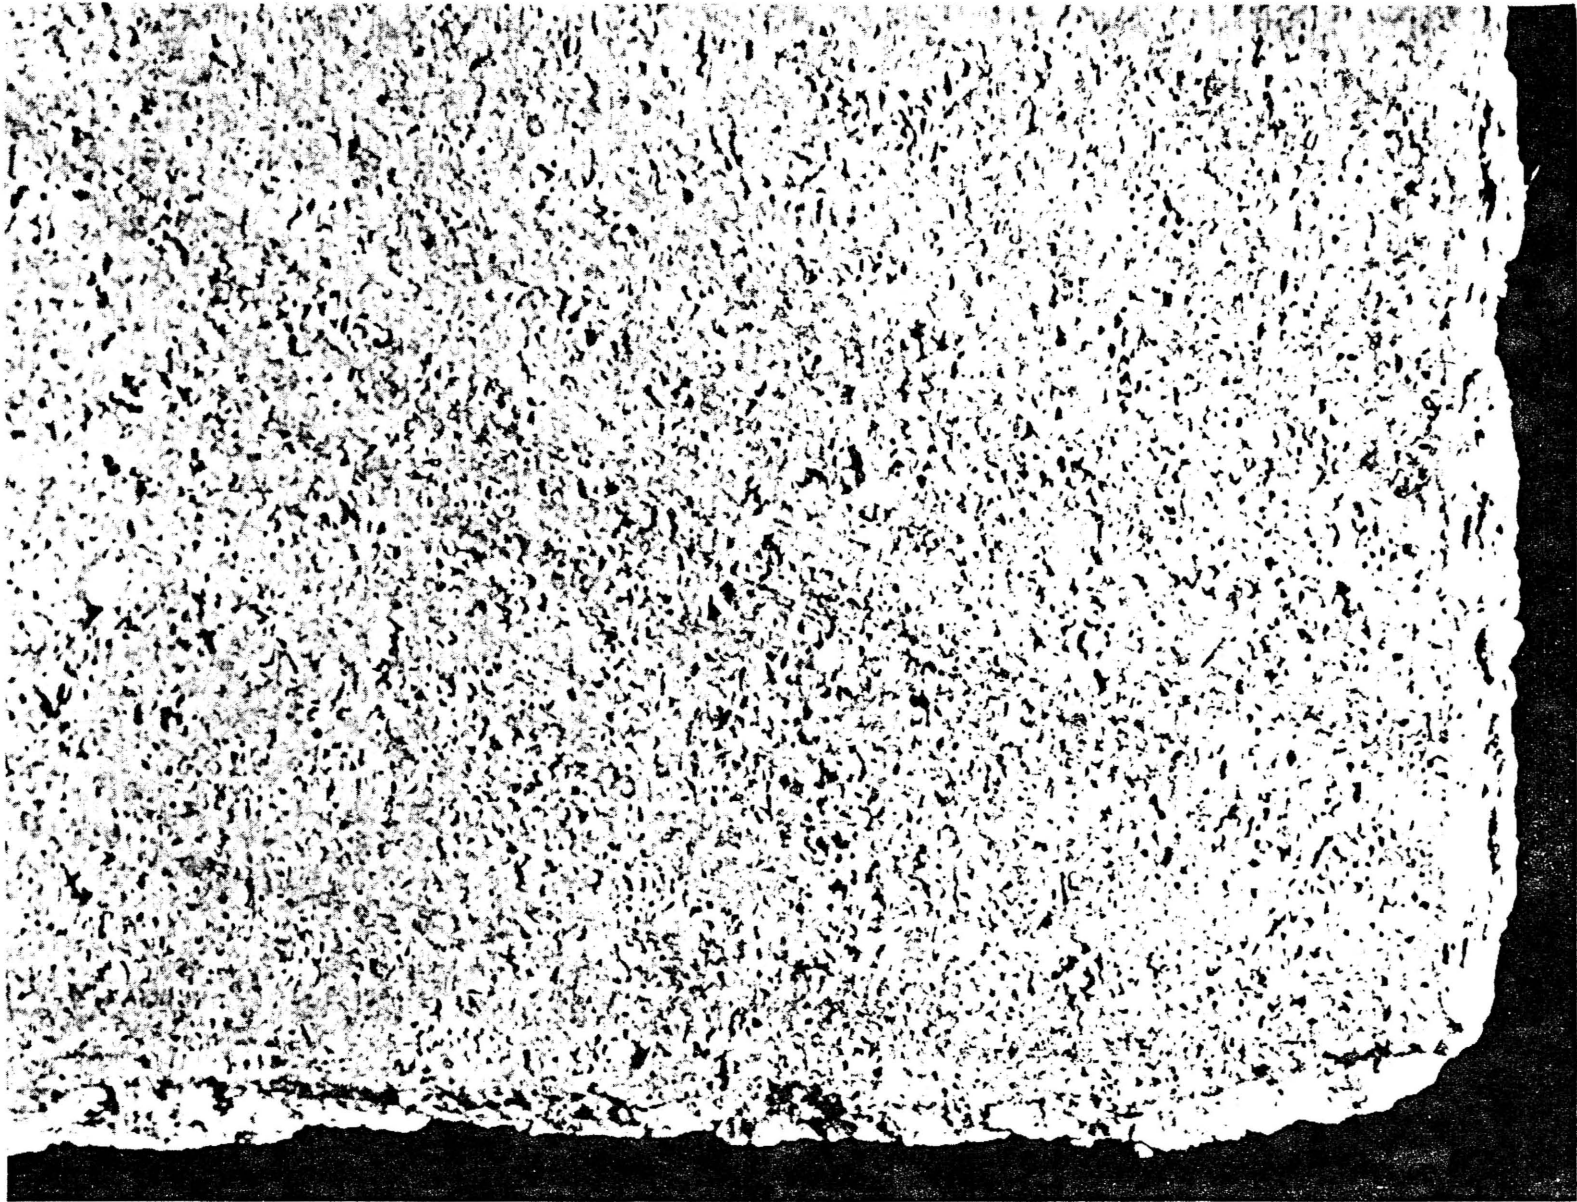
Figure 10. Same sample as Figure 9 showing a cross section cut which reveals the depth of reaction with SO_2 and water vapor.

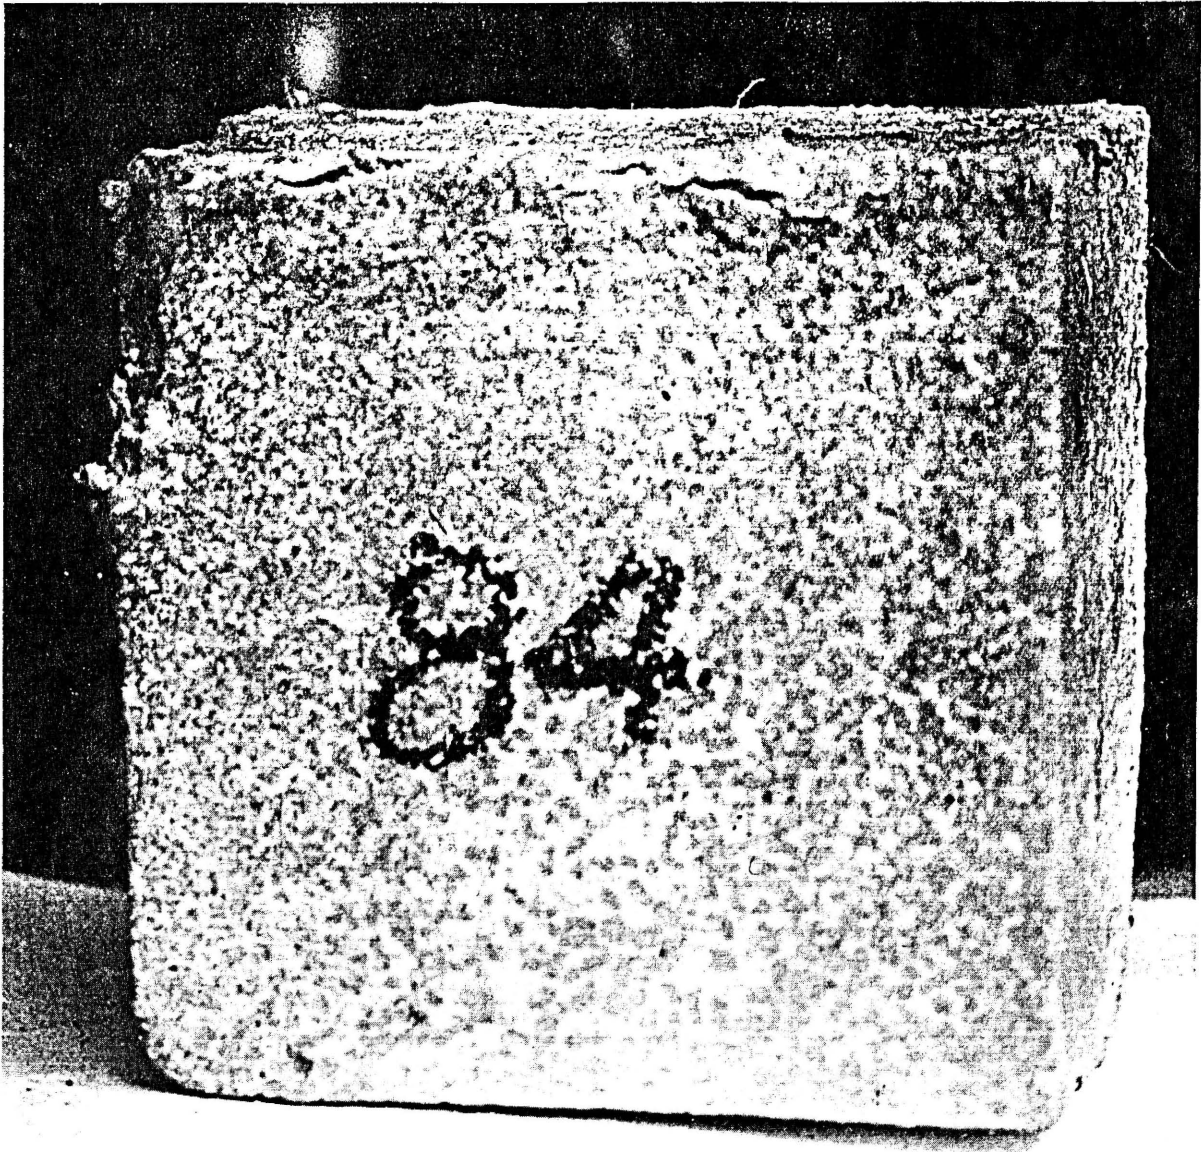
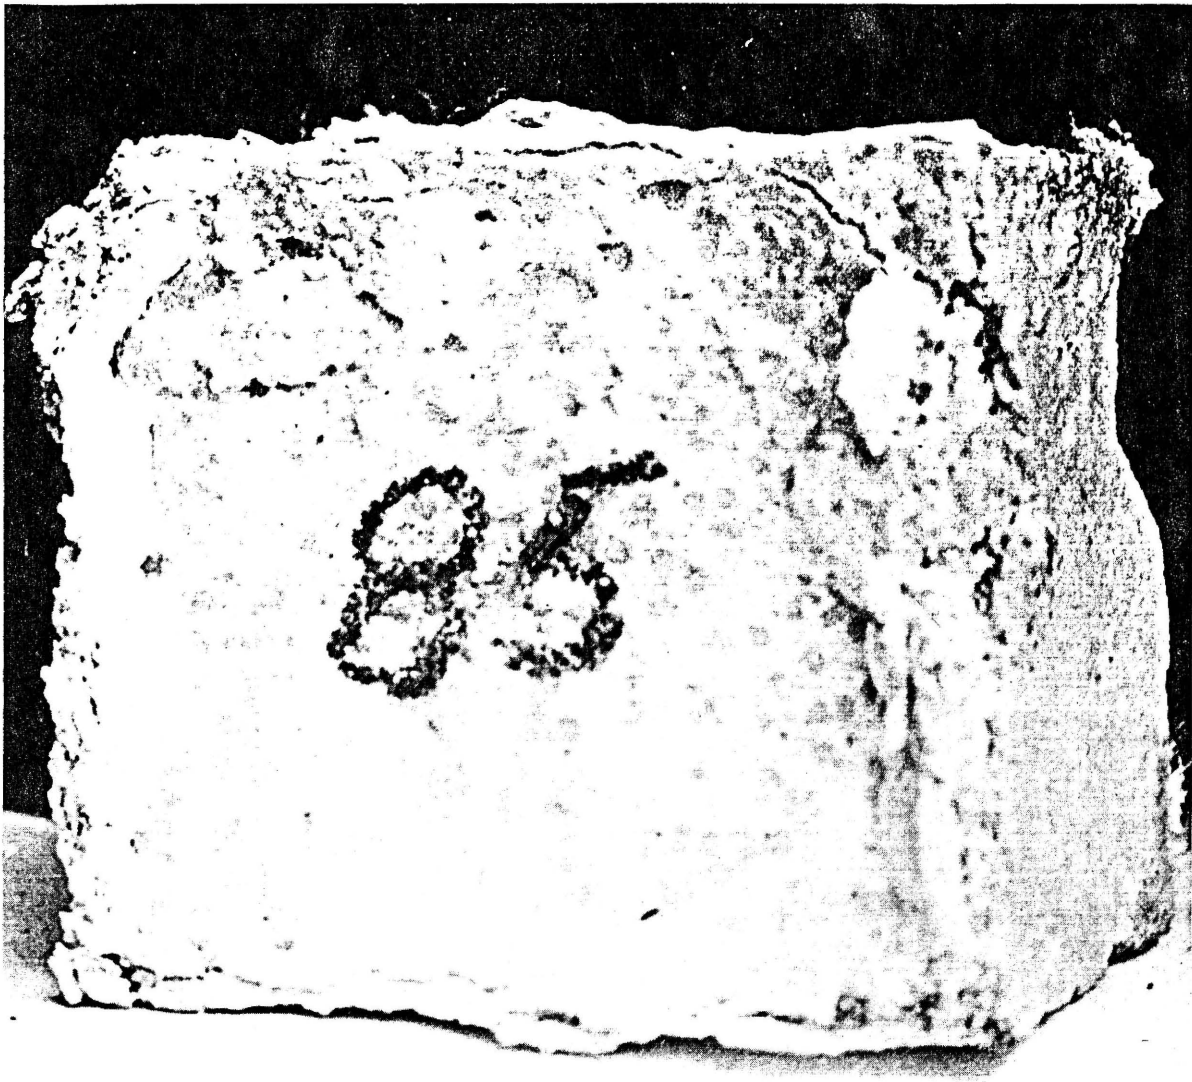
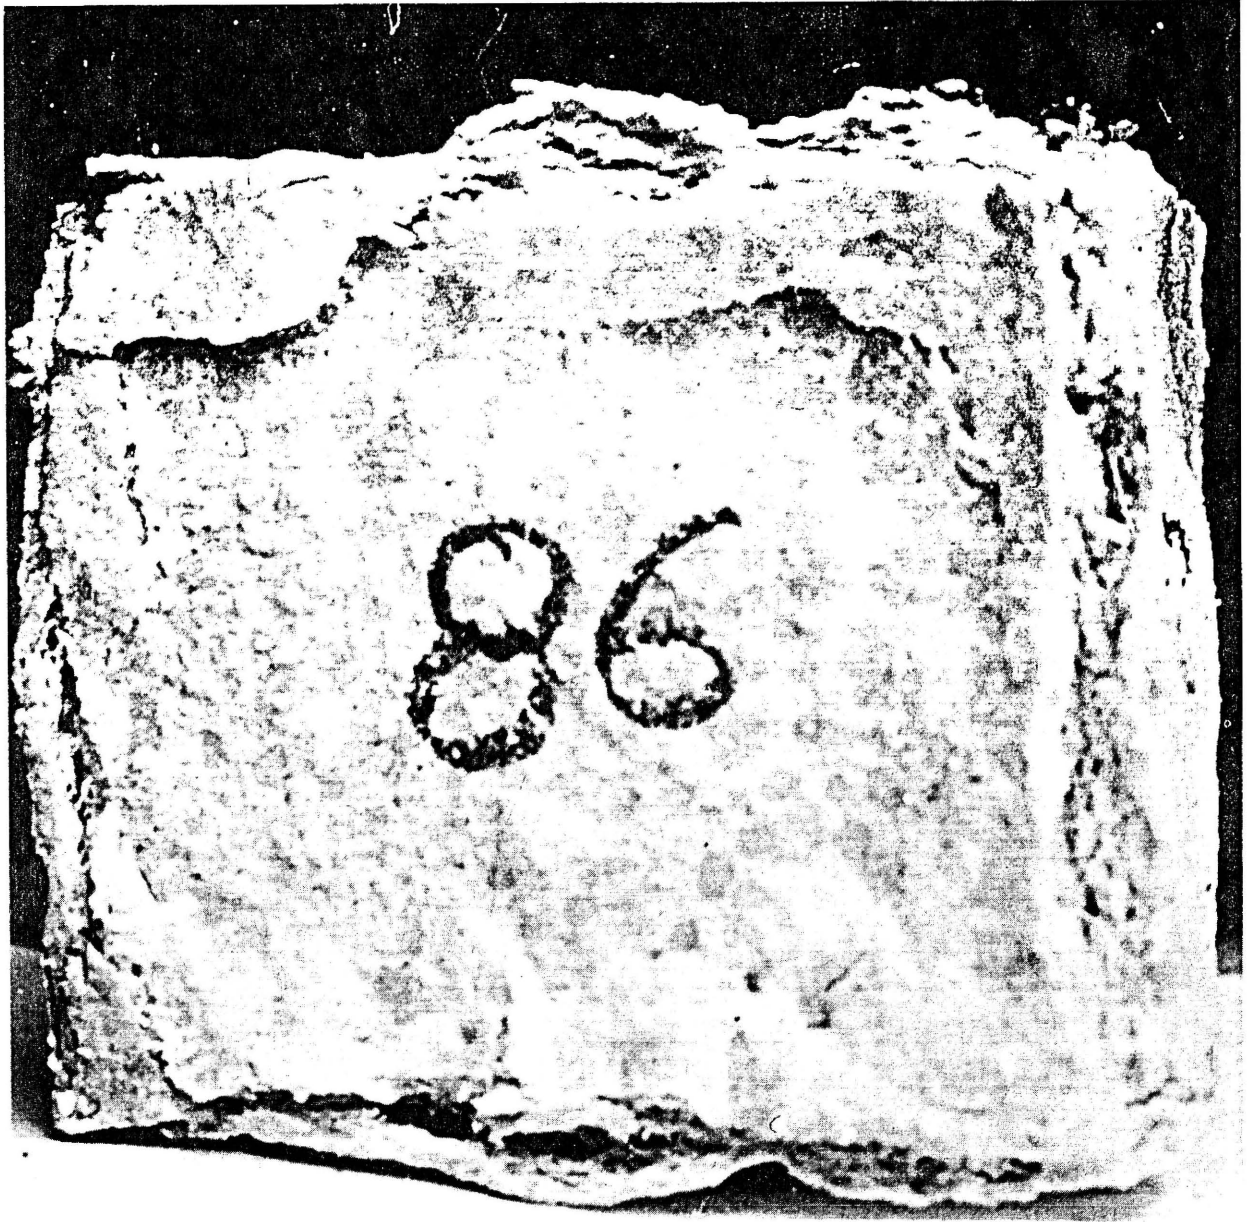
The results of these tests are pictorially summarized in Figures 11 (a, b, and c) which show one untreated sample and two hydrated silica treatment samples of Sanpete stone after 36 days in our accelerated aging test. It is evident the treated samples do not possess improved stability to our accelerated aging test, and presumably would not in actual use as a building material.

Figure 11(a). Sample #1, untreated Sanpete stone after 36 days in moist SO₂ atmosphere.

Figure 11(b). Sample #2, Sanpete stone treated with two coats of #1 hydrated silica solution after 36 days in moist SO₂ atmosphere.

Figure 11(c). Sample #3, Sanpete stone treated with two coats of #2 hydrated silica solution after 36 days exposure in moist SO₂ atmosphere.
