RECONNAISSANCE OF LANDSLIDES AND PRELIMINARY LANDSLIDE HAZARD ASSESSMENT ALONG A PORTION OF BROWNS PARK ROAD, DAGGETT COUNTY, UTAH

by Gregg Beukelman and Ben Erickson

REPORT OF INVESTIGATION 271
UTAH GEOLOGICAL SURVEY
a division of
UTAH DEPARTMENT OF NATURAL RESOURCES
2012

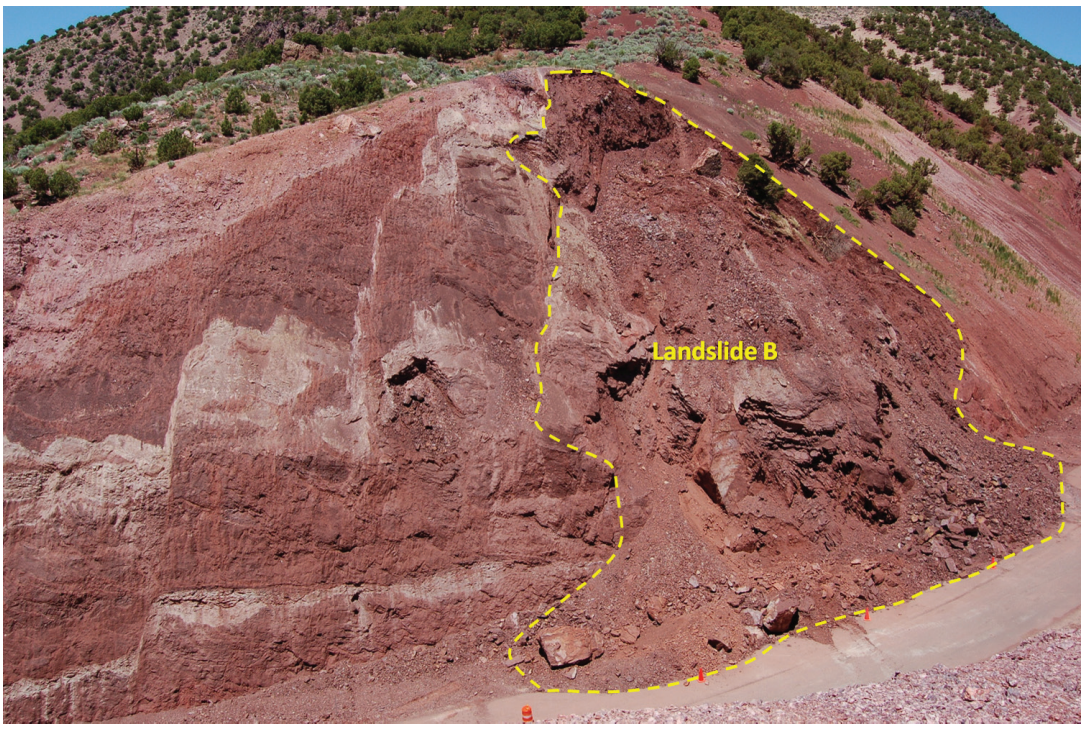
Figure 4. *Western cut slope of roadway through cut showing Landslide B. Browns Park Road with one lane blocked in the foreground. Bedrock is Upper Jesse Ewing Canyon Formation shale and silty sandstone. Numerous steeply dipping normal faults are marked by offset of light-colored beds in left part of photo. Photo taken on June 21, 2011.*

Landslide B is a translational rockslide that occurred adjacent to, and southwest of, Landslide A. This slide extends from the roadway to the top of the road cut slope; it is about 150 feet wide at the road elevation, and 50 feet wide at the crest of the cut slope (figures 4 and 5). During our reconnaissance, debris from this landslide blocked the southbound lane of Browns Park Road, limiting traffic to one lane. James Olsen, Daggett County Road Department, stated that landslide movement began in 2010, became much more significant in spring of 2011, and finally resulted in failure of nearly the entire height of the slope during the early part of the first week of June 2011 (figures 3, 4, and 6). Rockslide materials consist of dark red-brown silty sandstone and shale with interbedded silicified conglomerate. Based on road-cut exposures south of the rockslide, abundant near-vertical faults cut these materials (figure 4) resulting in intensely fractured bedrock that weathers to gravel-sized fragments. Daggett County Road Department personnel reported that fresh bedrock cobble-sized blocks that fall from the road cut typically weather to a soil-like material within a month. During the rockslide, a resistant sandstone bed approximately halfway up the slope slid downslope 5 to 15 feet while breaking into blocks more than 6 feet long on all sides with fresh, unweathered surfaces (figure 4).

Bedding planes are discontinuities or divisional planes that separate adjacent rock strata, and may have a large influence on the mechanical behavior of the rock mass. We measured bedding plane orientations (strike and dip) in nearby intact bedrock; strike ranges from N15°E to N30°W and dip ranges from 15°SE to 56°NE. The slope angles of the cut-slope surface that failed ranged from about 45° (1 Horizontal [H]:1 Vertical [V]) in the upper two-thirds of the slope to approximately 65° (1/2H:1V) in the lower one-third (figure 3). Relations between the surface-slope and bedding-plane angles result in bedding planes that locally dip out of the slope. Out-of-the-slope bedding dip conditions occur where bedding planes dip in the same general direction but at a shallower angle than the slope of the ground surface, and can promote translational landsliding due to low resisting forces. Observations of surface-of-rupture exposures suggest that landslide movement occurred along bedding planes.

Landslide B movement appears to have occurred on bedding planes that locally dip out of the slope. In addition, bedrock conditions, including intense fracturing and deep weathering, locally produce material that behaves more like soil or very weak rock than intact bedrock and is unstable on steep slopes. Possible methods of stabilizing this rockslide include reducing the road cut slope angle or using mechanical stabilization. Mitigation design should include an analysis of materials comprising the slope and their strength, discontinuity, and weathering parameters.

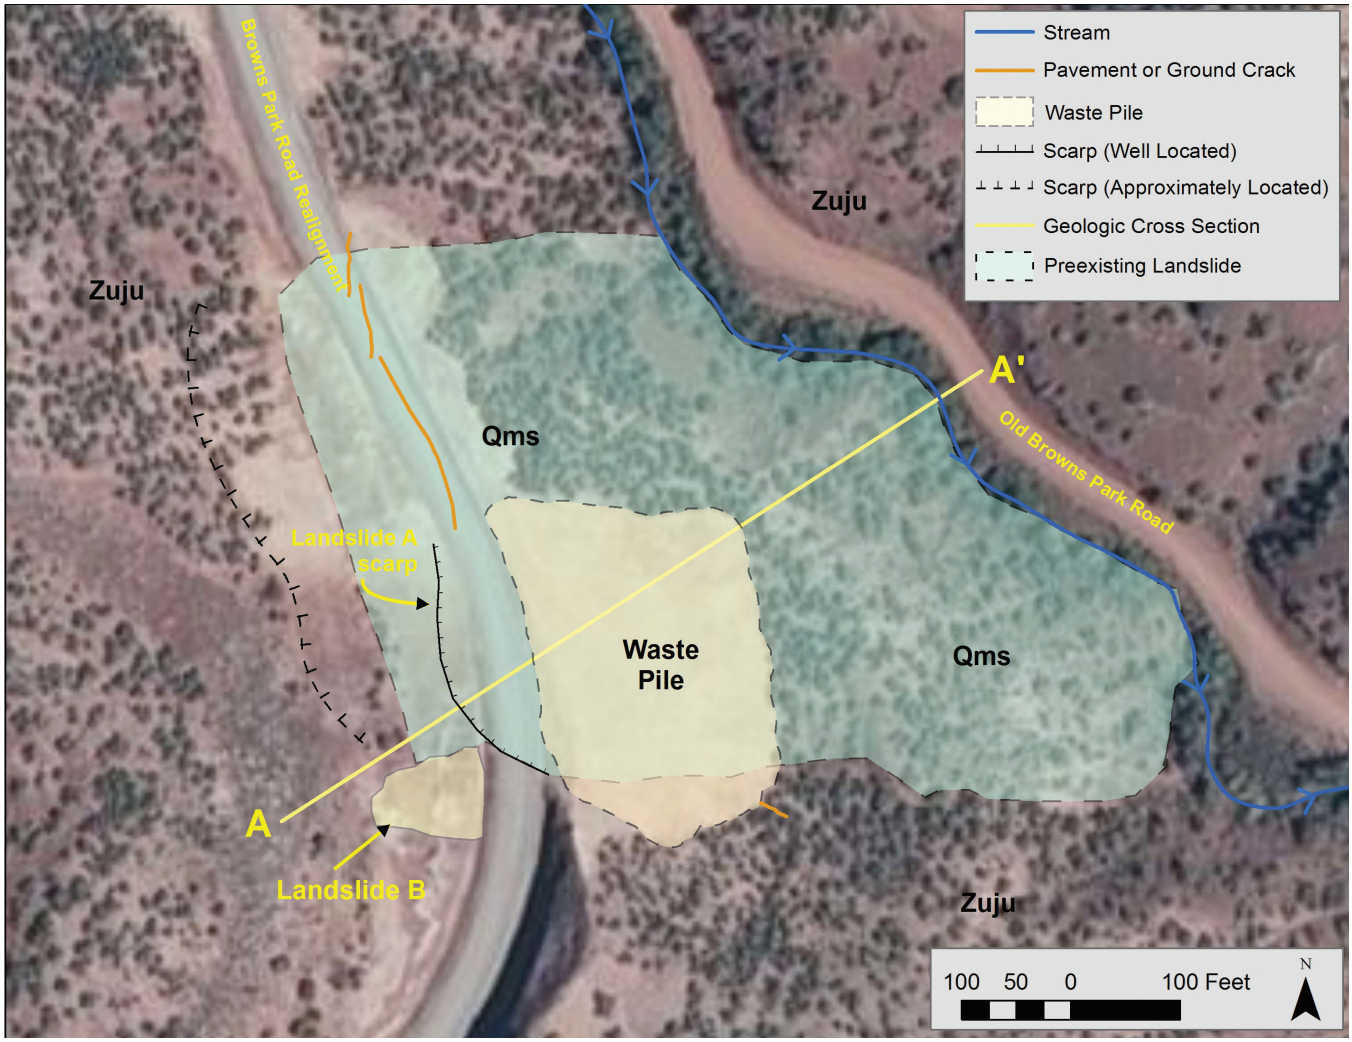
About 18.2 miles east of the Browns Park Road intersection with U.S. 191, we observed distress of the asphaltic concrete roadway pavement and a cut slope during our reconnaissance (figures 3 and 5). The distress included an approximately 195-foot-long, arcuate-shaped landslide scarp and abundant pavement cracking. Vertical offset across the scarp consisted of warping of the pavement at the scarp's northern end and pavement cracking on its southern end (figure 3). Vertical offset of the pavement was about 9 inches on the north and 6 inches on the south. Maximum deformation near the apex of the scarp, which extended approximately 29 feet west of the roadway into its cut slope, produced less than one foot of vertical offset of older landslide debris.

Figure 5. *Map of preexisting landslide, Landslide A scarp, and waste pile. Geologic cross section A–A' is shown on figure 8. Geologic units include landslide debris (Qms) and Upper Jesse Ewing Canyon Formation shale interbedded with quartzose and lithic sandstone (Zuju). Bedrock geology from Sprinkel (2006) and landslide and waste pile extents from this reconnaissance. Base from 2009 National Agriculture Imagery Program.*

5, 7, and 8) activities. The waste pile has dimensions of about 300 feet north to south, 200 feet east to west, and is up to 30 feet thick. Waste material was placed on top of a rotated surface developed by prior movement of the large preexisting landslide discussed above. In addition to the recent pavement distress related to scarp formation in the vicinity of the waste pile (figure 3), longitudinal pavement cracking with very slight vertical offset extended approximately 260 feet north from the waste pile. With the exception of a small ground crack near a small drainage that bounds the landslide to the south below the waste pile (figure 5) that may be related to this landslide, no landslide flank or toe features were observed. The observed features suggest an incipient partial reactivation of the preexisting landslide that has not developed to the point of full failure.

GIS analysis of the surface topography that existed prior to road construction suggests the base of the main scarp of the preexisting landslide was about at the current base of the cut slope (figure 5). Such a configuration would allow surface water runoff from both the cut slope and roadway to intercept the surface of rupture of the preexisting landslide. Groundwater transported to and along the surface of rupture could locally increase pore water pressure, promote weathering, and thereby produce a subsequent reduction in material strength which may contribute to landslide instability.

To fully understand the preexisting rockslide and its relation to Landslide A, the UGS recommends a more detailed investigation by a Utah-licensed engineering geologist and/or geotechnical engineer with significant experience in landslide investigation and mitigation. This investigation should address, at a minimum, the surface and subsurface geology; delineate ground-movement areas; define the surface of rupture; determine and monitor groundwater depths and sources; determine expansion and weathering characteristics that may lead to a subsequent reduction in material strengths; and provide recommendations for appropriate mitigation measures. Over time, if the preexisting landslide is not stabilized, future landsliding may cause extensive damage to the roadway resulting in a subsequent hazard to the public and increased maintenance and possible liability costs.

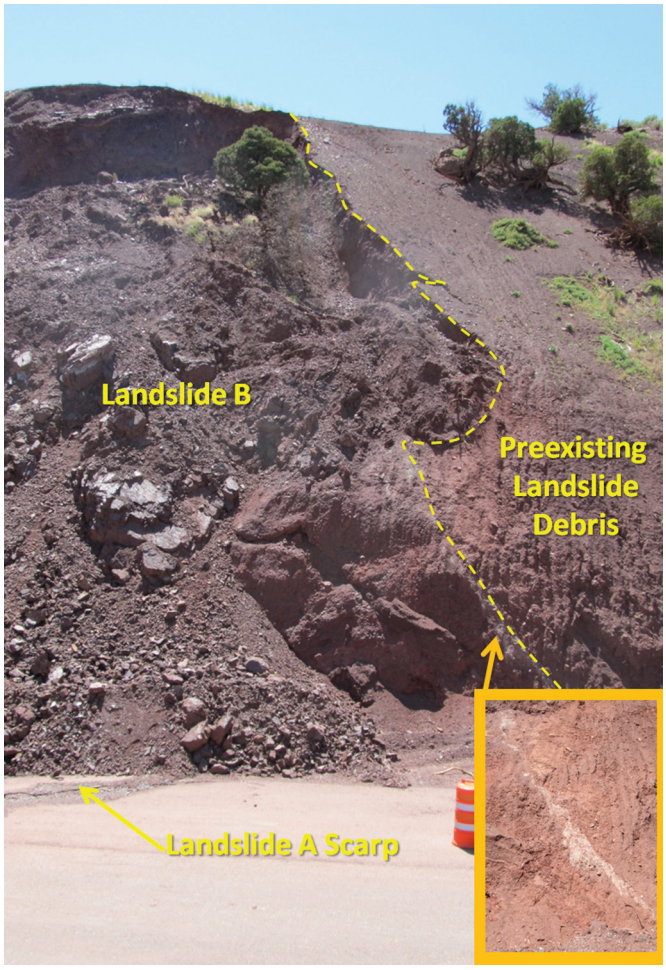
Figure 6. *Contact between Landslide B and preexisting landslide debris. Exposure in western road cut slope along Browns Park Road. Inset shows discoloration of material along right flank shear plane of preexisting landslide low on cut slope. Photo taken on June 21, 2011.*

The northern extent (left flank) of Landslide B appears to be limited by the presence of preexisting landslide debris, as Landslide B extends only to the southern margin of the preexisting landslide (figure 6). This configuration may be a result of the type of movement in Landslide B. Landslide B is a translational rockslide that occurred along bedding planes and continuous bedding planes were not observed within the landslide debris of the preexisting landslide.

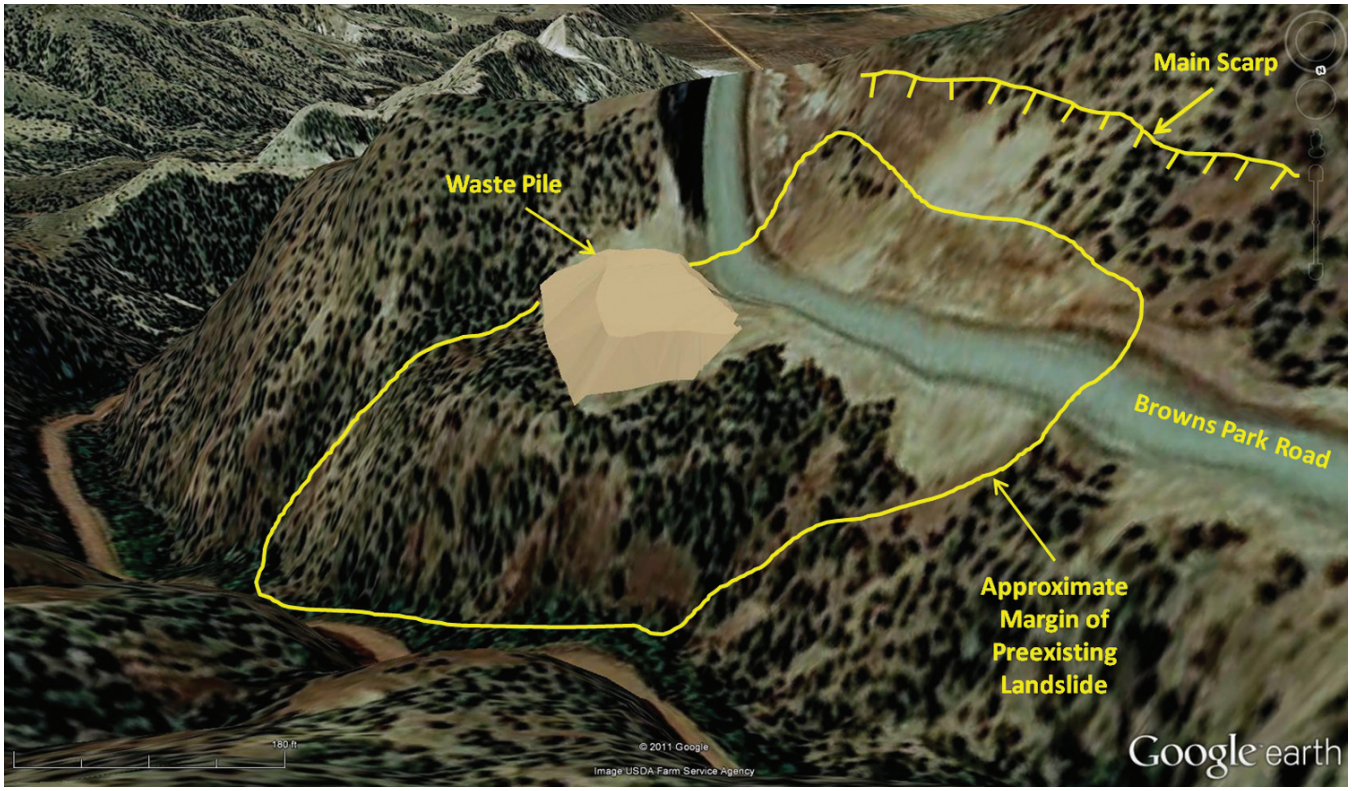
preexisting rockslide to be approximately 550 feet wide at the road and to extend about 700 feet downslope from its main scarp, about 200 feet above the road, to the stream at the bottom of the slope (figure 5). About 250 feet below the road, we observed a prominent back-tilted surface, formed during rotational movement of the rockslide (figure 7).

Figure 7. *Oblique view, looking south, of preexisting landslide and waste pile. Waste pile was constructed on top of a back-tilted surface created during previous landslide movement. Google Earth image from 2009 National Agriculture Imagery Program.*

Anthropogenic activities that may have contributed to the movement of Landslide A include placement of the waste pile on a back-tilted surface developed during earlier movement of the preexisting landslide, and modification of the upper portion of the landslide slope during the road realignment. Based on topographic data collected during

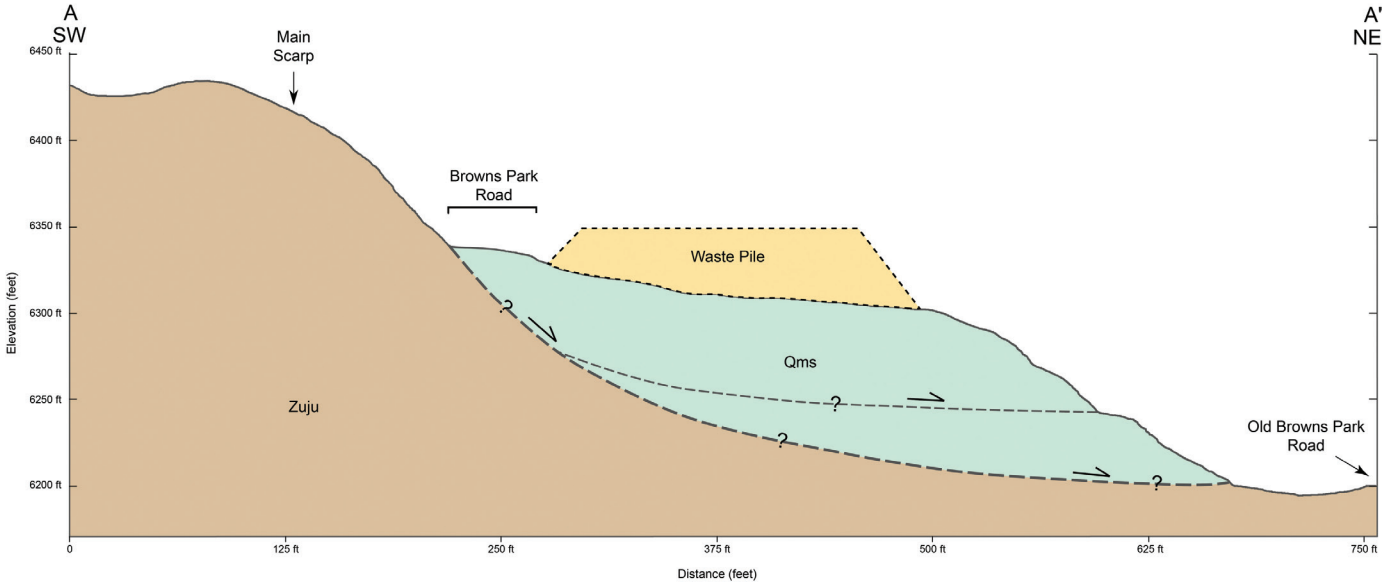
Figure 8. *Geologic cross section of preexisting landslide. Surface profile based on DEM of the pre-road realignment landscape. Bounds of preexisting landslide (Qms) and waste pile are from geologic mapping conducted during this reconnaissance. Landslide (Qms) overlies intensely fractured and weathered shale, sandstone, and siltstone with minor lenses of silicic conglomerate (Zuju). See figure 5 for cross section line location.*

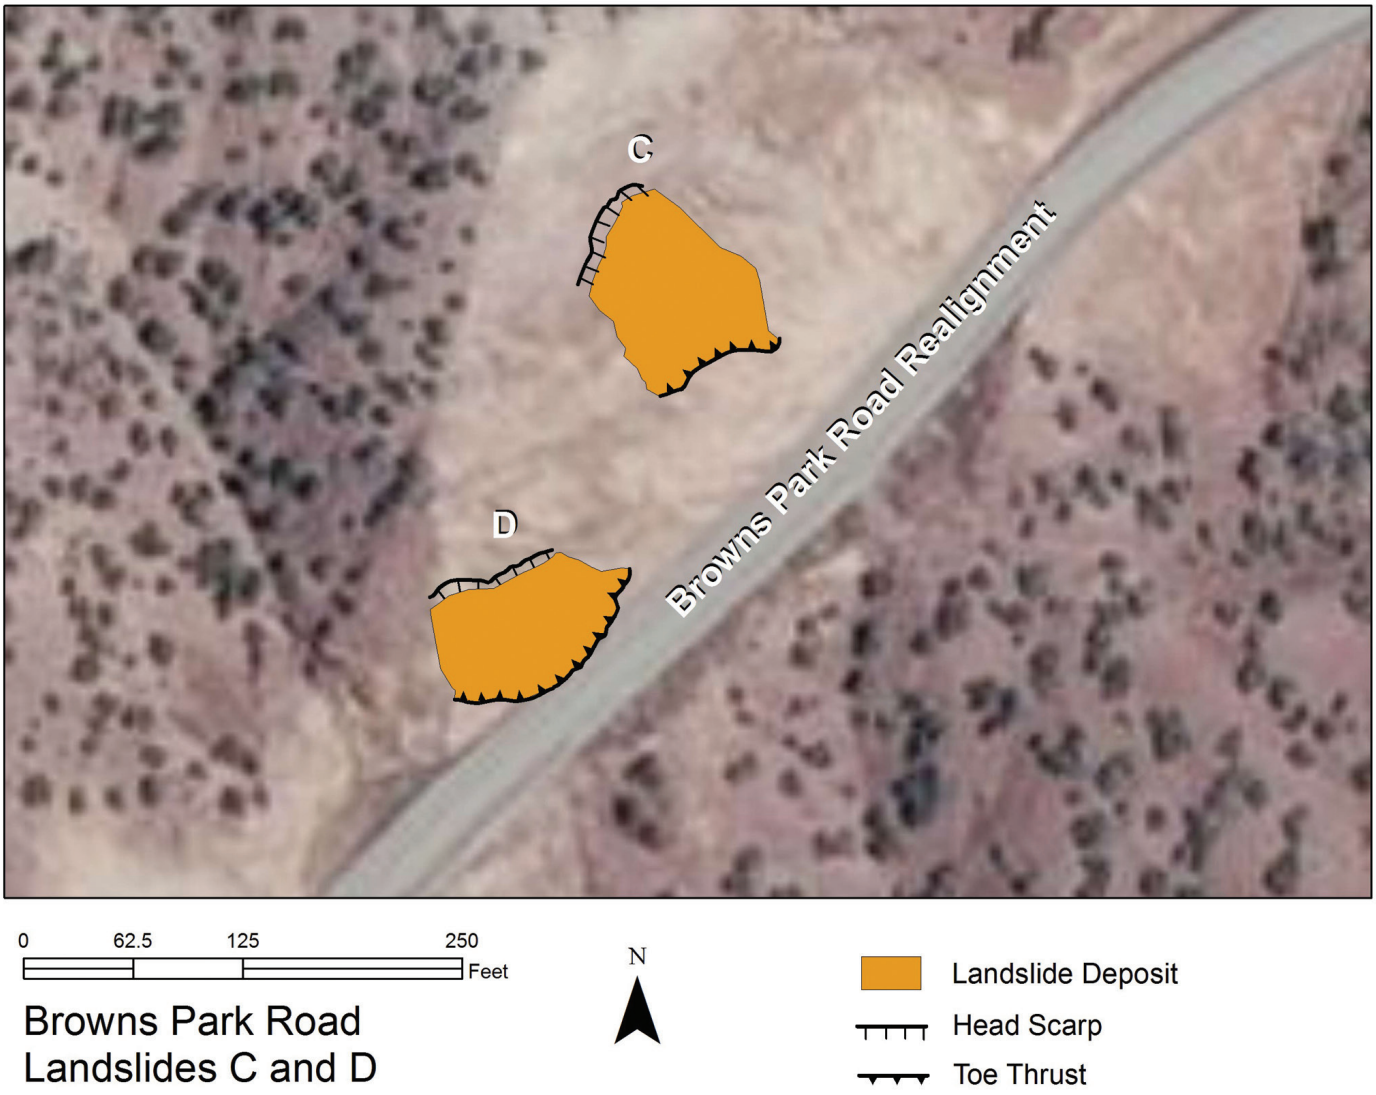
In addition to Landslides A and B, we investigated three south-facing cut-slope failures during our reconnaissance. Landslides C and D are on a cut slope about 18.6 miles from U.S. 191 (figures 2, 9, 10 and 11). The slope extends about 250 feet above the roadway at an angle of about 34° [1.5H:1V]. Landslide C is a translational rockslide near the middle of the slope that extends about 120 feet from its main scarp down slope to a well-developed toe thrust about 40 feet above the roadway (figure 10). The width of this rockslide ranges from about 68 feet at the main scarp to about 90 feet near the toe. The main scarp is about 13 feet high and exposes dark red-brown silty sandstone and silicified conglomerate with bedding-plane strike and dip of about N55°E, 65°SE. At the time of our reconnaissance, Landslide C had not affected the roadway. Although much of this road cut is underlain by intensely fractured and weathered bedrock, in the immediate vicinity of Landslides C and D less intense fracturing was observed, and landslide movement occurred along bedding planes.

Landslide D is also a translational rockslide on the same cut slope as Landslide C, about 110 feet farther to the southwest and 40 vertical feet lower (figure 9). Landslide D extends downslope a maximum of about 70 feet from its main scarp and ranges in width from about 76 feet at its main scarp to about 120 feet near its toe (figure 11). The main scarp is about 3 feet high and exposes the same dark red-brown silty sandstone as we observed in Landslide C. We measured a bedding plane at the main scarp having a strike and dip of N55°W, 42°SW. The toe of the landslide filled the road drainage ditch and impacted the guardrail.

Figure 9. *Locations of Landslides C and D. Both landslides are translational rockslides on a 34° (1.5H:1V) cut slope above Browns Park Road. Landslide D impacted a guardrail and filled the small roadside drainage ditch. Base from 2009 National Agriculture Imagery Program.*

Landslides C through E involve material similar to that at Landslide B. However, the relations between the orientation of bedrock bedding planes and slope angles differ, and thus do not result in the same out-of-the-slope bedding dip conditions observed at Landslide B. The lack of out-of-the-slope bedding dip conditions may have limited the downhill extent of these relatively small rockslides that have not, or have only marginally, impacted the roadway. Landslides C through E occurred on south-facing slopes as bedding-plane failures of more competent rock. Once mobilized, movement extended into more weathered materials downslope. Depending on conditions of the bedrock involved, their position on the slope, and climatic conditions, these landslides may impact the roadway in the future. Continued raveling of material above the landslides will result in headward expansion, but given the relation between surface cut-slope angles of about 34° (1.5H:1V) and the dip of bedding planes (42° to 65° [1H:1V to 1/2H:1V]), large-scale failure of the entire slope is not anticipated under the current conditions. However, as exposed materials continue to weather and with a reoccurrence of extreme precipitation events, future large-scale landsliding cannot be ruled out. Under current conditions, and at the discretion of Daggett County, mitigation of existing and future failures of these slopes may likely be limited to ongoing slope and road maintenance.

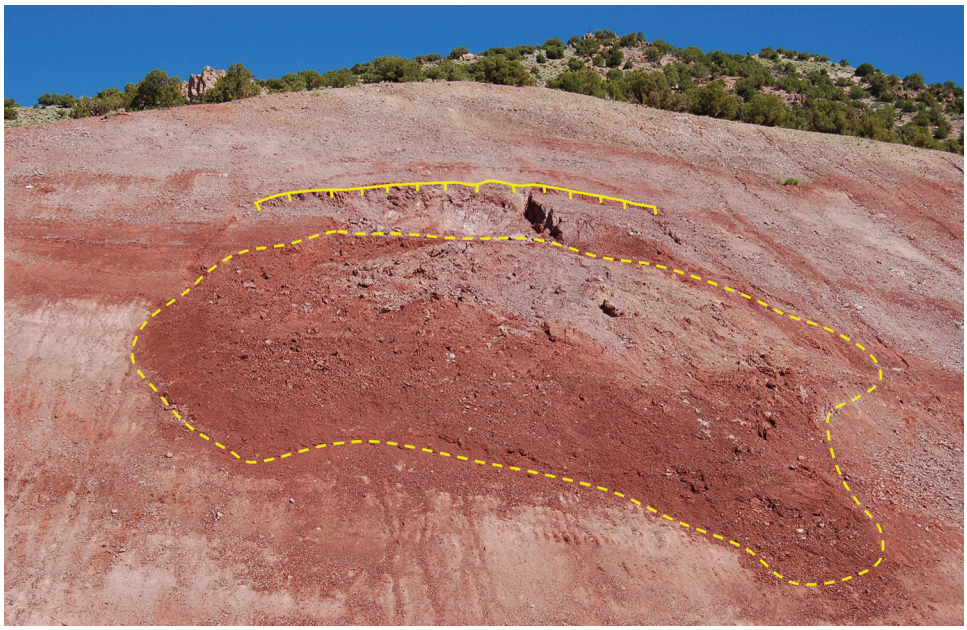
Figure 10. *Landslide C main scarp and deposits on road cut slope. Hachured yellow line marks main scarp and dashed yellow line shows approximate boundary of landslide deposits. Photo taken on June 22, 2011.*

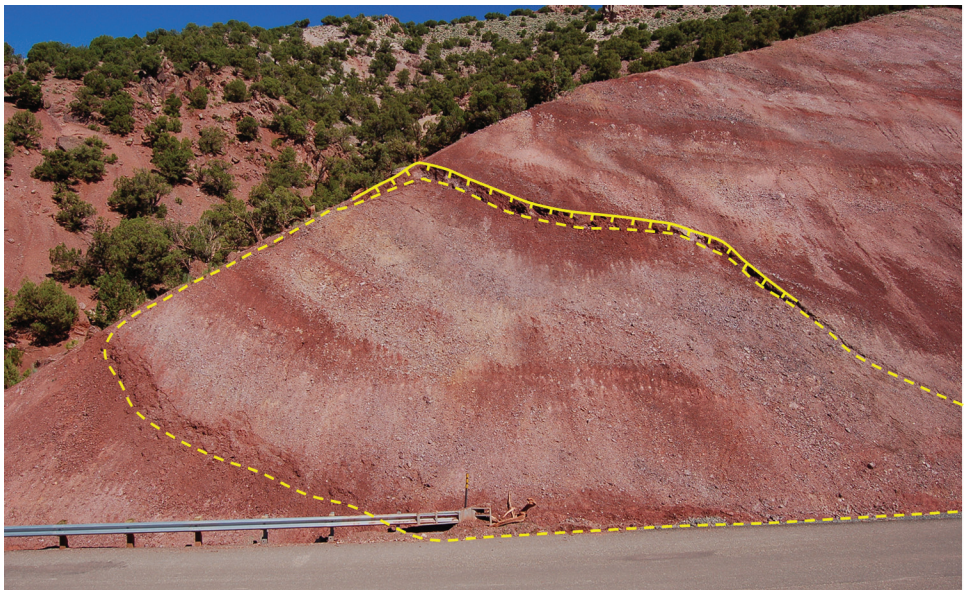
Figure 11. *Landslide D main scarp and a part of its deposits on road cut slope. Landslide deposits filled a small roadside ditch and covered a portion of a guardrail. Hachured yellow line marks main scarp and dashed line shows approximate boundary of landslide deposits. Photo taken on June 22, 2011.*

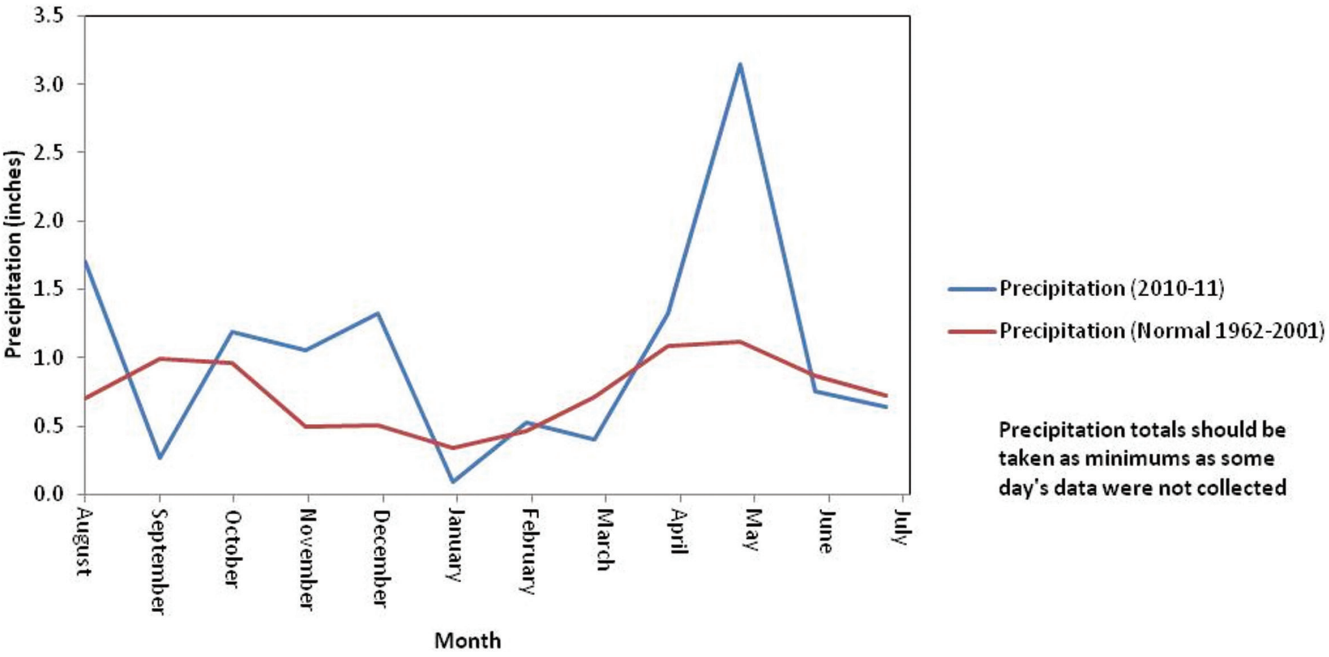
As elsewhere in Utah, the fall, winter, and spring of 2010–11 were unusually wet in the vicinity of the landslides. Between August 2010 and June 2011, the Jarvie Ranch weather station operated by the National Weather Service, approximately 2.5 miles southwest of the landslides, received 6.24 inches of precipitation, which is 148% of normal (Utah Climate Center, 2011) (figure 14). In addition to the wet seasonal conditions, Utah Climate Center (2011) data record two intense rain events that moved through the area in the latter part of May 2011 (figure 15). From May 15 to May 21, 1.91 inches of rain was recorded and from May 29 to May 31, 0.90 inches of rain fell.

Figure 14. *Monthly precipitation totals recorded at Jarvie Ranch weather station. Recent precipitation data are from August 2010 through June 2011 (Utah Climate Center, 2011). Normal precipitation is the monthly average from 1962 to 2001 (Western Regional Climate Center, 2011).*

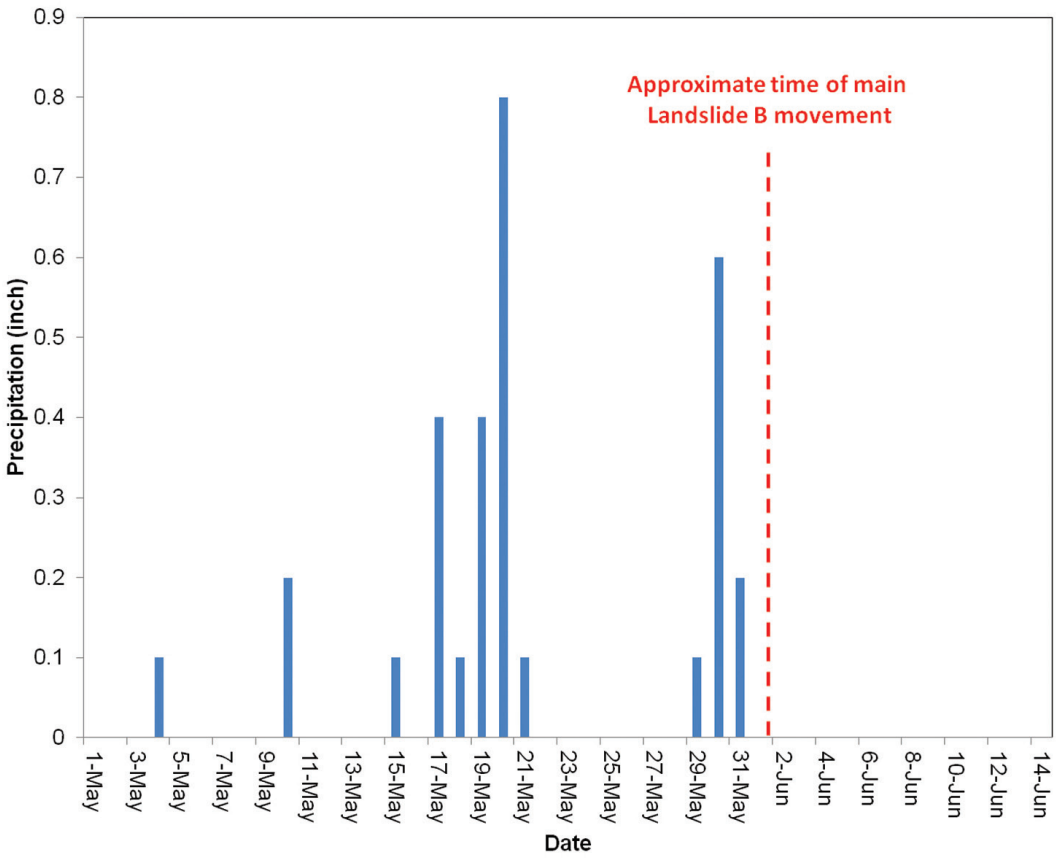
Storms that produce moderate to intense rainfall over several days are a common landslide trigger (Wieczorek, 1996). Shallow landslides are often generated on steep slopes during the most intense part of a storm as pore water pressures increase as a result of rapid infiltration of water into near-surface soils and weathered bedrock (Campbell, 1975; Ellen and others, 1988). The increased soil moisture results in an increase in local pore water pressure along discontinuities in bedrock and in unconsolidated surficial materials overlying the bedrock. Precipitation from a wetter than normal winter combined with storms that produced intense rains just before the reported date of the main movement of Landslide B (figures 14 and 15) suggest that precipitation was a significant contributing factor in the recent movement of all the observed landslides.

Figure 15. *Daily precipitation data for May and early June 2011. Data from the Jarvie Ranch weather station (Utah Climate Center, 2011).*
