TECHNICAL REPORTS FOR 1998 APPLIED GEOLOGY PROGRAM

compiled by
Greg N. McDonald

Report of Investigation 242 March 1999
UTAH GEOLOGICAL SURVEY
a division of
Utah Department of Natural Resources

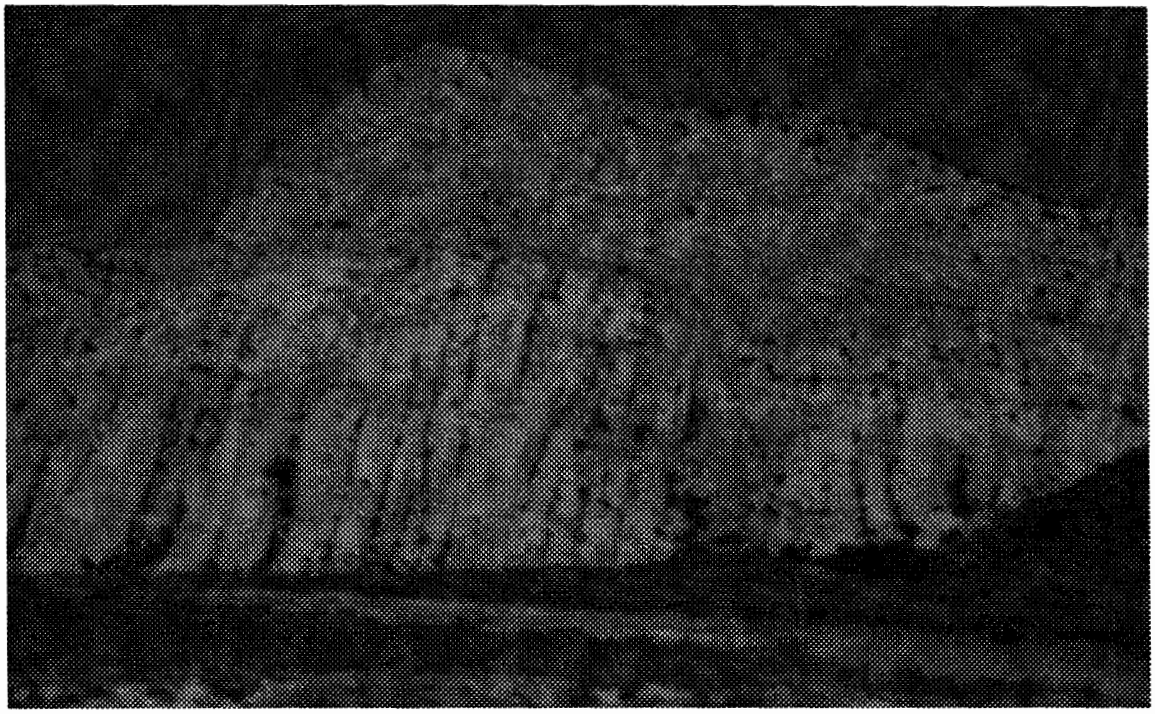
Attachment 5. Joints in the Navajo Sandstone along Lava Ridge immediately north of the Winchester Hills development. View to the northeast.

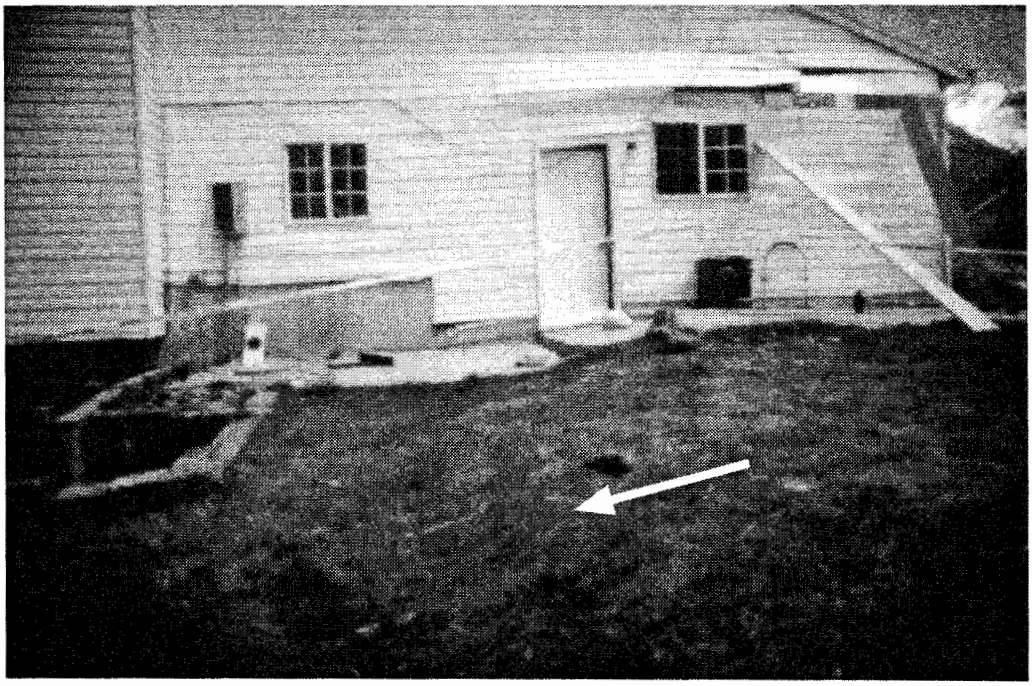
Attachment 3. Landslide damage on April 27, 1998, to house on lot 105. Arrow points to scarp position in lawn. View is to the east.

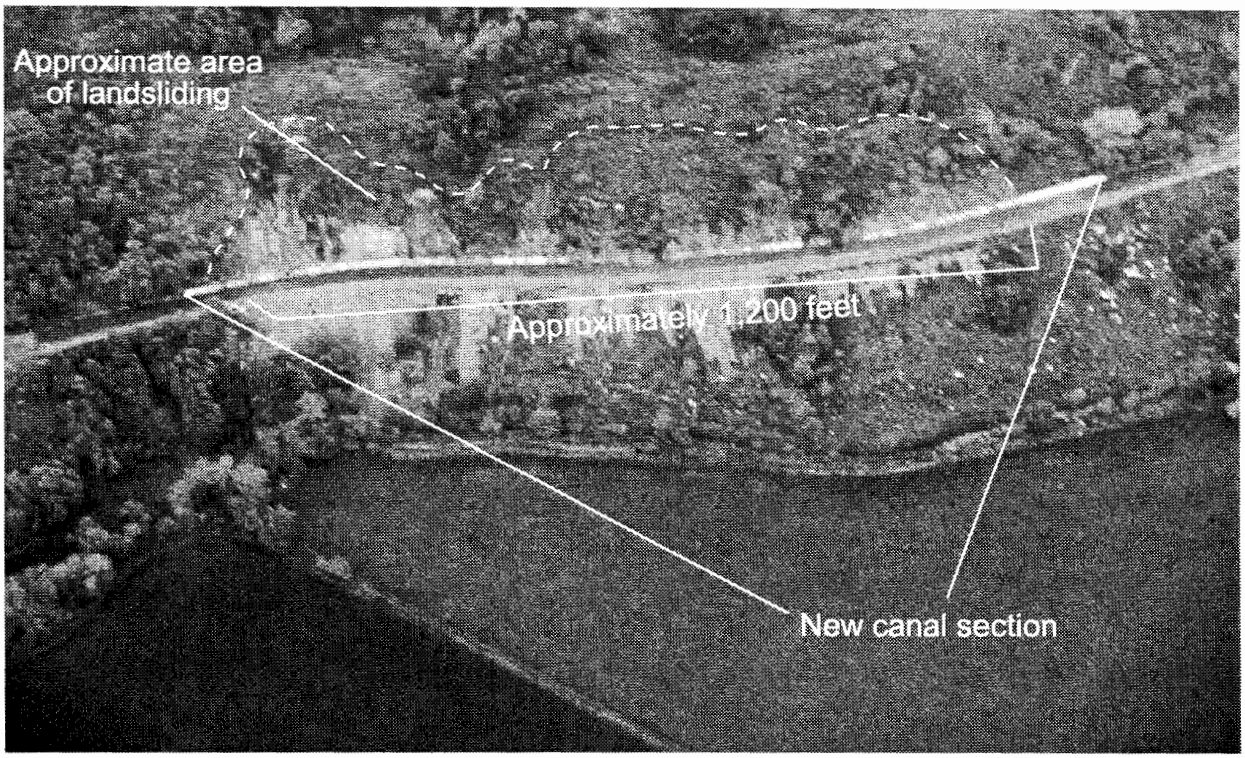
Attachment 2. Oblique aerial view of the 1998 landslide along the Davis-Weber canal in South Weber. A section of the canal was replaced in 1996, and nearly corresponds to the area of landsliding. Numerous scarps and ground cracks are evident on the slope in this area. Shallow earth sliding is occurring off the toe of the landslide.

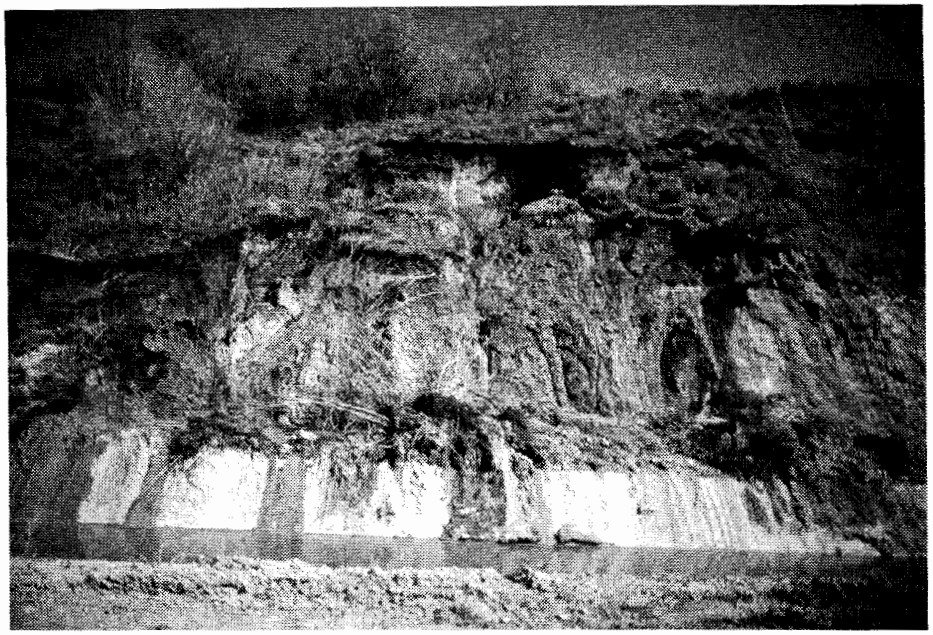
Attachment 3. South views of shallow earth sliding on the right (eastern) flank of the 1998 landslide in South Weber on May 1 (top) and May 11 (bottom). The Davis-Weber canal is in the foreground.

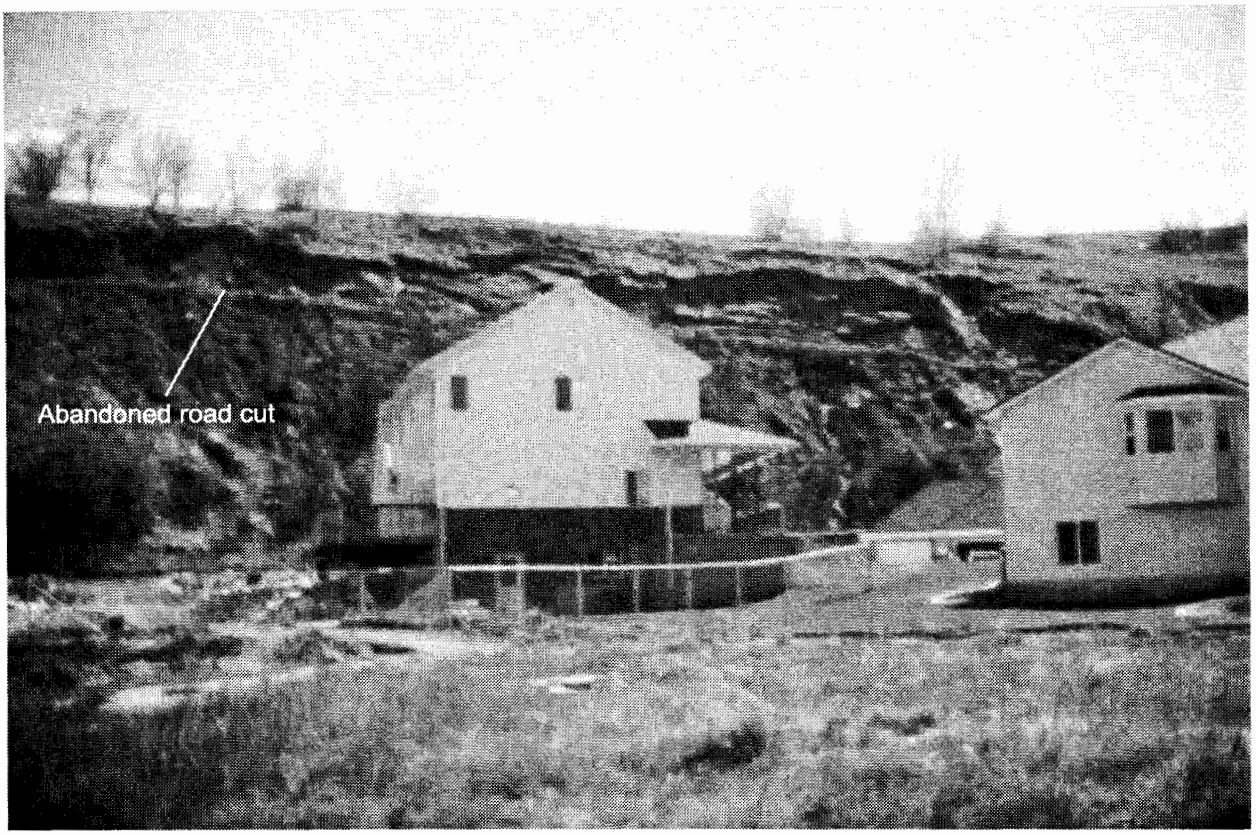
Attachment 3. South view of lower slope behind the Cedar Bench subdivision. Shallow earth slides are above and below the abandoned road cut.

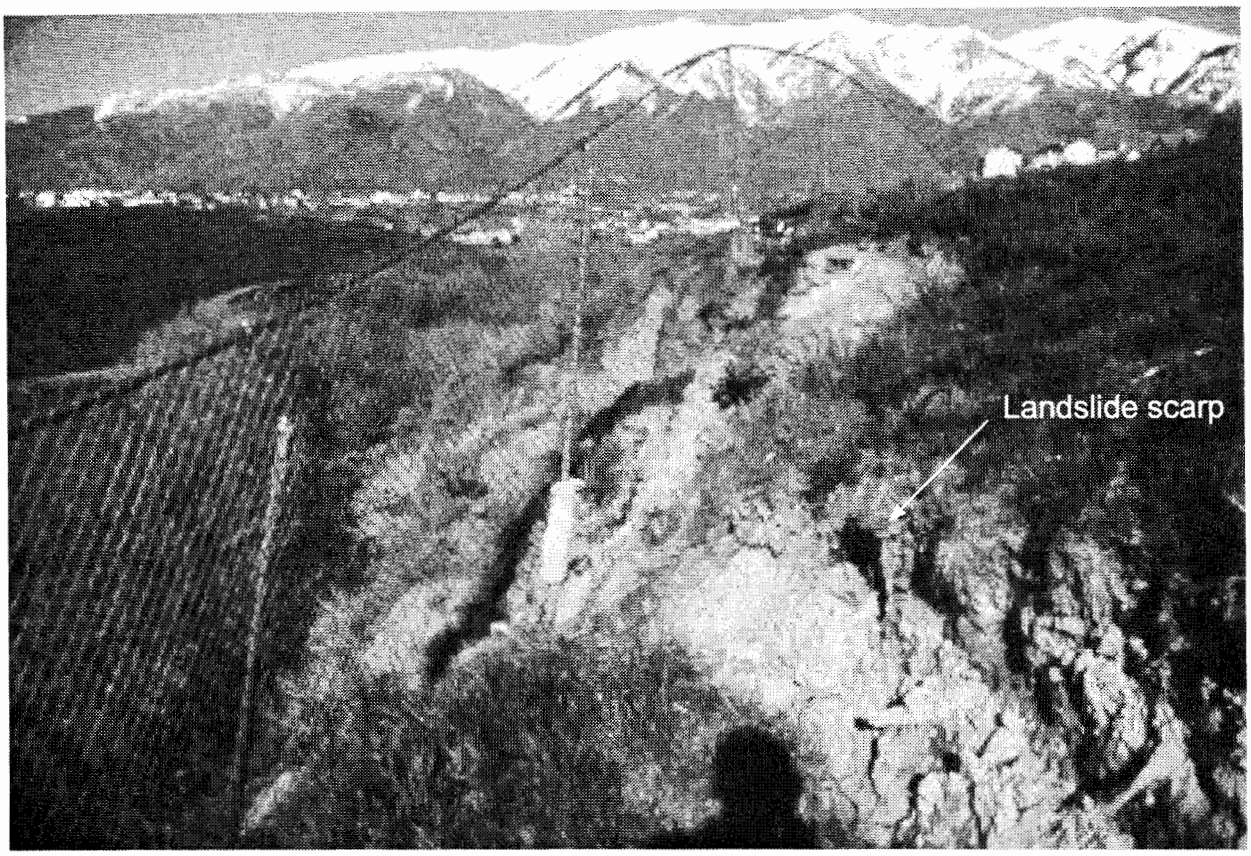
Attachment 2. South Fork Kays Creek landslide main scarp, showing damage to chain-link fence and lawn. Arrow points to scarp. The area left of the scarp has dropped down and moved to the left. View is to the east on April 29, 1998.

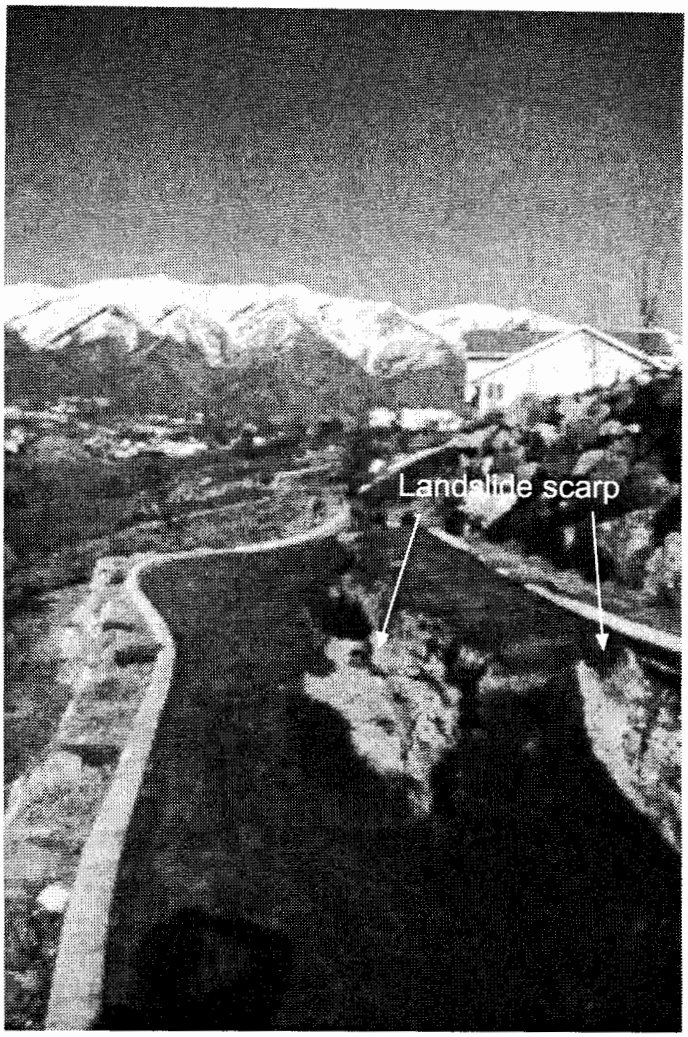
Attachment 3. South Fork Kays Creek landslide main scarp, showing damage to lawn. Arrows point to main scarp. The area left of the scarp has dropped down and moved to the left. View is to the east on April 29, 1998.

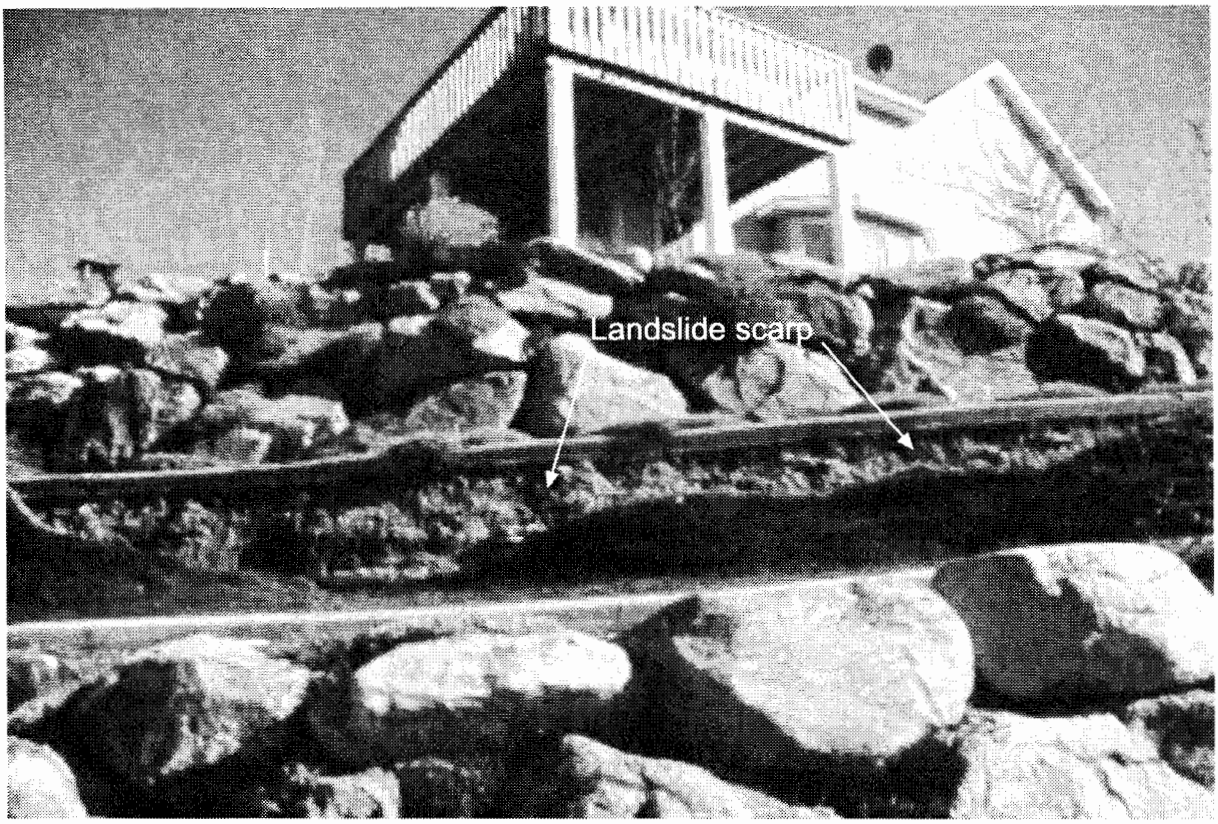
Attachment 4. South Fork Kays Creek landslide main scarp, showing damage to landscaping. Arrows point to main scarp. The area in front of the scarp (foreground) has dropped down relative to the area behind the scarp (background). View is to the east on April 29, 1998. The house at 1543 North 1050 East is in the background.

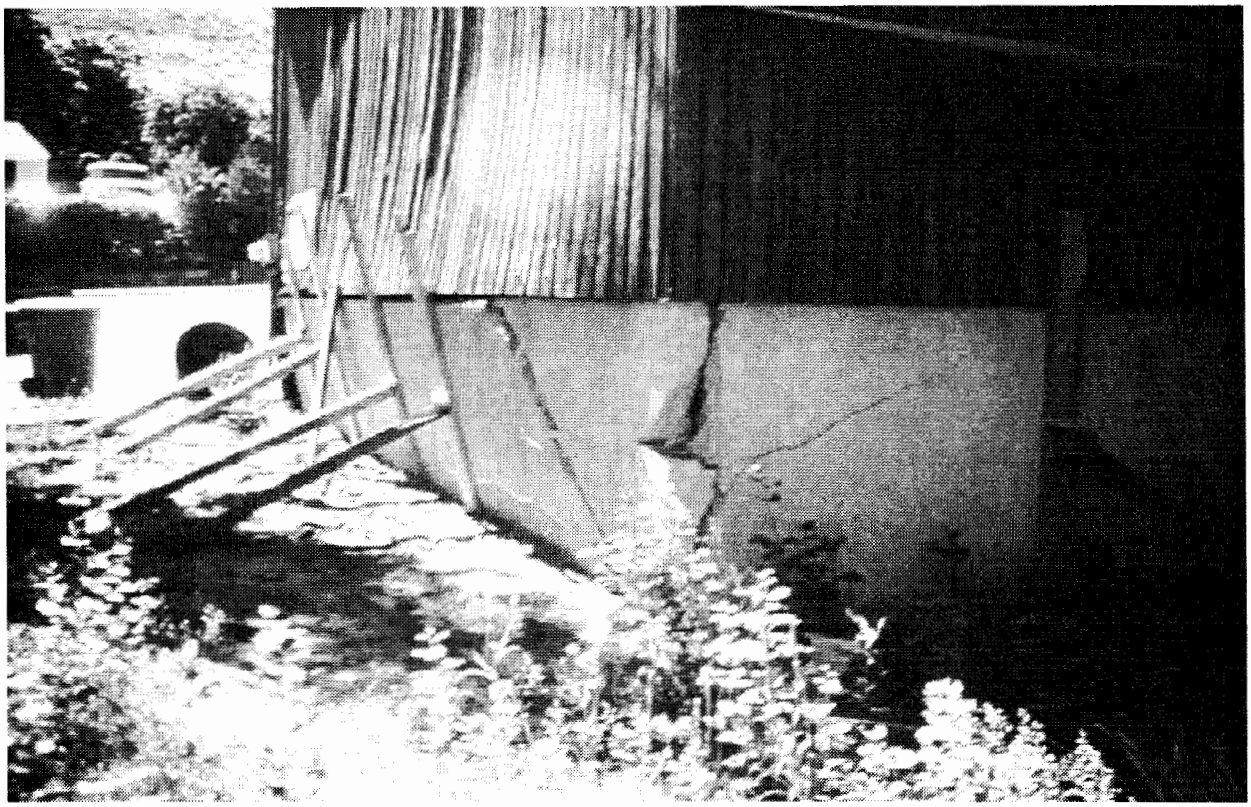
Attachment 3. Building distress in the north foundation wall of the house at 160 South Springhill Drive. View is to the southeast on July 6, 1998.

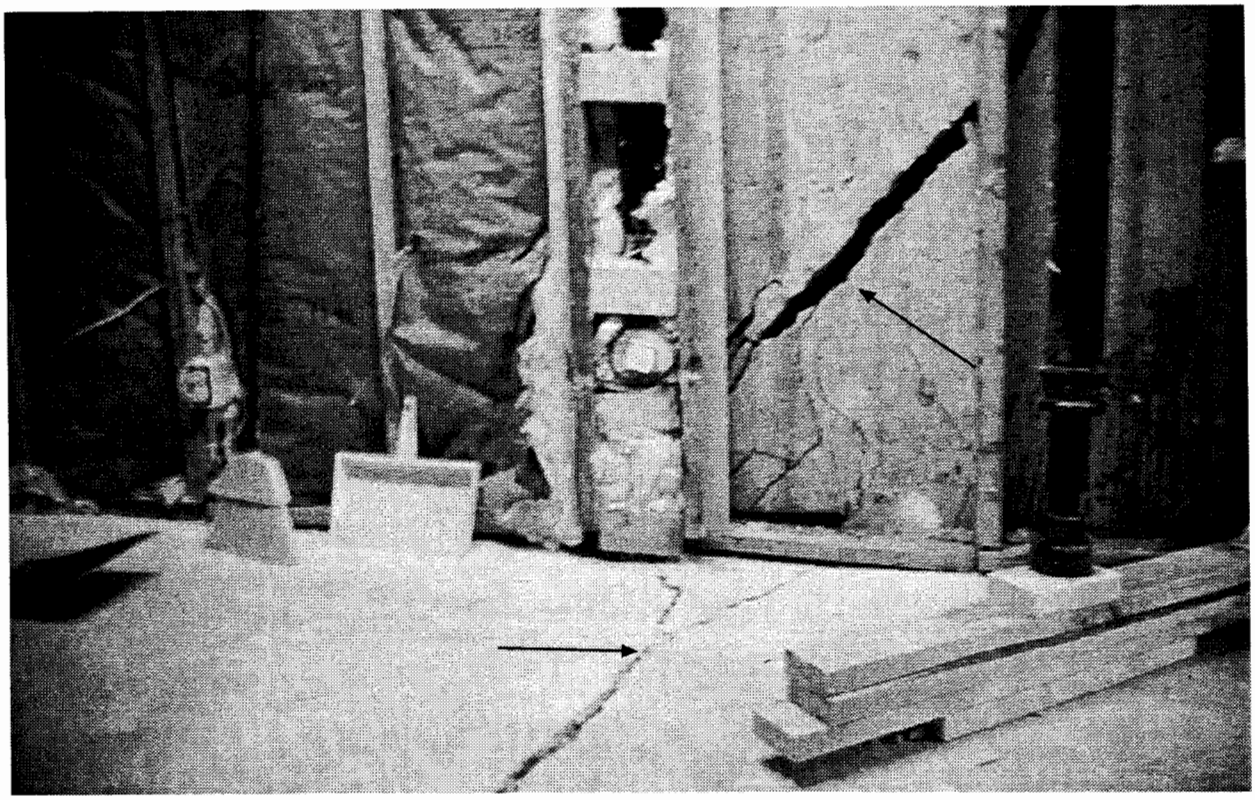
410 - Severe cracking of south foundation wall near southeast corner
Cracking of mortar in rock landscape wall and east garage foundation wall that may connect to cracks at 418 in south foundation wall
Large crack in garage floor

Attachment 5. Building distress in the south interior concrete foundation wall and floor at 410 Springhill Circle. Arrows point to cracks in the foundation wall and floor. View is to the south on July 1, 1998.

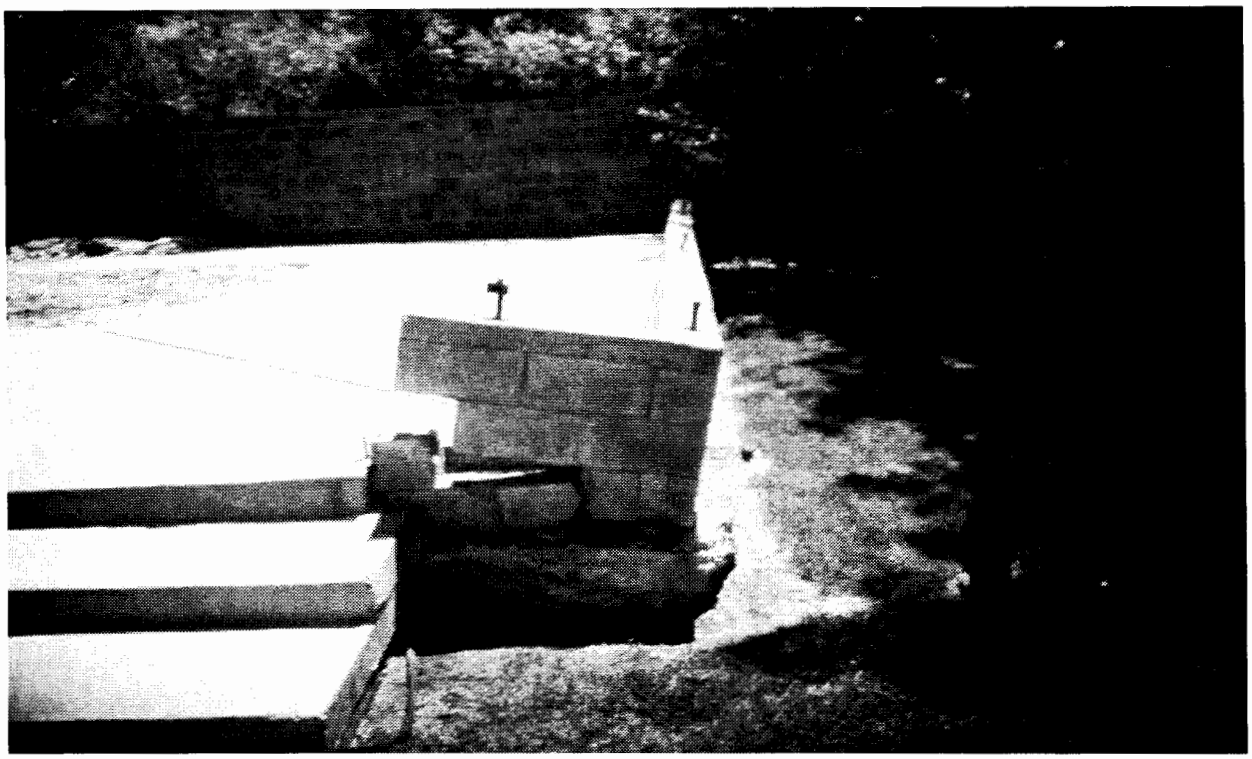
402 - Severe cracking of concrete slabs
South cinder-block wall has down-stepping crack along mortar
Cinder-block retaining wall rotated to the west
Large crack in garage floor

Attachment 7. Deformed cinder block retaining wall in the back yard of 402 Springhill Circle. View is to the south on July 6, 1998.

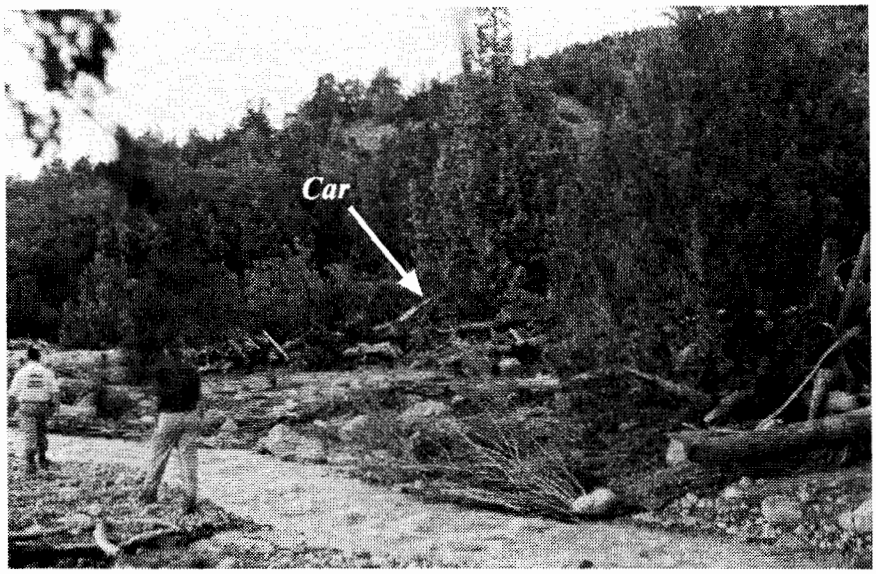
Attachment 2. A car belonging to campers was washed downstream and left stranded atop a mound of debris near the mouth of Canal Canyon on July 22.

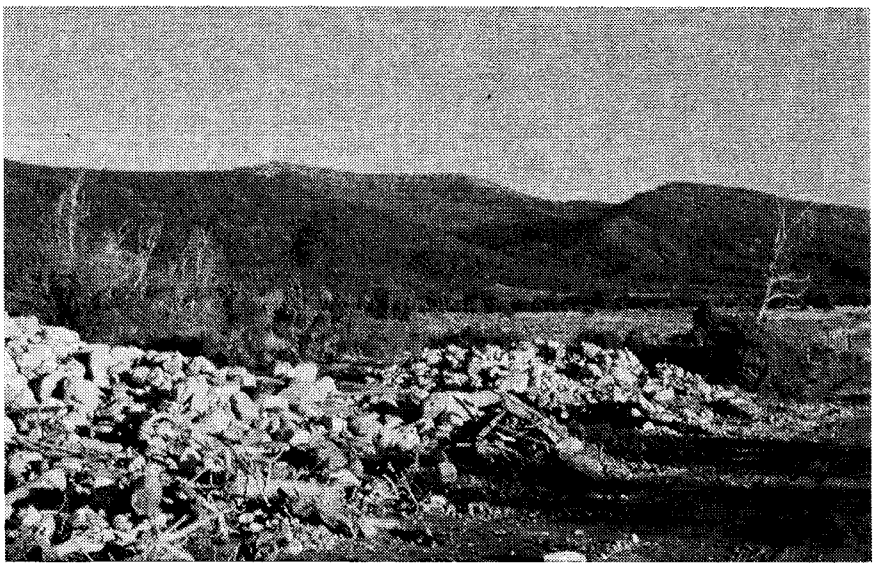
Attachment 4. Southeast view of Horseshoe Mountain at the head of Canal Canyon. Bouldery debris in the foreground was removed from Canal Creek by emergency-response teams after the July 22 flood.

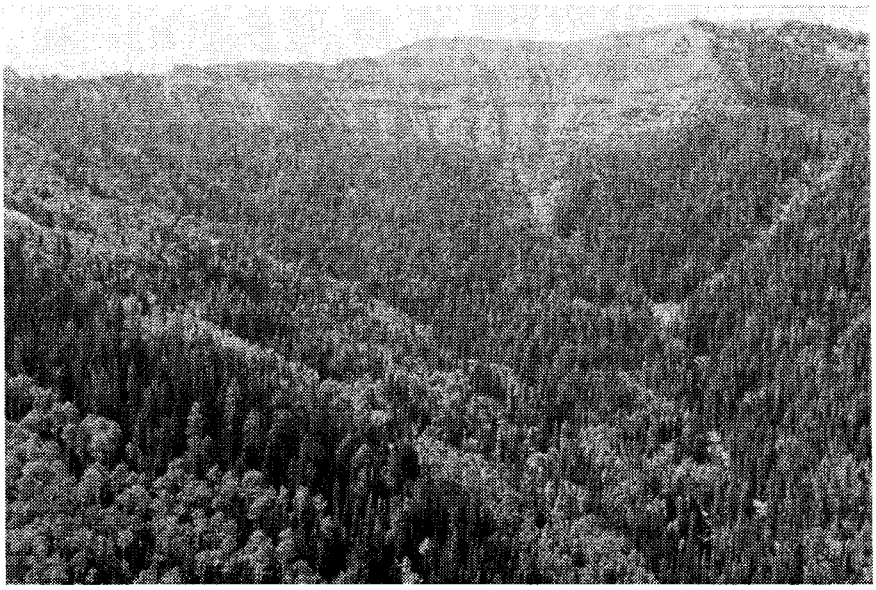
Attachment 5. Exposures of the North Horn Formation at the steep head of Temple Fork in upper Canal Canyon. The North Horn Formation is covered by colluvium and dense pine forest downslope.

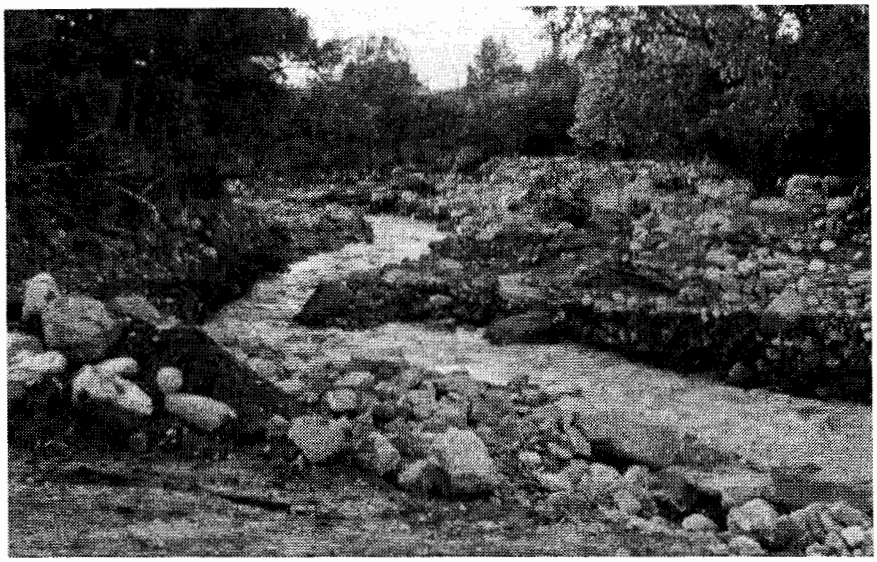
Attachment 6. Bouldery alluvial deposits in the incised flood plain of Canal Creek at the canyon mouth.

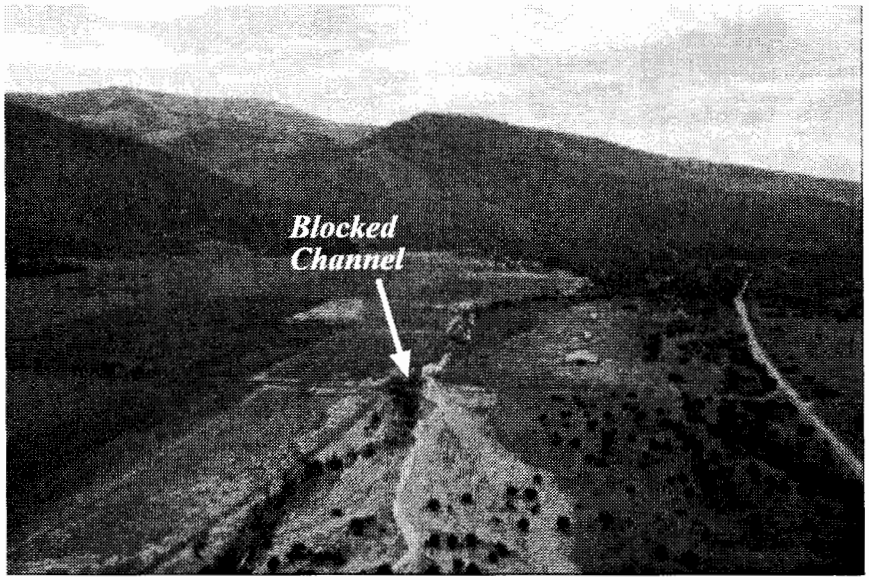
Attachment 7. Sheet flooding on Canal Creek on July 22 downstream of a channel blocked by debris, about 3 miles (5 km) southeast of Spring City.

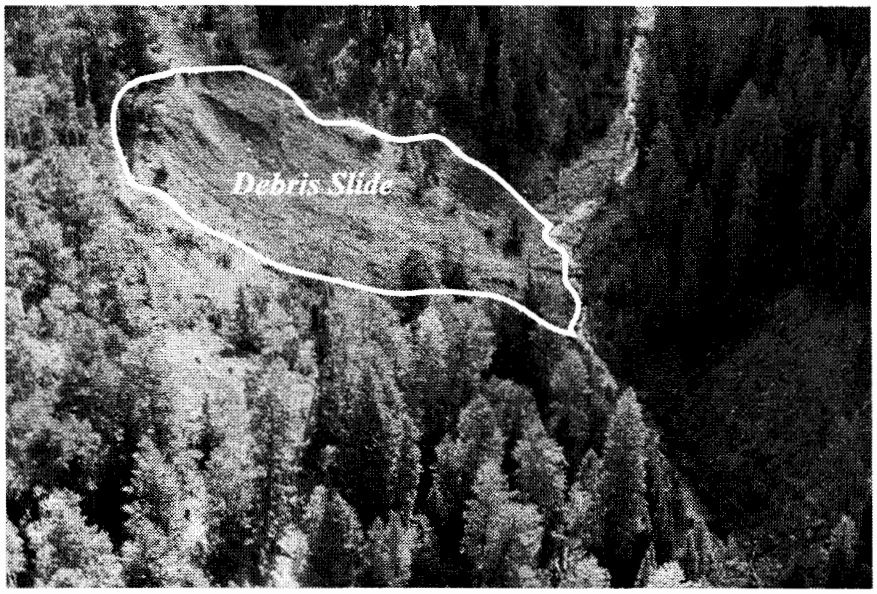
Attachment 8. A typical debris slide in upper Canal Canyon that was active during the July flooding. The creek is deflected around the slide toe, but material appears to have been rapidly eroded from the channel. No evidence exists of a landslide dam or ponding at this location.

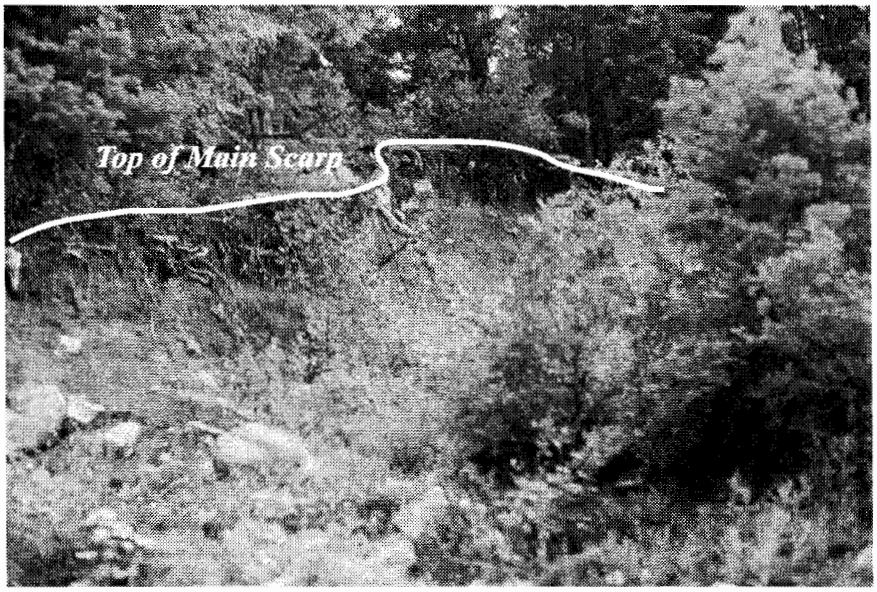
Attachment 9. The main scarp of an active slump near Canal Creek. The scarp is about 10 feet (3 m) high at this location. Most of the movement on the main scarp apparently predates the recent torrential rainfall, but a smaller secondary scarp downslope (not visible in this photo) recently moved.

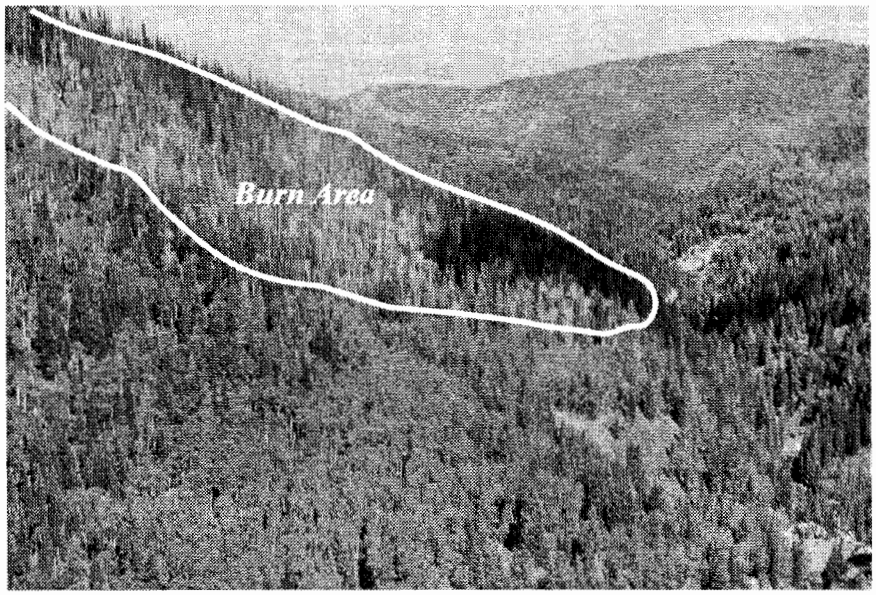
Attachment 11. Area of a controlled burn conducted in 1996 or 1997 on the slopes of upper Canal Canyon. Although burned areas are susceptible to slope instability, this area was stable during recent torrential rainfall.

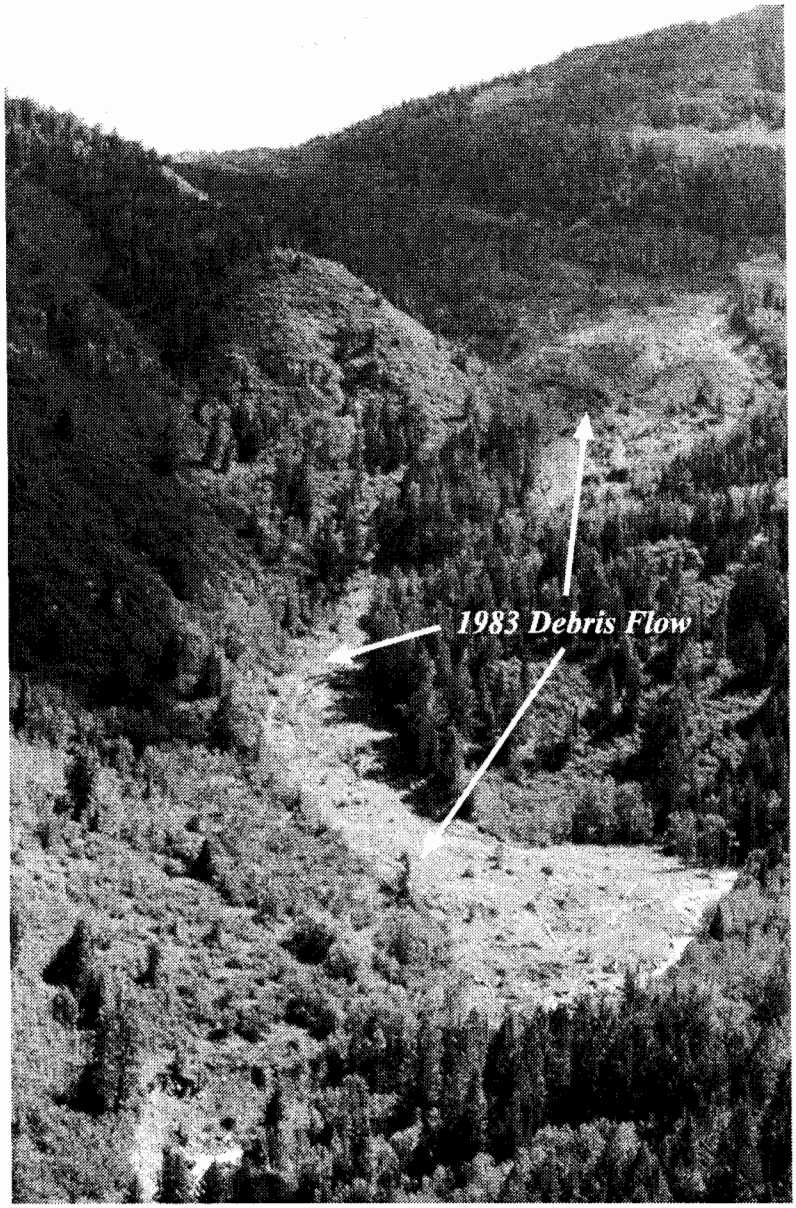
Attachment 12. An inactive debris flow on the flank of Knob Mountain above Oak Creek. Movement occurred during a period of rapid snowmelt in 1983.
