UTAH GEOLOGICAL AND MINERAL SURVEY

NO. 203

GEOLOGIC EVALUATION OF A PROPOSED LANDFILL SITE IN WEBER COUNTY, UTAH

November 1985

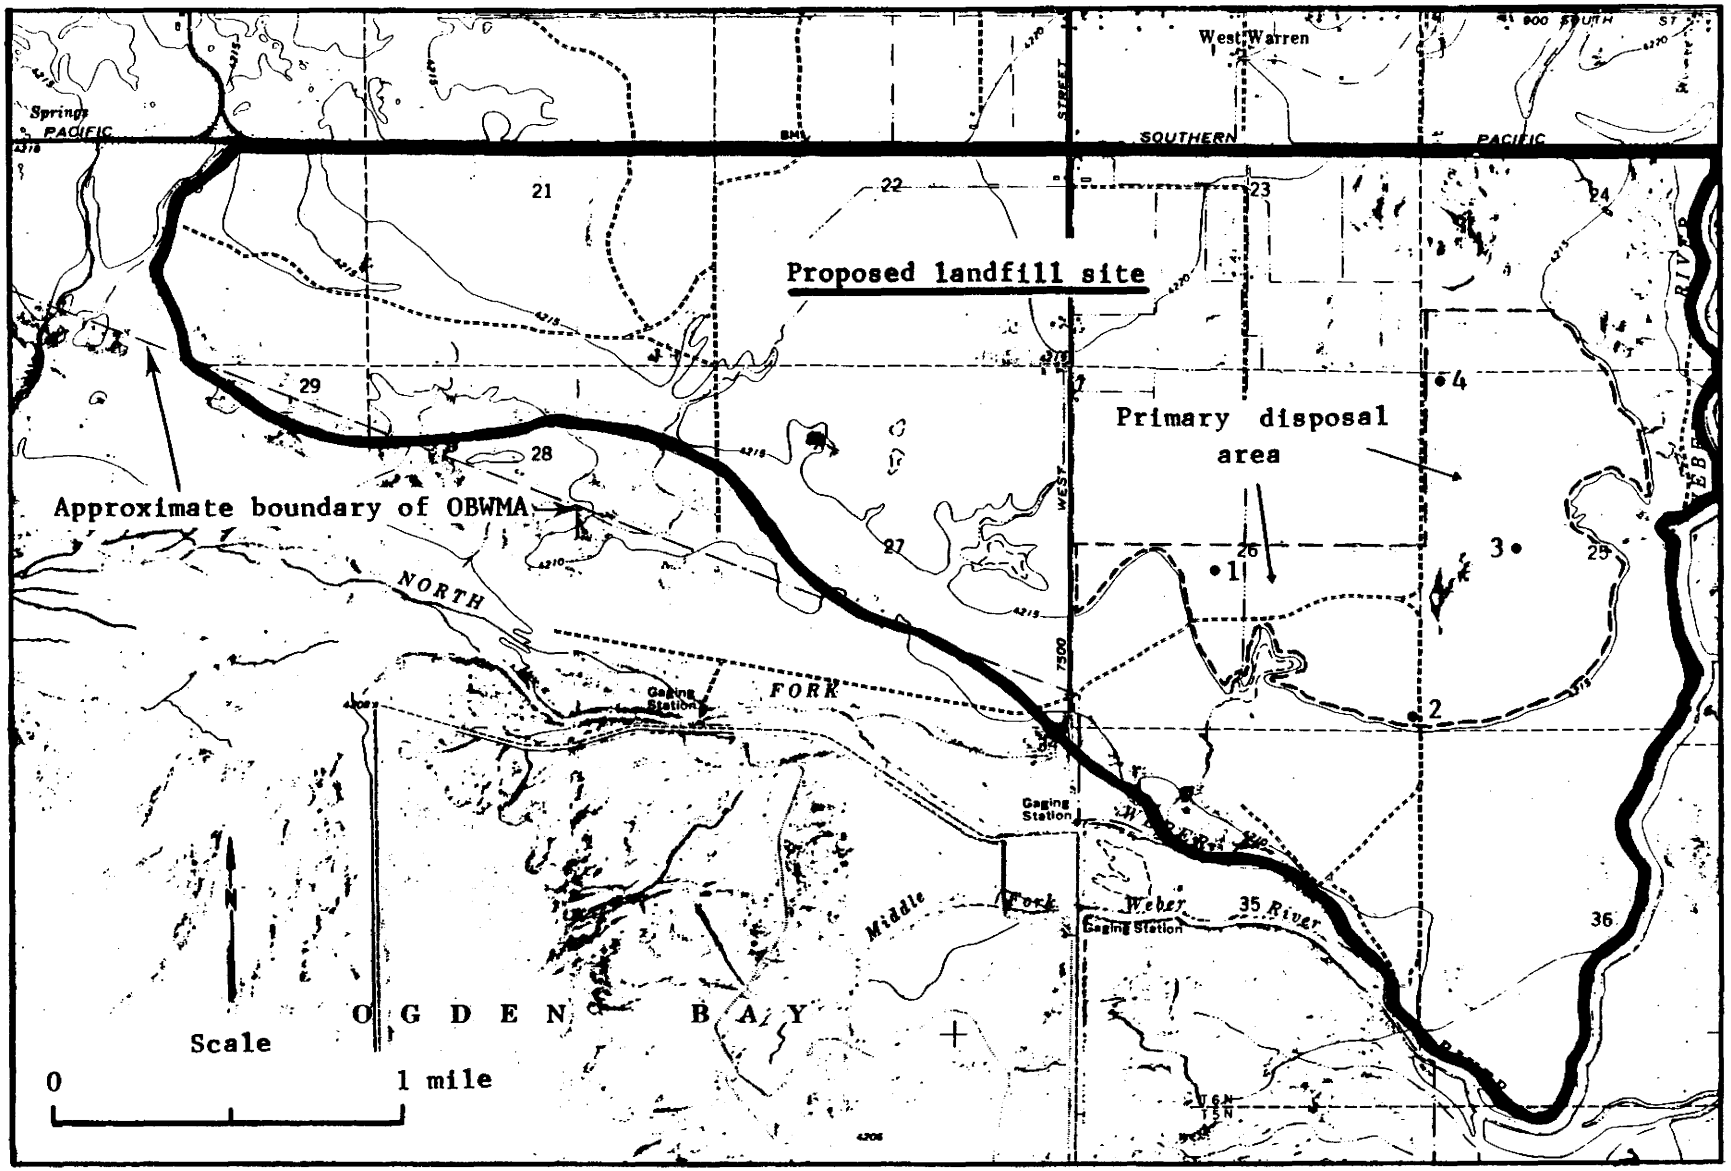
Figure 2. Proposed landfill site showing primary disposal area and test pit locations.

Four test pits were excavated within the primary disposal area of the proposed landfill (figure 2). Test pit soils were described according to the Unified Soil Classification System (USCS) (appendix A). The test pits were restricted to the southern half of section 26 and the western half of section 25, areas where permission to excavate was granted by private landowners. All test pits were located on or above 4,215 feet elevation. Three test pits were excavated into Leland soils, the other (test pit 2) into Warm Springs soil.

As shown by test pit excavations, shallow unconfined water-table conditions exist in the primary disposal area of the proposed landfill and are undoubtedly widespread across the entire site. Although no data are available on directional flow of this water, topographic evidence suggests that subsurface flow is southwest, toward the OBWMA and North Fork of the Weber River. Shallow ground-water flow in the western section of the landfill is likely southeast, toward the Weber River. Soil surveys conducted by the U.S. Soil Conservation Service during the 1960s show shallow ground-water depths in the area ranging from 0 feet (water table at surface) in Lakeshore soils and surface depressions to a maximum of 5 feet in Leland soils which cover most of the landfill site (Erickson and Wilson, 1968). Test pits excavated in Leland soils (numbers 1, 3, and 4, appendix B) revealed slightly greater depths to water, ranging from 5.2 to 6.2 feet.

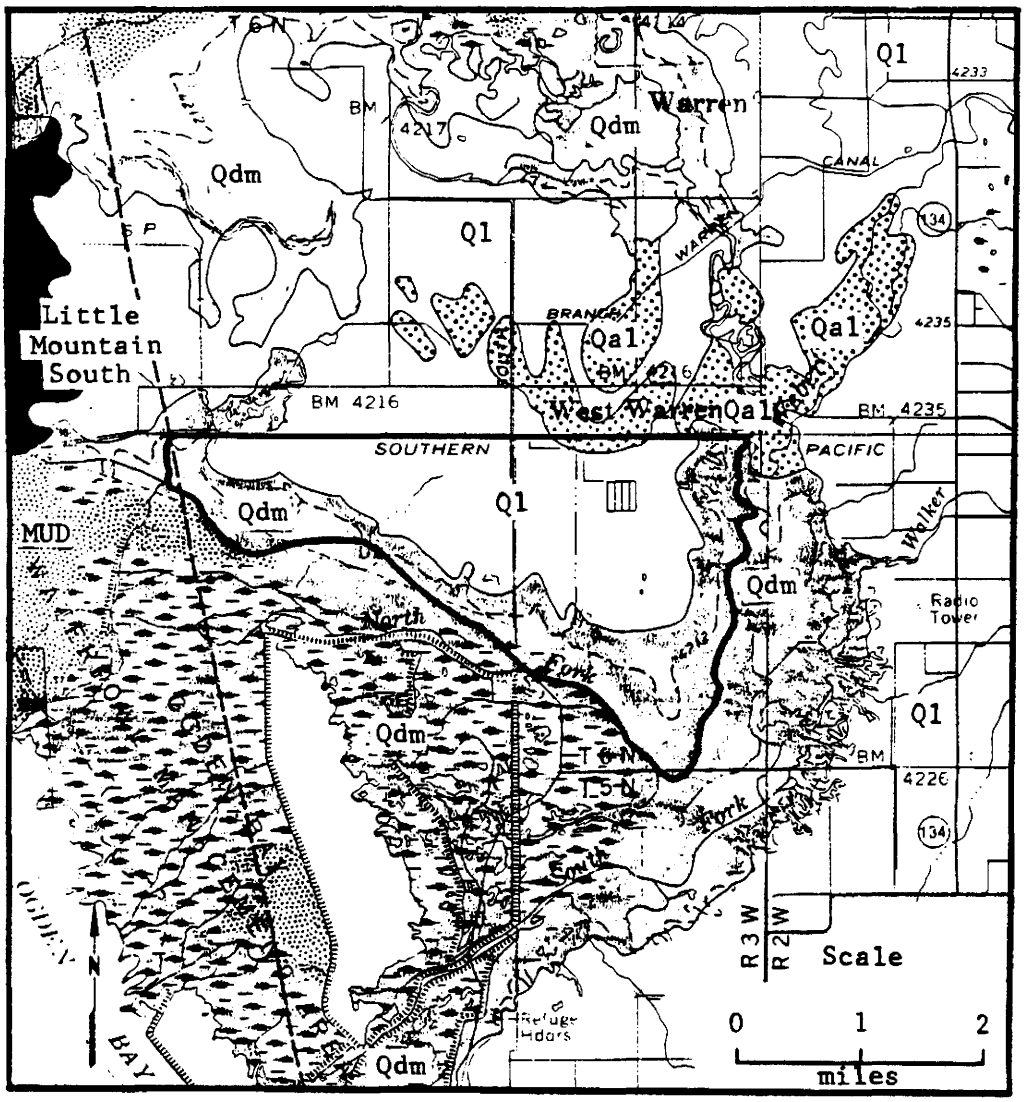
Figure 3 Surficial geologic map of proposed landfill and surrounding area (modified from Davis, 1985).

The site lies on an extensive lowland plain formed during the Quaternary Period by deposition of ancient Lake Bonneville and Great Salt Lake sediments in combination with delta deposits from the Weber River (Feth, 1955). These deposits are generally unconsolidated or semi-consolidated (Smith and Gates, 1963; Feth and others, 1966). The southern one-third of the site and that portion adjacent to the Weber River contain geologically recent, poorly-drained silt and clay (Qdm) deposited by Lake Bonneville and the Great Salt Lake (figure 3). These deposits are approximately 10 feet thick, fetid, salt-impregnated, and cover the area to an elevation of about 4,213 feet (Eardley and Gvosdetsky, 1960; Feth and others, 1966). The majority of the landfill site including the primary disposal area is covered by lacustrine deposits (Ql) composed of clay, silt, and sand (figure 3). These deposits attain a thickness of approximately 35 feet and cover much of the land surface between 4,210 and 4,300 feet elevation (Feth and others, 1966). Within the confines of the proposed landfill, the surface Ql deposits are composed primarily of low-permeabilty, salt-impregnated clay. Alternating beds of clay and well- to poorly-sorted sand underlie the surface clay. Alluvial silt and sand deposits (Qal) from river and stream channels are present in the northern part of the landfill site and crop out more extensively farther north and northwest of the landfill boundary (figure 3).

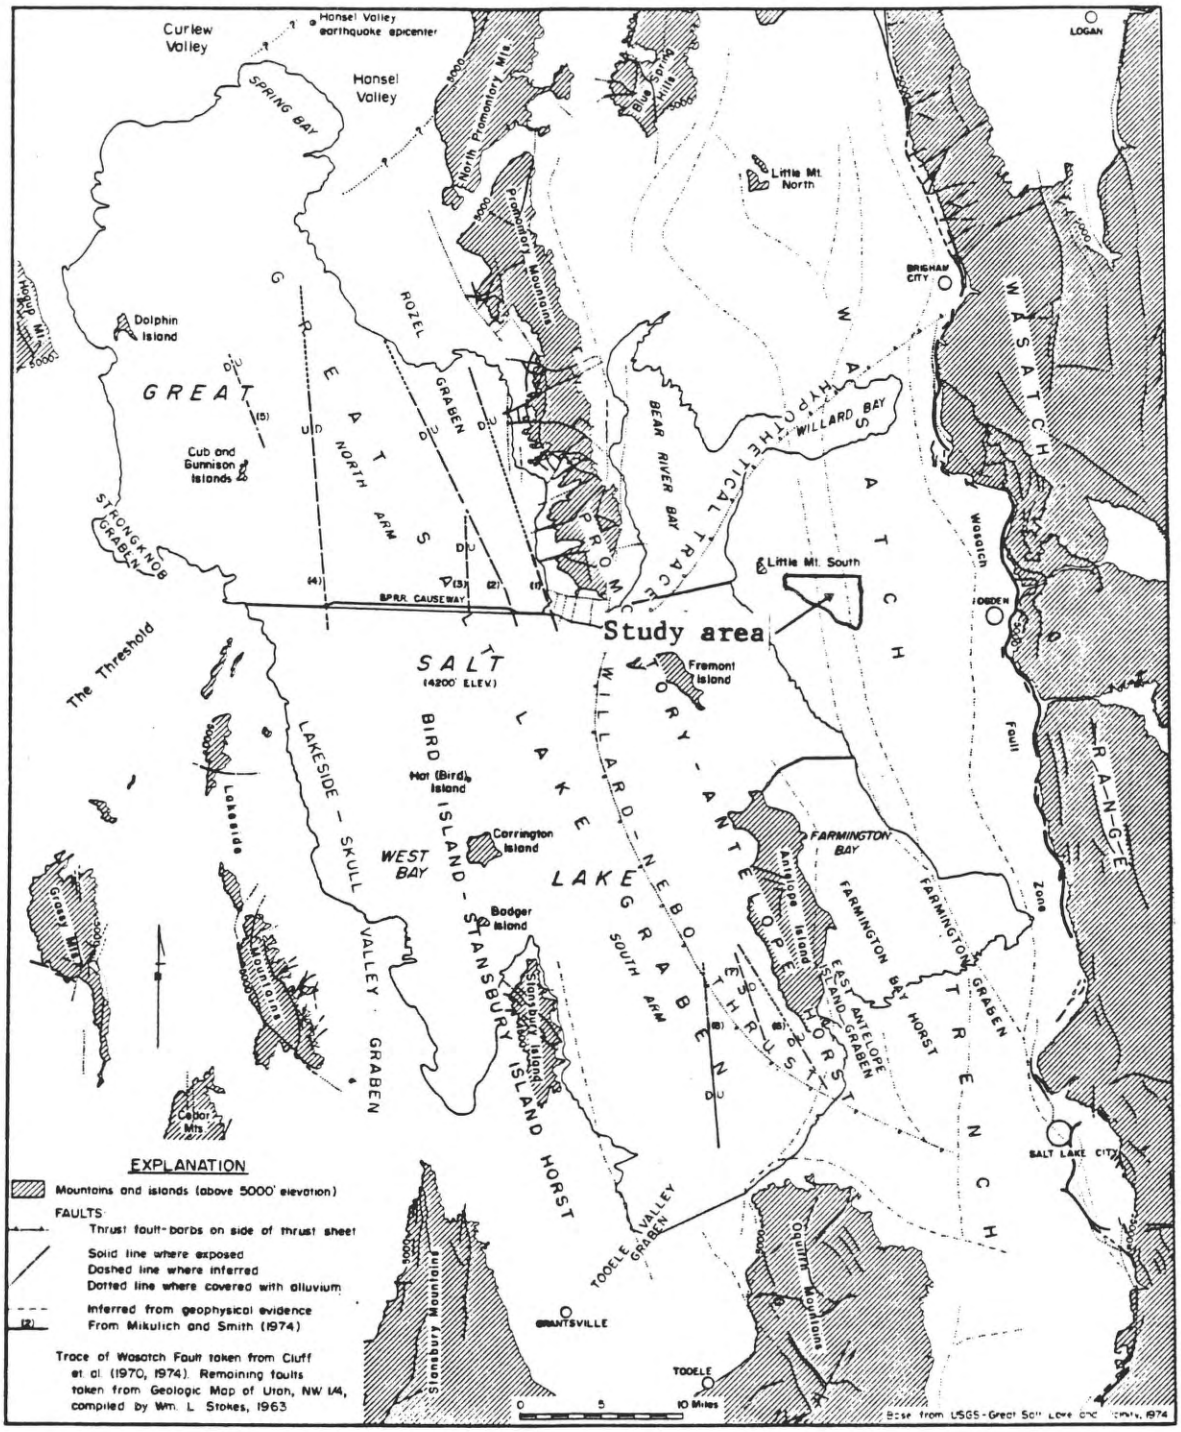
Figure 4. Proposed landfill site and surrounding major structural features and faults (after Stokes, 1980).

The main trace of the north-south-trending Wasatch fault is located approximately 9 miles east of the landfill site. In addition, Stokes (1963; 1980), using 1961 unpublished data supplied by Eardley, shows three geophysically inferred faults, one of which lies 7 miles east of the landfill site. The remaining two trend north-south and traverse the site through sections 24 and 25, and 22 and 27 respectively (figure 4). Feth and others (1966) depict an inferred north-south-trending fault crossing the extreme western part of the proposed landfill through section 20. Evidence for this fault was inferred by the presence of a series of warm springs rising to the surface in a somewhat linear pattern. Numerous other pre-Quaternary faults have been mapped west of the site in the Promontory Mountains (Olson, 1956). Except for the Wasatch fault, none of the faults mentioned have shown movement during Quaternary time, and none of the inferred faults crossing the site show evidence of surface rupture.

The proposed landfill lies in Utah Seismic Safety Advisory Council zone U-4 and the Uniform Building Code seismic zone 3. The three inferred faults beneath the site show no evidence of surface rupture or recent movement. However, earthquakes produced along the active Wasatch fault zone to the east could adversely affect the landfill. In the event of a major earthquake, the site can expect to experience strong ground shaking, possibly resulting in soil liquefaction and lateral spreading. These conditions could cause cracking or rupture of refuse cells, permitting leachate contamination of shallow unconfined ground water and surface waters.

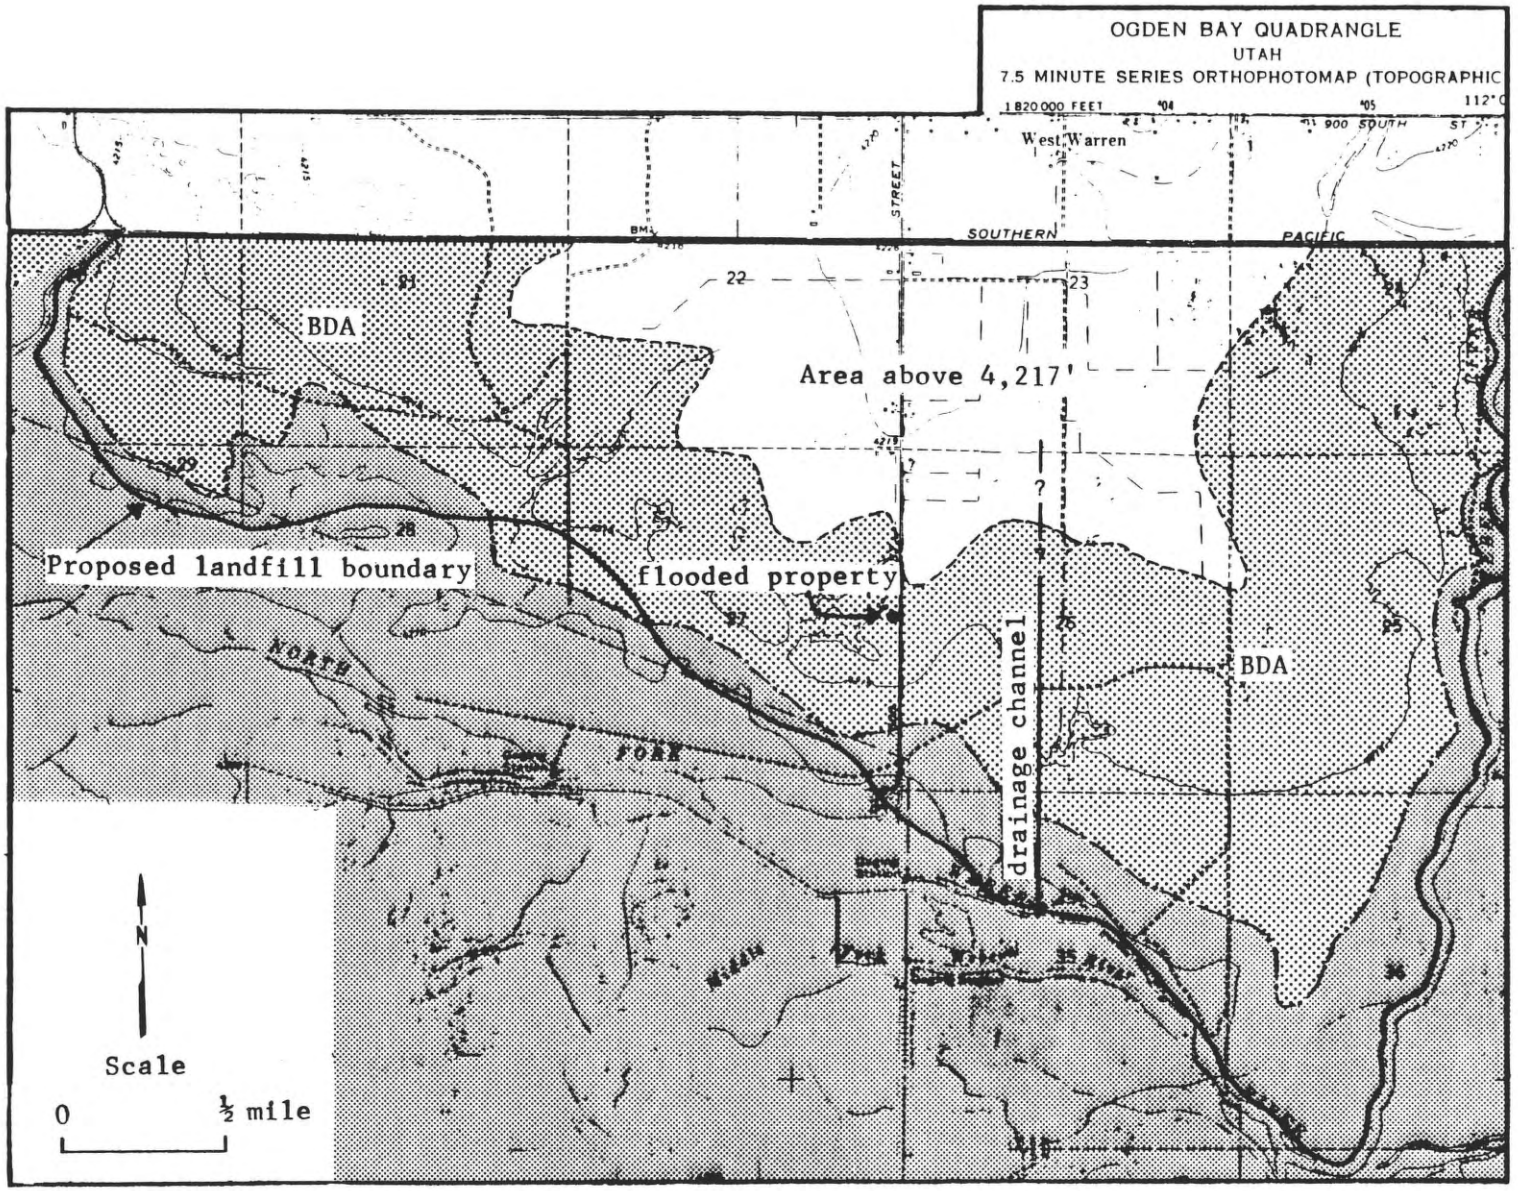
Figure 5. Proposed landfill site showing flooded property (•), drainage channel, Beneficial Development Area (BDA) of the Great Salt Lake (▨), and 100-year flood hazard zone of the Weber River (▨).

At the proposed landfill, areas bordering the Weber River, OBWMA, and the North Fork of the Weber River lie in the 100-year flood hazard zone of the Weber River (Federal Emergency Management Agency, 1982; figure 5). This zone generally extends to the 4,212-foot contour, the approximate historic extent of the Great Salt Lake, but does not include many natural marsh areas and lowlands currently inundated with water. In addition to natural drainages, canals, and ponds shown on the topographic map (figures 2 and 5), other areas not on the map currently sustain ponded surface water. A private residence located just west of 7500 West Street near the center of section 26 was flooded during early October of 1985 (figure 5). A water pump and drain pipes were visible in the front yard of this property. Furthermore, approximately one year ago the Weber County Department of Roads excavated a channel to facilitate drainage from section 26 south into the North Fork of the Weber River (Max Hunter, oral commun., Oct. 2, 1985) (figure 5).

Figure 5 shows a "Beneficial Development Area" (BDA) which covers all land around the Great Salt Lake shore area up to 4,217 feet in elevation. This elevation corresponds to a topographic threshold where the main body of the lake merges with shallow depressions in the Great Salt Lake Desert and to documented, prehistoric (10,000 years ago to the present) lake level rises (Currey and others, 1984). Geological evidence has shown that the Great Salt Lake has reached or exceeded 4,217 feet at least twice during the past 3,000 years (Currey and others, 1984). The most recent rise to 4,217 feet is believed to have occurred between 1670 and 1700 A.D. Geochemical modeling indicates that the Great Salt Lake may have reached or exceeded 4,217 feet as many as five times in the last 500 years (Utah Division of Comprehensive Emergency Management, 1985). Based on this information, policymakers have determined that land below 4,217 feet elevation is at risk from periodic flooding of the Great Salt Lake and recommend that further development is incompatible with flooding and should be discouraged below that elevation (Utah Division of Comprehensive Emergency Management, 1985). As shown on figure 5, most of the proposed landfill lies below 4,217 feet elevation, including the primary disposal area. Although approximately one-quarter

(about 960 acres) of the total proposed site lies above 4,217 feet elevation, this land could be affected by rising unconfined ground-water levels should the Great Salt Lake again rise to 4,217 feet.

A substantial portion of the proposed landfill lies below 4,217 feet elevation, in a Beneficial Development Area, where proposals have been made to limit or restrict land development due to flood potential of the Great Salt Lake. The long-term nature of a landfill further increases the risk of flooding.

Placing refuse above 4,215 feet elevation would probably prevent surface flooding of the landfill by a 100-year flood of the Weber River. However, documented rises of the Great Salt Lake to 4,217 feet and greater within prehistoric time show that most of the landfill site is at risk from periodic lake flooding. Moreover, it has been predicted that the lake could again rise to 4,217 feet (McKenzie and Gregor, 1985). If near average precipitation ensues in the future, the Great Salt Lake should decline from its current elevation. However, considering that the expected life of the proposed landfill has been estimated at 100 years, there is a realistic possibility that the Great Salt Lake could reach levels that would detrimentally affect the landfill, through direct surface flooding and/or rising of the shallow, unconfined ground-water table within this time frame. This possibility should be incorporated in planning for facilities located within close proximity of the lake.
