UTAH GEOLOGICAL AND MINERAL SURVEY

REPORT OF INVESTIGATION

NO. 208

TECHNICAL REPORTS FOR 1985
SITE INVESTIGATION SECTION

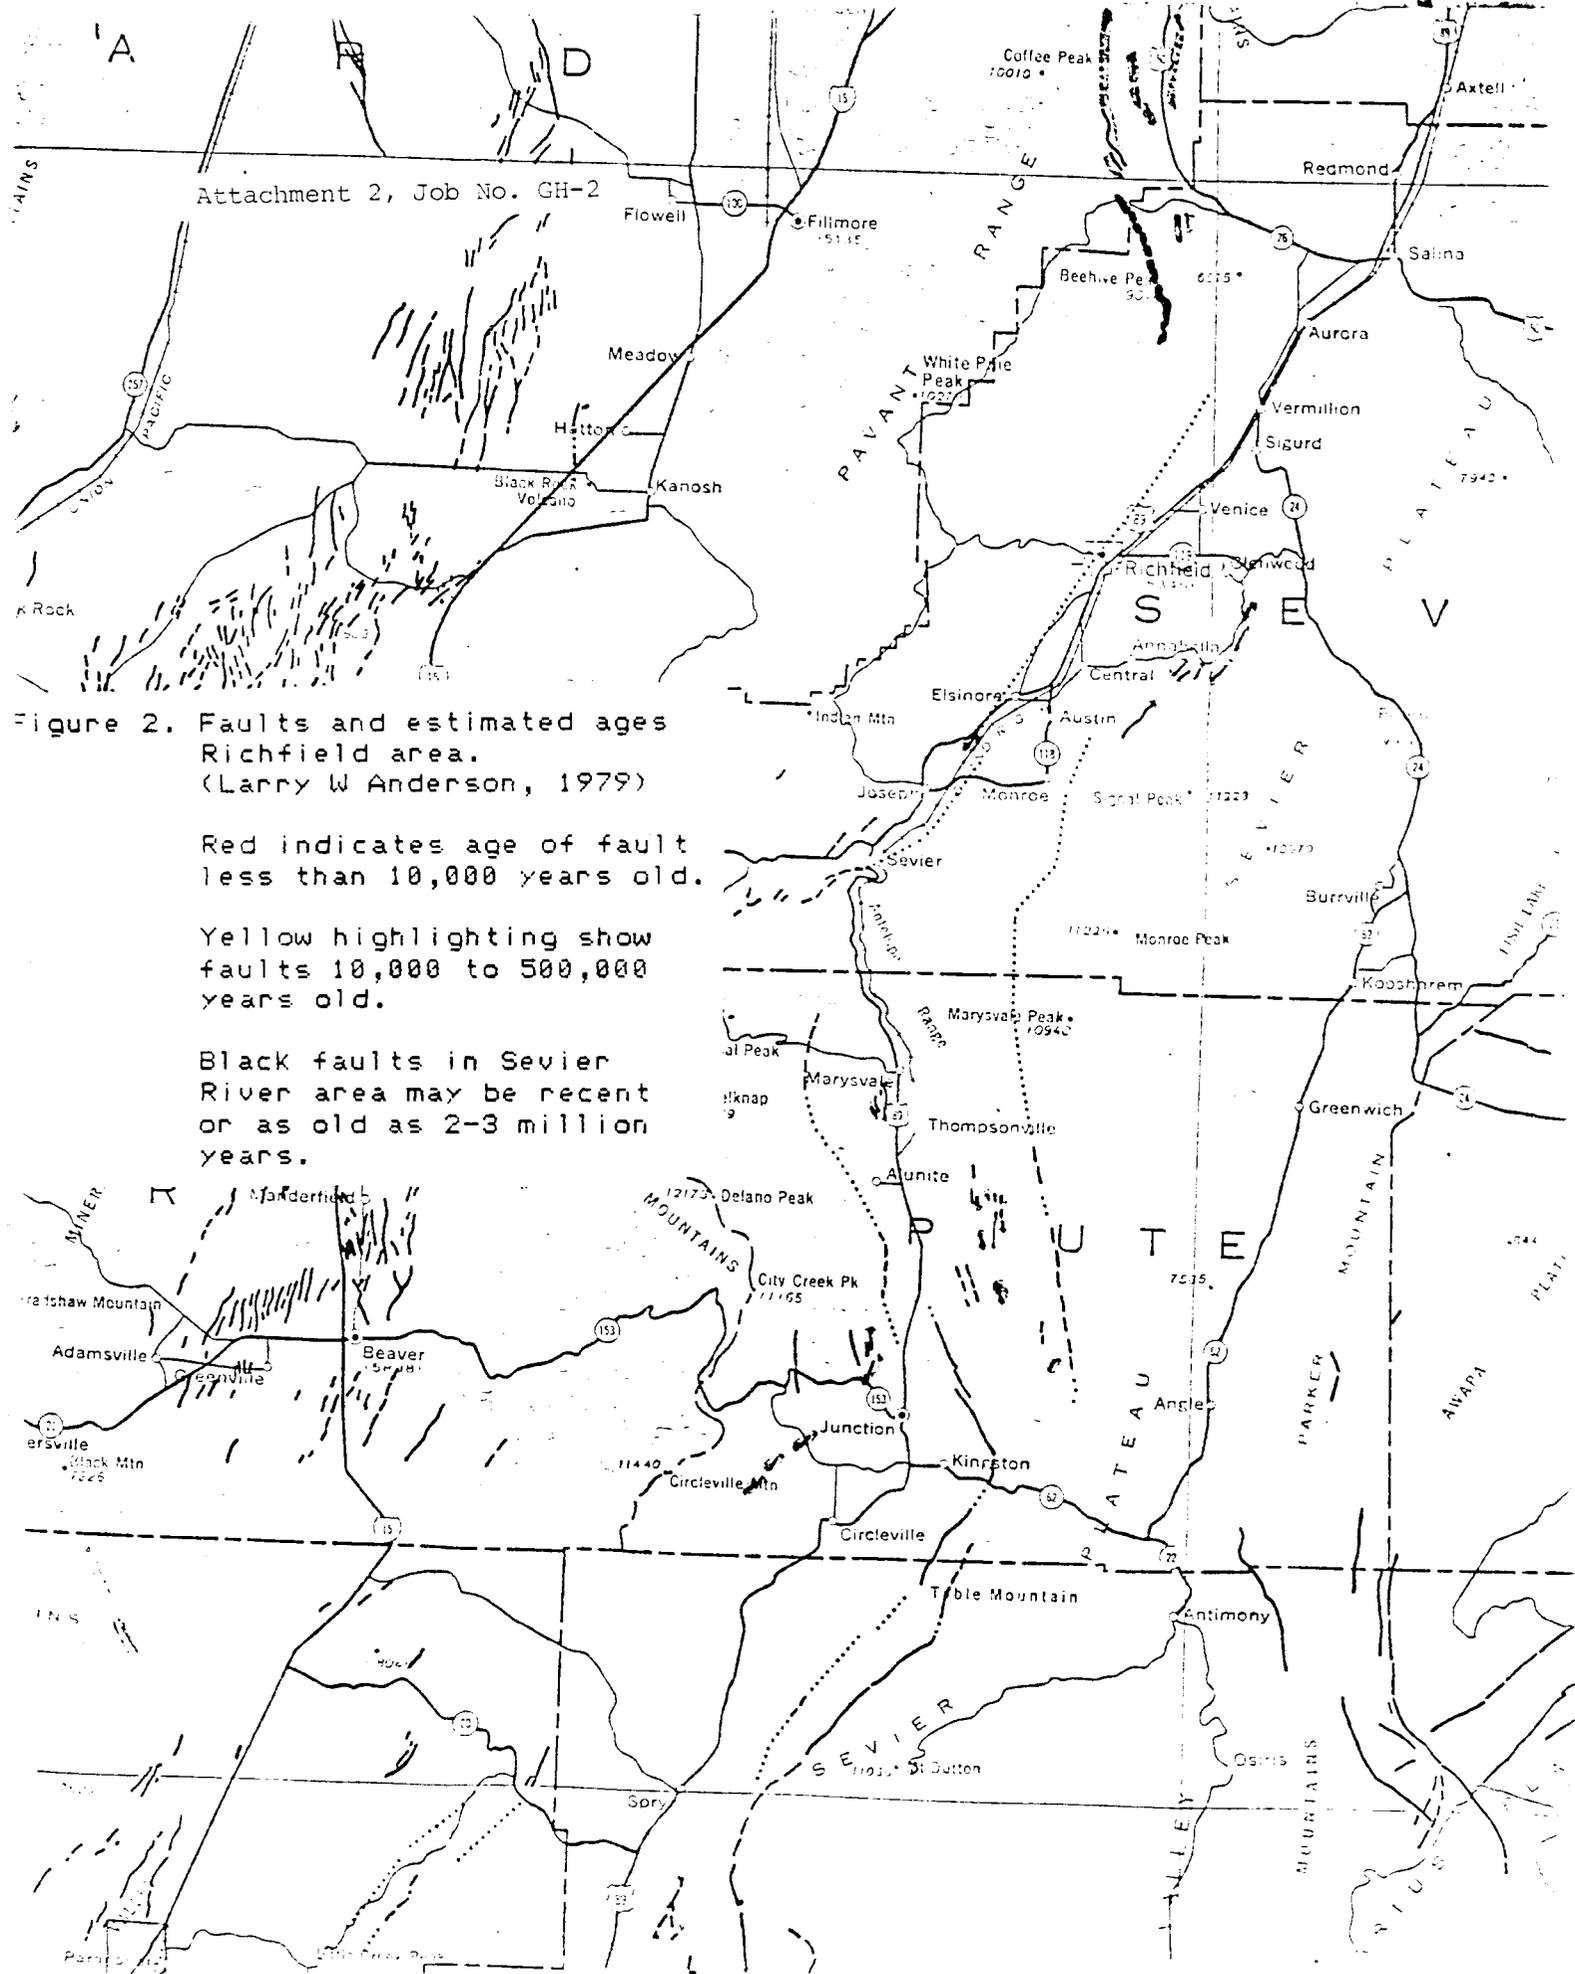
Figure 2. Faults and estimated ages Richfield area. (Larry W Anderson, 1979)

Figure 2 shows the surface faults in the Sevier River Valley as reported by Anderson and Miller (1979). Figure 3 (Arabasz and others, 1979) shows epicenters in the Richfield area greater than magnitude 1. The Elsinore Fault is inferred to be along the west edge of the Sevier River Valley. A second inferred fault along the east edge of the valley may also be an extension of the Sevier Fault. According to the University of Utah Seismograph Station a magnitude 7.0 earthquake occurred near Richfield on November 14, 1901, at approximately 4:40 a.m. and was followed by several aftershocks of magnitude 2. The Intensity is recorded as 8 to 9. This was Utah's largest historic earthquake. A 1921 event centered near Elsinore had a magnitude of about 5 with a minimum Intensity of 5. Four aftershocks ranging in magnitude from 2.3 to 4.3 were recorded over a period of two days. Earthquakes in Utah were not instrumented before 1962, therefore, magnitudes of pre-1962 events have been estimated from the intensity of the earthquakes using a arithmetic relationship. Figure 4 is a computer plot of south central Utah earthquake epicenters of magnitude greater than 1 that occurred between 1850 and 1983 (data courtesy of University of Utah Seismograph Station).

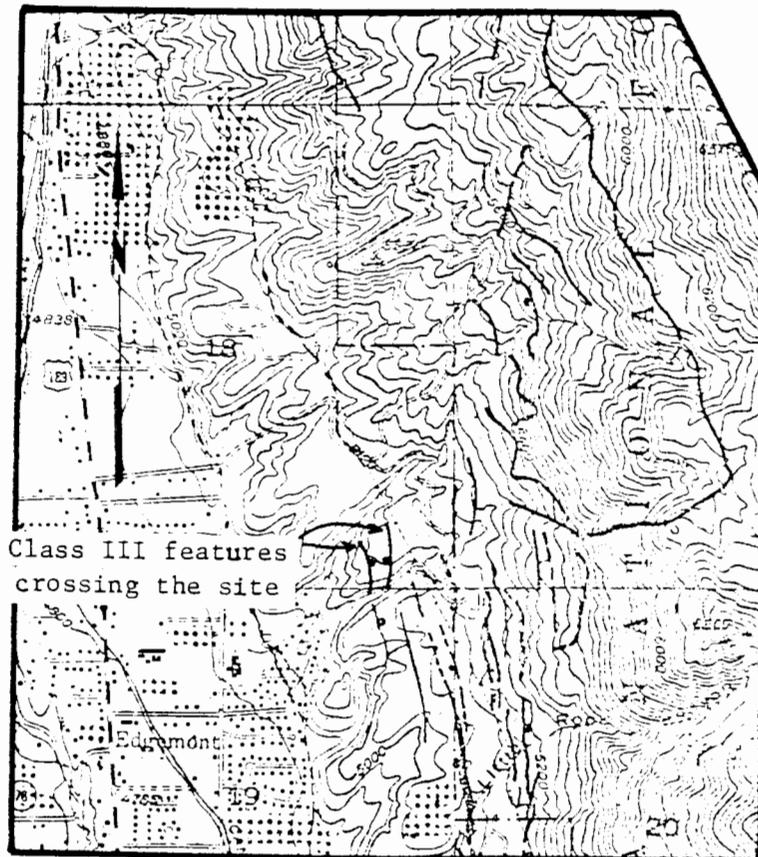
Class III features
crossing the site
