Landslide Investigation of Timber Lakes Estates, Wasatch County, Utah: Landslide Inventory and Preliminary Geotechnical-Engineering Slope Stability Analysis

MISCELLANEOUS PUBLICATION 05-9 November 2005
UTAH GEOLOGICAL SURVEY
a division of
UTAH DEPARTMENT OF NATURAL RESOURCES

**Landslide Investigation of Timber Lakes Estates, Wasatch County,
Utah: Landslide Inventory and Preliminary Geotechnical-Engineering
Slope Stability Analysis**

Revised March 31, 2005

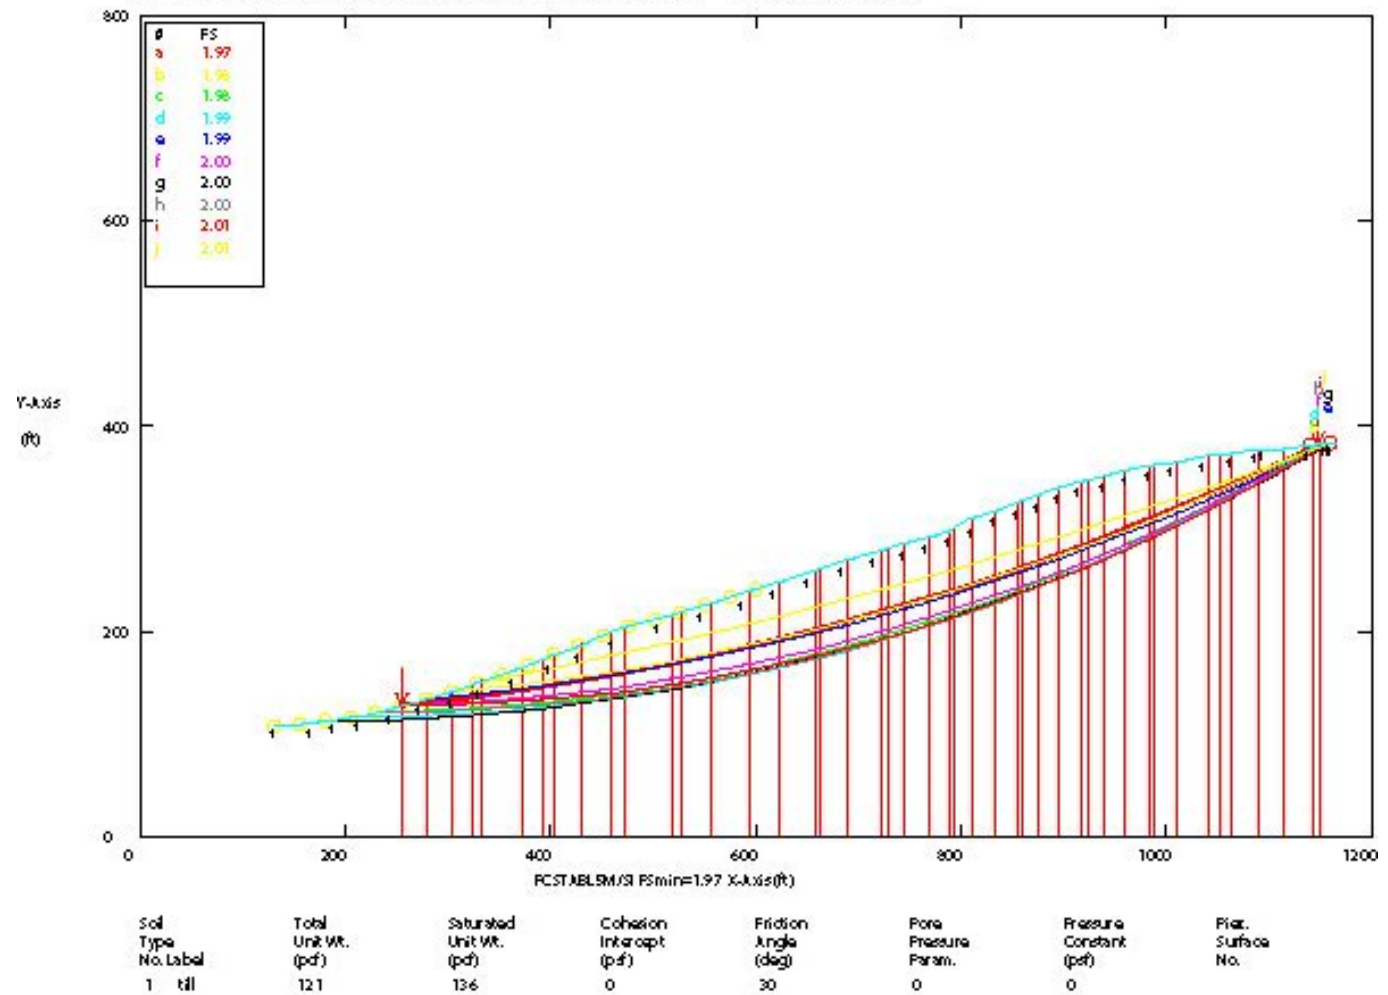
Cedar Bark Slide - Initiation

Peak Friction Angles (Case 1): We estimated peak friction angles of 16, 22 and 29 degrees under dry conditions, mid-level water table, and total saturation of the slide, respectively (Fig. 8, Table 4). Sample stability analyses are shown in Figure 9.

Figure 9a. Ten most critical slip surfaces of Cedar Bark landslide (Case 1 analysis) with no groundwater in the slide mass.

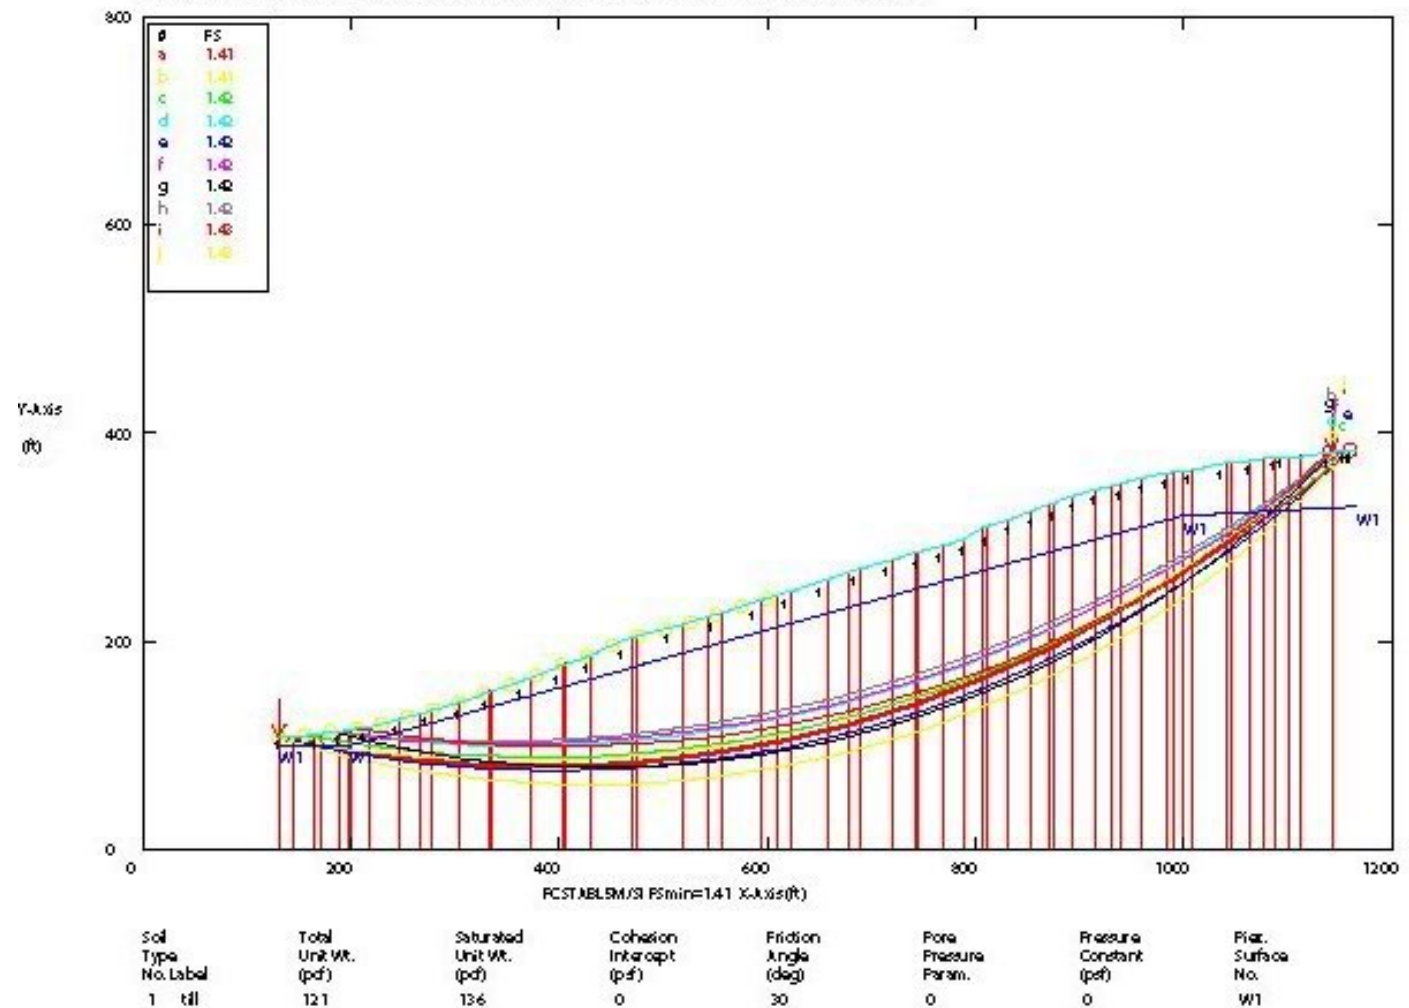
Cedar Bark Slide - Initiation

Figure 9b. Ten most critical slip surfaces of Cedar Bark landslide (Case 1 analysis) with groundwater mid-level in the slide mass.

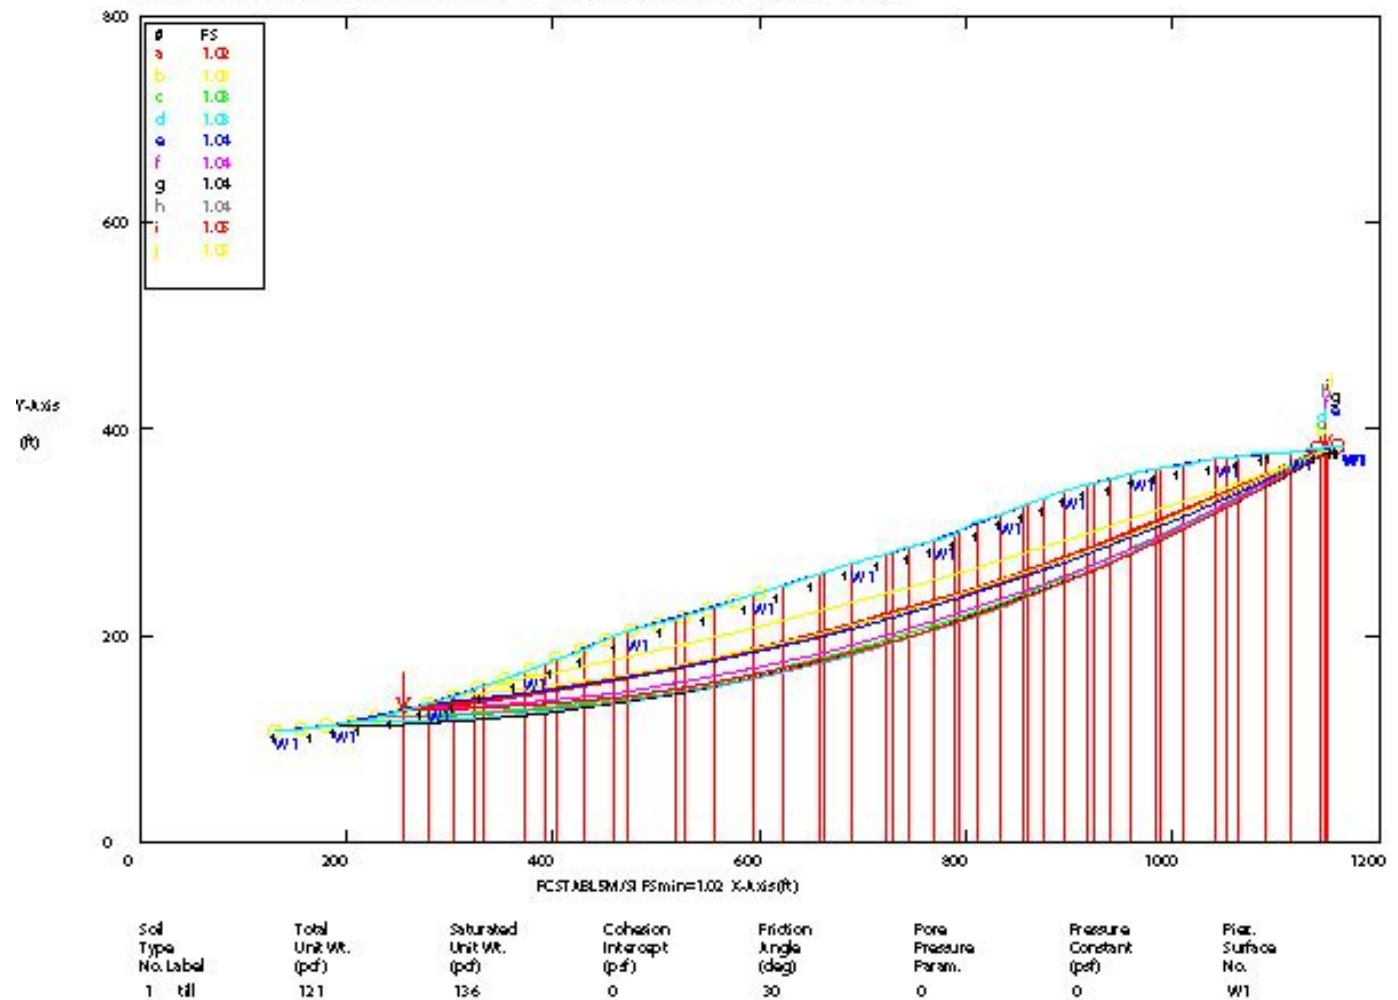
Cedar Bark Slide - Initiation

Figure 9c. Ten most critical slip surfaces of Cedar Bark landslide (Case 1 analysis) with groundwater saturating the slide mass.

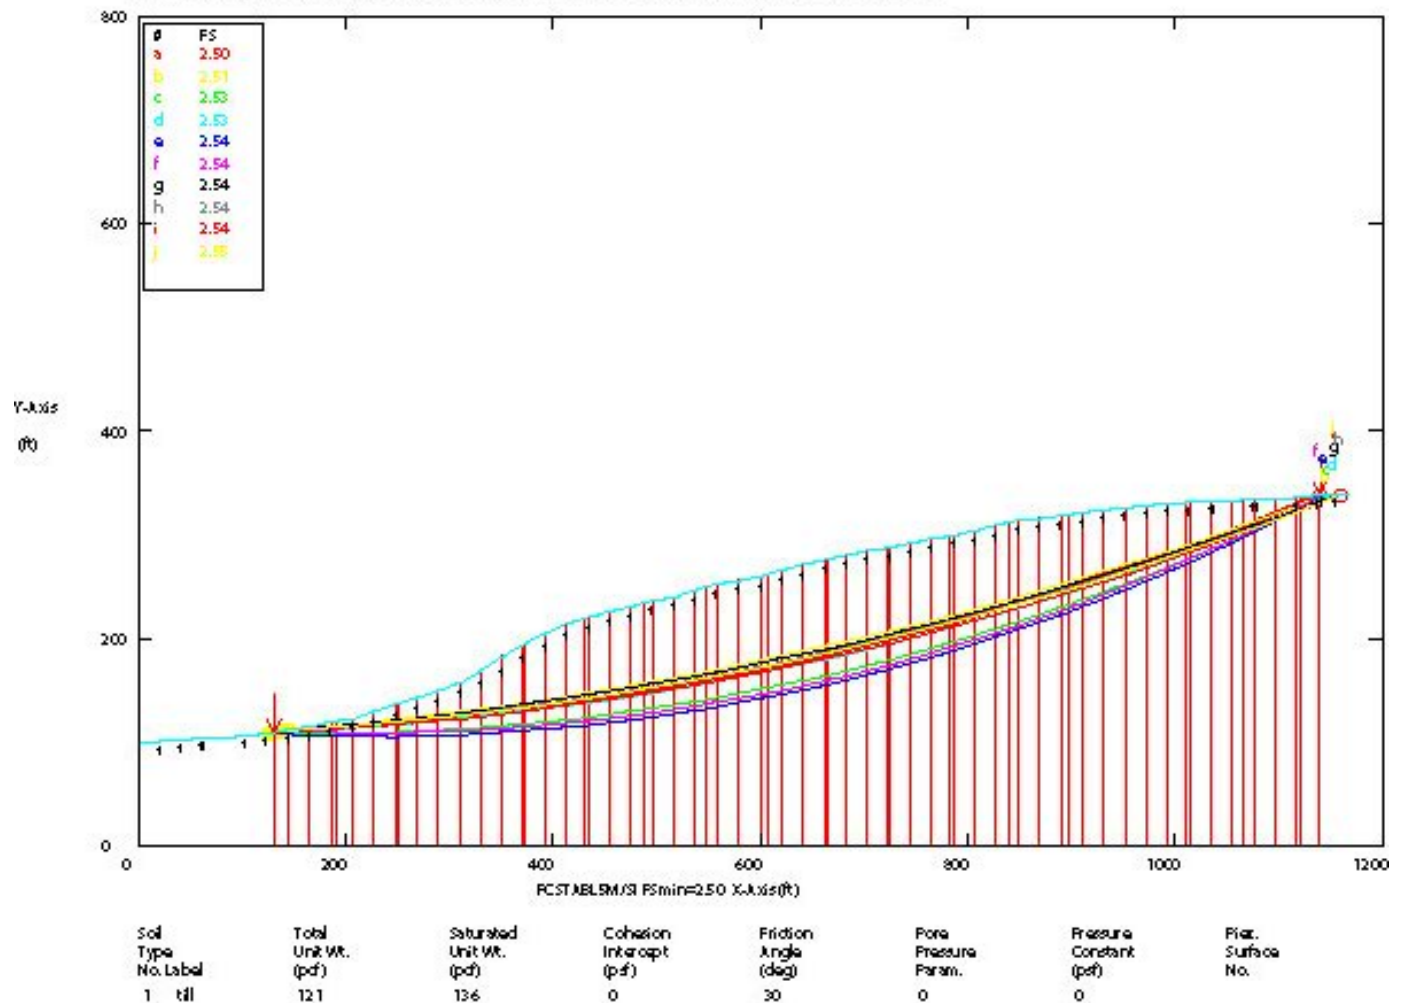
Cedar Bark Slide - Entire Slide Mass

Residual Friction Angles (Case 2): The factor of safety was greater than 1.0 for residual friction angles as low as 15 degrees under dry conditions (Fig. 10, Table 4). The factor of safety was 1.0 at a lower bound residual friction angle of ~16 degrees and mid-level groundwater table. The lower bound residual friction angle was ~23 degrees under simulated conditions of groundwater saturation. Sample stability analyses are shown in Figure 11.

Figure 11a. Ten most critical slip surfaces of Cedar Bark landslide (Case 2 analysis) with no groundwater in the slide mass.

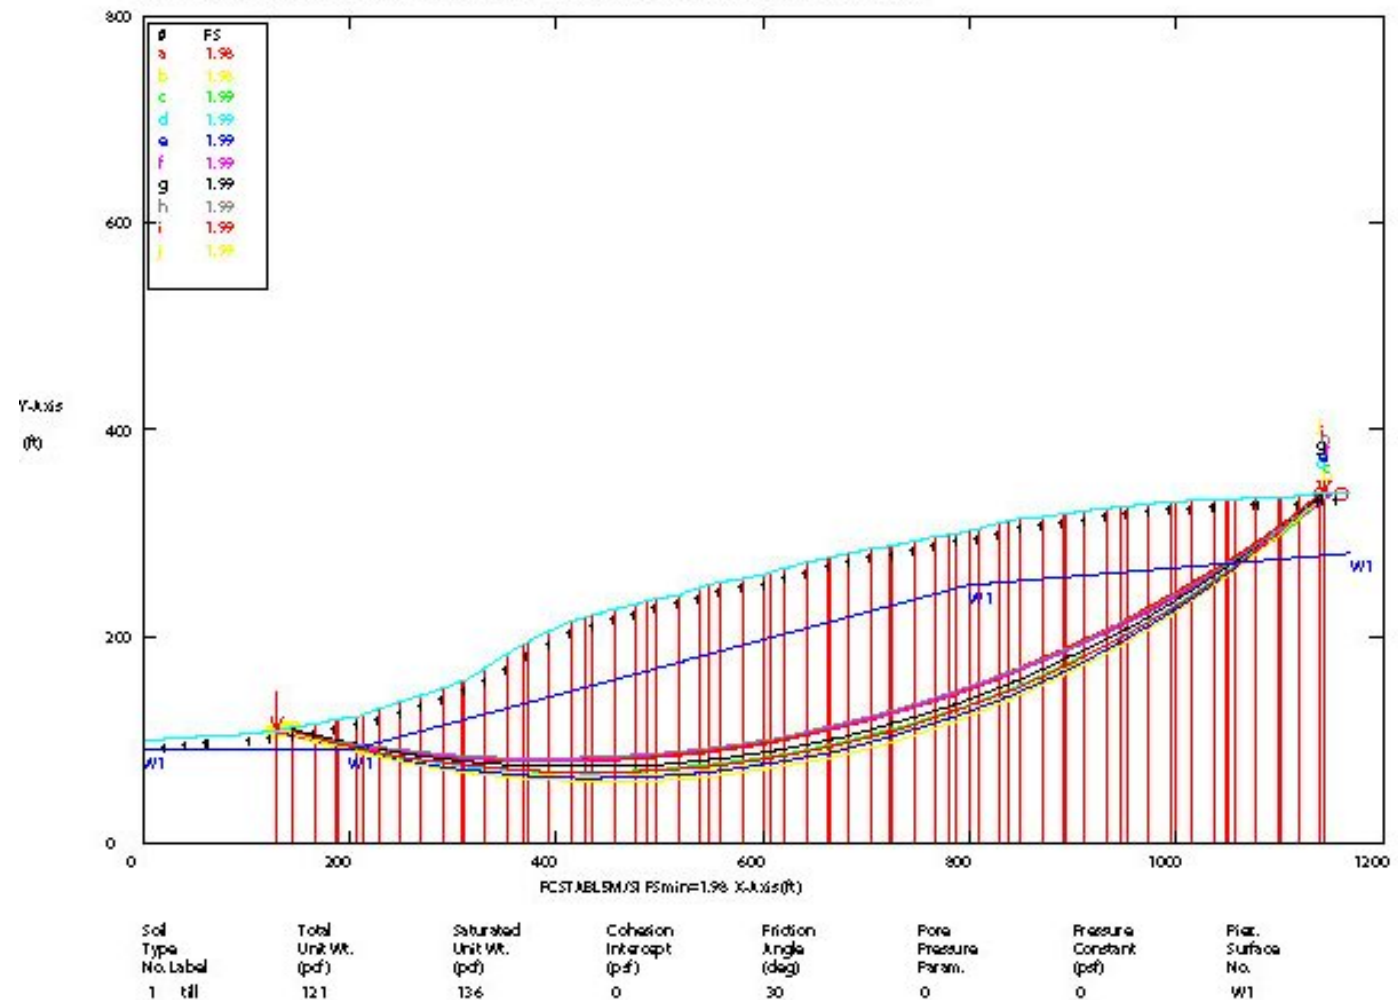
Cedar Bark Slide - Entire Slide Mass

Figure 11b. Ten most critical slip surfaces of Cedar Bark landslide (Case 2 analysis) with groundwater mid-level in the slide mass.

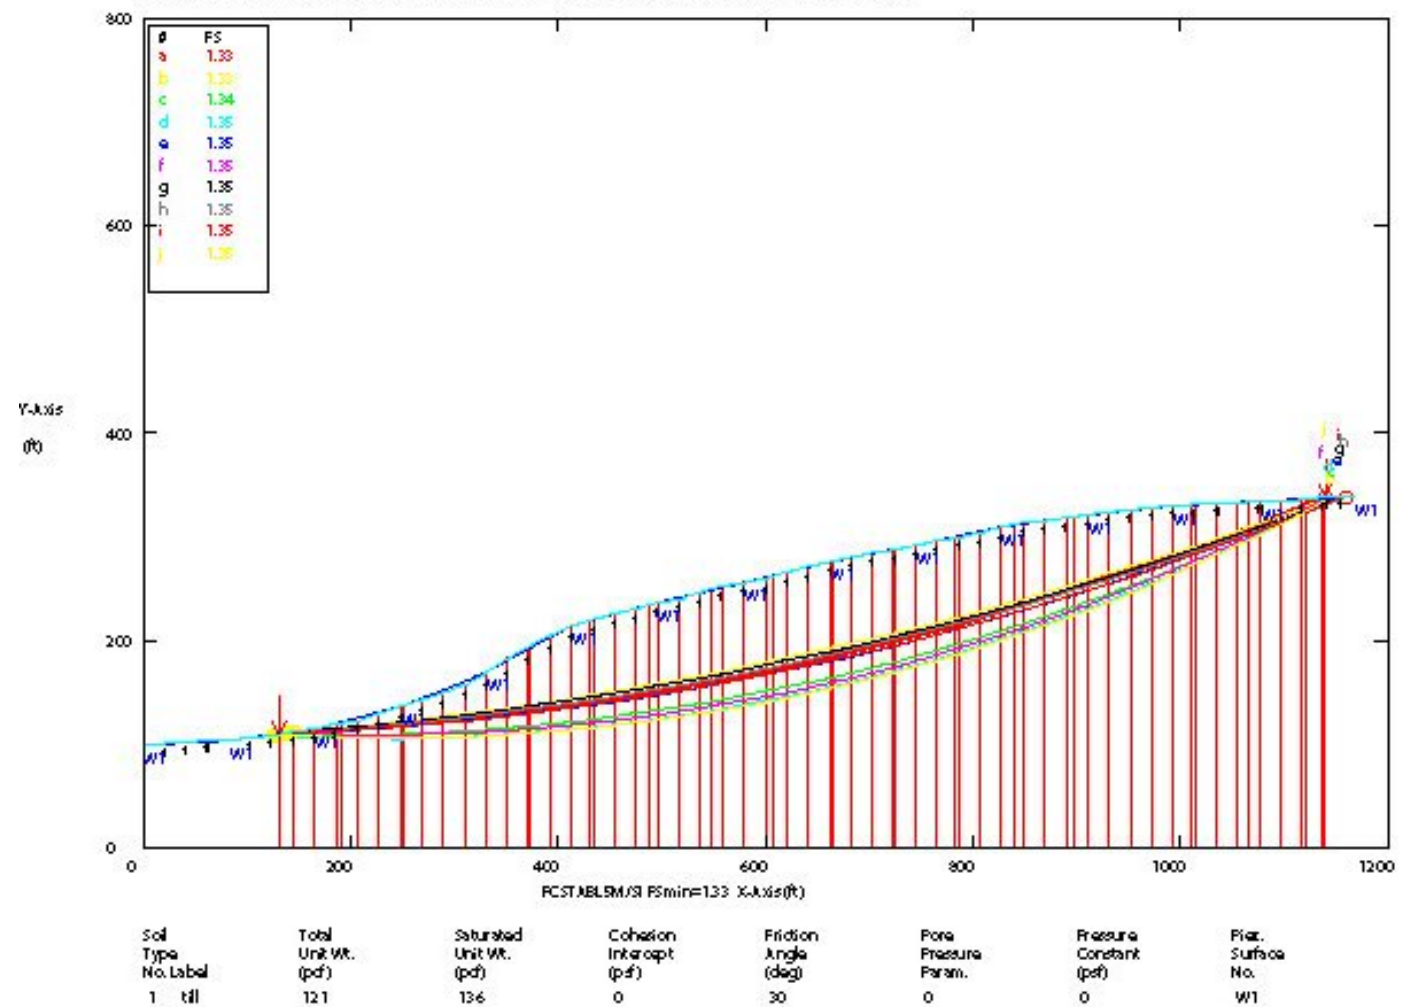
Cedar Bark Slide - Entire Slide Mass

Figure 11c. Ten most critical slip surfaces of Cedar Bark landslide (Case 2 analysis) with groundwater saturating the slide mass.

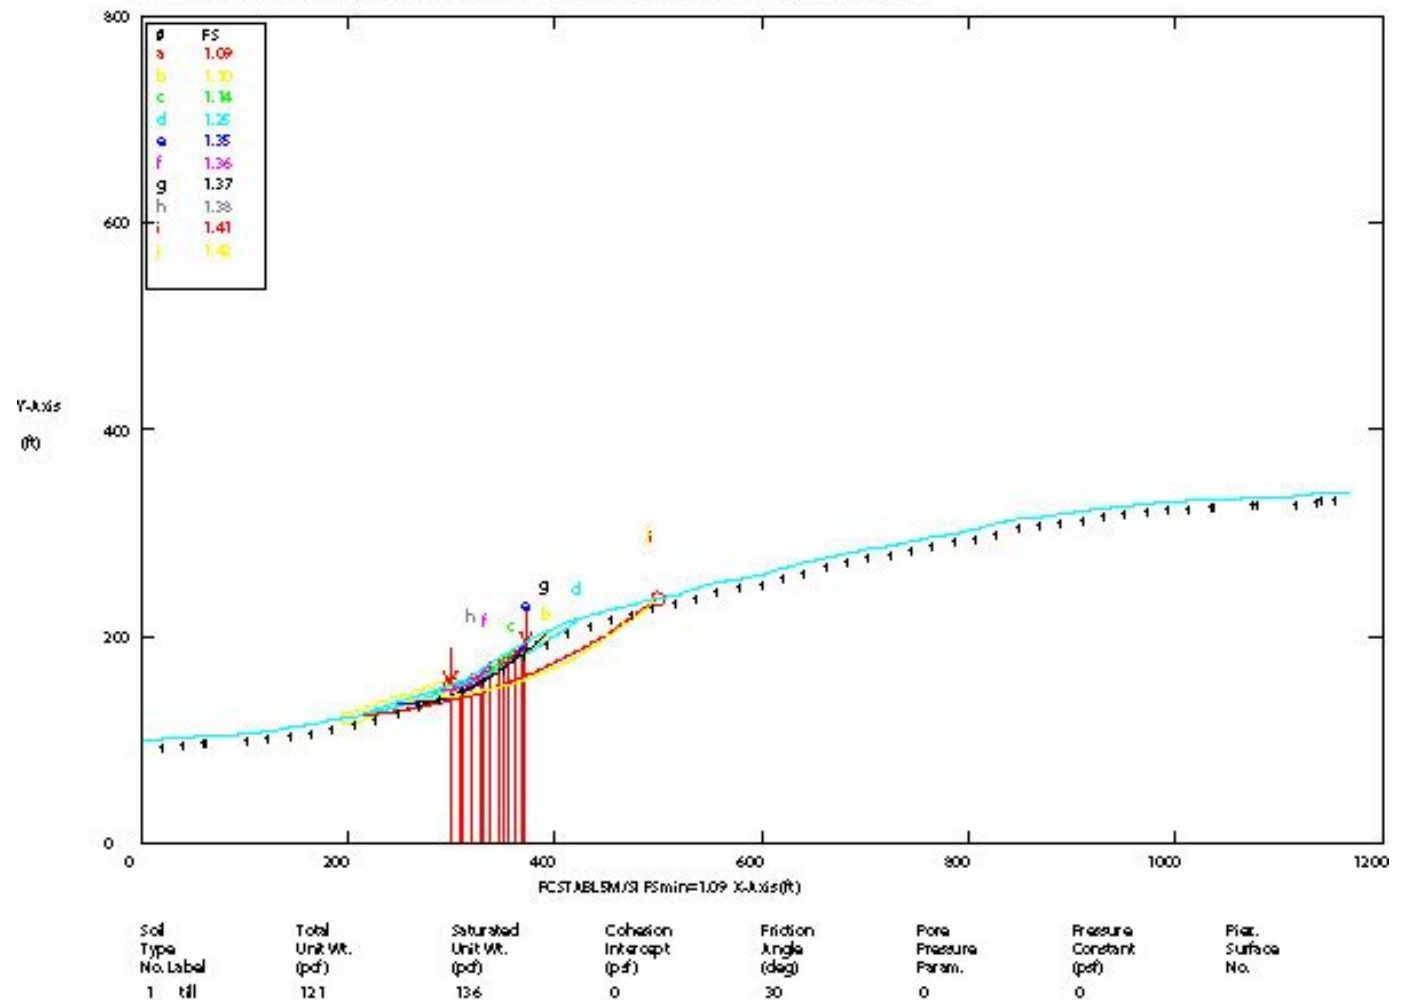
Cedar Bark Slide - Most Critical Area

Critical Segment (Case 3): The steep slope at the toe of the Cedar Bark slide is the most critical segment found by modeling (Fig. 12, Table 4). Debris slides and shallow slumps are probable under saturated conditions and possible under less than saturated conditions, given the projection of the friction angle curve between saturated and dry conditions for $FS = 1$ (Fig. 12; Table 4). Because the most critical segment has not yet failed, the peak friction angle for the glacial till must be greater than the minimum critical friction angle. Thus, the peak friction angle for the glacial till is greater than 27 degrees (Fig. 12; Table 4), provided cohesion is negligible and the materials that compose the most critical area are representative of materials at greater depth within the Cedar Bark slide. Sample stability analyses are shown in Figure 13.

Figure 13a. Ten most critical slip surfaces of Cedar Bark landslide (Case 3 analysis) with no groundwater in the slide mass.

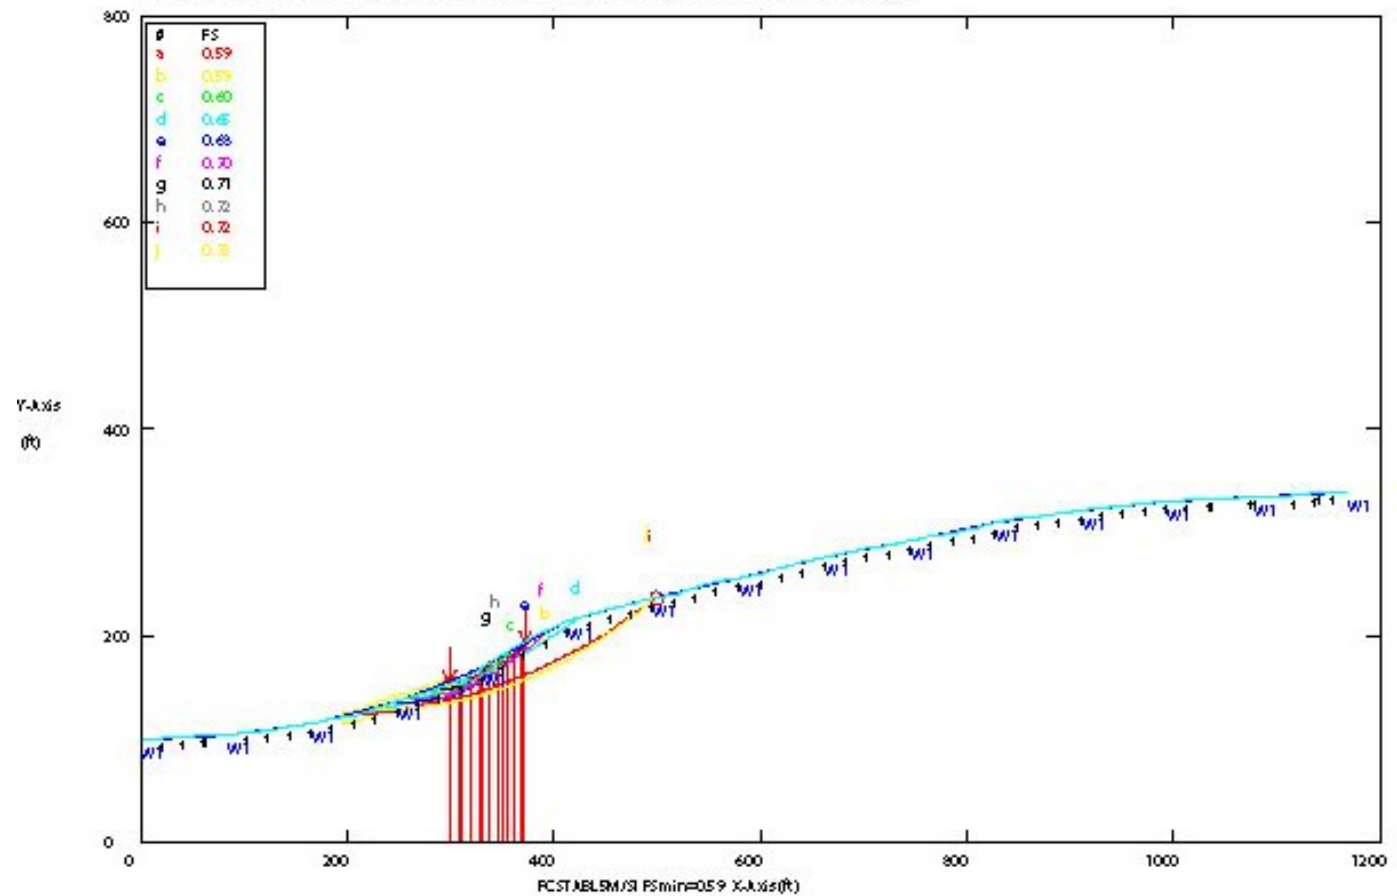
Cedar Bark Slide - Most Critical Area

Figure 13b. Ten most critical slip surfaces of Cedar Bark landslide (Case 3 analysis) with groundwater saturating the slide mass.

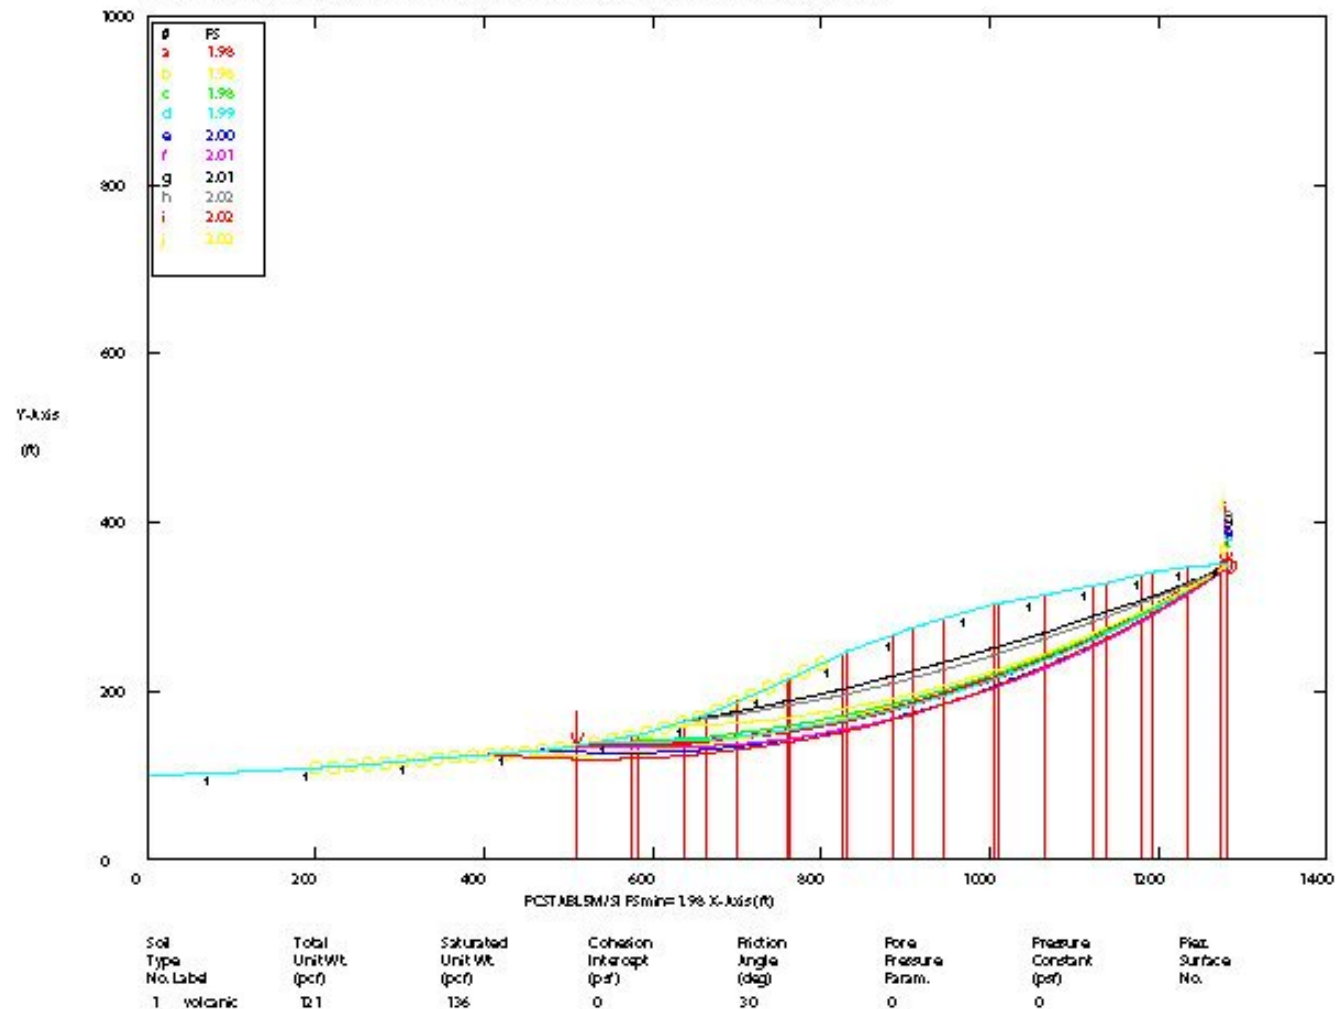
Beaver Bench Slide - Initiation

Peak Friction Angles (Case 1): We estimated peak friction angles of 16, 20 and 29 degrees under dry conditions, mid-level water table, and total saturation of the slide, respectively (Fig. 14, Table 5). Sample stability analyses are shown in Figure 15.

Figure 15a. Ten most critical slip surfaces of Beaver Bench landslide (Case 1 analysis) with no groundwater in the slide mass.

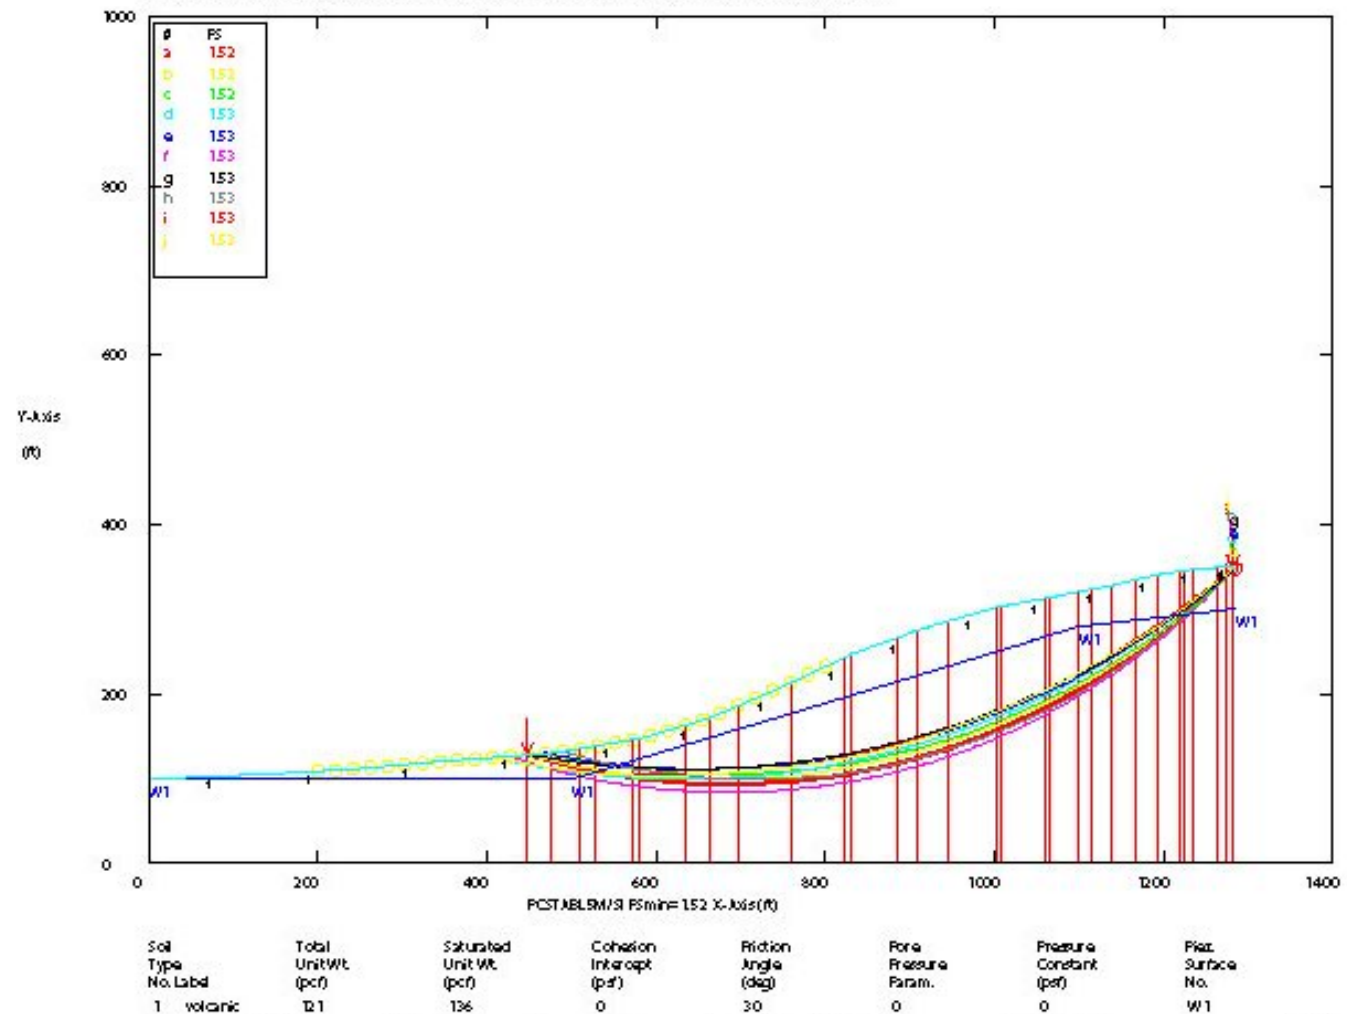
Beaver Bench Slide - Initiation

Figure 15b. Ten most critical slip surfaces of Beaver Bench landslide (Case 1 analysis) with groundwater mid-level in the slide mass.

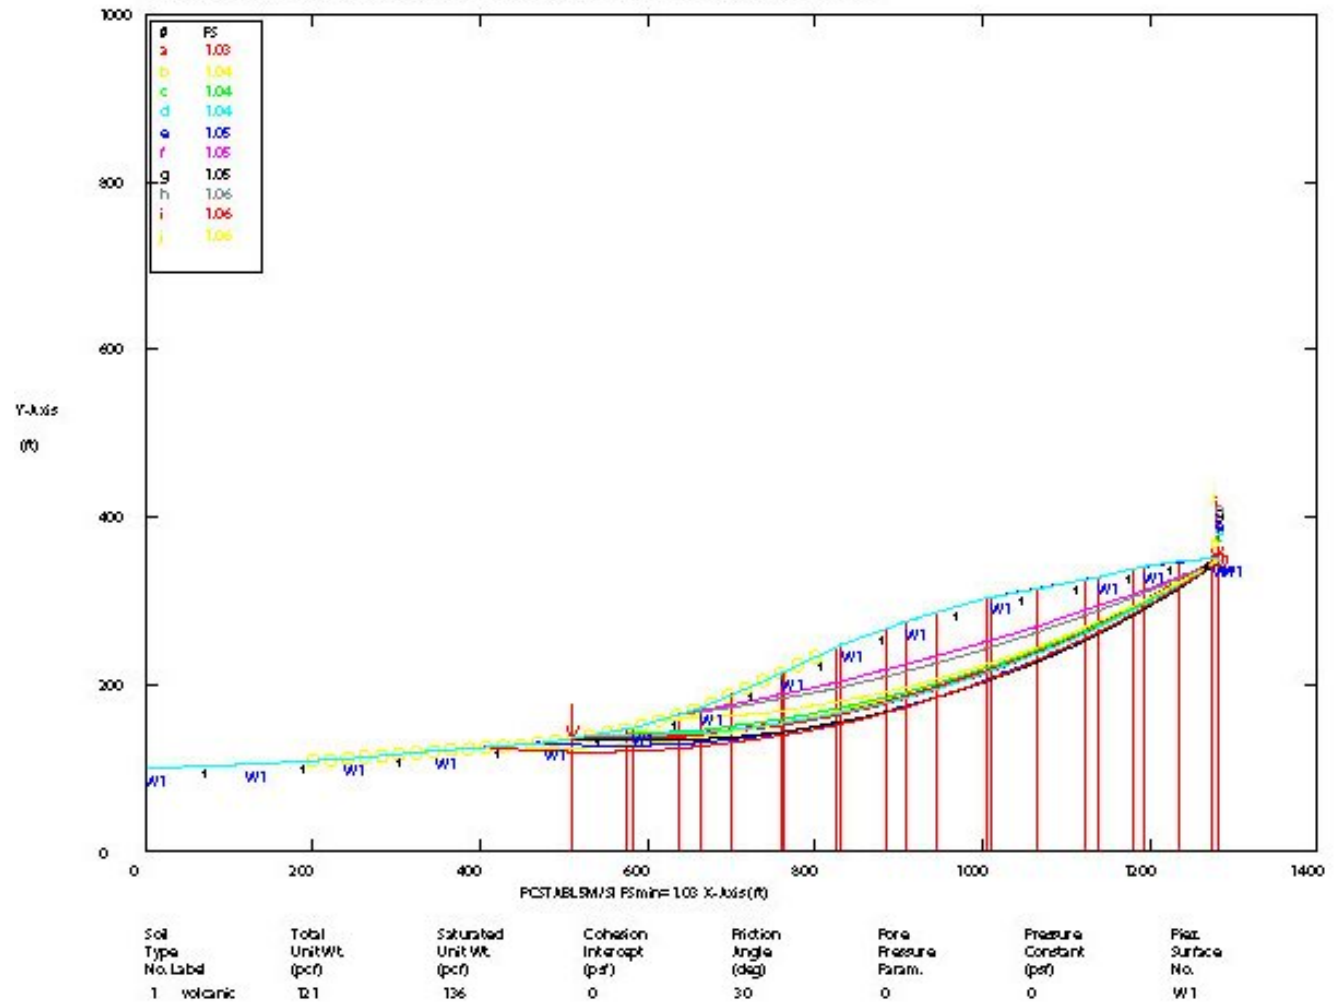
Beaver Bench Slide - Initiation

Figure 15c. Ten most critical slip surfaces of Beaver Bench landslide (Case 1 analysis) with groundwater saturating the slide mass.

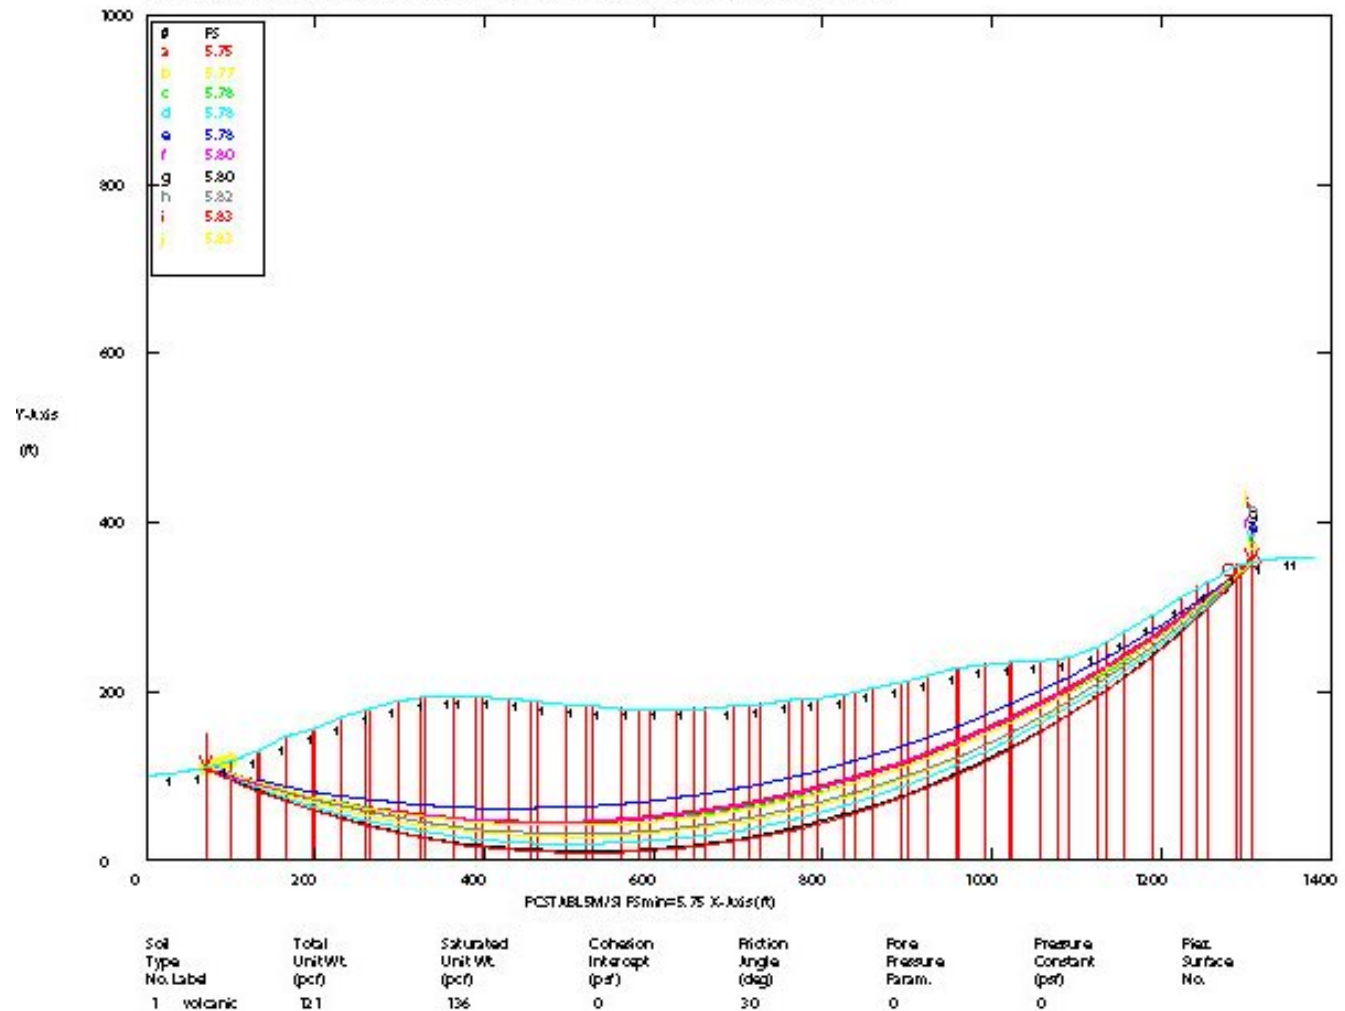
Beaver Bench Slide - Entire Slide Mass

Residual Friction Angles (Case 2): The factor of safety is greater than 1.0 even for very low friction angles of 15 degrees and saturated groundwater conditions (Fig. 16, 17; Table 5). Extrapolating from Figure 16, the residual friction angle under fully saturated groundwater conditions is approximately 12 degrees. Sample stability analyses are shown in Figure 17.

Figure 17a. Ten most critical slip surfaces of Beaver Bench landslide (Case 2 analysis) with no groundwater in the slide mass.

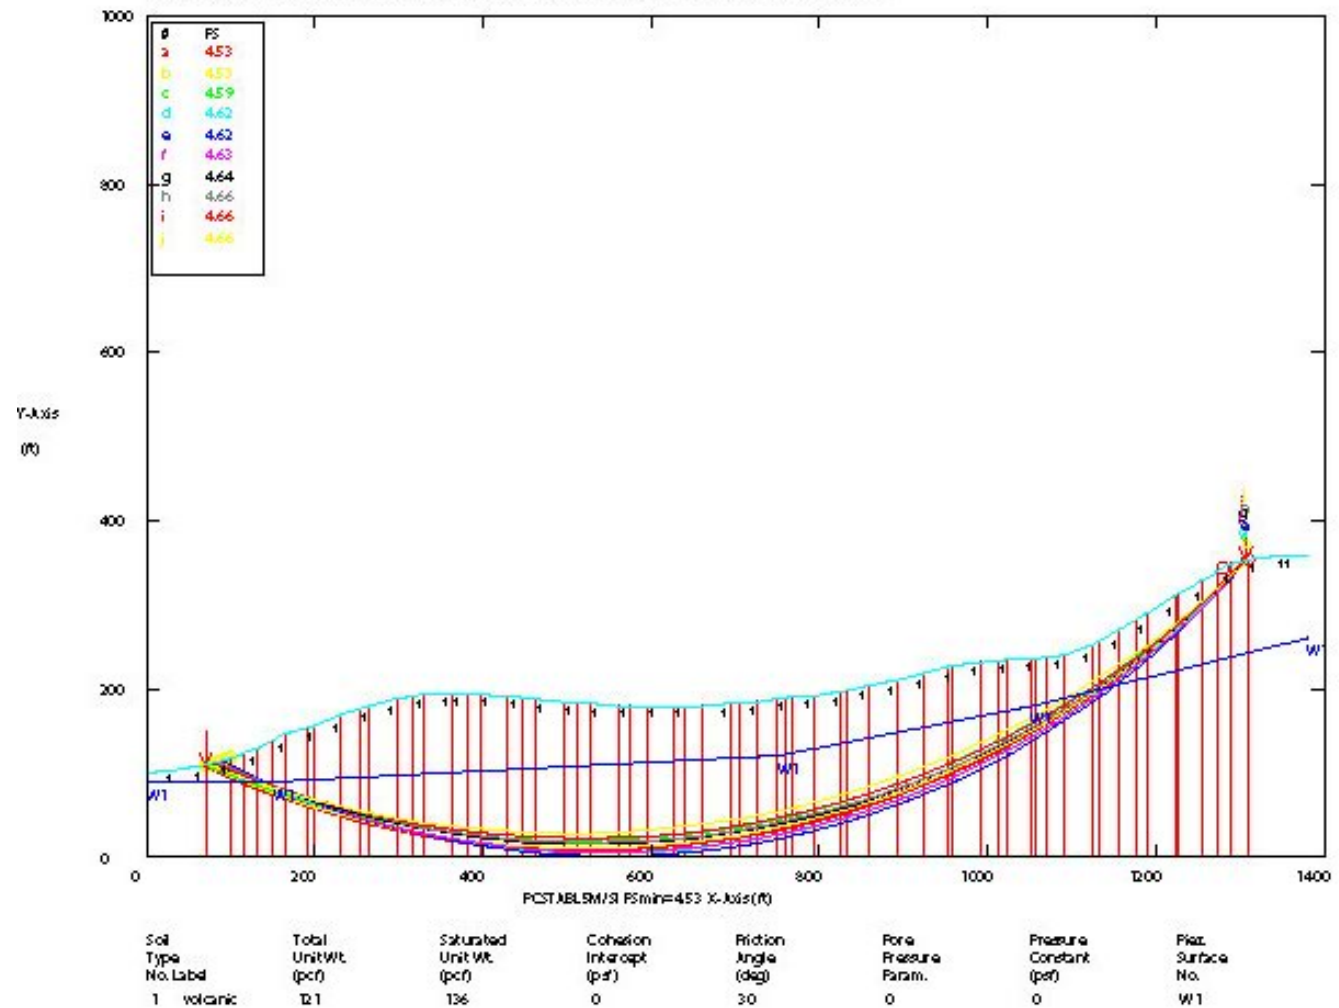
Beaver Bench Slide - Entire Slide Mass

Figure 17b. Ten most critical slip surfaces of Beaver Bench landslide (Case 2 analysis) with groundwater mid-level in the slide mass.

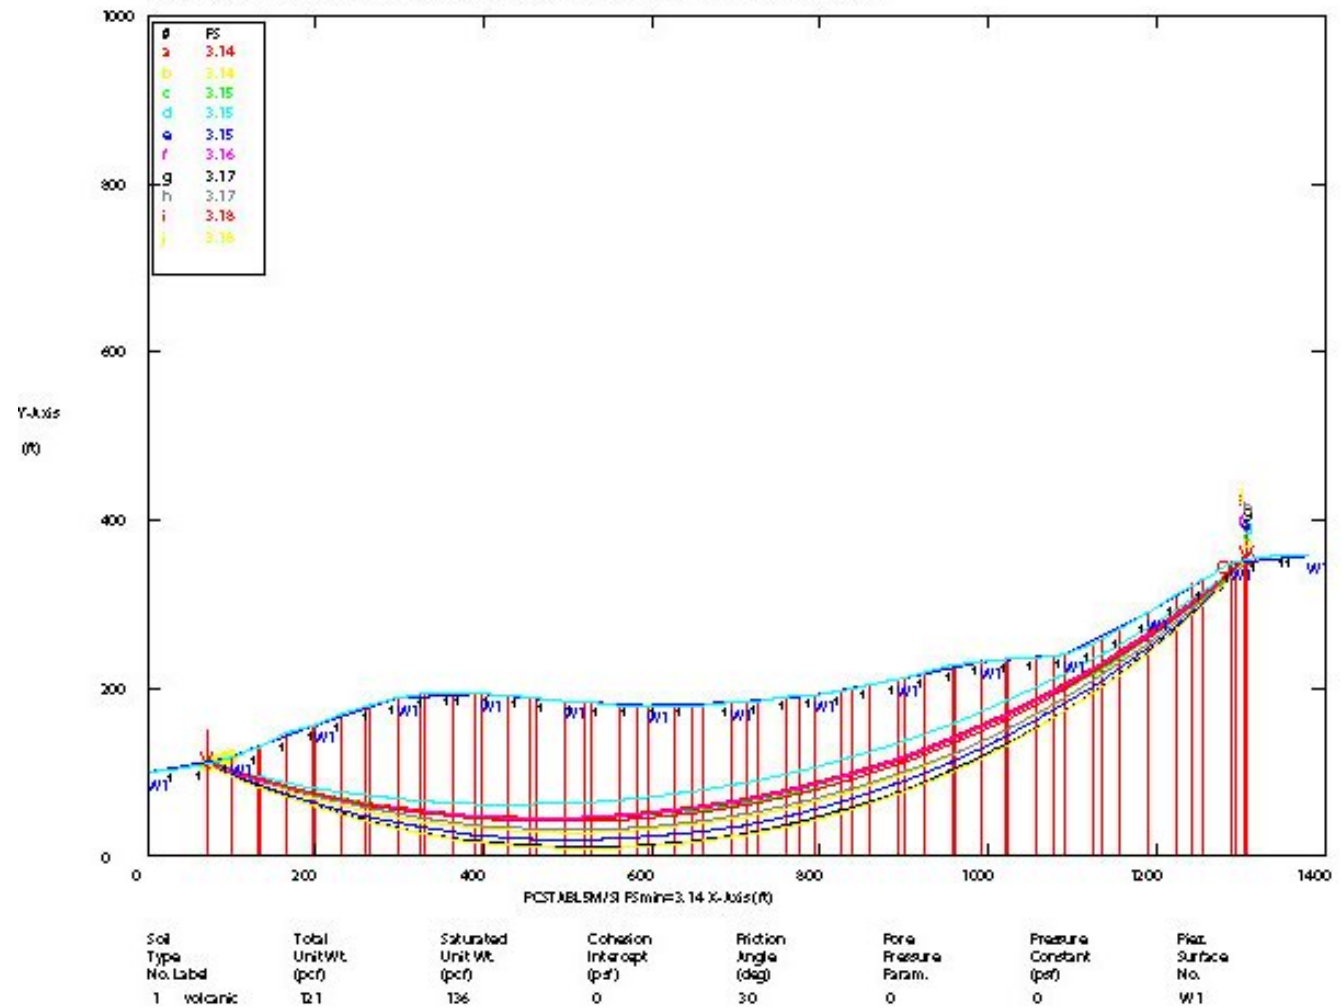
Beaver Bench Slide - Entire Slide Mass

Figure 17c. Ten most critical slip surfaces of Beaver Bench landslide (Case 2 analysis) with groundwater saturating the slide mass.

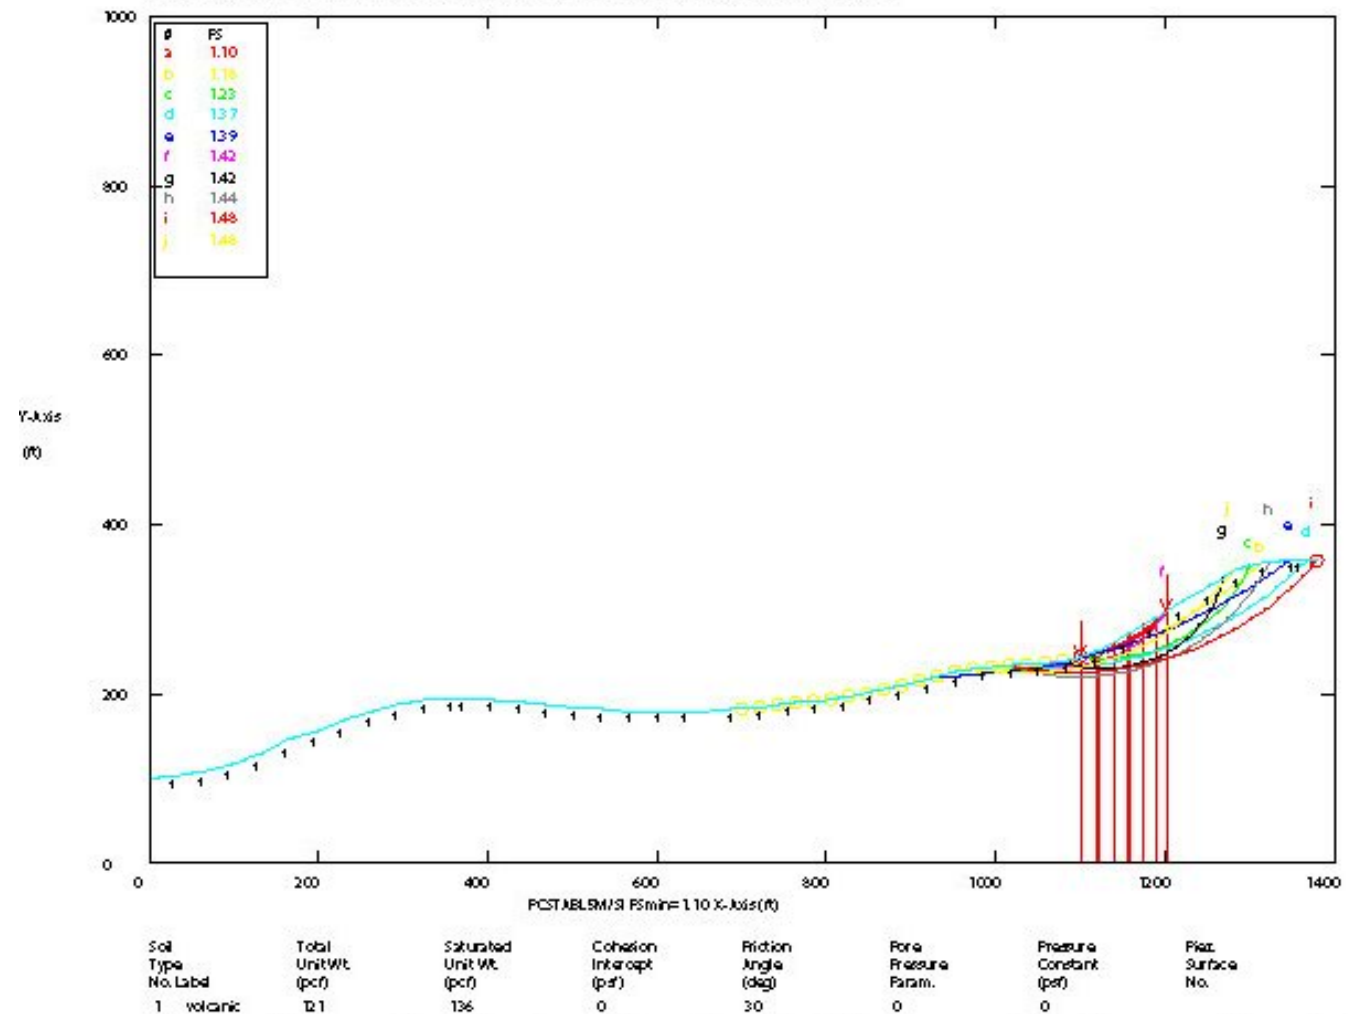
Beaver Bench Slide - Most Critical Area

Critical Segment (Case 3): The steep slope formed by the main scarp is the most critical segment identified by stability modeling (Fig. 18, Table 5), although the steep toe of the slide is nearly as critical. Debris slides and shallow slumps are probable under saturated groundwater conditions and possible under less than saturated conditions, given the projection of the friction angle curve between saturated and dry conditions for $FS = 1$ (Fig. 18; Table 5). Because the most critical segment has not yet failed, the peak friction angle for the Keetley Volcanics must be greater than the minimum critical friction angle. Thus, the peak friction angle for the Keetley Volcanics is greater than 27 degrees (Fig. 18; Table 5), provided cohesion is negligible and the materials that compose the most critical area are representative of materials at greater depth within the Beaver Bench slide. Sample stability analyses are shown in Figure 19.

Figure 19a. Ten most critical slip surfaces of Beaver Bench landslide (Case 3 analysis) with no groundwater in the slide mass.

The least stable parts of the landslides are located on steep slopes bounded by abrupt change in topographic gradient (Fig. 13, 19, 25). There are several specific features worthy of comment. The toe of the Beaver Bench slide is almost as steep as the main scarp, which was identified as the least stable segment. The steep toe of the slide should also be treated with caution during development. Loading the toe from above by constructing buildings should be avoided. The toe could also be destabilized by erosion, but this would require unusually high and persistent flow in the small creek at the base of the Beaver Bench slide.
