Landslide Investigation of Timber Lakes Estates, Wasatch County, Utah: Landslide Inventory and Preliminary Geotechnical-Engineering Slope Stability Analysis

MISCELLANEOUS PUBLICATION 05-9 November 2005
UTAH GEOLOGICAL SURVEY
a division of
UTAH DEPARTMENT OF NATURAL RESOURCES

**Landslide Investigation of Timber Lakes Estates, Wasatch County,
Utah: Landslide Inventory and Preliminary Geotechnical-Engineering
Slope Stability Analysis**

Revised March 31, 2005

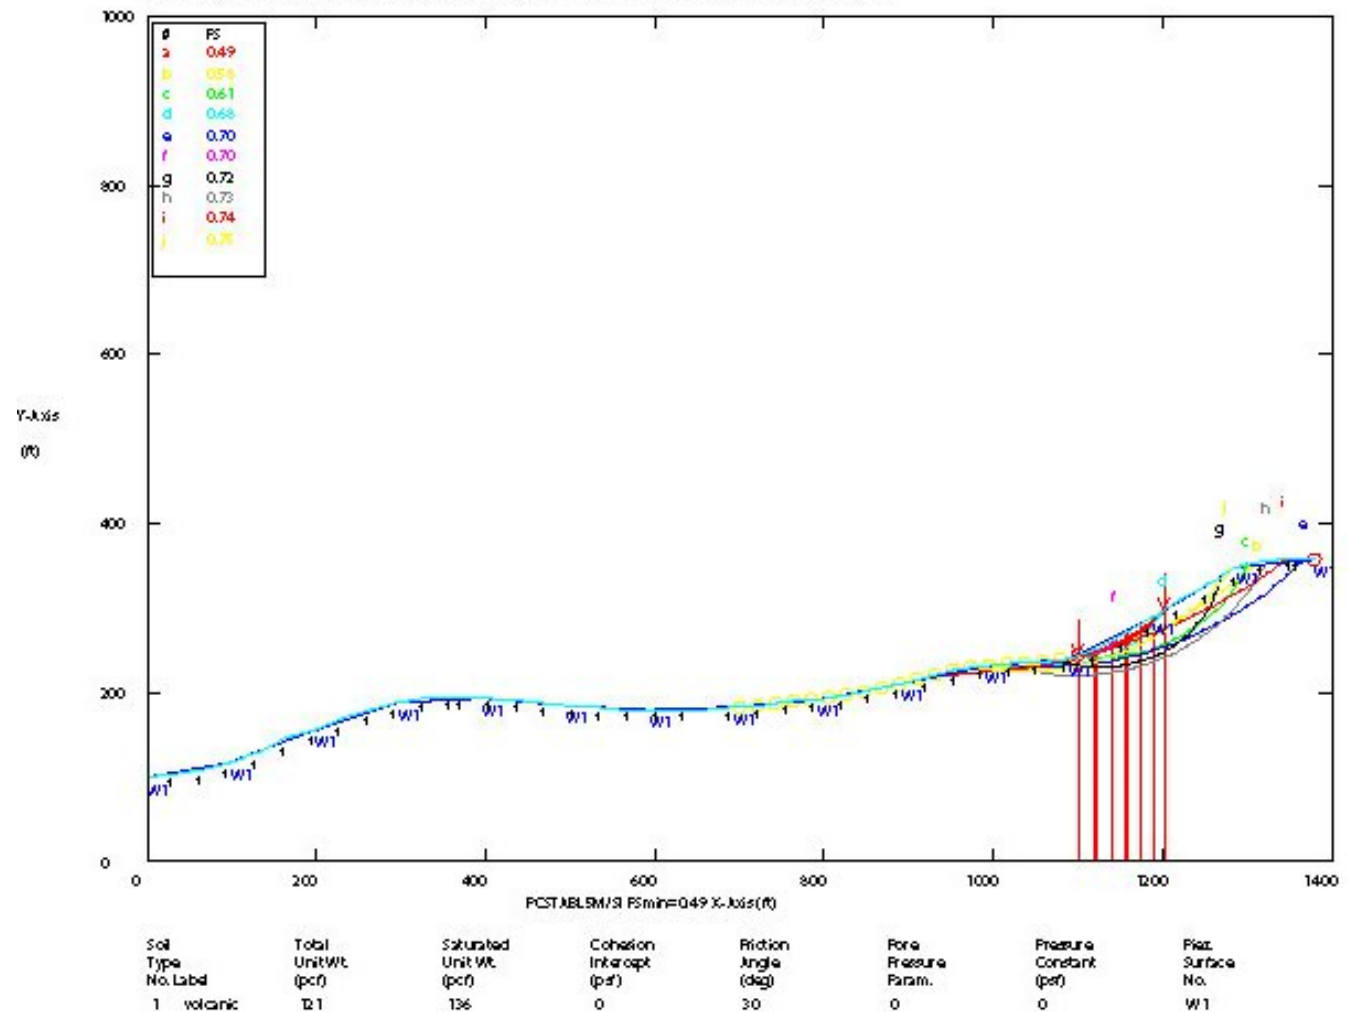
Beaver Bench Slide - Most Critical Area

Critical Segment (Case 3): The steep slope formed by the main scarp is the most critical segment identified by stability modeling (Fig. 18, Table 5), although the steep toe of the slide is nearly as critical. Debris slides and shallow slumps are probable under saturated groundwater conditions and possible under less than saturated conditions, given the projection of the friction angle curve between saturated and dry conditions for $FS = 1$ (Fig. 18; Table 5). Because the most critical segment has not yet failed, the peak friction angle for the Keetley Volcanics must be greater than the minimum critical friction angle. Thus, the peak friction angle for the Keetley Volcanics is greater than 27 degrees (Fig. 18; Table 5), provided cohesion is negligible and the materials that compose the most critical area are representative of materials at greater depth within the Beaver Bench slide. Sample stability analyses are shown in Figure 19.

Figure 19b. Ten most critical slip surfaces of Beaver Bench landslide (Case 3 analysis) with groundwater saturating the slide mass.

The least stable parts of the landslides are located on steep slopes bounded by abrupt change in topographic gradient (Fig. 13, 19, 25). There are several specific features worthy of comment. The toe of the Beaver Bench slide is almost as steep as the main scarp, which was identified as the least stable segment. The steep toe of the slide should also be treated with caution during development. Loading the toe from above by constructing buildings should be avoided. The toe could also be destabilized by erosion, but this would require unusually high and persistent flow in the small creek at the base of the Beaver Bench slide.

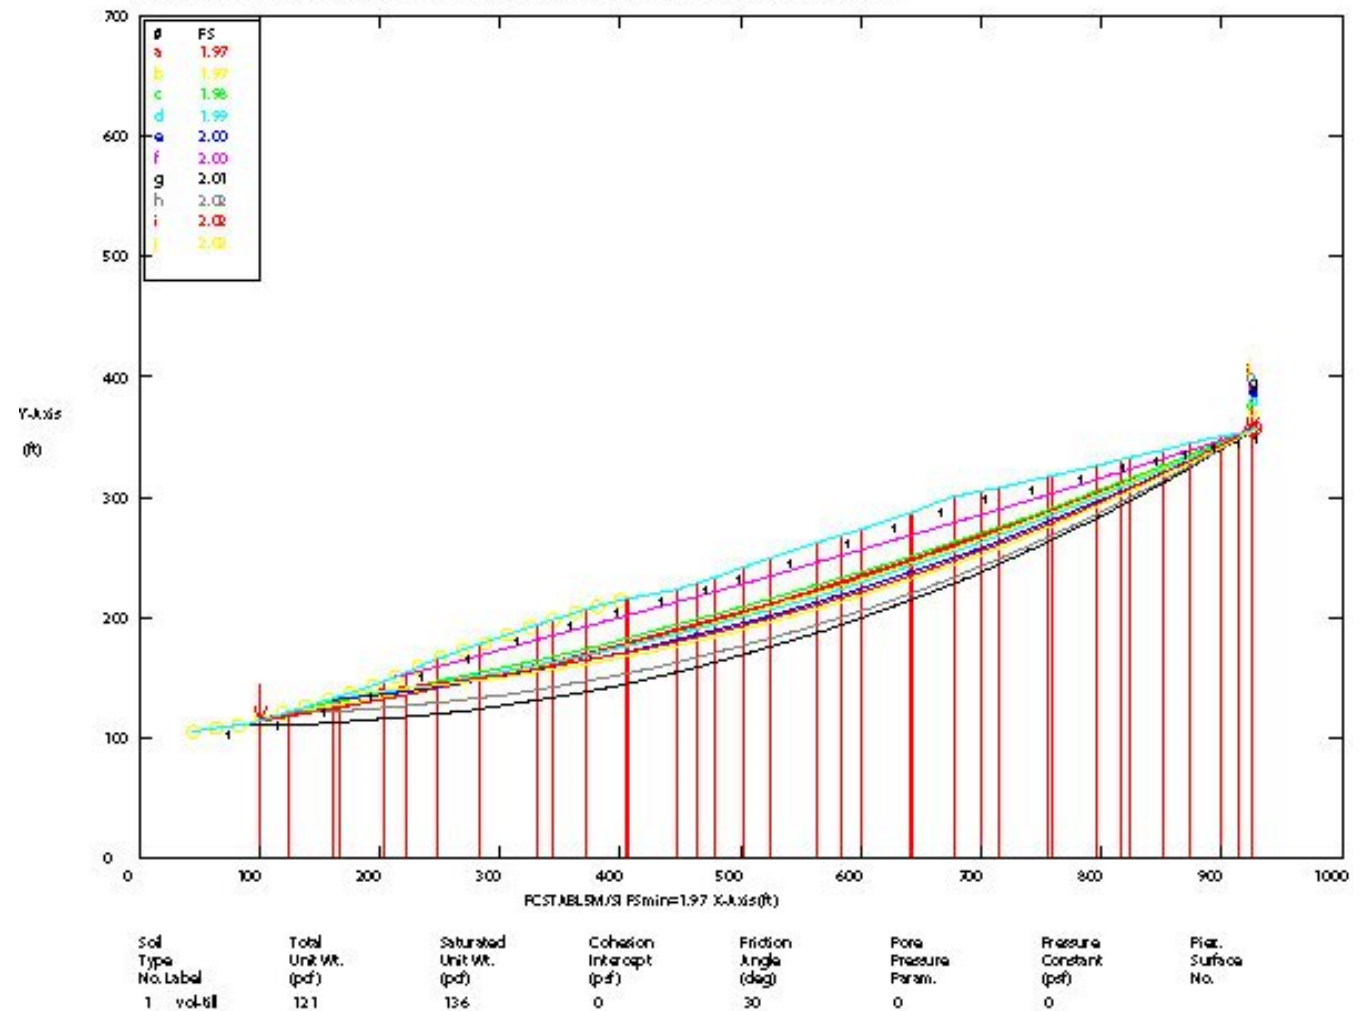
Blazing Star Slide - Initiation

Peak Friction Angles (Case 1): We estimated peak friction angles of 16, 23 and 29 degrees under dry conditions, mid-level water table, and total saturation of the slide, respectively (Fig. 20, Table 6). Sample stability analyses are shown in Figure 21.

Figure 21a. Ten most critical slip surfaces of Blazing Star landslide (Case 1 analysis) with no groundwater in the slide mass.

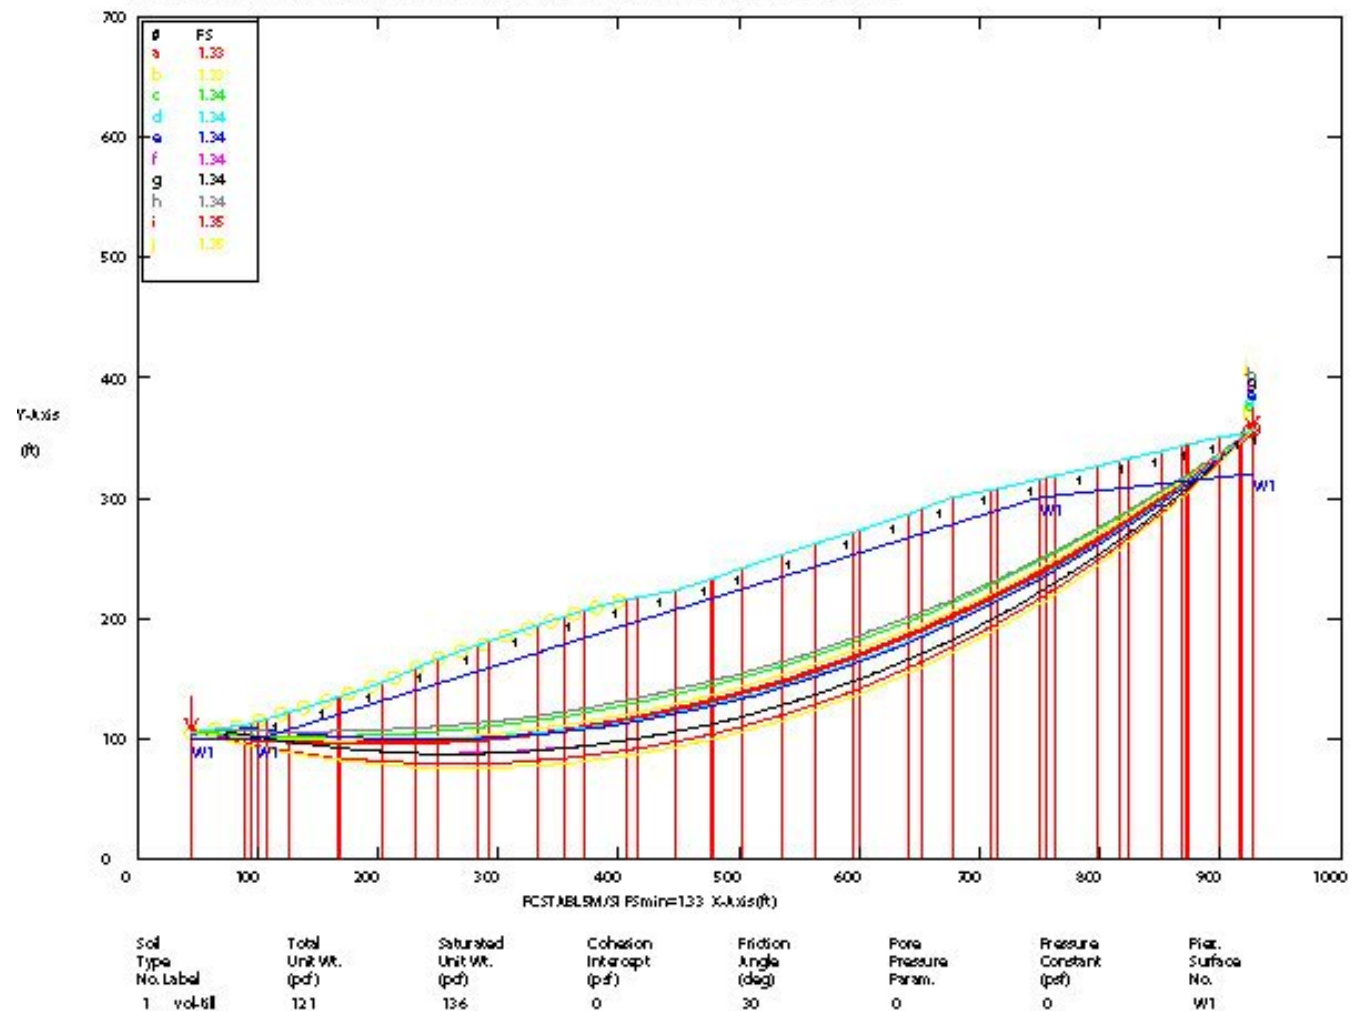
Blazing Star Slide - Initiation

Figure 21b. Ten most critical slip surfaces of Blazing Star landslide (Case 1 analysis) with groundwater mid-level in the slide mass.

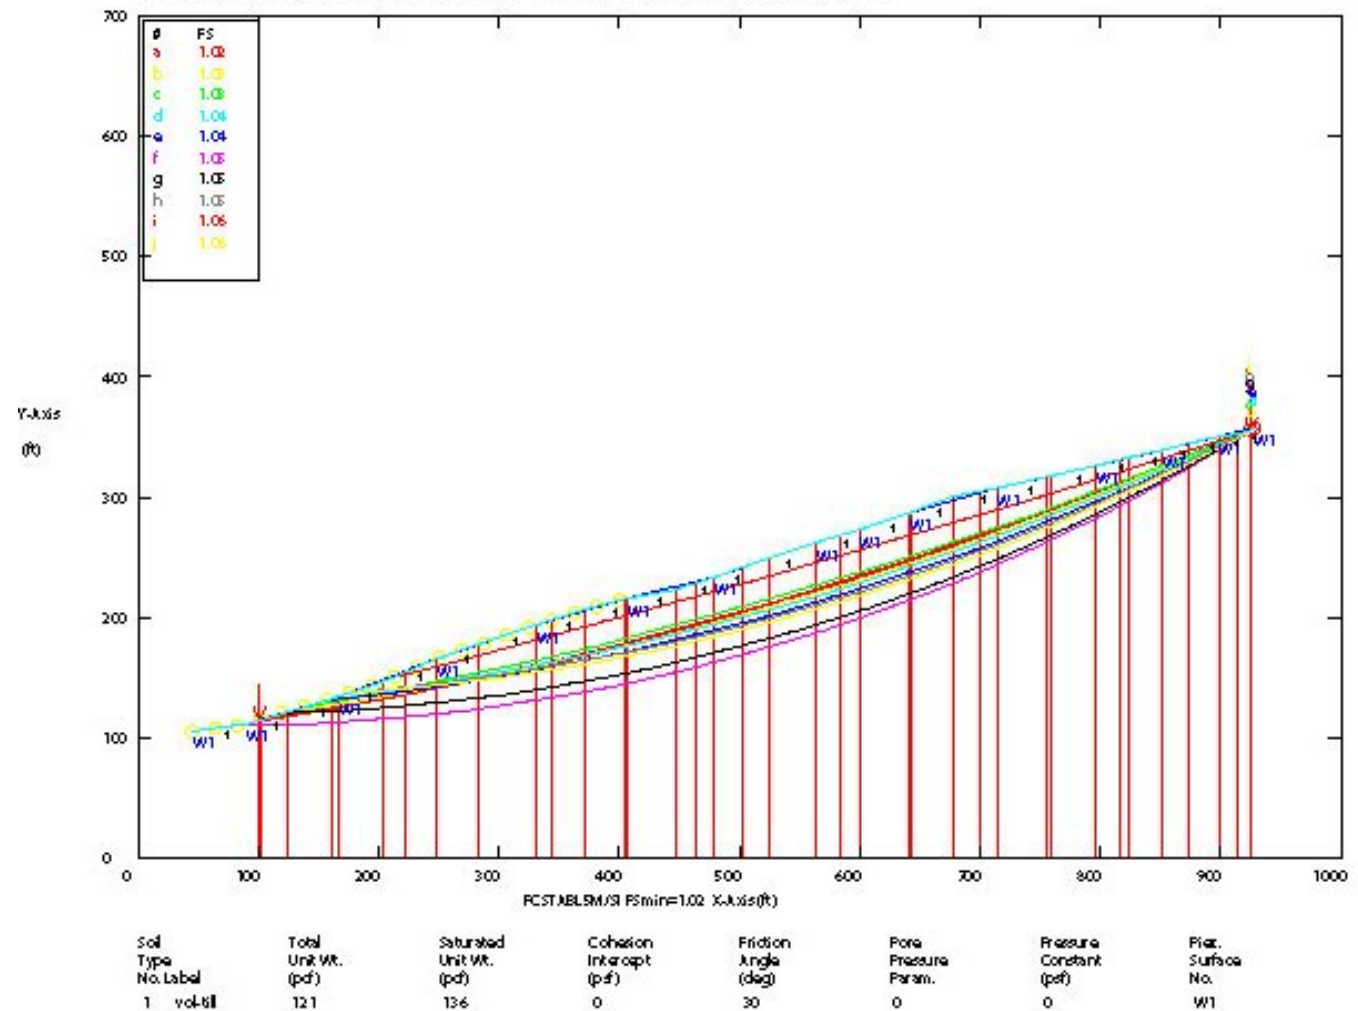
Blazing Star Slide - Initiation

Figure 21c. Ten most critical slip surfaces of Blazing Star landslide (Case 1 analysis) with groundwater saturating the slide mass.

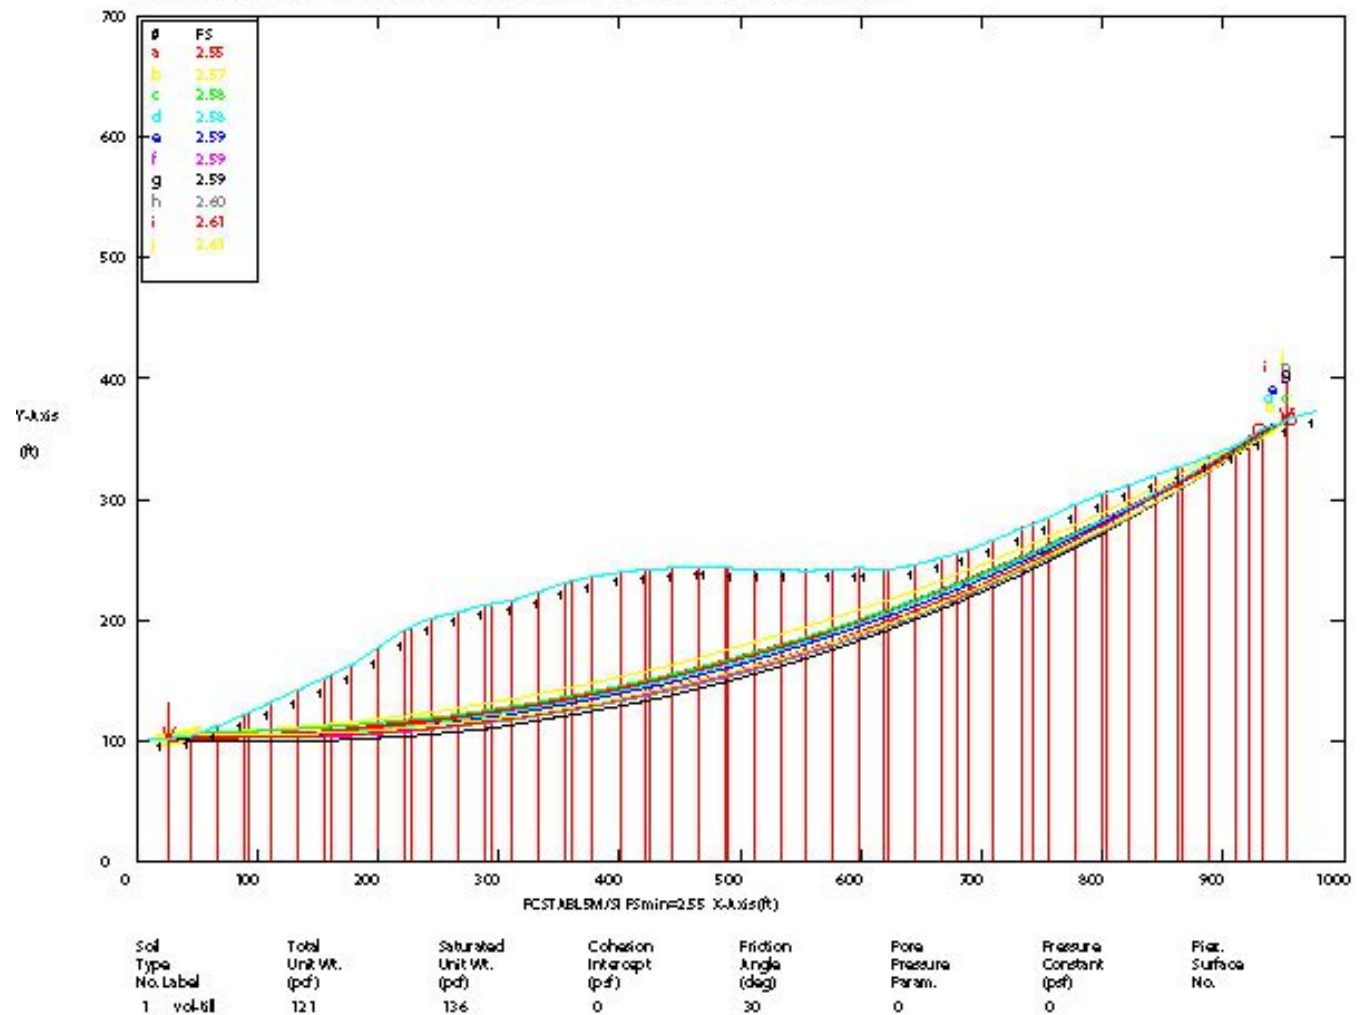
Blazing Star Slide - Entire Slide Mass

Residual Friction Angles (Case 2): The factor of safety is greater than 1.0 under dry conditions for friction angles as low as 15 degrees. Lower bound residual friction angles of 15 and 23 degrees were estimated under mid-level and saturated groundwater conditions (Fig. 22, Table 6). Sample stability analyses are shown in Figure 23.

Figure 23a. Ten most critical slip surfaces of Blazing Star landslide (Case 2 analysis) with no groundwater in the slide mass.

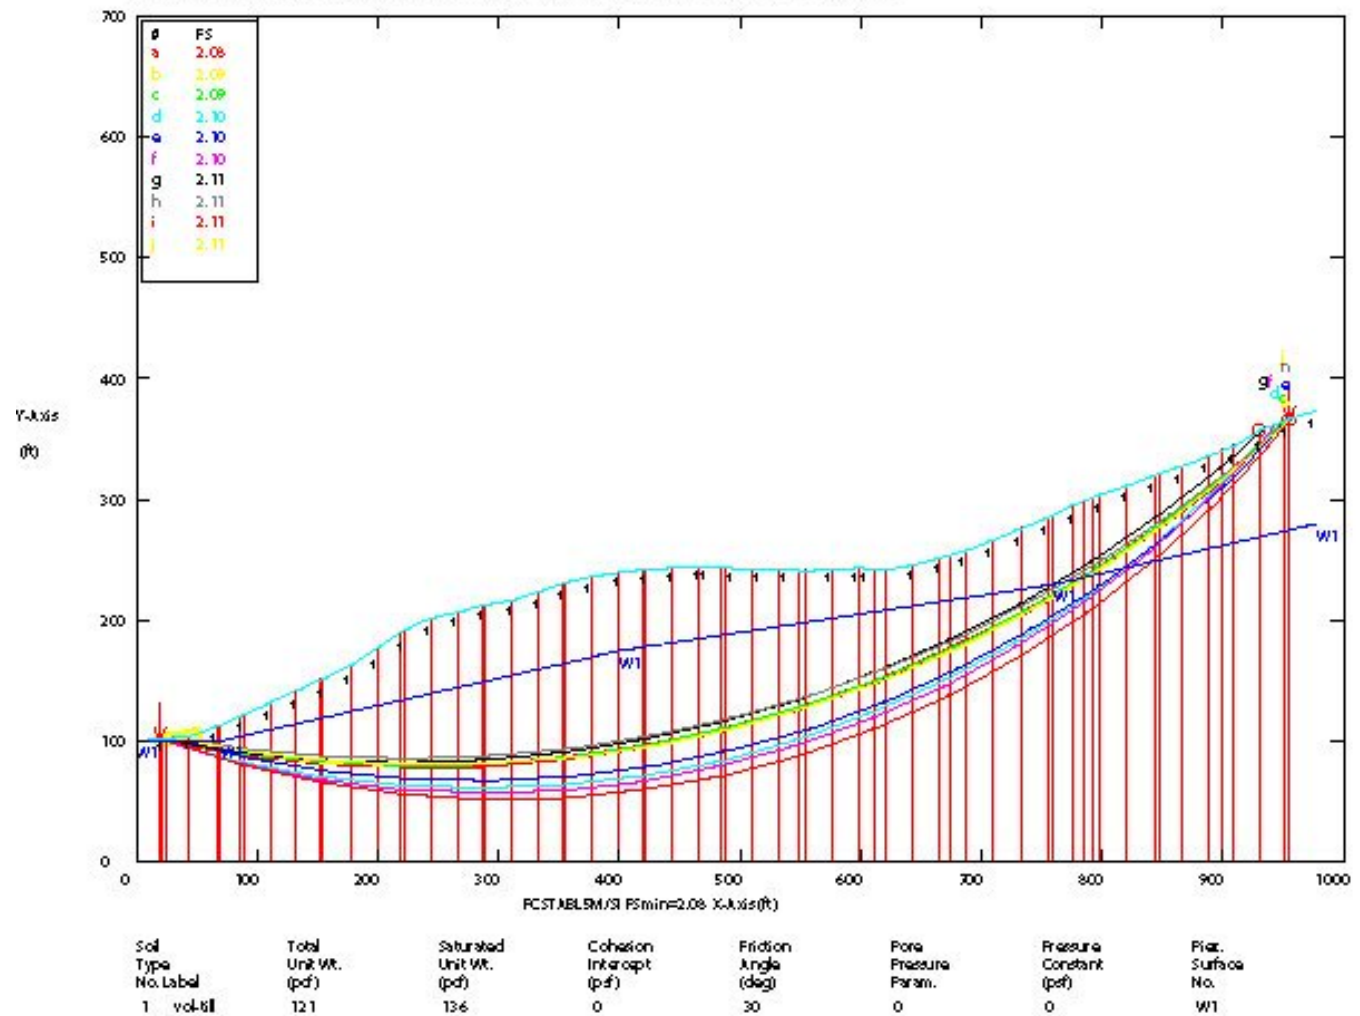
Blazing Star Slide - Entire Slide Mass

Figure 23b. Ten most critical slip surfaces of Blazing Star landslide (Case 2 analysis) with groundwater mid-level in the slide mass.

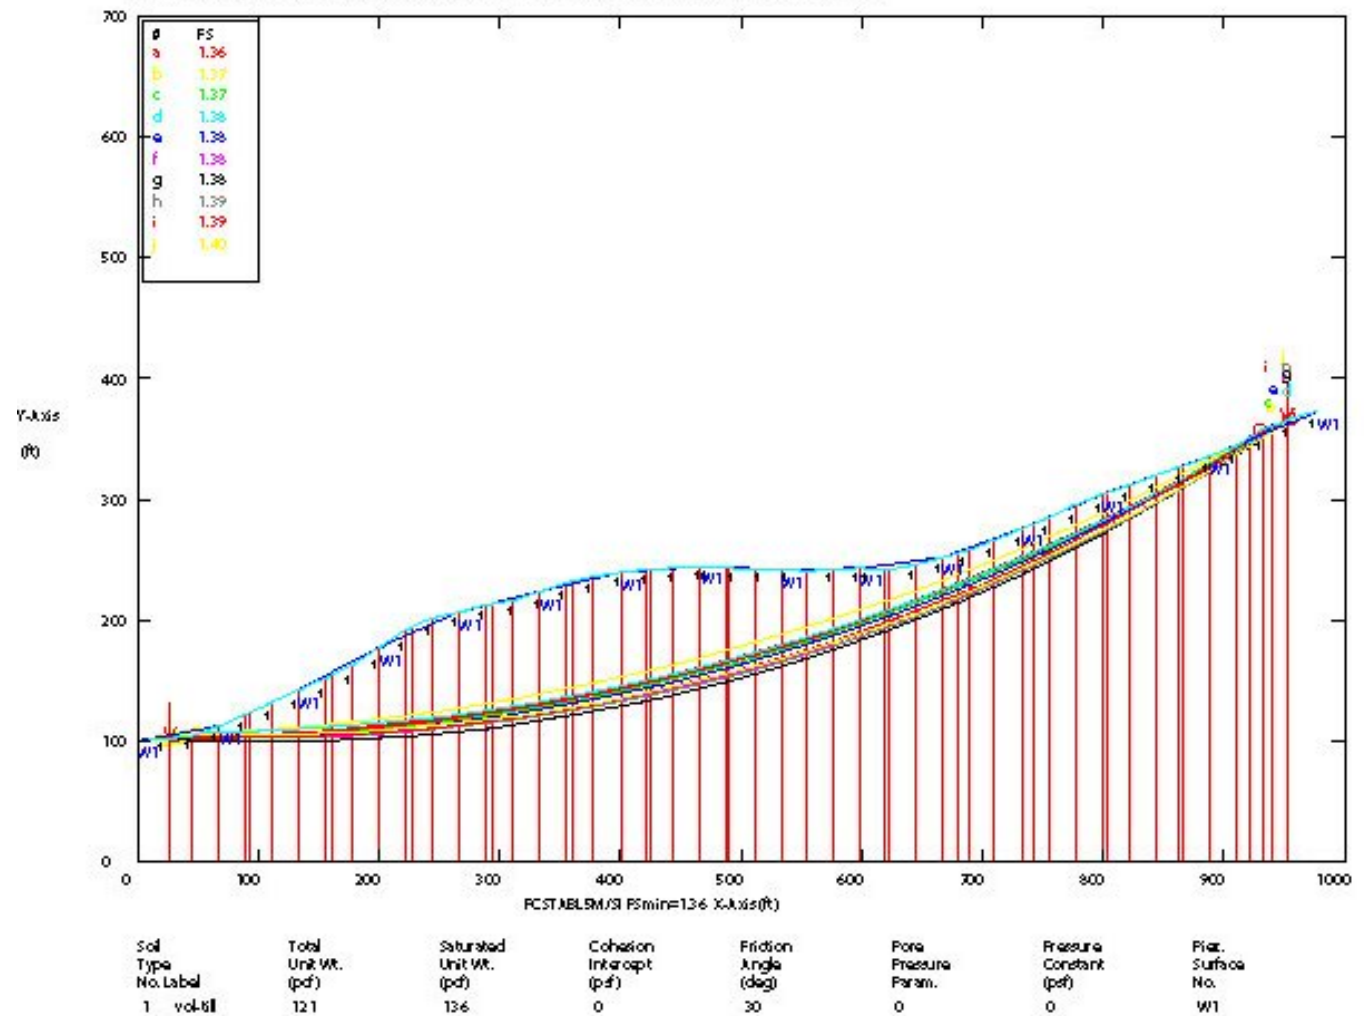
Blazing Star Slide - Entire Slide Mass
 Most Critical Surface, C:BS2SW_30.PLT By: Dan Neuffer 4/16/2001 3:36 pm

Figure 23c. Ten most critical slip surfaces of Blazing Star landslide (Case 2 analysis) with groundwater saturating the slide mass.

These types of uncertainties lead the Utah Geological Survey (Hylland, 1996) to recommend the use of conservative parameters and a factor of safety of greater than or equal to 1.5 in preliminary analyses such as those reported here. At mid-level and saturated groundwater conditions, if friction angles are less than 23 and 32 degrees, respectively, the present configuration of the Cedar Bark slide has a factor of safety of less than 1.5 (Figs. 10, 11; Table 4). Likewise, at mid-level and saturated groundwater conditions, if friction angles are less than 22 and 31 degrees, respectively, the present configuration of the Blazing Star slide has a factor of safety of less than 1.5 (Figs. 22, 23; Table 6).

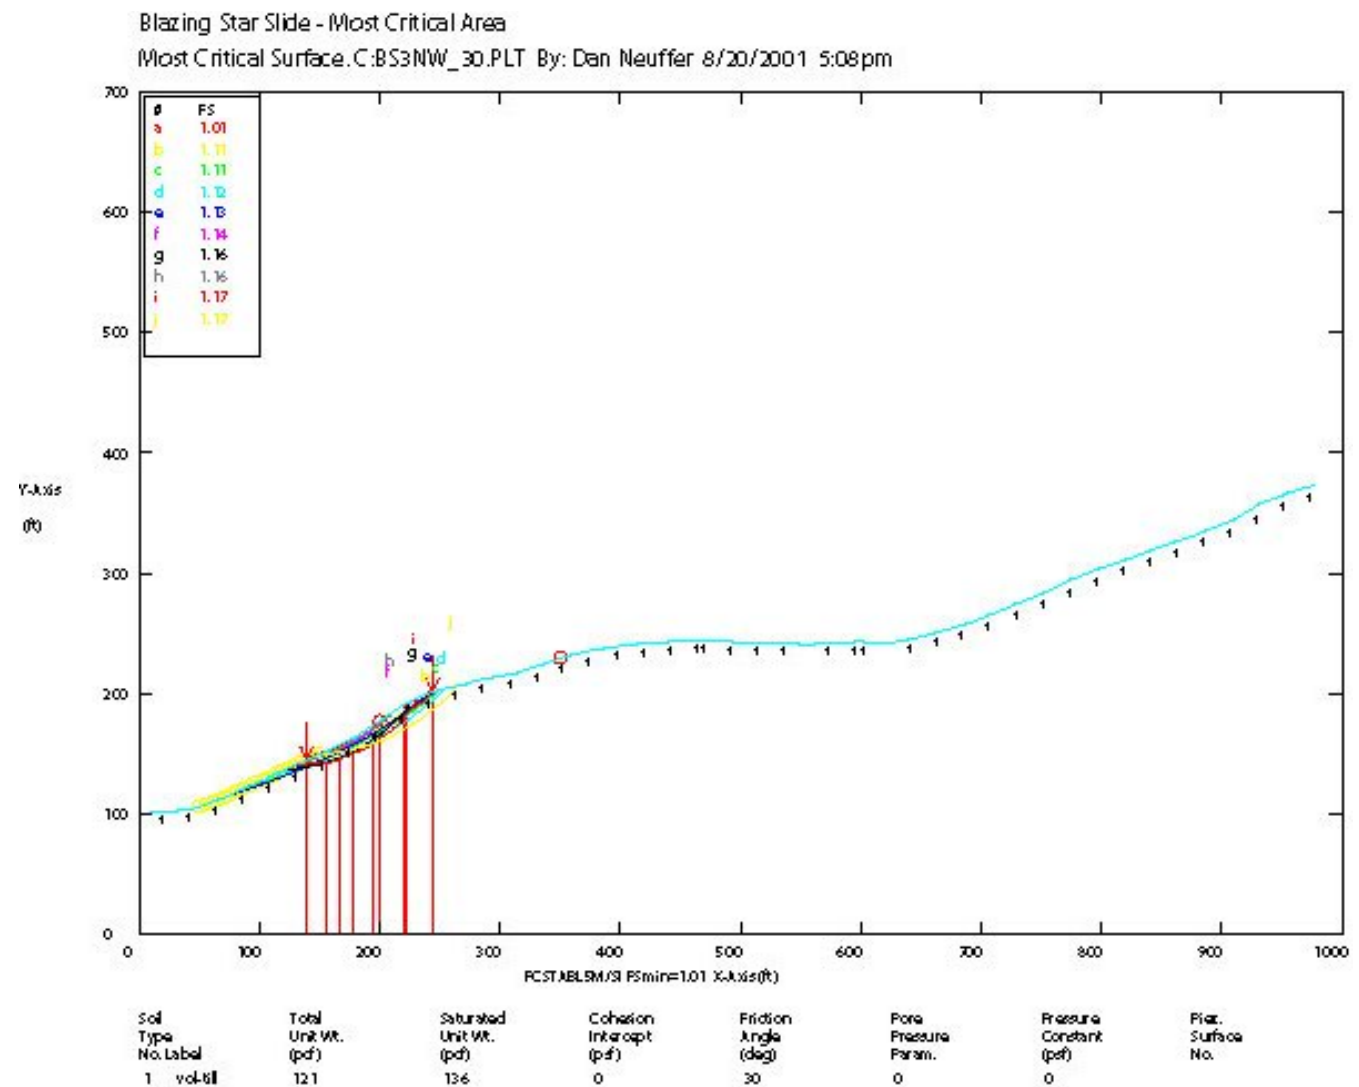
Critical Segment (Case 3): Debris slides and shallow slumps along the steep bank of Lake Creek are probable under saturated groundwater conditions and possible under less than saturated conditions, given the projection of the friction angle curve between saturated and dry conditions for $FS = 1$ (Fig. 24, Table 6). This result is substantiated by recent debris slides that were mapped in that area. One of these recent debris slides had a small spring at the base of the main debris slide scarp. The main scarp of the Blazing Star slide is nearly as steep as the toe, and, thus, is also prone to local instability. Sample stability analyses are shown in Figure 25.

Figure 25a. Ten most critical slip surfaces of Blazing Star landslide (Case 3 analysis) with no groundwater in the slide mass.

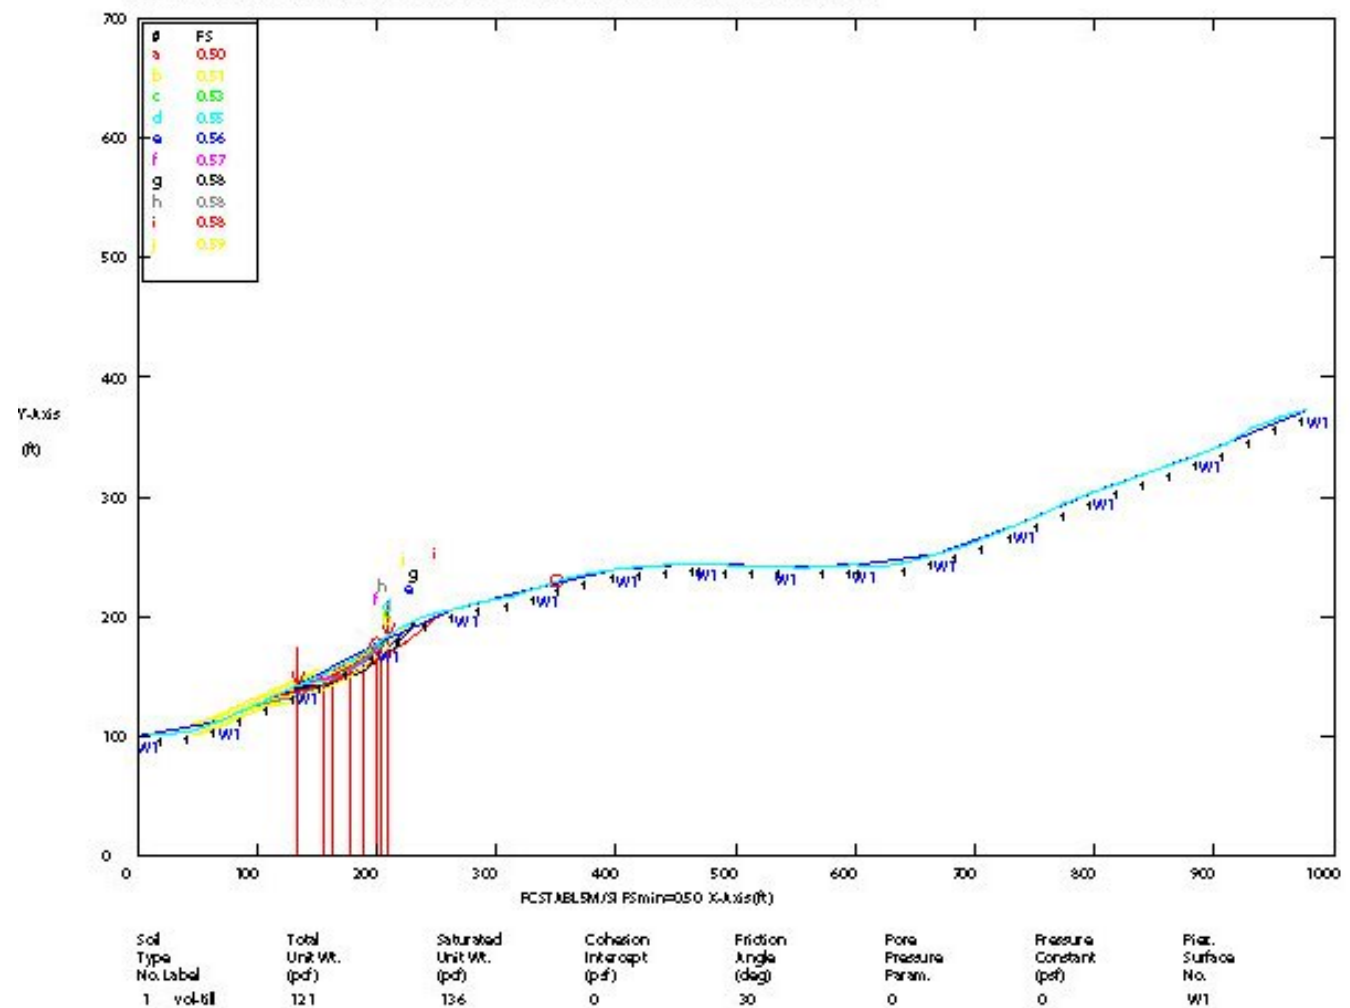
Blazing Star Slide - Most Critical Area

Figure 25b. Ten most critical slip surfaces of Blazing Star landslide (Case 3 analysis) with groundwater saturating the slide mass.
