## Utah Geological Survey

Project: Investigation of the April 11, 2009, 1550 East Provo rock fall, Provo, Utah			
By: Richard E. Giraud, P.G., Ashley H. Elliott, and Jessica J. Castleton	Date: 07-2-09	County: Utah	
USGS Quadrangles: Orem (1088), Bridal Veil Falls (1087)	Section/Township/Range: Sections 32 and 33, R. 3 E., T. 6 S., SLBM		
Requested by: Lewis Billings, Mayor, Provo City		Job number: 09-02

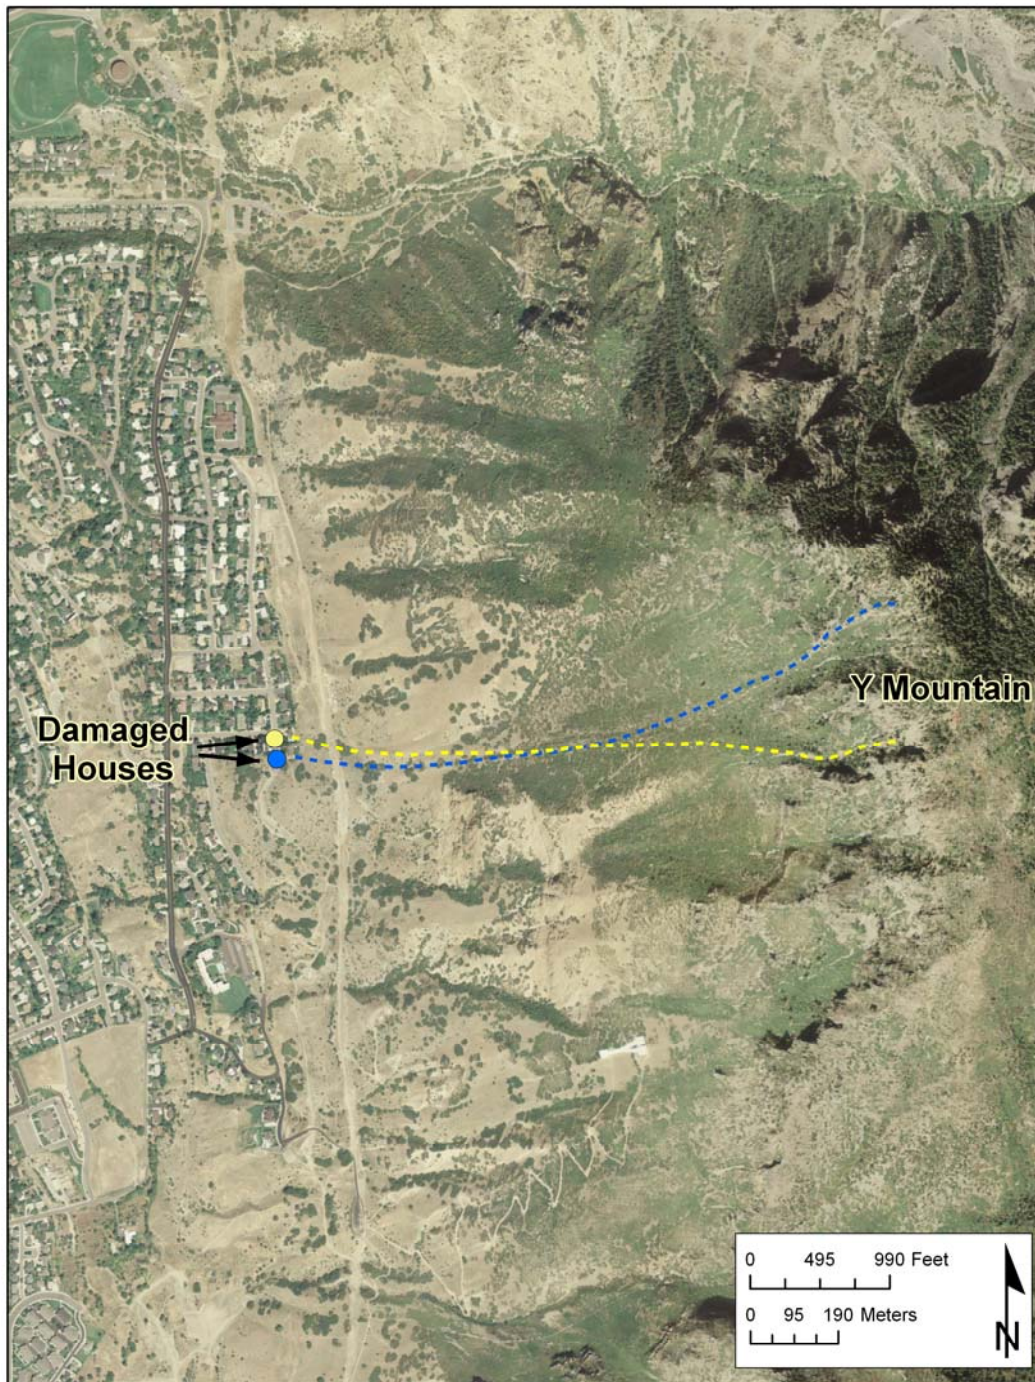
On April 11, 2009, around 11:30 a.m., rock detached from a cliff band producing a rock fall on the upper part of Y Mountain (figures 1 and 2) above Provo, Utah. Rock debris traveled down the west side of Y Mountain into a subdivision. One rock impacted and severely damaged a vacant house at 1496 North 1550 East (figure 3). Another rock damaged a fence and playhouse at 1522 North 1550 East (figure 4). The damaged house at 1496 North 1550 East is one lot north of 1468 North 1550 East, where a guest house was destroyed by a rock fall on May 12, 2005 (Christenson and Giraud, 2005). The 2005 and 2009 rock-fall paths are shown in figure 2.

**Figure 2.** 2006 NAIP orthophoto showing Y Mountain, the 2005 (blue) and 2009 (yellow) rock-fall paths, and damaged houses.
