Utah Geological Survey

Project: Investigation of the February 10, 2010, Rock Fall at 274 Main Street, Rockville, Utah			
By: Tyler R. Knudsen, P.G.	Date: March 9, 2010	County: Washington	
USGS Quadrangles: Springdale West	Section/Township/Range: Section 1, R. 11 W., T. 42 S., SLBM		
Requested by: Allen Brown, Mayor, Rockville City	Date report received at UGS: February 10, 2010	Job number: 10-1

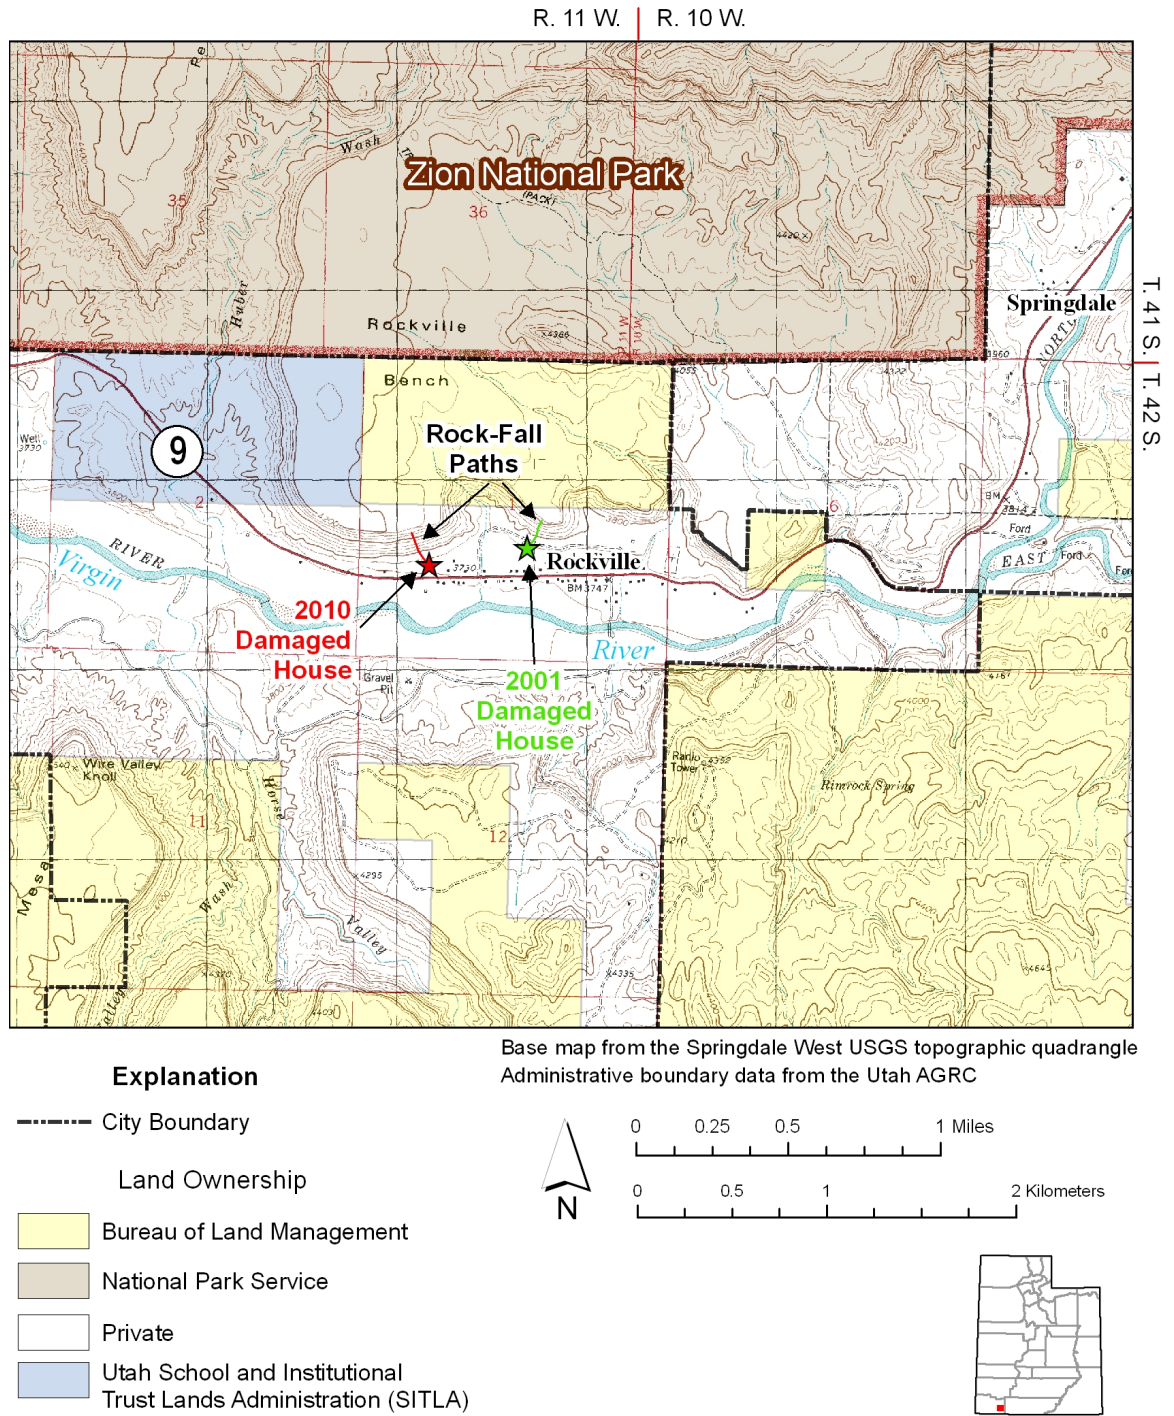
Figure 1. Location of the February 10, 2010, rock fall in Rockville, Utah. Also shown is the location of a rock fall that damaged a house in October 2001.
