Utah Geological Survey

Project: Reconnaissance of the April 9, 2006, 1650 East landslide, South Weber, Utah		
By: Richard E. Giraud, P.G. and Greg N. McDonald, P.G.	Date: 07-26-06	County: Davis
USGS Quadrangles: Ogden (1345)	Section/Township/Range: SW $\frac{1}{4}$ NE $\frac{1}{4}$ section 34, T. 5 N., R. 1 W., SLBLM	
Requested by: Ron Chandler, South Weber City Manager		Job number: 06-10

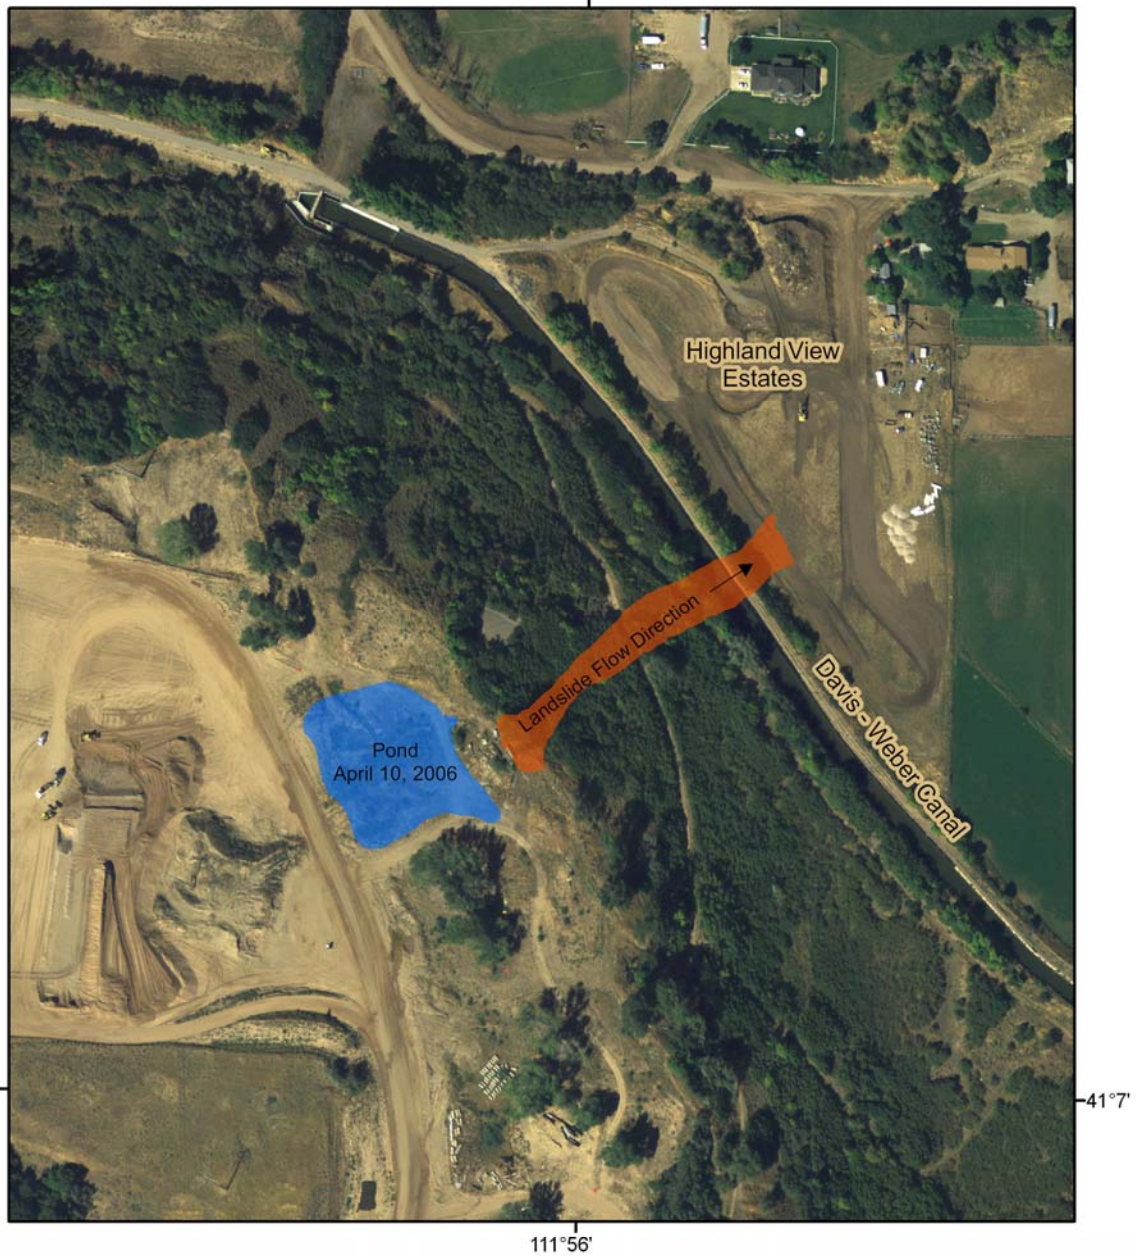
Figure 2. Image showing landslide flow direction, Highland View Estates subdivision, gravel pit pond, and the Davis-Weber Canal. The pond boundary is approximate and is based on oblique aerial photographs taken by Davis County Sheriff's Office personnel on the morning of April 10, 2006.

The 1650 East landslide was a rapid earth flow that started as a slide at the slope crest adjacent to a pond in a gravel pit (figures 2 and 5). The landslide main scarp extends a short distance back from the slope crest onto flat ground toward the pond in the gravel pit. The landslide is mostly a failure of fill pushed out of the gravel pit onto the upper slope to form a berm along the slope crest (figure 6). The landslide also involved native materials underlying and downslope of the fill. The slide at the crest mobilized into a flow that accelerated rapidly downslope, removing trees and crossing dirt roads, the canal, and a rock wall at the back of the lot before impacting the house at 7687 South 1650 East (figures 2 and 7). The landslide impact
