Report of Investigation

No. 198

TECHNICAL REPORTS FOR 1984

SITE INVESTIGATION SECTION

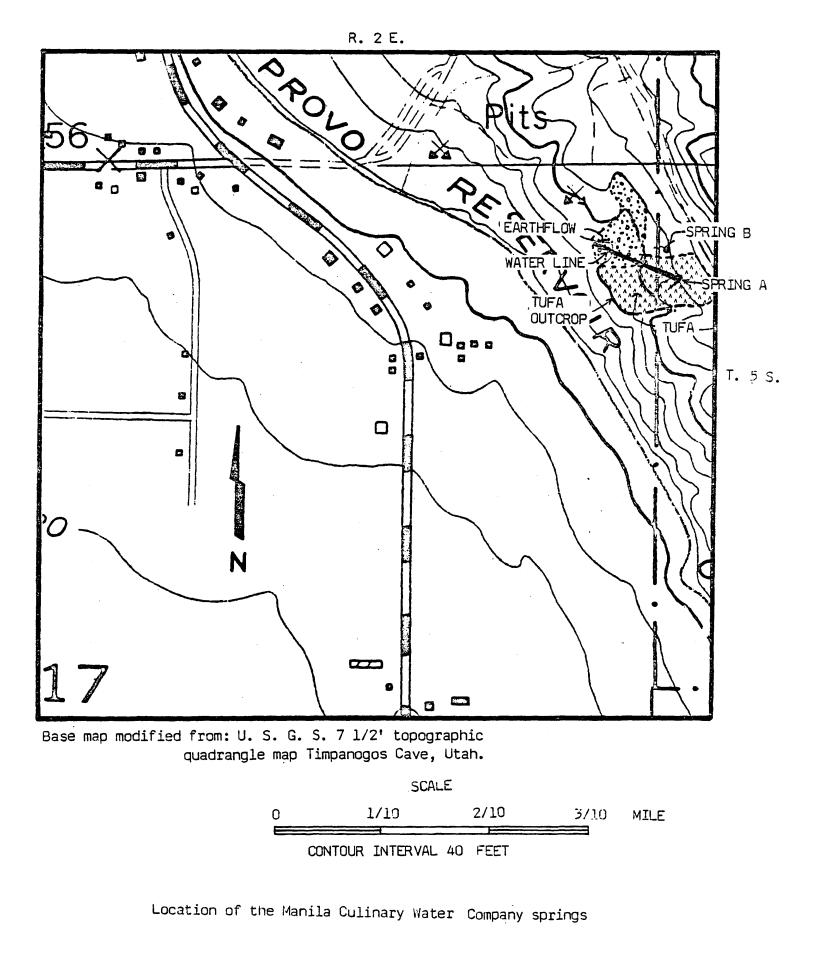
Location of the Manila Culinary Water Company springs area

According to Mr. Fugal (written commun., October 17, 1984), an earth flow has pushed a 6-inch cast iron pipe, connecting a spring collection box with a storage reservoir, out of alignment. See attachment 1 for the location of the water line with regard to the earth flow. Movement of the earth flow was first detected in February, 1983, but three surges have occured since then. The final recorded movement, in January, 1984, severed the line causing an offset of 4 feet vertically and 12 feet laterally. Prior to that time, the pipe was buried at a depth of approximately 4 feet in the vicinity of the break. To repair the damage, the water company installed 150 feet of new pipe at an average depth of 9 feet along the previous alignment. No movement of the pipe or the earth flow has been observed since installation of the new water line.

The earth flow consists of rock fragments in a clay and silt matrix weathered from the Manning Canyon Shale. The flow appears on pre-1973 air photographs (Cluff and others, 1973). Renewed movement of the flow was caused by increases in moisture content caused by a recent rise in the ground-water table. This rise is the result of the recent wet cycle adding more recharge to the local ground-water system. Mr. Fugal indicates no movement was detected from 1955 to 1983, suggesting that the earth flow was present prior to 1955 and the original water line was installed within the unstable material. Recent increases in moisture content of the flow resulted in movement that eventually severed the water line. It is not known at this time if the new, deeper water line has been placed below this material because no geologic examination was made of trenches dug for the new line. Lack of disruption in the new line may be due to non-movement of the earth flow or emplacement below the unstable material. Water discharging from spring B flows accross the earth flow.

It is not necessary to move the existing water line at this time. However, the line should be monitored closely for future movement. If such movement occurs, the pipe should be relocated to the south, off of the earth flow and on to the tufa deposit. This would place the pipe in a stable area. It is also recommended, that discharge from spring B be diverted away from the earth flow, to reduce moisture content of the unstable material and increase stability. Selected References

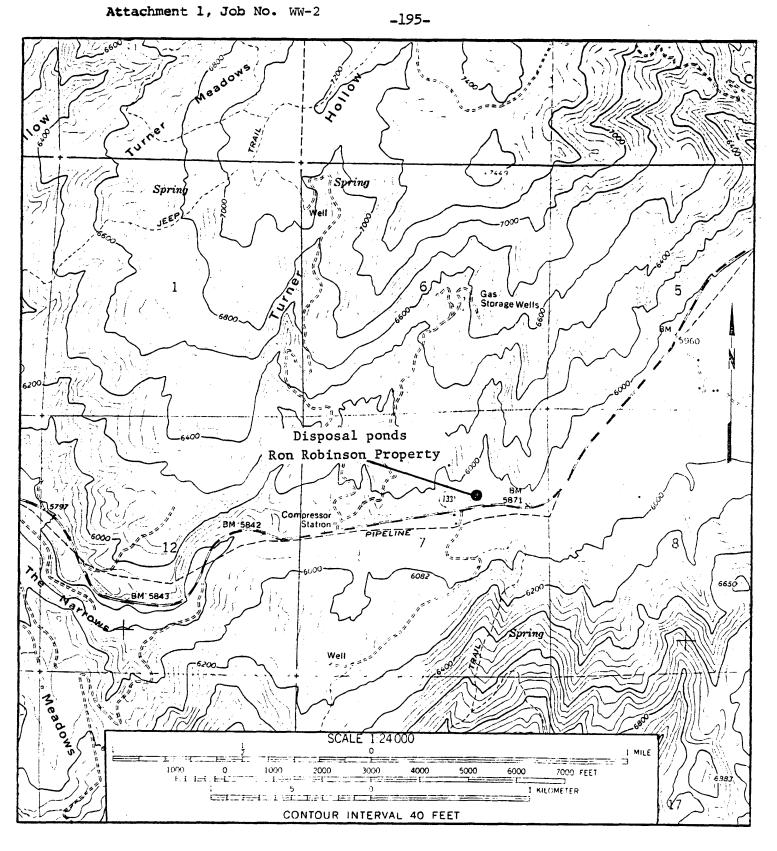
Location of wastewater disposal ponds, Ron Robinson property, Chalk Creek Canyon east of Coalville

Evidence of leakage through embankments was not found at the site. A stream channel up to 10 feet deep to the east and the highway cut to the south

were also checked for evidence of seepage from the ponds, but none was found. The possibility of downward leakage into aquifers beneath the ponds remains a possibility which can only be evaluated through subsurface investigations. No percolation tests on in situ soils or on lining materials have been made, and no monitoring wells have been drilled.

Potential problems in embankments are visible in the form of open longitudinal cracks along the crest of the southernmost embankment. These are an indication of soil shrinkage and cracking with subsequent erosion which may result in a piping or internal erosion problem in the embankment. These embankments were reportedly constructed with scrapers which removed material from the pond bottom and placed it in embankments. Control over compaction and moisture content during placement of the fill is not documented. In addition, a potential erosion problem exists in the northeast corner of the ponds where the stream from the canyon to the north is deflected to the east by the embankments. Embankment soils are fine-grained and no riprap has been placed to protect the fill from erosion. Undercutting is not evident to date, but extreme cutting may occur during a cloudburst flood.

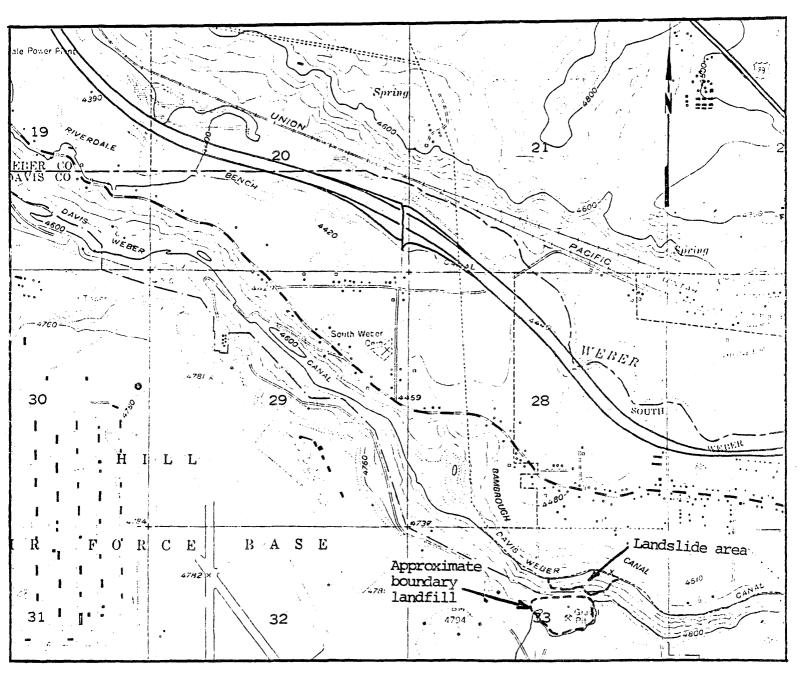
Location map showing approximate boundaries of landfill and landslide area

The landslides of concern to the Health Department form an inter-connecting series of slump-earth flow type failures for a distance of three to four hundred yards along the bluff. The largest failure is approximately 150 feet wide and extends from the perimeter fence of Hill Air Force Base at the top of the bluff to the Davis-Weber canal, a distance of about 225 feet. The failure planes along which the slippage is occurring appear to be shallow and show no evidence of passing under the canal. However, the canal has experienced considerable damage where the toes of the various slides have encroached on its right-of-way. The concrete liner on the upslope embankment has been destroyed in several places and landslide debris has partially filled the canal.

Information supplied by the Air Force indicates that a buffer zone of in-place, natural material exists between the edge of the bluff (perimeter fence) and the landfill. The headwall scarp for the largest slide is presently (4-16-84) at the perimeter fence and any renewed movement would begin to erode the buffer zone. The slides have been relatively stable during the past several days of warm, dry weather, but renewed wet weather, especially for a prolonged period, could cause futher movement.

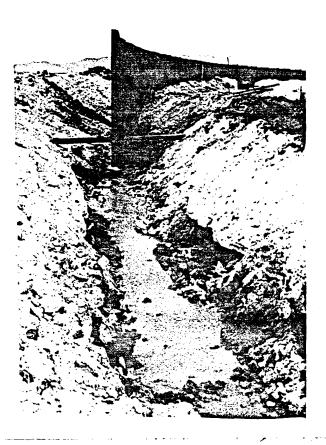
View of trench and pond wall under construction (Photo 1)
