UTAH GEOLOGICAL AND MINERAL SURVEY

Report of Investigation 218

TECHNICAL REPORTS OF THE  
WASATCH FRONT COUNTY GEOLOGISTS  
JUNE 1985 to JUNE 1988

Compiled by  
Bill D. Black and Gary E. Christenson

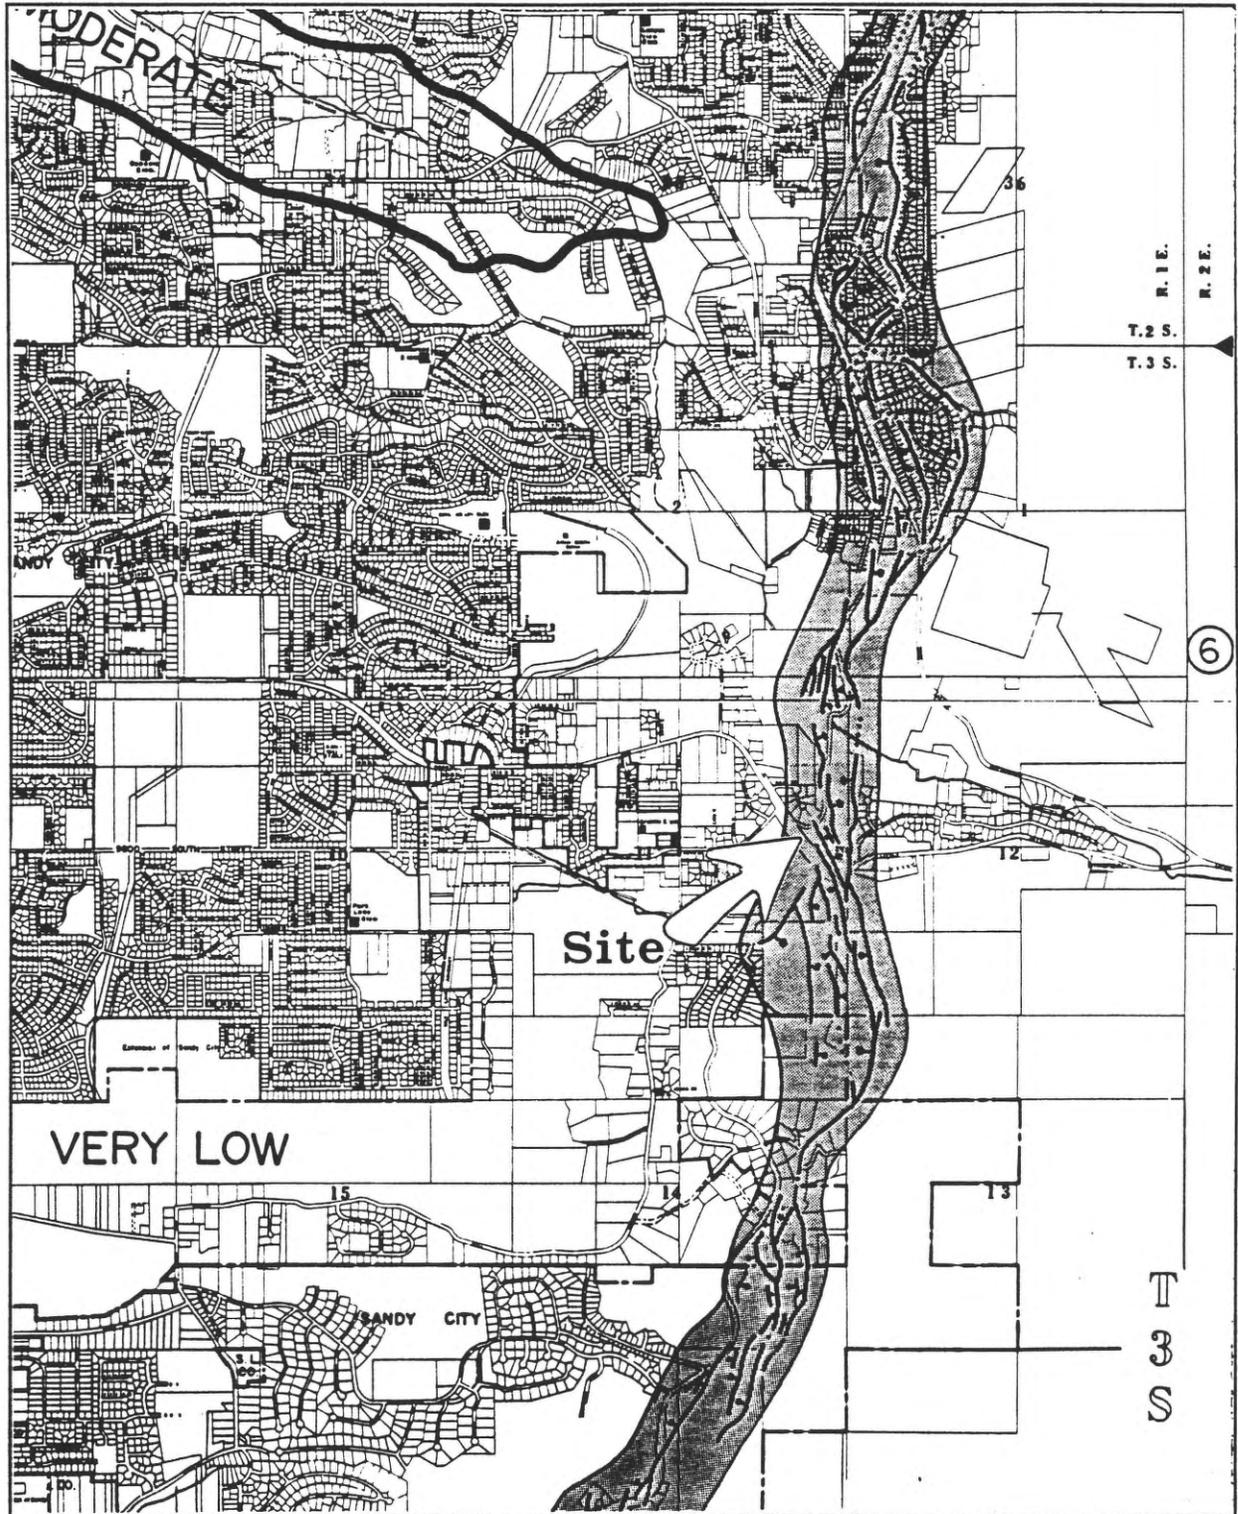
Figure 1. Surface Fault Rupture Special Study Area, see Figure 2 for explanation (Nelson, 1987a).

Surface faulting has occurred in the area around the site, and large fault scarps representing the main trace and principal antithetic faults are found to the east (figs. 1 and 6). Based on mapping of scarps, Scott and Shroba (1985) indicate that no faults run directly through the site, but several trend in its direction and if projected northward, would pass through the site. Inspection using aerial photography of the area (1958 U.S.D.A. AAL 21V #15-17) confirmed the location of faults as shown in figures 1 and 6, and also suggested the presence of two lineaments of possible seismic origin passing through the site.

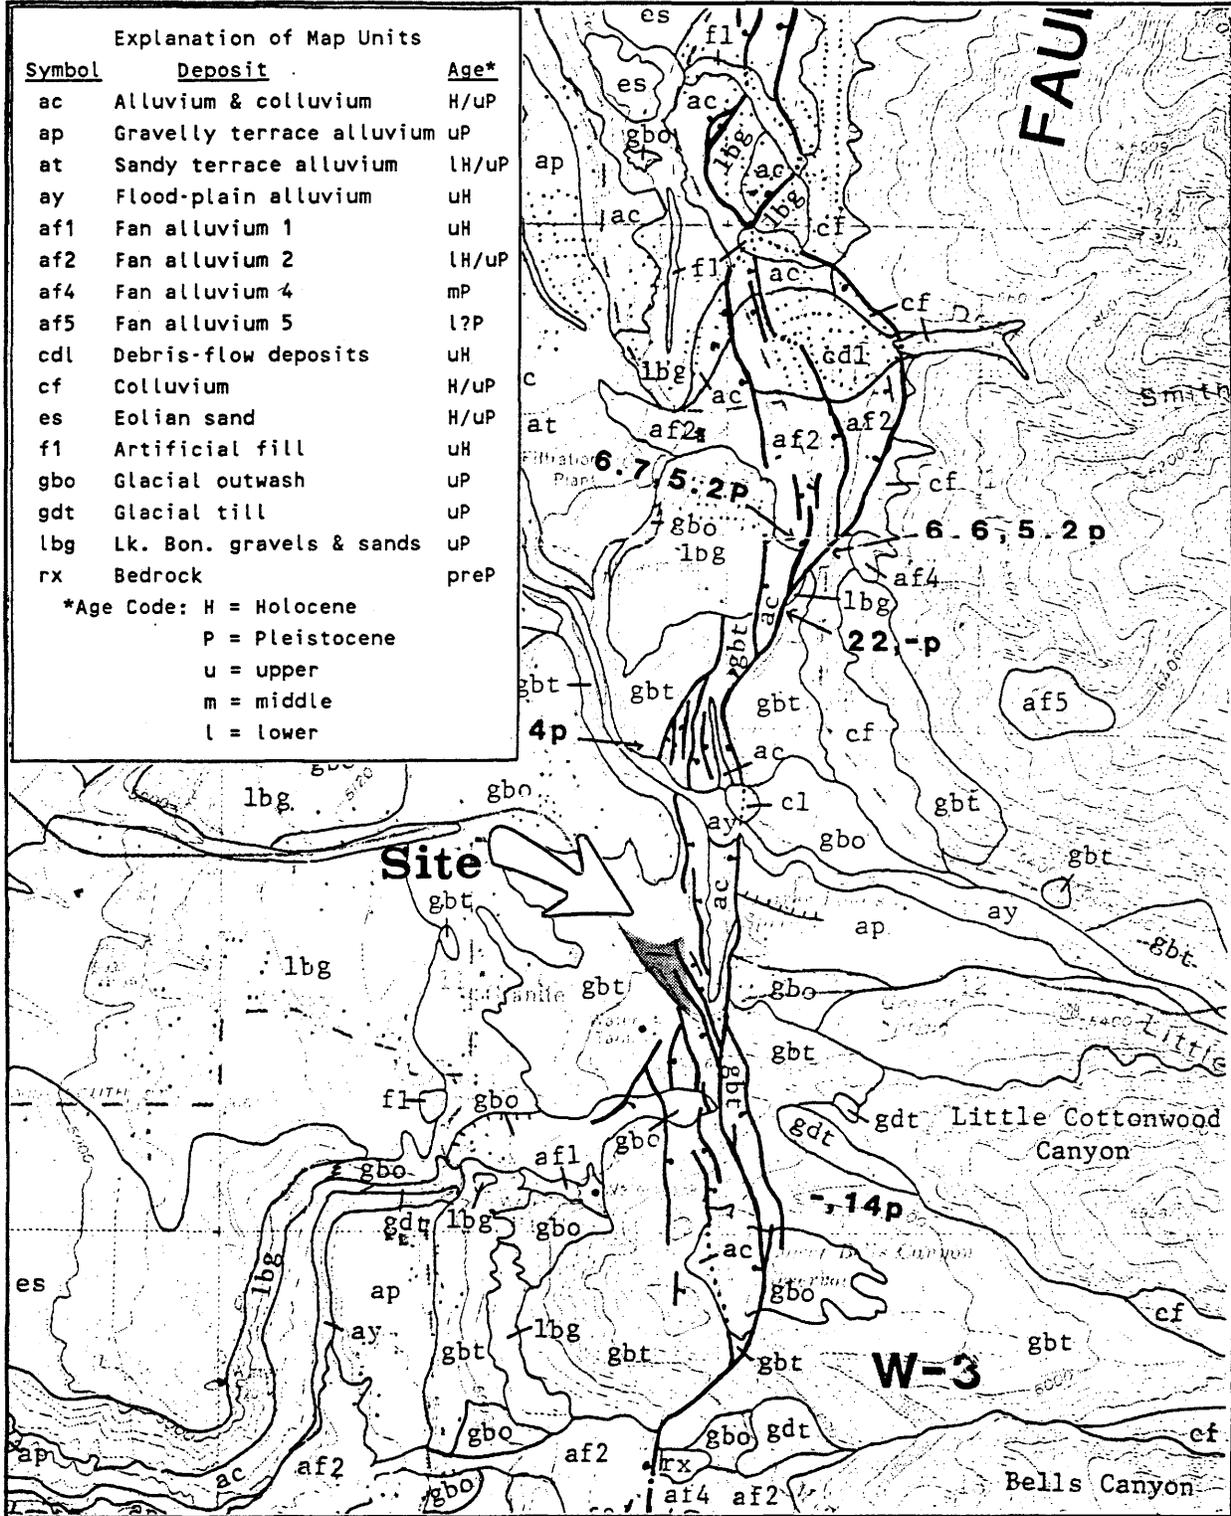
The site is underlain by Pinedale age (about 19,000 years old) glacial till deposited by glaciers from Little Cottonwood Canyon (Scott and Shroba, 1985; fig. 6). Boulders up to 6 feet (2m) are scattered across the site. The till exhibits a well-developed soil profile, and units observed in the trench (fig. 4) consisted of:

Figure 6. Surficial geologic map of the area around the proposed fire station site (Scott and Shroba, 1985).

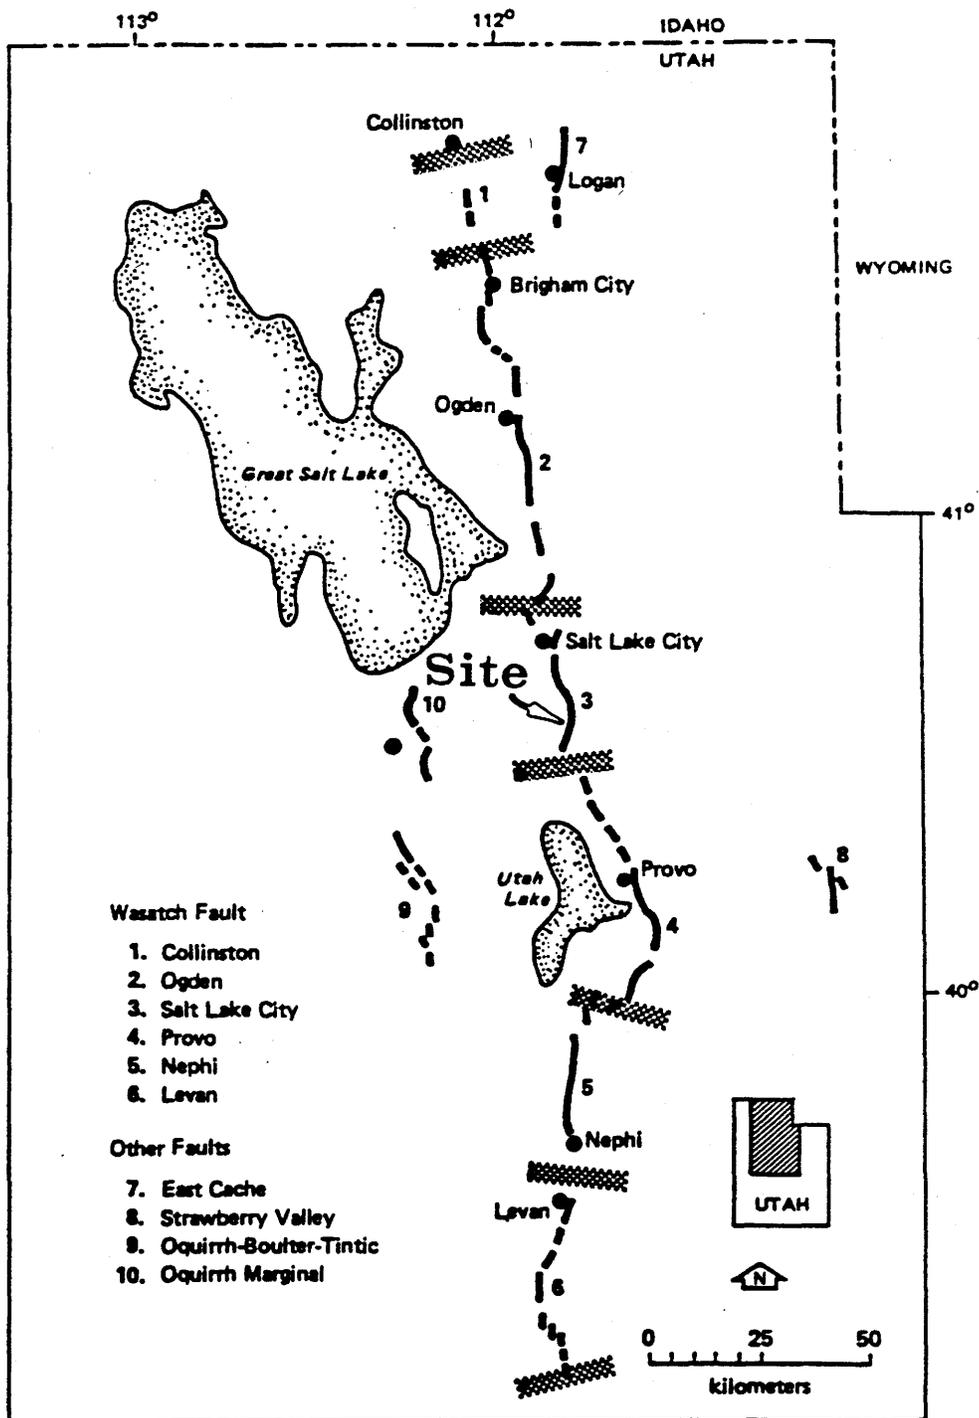
The proposed site lies within the Intermountain Seismic Belt (fig. 7) on the Salt Lake segment of the Wasatch Fault (fig. 8), near the western edge of the fault zone. In this region the fault zone is a wide area (1200 feet; 366m) of complex branching faults. The Wasatch Front has been designated in the Uniform Building Code (UBC) as a Zone 3 seismic area, where "major damage" may result from an earthquake (Modified Mercalli Intensity VIII or higher, appendix C).

Figure 8. The segments of the Wasatch Fault. The site is located along the Salt Lake segment (Schwartz and Coppersmith, 1984).

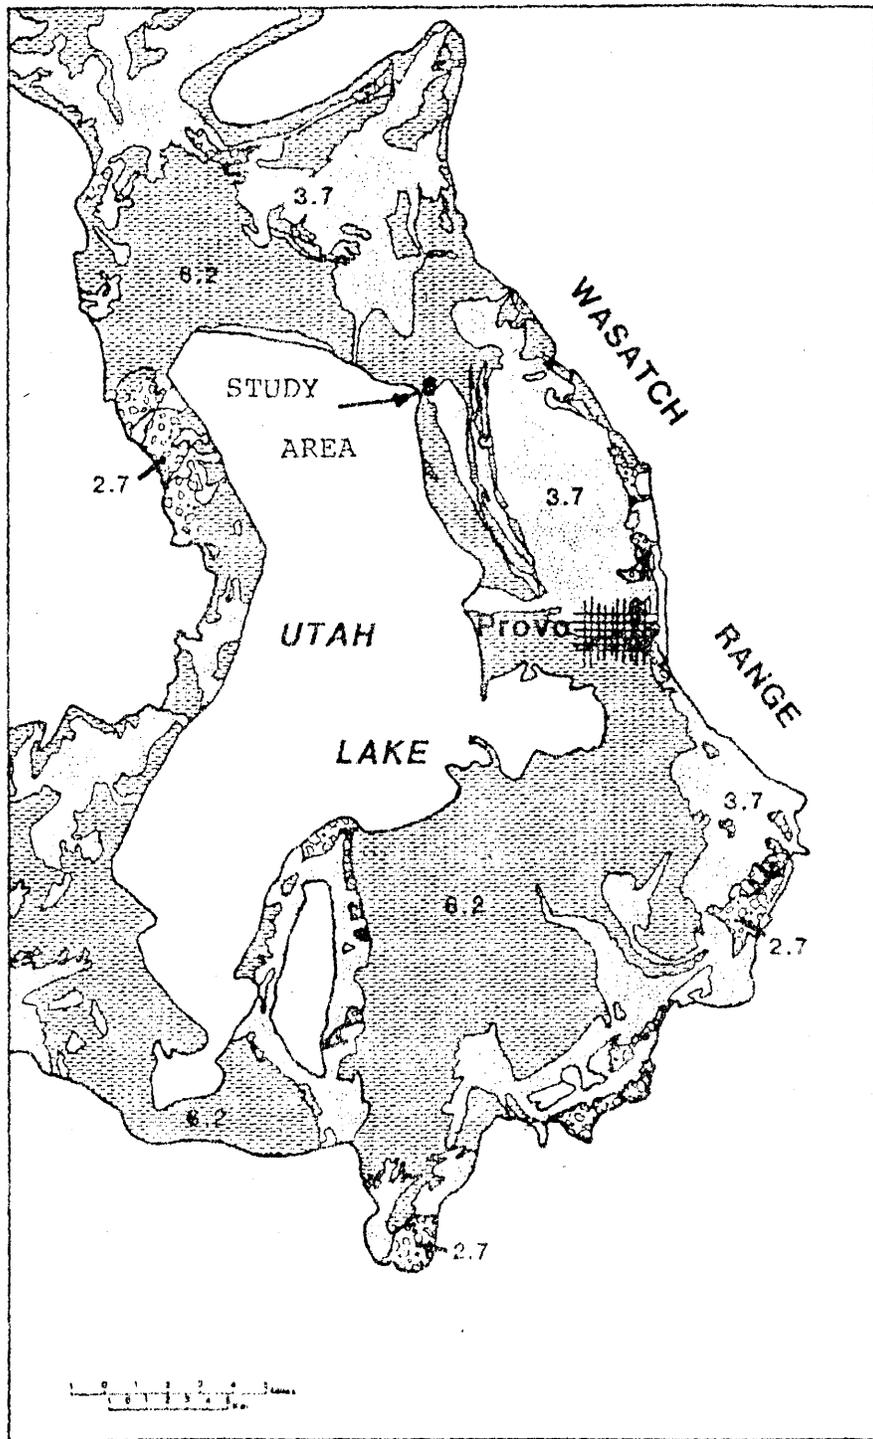
Figure 2. Map showing the relative ground shaking in response to a theoretical earthquake. The numbers indicate average (mean) response of the ground relative to locations in bedrock. Adapted from Rogers and others (1984).

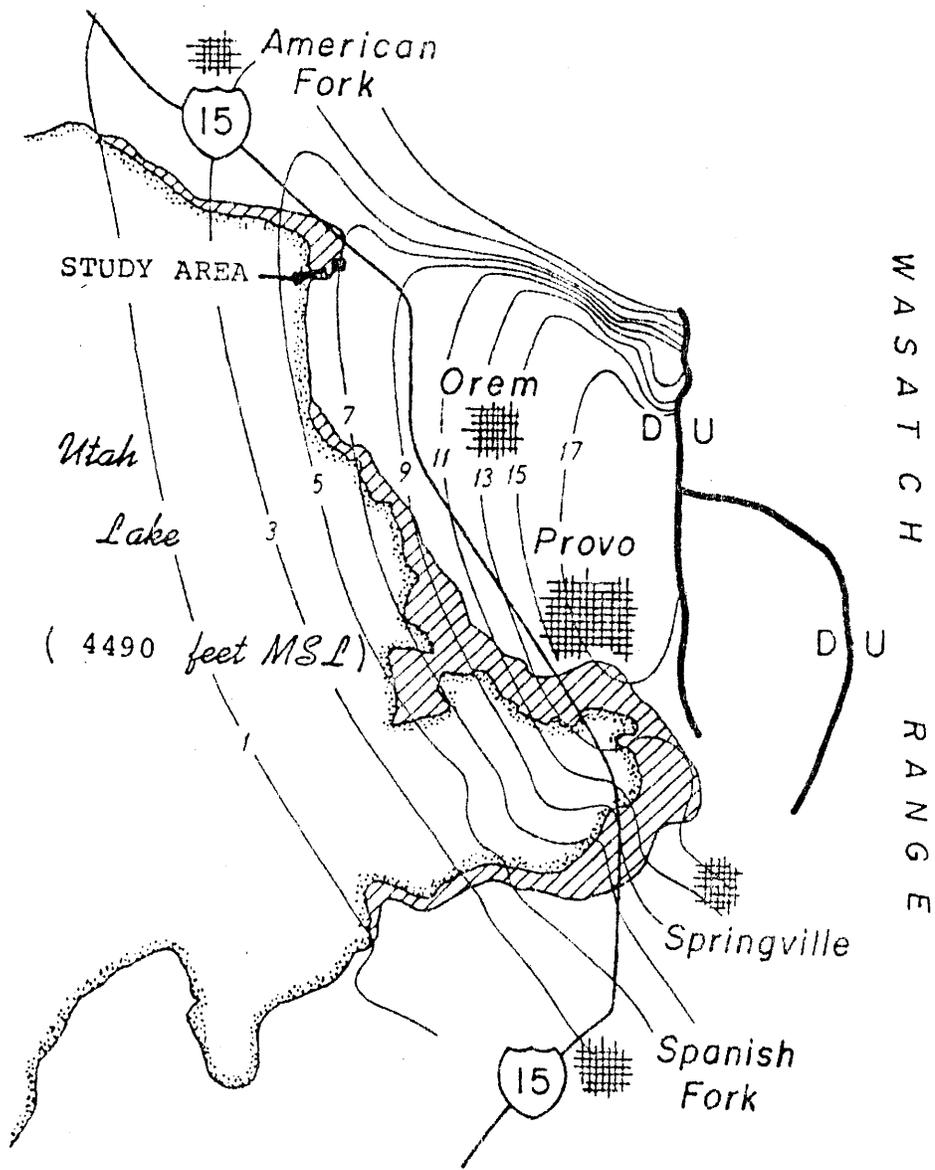
No known faults have been mapped through the site. The nearest trace of the Wasatch fault zone is about 3 1/2 miles to the east (fig. 3). Dustin and Merritt (1980) make reference to faults in the site. However, surface fault rupture along

the Wasatch fault could indirectly affect the site due to downdropping and tilting of the basin toward the mountains causing a shift in Utah Lake to the east (fig. 3, Smith and Richins, 1984). Keaton (1986) indicates that if this were to occur at the same magnitude as that of the 1959 Hebgen Lake earthquake the area around the county buildings may experience ponded water.

Figure 3. Map showing the Wasatch Fault zone in relation to the study area. Faults are depicted as the heavy black lines. The down-dropped side is designated with a "D" and "U" is on the up-thrown side. Thinner lines with numbers indicate, in feet, the possible seismic tilt if an earthquake with the same deformation as the 1959 Hebgen Lake event were to occur. Adapted from Smith and Richins (1984).

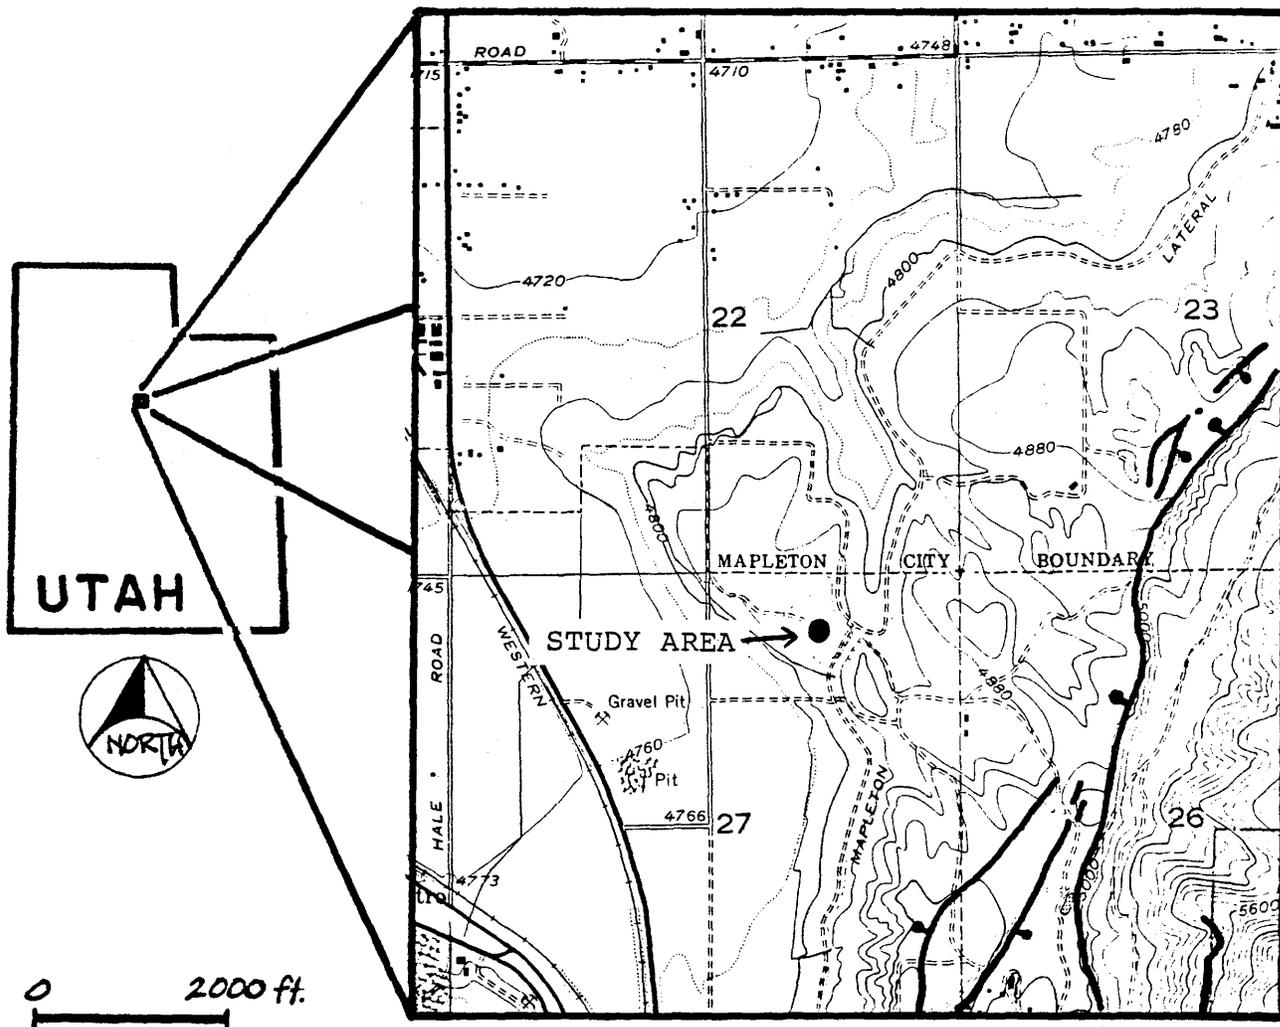
Figure 1. Map showing the location selected by Mapleton City for a water tank. Faults are depicted by heavy lines, with the bar and ball on the downthrown side. Fault mapping adapted from Machette (unpublished data, 1987).

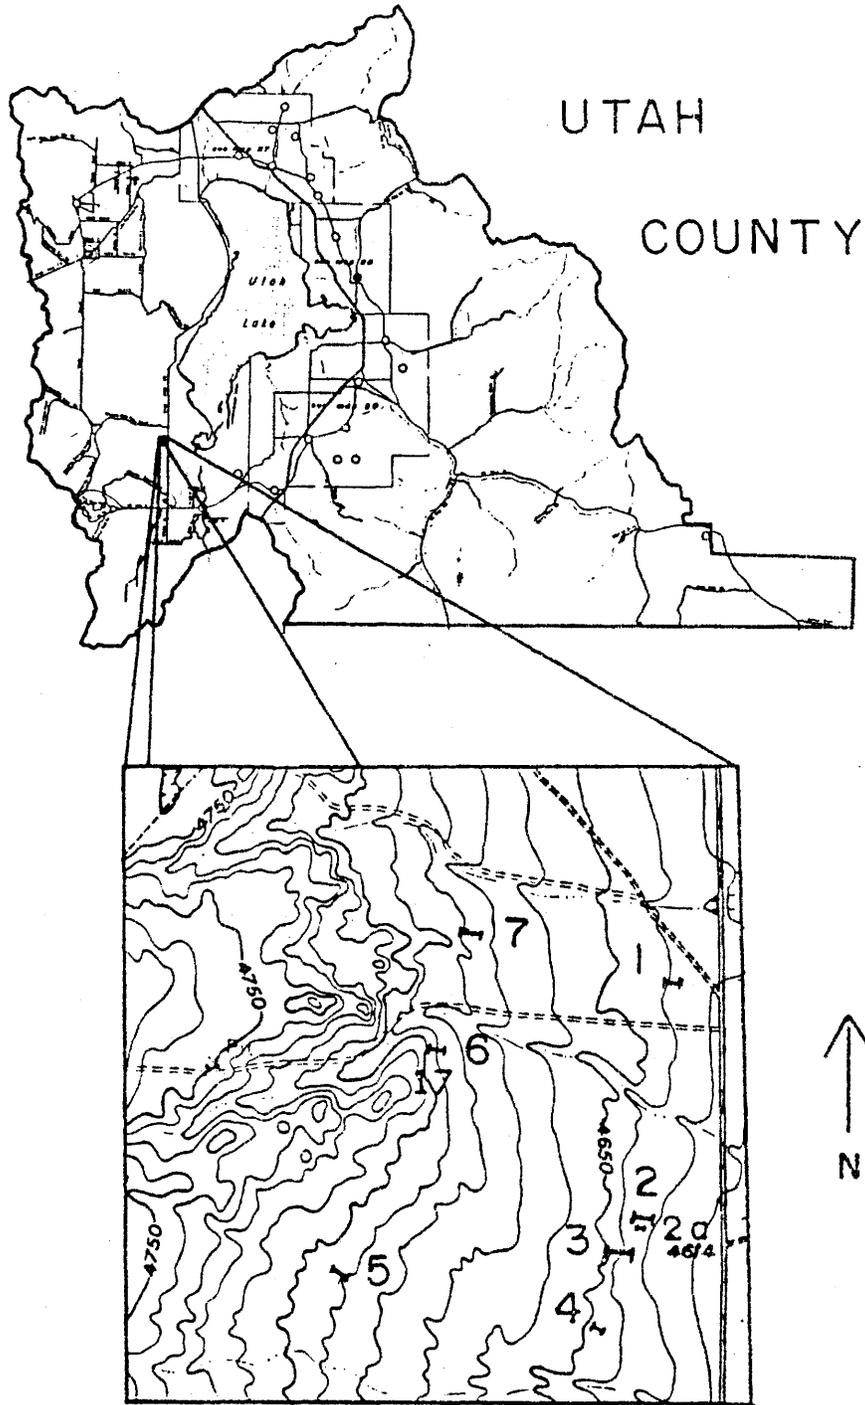
Trenches were numbered from north-to-south on the eastern lineament (L1, trenches numbered 1 to 4, fig 2.) and from south-to-north on the western lineament (L2, trenches numbered 5 to 7, fig. 2). The eighth trench (number 2a, fig 2) was parallel to trench number 2 to verify continuity of the sediments through a disturbed area. Horizontal level lines were used for elevation control and reference to bedding and features in logging trenches. The original scale of the trench logs was 1:50.

Figure 1. Map showing the location of the study area, Section 17, T. 9 S., R. 1 W., SLB&M, Goshen Valley, Utah. Single digit numbers refer to trenches. See text for logs and descriptions of trenches.

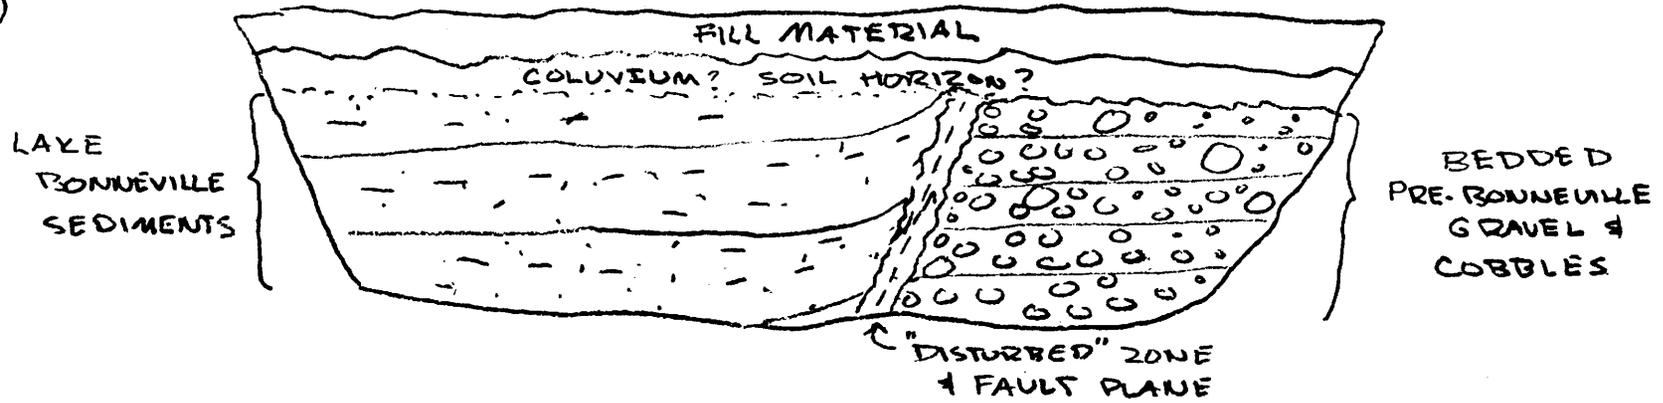
(A)

FIGURE 2:  
 GENERALIZED TRENCH DIAGRAMS  
 PROPOSED DRESDEN PLACE APARTMENT COMPLEX  
 NOT TO SCALE!
