TECHNICAL REPORTS FOR 1992 - 1993 APPLIED GEOLOGY PROGRAM

REPORT OF INVESTIGATION 224 APRI **UTAH GEOLOGICAL SURVEY** *a division of* UTAH DEPARTMENT OF NATURAL RESOURCES TAKE PRICEIN

Project: Geologic hazards investigation for a proposed fire station site in Lewiston, Cache County, Utah				Requesting Agency: Lewiston City/ Cache County Fire Department
^{ву:}]	Bill D. Black Gary E. Christenson	Date: 2 - 25 - 92	_{County:} Cache County	Job No:
USCS Quadrangle: Richmond (1494)				92-02 (PF-1)

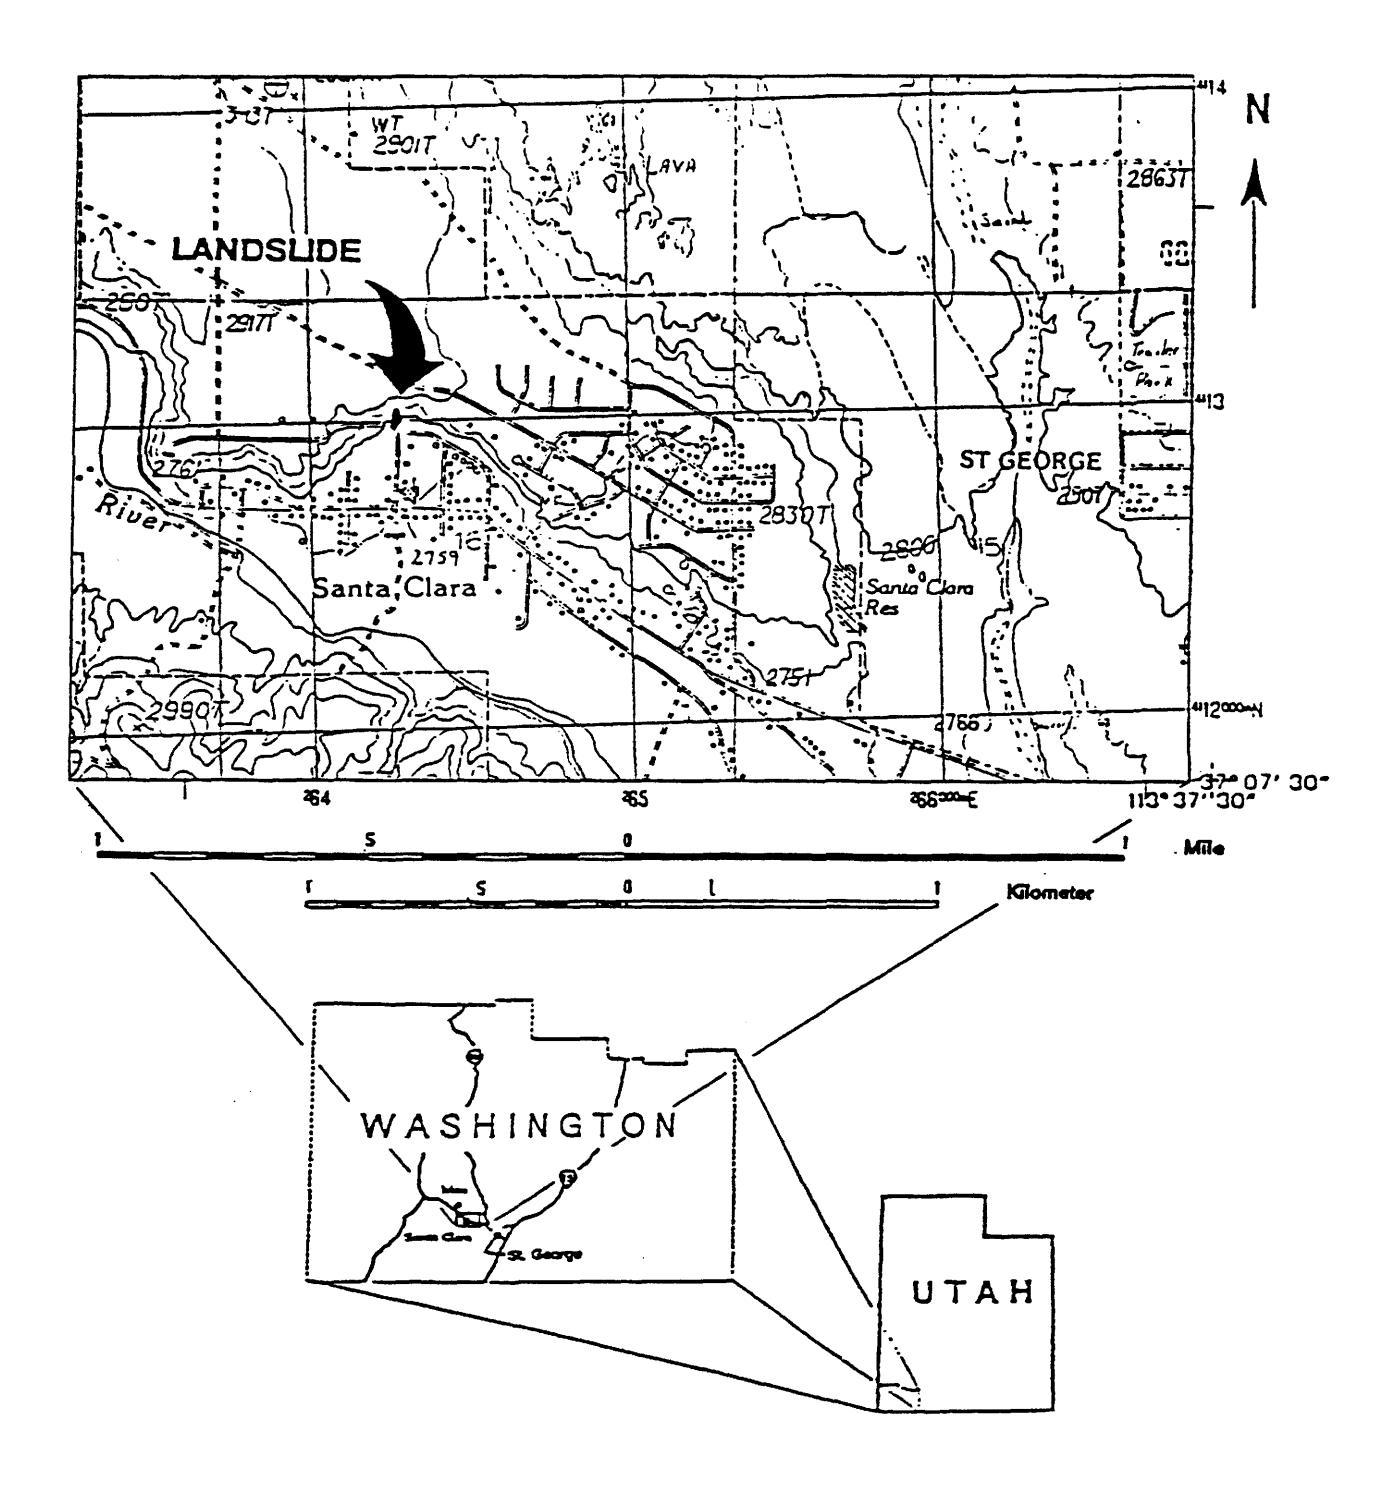
Figure 1. Location map of 1992 Truman Drive landslide.

In response to a request to the Utah Geological Survey by Kimball N. Wallace, Santa Clara City Engineer, I conducted a geologic reconnaissance from May 18-20, 1992, of a landslide on the north side of Truman Drive, Santa Clara, Utah. The landslide is in the NW1/4 section 16, T. 42 S., R. 16 W., Salt Lake Base Line and Meridian (figure 1). The landslide, which has been moving since early May, 1992, is along a south-facing bluff at the southern margin of the Santa Clara Bench, adjacent to the left flank of another landslide which occurred in 1981 (Lund, 1981). Truman Drive has periodically been partially blocked by the toe of the 1992 landslide since movement began (Kimball N. Wallace, verbal communication, May 18, 1992), and a chain-link fence and utility lines in the back yard of the Willard residence at the top of the bluff were undermined by the main scarp of the landslide on May 17, 1992.

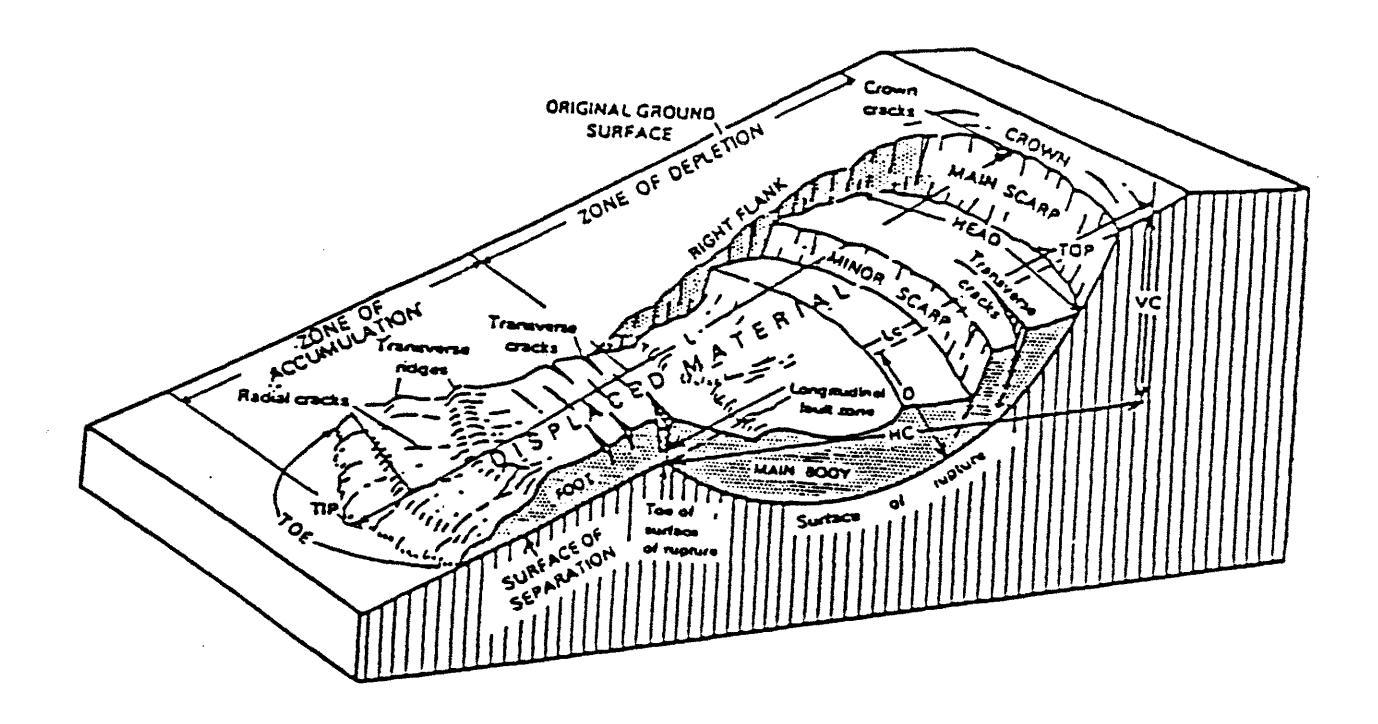
Figure 2. Block diagram of features commonly associated with a rotational slump and earthflow (adapted from Varnes, 1978).

The Truman Drive landslide is a rotational slump and earthflow (figure 2) measuring approximately 200 feet in length and 70 (near the main scarp) to 100 feet (near the toe) in width. The main scarp is approximately 8-10 feet high and the toe of the landslide is up to 10-15 feet thick. The landslide deposit contained several minor scarps with vertical offsets up to 3 feet. Transverse cracks were present along the right flank of the landslide. The landslide was still moving at a very slow, almost imperceptible, rate at the time of my last reconnaissance at 2:00 p.m. on May 20, 1992.
