TECHNICAL REPORTS FOR 1996 APPLIED GEOLOGY PROGRAM

*compiled by
Bea H. Mayes*

REPORT OF INVESTIGATION 231 1997
UTAH GEOLOGICAL SURVEY
a division of
UTAH DEPARTMENT OF NATURAL RESOURCES

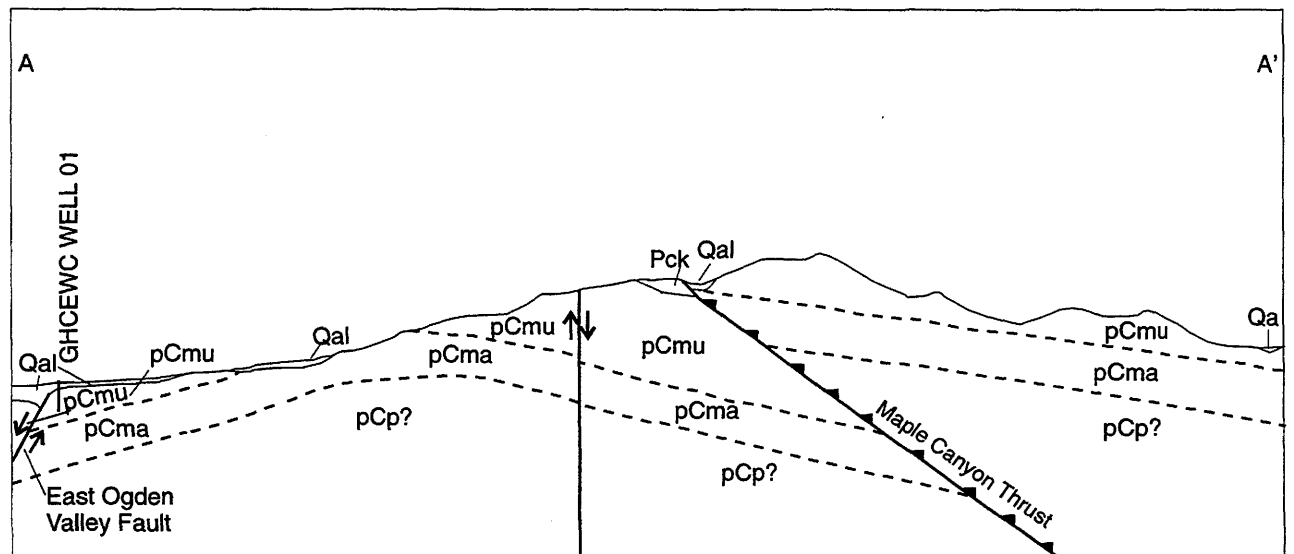
Attachment 3. Geologic cross section trending north-south through GHCEWC well. Based on geology modified from Crittenden (1972). See attachment 2 for location and explanation.

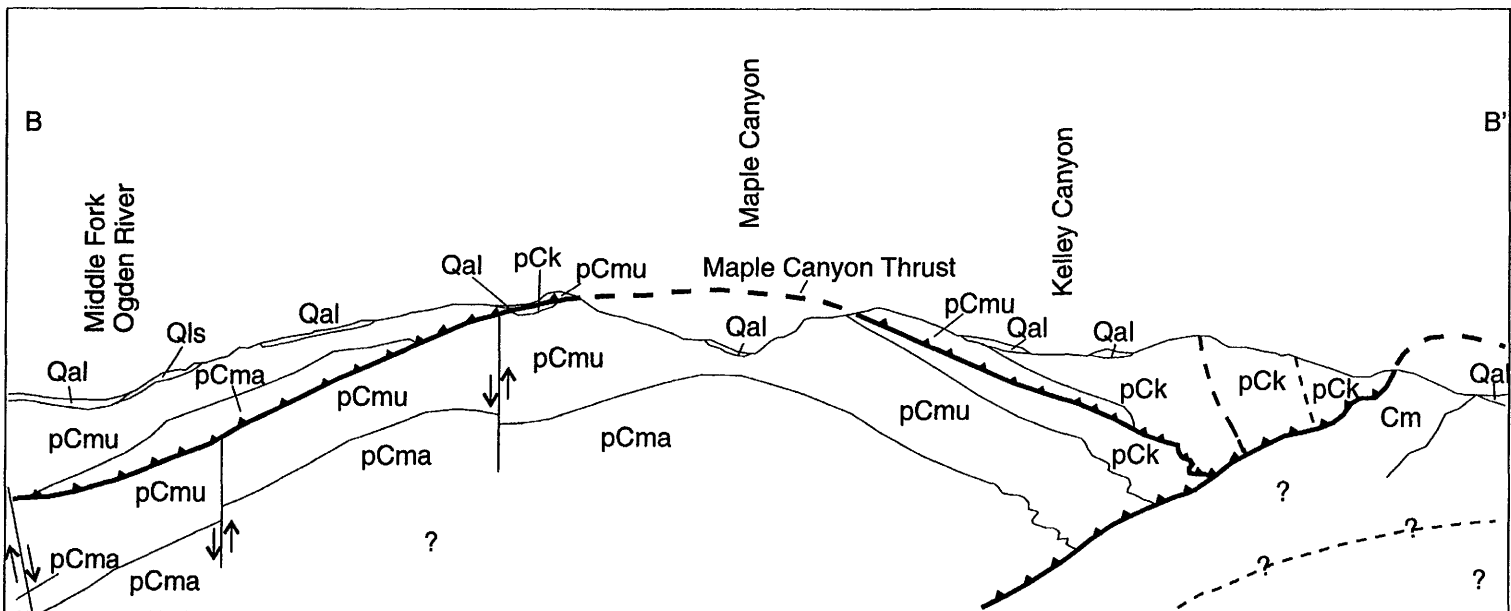
Attachment 4. Geologic cross section trending NW-SE in the Maple and Kelley Canyon areas (from Crittenden, 1972). See attachment 2 for location.

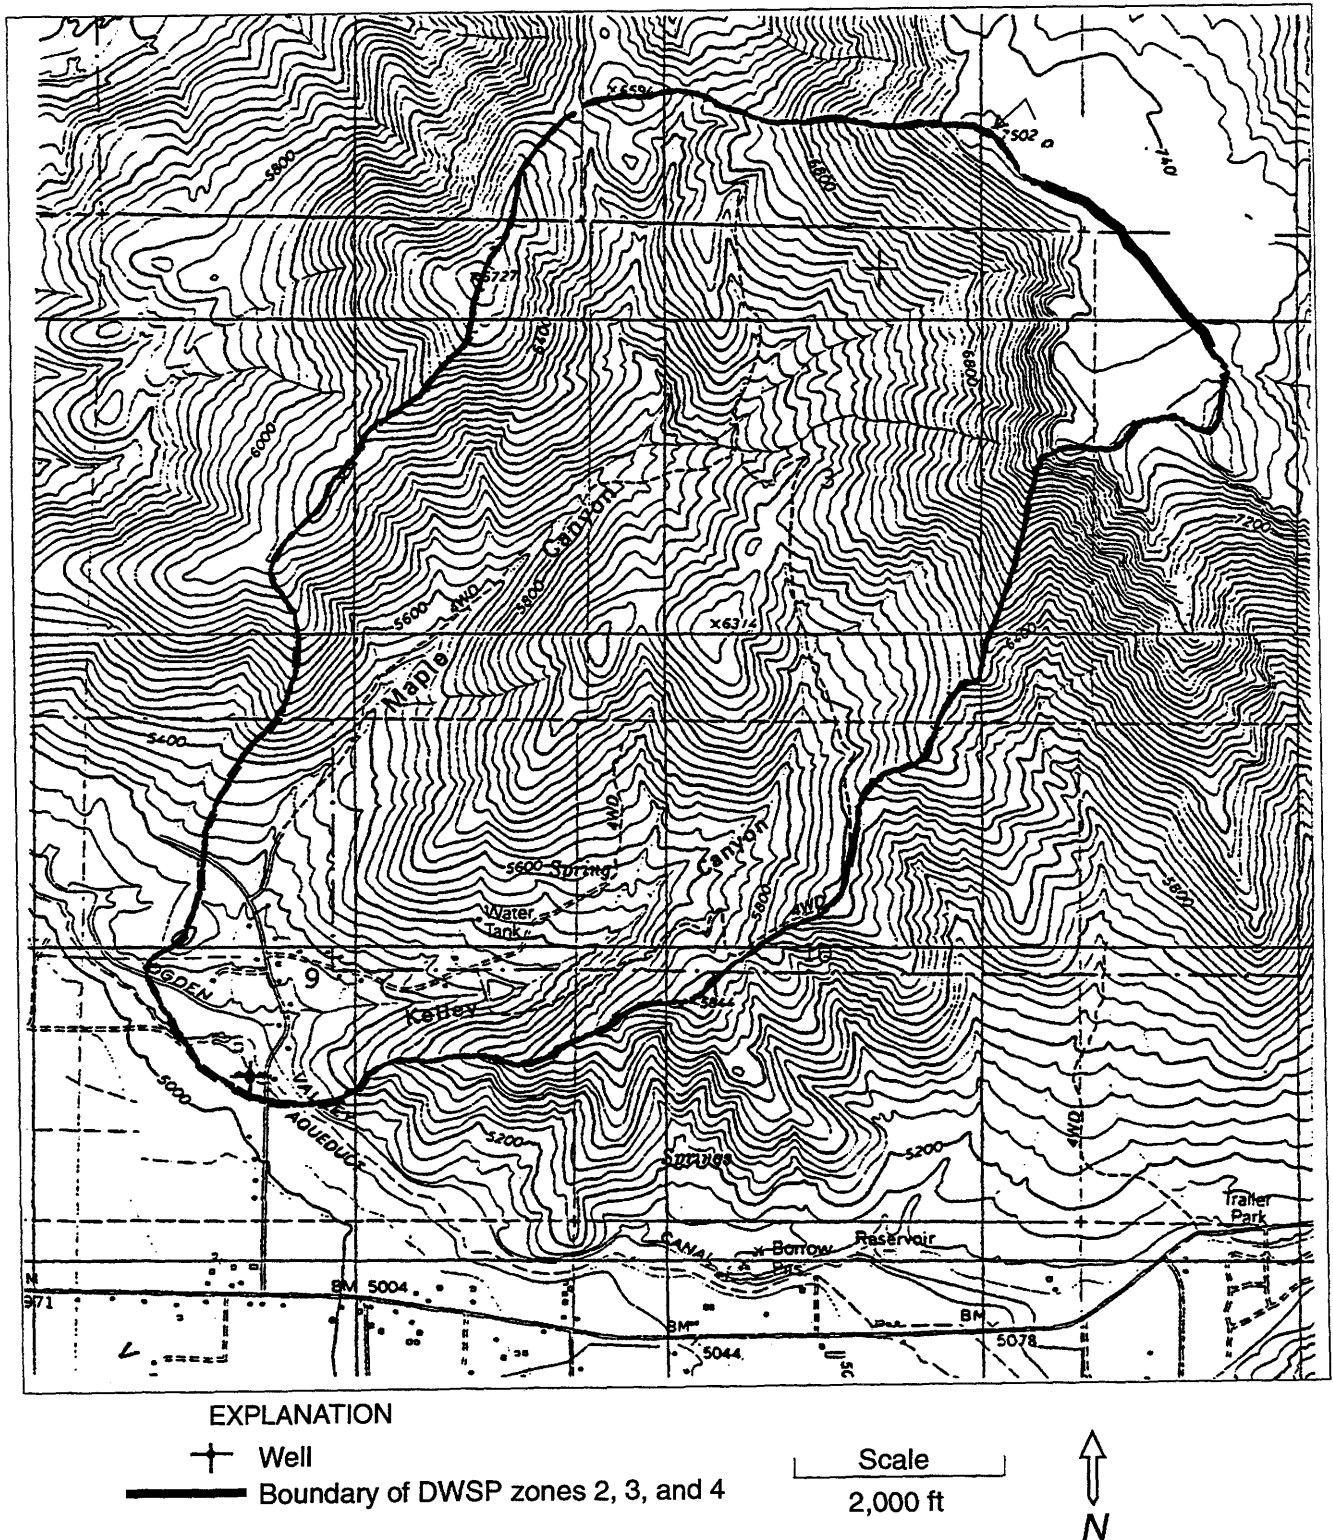
Attachment 6. Map showing boundary of drinking-water-source-protection (DWSP) zones 2, 3, and 4.

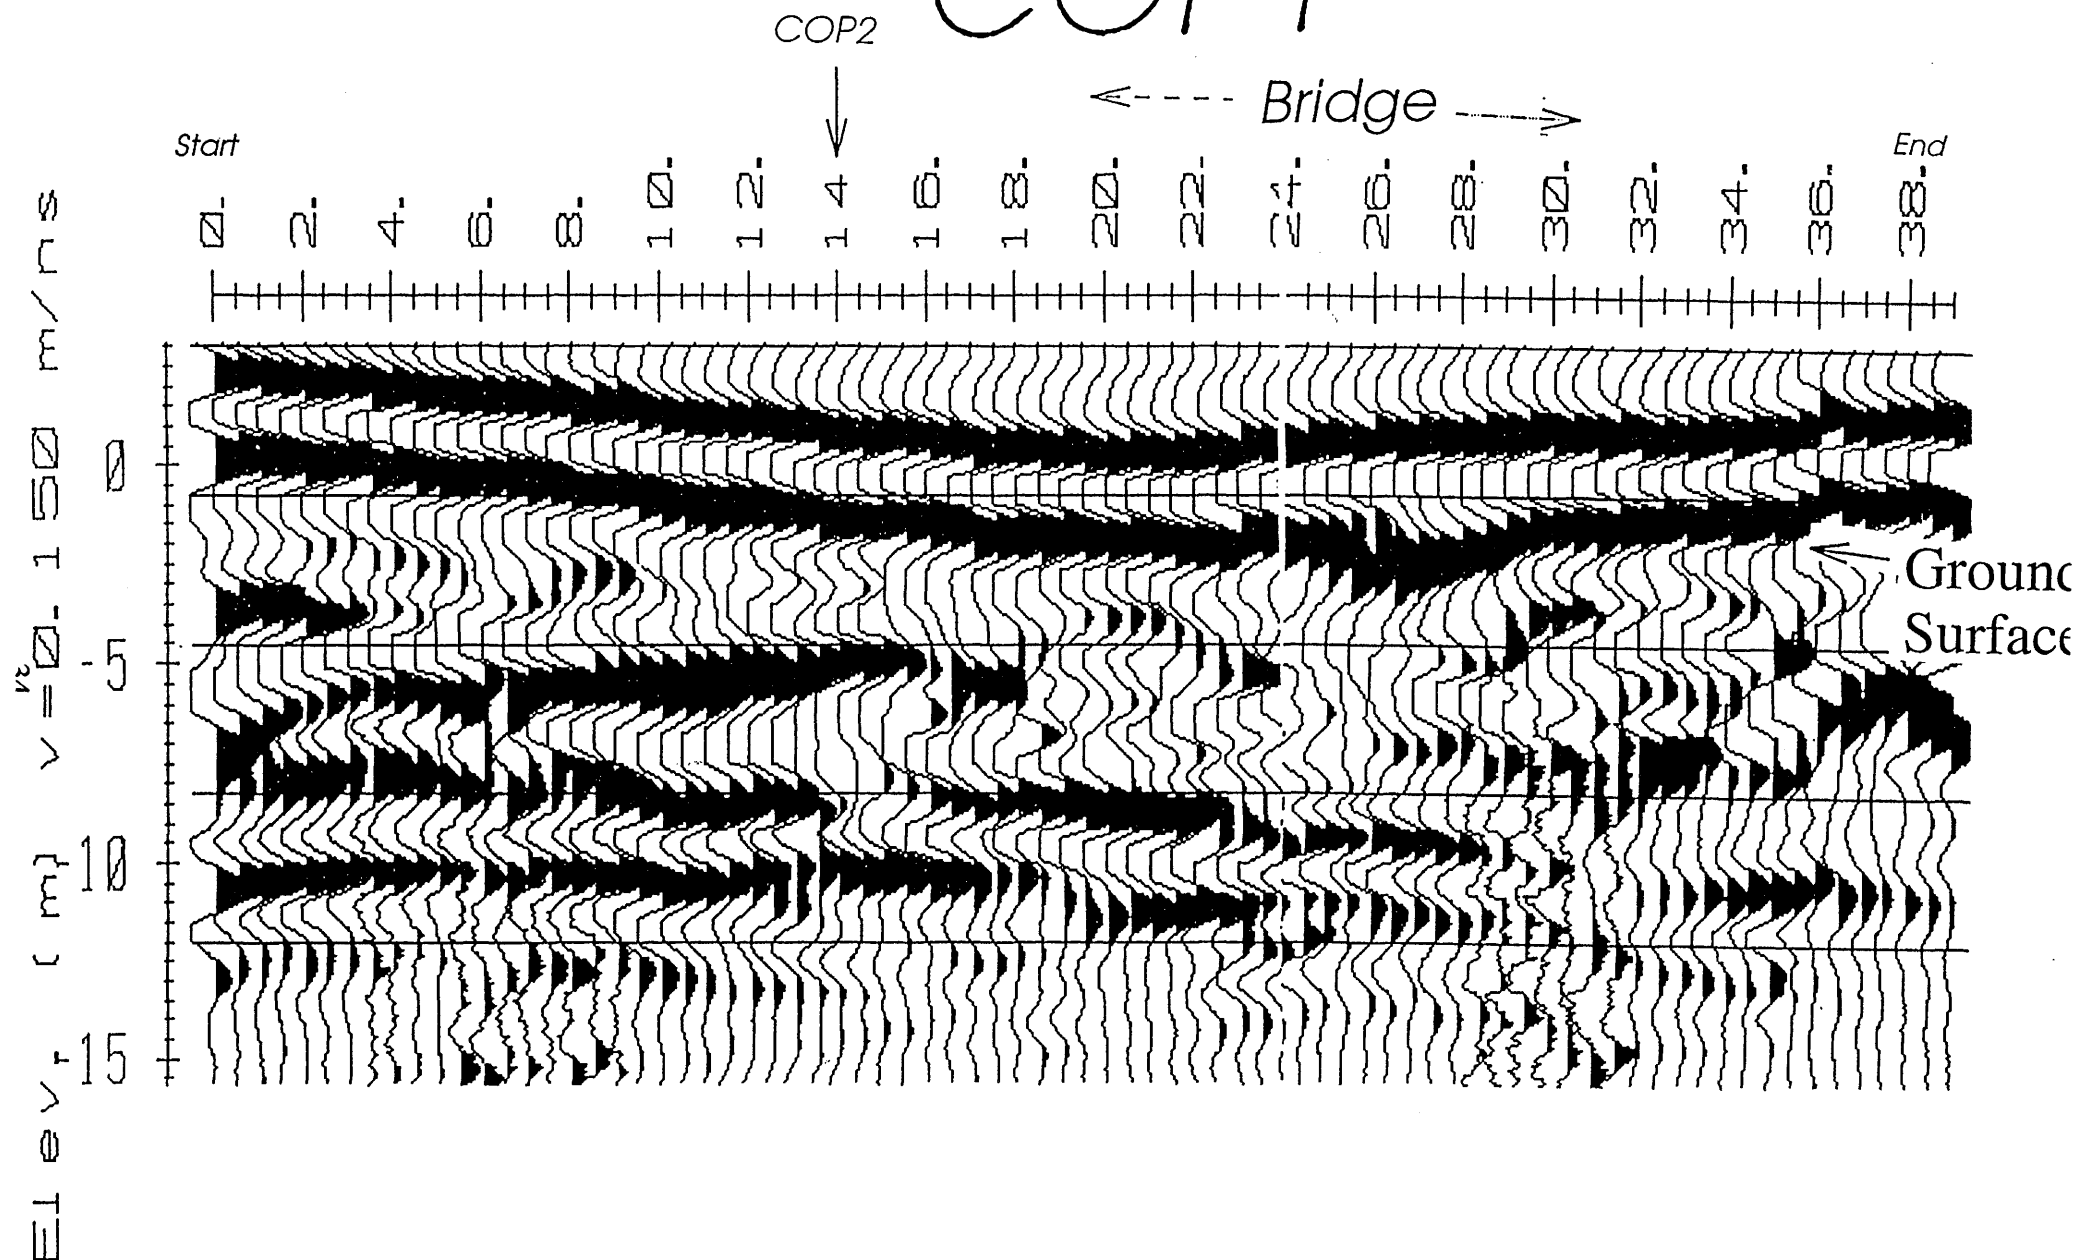
FIGURE 2b.

Figure 2. COP data for lines COP1, COP2, and COP3. Offset and depth units are in meters, and the data are corrected to a flat datum plane about 2 meters above the bridge elevation. The ground surface is along the arrow depicted on the RHS, and units are in meters. Figure 5 should be used to convert the apparent depths here to actual depths.

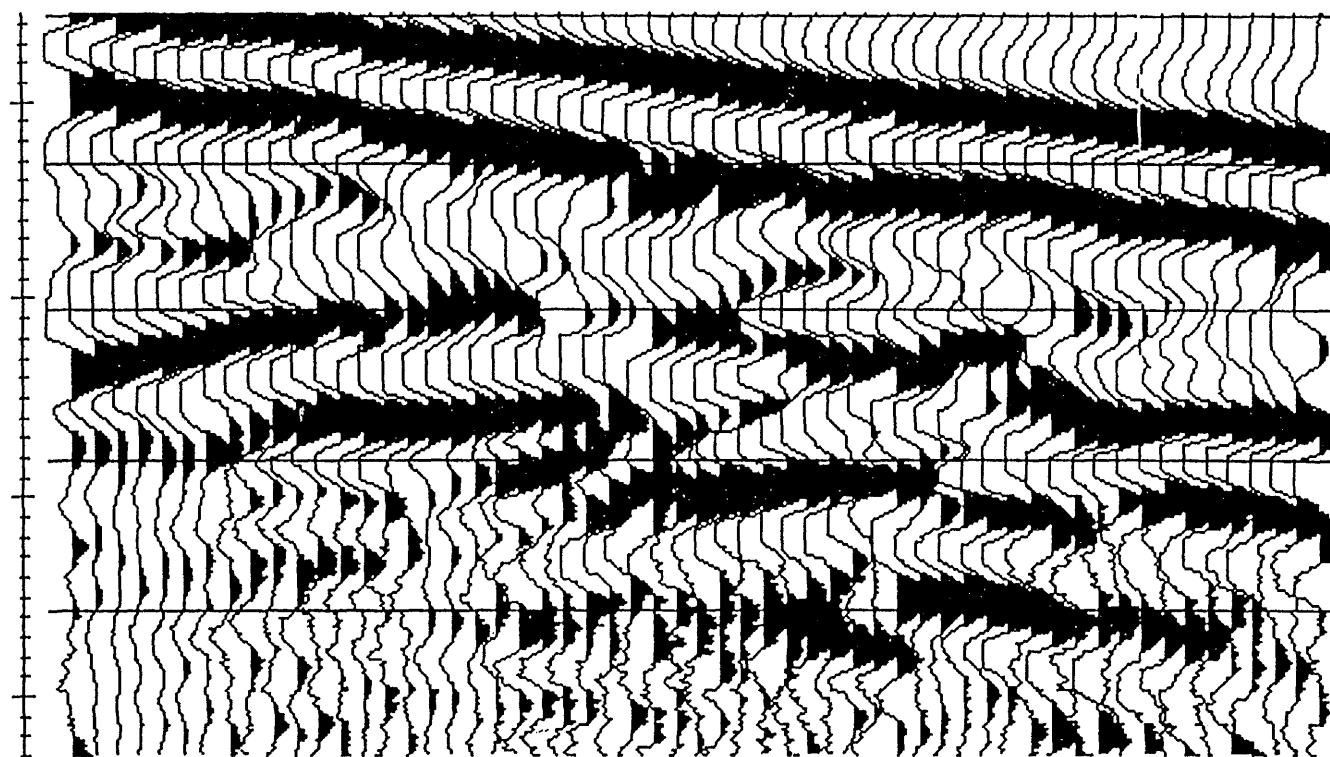
FIGURE 3a

Note the dipping reflectors along the RHS of the COP2 line in Figure 3. The continuity of these reflectors become interrupted over the sinkhole area, with some possible slumping of the reflectors. It is important to discover the geologic reason for these jointing+slumping observations. These features are consistent with a sinkhole filled in with competent rubble.

Figure 3. Same as Figure 2 except lines are drawn to indicate faults/joints, and frowns are drawn to indicate diffraction events.

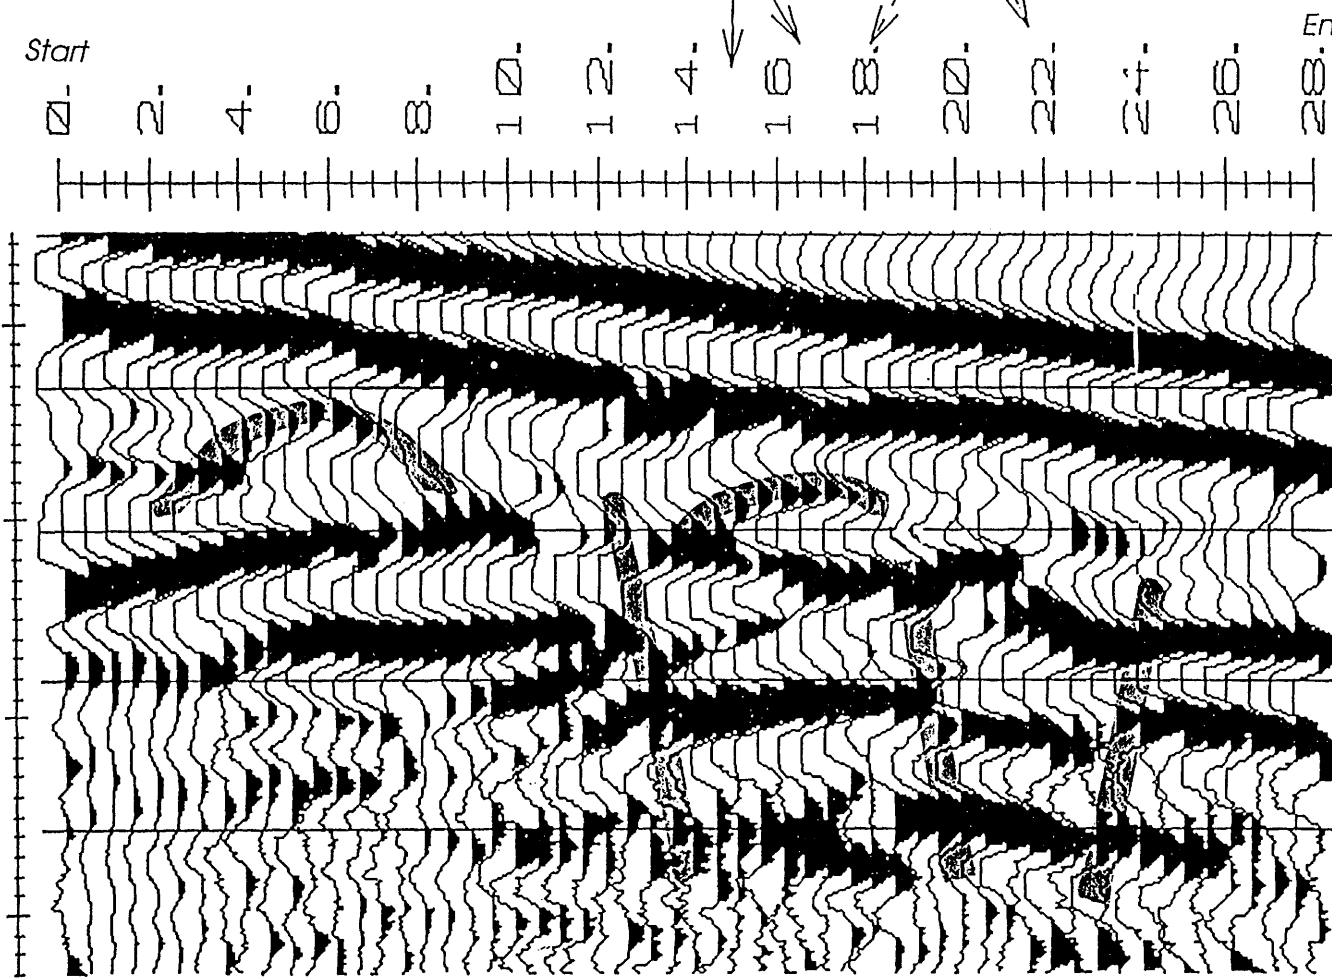
FIGURE 4

Figure 4 depicts the COP1 line shown in Figure 3, except a longer time window of data is displayed. These data show good reflections to depths greater than 40 m.

Figure 4. COP1 line for a longer recording time and a different gain. Note the high quality reflections from deep depths.

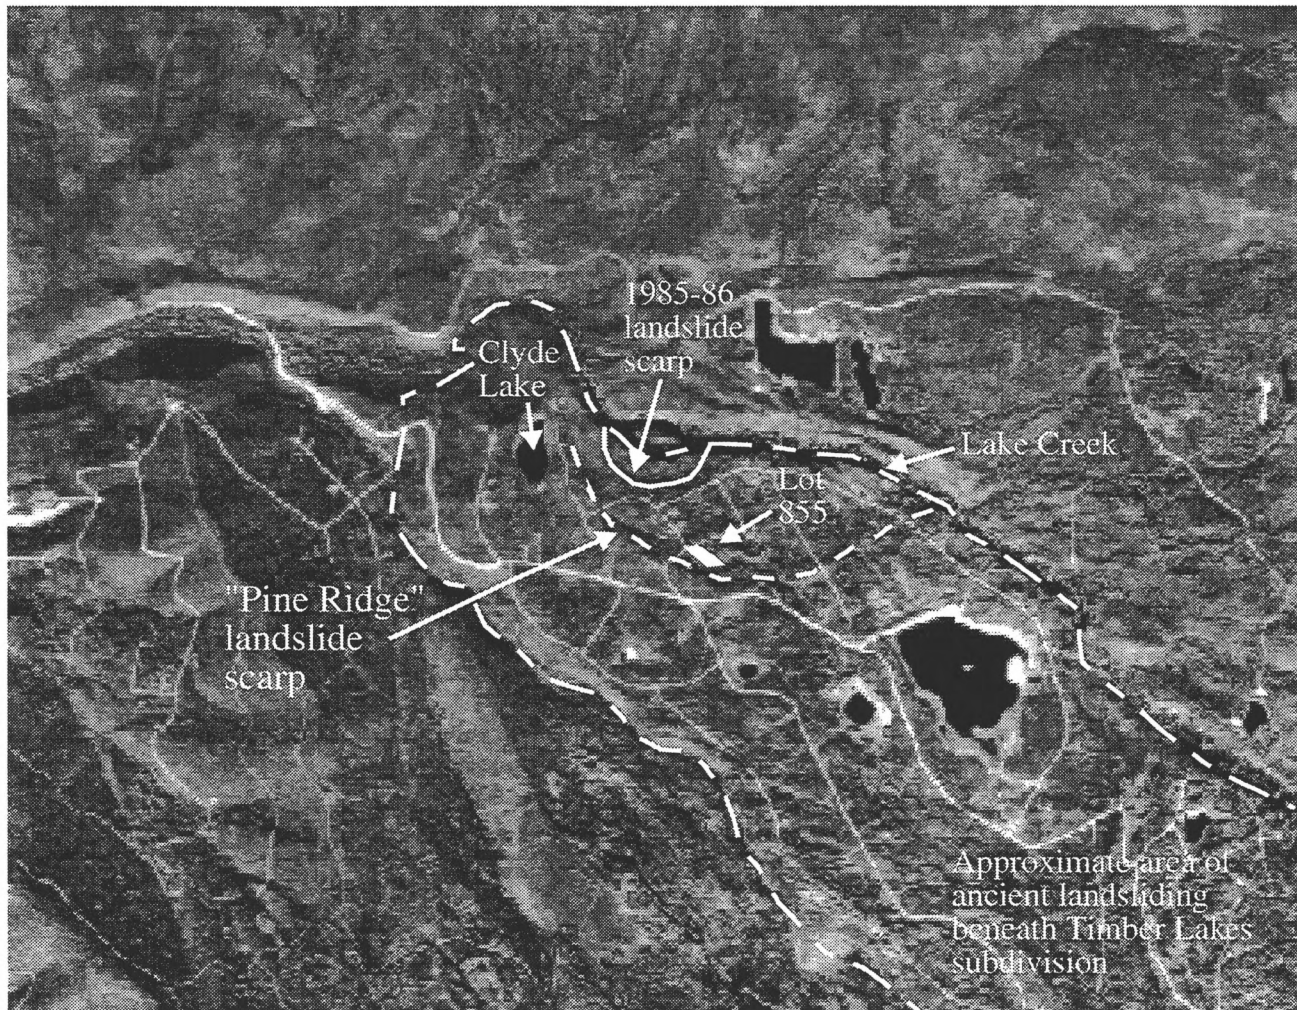
Attachment 1. Air-photo map of the "Pine Ridge" landslide, 1985-86 landslide, and limits of older prehistoric landsliding (Hylland and Lowe, in preparation) possibly affecting lot 855 at the Timber Lakes subdivision, Wasatch County, Utah. Location of scarps and landslide area boundary are approximate.

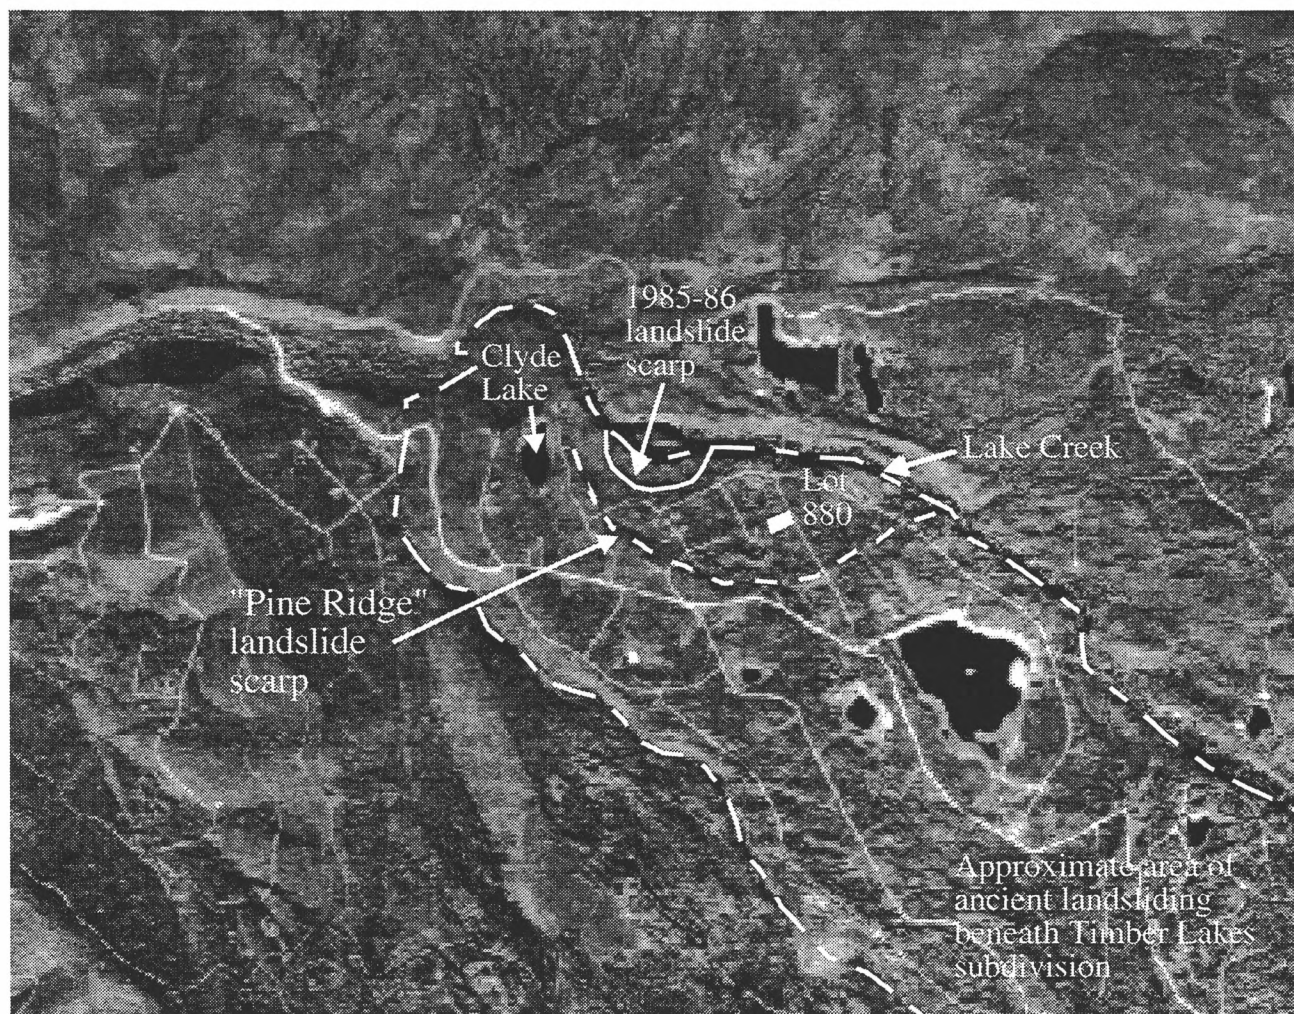
Attachment 1. Air-photo map of the "Pine Ridge" landslide, 1985-86 landslide, and limits of older prehistoric landsliding (Hyland and Lowe, in preparation) possibly affecting lot 880 at the Timber Lakes subdivision, Wasatch County, Utah. Location of scarps and landslide area boundary are approximate.

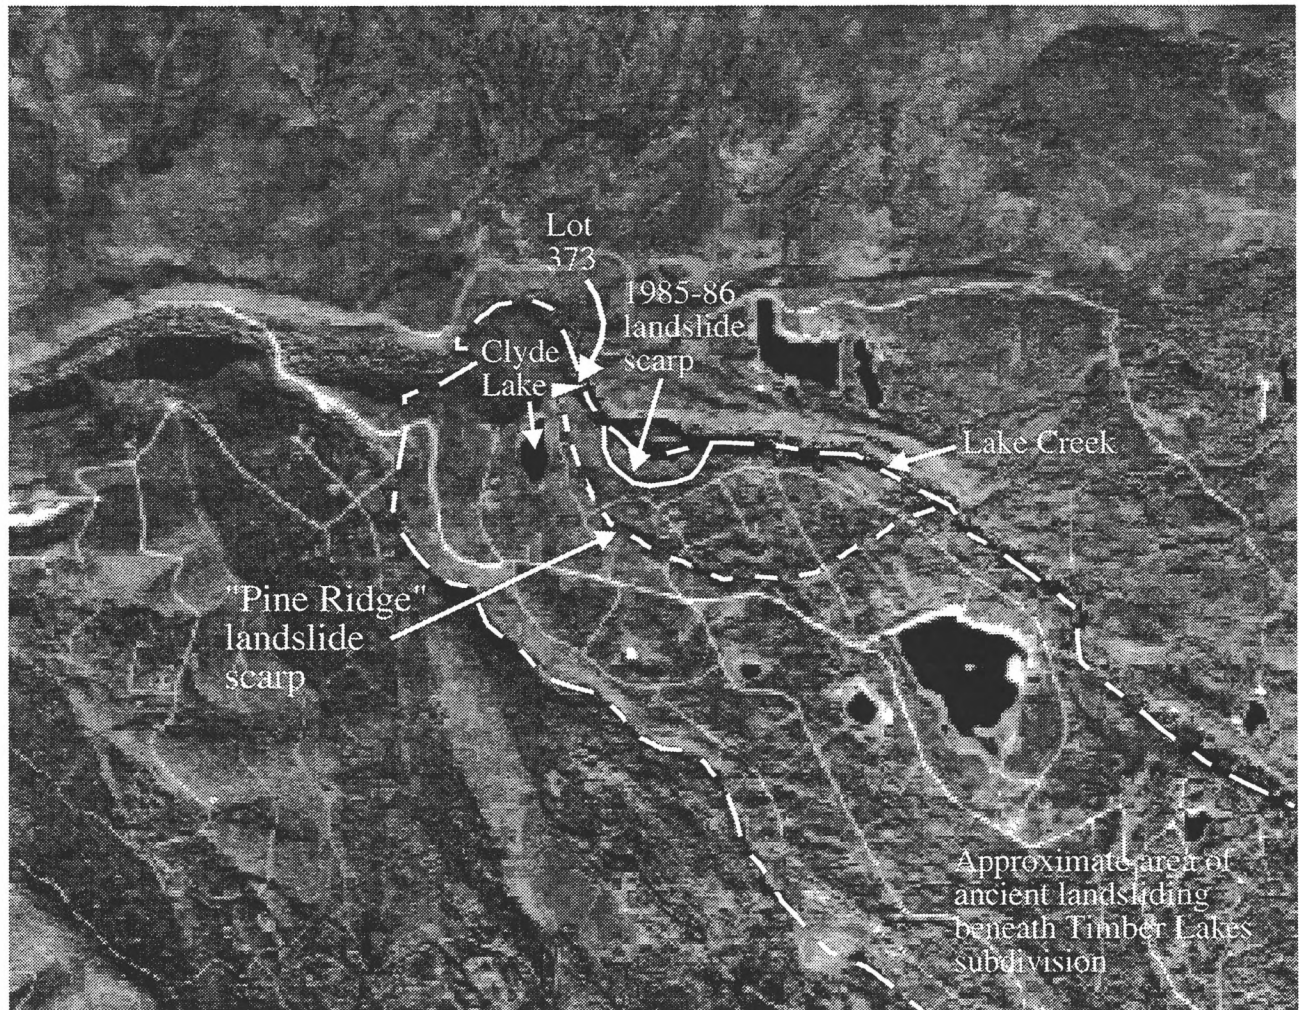
Attachment 1. Aerial photograph showing the "Pine Ridge" landslide, including a portion which reactivated in 1985-86, and limits of older prehistoric landsliding (Hylland and Lowe, in preparation) in relation to lot 373 at Timber Lakes Estates, Wasatch County, Utah. Locations of scarps and landslide-area boundary are approximate. The landslides which abut lot 373 to the northwest and northeast are not shown.
