# TECHNICAL REPORTS FOR 1997 APPLIED GEOLOGY PROGRAM

REPORT OF INVESTIGATION 236  
UTAH GEOLOGICAL SURVEY

March 1998

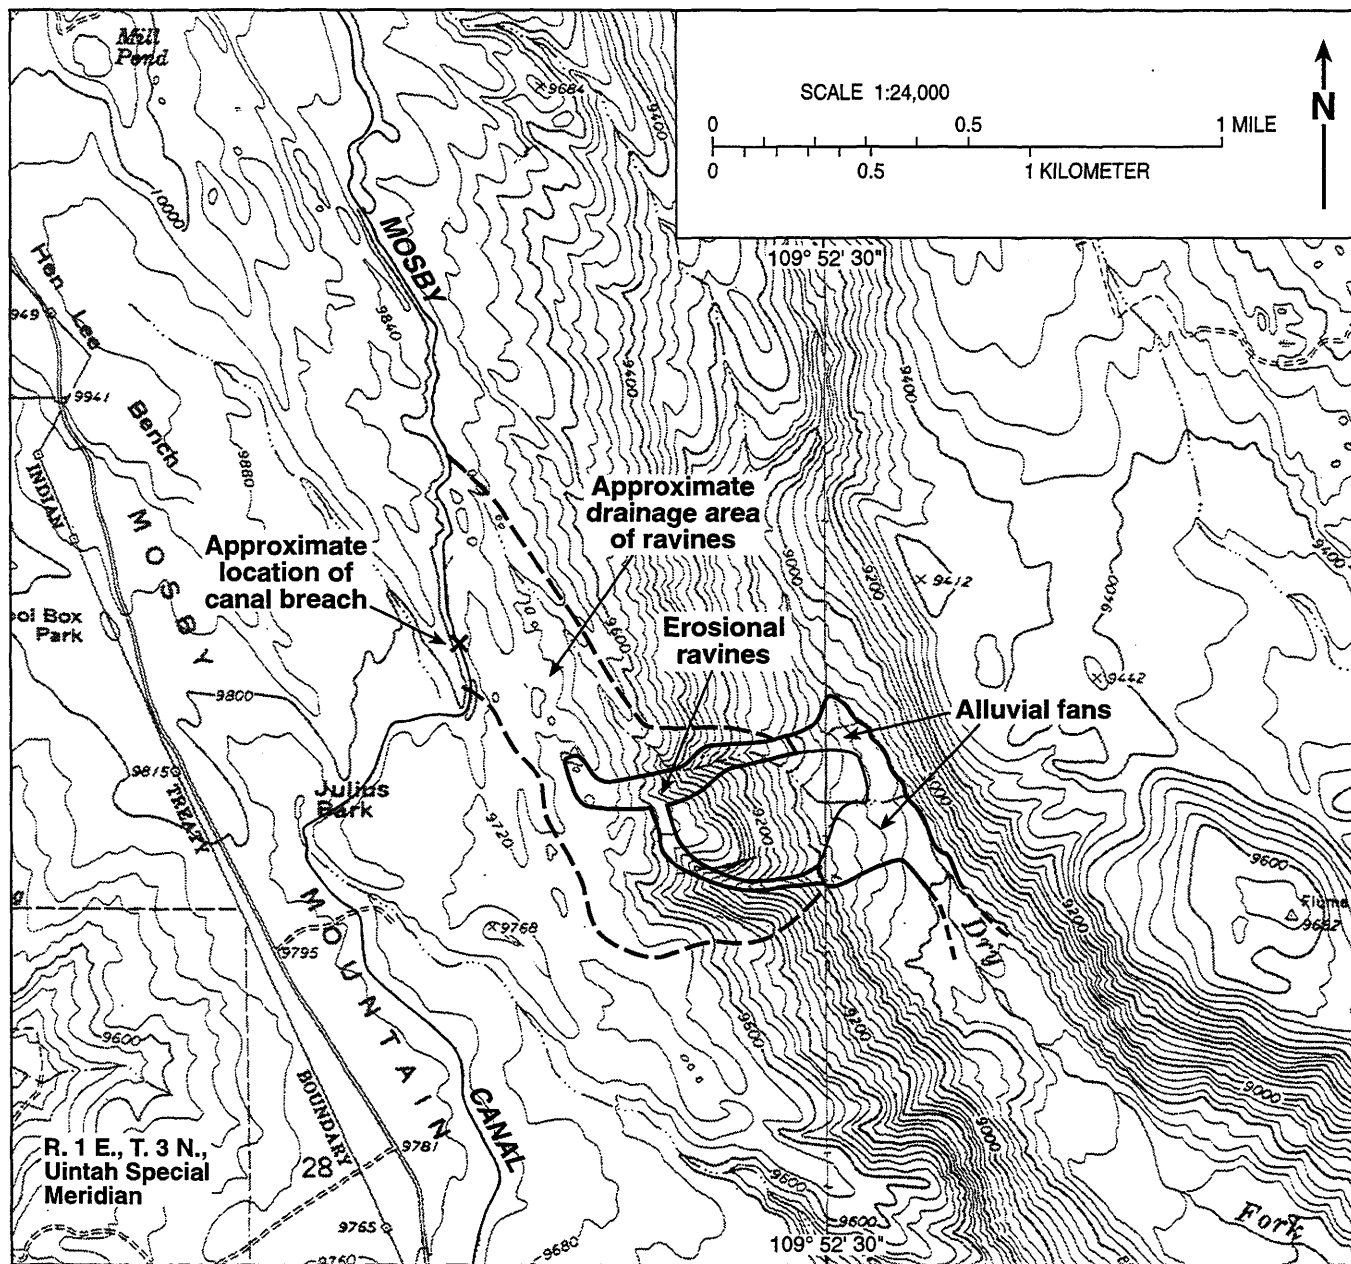
Attachment 2. Location map showing erosional ravines, alluvial fan, canal breach, and the approximate drainage area of ravines.

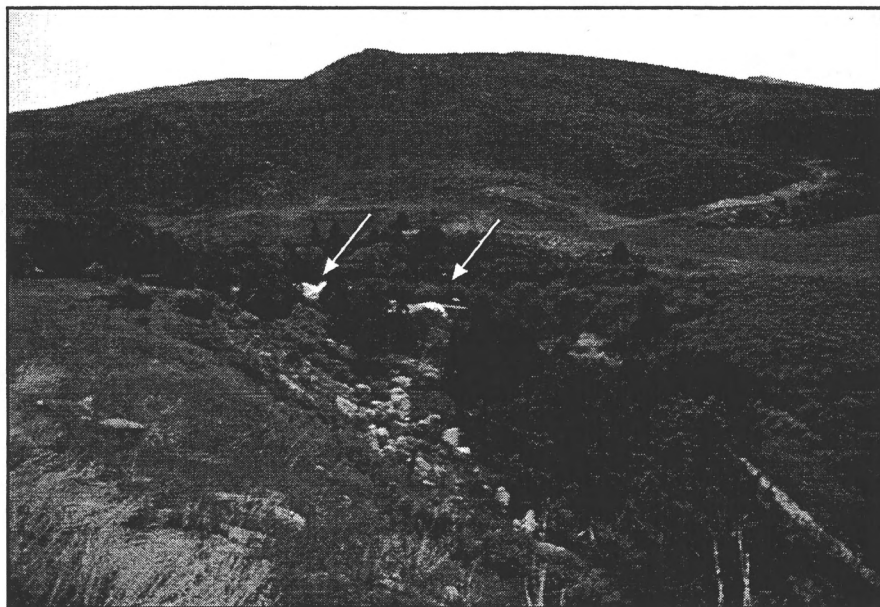
**Attachment 10.** Engineering test facility directly downstream of the landslide. Arrows indicate buildings and structures. View is to the east-southeast.

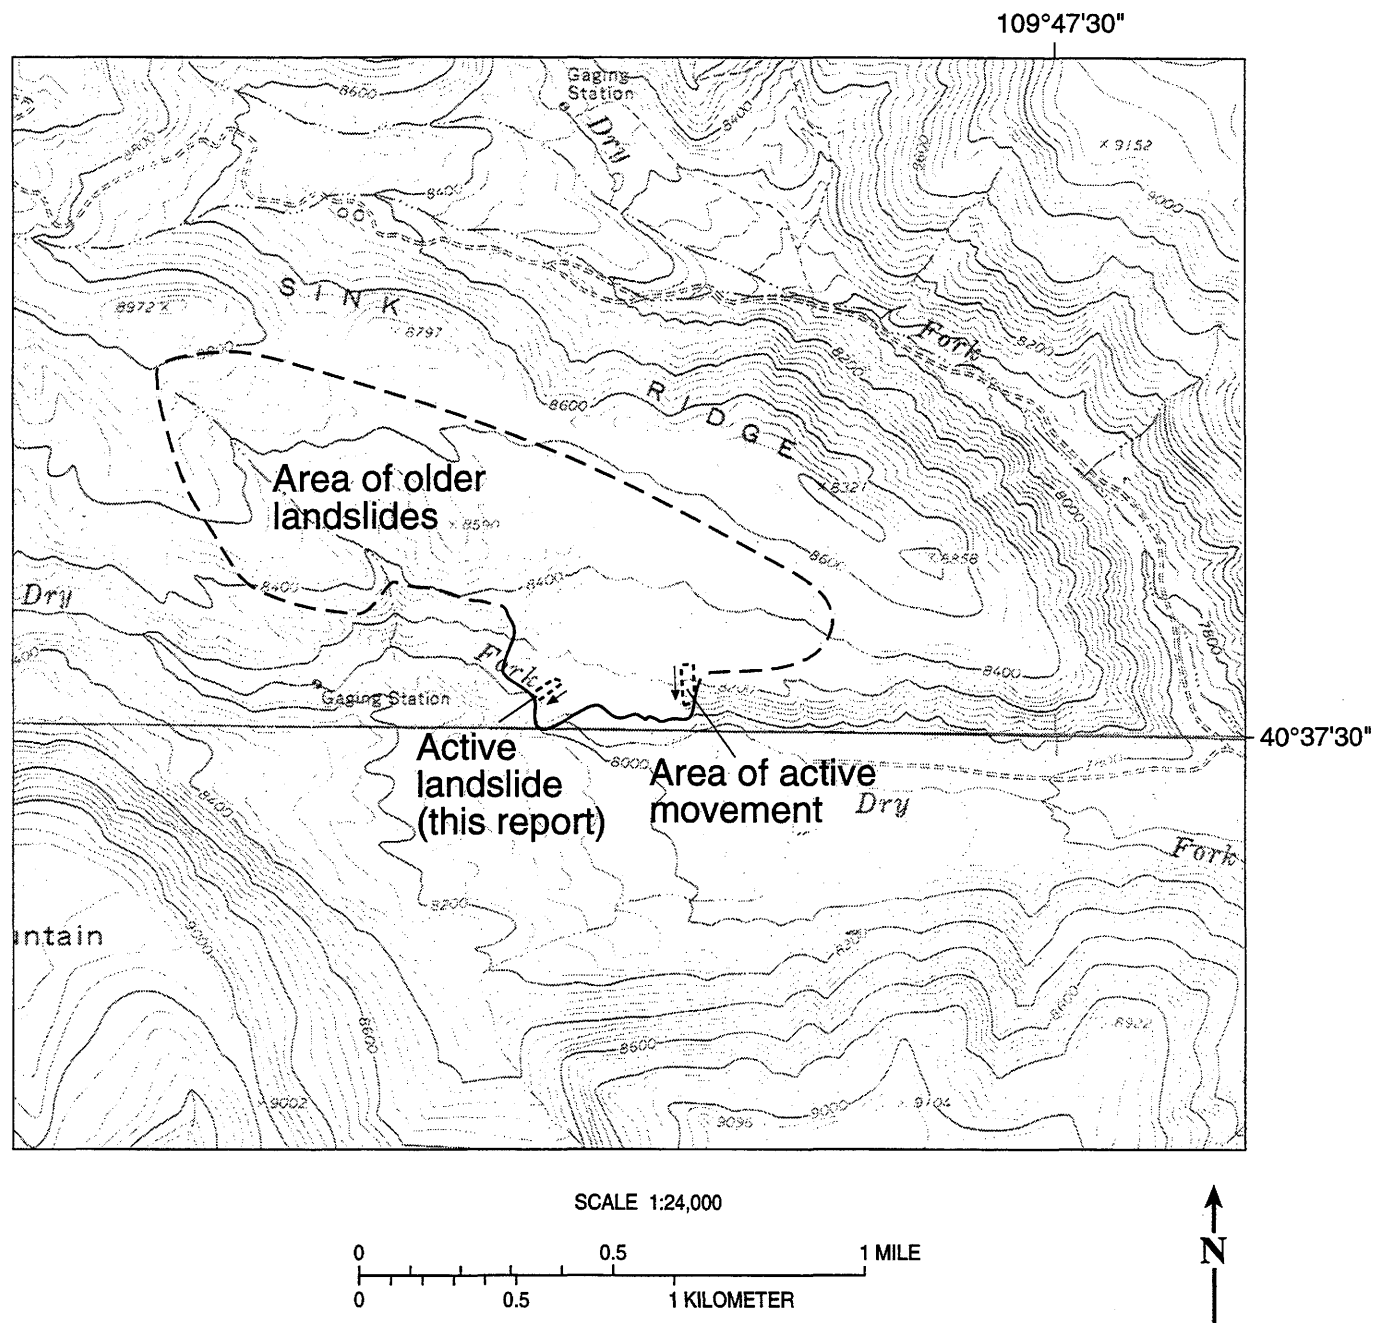
Attachment 2. Location map showing approximate outline of older landslides (modified from Carrara, 1980) and active landslide movement, September 23, 1997.
