TECHNICAL REPORTS FOR 2000-01 GEOLOGIC HAZARDS PROGRAM

REPORT OF INVESTIGATION 250
UTAH GEOLOGICAL SURVEY
a division of
Utah Department of Natural Resources

TECHNICAL REPORT SITES 2000-01

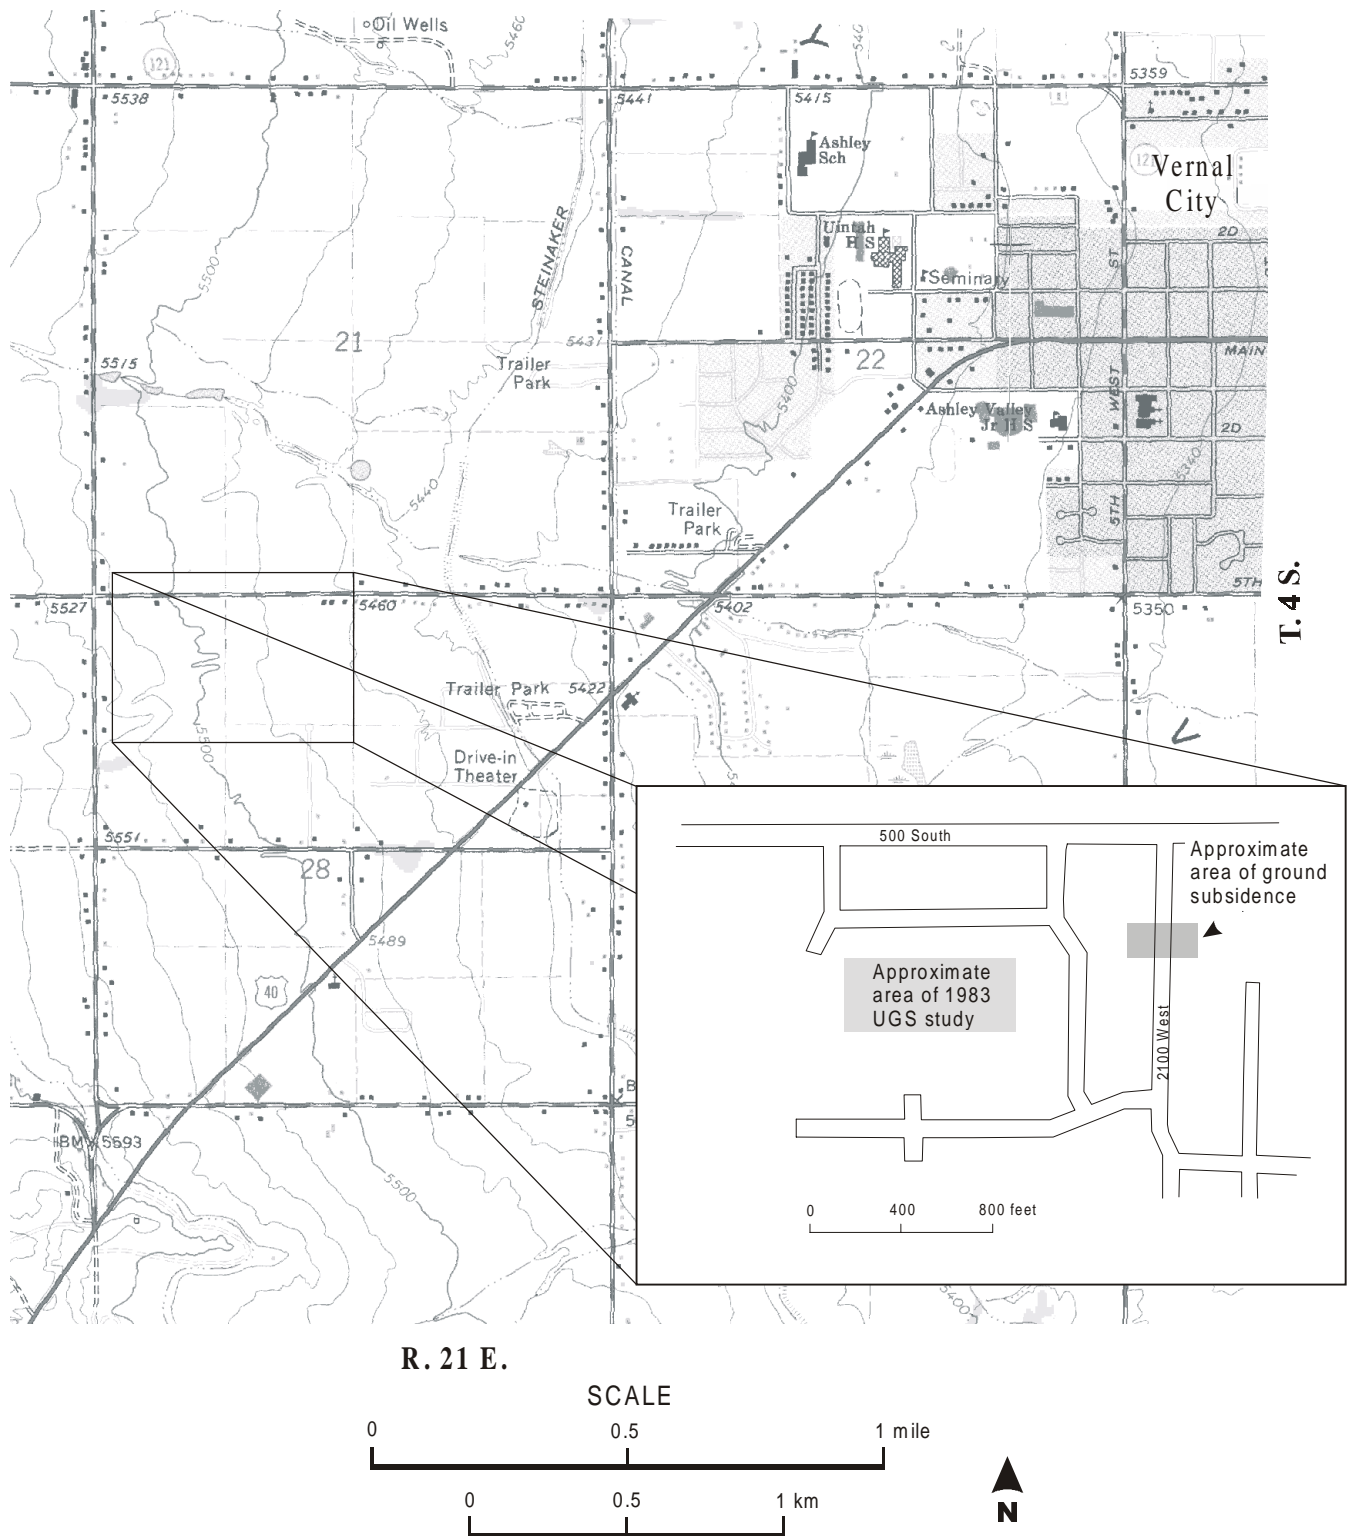
Attachment 1. Location and site map.

Ground subsidence at the site has recently affected a roadway and at least two residential properties: one west (592 South) and one east (595 South) of 2100 West (attachment 1). We did not investigate adjacent properties in detail or survey the neighborhood for other damaged houses, although the neighboring property south of 595 South may also be distressed. The affected subdivision was developed and incorporated into Vernal City in the early 1980s. Underground utilities including water and sewer lines were installed along 2100 West at that time and the road was paved in the early 1990s. Aerial photos (1963) indicate that prior to development the area consisted primarily of irrigated farmland with a few roads and houses with yards. A gravel road was present along what is now 2100 West. Undeveloped parcels of land remain in the area including several acres approximately a block west of the affected site owned by the local school district.

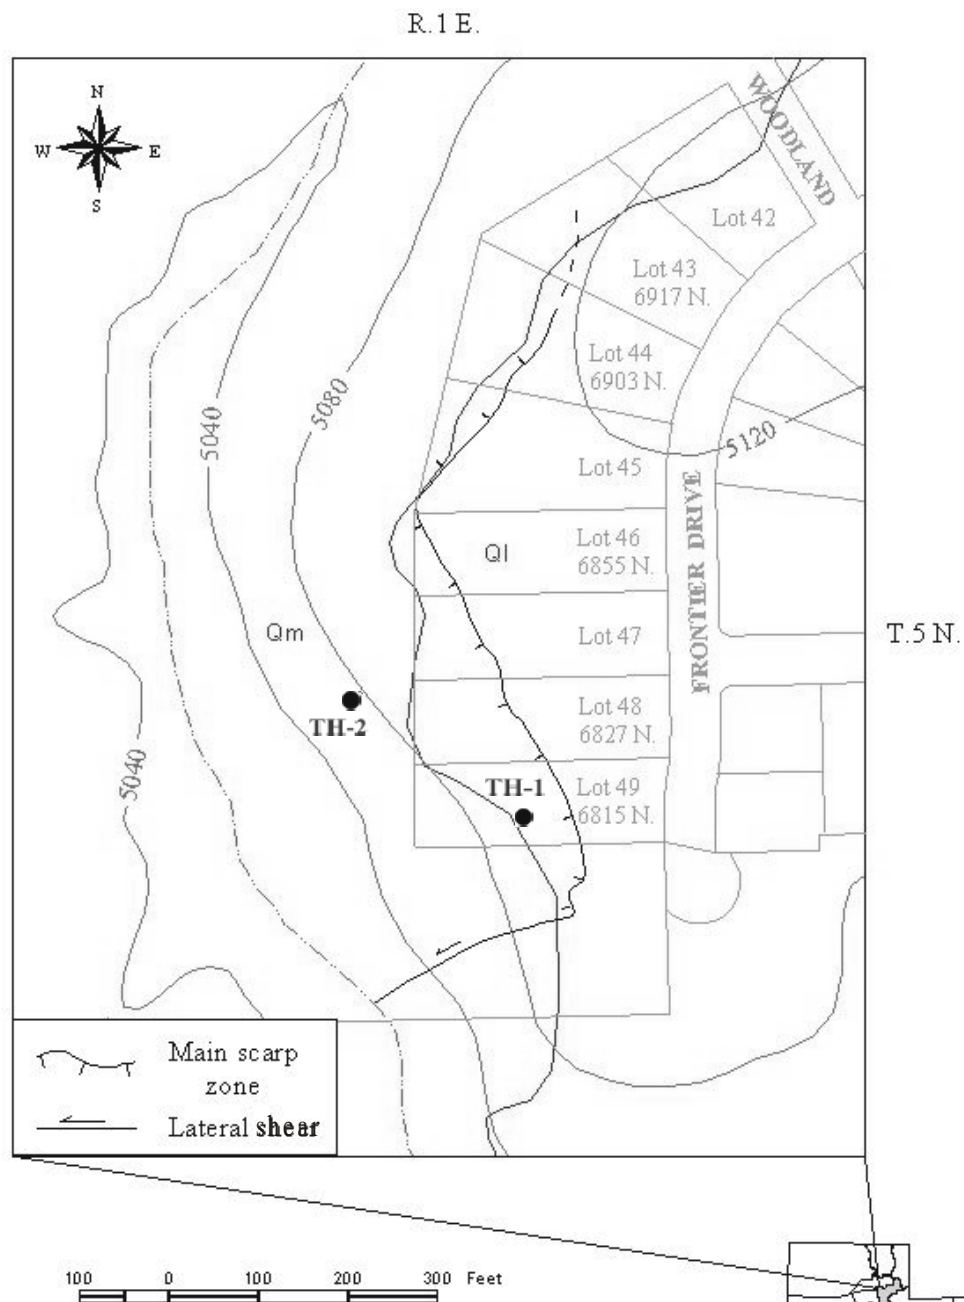
The Frontier Drive landslide is about 800 to 1,000 feet wide (north-south) and, on average, about 300 feet long (east-west). Table 1 summarizes the landslide width measurement data. Based on these dimensions, I estimate the landslide area to be about 27,000 to 33,000 square yards. Rock was encountered beneath the landslide deposits at depths of 68 and 28 feet in two boreholes (Earthtec Testing and Engineering, P.C. [Earthtec], 2001). Assuming an average depth of about 50 feet for the landslide deposits, I estimate the landslide volume to be between approximately 440,000 and 560,000 cubic yards.

Figure 1. Location and sketch map of the Frontier Drive landslide in Mountain Green, Morgan County, Utah. The landslide is bounded on the east by a main scarp zone and on the west by an unnamed creek. The main scarp zone transitions to the north into a zone of ground cracking (dashed line). The main scarp zone roughly coincides with the contact between landslide deposits (Qm) and lacustrine deposits (Ql) of King and others (in preparation). A lateral shear bounds the landslide on the south. Earthtec (2001) boreholes TH-1 and TH-2 shown.

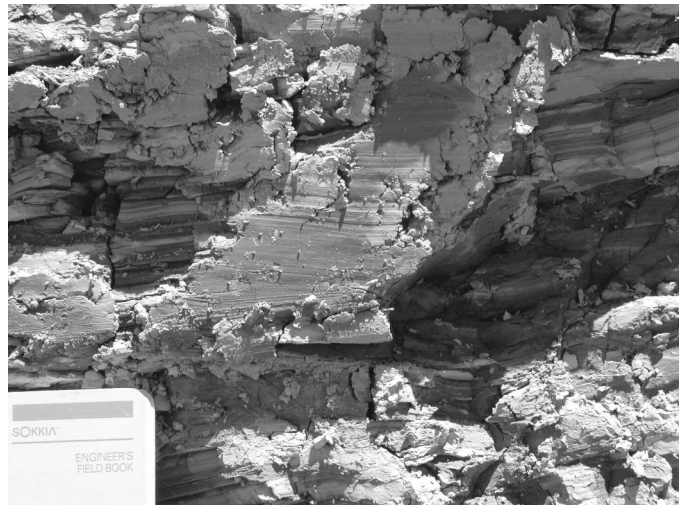
Frontier Drive consist of reddish brown, laminated clay (figure 5). Atterberg limits tests of the clay soils by Earthtec (2001) indicate the soils consist of low (CL) and high plasticity (CH) clay. The arcuate scarp-like features that appear on the September 17, 1980, aerial photograph are in the area mapped by King and others (in preparation) as lacustrine deposits. Whereas the features may be caused by landsliding, their exact origin is uncertain.

Figure 5. Exposure of laminated lacustrine clay south of the Frontier Drive landslide. Field book shown for scale.

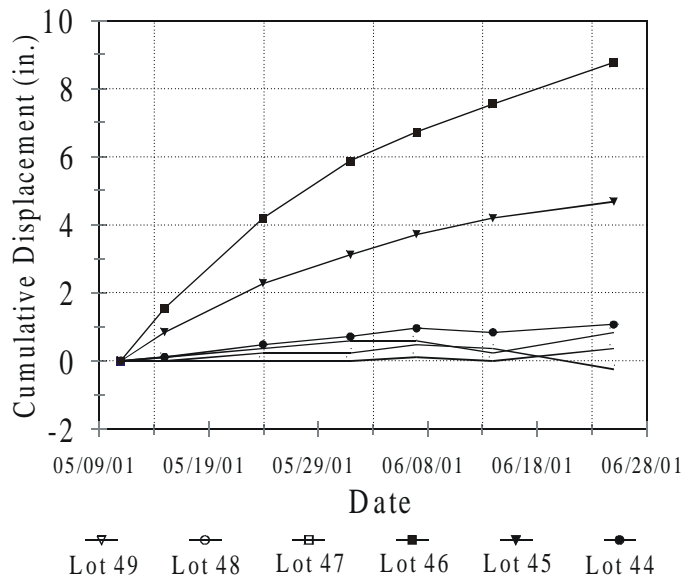
Landslide movement continued throughout the period of this investigation (May 11, 2001 through June 25, 2001). Figure 7 shows cumulative displacement (movement) for this period at six survey stations in the main scarp zone. The survey stations measure stretching (extension) across the main scarp zone. The data show movement at the four northernmost stations (on or near [west of] lots 44 through 47). Field observations suggest movement possibly occurred at the other two southern stations (on lots 48 and 49), but the measurements indicate that the movement, if any, was less than the accuracy of the measurement technique. The maximum average rate of movement declined from a slow rate in early May to a very slow rate in late June. The absence of any significant movement in the main scarp zone in the southern part of the landslide may be due to the ability of the numerous minor scarps downslope of the main scarp zone (figure 8) to accommodate movement.

Figure 7. Cumulative displacement plot showing the amount of stretching across the main scarp zone between May 11 and June 25, 2001. Up to 8.8 inches of stretching occurred at lot 46 (6855 N.). Whereas movement continued through the period of measurement, the rate of movement decreased. Apparent movement amounts of less than a half inch are likely the result of measurement error or stake disturbance, and not landslide movement.

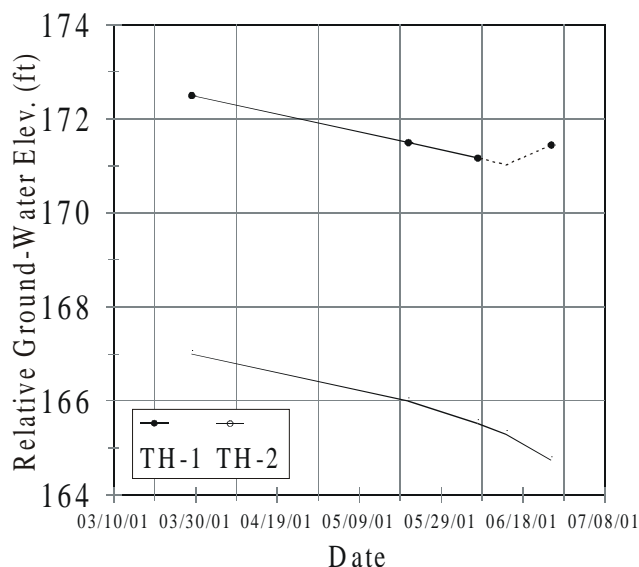
Ground water in the slope is relatively shallow and ground-water levels declined slightly since the initial measurement by Earthtec (2001) in late March. During the measurement period (March 29 through June 25, 2001), ground water was about 18 to 19.5 feet deep in Earthtec's well TH-1 located near the main scarp zone. Ground water was less than 5 feet deep in Earthtec's well TH-2 located downslope of the main scarp and about 20 feet lower in elevation than well TH-1. Ground-water levels declined by about 1.3 to 1.5 feet between March 29 and June 25, 2001. Figure 9 shows that the rate of ground-water-level decline was relatively constant. Earthtec (2001) observed numerous seeps in the hillside in March that gradually dried up sometime after late April. Based on this

observation, I infer that ground water was near or at the surface in the lower slope in March. The slight decline in ground-water levels in the lower slope was sufficient to dry up the seeps in this area. Comparison of figure 7 with figure 9 indicates that the rate of landslide movement decreased with declining ground-water levels.

Figure 9. Plot showing fluctuation in ground-water levels in two wells in the Frontier Drive landslide. Ground-water levels declined about 1.3 to 1.5 feet from March 29 to June 25, 2001. Well TH-1 is located in the main scarp zone on lot 49. Well TH-2 is located downslope of lot 48. Dashed line shows inferred level where data are lacking.
