MOVEMENT HISTORY AND PRELIMINARY HAZARD ASSESSMENT OF THE HEATHER DRIVE LANDSLIDE, LAYTON, DAVIS COUNTY, UTAH

Richard E. Giraud
Utah Geological Survey

REPORT OF INVESTIGATION 251 MARCH 2002
UTAH GEOLOGICAL SURVEY
a division of
UTAH DEPARTMENT OF NATURAL RESOURCES

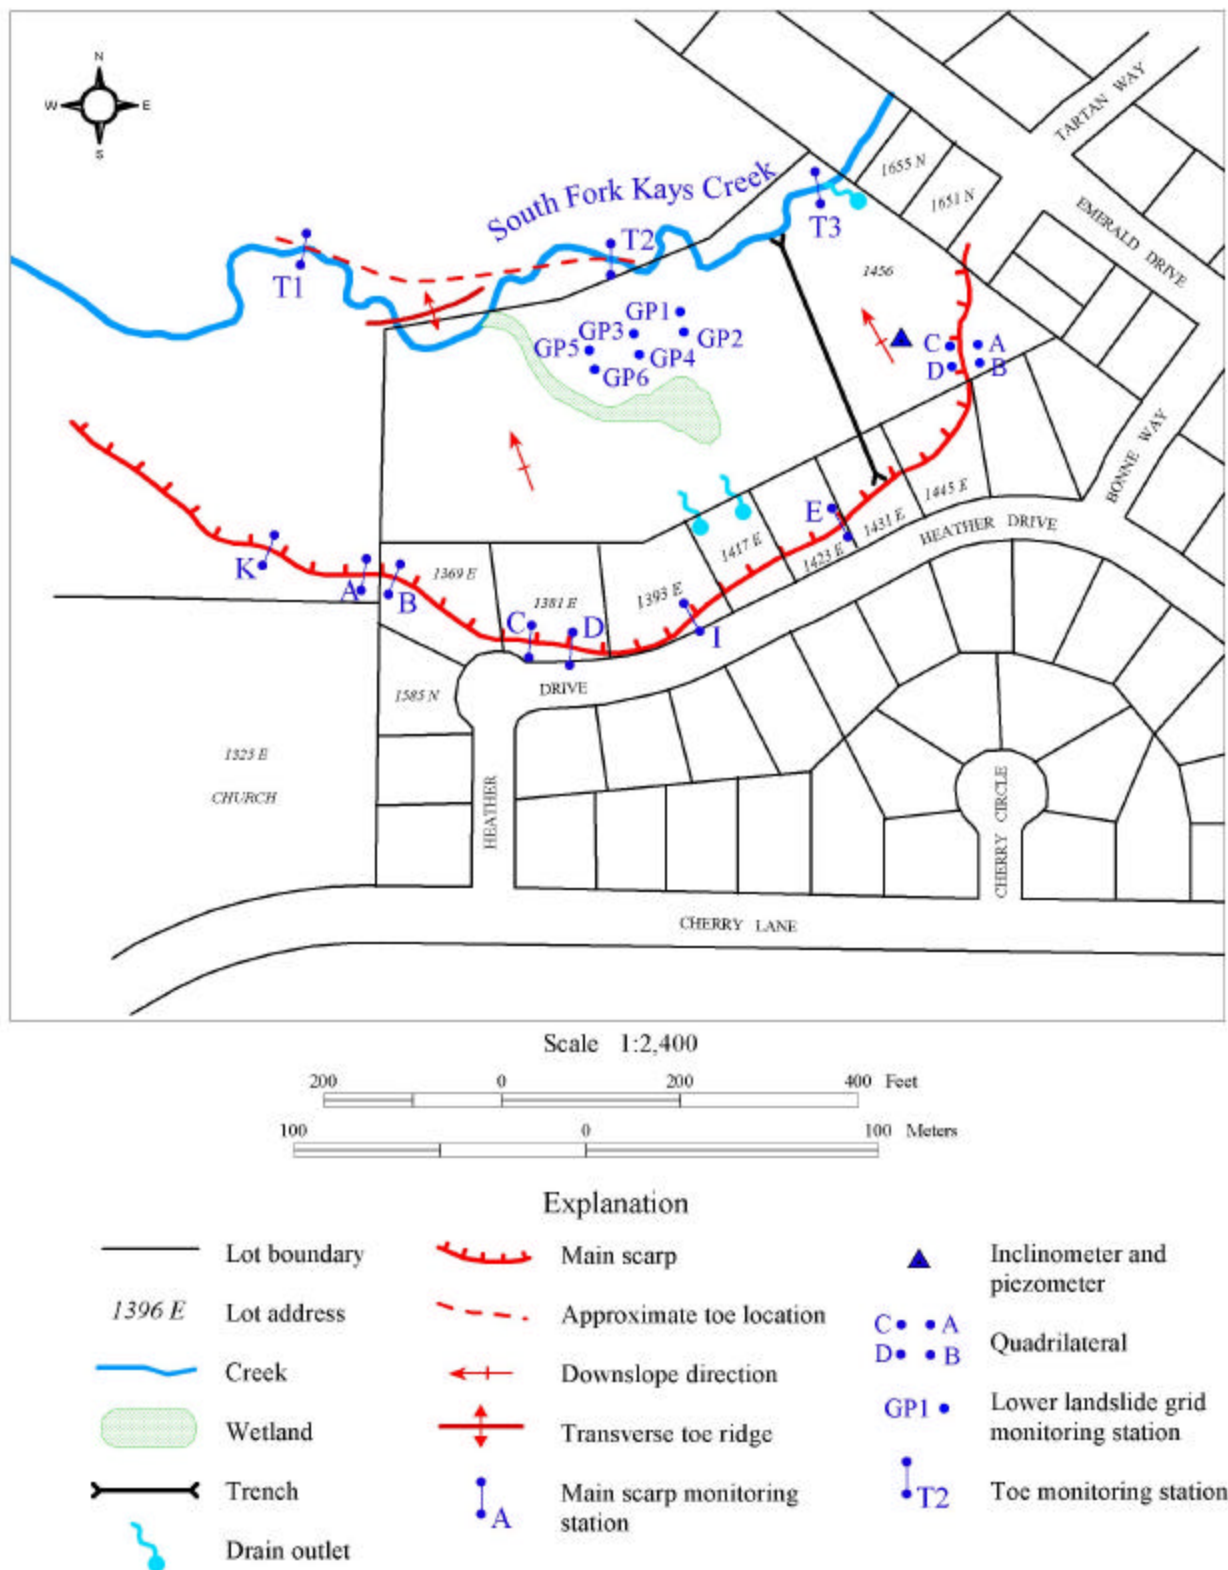
A landslide in Layton north of Heather Drive (figures 1 and 2) damaged houses, lots, and utilities during July and August 2001, forcing residents to evacuate homes and suffer significant economic losses. Six houses either straddled the landslide main scarp or were on the landslide head (figure 2). Of the six houses, three were moved off the landslide and three were demolished due to landslide-related damage. The landslide also restricted flow in South Fork Kays Creek, forcing Davis County to clear the channel to maintain flow. This report summarizes landslide movement, discusses future hazard potential, and provides recommendations for homeowners, Layton City, Davis County, and others to consider in managing landslide risk. Future landslide movement could impact additional houses and property, damage Heather Drive and underground utilities, and further restrict the flow of South Fork Kays Creek. The Utah Geological Survey (UGS) documented landslide features, monitored landslide movement, assessed the landslide hazard, and, in its role in emergency response, provided advice and recommendations to Layton City and homeowners.

Figure 2. Heather Drive landslide area showing landslide features, monitoring locations, residential lots, and streets (modified from Layton City plat).

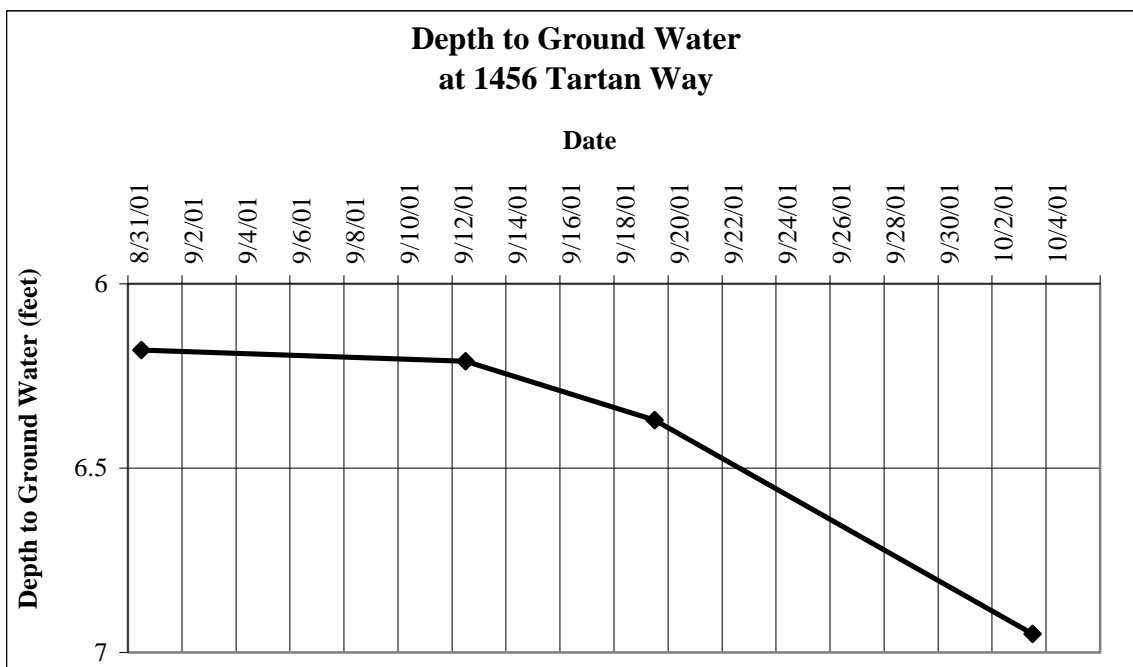
AGEC installed a piezometer with the inclinometer at 1456 Tartan Way (figure 2) in the lower and eastern part of the landslide. The UGS collected water-level data from this piezometer from August 31 to October 3, 2001 (figure 5). During this time period the ground-water level dropped 0.8 foot. This ground-water level approximately 6 feet below the ground surface indicates confined ground water at depth because the trench, excavated to depths of 20 feet immediately west of the piezometer, was open for several days and did not encounter shallow unconfined ground water. Thus ground water is shallow and unconfined in the landslide head and crown, but is deeper and confined within or below the eastern portion of the landslide at 1456 Tartan Way.

Figure 5. Plot of depth to ground water at 1456 Tartan Way.

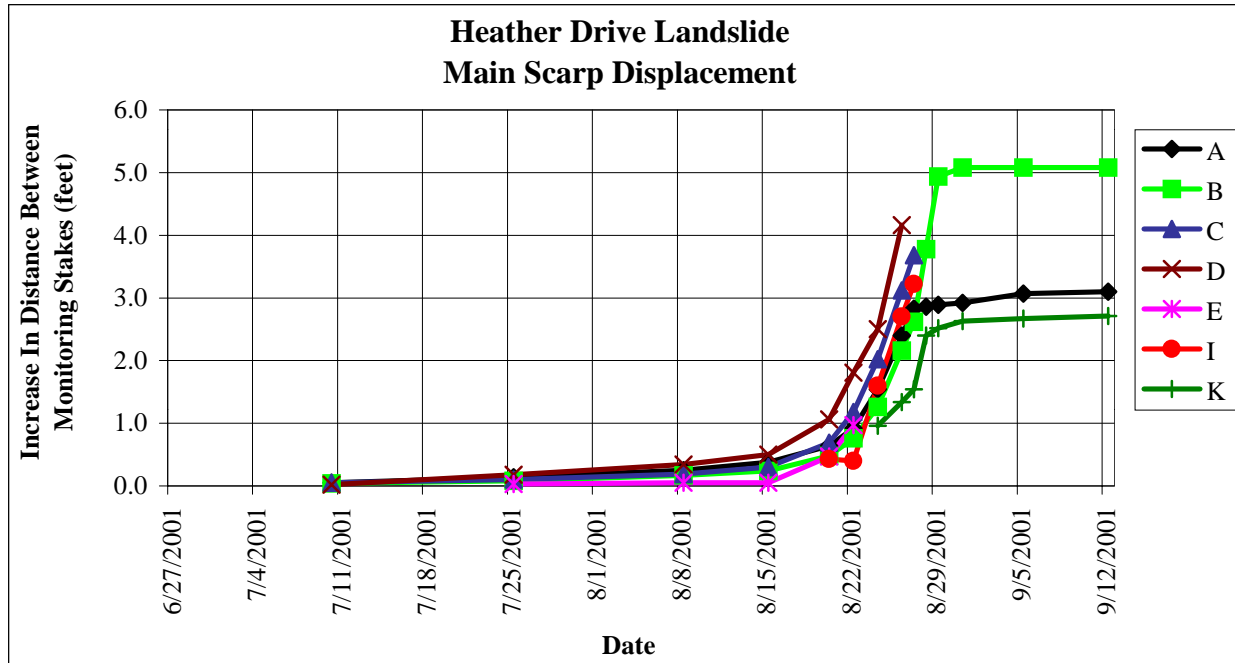
6 (a)

Figure 6a shows the increases in distance measured across main-scarp monitoring stations from June 27 to October 3, 2001. Because the main-scarp height continually increased and interfered with movement measurements (see Scope and Methods section), figure 6a qualitatively shows the history and timing of landslide movement rather than cumulative main scarp displacement. The landslide moved very slowly in June, July, and early August (figure 6a), but on August 15 the rate of landslide movement increased until nearly all movement stopped on August 31. Most movement on the main scarp occurred between August 20 and 29. The most dramatic movement occurred between 6:00 p.m. on August 27 and 8:00 a.m. on August 28 when a vertical displacement of 2 to 2.5 feet occurred on the main scarp (Scott Carter, Layton City, verbal communication, August 28, 2001). As a result, a road constructed on the afternoon of August 27 to move the house at 1381 E. Heather Drive off the landslide was displaced. On August 25 and 26, prior to this pulse of movement, the vertical displacement rate of the driveway slab at 1381 E. was approximately 1 foot per day. The relatively rapid rate of movement between August 20 and 29 hampered efforts to move houses and severely distressed the houses at 1393 E. and 1417 E. Heather Drive. Main-scarp displacements were largest in the

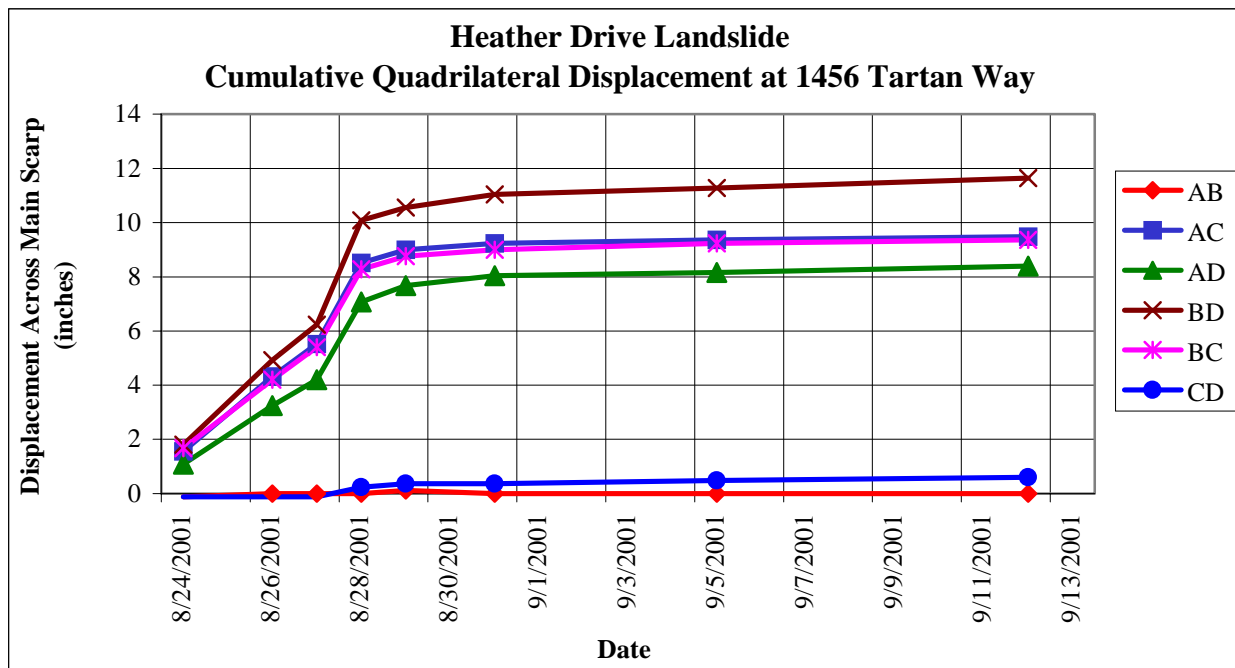
6 (b)

As main-scarp development progressed downslope of 1445 E. Heather Drive onto 1456 Tartan Way in mid-August, a quadrilateral (Baum and others, 1988 [figures 2, 3d]) was installed across the scarp to measure possible right-lateral shearing along a suspected landslide flank. Figure 6b shows cumulative measured extension across the quadrilateral stakes from August 24 to October 3, 2001. The quadrilateral diagonals AD and BC have nearly equal displacements indicating little right-lateral shear along the scarp. These diagonal displacements and displacements perpendicular to the scarp (AC and BD) indicate landslide movement in a northwest direction. The quadrilateral data also show that nearly all landslide movement stopped by August 31.

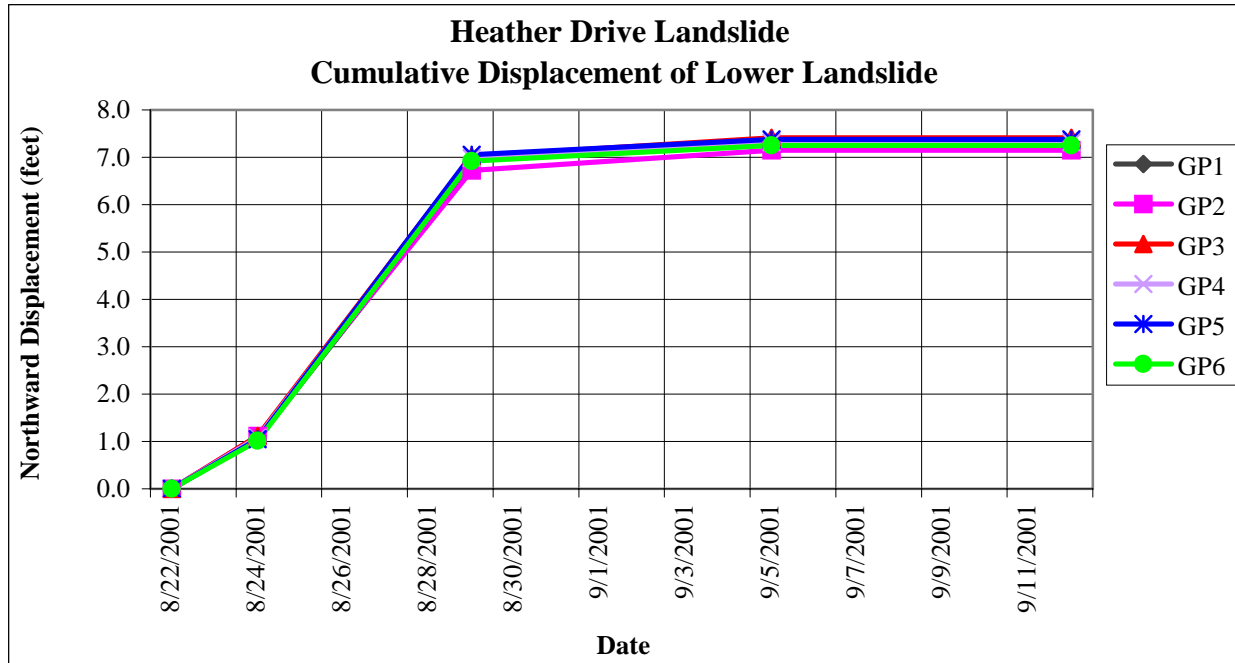
6 (c)

As the main-scarp height increased, movement was suspected on the lower portion of the landslide even though ground cracks were not present. On August 22, 2001, the UGS established a grid of six survey stakes on the lower landslide (figure 2). Resurvey of the grid on August 24 confirmed movement in the lower slope. Figure 6c shows a cumulative 7.1 –7.5 feet of northward displacement of the six grid points relative to a surveying base station north of South Fork Kays Creek between August 22 and September 5. Most of the movement recorded on the lower landslide occurred between August 22 and 29. Nearly equal northward movement of all points within the 100-foot grid width suggests this portion of the landslide moved northward as an intact mass.

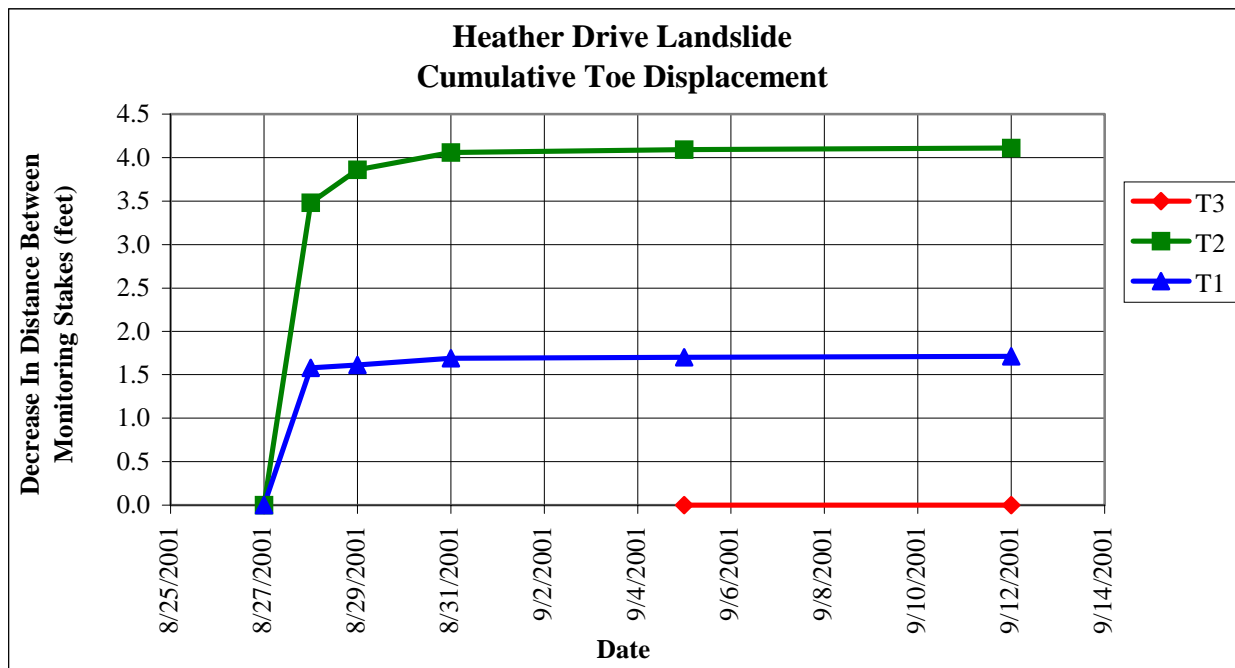
6 (d)

As ground cracks developed in the south bank of the creek, monitoring stations (T1, T2, and T3) were established across the creek to measure the amount of toe displacement and rate of landslide movement into the creek. Figure 6d shows the cumulative toe displacement measured across the creek from August 27 to October 31, 2001. Nearly 4.1 feet of northward movement was recorded at station T2. Station T1 showed 1.7 feet of toe displacement. Station T3 showed no toe displacement but was established after August 31 when nearly all landslide toe movement had stopped.
