ACTIVE LANDSLIDES

IN THE CREEKSIDE DRIVE AREA, MOUNTAIN GREEN, MORGAN COUNTY, UTAH, BETWEEN JUNE 2005 AND DECEMBER 2006

REPORT OF INVESTIGATION 260
UTAH GEOLOGICAL SURVEY
a division of
Utah Department of Natural Resources
2007

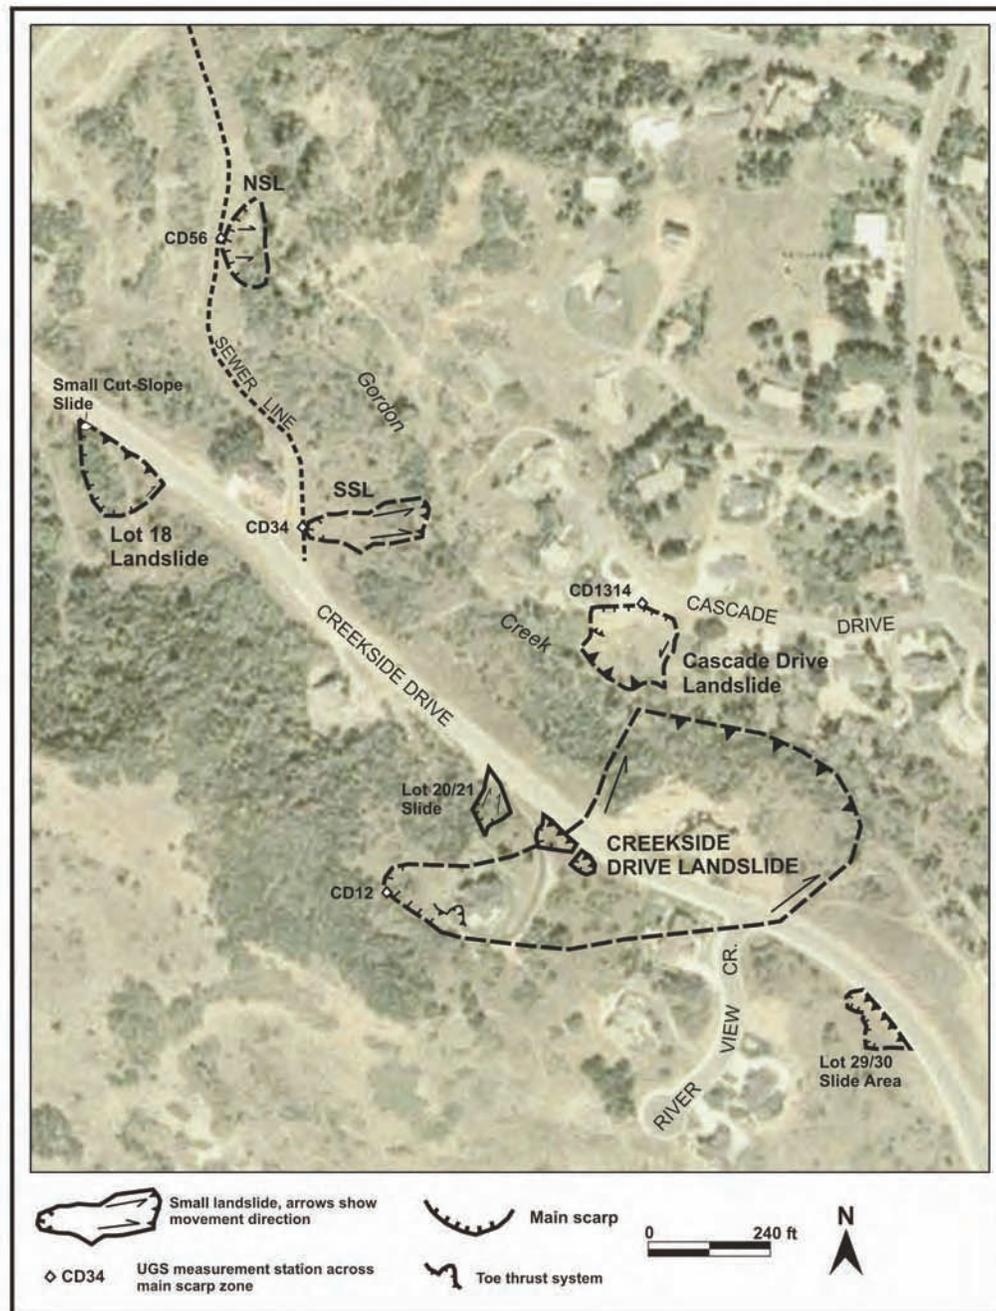
Figure 2. Aerial photograph showing approximate locations of active landslides in the Creekside Drive area, Mountain Green, in 2005 and 2006. Landslides include the Creekside Drive, Cascade Drive, Lot 18, Northern Sewer-Line (NSL), and Southern Sewer-Line (SSL) landslides, and five small slides along Creekside Drive. Toe of possible upper shallow slide in head of Creekside Drive landslide also shown. All boundaries and dimensions of landslides are approximate. Solid lines used to define boundaries of smaller slides.

By 2006, six other landslides were identified, including two moderate-size landslides (shown on figure 2) that both affected vacant land, one of which also threatened a house on Cascade Drive. Two small landslides also were identified near the intersection of Creekside Drive and Wasatch Drive, one in an embankment and another in a nearby cut slope. A very small rotational slide occurred in a cut slope near the north end of the driveway at 6067 N. Creekside Drive. In addition, an embankment failure also occurred along the lower part of the access road on lot 20.

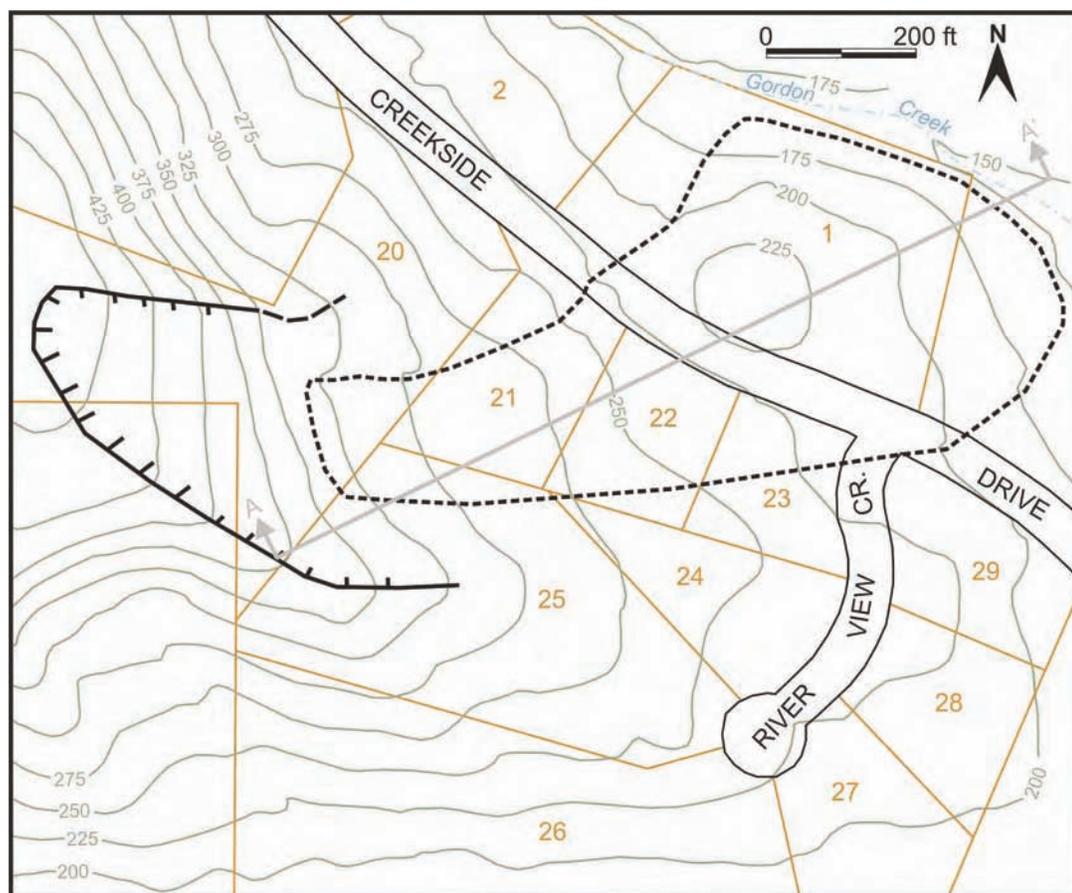
The landslide that severely damaged the house at 6023 N. Creekside Drive (lot 21) and affected two others was the largest and deepest of the Creekside Drive area slides in 2005. The exact dimensions of the landslide remain unknown due to the lack of continuous ground deformation features along its perimeter. However, the landslide is approximately 850 feet long in a northeast direction, and 500 feet wide along its toe near Gordon Creek. Table 1 summarizes the approximate dimensions, relief, and average slope of the landslide. Figure 3 shows the probable boundaries of the pre-existing landslide, prior to 2005, mapped using a detailed topographic map of the area. The landslide narrows considerably upslope and is shorter and steeper along its left flank than along its right flank. An inclinometer installed by Cot-

Figure 3. Map of probable pre-existing Creekside Drive landslide prior to 2005. Solid hachured line is main scarp. Dashed line is likely deposit boundary. Line of geologic cross section (figure 4) shown by A-A'. Highlands West lot numbers shown. Landslide mapping based on topographic map provided by David Simon (Simon-Bymaster Inc.).

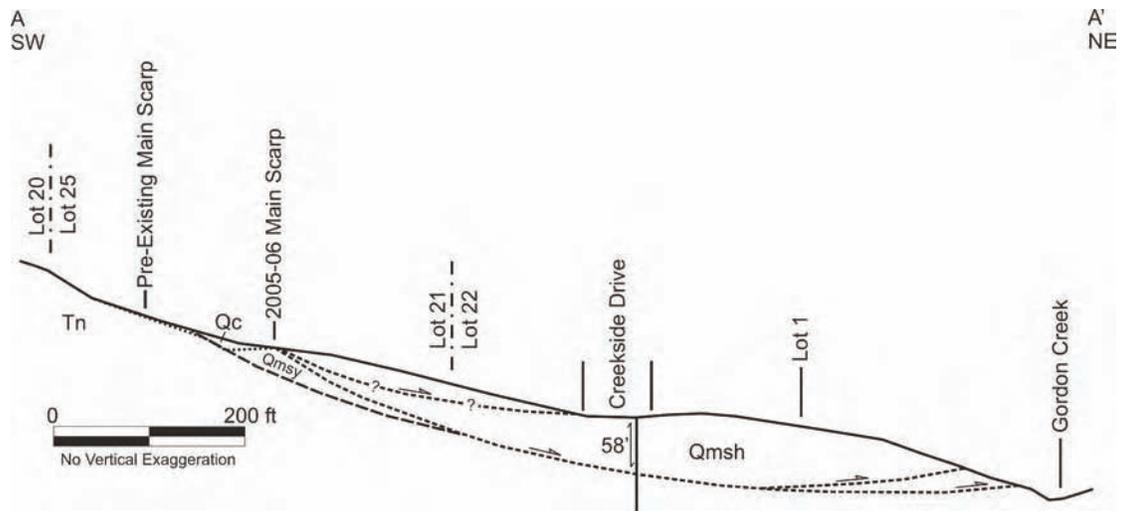
Figure 4. Geologic cross section through the Creekside Drive landslide (Qmsh). Short dashed lines show probable geometry of landslide. Queried dashed line is possible shallow slide that has a surface of rupture which daylights near Creekside Drive. Other small shallow slides not shown (see text). Long dashed line shows probable upslope extension of inactive surface of rupture of pre-existing slide (Qmsy). Dotted line shows possible contact between colluvium (Qc) associated with main scarp of pre-existing slide and landslide deposits. Landslide underlain by weathered Norwood Tuff (Tn). Solid vertical line shows approximate location of inclinometer installed by Cotton Shires & Associates, Inc., in 2006 and depth of active slide. See figure 3 for section line location.

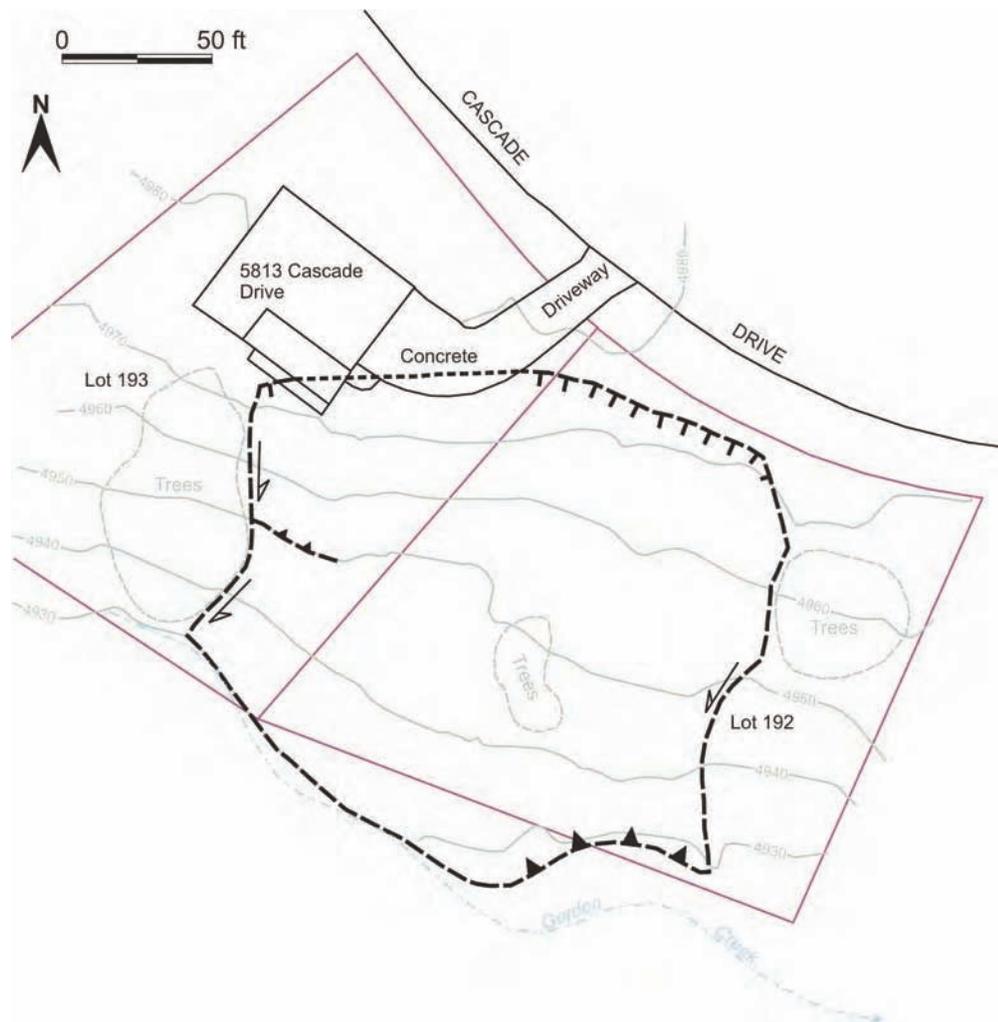
By late April 2006, a moderate-size landslide was affecting lots 192 and 193 north of Gordon Creek on the southwest side of Cascade Drive, and threatened a house at 5813 Cascade Drive on the northwestern of the two lots (lot 193) (figures 12 and 13). However, most of the slide occupied the vacant southeastern lot (lot 192). The landslide was approximately square-shaped in plan view, roughly 170 feet wide at its head and about 160 feet long. A detailed topographic map provided by Mr. David Simon (Simon-Bymaster Inc., written communication, December 2006) shows the local relief to be about 47 feet, indicating an average slope of about 29 percent (table 4).

Well-defined ground-deformation features consisted of a main scarp, flanks, and local toe folds (figure 13). On April 21, 2006, the main-scarp offset ranged from about 2 to 5 feet, increasing toward the west and the southeast corner of the house at 5813 Cascade Drive (figure 13A, 13B).

The main scarp extended beneath part of a curved concrete driveway on the east side of the house. Offset on the main scarp had left the slab partly suspended above the ground surface about 2.4 feet. By early May, jacks had been placed underneath the driveway slab by the homeowner to support it (figure 13E). Both the west and east flanks of the landslide were well defined and could be traced from the main scarp to near Gordon Creek. In the lower slope, the flanks had positive relief relative to the surrounding slope (the ground was higher on the slide side of the flank). Local relief across the flank ranged from about 1 to 4 feet and was highest on the east flank of the slide (figure 13D). Near the southeast corner of the slide, landslide deposits overthrust

Figure 12. The Cascade Drive landslide in April 2006. Hachured line is main scarp. Short dashed line is estimated location of scarp beneath concrete driveway and other slabs. Triangles show toe or internal thrust where observed. Most internal deformation features not mapped.

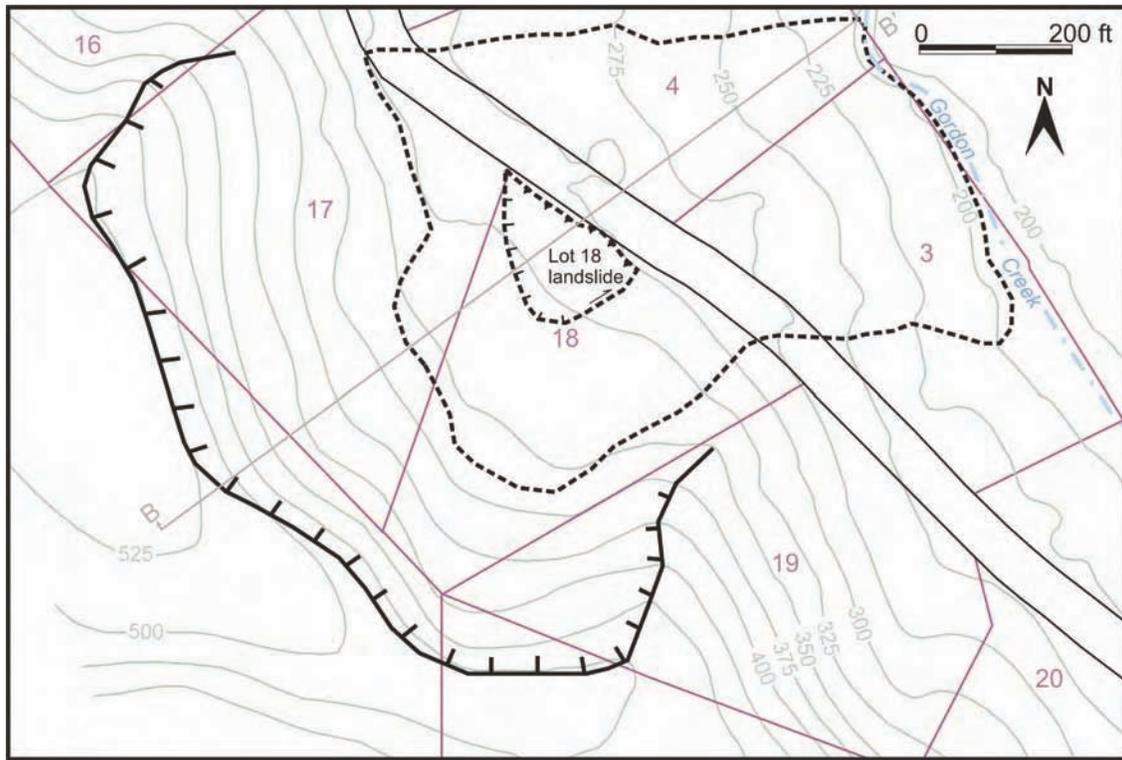
Another landslide occurred in 2006 on the north part of vacant lot 18 southwest of Creekside Drive. The boundary of the landslide was well defined by ground-deformation features, including a main scarp and toe. The landslide was a partial reactivation of a large, rotational, deep-seated slide that forms a large amphitheater occupied by lots 17 and 18 (figures 14 and 15). The 2006 landslide formed between the sidewalk along the southwest edge of Creekside Drive and the crest of the slope that fronts the lot on the northeast. Table 4 summarizes the approximate dimensions, relief, and average slope of the slide.

Figure 14. Lot 18 area showing probable pre-existing landslide and the Lot 18 slide. Solid hachured line is the main scarp of the large, deep-seated pre-existing landslide. Dashed line is the approximate boundary of the pre-existing landslide deposit. Triangles and hachures show toe and main scarp of the 2006 Lot 18 landslide, respectively. Arrow indicates movement direction along right flank of slide. Flat area south of lot “18” label is back-tilted surface with a sag pond in the southeast corner (see figure 16D). Line of geologic cross section (figure 15) shown by B-B’.

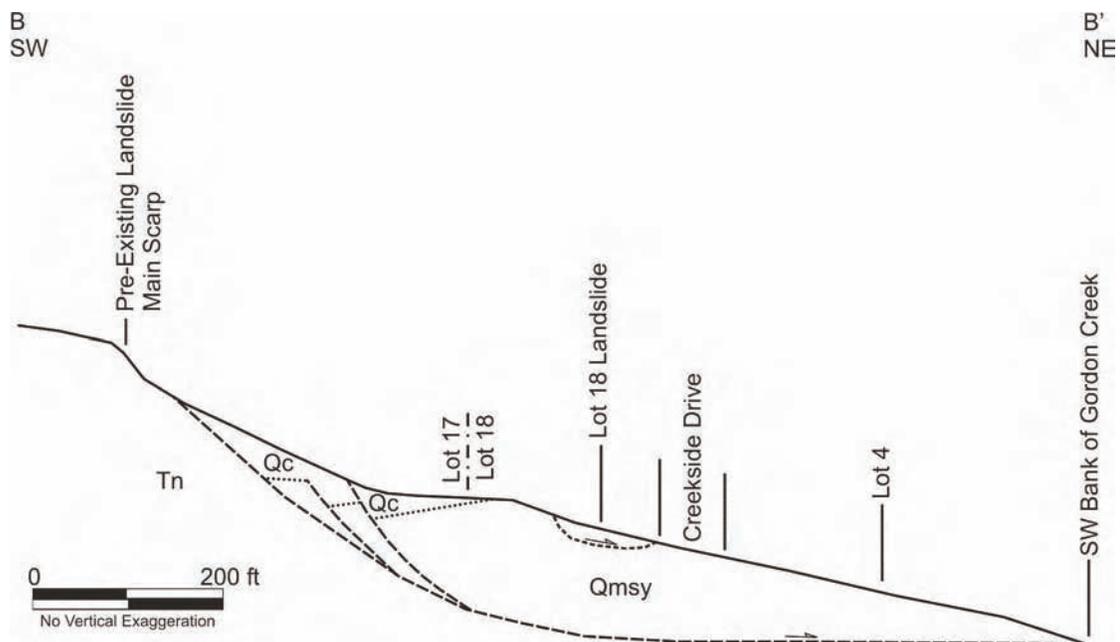
Figure 15. Geologic cross section showing relationship between the Lot 18 landslide and the large, pre-existing, deep-seated slide (Qmsy). Short dashed line shows probable geometry of Lot 18 landslide. Long dashed lines show possible geometry of deep-seated landslide. Dotted line shows possible offset in colluvium (Qc) from movement of large slide. Landslide likely overlies weathered Norwood Tuff (Tn).

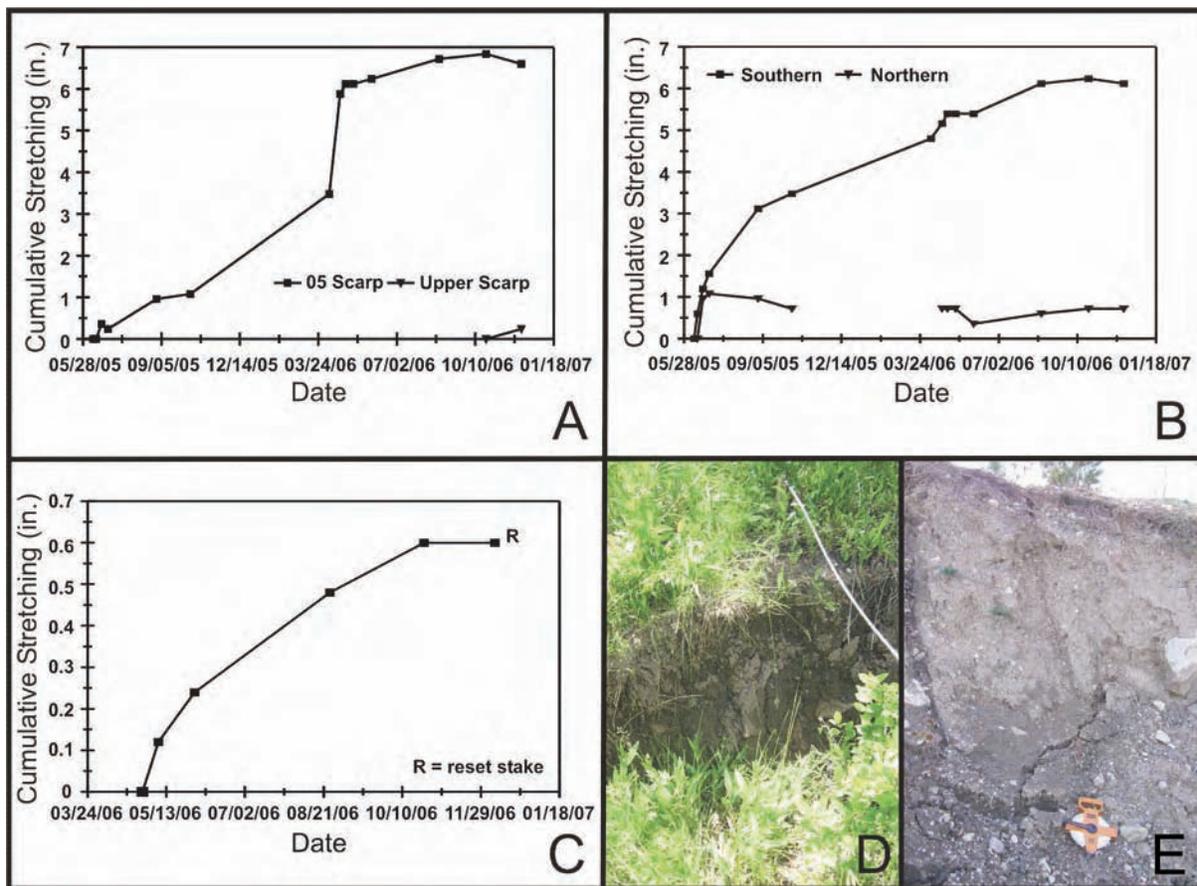
Nearly continuous minor movement (stretching) was measured across the main scarp upslope of the house at 6023

N. Creekside Drive between June 14 and October 12 (figure 18A). The apparent lack of movement between June 10 and 14 (first two measurements on the plot) is likely an artifact of the detection limit, or resolution, of our measurement technique over a short four-day time span. The plot suggests that movement may have suspended for a short time in late June before resuming, but the detection limit issue may also be the cause for the downward deflection in the curve during that time period that spanned only eight days. Figure 18B shows continuous minor movement of the Southern Sewer-Line landslide in 2005 similar to the movement of the Creekside Drive landslide. However, movement of the Northern Sewer-Line landslide suspended in late June 2005 (Ashland, 2006).

Figure 18. Plots showing cumulative stretching (movement) across main-scarp zones of three of the Creekside Drive-area landslides. (A) Cumulative stretching across main-scarp zone of the Creekside Drive landslide. Plot shows nearly continuous movement between June 10, 2005, and December 28, 2006. Note the rapid acceleration in the rate of movement in April 2006 coincident with the end of snowmelt. Scarp spanned by stake station shown in D. By 2006, another scarp had formed upslope. Lower curve shows stretching across upper scarp in late 2006. (B) Cumulative stretching across main-scarp zones of the Southern Sewer-Line and Northern Sewer-Line landslides. Plot shows continuous movement of the Southern Sewer-Line landslide for measurement period, but movement of the Northern Sewer-Line landslide suspended by late June 2005. Fresh ground crack at base of main scarp of the Southern Sewer-Line landslide (E) confirms continued main-scarp offset in late 2005. (C) Plot showing continuous stretching across main-scarp zone of the Cascade Drive landslide between April 28 and October 24, 2006. Movement may have suspended in late 2006.

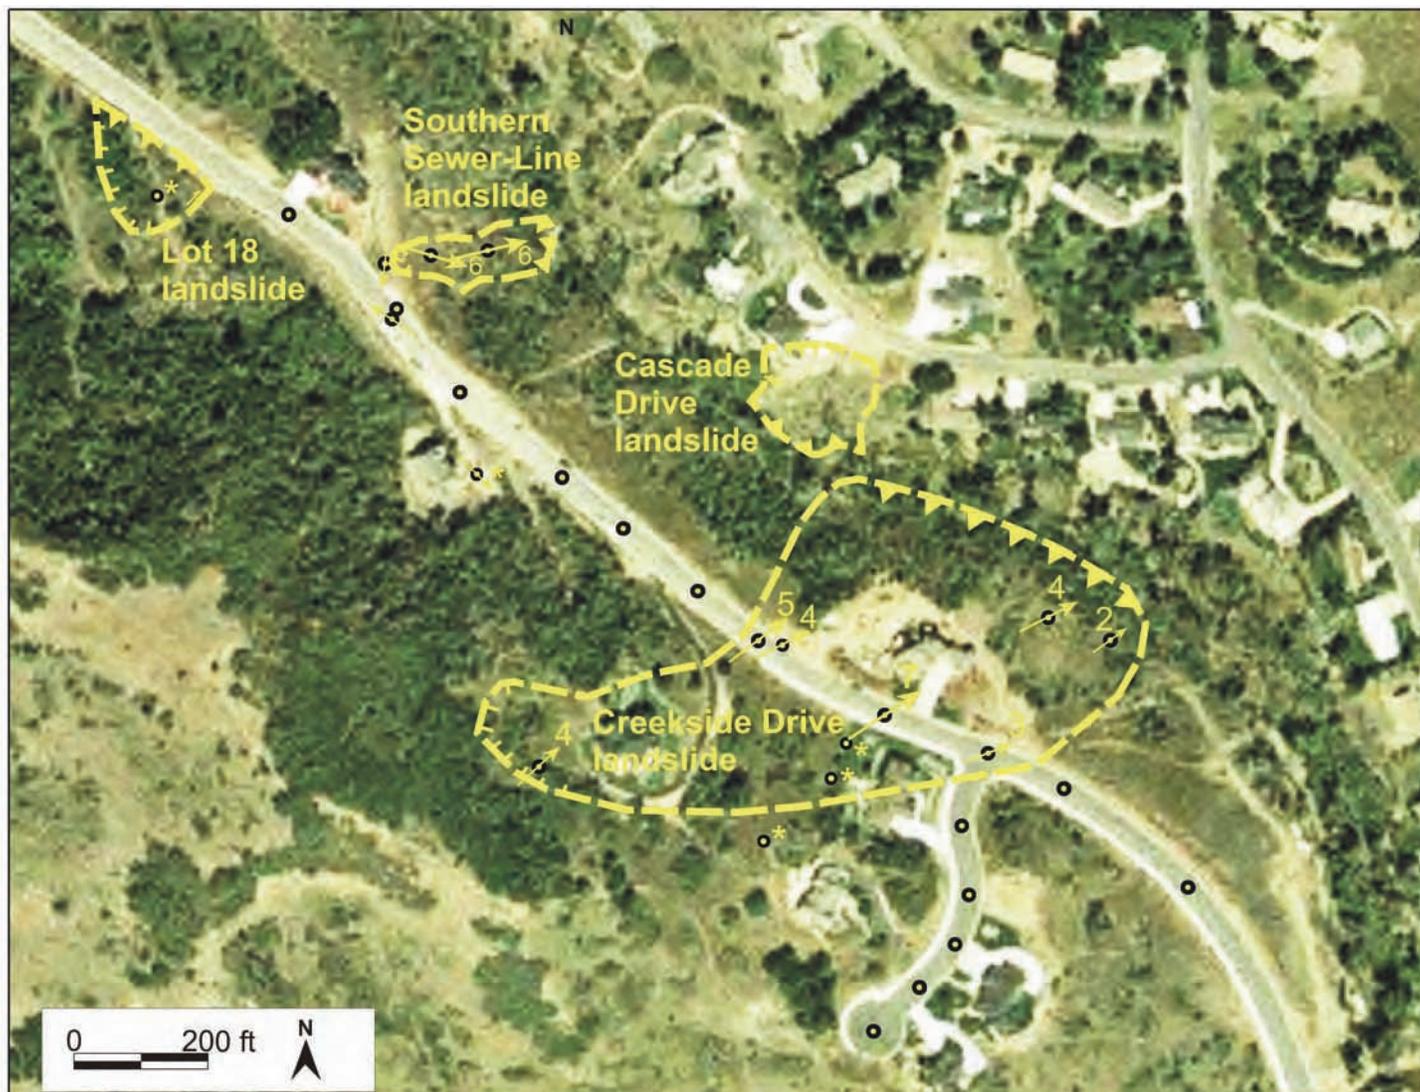
boundaries of the Creekside Drive landslide (figure 19). Detailed movement monitoring using a survey-grade Global Positioning System (GPS) device provided information on the total movement amounts of two of the three largest 2005 landslides (the Creekside Drive and Southern Sewer-Line slides), defined movement distribution and patterns, and provided constraints on the boundaries of the Creekside Drive slide.

Figure 19. Results of landslide movement monitoring using a survey-grade Global Positioning System device. Arrows show movement directions. Movement amounts shown in centimeters for period between November 1, 2005, and June 23, 2006. Asterisks indicate survey points installed in April 2006 after most movement had already occurred.
