UTAH GEOLOGICAL AND MINERAL SURVEY

REPORT OF INVESTIGATION

NO. 208

TECHNICAL REPORTS FOR 1985  
SITE INVESTIGATION SECTION

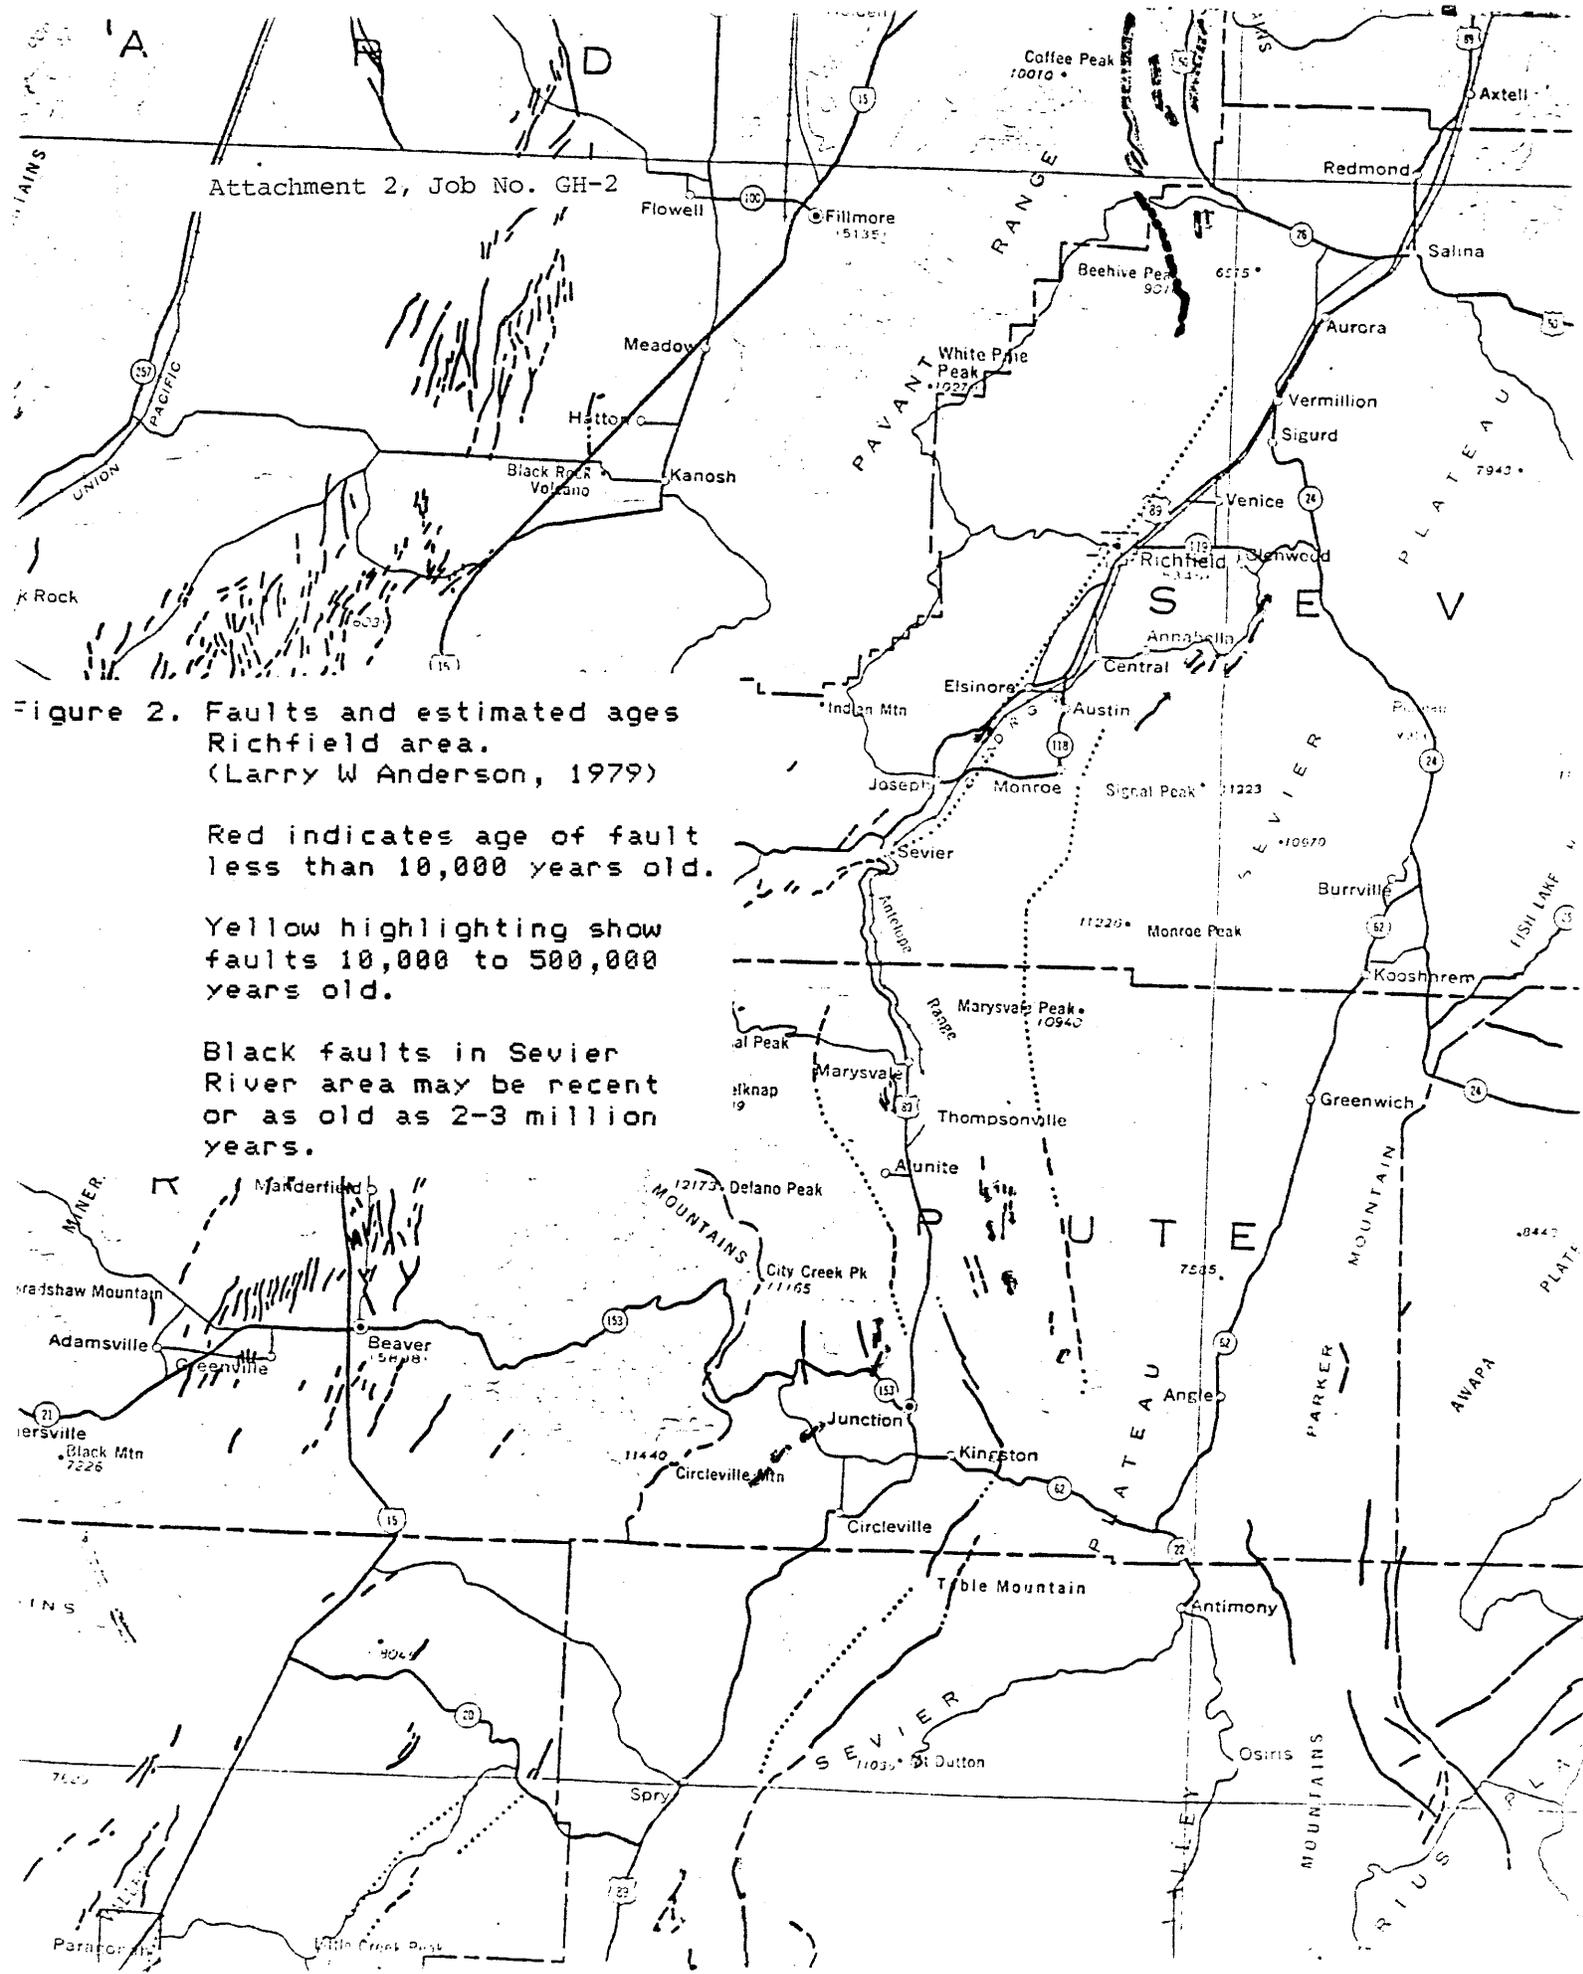
Attachment 2, Job No. GH-2

Figure 2 shows the surface faults in the Sevier River Valley as reported by Anderson and Miller (1979). Figure 3 (Arabasz and others, 1979) shows epicenters in the Richfield area greater than magnitude 1. The Elsinore Fault is inferred to be along the west edge of the Sevier River Valley. A second inferred fault along the east edge of the valley may also be an extension of the Sevier Fault. According to the University of Utah Seismograph Station a magnitude 7.0 earthquake occurred near Richfield on November 14, 1901, at approximately 4:40 a.m. and was followed by several aftershocks of magnitude 2. The Intensity is recorded as 8 to 9. This was Utah's largest historic earthquake. A 1921 event centered near Elsinore had a magnitude of about 5 with a minimum Intensity of 5. Four aftershocks ranging in magnitude from 2.3 to 4.3 were recorded over a period of two days. Earthquakes in Utah were not instrumented before 1962, therefore, magnitudes of pre-1962 events have been estimated from the intensity of the earthquakes using a arithmetic relationship. Figure 4 is a computer plot of south central Utah earthquake epicenters of magnitude greater than 1 that occurred between 1850 and 1983 (data courtesy of University of Utah Seismograph Station).

Figure 2. Faults and estimated ages Richfield area. (Larry W Anderson, 1979)

Yellow highlighting show faults 10,000 to 500,000 years old.

Black faults in Sevier River area may be recent or as old as 2-3 million years.

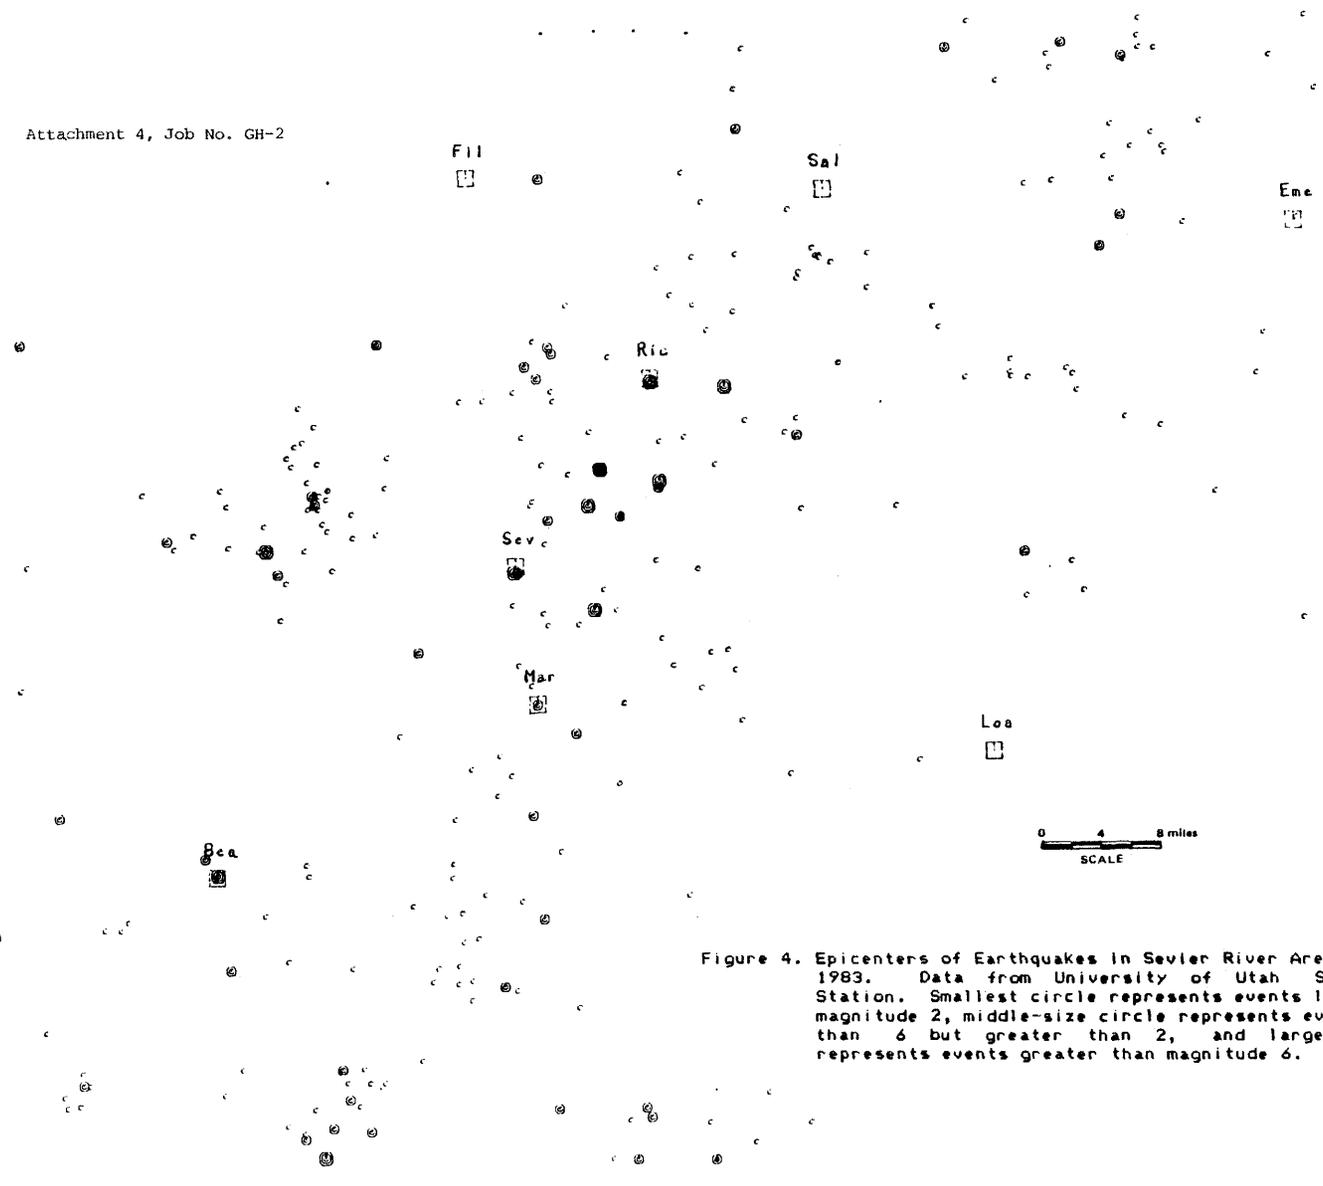
Figure 4. Epicenters of Earthquakes in Sevier River Area, 1850 to 1983. Data from University of Utah Seismograph Station. Smallest circle represents events less than magnitude 2, middle-size circle represents events less than 6 but greater than 2, and largest symbol represents events greater than magnitude 6.

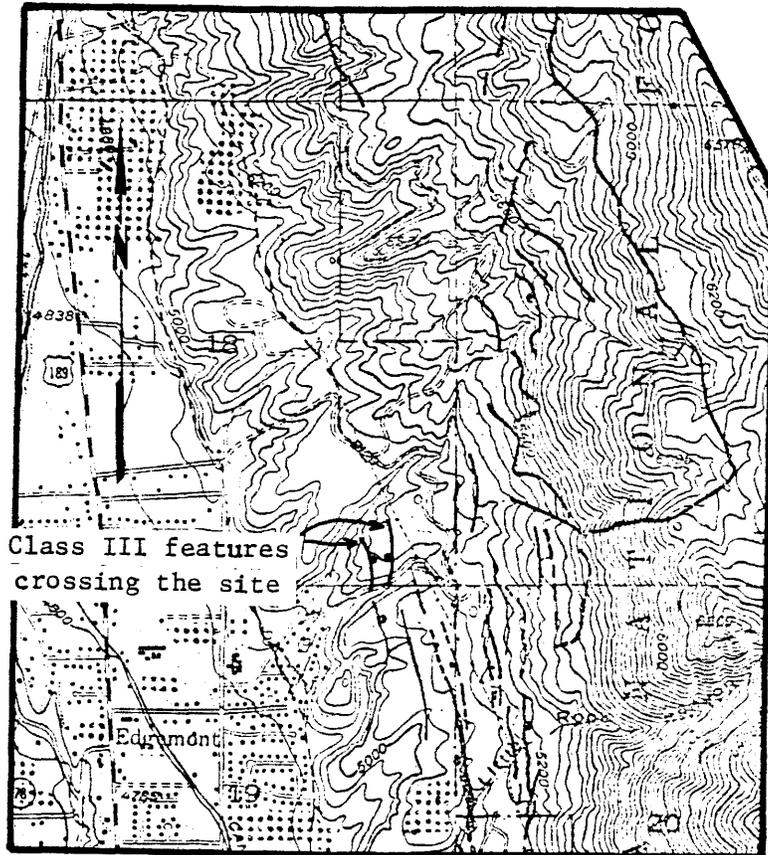
Class III features  
crossing the site
