# TECHNICAL REPORTS FOR 1998 APPLIED GEOLOGY PROGRAM

compiled by  
Greg N. McDonald

Report of Investigation 242      March 1999  
UTAH GEOLOGICAL SURVEY  
*a division of*  
Utah Department of Natural Resources

**TECHNICAL REPORTS FOR 1998  
APPLIED GEOLOGY PROGRAM**

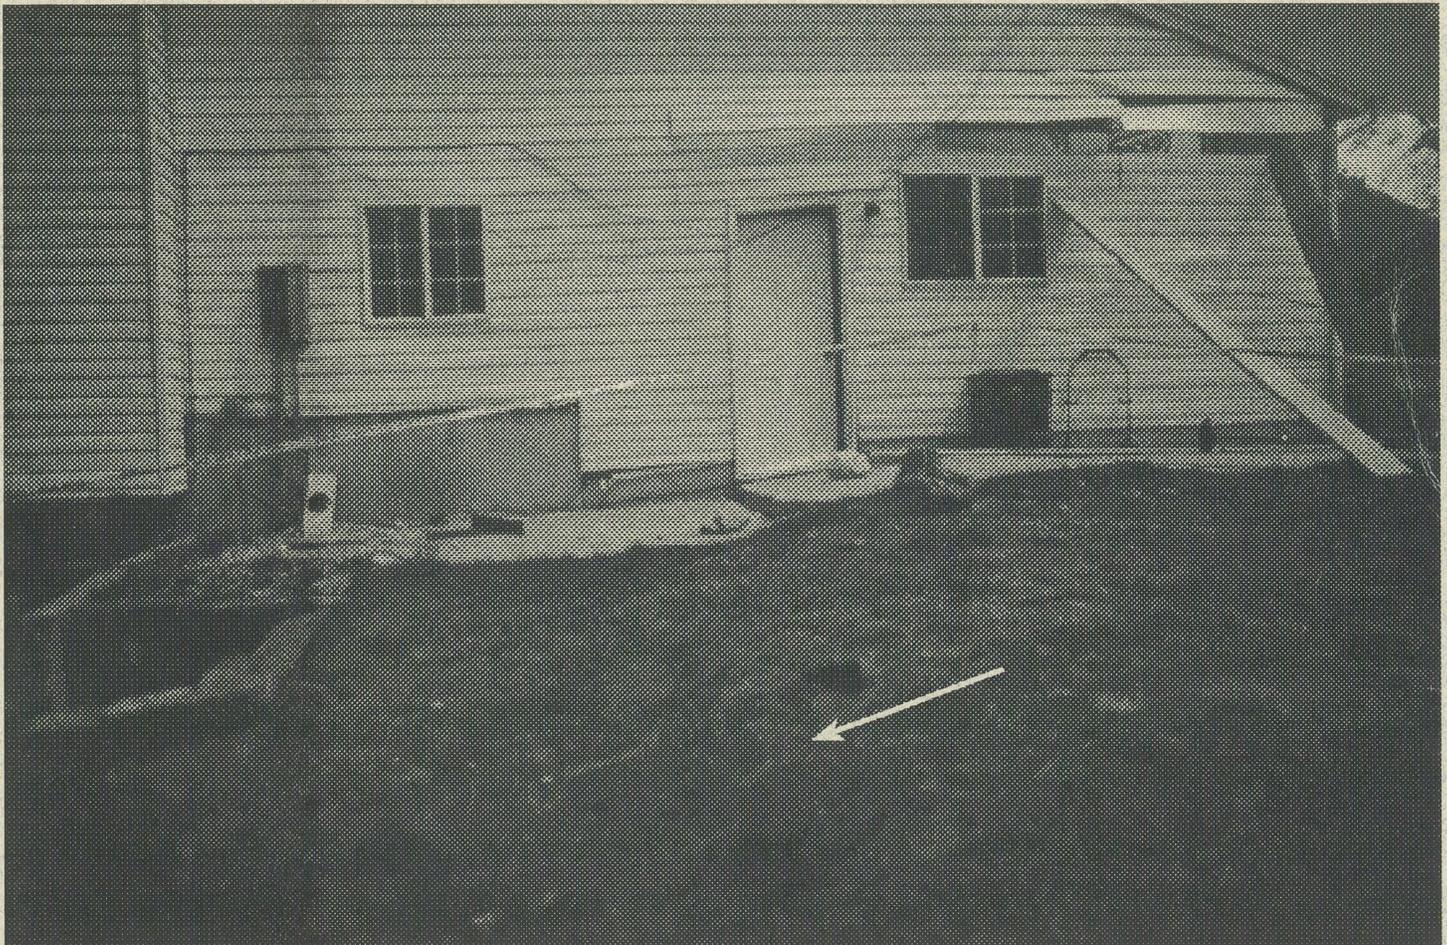
Cover photo: Landslide damage to house at 1851 East Sunset Drive, Layton, Utah. Arrow points to scarp position in lawn. View is to the east. Photo taken on April 27, 1998, by Richard Giraud.

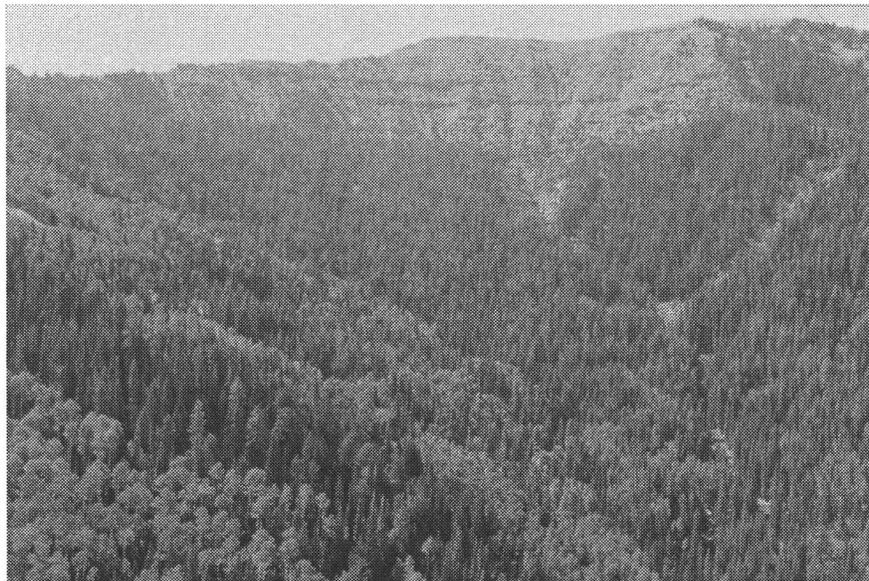
**Attachment 5.** Exposures of the North Horn Formation at the steep head of Temple Fork in upper Canal Canyon. The North Horn Formation is covered by colluvium and dense pine forest downslope.
