TECHNICAL REPORTS FOR 2002–2009 GEOLOGIC HAZARDS PROGRAM

COMPILED BY ASHLEY H. ELLIOTT

Report of Investigation 269
Utah Geological Survey
a division of
Utah Department of Natural Resources
2010

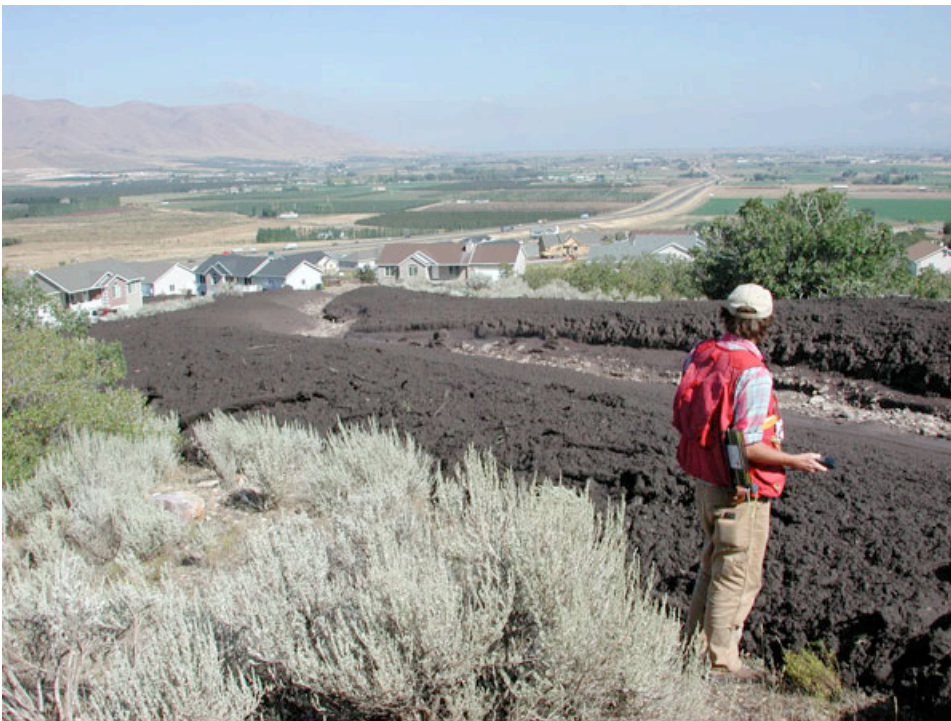
(b) Levee deposits of tributary 4 north lobe on the fan apex.
Figure 4. Debris-flow deposits.

The debris flow from tributary 4 was the most damaging of the five. When the flow reached the mouth of tributary 4, it split into two lobes. The larger, north lobe flowed through the Santaquin subdivision causing substantial property damage (figure 4a, figure 5). Most of the north lobe did not follow city streets but established a direct path down the alluvial fan. Subsequent floodwater traveled down roadways. The south lobe flowed down an undeveloped portion of the fan and deposited debris on a newly excavated subdivision road south of the existing development.

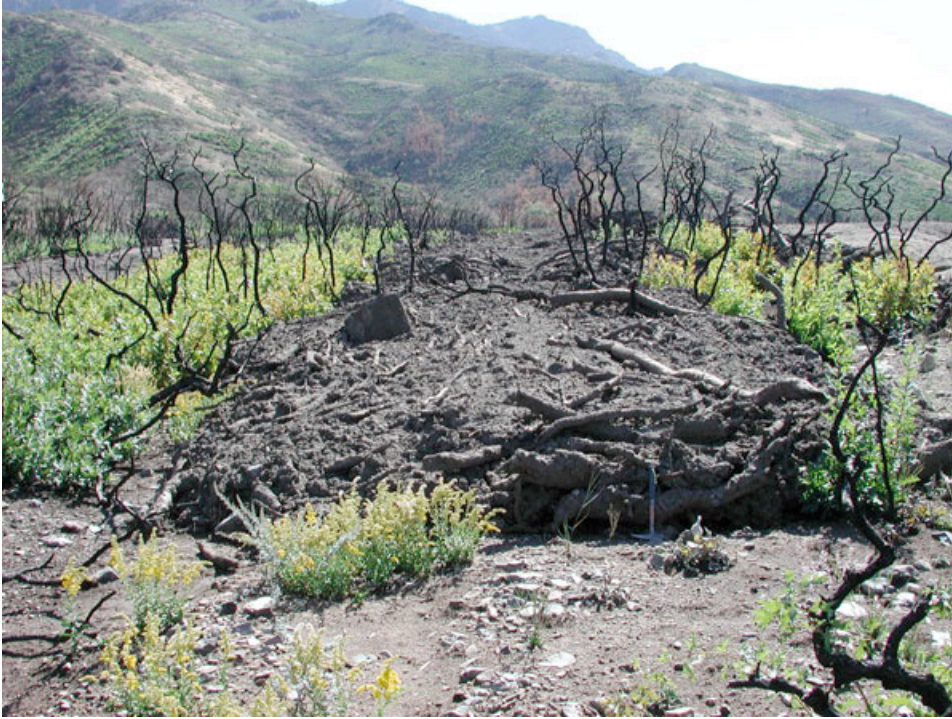
(c) Toe of tributary 5 overbank deposit north of main lobe.

The debris flow from tributary 5 deposited sediment at the mouth of the drainage east of developed areas. Post debris-flow floodwater reached a subdivision, including a newly excavated road; however, no major property damage was reported. The debris-flow deposit on the upper portion of the fan contained considerable woody debris and trees up to several inches in diameter (figure 4c). Near the top of the deposit a moderate-sized lobe is present north of the main flow that contains much less woody debris and large clasts, and likely represents a later surge.

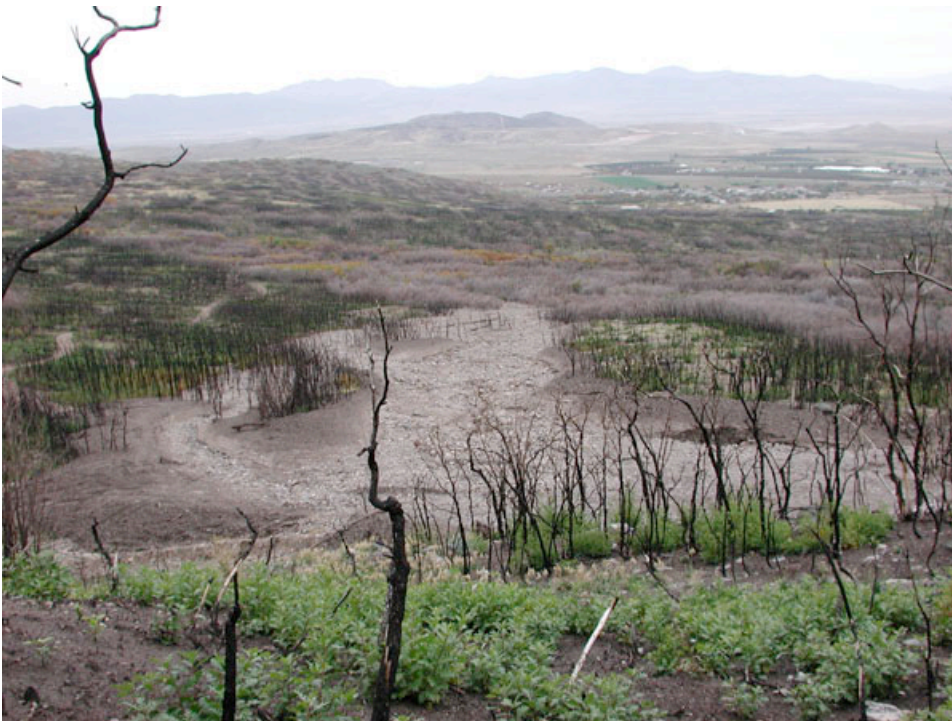
(d) View of tributary 6 deposit looking downfan (eastward).

The tributary 6 deposit was similar in character to the tributary 5 deposit. Neither the debris flow nor associated floodwater affected any developed areas (figure 4d).

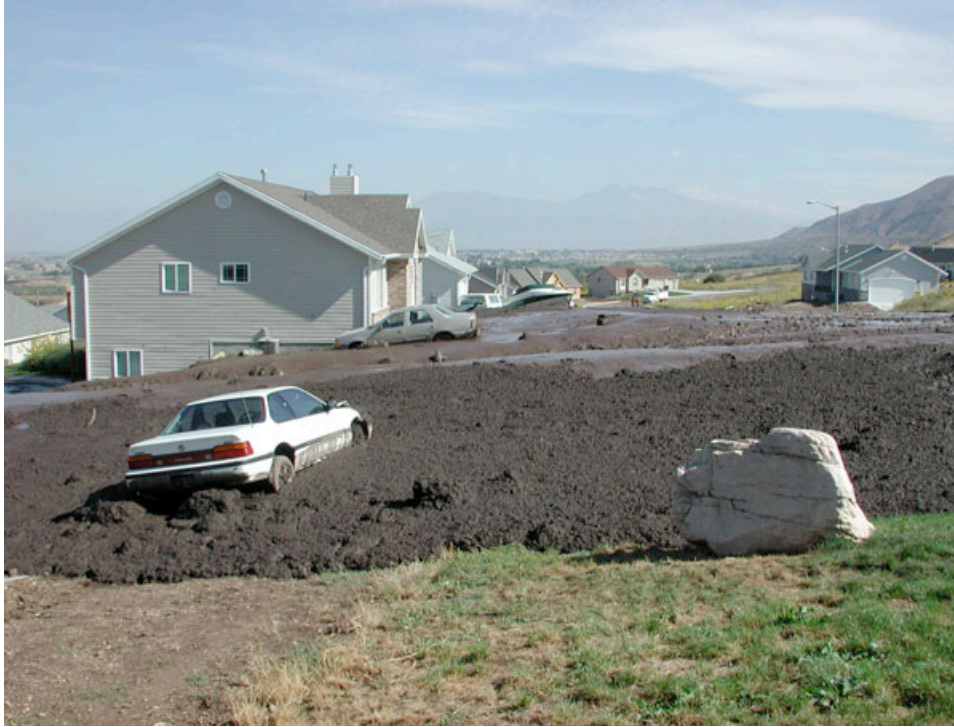
(a) Debris-flow sediment deposited at the intersection of Lambert Avenue and Apple View Street. The debris flow rafted vehicles and filled basements with sediment.

Three of the five debris flows and associated flooding caused damage to infrastructure, property, and houses in the communities of Santaquin and Spring Lake. Most of the damage occurred at the Santaquin subdivision from the north lobe of the tributary 4 debris flow. Vehicles were moved (figure 5a), some were pushed into houses; basements were flooded and filled with debris as ground-level windows were broken (figure 5b); house and garage doors were buckled inward (figure 5c); and the back wall of one house was broken by impact forces (figure 5d). A preliminary report prepared by Ryan Pietramali of the Utah Division of Emergency Services indicates five homes and two businesses received major damage and 27 homes received minor damage at a total cost of about \$500,000 (U.S. Small Business Administration Damage Assessment Report dated September 19, 2002).

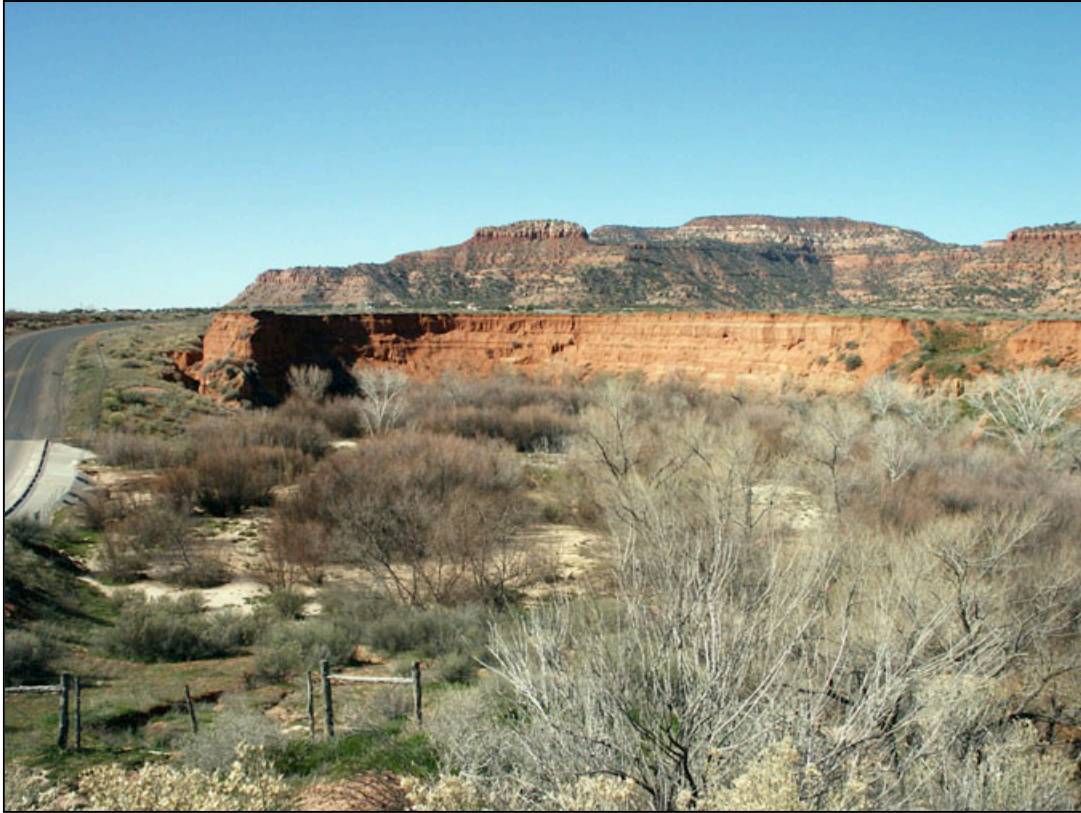
Figure 3. *View to the southwest of Kanab Creek, showing the steep-walled arroyo that formed due to floods in the 1880s.*

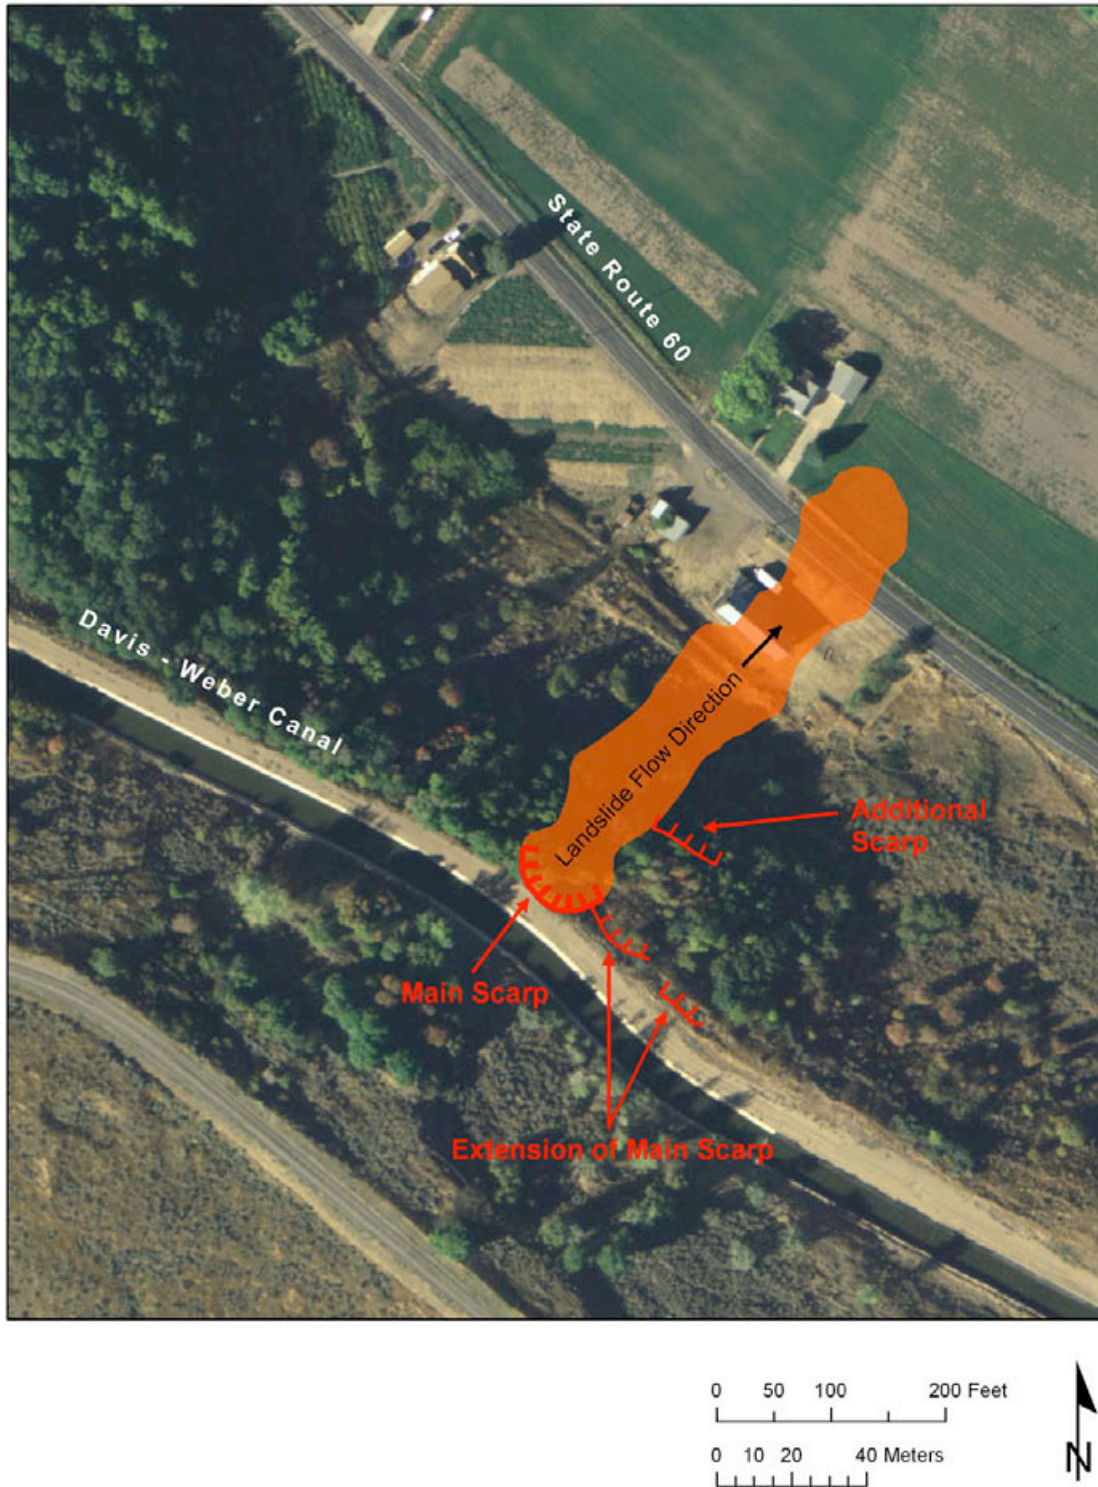
The landslide occurred shortly after 6 p.m., and demolished a barn, took out telephone poles, and blocked State Route 60 (South Weber Drive) (figures 2, 3, 4). The landslide is approximately 480 feet long and 80 feet wide at its widest point (figure 3) and between stations 305 and 310 on the Davis-Weber Canal. According to Nolan Birt (verbal communication, March 4, 2005), the barn owner who witnessed the event, the total landslide travel time was about a

Figure 3. Image showing landslide flow direction, the Davis-Weber Canal, main scarp, other scarps, and runout beyond State Route 60 (South Weber Drive).

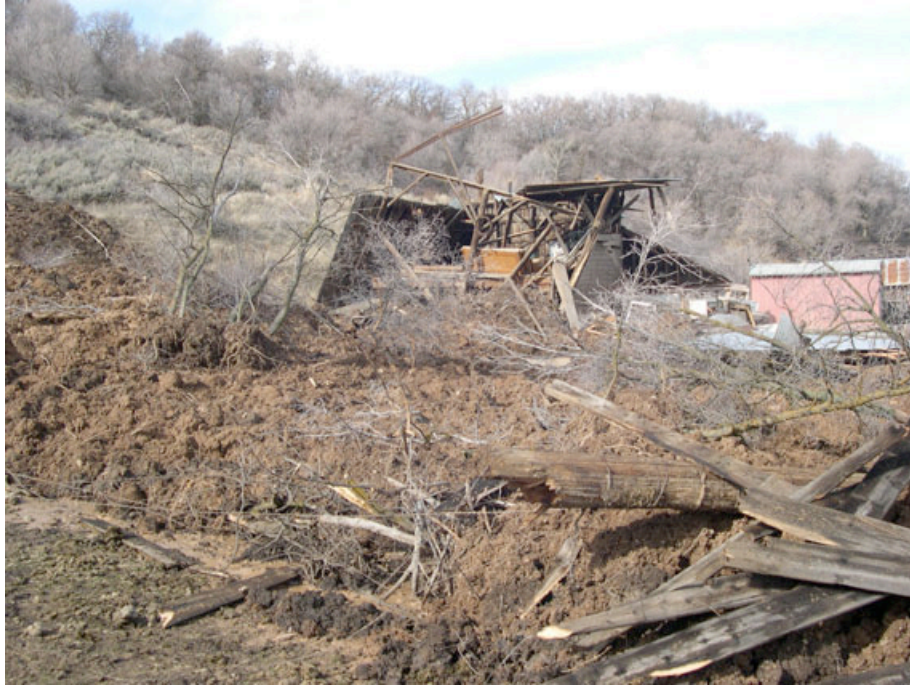
Figure 4. *Looking across the lower part of the landslide at the demolished barn. The clump of trees in the foreground was rafted downslope on top of the landslide debris.*

minute and the barn provided no resistance to landslide movement. Based on this approximate travel time, the estimated landslide velocity is about 8 feet per second, which classifies as very rapid landslide movement (Cruden and Varnes, 1996). The landslide is just below the Davis-Weber Canal and likely started moving as a rotational slide, but likely transformed into a rapid earth flow about midway downslope and ran out 150 feet beyond the toe of the slope across State Route 60 and onto a flat field. Grass, shrubs, and trees cover this northeast-facing slope. Some trees were rafted on top of the landslide debris (figure 4).

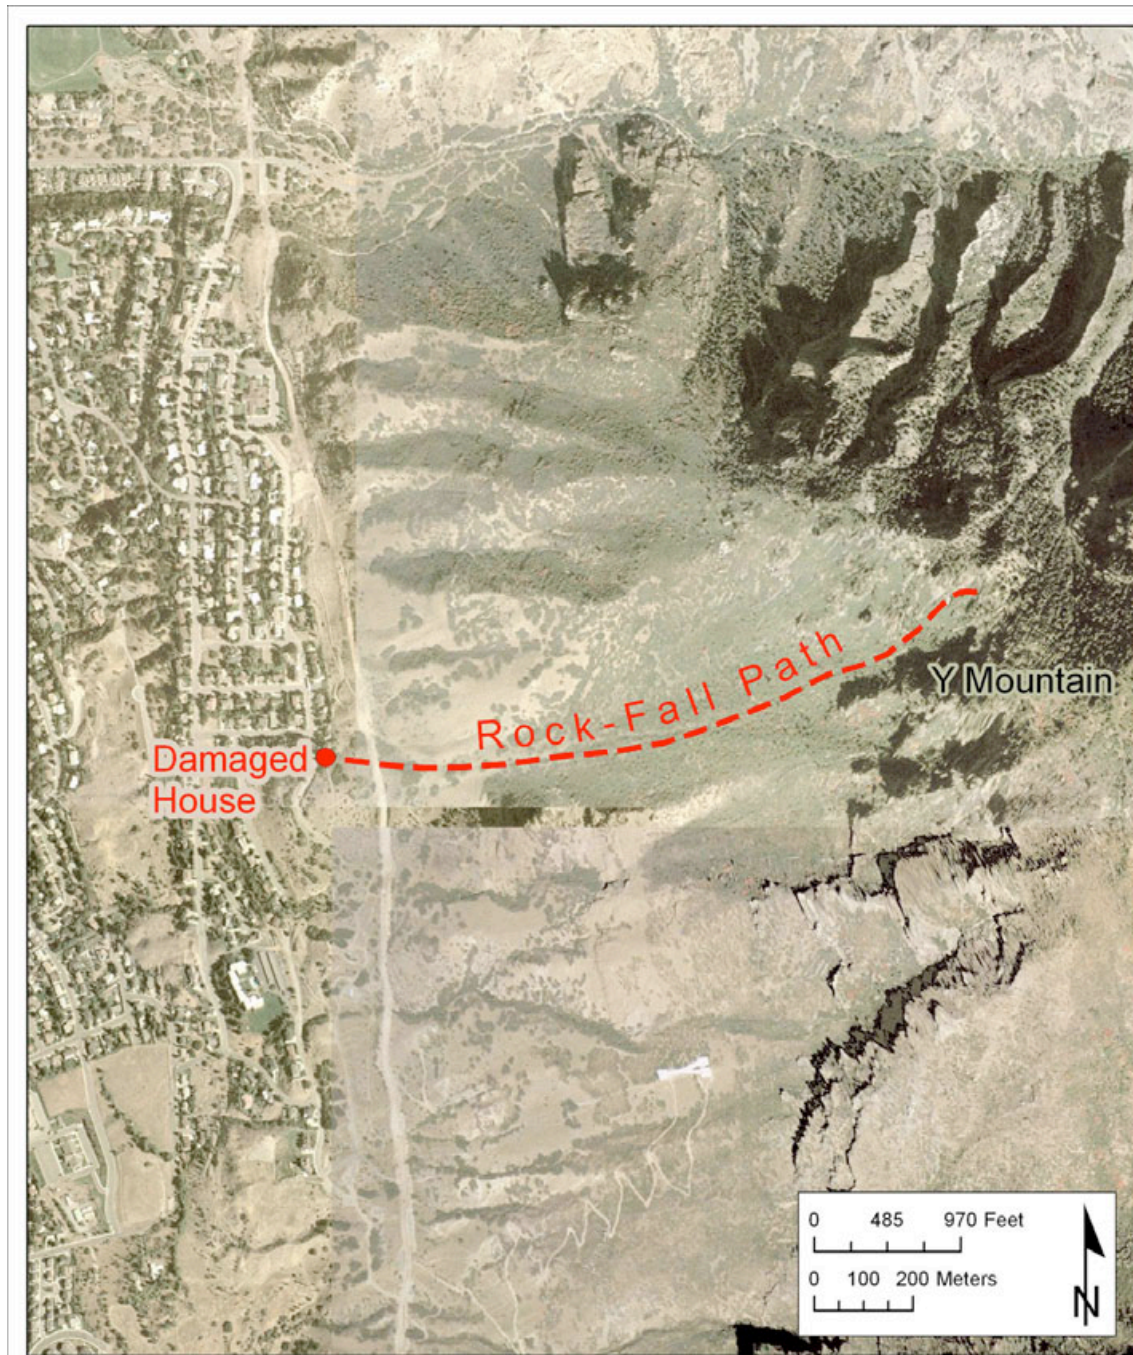
Figure 2. “Y” Mountain source area, the rock-fall path, and damaged house.

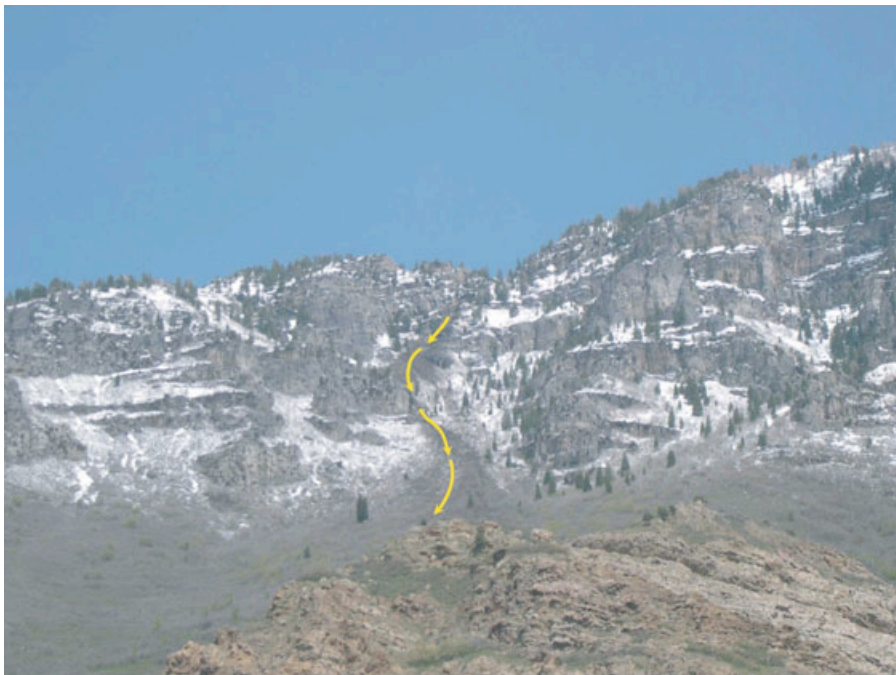
Figure 4. View east to the rock-fall source area in the Mississippian Desert Limestone on the north end of “Y” Mountain showing path of the rock fall (arrows) as indicated by dark soil and rock fragments on the snow surface.

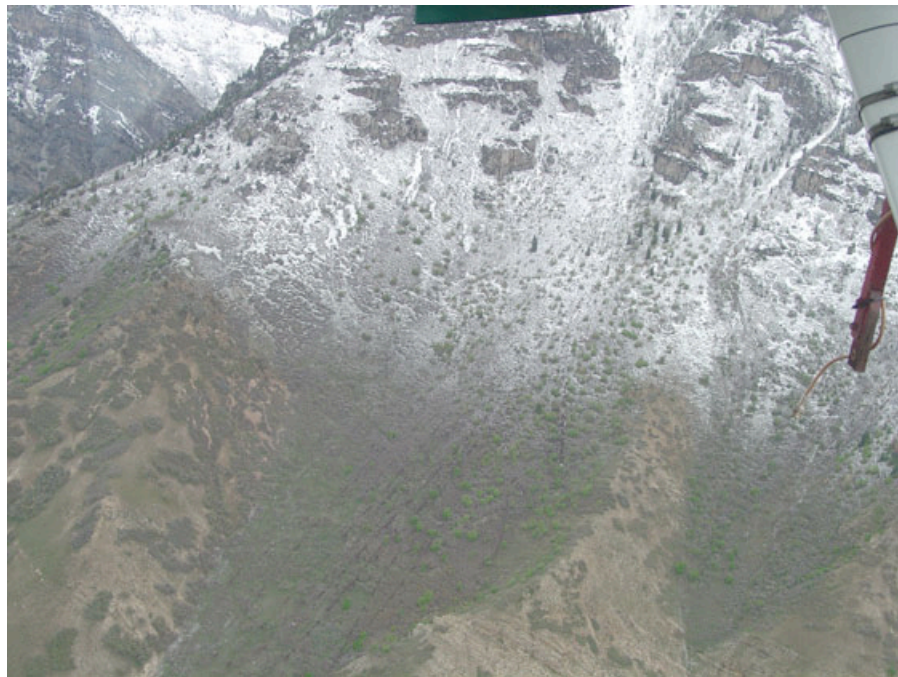
Figure 6. View of the rock fall runout track on May 17, 2005. Dark brown soil streaks show the path of rocks that traveled downslope. Recent snowfall obscures the runout track in the upper part of the photo (photo by Dave Bennett).

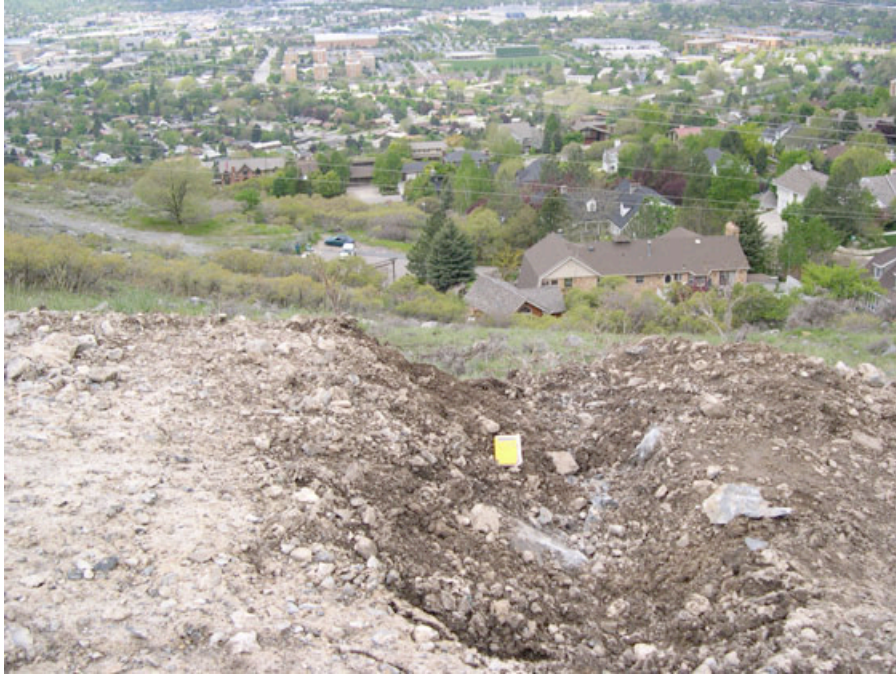
Figure 7. *Impact crater (bounce mark) on the slope just above the guest house (yellow object is notebook for scale).*

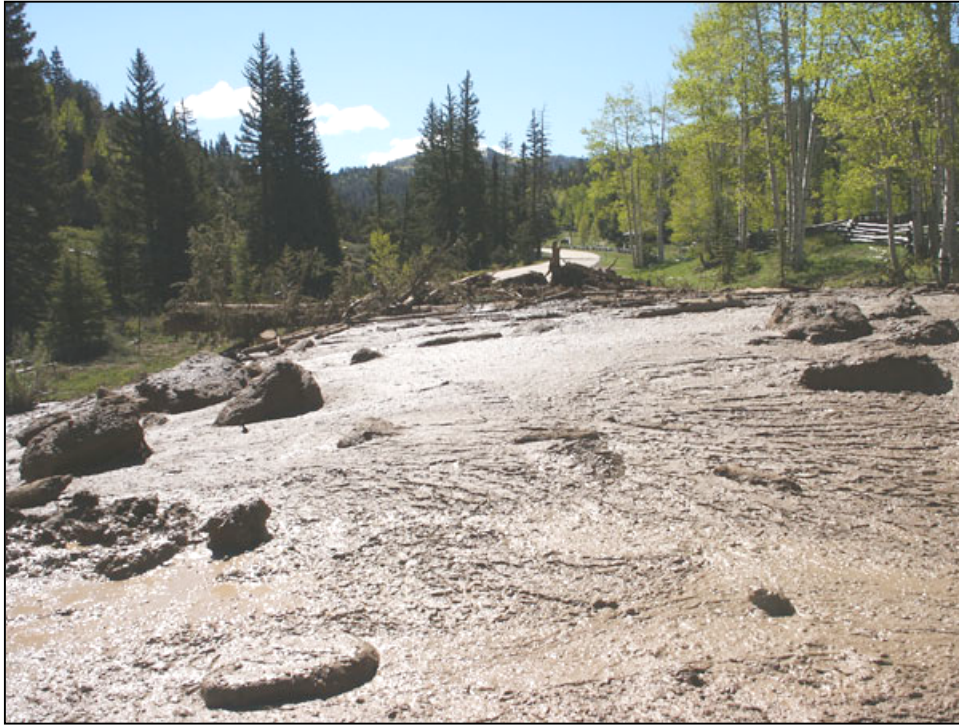
Figure 2. Location where the Black Mountain debris flow crossed SR-14 on June 3, 2005; photo was taken on June 4 about 30 hours after the debris flow occurred during UDOT cleanup operations.

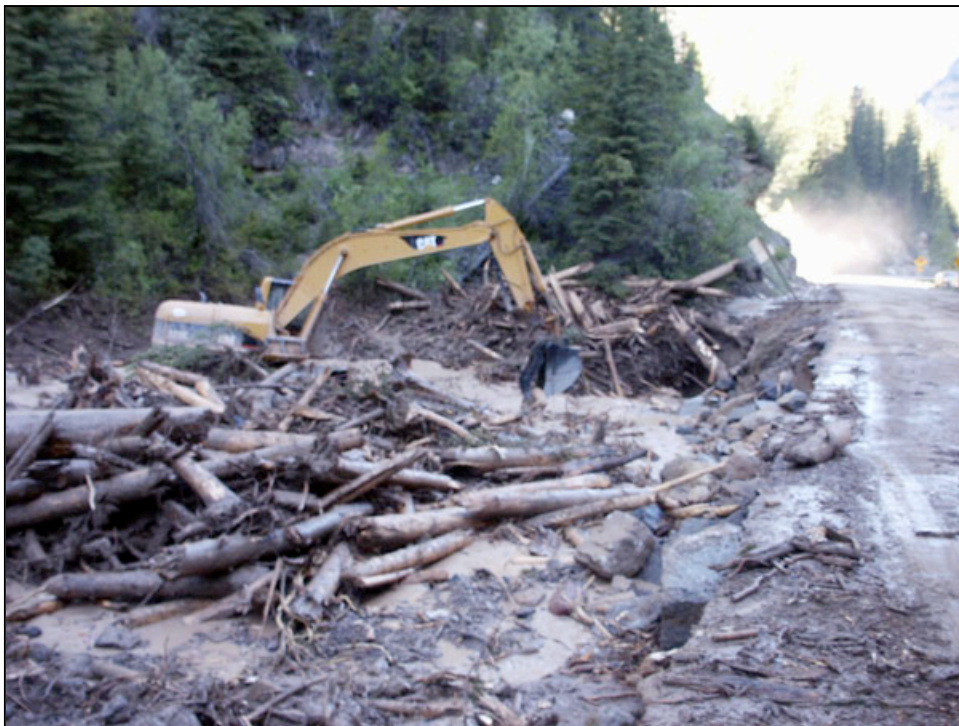
Figure 3. Log jam created by the Black Mountain debris flow at a box culvert beneath SR-14.

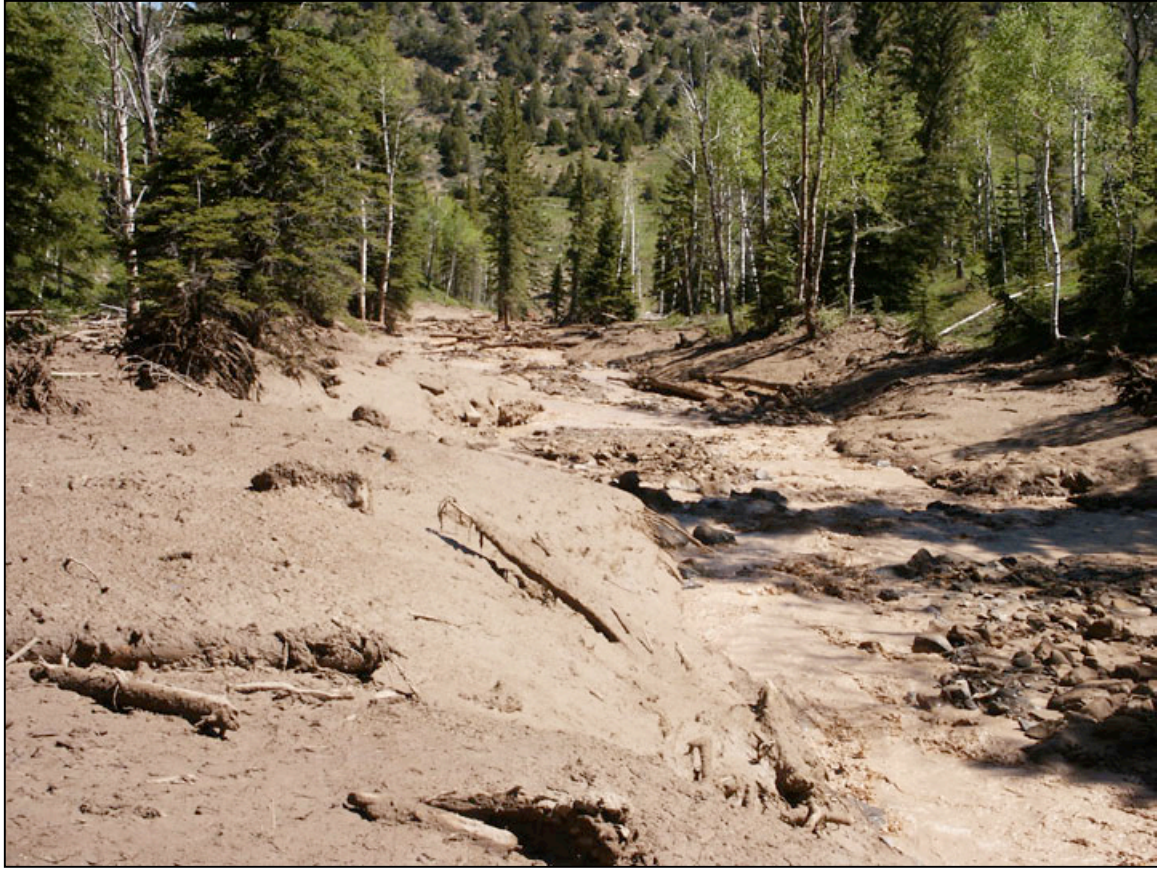
Figure 8. *Scoured channel of the un-named tributary of Crow Creek about 0.6 miles above the juncture of the two streams.*

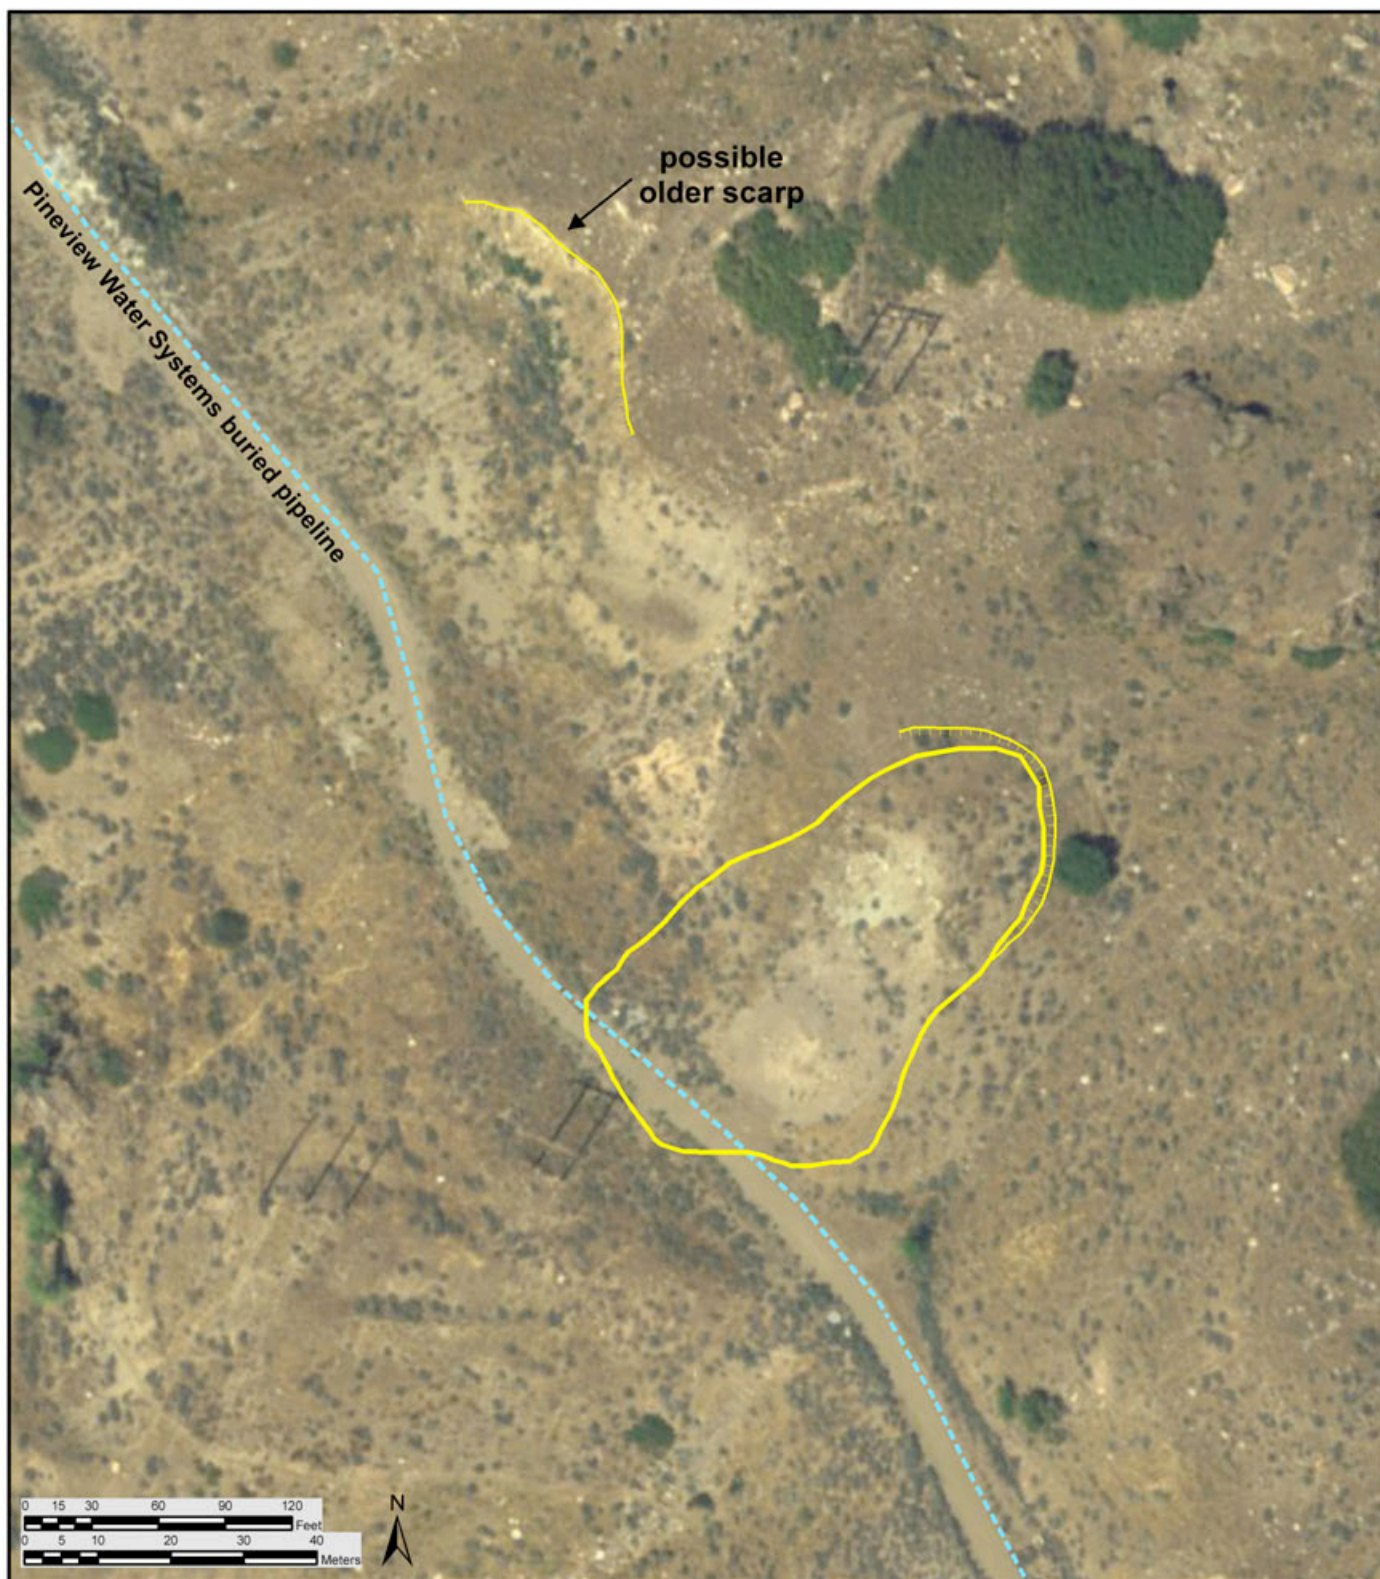
Figure 2. April 15, 2005, landslide deposit and main scarp.

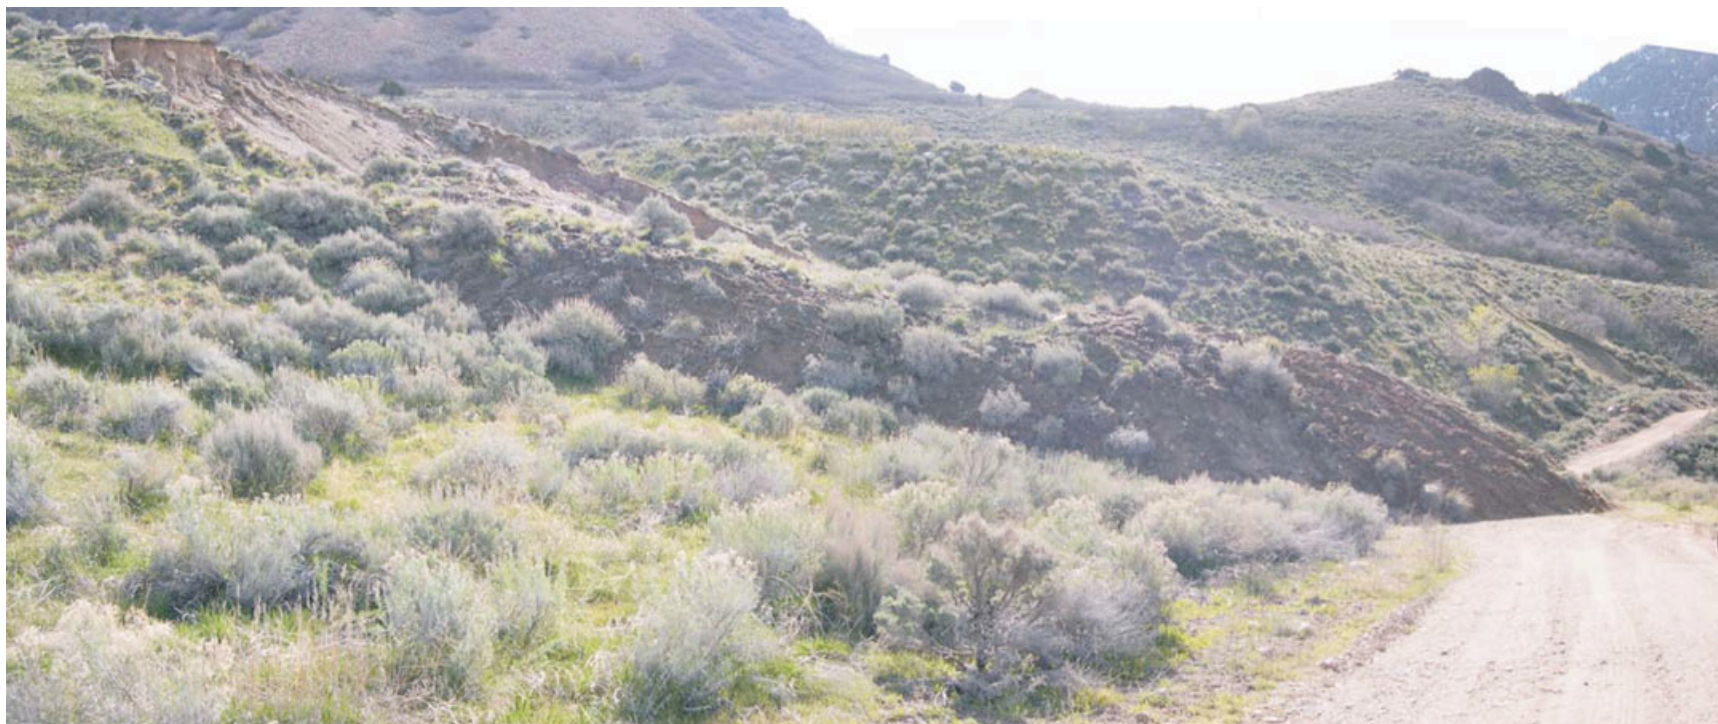
Figure 3. Side view of landslide looking southeast.

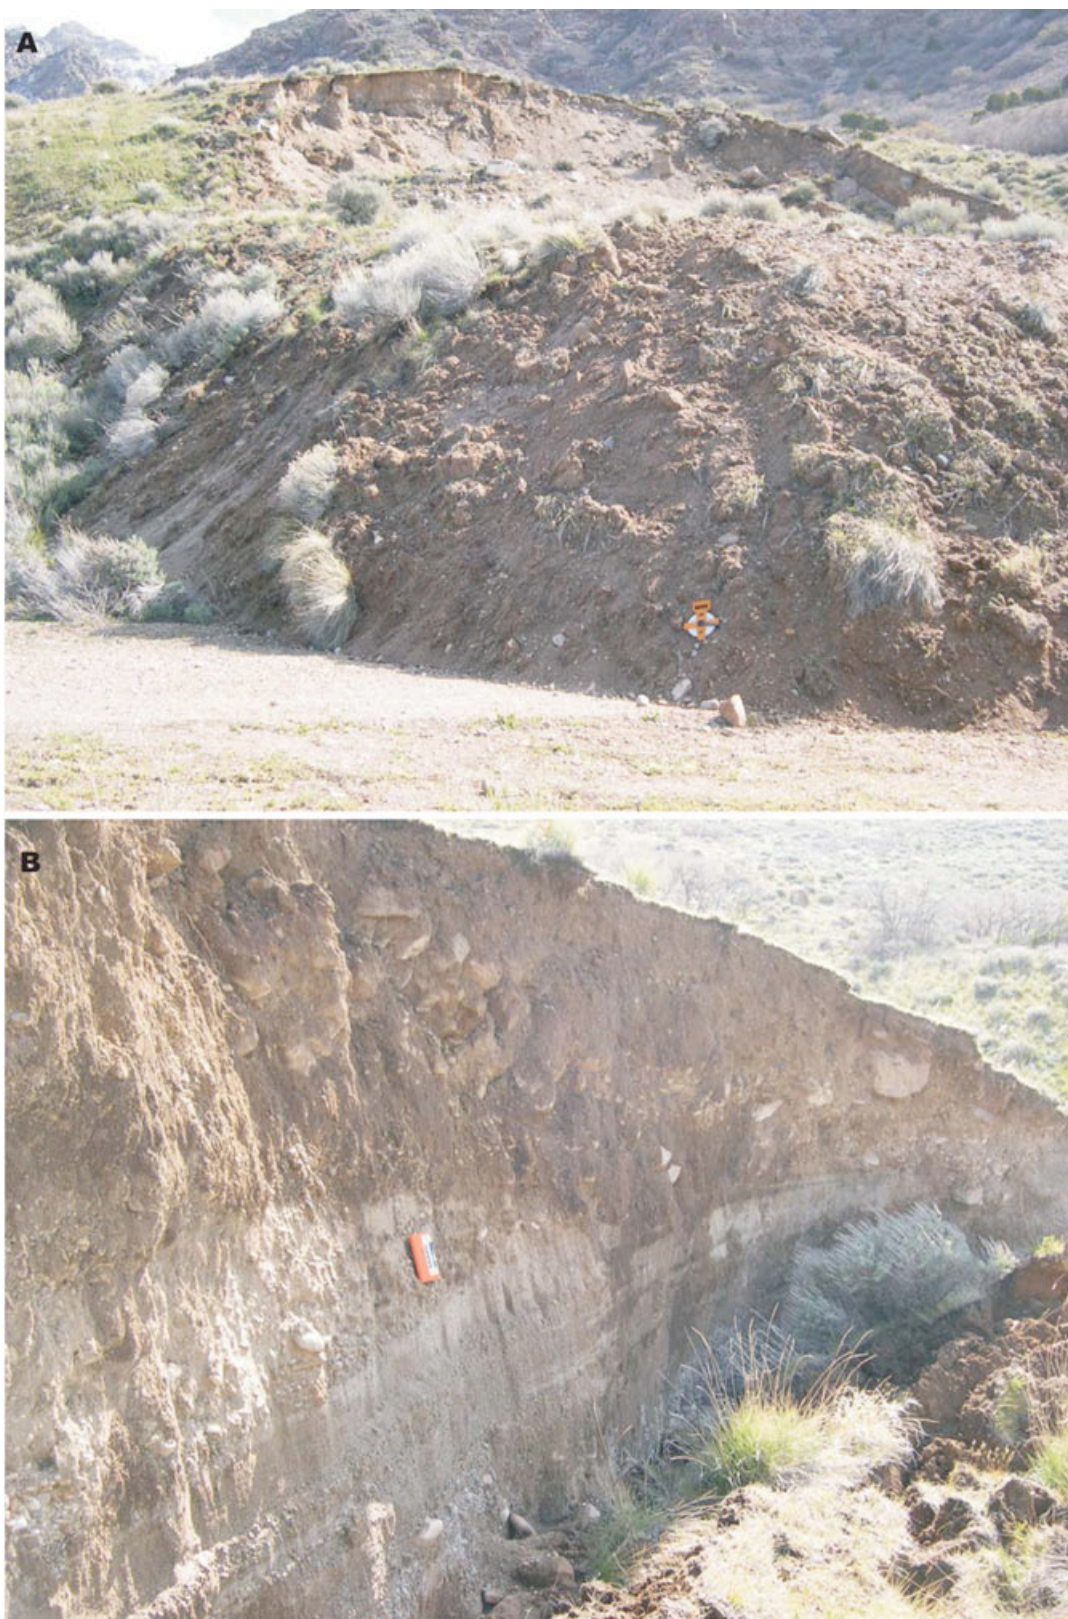
Figure 4. a) Landslide main scarp and toe of deposit covering road.
b) Main scarp exposure showing post-Bonneville alluvium and colluvium overlying lacustrine sand and gravel.

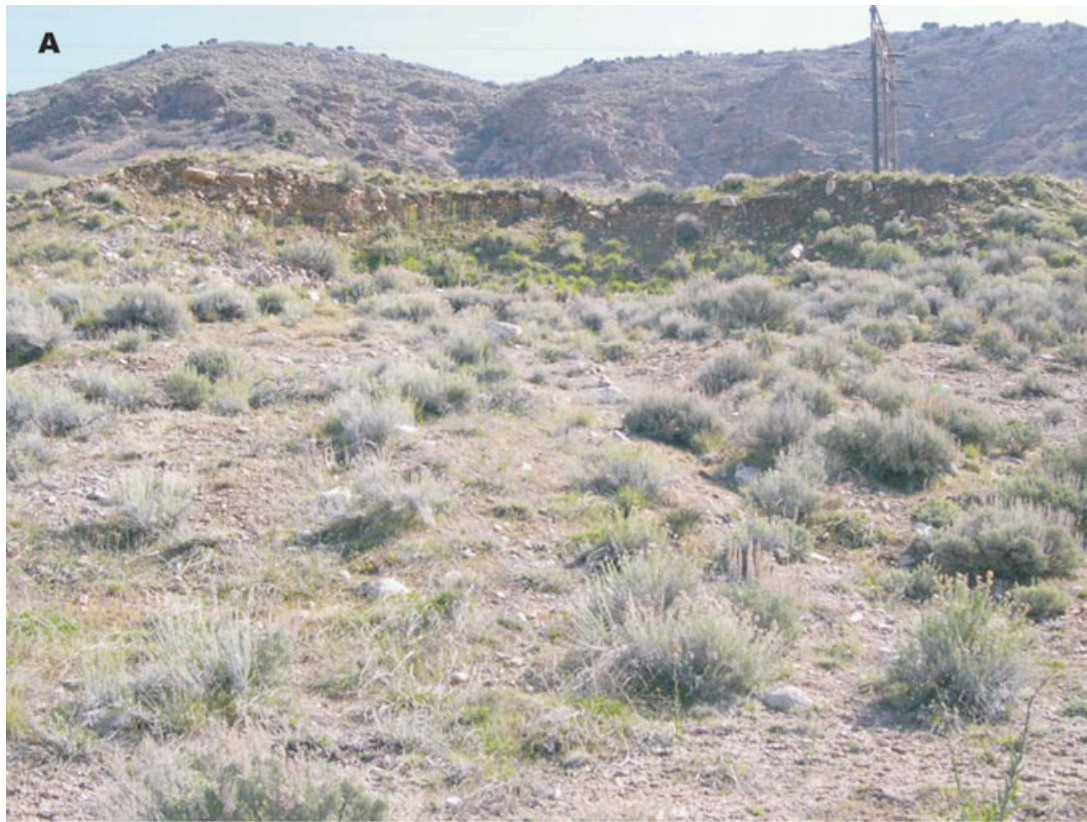
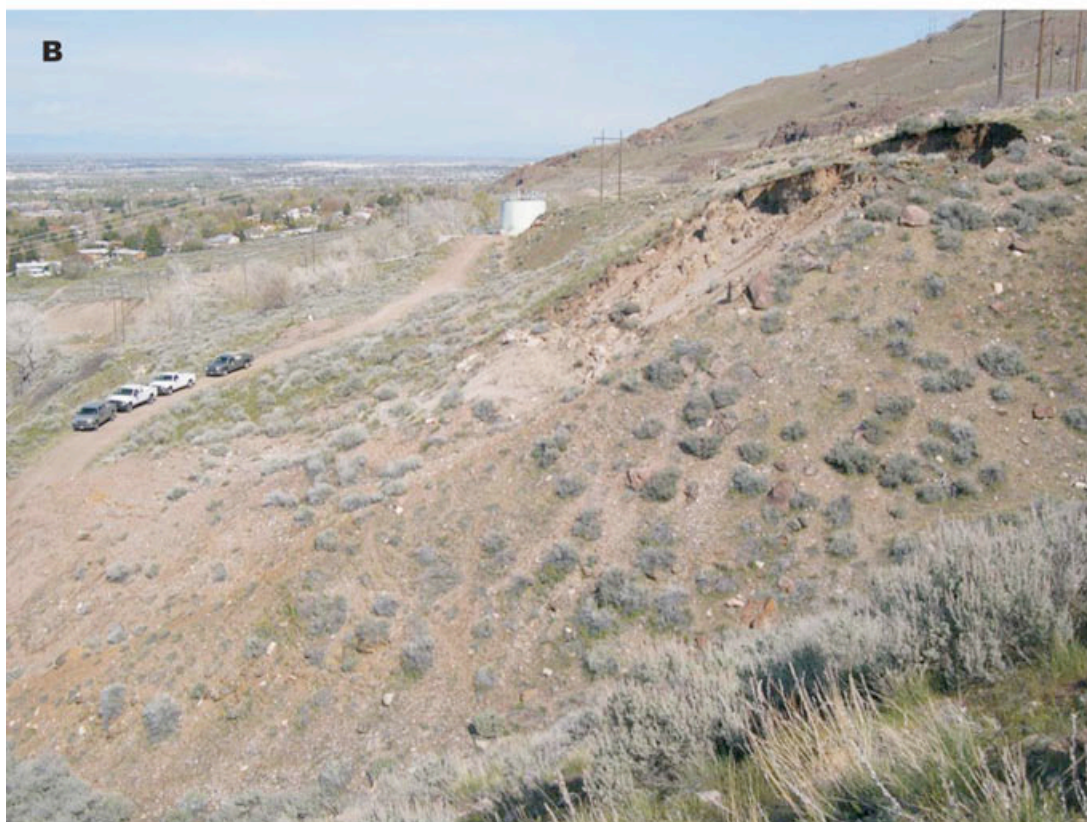
Figure 5. a) Possible older landslide scarp northwest of 2005 landslide.
 b) Side view of 2005 landslide showing down-dropped blocks of soil at head.

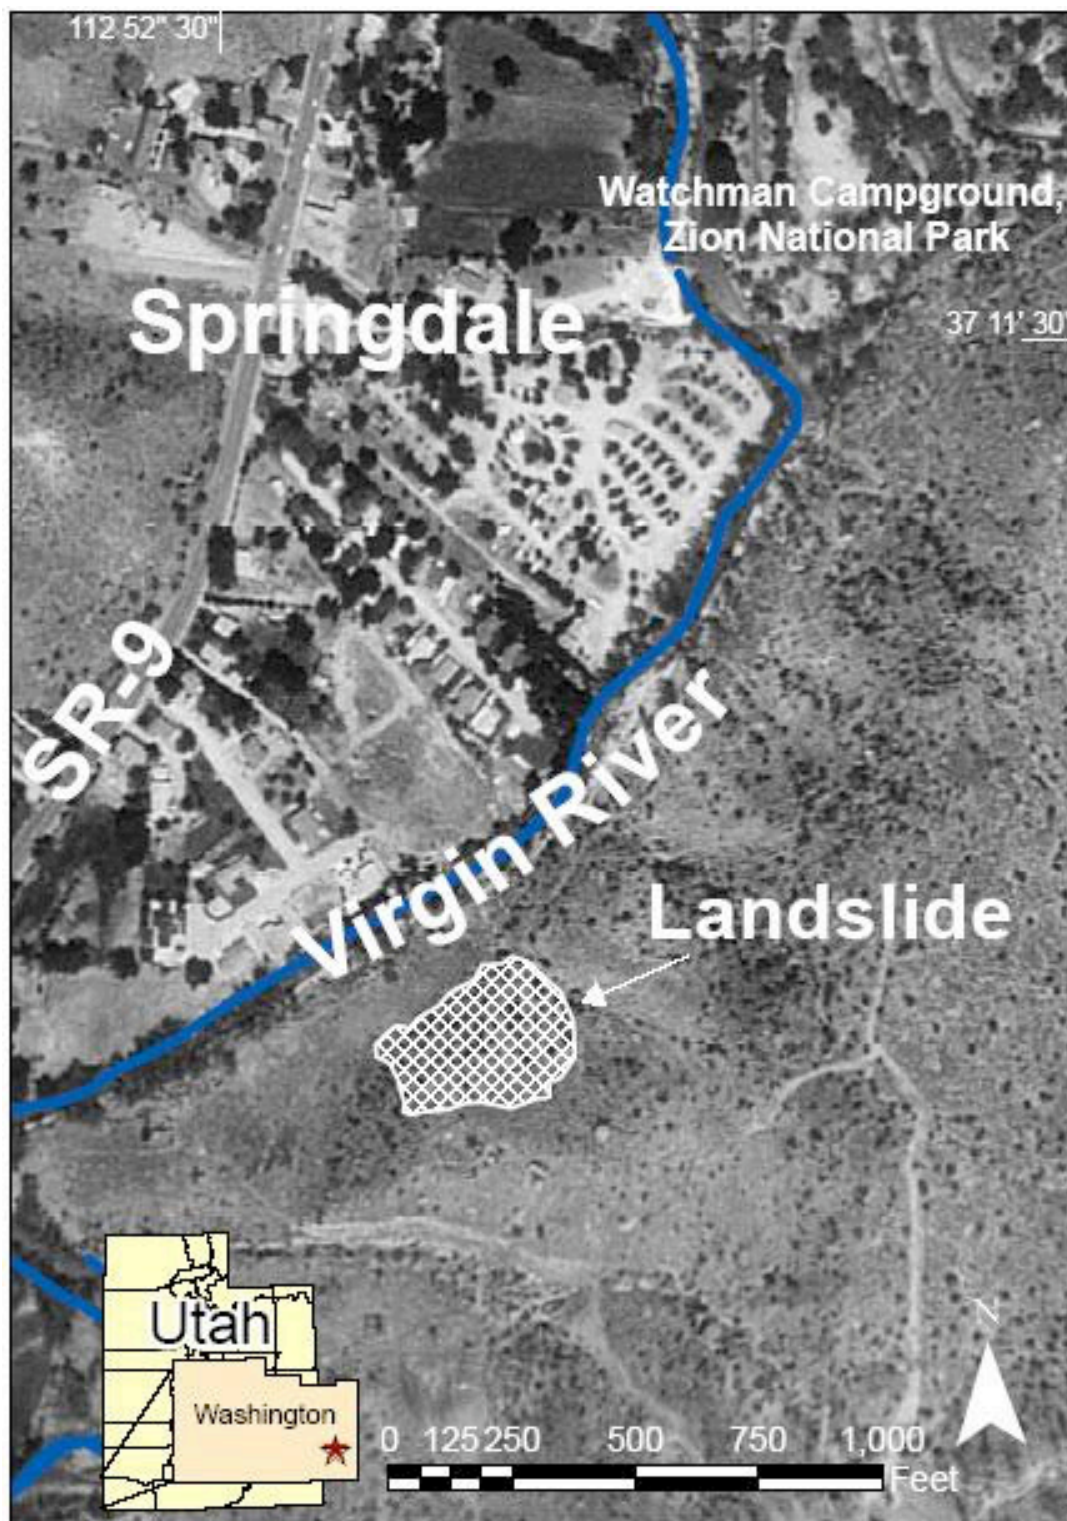
Figure 2. Rotational slump landslide formed during May 2005 on the east side of the Virgin River in Springdale, Utah (base map U.S. Geological Survey Springdale East 7.5' orthophoto quadrangle).

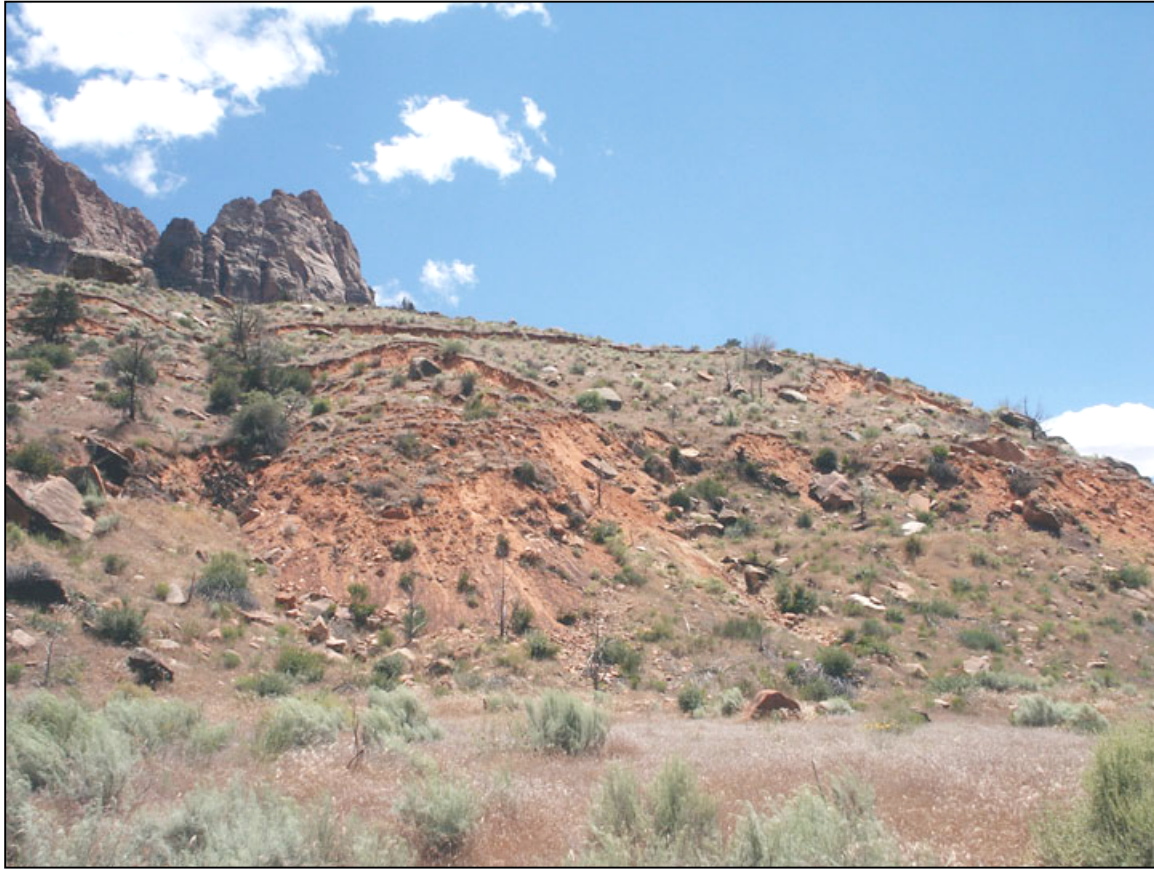
Figure 3. *View to the east of the landslide in Springdale on the east side of the Virgin River; landslide formed progressively during May 2005.*
