TECHNICAL REPORTS FOR 2002–2009 GEOLOGIC HAZARDS PROGRAM

COMPILED BY ASHLEY H. ELLIOTT

Report of Investigation 269
Utah Geological Survey
a division of
Utah Department of Natural Resources
2010

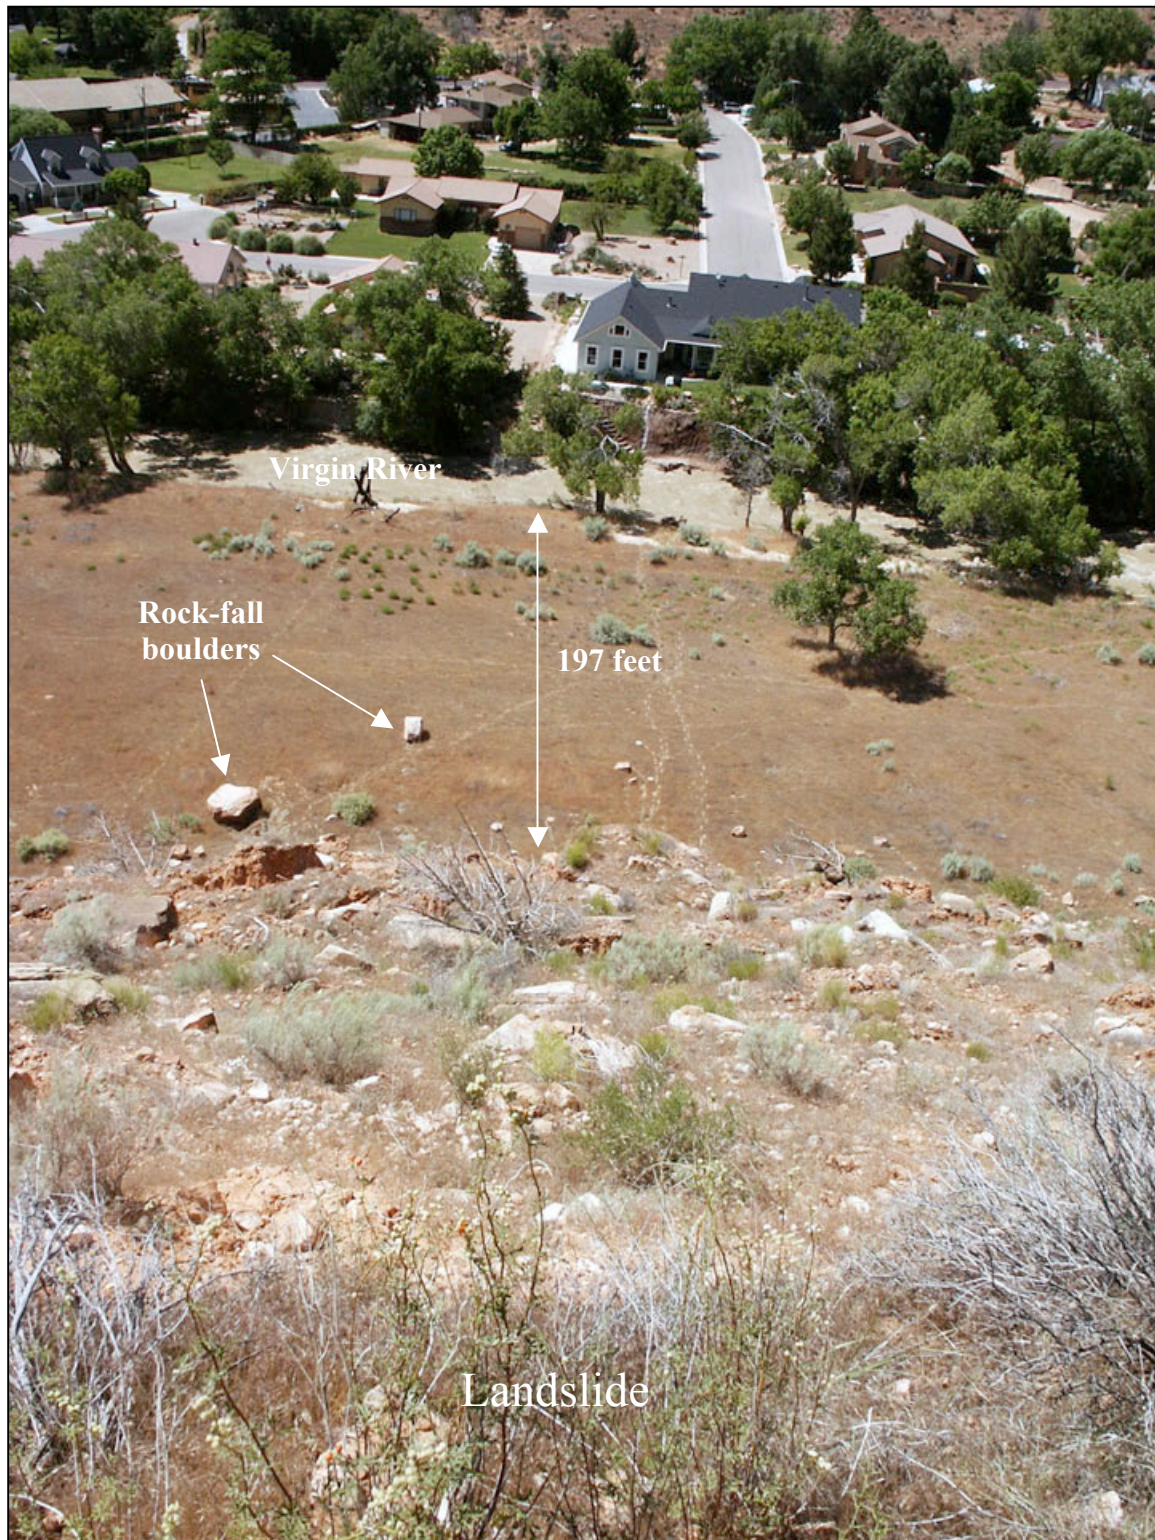
Figure 4. View from the landslide toward the Virgin River, showing the 197 feet of separation between the landslide toe and the river; note the rock-fall boulders that have rolled from the landslide surface onto the alluvial terrace deposits along the river.

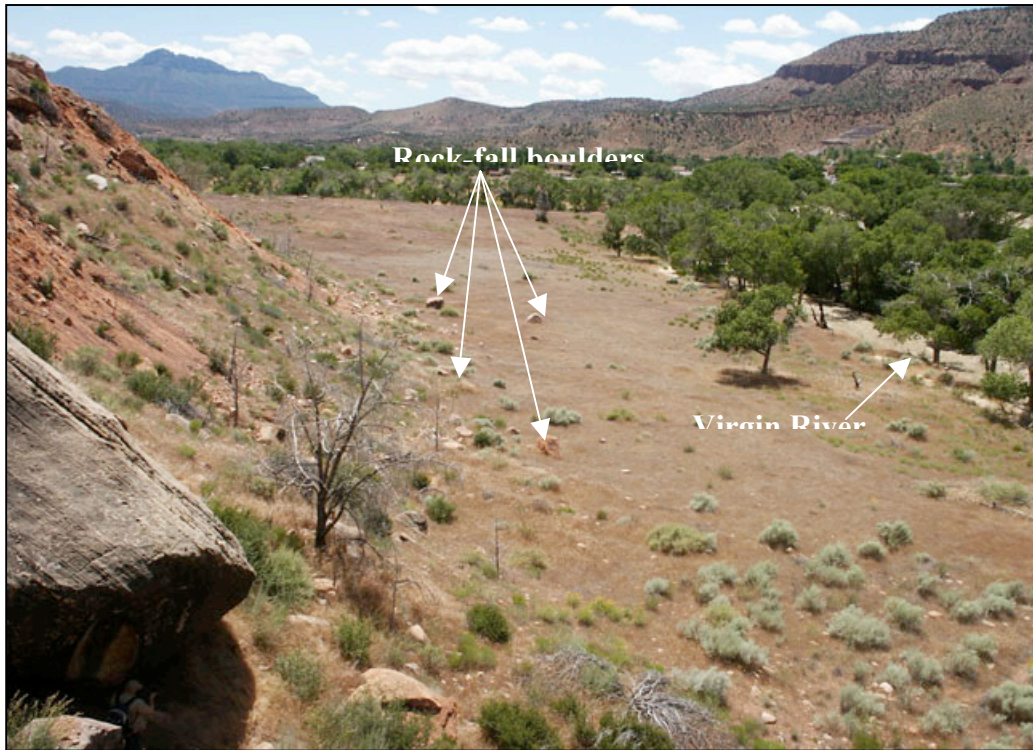
Figure 5. Rock-fall boulders at the base of the landslide; most have accumulated within a few feet of the landslide toe, but a few have rolled farther out on the alluvial terrace bordering the Virgin River.

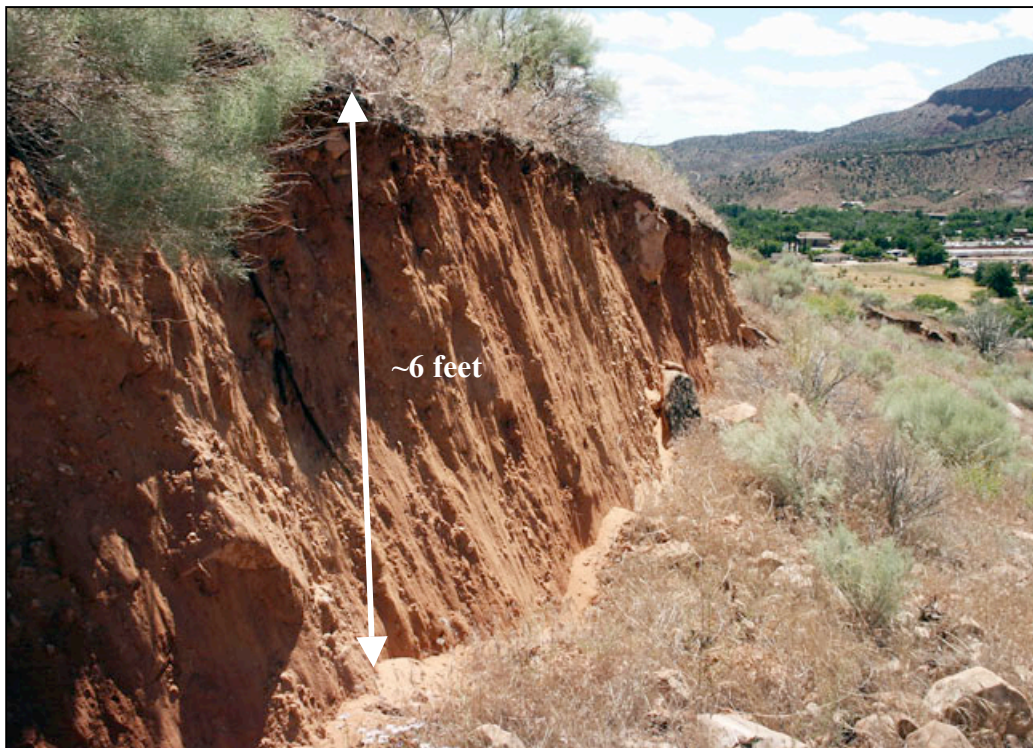
Figure 6. Landslide main scarp.

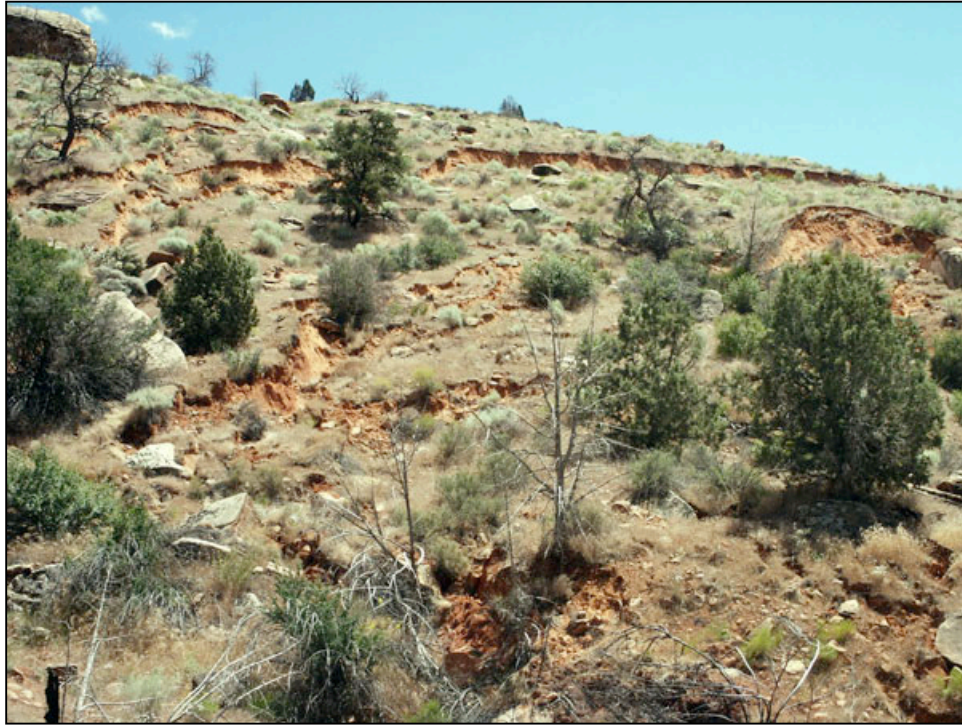
Figure 7. *Transverse scarps within the landslide mass.*

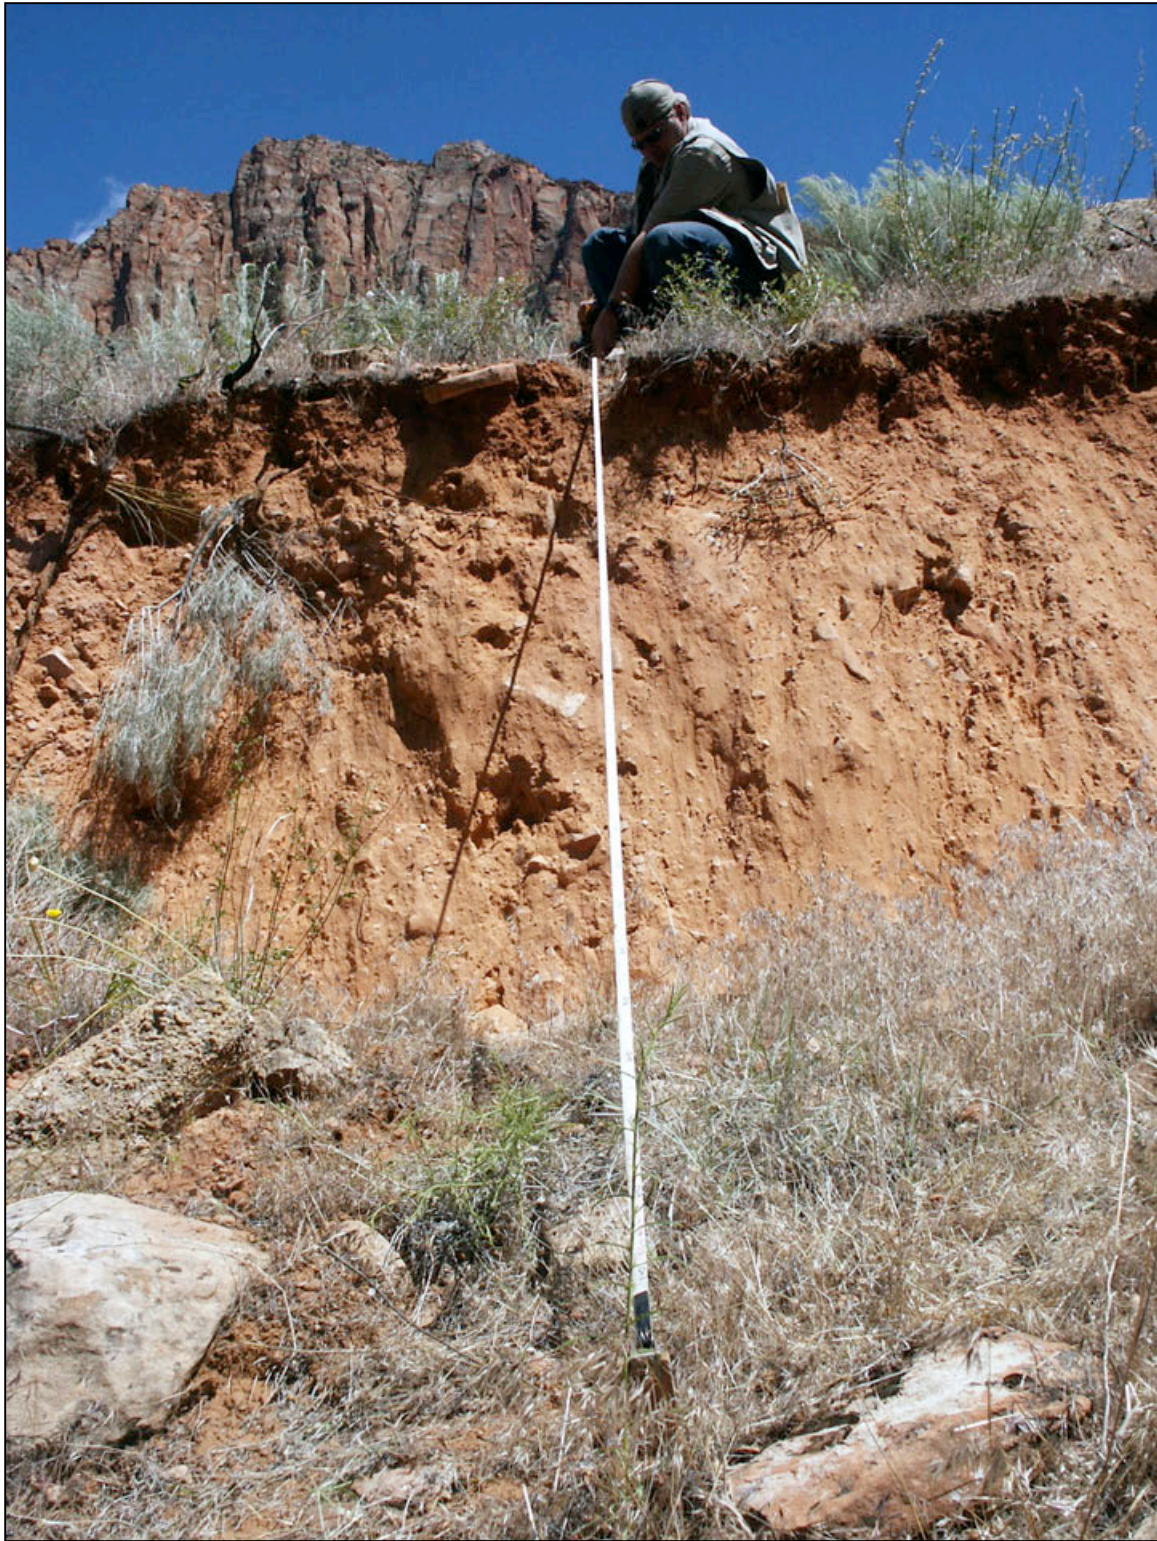
Figure 9. North monitoring station; distance between wooden stakes is 13.25 feet.

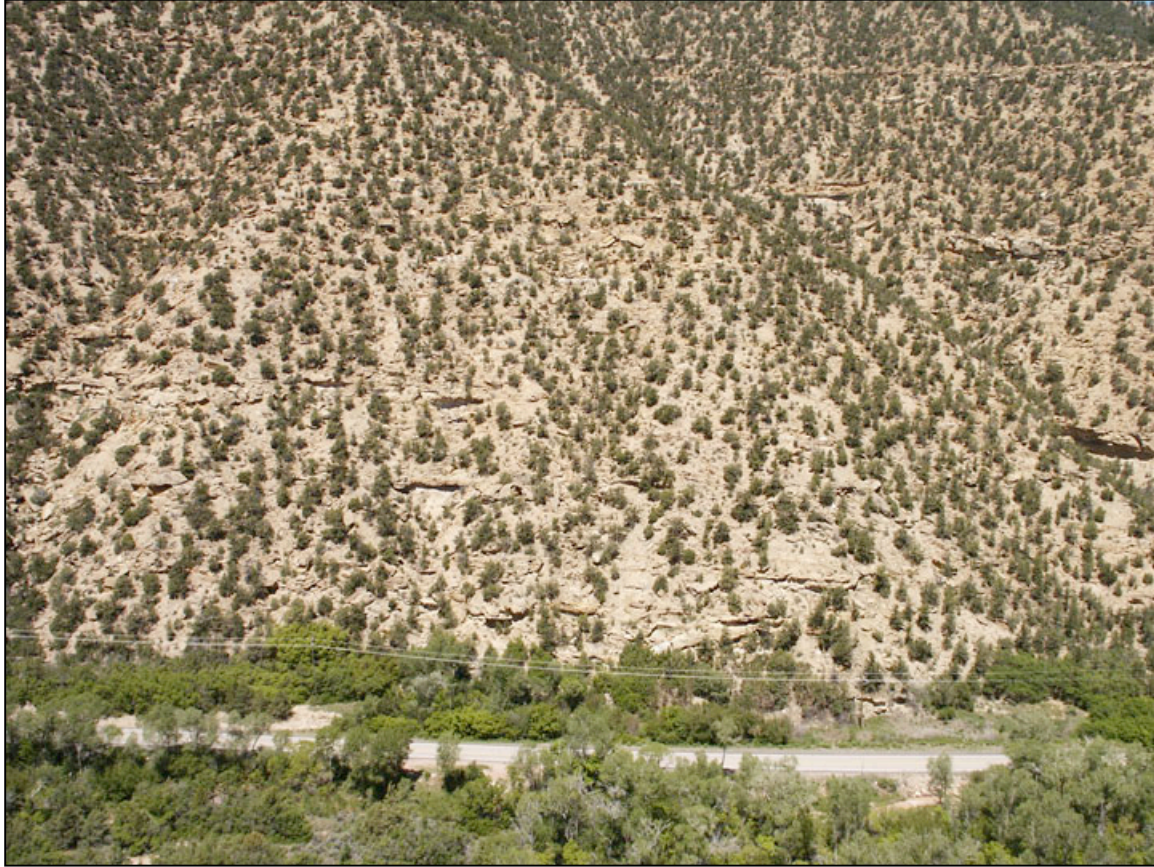
Figure 2. *West wall of Parowan Canyon as it appears directly across from the June 3, 2005, rock fall that damaged the Parowan City penstock. The nearly continuous exposures of the Cretaceous Iron Springs Formation with sparse vegetative cover of pinyon pine and juniper shown here are similar to the conditions on the east canyon wall where the rock fall occurred. SR-143 and the dense riparian vegetation along Parowan Creek are visible at the bottom of the photo.*

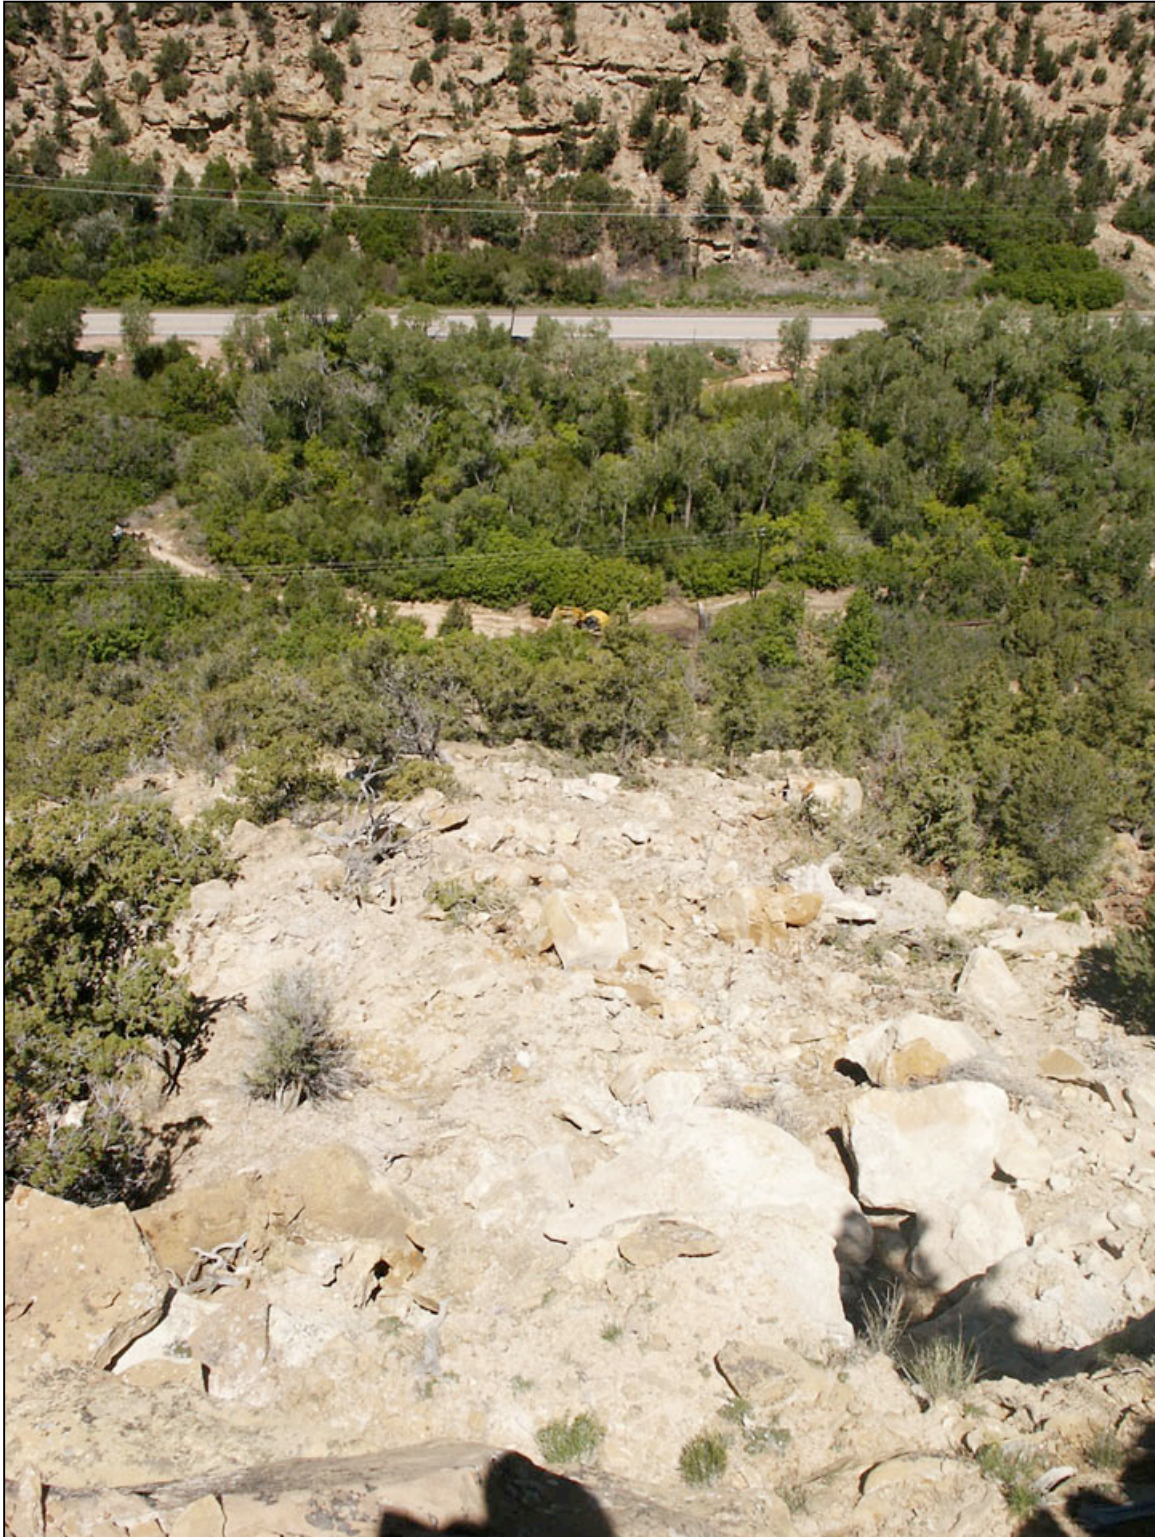
Figure 4. Rock-fall path stripped of vegetation down the east side of Parowan Canyon. Note the narrow canyon bottom, which accommodates SR-143, Parowan Creek, and the penstock and service road.

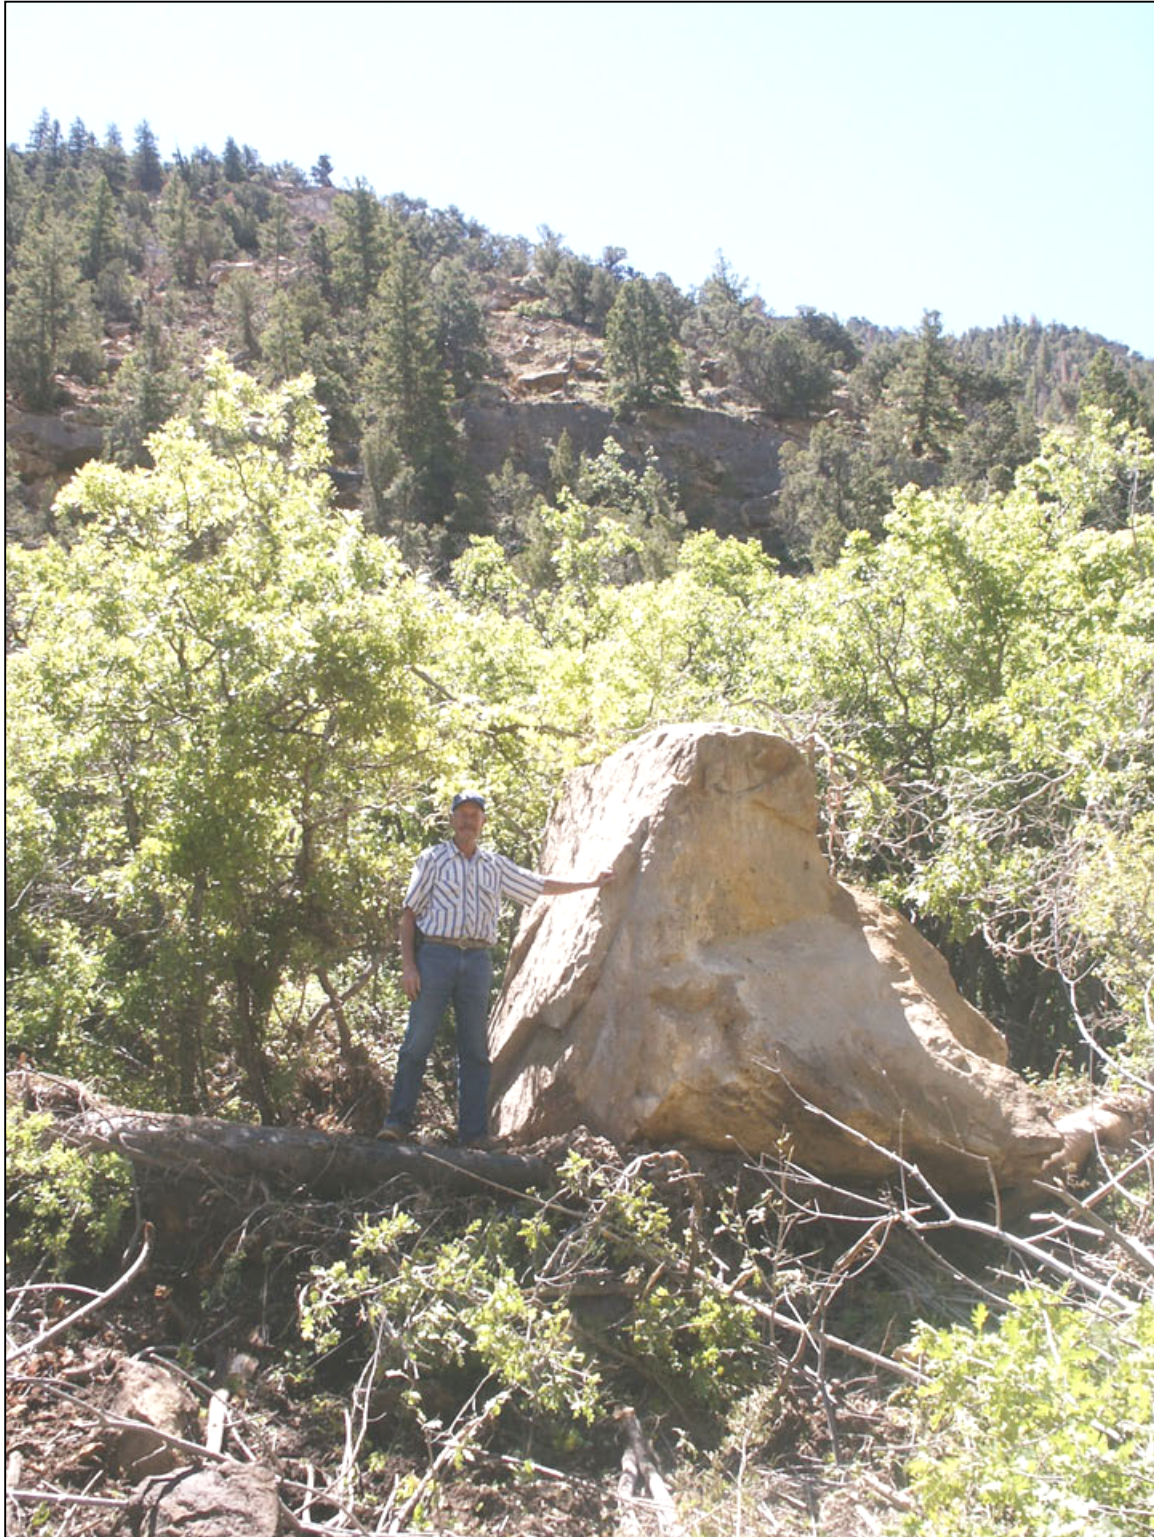
Figure 5. Sandstone boulder weighing an estimated 80 tons resting directly on top of a section of the Parowan City penstock. The rock-fall path down the east wall of Parowan Canyon is visible through the trees below the skyline.

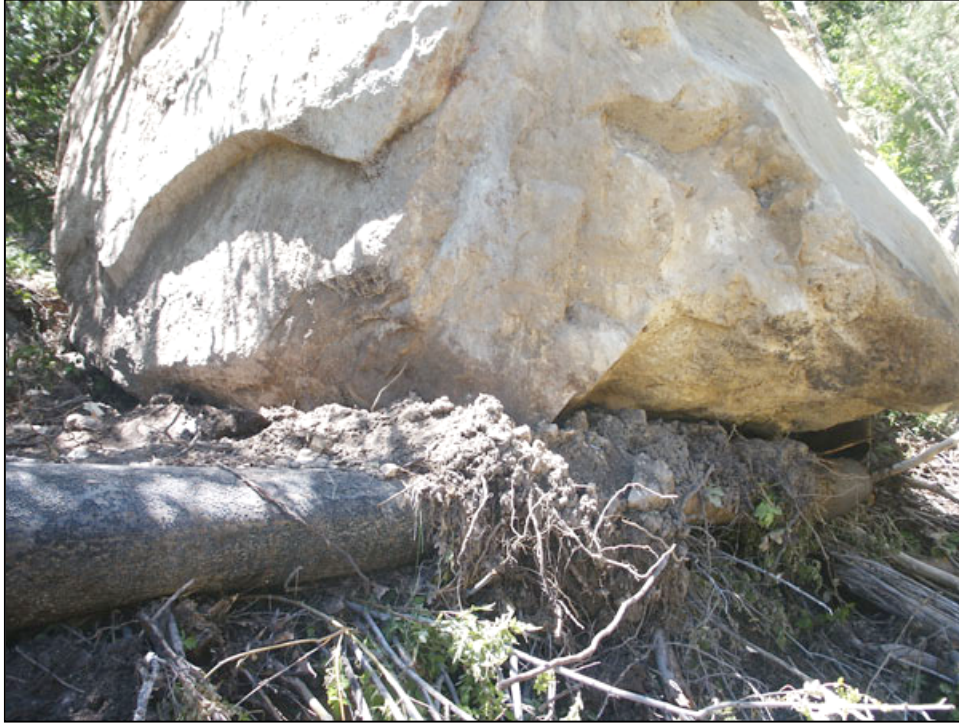
Figure 6. Approximately 80-ton boulder resting on top of the 26-inch diameter Parowan City penstock pipe.

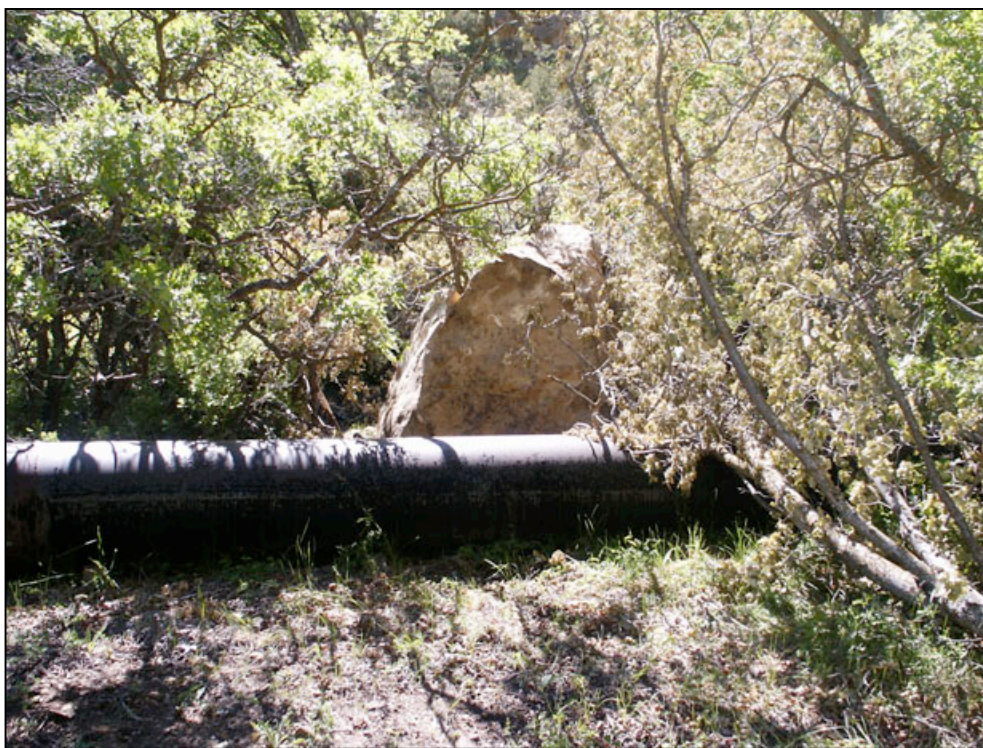
Figure 9. Approximately 13-ton rock-fall boulder, which stopped just before striking the Parowan City penstock.

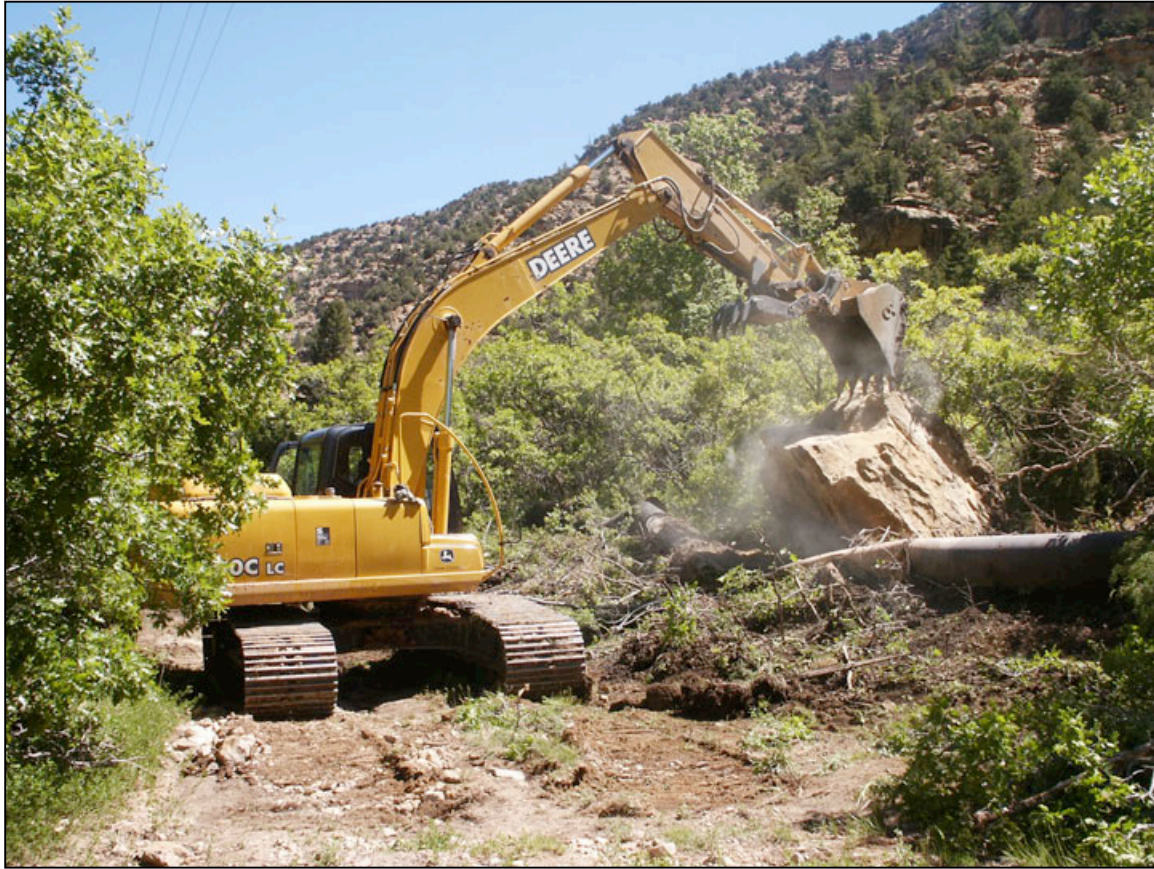
Figure 10. Trackhoe removing the 80-ton boulder from on top of the Parowan City penstock.

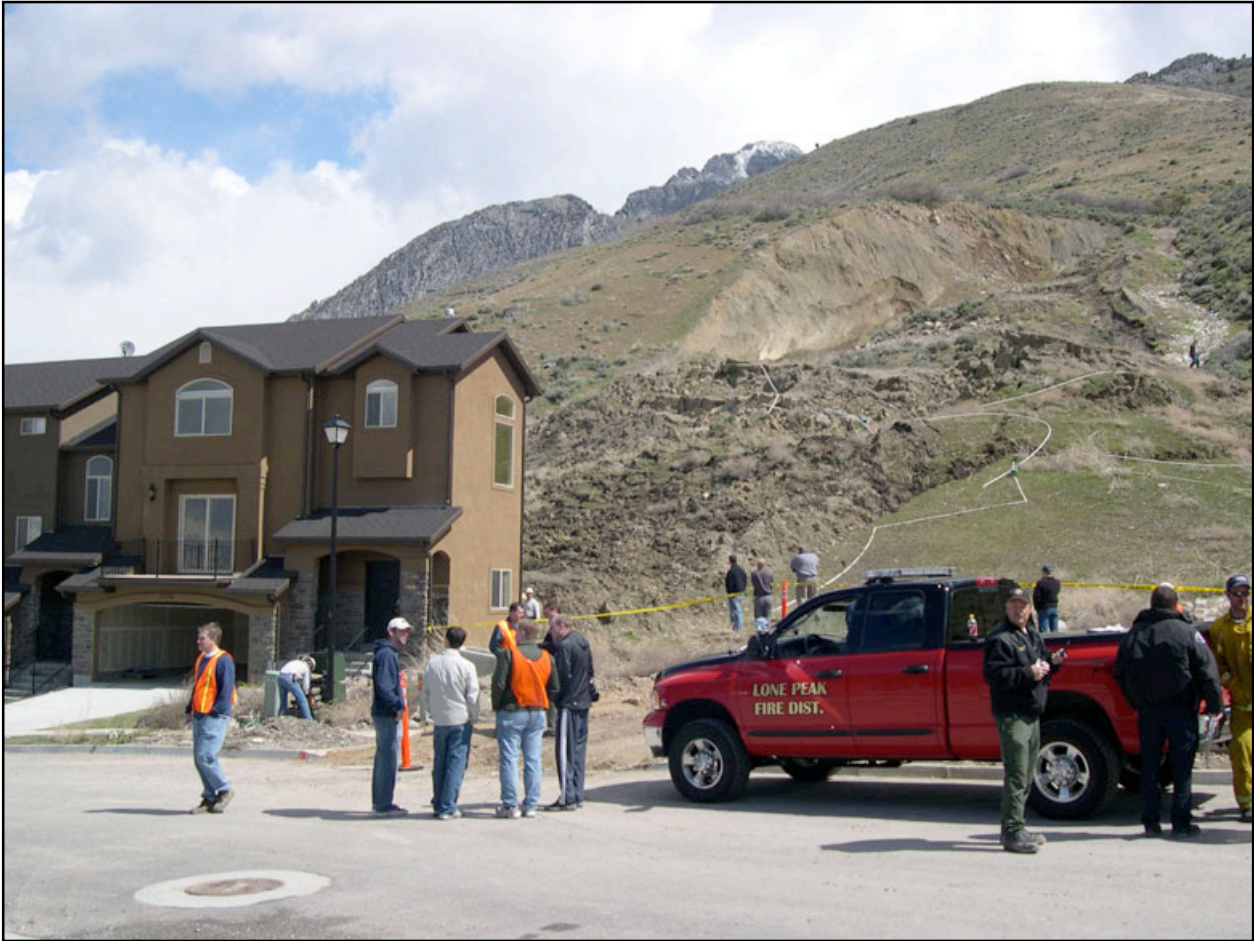
Figure 2. View to the northeast of the landslide on April 29, 2005, from Sage Vista Lane.

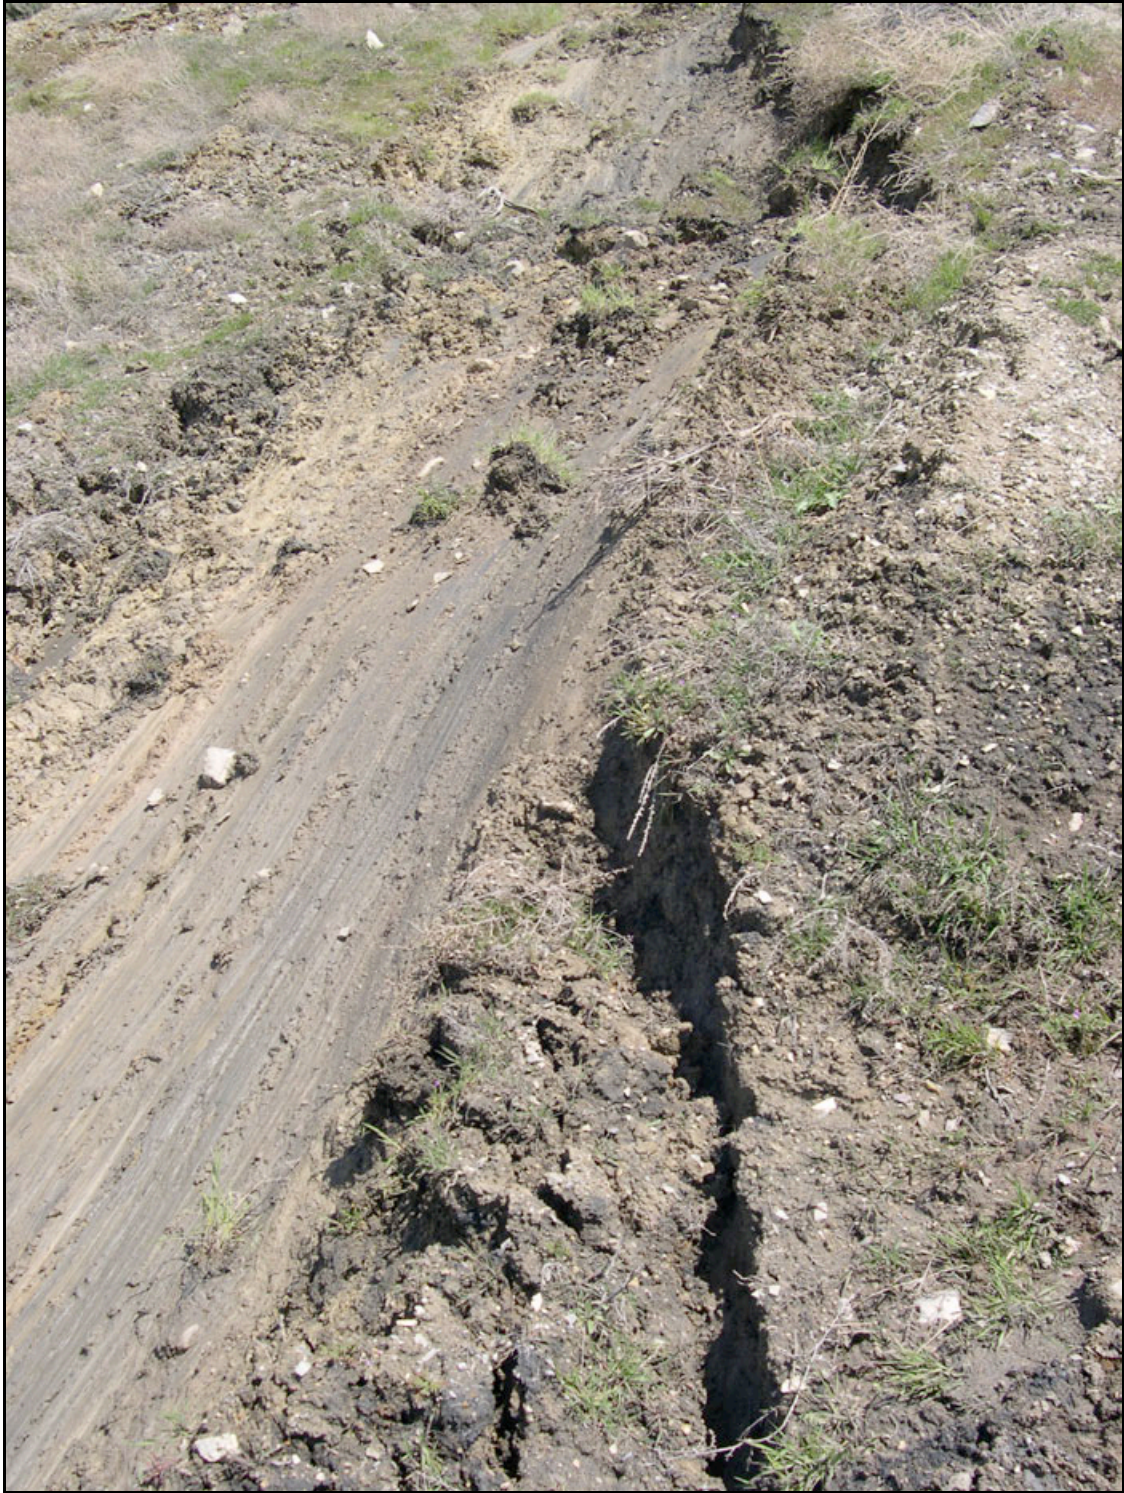
The middle part of the landslide was relatively intact and consisted of fractured soil, whereas the upper part of the landslide was somewhat more deformed and disrupted. A cobble-lined drainage ditch in this area remained mostly linear suggesting that it was mostly translated in intact and undeformed blocks (figure 6). Dark gray, highly polished slickensides were locally exposed on top of exposed black clay in the upper part of the landslide, suggesting the upper part of the slide is locally shallow (possibly less than 10 feet deep; figure 7).

Figure 7. *View of slickensides in the upper, shallow part of the landslide.*

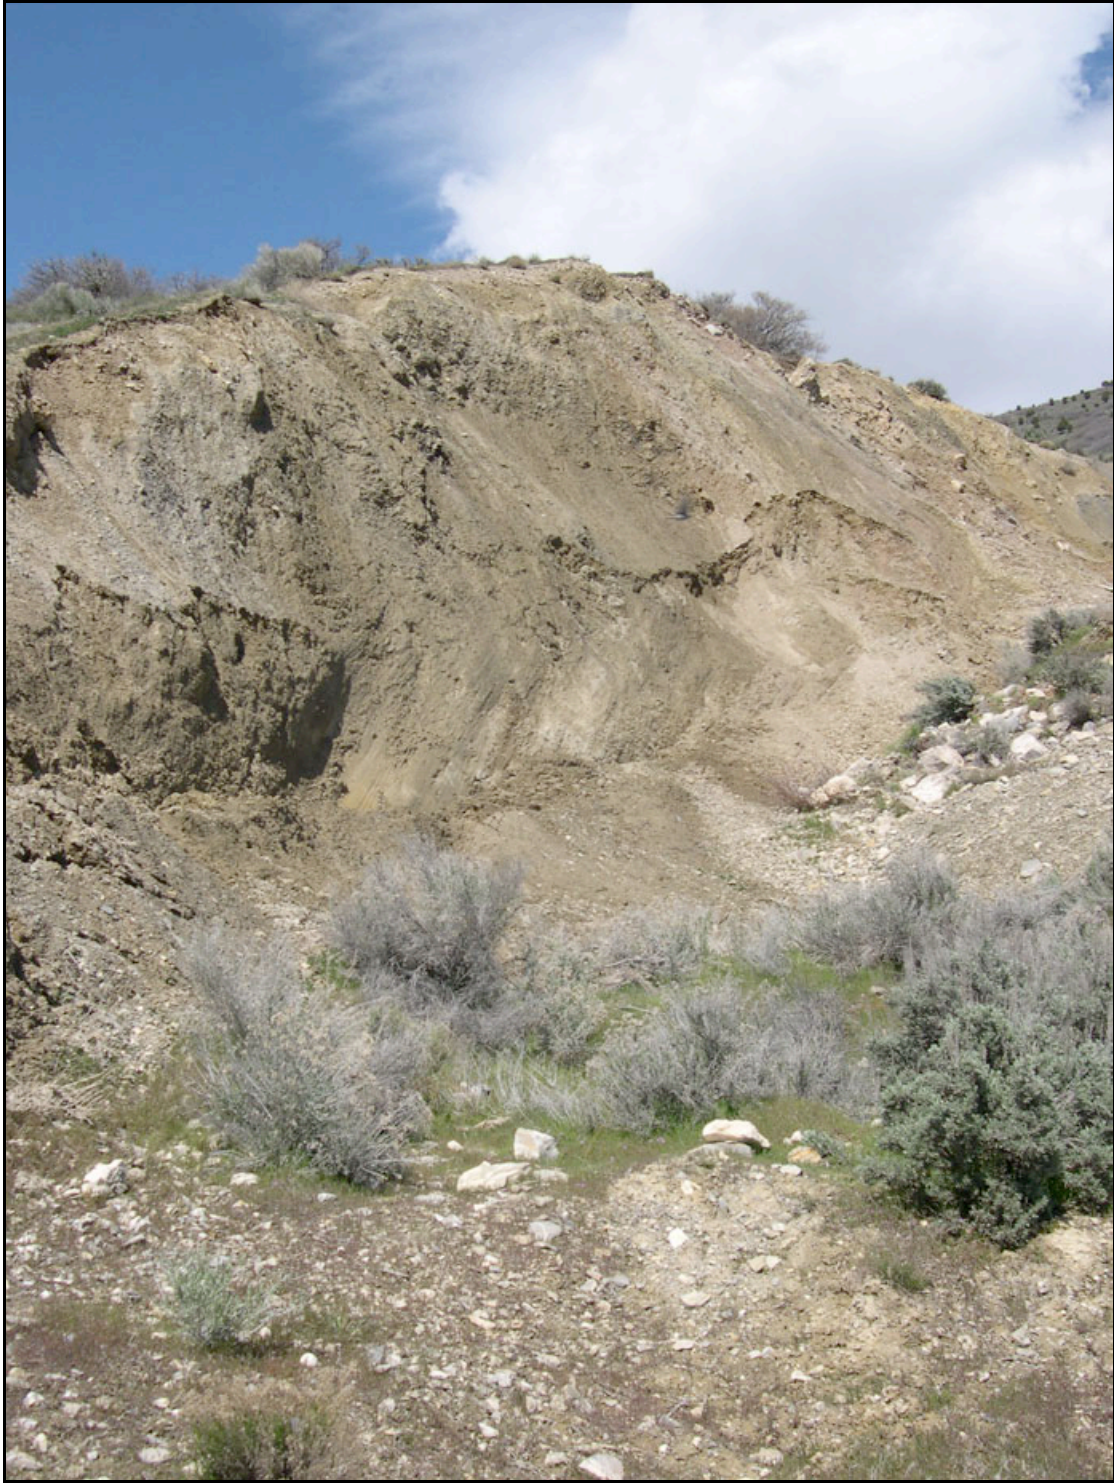
On May 5 we observed cracks in the crest of the south-facing scarp that extended several feet back from the top of the scarp. These cracks intersected the scarp at an acute angle. Significant raveling of the south-facing scarp occurred during the extended period of rain that ended on May 13. A triangular-shaped colluvial wedge of the eroded debris from the scarp formed near its center, and was approximately two-thirds the height of the scarp by May 31. The additional weight from this colluvium likely further destabilized the slide. On May 31, additional fresh cracks were superimposed atop a healed crown crack likely associated with movement of the slide in 1983, about 10 feet upslope of the top of the scarp.

Figure 8. View of south-facing scarp along north edge of landslide on April 29, 2005. The upper part of the scarp is from movement of the slide in 1983. The lower nearly vertical part is from movement of the Sage Vista Lane landslide in 2005.

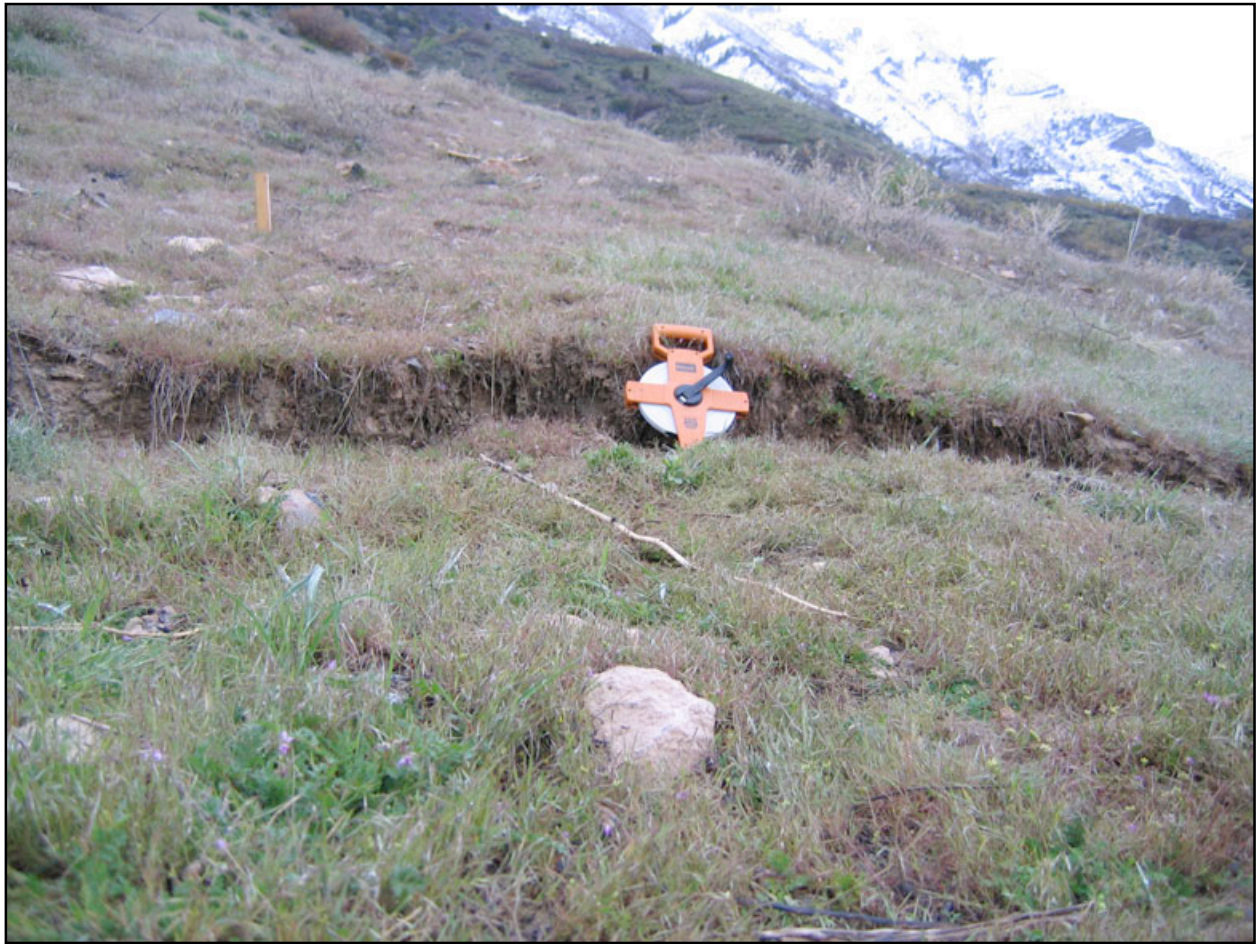
On April 29, two additional, small, fresh scarps existed upslope of the main landslide in the prehistoric landslide complex that defined the upslope extent of two separate active shallow slides (figure 3). The scarps occurred within or near areas that had been disturbed by exploratory excavations (test pits or trenches) and subsequently backfilled several years prior to the 2005 landslide. The scarps were several inches high and connected to flanking structures such as ground cracks. The lower of the two slides had an internal longitudinal crack in its upper part and a main scarp that was several inches high with a fissure at least 2.5 feet deep (figure 13). The lower extent of the two upper landslides was unclear due to the absence of well-defined toe or flanking structures. By May 5, the two scarps had joined together to form a continuous scarp zone, suggesting the two small landslides had joined into a single slide (figure 3).

Figure 13. View of main scarp of small landslide upslope of main slide on May 12, 2005. By May 5, 2005 another scarp connected this small slide to one farther upslope joining the two slides into a single shallow landslide.

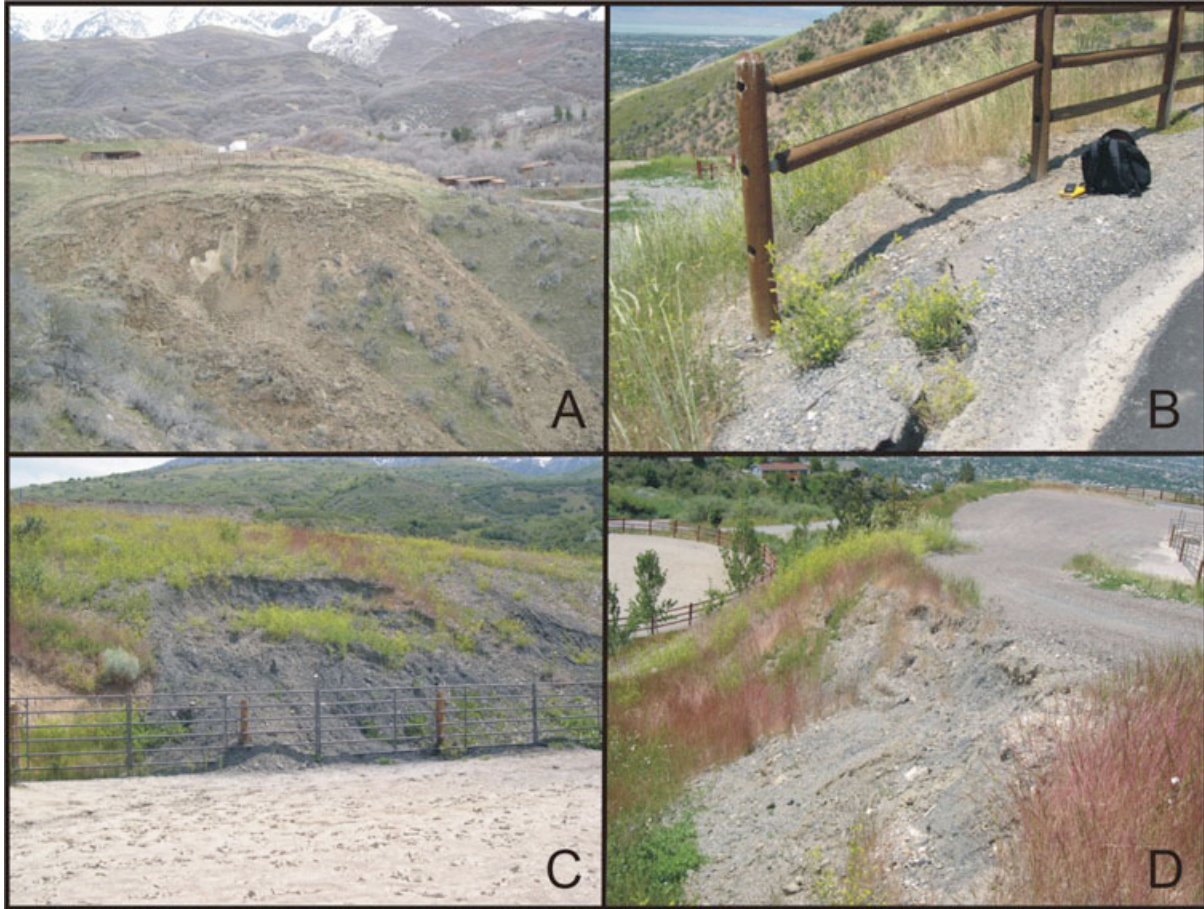
Figure 2. Landslides in 2005 on horse ranch east of East Lawn Memorial Hills Cemetery, Provo. (A) View to the east of north part of main landslide on March 17. (B) Minor offset on main scarp of small companion slide to main landslide southeast of tack shed that caused minor damage to fence. View is to the west. (C) View to the east of small landslide northeast of riding arena in highly weathered Manning Canyon Shale or debris derived from the shale. Movement direction is to the west-southwest. (D) View to the west-southwest of main scarp of small landslide east of barn. Movement direction is to the southeast. Photographs of small landslides (B, C, and D) taken on June 23.

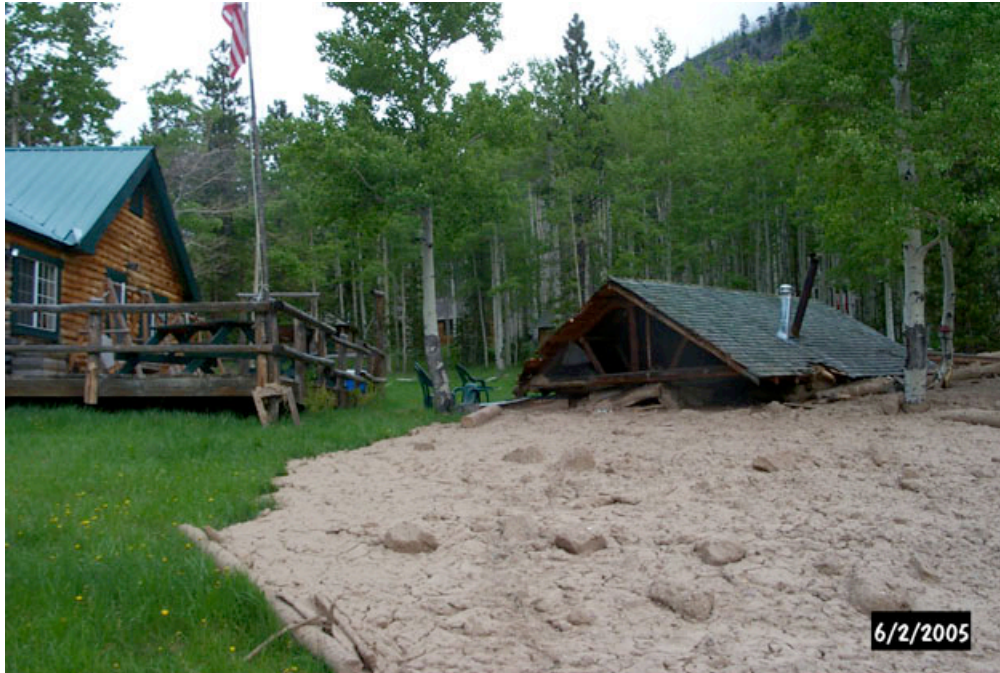
Figure 2. The roof of the Chepta cabin lies on the toe of the U-Bar Ranch debris-flow deposit. The cabin roof is approximately 180 feet downslope of the original cabin position. The U-Bar Ranch lodge (building with green metal roof) is left of the deposit. Photo by Dave Herron, U.S. Forest Service.

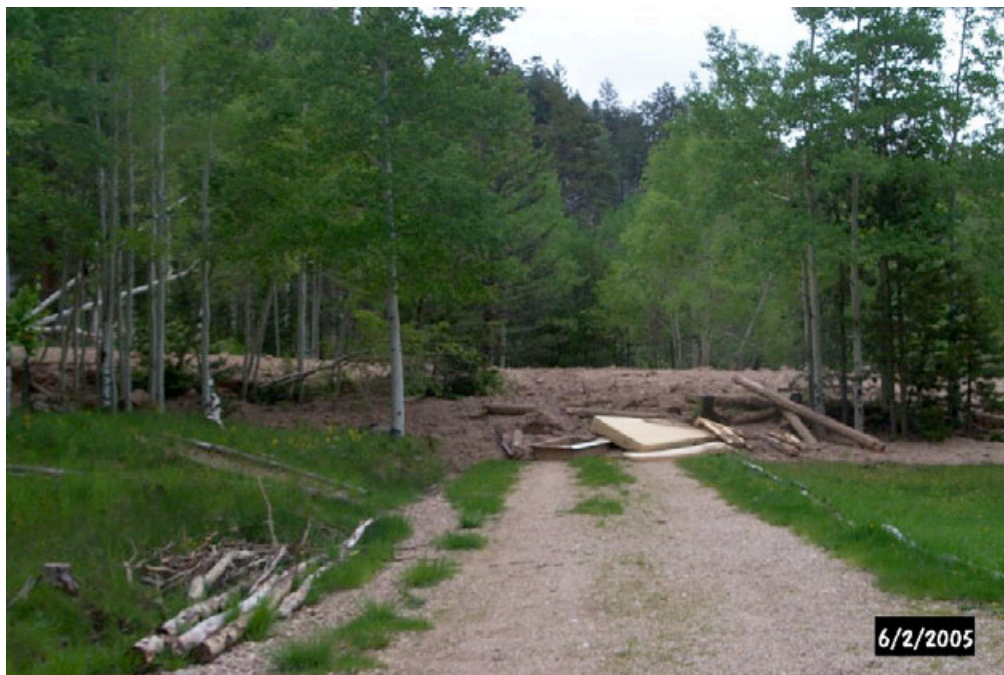
Figure 3. The U-Bar Ranch debris-flow deposit. The deposit is 4 to 5 feet thick and is blocking the access road into the ranch. The mattress and cut logs on the road are from the demolished Chepta log cabin. Photo by Dave Herron, U.S. Forest Service.
