TECHNICAL REPORTS FOR 2002–2009 GEOLOGIC HAZARDS PROGRAM

COMPILED BY ASHLEY H. ELLIOTT

Report of Investigation 269
Utah Geological Survey
a division of
Utah Department of Natural Resources
2010

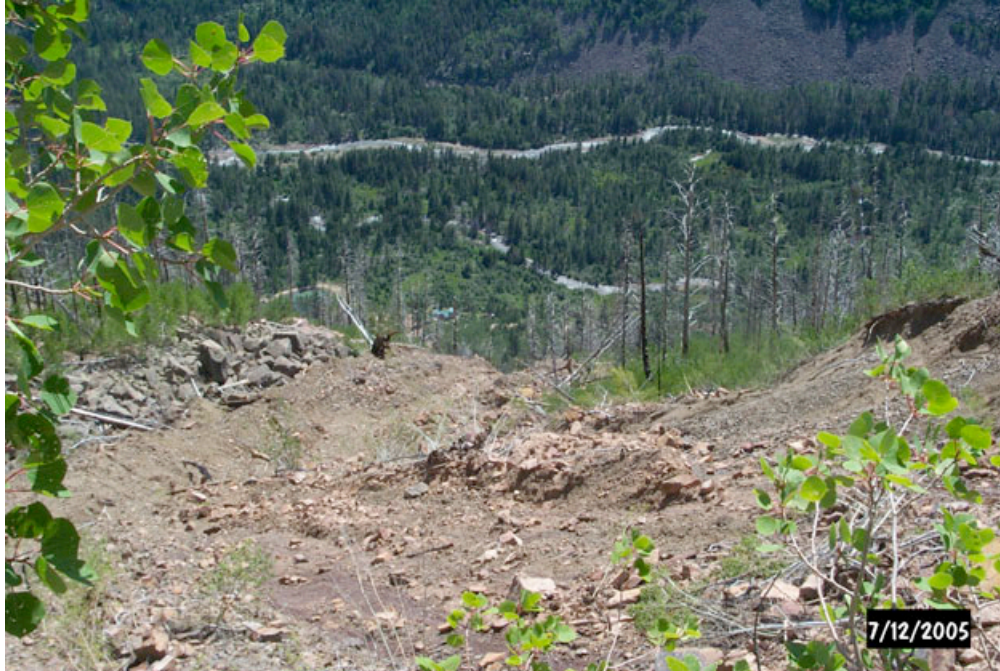
Figure 4. View looking west down the U-Bar Ranch debris slide toward the Uinta River, showing smaller slide blocks within the slide and weathered shale adjacent to the slide. The travel angle from the debris slide to ranch lodge (building with green roof in center of photo) is 27°. Photo by Dave Herron, U.S. Forest Service.

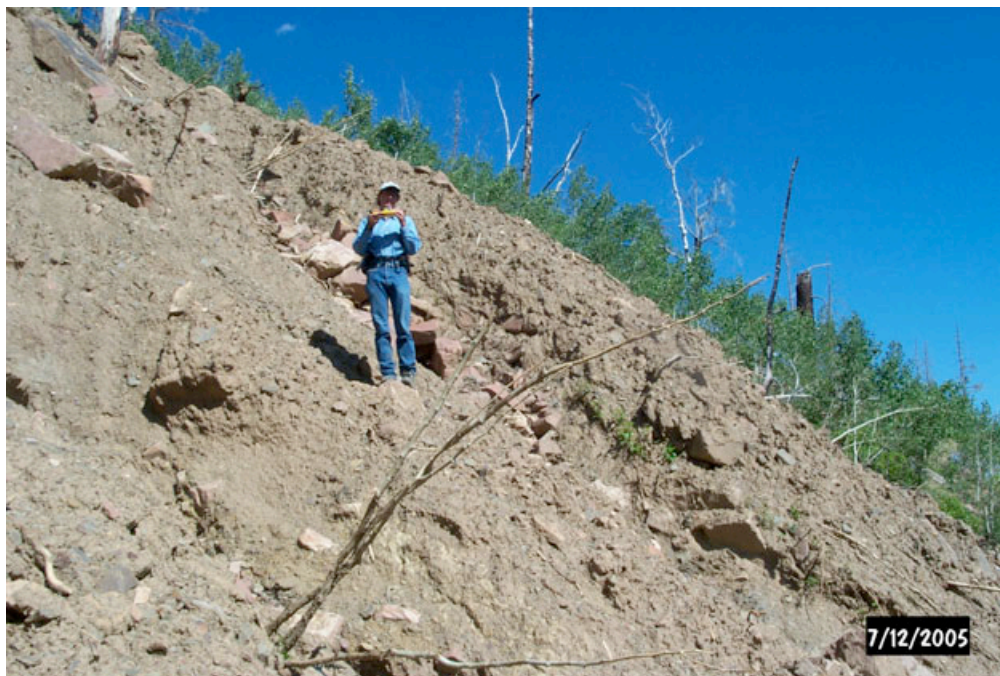
Figure 5. Left-bank channel levee of U-Bar Ranch debris flow at 8800 feet elevation. The levee is deposited on a 27-30° slope indicating a viscous phase of the debris flow. Photo by Dave Herron, U.S. Forest Service.

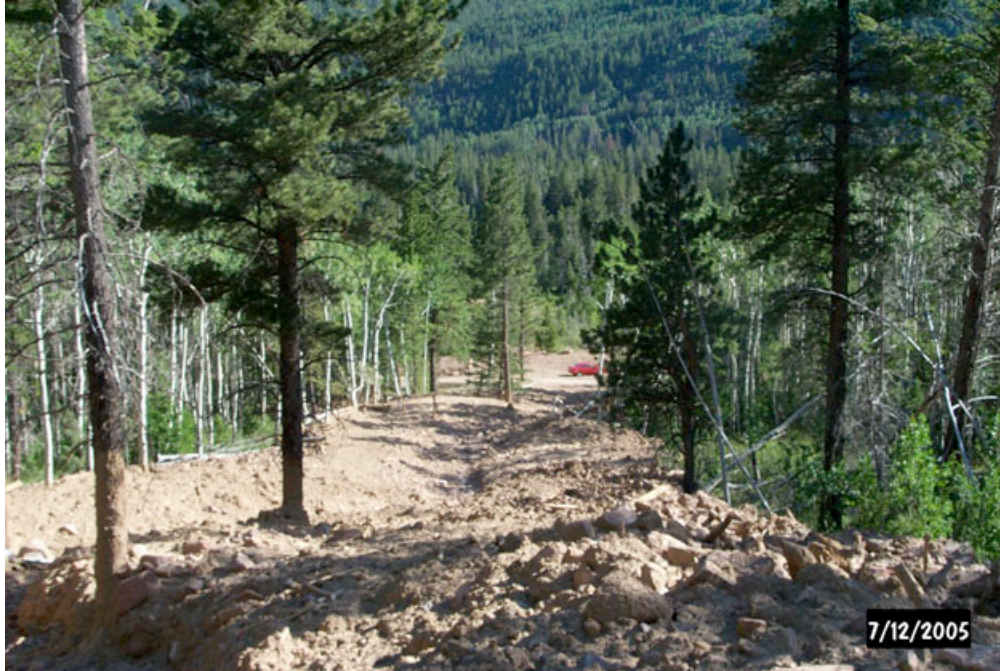
Figure 6. View looking west down the lower U-Bar Ranch flow path. Maximum flow depth shown by mud lines and boulder impact on tree trunks is 4 to 5 feet. The deposit toe is just beyond the red car. Photo by Dave Herron, U.S. Forest Service.

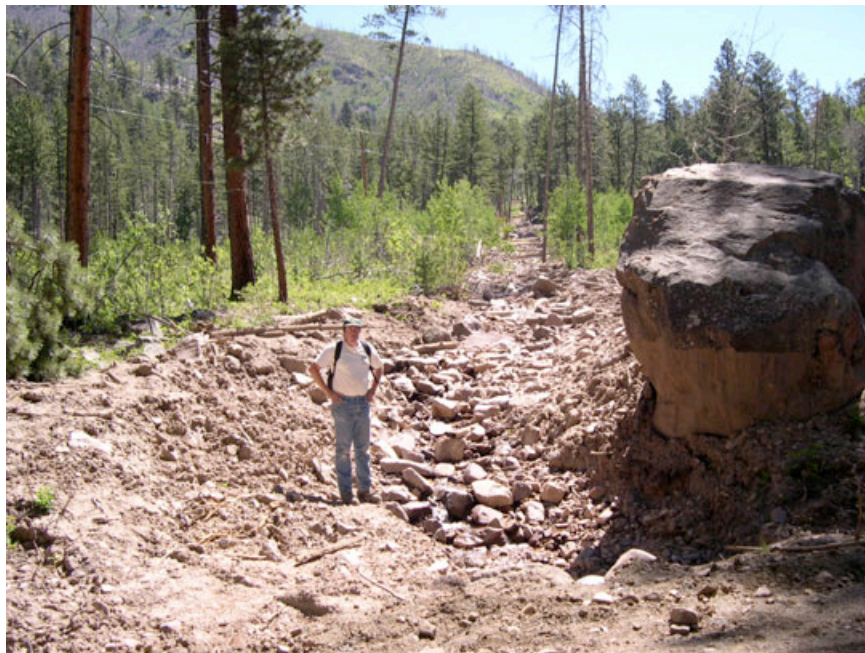
Figure 7. Looking up the alluvial-fan channel from Forest Service Road 118 and Wandin Campground. The Wandin Campground flow plugged the culvert at the bottom of the photo and flowed across the road into the campground. The mud line on the large boulder indicates a maximum flow depth of 3.8 feet. This large boulder indicates the size of boulders transported by previous debris flows.

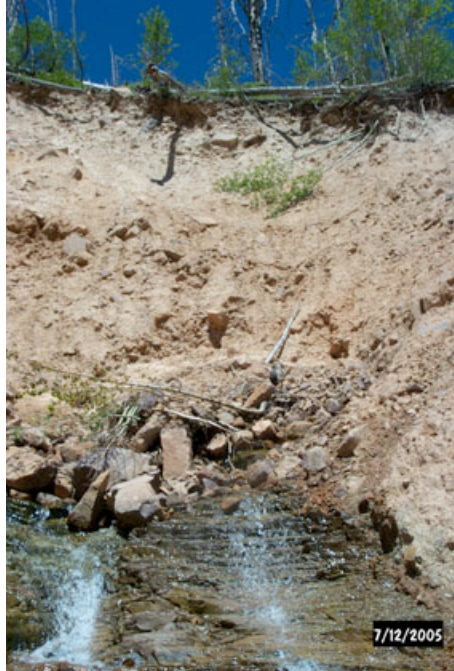
Figure 8. Wandin Campground debris-slide main scarp. The scarp is 20-25 feet high and exposes unconsolidated till and colluvium. A spring is flowing over shale bedrock in the lower part of the photo. Photo by Dave Herron, U.S. Forest Service.

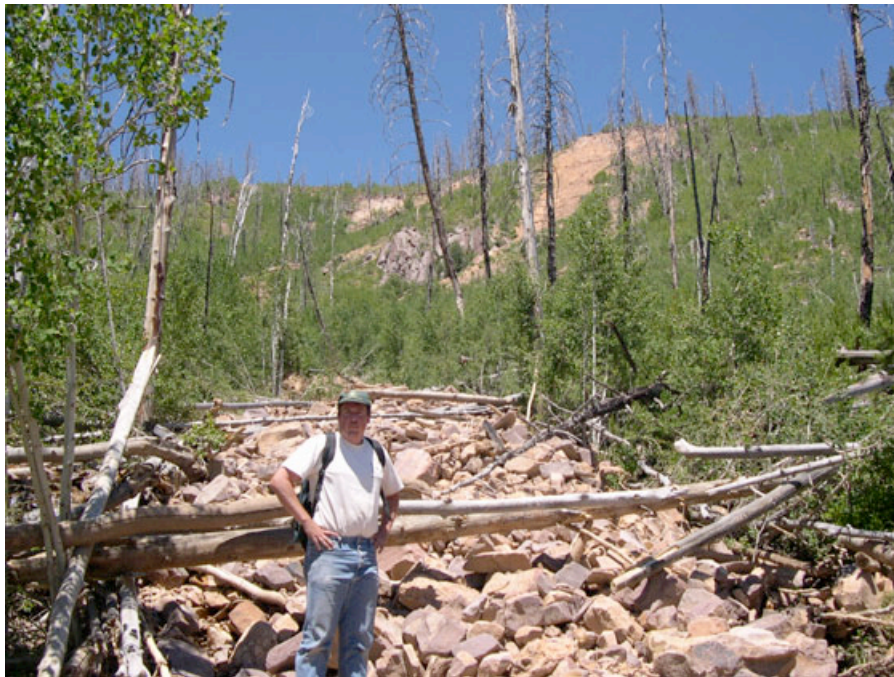
Figure 9. Wandin Campground debris-flow channel plug at 8880 feet elevation. The two light-colored areas without vegetation in the upper part of the photo are debris slides. The debris slide on the left is the source of the 2005 Wandin Campground debris flow. The debris slide on the right occurred between 1993 and 2004.

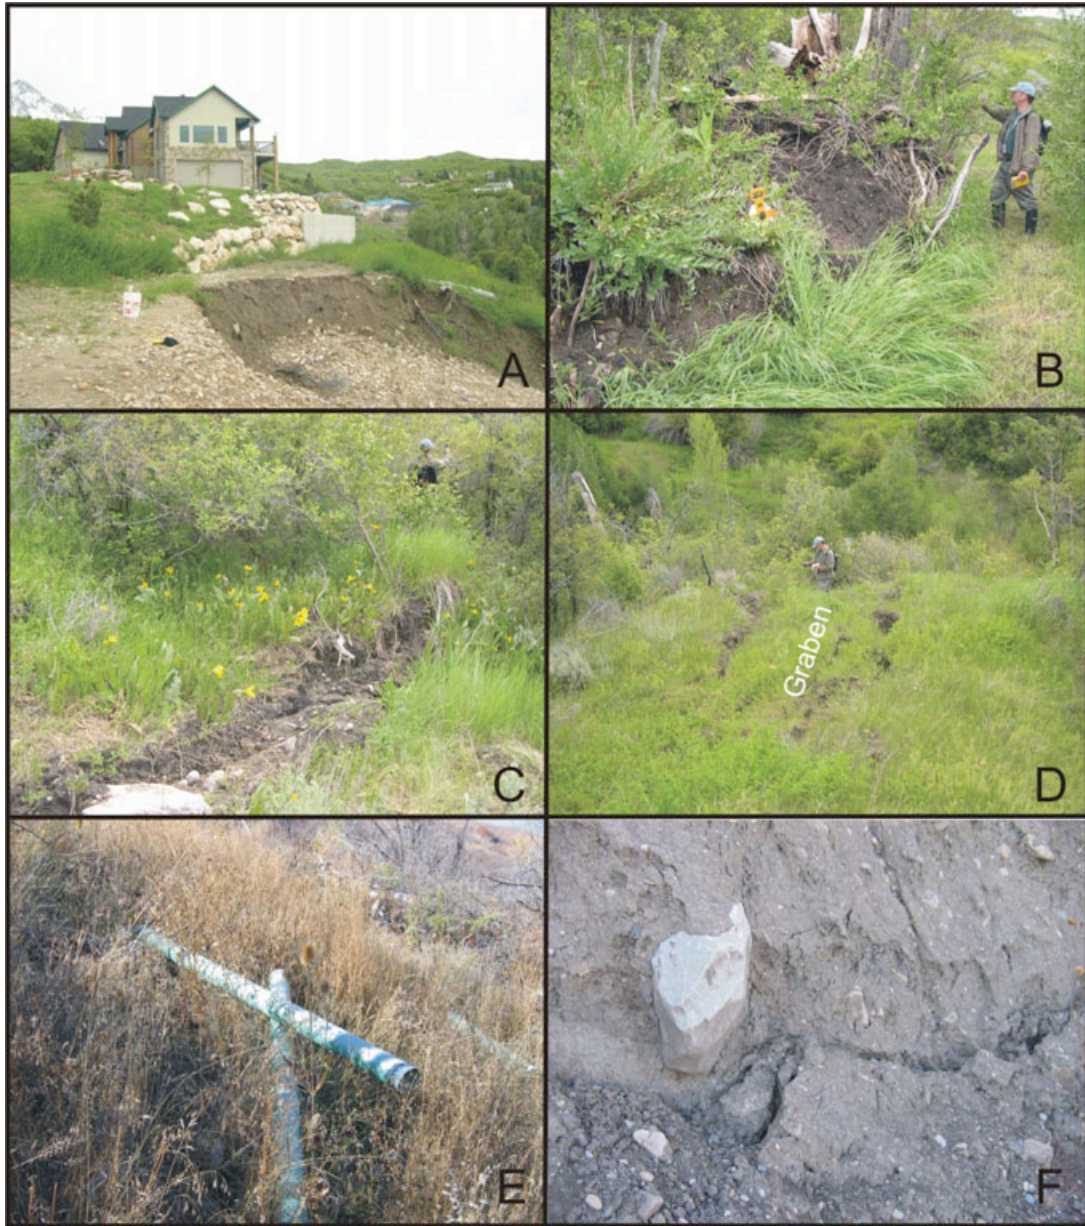
Figure 3. Southern Sewer-Line landslide. (A) View to the northwest of main scarp of the Southern Sewer Line landslide. Landsliding destroyed the eastern part of the sewer corridor embankment, but had not exposed the sewer pipe as of January 13, 2006. House at 6110 N. Creekside Drive visible in background. (B) View to the northwest of toe of the landslide. Lower toe thrust/fold is approximately 5 feet high. West edge of Gordon Creek (not visible just to the right of the edge of the photograph) was only 3.4 feet from toe on October 12, 2005. (C) View downslope of right-flank shear cutting across natural slope. (D) View downslope of east-trending graben in lower part of slide. (E) Broken drainpipe in lower part of slide. Upslope pipe displaced about 3.9 feet downslope. (F) Recent offset of main scarp on November 1, 2005, due to continued movement of slide in latter part of 2005.

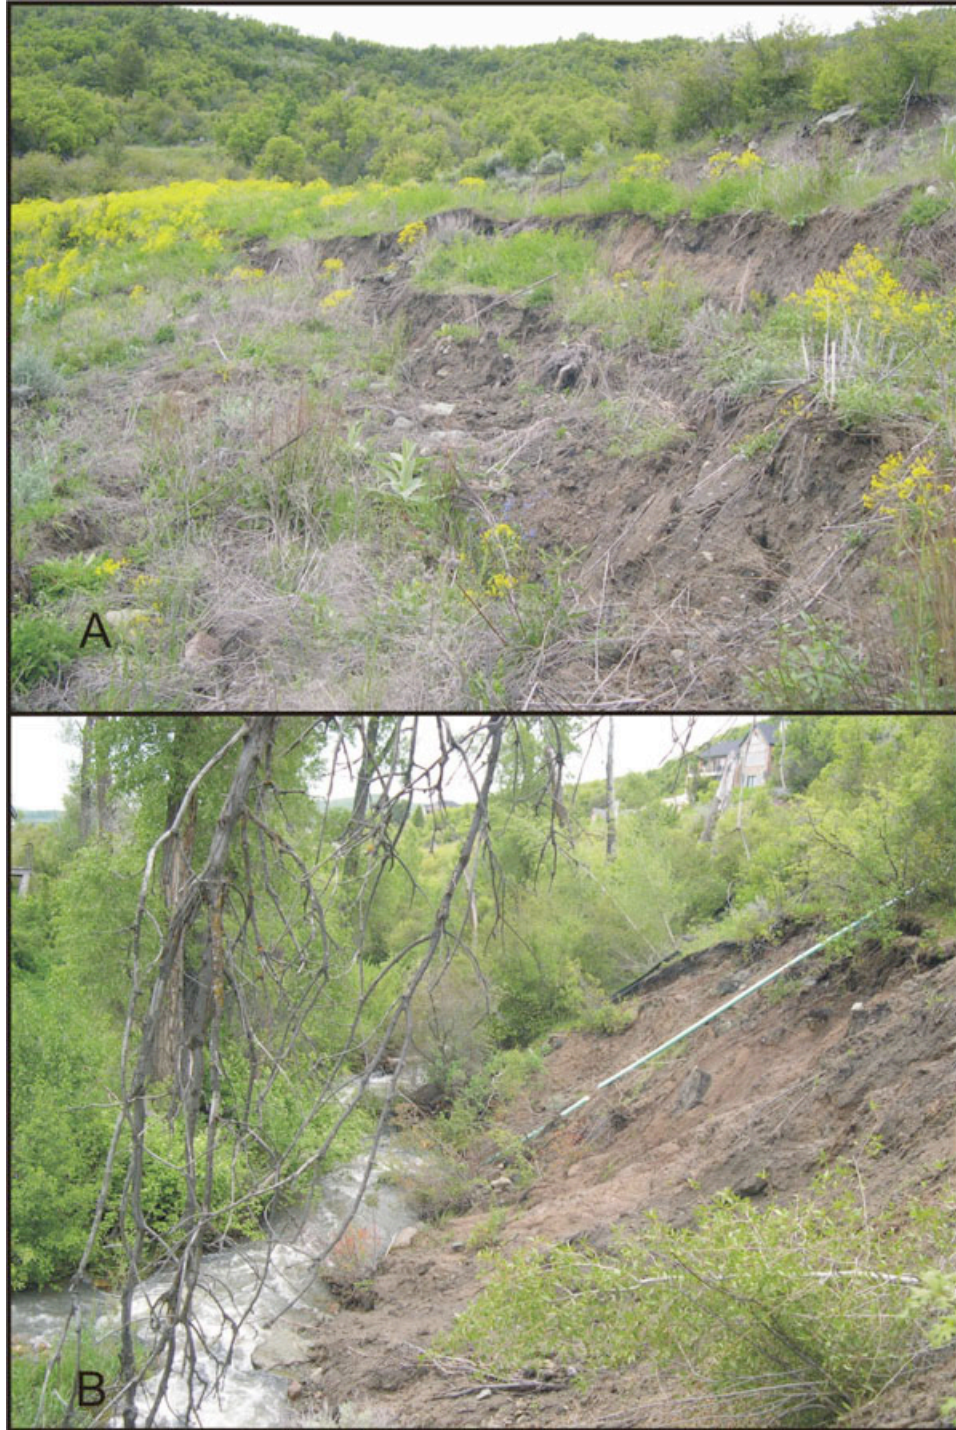
Figure 4. Northern Sewer-Line landslide. (A) View to the south-southwest of main scarp zone of the landslide. Top of main scarp was only a few feet from the east edge of the sewer-line corridor. (B) View to the south of toe of the landslide along Gordon Creek. Note drainpipe exposed along south flank of landslide.

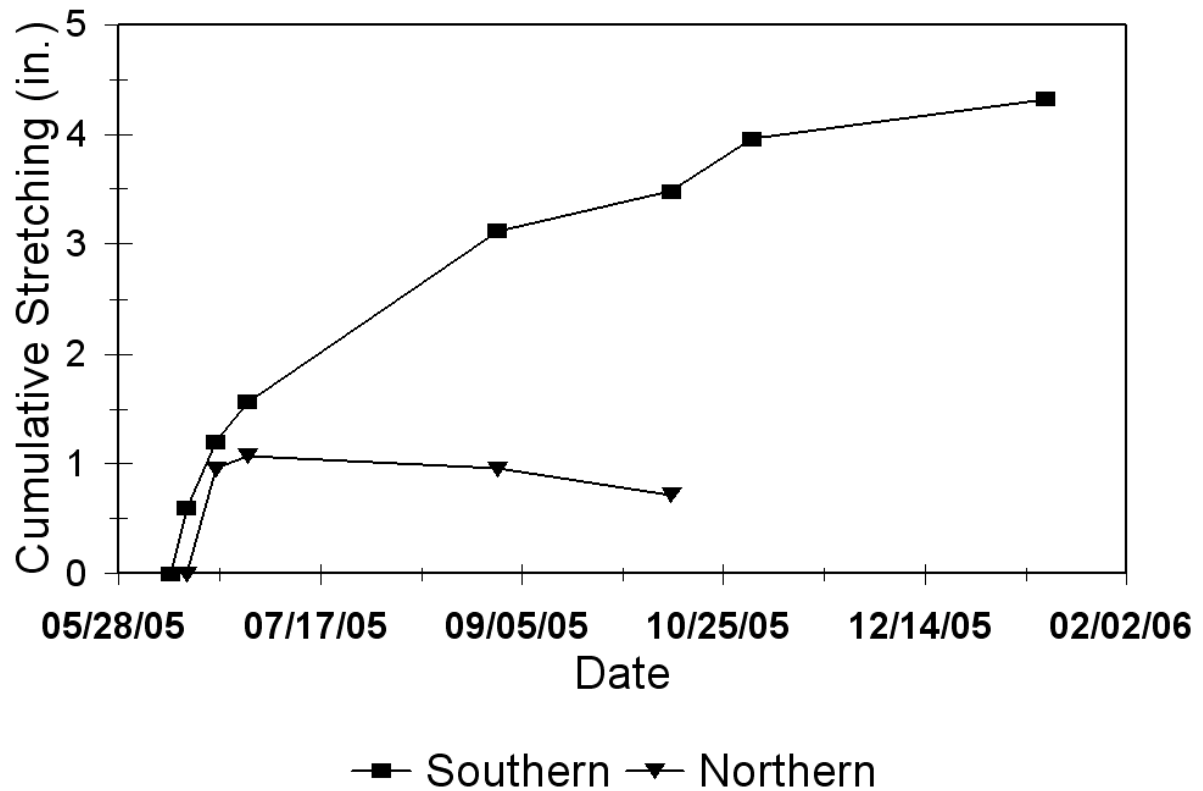
Figure 5. Landslide movement and ground deformation between June 10, 2005 and January 13, 2006. Plot shows continuous movement (stretching) at survey stake station across main scarp of the Southern Sewer-Line landslide (squares). The rate of movement slowed in late June, but movement continued at a relatively steady rate through January 13, 2006. At the Northern Sewer-Line landslide (triangles), movement continued through most of June, but likely suspended by the end of the month. Subsequent minor shortening across main scarp zone is likely due to collapse of extensional fissures separating soil blocks in zone.

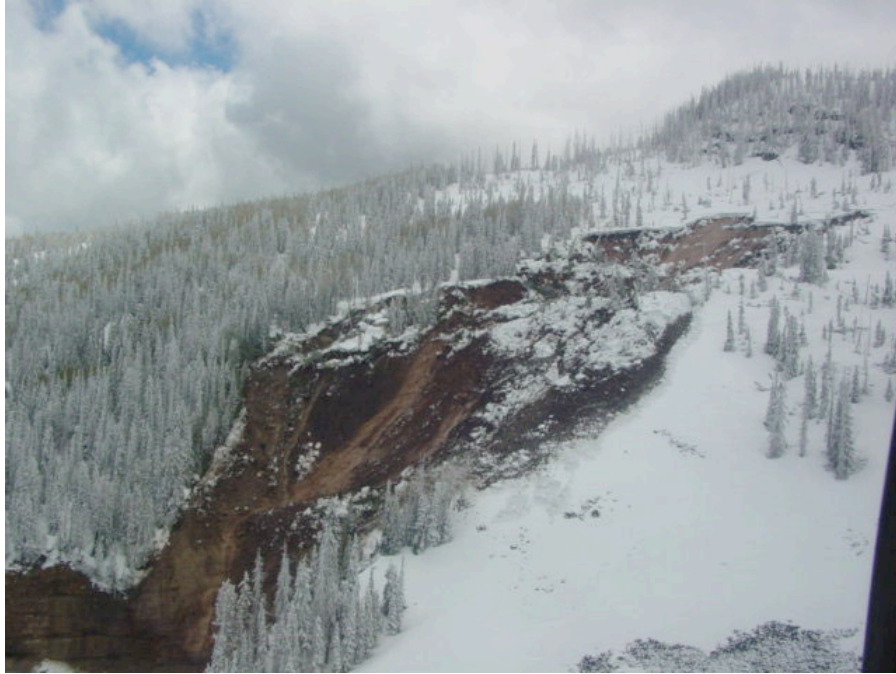
The upper landslide has a very rough surface and consists of clay-rich debris with angular cobbles and boulders of basalt and sandstone (figures 3, 7). Where exposed downslope from the main scarp of the upper landslide, the rupture surface beneath the upper part of the upper landslide is shallow and movement only involved the upper few vertical feet of slope (figure 7). The rupture surface dipped from 30 to 34°, and formed in weathered, soft, low strength, shale and mudstone. However the rupture surface becomes significantly deeper downslope, and we estimate it was 40 to 50 feet deep where the lower landslide catastrophically failed into the mountain channel (figures 5 and 6). Timber harvest and subsequent loss of root strength likely had little influence on landslide stability because of the deep rupture surface. Several springs were present in the evacuated area and were discharging from the exposed rupture surface.

Aerial photos and field observations indicate an approximate 3-foot-thick snowpack remained on Black Mountain on June 3, 2005 (figure 3). The remaining snowpack indicates that only partial snowpack melting was sufficient to trigger landslide movement. A rapid rate of snowmelt over several days may be a more critical parameter in triggering landslides than the total volume of snow melted and water added. Melting of an above average snowpack in 1983 triggered numerous landslides in Utah, and Wieczorek and others (1989) observed that most of those landslides triggered during the most rapid period of snowmelt.

Figure 3. The remaining upper landslide on the north side of Black Mountain. The upper landslide is perched above the narrow mountain channel (figure 4) that is out of view and below the photo. Photo taken on June 3, 2005, by Lt. David Excel, Utah Highway Patrol.

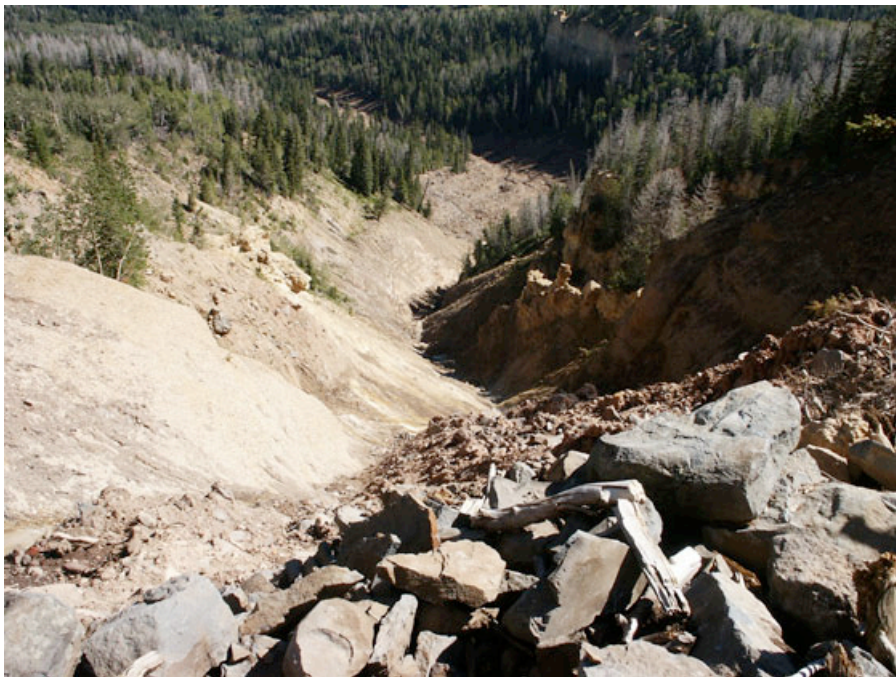
Figure 4. View down the steep, narrow mountain channel. The lower part of the landslide released into the channel and was transformed into a rapidly moving debris flow. Part of the debris-flow path is evident below the channel.

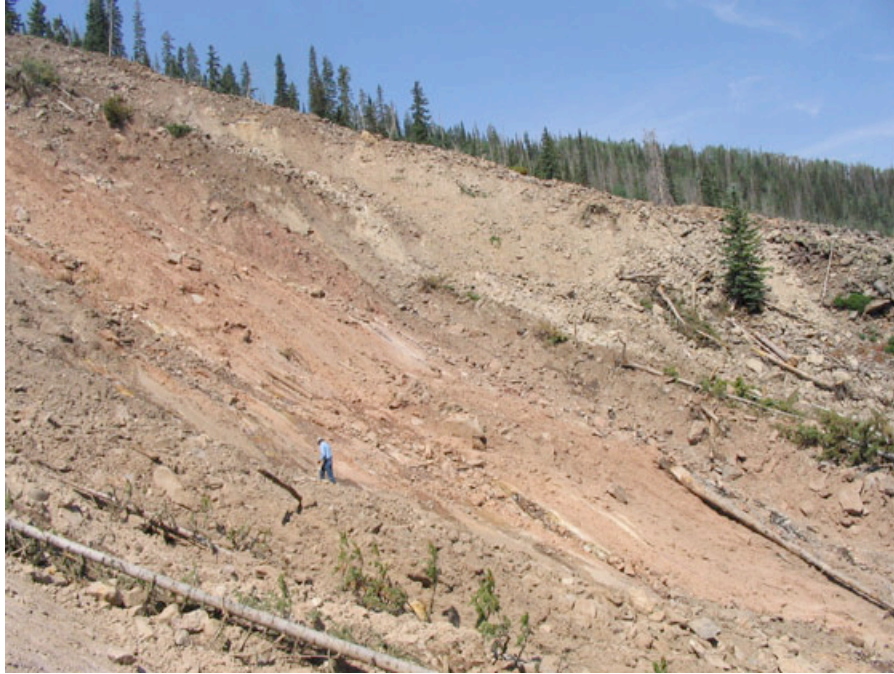
Figure 5. View west into the evacuated area of the lower landslide. The estimated evacuated volume is 50,000 to 60,000 yd³. The landslide left flank (upper part of photo) exposes basalt talus. The reddish colored material is weathered shale and mudstone and is the landslide rupture surface.

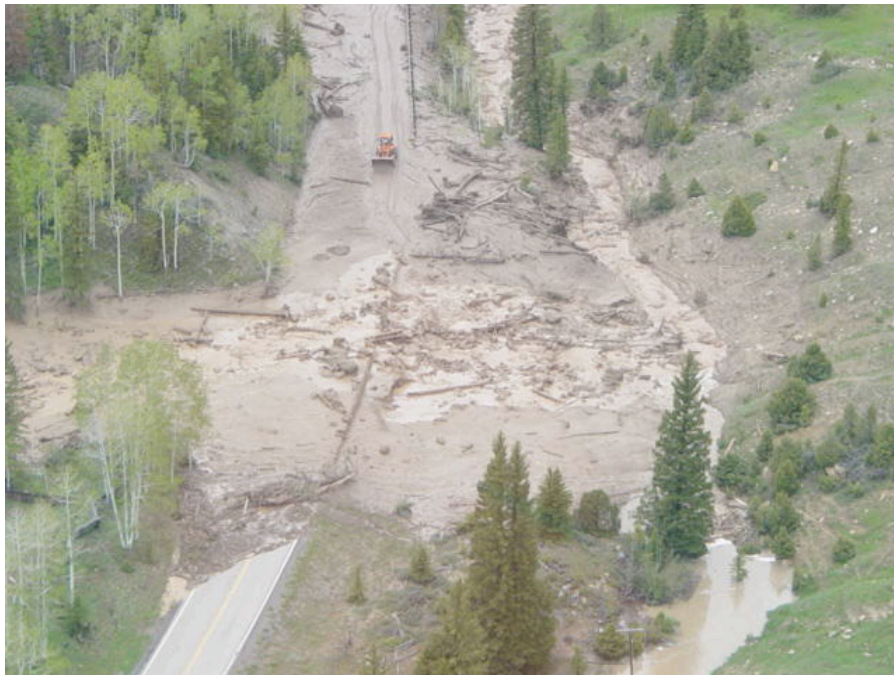
The major structure at risk from future debris flows originating on the north side of Black Mountain is SR-14, which is subject to culvert blockage, overtopping, erosion, and sediment burial. The unnamed stream valley above SR-14 is presently undeveloped, and building structures in the bottom of the valley is not recommended unless the debris-flow hazard is reduced to an acceptable level. Downstream from the unnamed drainage, potential impacts along Crow Creek and Cedar Canyon include further erosion and damage to SR-14, blocked

Figure 8. View northwest of SR-14 blocked by sediment from the Black Mountain debris flow. Crow Creek is on the right. Photo taken on June 3, 2005, by Lt. David Excel, Utah Highway Patrol.

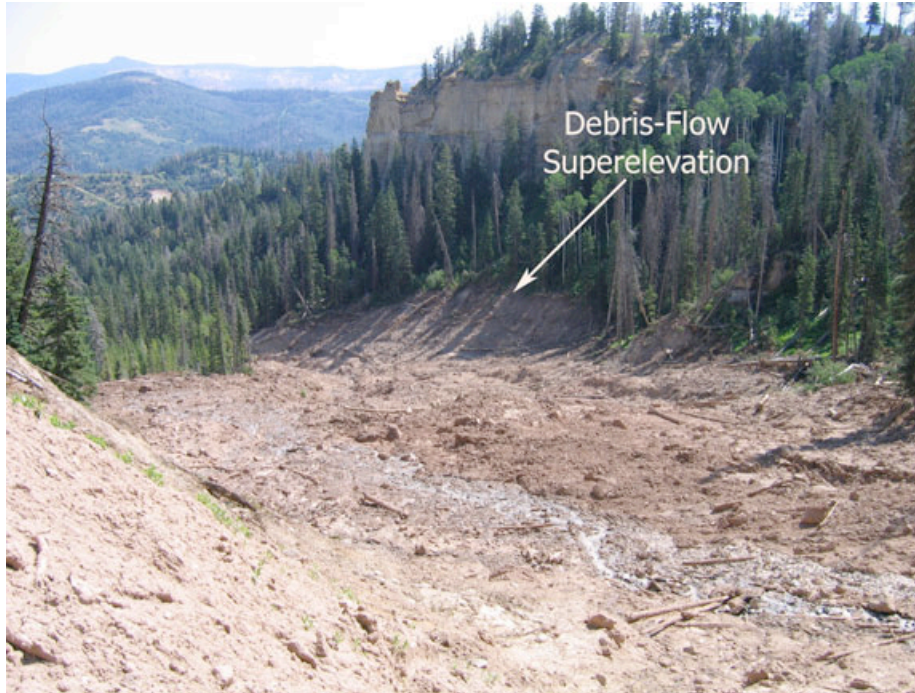
The upper valley debris-flow deposit below the mountain channel is up to 550 feet wide and locally up to 10 feet thick (figure 9). Below an elevation of 8800 feet the deposit narrows and from 8440 to 8400 feet elevation a small lobe of material was deposited along the west edge of the valley (figure 2). The upper valley deposit has an average slope of 16% (9°), an estimated volume of 55,000 yd³, and covers an area of 13.7 acres. The deposit thins downvalley and is only 1 to 2 feet thick immediately upstream from the lower valley deposit. The largest observed boulder in the deposit is 22 feet long (figure 10). The drainage channel along the upper deposit

Along the upper-valley deposit margins, the debris flow removed mature, similar-aged conifer trees, and left distinct tree trim lines (figures 9, 10, 11). Based on their size, these trees were a minimum of 100 years old and likely were older (Burrows and Burrows, 1976), which suggests that a minimum of 100 years has passed since the last large debris flow in this drainage. We observed pre-2005 debris-flow deposits at an elevation of 8800 feet along the west margin of the 2005 deposit. Relatively young conifer trees 4 to 5 inches in diameter are growing on this deposit, which suggests that the deposit is relatively young and possibly related to a small-volume historical debris flow. On aerial photos, we observed young debris-flow deposits immediately below the steep, narrow mountain channel. These small-volume deposits likely represent relatively high frequency, low-volume flows that occur more frequently than large-volume flows.

Figure 9. Northeast view down the upper stream valley at the debris-flow deposit below the narrow mountain channel. The debris flow had sufficient velocity to superelevate up onto the valley side below the sandstone cliff.

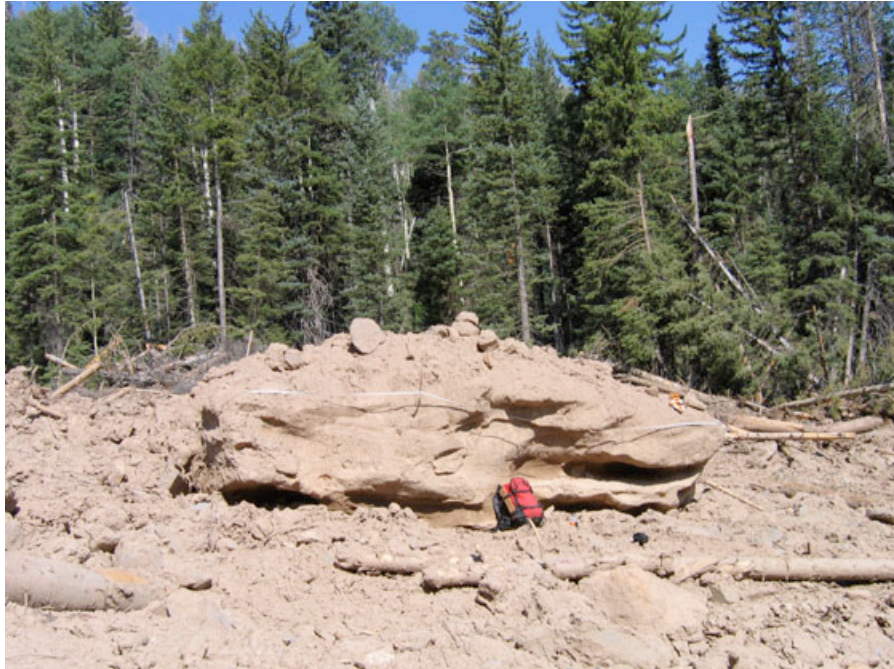
Figure 10. Large boulder transported by the debris flow now part of the upper valley deposit. The boulder measures 22 feet long, 9.5 feet wide, and 6.5 feet high. The tree trim line is evident in the background.

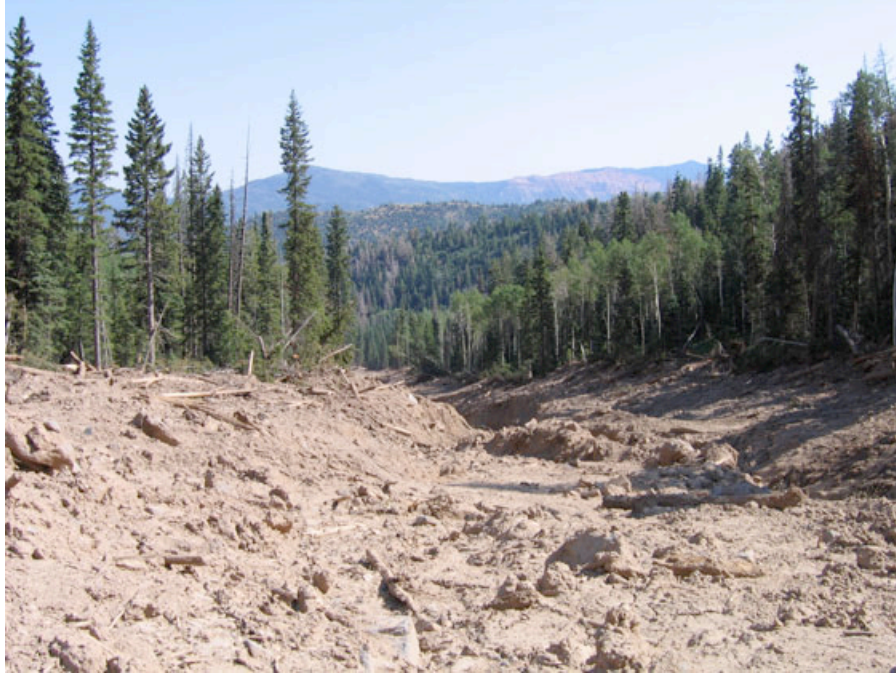
Figure 11. Upper valley debris-flow deposit showing the rough, wide, and thick deposit and distinct tree trim lines along the deposit flanks.

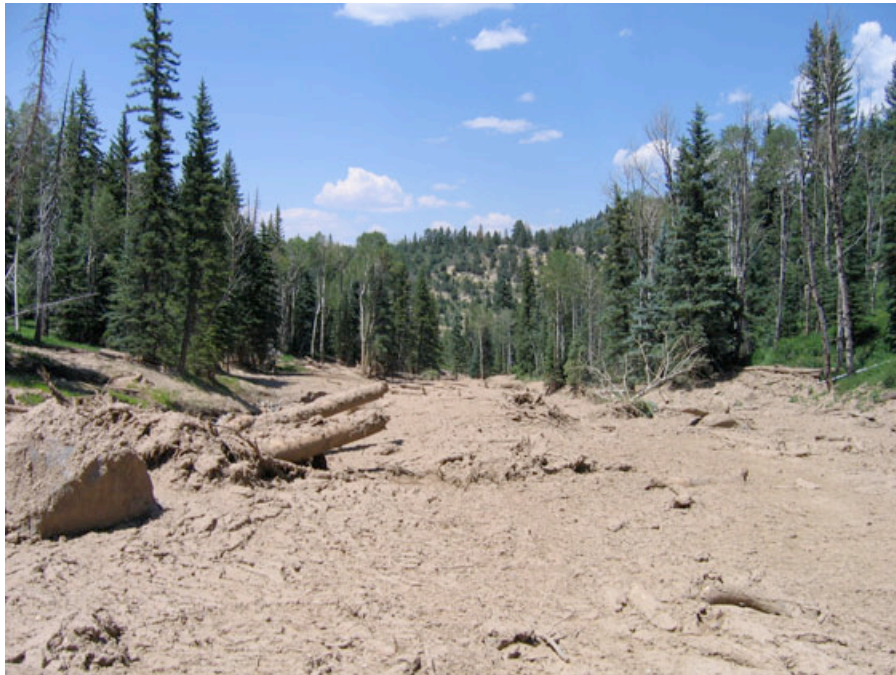
The break between the upper and lower valley deposits is at an elevation of 8360 feet (figure 2). Compared to the upper valley deposit, the lower valley deposit is narrower, thinner, smoother, and lacks the demolished forest and tree trim lines (figure 12). The drainage channel was locally scoured up to 3 feet deep, but erosion from the lower valley did not add a significant volume of material to the debris flow. The lower valley deposit is generally 1 to 2 feet thick, has an average slope of 9% (5°), an estimated volume of 18,000 yd³, and area of 12.9 acres.

Figure 12. Lower valley deposit showing the relatively smooth, narrow, thin deposit compared to the upper valley deposit.

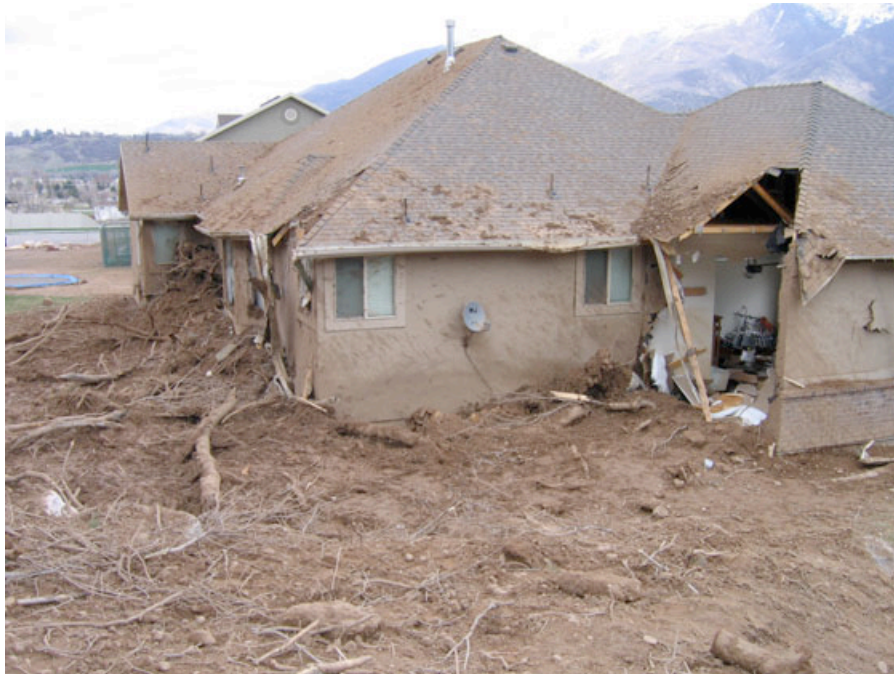
The landslide occurred around 9:30 p.m. on the evening of April 9, 2006. It flowed over and damaged the Davis-Weber Canal at the base of the slope, and impacted the back of the house at 1650 East 7687 South below the canal (figures 3 and 4). The landslide caused significant damage to the house, injured a child inside the house, and prompted evacuation of nearby houses. The purpose of our investigation was to determine the cause of the landslide, document physical characteristics of the landslide, and evaluate the remaining landslide hazard to aid South Weber City in determining when to allow evacuated residents to return and in assessing the long-term risk to development at the base of the bluff.

Figure 4. Damage to the house and garage at 1650 East 7687 South.

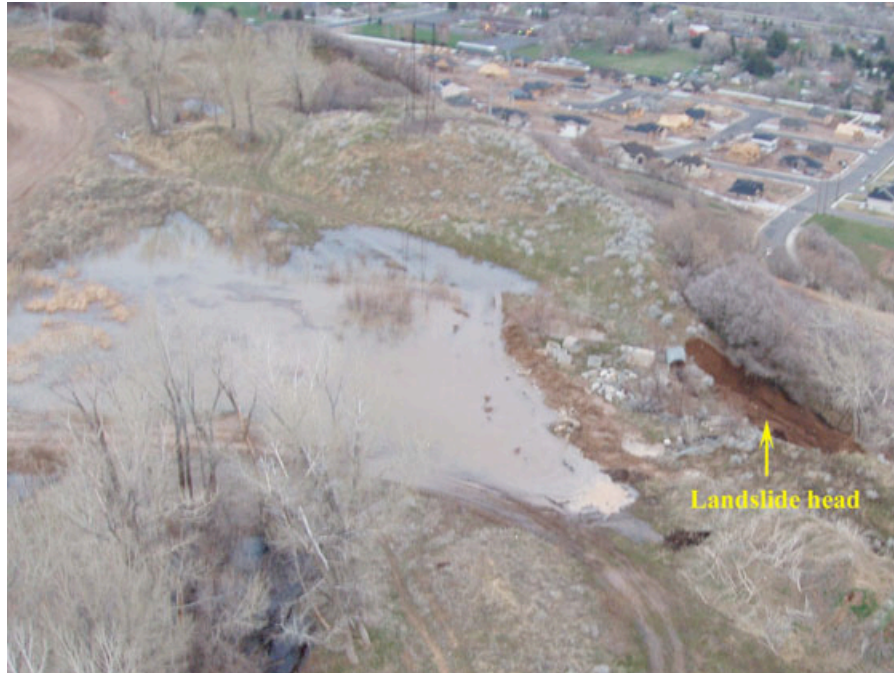
Figure 5. View looking northwest at the pond in the gravel pit and the landslide head (arrow). A berm was placed between the pond and the landslide to prevent water from flowing onto the landslide. Photo taken on the morning of April 10, 2005, by Davis County Sheriff's Office personnel.

the pond (figure 5) also indicate the presence of perennial shallow ground water since surface-water runoff alone would not sustain this vegetation. Cottonwood trees growing along the slope crest also indicate shallow ground water (figure 6). Following the landslide, a soil berm was placed between the pond and the landslide to prevent pond water from flowing onto the landslide head (figure 5).

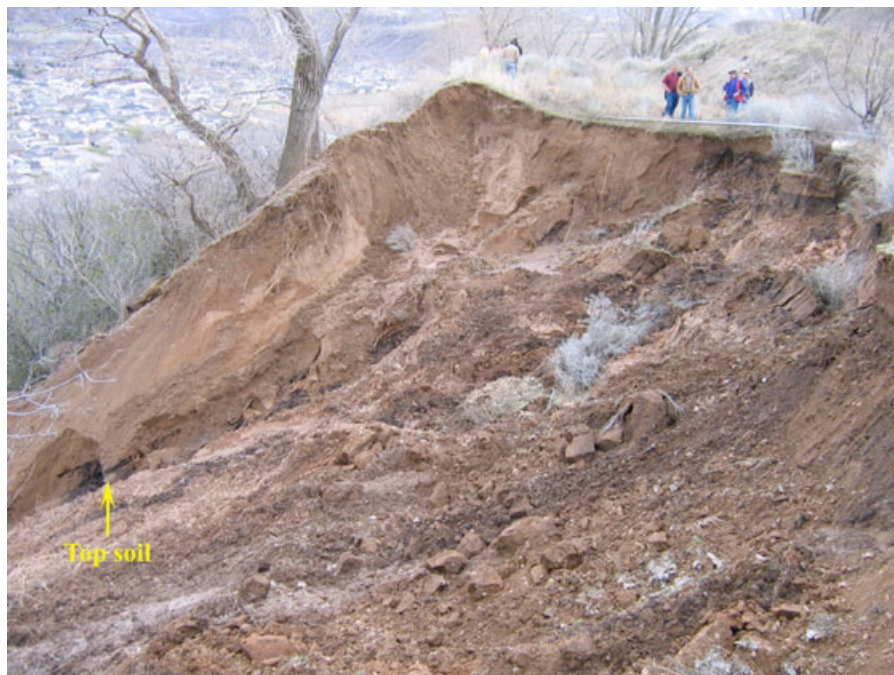
Figure 6. View to the southeast showing landslide main scarp and fill placed on the upper slope. Near the left edge of the photo, black top soil at the base of the scarp (arrow) underlying the brown fill is evident and indicates the original slope surface.

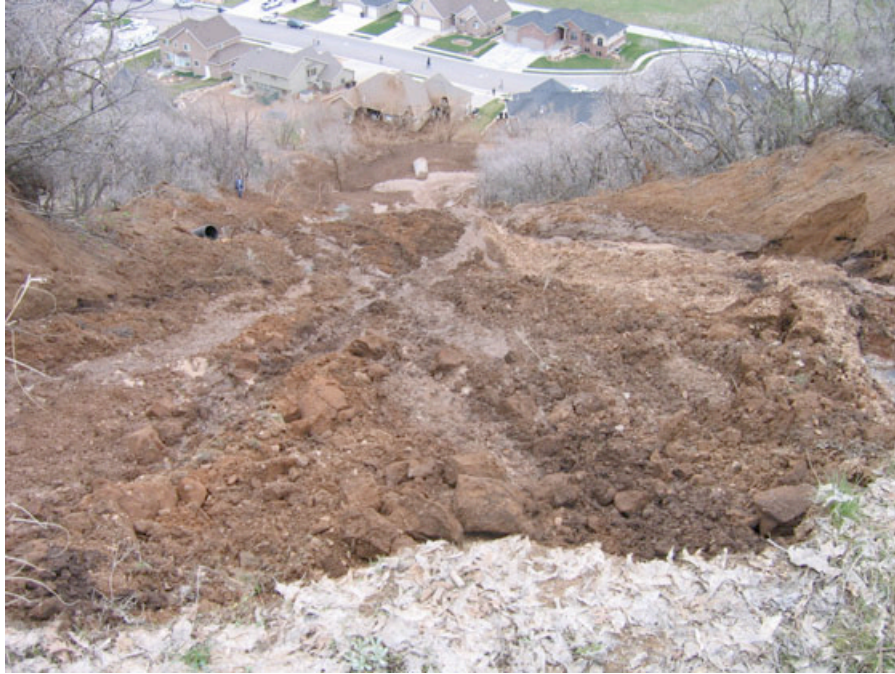
The 1650 East landslide was a rapid earth flow that started as a slide at the slope crest adjacent to a pond in a gravel pit (figures 2 and 5). The landslide main scarp extends a short distance back from the slope crest onto flat ground toward the pond in the gravel pit. The landslide is mostly a failure of fill pushed out of the gravel pit onto the upper slope to form a berm along the slope crest (figure 6). The landslide also involved native materials underlying and downslope of the fill. The slide at the crest mobilized into a flow that accelerated rapidly downslope, removing trees and crossing dirt roads, the canal, and a rock wall at the back of the lot before impacting the house at 7687 South 1650 East (figures 2 and 7). The landslide impact

Figure 7. View looking down the landslide flow path at the damaged house at 1650 East 7687 South. The culvert in the lower slide path above the house was originally in the gravel pit. Subsequent water flow eroded the right side of the landslide.

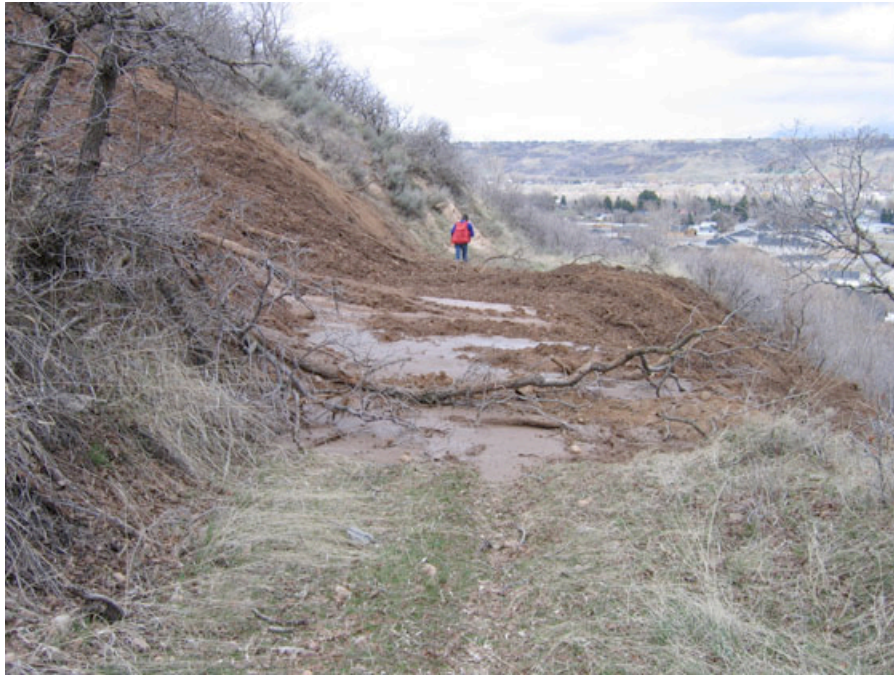
Figure 10. *Landslide material deposited on a dirt road midslope above the Davis-Weber Canal.*

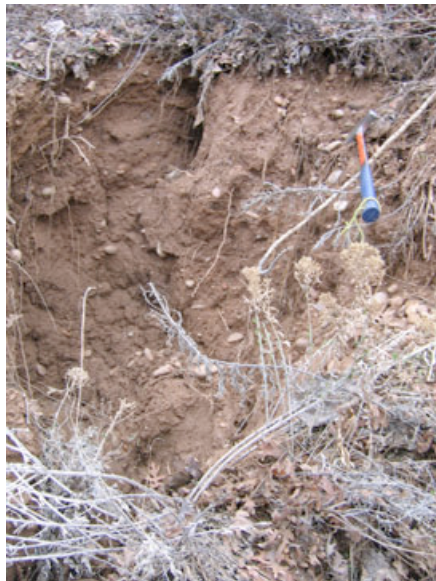
Figure 11. Piping holes in the upper slope near the landslide flanks. (a) Small piping hole near the landslide right flank. (b) Large piping hole adjacent to the landslide left flank.

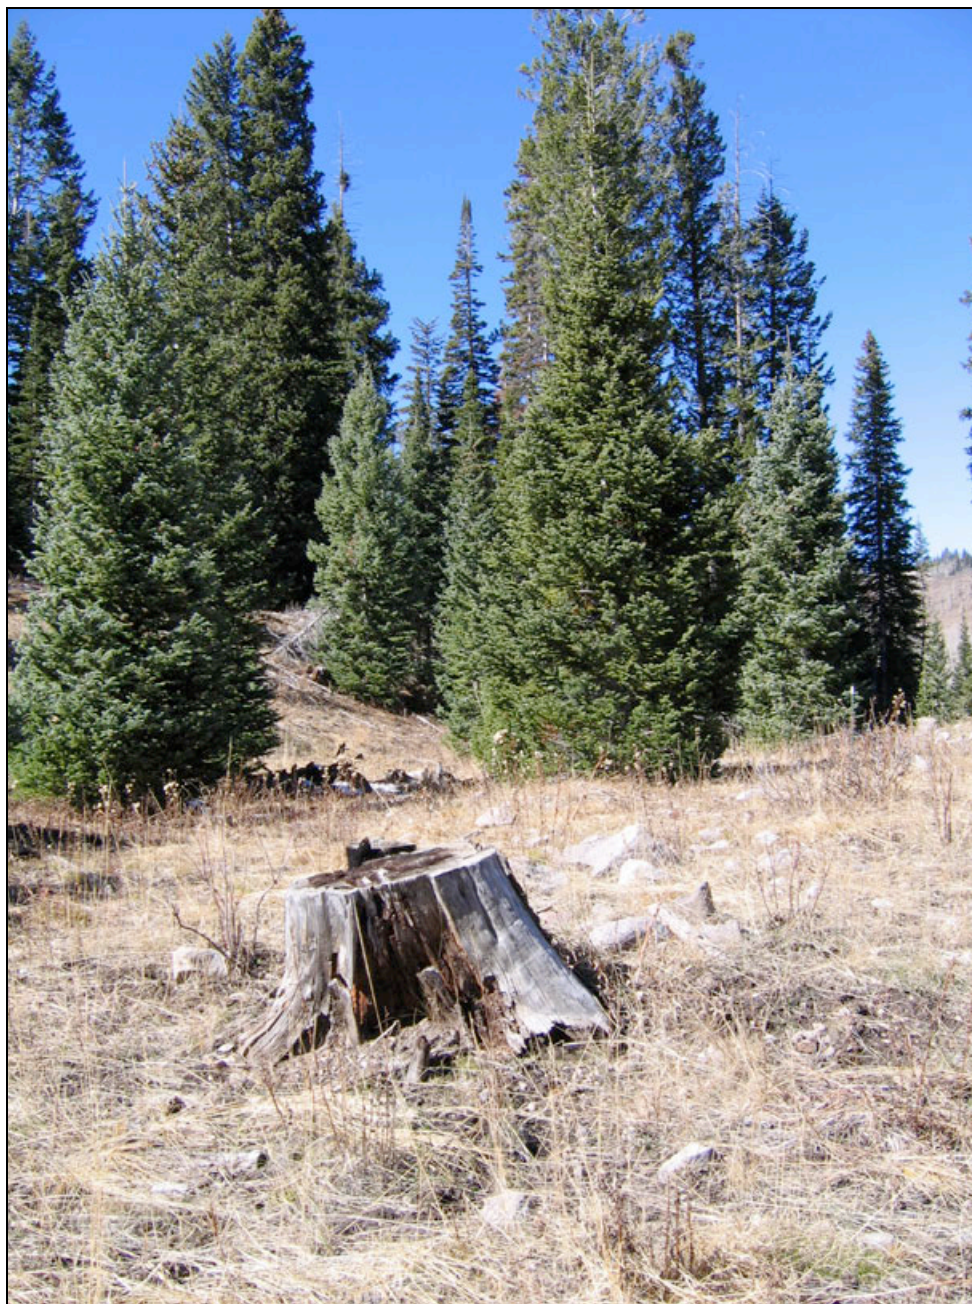
Figure 2. View toward the west of back-tilted surface in upper part of landslide. Note that whereas the living trees are vertical, the tree stump is tilted, suggesting back-tilting occurred during lifetime of tree.

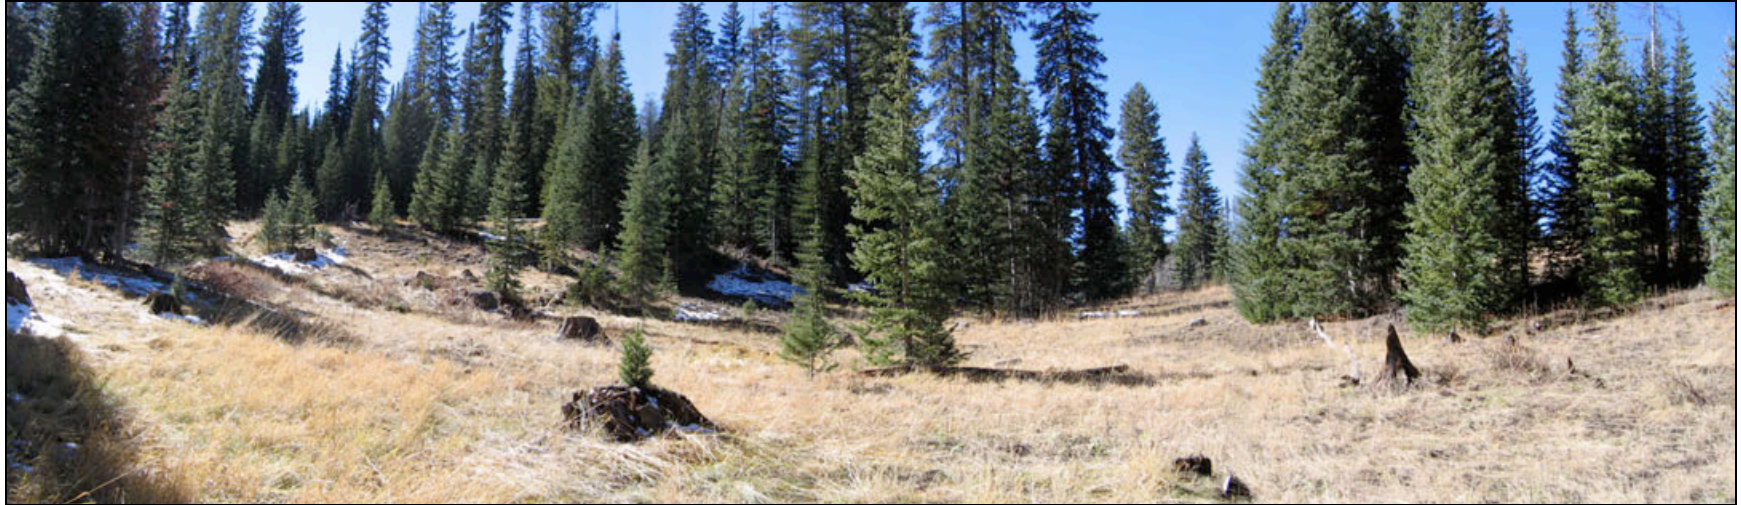
Figure 3. View toward the west from right flank of landslide showing back-tilted surface (right) at right step in right-flank shear zone. Note that the tree stumps are tilted, but the living trees are vertical.

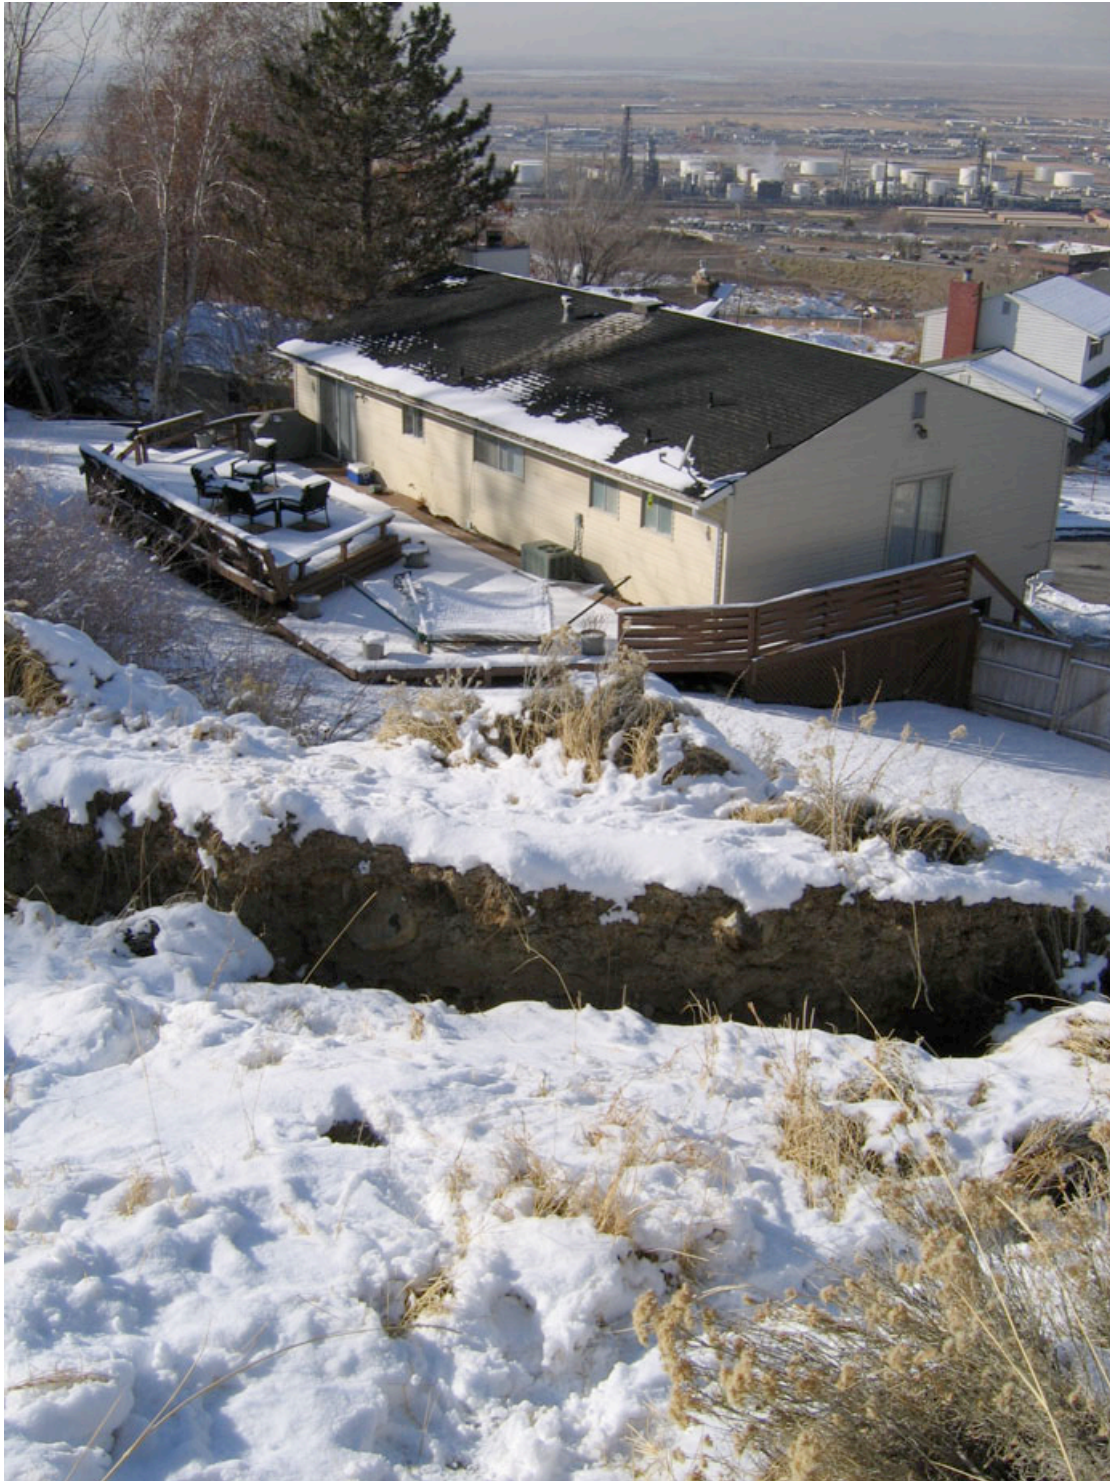
Figure 7. View downslope and to the west of lowermost antithetic (uphill-facing) scarp in the main scarp zone. Photograph taken in December 2008.
