TECHNICAL REPORTS FOR 2002–2009 GEOLOGIC HAZARDS PROGRAM

COMPILED BY ASHLEY H. ELLIOTT

Report of Investigation 269
Utah Geological Survey
a division of
Utah Department of Natural Resources
2010

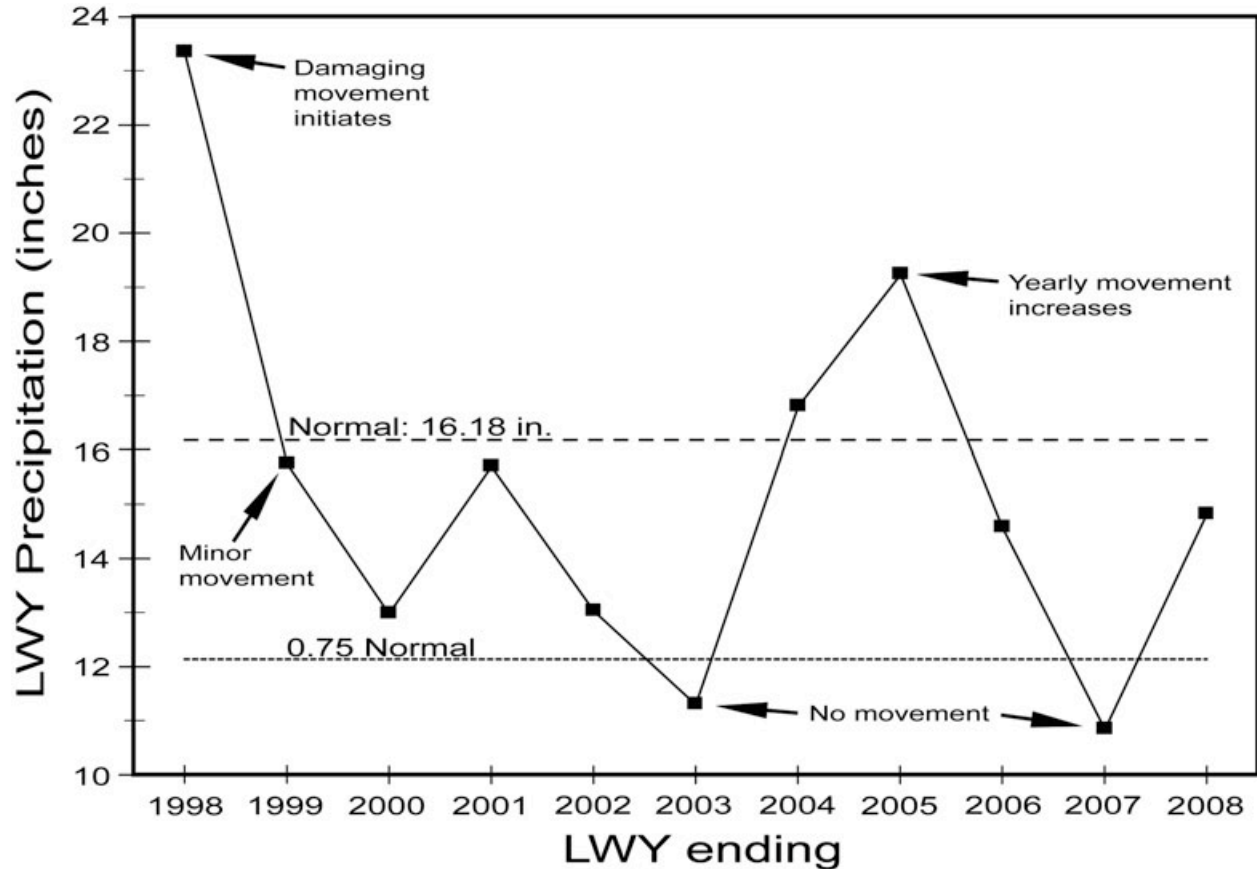
Figure 8. Salt Lake City precipitation for landslide water years (LWY) ending between 1998 and 2008 annotated with movement history of the Springhill landslide. Damaging movement initiated in 1998 during the second-wettest LWY on record dating back to 1875 in Salt Lake City. Minor movement of landslide occurred during drier-than-normal period between 1999 and 2002. By 2003, movement may have suspended during exceptional dry conditions (LWY precipitation was less than 75 percent of normal). Damaging movement started again in 2005 during the second-wettest LWY in the measurement period. Beginning in 2005, annual movement amounts reached 4 inches (10 cm) or more. Despite drier-than-normal conditions in the following years, movement continued and annual movement amounts increased, except in exceptionally dry 2007. Annual movement amounts reached as high as 9 inches (23 cm) by 2008. LWY precipitation data compiled from provisional data in monthly National Weather Service climatological reports. Normal precipitation for Salt Lake City from Ashland (2003).

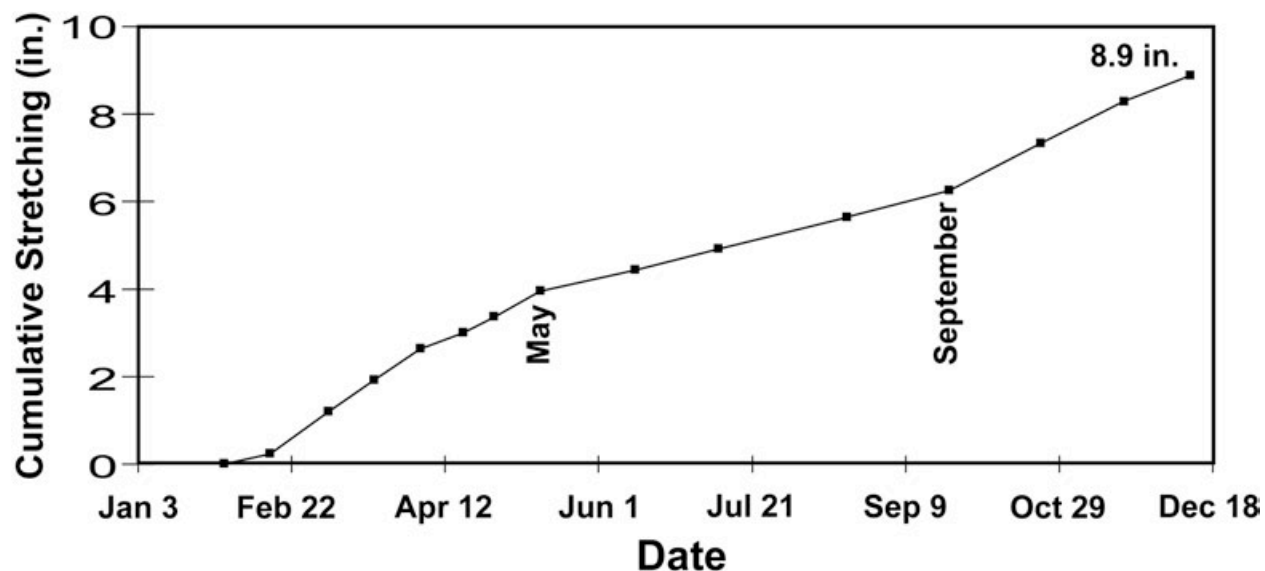
Figure 9. Cumulative stretching across main scarp zone in 2008. Total stretching was about 8.9 inches (23 cm). Changes in the rate of movement occurred in May and September, separated by periods during which movement occurred at a nearly constant rate. A gradual increase in the rate of movement also occurred in early February. Ground deformation measurements were taken between January 31 and December 11.

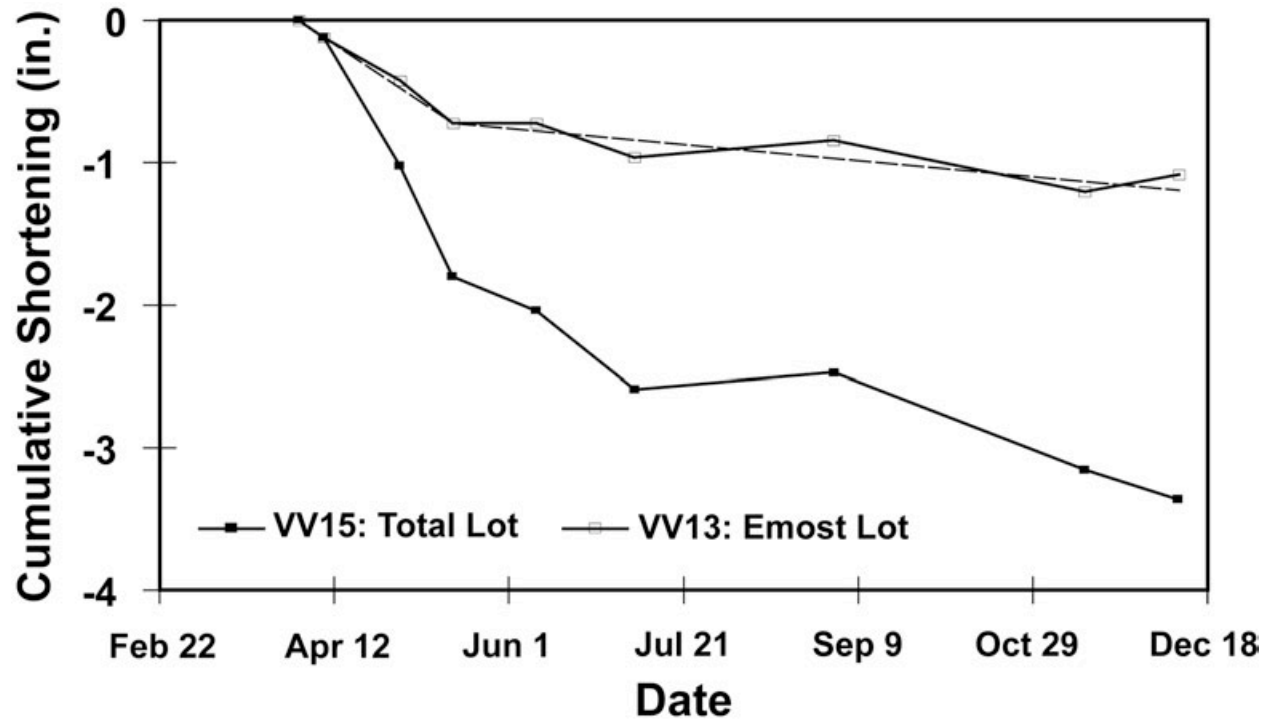
Figure 10. Cumulative shortening across the toe thrust system at lot 157 Valley View Drive between April and December 2008. Upper curve shows cumulative shortening across southeasternmost two toe thrusts (figure 2). Lower curve shows cumulative shortening across entire toe thrust system, which was about 3.4 inches (9 cm) over the eight-month measurement period between April 2 and December 10. A decrease in the rate of movement occurred in May, similar to that observed in the upper part of the landslide, likely in response to declining ground-water levels in the dry period between March and July 2008. Dashed line shows probable deformation curve removing measurement error.

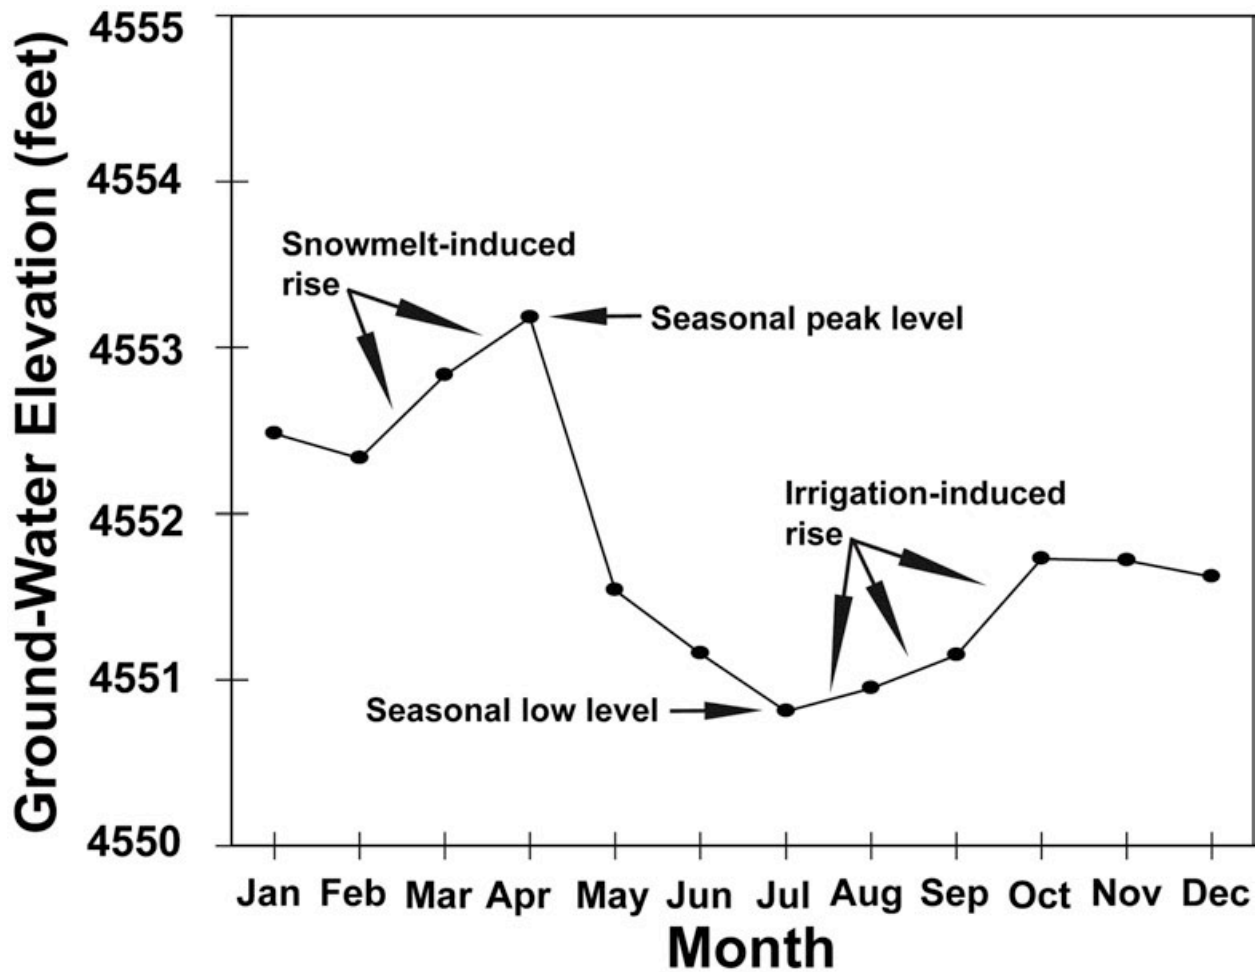
Figure 11. Seasonal fluctuation in ground-water level in observation well P-4 in 2006. Rise in ground-water level between February and April to seasonal peak level is due mostly to infiltration of snowmelt. Seasonal low ground-water level occurs in response to dry hot weather and evapotranspiration. The rise in ground-water level between July and October is likely due to local landscape irrigation. Subsequently, the ground-water level declines in the fall and early winter. The rate of landslide movement typically increases with rising ground-water levels in the early part of the year and decreases as ground-water levels decline from the seasonal peak levels.

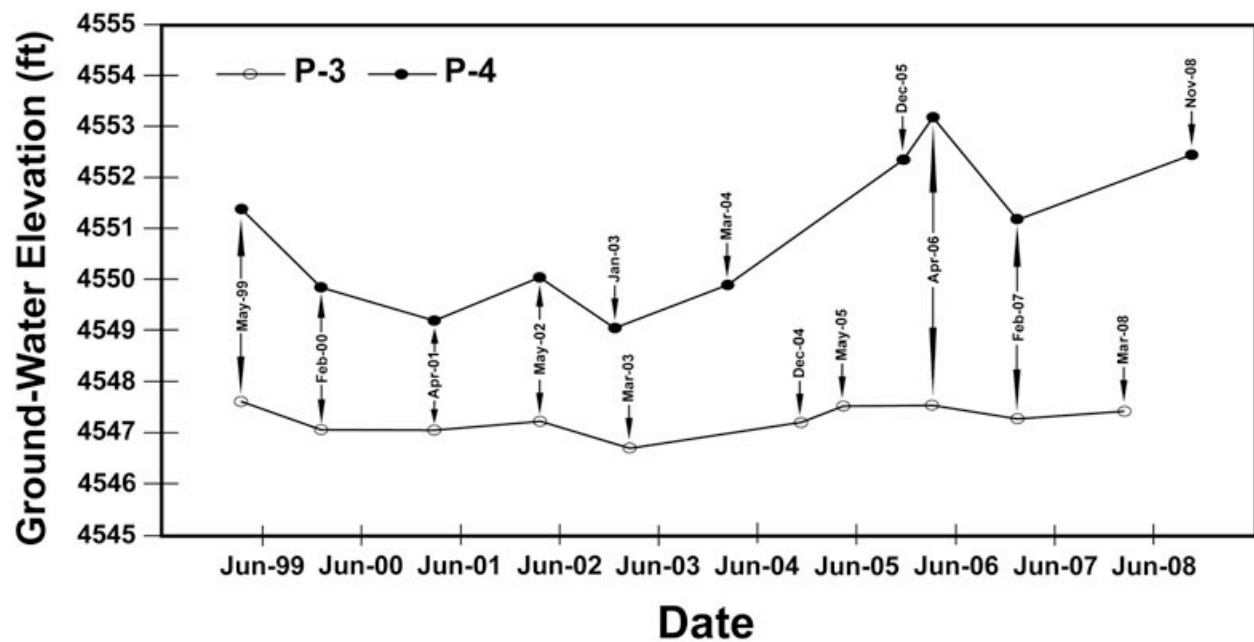
Figure 12. Fluctuations in seasonal peak ground-water levels (SPGWL) in observation wells P-3 and P-4 between 1999 and 2008. The SPGWL coincides with the lowest stability of the landslide during the year, and thus is a basis for assessing the relative stability of the landslide. High SPGWLs since 2005, most evident in P-4, coincide with increased annual movement amounts, except in 2007.

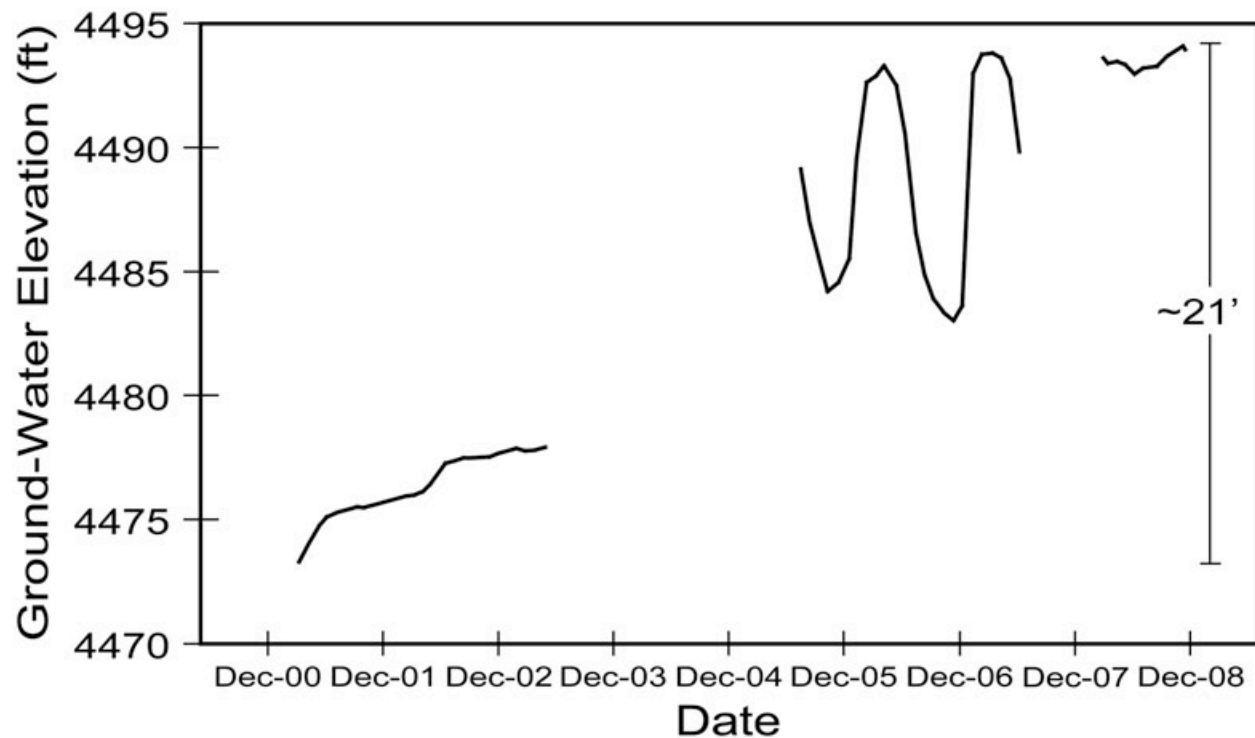
Beginning in 2001, the ground-water level in observation well P-5, near the toe of the landslide, began to rise (figure 13). By 2005, seasonal fluctuations in ground-water level were observed with the highest level occurring in the early part of the year likely the result of the infiltration of snowmelt. The ground-water level rose at least 20 feet (6 m) by April 2006, a significant rise for which the cause remains unknown, and in 2008 was sustained within a foot of this peak level throughout the year. By November 2008, the ground-water level had risen to its highest level, rising a total of 21 feet (6.4 m) since 2001. The rising ground-water level in observation well P-5 is a concern if it also indicates a similar rise in ground-water levels in the toe of the landslide because such a rise results in a reduction in the frictional forces acting to resist downslope movement. The sustained high seasonal peak ground-water level near (and possibly in) the toe of the landslide since at least 2006 may be the primary cause of the increase in annual movement, and the sustained high ground-water level near the toe in 2008 may explain the continuous movement throughout the year.

Figure 13. Rise in ground-water level in observation well P-5 near toe of the landslide since 2001. Observation well was dry when initially installed in 1998 until March 2001. Between March 2001 and April 2006 the ground-water level rose nearly 20 feet (6 m). Ground-water levels between 2005 and early 2007 fluctuated seasonally, with the peak levels following snowmelt. By November 2008, the ground-water level had risen to its highest level, rising a total of 21 feet (6.4 m) since 2001. Gaps indicate periods when observation well was not accessible.

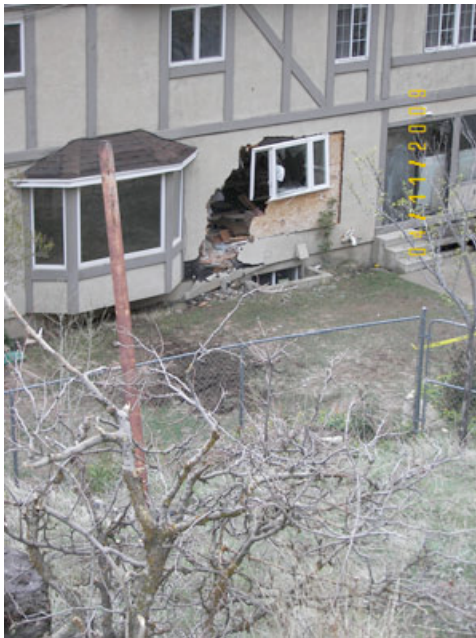
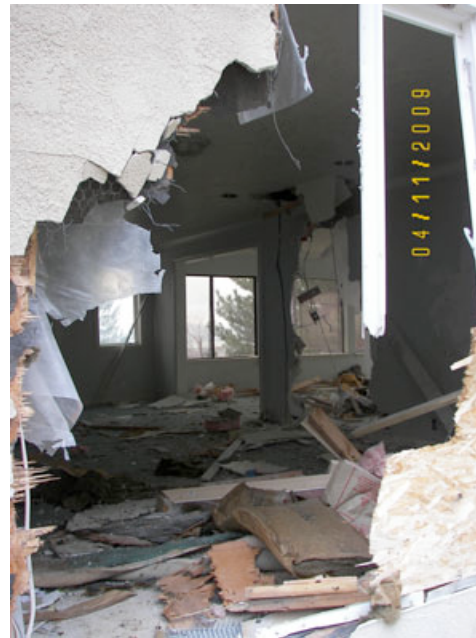
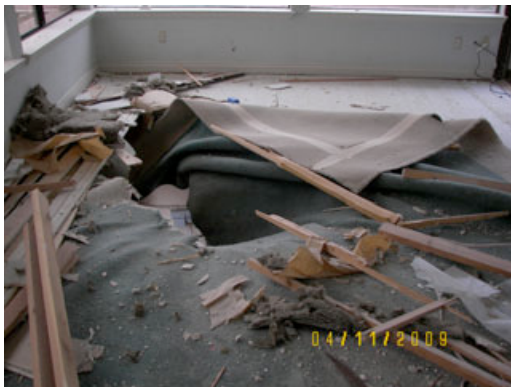
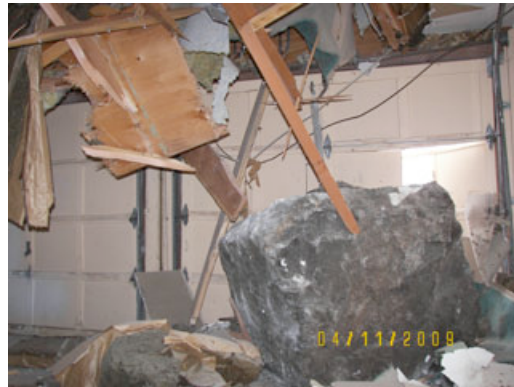
On April 11, 2009, rock-fall debris bounced and rolled downslope and damaged a vacant house and playhouse (figures 3 and 4). The rock that damaged the vacant house at 1496 North 1550 East traveled through the house and into the garage. Figure 3 shows house damage and figure captions describe the rock's travel path through the house. We estimate the rock's dimensions to be 4 x 5 x 4 feet (figure 3D) and weight to be about 6 tons. The dimensions of this rock are similar to other equidimensional to rectangular rock-fall boulders deposited on the alluvial fan to the south. The rock that damaged the playhouse at 1522 North 1550 East (figure 4) bounced into a chain link fence, pushing the fence into the playhouse. We estimate the rock's dimensions to be 2 x 4 x 3 feet and weight to be about 1.8 tons.

Figure 3. Rock-fall damage to a vacant house at 1496 North 1550 East (Provo Fire Department photos). **A.** The rock bounced downslope, impacted and bent the red steel post, traveled over the chain link fence, impacted the lawn leaving a bounce mark, and entered through the back wall with an upward bounce trajectory. **B.** Looking through the back wall into the house. Once inside with an upward trajectory, the rock impacted the ceiling and traveled downward through an interior wall and then down through the floor into the garage below. **C.** Hole in the floor where the rock traveled into the garage below. As the rock traveled through the floor it pulled carpet into the garage below. **D.** The rock stopped inside the garage. The rock size is estimated to be 4 x 5 x 4 feet and broke through part of a garage door.

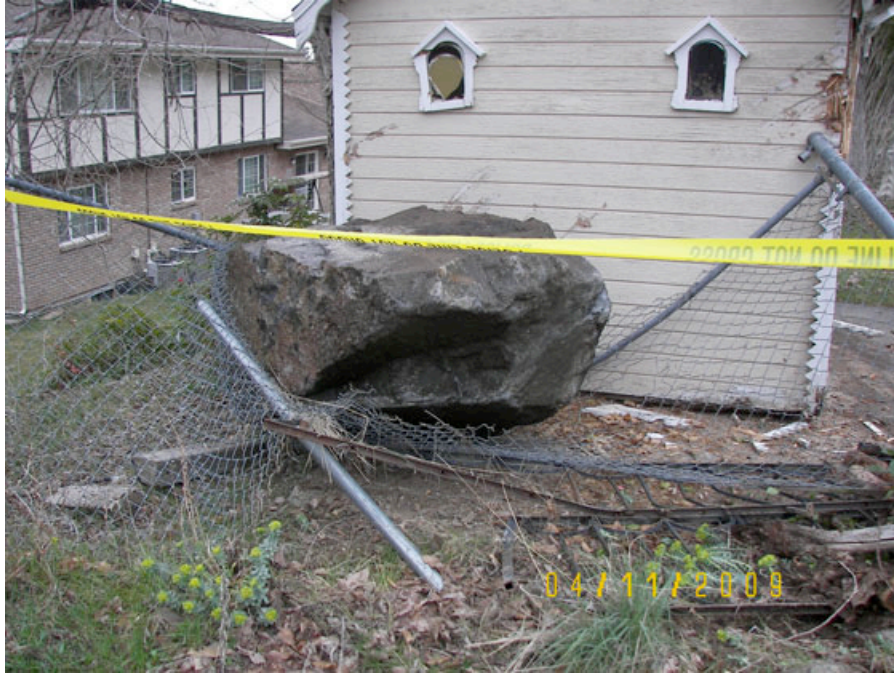
Figure 4. Rock-fall damage to chain link fence and playhouse at 1522 North 1550 East (Provo Fire Department photo). The rock size is estimated to be 2 x 4 x 3 feet.

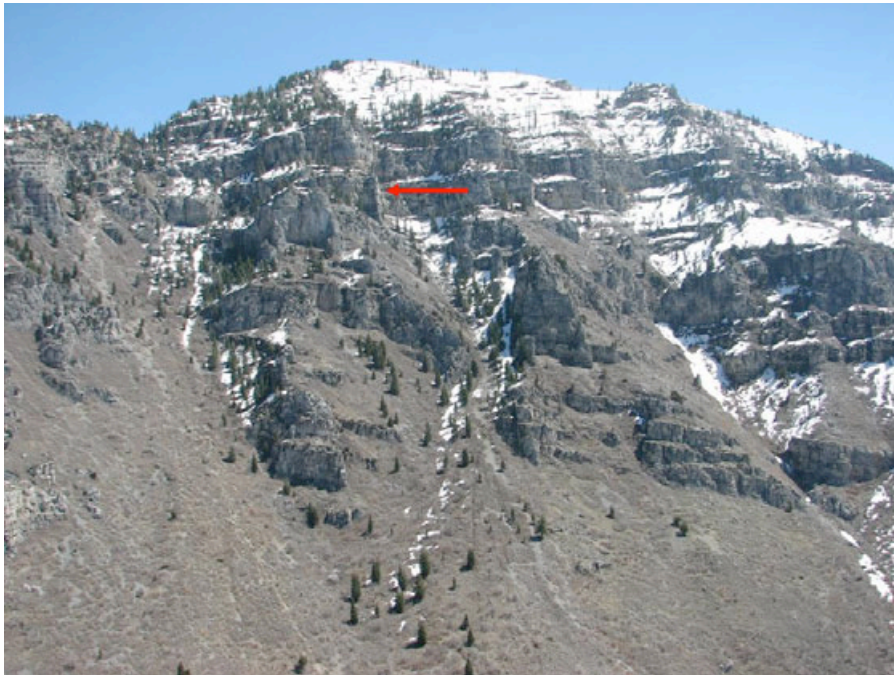
Figure 5. West side of Y Mountain and extensive rock-fall source cliff bands. Steep, smooth mountain slopes below the cliff bands promote high rock-fall velocity and long runout distance. Red arrow points to the 2009 rock-fall detachment location.

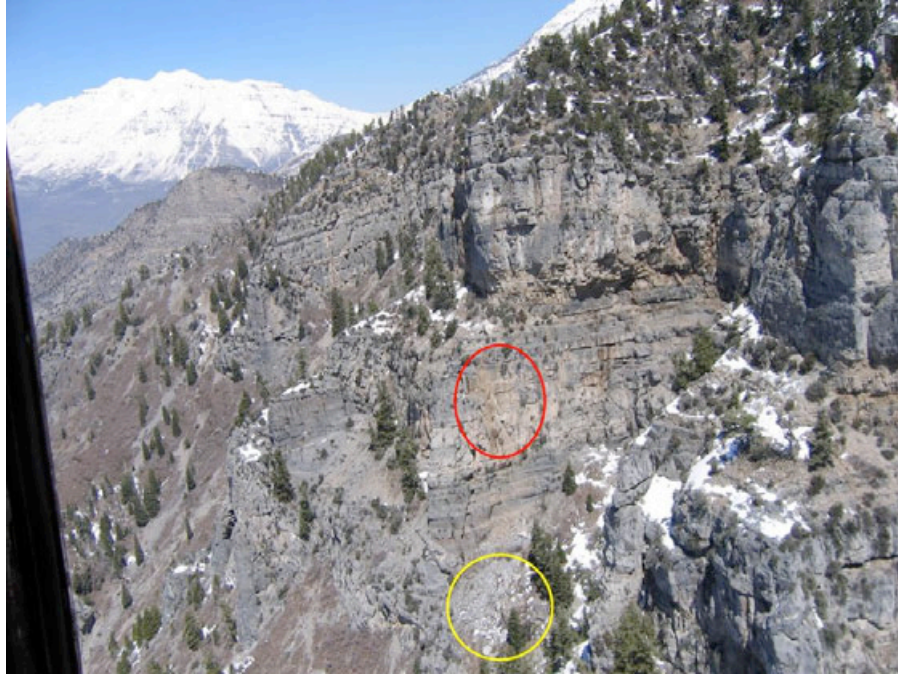
The rock fall initiated in Deseret Limestone (figures 5 and 6) at approximately 7,700 feet elevation. The limestone cliffs are massive beds broken by discontinuities or cracks that consist of joints, fractures, and bedding planes (figure 6). Weathering along these discontinuities weakens the rock mass and creates opportunities for triggering mechanisms such as frost and root wedging, rainfall, snowmelt, or earthquakes to initiate rock fall. The orientation and spacing of discontinuities determine the overall stability and generally the initial size and shape of rock fall produced. The limestone bedding planes are flat to gently dipping and joints are near vertical, widely spaced, and perpendicular to bedding planes. The orientation, spacing, and intersection of bedding planes and joints produce large, roughly equidimensional to rectangular rock-fall blocks. The rock-fall-detachment surface is above an undercut cliff face that likely

Figure 6. Rock-fall detachment surface (red circle), photo taken 9 days after April 11, 2009. Rock debris impacted the talus slope below the cliff band (yellow circle). Cliff face undercutting is apparent below the detachment surface.

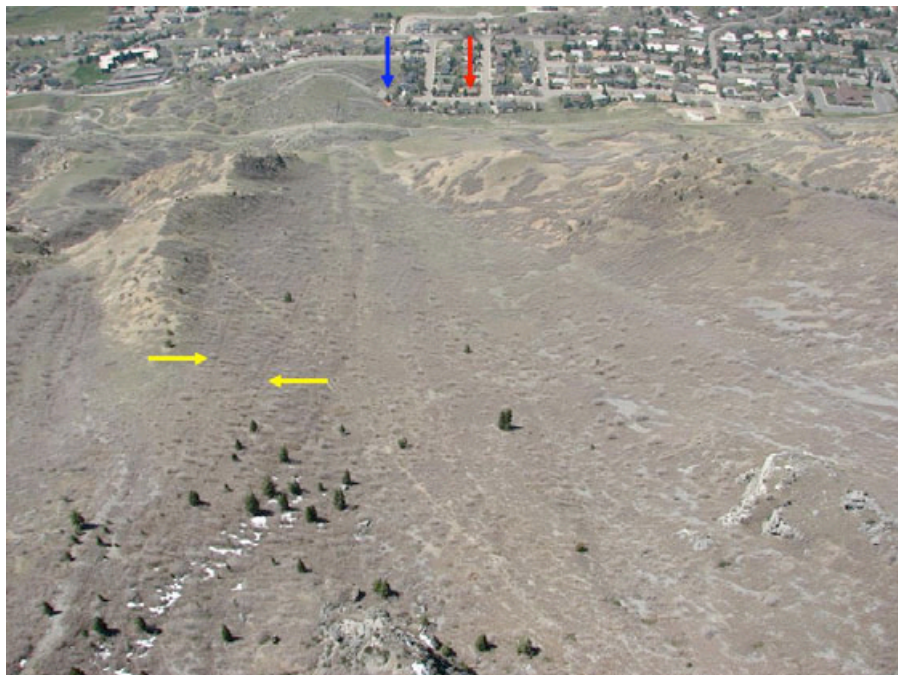
Following April 11, 2009, multiple fresh rock-fall paths were present on Y Mountain (figure 7, 8C, 8D). After detaching from the cliff face, rocks dropped vertically and then impacted the steep talus slope below, churning up talus, soil, and vegetation (figure 6). The rock debris then traveled down a small talus-lined gully. Freshly deposited rock was observed on the talus slope and in the gully. Rock debris continued rolling and bouncing down the mountain flank creating multiple linear rock-fall paths, shown by fresh bounce marks, or impact craters, and damaged vegetation (figures 7 and 8). The vertical drop along the cliff face and the steep 37° talus slope and gully likely provided a high initial velocity to rock debris. The firm mountain slopes that range from 27° to 35° maintained rock debris momentum, promoting the long runout distance into the subdivision. The rock debris traveled approximately 2,500 vertical feet and 5,000 feet slope distance to reach the affected structures. The mountain slopes are part of a small drainage basin that funnels rock-fall debris onto the alluvial fan below (figure 7).

Figure 7. View downslope showing rock-fall paths on Y Mountain above the subdivision. Yellow arrows point to two of multiple April 11, 2009, rock-fall paths. Older rock-fall paths are also evident. Blue and red arrows point to houses impacted in 2005 and 2009 respectively (also see figure 9).

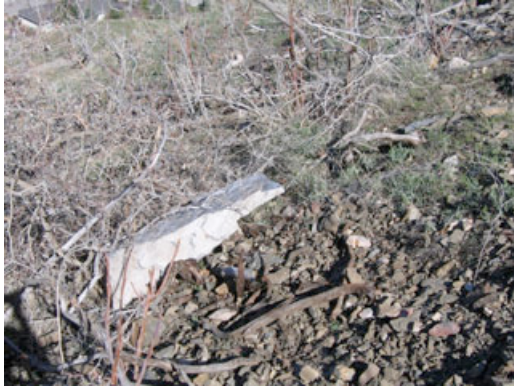
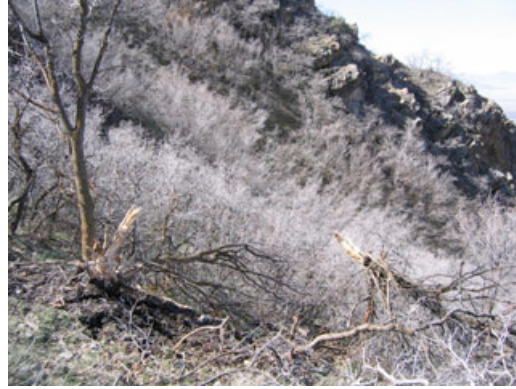
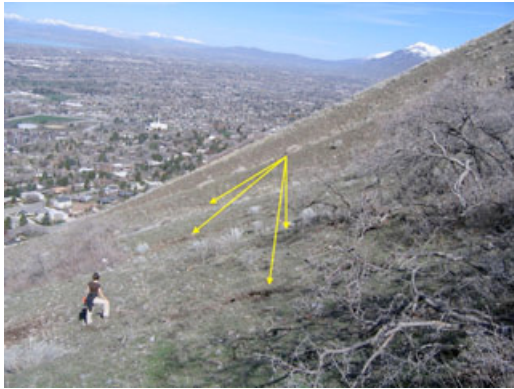
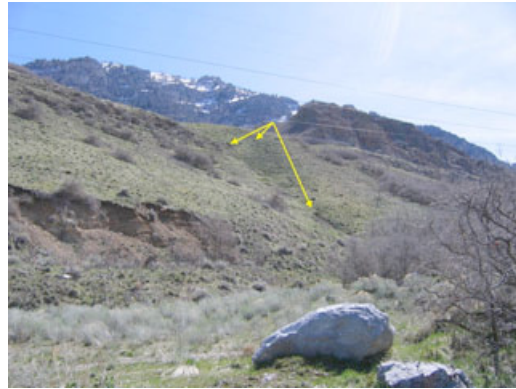
Figure 8. Rock-fall travel paths. **A.** A smaller rock that broke off a larger piece as it traveled downslope. **B.** Rock fall damaged oak brush. **C.** Multiple travel paths (yellow arrows). **D.** Multiple travel paths (yellow arrows) evident directly above the damaged house and playhouse.

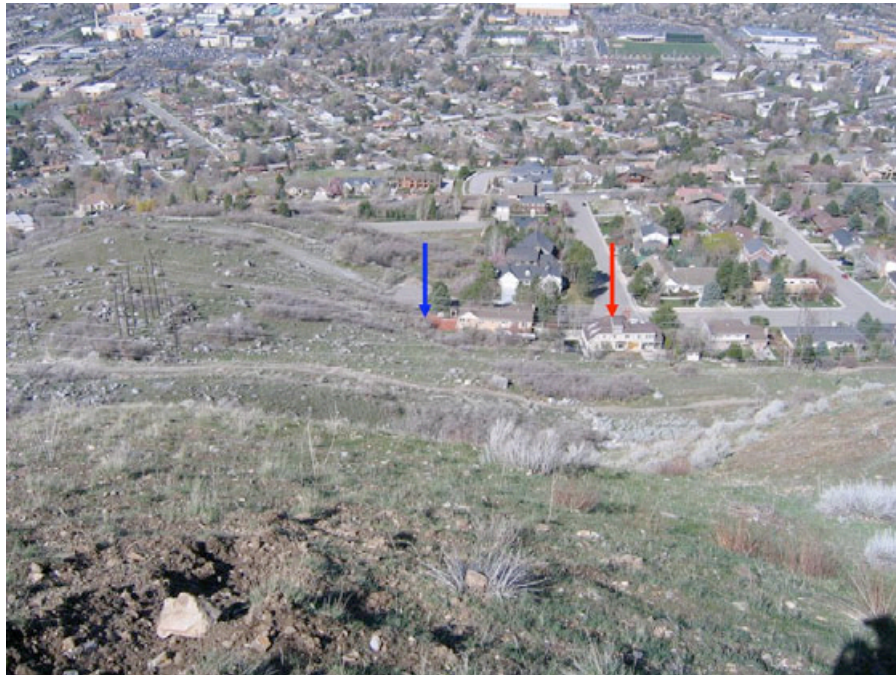
Figure 9. Previous guest house location destroyed by the 2005 rock fall (blue arrow) and the house damaged by the 2009 rock fall (red arrow). Rock-fall boulders on the alluvial fan left of the blue arrow and the slope above the impacted houses show the distribution and size of historical and prehistorical rock fall and the proximity of houses to the hazard.

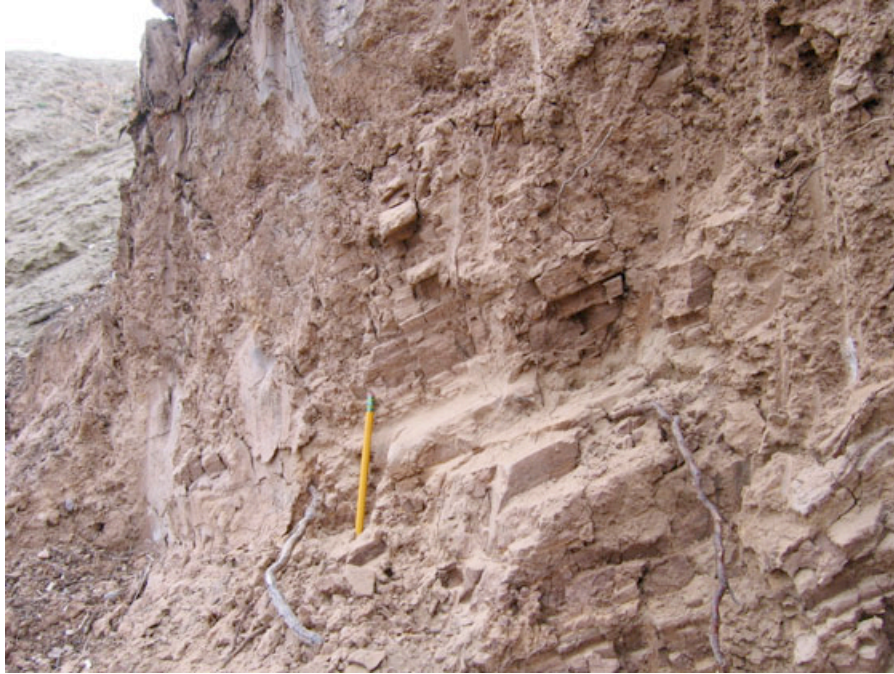
Figure 1. View of cut slope at 1681 East Hillsboro Drive showing tilted Lake Bonneville sediments. The bedding strikes N. 65° W. and dips 38° NE. Photograph taken on November 11, 2005.

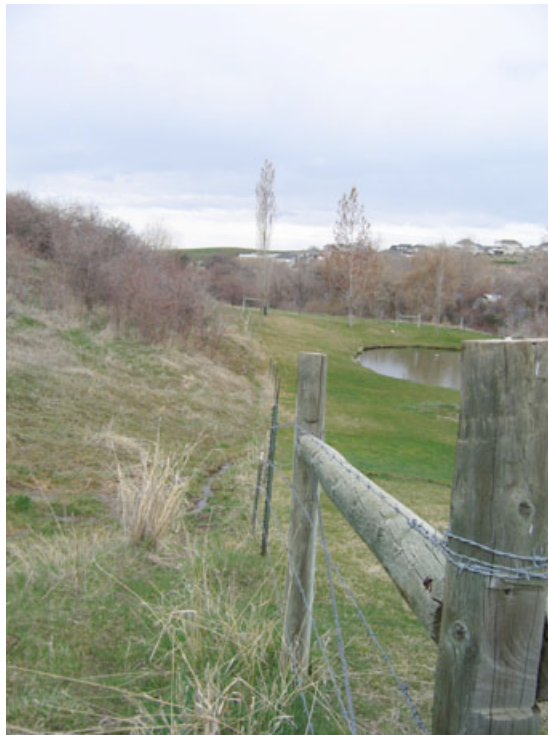
Figure 2. View west of fence displaced by landslide movement in lower slope north and downslope of 1681 East Hillsboro Drive. Photograph taken on April 10, 2006.
