INVESTIGATION OF THE FEBRUARY 10, 2010, ROCK FALL AT 274 WEST MAIN STREET, AND PRELIMINARY ASSESSMENT OF ROCK-FALL HAZARD, ROCKVILLE, WASHINGTON COUNTY, UTAH

by Tyler R. Knudsen

REPORT OF INVESTIGATION 270
UTAH GEOLOGICAL SURVEY
a division of
UTAH DEPARTMENT OF NATURAL RESOURCES
2011

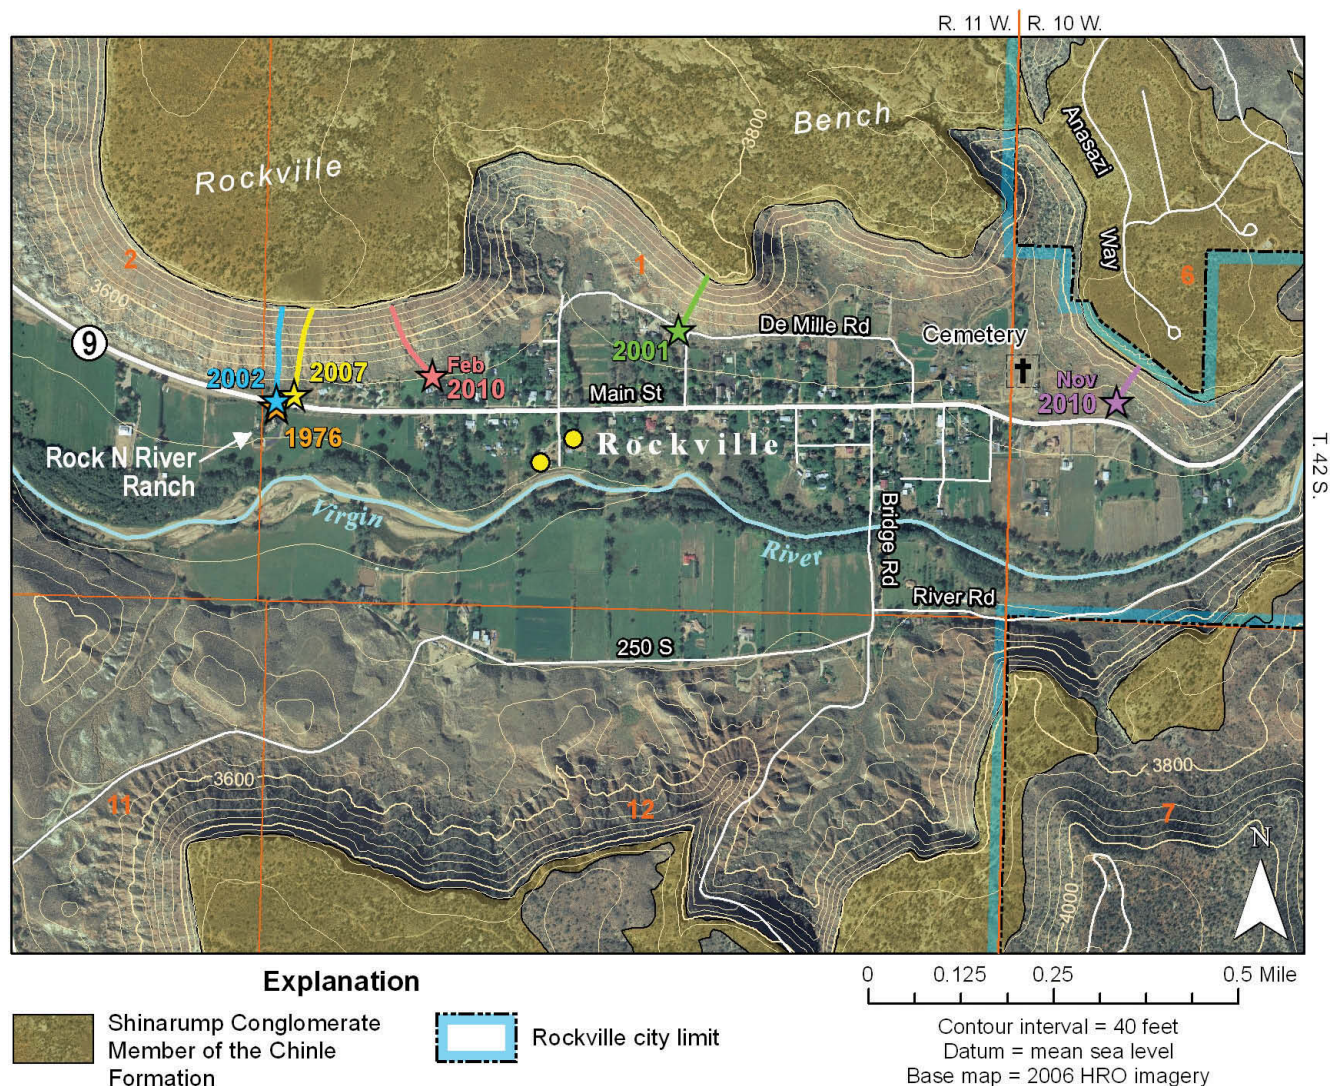
Figure 2. Historical rock falls (stars) and their travel paths (bold colored lines). Yellow circles show locations of isolated boulders interpreted to be cliff-retreat deposits. Shinarump outcrop pattern from Willis and others (2002).

At least six relatively large rock falls sourced from the Shinarump cliff have occurred within the past 35 years in Rockville (figure 2), five of them within the past nine years. Undoubtedly, additional historical rock falls have occurred in the area but were poorly documented, and details such as timing, location, size, and damage are lacking. A discussion of documented rock falls in the area follows.

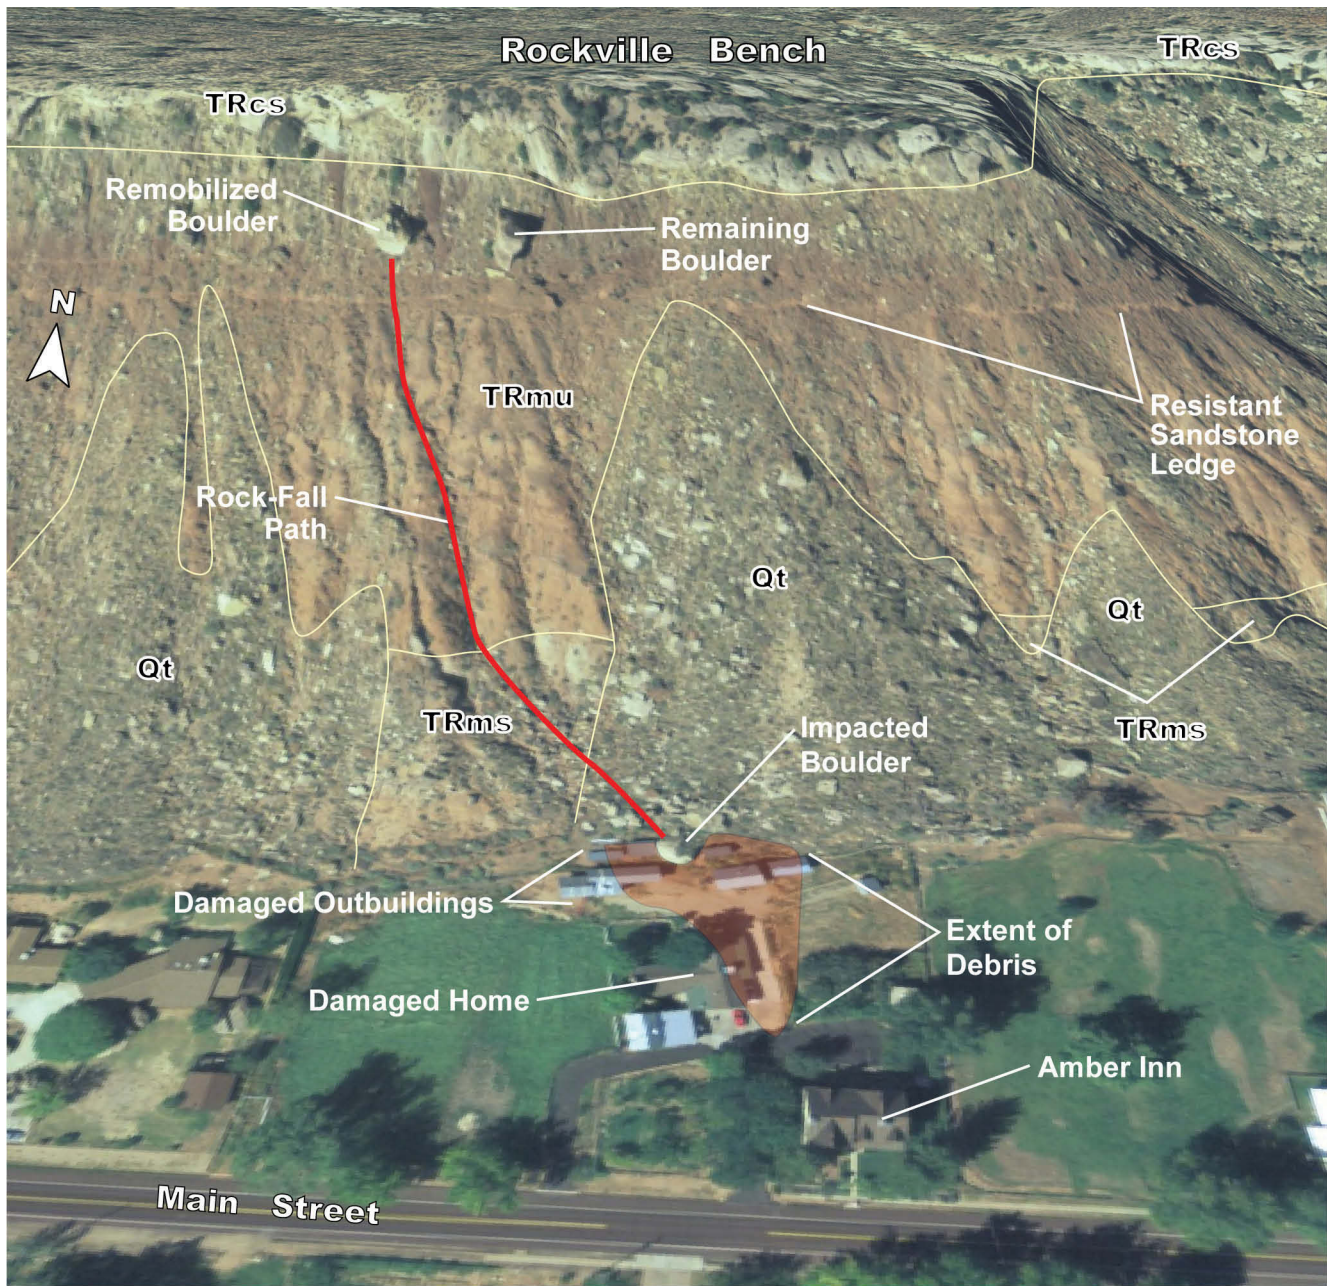
Figure 3. Three-dimensional model of the February 2010 rock-fall site constructed by draping 2006 HRO imagery over a 10-meter-resolution digital elevation model. Rock-fall source area, path (red line), extent of post-impact debris, and damaged structures are shown. Rockville Bench geology modified from Willis and others (2002): TRcs = Shinarump Conglomerate Member of the Triassic Chinle Formation, TRmu = upper red member of the Triassic Moenkopi Formation, TRms = Shnabkaib Member of the Moenkopi Formation; Qt = Quaternary talus deposits.

The rock fall consisted of a single remobilized sandstone talus boulder of the Shinarump Conglomerate Member of the Triassic Chinle Formation that had been resting on the steep south-facing slope just below the resistant Shinarump cliff that caps the Rockville Bench mesa (figure 3). The Shinarump outcrop is about 320 feet above the valley floor. The boulder had previously detached from the cliff, traveled a slope distance of about 40 feet, and came to rest on a 44° slope underlain by shale, siltstone, and sandstone of the upper red member of the Triassic Moenkopi Formation. A review of historical orthophotography showed that the boulder had been at that position, 290 vertical feet above the slope's base, since at least 1993 (figure 7). Well-developed desert varnish observed on the likely cliff detachment surface and local residents' accounts indicate that the talus boulder may have been resting at that position for several decades. Downslope-oriented grooves in the boulder's slope-detachment surface indicated that the boulder's initial movement was translational, parallel to the slope (figure 8). After sliding about 15 feet, the boulder fell over a resistant sandstone ledge that forms a 12-foot-high cliff and

began rolling down a shallow talus-lined gully (figure 3). Near the bottom of the gully, the boulder deflected to the southeast, collided with a large boulder at the base of the slope, and shattered into numerous smaller fragments (figure 4). Most of the rock fragments traveled onto the property at 274 West Main Street by rolling, bouncing, or as airborne projectiles.

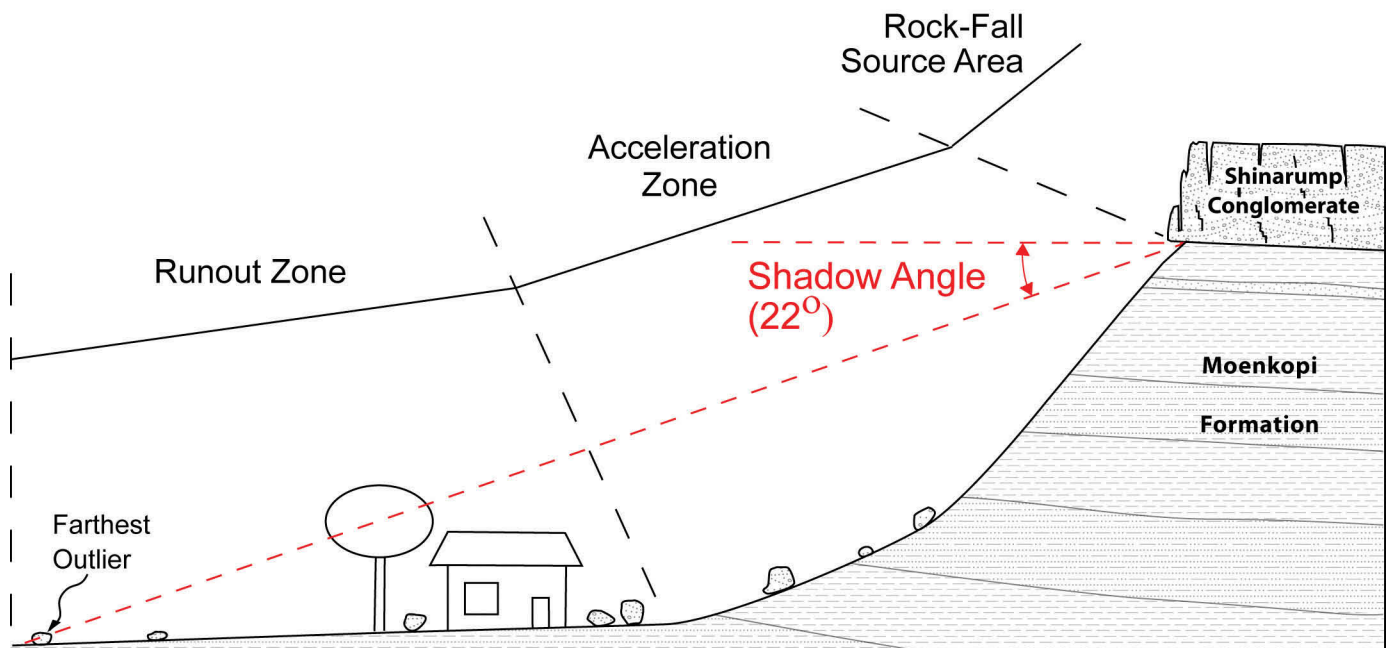
The average angle of an imaginary line extending from the bottom of a rock-fall source to the rocks' resting place is termed the "shadow angle" (figure 19; Evans and Hungr, 1993; Wiczorek and others, 1998). Shadow angles vary based on rock type, boulder shape, slope steepness, slope composition, and rock source height. Minimum shadow angles measured from outlying boulders farthest from the source are used to estimate maximum

rock-fall runout distances for rock-fall-hazard evaluations (figure 19).

Figure 19. Components of a characteristic path profile for rock falls sourced from Rockville Bench (modified from Lund and others, 2008). The 22° shadow angle shown is a reasonable value for estimating maximum runout distance in the Rockville area.

A 22° shadow angle from the base of the Shinarump cliff places many homes, roads, and other facilities in the northern part of Rockville within a high rock-fall-hazard area. Several structures south of the Virgin River on River Road (figure 2) may also be at risk from falling rock originating from the Shinarump-capped mesa to the south.

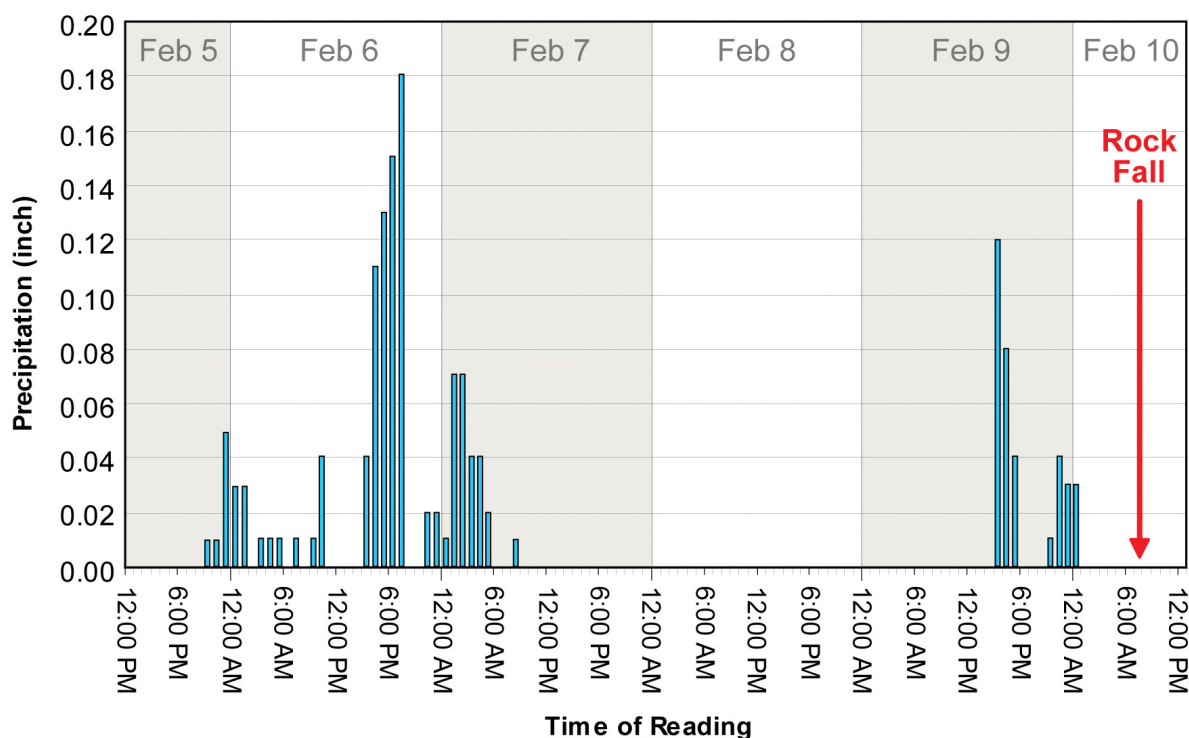
Figure 21. February 5–10, 2010, hourly rain-gage data from Zion Canyon RAWS station (MesoWest, 2010).

a prolonged period of rain during February 5–9 that produced 1.38 inches of precipitation at the Zion Canyon RAWS MesoNet station (MesoWest, 2010; figure 21) about 4.5 miles northeast of Rockville. Station records show that 0.35 inch of rain fell the evening before the rock fall. Although it was not raining at the time of the rock fall, soil and rock slopes near the source area were still saturated when I visited the site approximately nine hours after the rock fall occurred. Observation of the detachment area revealed a zone of saturation extending 1 to 2 feet inward from the outer perimeter of the boulder's footprint. Although saturation of the relatively weak siltstone and mudstone beneath the boulder likely affected the timing of the rock fall, the precise failure mechanism is unclear. Surface water may have eroded material from beneath the boulder causing instability, or increased pore water pressure within the silty and clayey material beneath and/or buttressing the boulder may have resulted in a reduction of cohesion and subsequent failure.
