# RECONNAISSANCE OF LANDSLIDES AND PRELIMINARY LANDSLIDE HAZARD ASSESSMENT ALONG A PORTION OF BROWNS PARK ROAD, DAGGETT COUNTY, UTAH

by Gregg Beukelman and Ben Erickson

**REPORT OF INVESTIGATION 271**  
**UTAH GEOLOGICAL SURVEY**  
*a division of*  
**UTAH DEPARTMENT OF NATURAL RESOURCES**  
**2012**

*Cover Photo: View of Browns Park Road damaged from one of five landslides in lower Jesse Ewing Canyon, Daggett County, Utah*

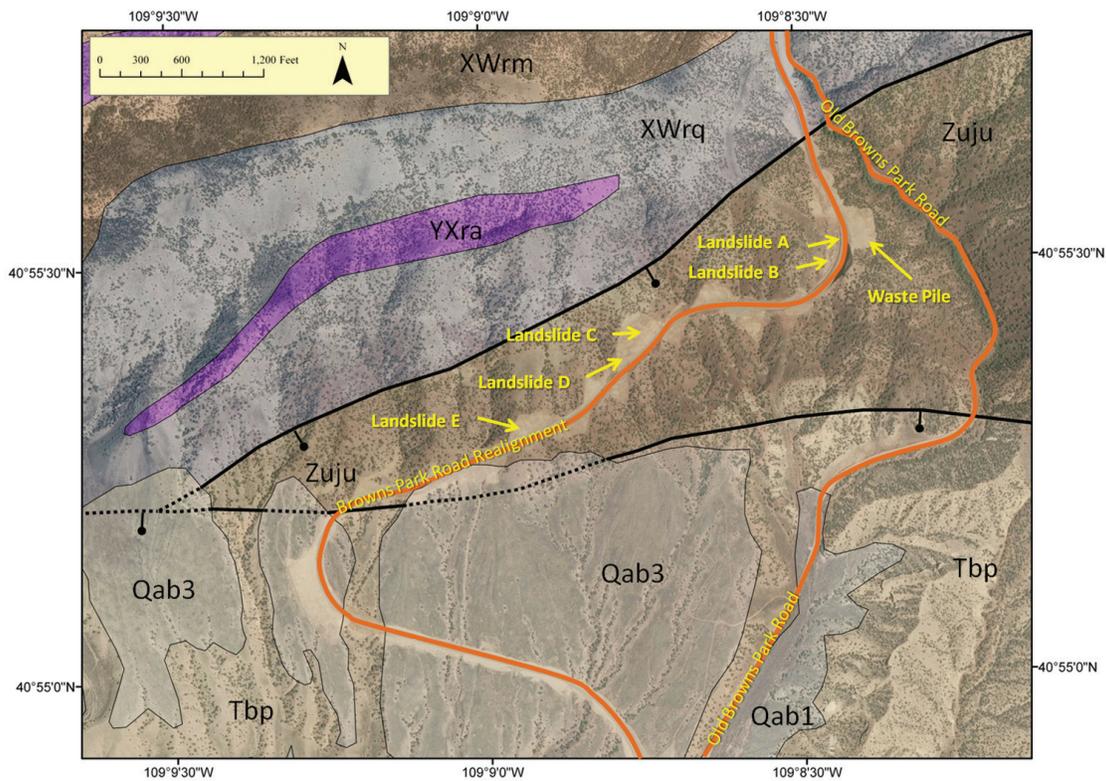
**Figure 2.** Landslides along Browns Park Road investigated in this reconnaissance. Regional faults shown in black (bar and ball on down-dropped side, dotted where concealed). Geologic units include Browns Park piedmont alluvium (Qab1 [youngest] and Qab3 [older]); Browns Park Formation sandstone, with siltstone, conglomerate, and rhyolitic air-fall tuff (Tbp); Upper Jesse Ewing Canyon Formation shale interbedded with quartzose and lithic sandstone (Zuju); and Red Creek Quartzite containing three rock types: amphibolite (YXra), metaquartzite (XWrq), and mica schist (XWrm). Geology from Sprinkel (2006), base from 2009 National Agriculture Imagery Program.

Although other landslides exist in the area, this reconnaissance addresses five landslides that occurred during 2011 in slopes modified during the 2009 realignment of Browns Park Road in lower Jesse Ewing Canyon (figure 2). Landslide activity along the Browns Park Road realignment began in 2010, but became more pronounced in the spring of 2011 (James Olsen, Daggett County Road Department supervisor, verbal communication, 2011).
