# **THE ORIGIN AND EXTENT OF EARTH FISSURES IN ESCALANTE VALLEY, SOUTHERN ESCALANTE DESERT, IRON COUNTY, UTAH**

**SPECIAL STUDY 115  
UTAH GEOLOGICAL SURVEY**  
*a division of*  
**Utah Department of Natural Resources**

The Utah Geological Survey investigated five earth fissures that formed in Escalante Valley in southwestern Utah. The fissures were discovered after a warm winter storm on January 8-12, 2005 caused flooding in the valley, and infiltrating floodwater and sheetwash enlarged the fissures. The fissures range in length from about 100 meters (330 ft) to more than 400 meters (1300 ft), and form a discontinuous nine-kilometer-long (5.6 mi) generally north-trending zone roughly centered on the community of Beryl Junction. In places, the floodwater eroded gullies along the fissures that were up to three meters (10 ft) wide and two meters (6.6 ft) deep. Local residents reported that floodwater flowed into the fissures for a period of a day or more during the height of the flooding, and that vortices formed in the floodwater over some fissures.

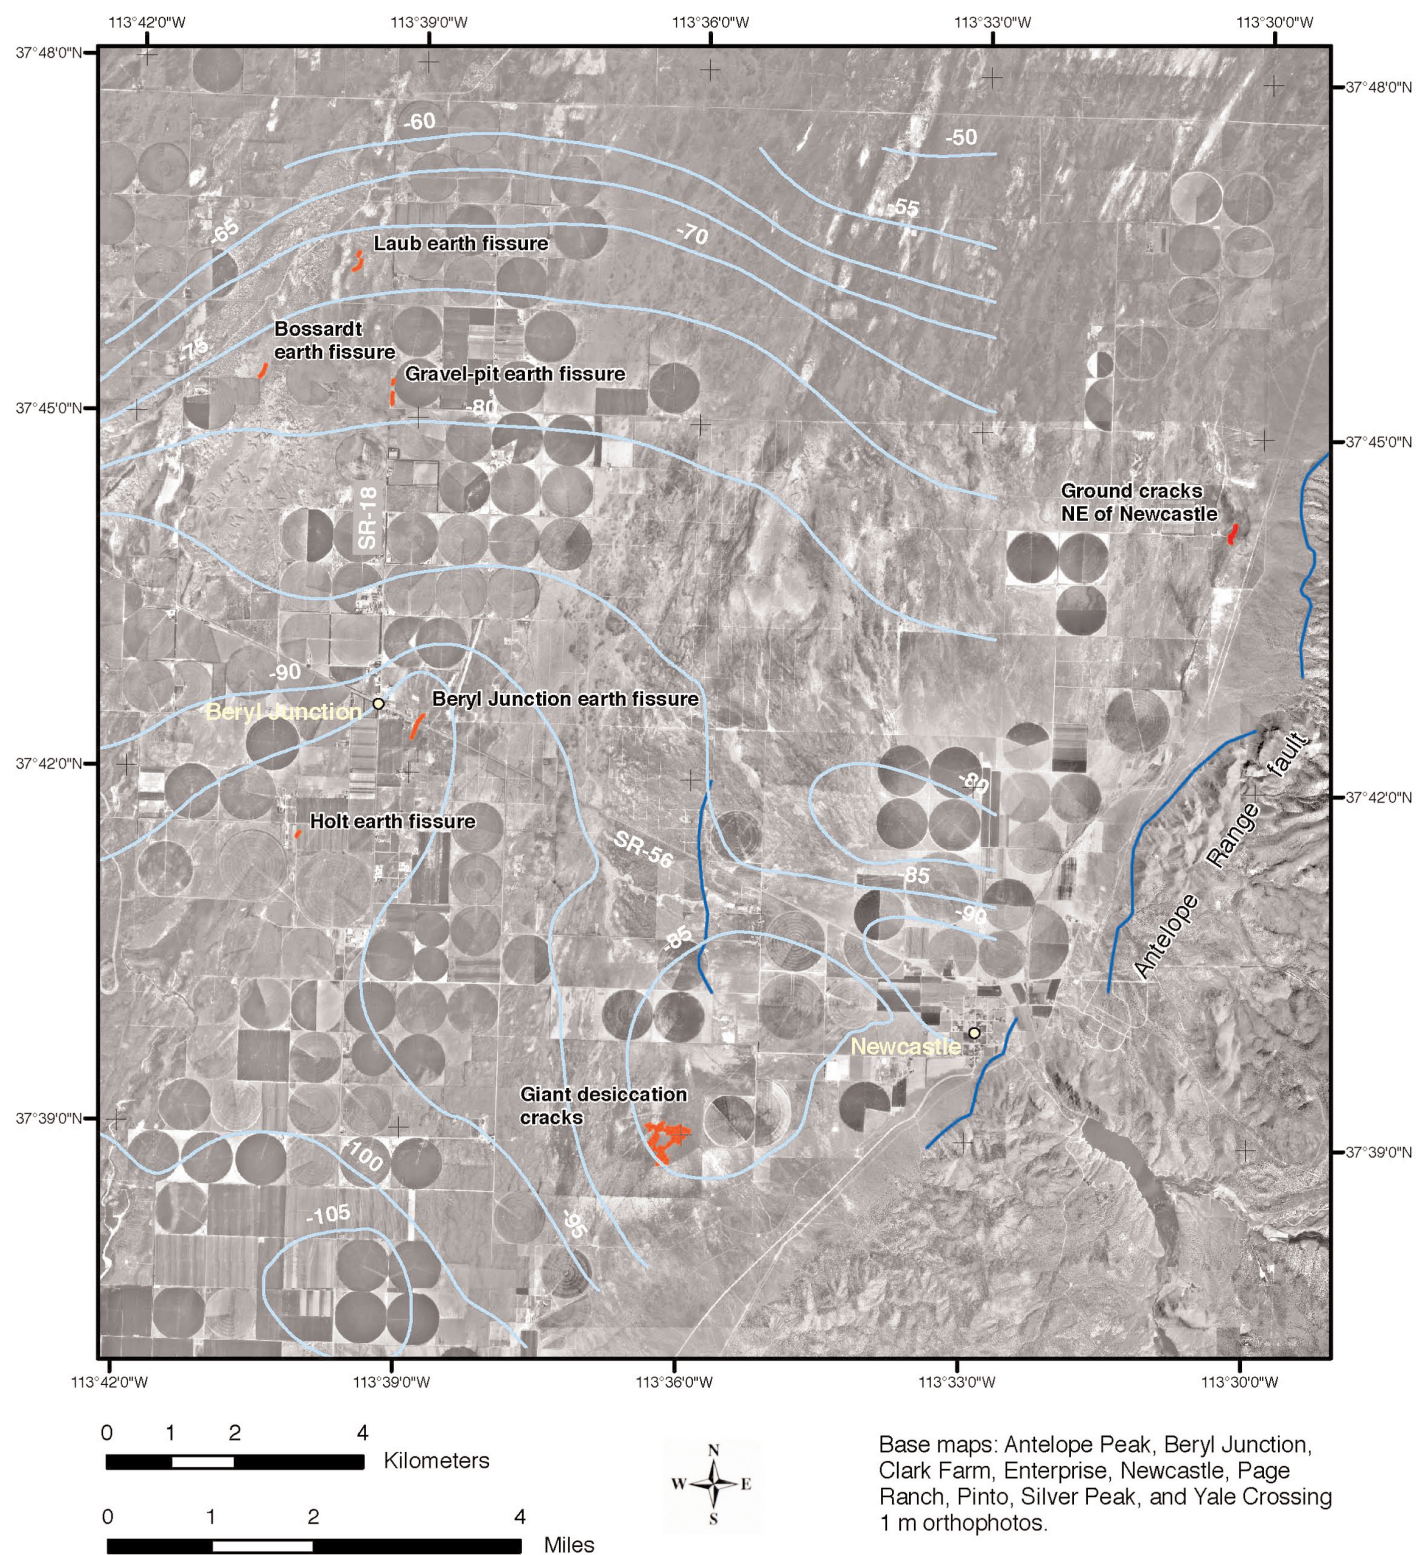
**Figure 4.** Change in ground-water level (light blue contours, in feet; negative value indicates decline) from 1949 to 2002 in the Escalante Valley, and locations of Beryl Junction, Holt, gravel-pit, Bossardt, and the Laub earth fissures; ground cracks northeast of Newcastle; and giant desiccation cracks southwest of Newcastle.

Water Resources, 2005; Christiansen, 2003). Ground-water decline decreases north of Beryl Junction, where total decline is 60 feet (18 m). Two of the earth fissures investigated during this study are in a zone of high drawdown shown in figure 4, which has declined over 95 feet (29 m) since the late 1940s. For the year 2002, the total volume of ground water withdrawn in the entire Escalante Desert was approximately 99,000 acre-feet (122 hm<sup>3</sup>; Christiansen, 2003). Total withdrawal within Escalante Valley is likely a large but undocumented portion of this total.

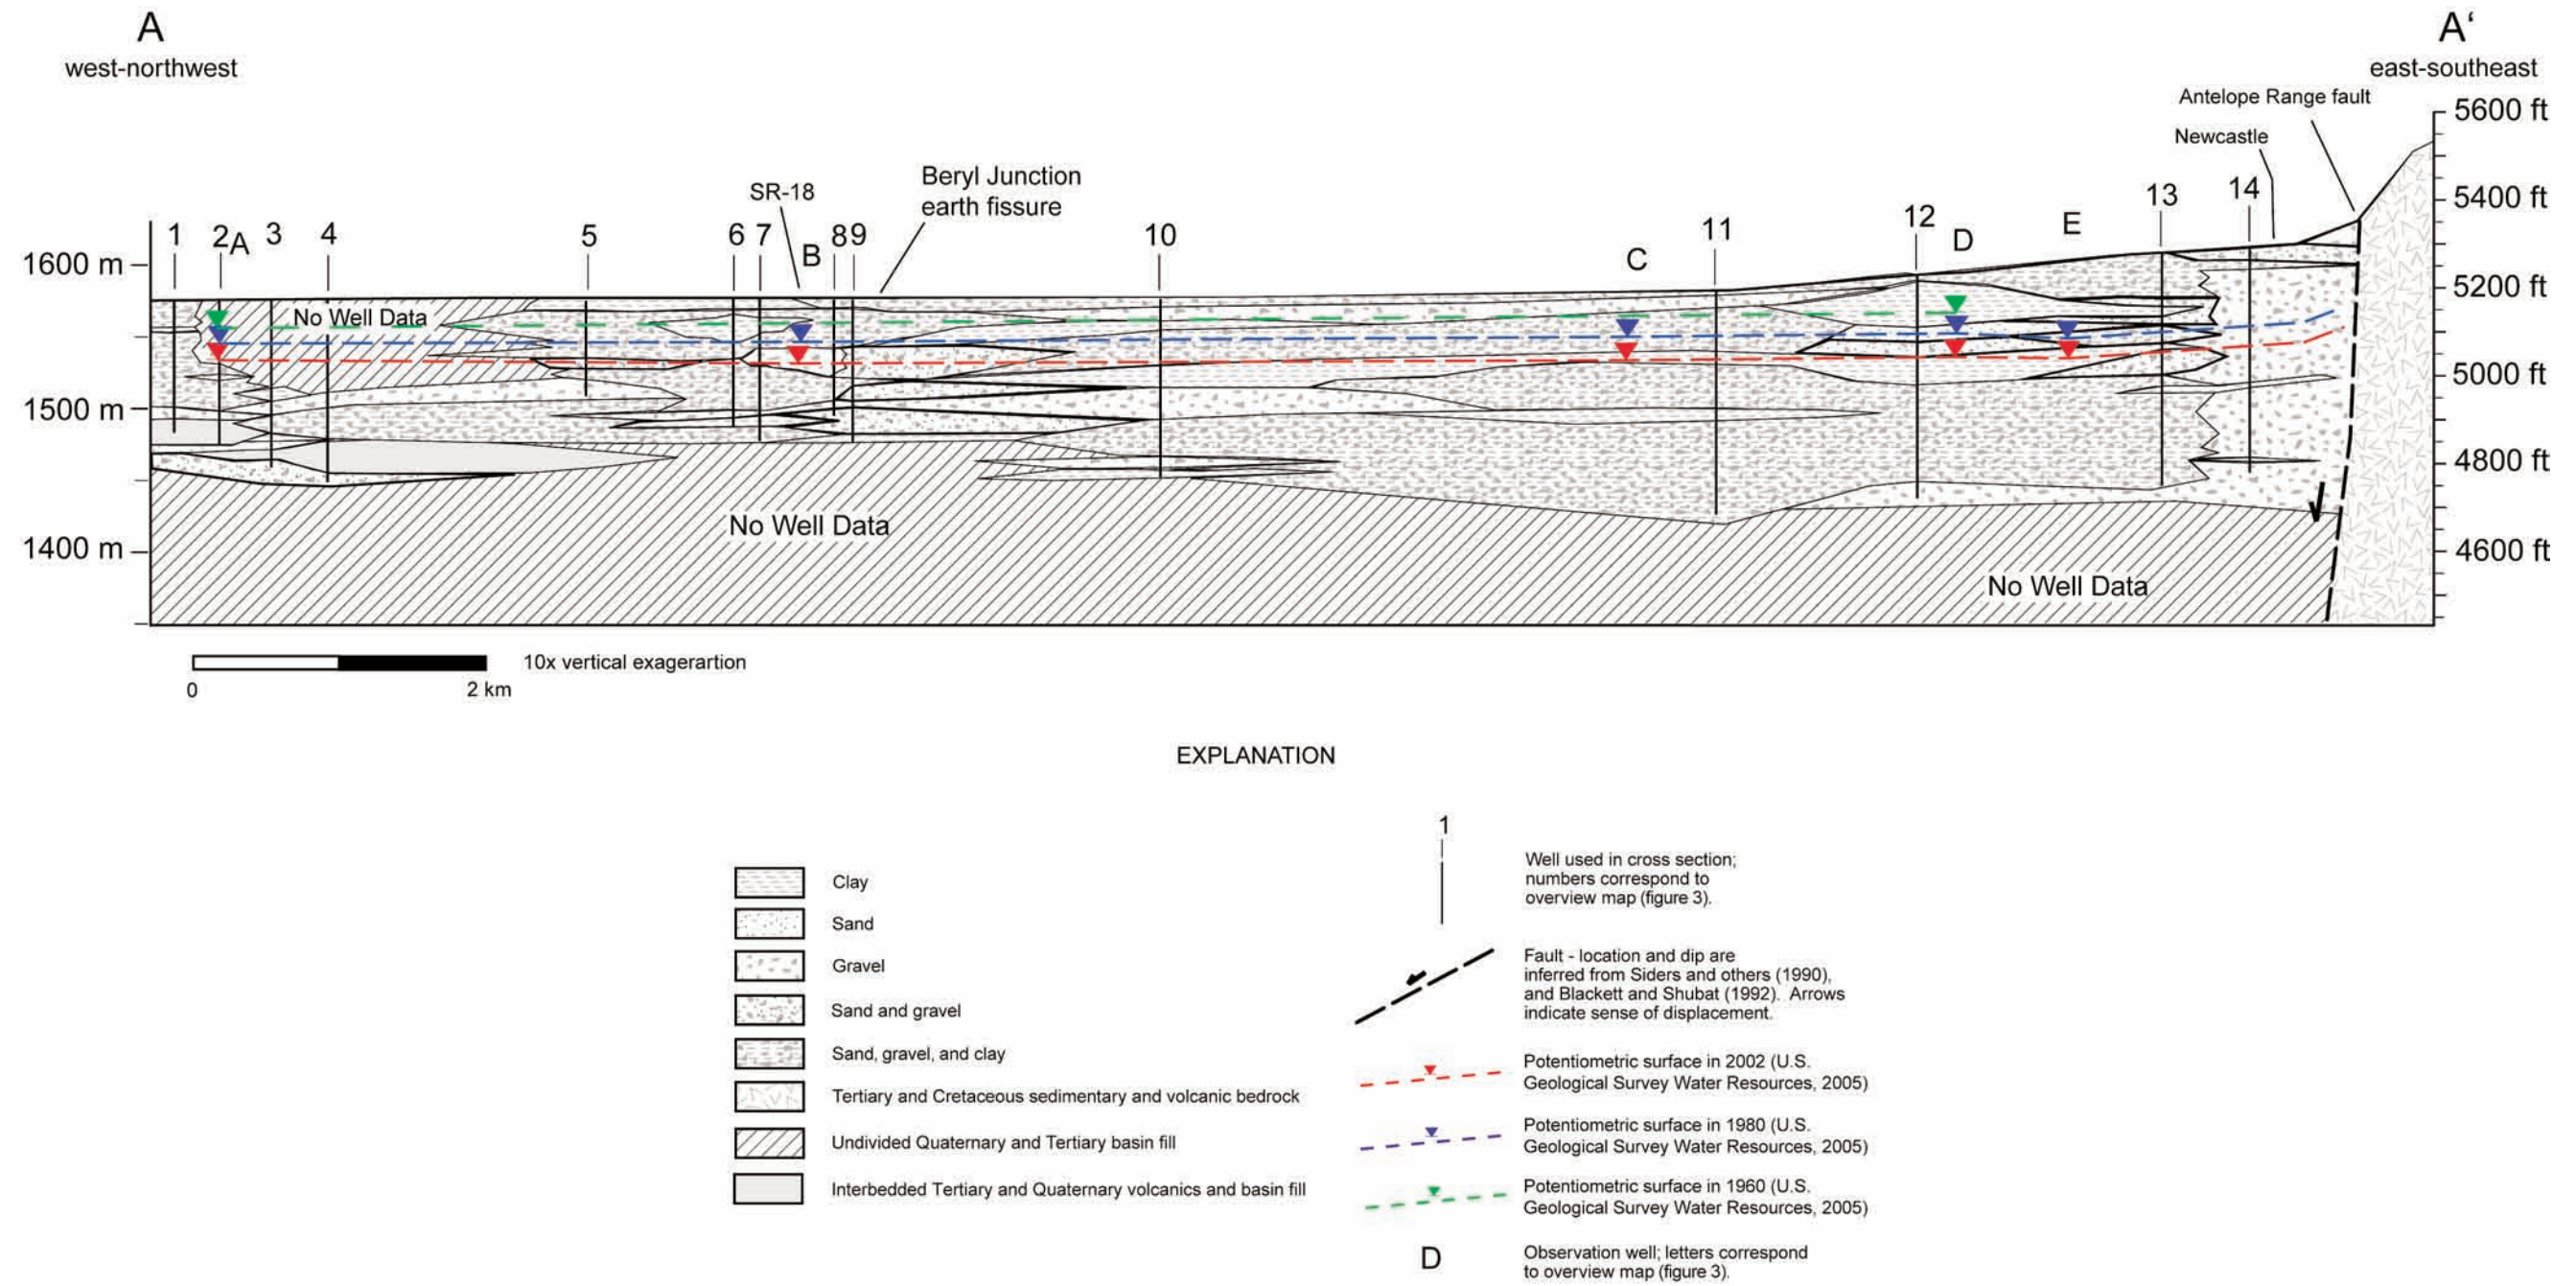
**Figure 5.** Geologic cross section A-A' from water-well logs, oriented west-northwest to east-southeast across Escalante Valley south of SR-56. Water-level data are from U.S. Geological Survey Water Resources (2005). Location of cross section shown on figures 1, 2, and 3. Well numbers and letters correspond to figure 3 and tables 1 and 2.

A west-northwest to east-southeast cross section constructed from water-well logs shows a relatively complex basin-fill stratigraphy, which is composed of intermixed clay, sand, and gravel across much of Escalante Valley (figure 5; table 2). Near the earth fissure that intercepts SR-56, well logs show sand, gravel, and clay in the upper 46 meters (150 ft) of the basin fill, which overlies dominant sand and gravel in the lower portions of these wells (figure 5). Well logs suggest that the basin fill increases in clay content to the north and east toward the center of Escalante Valley.

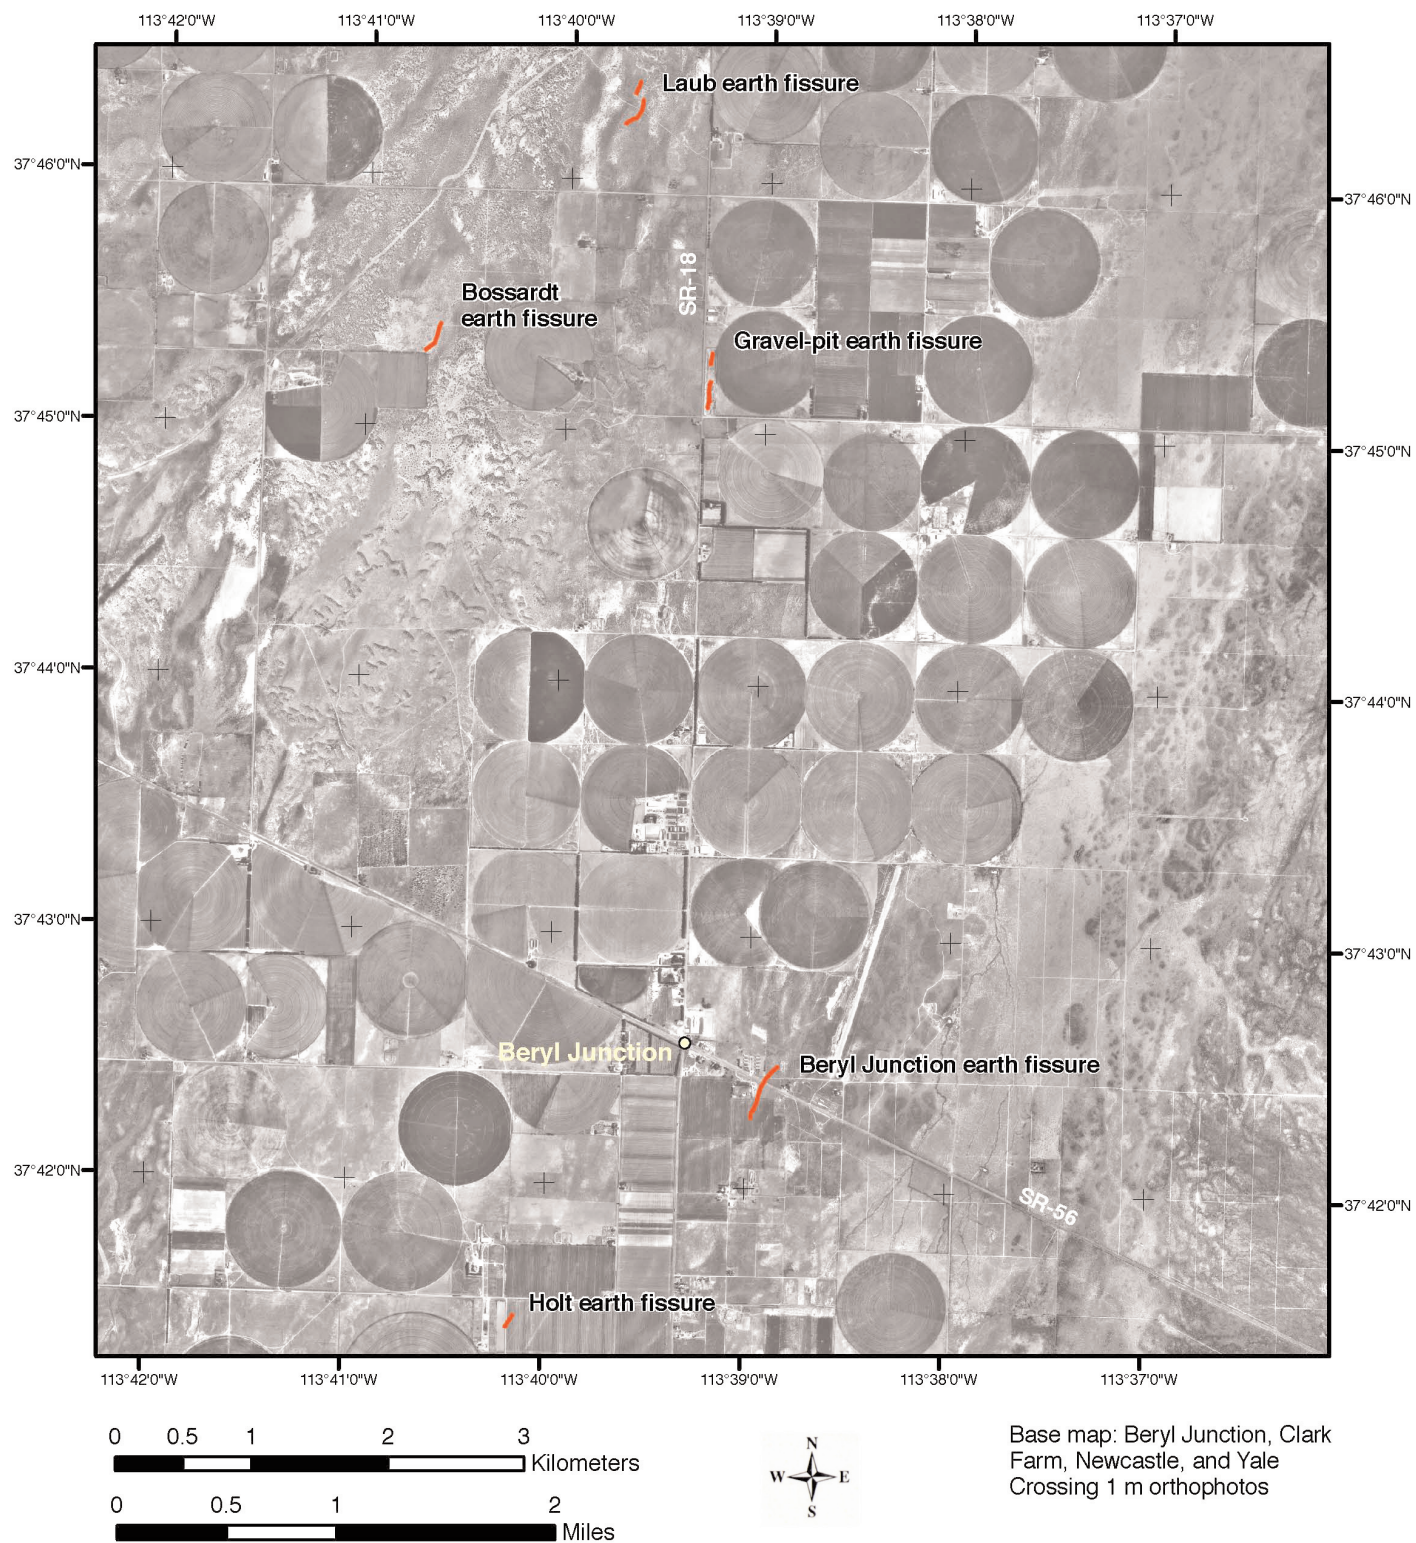
This investigation identified five earth fissures in Escalante Valley following the flood of January 8-12, 2005 (figure 7). The longest fissure is near Beryl Junction near the center of Escalante Valley, and other fissures are 2.4 kilome-

ters (1.5 mi) southwest (Holt fissure), 5.0 kilometers (3.1 mi) north (gravel-pit fissure), 5.5 kilometers (3.5 mi) northwest (Bossardt fissure), and 7.0 kilometers (4.4 mi) north (Laub fissure) of Beryl Junction (figure 7). In addition, we include a brief description of two separate zones of ground cracking, located 8.5 kilometers (5.3 mi) northeast and 5.0 kilometers (3.1 mi) west-southwest of Newcastle (figure 4).

**Figure 7.** Location of the Beryl Junction, Holt, gravel-pit, Bossardt, and Laub earth fissures.

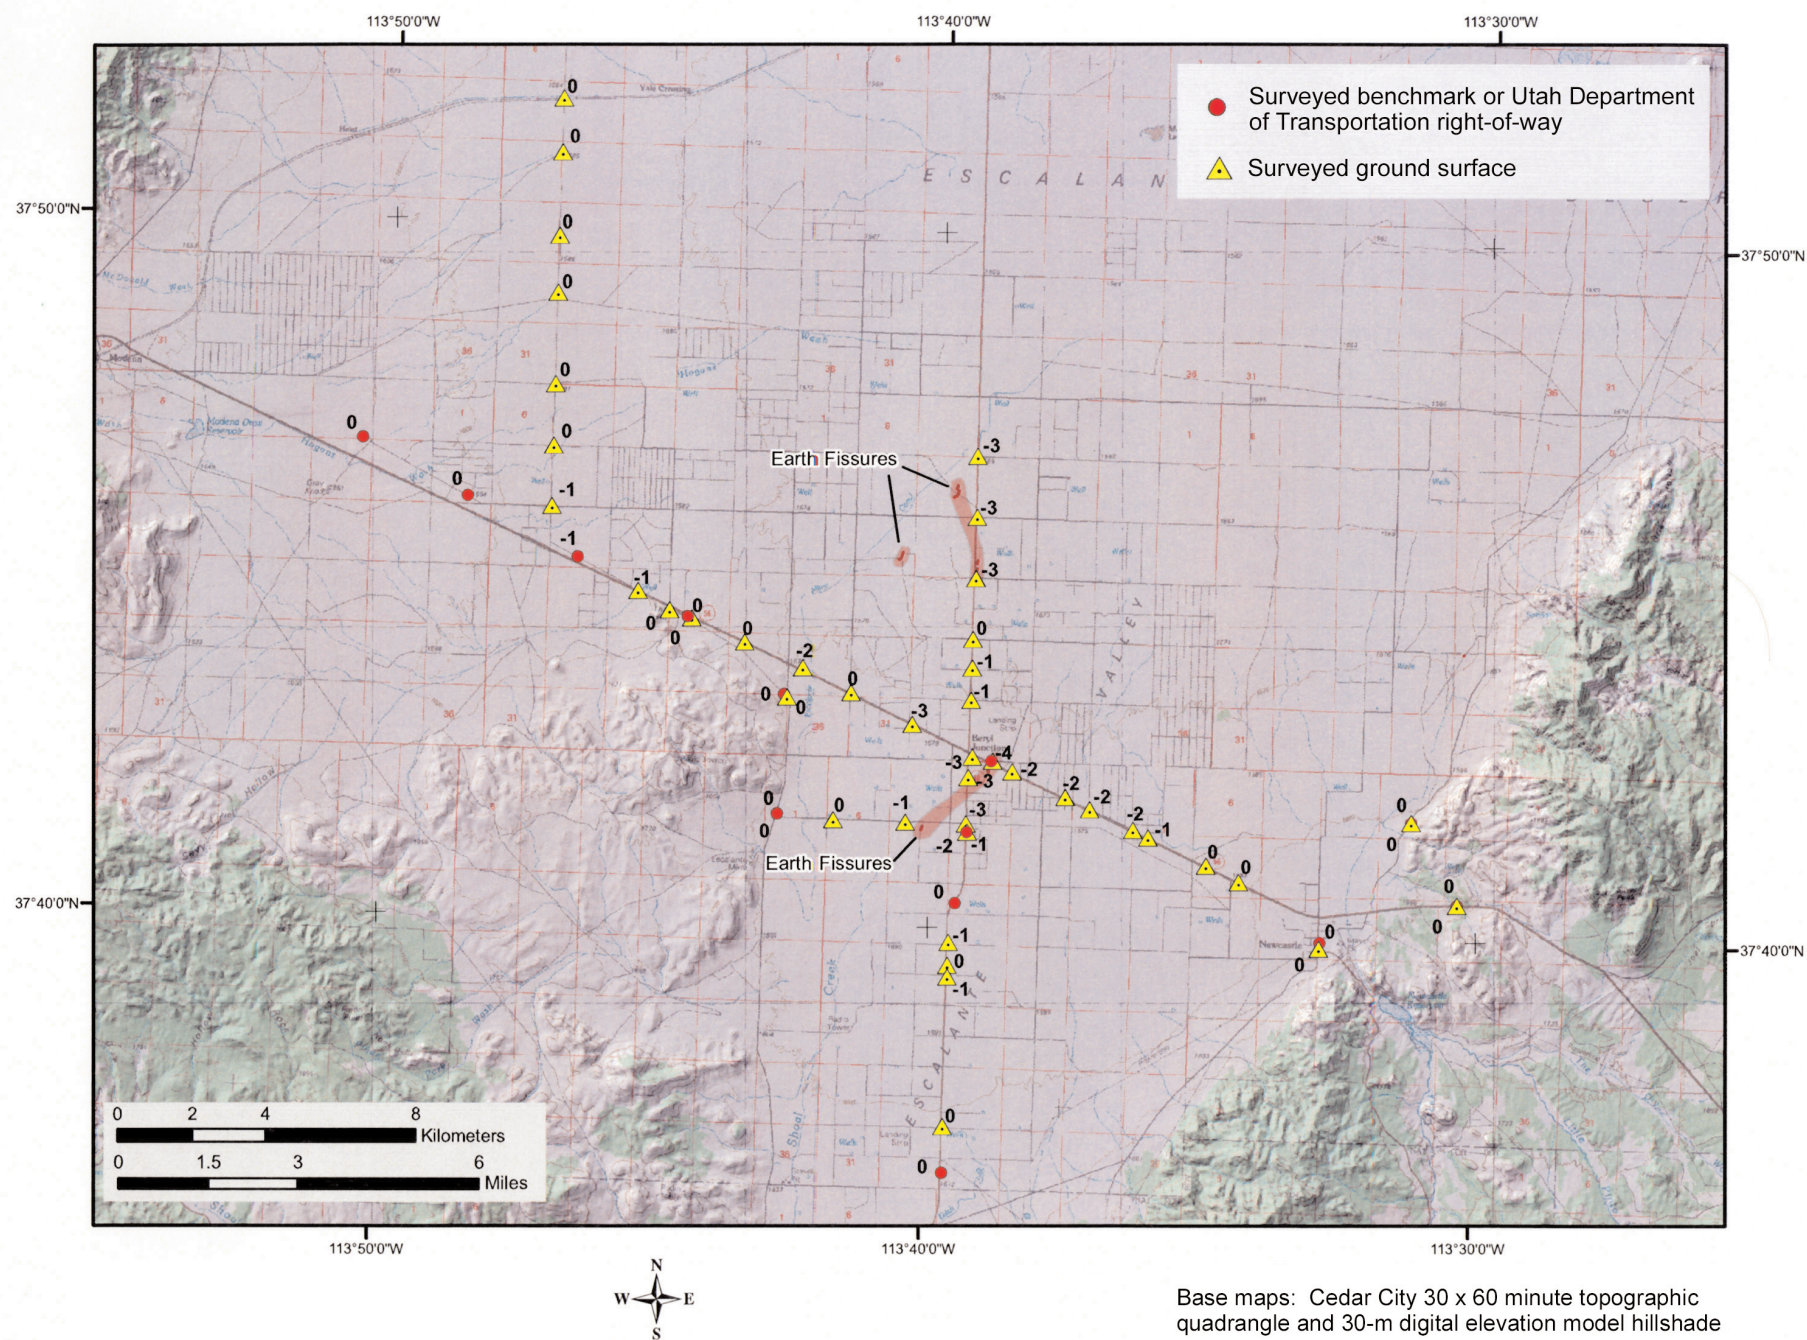
We performed high-resolution Global Positioning System (GPS) surveying of the ground surface, Utah Department of Transportation (UDOT) right-of-way markers, and National Geodetic Survey (NGS) and USGS benchmarks using a Trimble 5800 real-time kinematic GPS system having accuracy specifications of  $\pm 0.01$  meters horizontal and  $\pm 0.02$  meters vertical. Our survey included a 32-kilometer-long (20 mi) northwest to southeast transect along SR-56, a north-south transect along SR-18 from 11 kilometers (7 mi) south to 8 kilometers (5 mi) north of Beryl Junction, and a 12-kilometer-long (7.5 mi) north-south transect in a farmed area north of SR-56 between Modena and Beryl Junction. The data were compared to older elevations for benchmarks, 1972 USGS 7.5-minute topographic quadrangles, and UDOT surveys performed in 1941 and 1955. Figure 15 shows GPS stations surveyed for this study with elevation differences between our GPS survey results and older elevation data, rounded to the nearest foot. The changes in elevation represent different time periods, depending on the date of the initial survey, so values in figure 15 do not necessarily represent the total decline in ground-surface elevations since subsidence began. In addition, these data should be considered approximate because the older elevation data available for comparison are limited and are based on dated, less accurate surveying methods compared to modern GPS techniques. Our GPS surveying was done strictly for scientific purposes and does not represent the work of a Utah licensed surveyor.

**Figure 15.** GPS survey points with measured subsidence (feet) since initial surveys were performed (1941, 1955, and 1972).
