CHARACTERIZATION AND HAZARD ZONATION OF THE MEADOW CREEK LANDSLIDE AFFECTING STATE ROUTE 9, PART OF THE COAL HILL LANDSLIDE COMPLEX, WESTERN KANE COUNTY, UTAH

by Francis X. Ashland, Greg N. McDonald, Lucas M. Shaw, and James A. Bay

SPECIAL STUDY 131
UTAH GEOLOGICAL SURVEY
a division of
UTAH DEPARTMENT OF NATURAL RESOURCES
2009

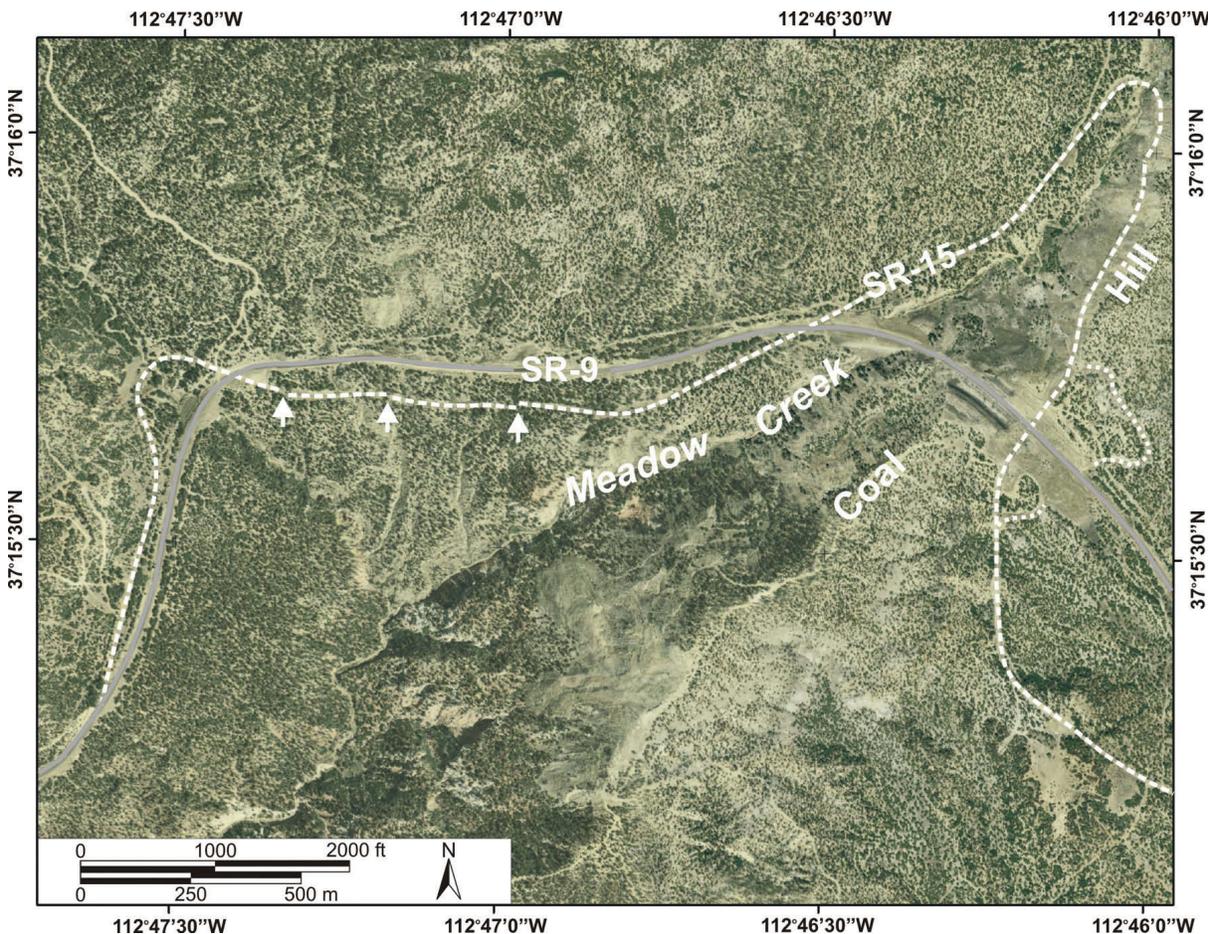
Figure 3. Aerial photograph showing current State Route 9 (SR-9) and abandoned State Route 15 (SR-15) in the Coal Hill area, western Kane County, Utah. SR-15 alignment was abandoned in 1964. The new highway was subsequently renumbered as SR-9 in 1978. Arrows show where abandoned SR-15 is offset or severed by landslide movement. Detached dotted lines on southeast side of Coal Hill show temporary alignment of SR-15 used during construction of present highway across Coal Hill (circa 1963–64).

abandoned in 1964. SR-15 was renumbered in 1978, becoming State Route 9 (SR-9), so that the former route number could be used for Interstate 15 (I-15 on figure 1). Photographs taken in 1986 (Doelling and Davis, 1989) show offset of the abandoned highway (former SR-15).

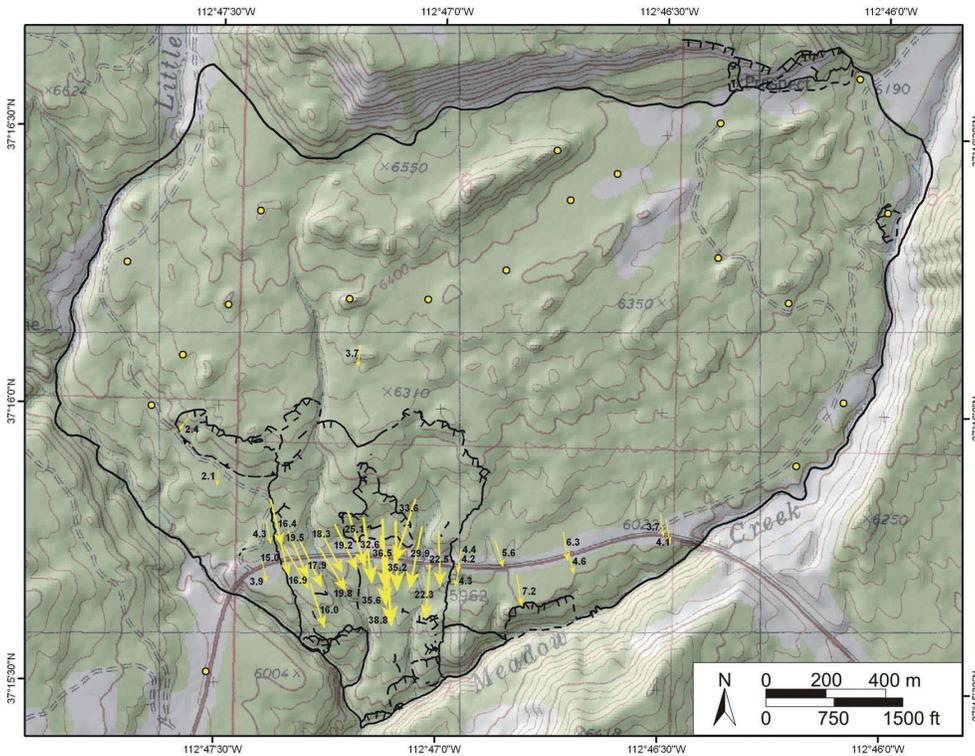
Our movement monitoring results for the area upslope of SR-9 (figure 23) through June 2007 (a measurement period spanning less than 20 months) do not suggest movement of the entire Meadow Creek landslide; however, such movement cannot be completely ruled out. Movement in the apparently inactive part of the landslide may be occurring at rates too slow to detect over the relatively short measurement interval. If the average movement rate in the upper part of the Meadow Creek landslide was less than 0.6 inch per year (<1.6 cm/yr) then the total maximum movement during the 20-month measurement period would have been about 1 inch (2.5 cm) and near the detection threshold of the movement monitoring technique.

Assuming the possibility of undetected movement of the entire landslide, the variation in the rate of movement in the slide may be due to differences in the slope of both the ground surface and the underlying surface of rupture (sliding). Most of the survey points where movement was not detected are

Figure 23. GPS-measured movement in southern and west-central parts of the Meadow Creek landslide between fall 2005 and June 2007. Movement amounts (inches) and directions shown by yellow arrows. Yellow dots indicate survey points where no movement was detected. Boundaries of landslide 1 and other slides shown for reference (see plate 1 for further details). Base from U.S. Geological Survey Clear Creek Mountain 7.5' quadrangle. Shaded relief from 10-meter DEM.

in the northern part of the landslide where the average slope ranges between 9 and 13 percent, flatter than the average slope of landslide 1 and the abutting southern part of the Meadow Creek slide. Where movement was detected in the southern part of the landslide, but outside the limits of landslide 1, the average slope exceeds 11 percent, and generally ranges between 13 and 16 percent. This active area also includes the moderate to steep bluff along Meadow Creek that generally exceeds 25 percent slope.

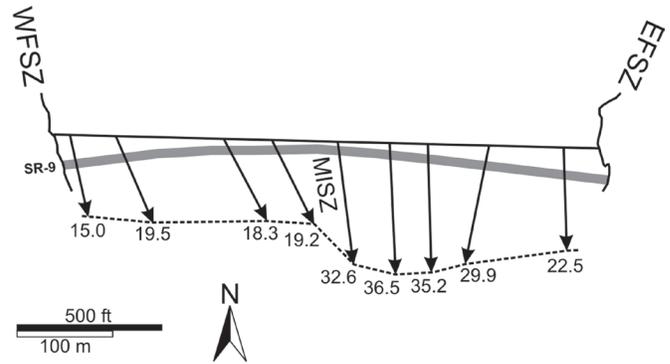
Figure 25. Variation in displacement across landslide 1. Figure shows the horizontal displacement (inches) of a hypothetical straight line across the slide during the measurement period (October 2005 to June 2007). Displacement has a generally bow-shaped pattern (in plan view) increasing toward the right center of the slide from both flanks. A significant step in displacement occurs across the main internal shear zone (MISZ). Parts of east- and west-flank shear zones (EFSZ, WFSZ) and SR-9 shown.

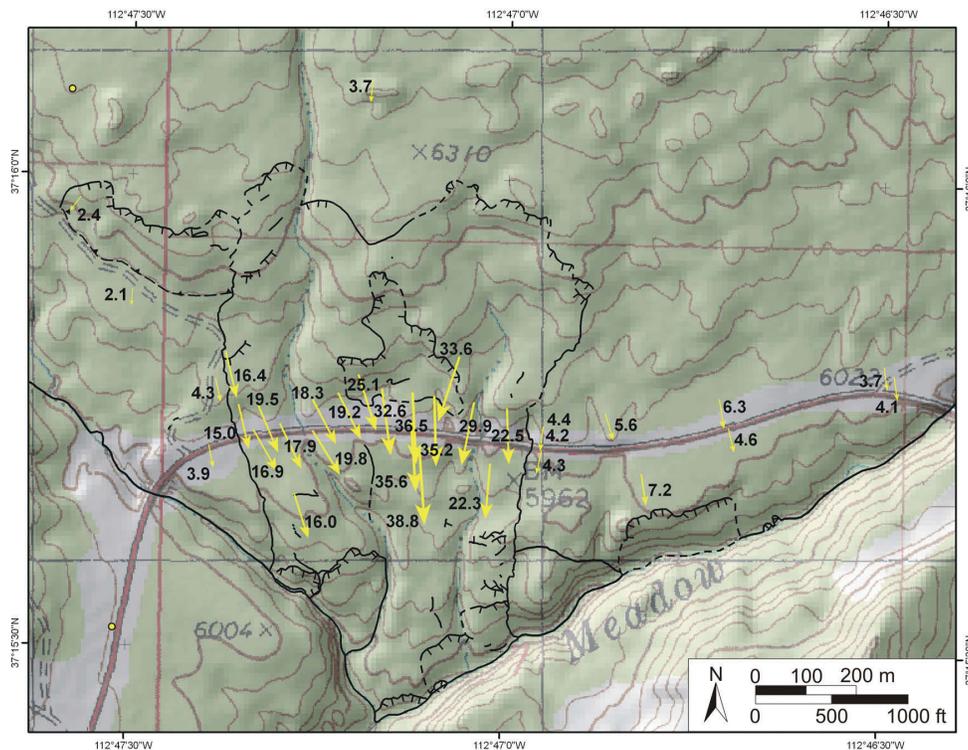
Figure 24. Movement in and near landslide 1 between fall 2005 and June 2007. Movement amounts (inches) and directions shown by yellow arrows. Boundaries of landslide 1 and other slides shown for reference (see plate 1 for further details). Base from U.S. Geological Survey Clear Creek Mountain 7.5' quadrangle. Shaded relief from 10-meter DEM.

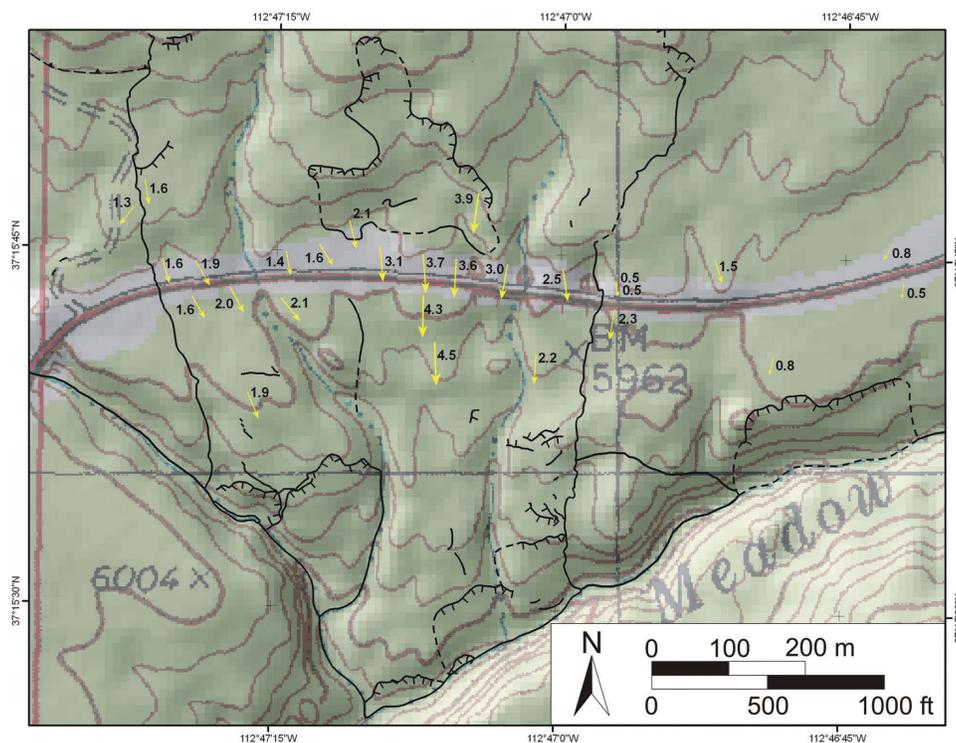
between early October (October 5 through 7) and mid-November (November 17 and 18) 2005 (figure 26). Movement was also detected during this period in the southern part of the Meadow Creek landslide to a lesser degree of certainty where most movement amounts were below our inferred resolution. The data suggest that the southern part of the Meadow Creek landslide complex, including landslide 1, had remained

active throughout most of 2005. Movement amounts for this six-week period ranged from about 1.6 inches (4 cm) near the west flank to 4.5 inches (11 cm) in the central part of landslide 1, the maximum amount corresponding to an average rate of movement of about 38 inches per year (97 cm/yr). Movement amounts near the east-flank shear zone ranged between about 2.2 and 2.5 inches (5.6–6.4 cm). The data shown on figure 27 suggest that movement likely continued through the early part of 2006.

Figure 26. Movement in and near landslide 1 between early October and mid-November 2005. Movement amounts (inches) and directions shown by yellow arrows. Boundaries of landslide 1 and other slides shown for reference (see plate 1 for further details). Base from U.S. Geological Survey Clear Creek Mountain 7.5' quadrangle. Shaded relief from 10-meter DEM.

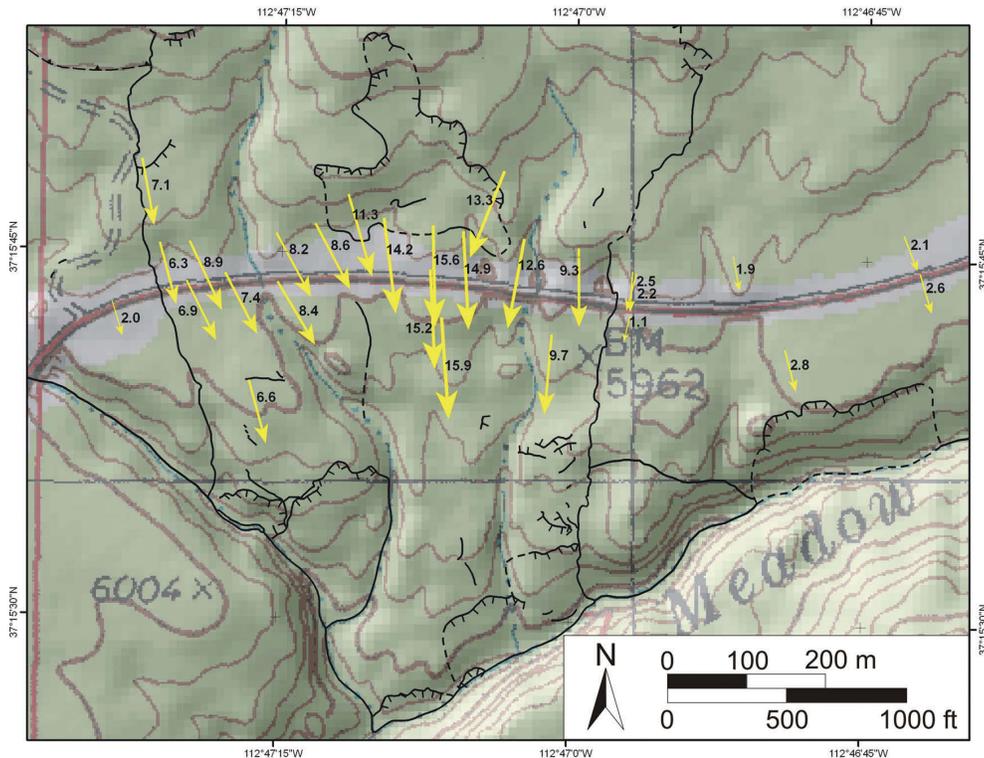
Figure 27. Movement in and near landslide 1 between mid-November 2005 and mid-June 2006. Movement amounts (inches) and directions shown by yellow arrows. Boundaries of landslide 1 and other slides shown for reference (see plate 1 for further details). Base from U.S. Geological Survey Clear Creek Mountain 7.5' quadrangle. Shaded relief from 10-meter DEM.

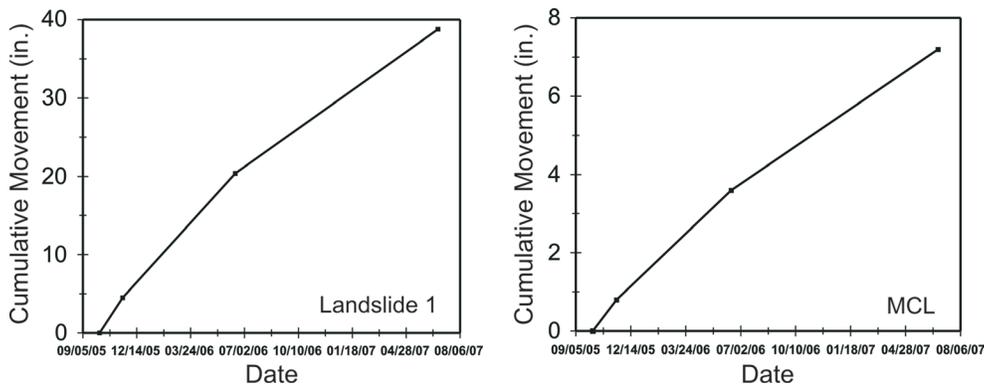
Figure 28. Cumulative movement history of landslide 1 and southern Meadow Creek landslide (MCL) between October 2005 and June 2007. Plots are for GPS stations with maximum movement during measurement period (see figure 23). Plots show that whereas the total movement of landslide 1 was five times greater than that of the lower part of the Meadow Creek landslide (note change in vertical scale), the change in movement rates were similar. The movement rates at both slides decreased in the dry years (2006 and 2007) following the 2005 wet year.

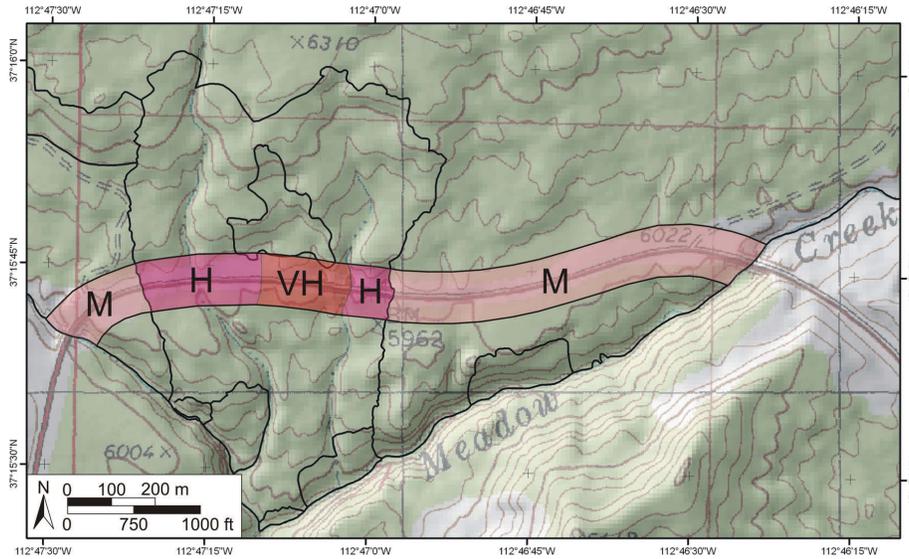
Figure 29. Movement-based zonation map of the SR-9 corridor. VH – very high, H – high, and M – moderate. See table 5 for additional explanation of hazard categories. Boundaries of landslide 1 and other slides shown for reference (see plate 1 for further details). Base from U.S. Geological Survey Clear Creek Mountain 7.5' quadrangle. Shaded relief from 10-meter DEM.

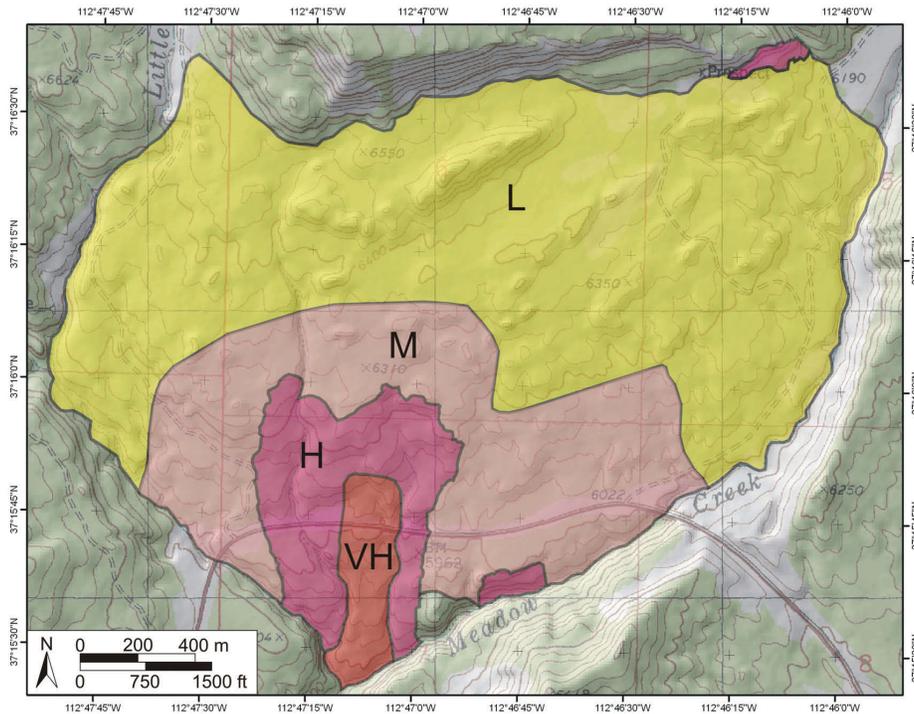
Figure 30. Movement-based zonation map of the Meadow Creek landslide. VH – very high, H – high, M – moderate, and L – low. See table 5 for additional explanation of hazard categories. Hazard-category boundaries based on movement measurements, mapped landslide boundaries, location of internal deformation features, and other field observations. Base from U.S. Geological Survey Clear Creek Mountain 7.5' quadrangle. Shaded relief from 10-meter DEM.

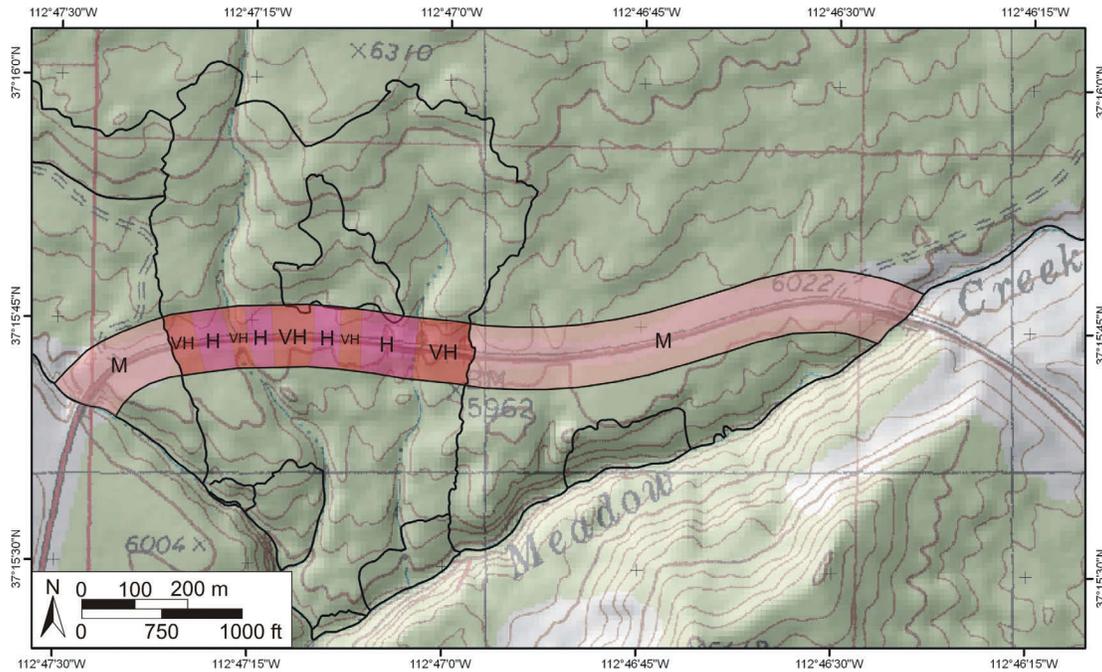
Figure 31. Distress-based zonation map of the SR-9 corridor. VH – very high, H – high, and M – moderate. See text for discussion of hazard categories. Boundaries of landslide 1 and other slides shown for reference (see plate 1 for further details). Base from U.S. Geological Survey Clear Creek Mountain 7.5' quadrangle. Shaded relief from 10-meter DEM.
