GEOLOGIC HAZARDS OF THE BULLFROG AND WAHWEAP HIGH-USE AREAS OF GLEN CANYON NATIONAL RECREATION AREA, SAN JUAN, KANE, AND GARFIELD COUNTIES, UTAH, AND COCONINO COUNTY, ARIZONA

by Tyler R. Knudsen, Adam I. Hiscock, William R. Lund, and Steve D. Bowman

SPECIAL STUDY 166
UTAH GEOLOGICAL SURVEY 2020
UTAH DEPARTMENT OF NATURAL RESOURCES
in cooperation with the National Park Service

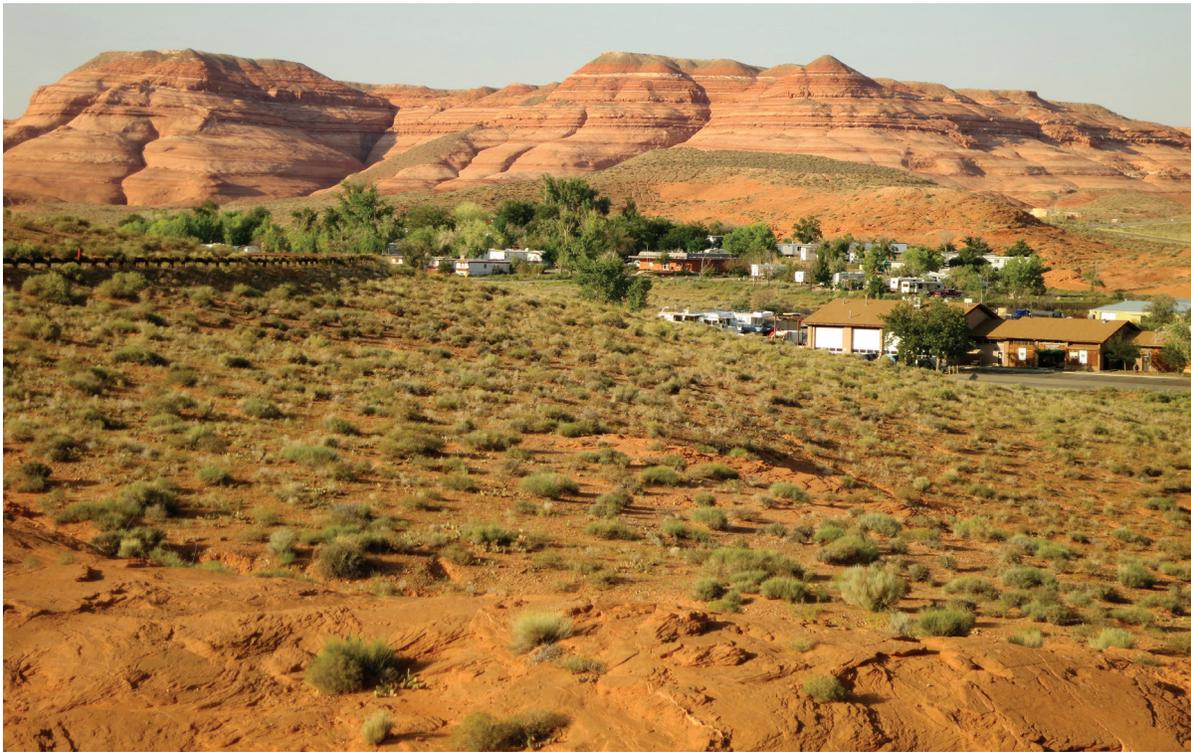
Figure 7. Facilities near Bullfrog are underlain by a thin mantle of mixed eolian-alluvial sand covering the Entrada Sandstone. Photo taken on August 19, 2015; view is to the northeast.

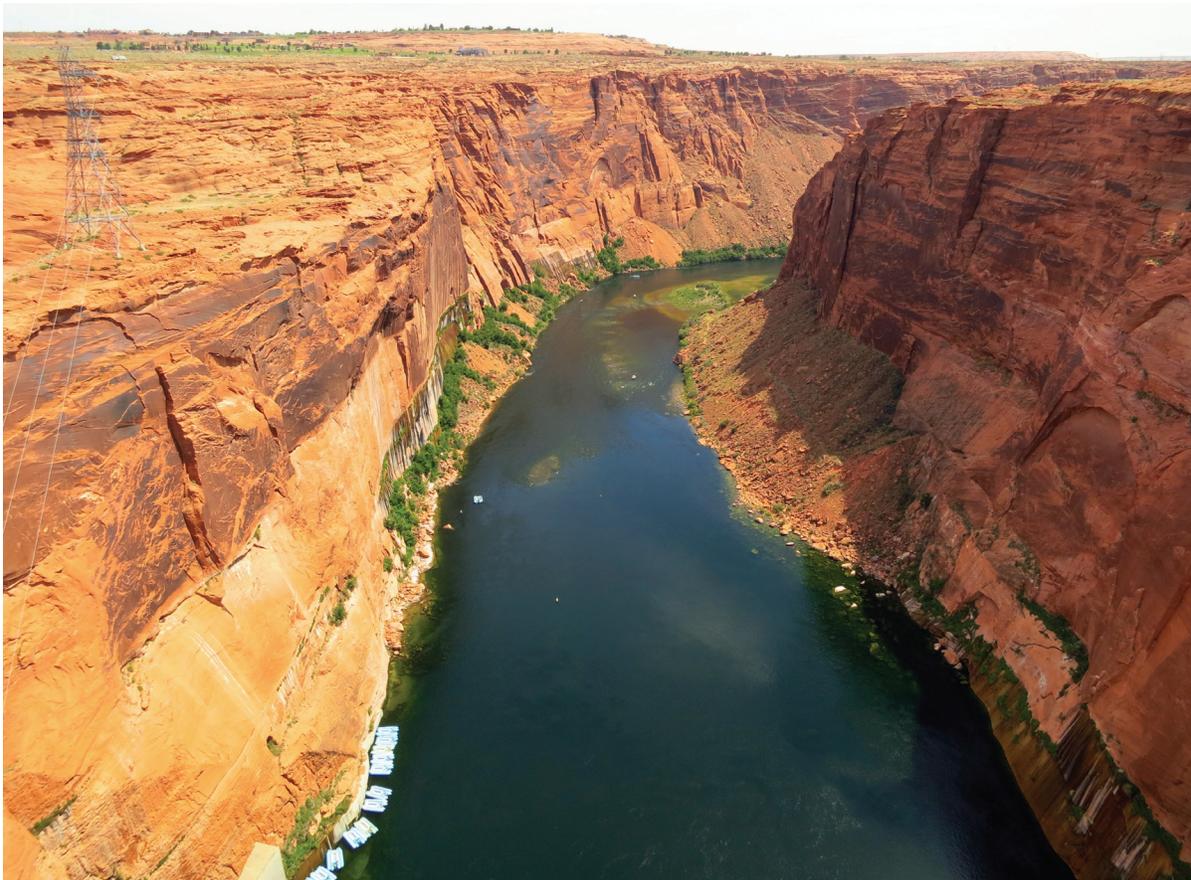
Figure 8. South-directed view of Glen Canyon and the Colorado River below Glen Canyon Dam. Canyon walls are jointed Navajo Sandstone. Talus deposits mantling lower slopes attest to the high rates of rockfall in the canyon. Photo taken on May 11, 2014.

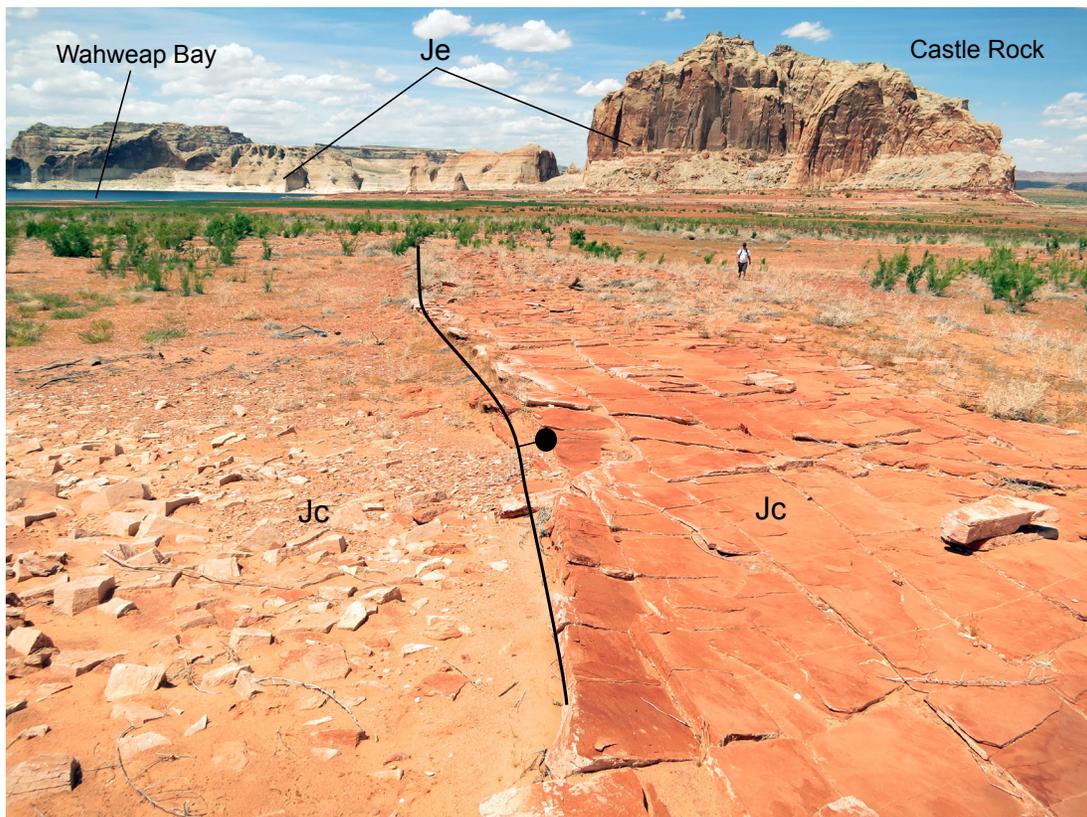
Figure 9. Foreground: a small-displacement normal fault juxtaposes different strata within the Carmel Formation (Jc) on Antelope Island near the Utah-Arizona border; bar and ball on downthrown side of fault. Distance: tall mesas of Entrada Sandstone (Je) bound the northern margin of Wahweap Bay. Photo taken on May 12, 2015; view is to the north.

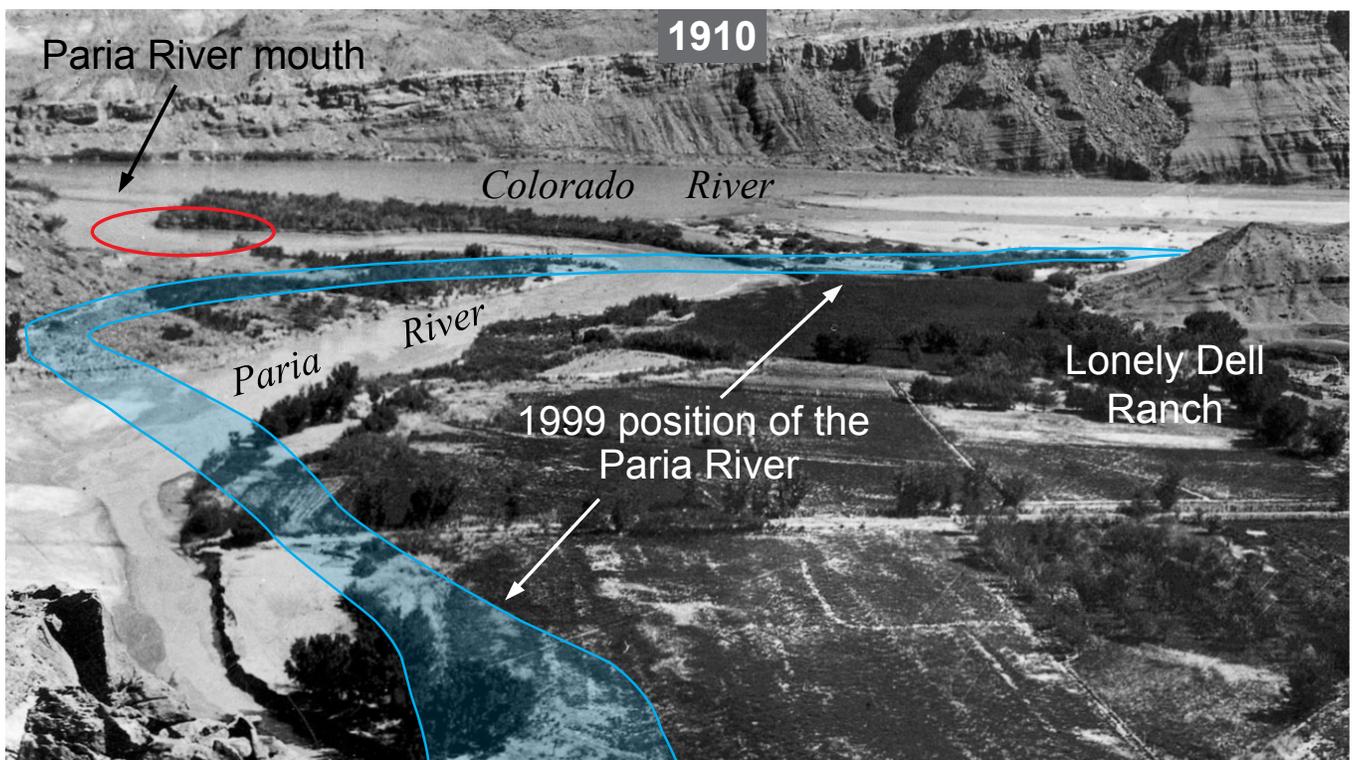
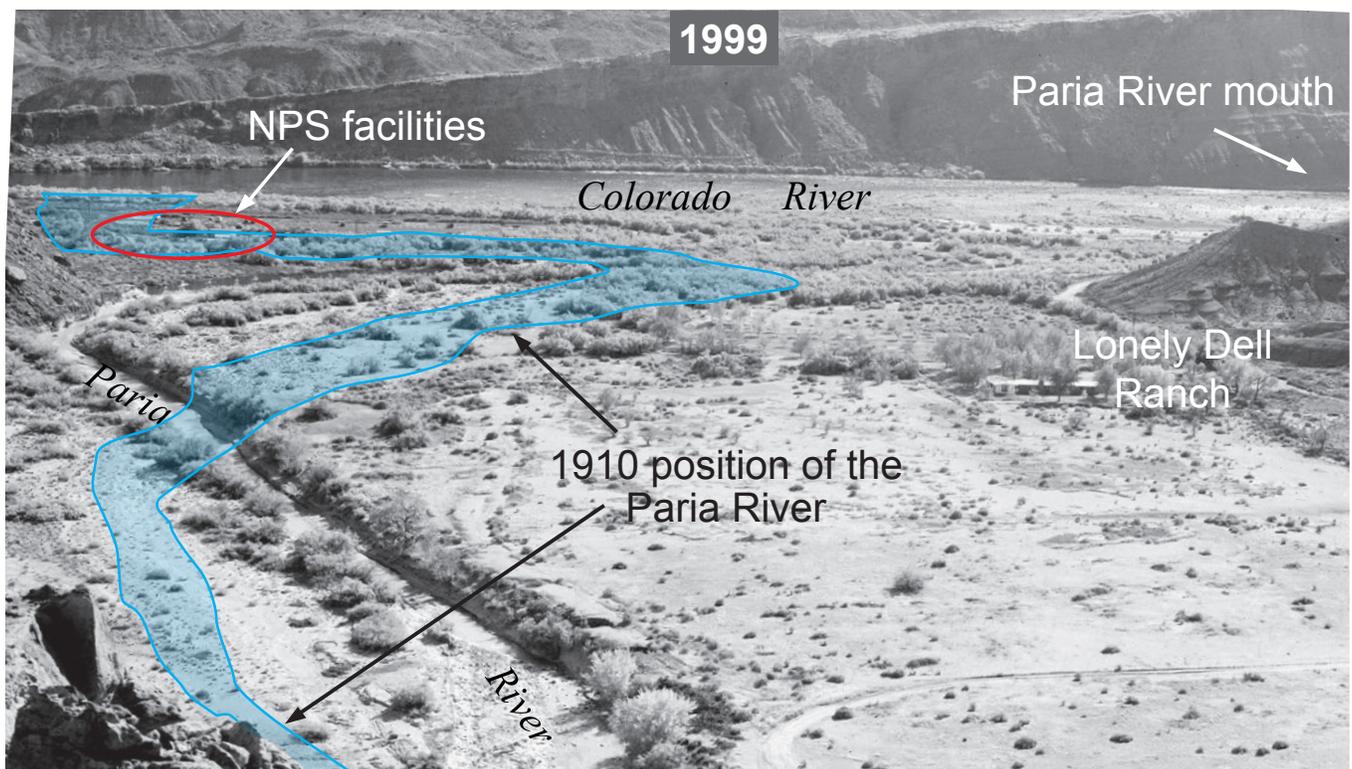
Figure 12. Photographs taken from the same vantage point of the confluence of the Paria and Colorado River in 1910 and 1999 near Lees Ferry; view is to the southeast. Red ellipse indicates location of the NPS maintenance facilities, which are coincident with the Paria River in 1910. Modified from Webb and Hereford (2003); 1910 photograph is by Albert H. Jones, courtesy of the Cline Library, Northern Arizona University; 1999 photograph by Robert Webb, U.S. Geological Survey.

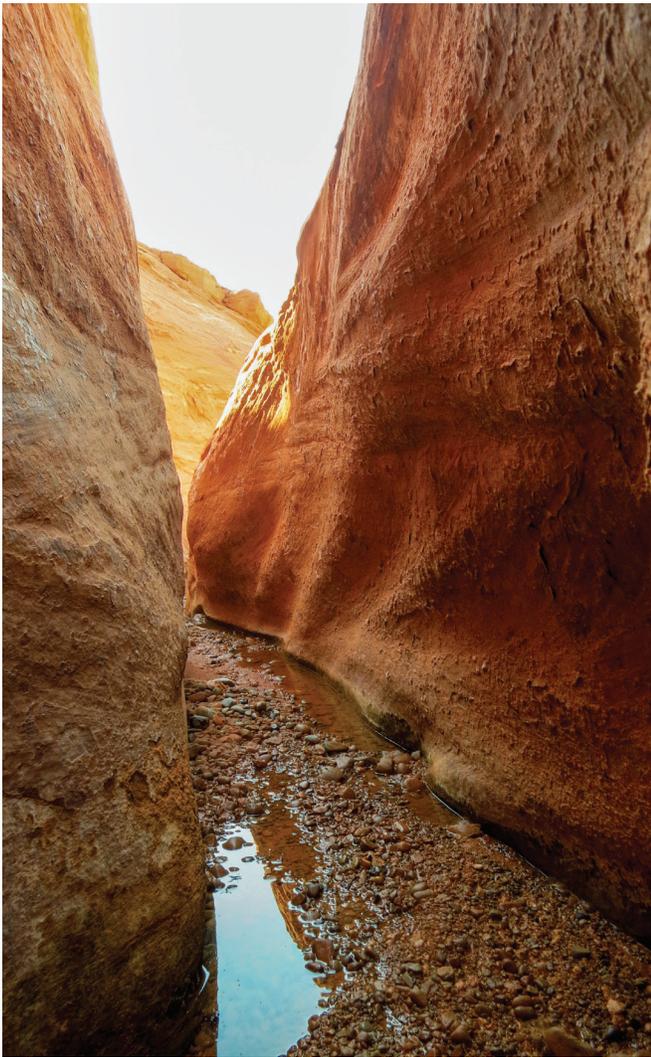
Figure 15. Short, unnamed slot canyon formed in Entrada Sandstone near the Bullfrog Visitor Center. The closely spaced, near-vertical walls of slot canyons can make it difficult for hikers and canyoneers to see approaching thunderstorms and to escape flash floods. Photo taken August 20, 2016.

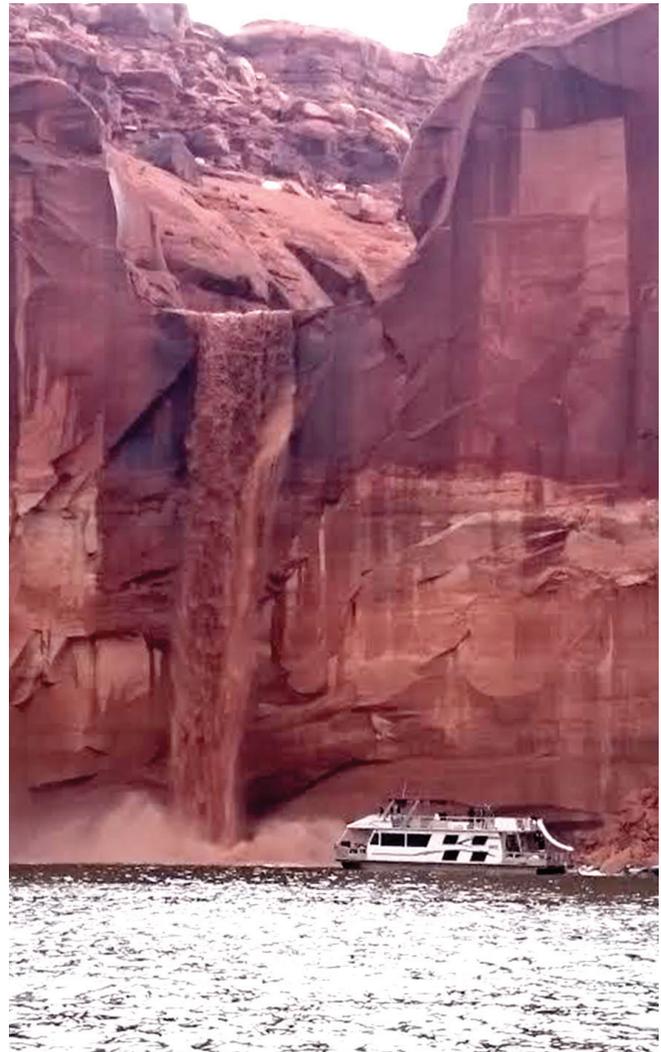
aware of the potentially high flood hazard. On June 6, 2015, intense rain from a thunderstorm caused a flash flood in an unnamed slightly hanging tributary of Crystal Springs Canyon. A boating group camping near the normally dry tributary's mouth (estimated to be about 15 to 20 feet (5–6 m) above lake level at the time) was stranded for several hours as the plunging floodwaters created a powerful eddy that ripped their three boats from their anchors and tossed them about (NOAA, 2016b; KSL, 2016). One 23-foot boat was hit and submerged by large boulders entrained in the cascading floodwaters and was a total loss.

Figure 16. Flash flood water plunges into Lake Powell from a normally dry hanging tributary on June 6, 2015. Such hanging drainages pose a significant hazard to boaters because they can be difficult to recognize from lake level. Photo courtesy of Valerie Reynolds, National Park Service.

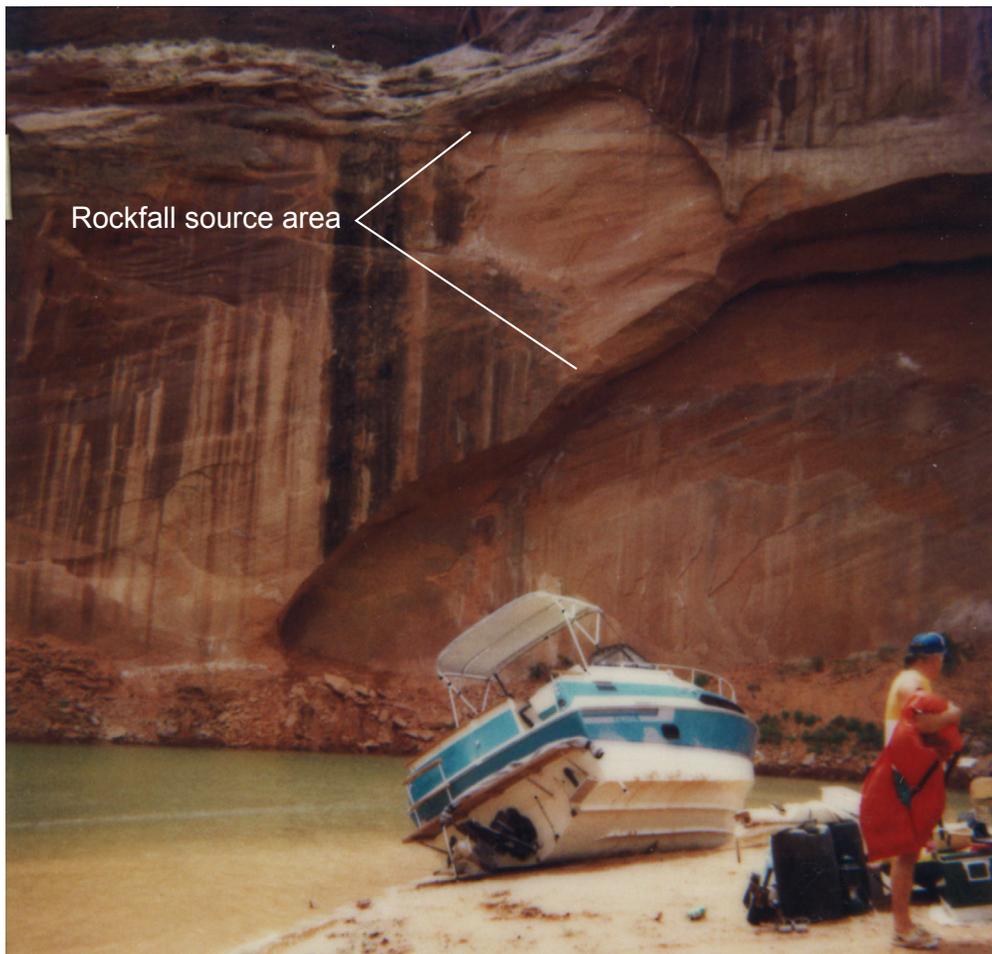
Rockfalls can produce large displacement waves that can greatly extend the hazard beyond the immediate area affected by the falling rock (Roberts and others, 2014). Displacement waves result from the rapid entry of landslides or rockfalls into enclosed water bodies (Hermanns and others, 2013; Roberts and others, 2014). Depending on the size of the mass entering the water, a displacement wave may have the form of a frontal push or a tsunami-like body wave (de Blasio, 2011). Large rockfalls in narrow channels that typify much of Lake Powell can produce sizeable waves capable of swamping boats and running up adjacent shorelines, damaging anchored boats and causing injury or death to campers. In June 1974, a large rock slab released from a Navajo Sandstone cliff in the main channel of Lake Powell near Iceberg Canyon. The resulting displacement wave lifted a boat anchored across the main channel and deposited it 40 feet from the shoreline (Grundvig, 1980). In June 1987, a rockfall in Llewellyn Gulch caused a large wave that grounded a nearby speedboat, injuring the boat operator (figure 22) (NPS, unpublished internal documents).

Figure 22. Speedboat beached by a large displacement wave caused by rockfall in Llewellyn Gulch. National Park Service photo taken June 5, 1987.

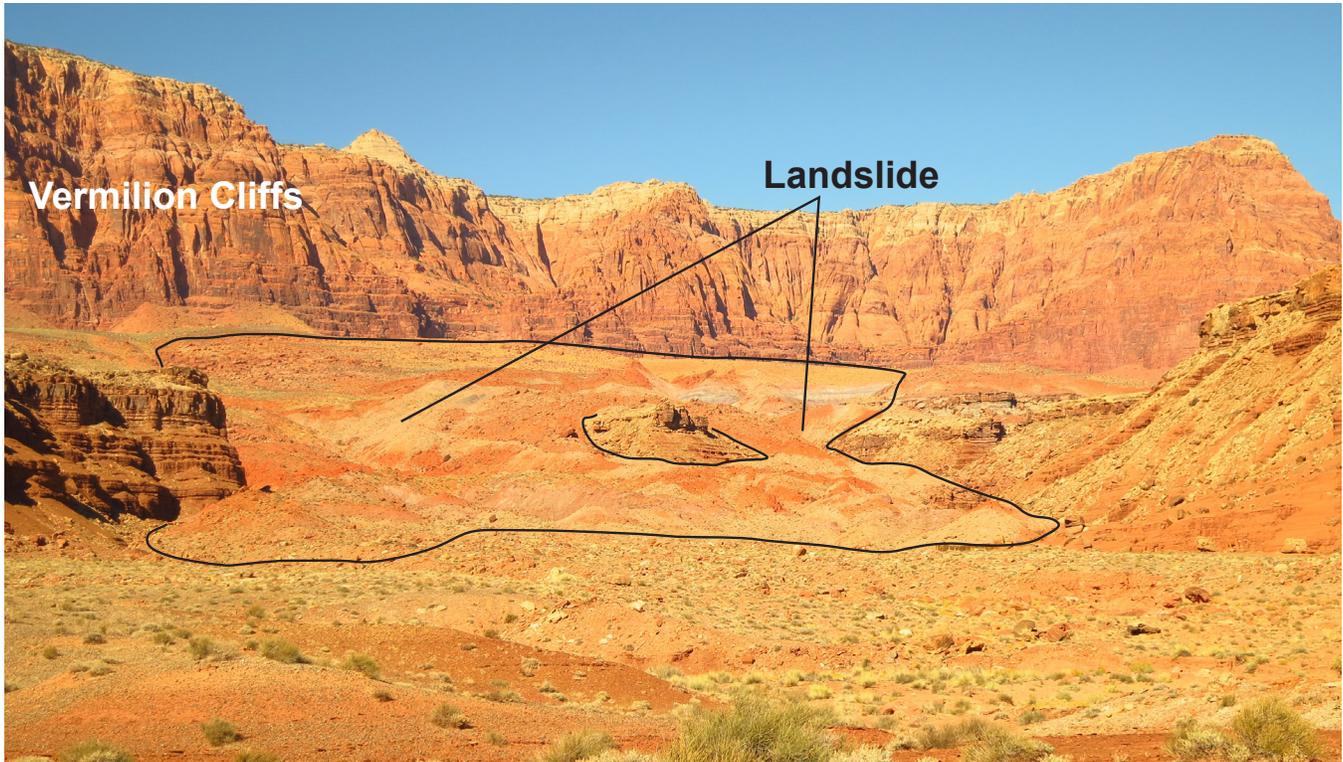
Figure 27. Nearly 1-mile-long landslide sourced from clay-rich upper Chinle Formation near Lees Ferry. The long, earthflow-type deposit indicates that groundwater was higher at the time of movement than it is today.
