INTRODUCTION

FLOOD AND DEBRIS-FLOW HAZARDS STATE ROUTE 9 CORRIDOR GEOLOGIC-HAZARD STUDY AREA, WASHINGTON COUNTY, UTAH

by
Tyler R. Knudsen and William R. Lund
2013

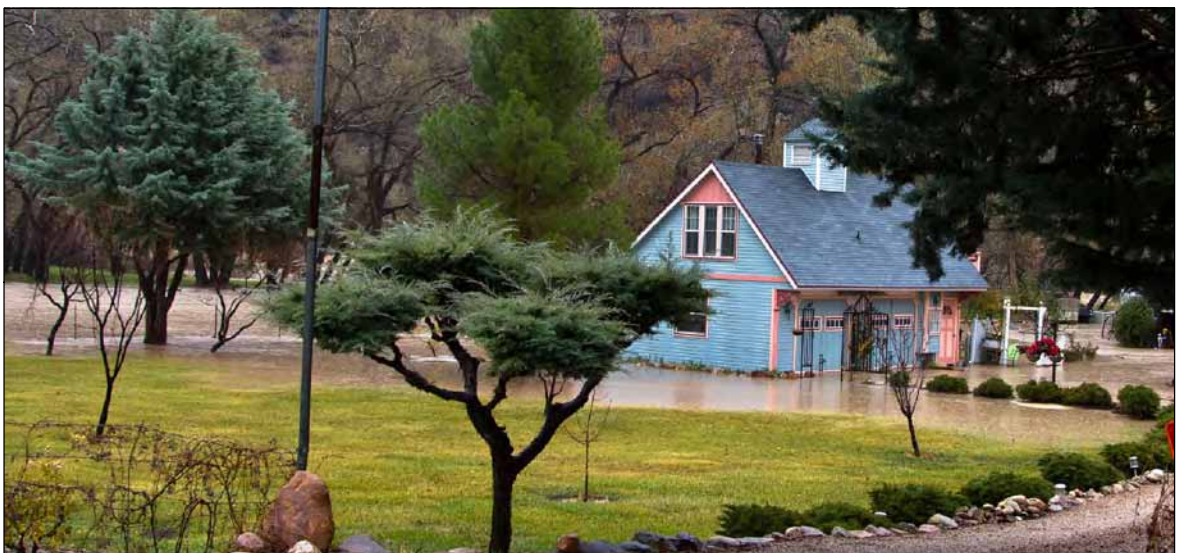
Figure 1. Rockville home damaged by flooding on the Virgin River in December 2010 (photo credit Kurt Sparrowberg).

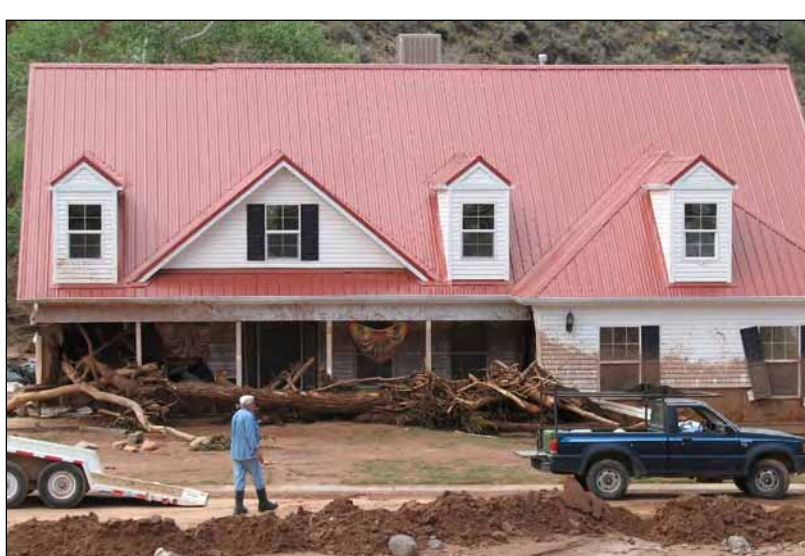
Figure 2. Home damaged by flash flooding on North Creek near Virgin in August 2007.
