SALT TECTONICS-RELATED GROUND DEFORMATION HAZARD MAP OF THE MOAB QUADRANGLE, GRAND COUNTY, UTAH

Jessica J. Castleton, Ben A. Erickson, and Emily J. Kleber

2018

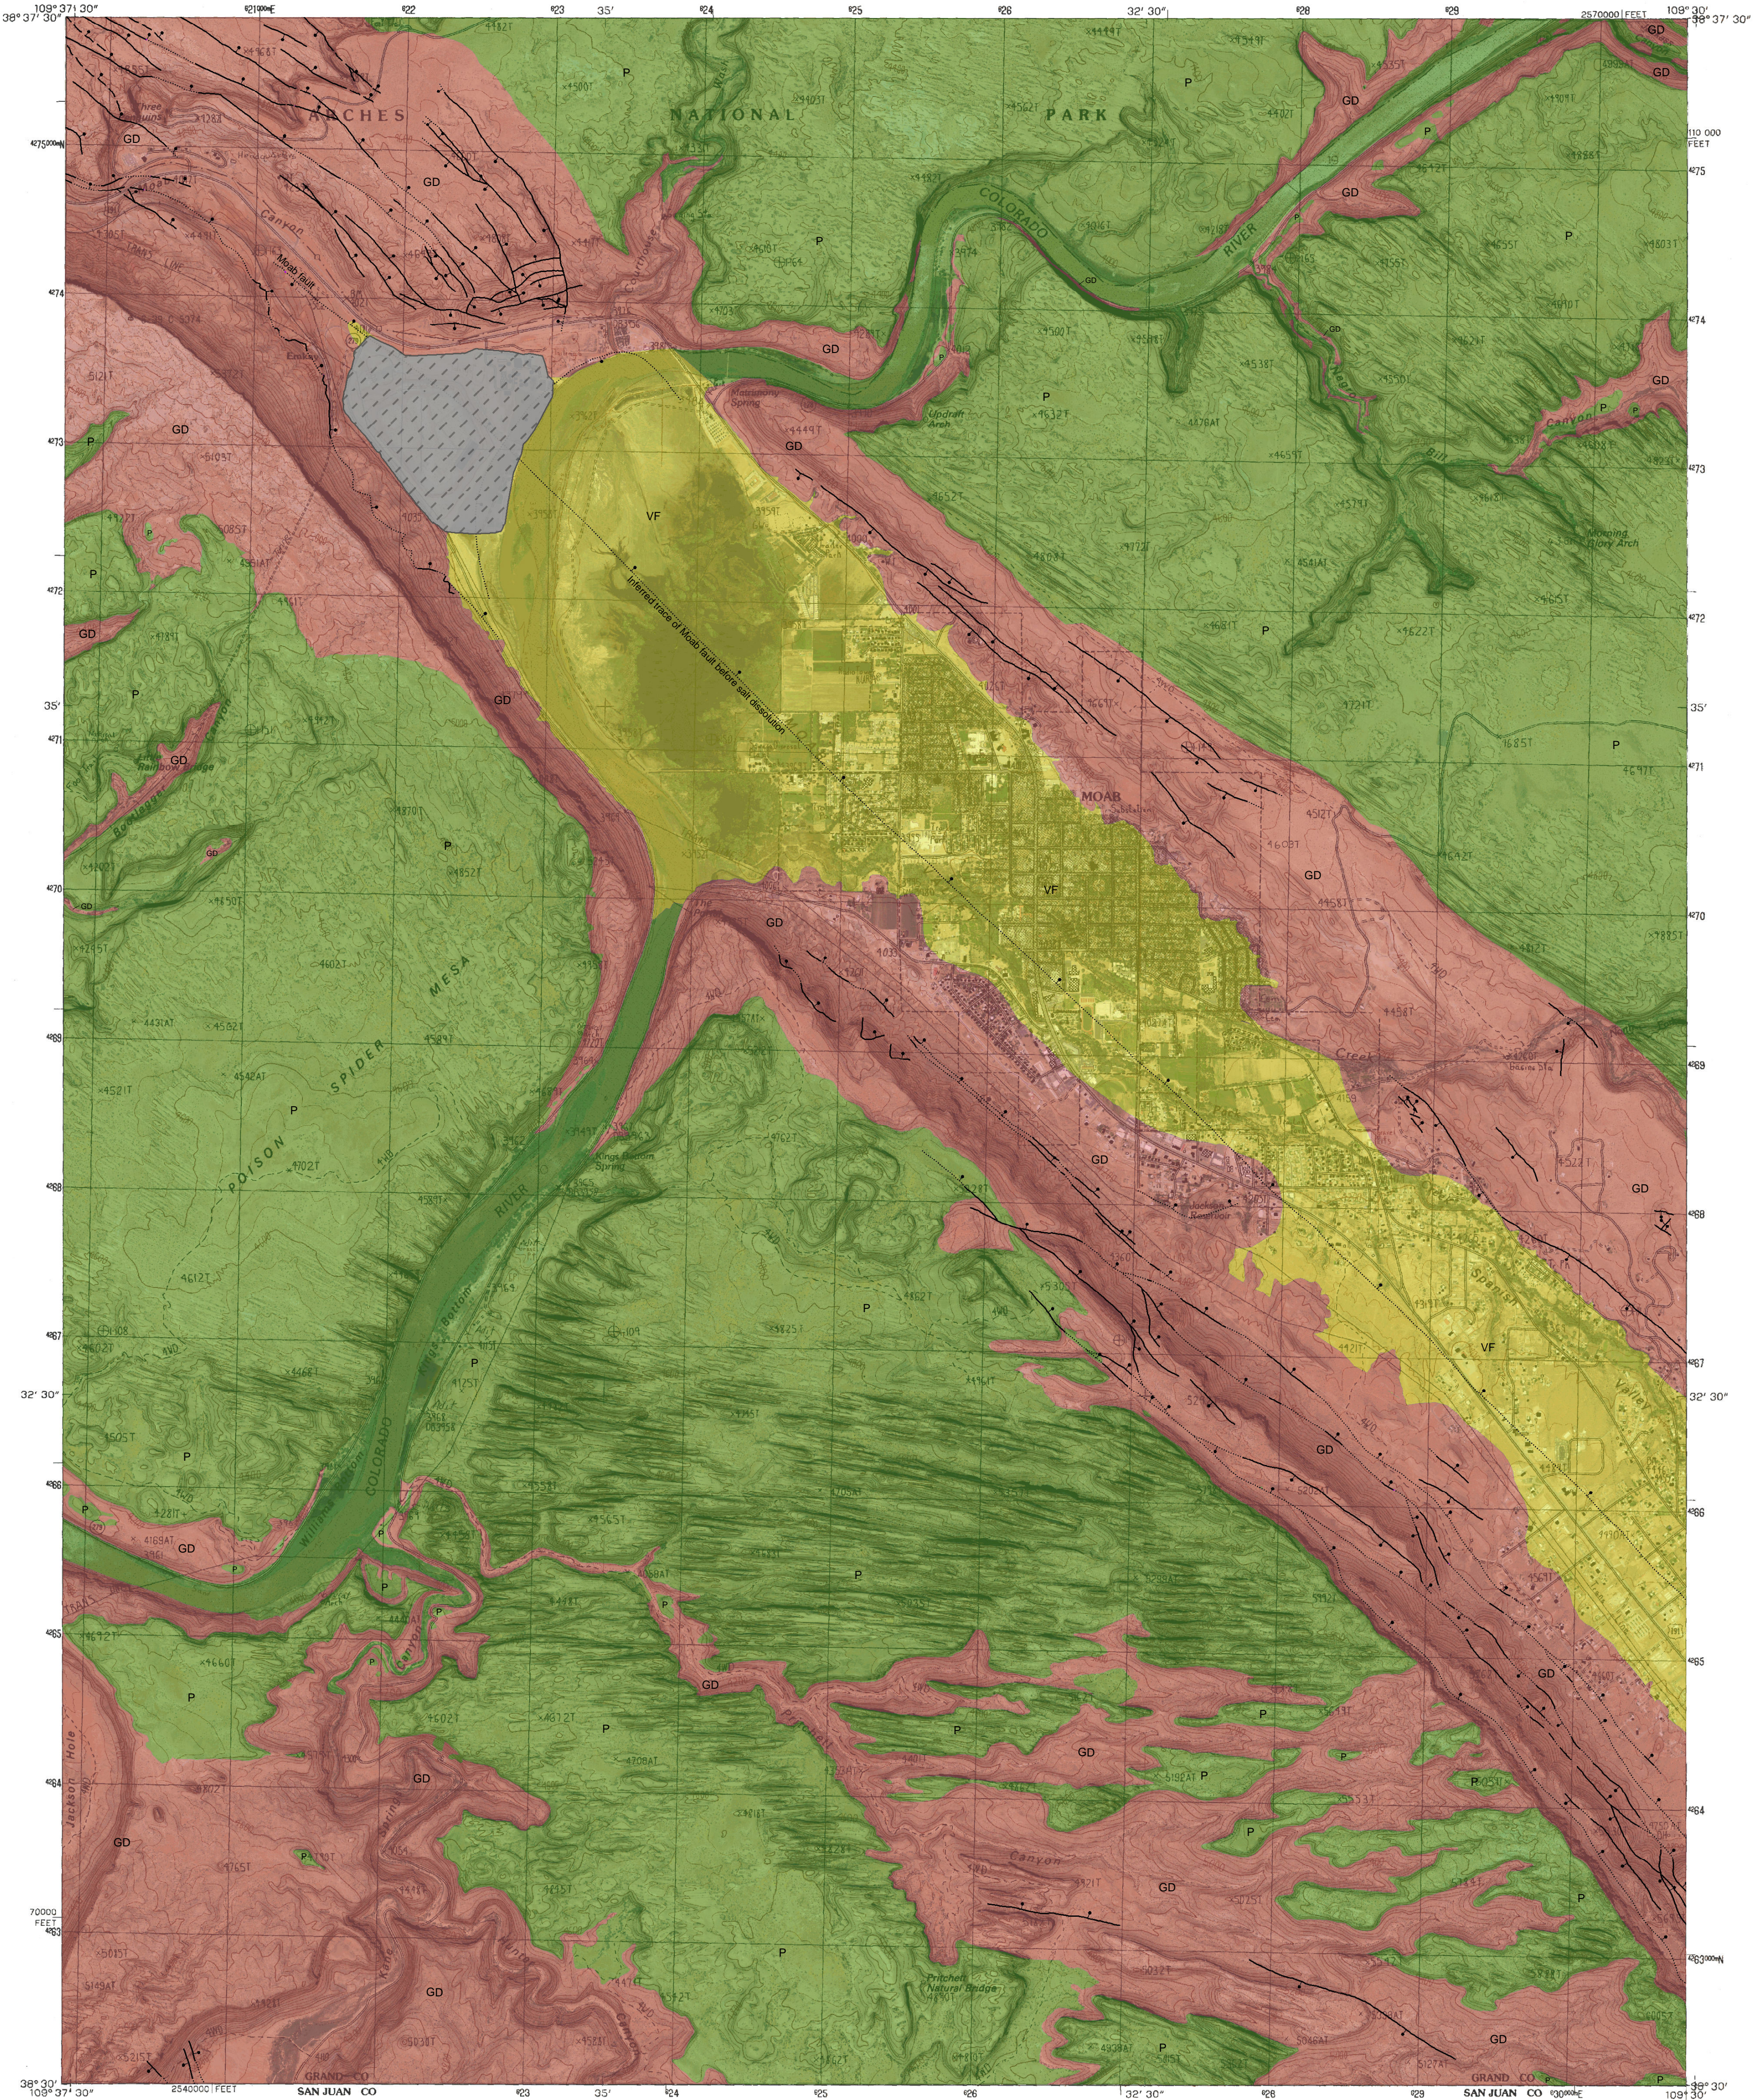
- Not Mapped** – Area not mapped due to significant and ongoing human disturbance.
- Well-located fault related to salt tectonics with an unknown activity class** – Surface-fault-rupture-hazard investigations recommended for all structures intended for human occupancy and all International Building Code (IBC; International Code Council, 2014) Risk Category IIa, IIb, III, and IV structures (see Lund and others, 2016). Ball and bar on downthrown side of fault.
- Approximately located or concealed fault related to salt tectonics with an unknown activity class** – Surface-fault-rupture-hazard investigations recommended for all IBC Risk Category III and IV structures (see Lund and others, 2016). Studies for IBC Risk Category IIa and other structures for human occupancy remain prudent because a low likelihood of surface faulting still exists. Ball and bar on downthrown side of fault.

- GD** **Ground Deformation** – Severe ground deformation related to salt tectonics, causing tilting and/or damage to structures due to differential settlement, lateral earth pressures, ground cracks or displacements in fractured rock, and ground collapse including sinkhole formation.
- VF** **Potential Valley Floor Subsidence** – Potential ground subsidence causing tilting and/or damage to structures due to differential settlement, lateral earth pressures, ground cracks or displacements in fractured rock, and ground collapse, including sinkhole formation.
- P** **Plateau Subsidence** – Potential regional and local subsidence causing fracturing and displacement of rock. Fractures weaken the rock and can lead to unstable conditions in road cuts and tunnels, increase potential for aquifer contamination, and increase susceptibility to rockfall and slope instability.

This map shows the potential for ground deformation and subsidence, fractured rock and faulting related to salt tectonics. Due to the unpredictable nature of salt tectonics, we have mapped ground deformation based on analysis of geologic units, mapped faults, and existing ground deformation. Ground deformation in this area may be severe. Continued ground deformation and subsidence, possible surface fault rupture, and other hazards such as sinkhole formation, ground cracking, differential settlement, and widespread subsurface erosion can occur in the zone of ground deformation. Also mapped is the potential for valley floor subsidence which can cause tilting and/or damage to structures due to differential settlement, lateral earth pressures, ground cracks or displacements in fractured rock, and ground collapse including sinkhole formation. The plateau and canyon areas are subject to regional and local subsidence causing fracturing and displacement of rock. Fractures weaken the rock mass and can lead to unstable conditions in road cuts and tunnels, increase potential for aquifer contamination, and increase susceptibility to rockfall and slope instability. Potentially active, salt-tectonic, gravity-related faults within the Moab quadrangle are shown on the map. Surface faulting may occur along these faults or anywhere along the valley margins. Mapped faults are related to salt dissolution at depth (see Guerrero and others, 2014) and therefore have an unknown activity class. The inferred trace of the Moab fault does not include a special study zone because of the age of faulting (see associated text).
