THE JUNE 3, 2005, BLACK MOUNTAIN DEBRIS FLOW, IRON COUNTY, UTAH

Richard E. Giraud

ABSTRACT

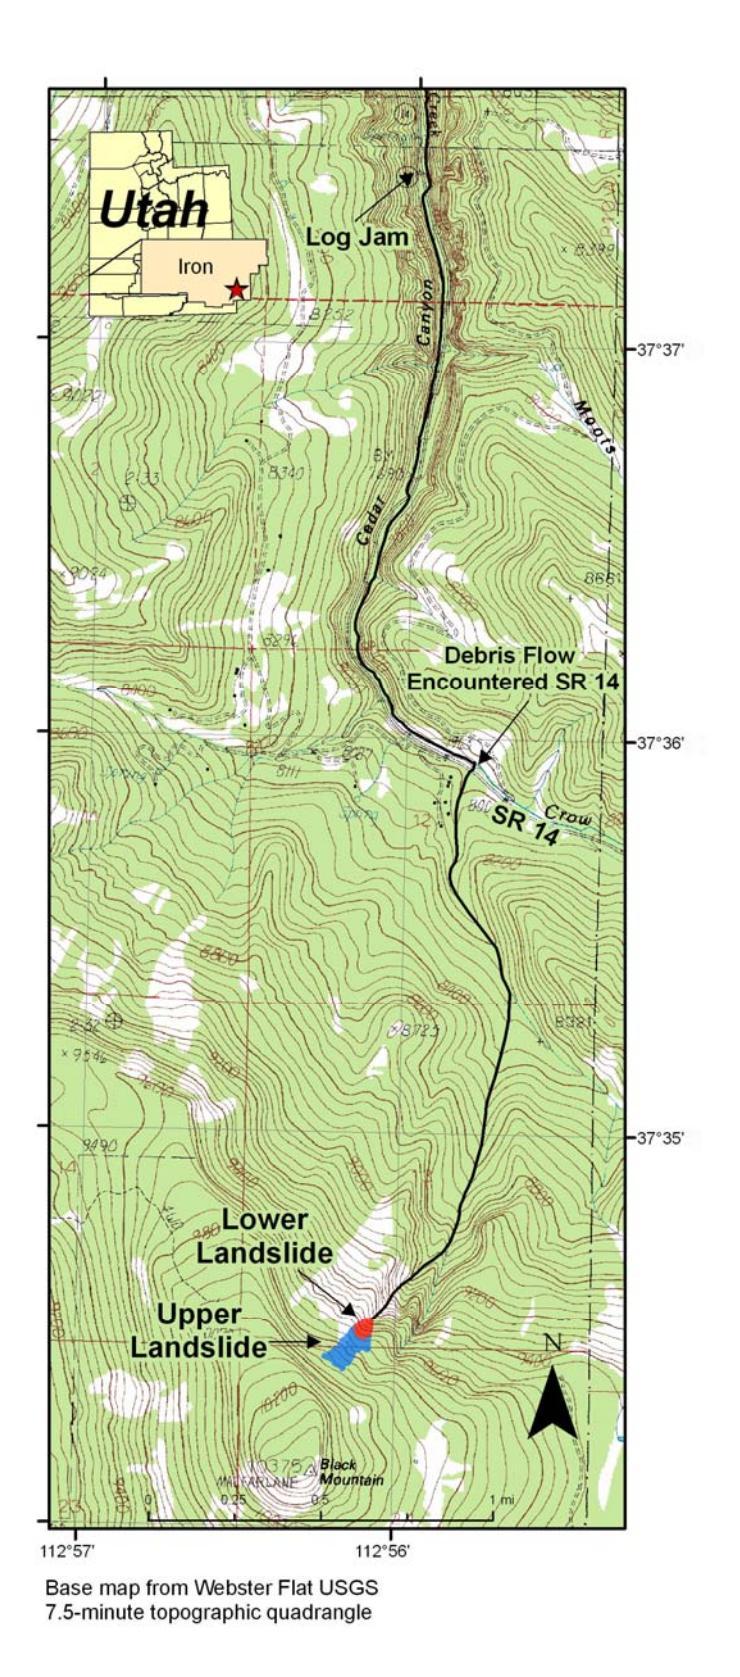
Figure 1. Map showing upper and lower landslide and flow path (heavy black line) of the Black Mountain debris flow and related flooding in Cedar Canyon.

On the morning of June 3, 2005, a pre-existing landslide on the north side of Black Mountain in southeastern Iron County reactivated and generated a large debris flow, which flowed approximately 1.6 miles down an unnamed stream drainage before encountering Utah State Route 14 (SR-14) and Crow Creek (figure 1). Lund and others (2005) made a reconnaissance on June 4, 2005, to document the event, determine the debris flow source, and evaluate the resulting damage. The debris flow buried a 100-foot-long section of SR-14 with mud, boulders, and large trees, and then continued down Crow Creek (Cedar Canyon) causing erosion and flood damage to SR-14 at several locations and blocking culverts with large tree trunks and gravel- to boulder-size debris (figure 1) (Lund and others, 2005). Water from Crow

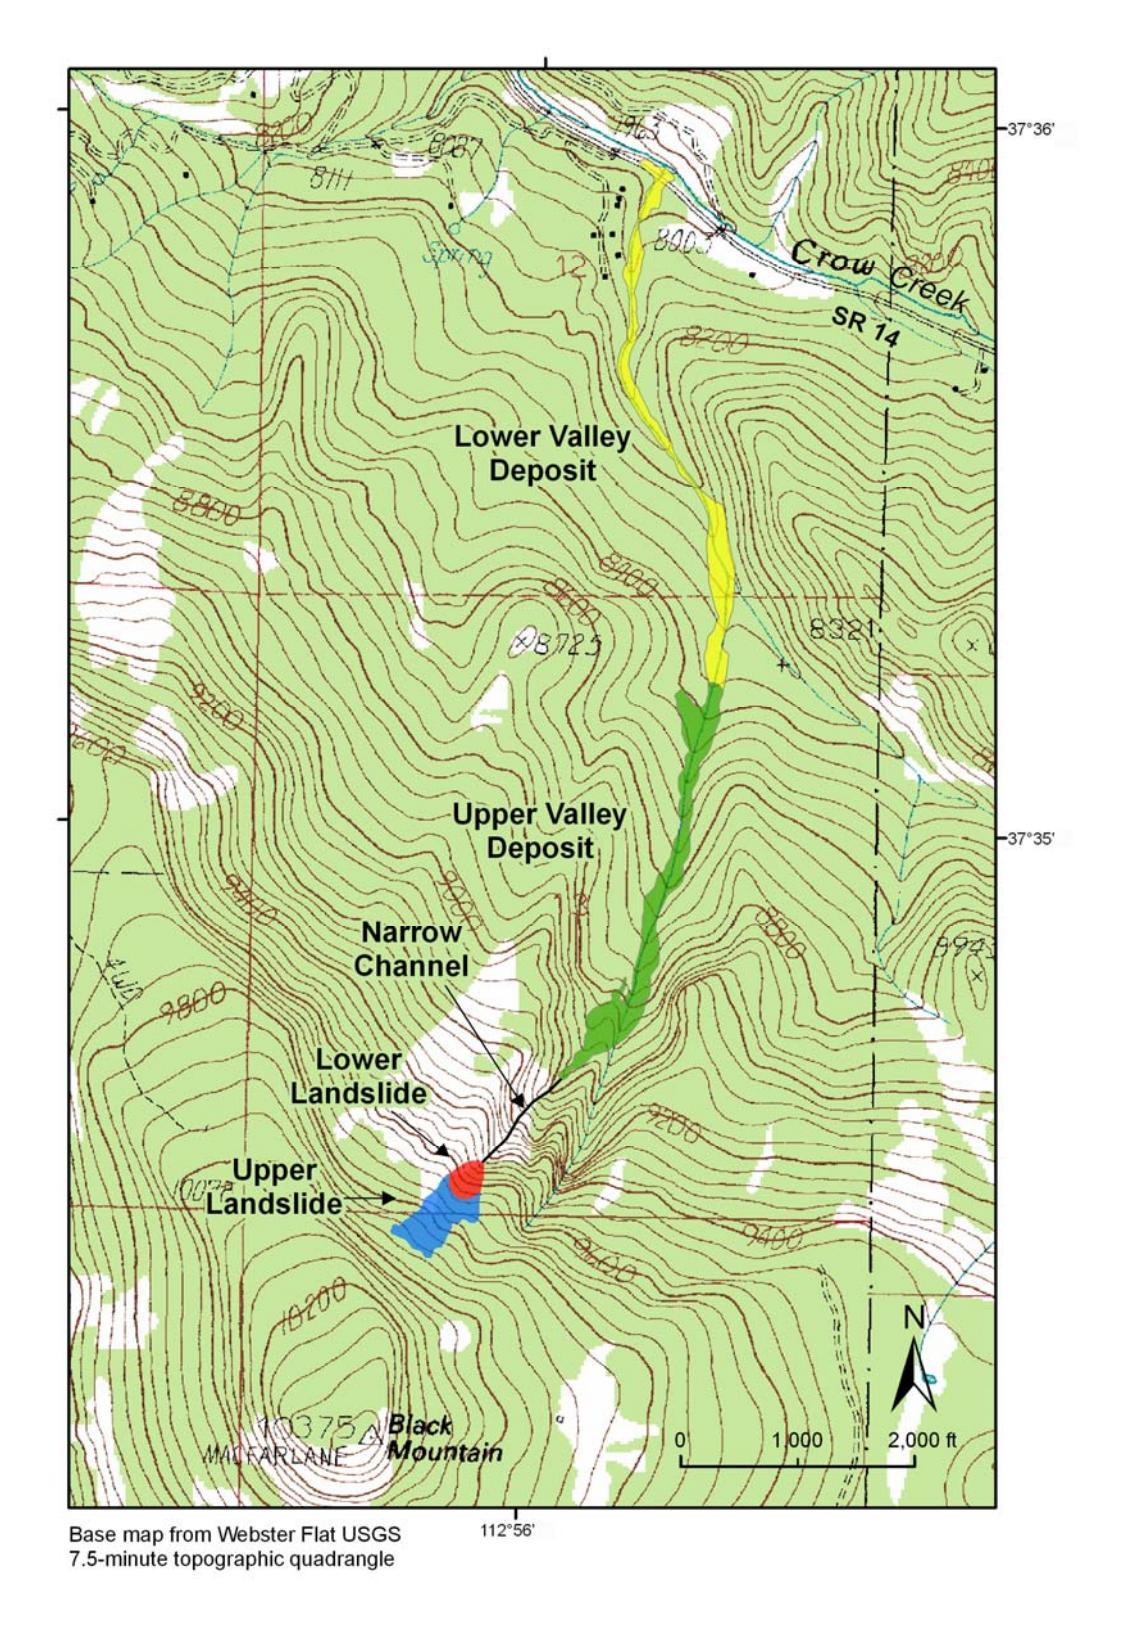
Figure 2. Map showing upper and lower landslide, narrow channel, and upper and lower valley debris-flow deposits.

The Black Mountain landslide consists of two distinct parts, an upper and a lower landslide (figure 2). Table 1 shows the physical characteristics of the upper and the lower landslide. The upper landslide is shown in figures 2 and 3. On June 3, 2005, the lower landslide catastrophically released into the steep, narrow mountain channel (figures 2 and 4), and quickly

Based on deposit character, we mapped upper and lower debris-flow deposits in the unnamed stream valley (figure 2). The upper valley deposit covers and obscures the pre-existing flow topography and previous debris-flow deposits. The upper and lower valley debris-flow deposits are composed of gravel, sand, silt, and clay with boulders and cobbles of basalt and sandstone. The debris flow demolished a forest along the upper valley floor, and both upper and lower valley debris-flow deposits contain tree trunks and woody debris. Both matrix-supported and clast-supported textures were observed in the deposits.

The upper valley debris-flow deposit below the mountain channel is as much as 550 feet wide and locally as much as 10 feet thick (figure 9). Below an elevation of 8800 feet the deposit narrows, and from 8440 to 8400 feet elevation a small lobe of material was deposited along the west edge of the valley (figure 2). The deposit thins downvalley and is only 1 to 2 feet thick immediately upstream from the lower valley deposit. The largest observed boulder in the deposit is 22 feet long (figure 10). We measured scour depths as deep as 30 feet in the drainage channel along the upper deposit; however, the original channel depth is unknown. Along the drainage channel, stream flow late in the debris flow event incised into 2005 debris-flow deposit. The upper deposit is wide and has a rough surface (figures 9 and11).

The break between the upper and lower valley deposits is at an elevation of 8360 feet (figure 2). Compared to the upper valley deposit, the lower valley deposit is narrower, thinner, smoother, and lacks the demolished forest and tree trim lines (figure 12). The drainage channel was locally scoured as deep as 3 feet, but erosion from the lower valley did not add a significant volume of material to the debris flow. The lower valley deposit is generally 1 to 2 feet thick, has an average slope of 9% (5°), an estimated volume of 18,000 cubic yards, and area of 12.9 acres.

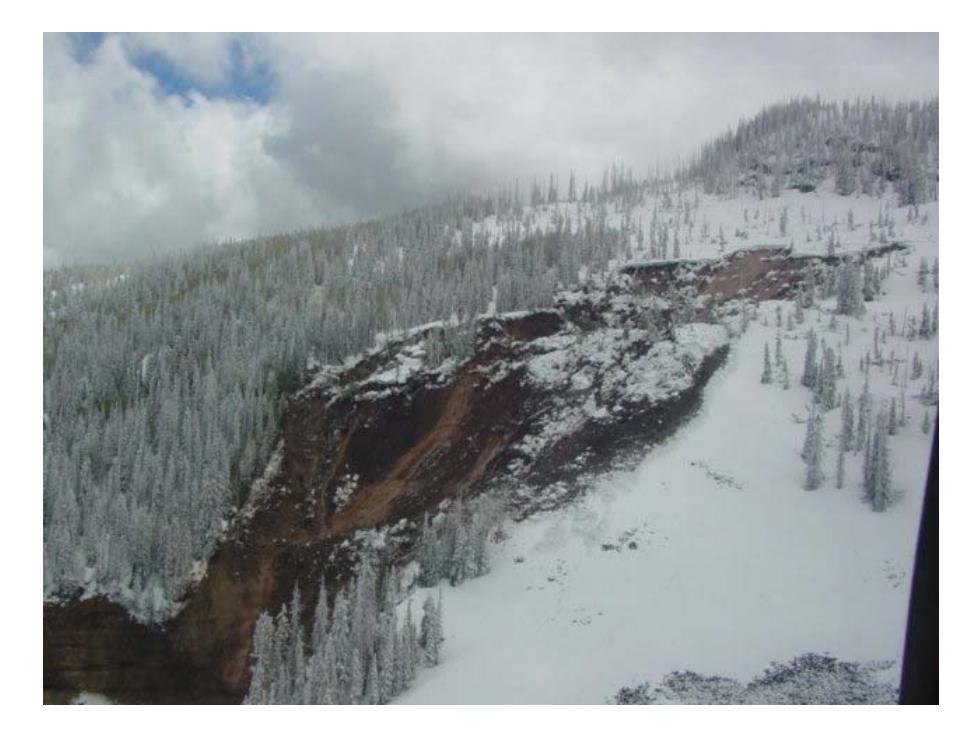
Figure 3. The remaining upper landslide on the north side of Black Mountain. The upper landslide is perched above the narrow mountain channel (figure 4) that is out of view and below the photo. Photo taken on June 3, 2005, by Lt. David Excel, Utah Highway Patrol.

The upper landslide has a very rough surface and consists of clay-rich debris with angular cobbles and boulders of basalt and sandstone (figures 3 and 7). Where exposed downslope from the main scarp of the upper landslide, the rupture surface beneath the upper part of the upper landslide is shallow and movement involved only the upper few vertical feet of slope (figure 7). The rupture surface dips from 58 to 67% (30 to 34°) and formed in weathered, soft, low-strength shale and mudstone. However, the rupture surface becomes significantly deeper downslope, and we estimate it was 40 to 50 feet deep where the lower landslide catastrophically failed into the mountain channel (figures 5 and 6). Several springs are present in the evacuated area and were discharging in late July 2005 from the exposed rupture surface.

Aerial photos and field observations indicate a snowpack approximately 3 feet thick remained on Black Mountain on June 3, 2005 (figure 3). The remaining snowpack indicates that only partial snowpack melting was sufficient to trigger landslide movement. A rapid rate of snowmelt over several days may be a more critical parameter in triggering landslides than the total volume of snow melted and water added. Melting of an above-average snowpack in 1983 triggered numerous landslides in Utah, and Wieczorek and others (1989) observed that most of those landslides triggered during the most rapid period of snowmelt.

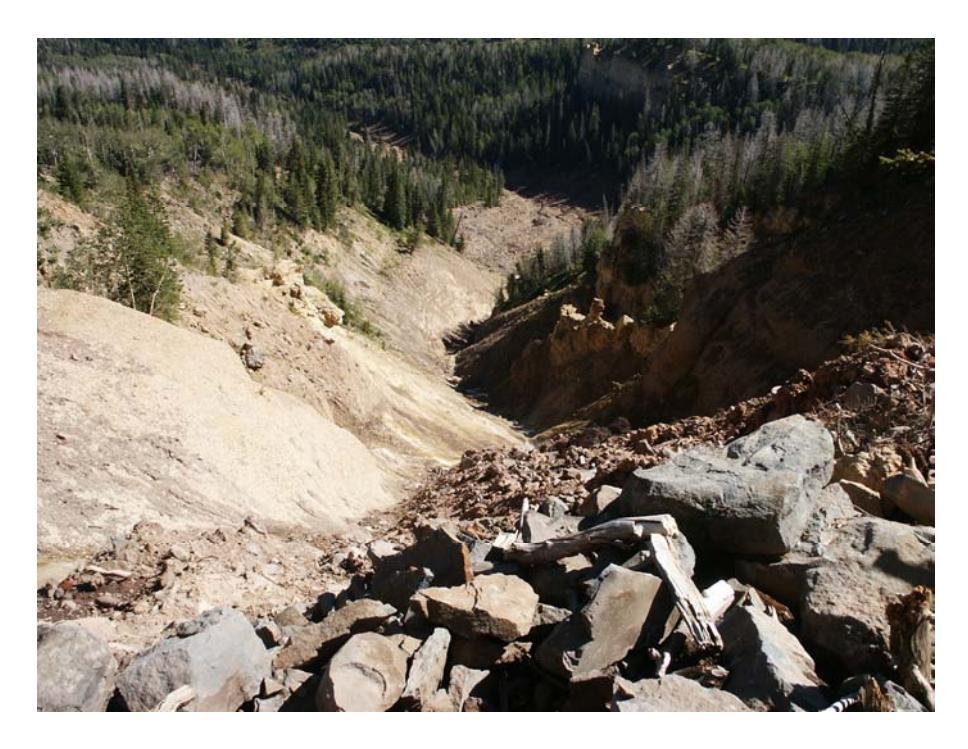
Figure 4. View down the steep, narrow mountain channel. The lower part of the landslide released into the channel and was transformed into a rapidly moving debris flow. Part of the debris-flow path is evident below the channel.

The steep, narrow mountain channel played an important role in the formation of the debris flow by promoting mixing and acceleration of landslide material released into the channel (figure 4). The channel is a distinct topographic feature at the head of the unnamed stream valley (figure 2). The channel has an average gradient of 45% (24°), but steeper parts have gradients of as much as 103% (46°). The channel also has several short, vertical drops, which accelerated mixing of material moving down the channel. Snowmelt water in the narrow channel and in the unnamed stream valley below was incorporated into the flowing mass. Upon exiting the channel, the rapidly moving debris flow superelevated (climbed) up onto the east wall of the unnamed stream valley (figures 2 and 9). The debris flow then quickly traveled the 1.6 miles to SR-14 and Crow Creek. The long runout distance is due to the water content of the flow, the

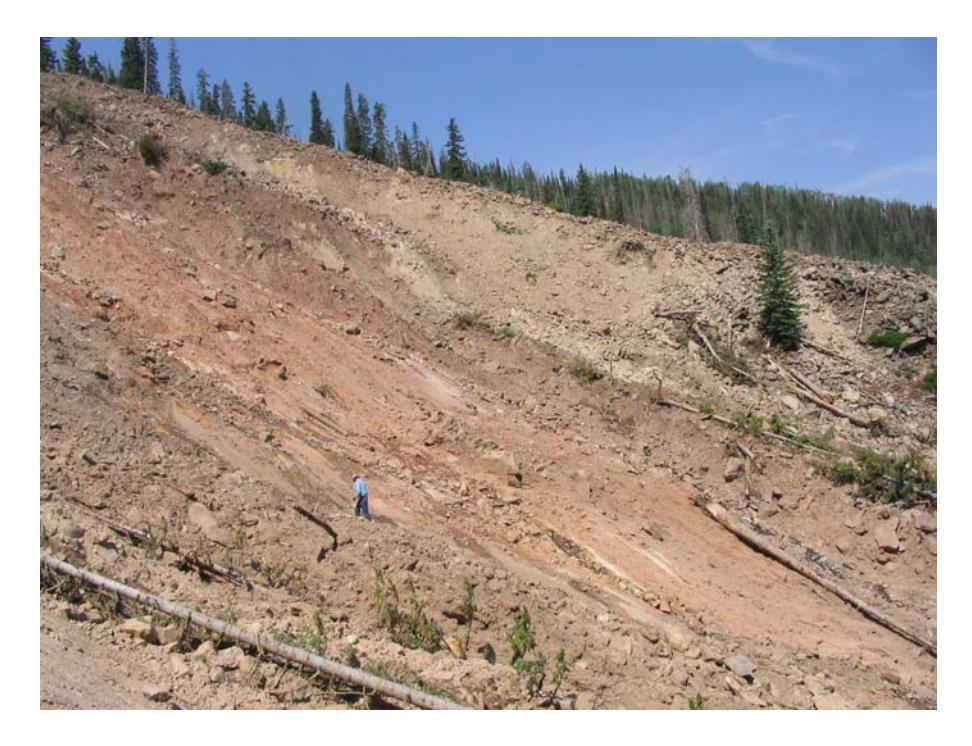
Figure 5. View west into the evacuated area of the lower landslide. The estimated evacuated volume is 50,000 to 60,000 cubic yards. The landslide left flank (upper part of photo) exposes basalt talus. The reddish colored material is weathered shale and mudstone and is the landslide rupture surface.

transformed into the Black Mountain debris flow. The upper landslide moved downslope but did not release into the channel and remains perched on the mountain slope. A large evacuated area now exists where the lower landslide was formerly located (figure 5). We estimate the volume of lower landslide material released was between 50,000 and 60,000 cubic yards. An estimated 155,000 to 160,000 cubic yards of material remains in the upper landslide, which is perched above the narrow channel (figure 6). The landslide volume estimates are based on methods outlined by Cruden and Varnes (1996, p. 42-43). Based on the position of the pre-existing landslide's main scarp as indicated on 2004 aerial photos, the main scarp of the upper 2005 landslide is 400 feet upslope and slightly to the west. Both the upper and lower landslides have steep slopes (table 1).

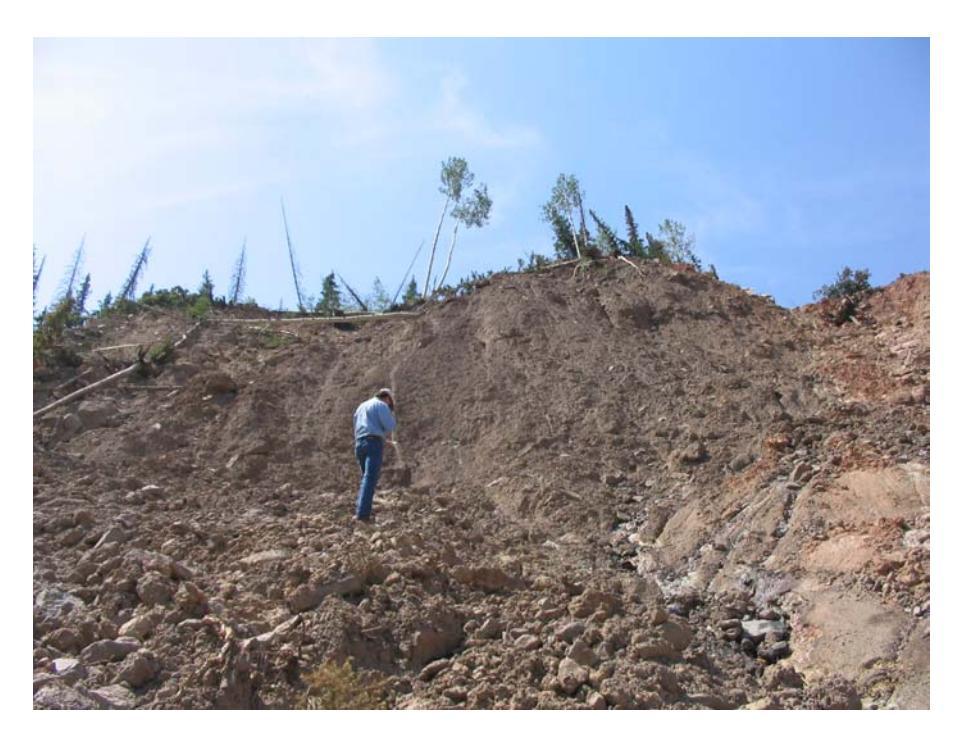
Figure 6. View from the evacuated area of the lower landslide toward the remaining upper landslide. The upper landslide lies on a steep rupture surface.

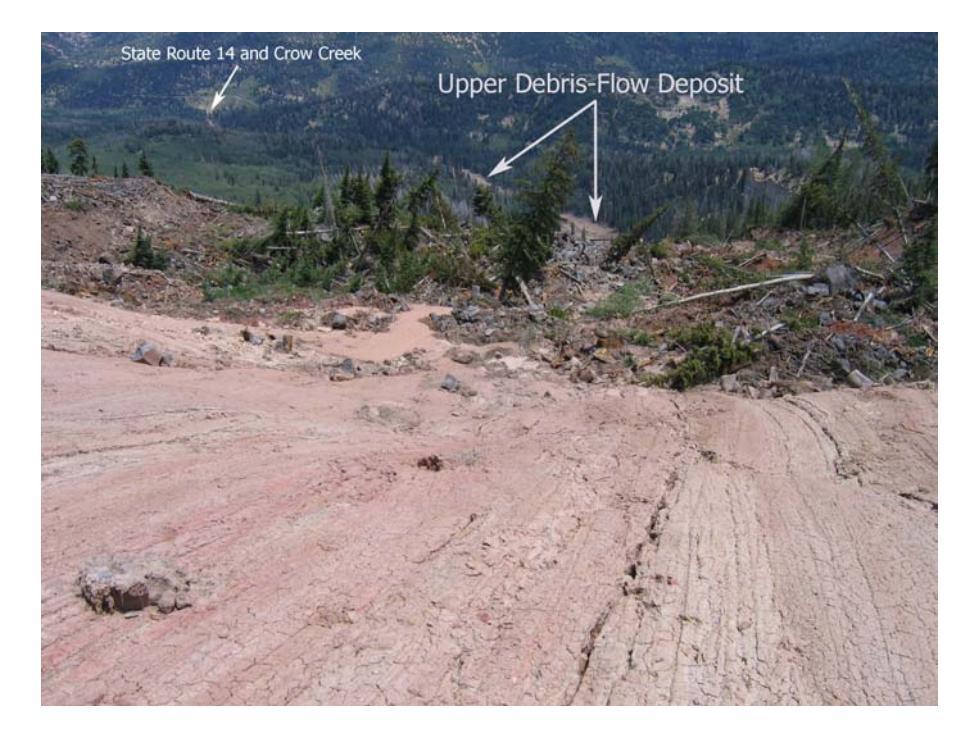
Figure 7. View from the upper landslide main scarp toward Crow Creek and SR-14. The main scarp is covered with slickensides. The debris-flow path and deposits are evident in the unnamed tributary stream valley to Crow Creek.

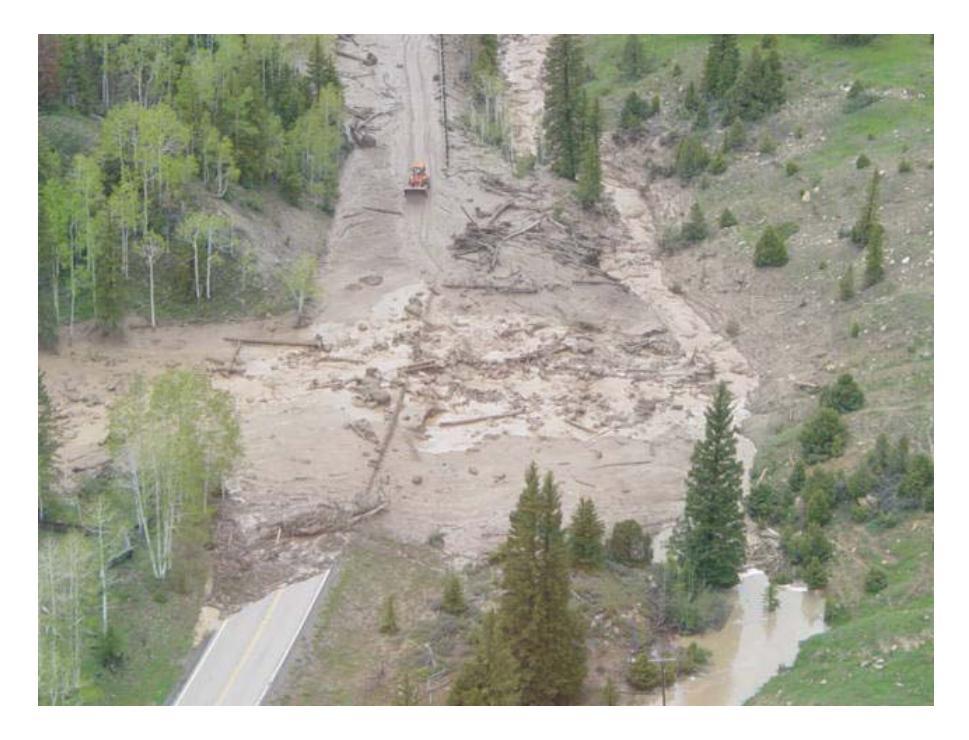
Figure 8. View northwest of SR-14 blocked by sediment from the Black Mountain debris flow. Crow Creek is on the right. Photo taken on June 3, 2005, by Lt. David Excel, Utah Highway Patrol.

Once the lower landslide released into the steep, narrow mountain channel, rapid mixing of the landslide mass quickly transformed it into a debris flow. As it proceeded down the 1200-foot-long channel, the debris flow scoured additional debris from the channel bottom and sides before exiting into the more gently sloping unnamed tributary stream valley to Crow Creek. The debris flow continued down the valley, scouring additional sediment, taking out trees, and depositing large volumes of sediment (figure 2). The debris flow plugged the box culvert under SR-14 with sediment and then overtopped the road, depositing sediment and blocking the highway (figure 8). Lund and others (2005) discussed the damages downstream in Crow Creek and Cedar Canyon.

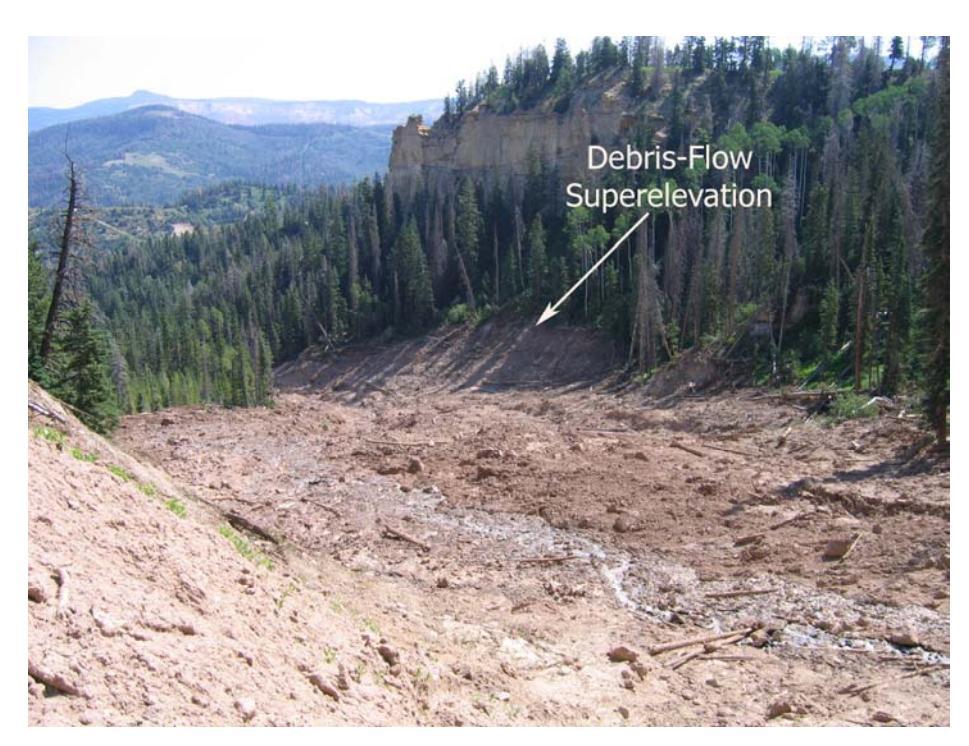
Figure 9. Northeast view down the upper stream valley at the debris-flow deposit below the narrow mountain channel. The debris flow had sufficient velocity to superelevate up onto the valley side below the sandstone cliff.

Along the upper valley deposit margins, the debris flow removed mature, similar-aged conifer trees, and left distinct tree trim lines (figures 9, 10, and 11). Based on their size, these trees were a minimum of 100 years old and likely were older (Burrows and Burrows, 1976), which suggests that a minimum of 100 years had passed since the last similarly large debris flow in this drainage. We observed pre-2005 debris-flow deposits at an elevation of 8800 feet along the west margin of the 2005 deposit. Relatively young conifer trees 4 to 5 inches in diameter are growing on this deposit, which suggests that the deposit is relatively young and possibly related to a small-volume historical debris flow. On aerial photos, we observed young debris-flow deposits likely represent relatively high-frequency, small-volume flows that occur more frequently than large-volume flows.

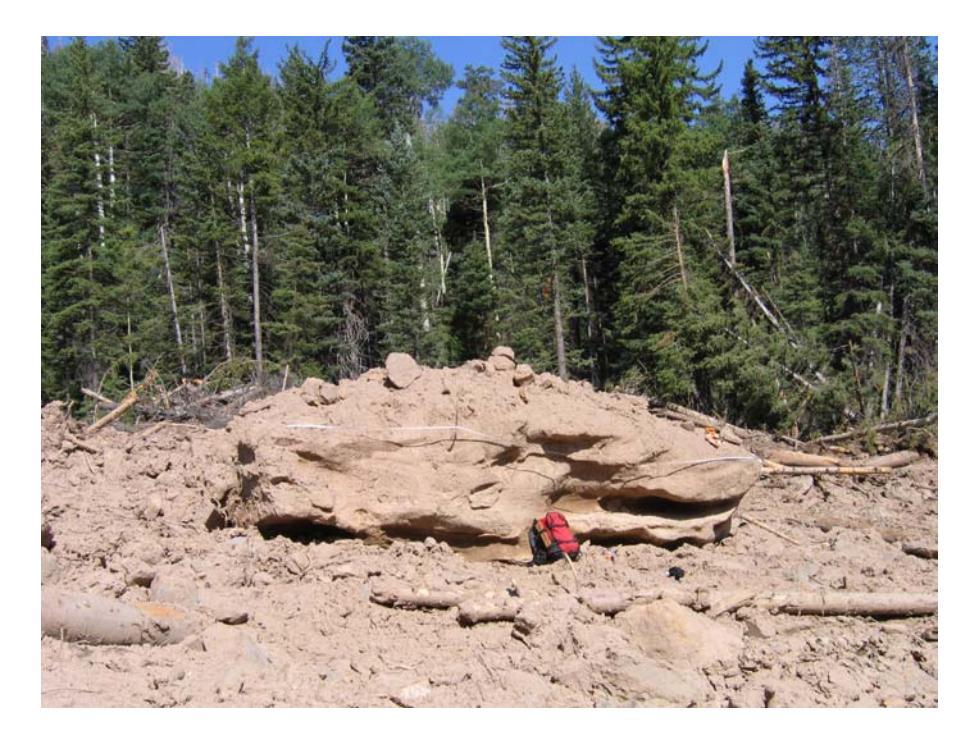
Figure 10. Large boulder transported by the debris flow, now part of the upper valley deposit. The boulder measures 22 feet long, 9.5 feet wide, and 6.5 feet high. The tree trim line is evident in the background.

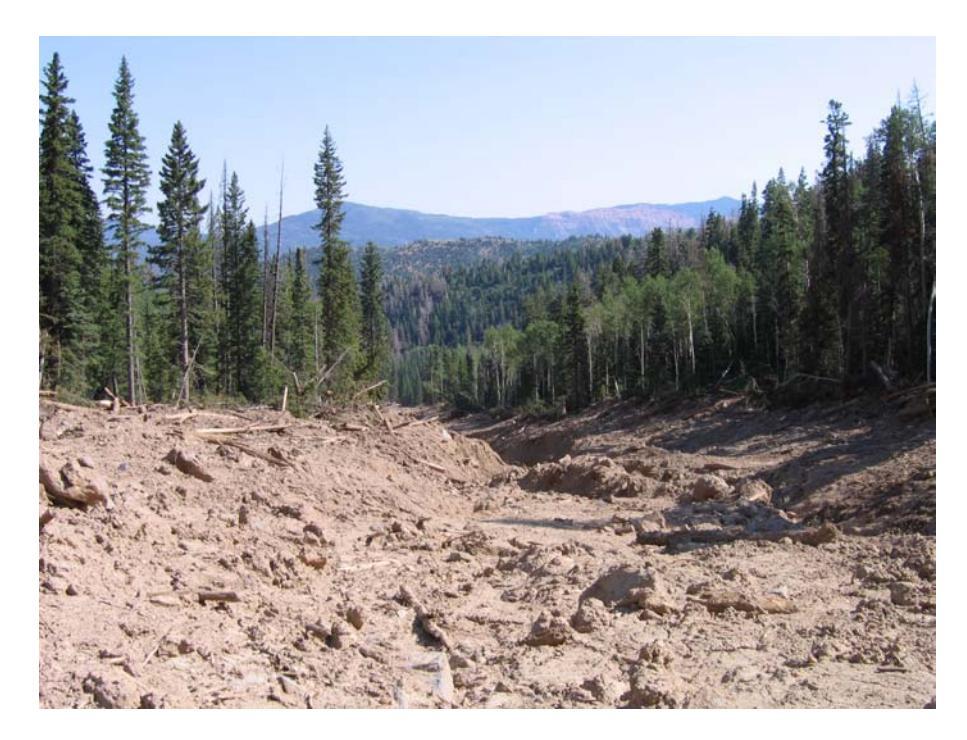
Figure 11. Upper valley debris-flow deposit showing the rough, wide, and thick deposit and distinct tree trim lines along the deposit flanks.

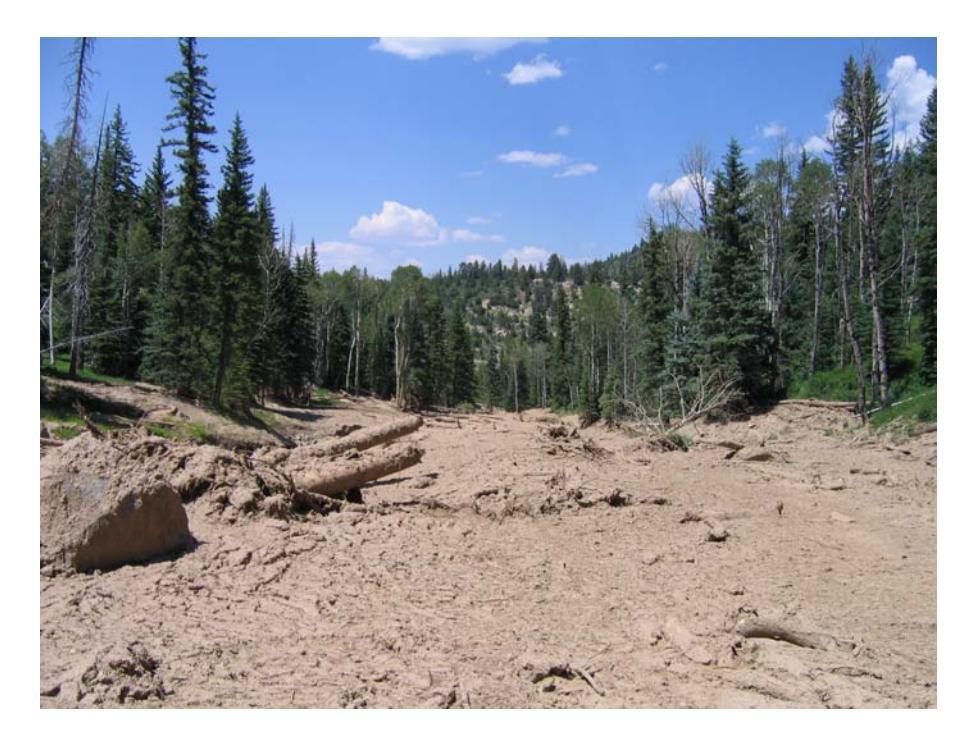
Figure 12. Lower valley deposit showing the relatively smooth, narrow, thin deposit compared to the upper valley deposit.

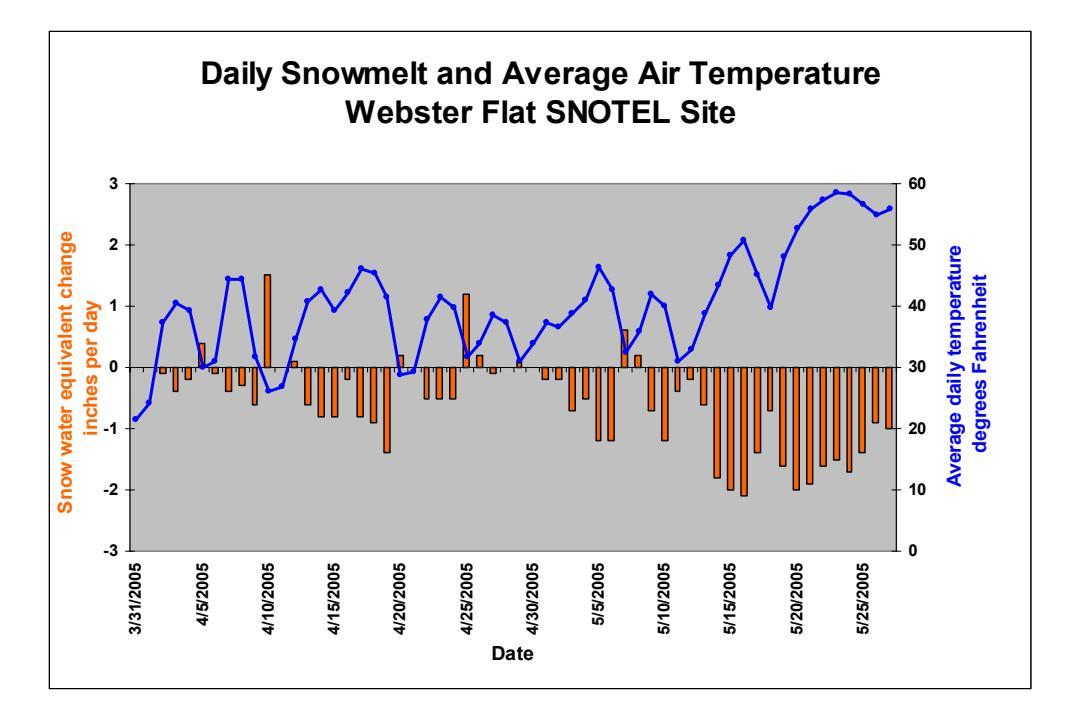
Figure 13. Daily snowmelt and average daily temperature at the Webster Flat SNOTEL site. From May 14 to May 27, 2005, an average of 1.5 inches of water per day melted from the snowpack.

The rate of snowmelt depends primarily on air temperature, which in turn relates to the timing of snowmelt-generated landslides (Chleborad, 1997, 1998). A strong relation exists between snowmelt landslides and rising spring temperatures in the central Rocky Mountains (Chleborad, 1997; Chleborad and others, 1997). Figure 13 is a plot of daily snowmelt and average daily temperature at the Webster Flat SNOTEL site, which melted out on May 27, 2005. Even though the SNOTEL site melted out six days before the landslide and debris flow occurred, the SNOTEL data can be used to infer temperatures and snowmelt patterns on Black Mountain. At the Webster Flat SNOTEL site, snowmelt generated an average of 1.5 inches of water per day from May 14 through May 27, 2005. This period of rapid snowmelt rate at the Black Mountain landslide was probably slightly less due to the area's north aspect and higher elevation. The average daily temperature remained high through June 3, 2005 (figure 14), which suggests rapid snowmelt preceding the landslide and debris-flow events.

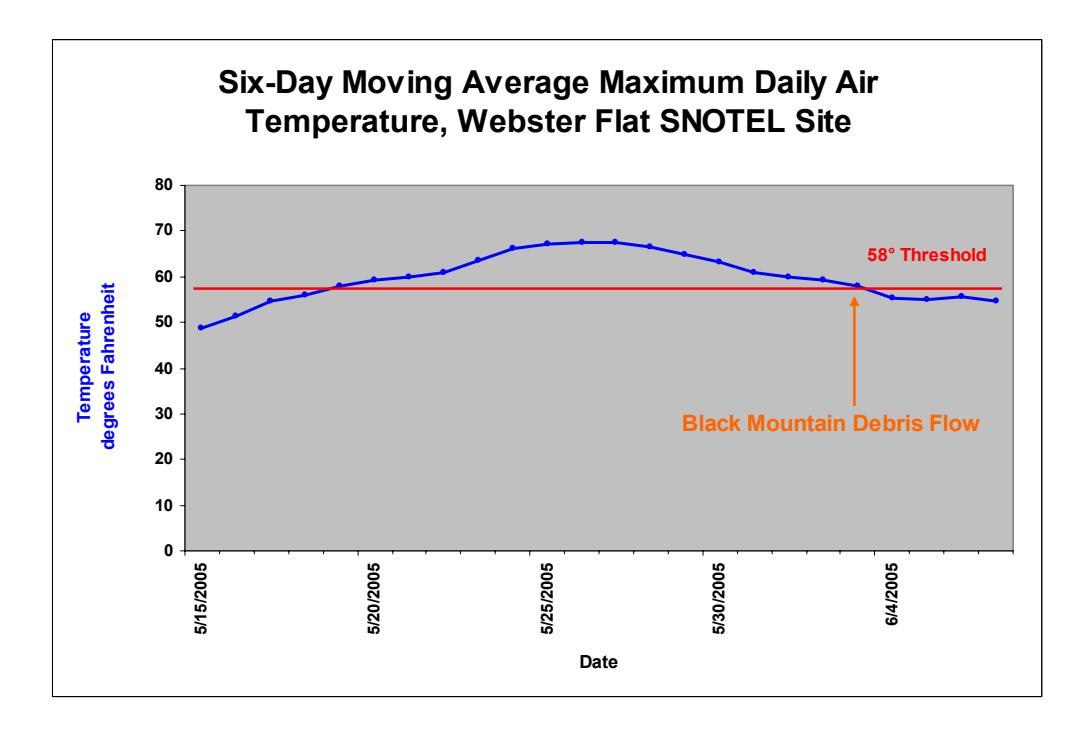
Figure 14. Six-day moving average maximum daily air temperature at the Webster Flat SNOTEL site. The Black Mountain debris flow occurred 16 days after the 58°F threshold was reached at the Webster Flat SNOTEL site.

Chleborad and others (1997) used a six-day moving average of daily maximum air temperature with an optimum threshold of 58°F for anticipating the onset of snowmelt-generated landslides. Their study concluded that most snowmelt-triggered landslides occur within two weeks after the first yearly occurrence of this threshold. Figure 14 shows the six-day moving average of daily maximum temperature at the Webster Flat SNOTEL site. The first occurrence of the 58°F threshold was on May 19, 2005. The Black Mountain debris flow occurred on June

3, 2005, 16 days after reaching the temperature threshold at Webster Flat. Sixteen days is longer than Chleboard's two-week period for most snowmelt-generated landslides, but Chleborad and others (1997) did observe some landslides triggering within three weeks. Also, the longer-than-two-week period may be due to the higher elevation and north aspect of the landslide and therefore cooler temperatures as compared to the SNOTEL site. The landslide also has a deep surface of rupture, and the time required to increase the pore-water pressure at depth was likely longer.
