GEOLOGIC HAZARDS AND LAND-USE PLANNING FOR TOOELE VALLEY AND THE WEST DESERT HAZARDOUS INDUSTRY AREA, TOOELE COUNTY, UTAH

Barry J. Solomon and Bill D. Black, editors

OPEN-FILE REPORT 318
UTAH GEOLOGICAL SURVEY
a division of
UTAH DEPARTMENT OF NATURAL RESOURCES

October 1995

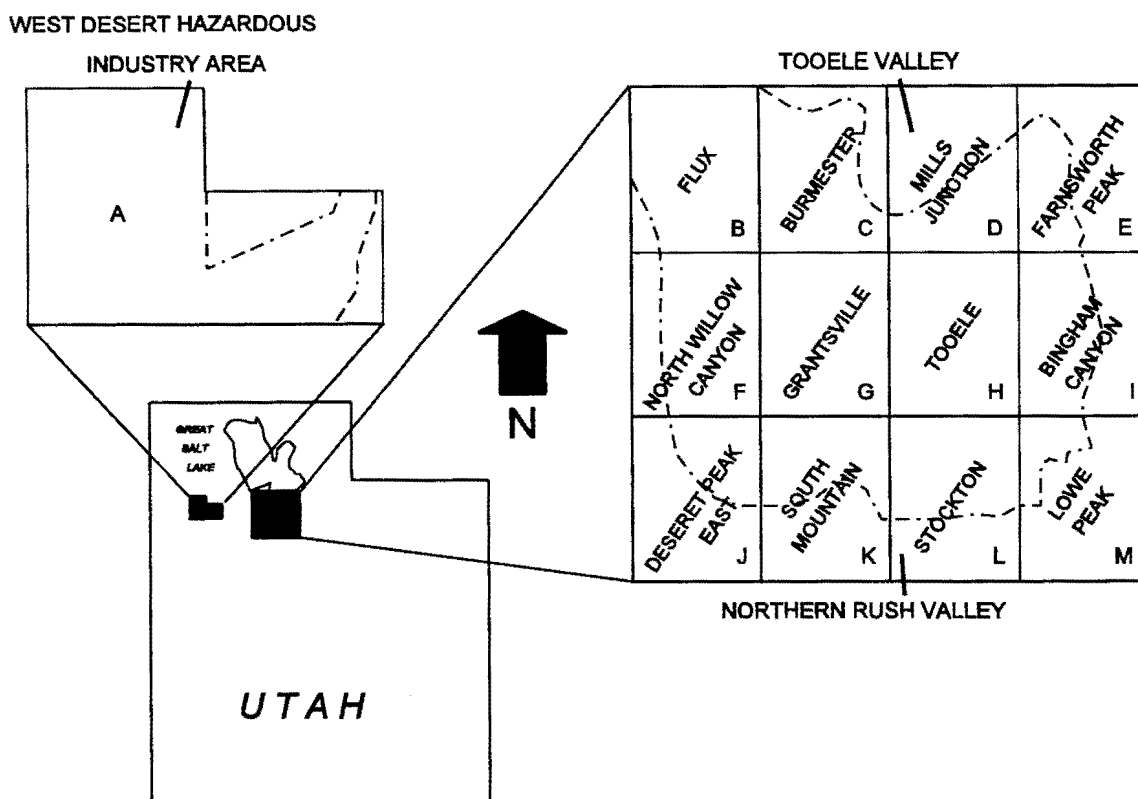
Figure A-2. Index map of Tooele Valley and the West Desert Hazardous Industry Area. Letters A through M are used in plate designations and table A-1. Study area boundaries are shown by dashed lines.

Mountains. The study area includes portions of twelve U.S. Geological Survey 7.5-minute topographic quadrangles (figure A-2).

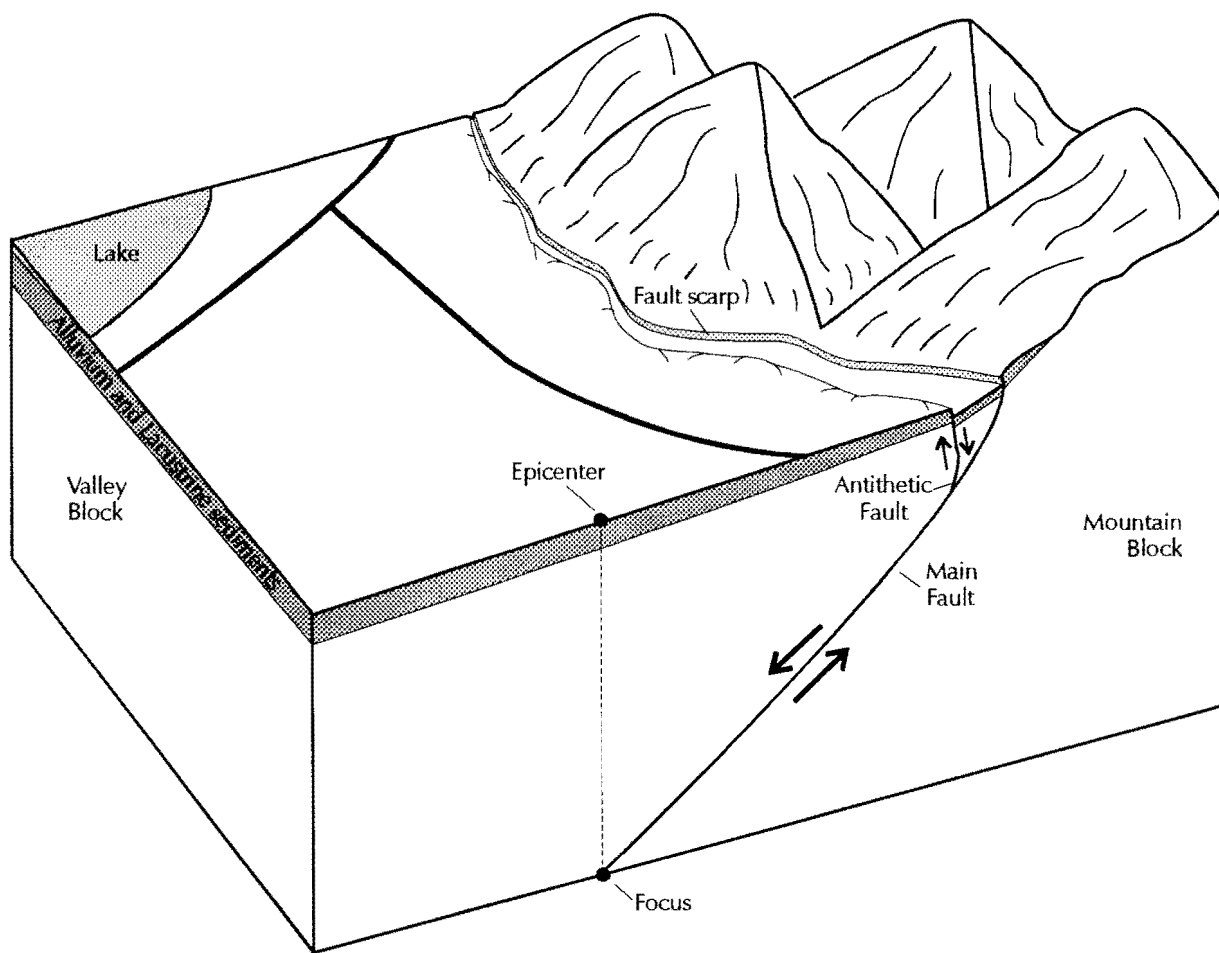
Figure B-1. Diagram of a normal fault showing relationship of the epicenter to the focus, and the trace of surface rupture (fault scarp). The fault plane likely dips 50-60 degrees toward the valley. Note the focus of the earthquake is beneath the valley (downdropped) block, not on the trace of surface rupture (modified from Robison, 1993).

Studies have indicated evidence for active faulting on the OFZ. Paleoseismic data from trenches excavated across scarps near the mouths of Big Canyon (plate 1E) and Pole Canyon (plate 1D) suggest the most-recent surface-rupturing earthquake (MRE) occurred from 4,300 to 6,900 years

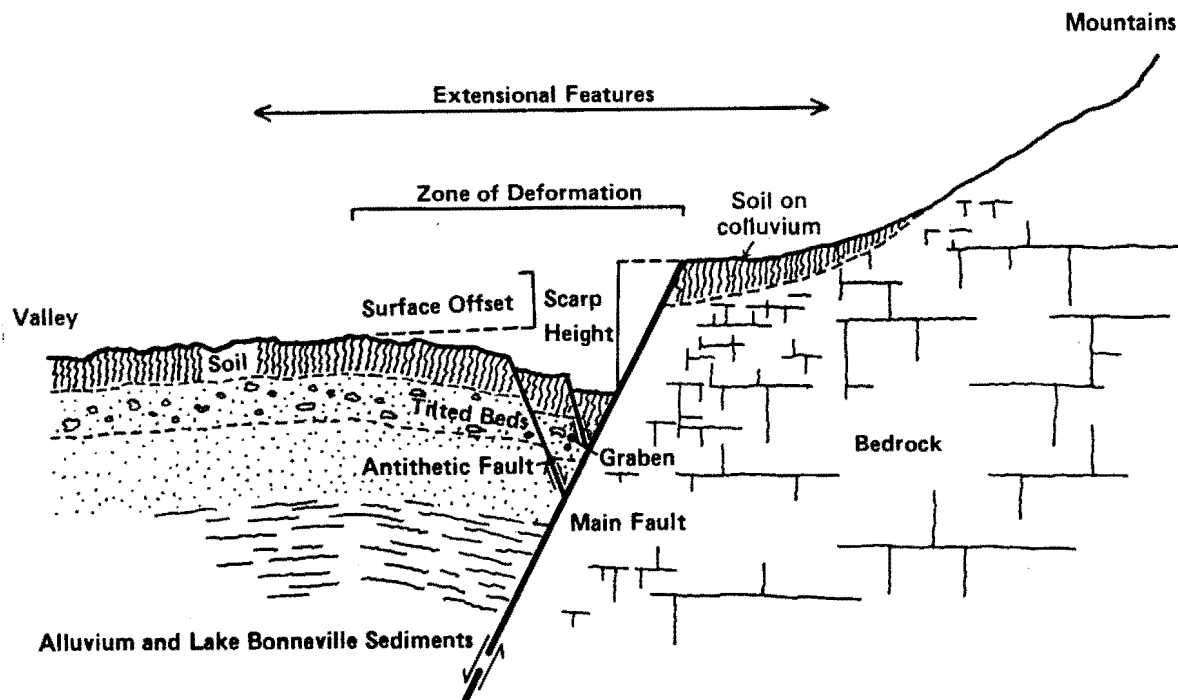
Figure B-2. Diagram of a normal-fault zone showing typical features near the ground surface. Although the sketch is not to scale, surface offset is usually 6-9 feet (2-3 m) (Robison, 1993).

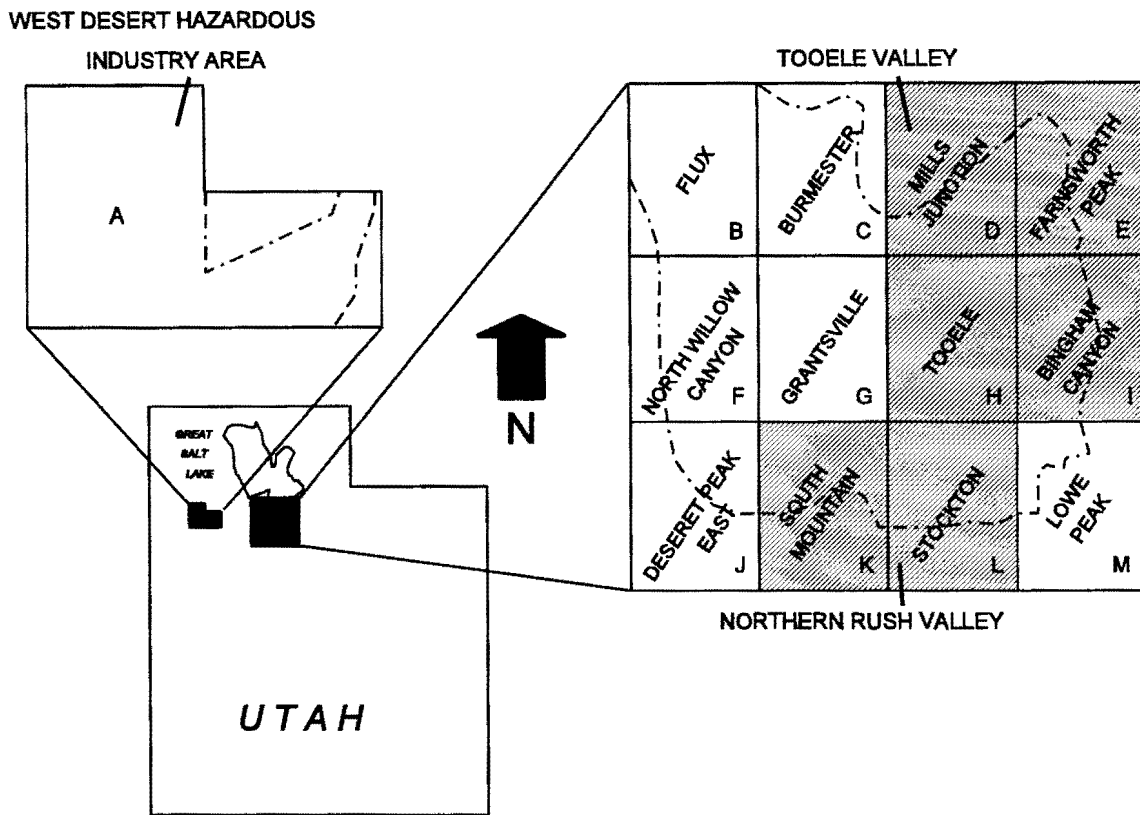
Figure B-3. Index map of areas (crosshatched) where surface-fault-rupture hazards are mapped on plate 1. Letters are used in plate designations. Study area boundaries are shown by dashed lines.

Plate 1 shows main fault traces with the greatest potential for future movement in the Tooele Valley study area (figure B-3). These maps also indicate special study areas where surface-fault-rupture hazards need to be considered for certain land uses (table 1). The special study areas, which follow fault traces mapped by Solomon (1993), are about 500 feet (152 m) wide on both the upthrown and downthrown sides of the main fault scarp. Site-specific investigations addressing surface-fault-rupture hazards are needed in special study areas because the fault maps are not detailed enough to include all fault traces and delineate zones of deformation at a particular location.

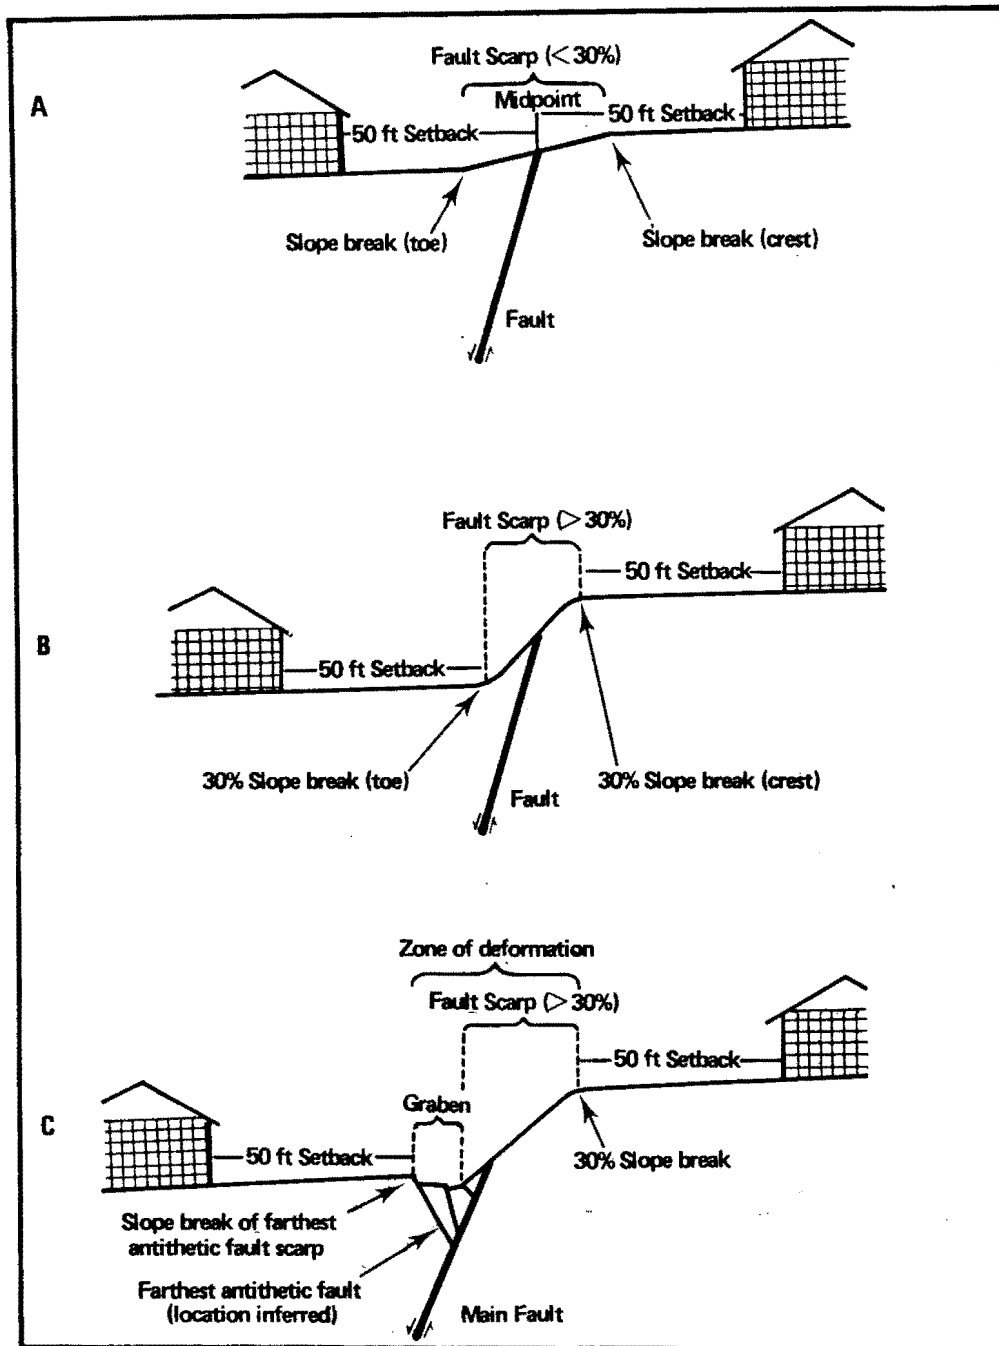
Figure B-4. Diagram of recommended minimum setback distances, relative to fault scarps, in areas where trenching studies are not performed. Recommended setback distances are: (A) 50 feet from the midpoint of a scarp that is less than a 30-degree slope, (B) 50 feet from the top and bottom slope break on a scarp that is greater than a 30-degree slope, and (C) 50 feet from the slope break (at the top of the scarp) and the farthest antithetic fault for scarps where a graben is present (Robison, 1993).

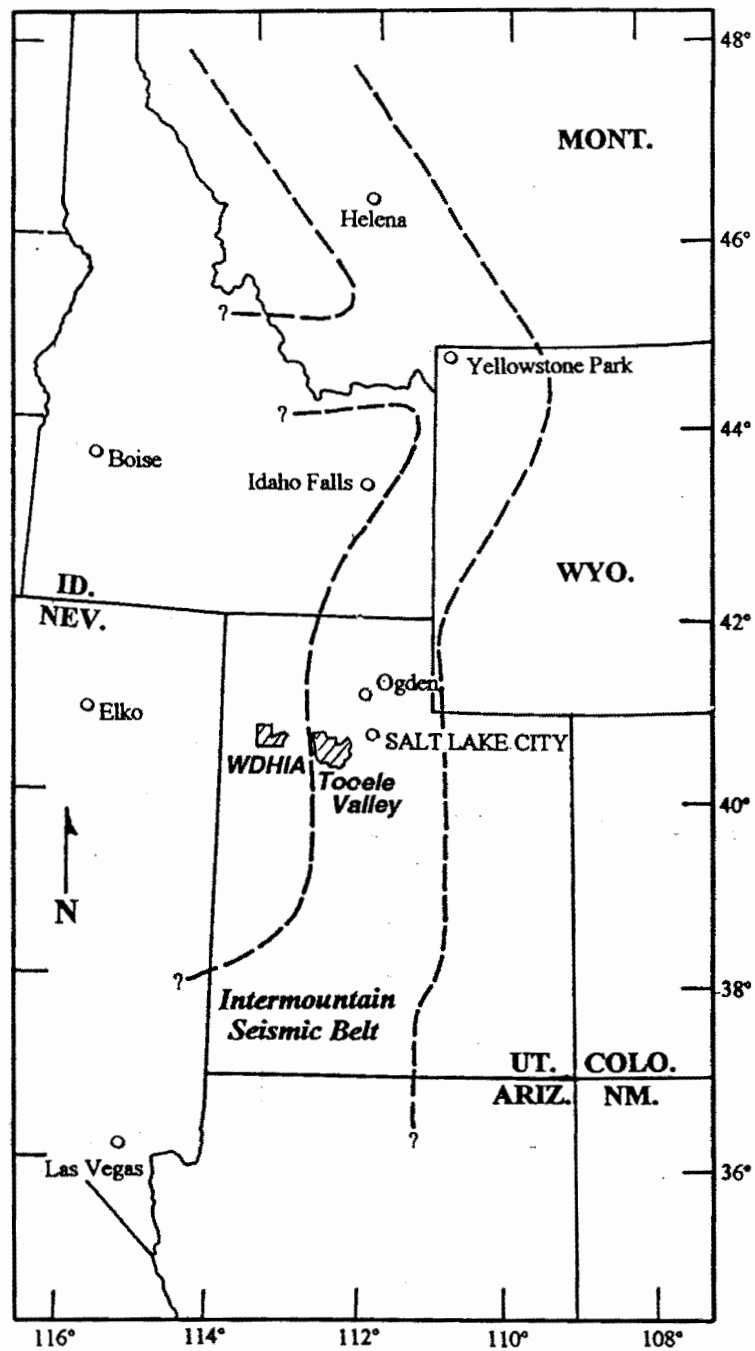
Figure C-1. Tooele Valley and the West Desert Hazardous Industry Area with respect to the Intermountain seismic belt (modified from Arabasz and Smith, 1981).

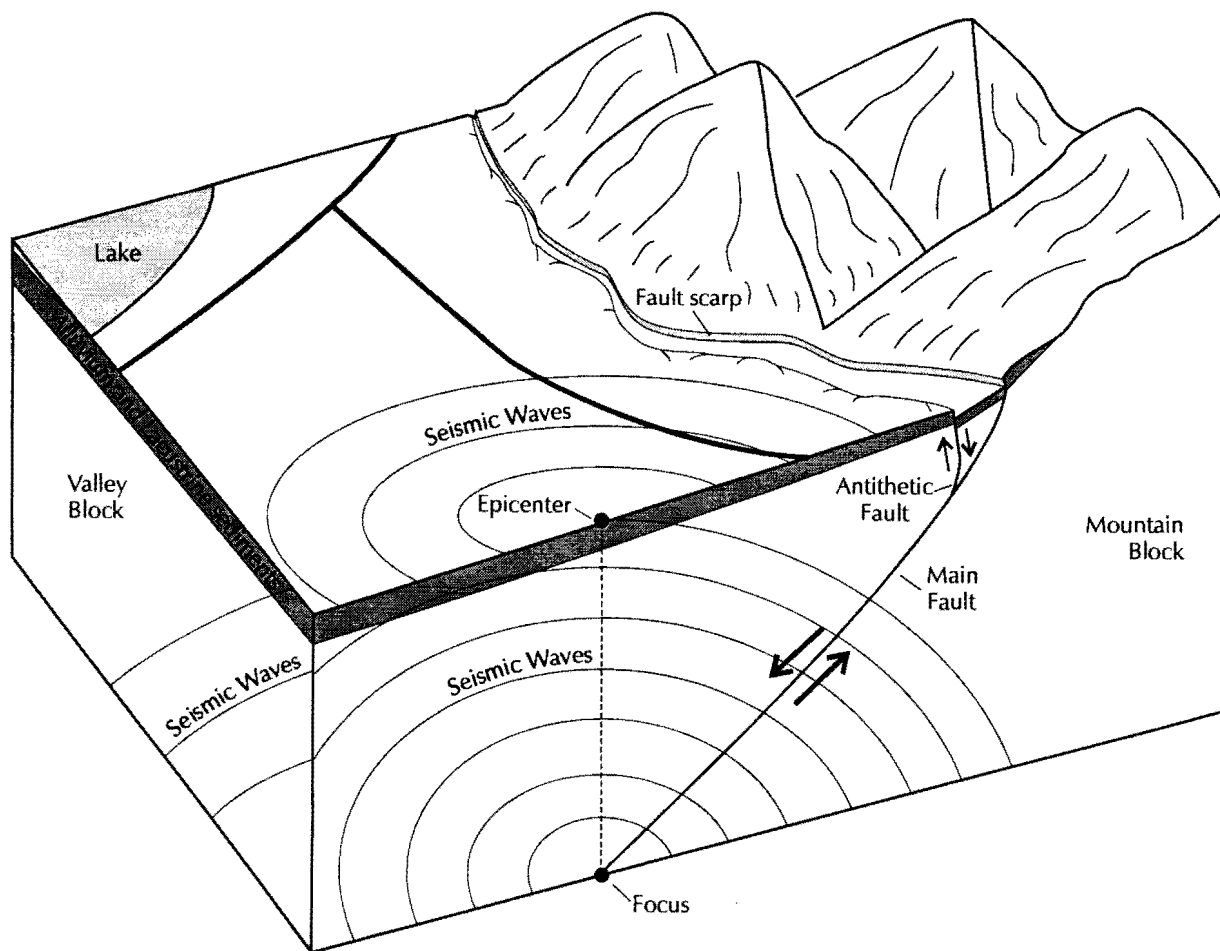
Figure C-2. Diagram showing factors affecting ground shaking, including: fault location, earthquake focus and epicenter, surficial deposits, and propagation of seismic waves (modified from Robison, 1993).

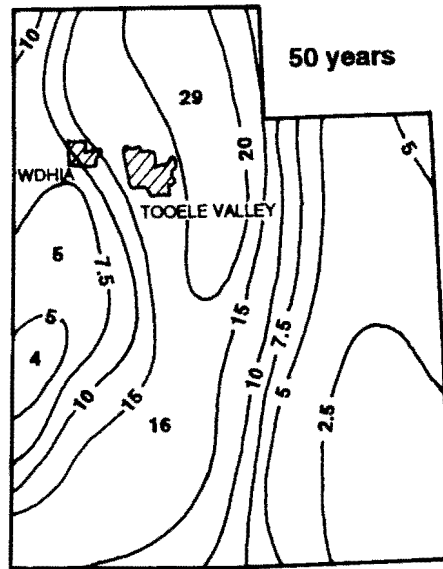
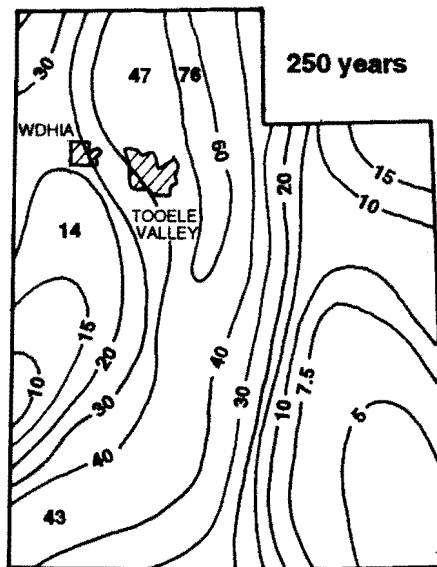
Figure C-3. Expected horizontal acceleration on bedrock in Utah with a 10% chance of being exceeded in 50 and 250 years (after Algermissen and others, 1990). Tooele Valley and the West Desert Hazardous Industry Area (WDHIA) are crosshatched.

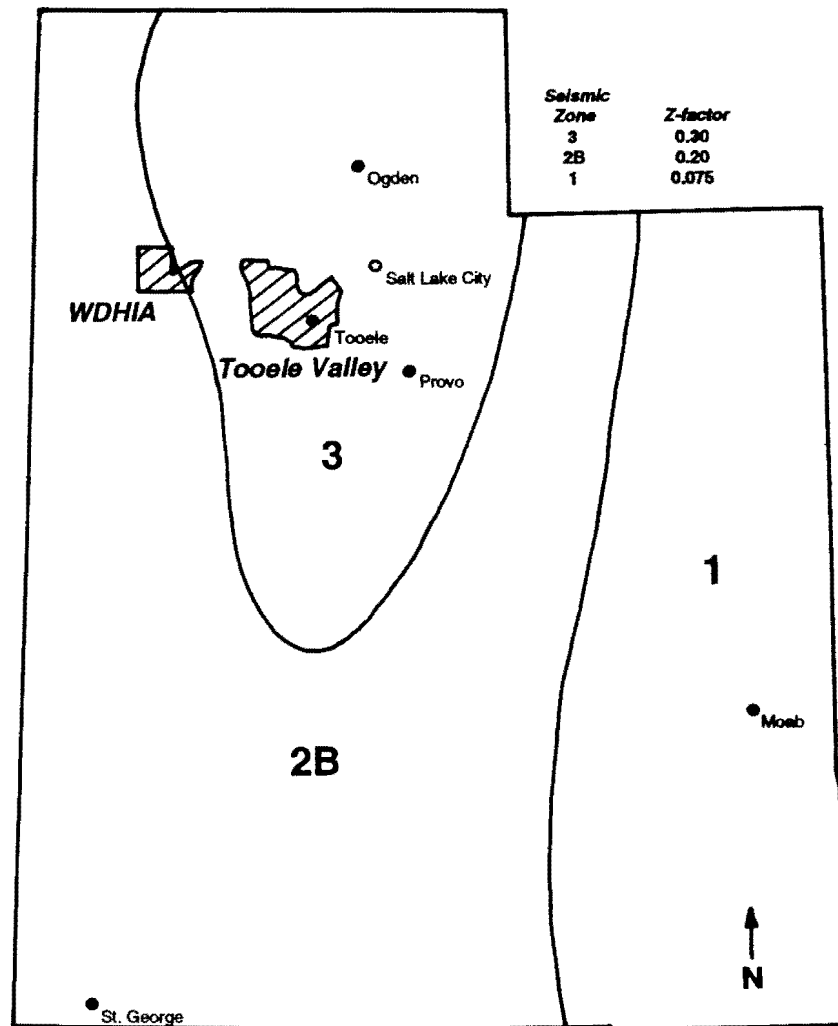
Figure C-4. The UBC seismic zone map of Utah. Tooele Valley and the West Desert Hazardous Industry Area (WDHIA) are crosshatched (from International Conference of Building Officials, 1994).

Site-specific evaluations of ground-shaking hazards involve accurate determination of Z (expected peak horizontal accelerations) and S (site coefficients) factors. The Z factor can be taken directly from the seismic zone map, but site coefficients (table C-2) are determined either by drilling or estimation based on geologic conditions and existing geotechnical data. Site-specific probabilistic estimates of earthquake ground motions are generally only performed for certain high-cost, high-occupancy, or environmentally-sensitive critical facilities. Details of methods used to perform such studies are beyond the scope of this report, but are available in Reiter (1990) and Krinitsky and others (1993). Adequate plan checks by qualified building officials are recommended prior to issuance of building permits to ensure proper enforcement of seismic building code provisions.

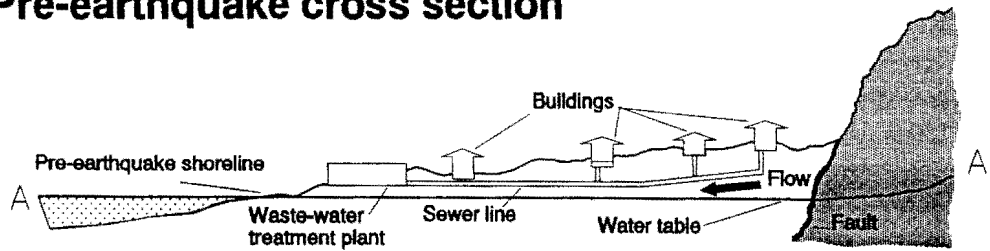
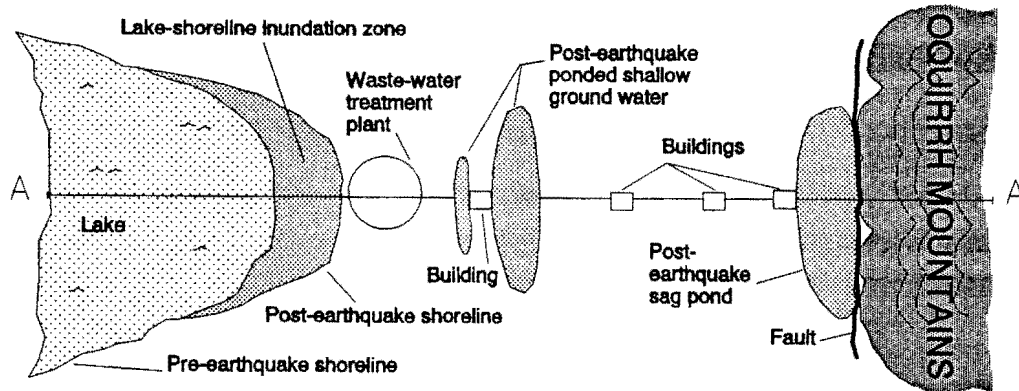
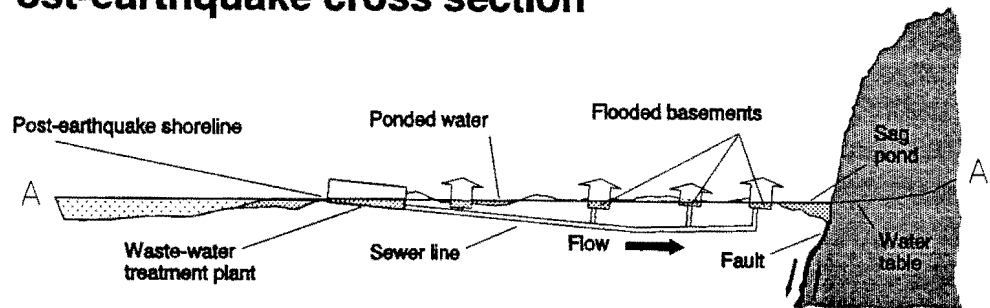
Figure D-1. Hypothetical plan view and cross sections showing tectonic subsidence accompanying a surface-faulting earthquake. Top cross section shows the lake shoreline and structures on the plan view (below) in their pre-earthquake position. Bottom cross section shows the possible effects of tectonic subsidence and their extent on the plan view (above), including inundation along the lake shoreline (lake shoreline inundation zone); post-earthquake flooding, ponded water, and sag ponds (produced by backtilting) due to the rising water table; and changes in gradient from backtilting causing a reversal of flow in sewer lines (modified from Robison, 1993).

The magnitude and extent of tectonic subsidence along the OFZ is unclear, and a study similar to Keaton (1987) is required to better define the amount and extent of potential subsidence. Without such a study, estimates of the amount of subsidence can be made based on the amount of fault offset per earthquake event (from paleoseismic data) and the extent of subsidence from similar historical events. Site investigations may determine the depth to ground water and surface elevation, which can then be compared to the amount of subsidence to define areas of potential lake-margin flooding and ponded shallow ground water. Vulnerable essential facilities such as wastewater-treatment plants and hazardous-waste facilities should also consider potential tilting.

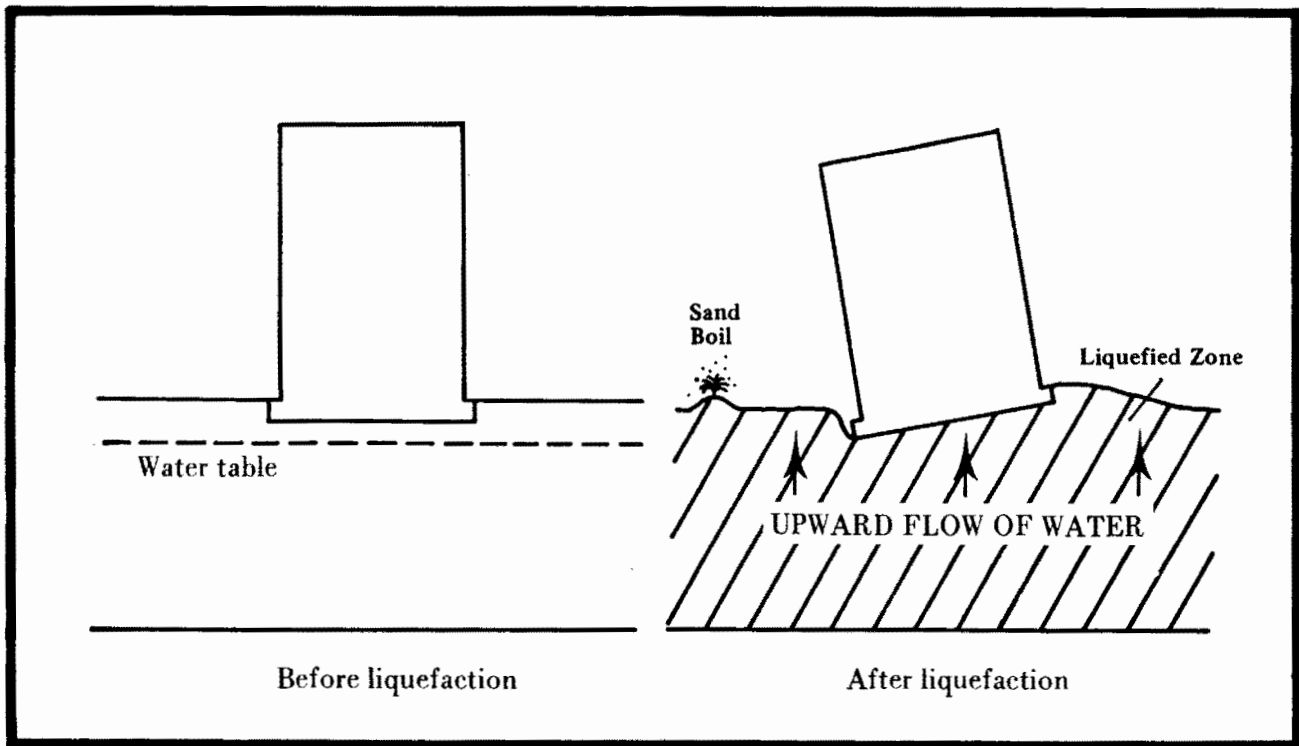
Figure E-1. Tilting of a building due to liquefaction and loss of bearing strength in the underlying soil, allowing the building to settle and tilt (Youd, 1984, in National Research Council, 1985).

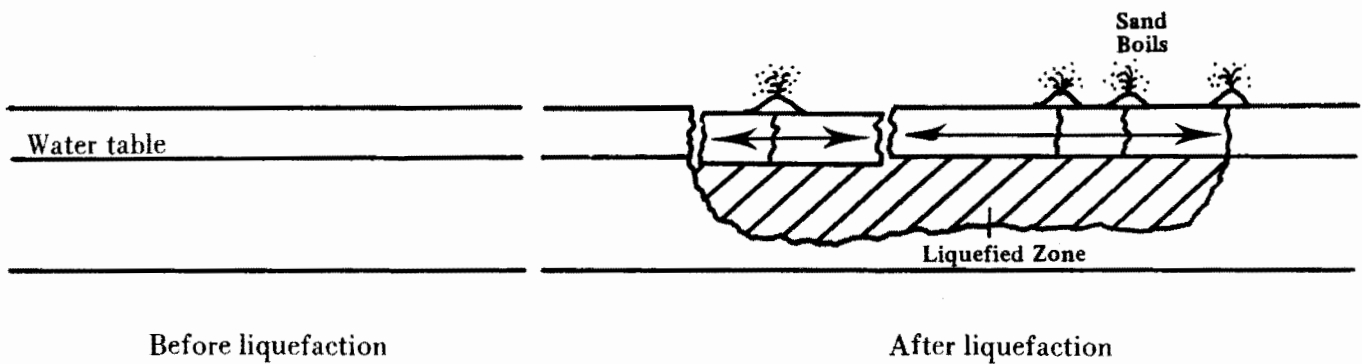
Figure E-2. Diagram of liquefaction-induced ground oscillation. Liquefaction occurs in the cross-hatched zone and causes ground settlement, opening and closing of fissures, and sand boils as the surface layer detaches from the surrounding firm ground (Youd, 1984, in National Research Council, 1985).

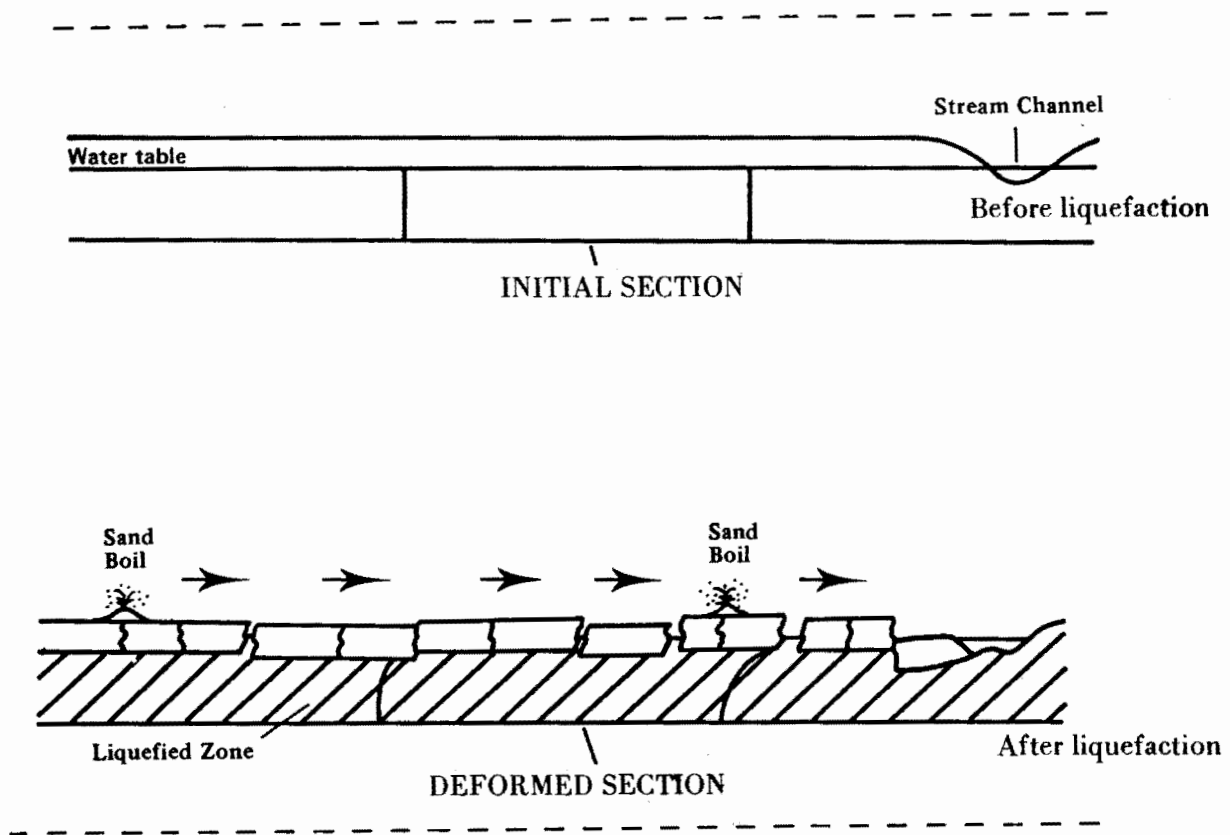
Figure E-3. Diagram of a lateral spread. Liquefaction occurs in the cross-hatched zone, causing the surface layer to detach from surrounding firm ground and move downslope (Youd, 1984, in National Research Council, 1985).

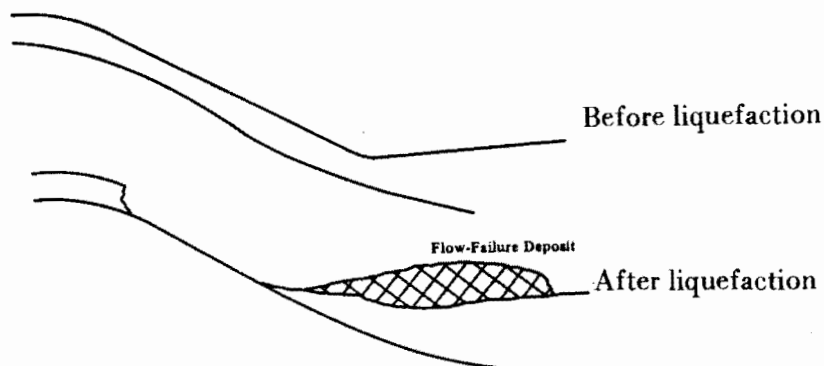
Figure E-4. Diagram of a flow failure. Liquefaction beneath the ground surface causes a loss of shear strength, allowing the soil mass to flow down the steep slope (Youd, 1984, in National Research Council, 1985).

Where ground-surface slopes are steeper than about 5.0 percent, slope failure may occur in the form of flow landslides (Anderson and others, 1982; figure E-4). They are comprised chiefly of liquefied soil or blocks of intact material riding on a liquefied layer (National Research Council, 1985). Flow landslides can cause soil masses to be displaced several miles (Tinsley and others, 1985).

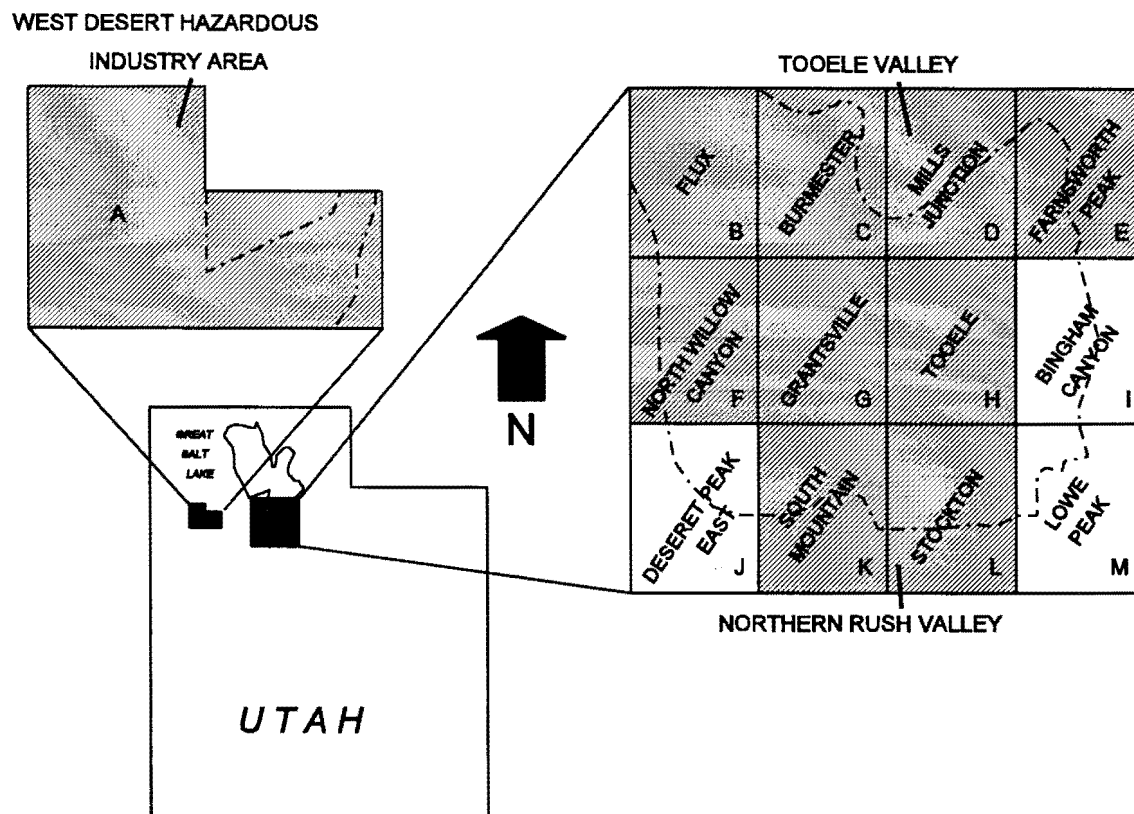
Figure E-5. Index map of areas (crosshatched) where liquefaction susceptibility is mapped on plate 2. Letters are used in plate designations. Study area boundaries are shown by dashed lines.

prepared for quadrangles in Tooele Valley and the WDHIA where liquefaction hazards are likely (figure E-5). Although the probability of earthquake ground shaking sufficient to cause liquefaction was not included in this assessment, there is a significant potential for liquefaction-induced ground failure to cause severe damage in areas of high susceptibility in Tooele Valley (Mabey and Youd, 1989). Because of a lesser earthquake potential, the hazard is substantially lower in the WDHIA.

Liquefaction susceptibility was determined primarily from geologic and ground-water data. In areas that may have sediments susceptible to liquefaction where the depth to ground water is less than 50 feet (15 m), susceptibility was mapped as: (1) high, if the depth to ground water is less than 10 feet (3 m); (2) moderate, if the depth to ground water is from 10 to 30 feet (3-9 m); or (3) low, if the depth to ground water was from 30 to 50 feet (9-15 m). Areas with a very low liquefaction susceptibility do not have susceptible sediments, or have ground-water depths greater than 50 feet

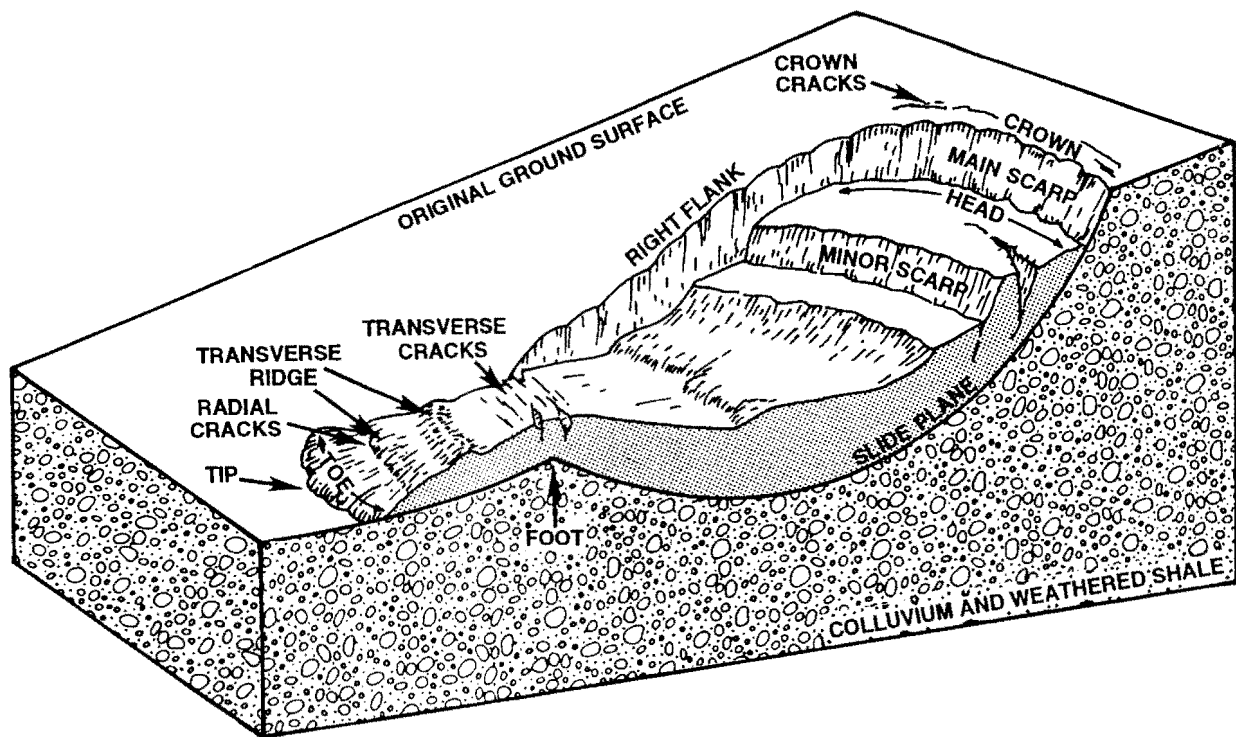
Figure G-1. Block diagram of a rotational landslide (slump) and earth flow (modified from Varnes, 1978).

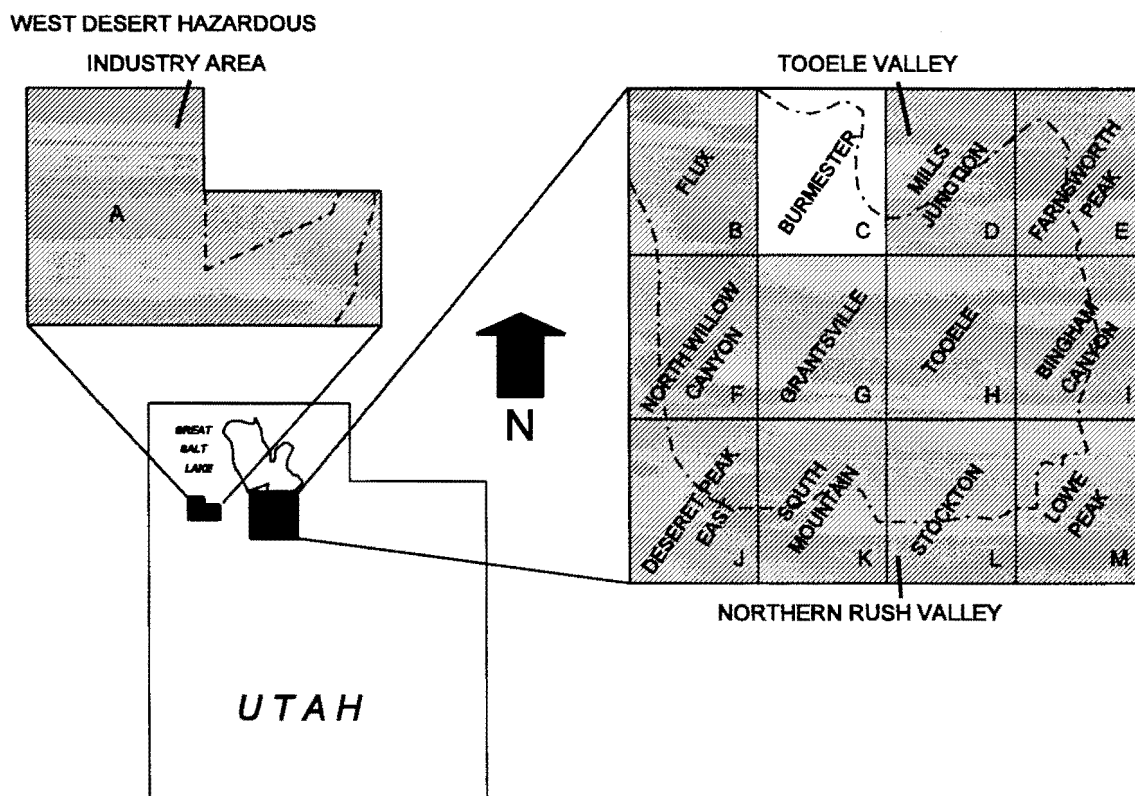
Figure G-2. Index map of areas (crosshatched) where landslide hazards are mapped on plate 1. Letters are used in plate designations. Study area boundaries are shown by dashed lines.

Plate 1 shows the slope stability of natural slopes under static (non-earthquake) conditions for Tooele Valley and the WDHIA (figure G-2). Slope stability was estimated from geologic maps, slope steepness, and the presence of existing landslides. Four categories were used: high, moderate, low, and very low.

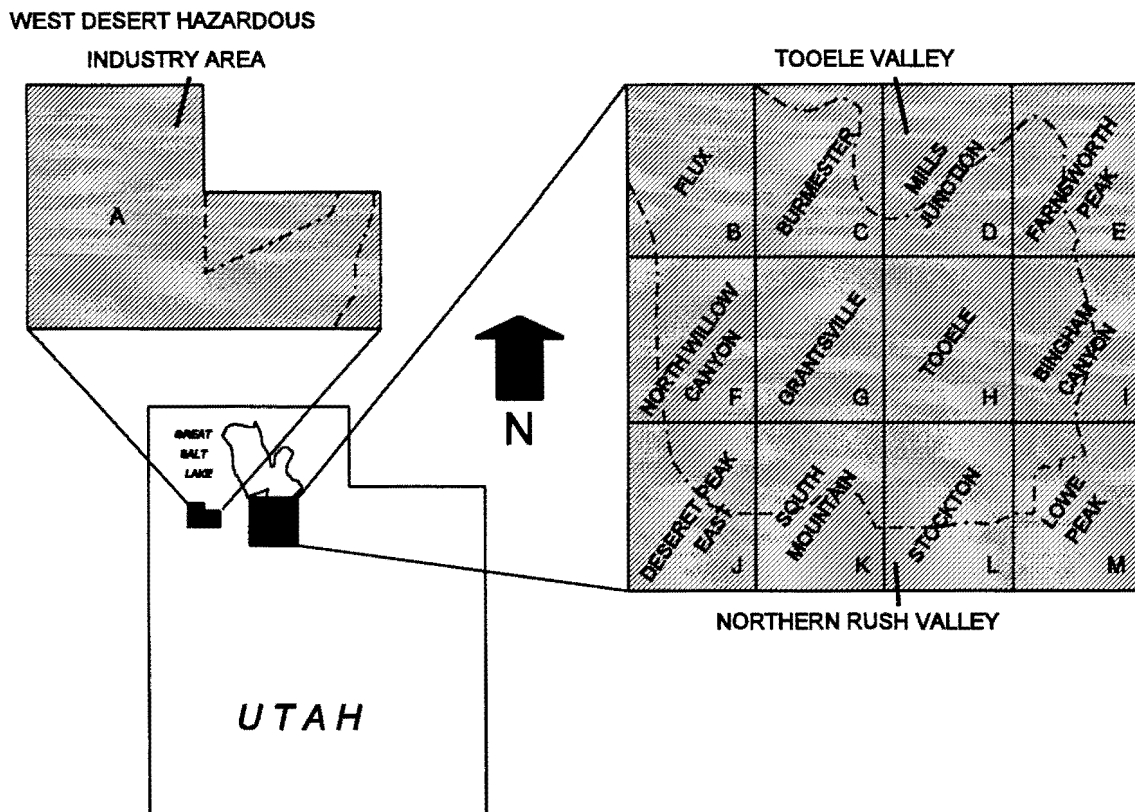
Figure H-1. Index map of areas (crosshatched) where debris-slide, debris-flow, debris-flood, and stream-flood hazards are mapped on plate 3. Letters are used in plate designations. Study area boundaries are shown by dashed lines.

Mapped on plate 3 are 104 debris slides and flows in the Oquirrh Mountains, most of which occurred during 1983 and 1984. They were identified using 1:40,000-scale air photos and field reconnaissance. Where identifiable, the travel paths and deposits of these failures are also shown. No debris slides or debris flows were identified in the Stansbury Mountains or the WDHIA. There are two probable pre-historic debris flows which originated near Stockton. Debris slides and flows in the Oquirrh Mountains occurred only in the southern half of the study area, between Soldier Canyon on the south and Flood Canyon on the north. All but a few are in Settlement, Middle, Pass, and Flood Canyons. No debris flows and only four debris floods deposited material beyond canyon mouths during 1983 or 1984, when debris floods in Pass and Swensons Canyons in the Oquirrh Mountains deposited sand and gravel on alluvial fans east of the town of Lincoln up to 1.5 miles (2.4 km) from the base of the mountains. Two small, unnamed canyons in the northern Stansbury Mountains northwest of Timpie Valley also yielded debris floods that deposited material on alluvial fans beyond the canyon mouths.

Slope-failure susceptibility in debris-flow source areas (source-area susceptibility on plate 3) provides a relative rating of susceptibility to failure, but does not estimate probability or likelihood of failure for a given time period. The frequency of occurrence (recurrence) of debris-slide and debris-flow events in a drainage basin depends upon climatic factors as well as the availability of debris. The map ratings are based mainly on the presence of pre-existing slope

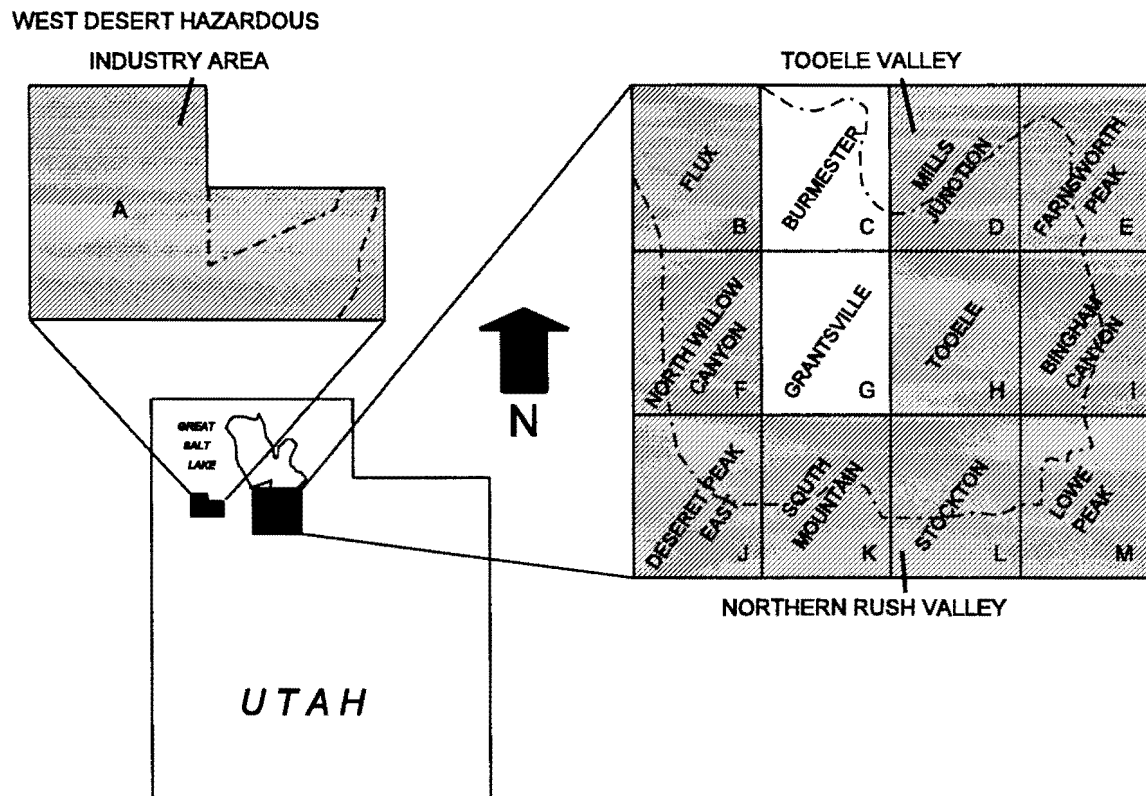
Figure I-1. Index map of areas (crosshatched) where rock-fall hazards are mapped on plate 4. Letters are used in plate designations. Study area boundaries are shown by dashed lines.

Plate 4 shows areas that may be susceptible to a rock-fall hazard in Tooele Valley and the WDHIA (figure I-1). The primary factor in determining these areas is the presence of a source for rock-fall clasts. If there are no rocks on a slope, the rock-fall hazard is low. Case (1987c, 1988b) identified some of the range-front slopes, called spurs, along the Oquirrh Mountains in Tooele Valley on which a rock-fall source was found. Additional source areas along the Oquirrh, Stansbury, and Cedar Mountains, South Mountain, and the Grayback Hills, were identified during this study.

The hazard area for each susceptible spur was determined using a computer model called the Colorado Rock-fall Simulation Program (CRSP) (Pfeiffer and Higgins, 1988). This program was primarily designed to predict rock bounce heights, but was used here to simulate maximum travel distances of rock clasts. The program incorporates factors such as velocity, rock size and shape, roughness of the travel surface, and topography of the slope. Rock-fall events were simulated using the highest and steepest potential rock-fall source areas. Rocks were started with

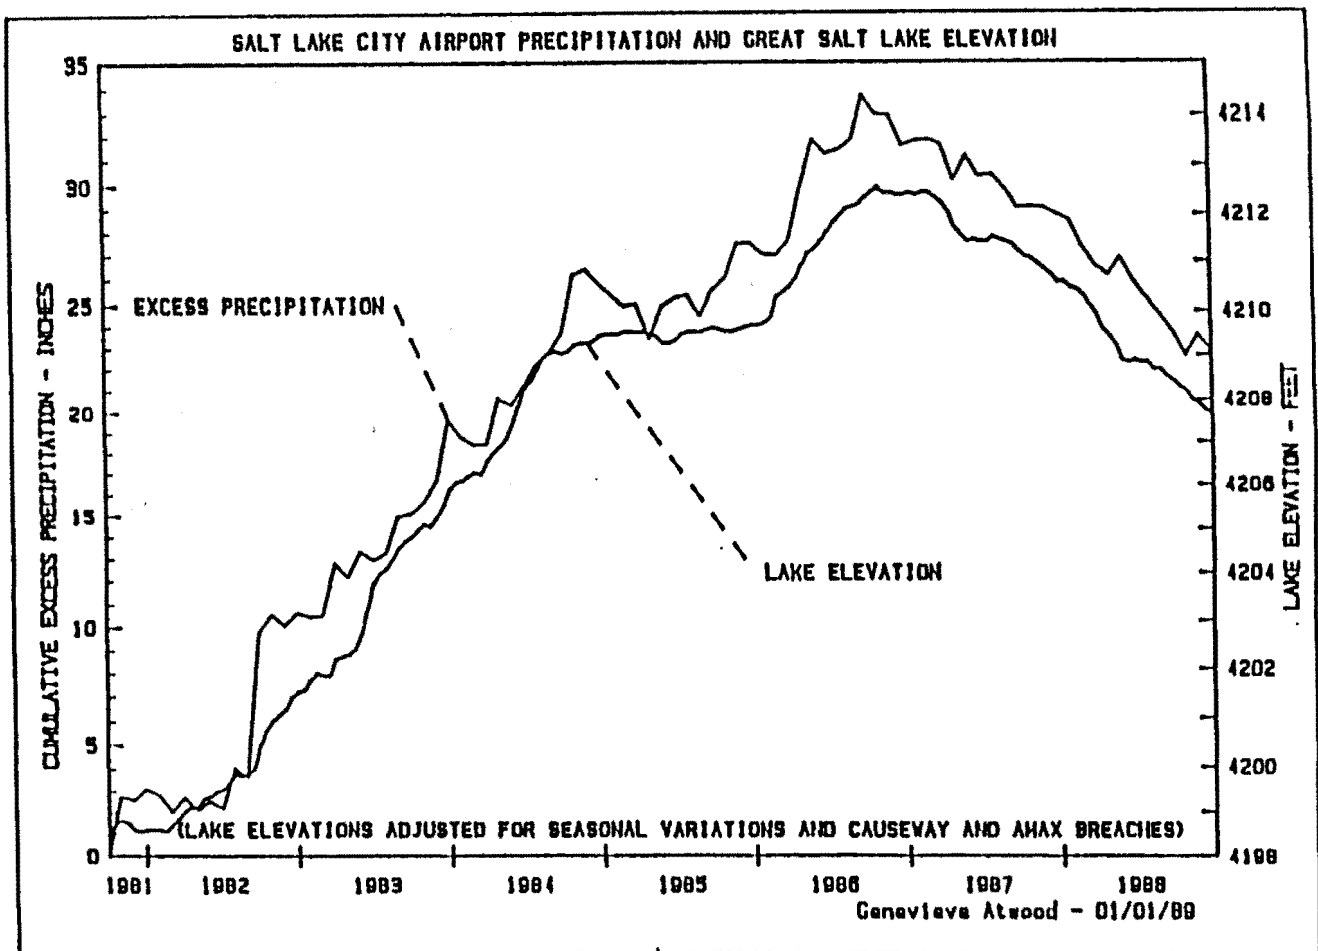
Figure J-1. Graph showing the effect of cumulative excess precipitation on Great Salt Lake elevation. Lake elevations have been adjusted to remove seasonal water-level variations and the effects of the Great Salt Lake causeway and Amax dike breaches (Atwood and Mabey, written communication, 1989).

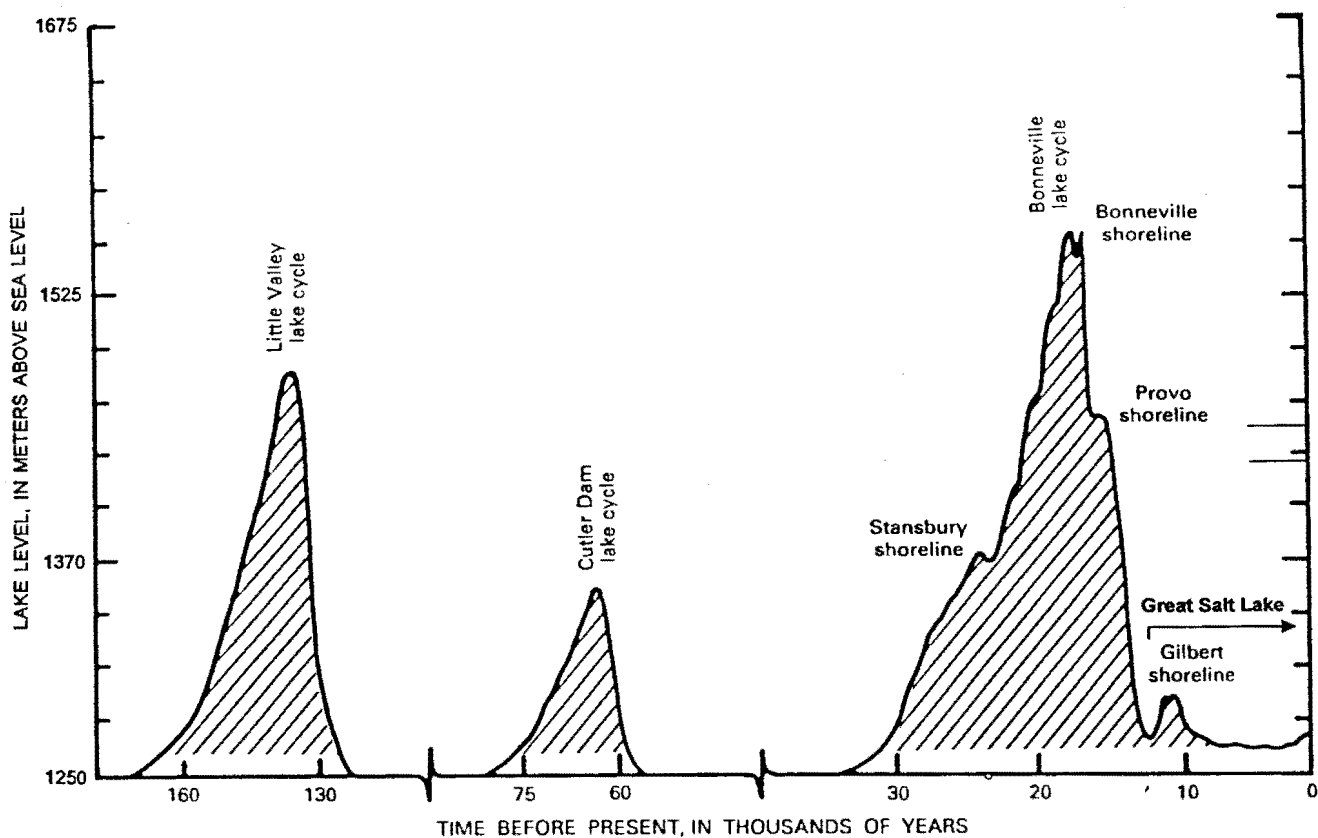
Figure J-2. Diagram showing a hydrograph of probable lake levels in the Lake Bonneville (Great Salt Lake) basin for the past 150,000 years (modified from Currey and Oviatt, 1985; and Machette and others, 1987).
