GEOLOGIC HAZARDS AND LAND-USE PLANNING FOR TOOELE VALLEY AND THE WEST DESERT HAZARDOUS INDUSTRY AREA, TOOELE COUNTY, UTAH

Barry J. Solomon and Bill D. Black, editors

OPEN-FILE REPORT 318
UTAH GEOLOGICAL SURVEY
a division of
UTAH DEPARTMENT OF NATURAL RESOURCES

October 1995

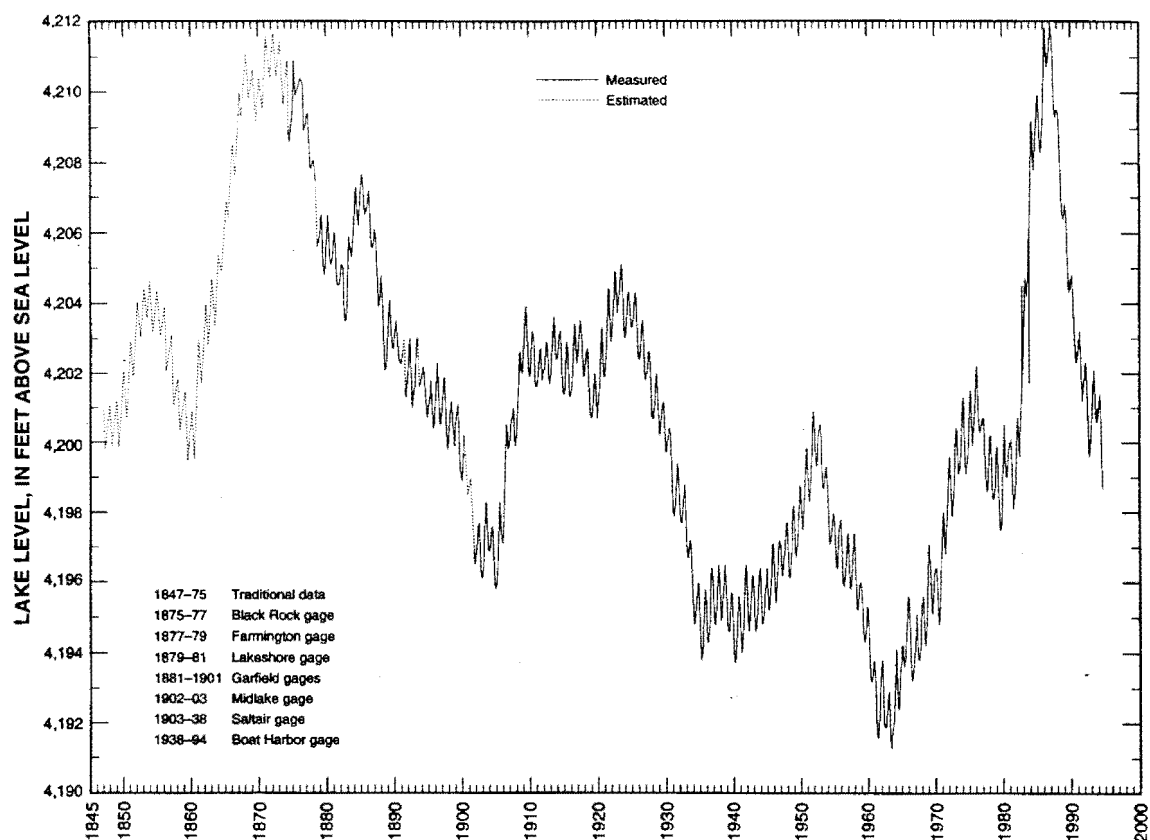
Figure J-3. Historical Great Salt Lake hydrograph.

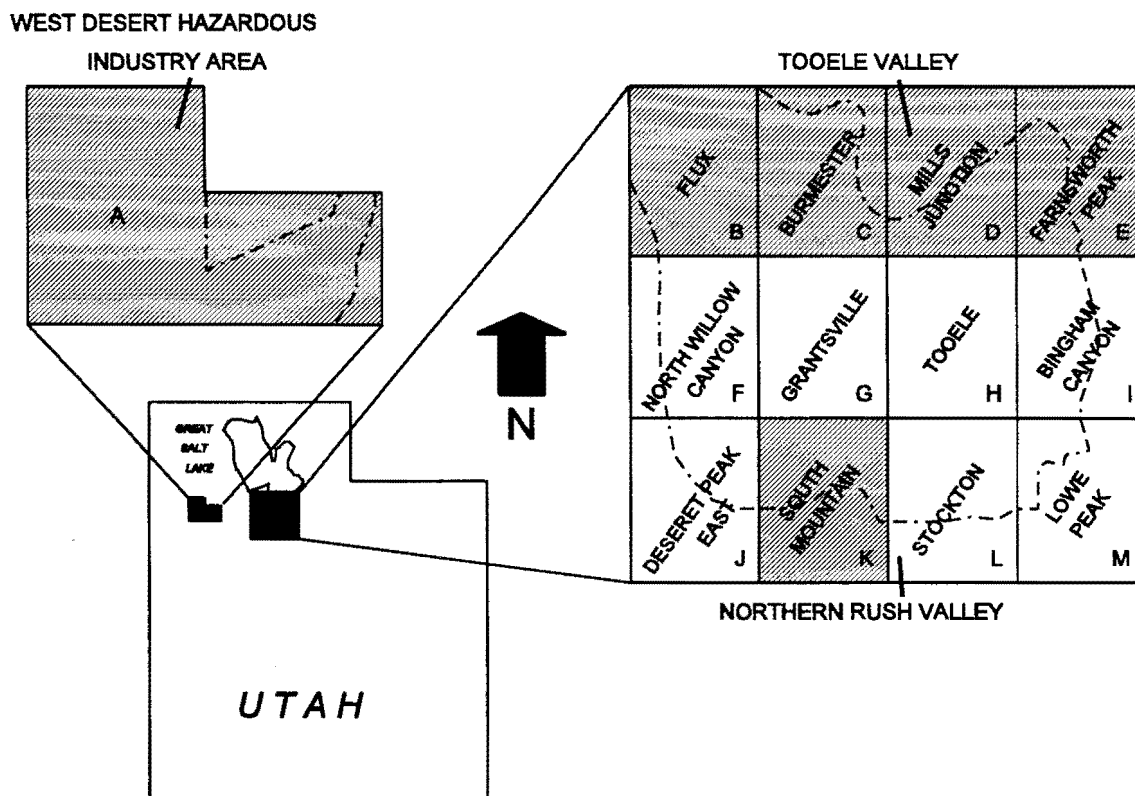
Figure J-4. Index map of areas (crosshatched) where lake-flooding, ponding, and sheet-flooding hazards are mapped on plate 1. Letters are used in plate designations. Study area boundaries are shown by dashed lines.

Plate 1 depicts areas that may be subject to ponding and sheet flooding, and lake flooding (figure J-4). Areas subject to ponding and sheet flooding are restricted to mudflats in the western WDHIA, northern Tooele Valley, and Rush Lake. Areas in Tooele Valley along the southern shoreline of Great Salt Lake, where the proposed lake flooding beneficial development strategy is recommended, include all areas below an elevation of 4,217 feet (1,285 m). The location of the 4,217-foot (1,285-m) contour has been interpolated from 1:24,000 scale U. S. Geological Survey topographic quadrangle maps. Areas in northern Rush Valley include areas below an elevation of 4,979 feet (1,518 m), which were defined as the potential flood boundary for Rush Lake in Harty and Christenson (1988). However, these lines are only approximate and accurate field surveys should be performed prior to development.

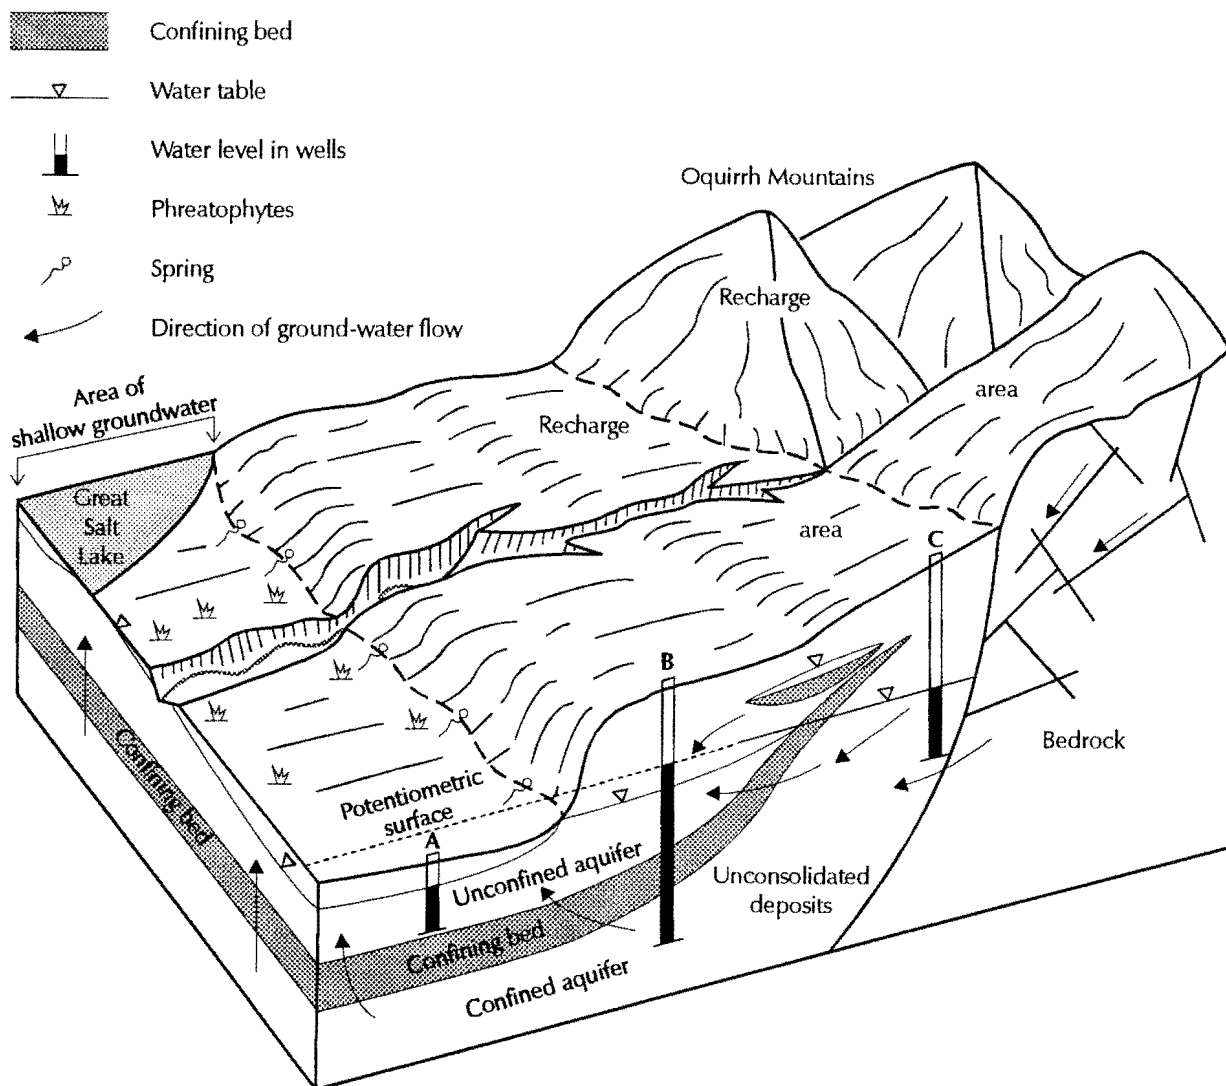
Figure K-1. Diagram of ground water in Tooele Valley showing: unconfined and confined aquifer, confining bed, perched water, water table, potentiometric surface, recharge area, and area of shallow ground water. Note level of water in well B rises above water table due to artesian (confined) conditions (modified from Hely and others, 1971).

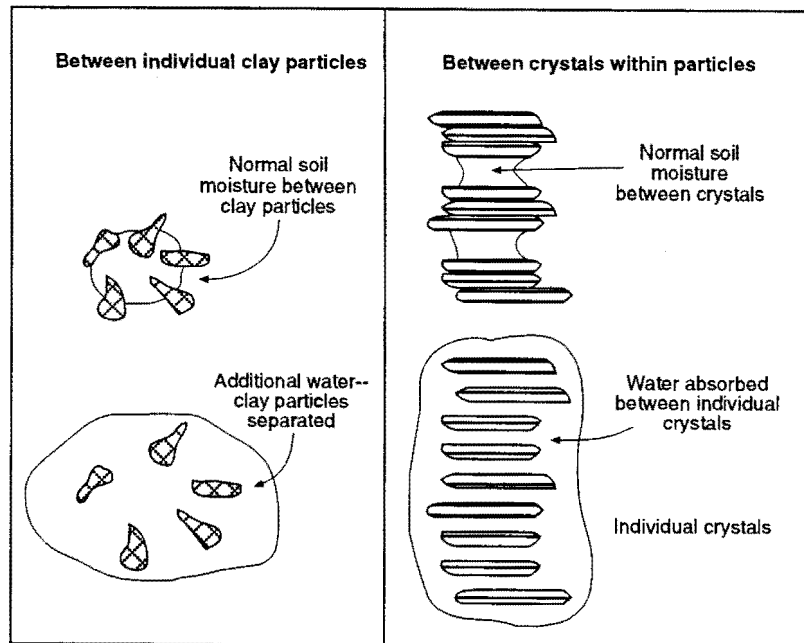
Figure L-1. Diagram of water-absorption processes in clay minerals (modified from Mulvey, 1992).

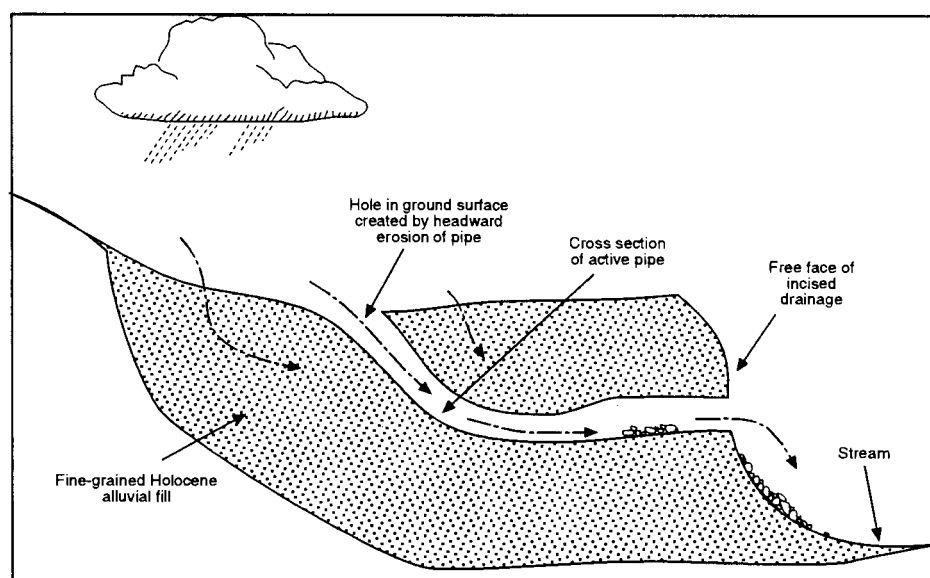
Figure L-2. Cross section of a pipe in Holocene alluvium (modified from Mulvey, 1992).

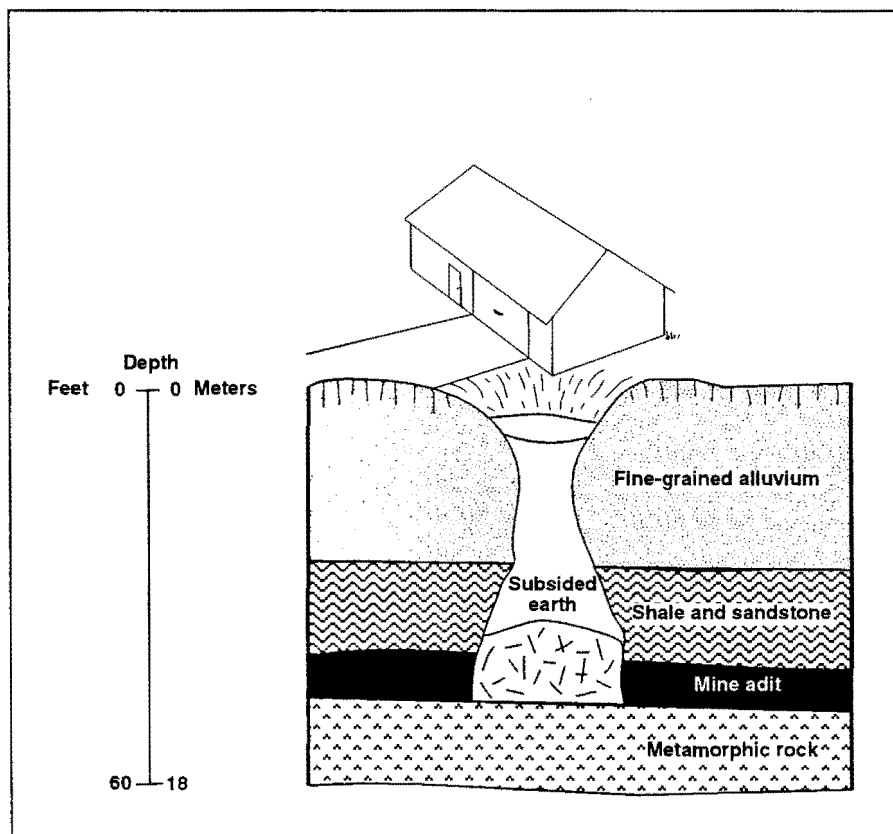
Figure L-3. Cross section of a subsidence pit, under a house, in an area of thick soil cover (modified from Turney, 1985).

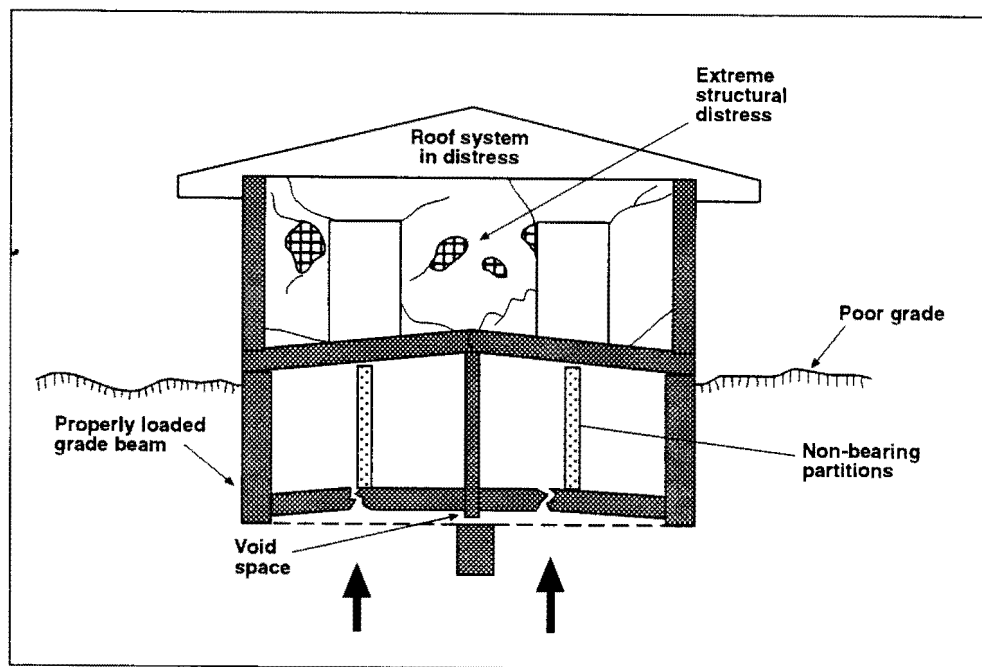
Figure L-4. Typical major house damage from expansive soils (from Holtz and Hart, 1978).

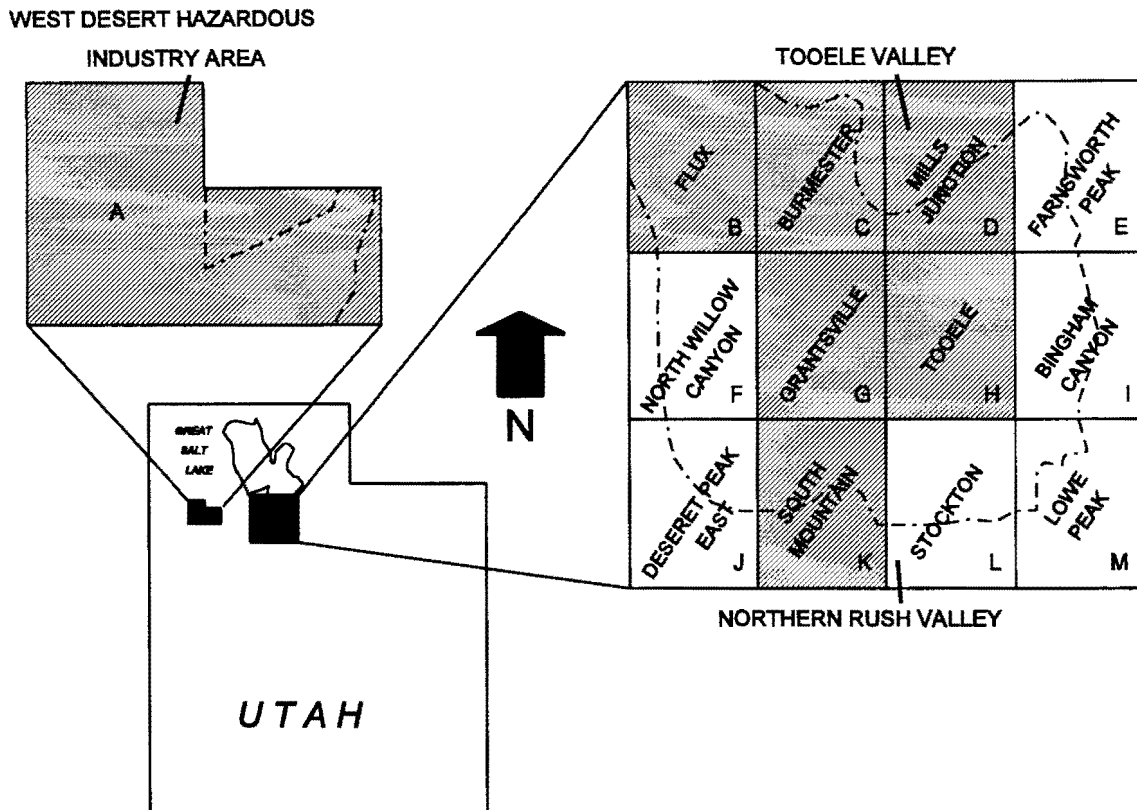
Figure L-5. Index map of areas (crosshatched) where problem soils are mapped on plate 5. Letters are used in plate designations. Study area boundaries are shown by dashed lines.

Plate 5 shows the likely extent of expansive and gypsiferous soils, based on surficial geology, in the WDHIA and Tooele Valley (figure L-5). The map is designed to highlight areas where these soils may be present and should be evaluated in standard soil-foundation investigations prior to development. In hazard areas, improperly designed roads and structures can be susceptible to damage. The maps are generalized and other localized areas may occur outside of mapped problem-soil areas. Areas where piping or mine subsidence may be found were not mapped.

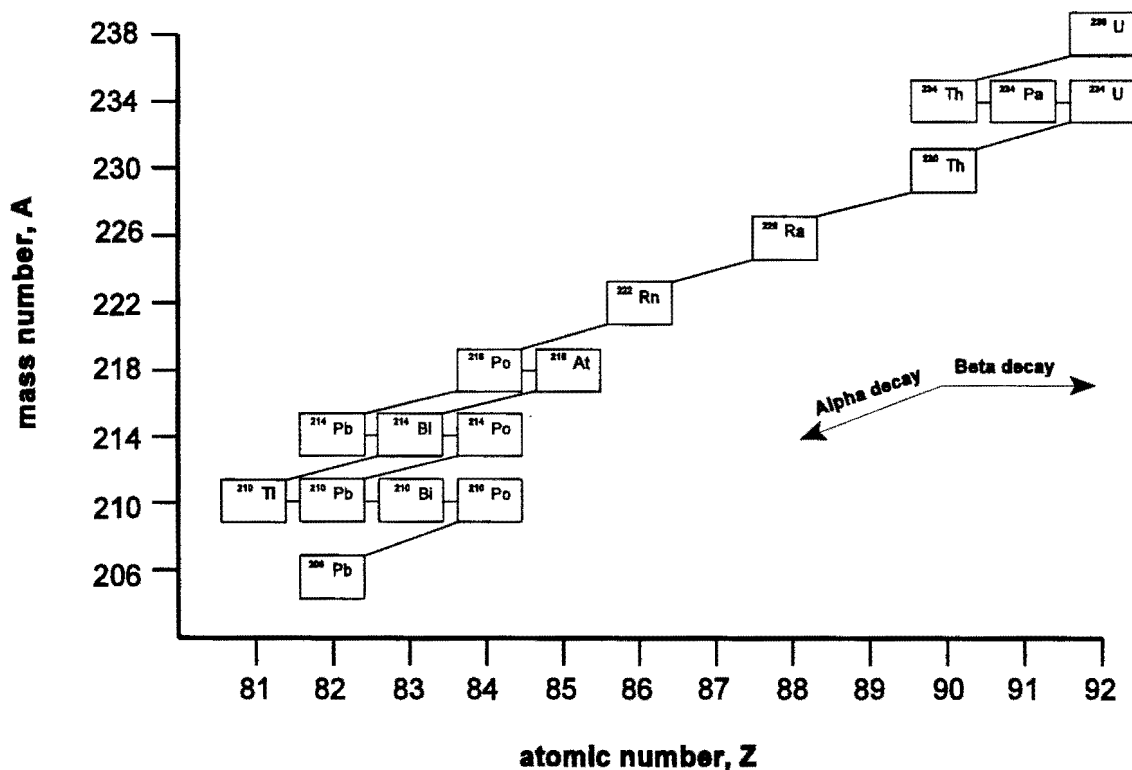
Figure M-1. Uranium (^{238}U) decay series. Radon (^{222}Rn) is derived from radium (^{226}Ra) and is the only isotope in the series that is a gas. Because it is inert, radon also has the ability to move with air or water without participating in chemical reactions (modified from Durrance, 1986).

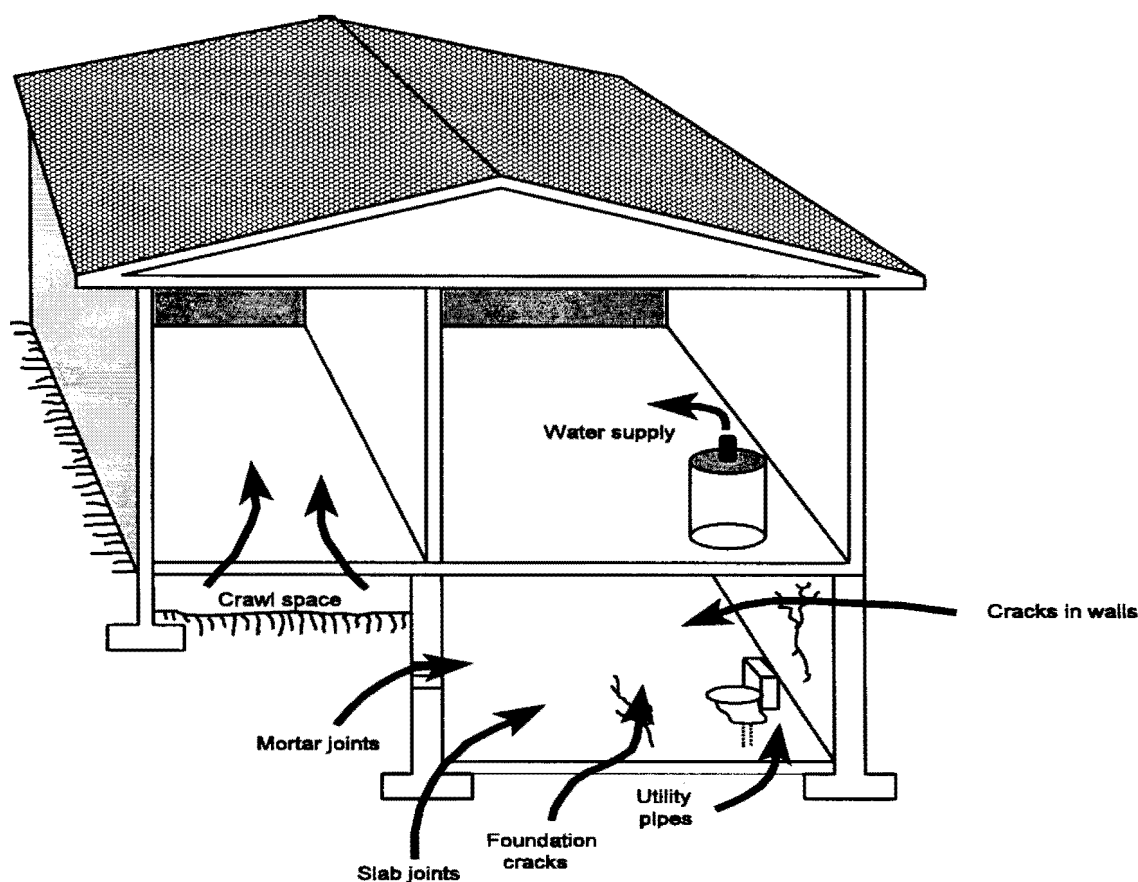
Figure M-2. Various pathways for radon to enter a home. Most of the entry routes are in the basement, because that is the part of the house with the greatest surface area exposed to the surrounding soil (modified from U.S. Environmental Protection Agency, 1992).

porous building materials or openings below grade, and (4) have a lower atmospheric pressure inside than outside.

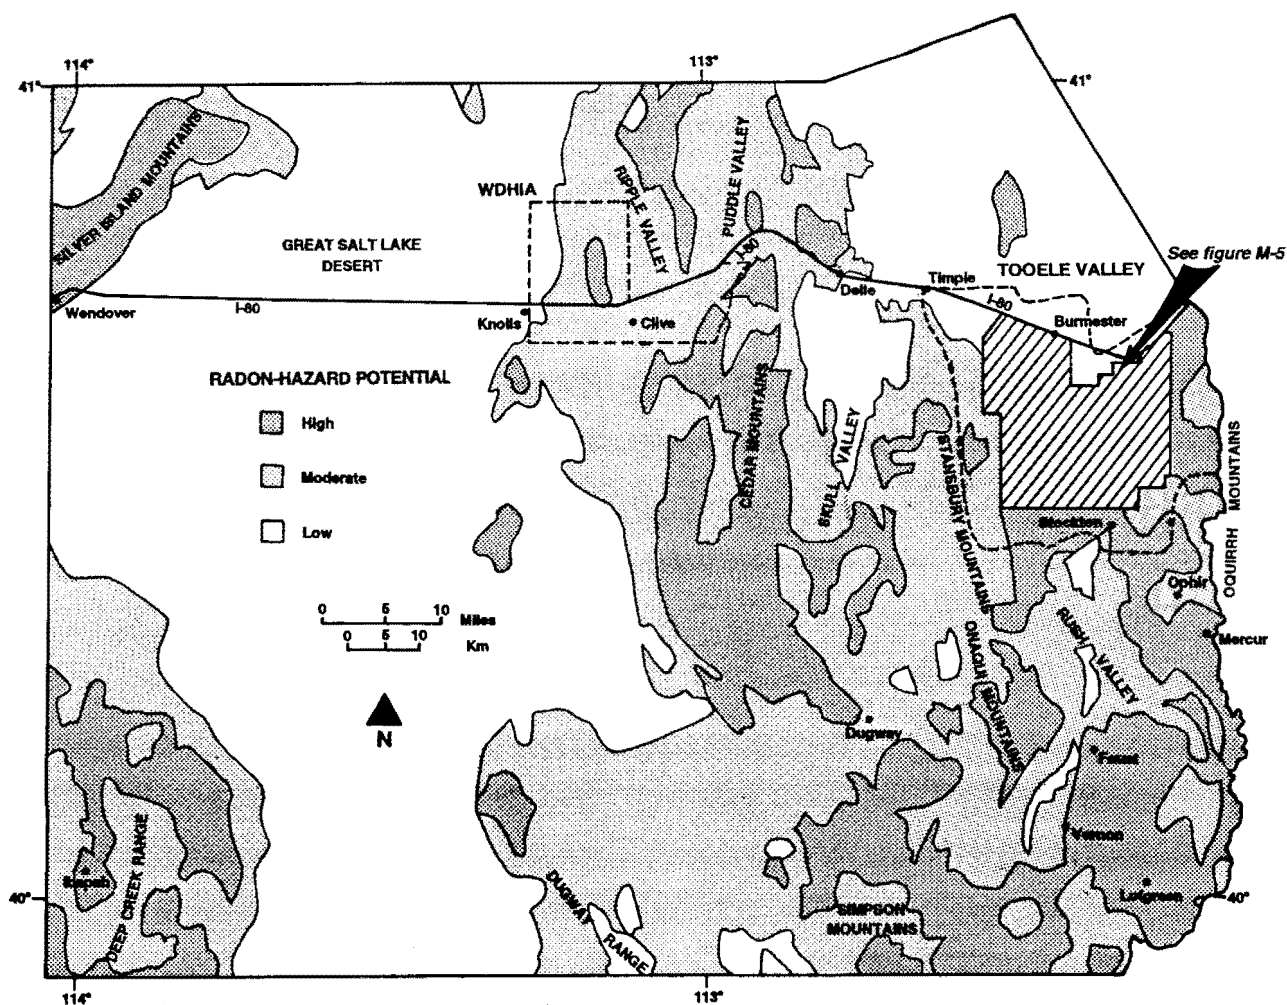
Figure M-4. Radon hazard potential of Tooele County from geologic factors (modified from Black, 1993).

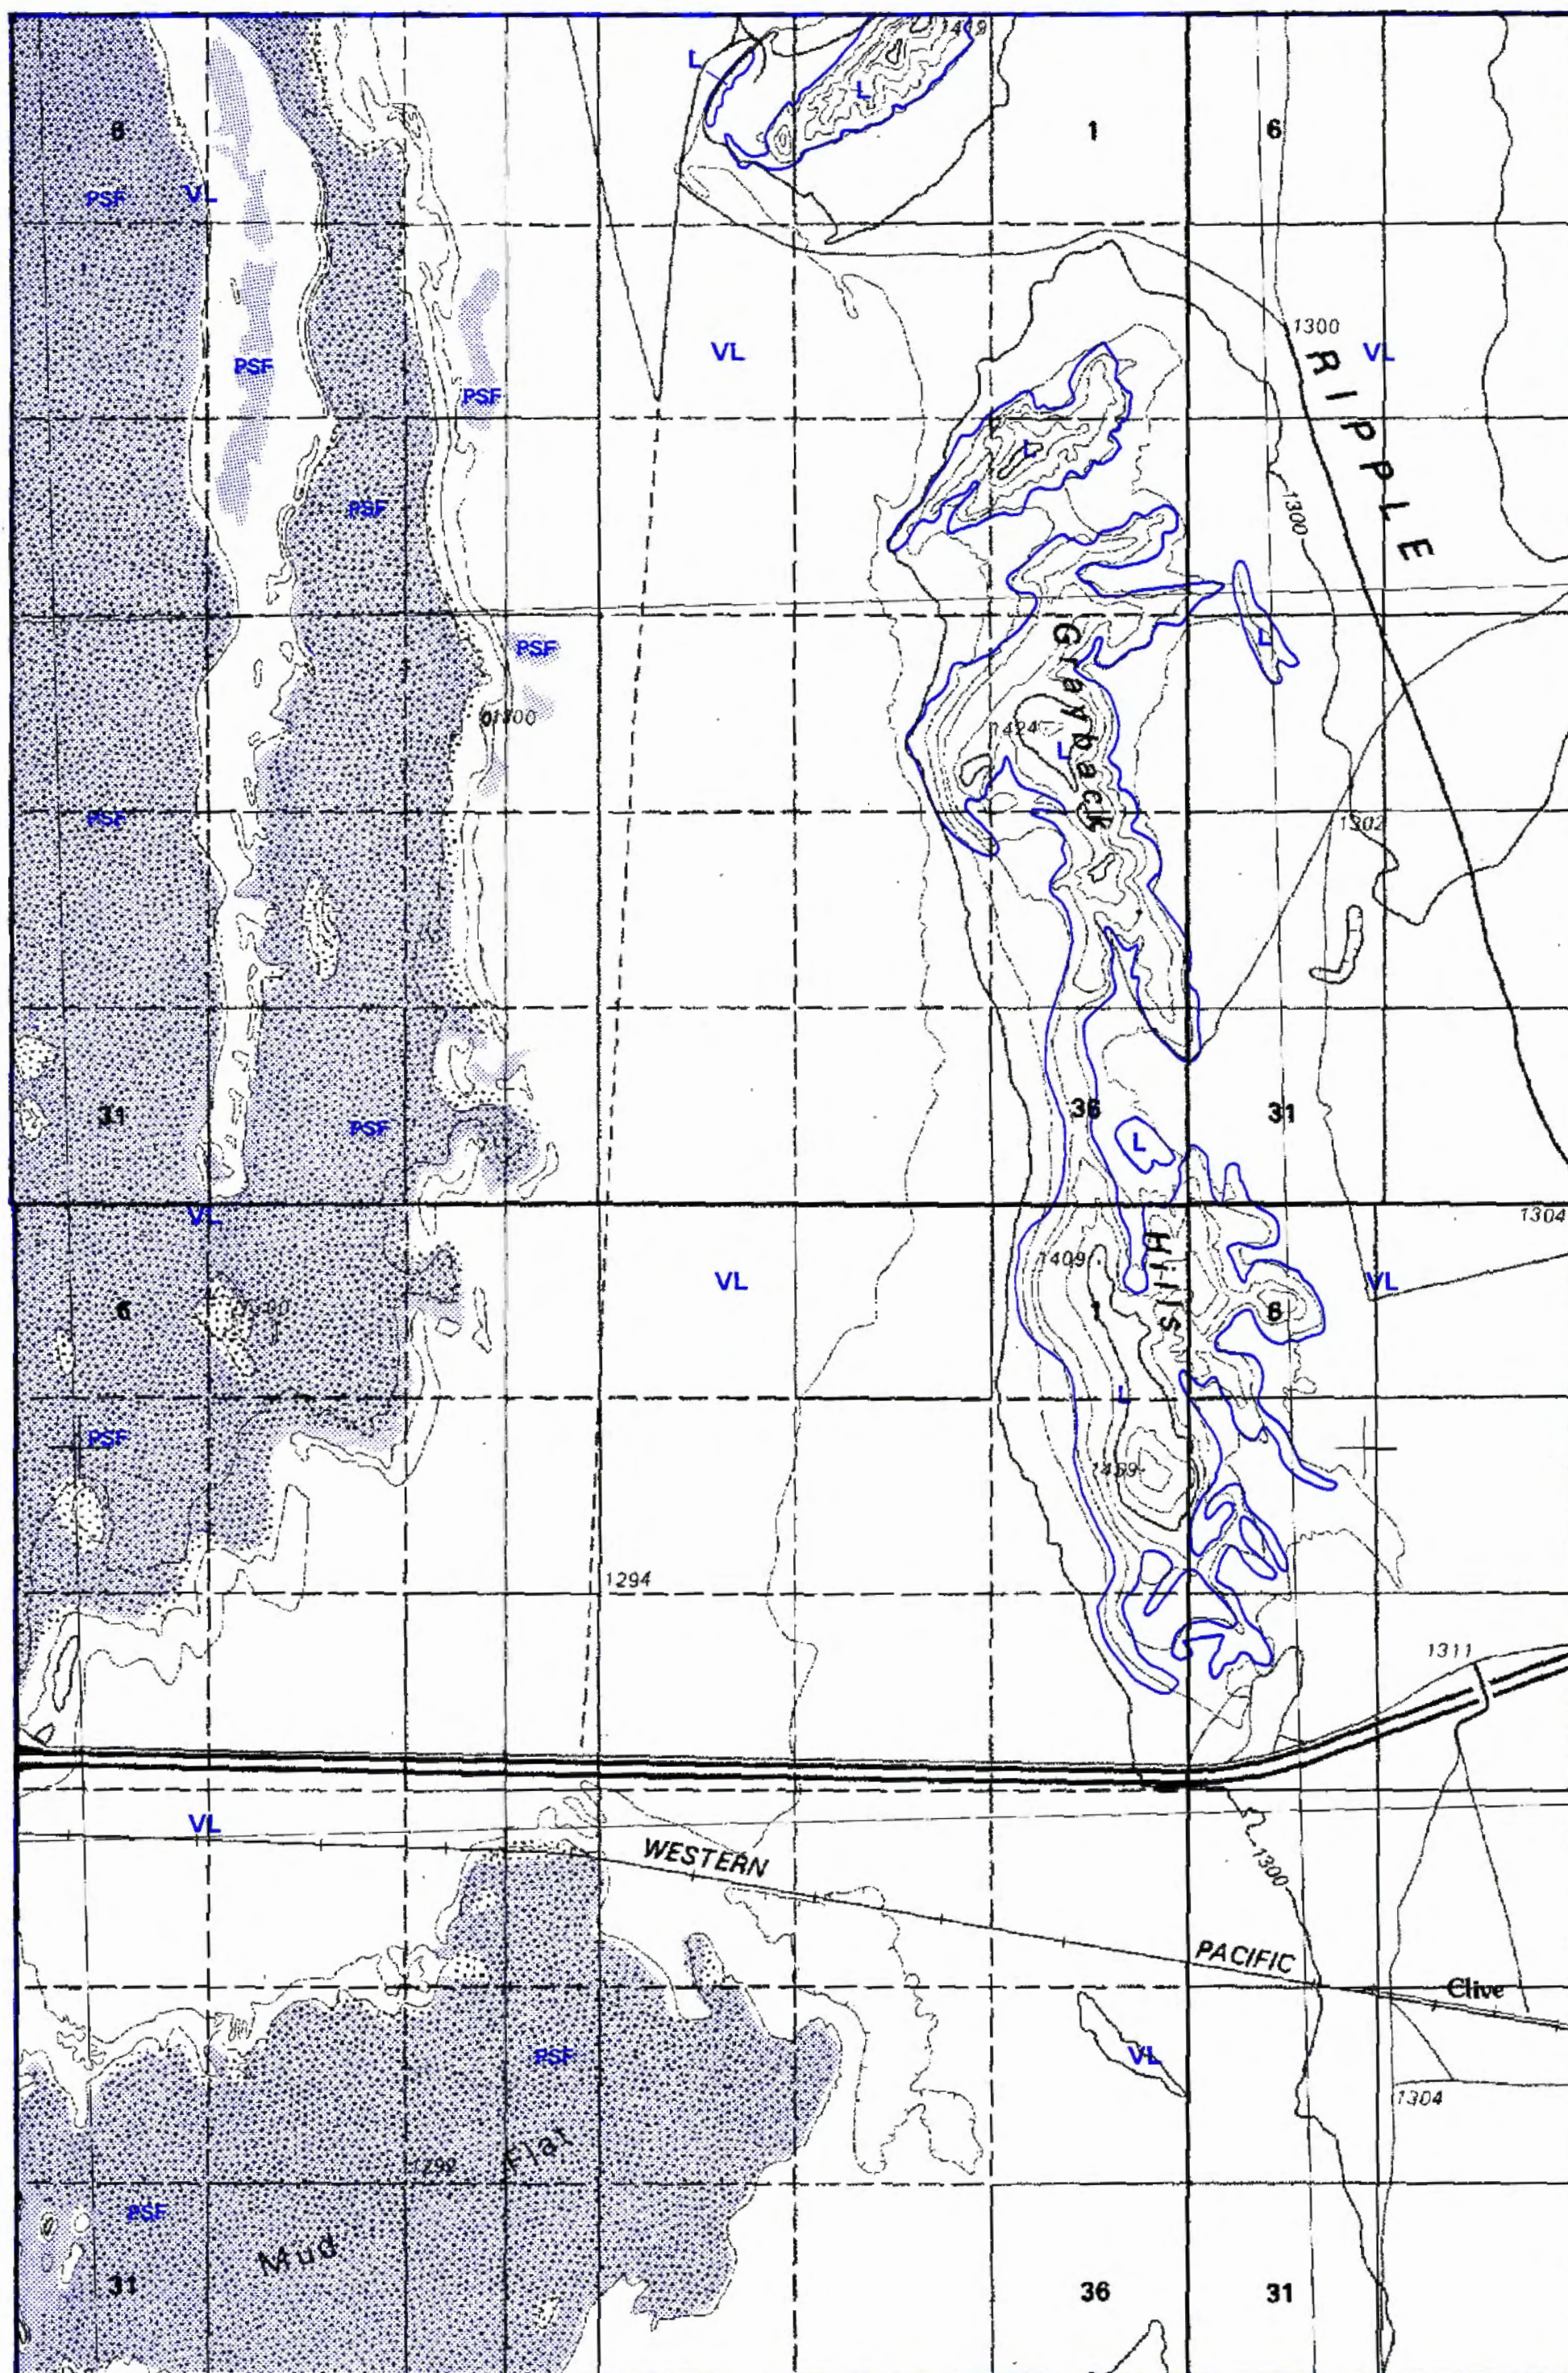
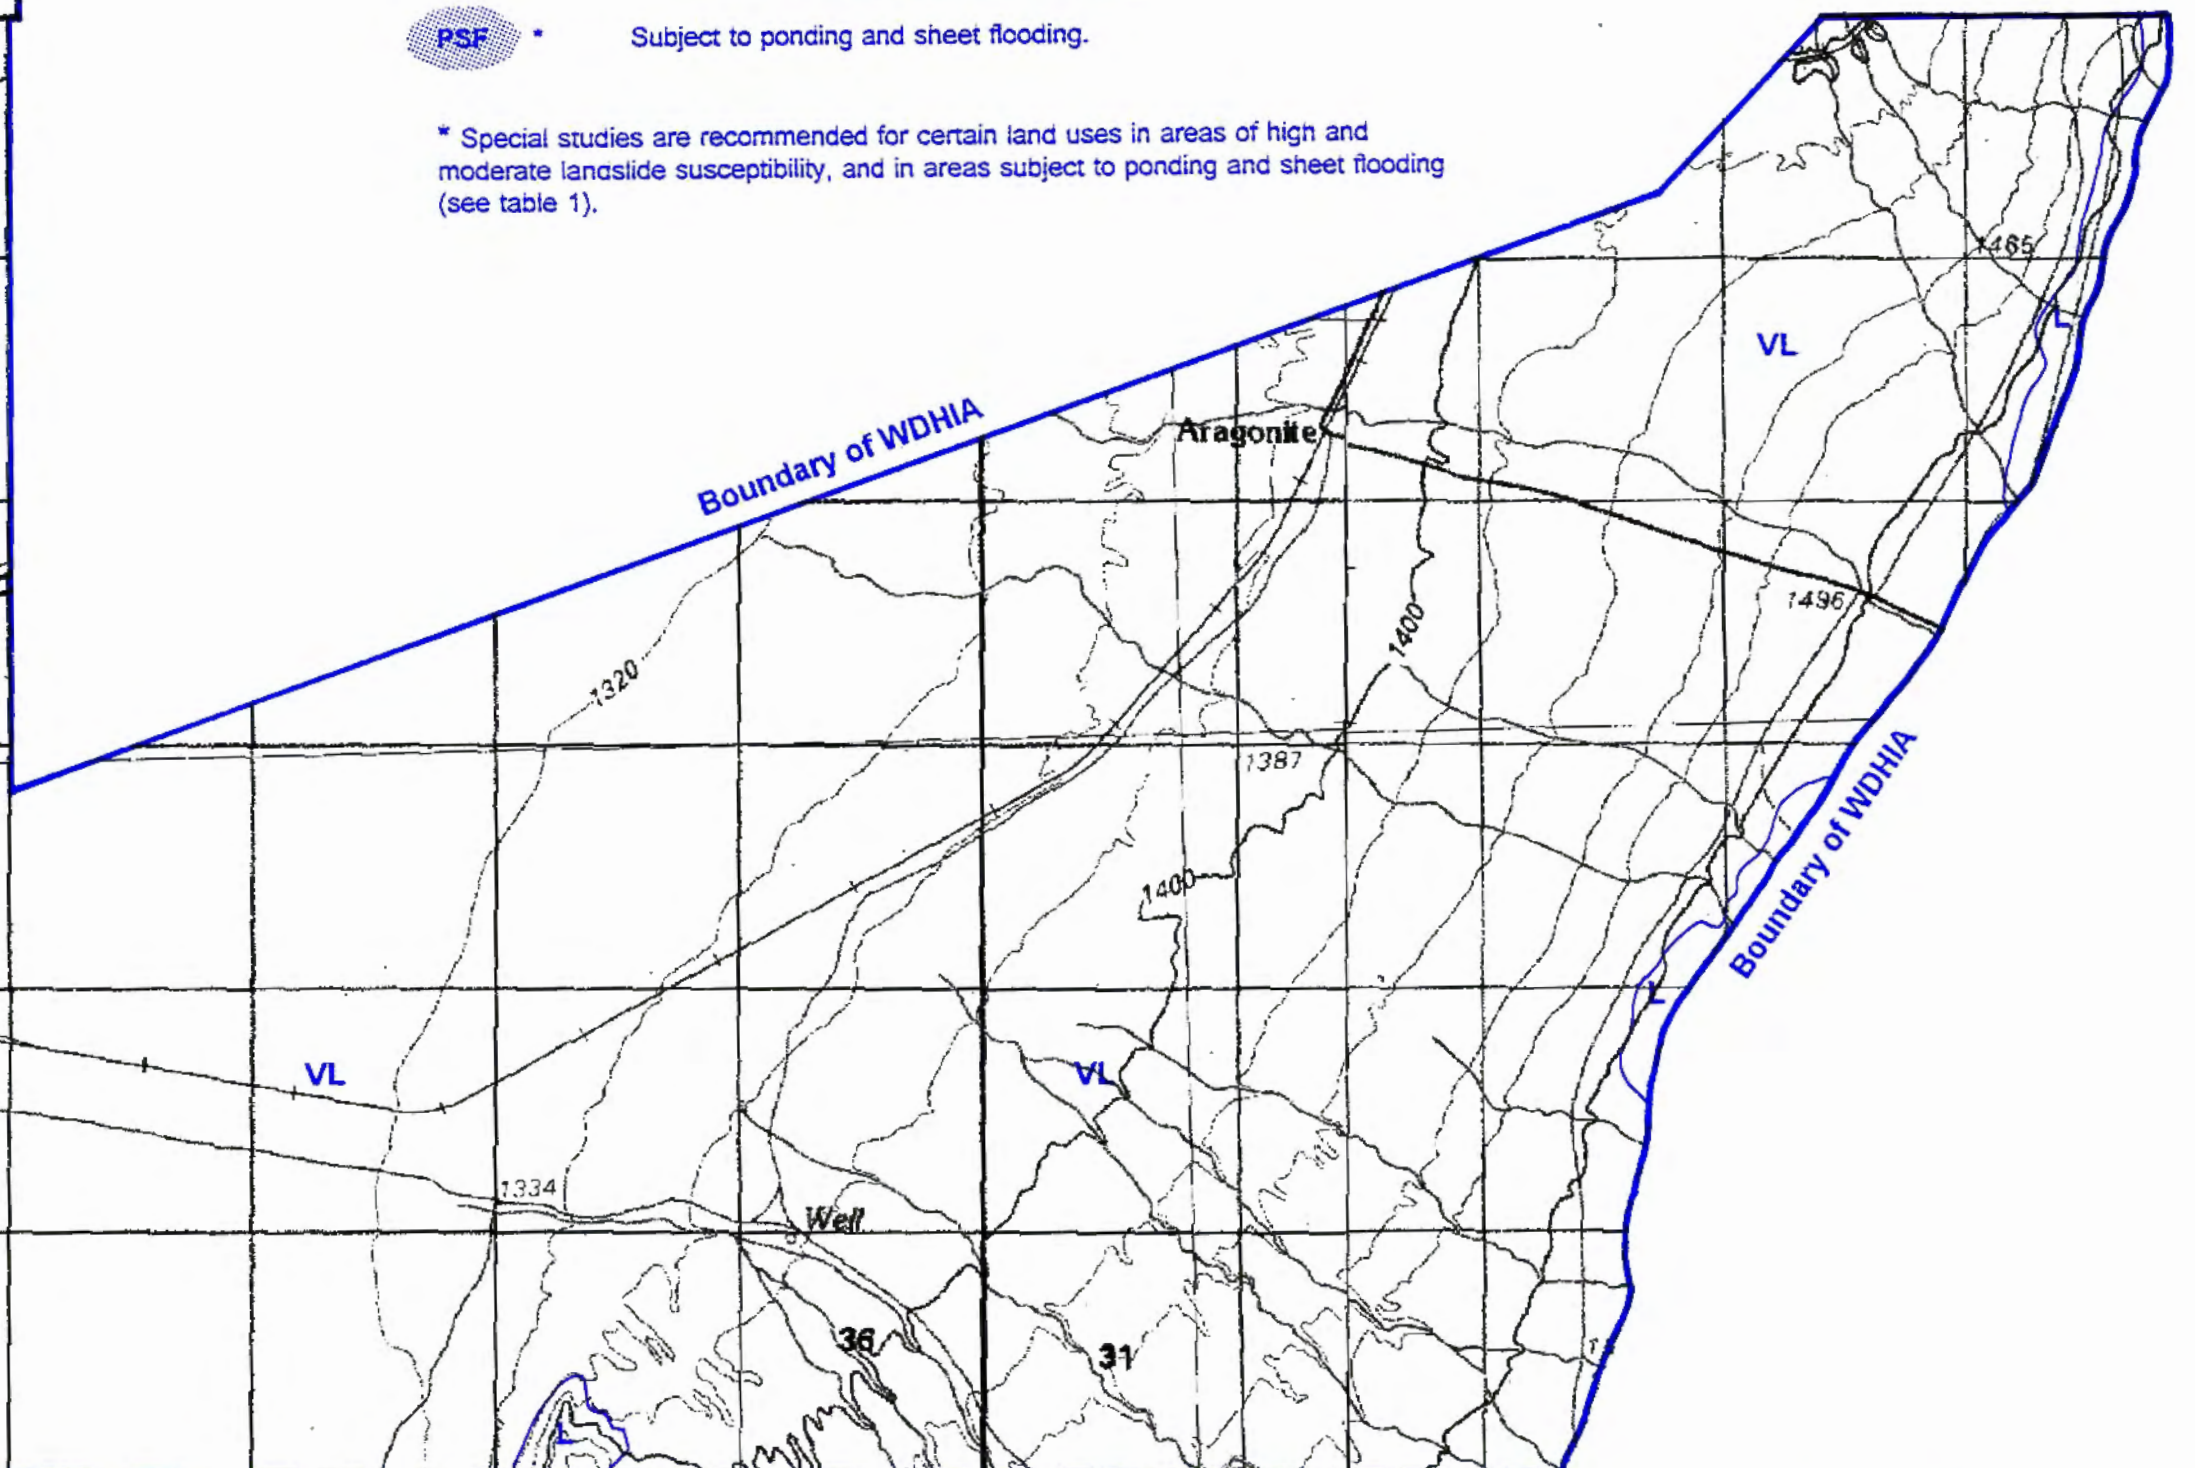
Landslide, lake-flooding, and ponding and sheet-flooding hazards, Flux quadrangle, Tooele County, Utah.

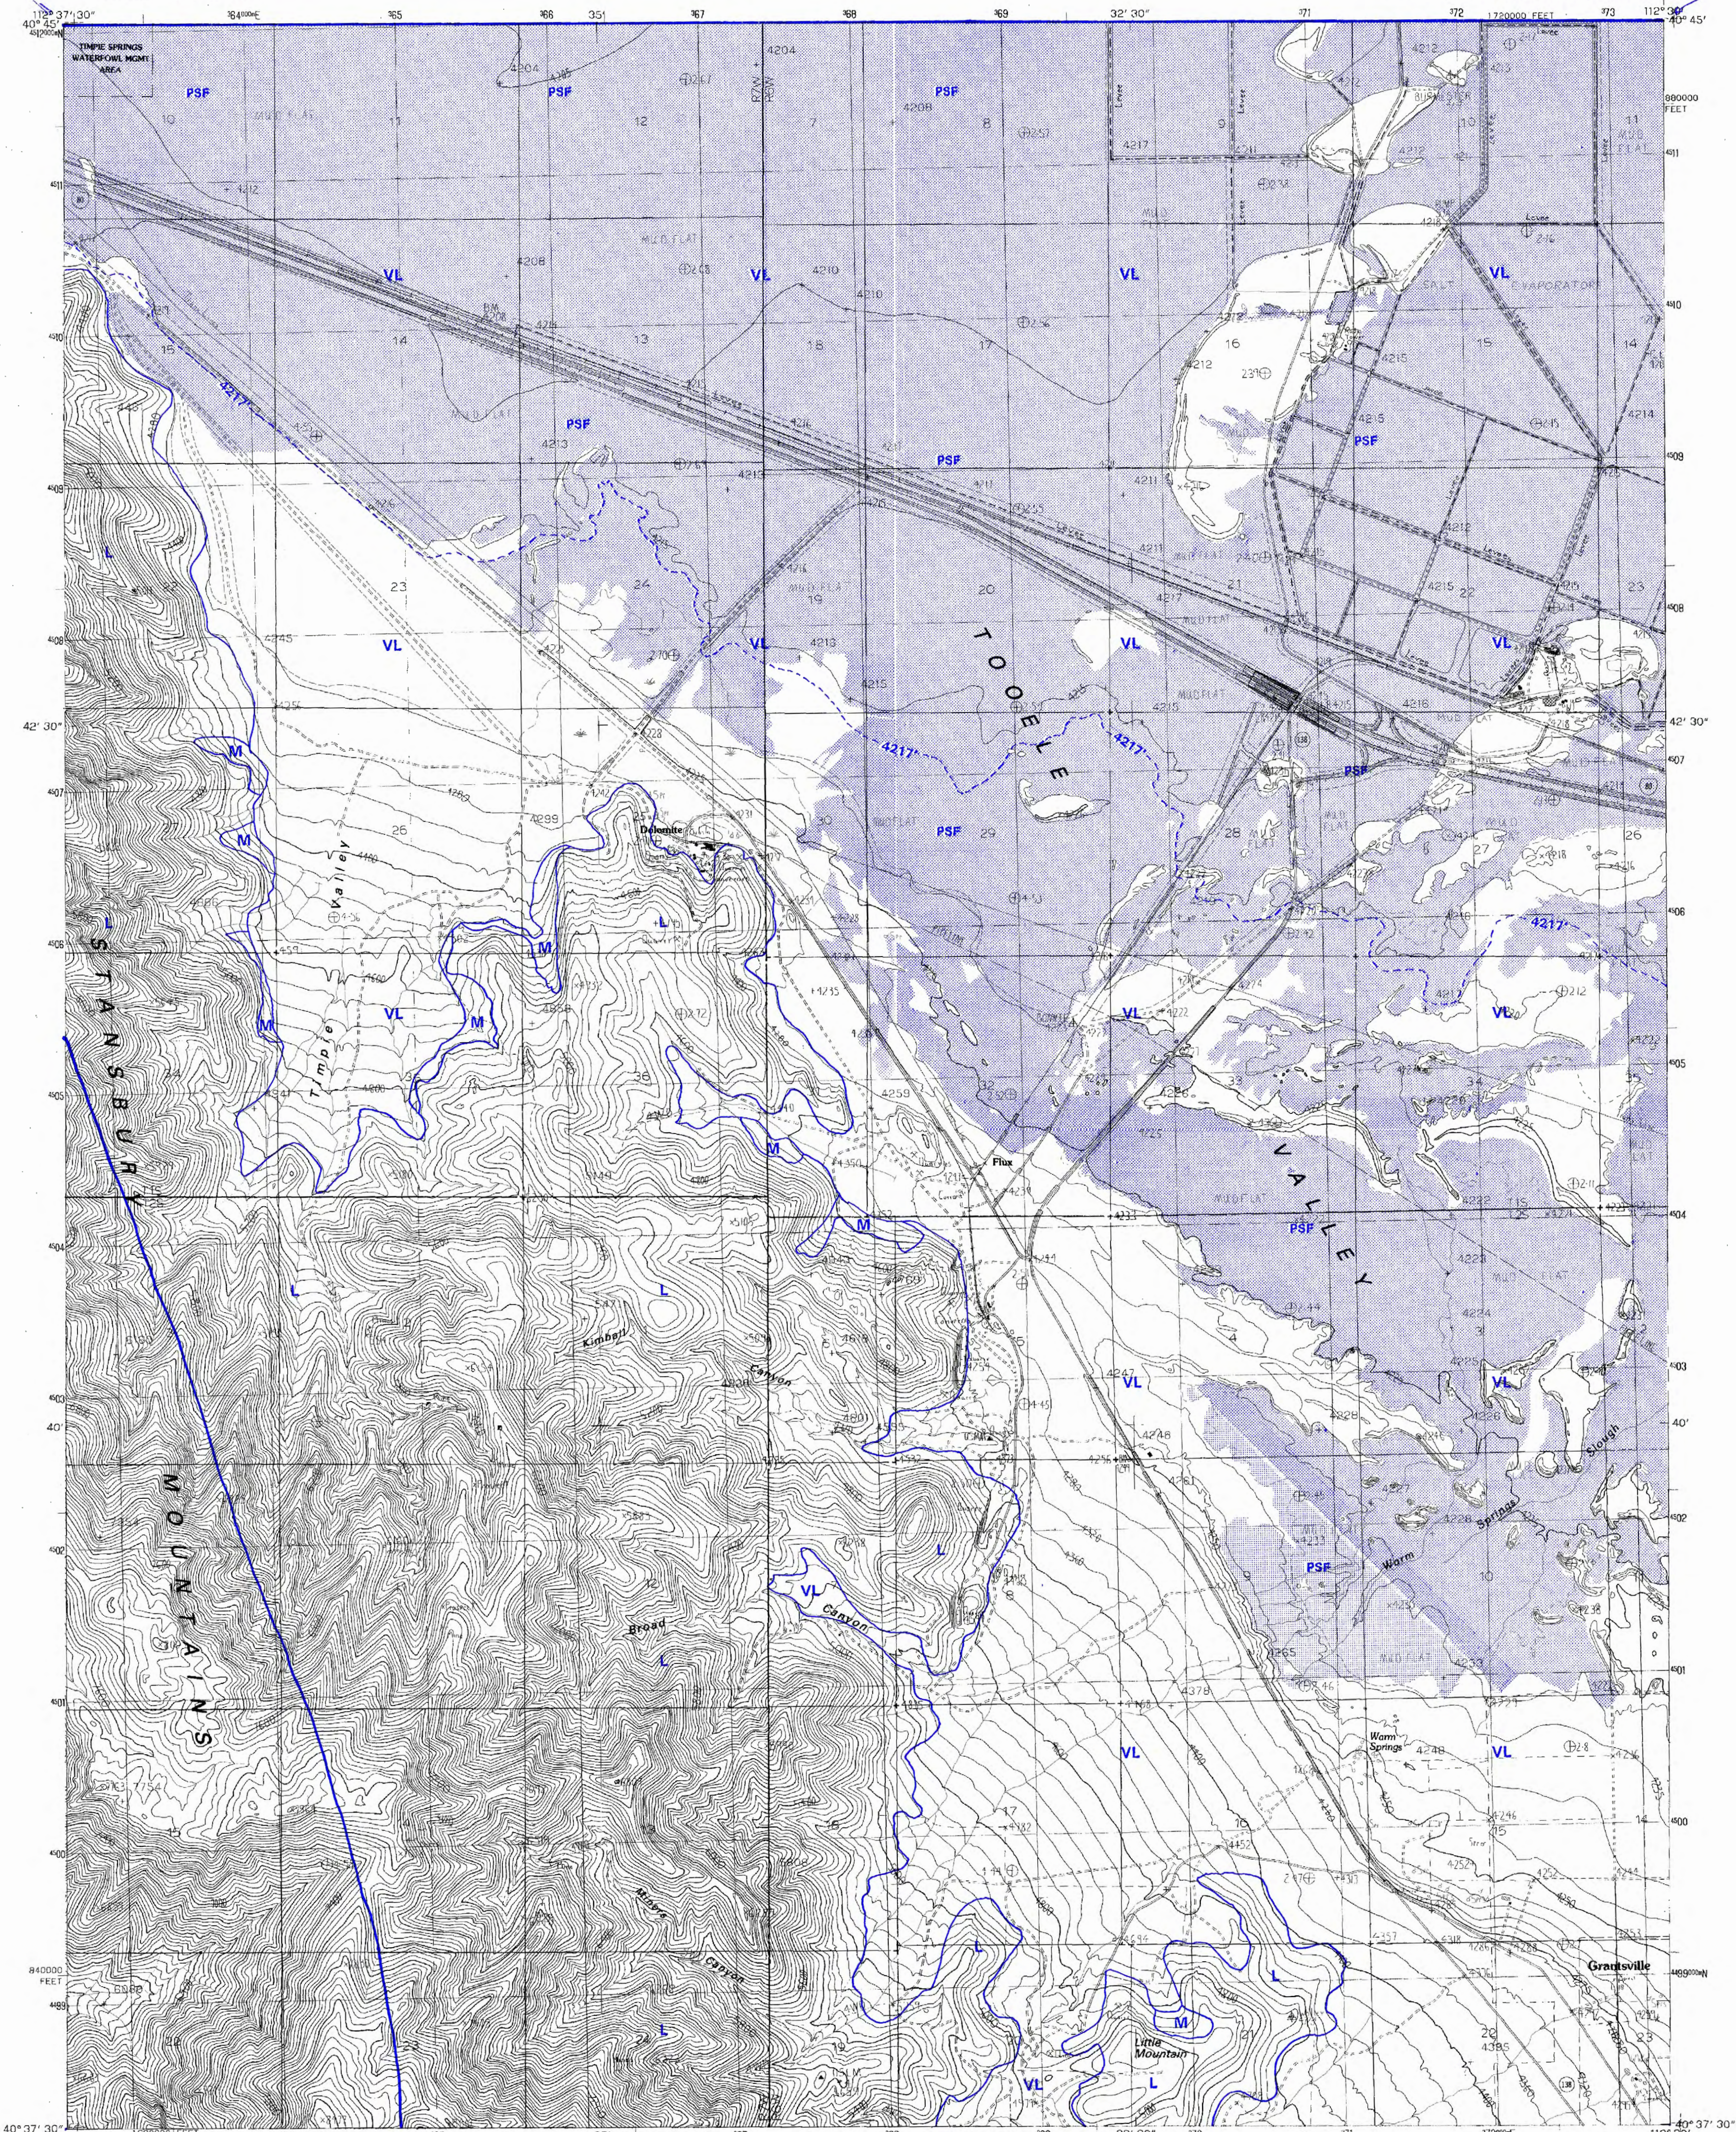
FLUX QUADRANGLE
UTAH-TOOELE CO.
7.5 MINUTE SERIES (TOPOGRAPHIC)

- Landslide susceptibility**
- H* High; includes existing landslides (crosshatched).
 - M* Moderate.
 - L Low.
 - VL Very low.
- Lake flooding, and ponding and sheet flooding**
- 4217' --- Boundary of the "Beneficial Development Area" (4217-foot [1285-m] contour). Areas below this elevation are subject to lake flooding and land use must be compatible with potential flood hazards.
 - PSF Subject to ponding and sheet flooding.
- * Special studies are recommended for certain land uses in areas of high and moderate landslide susceptibility, and in areas subject to ponding and sheet flooding (see table 1).
