GEOLOGIC HAZARDS AND LAND-USE PLANNING FOR TOOELE VALLEY AND THE WEST DESERT HAZARDOUS INDUSTRY AREA, TOOELE COUNTY, UTAH

Barry J. Solomon and Bill D. Black, editors

OPEN-FILE REPORT 318
UTAH GEOLOGICAL SURVEY
a division of
UTAH DEPARTMENT OF NATURAL RESOURCES

October 1995

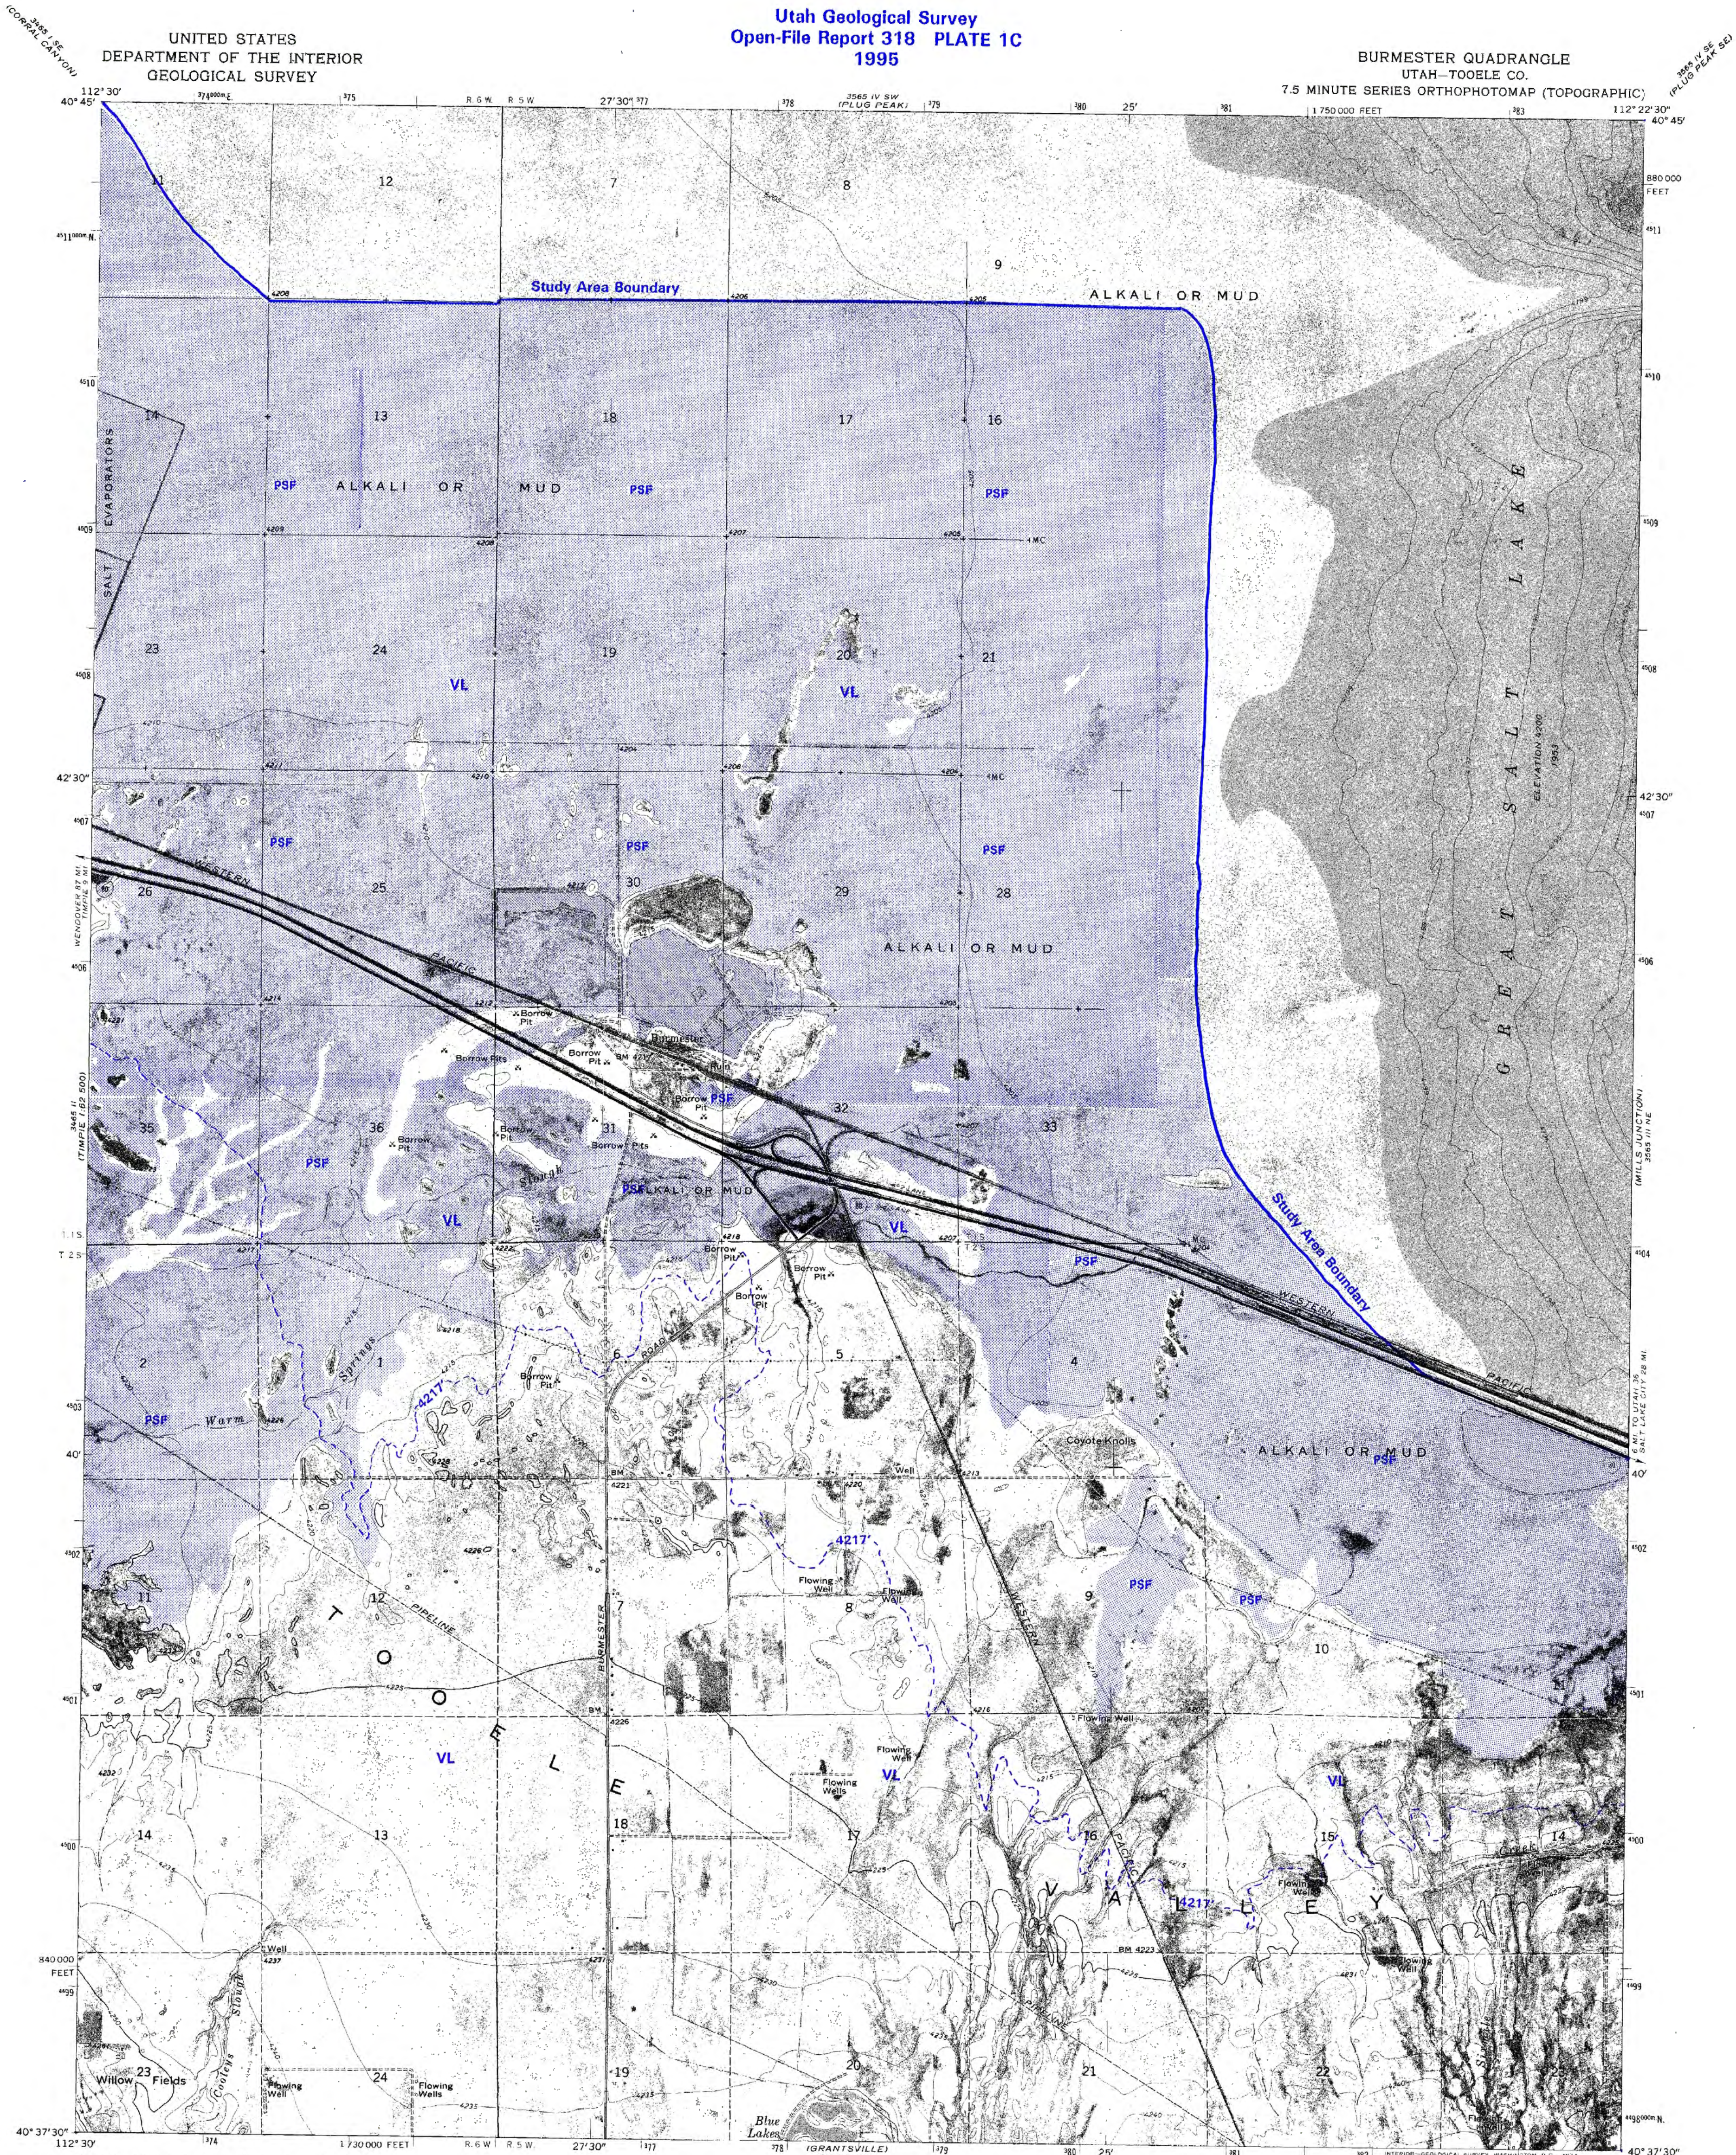
Utah Geological Survey
Open-File Report 318 PLATE 1C
1995

Landslide, lake-flooding, and ponding and sheet-flooding hazards, Burmester quadrangle, Tooele County, Utah.

Lake flooding, and ponding and sheet flooding
Boundary of the "Beneficial Development Area" (4217-foot [1285-m] contour). Areas below this elevation are subject to lake flooding and land use must be compatible with potential flood hazards.
PSF Subject to ponding and sheet flooding.

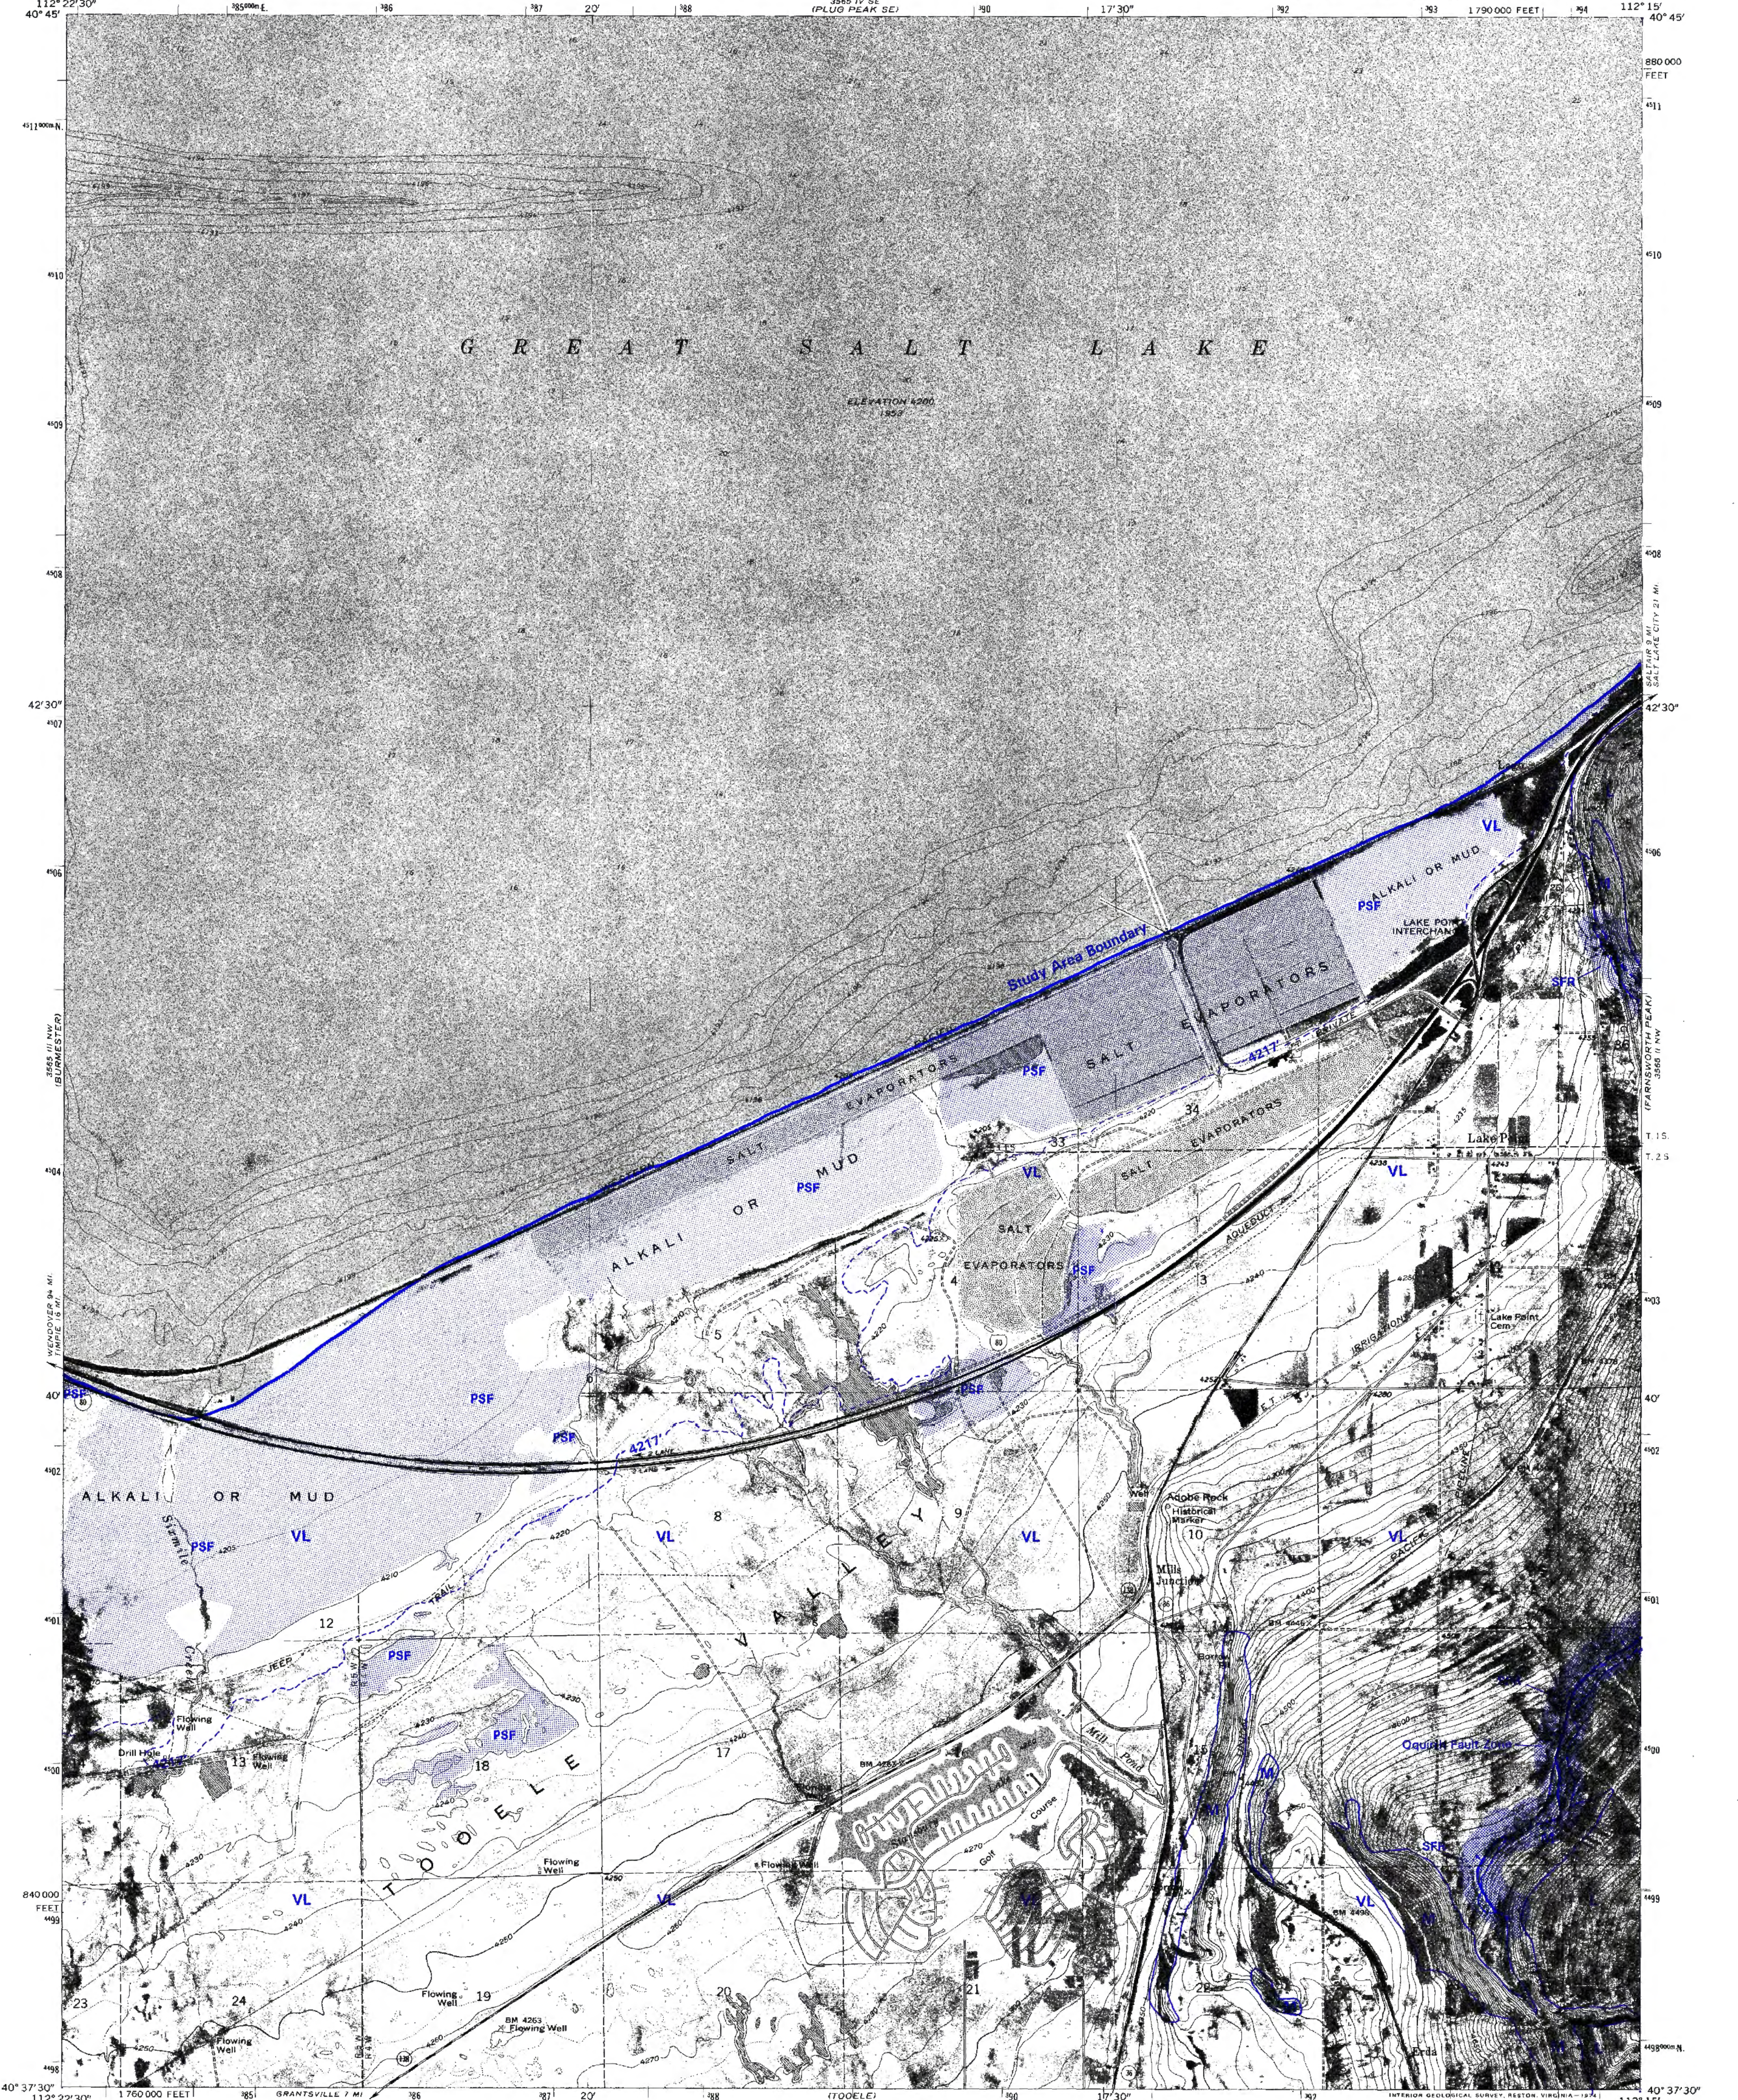
Landslide, surface-fault-rupture, lake-flooding, and ponding and sheet-flooding hazards, Mills Junction quadrangle, Tooele County, Utah.

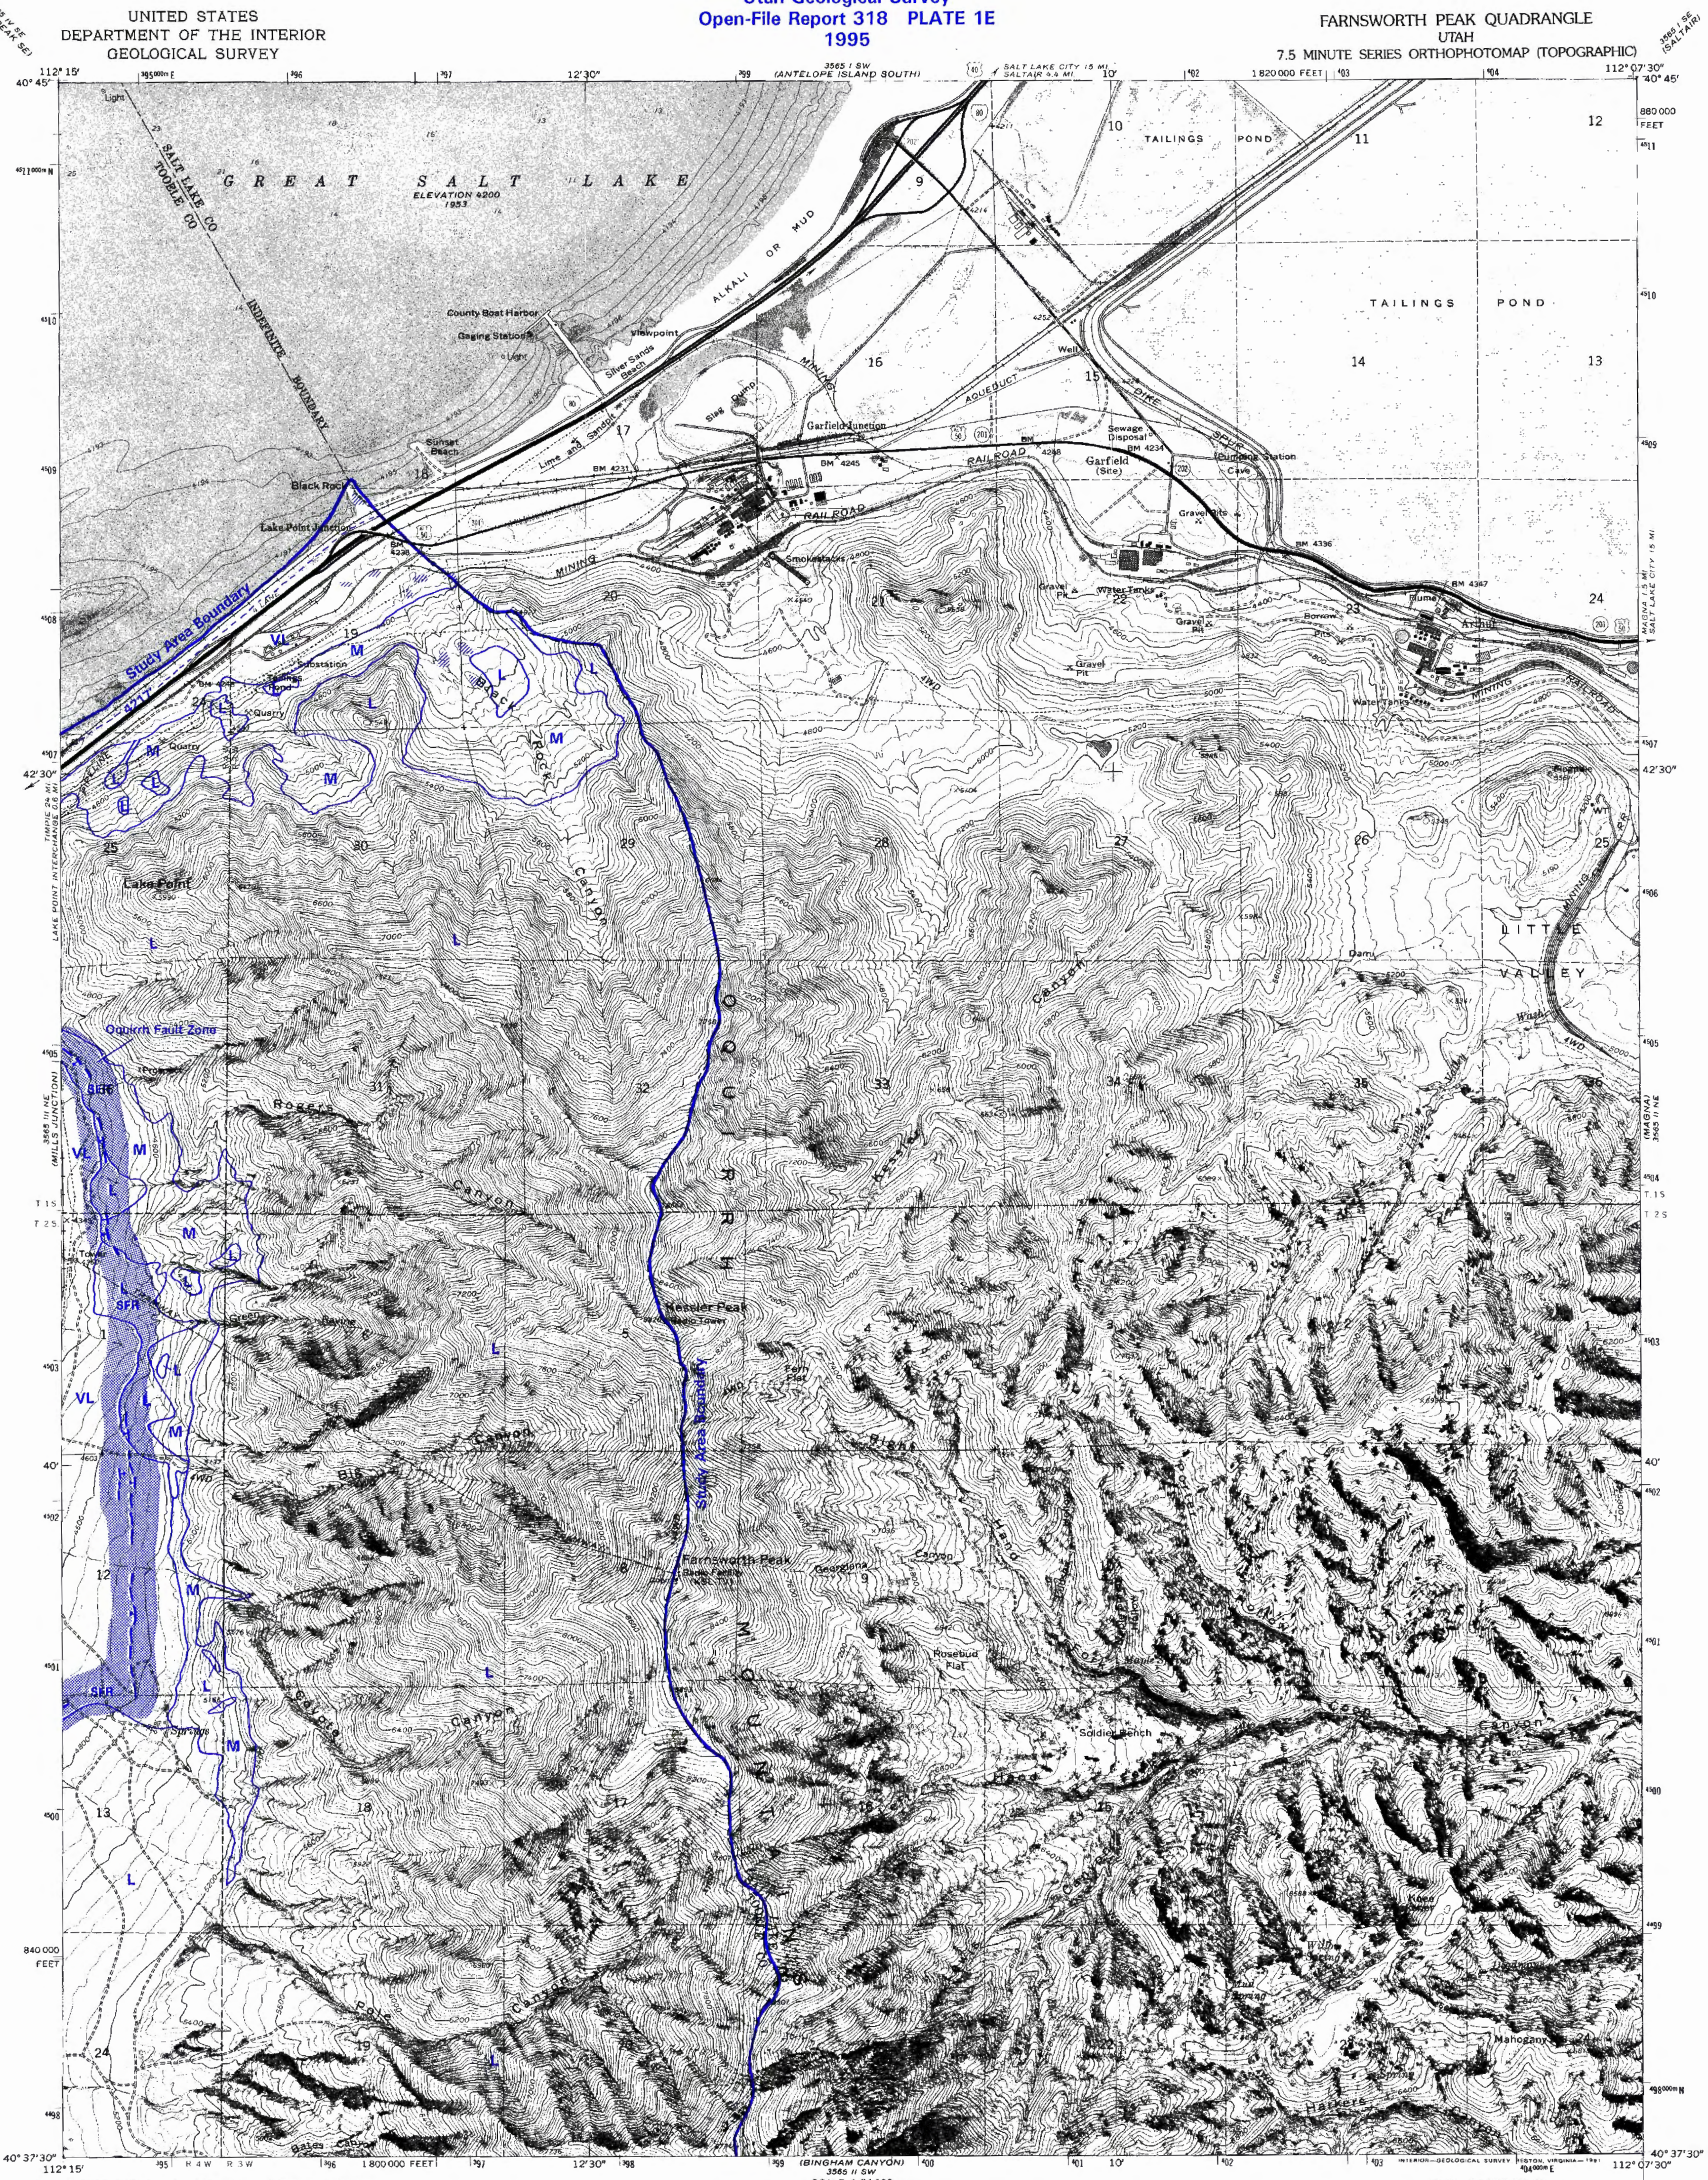
Landslide, surface-fault-rupture, and lake-flooding hazards, Farnsworth Peak quadrangle, Tooele County, Utah.

- Landslide susceptibility**
- H* High; includes existing landslides (crosshatched).
 - M* Moderate.
 - L Low.
 - VL Very low.
- Surface fault rupture**
- Main trace of active faults with evidence of possible Quaternary movement (within the past 1.6 million years). Dashed where inferred, bar and ball on downthrown side.
 - SFR * Possible surface fault rupture.
- Lake flooding**
- Boundary of the "Beneficial Development Area" (4217-foot [1285-m] contour). Areas below this elevation are subject to lake flooding and land use must be compatible with potential flood hazard.
- * Special studies are recommended for certain land uses in areas of (1) high and moderate landslide susceptibility, and (2) possible surface fault rupture (see table 1).

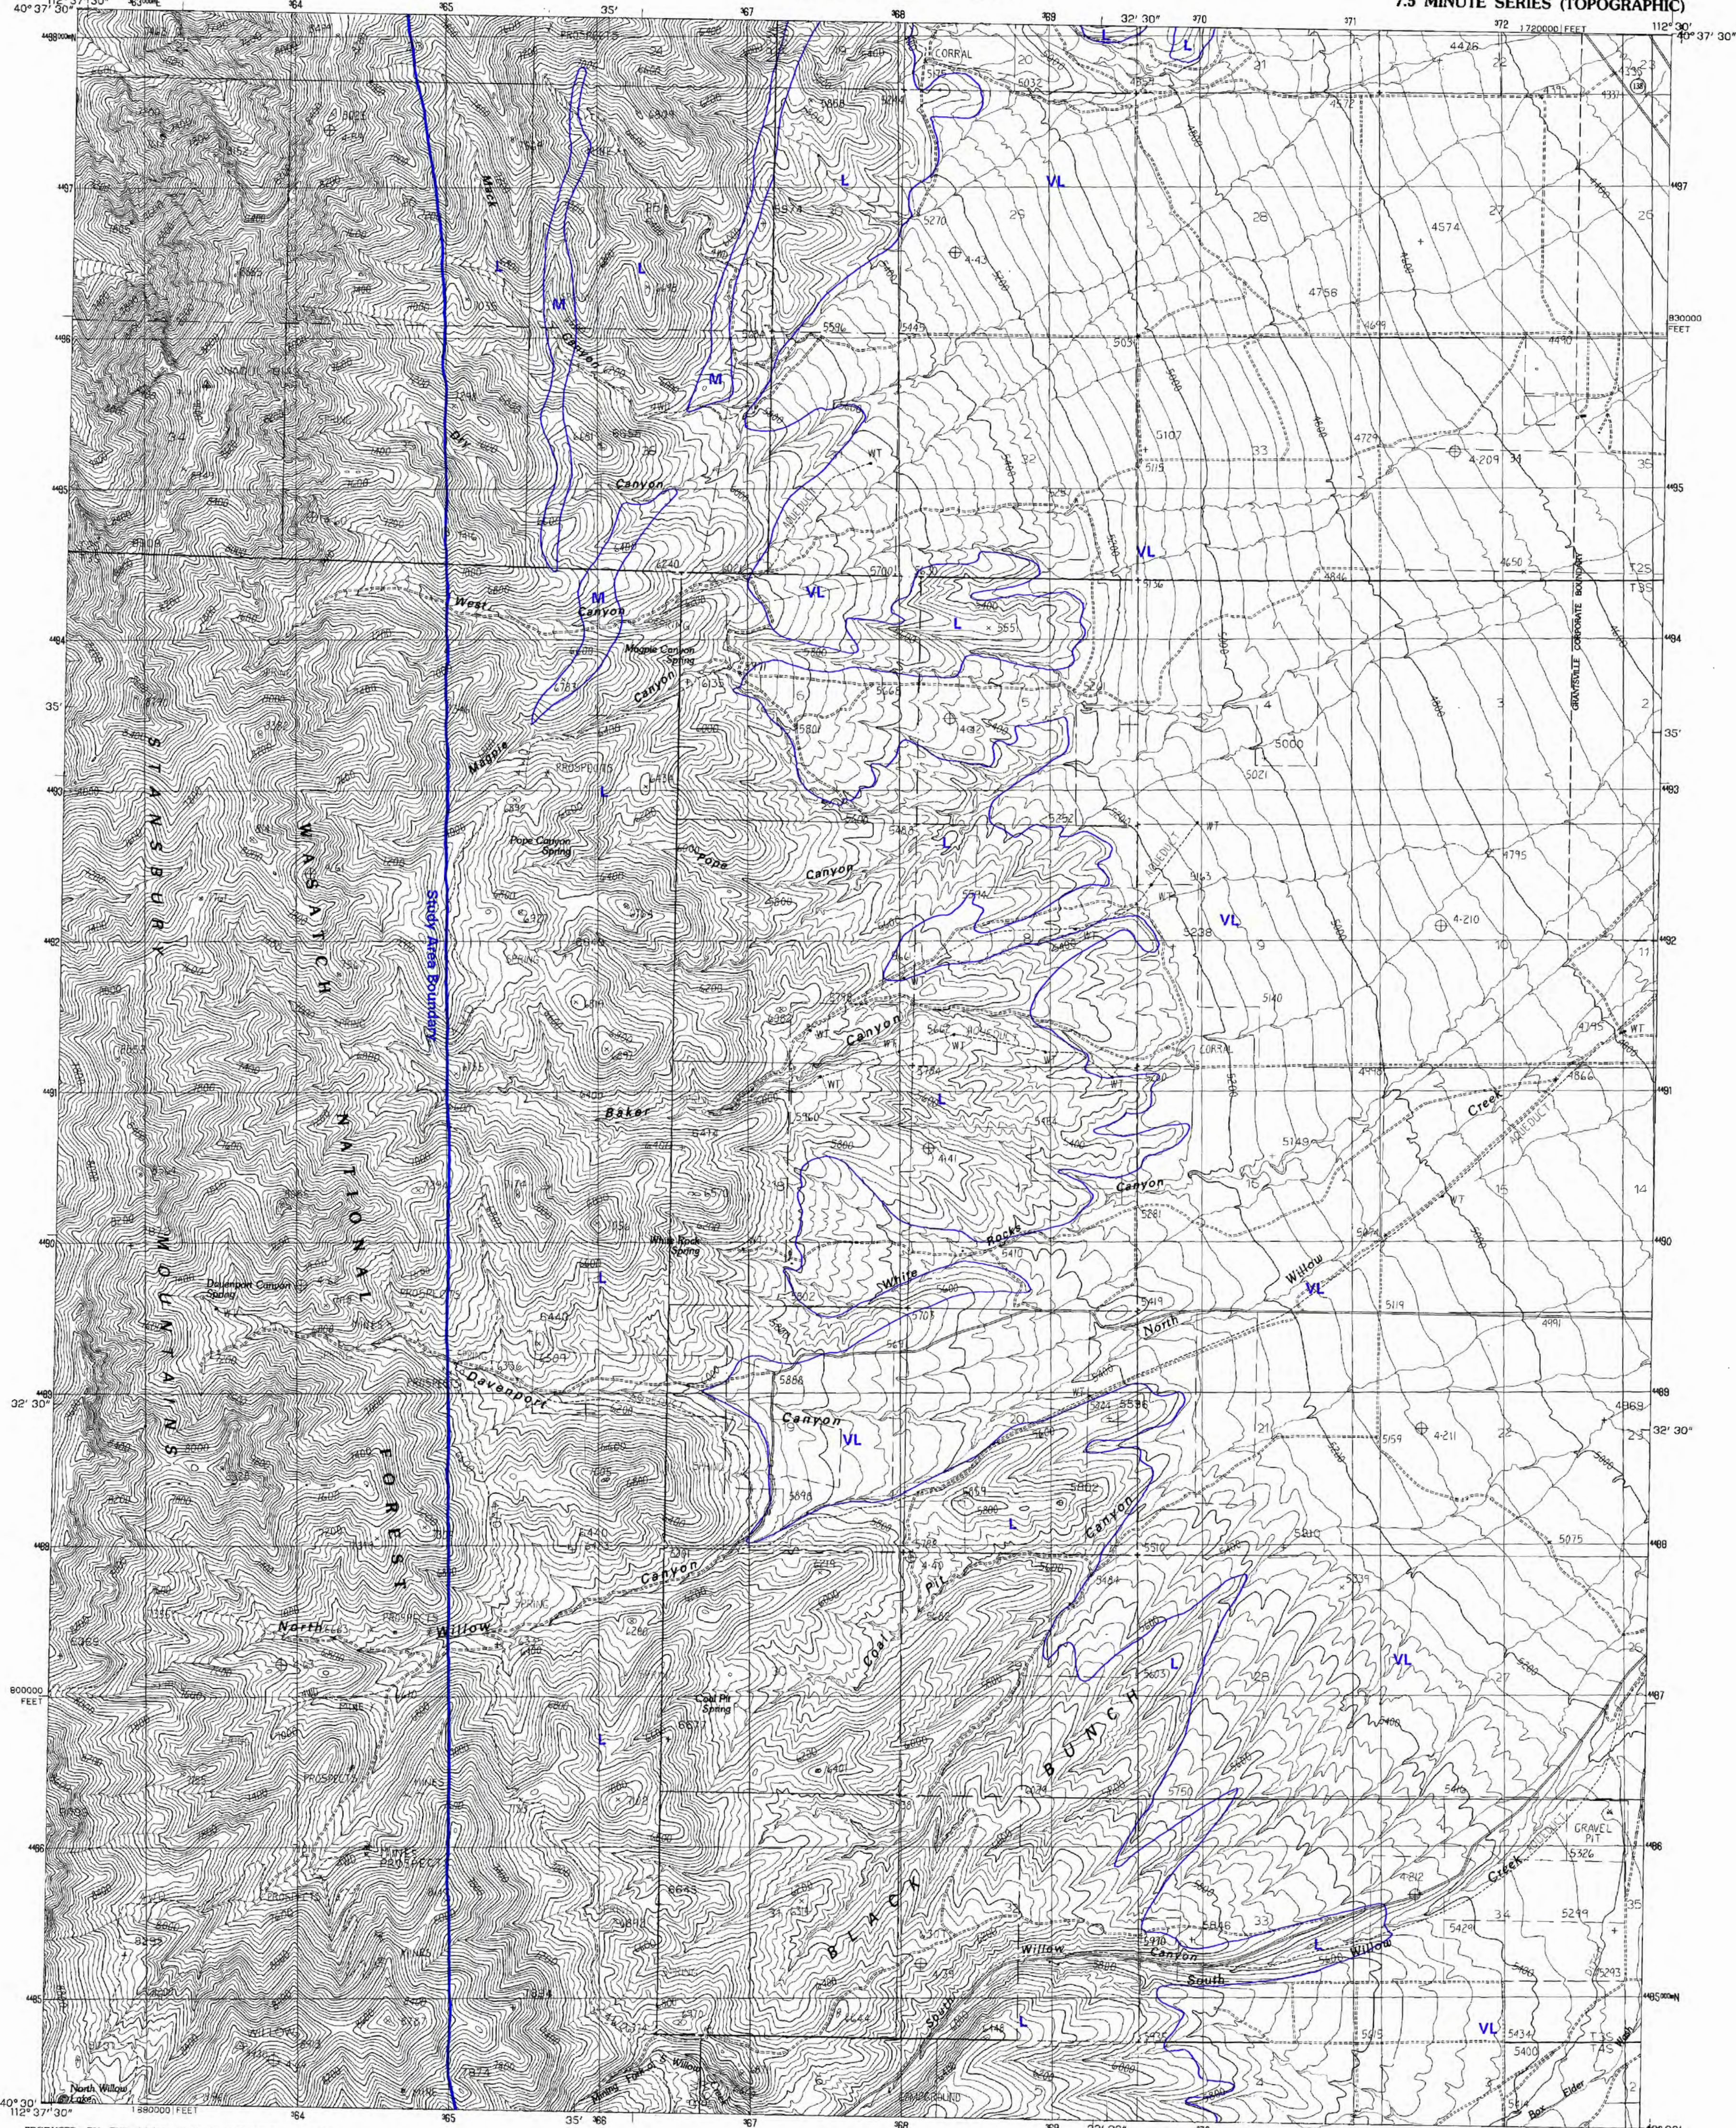
MAPPED BY KIMM M. HARTY
DRAFTED BY NOAH P. SNYDER
Utah Geological Survey
Open-File Report 318 PLATE 1F
1995

Landslide hazards, North Willow Canyon quadrangle, Tooele County, Utah.

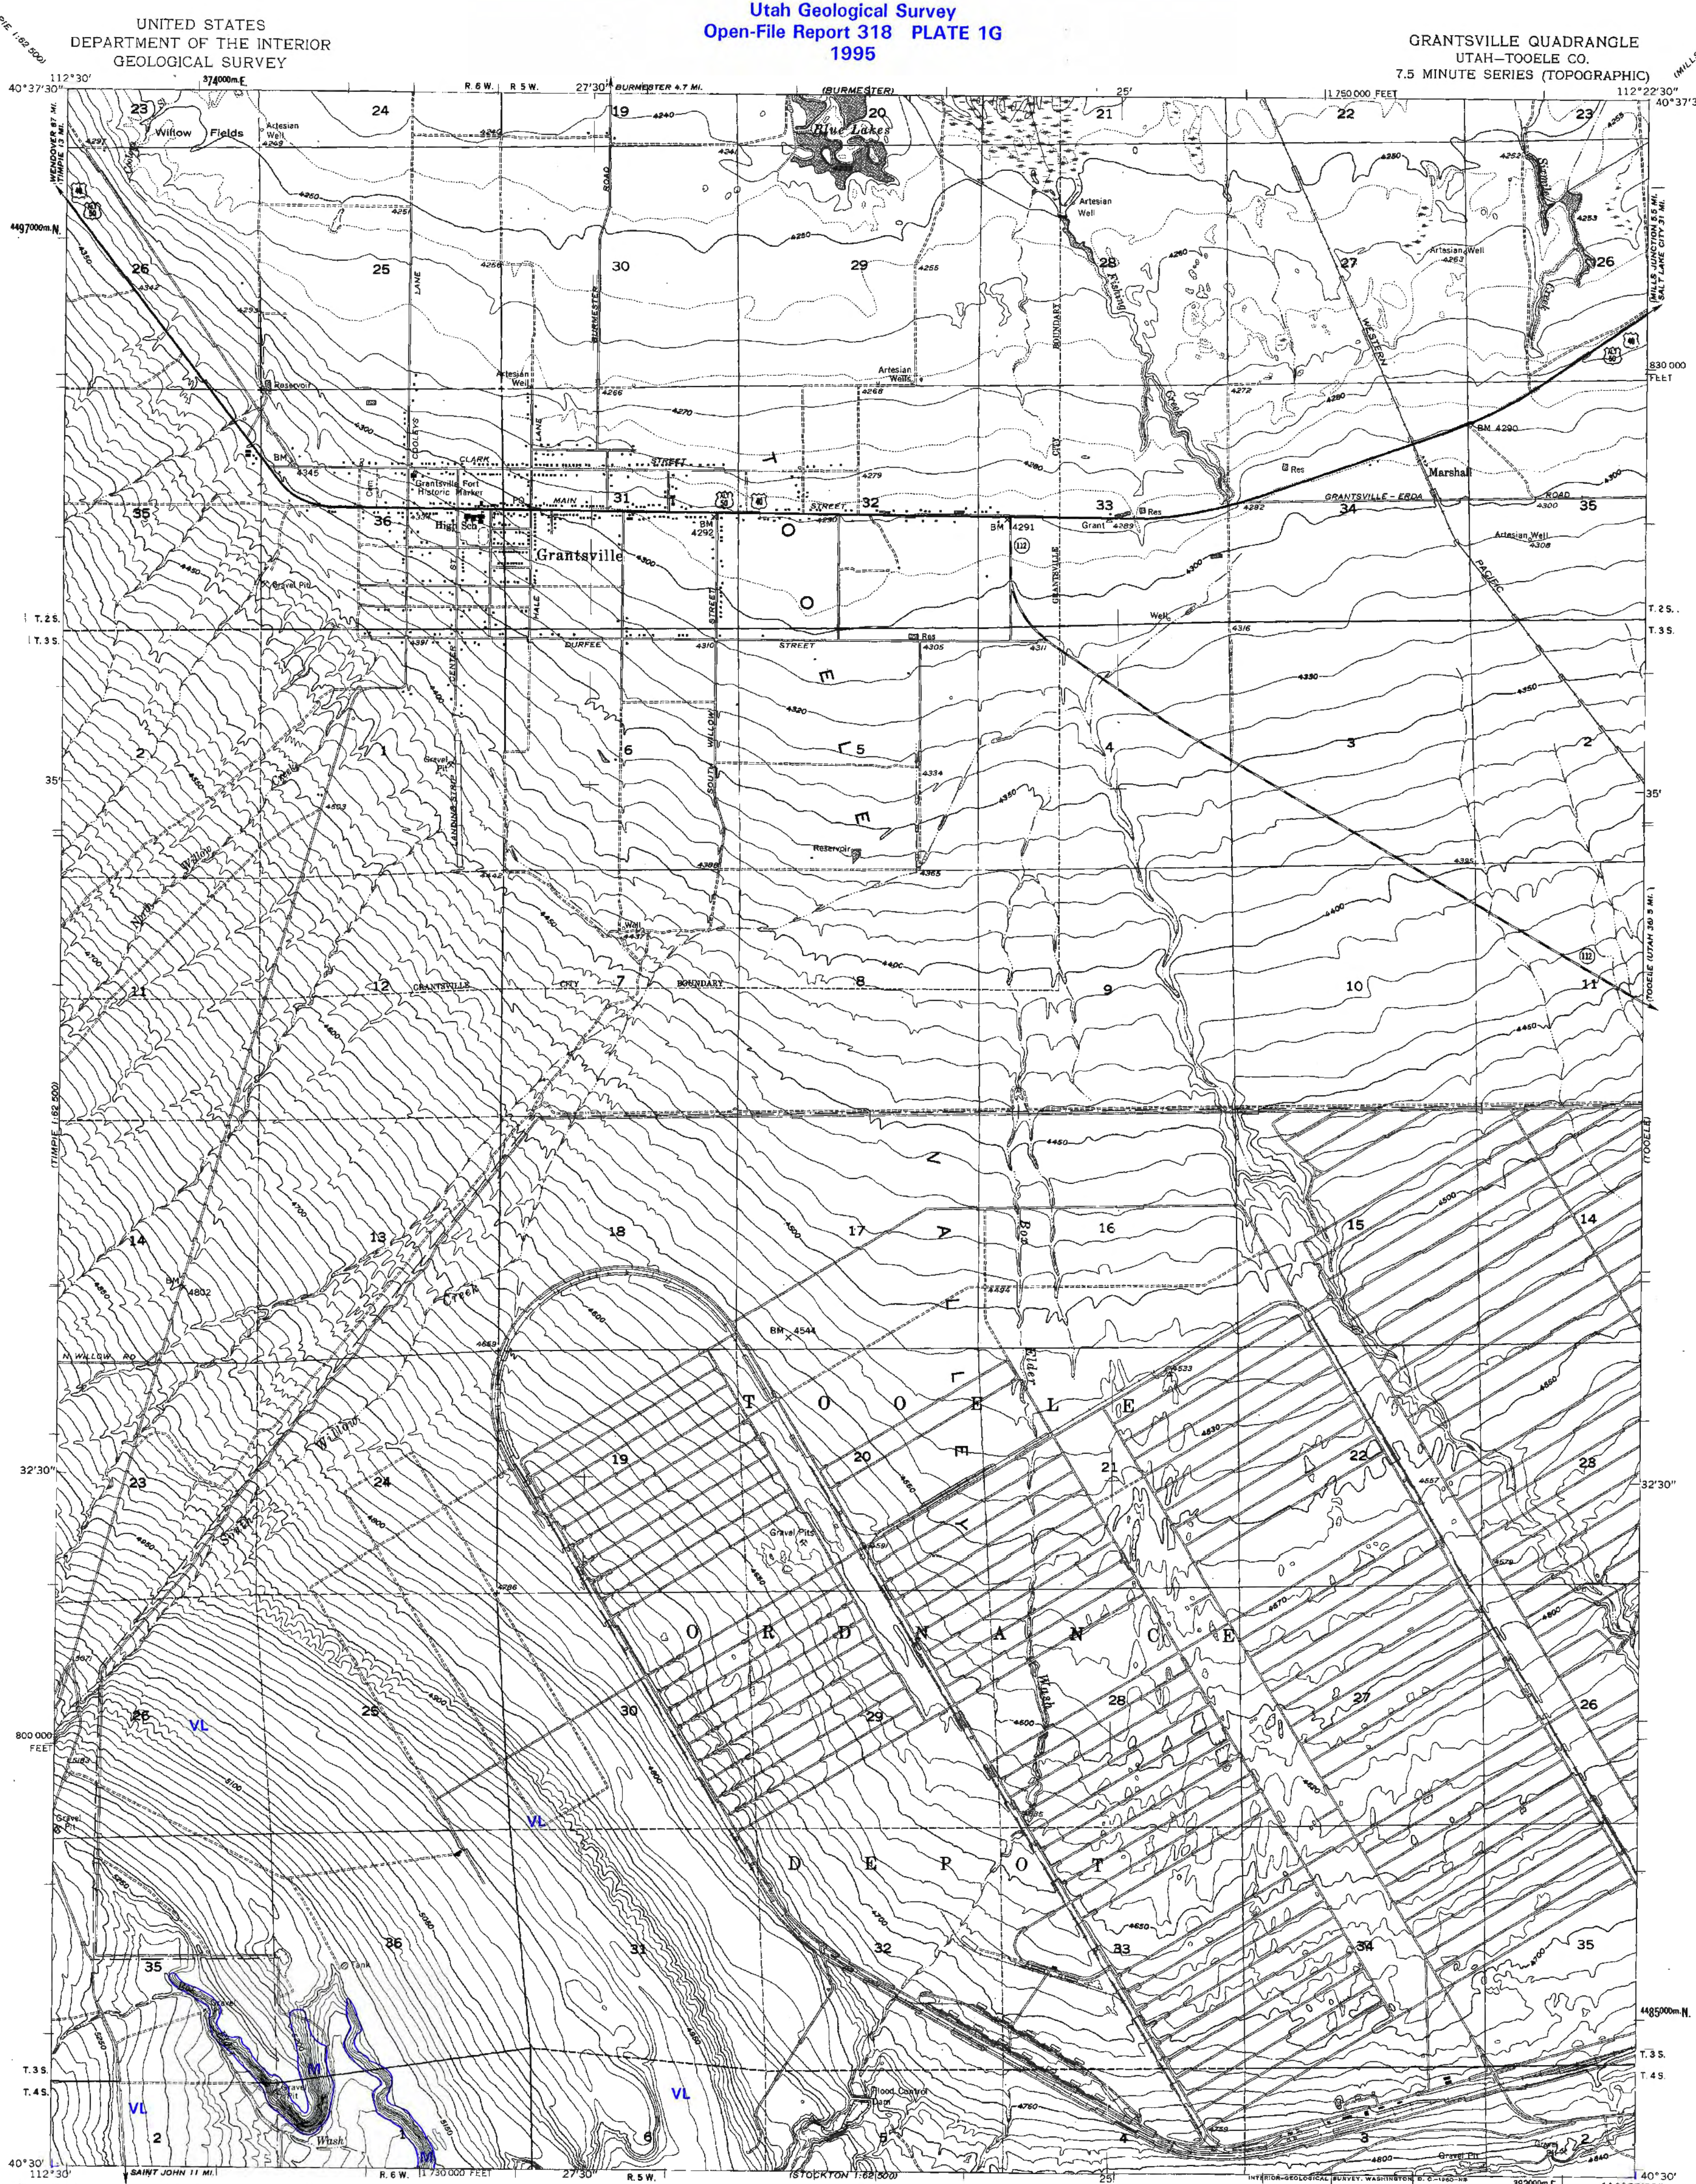
Utah Geological Survey
Open-File Report 318 PLATE 1G
1995

Landslide hazards, Grantsville quadrangle, Tooele County, Utah.

- H* High; includes existing landslides (crosshatched).
- M* Moderate.
- L Low.
- VL Very low.

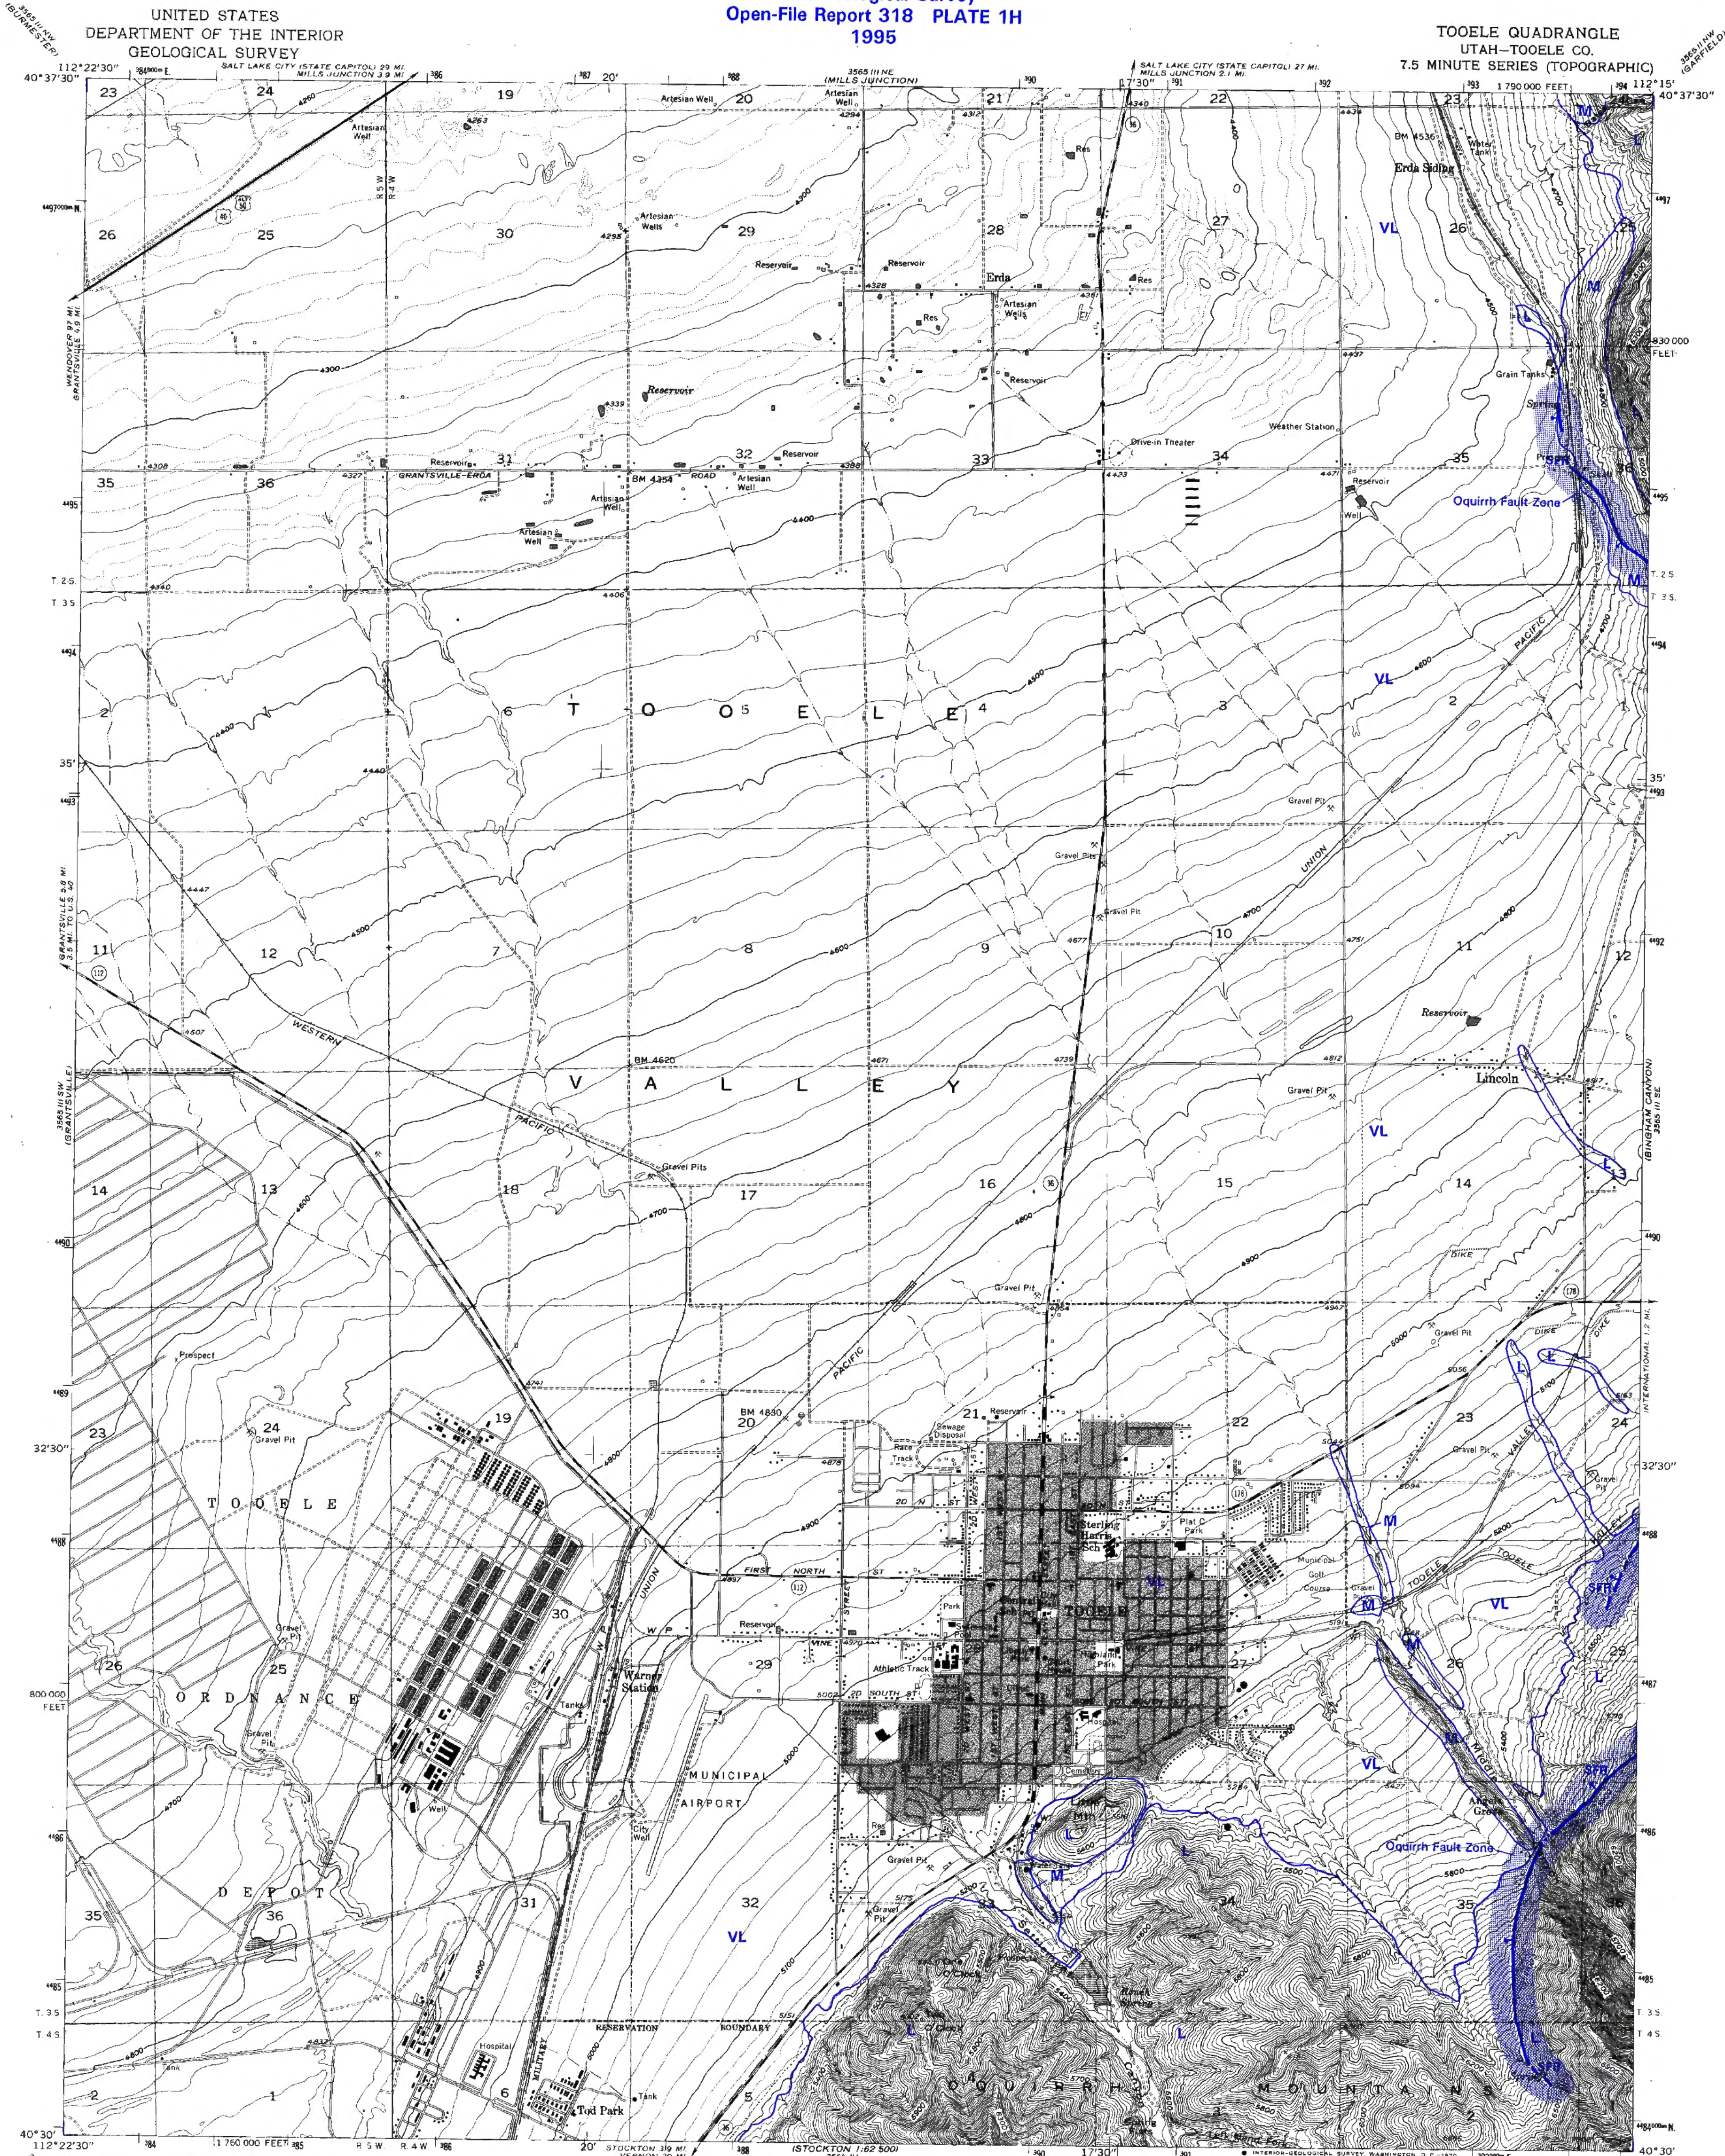
Utah Geological Survey
Open-File Report 318 PLATE 1H
1995

Landslide and surface-fault-rupture hazards, Tooee quadrangle,
Tooee County, Utah.

- Main trace of active faults with evidence of possible Quaternary movement (within the past 1.6 million years). Dashed where inferred, bar and ball on downthrown side.
- Possible surface fault rupture.
