GEOLOGIC HAZARDS AND LAND-USE PLANNING FOR TOOELE VALLEY AND THE WEST DESERT HAZARDOUS INDUSTRY AREA, TOOELE COUNTY, UTAH

Barry J. Solomon and Bill D. Black, editors

OPEN-FILE REPORT 318
UTAH GEOLOGICAL SURVEY
a division of
UTAH DEPARTMENT OF NATURAL RESOURCES

October 1995

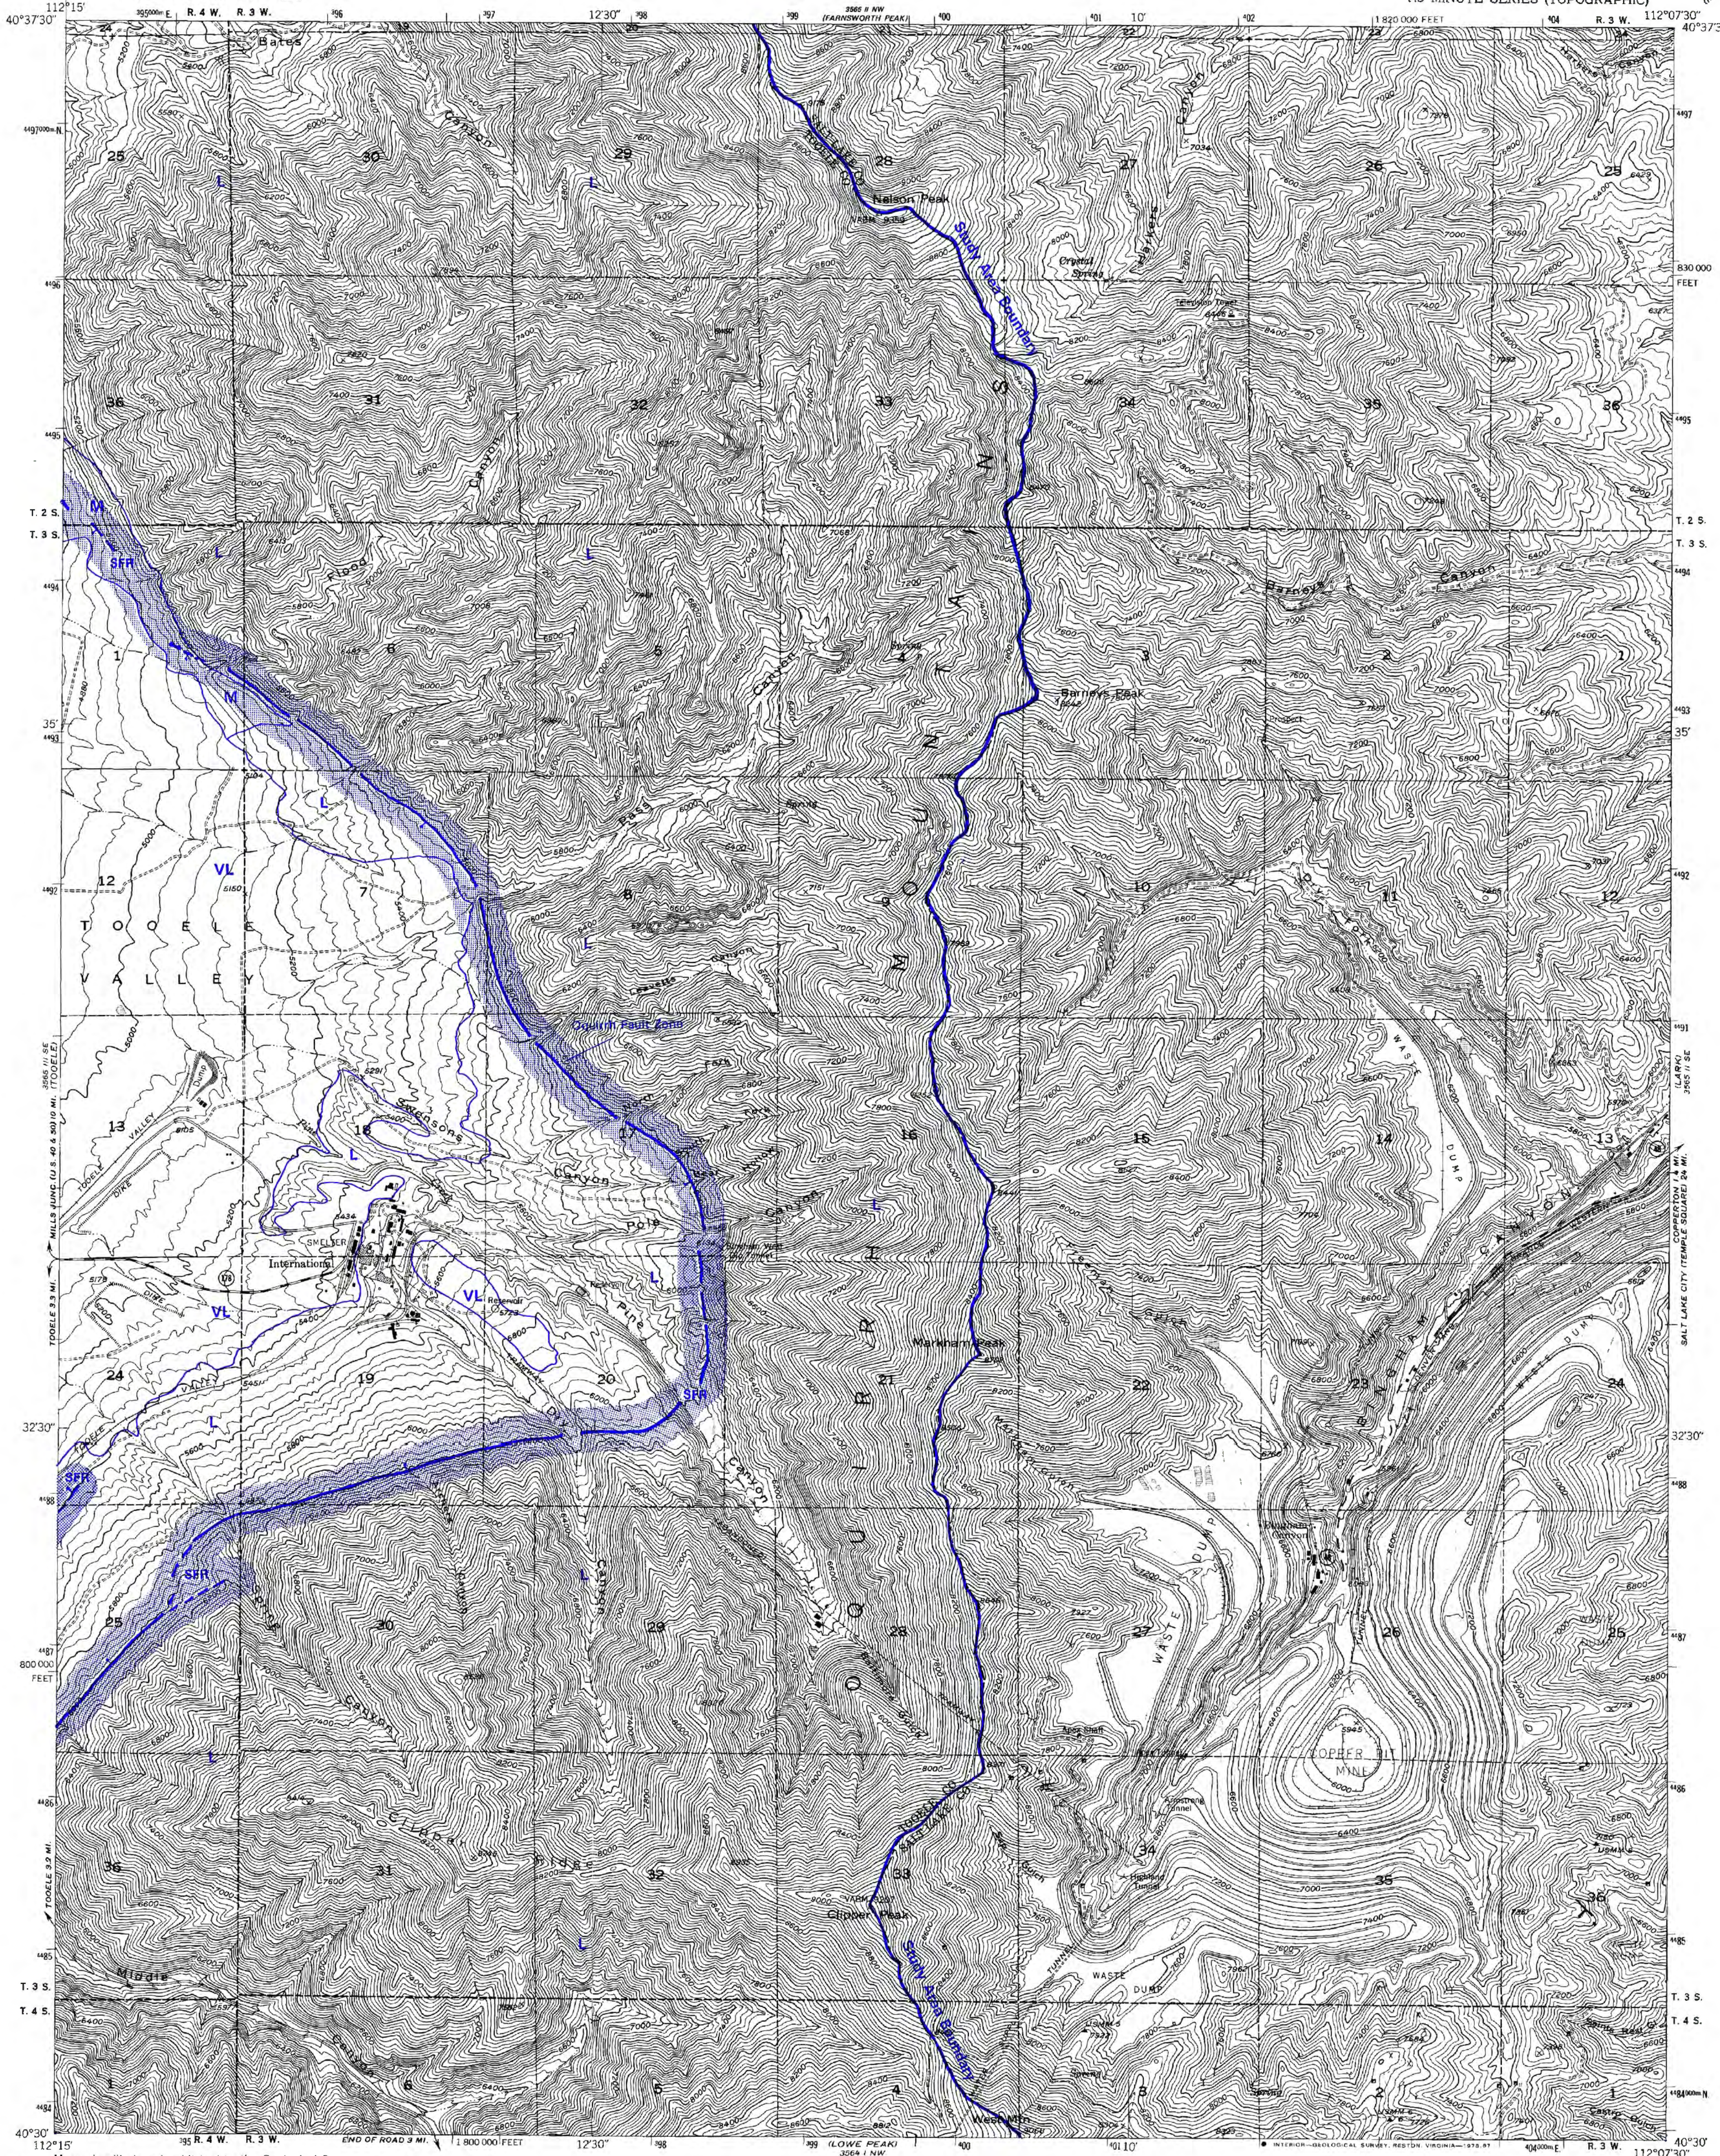
Landslide and surface-fault-rupture hazards, Bingham Canyon quadrangle, Tooele County, Utah.

Main trace of active faults with evidence of possible Quaternary movement (within the past 1.6 million years). Dashed where inferred, bar and ball on downthrown side.
Possible surface fault rupture.

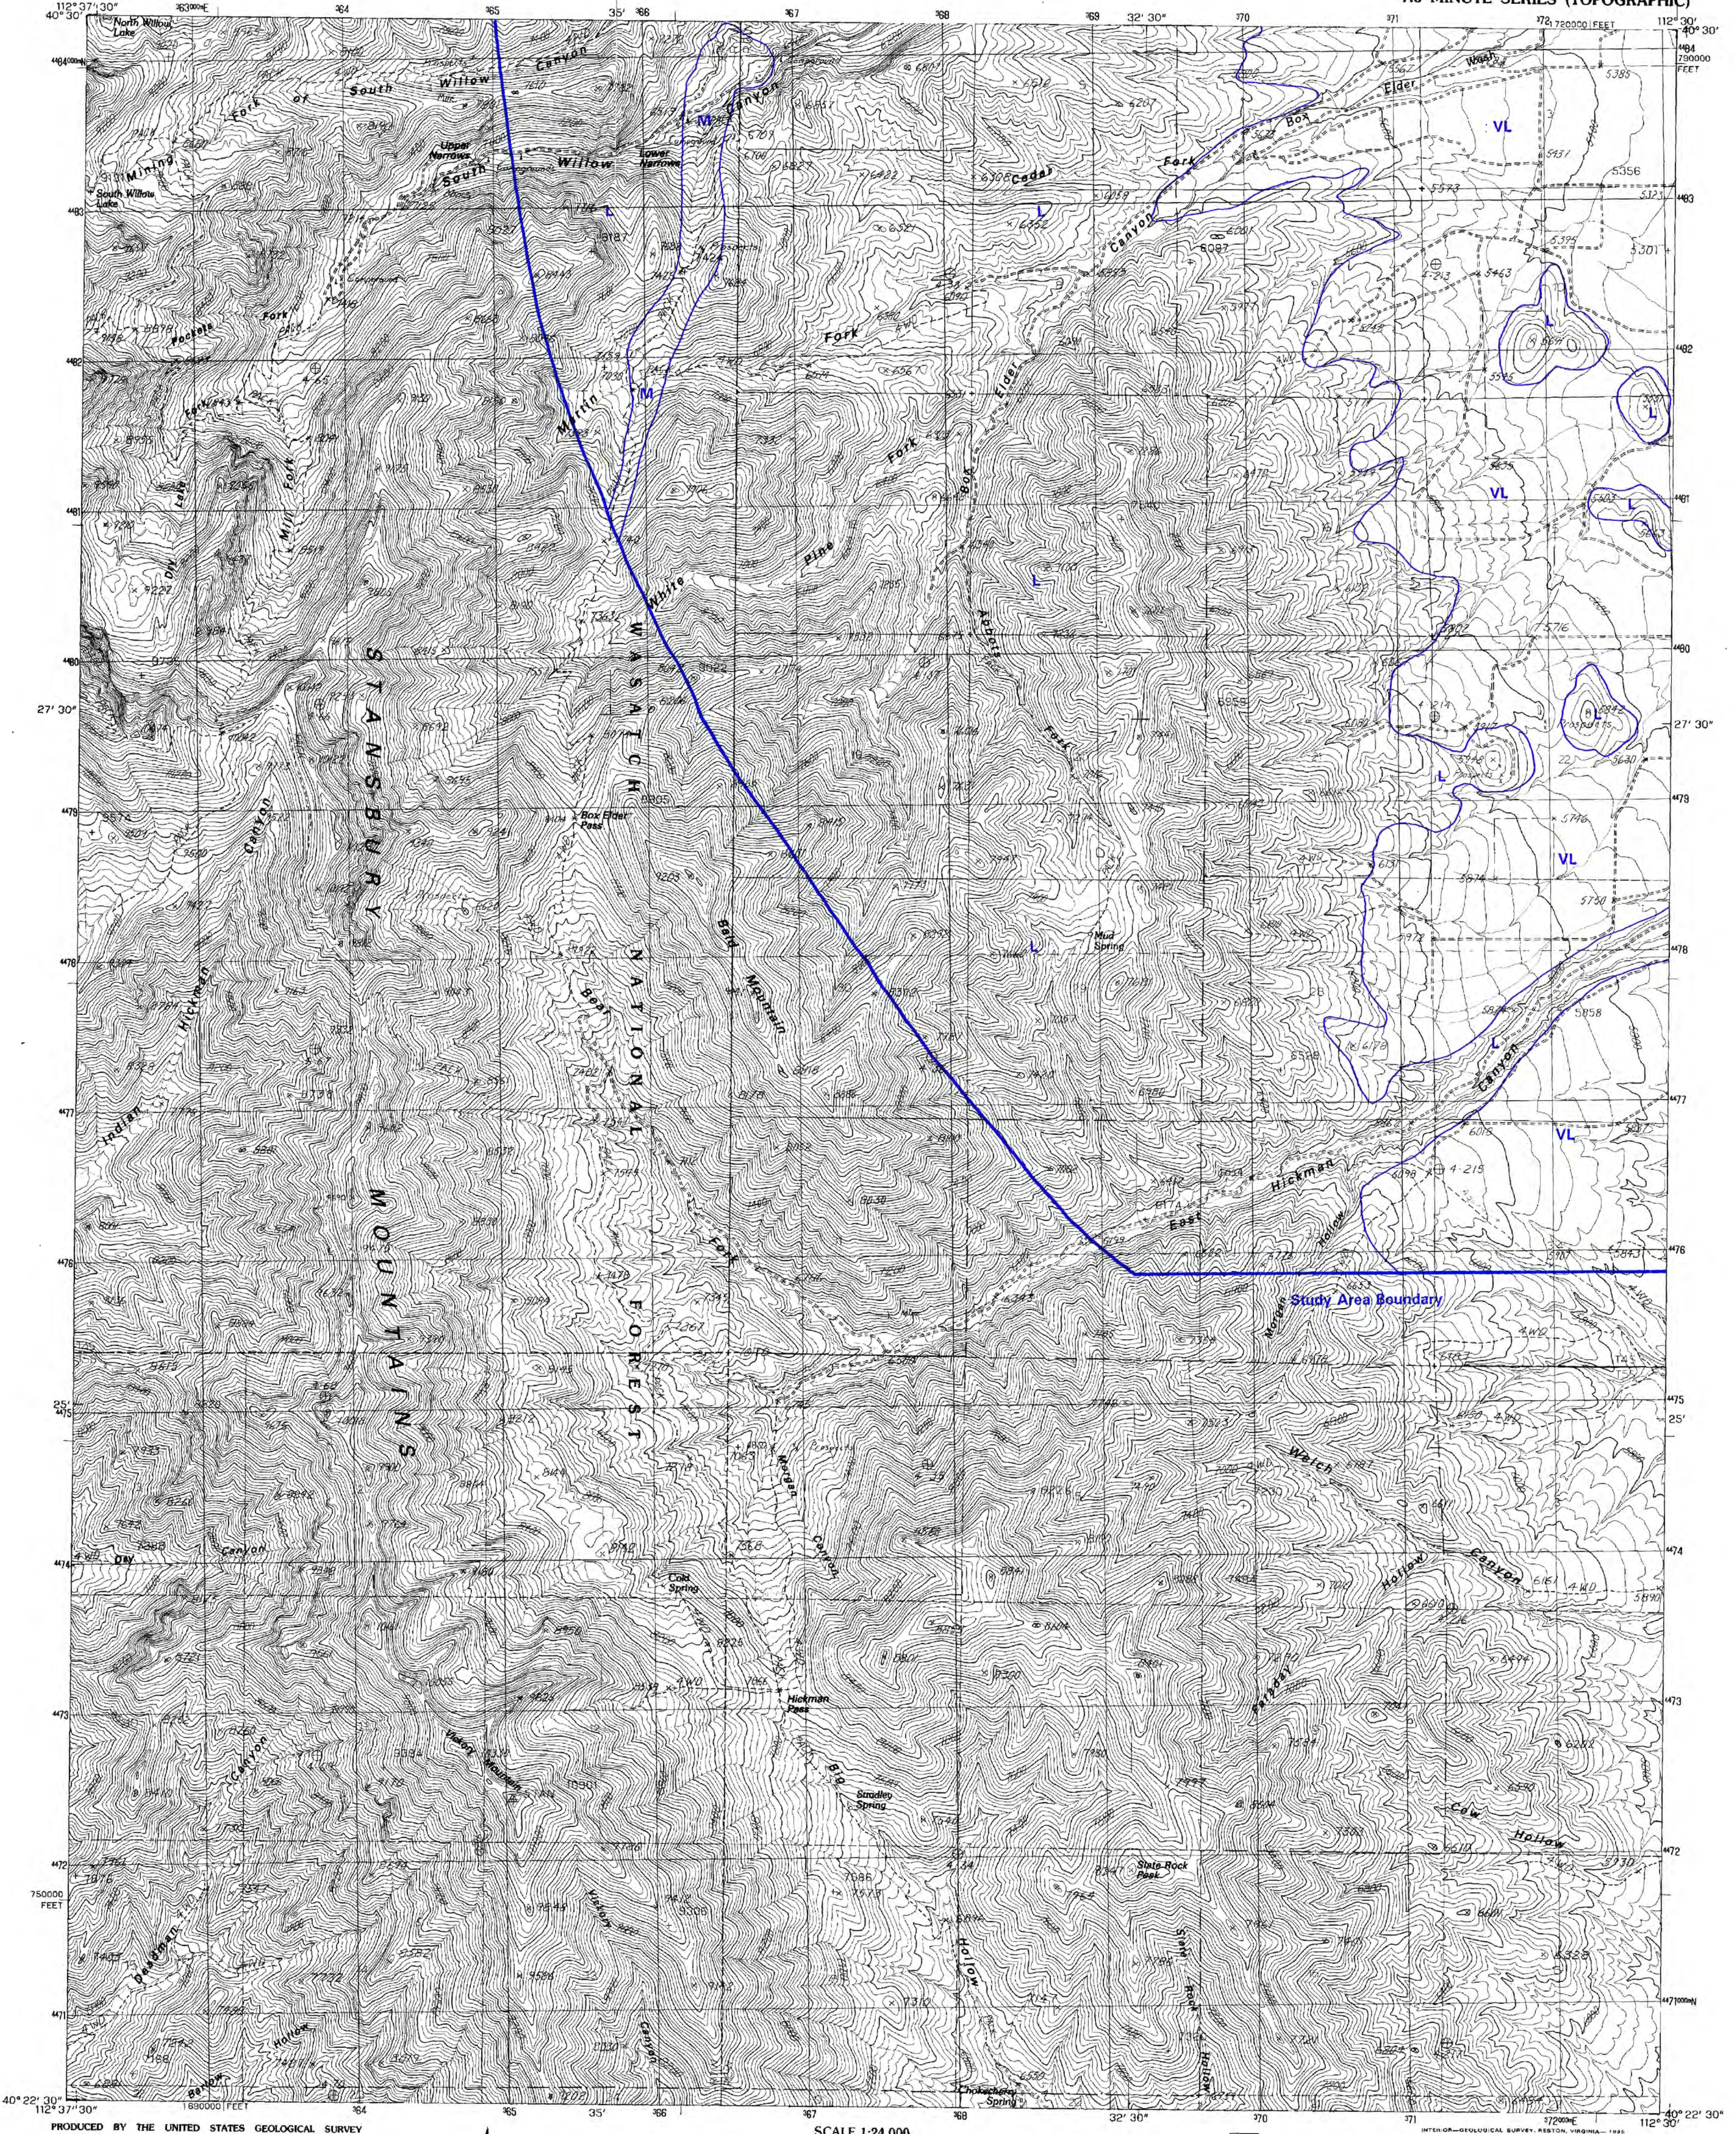
Landslide hazards, Deseret Peak East quadrangle, Tooele County, Utah.

- H* High; includes existing landslides (crosshatched).
- M* Moderate.
- L Low.
- VL Very low.

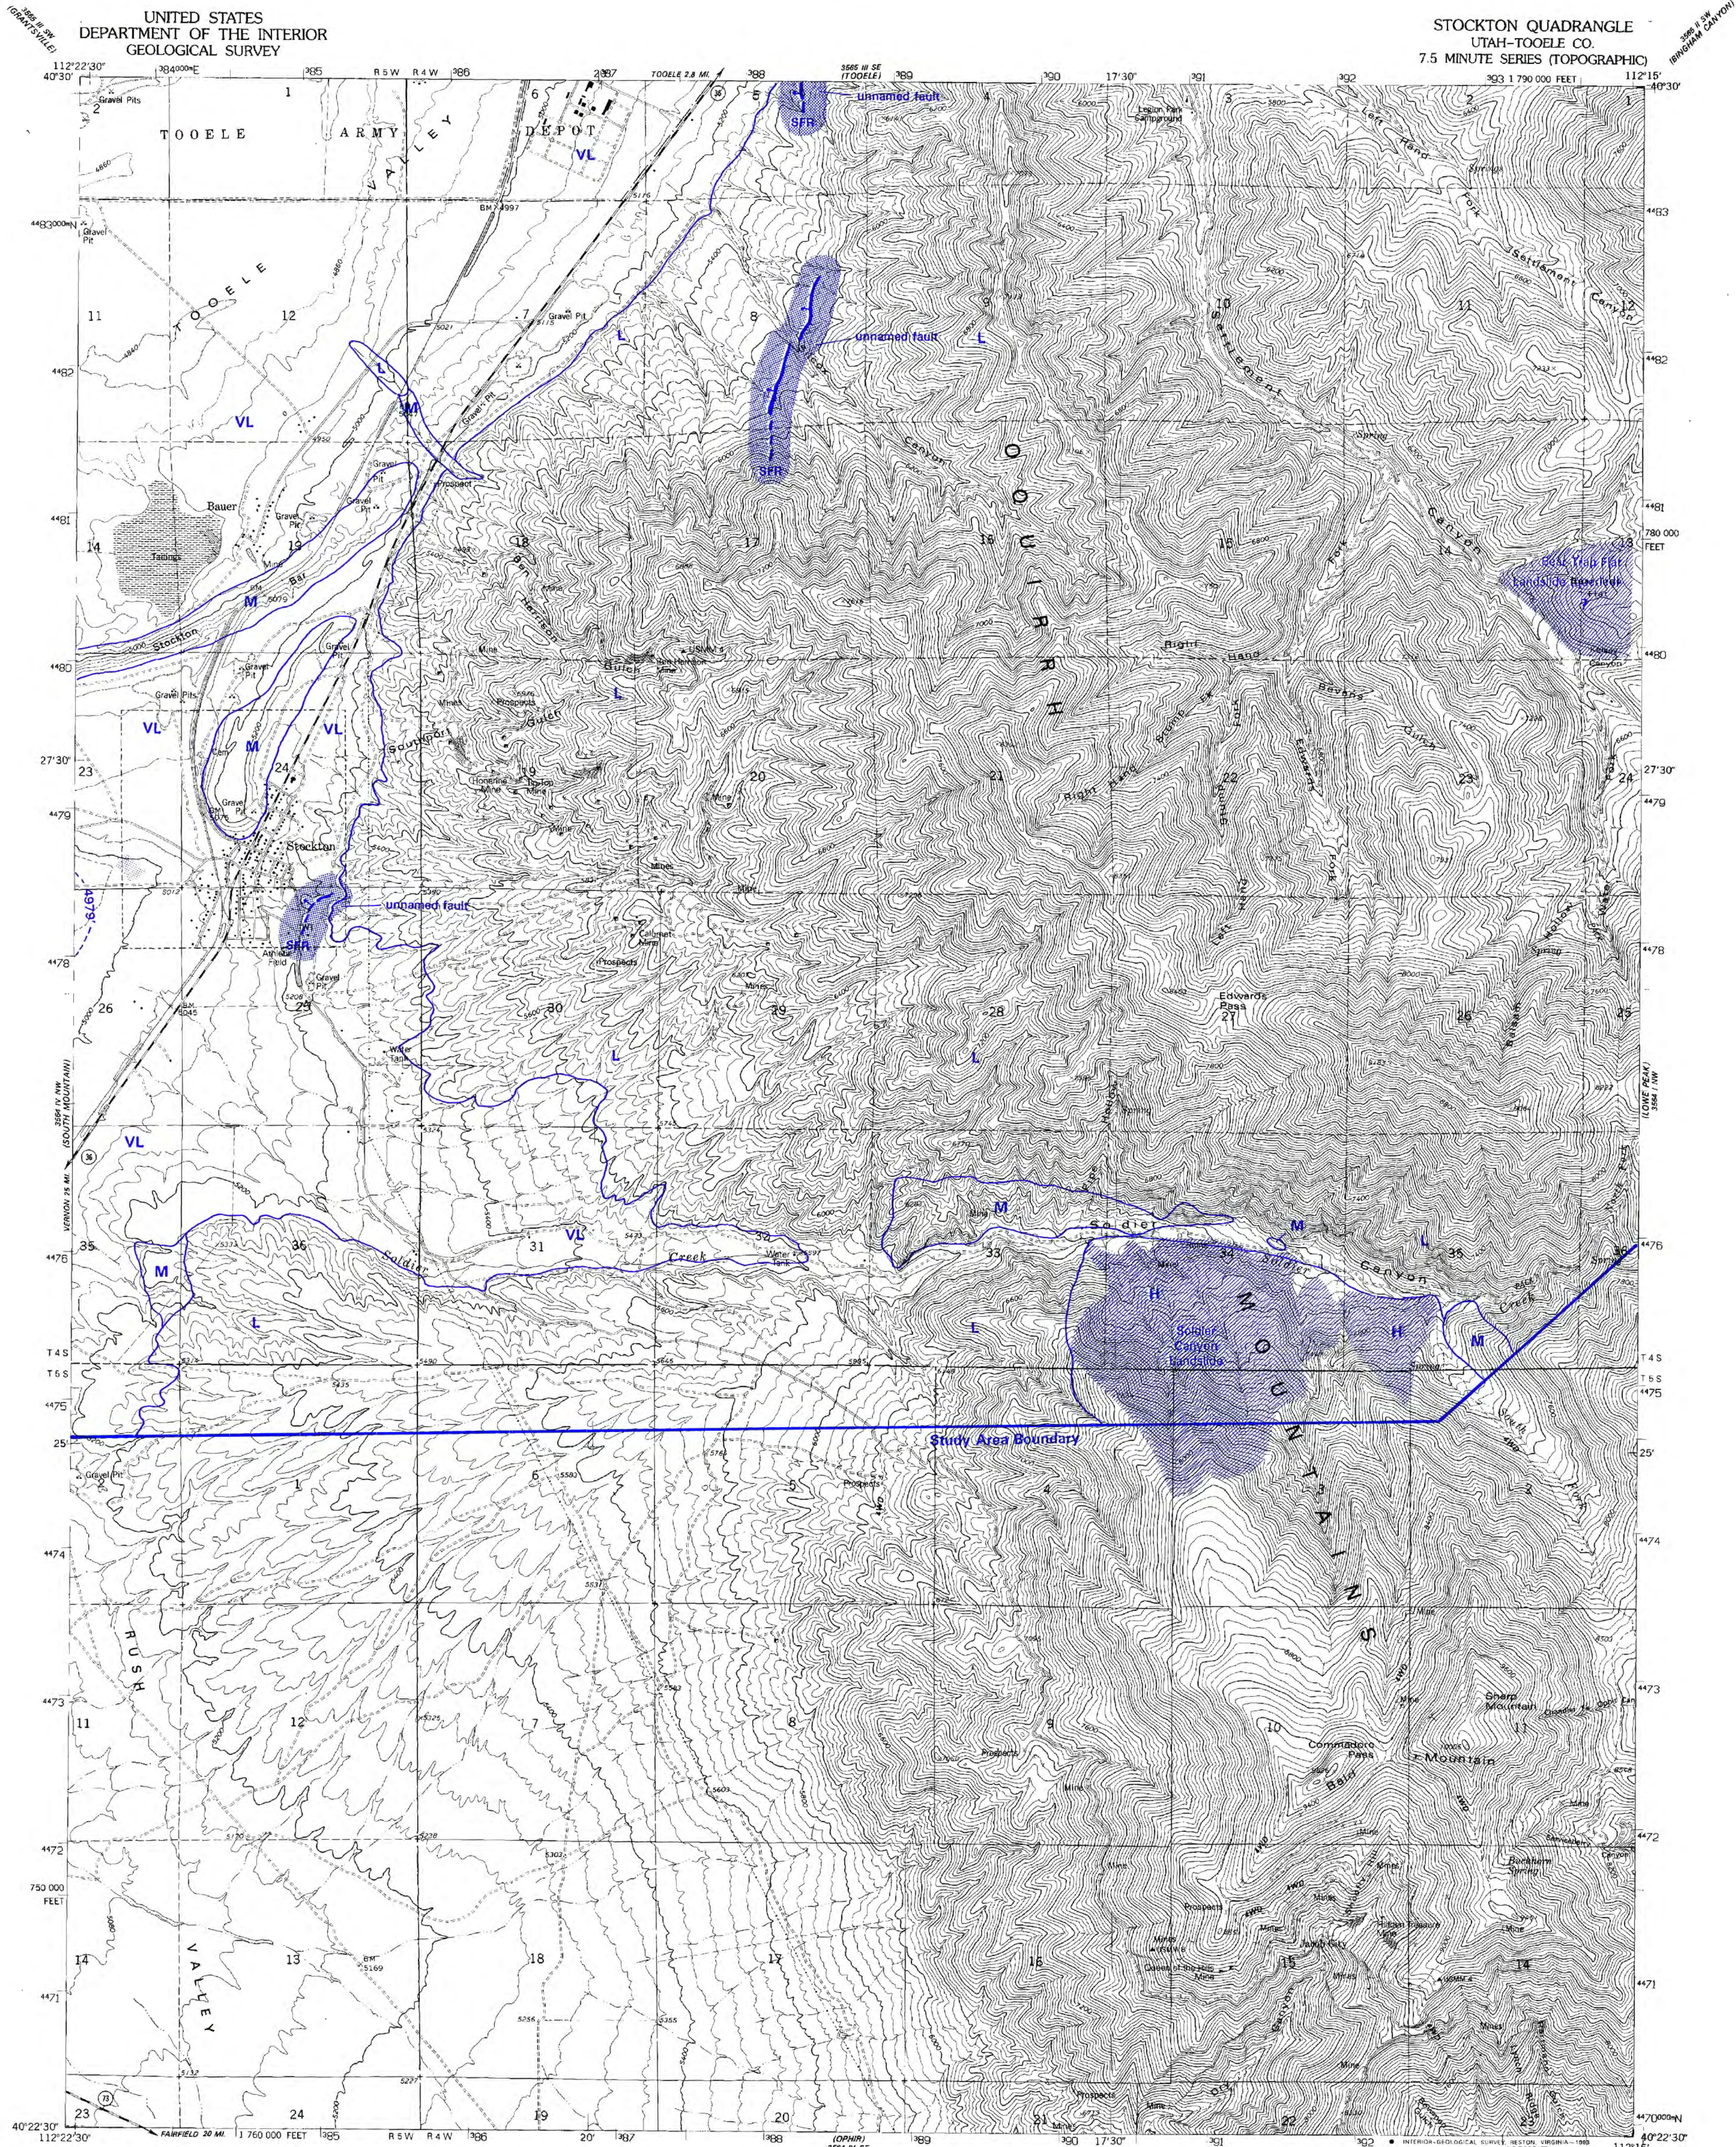
Landslide, surface-fault-rupture, and lake-flooding hazards, Stockton quadrangle, Tooele County, Utah.

- Main trace of active faults with evidence of possible Quaternary movement (within the past 1.6 million years). Dashed where inferred, bar and ball on downthrown side.
- SFR* Possible surface fault rupture.

- Measured historic high of Rush Lake (4,979-foot [1,518-m] contour). Areas below this elevation are subject to lake flooding and land use must be compatible with potential flood hazards.

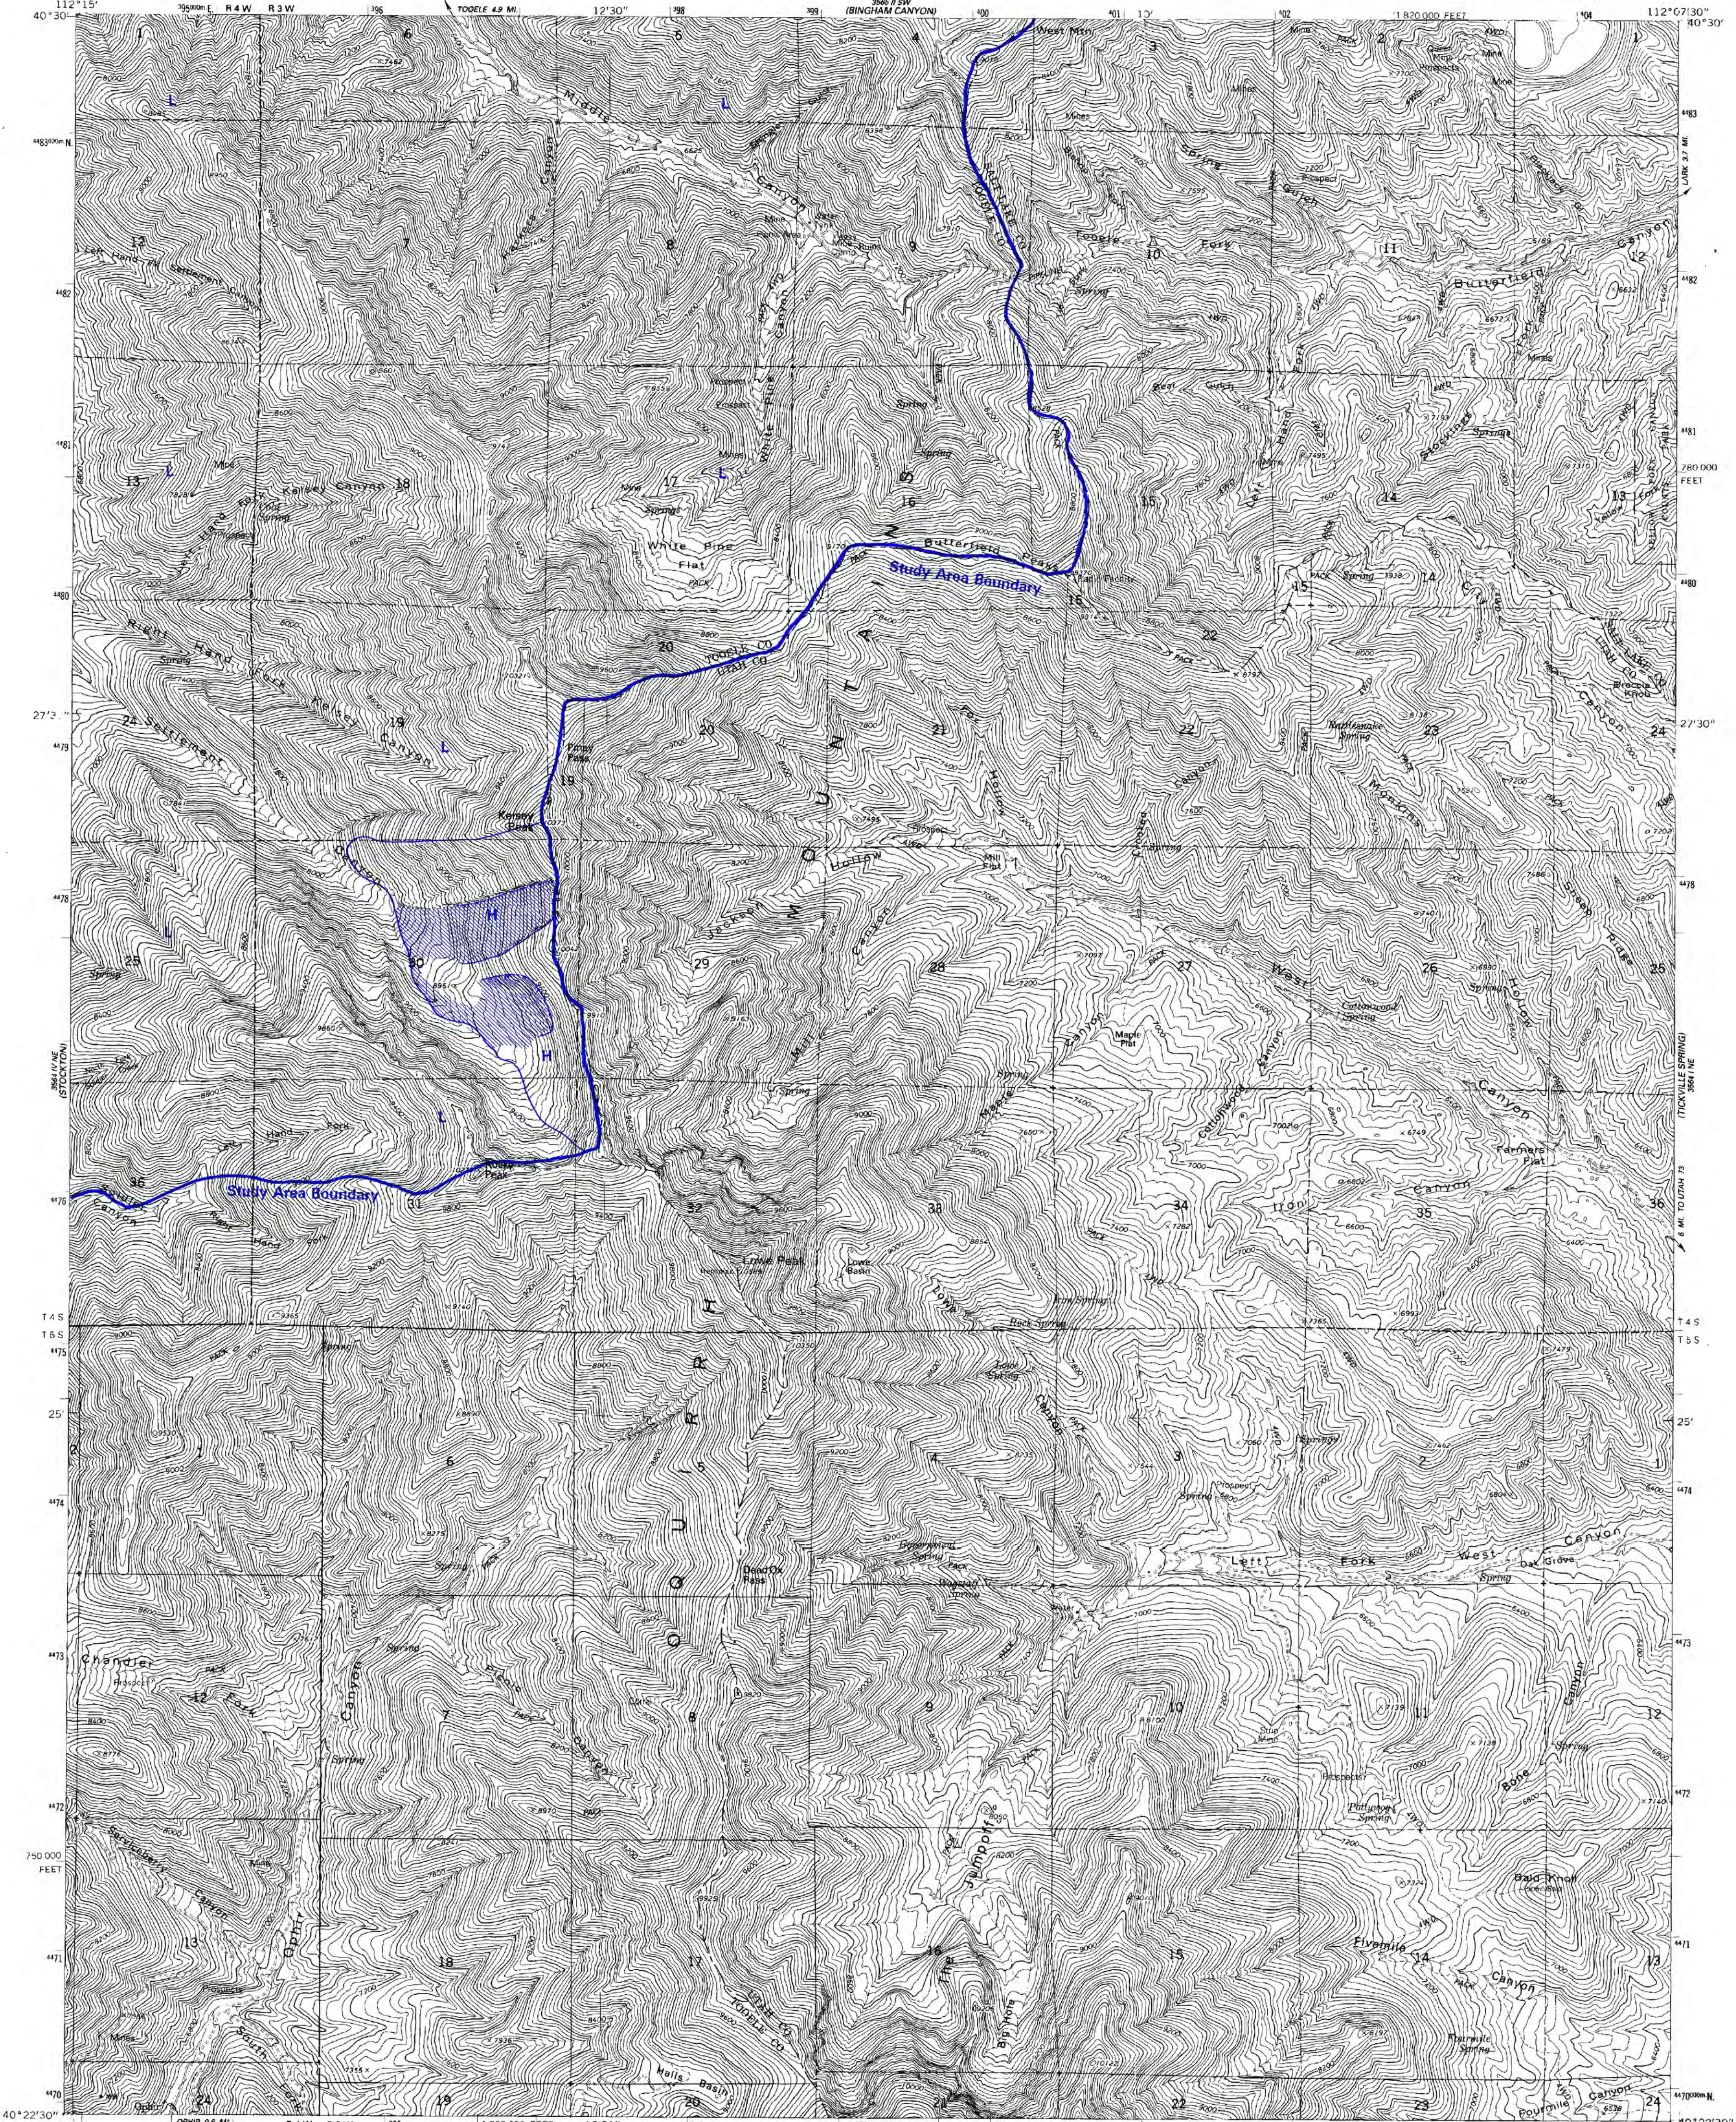
Landslide hazards, Lowe Peak quadrangle, Tooele County, Utah.

- H* High; includes existing landslides (crosshatched).
M* Moderate.
L Low.
VL Very low.
Landslide scarps.

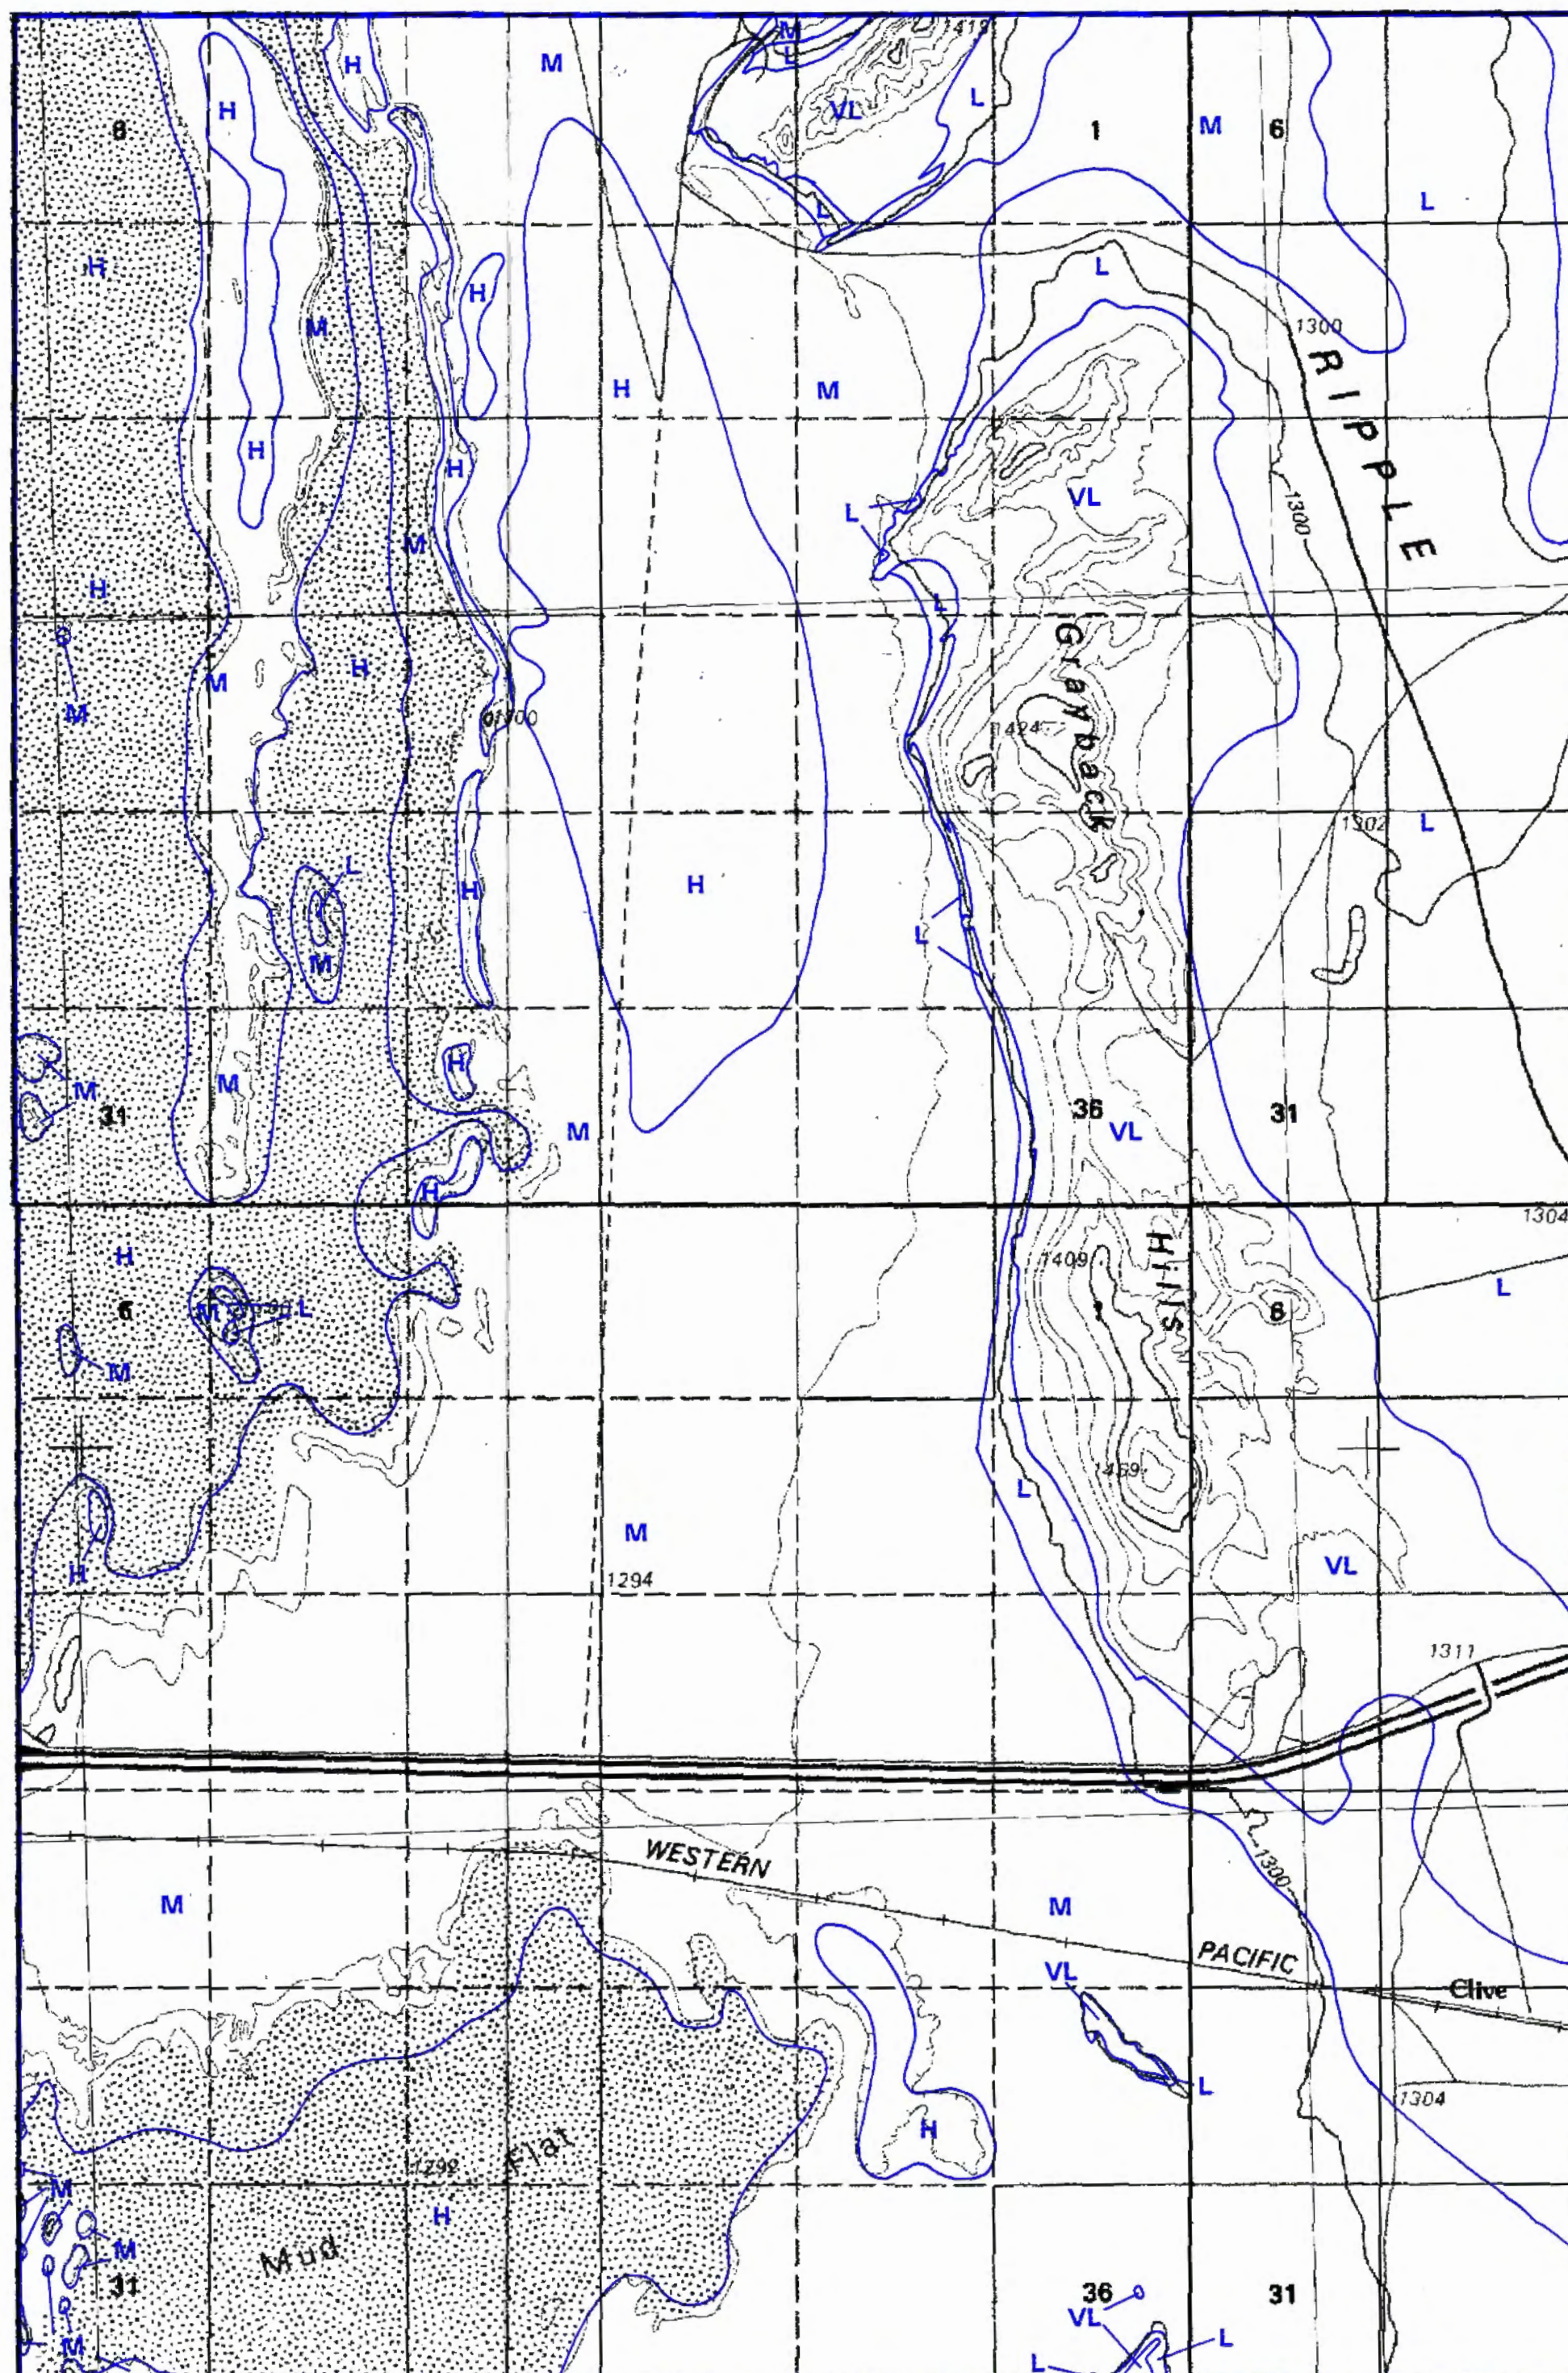
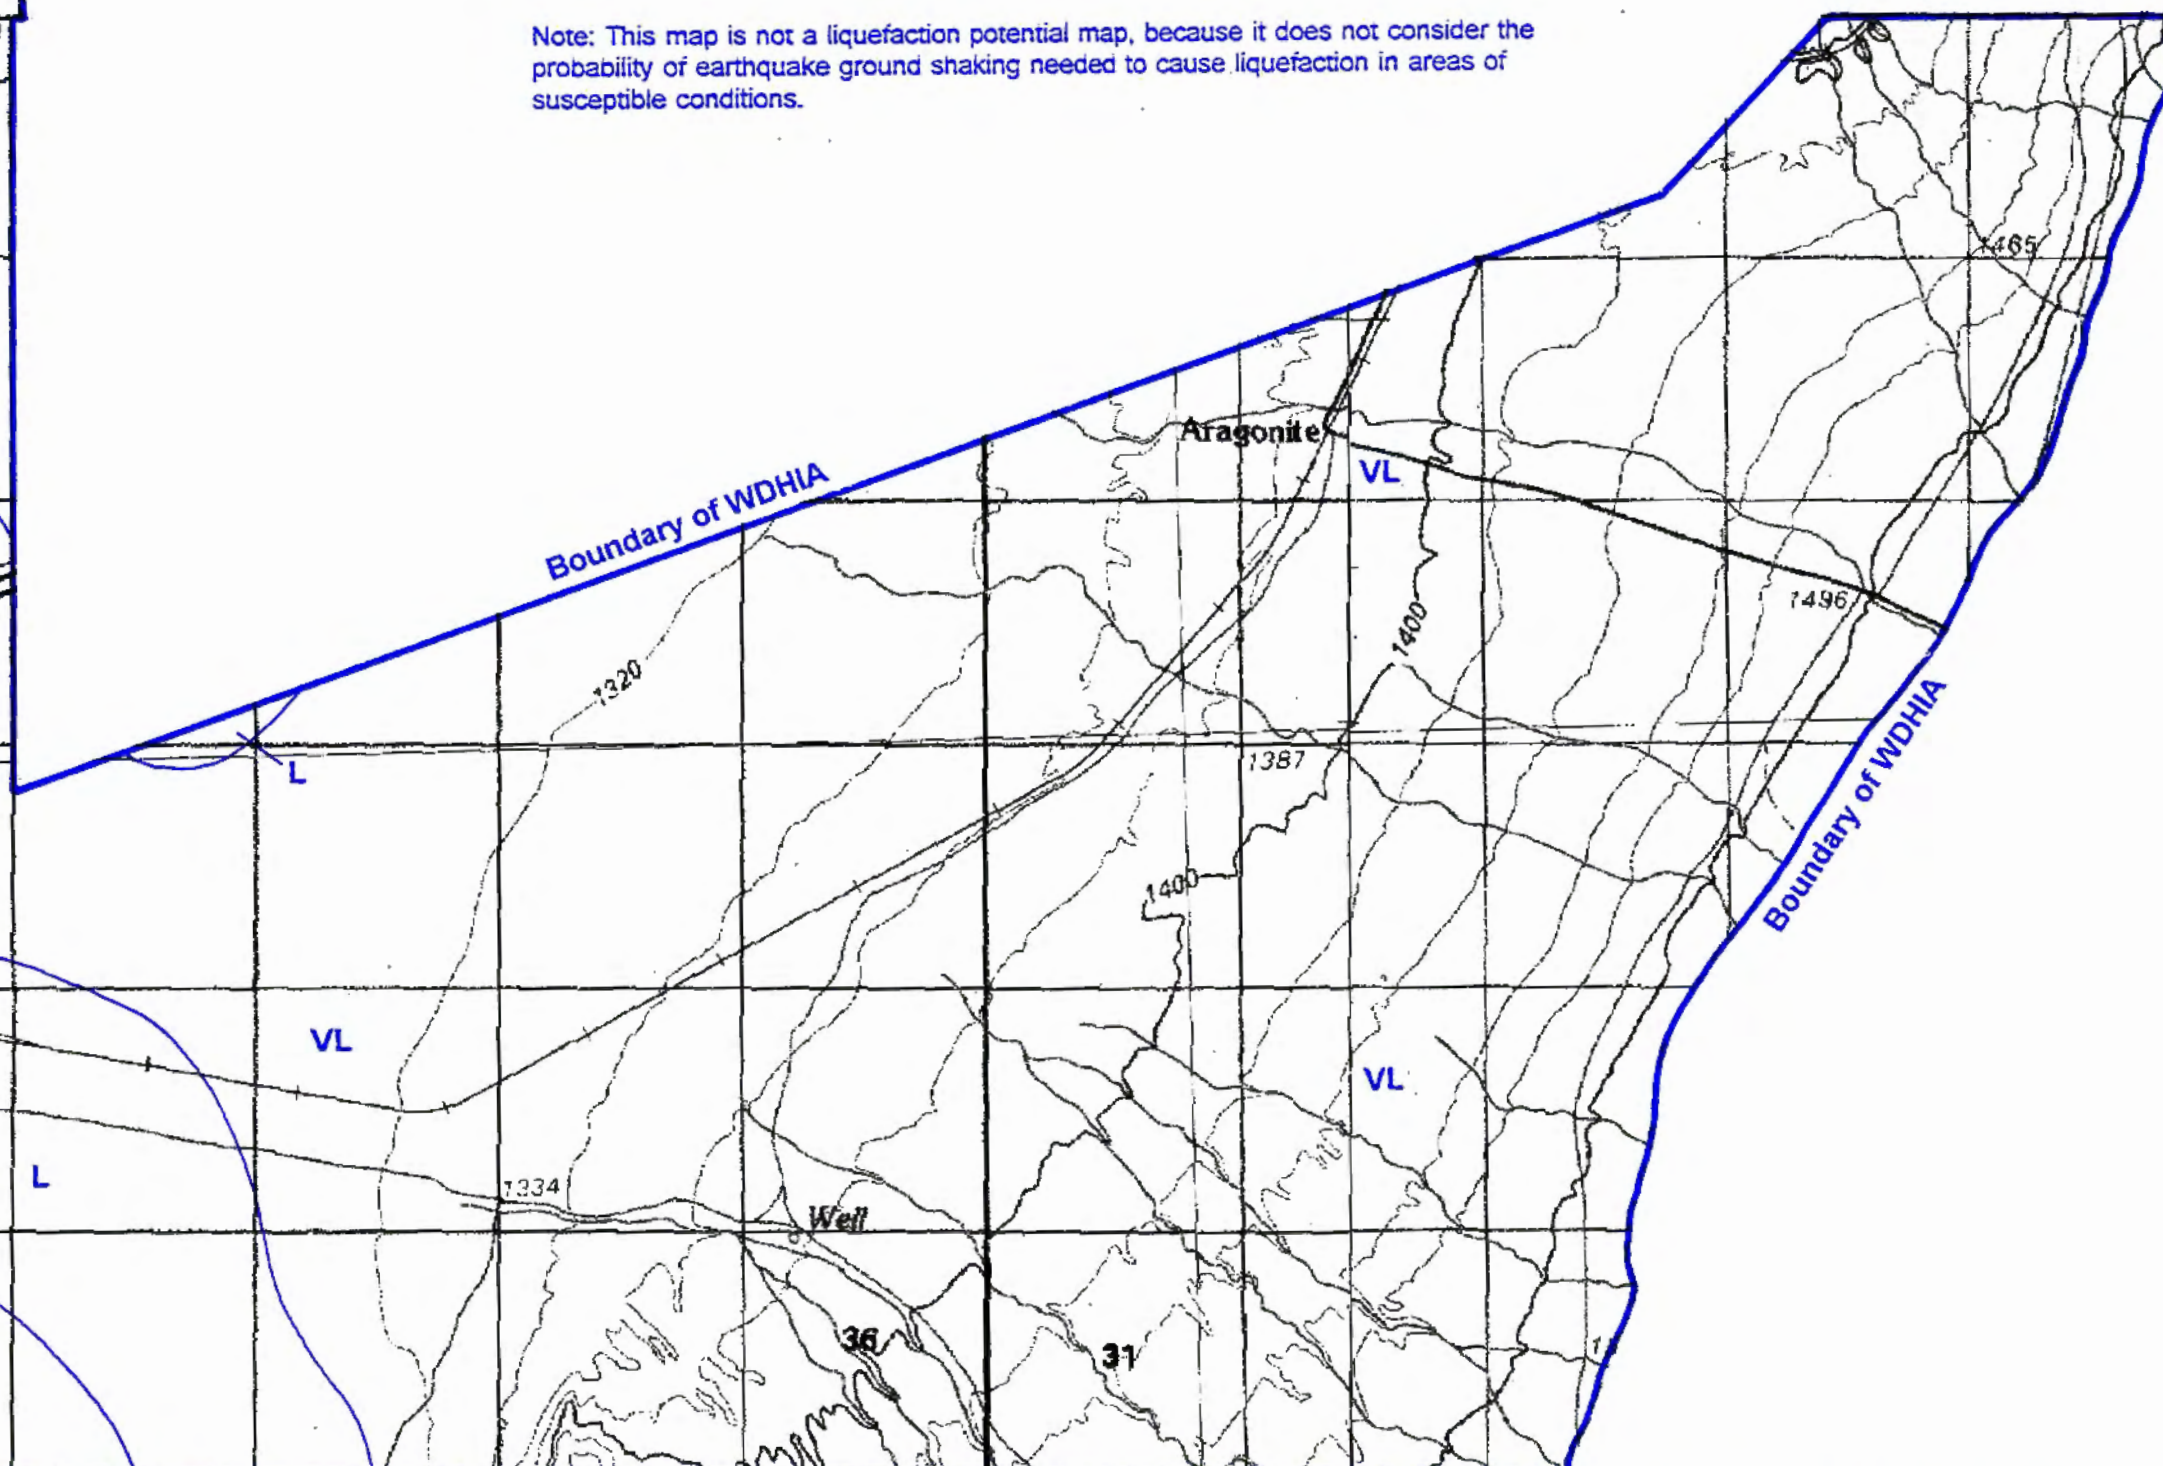
Liquefaction susceptibility, Flux quadrangle, Tooele County, Utah.
