GEOLOGIC HAZARDS AND LAND-USE PLANNING FOR TOOELE VALLEY AND THE WEST DESERT HAZARDOUS INDUSTRY AREA, TOOELE COUNTY, UTAH

Barry J. Solomon and Bill D. Black, editors

OPEN-FILE REPORT 318
UTAH GEOLOGICAL SURVEY
a division of
UTAH DEPARTMENT OF NATURAL RESOURCES

October 1995

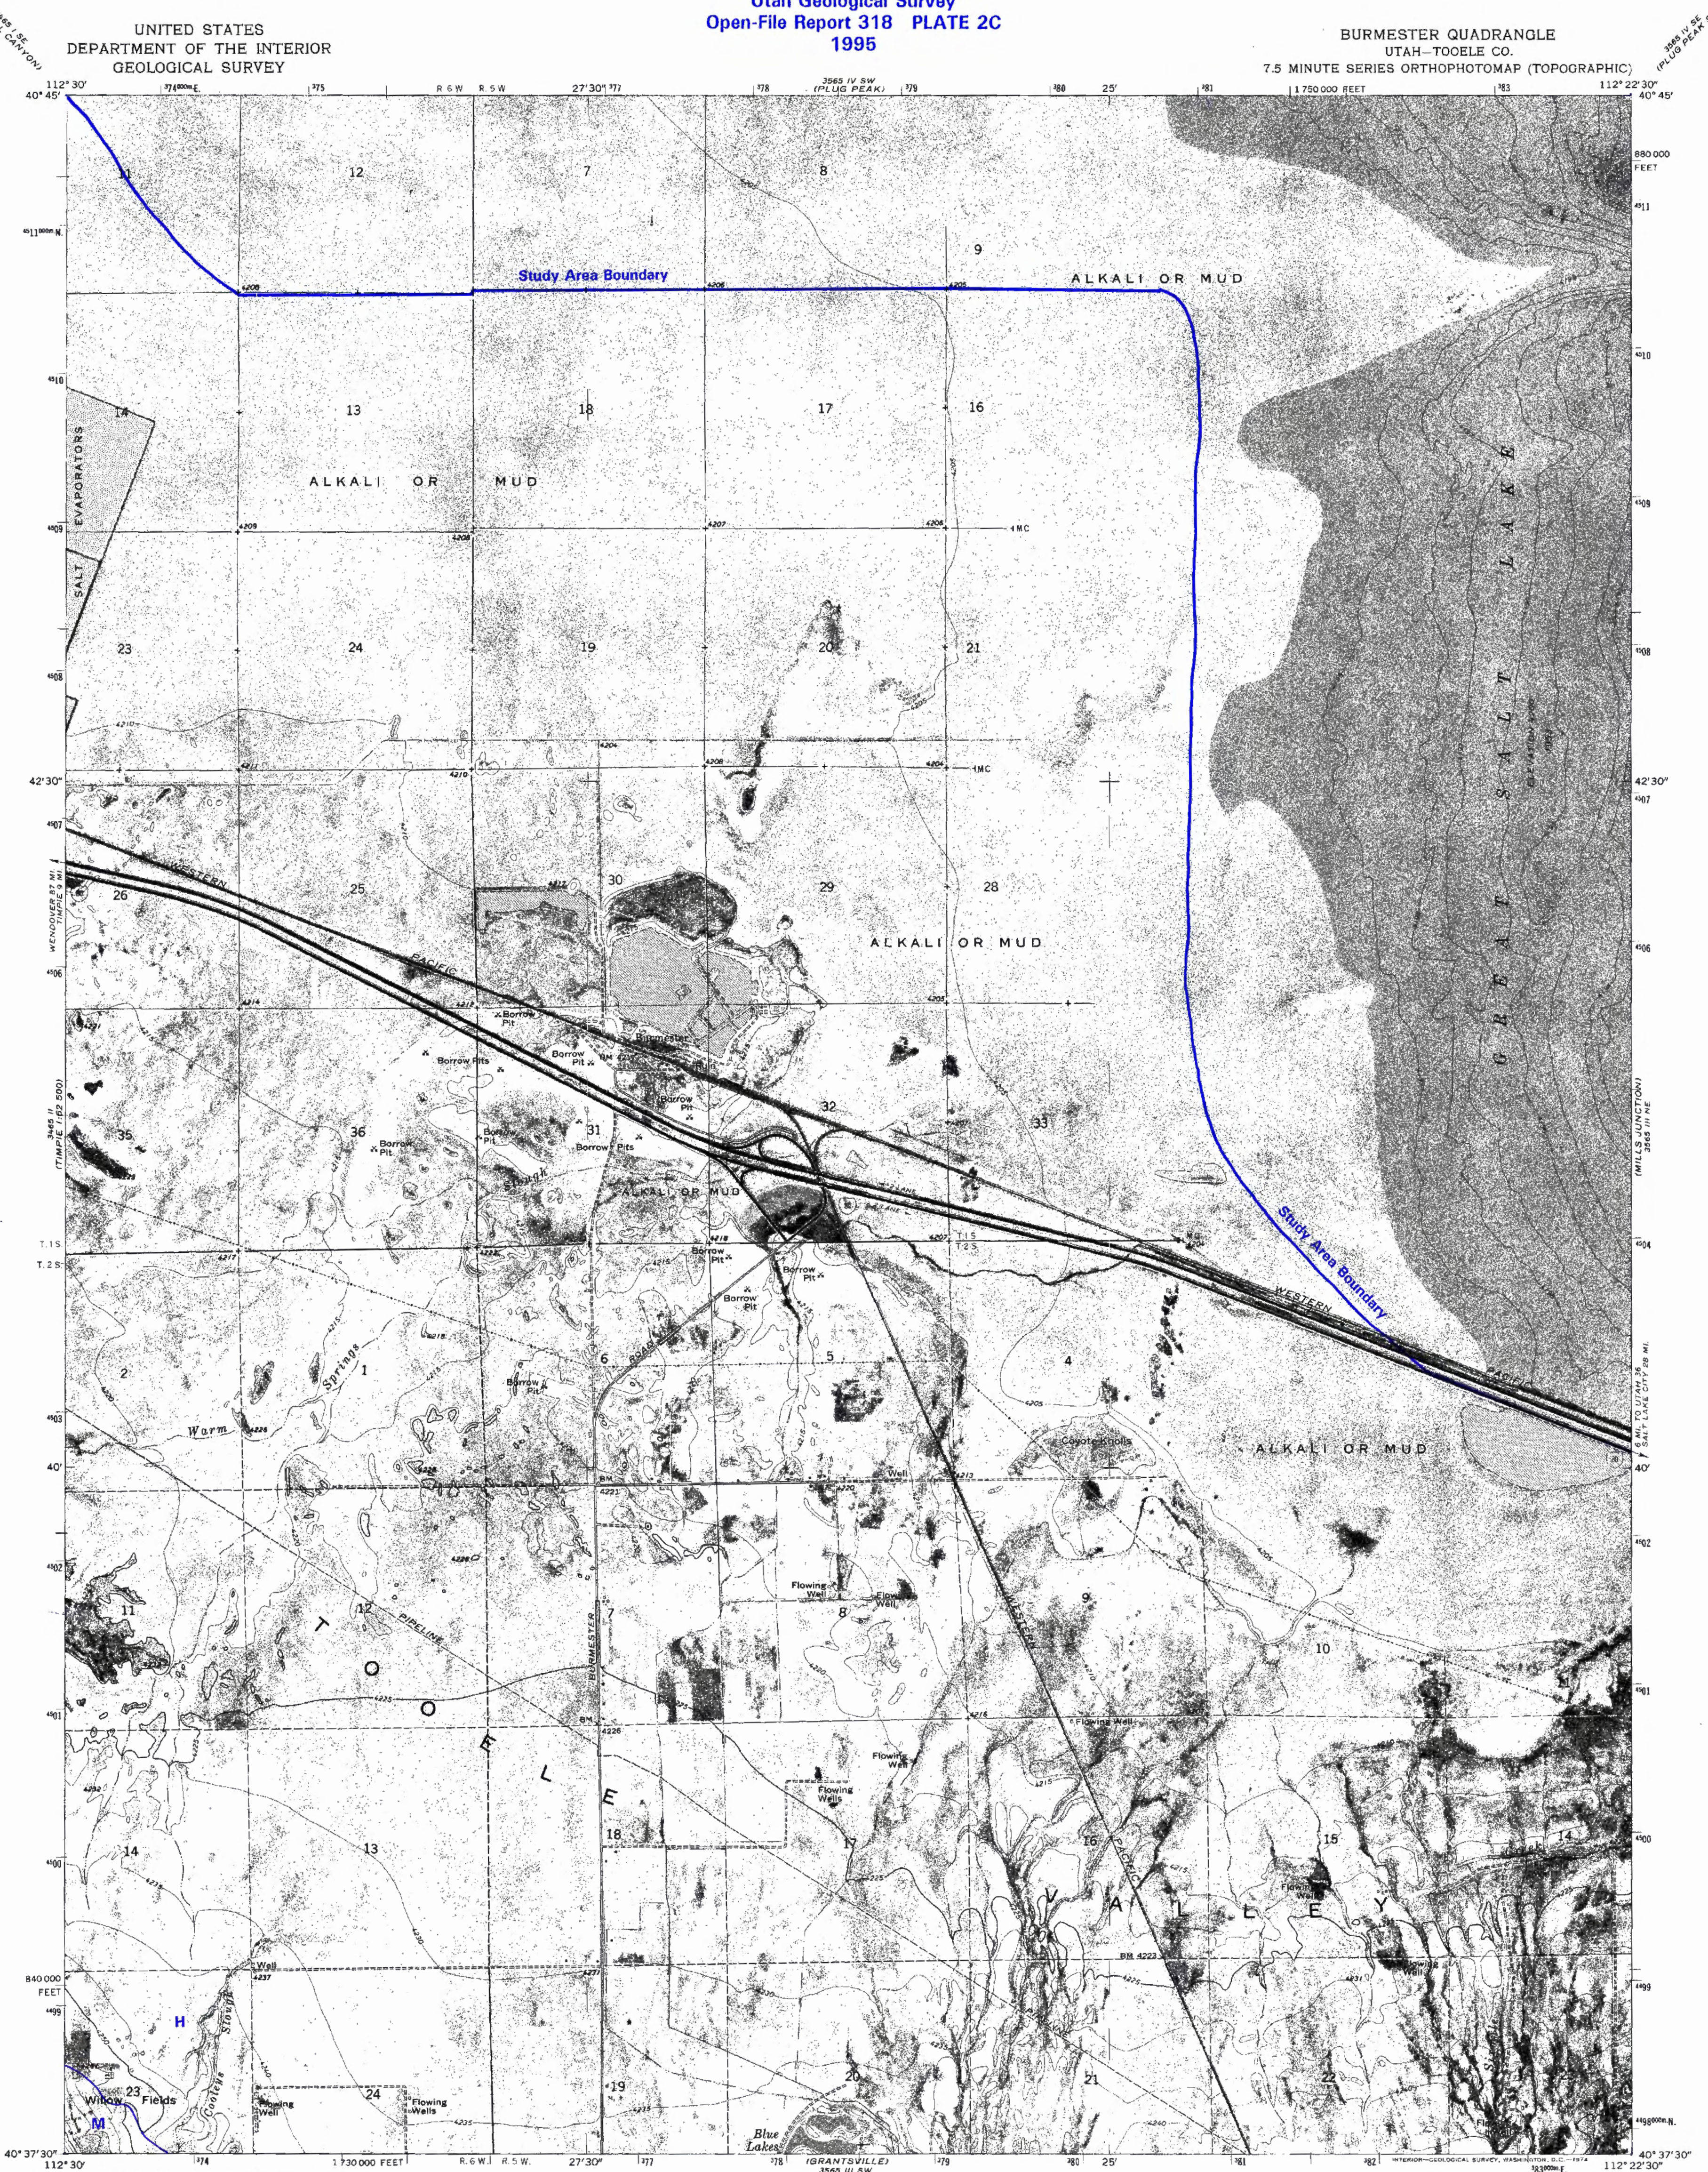
Liquefaction susceptibility, Burmester quadrangle, Tooele County, Utah.

- H*** High; possible susceptible soil conditions and depth to ground water less than 10 feet (3 m).
- M*** Moderate; possible susceptible soil conditions and depth to ground water from 10 to 30 feet (3-9 m).
- L** Low; possible susceptible soil conditions and depth to ground water from 30 to 60 feet (9-15 m).
- VL** Very low; rock, unsusceptible soil conditions, or depth to ground water greater than 60 feet (15 m).

Note: This map is not a liquefaction potential map, because it does not consider the probability of earthquake ground shaking needed to cause liquefaction in areas of susceptible conditions.

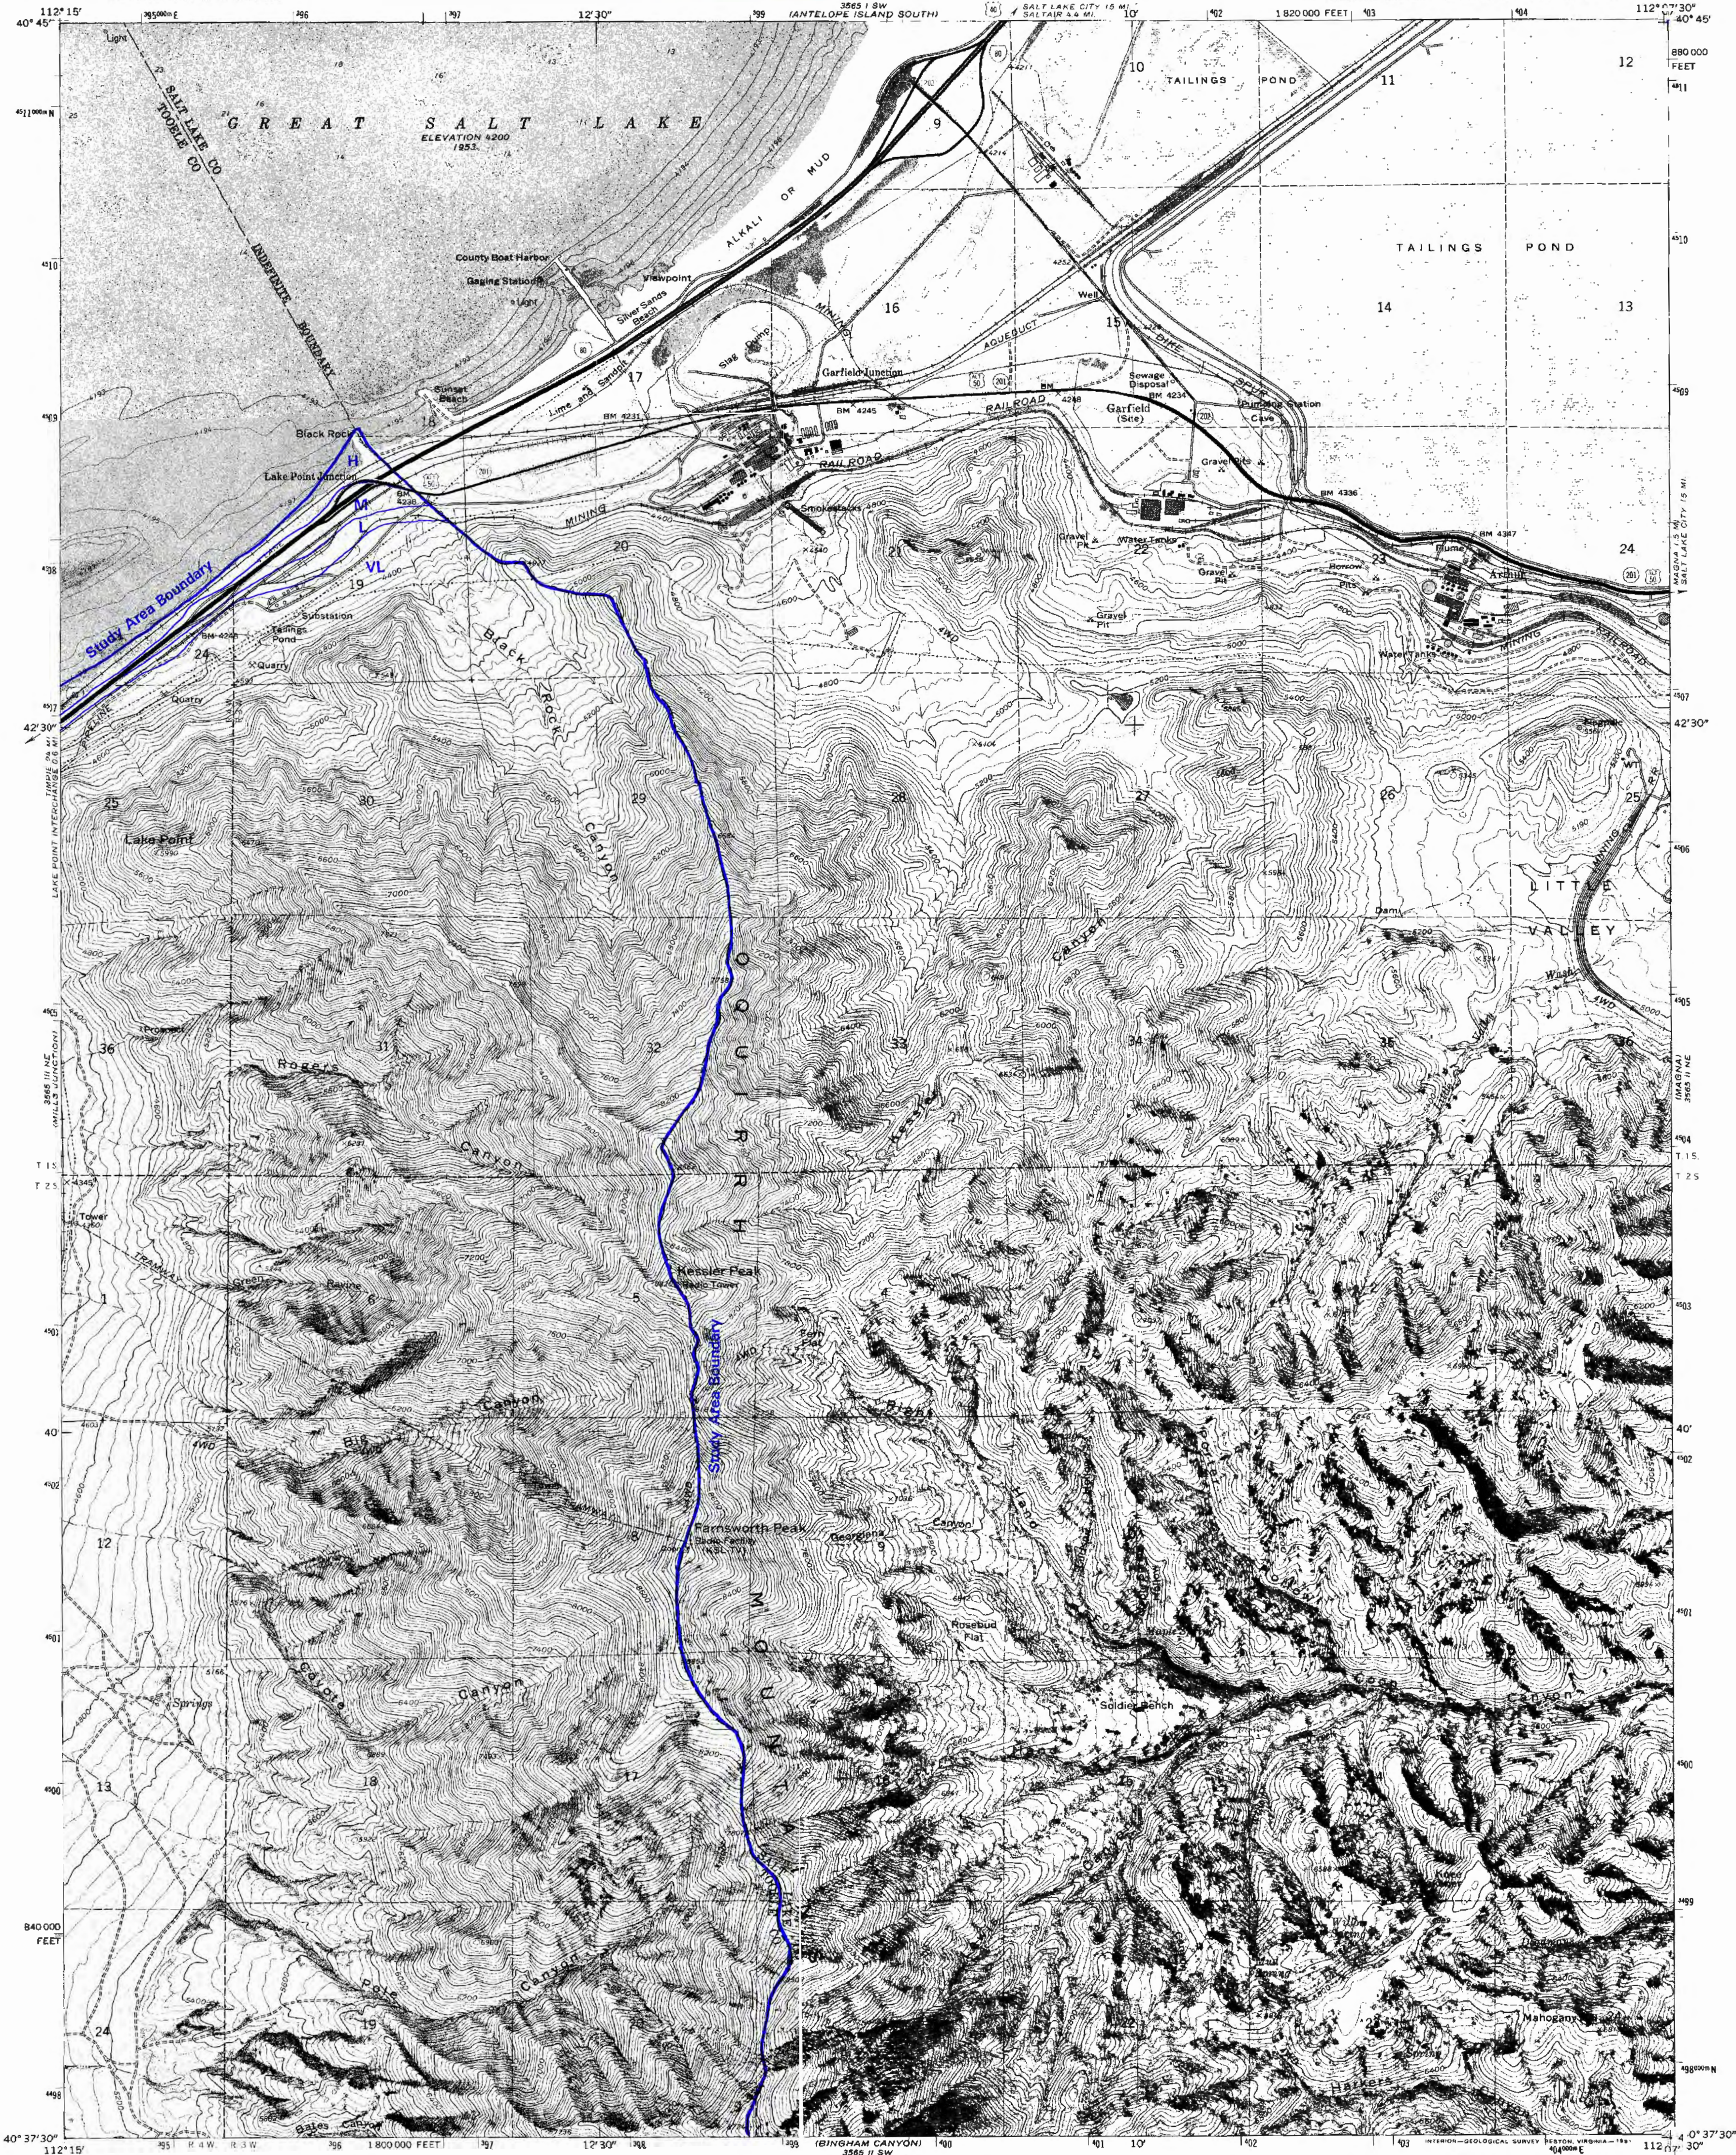
Liquefaction susceptibility, Farnsworth Peak quadrangle, Tooele County, Utah.

- H*** High; possible susceptible soil conditions and depth to ground water less than 10 feet (3 m).
- M*** Moderate; possible susceptible soil conditions and depth to ground water from 10 to 30 feet (3-9 m).
- L** Low; possible susceptible soil conditions and depth to ground water from 30 to 50 feet (9-15 m).
- VL** Very low; rock, unsusceptible soil conditions, or depth to ground water greater than 50 feet (15 m).

* Special studies are recommended for certain land uses in areas of high and moderate liquefaction susceptibility (see table 1).

Note: This map is not a liquefaction potential map, because it does not consider the probability of earthquake ground shaking needed to cause liquefaction in areas of susceptible conditions.

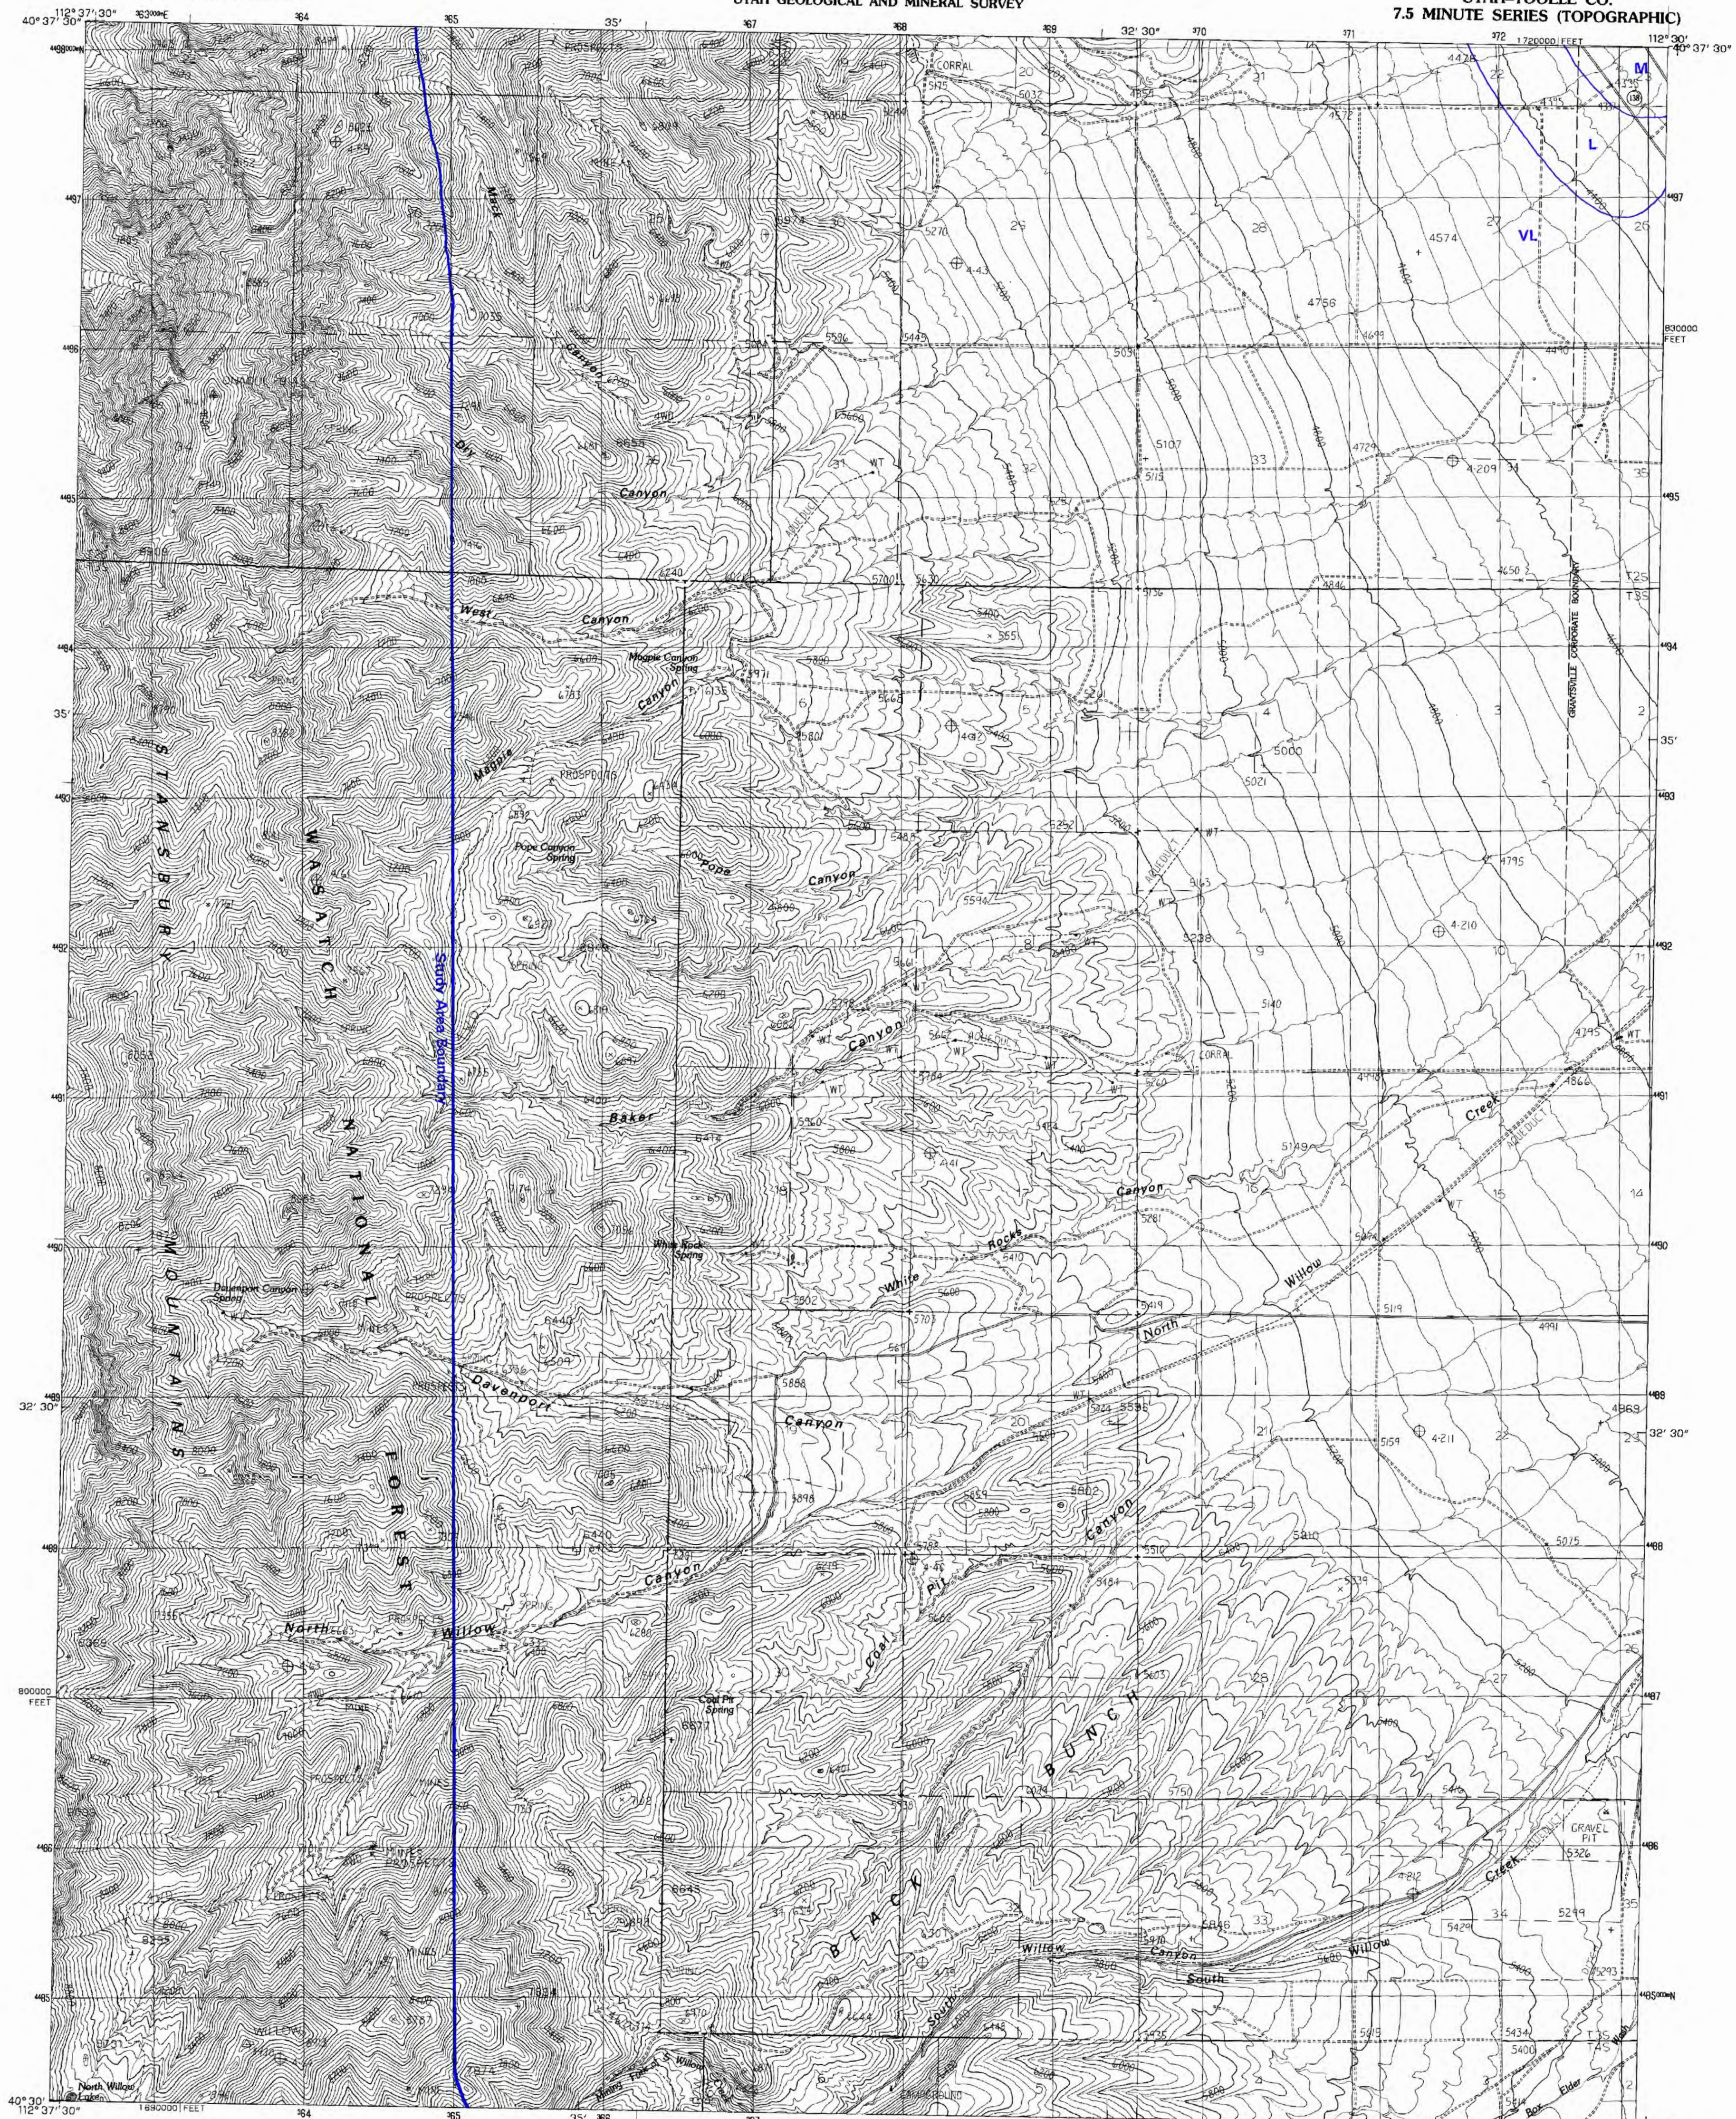
Liquefaction susceptibility, North Willow Canyon quadrangle, Tooele County, Utah.

- H*** High; possible susceptible soil conditions and depth to ground water less than 10 feet (3 m).
- M*** Moderate; possible susceptible soil conditions and depth to ground water from 10 to 30 feet (3-9 m).
- L** Low; possible susceptible soil conditions and depth to ground water from 30 to 50 feet (9-15 m).
- VL** Very low; rock, unsuitable soil conditions, or depth to ground water greater than 50 feet (15 m).

* Special studies are recommended for certain land uses in areas of high and moderate liquefaction susceptibility (see table 1).

Note: This map is not a liquefaction potential map, because it does not consider the probability of earthquake ground shaking needed to cause liquefaction in areas of susceptible conditions.

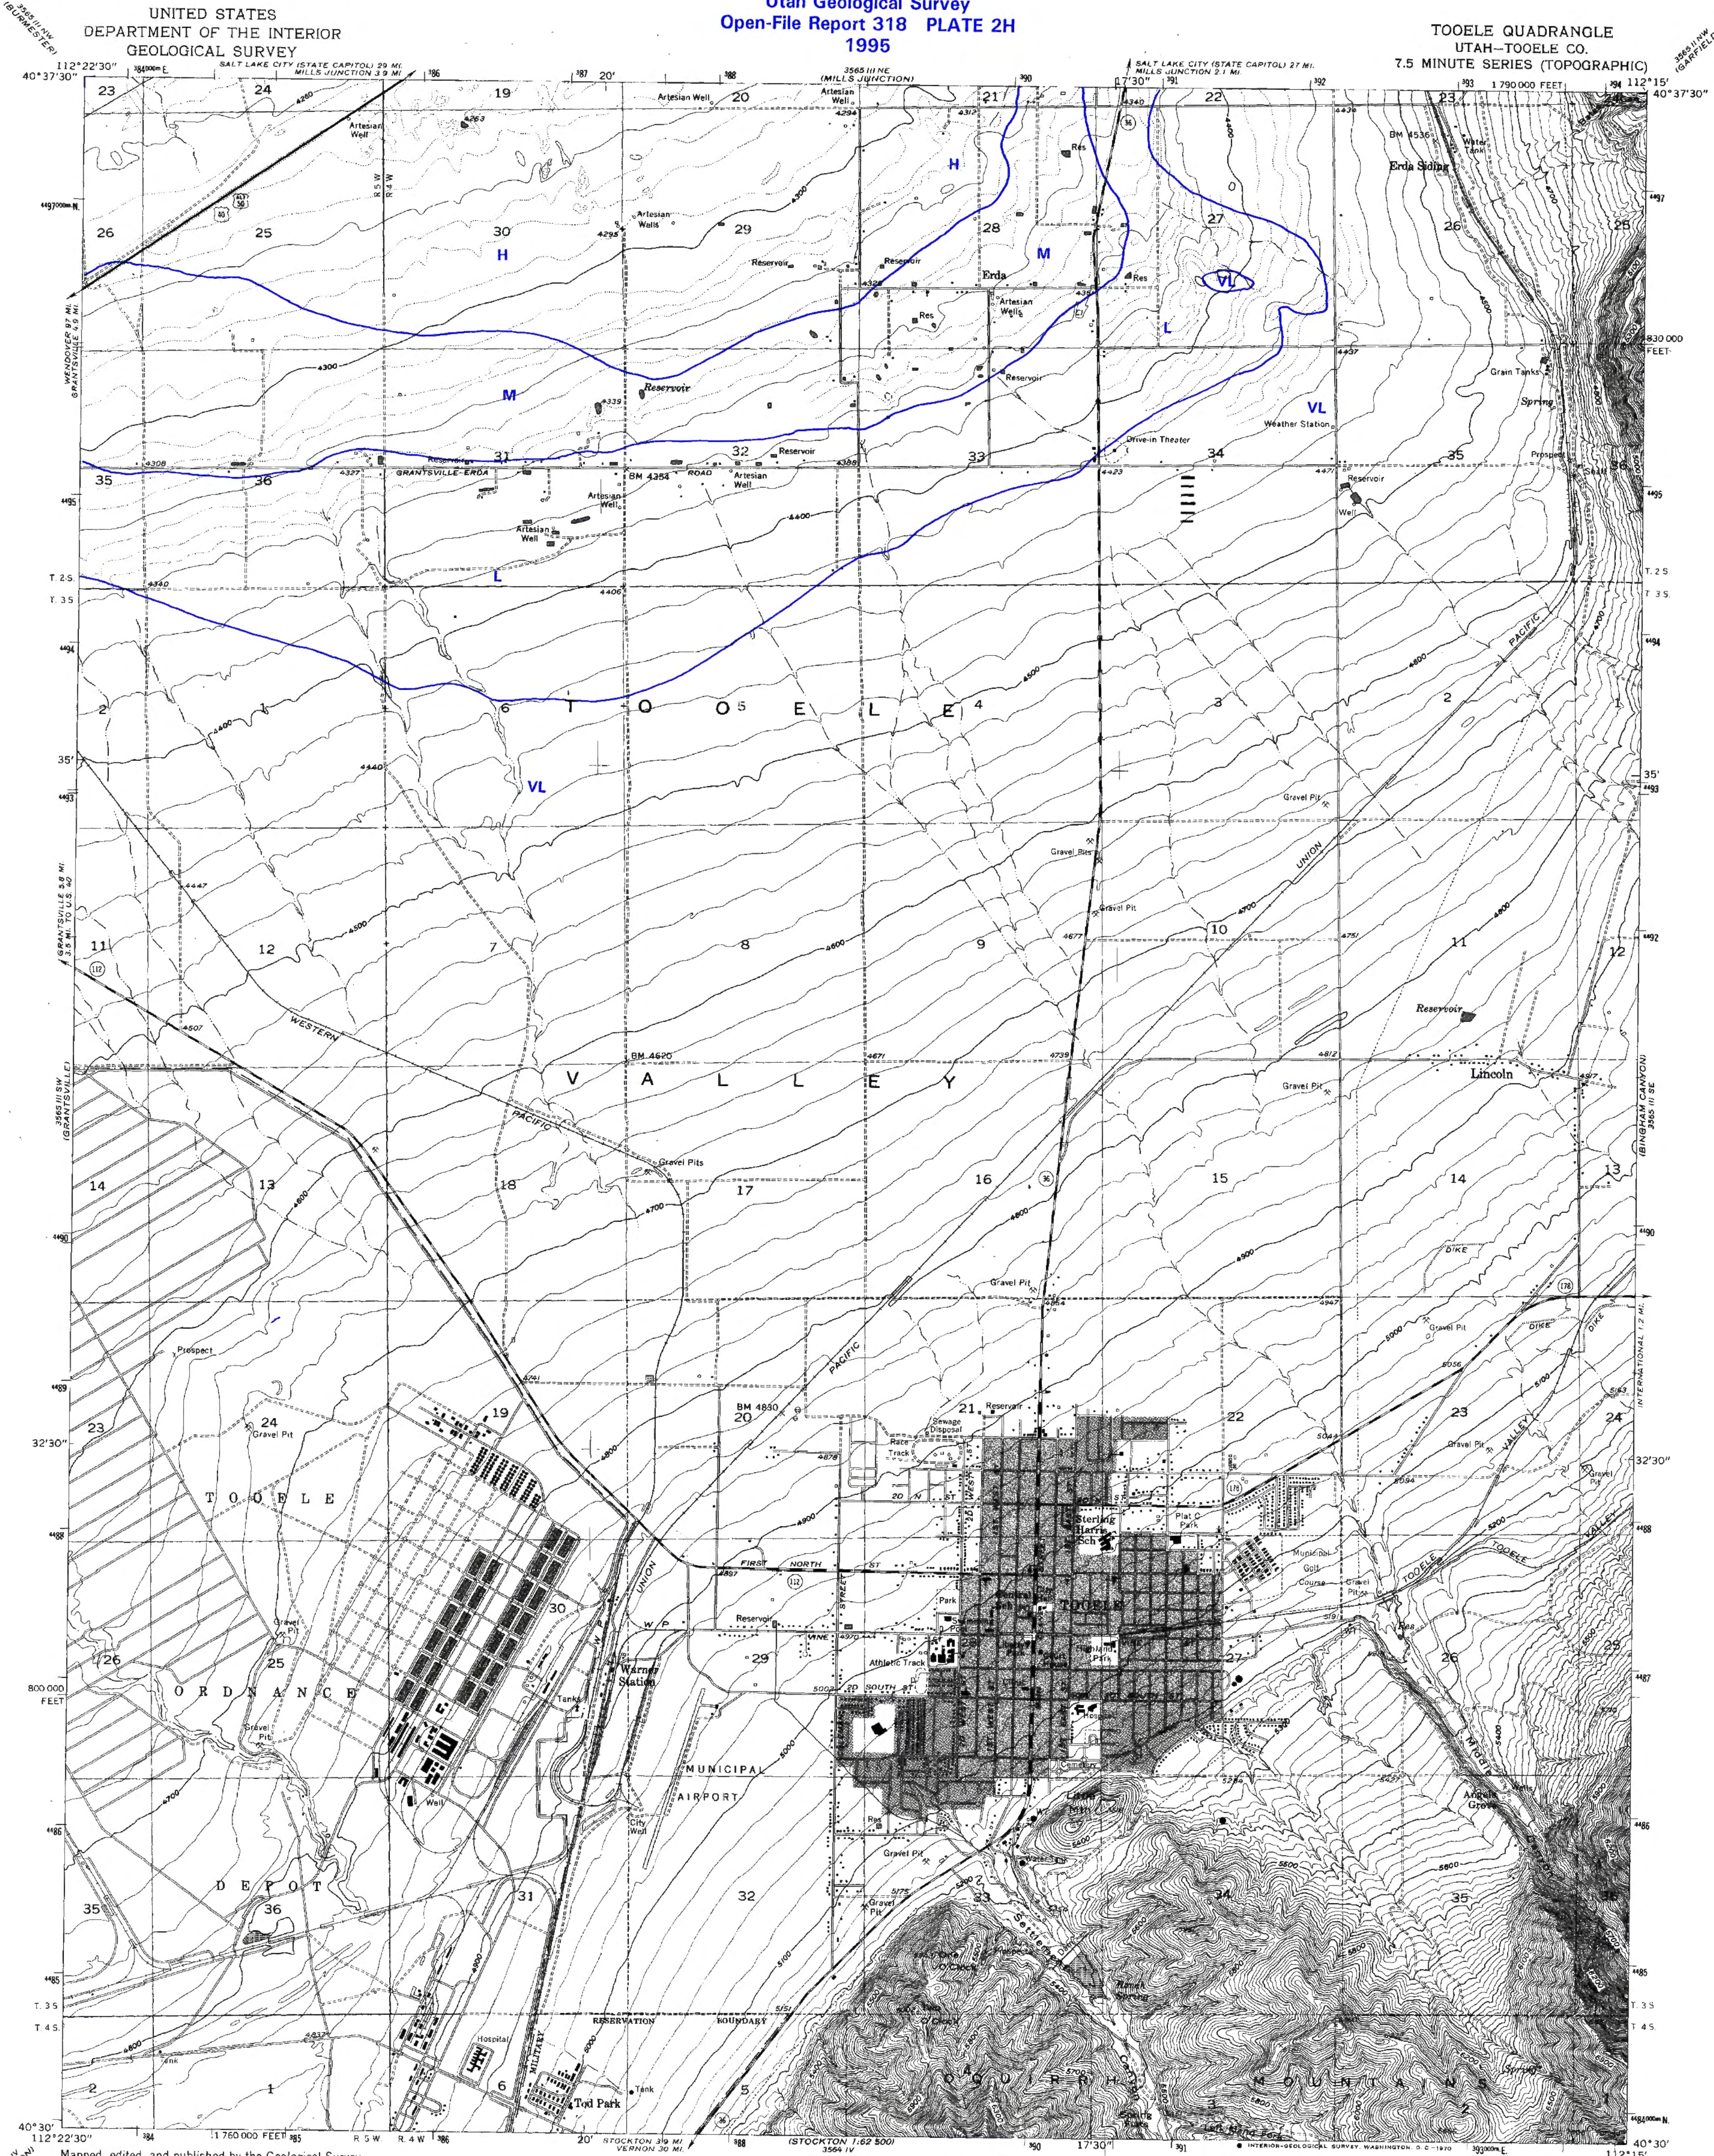
Utah Geological Survey
Open-File Report 318 PLATE 2H
1995

Liquefaction susceptibility, Tooele quadrangle, Tooele County, Utah.

- EXPLANATION**
- H*** High; possible susceptible soil conditions and depth to ground water less than 10 feet (3 m).
 - M*** Moderate; possible susceptible soil conditions and depth to ground water from 10 to 30 feet (3-9 m).
 - L** Low; possible susceptible soil conditions and depth to ground water from 30 to 50 feet (9-15 m).
 - VL** Very low; rock, unsusceptible soil conditions, or depth to ground water greater than 50 feet (15 m).

* Special studies are recommended for certain land uses in areas of high and moderate liquefaction susceptibility (see table 1).

Note: This map is not a liquefaction potential map, because it does not consider the probability of earthquake ground shaking needed to cause liquefaction in areas of susceptible conditions.

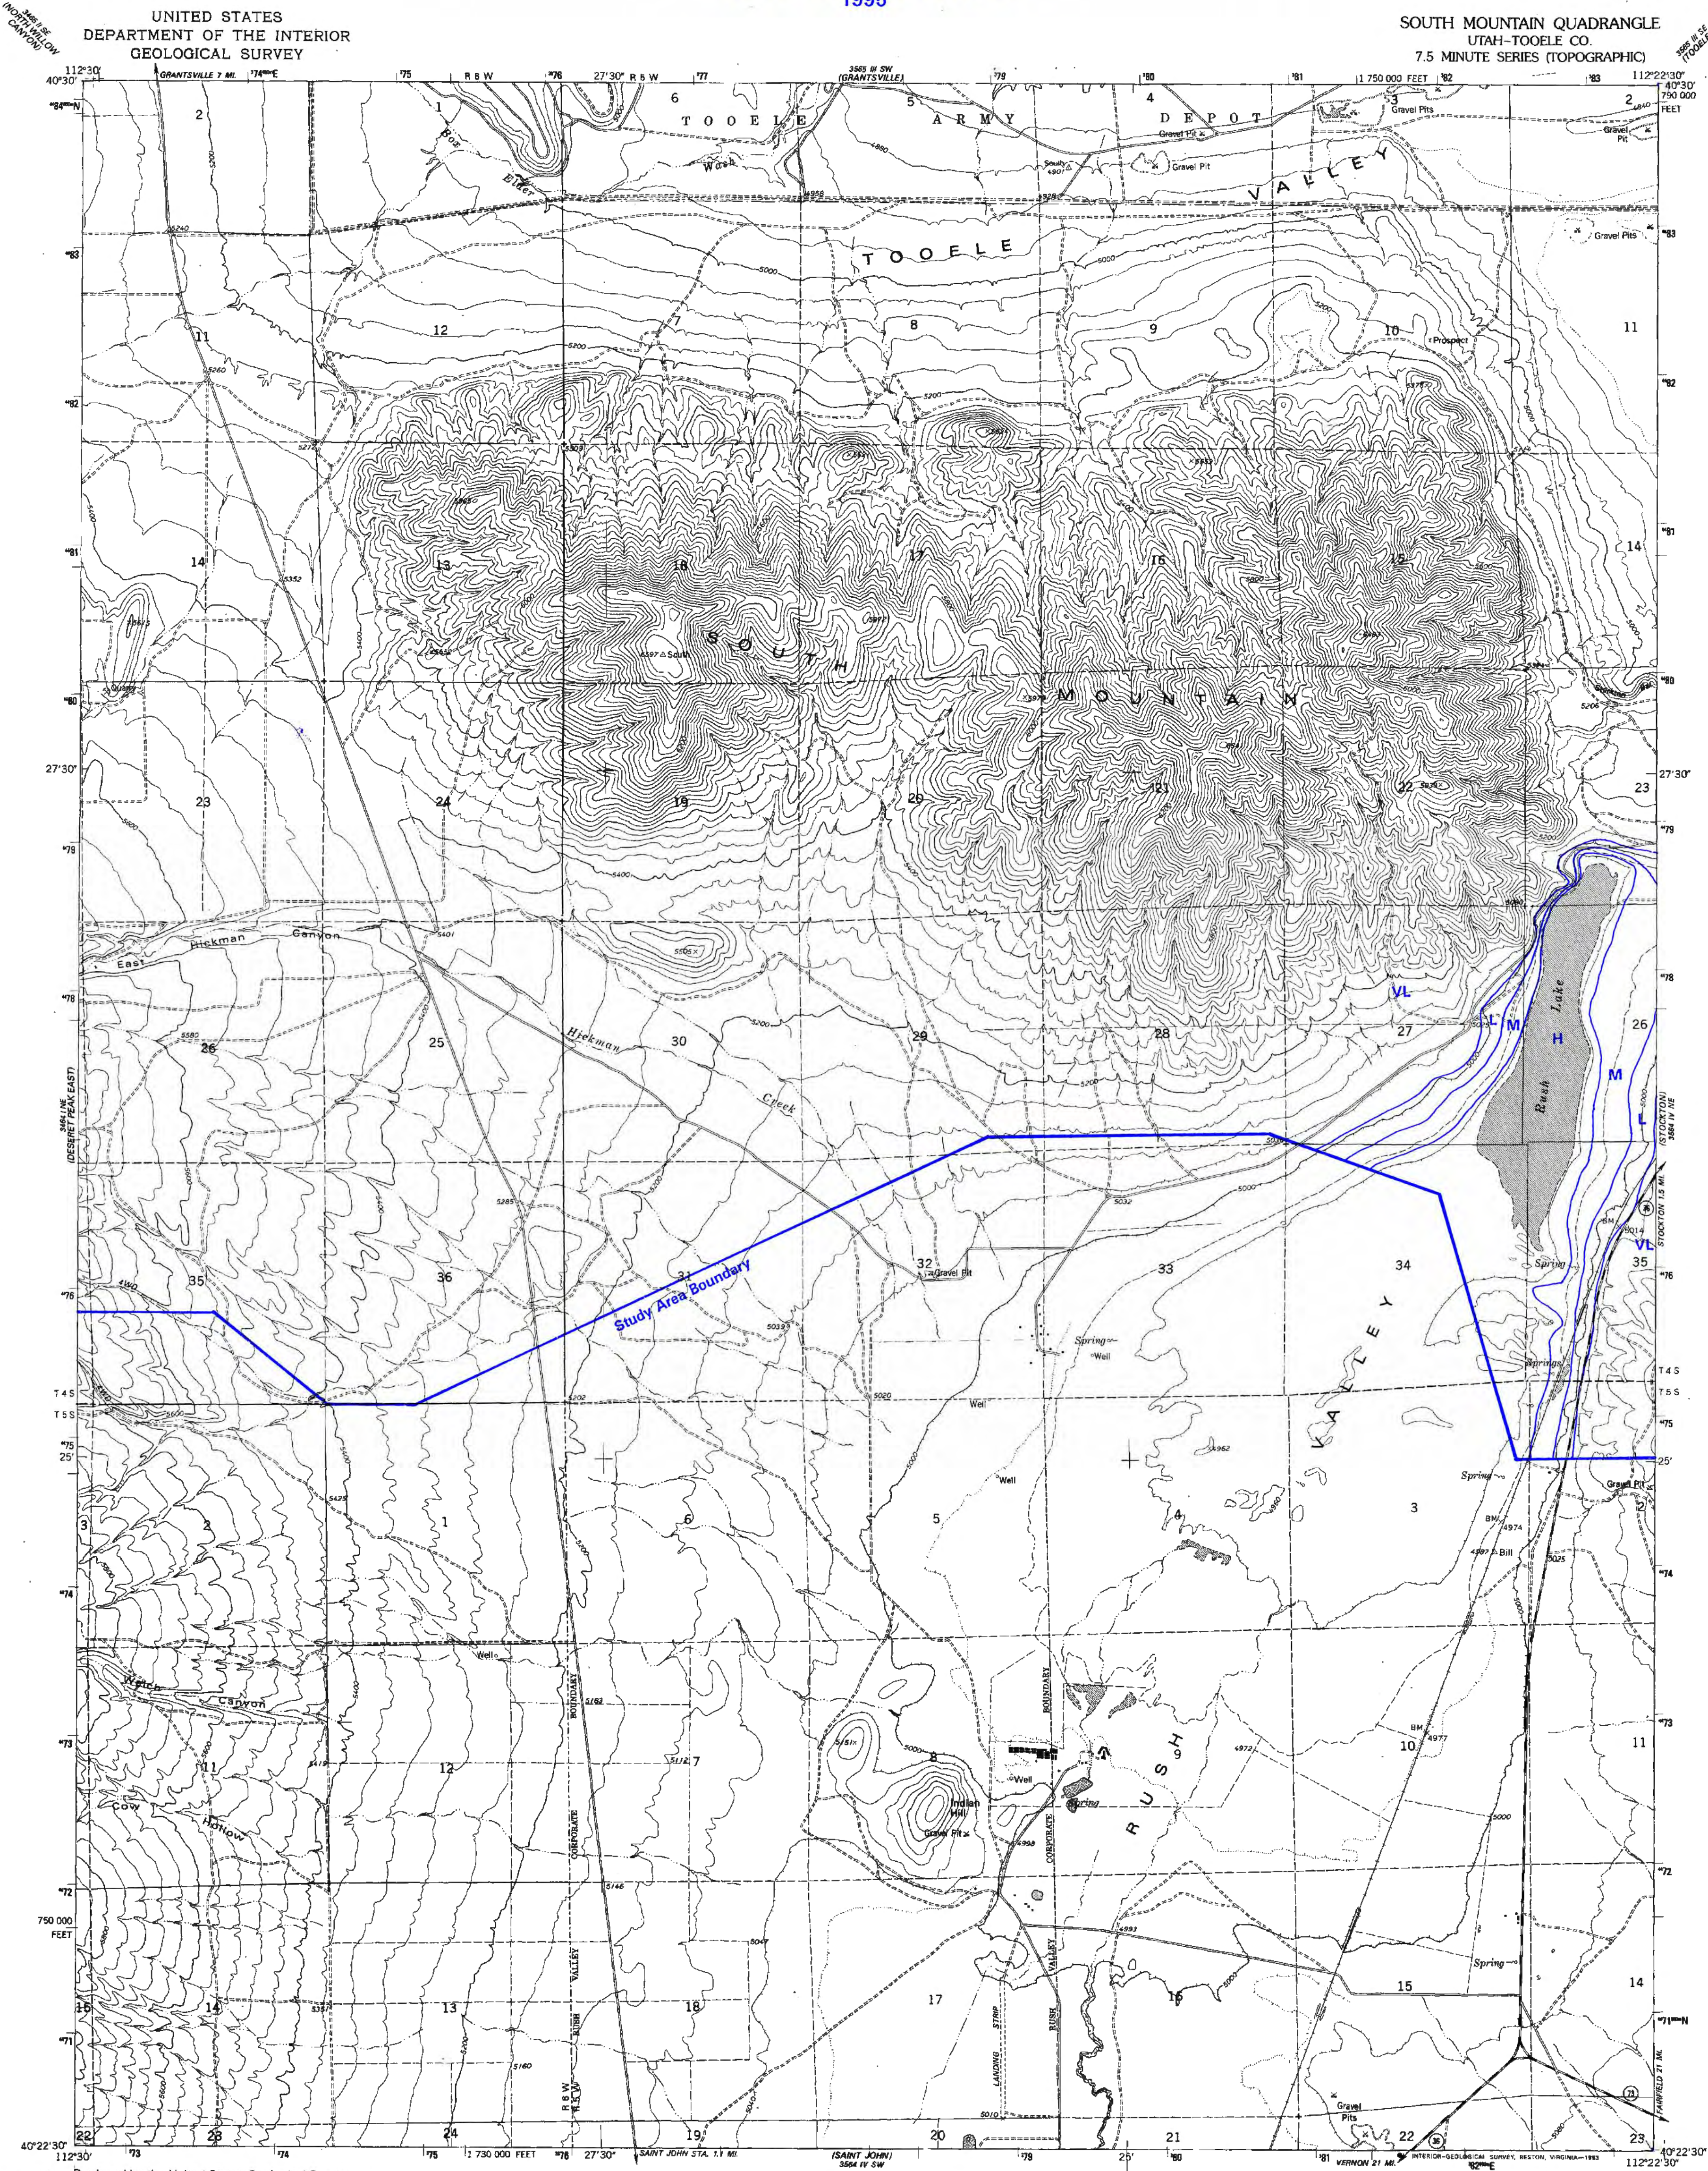
Utah Geological Survey
Open-File Report 318 PLATE 2K
1995

Liquefaction susceptibility, South Mountain quadrangle, Tooele County, Utah.

- H*** High; possible susceptible soil conditions and depth to ground water less than 10 feet (3 m).
- M*** Moderate; possible susceptible soil conditions and depth to ground water from 10 to 30 feet (3-9 m).
- L** Low; possible susceptible soil conditions and depth to ground water from 30 to 50 feet (9-15 m).
- VL** Very low; rock, unsusceptible soil conditions, or depth to ground water greater than 50 feet (15 m).

* Special studies are recommended for certain land uses in areas of high and moderate liquefaction susceptibility (see table 1).

Note: This map is not a liquefaction potential map, because it does not consider the probability of earthquake ground shaking needed to cause liquefaction in areas of susceptible conditions.
