GEOLOGIC HAZARDS AND LAND-USE PLANNING FOR TOOELE VALLEY AND THE WEST DESERT HAZARDOUS INDUSTRY AREA, TOOELE COUNTY, UTAH

Barry J. Solomon and Bill D. Black, editors

OPEN-FILE REPORT 318
UTAH GEOLOGICAL SURVEY
a division of
UTAH DEPARTMENT OF NATURAL RESOURCES

October 1995

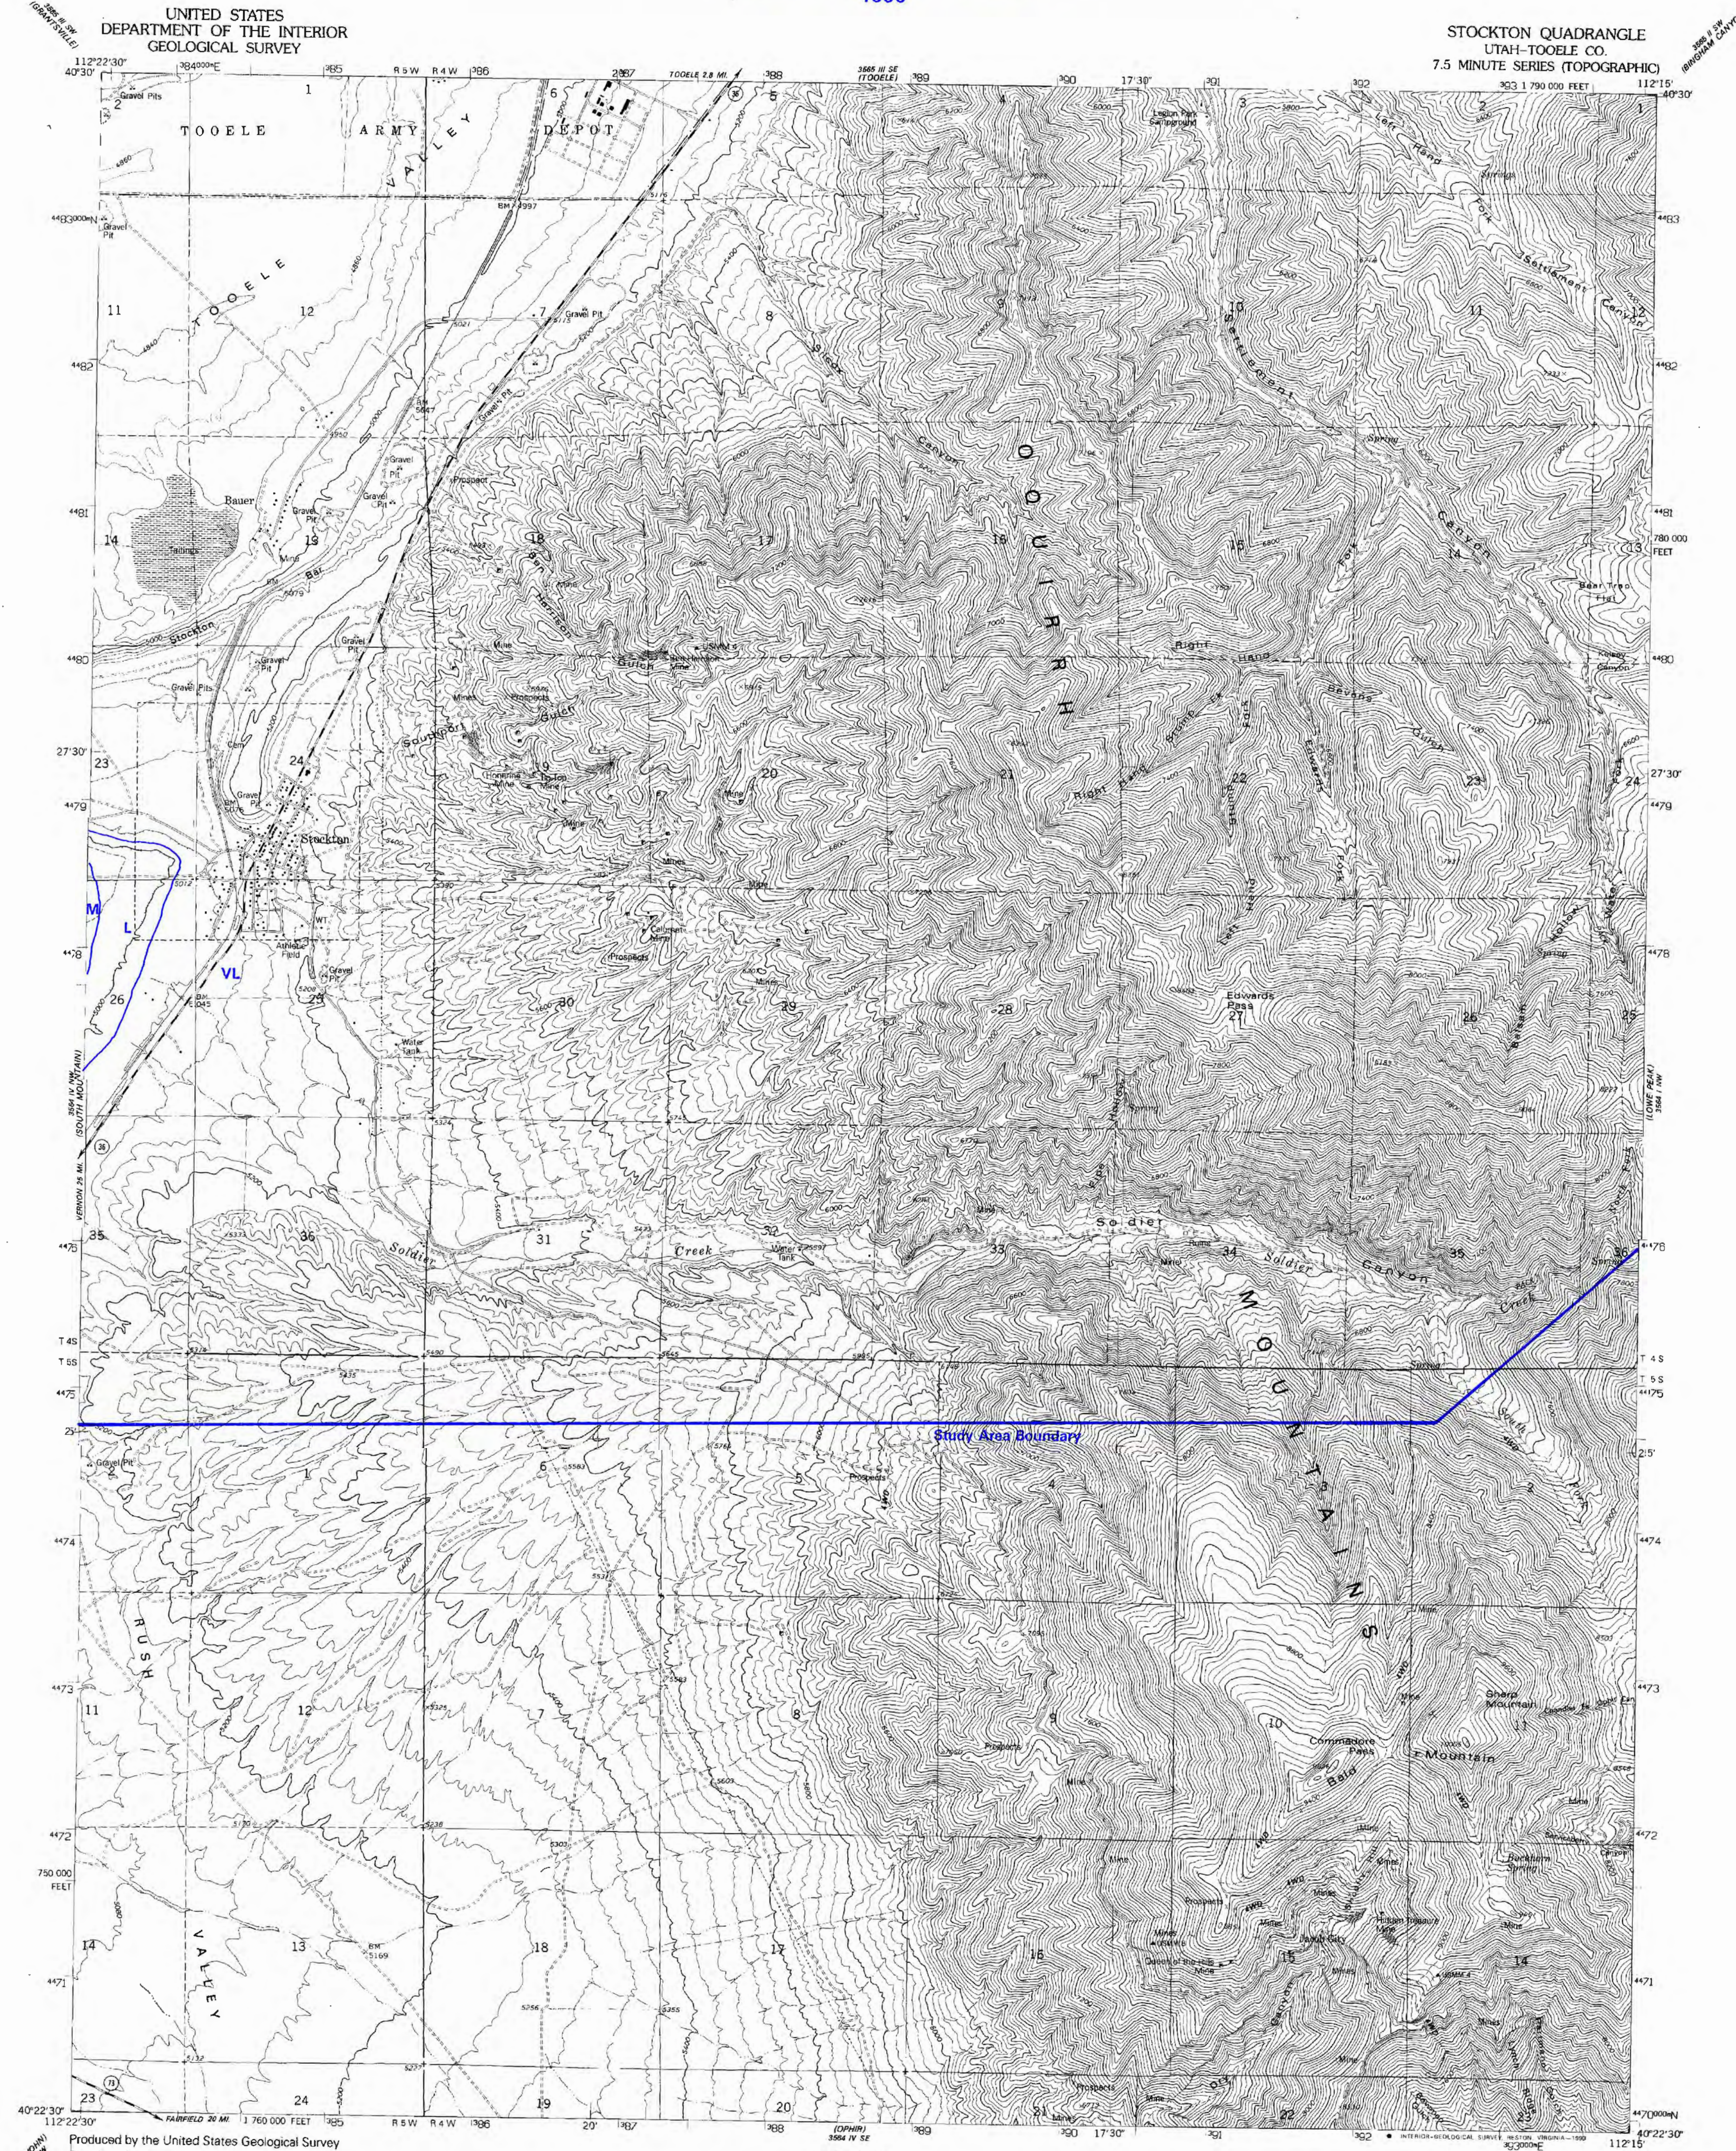
STOCKTON QUADRANGLE
UTAH-TOOELE CO.
7.5 MINUTE SERIES (TOPOGRAPHIC)

Liquefaction susceptibility, Stockton quadrangle, Tooele County, Utah.

- H*** High; possible susceptible soil conditions and depth to ground water less than 10 feet (3 m).
- M*** Moderate; possible susceptible soil conditions and depth to ground water from 10 to 30 feet (3-9 m).
- L** Low; possible susceptible soil conditions and depth to ground water from 30 to 50 feet (9-15 m).
- VL** Very low; rock, unsusceptible soil conditions, or depth to ground water greater than 50 feet (15 m).

* Special studies are recommended for certain land uses in areas of high and moderate liquefaction susceptibility (see table 1).

Note: This map is not a liquefaction potential map, because it does not consider the probability of earthquake ground shaking needed to cause liquefaction in areas of susceptible conditions.

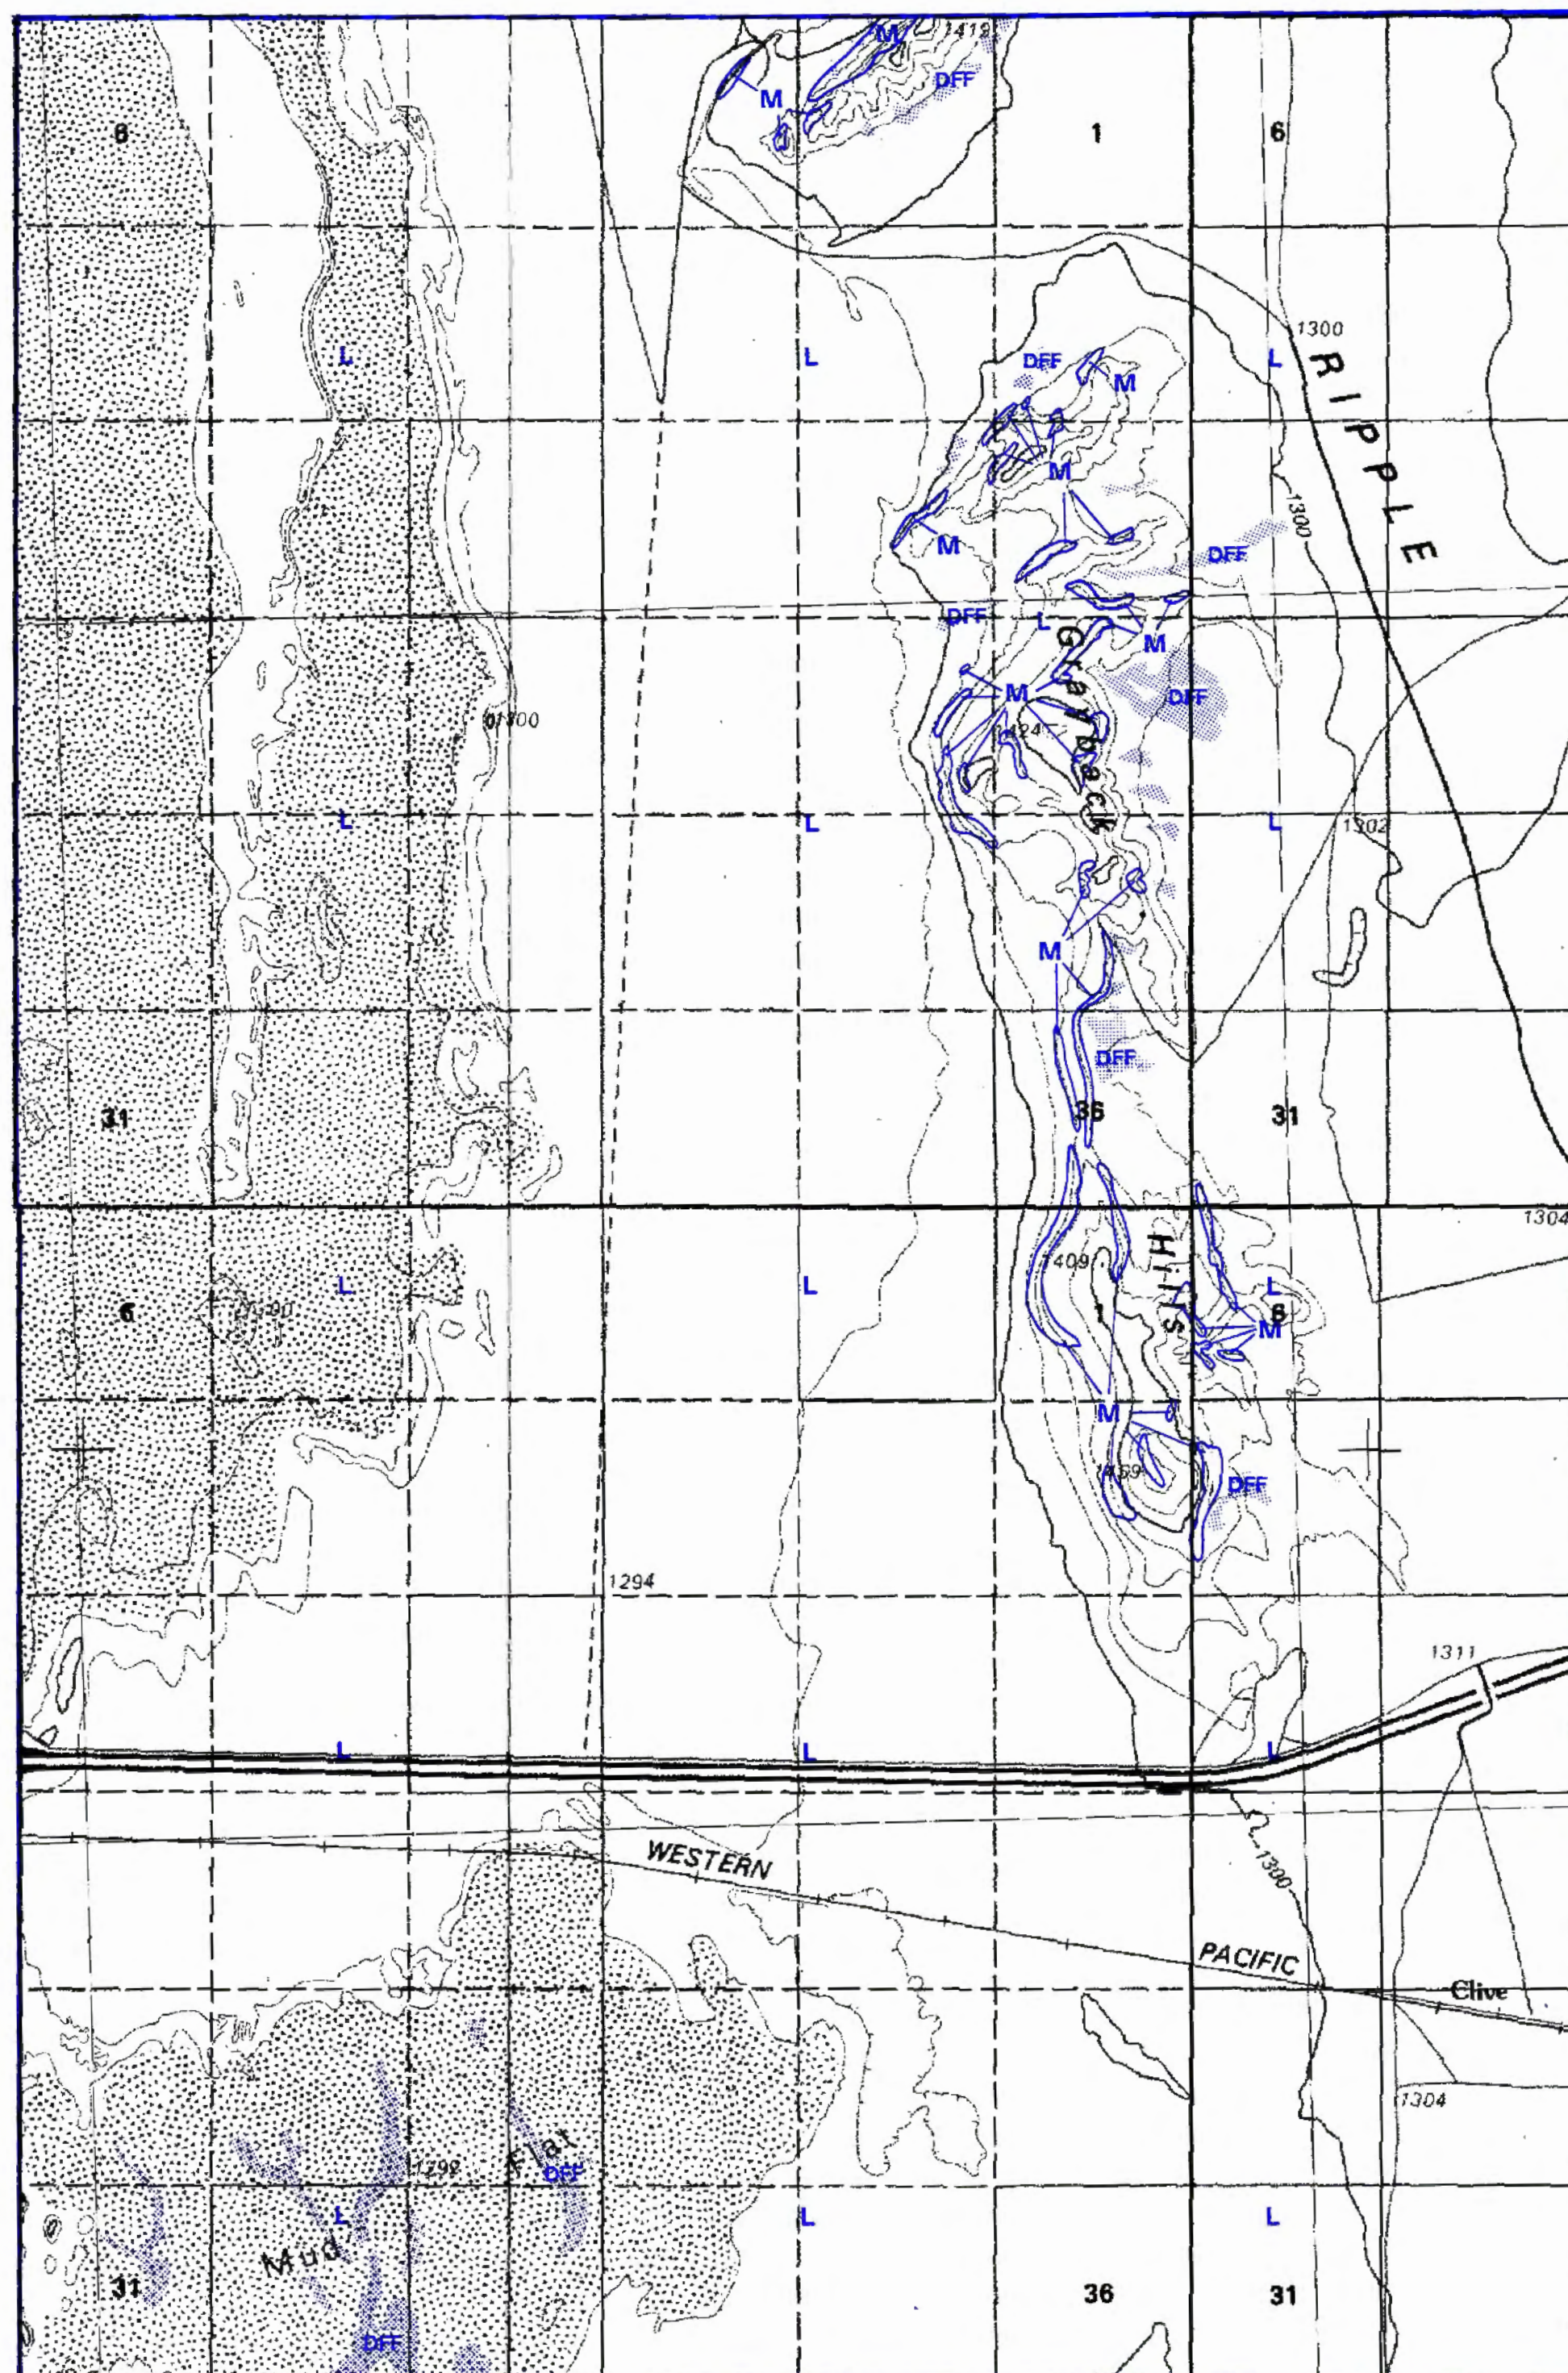
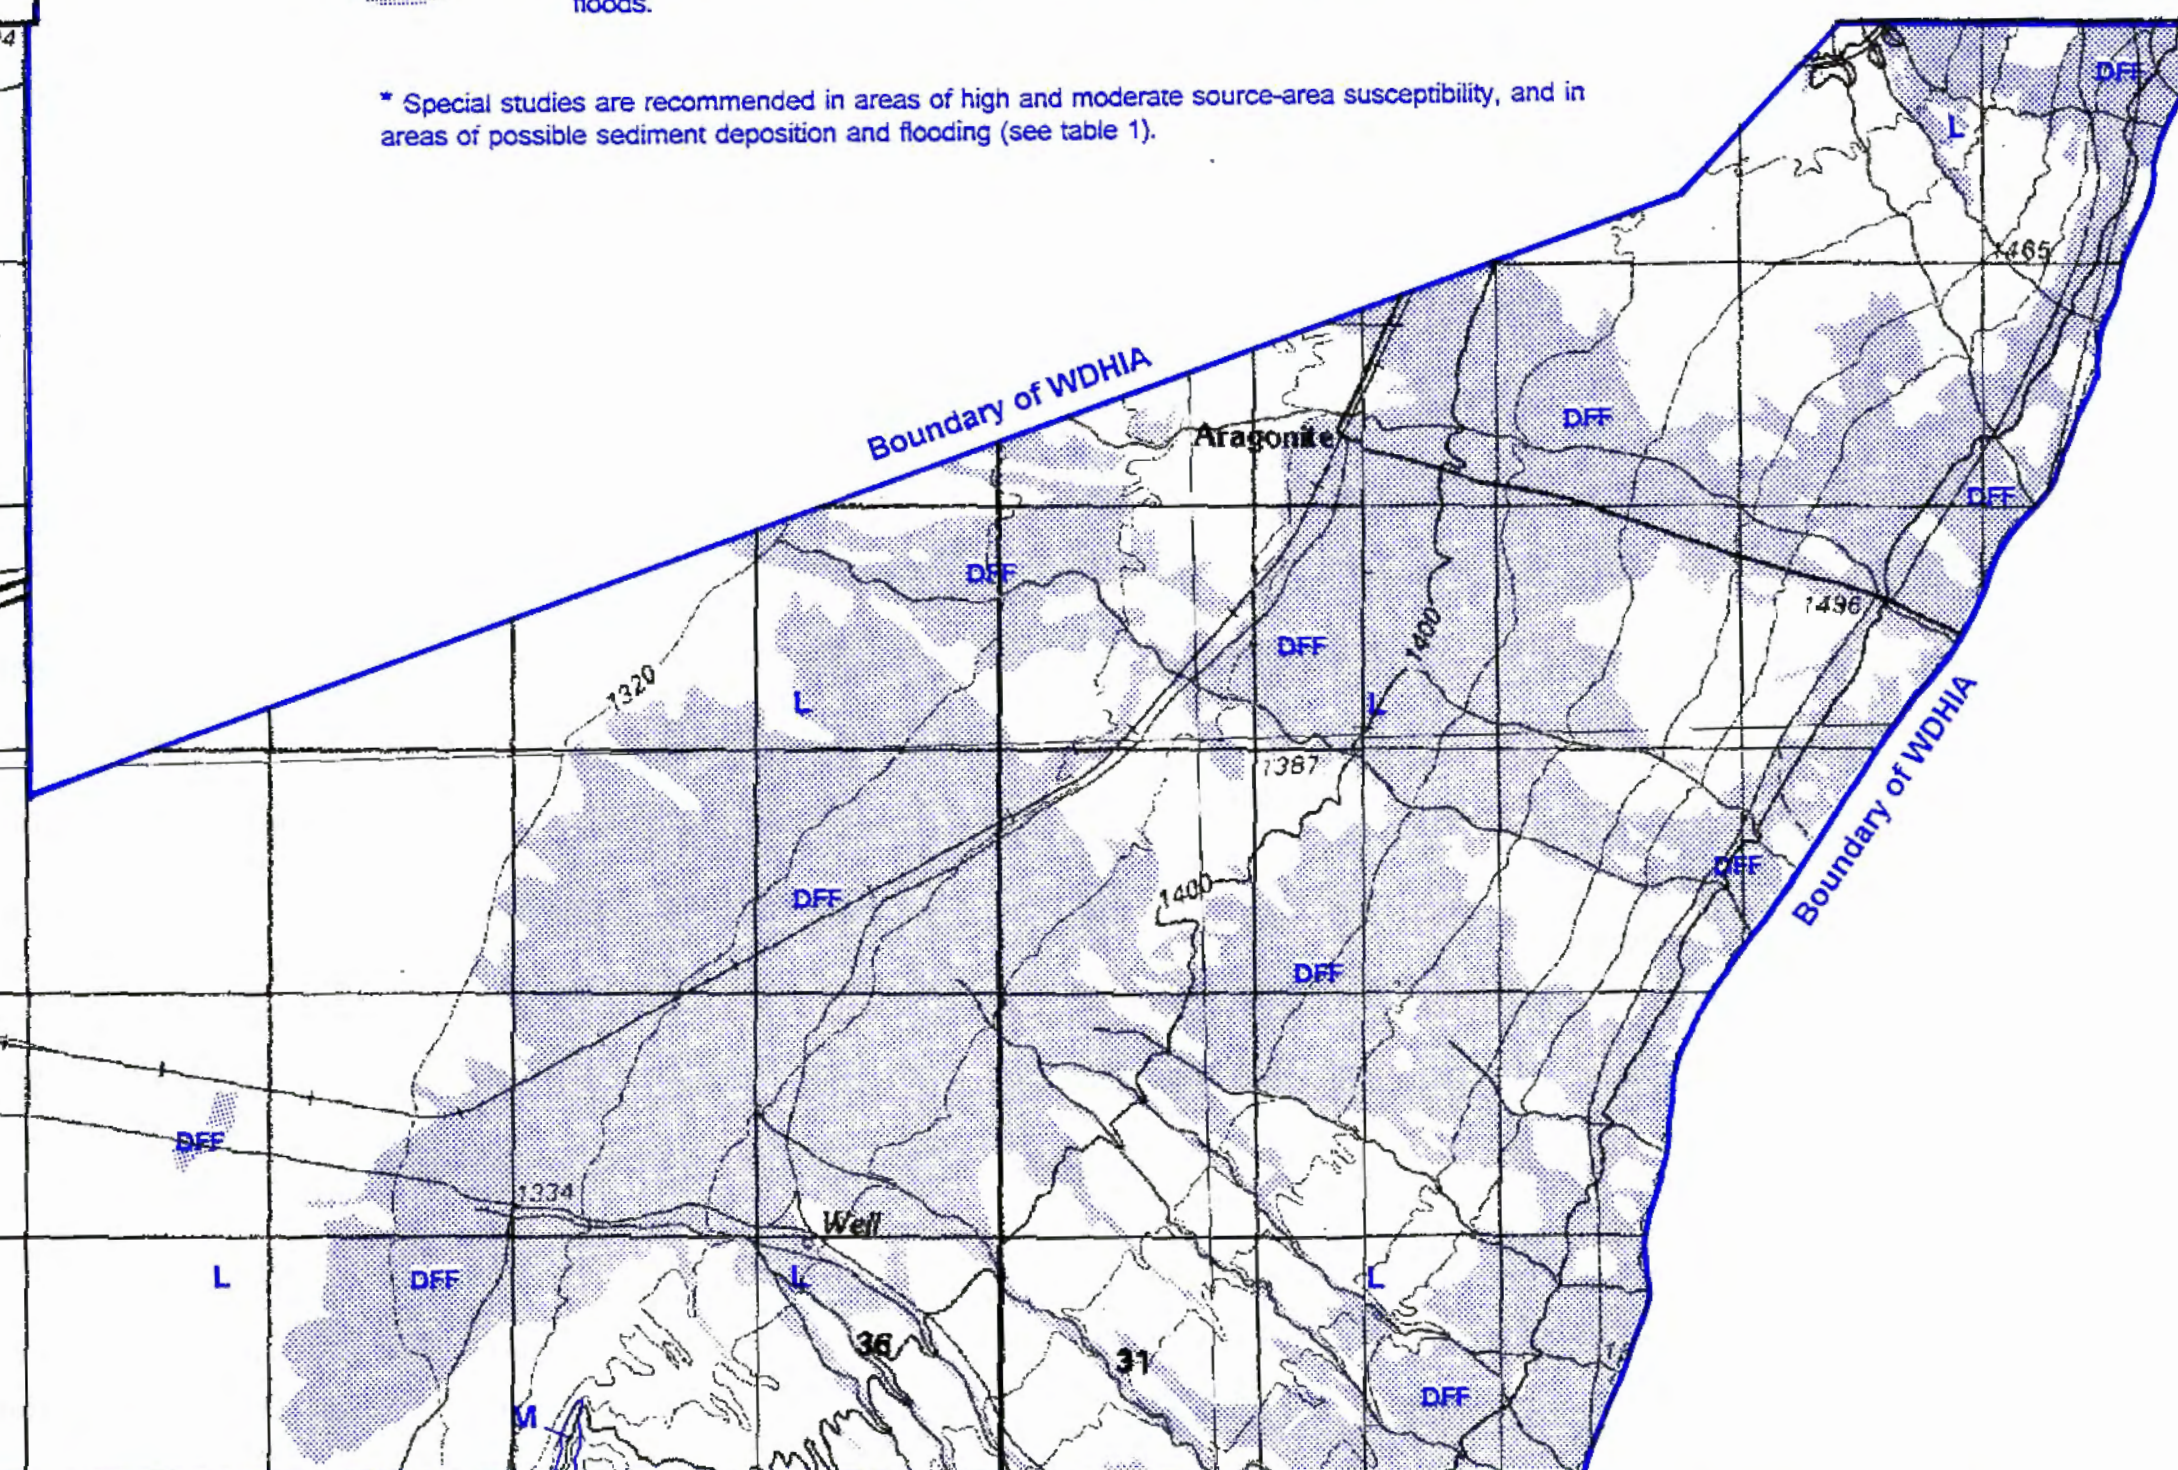
Debris-slide, debris-flow, debris-flood, and stream-flood hazards, Flux quadrangle, Tooele County, Utah.

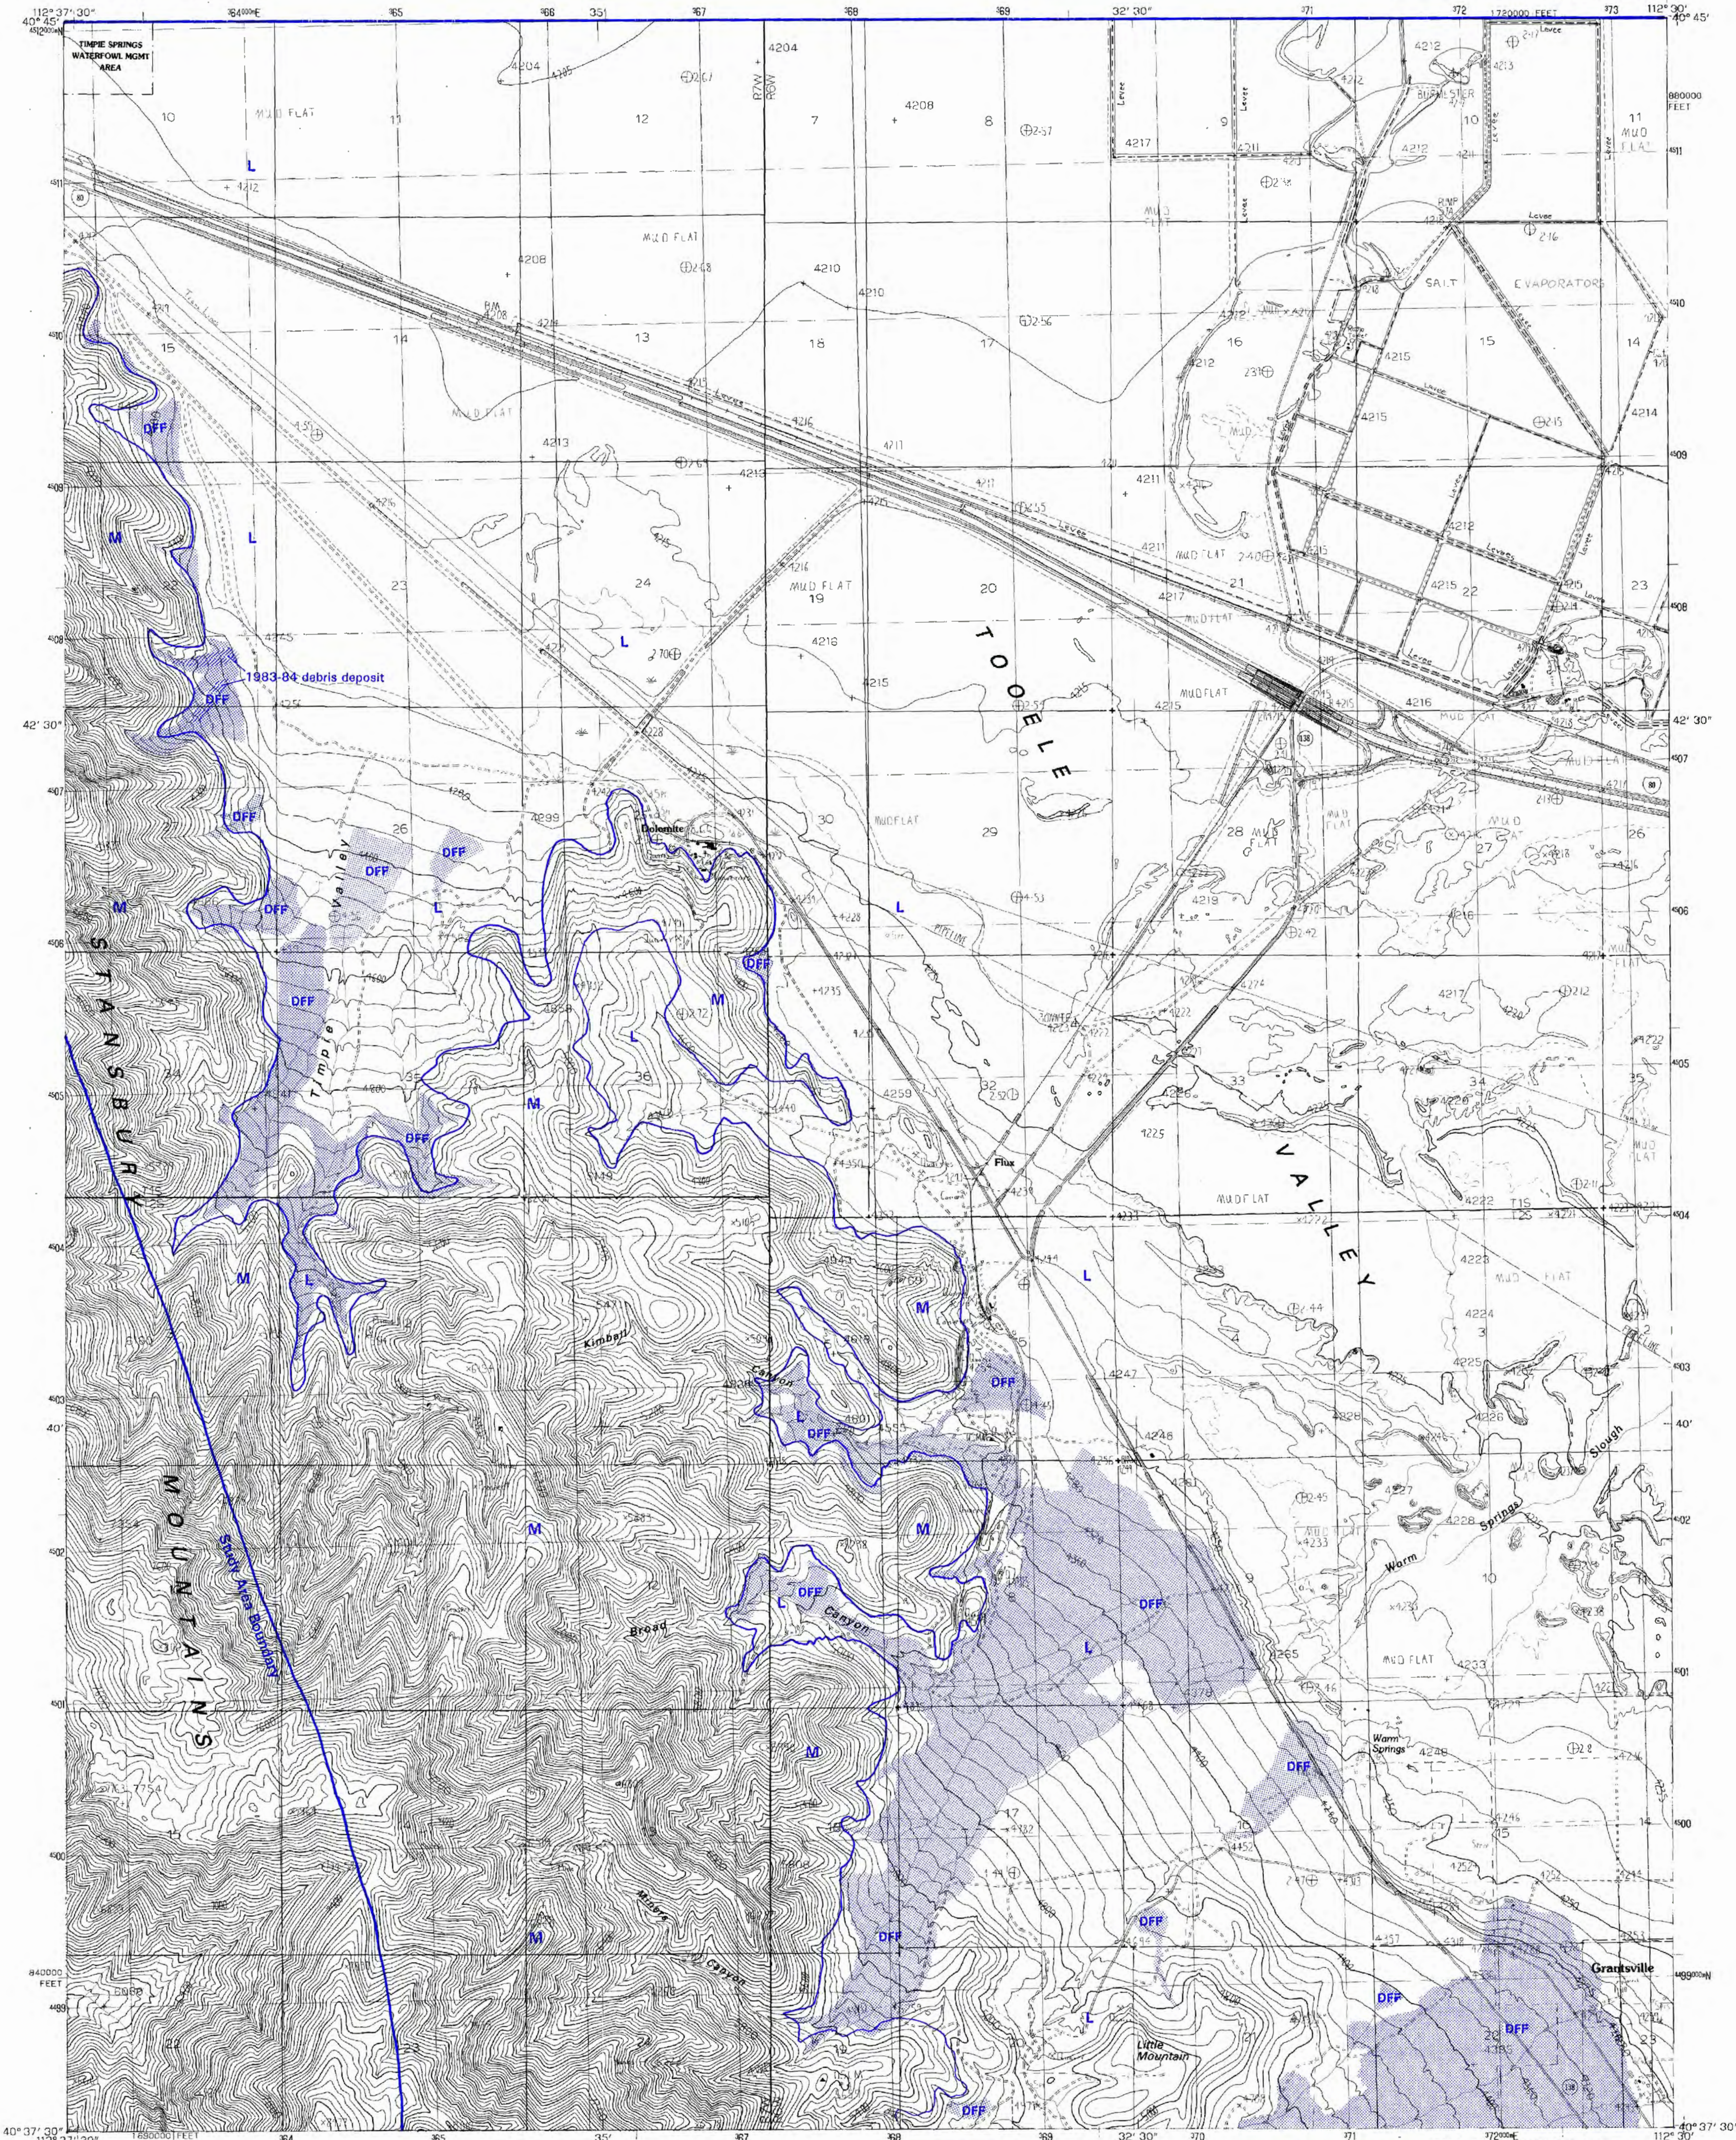
FLUX QUADRANGLE
UTAH-TOOELE CO.
7.5 MINUTE SERIES (TOPOGRAPHIC)

- H* High; includes slopes that failed during the 1983-84 wet years.
- M* Moderate.
- L Low.

* Special studies are recommended in areas of high and moderate source-area
susceptibility, and in areas of possible sediment deposition and flooding (see
table 1).

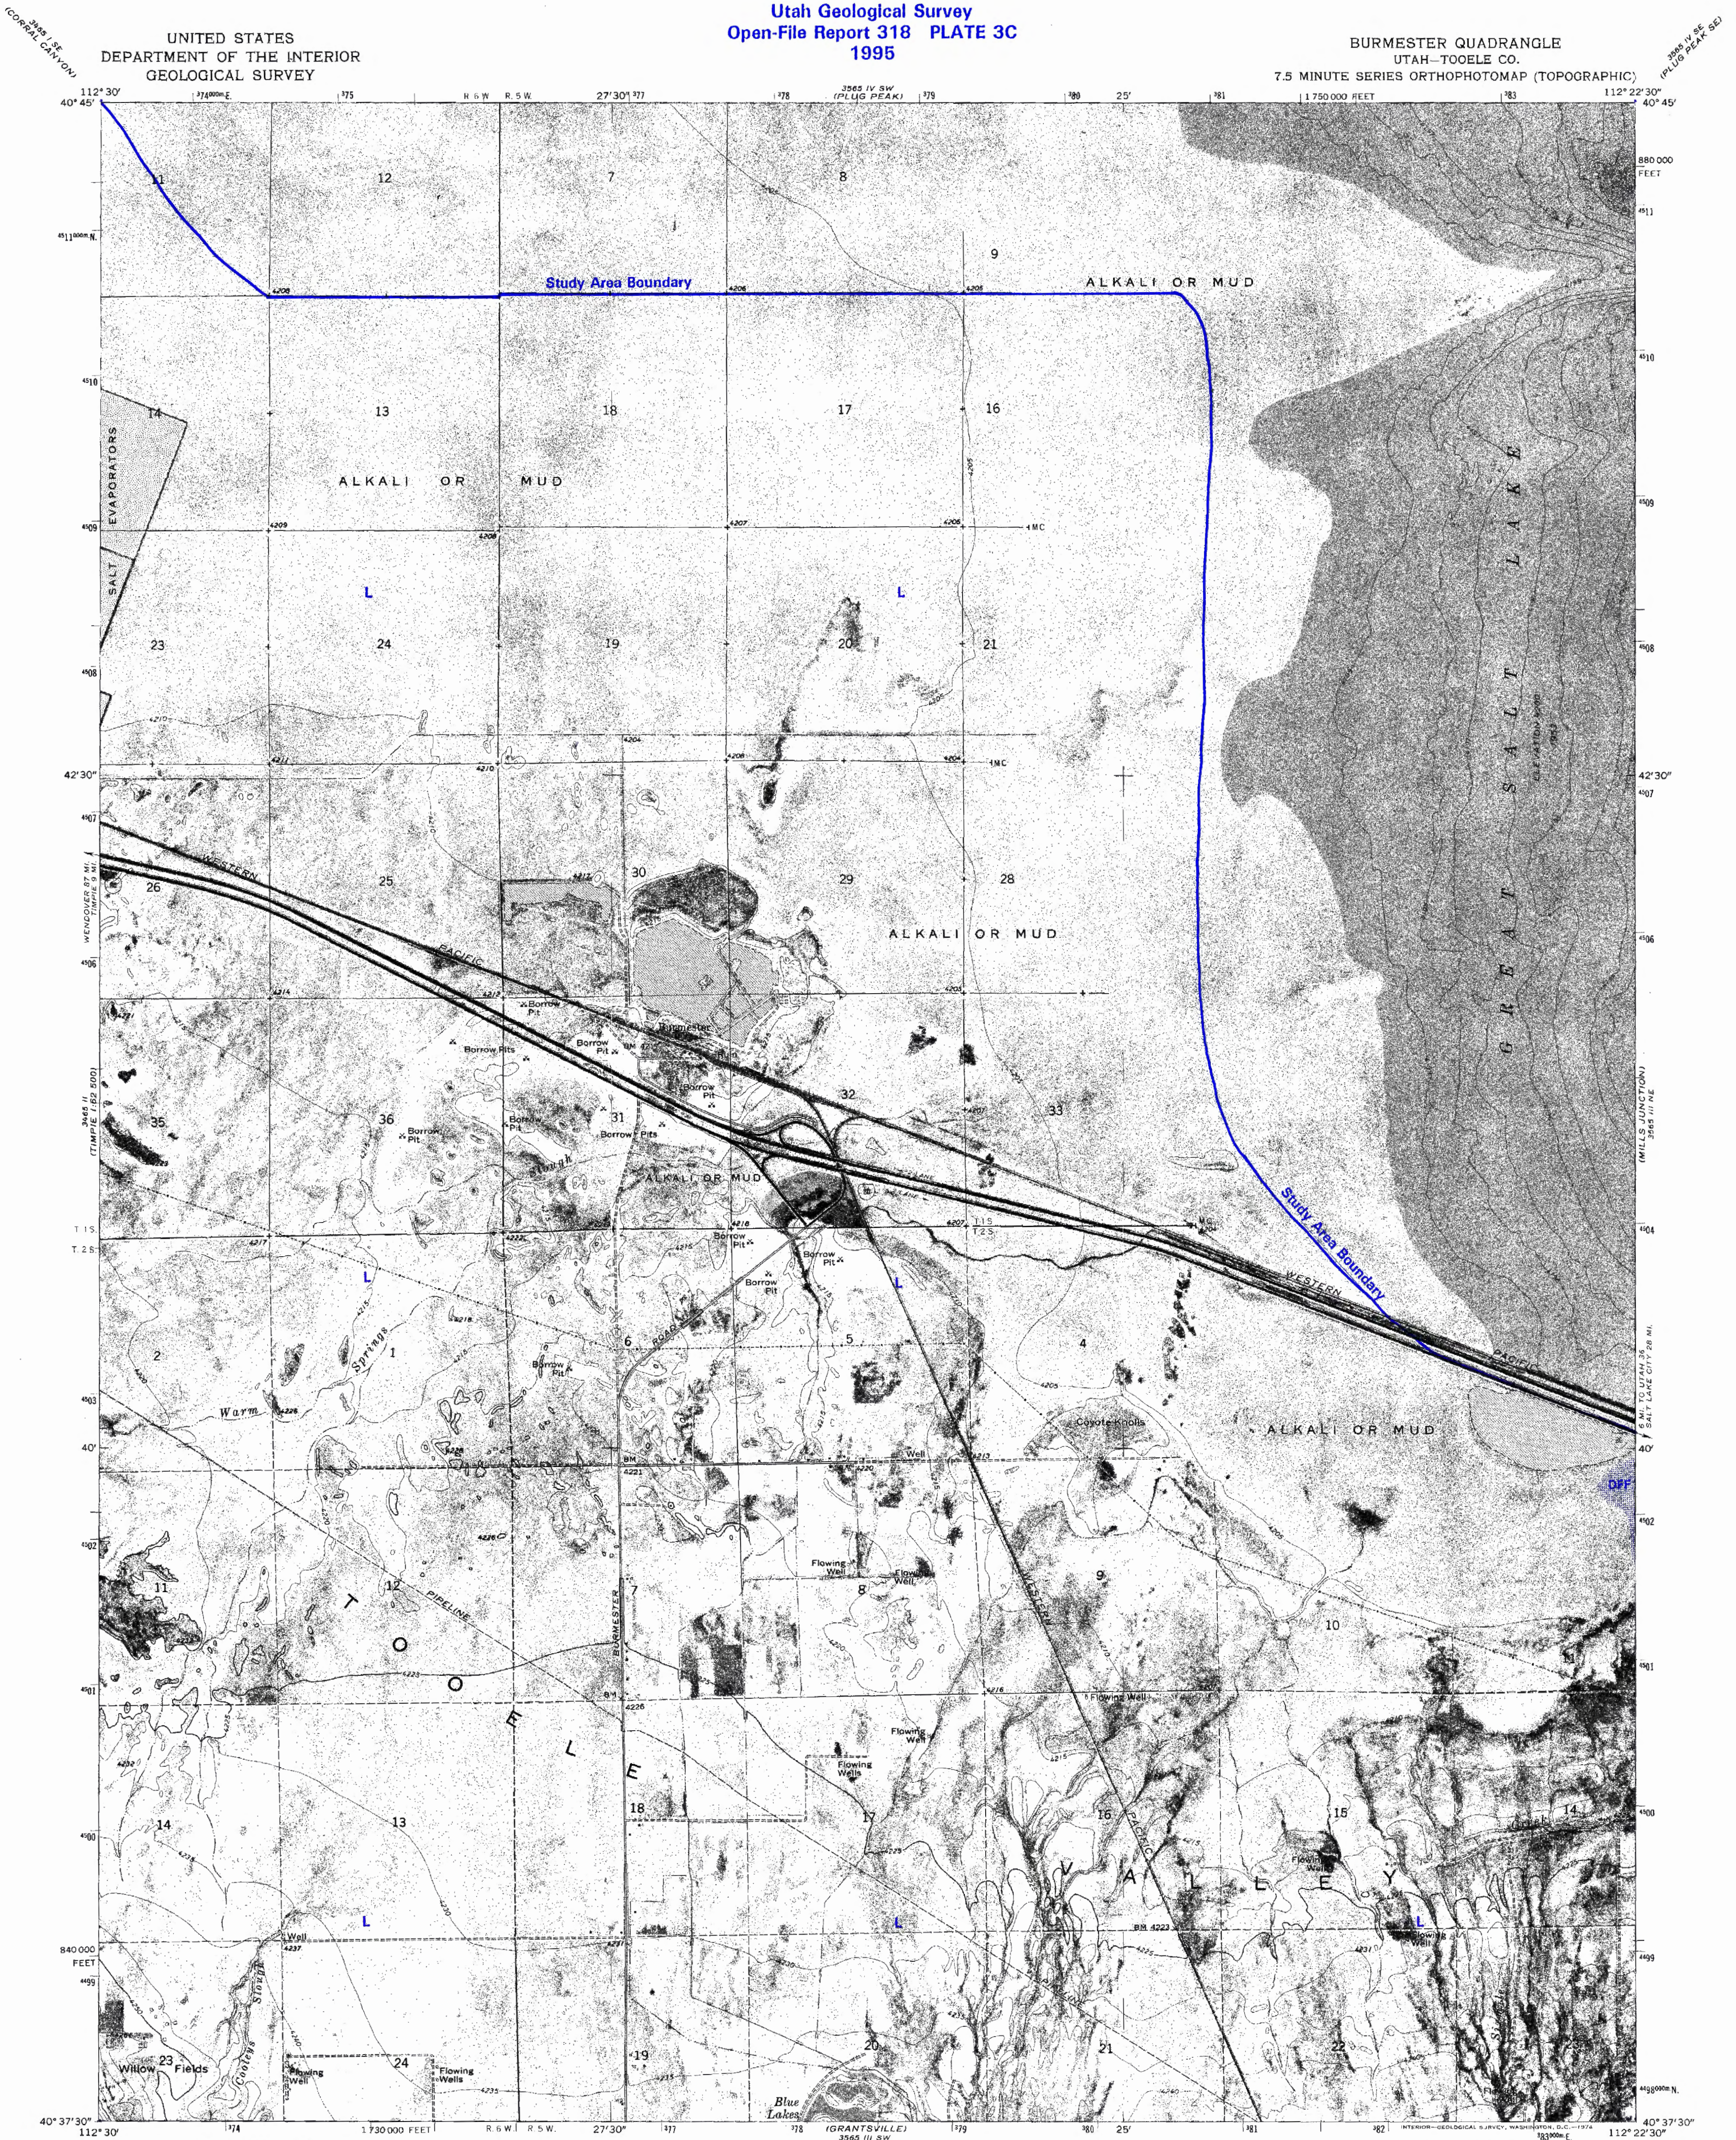
Utah Geological Survey
Open-File Report 318 PLATE 3C
1995

Debris-slide, debris-flow, debris-flood, and stream-flood hazards, Burmester quadrangle, Tooele County, Utah.

- H* High; includes slopes that failed during the 1983-84 wet years.
M* Moderate.
L Low.

* Special studies are recommended in areas of high and moderate source-area susceptibility, and in areas of possible sediment deposition and flooding (see table 1).

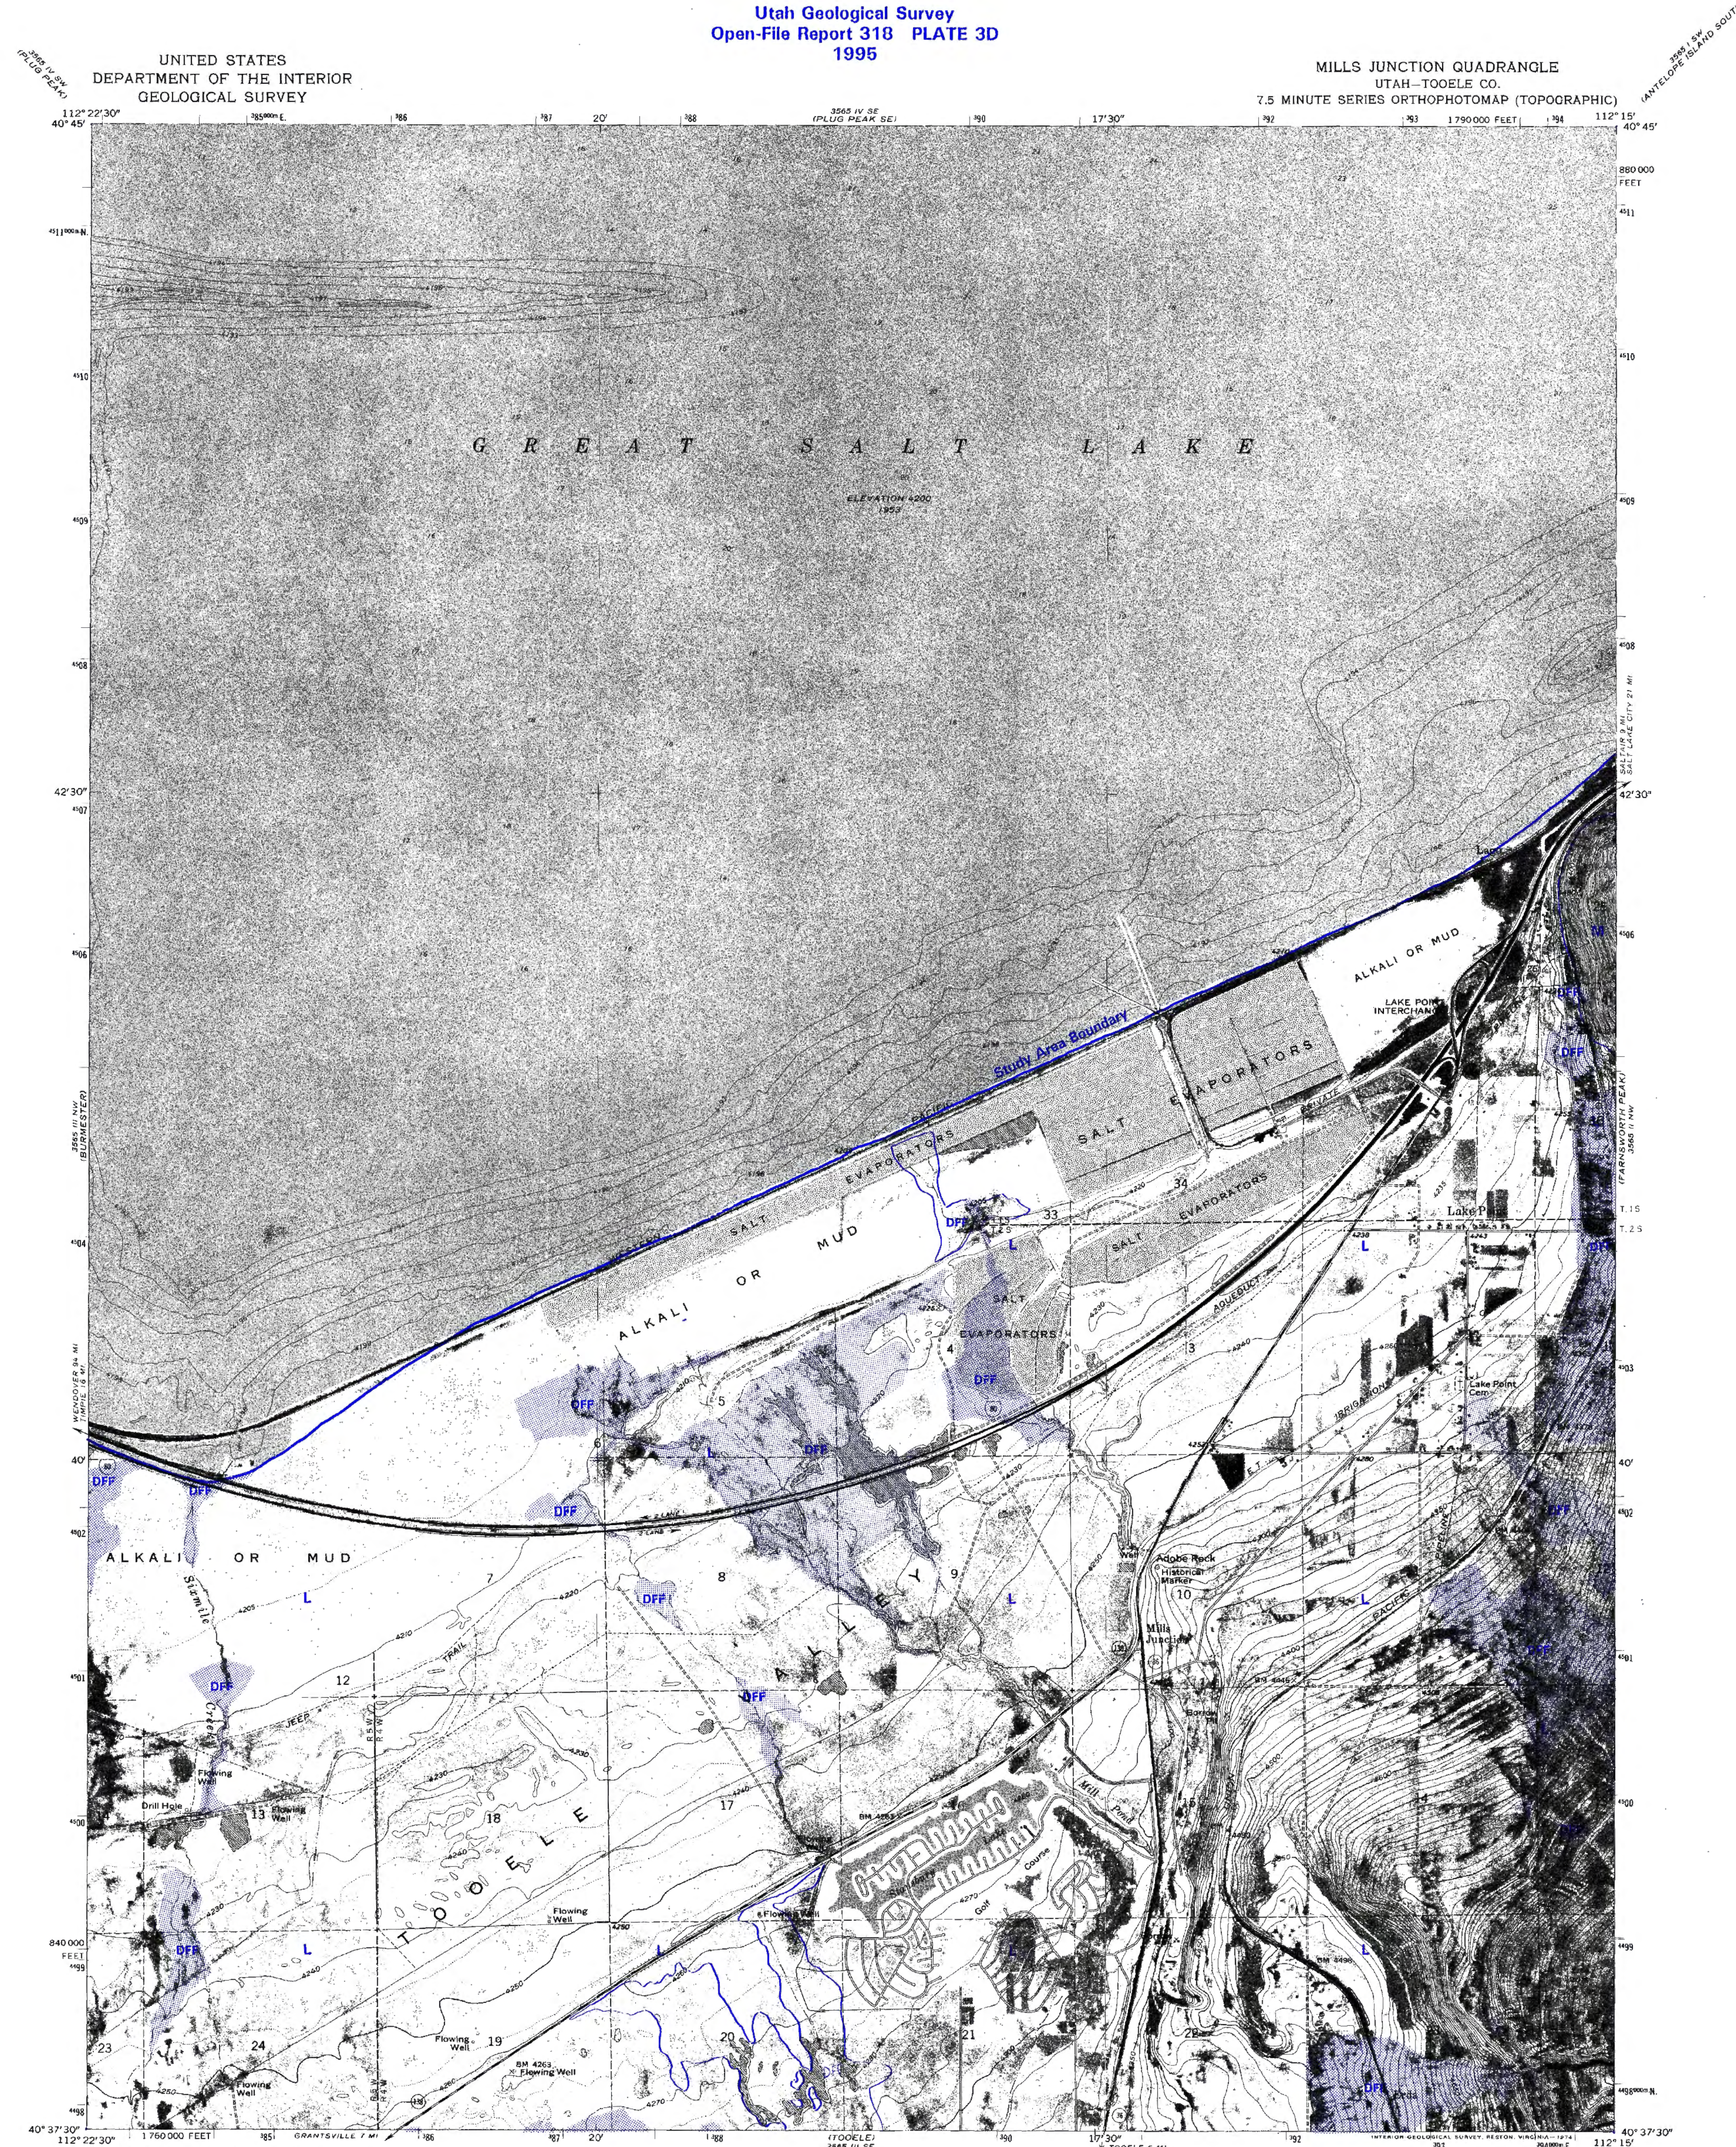
MILLS JUNCTION QUADRANGLE
UTAH—TOOELE CO.
7.5 MINUTE SERIES ORTHOPHOTOMAP (TOPOGRAPHIC)

Debris-slide, debris-flow, debris-flood, and stream-flood hazards, Mills Junction quadrangle, Tooele County, Utah.

- H* High; includes slopes that failed during the 1983-84 wet years.
M* Moderate.
L Low.

- OFF* Possible sediment deposition and flooding from debris flows, debris floods, and stream floods; includes 1983-84 debris deposits (crosshatched).

* Special studies are recommended in areas of high and moderate source-area susceptibility, and in areas of possible sediment deposition and flooding (see table 1).
