GEOLOGIC HAZARDS AND LAND-USE PLANNING FOR TOOELE VALLEY AND THE WEST DESERT HAZARDOUS INDUSTRY AREA, TOOELE COUNTY, UTAH

Barry J. Solomon and Bill D. Black, editors

OPEN-FILE REPORT 318
UTAH GEOLOGICAL SURVEY
a division of
UTAH DEPARTMENT OF NATURAL RESOURCES

October 1995

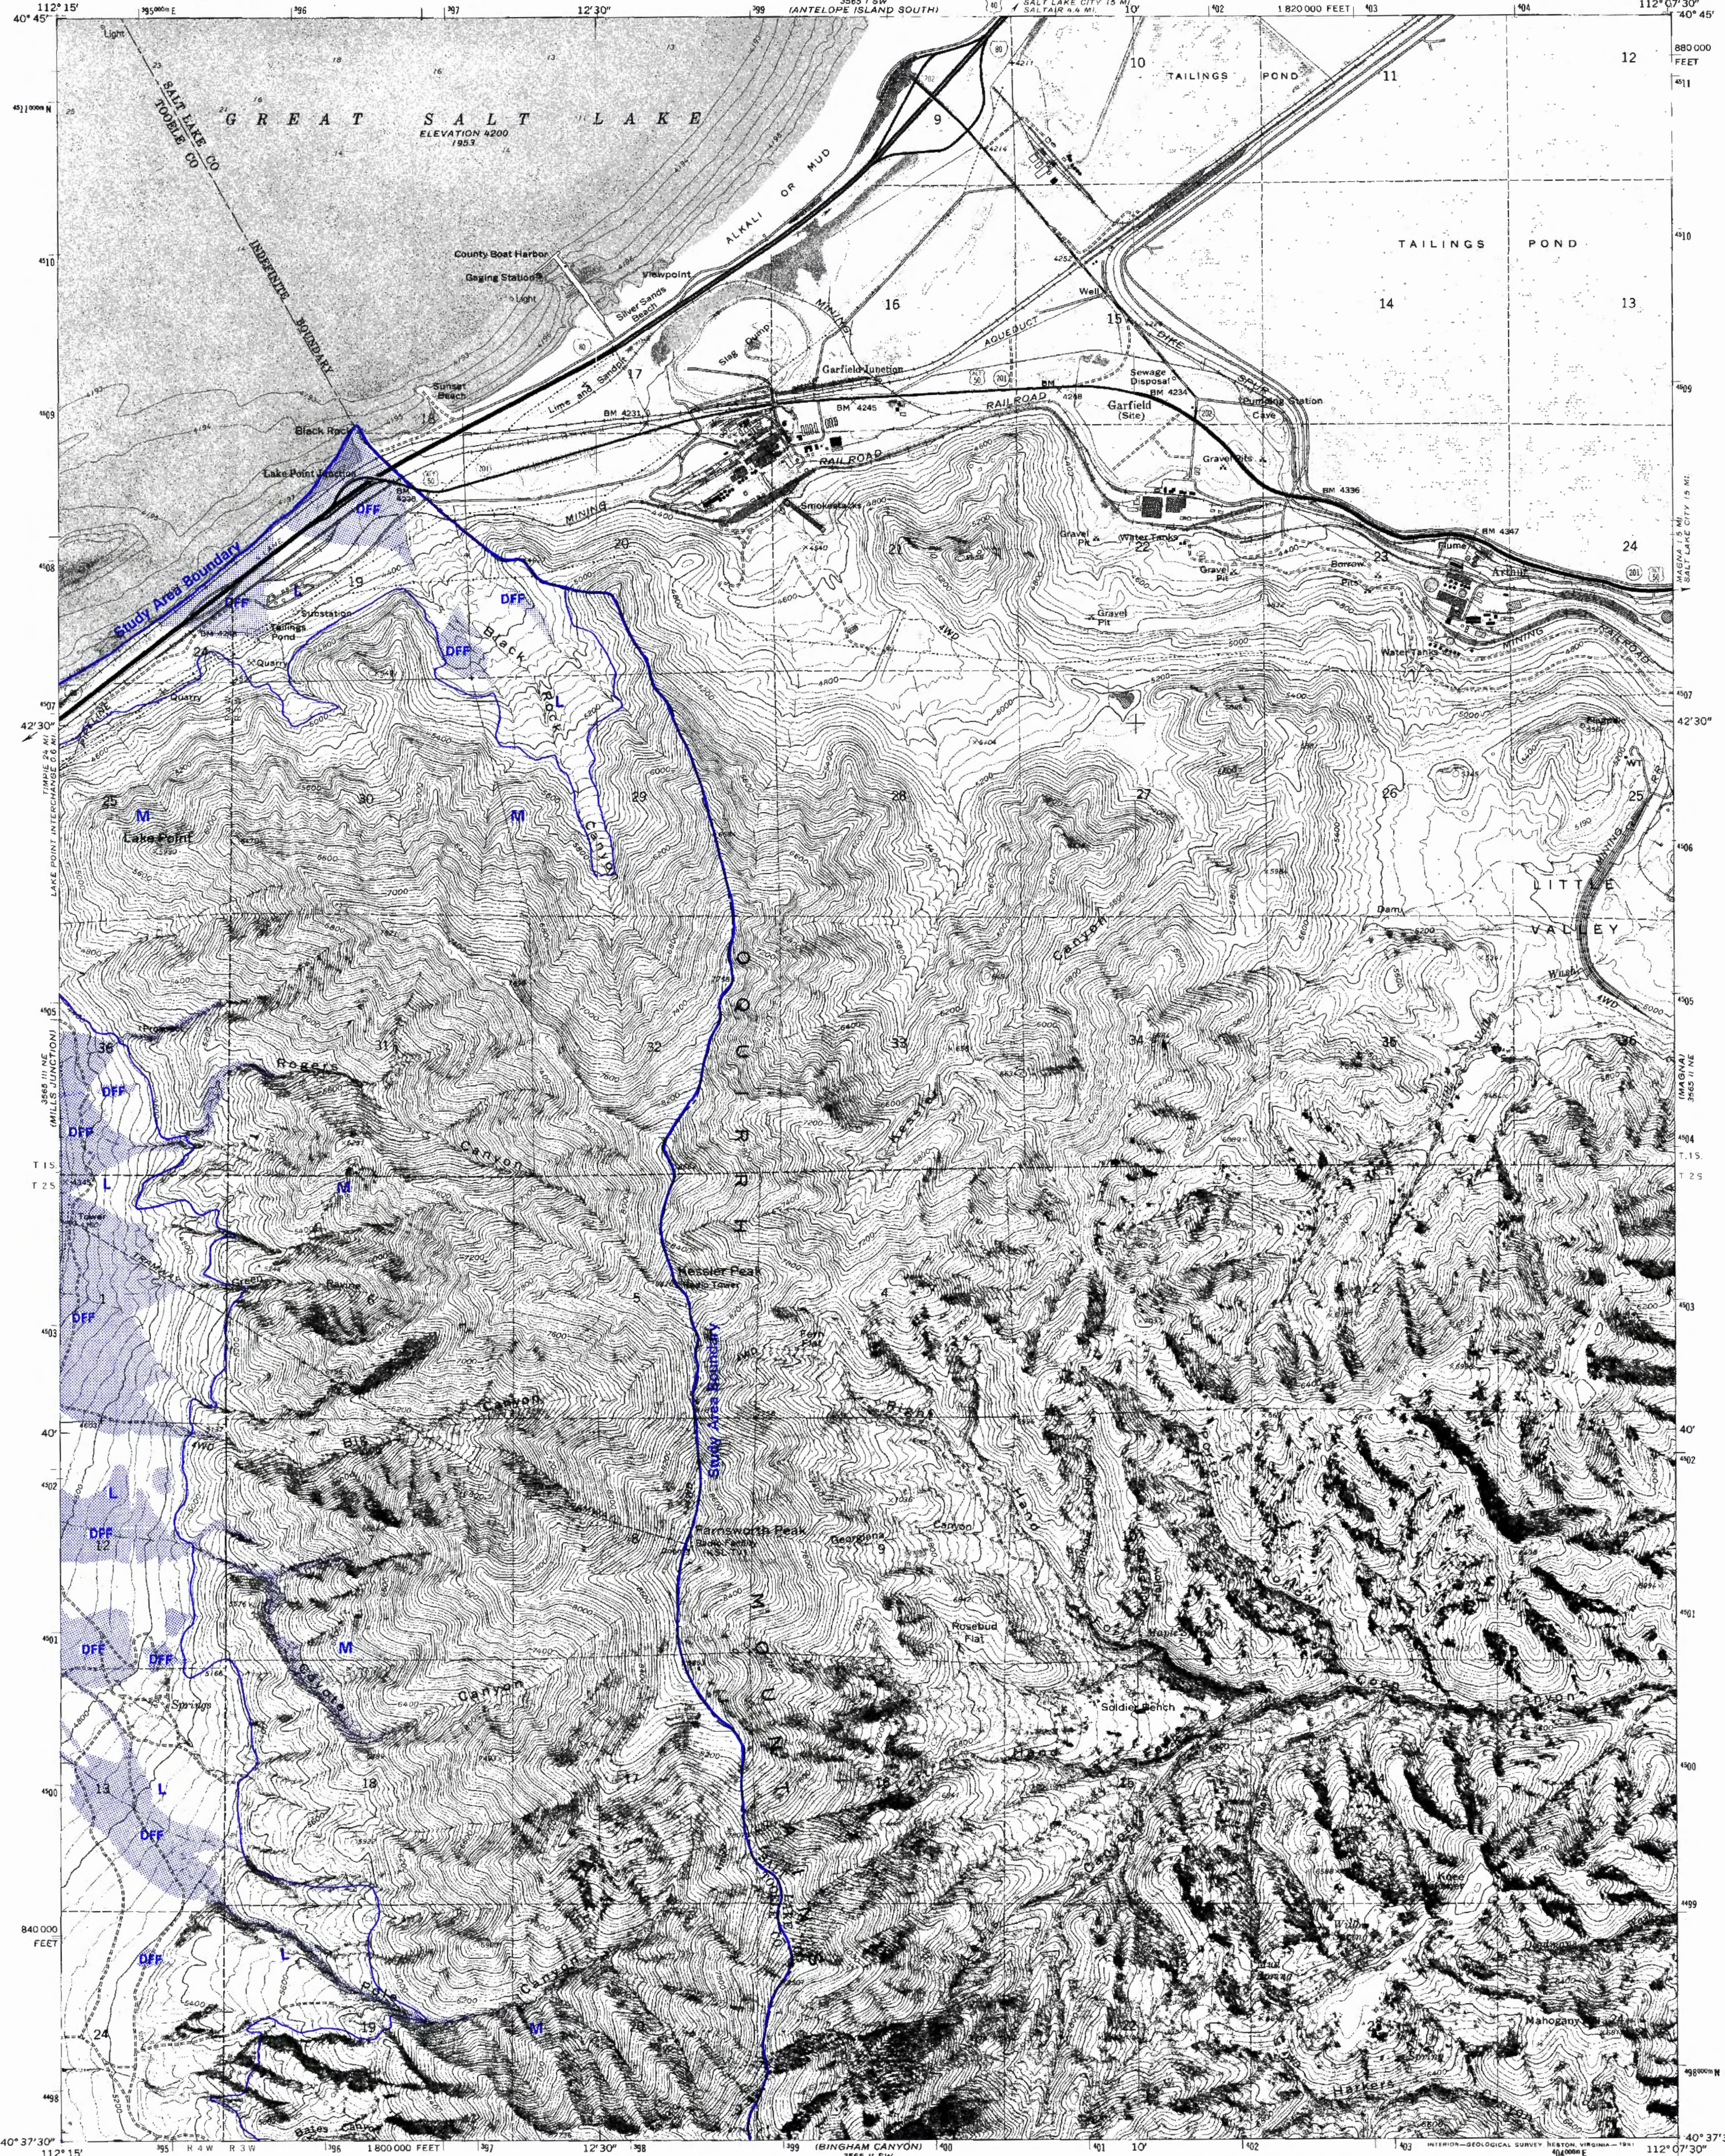
FARNSWORTH PEAK QUADRANGLE
UTAH

Debris-slide, debris-flow, debris-flood, and stream-flood hazards, Farnsworth Peak quadrangle, Tooele County, Utah.

- H* High; includes slopes that failed during the 1983-84 wet years.
- M* Moderate.
- L Low.

- DFF* Possible sediment deposition and flooding from debris flows, debris floods, and stream floods; includes 1983-84 debris deposits (crosshatched).

* Special studies are recommended in areas of high and moderate source-area susceptibility, and in areas of possible sediment deposition and flooding (see table 1).

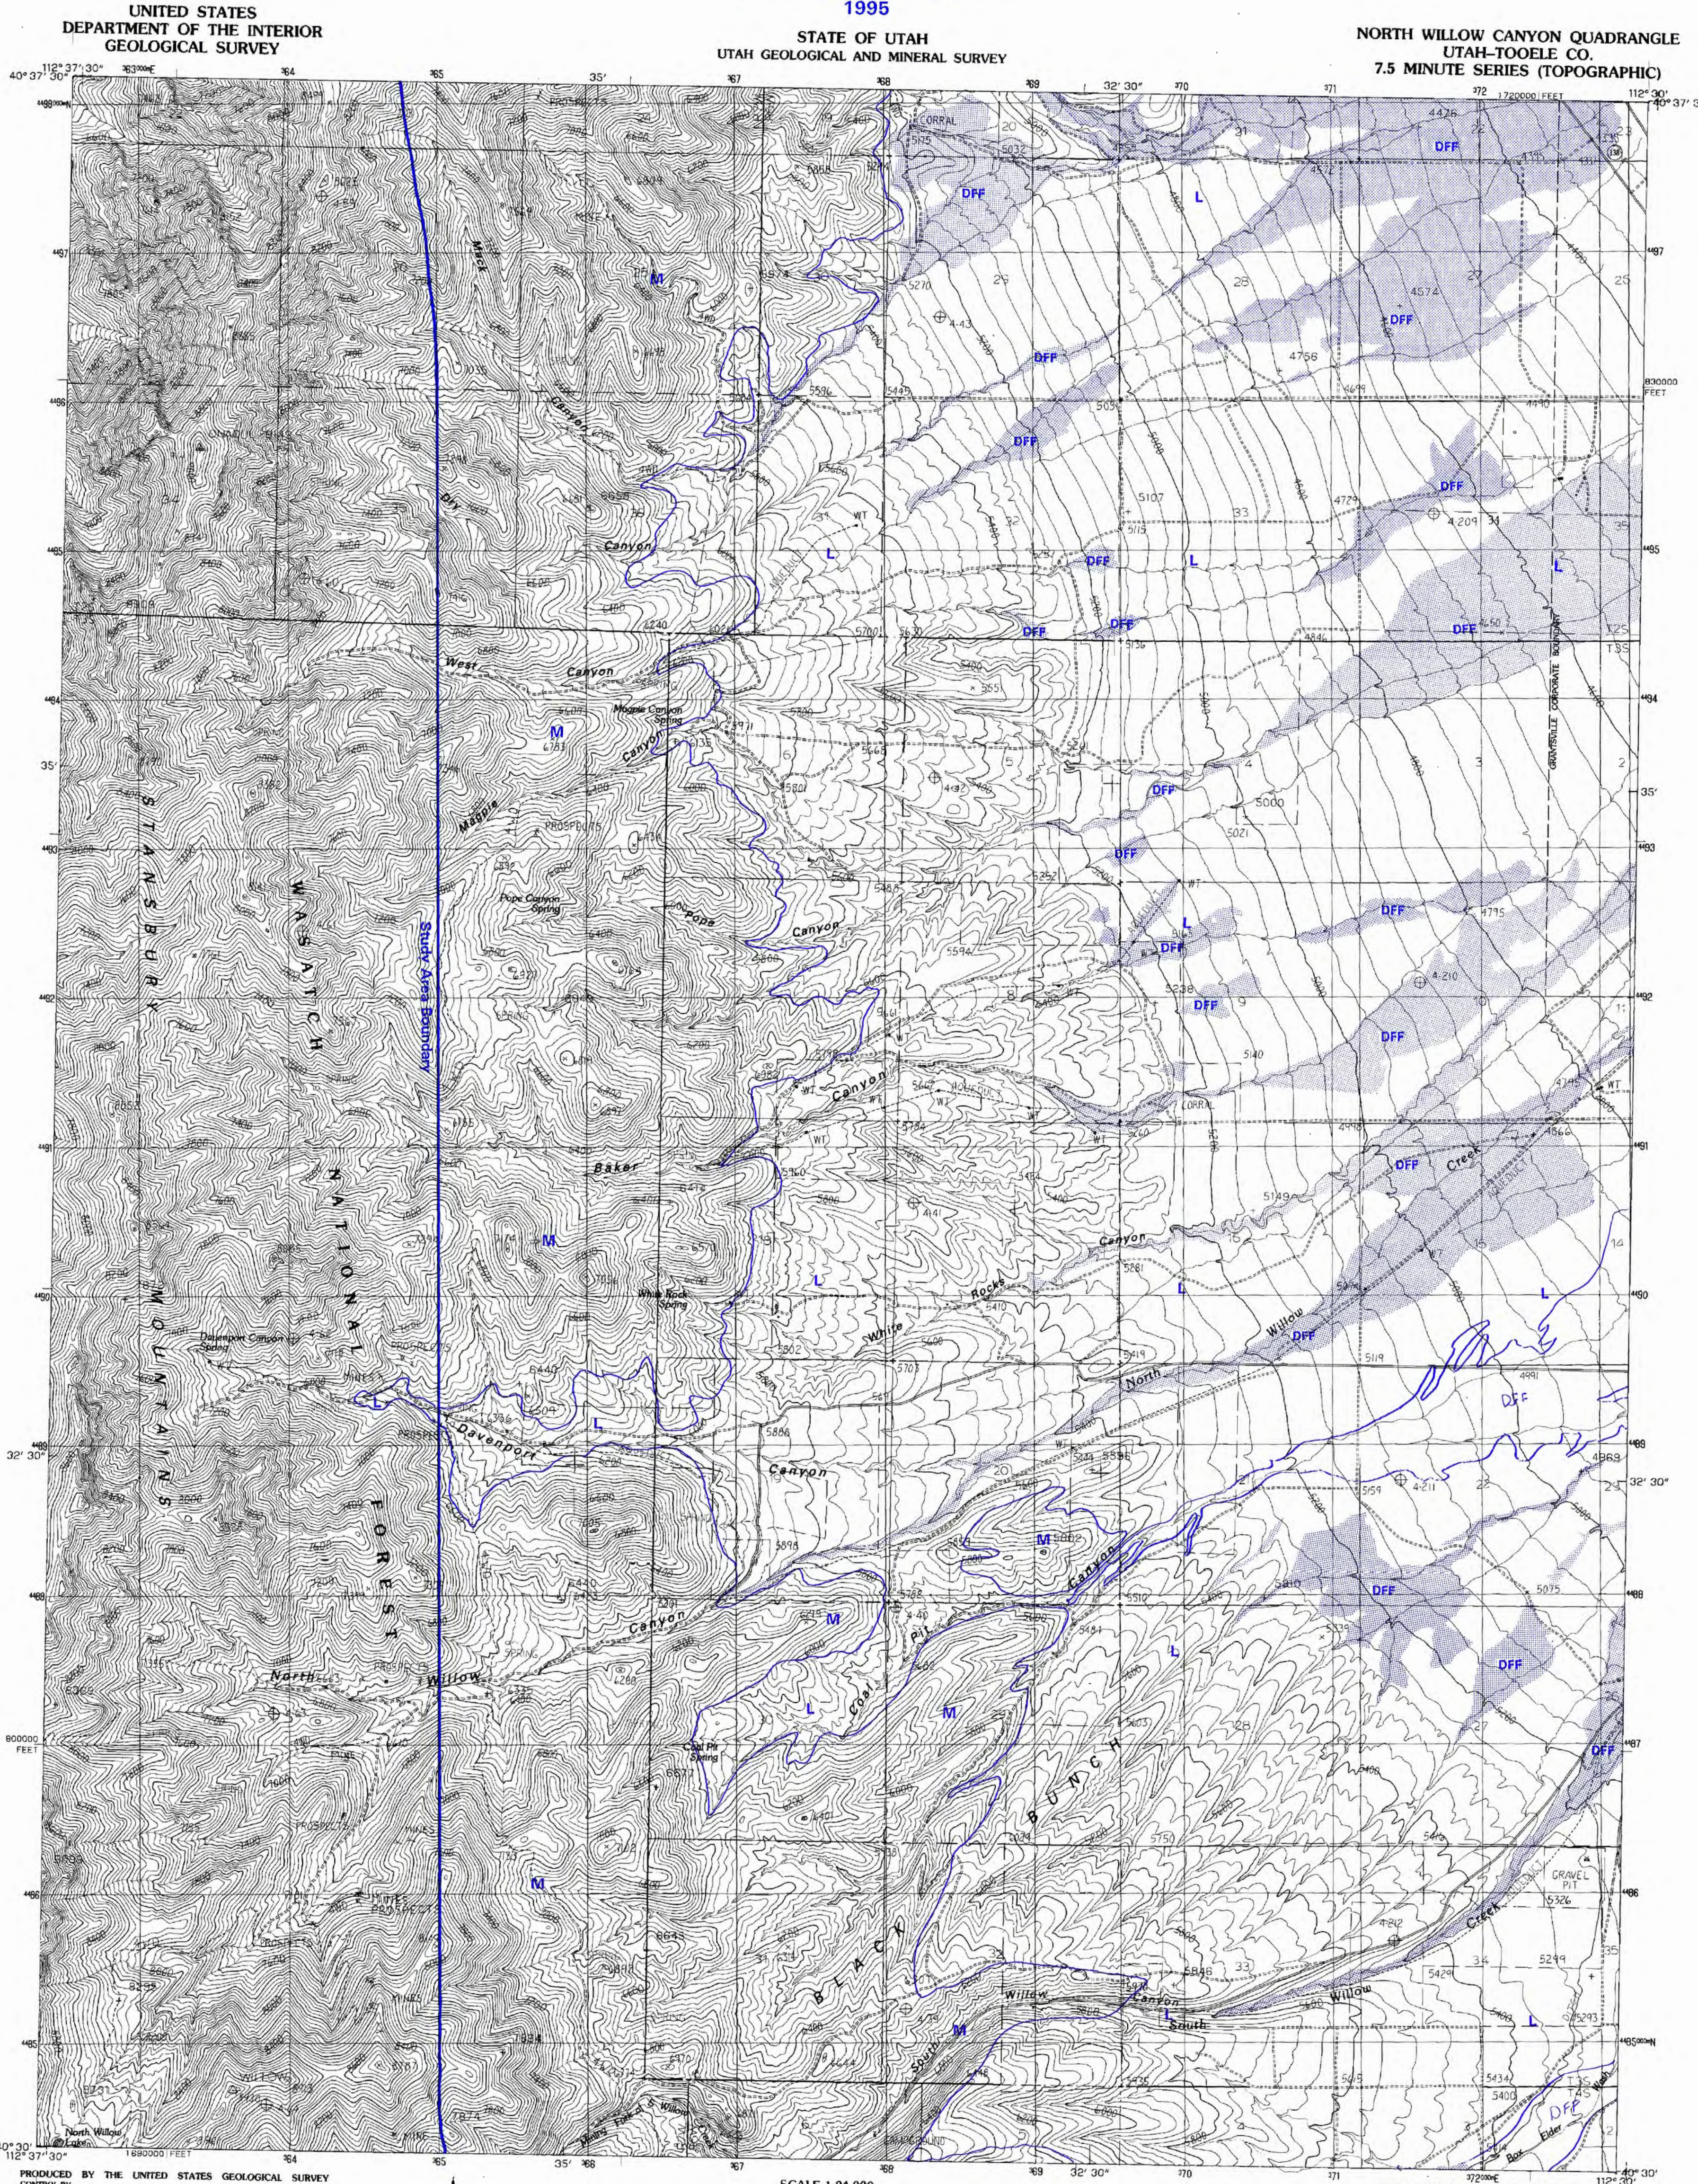
NORTH WILLOW CANYON QUADRANGLE
UTAH-TOOELE CO.
7.5 MINUTE SERIES (TOPOGRAPHIC)

Debris-slide, debris-flow, debris-flood, and stream-flood hazards, North Willow Canyon quadrangle, Tooele County, Utah.

- H*** High; includes slopes that failed during the 1983-84 wet years.
- M*** Moderate.
- L** Low.

- DFF *** Possible sediment deposition and flooding from debris flows, debris floods, and stream floods; includes 1983-84 debris deposits (crosshatched).

* Special studies are recommended in areas of high and moderate source-area susceptibility, and in areas of possible sediment deposition and flooding (see table 1).

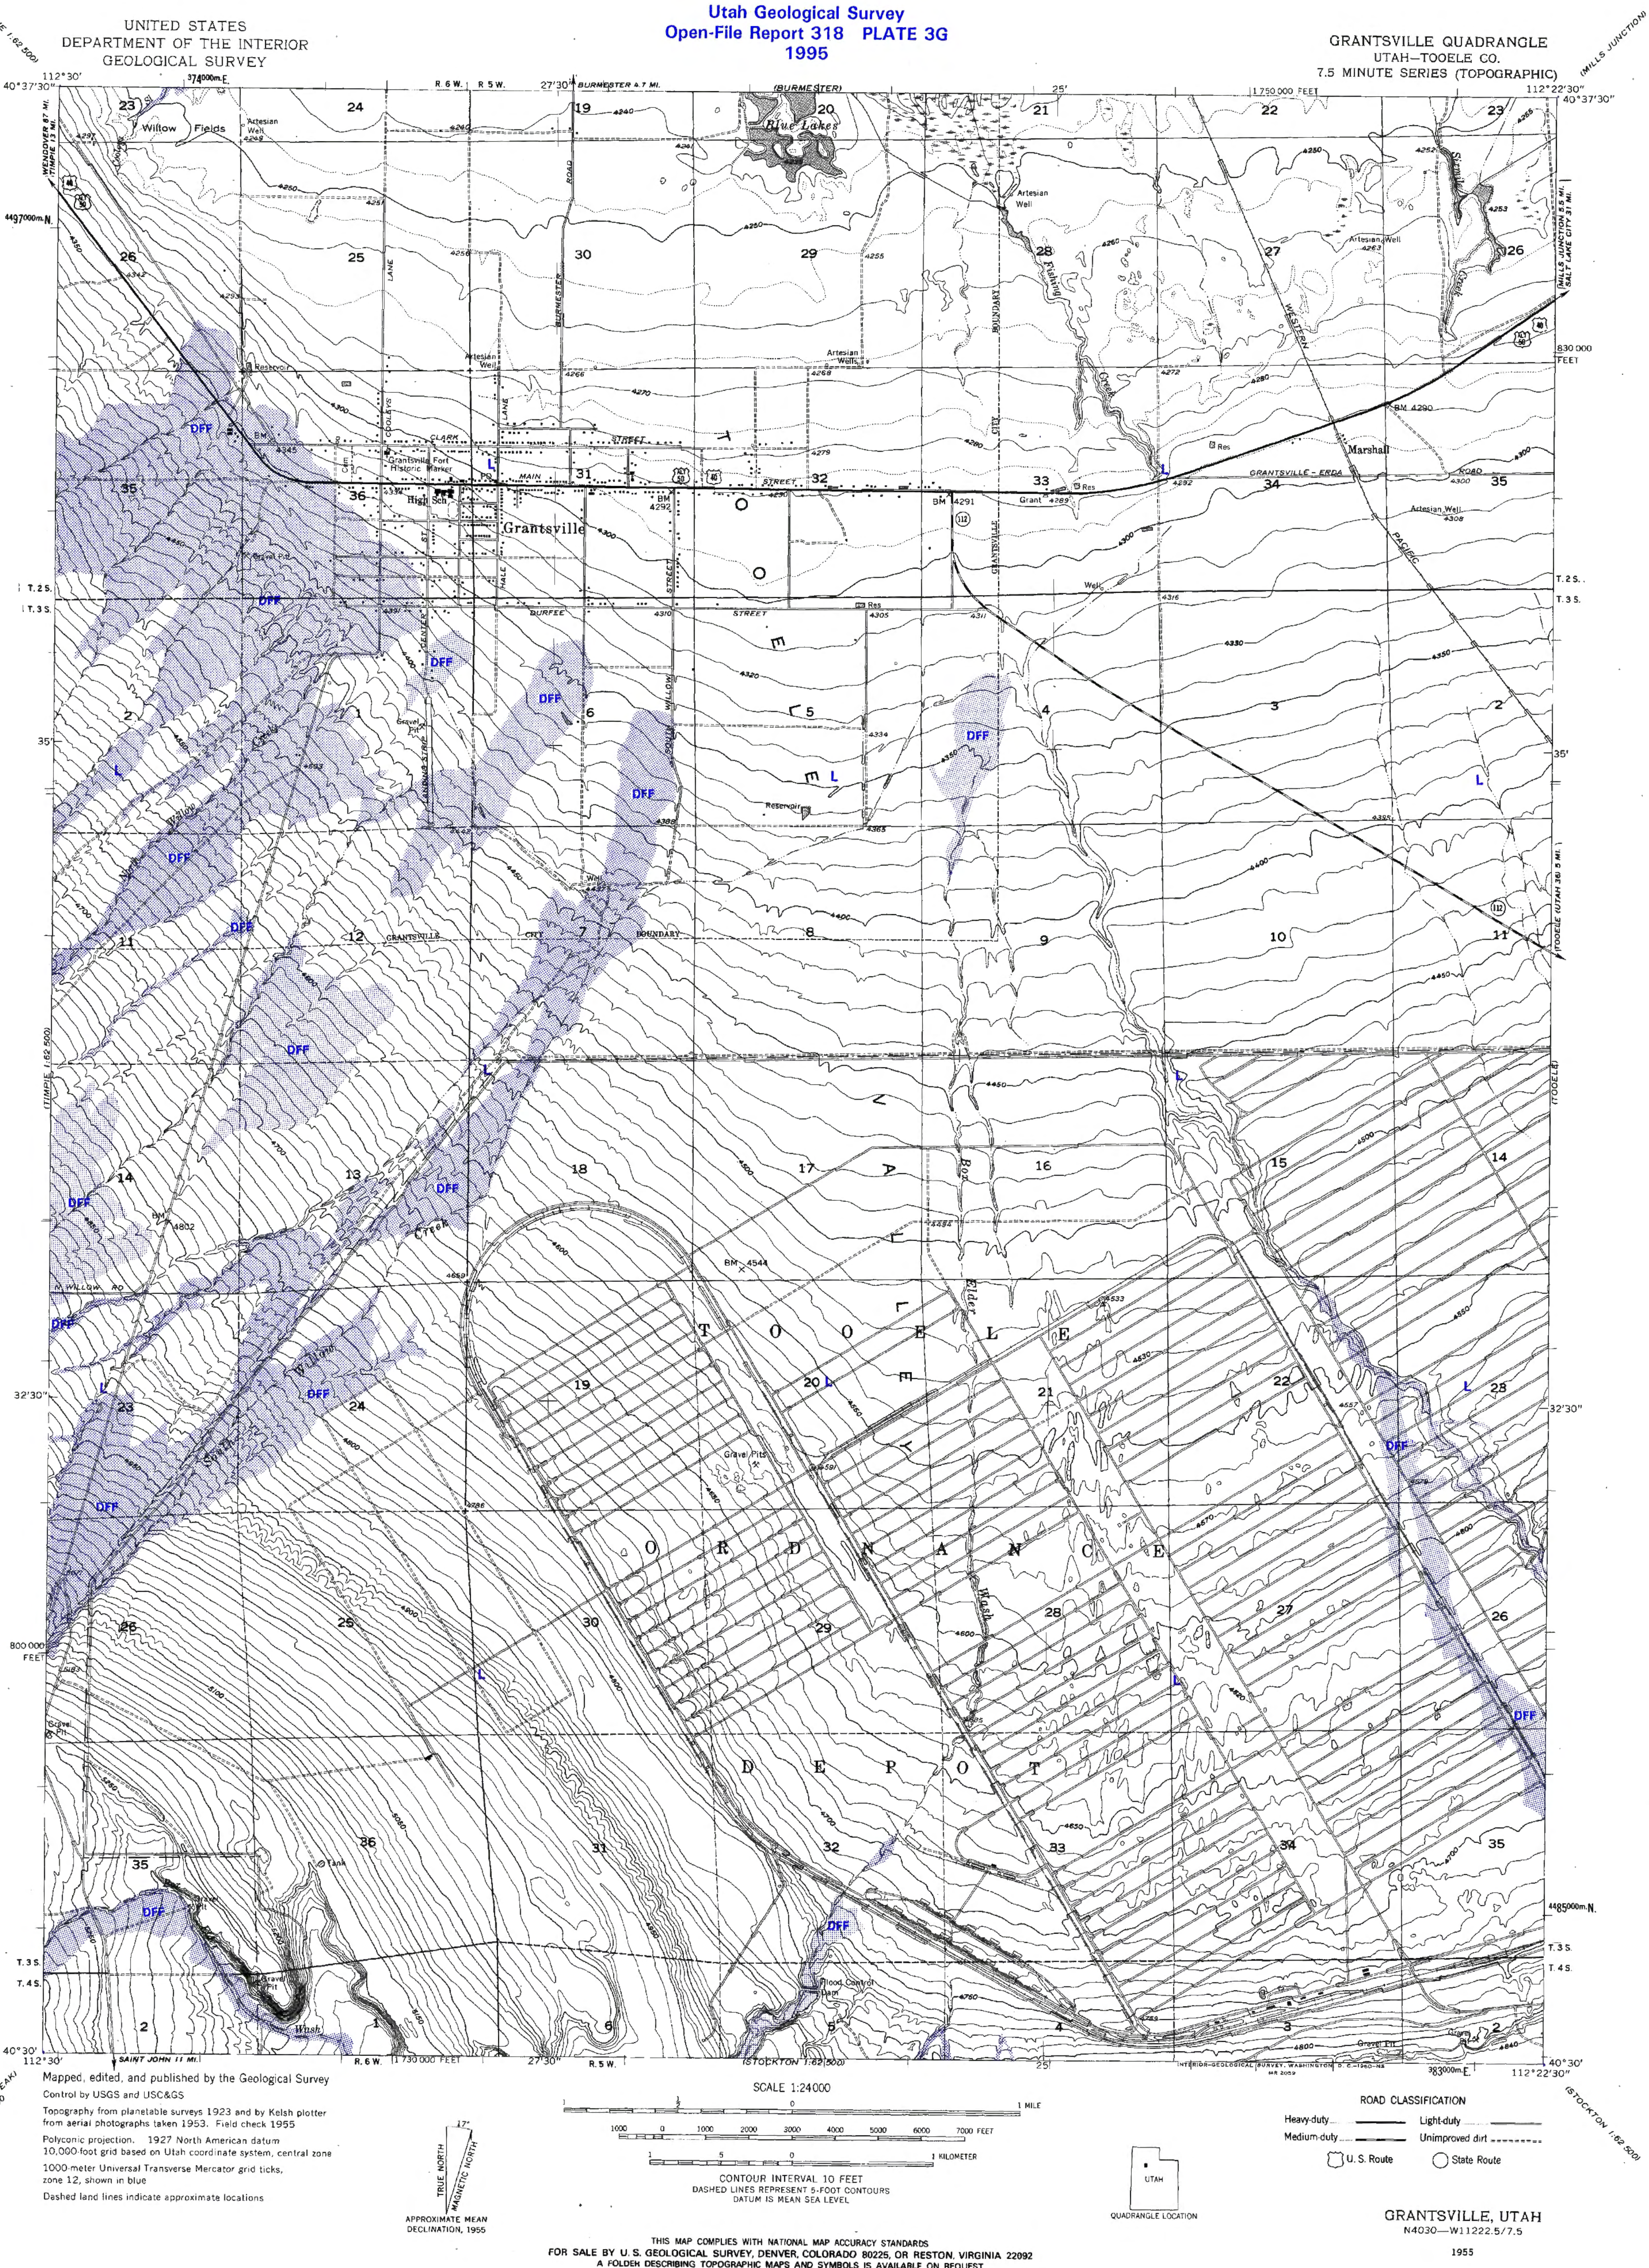
Debris-slide, debris-flow, debris-flood, and stream-flood hazards, Tooele quadrangle, Tooele County, Utah.

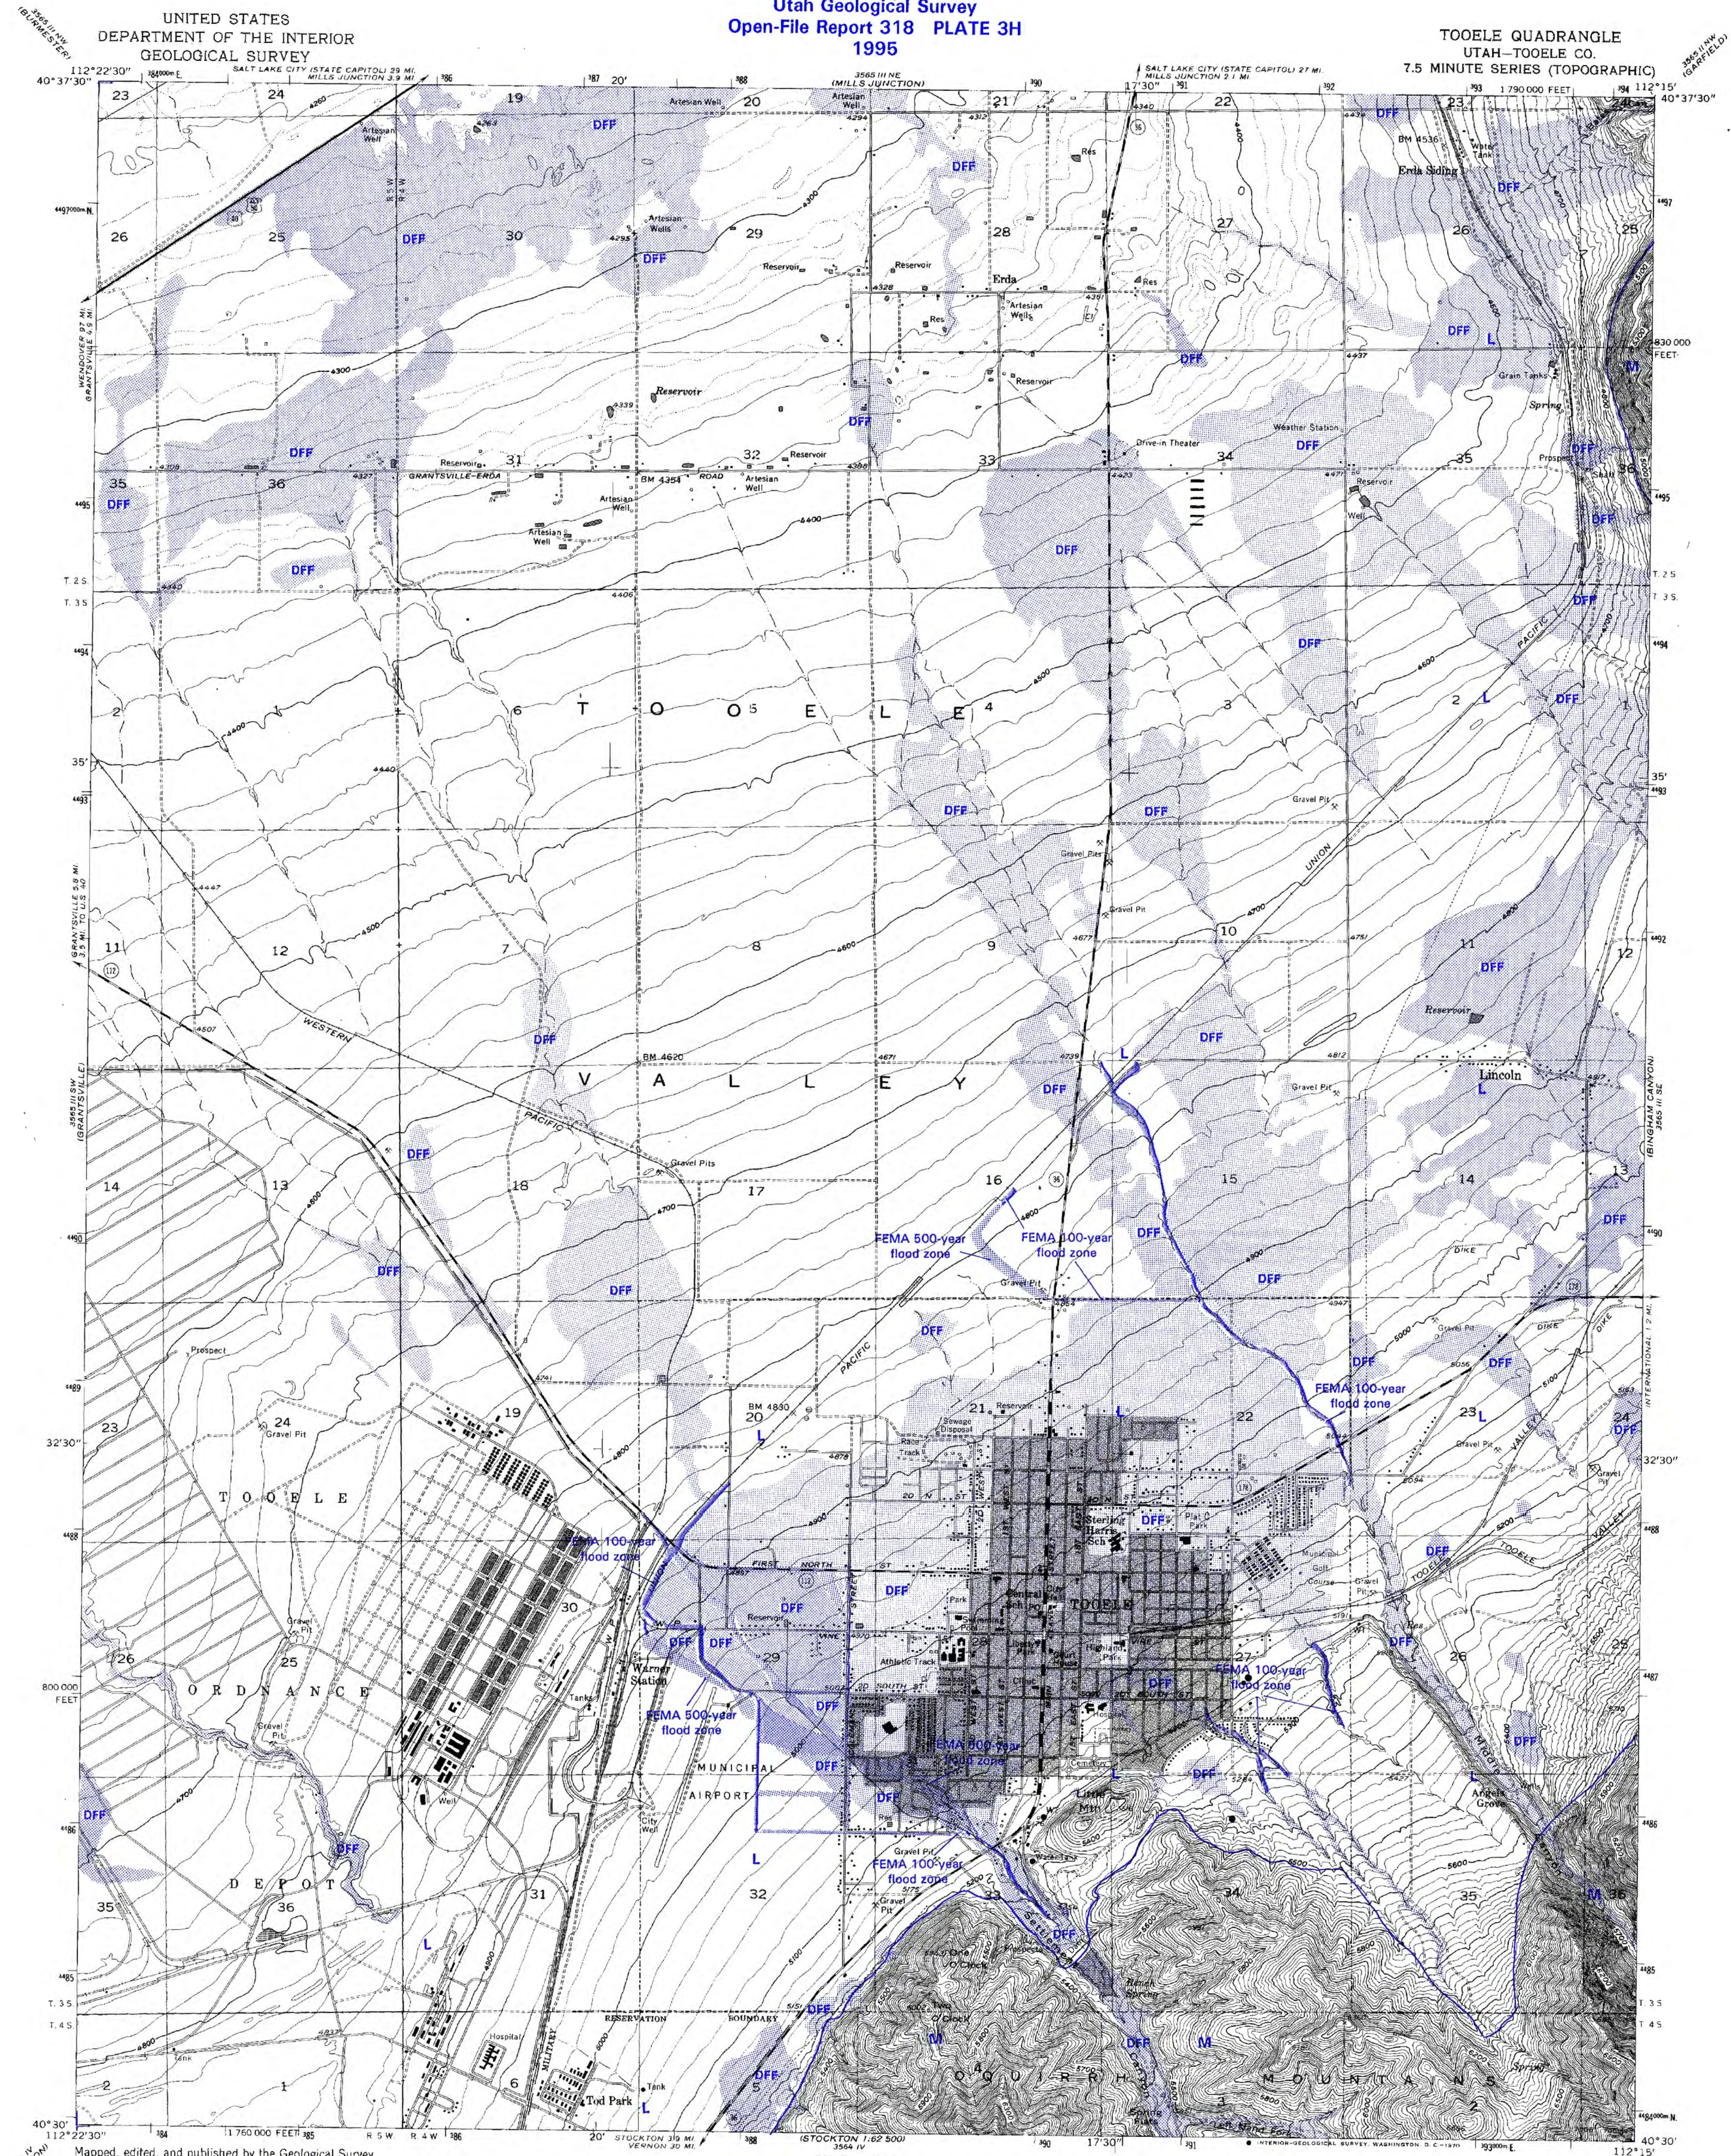
Utah Geological Survey
Open-File Report 318 PLATE 3H
1995

H* High; includes slopes that failed during the 1983-84 wet years.

* Special studies are recommended in areas of high and moderate source-area susceptibility, and in areas of possible sediment deposition and flooding (see table 1).

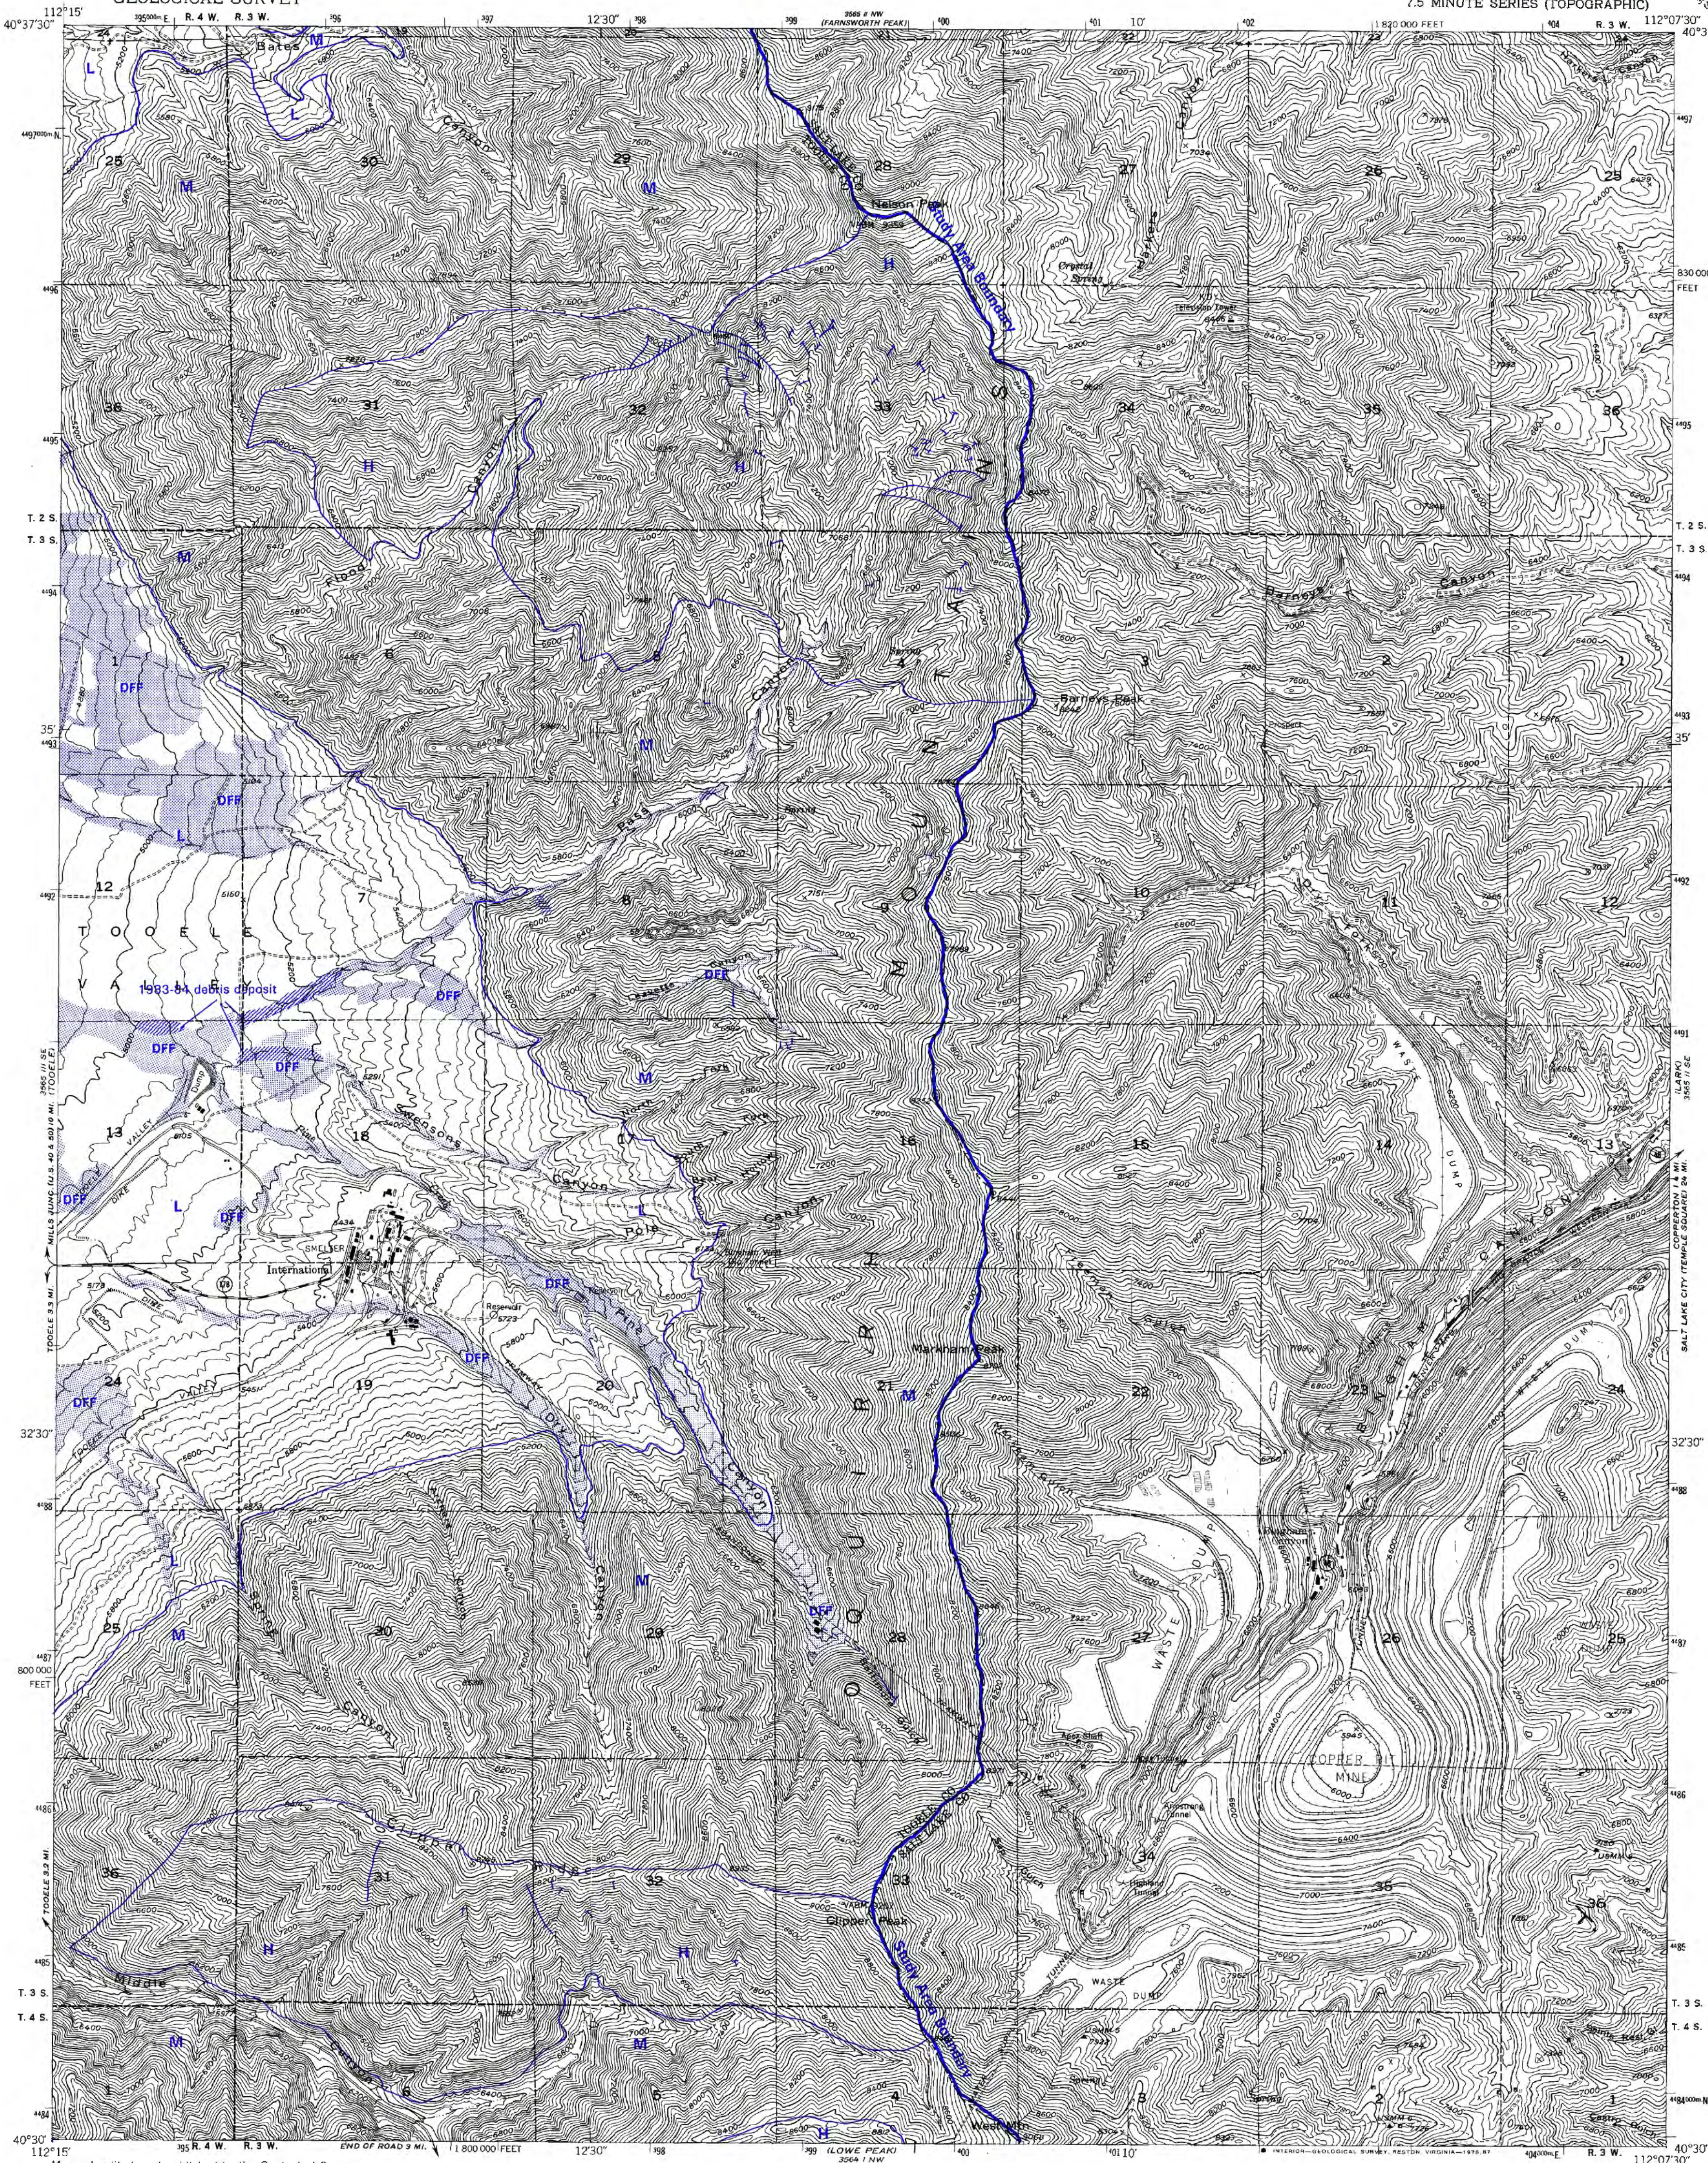
Debris-slide, debris-flow, debris-flood, and stream-flood hazards, Bingham Canyon quadrangle, Tooele County, Utah.

High; includes slopes that failed during the 1983-84
wet years.

Debris deposition and flood hazard

Possible sediment deposition and flooding from debris flows,
debris floods, and stream floods; includes 1983-84 debris
deposits (crosshatched).

* Special studies are recommended in areas of high and moderate source-
area susceptibility, and in areas of possible sediment deposition and
flooding (see table 1).

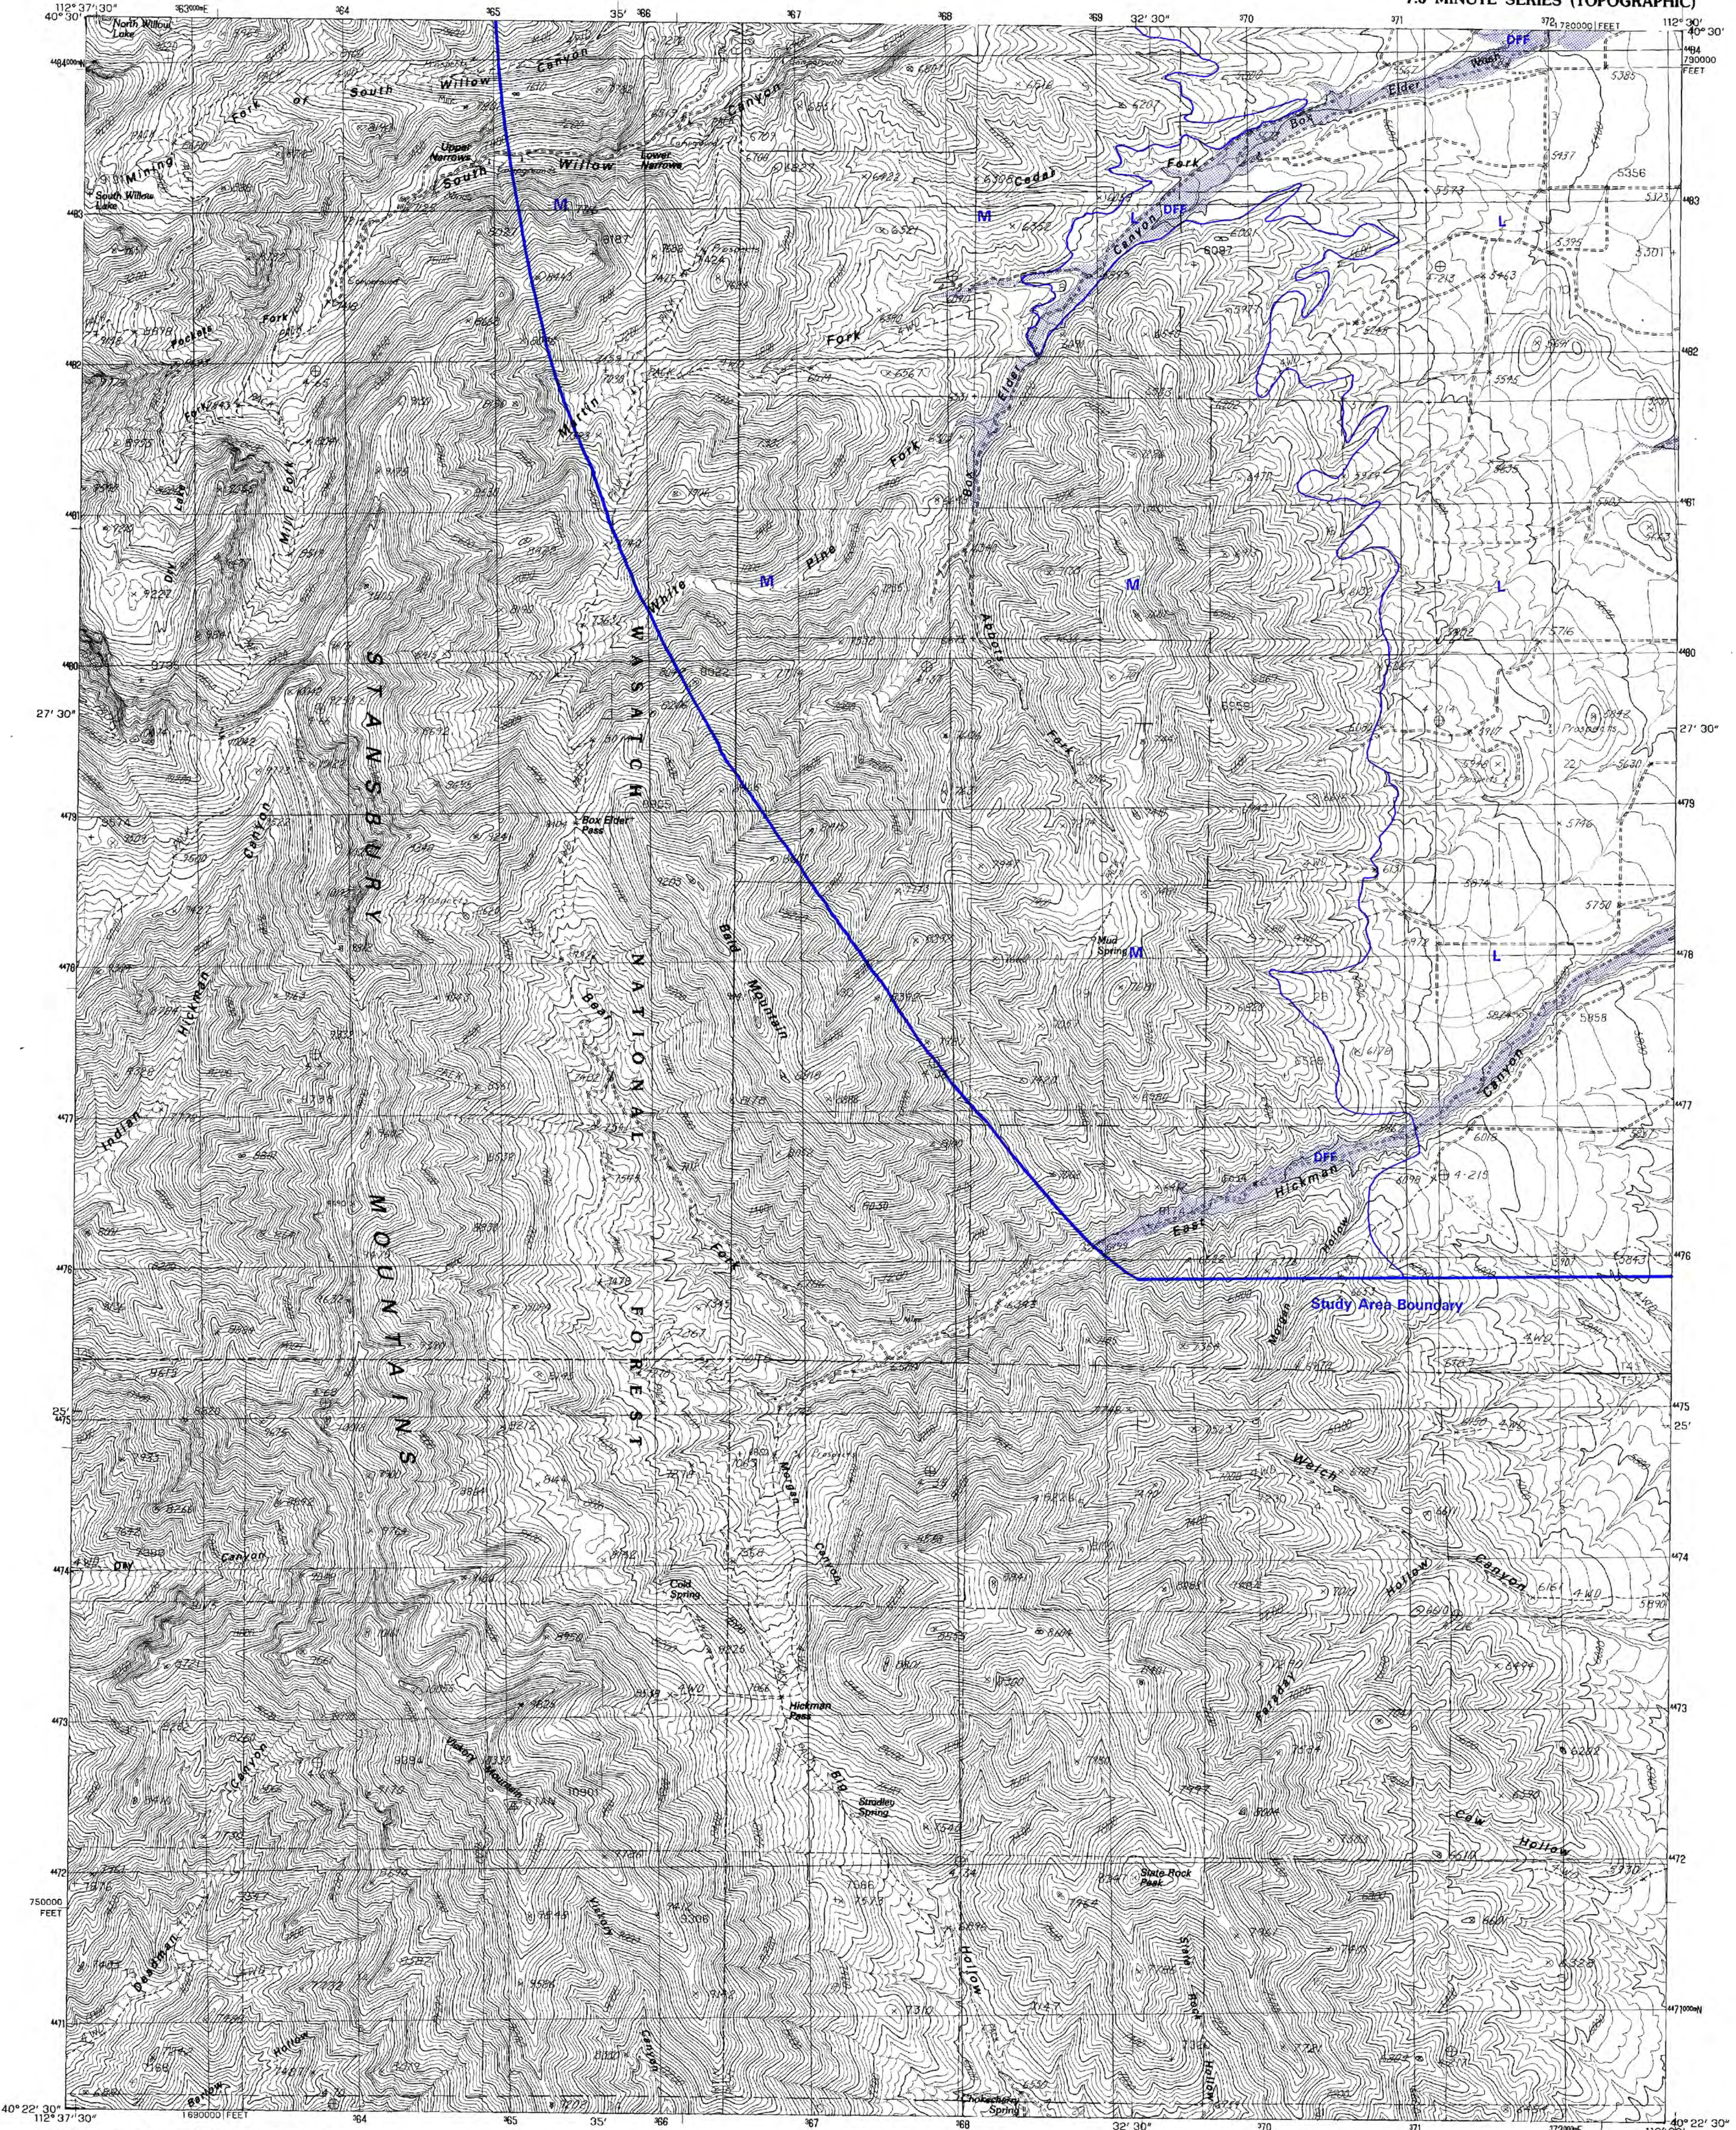
Debris-slide, debris-flow, debris-flood, and stream-flood hazards, Deseret Peak
East quadrangle, Tooele County, Utah.

- H* High; includes slopes that failed during the 1983-84 wet years.
M* Moderate.
L Low.

Debris deposition and flood hazard

* Special studies are recommended in areas of high and moderate source-area
susceptibility, and in areas of possible sediment deposition and flooding (see
table 1).
