GEOLOGIC HAZARDS AND LAND-USE PLANNING FOR TOOELE VALLEY AND THE WEST DESERT HAZARDOUS INDUSTRY AREA, TOOELE COUNTY, UTAH

Barry J. Solomon and Bill D. Black, editors

OPEN-FILE REPORT 318
UTAH GEOLOGICAL SURVEY
a division of
UTAH DEPARTMENT OF NATURAL RESOURCES

October 1995

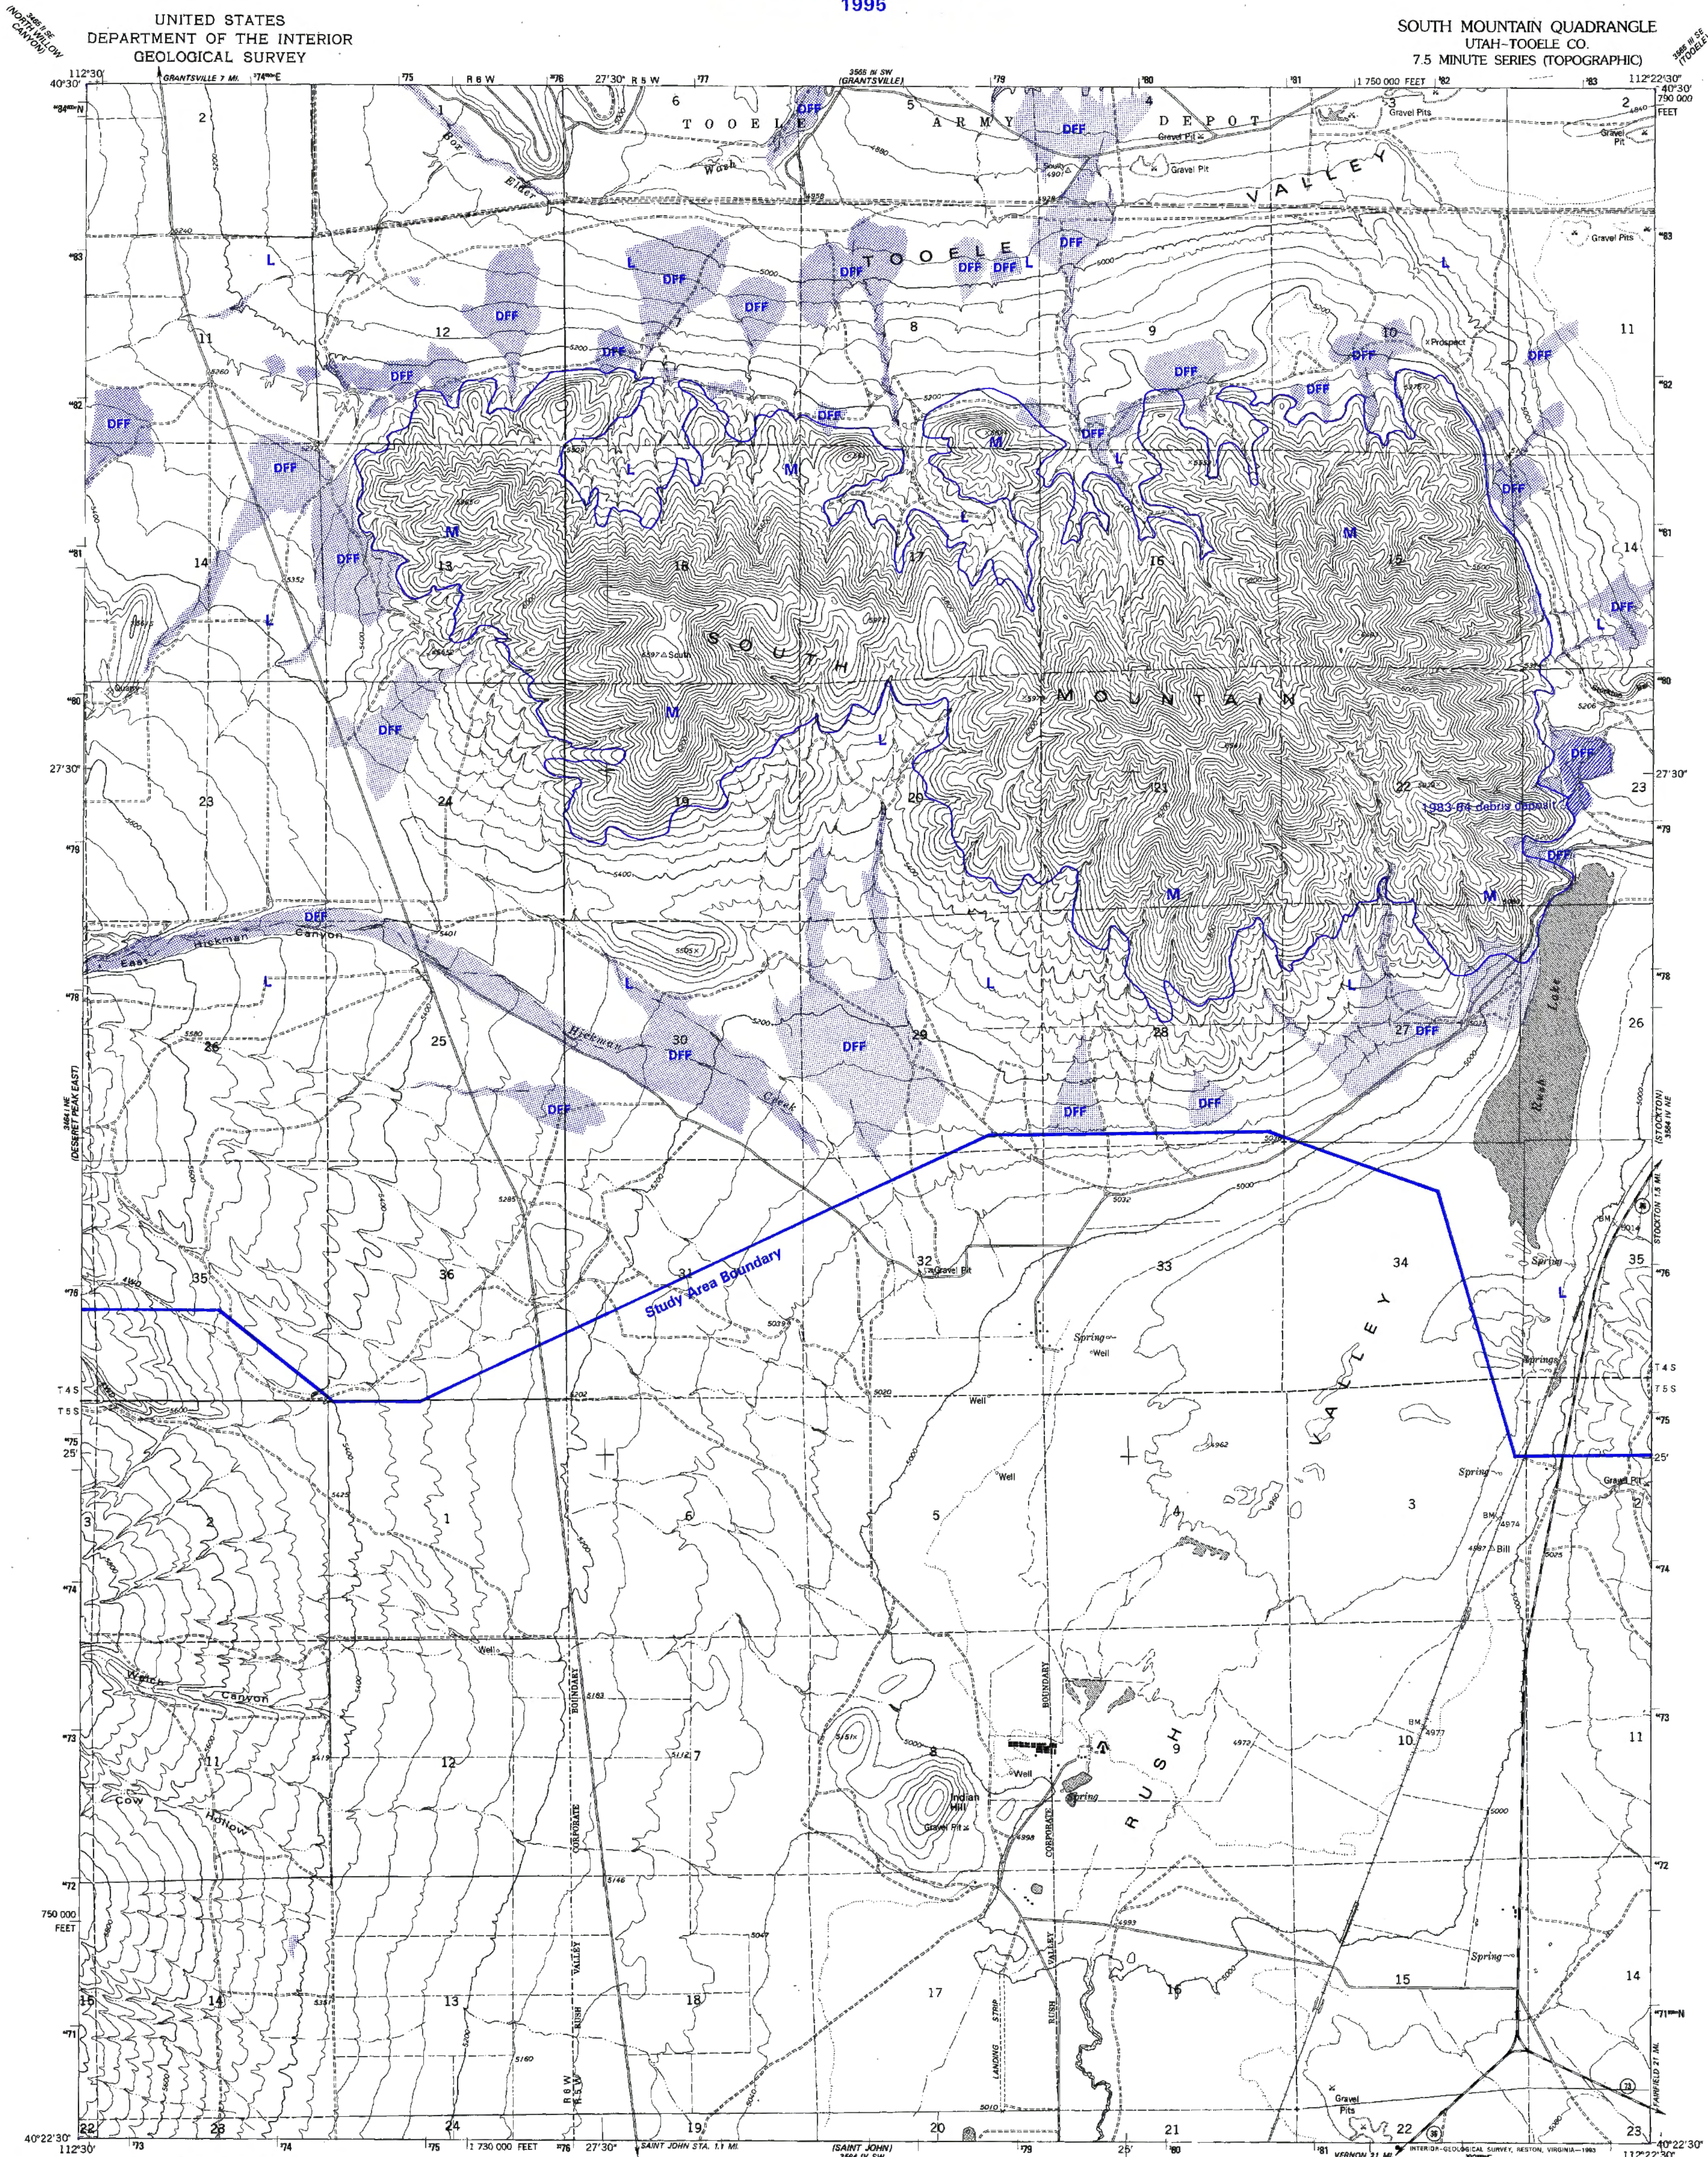
Debris-slide, debris-flow, debris-flood, and stream-flood hazards, South Mountain quadrangle, Tooele County, Utah.

- H* High; includes slopes that failed during the 1983-84 wet years.
- M* Moderate.
- L Low.

Debris deposition and flood hazard

- DFF* Possible sediment deposition and flooding from debris flows, debris floods, and stream floods; includes 1983-84 debris deposits (crosshatched).

* Special studies are recommended in areas of high and moderate source-area susceptibility, and in areas of possible sediment deposition and flooding (see table 1).

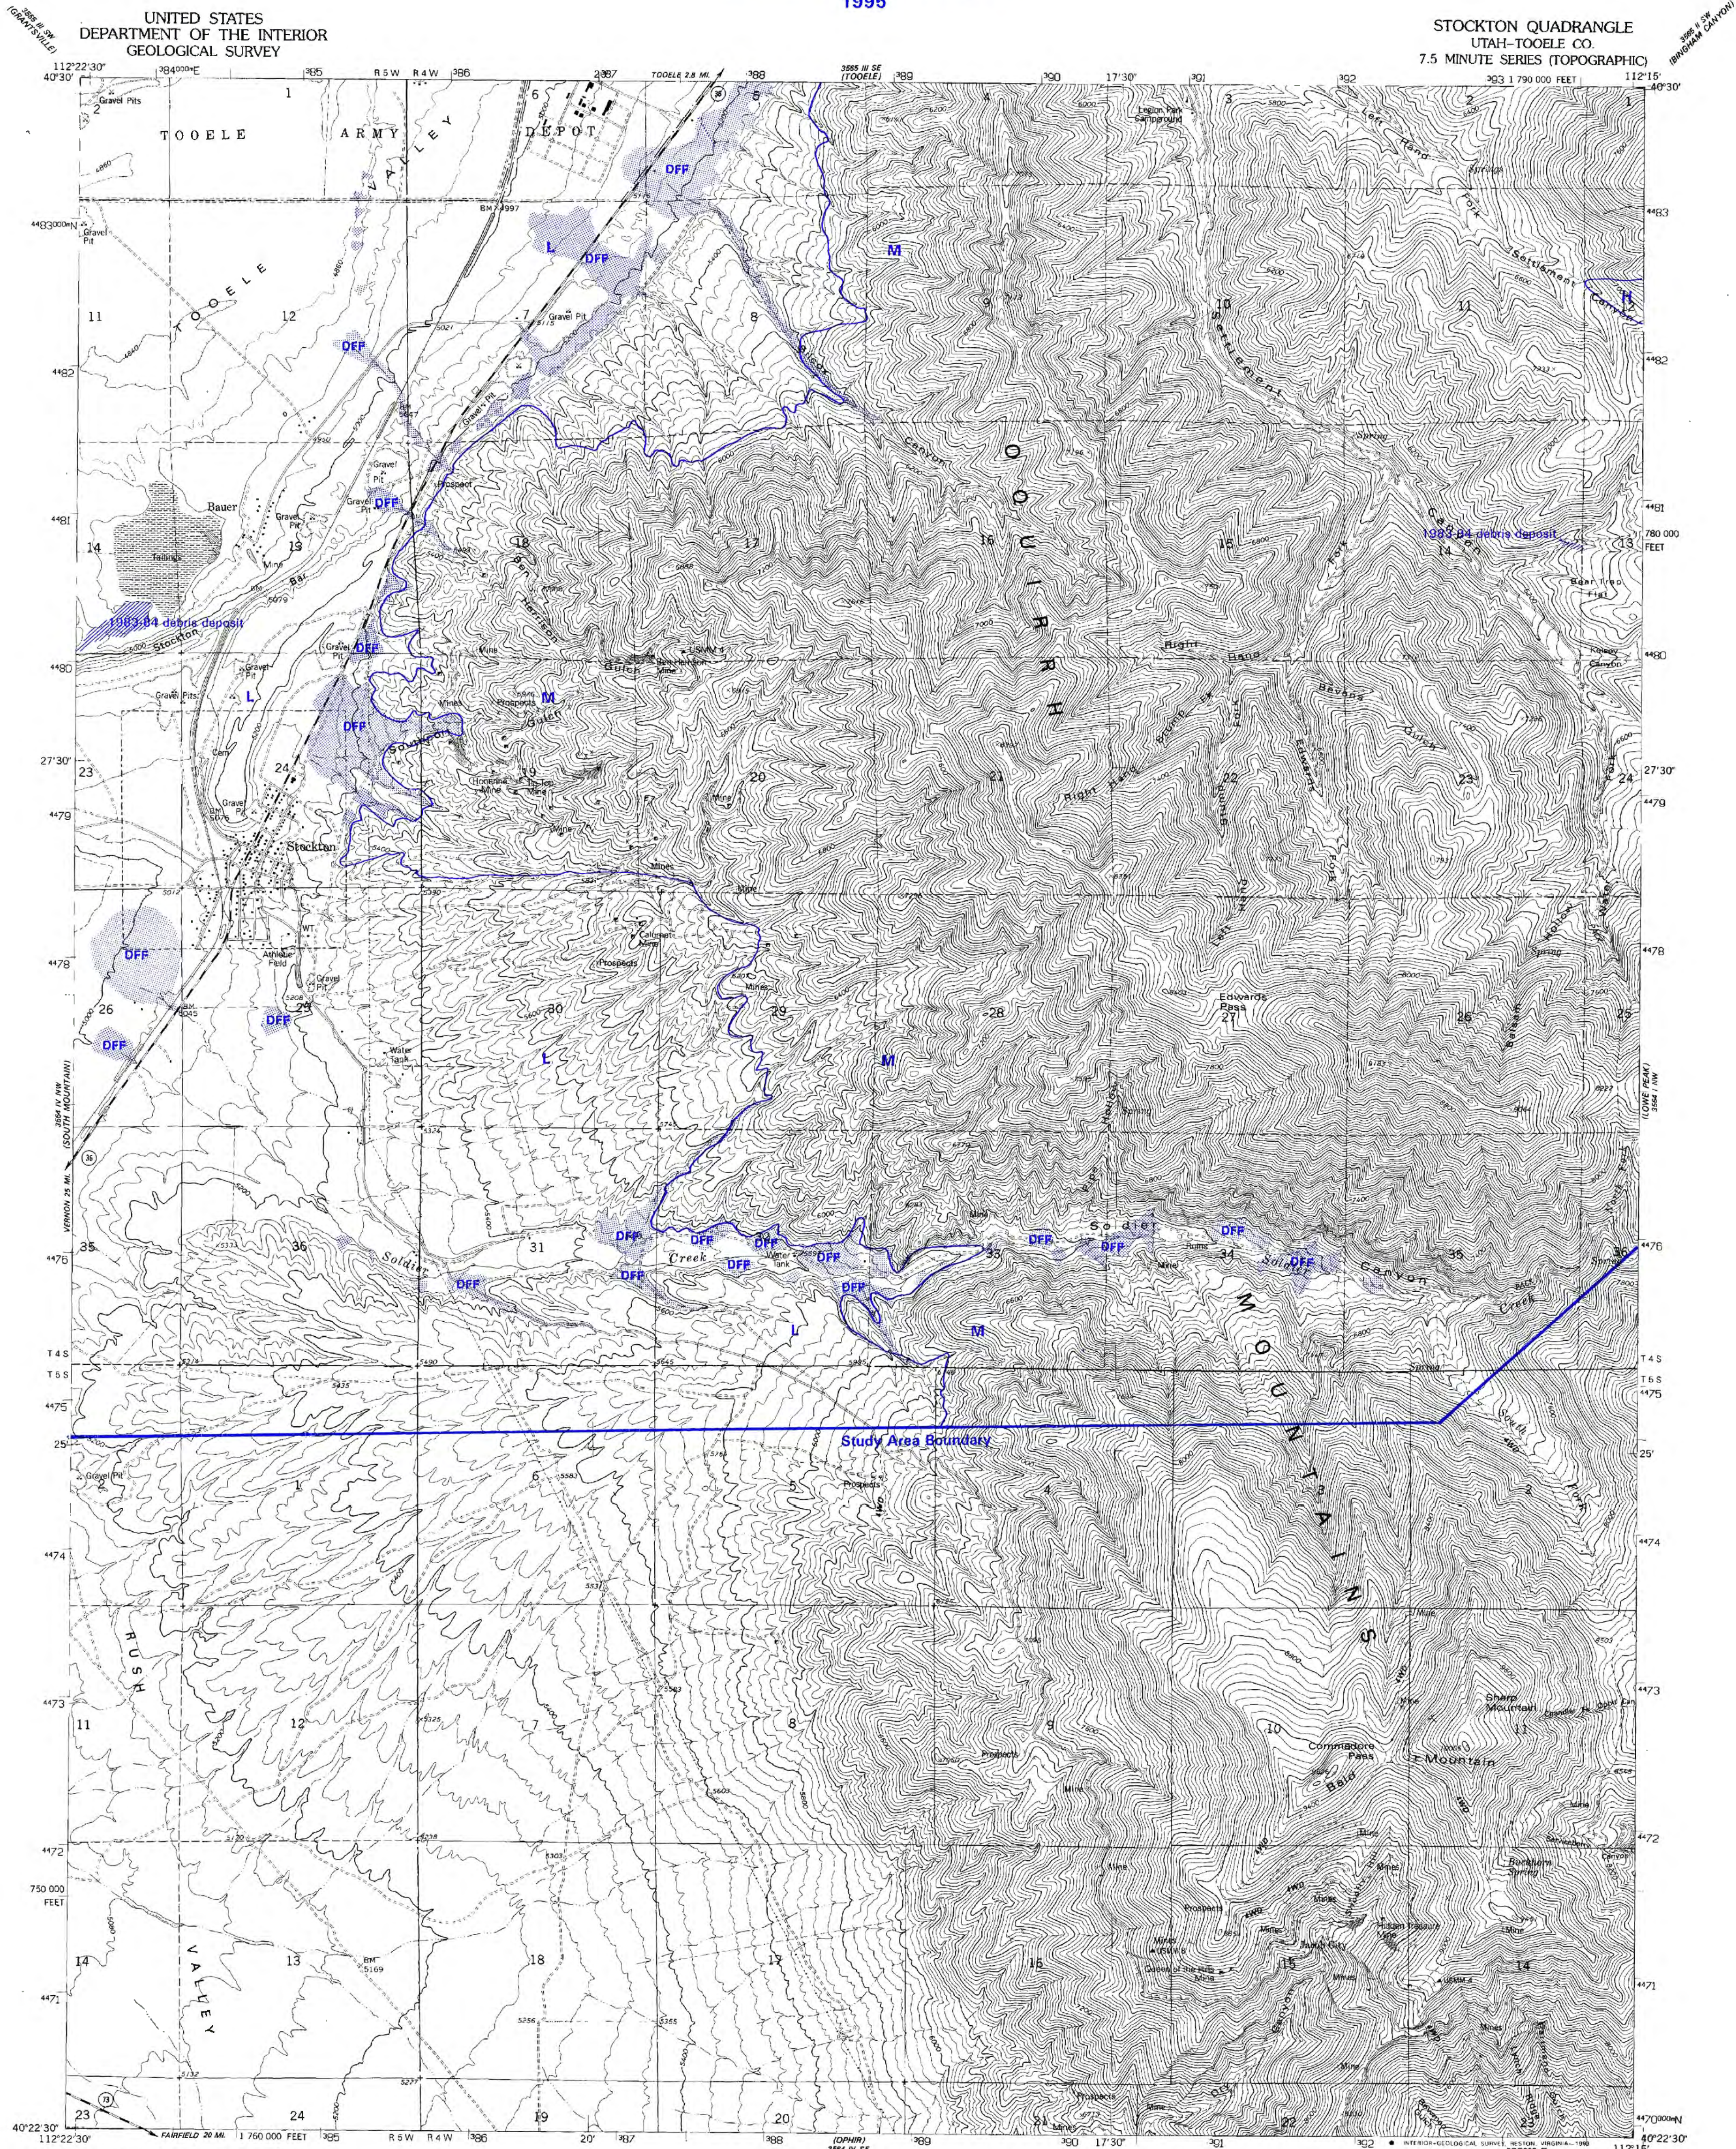
Debris-slide, debris-flow, debris-flood, and stream-flood hazards, Stockton quadrangle, Tooele County, Utah.

- H*** High; includes slopes that failed during the 1983-84 wet years,
M* Moderate.
L Low.

Debris deposition and flood hazard

* Special studies are recommended in areas of high and moderate source-area
susceptibility, and in areas of possible sediment deposition and flooding (see
table 1).

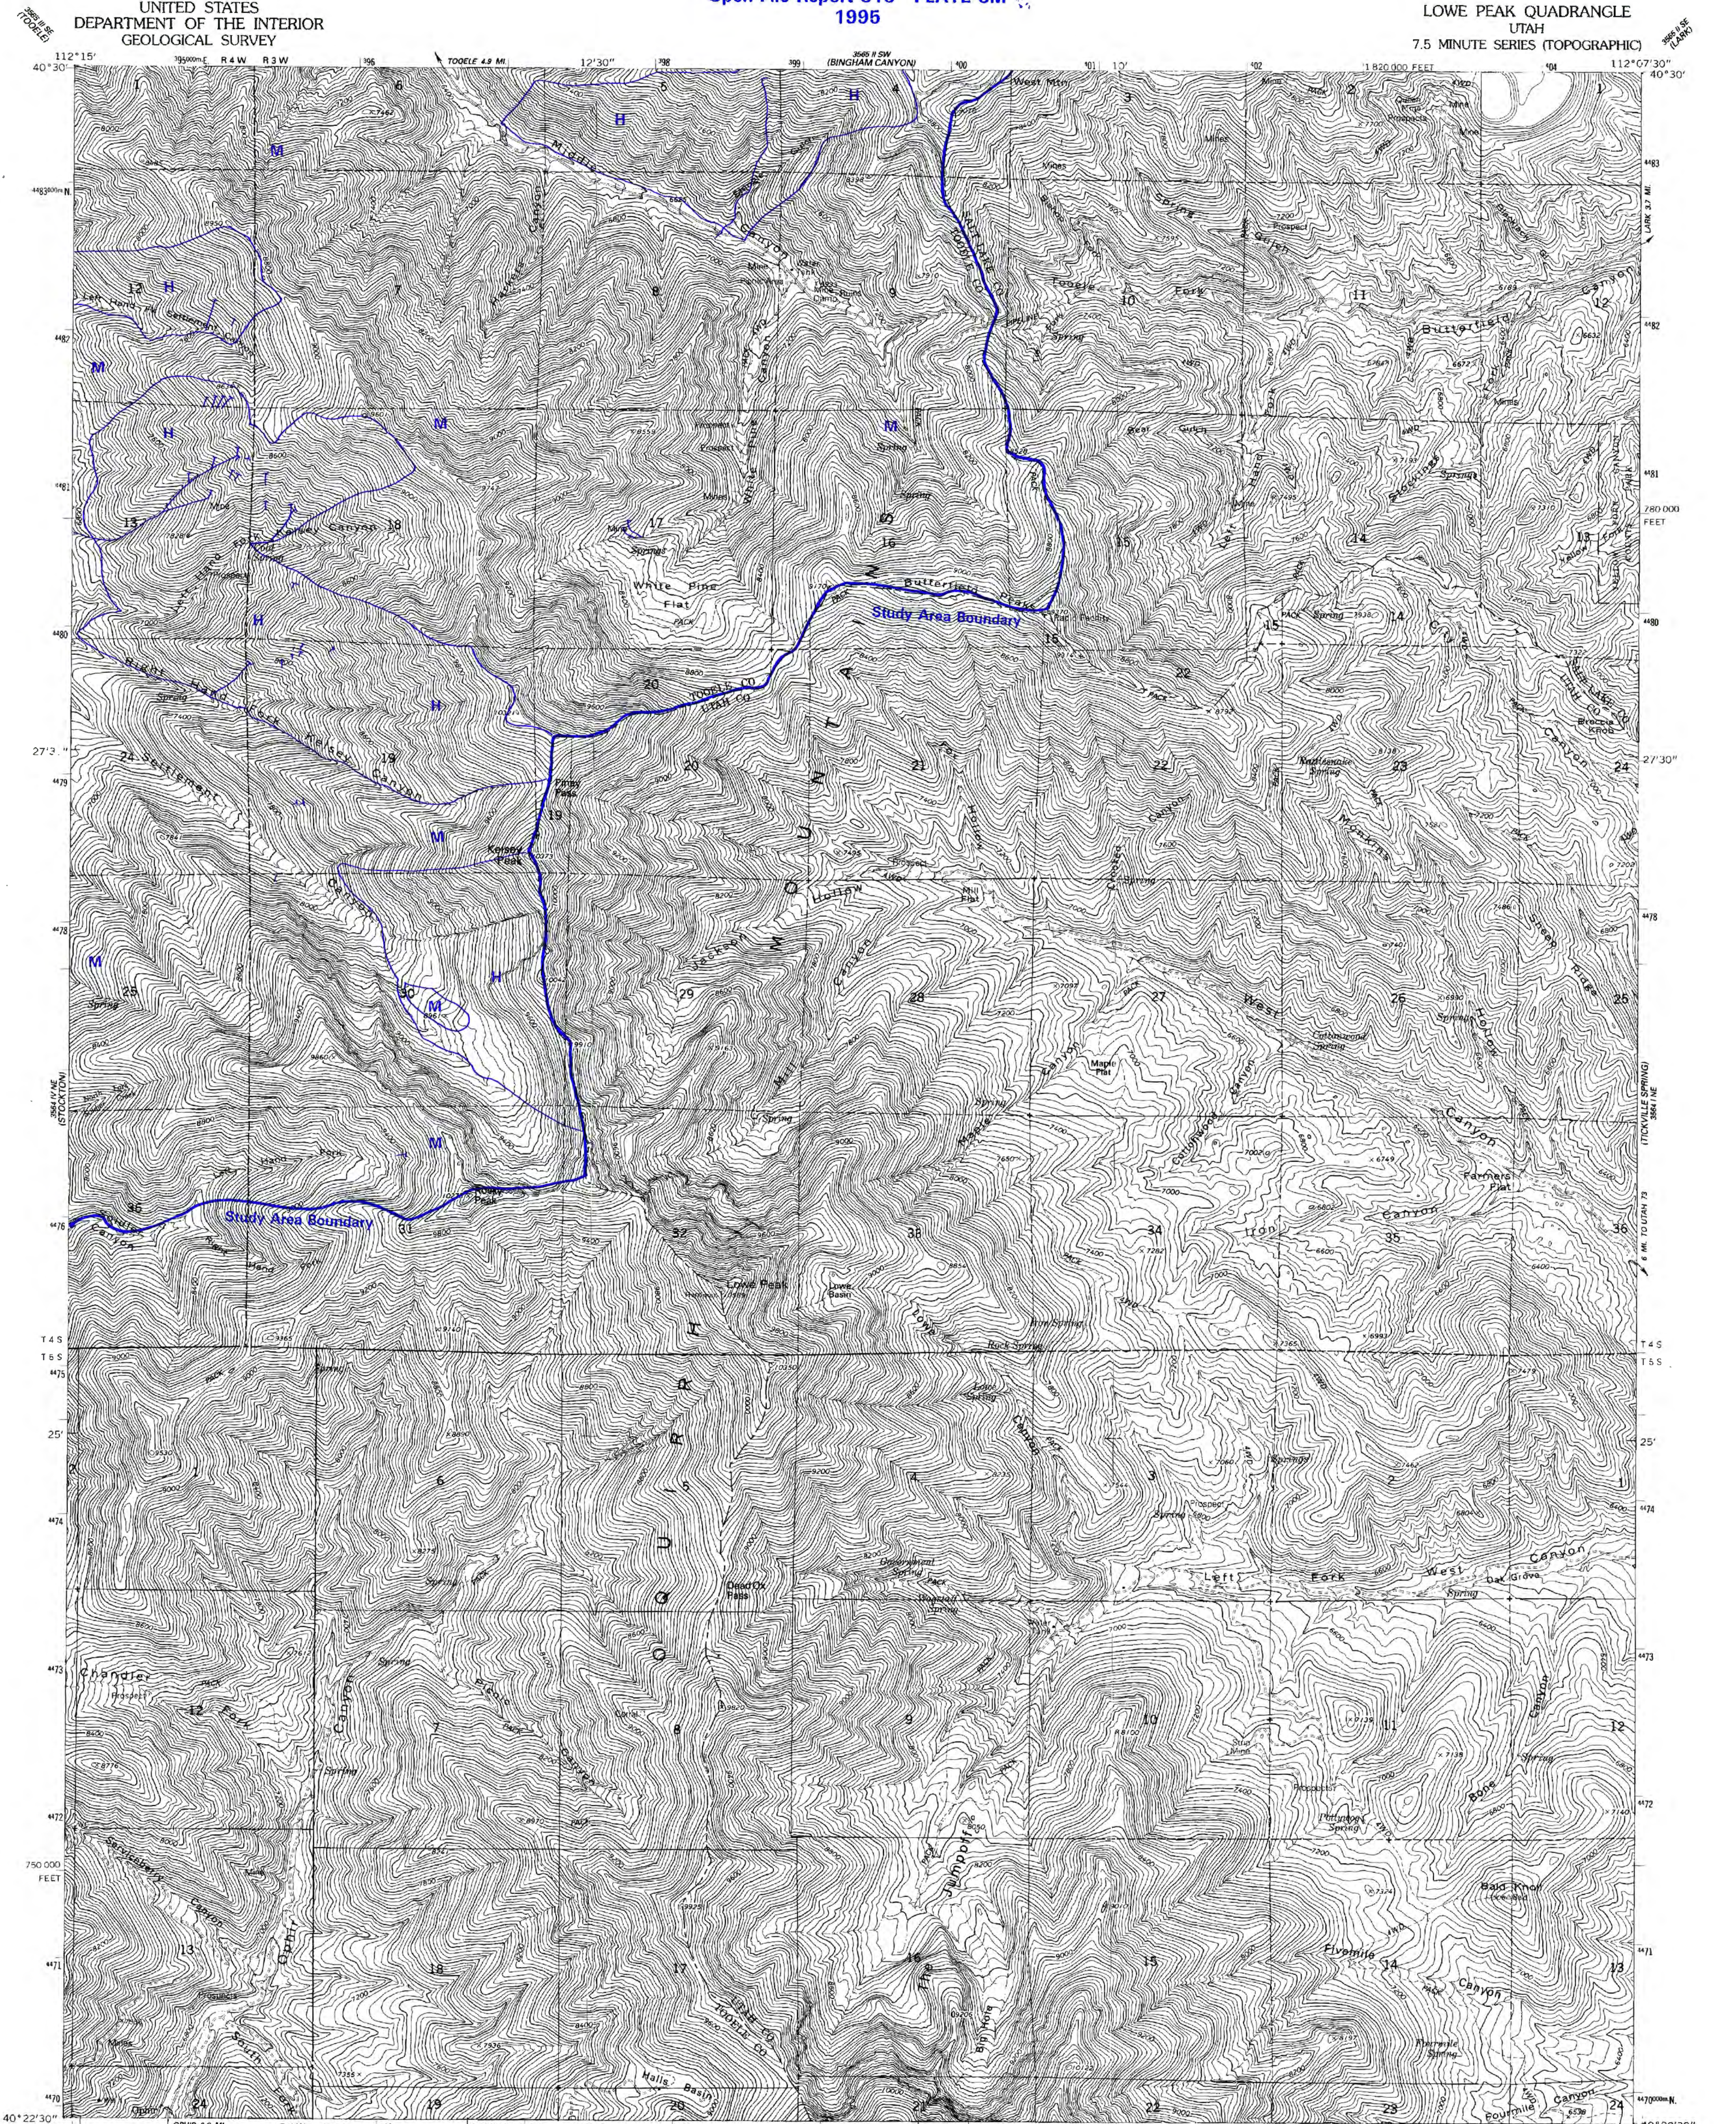
Debris-slide, debris-flow, debris-flood, and stream-flood hazards, Lowe Peak quadrangle, Tooele County, Utah.

H* High; includes slopes that failed during the 1983-84 wet years.
M* Moderate.
L Low.

* Special studies are recommended in areas of high and moderate source-area susceptibility (see table 1).

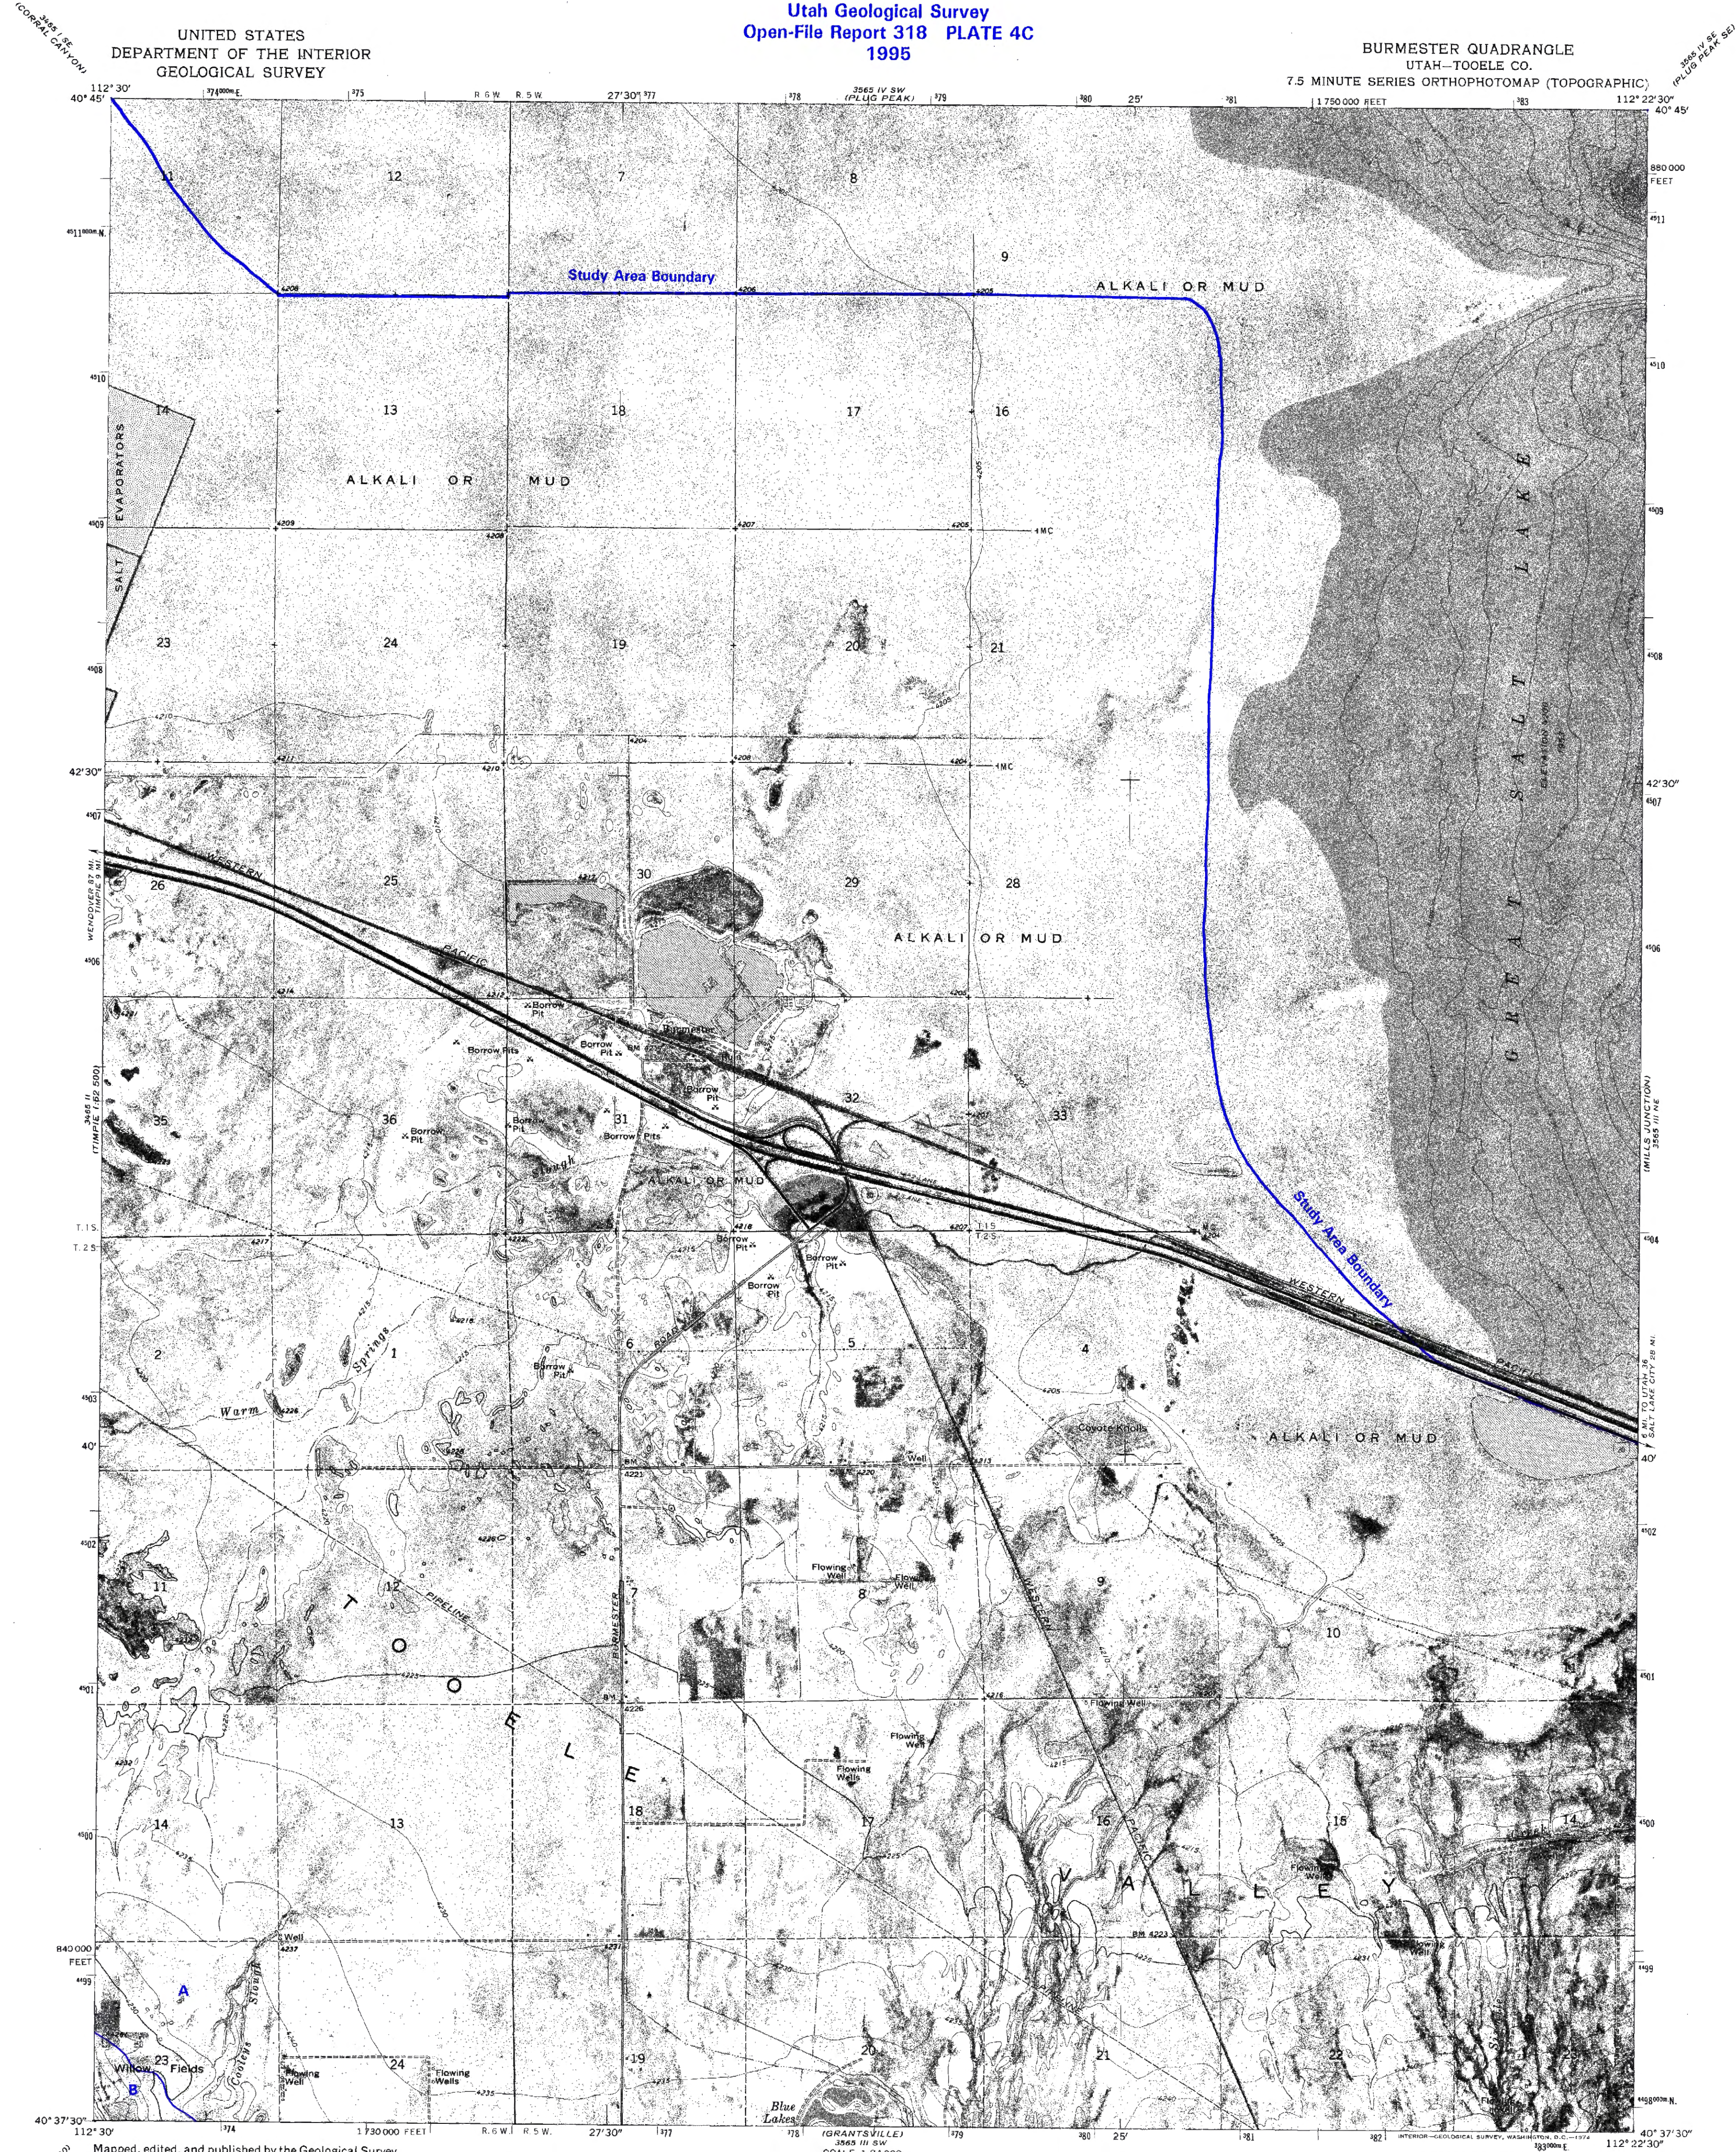
Depth to ground water, Burmester quadrangle, Tooele County, Utah.

- A* Less than 10 feet (3 m).
- B 10 to 30 feet (3-9 m).
- C 30 to 60 feet (9-15 m).
- D Greater than 60 feet (15 m).

* Special studies are recommended in areas where the depth to ground water is less than 10 feet (3 m) (see table 1).

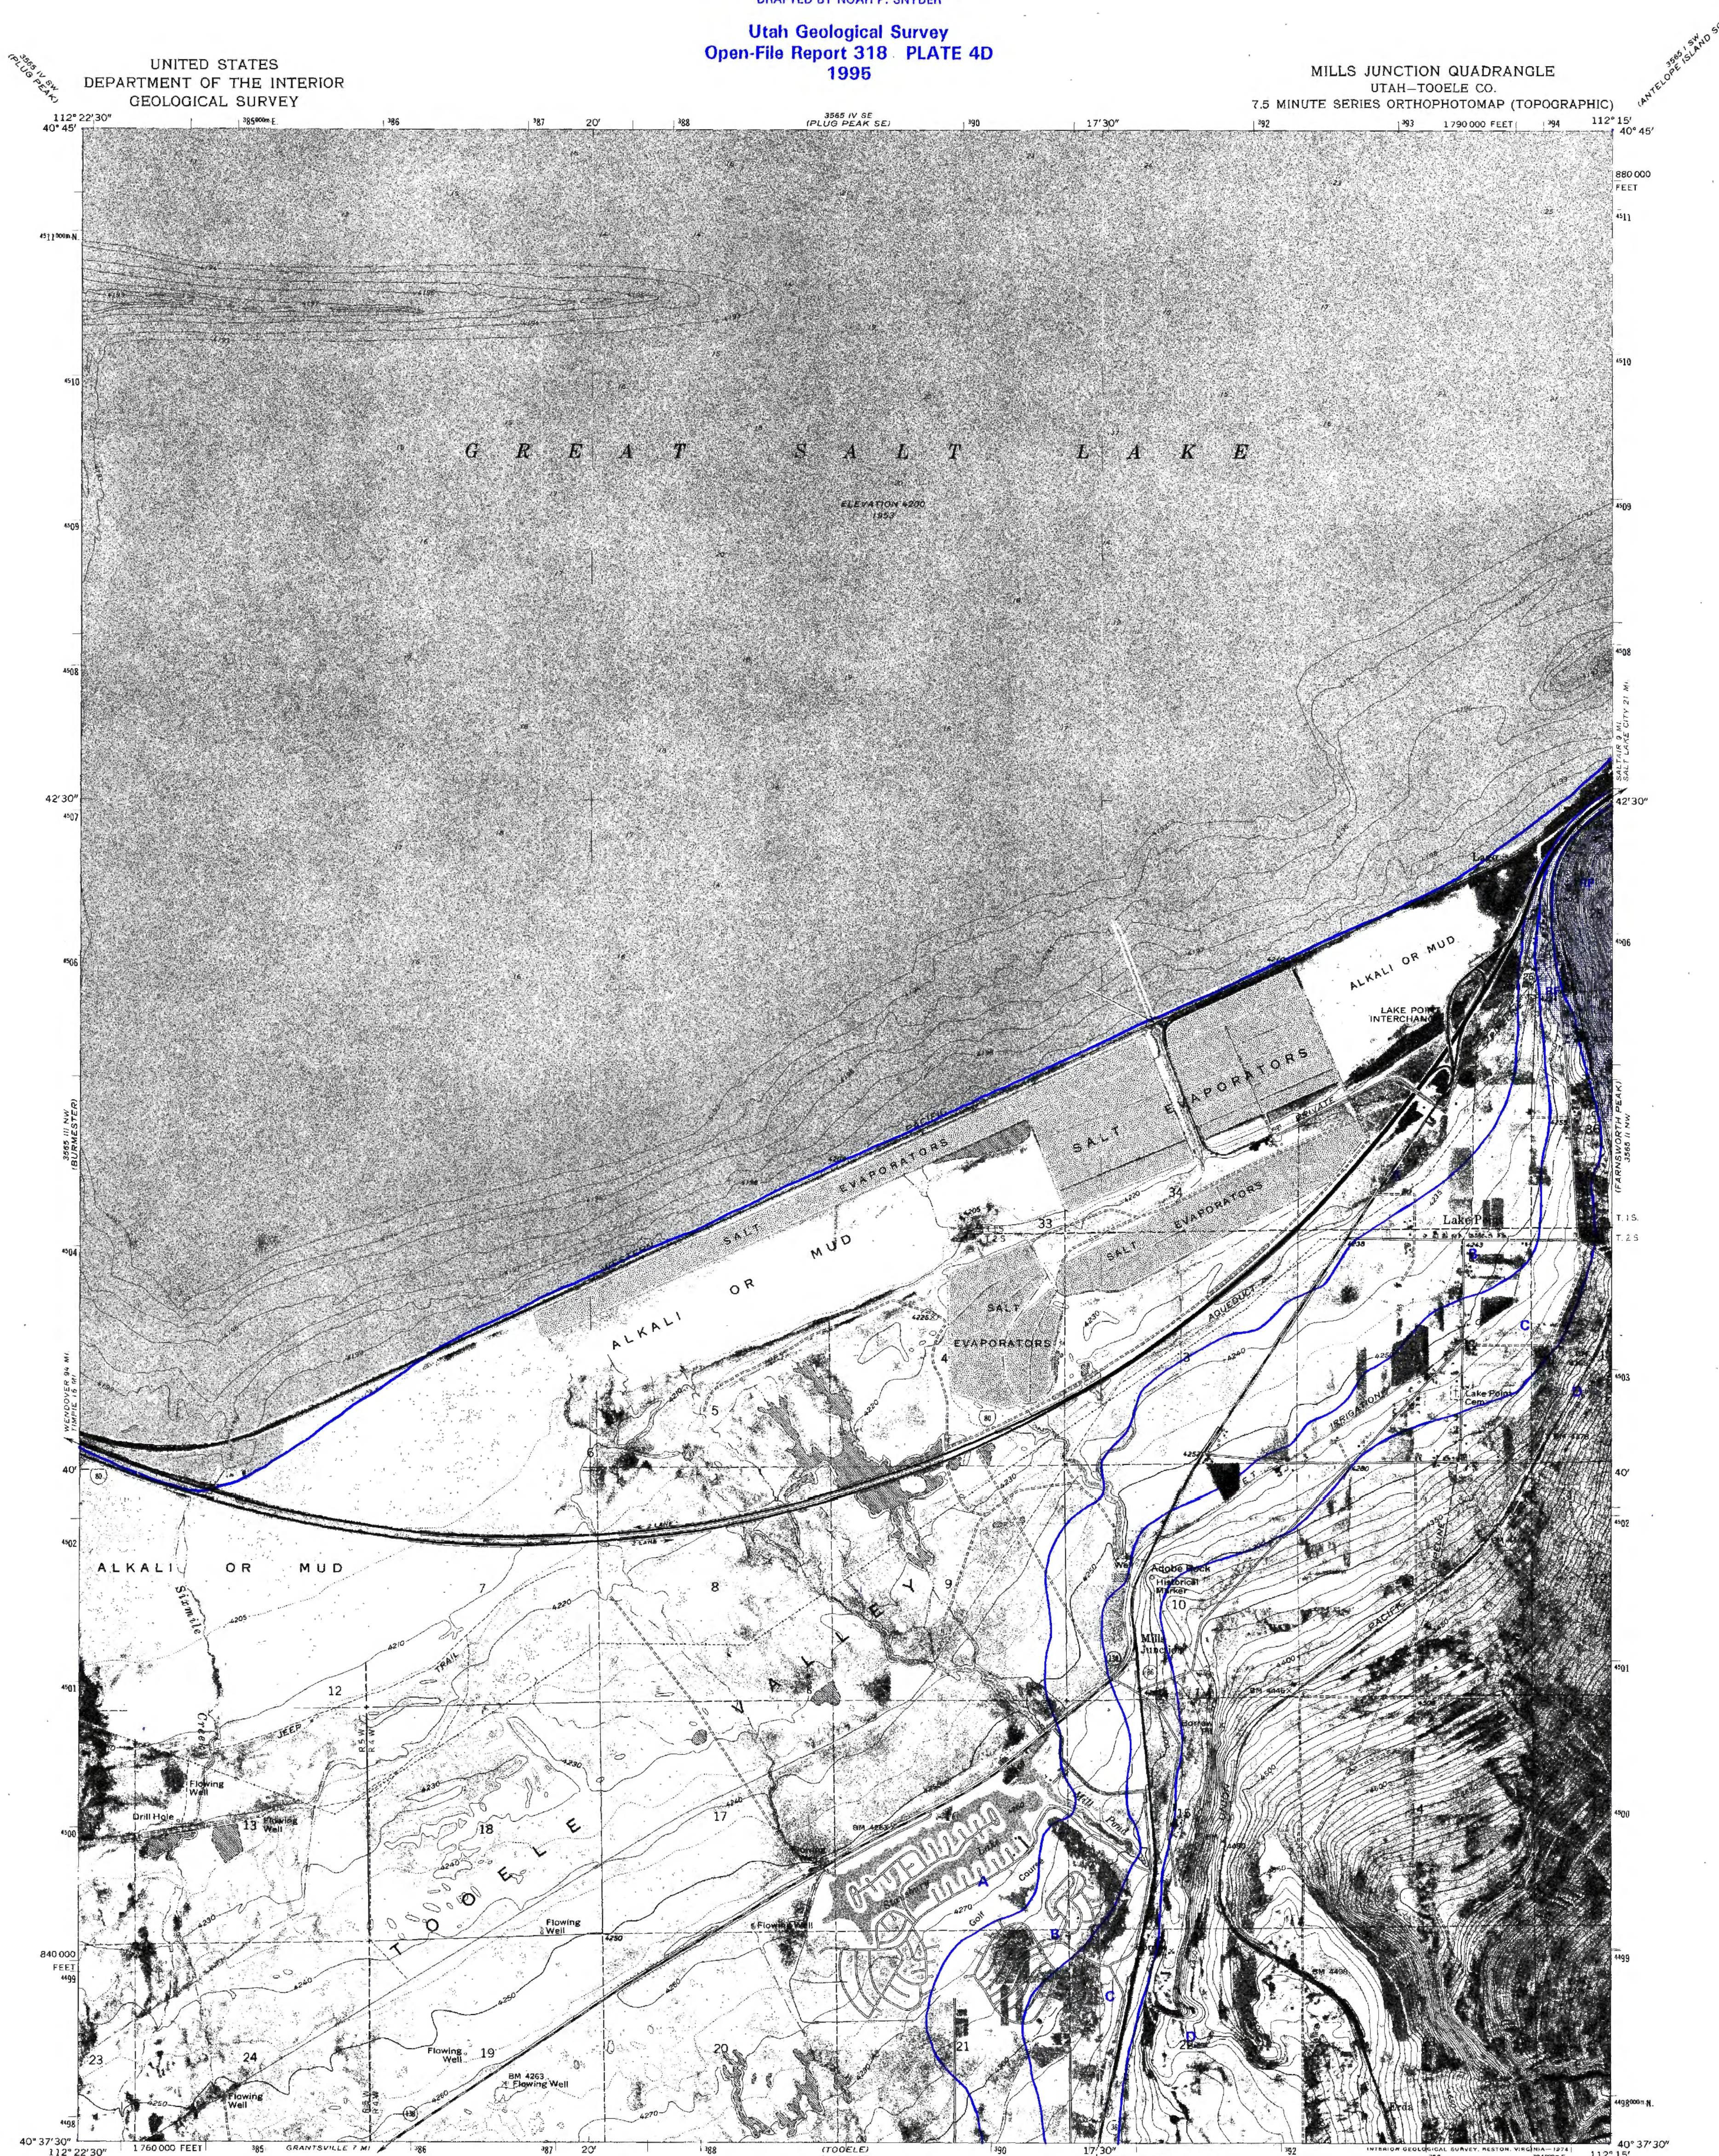
Rock-fall hazard and depth to ground water, Mills Junction quadrangle, Tooele County, Utah.

* Special studies are recommended in areas subject to rock fall and where the depth to ground water is less than 10 feet (3 m) (see table 1).

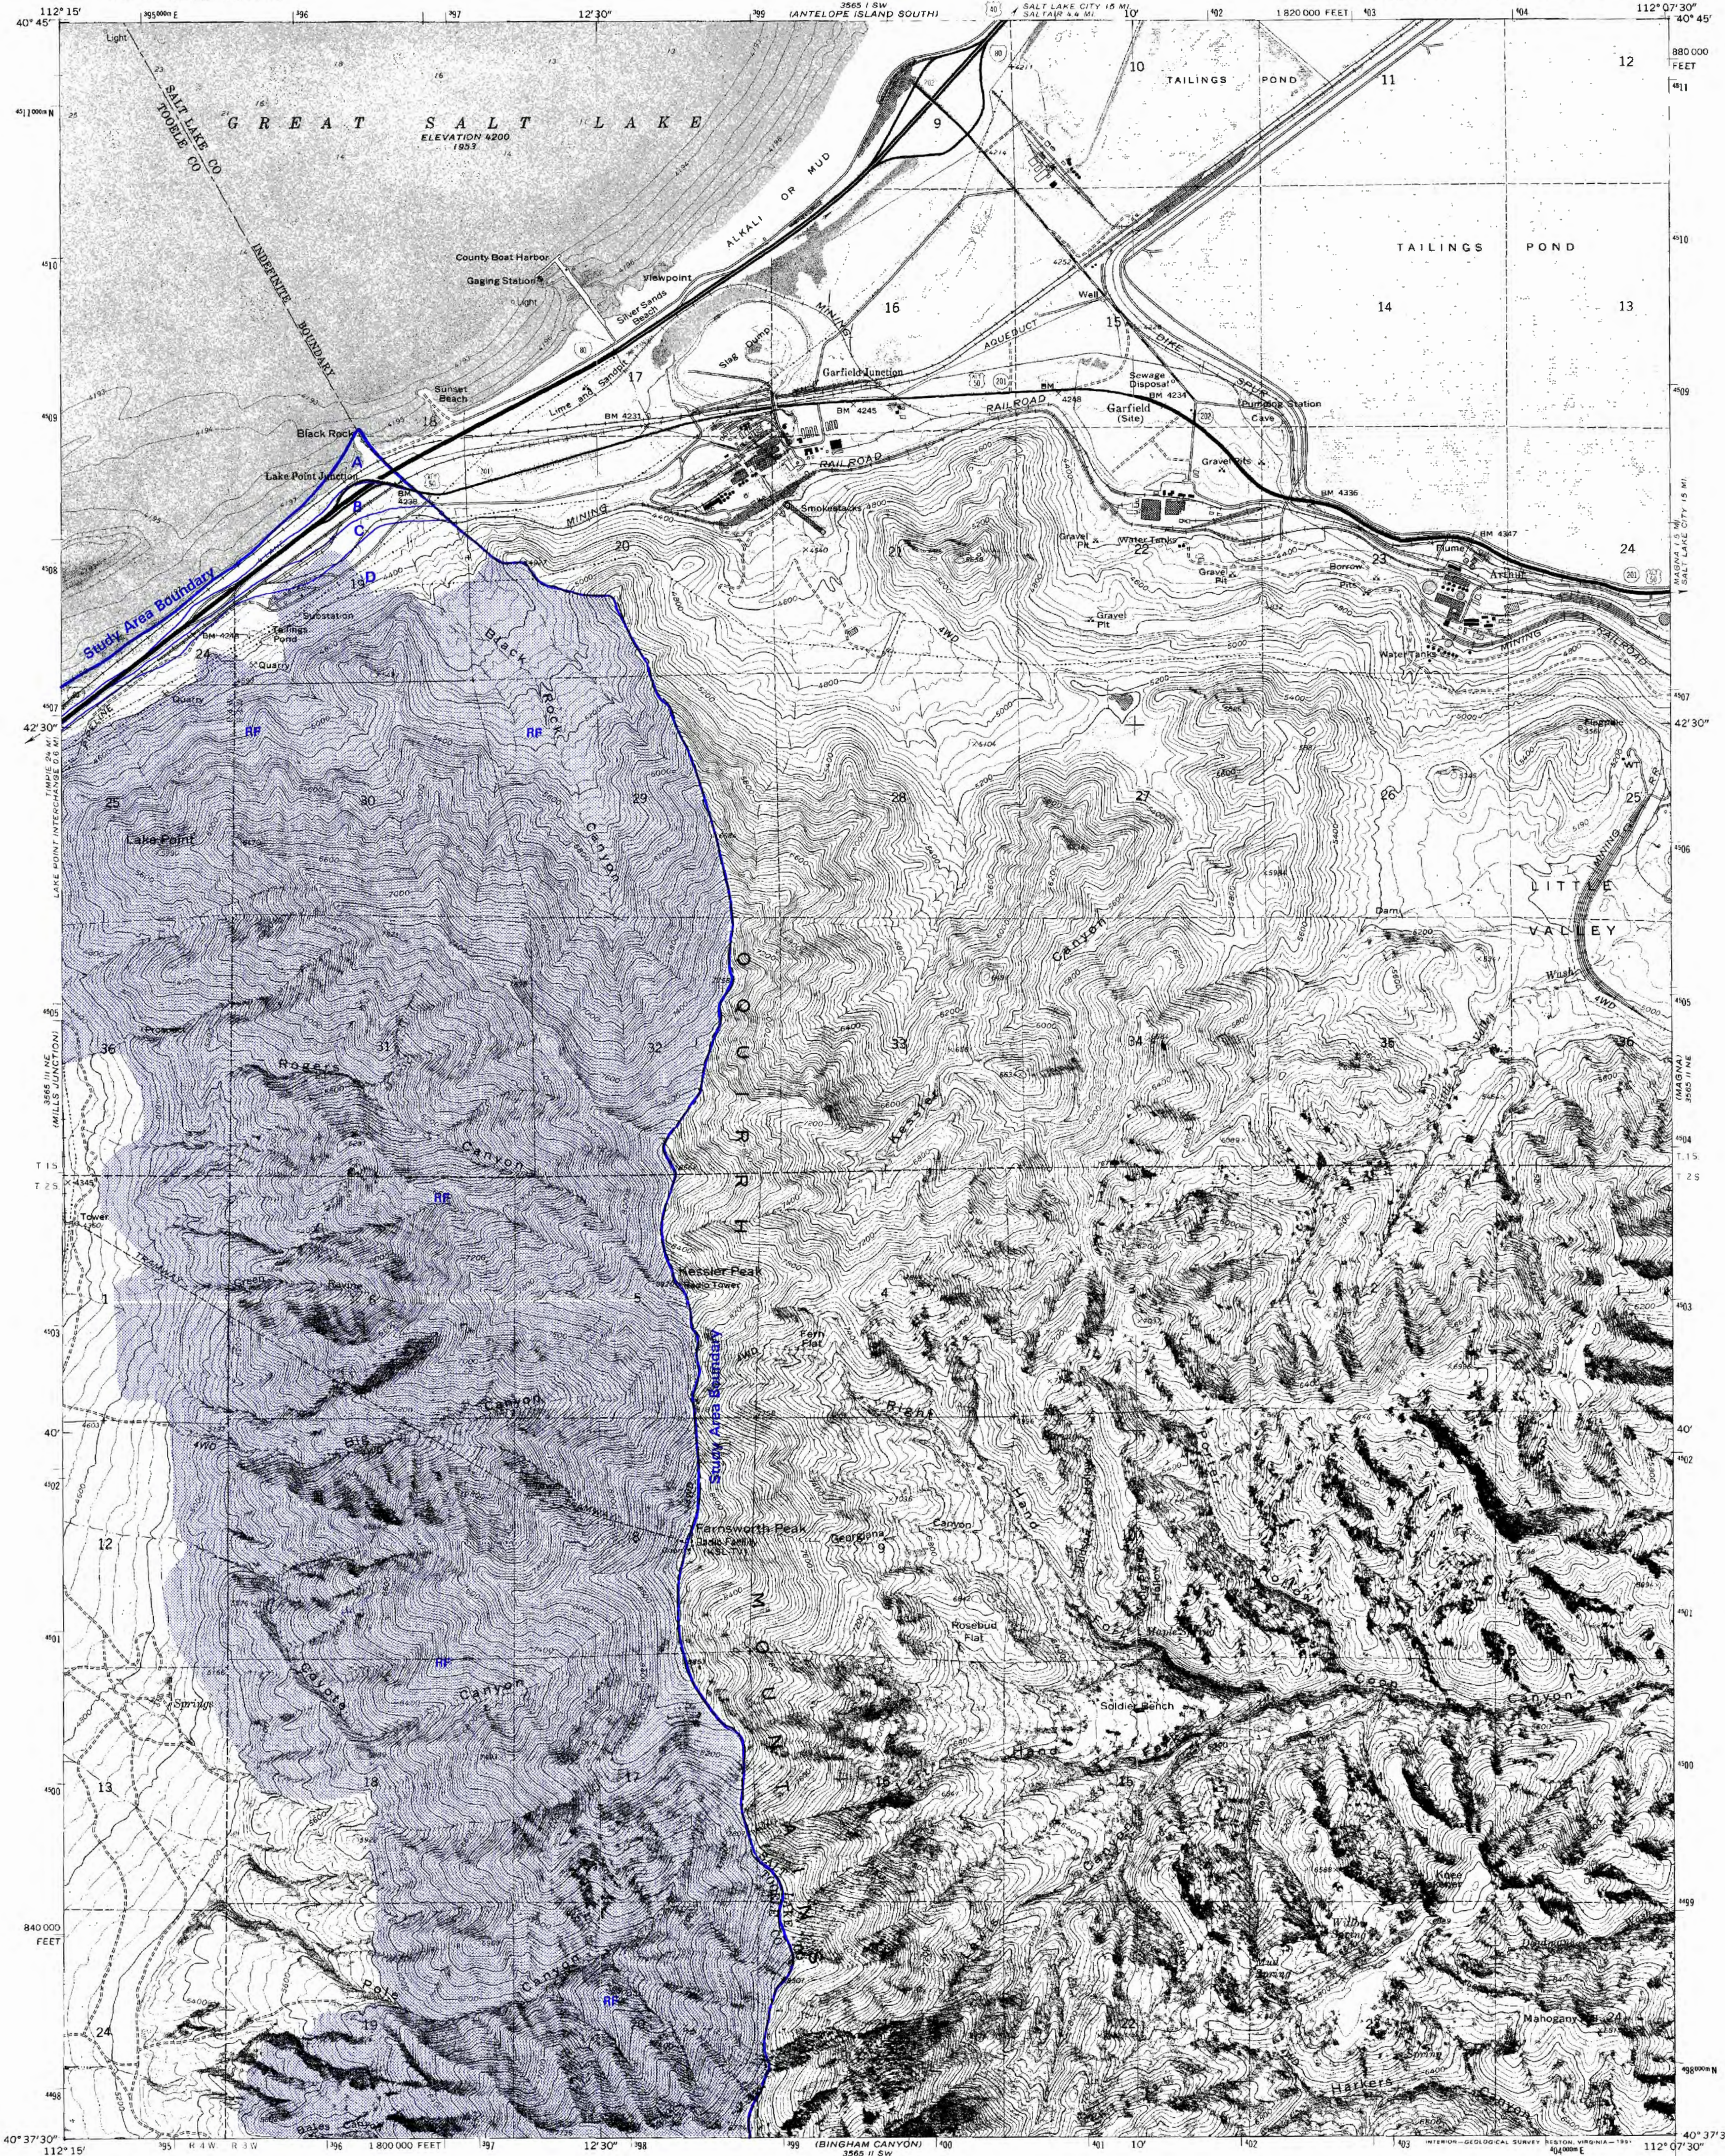
Rock-fall hazard and depth to ground water, Farnsworth Peak quadrangle, Tooele County, Utah.

- Rock fall
- Potentially subject to impact by rock fall.
- Depth to ground water
- A* Less than 10 feet (3 m).
B 10 to 30 feet (3-9 m).
C 30 to 50 feet (9-15 m).
D Greater than 50 feet (15 m).

* Special studies are recommended in areas subject to rock fall and where the depth to ground water is less than 10 feet (3 m) (see table 1).
