GEOLOGIC HAZARDS AND LAND-USE PLANNING FOR TOOELE VALLEY AND THE WEST DESERT HAZARDOUS INDUSTRY AREA, TOOELE COUNTY, UTAH

Barry J. Solomon and Bill D. Black, editors

OPEN-FILE REPORT 318
UTAH GEOLOGICAL SURVEY
a division of
UTAH DEPARTMENT OF NATURAL RESOURCES

October 1995

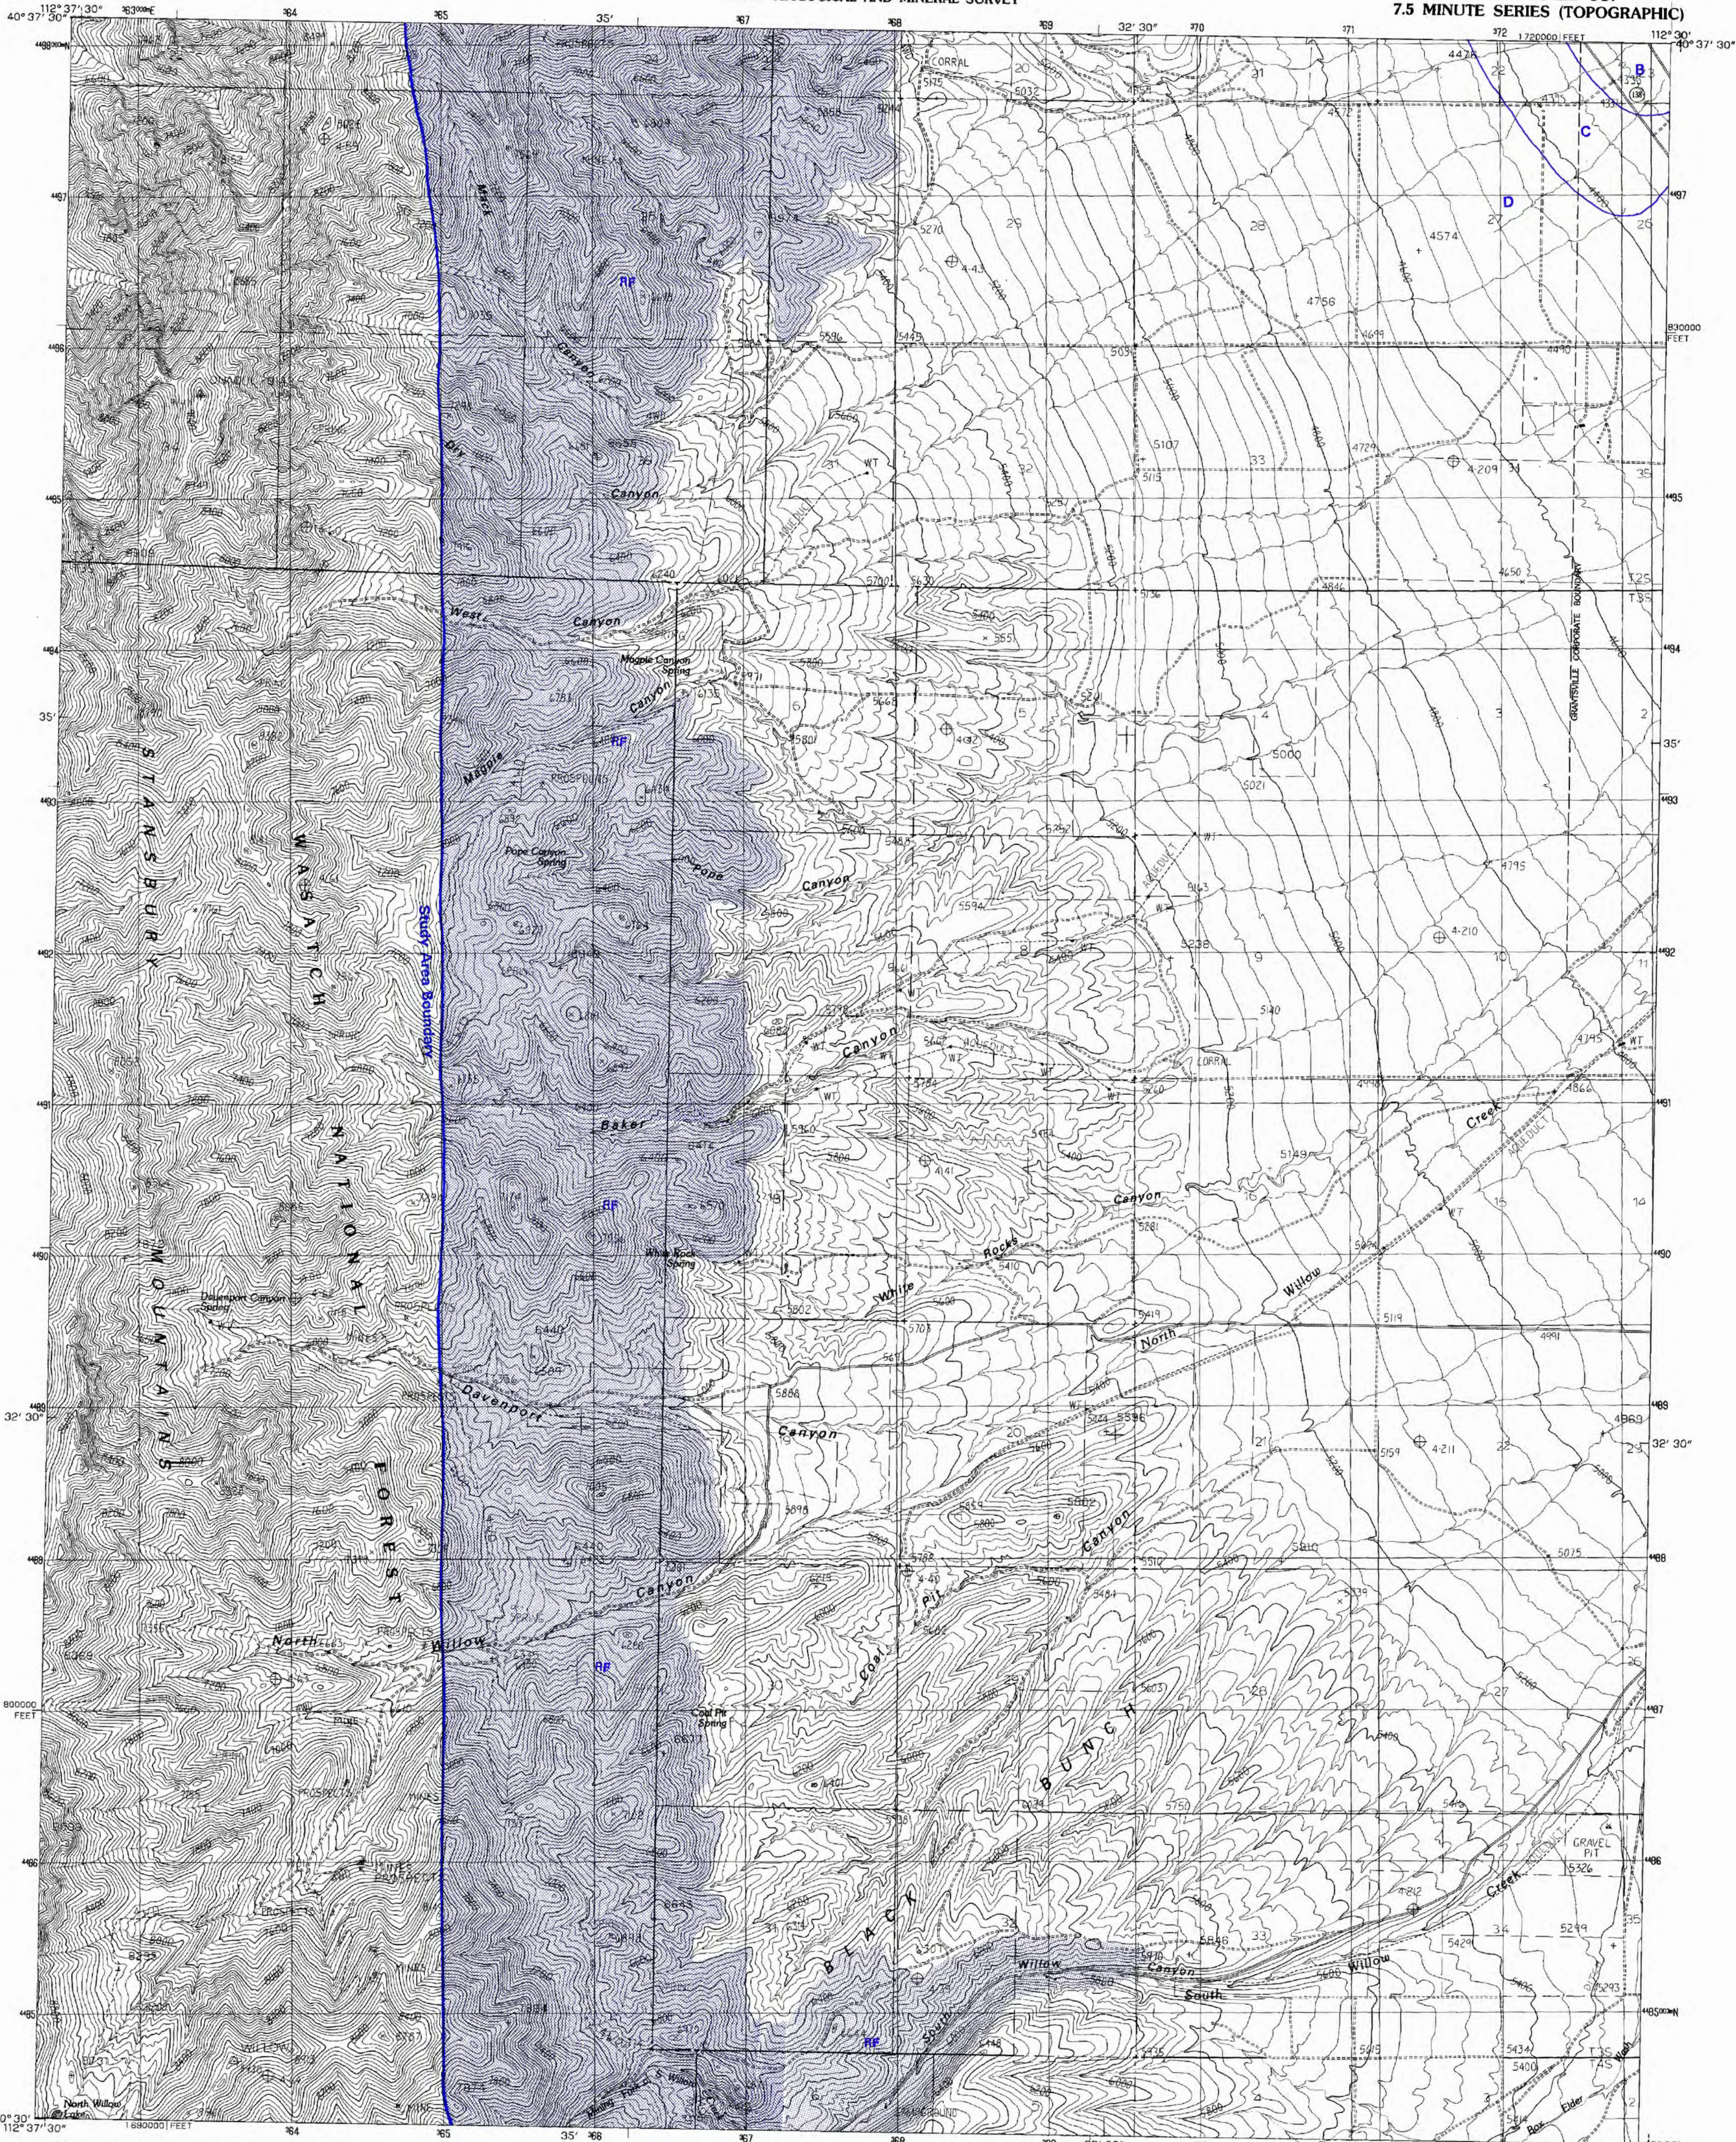
Rock-fall hazard and depth to ground water, North Willow Canyon quadrangle, Tooele County, Utah.

Depth to ground water
A* Less than 10 feet (3 m).
B 10 to 30 feet (3-9 m).
C 30 to 50 feet (9-15 m).
D Greater than 50 feet (15 m).

* Special studies are recommended in areas subject to rock fall and where the depth to ground water is less than 10 feet (3 m) (see table 1).

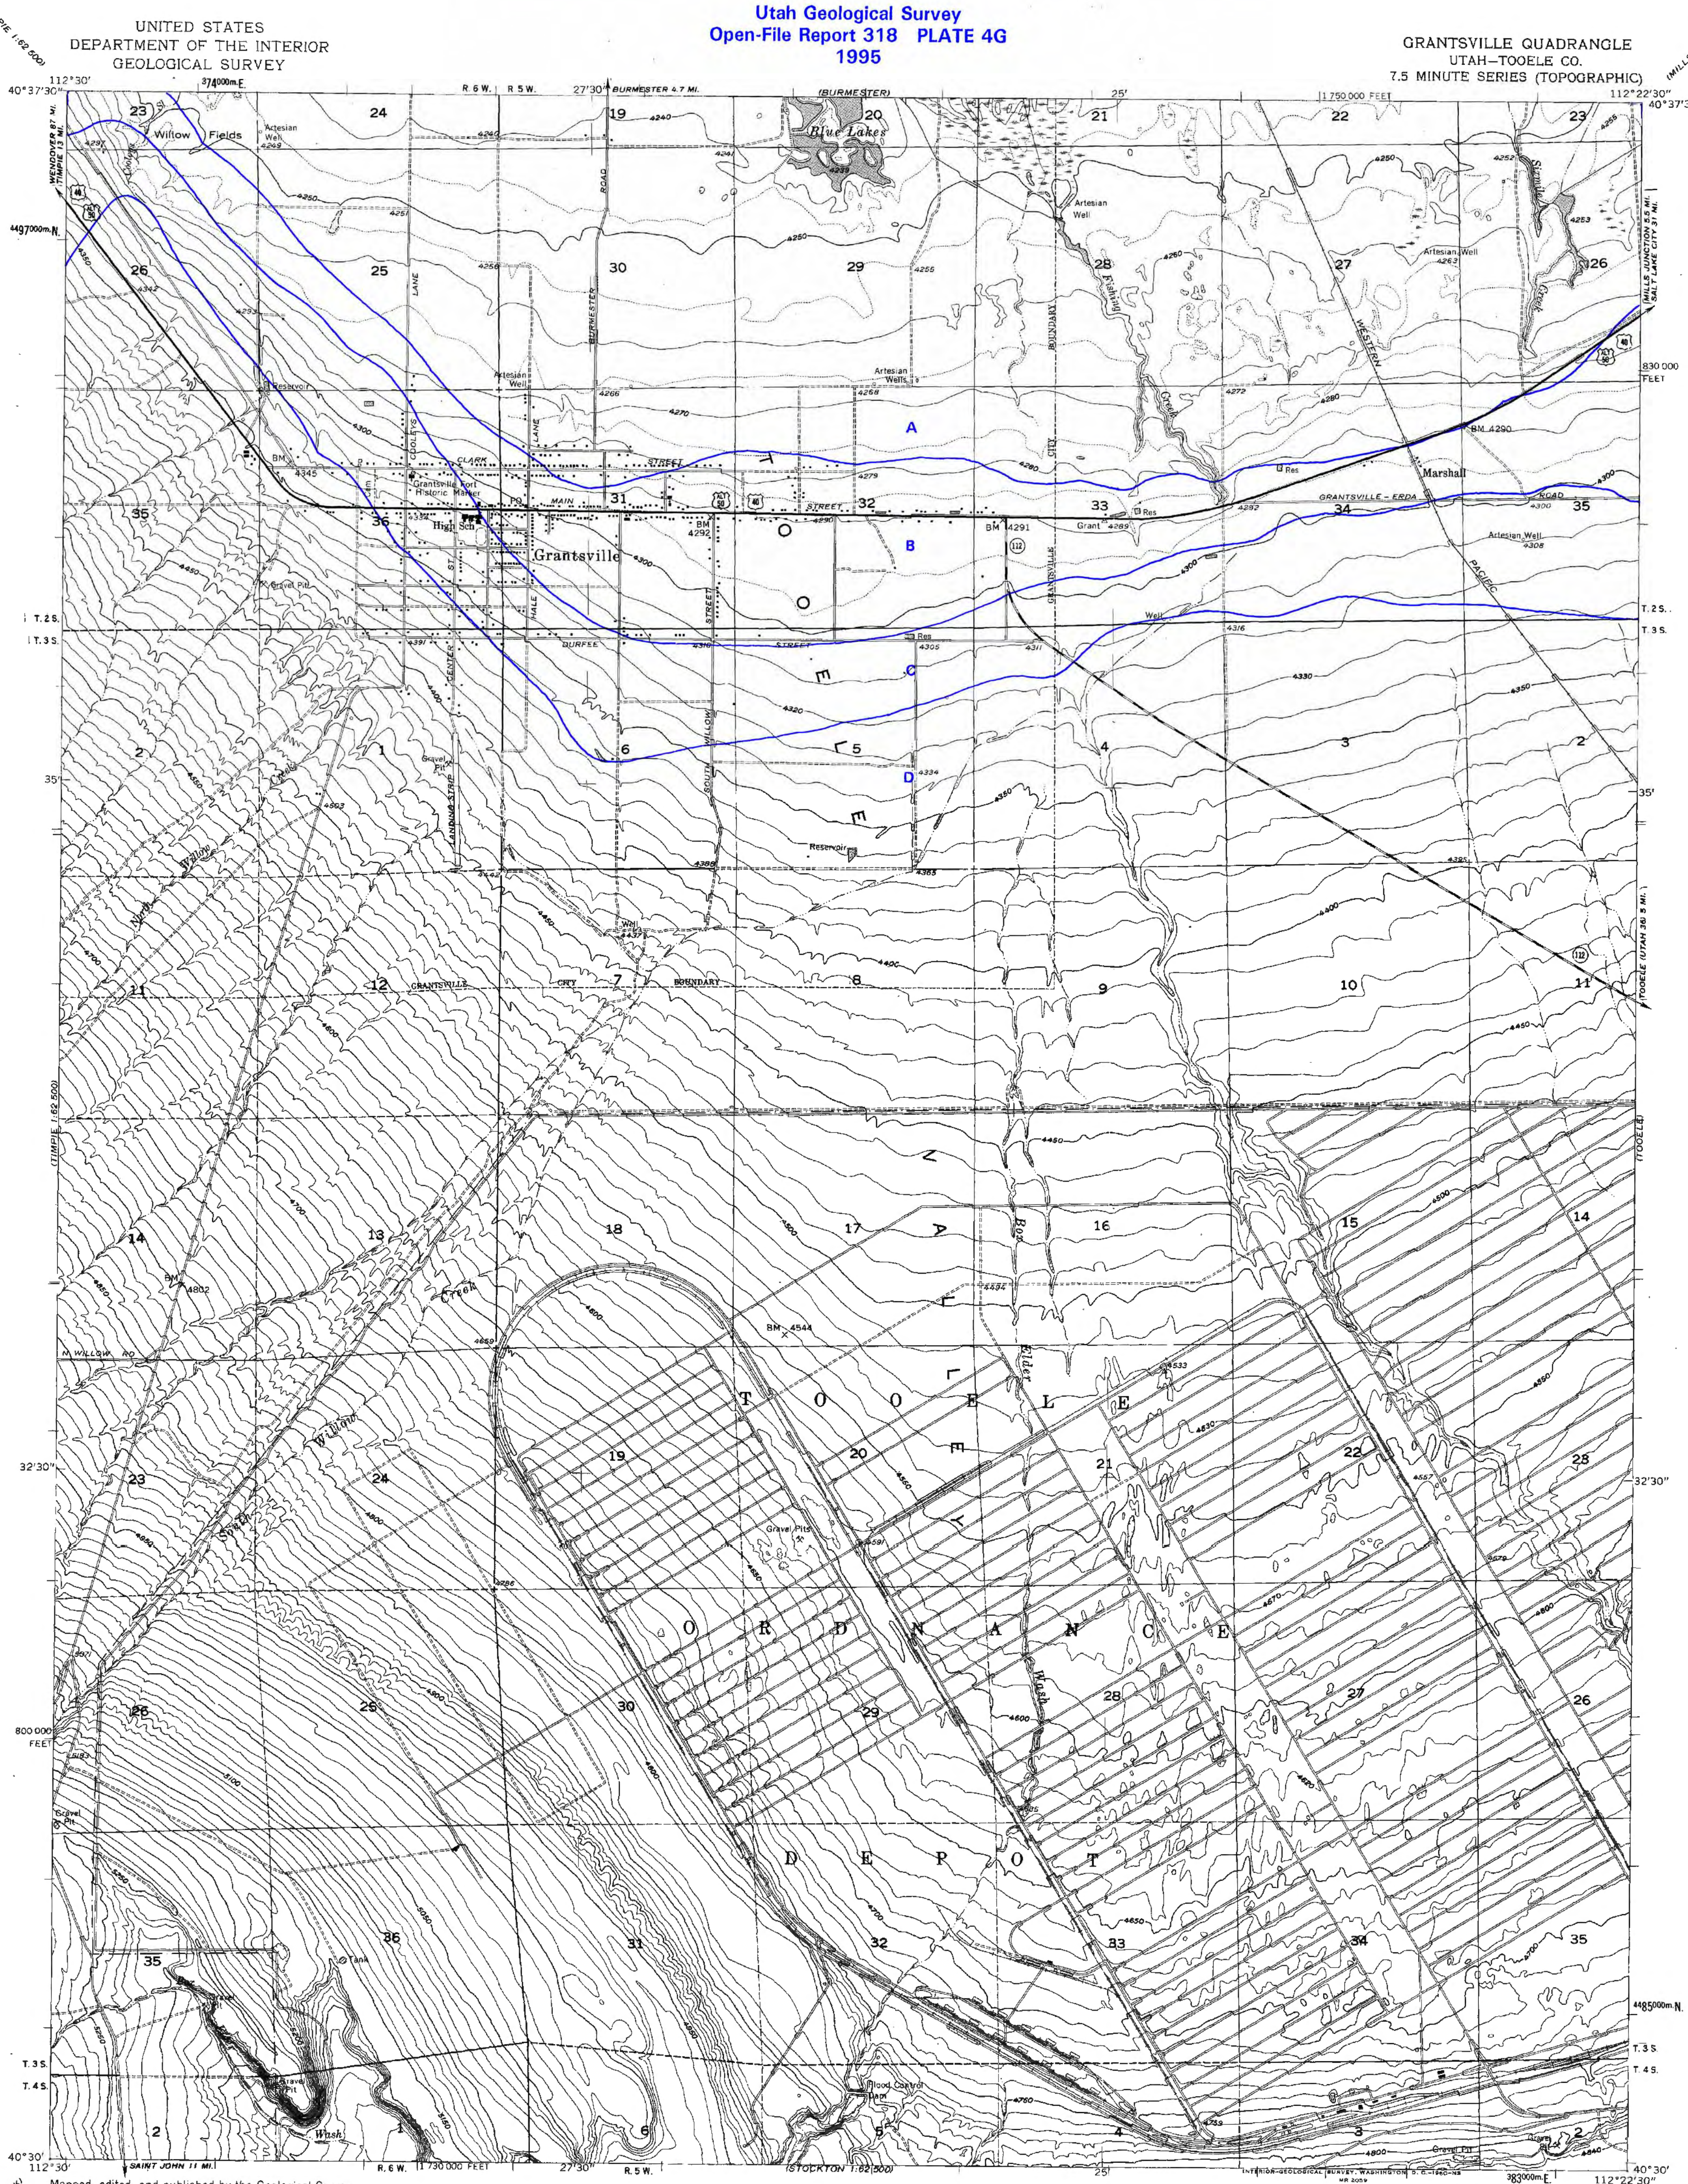
Depth to ground water, Grantsville quadrangle, Tooele County, Utah.

- A* Less than 10 feet (3 m).
- B 10 to 30 feet (3-9 m).
- C 30 to 50 feet (9-15 m).
- D Greater than 50 feet (15 m).

* Special studies are recommended in areas where the depth to ground water is less than 10 feet (3 m) (see table 1).

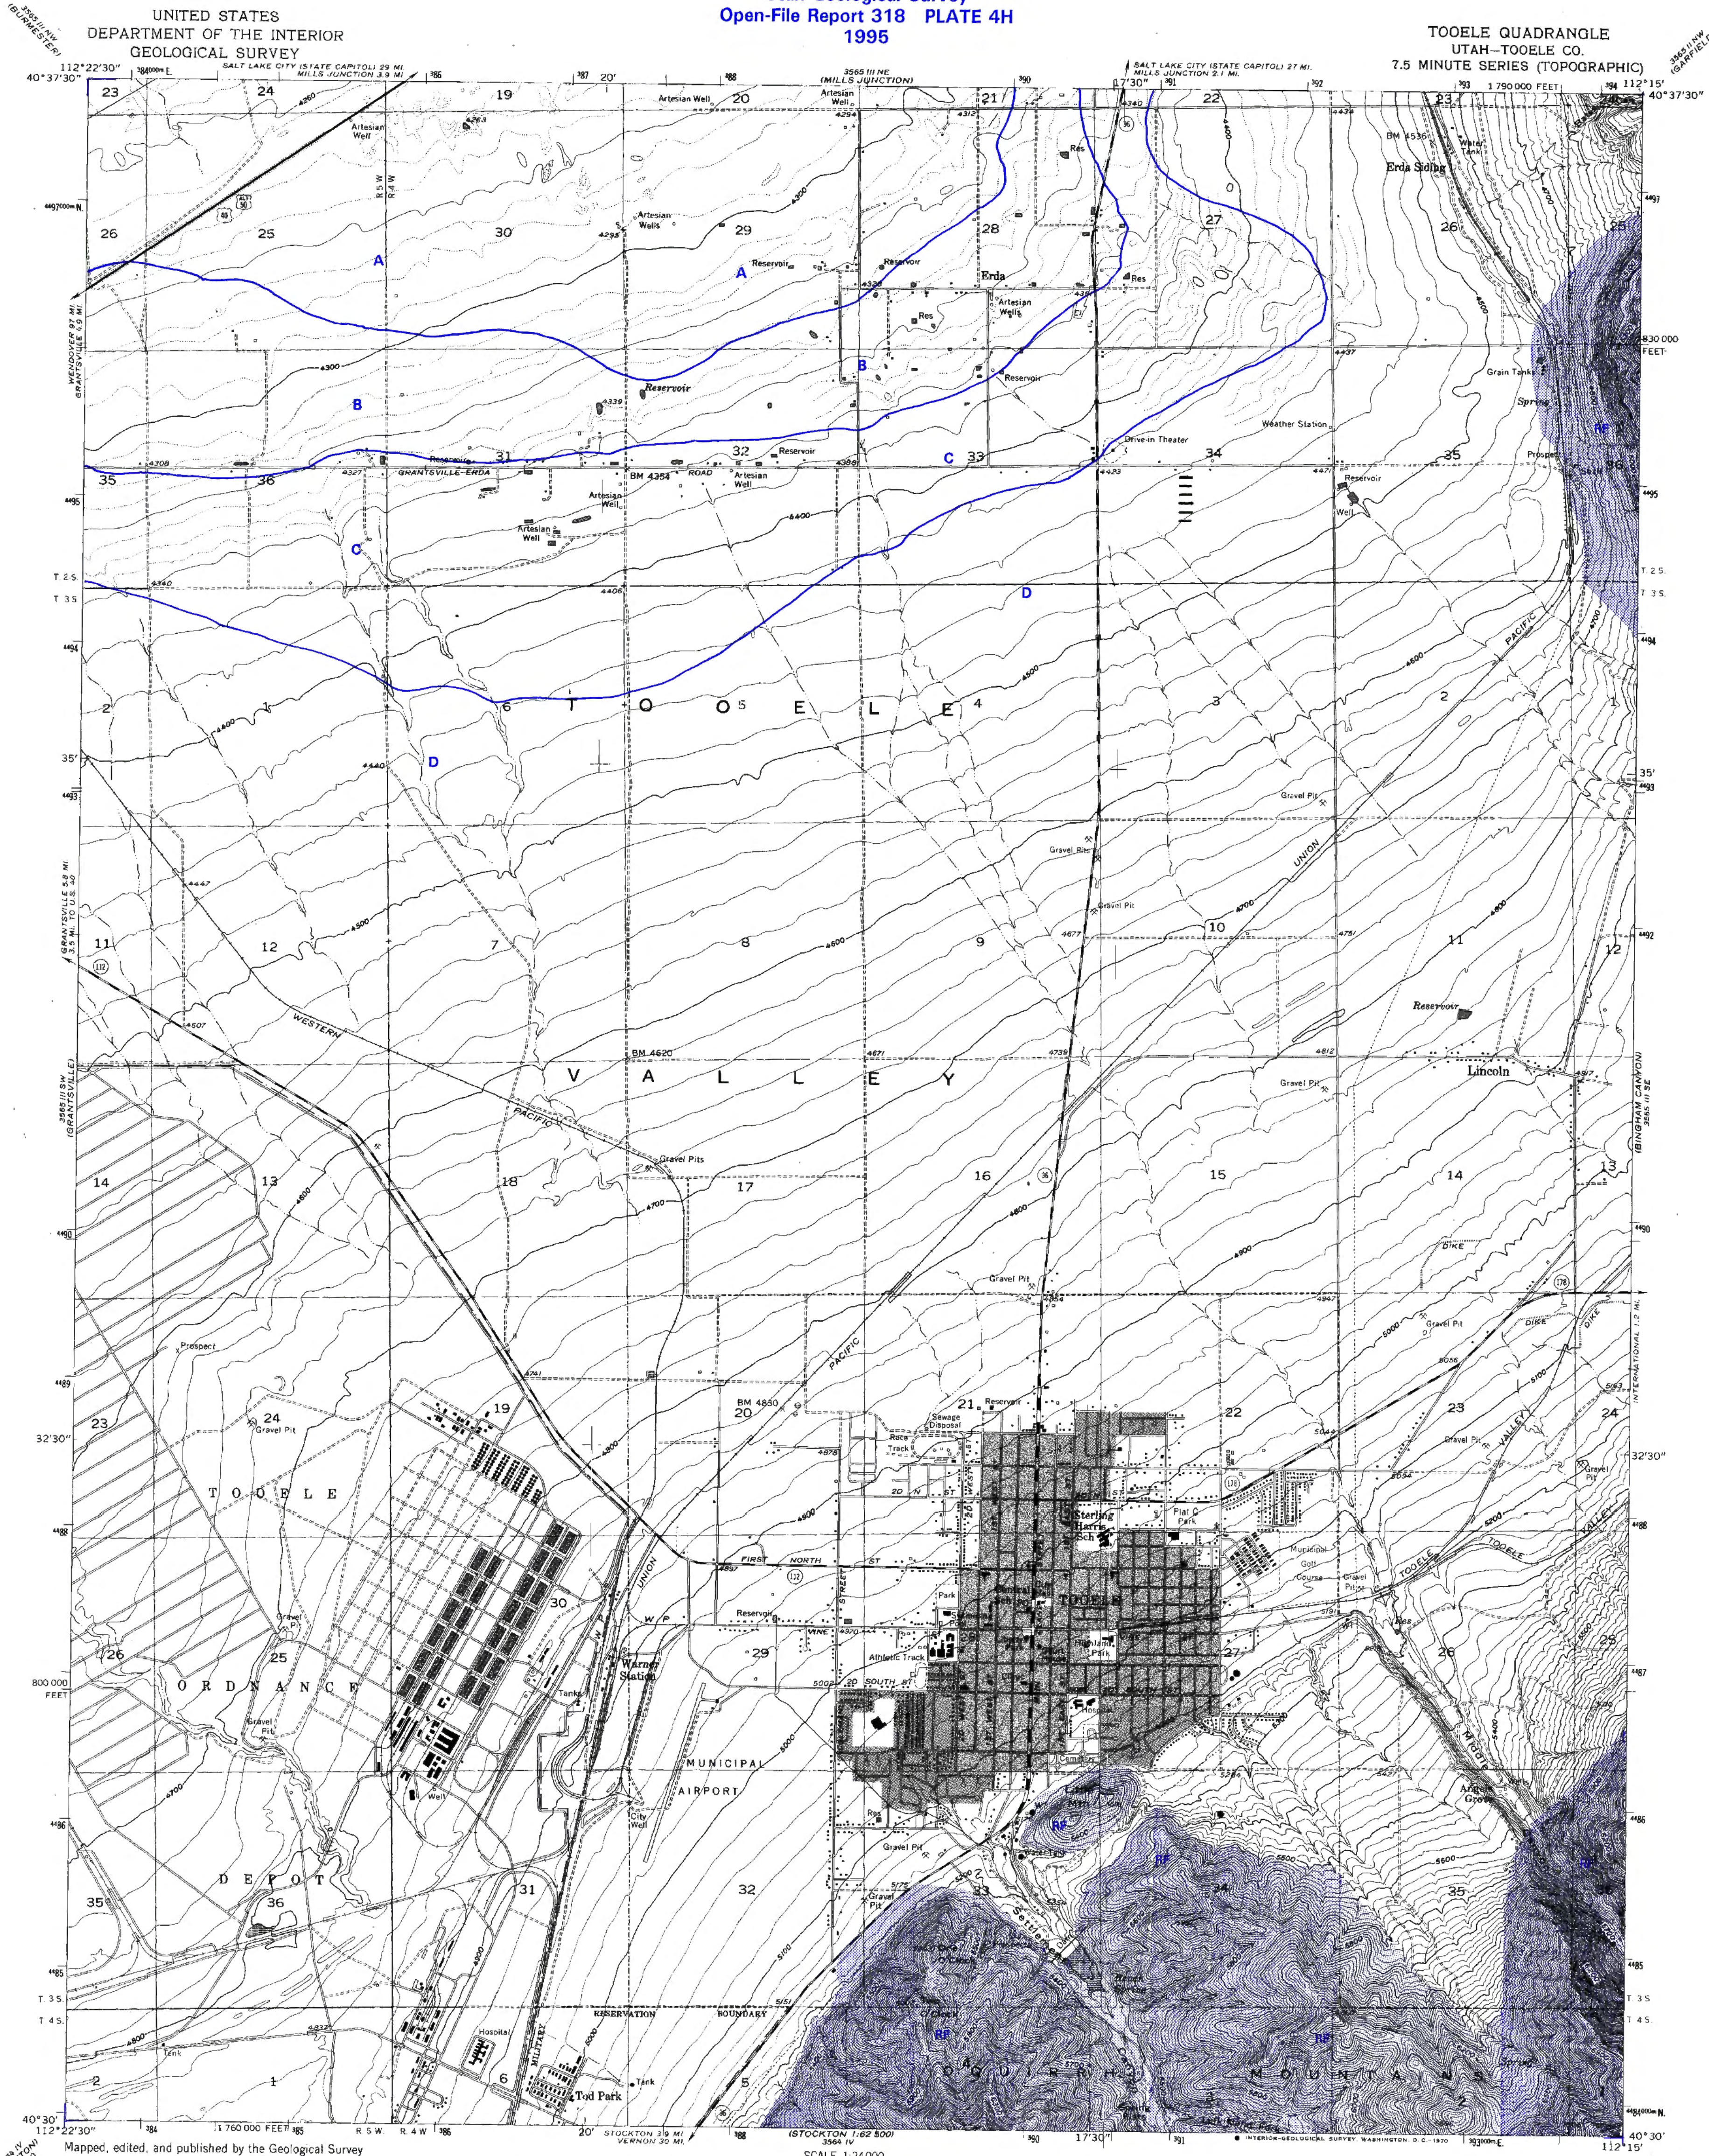
Rock-fall hazard and depth to ground water, Tooele quadrangle, Tooele County, Utah.

A* Less than 10 feet (3 m).
B 10 to 30 feet (3-9 m).
C 30 to 50 feet (9-15 m).
D Greater than 50 feet (15 m).

* Special studies are recommended in areas subject to rock fall and where the depth to ground water is less than 10 feet (3 m) (see table 1).

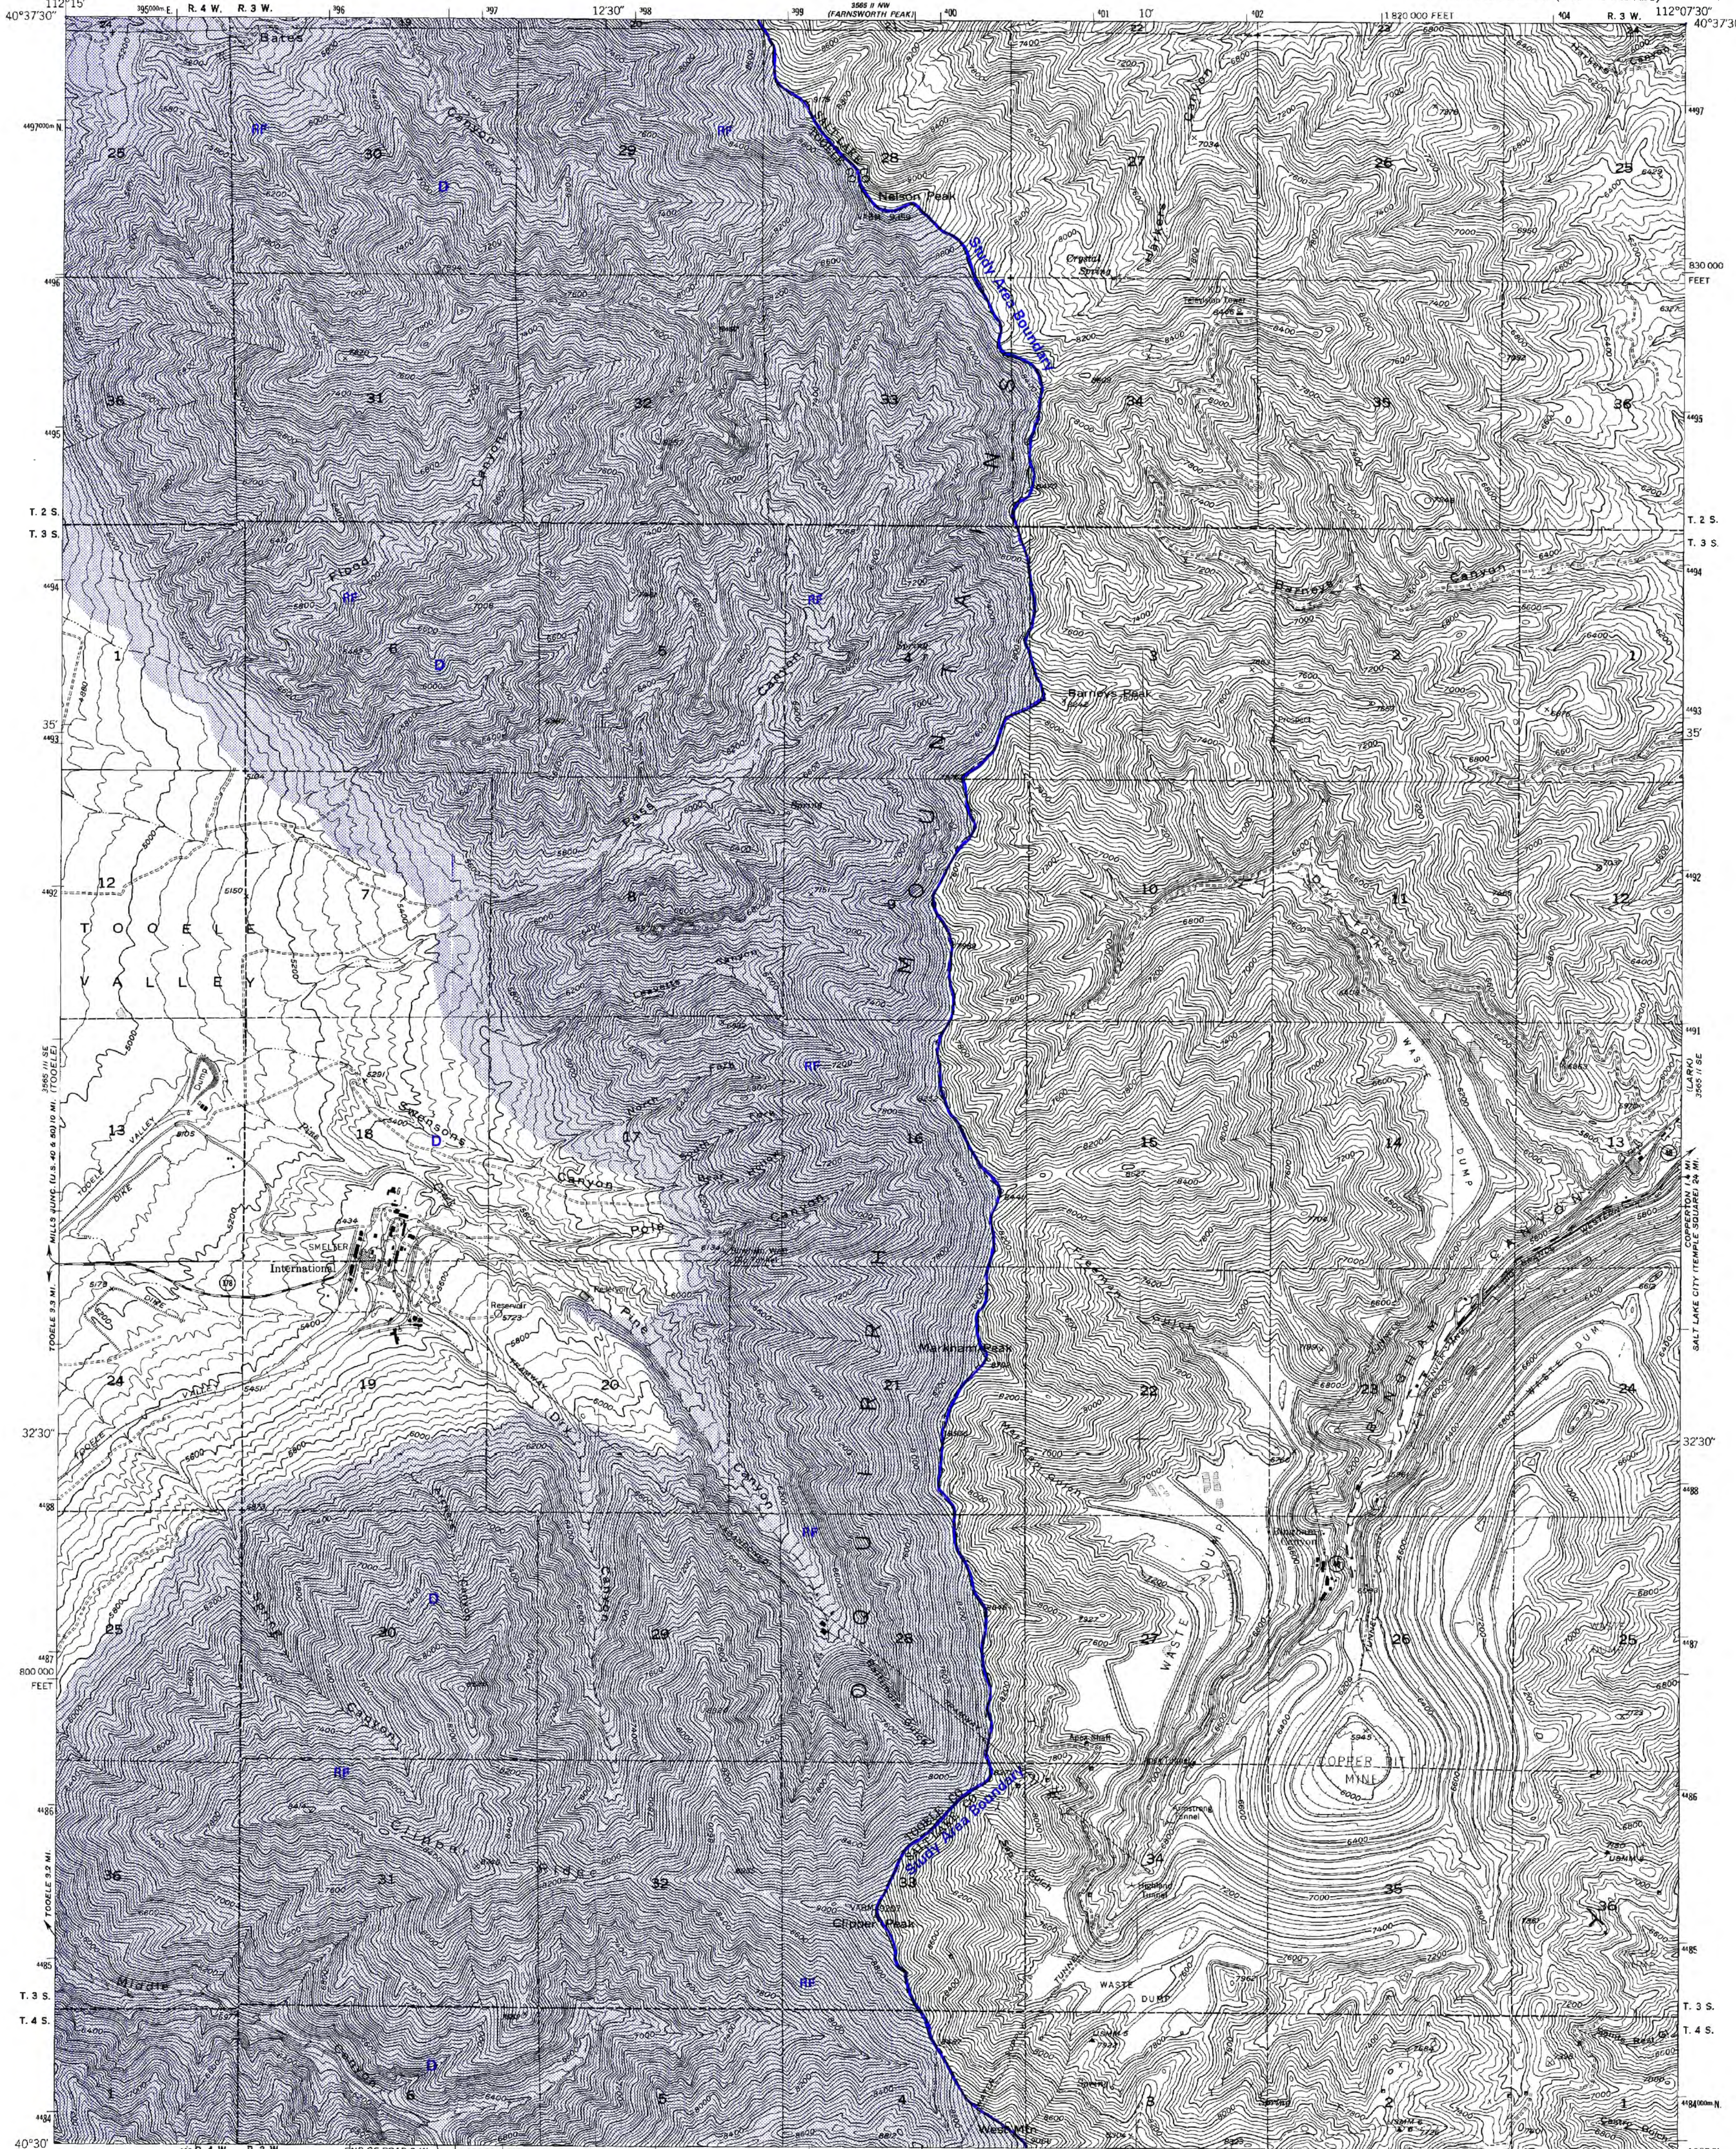
Rock-fall hazard and depth to ground water, Bingham Canyon quadrangle,
Tooele County, Utah.

* Special studies are recommended in areas subject to rock fall and where the depth
to ground water is less than 10 feet (3 m) (see table 1).

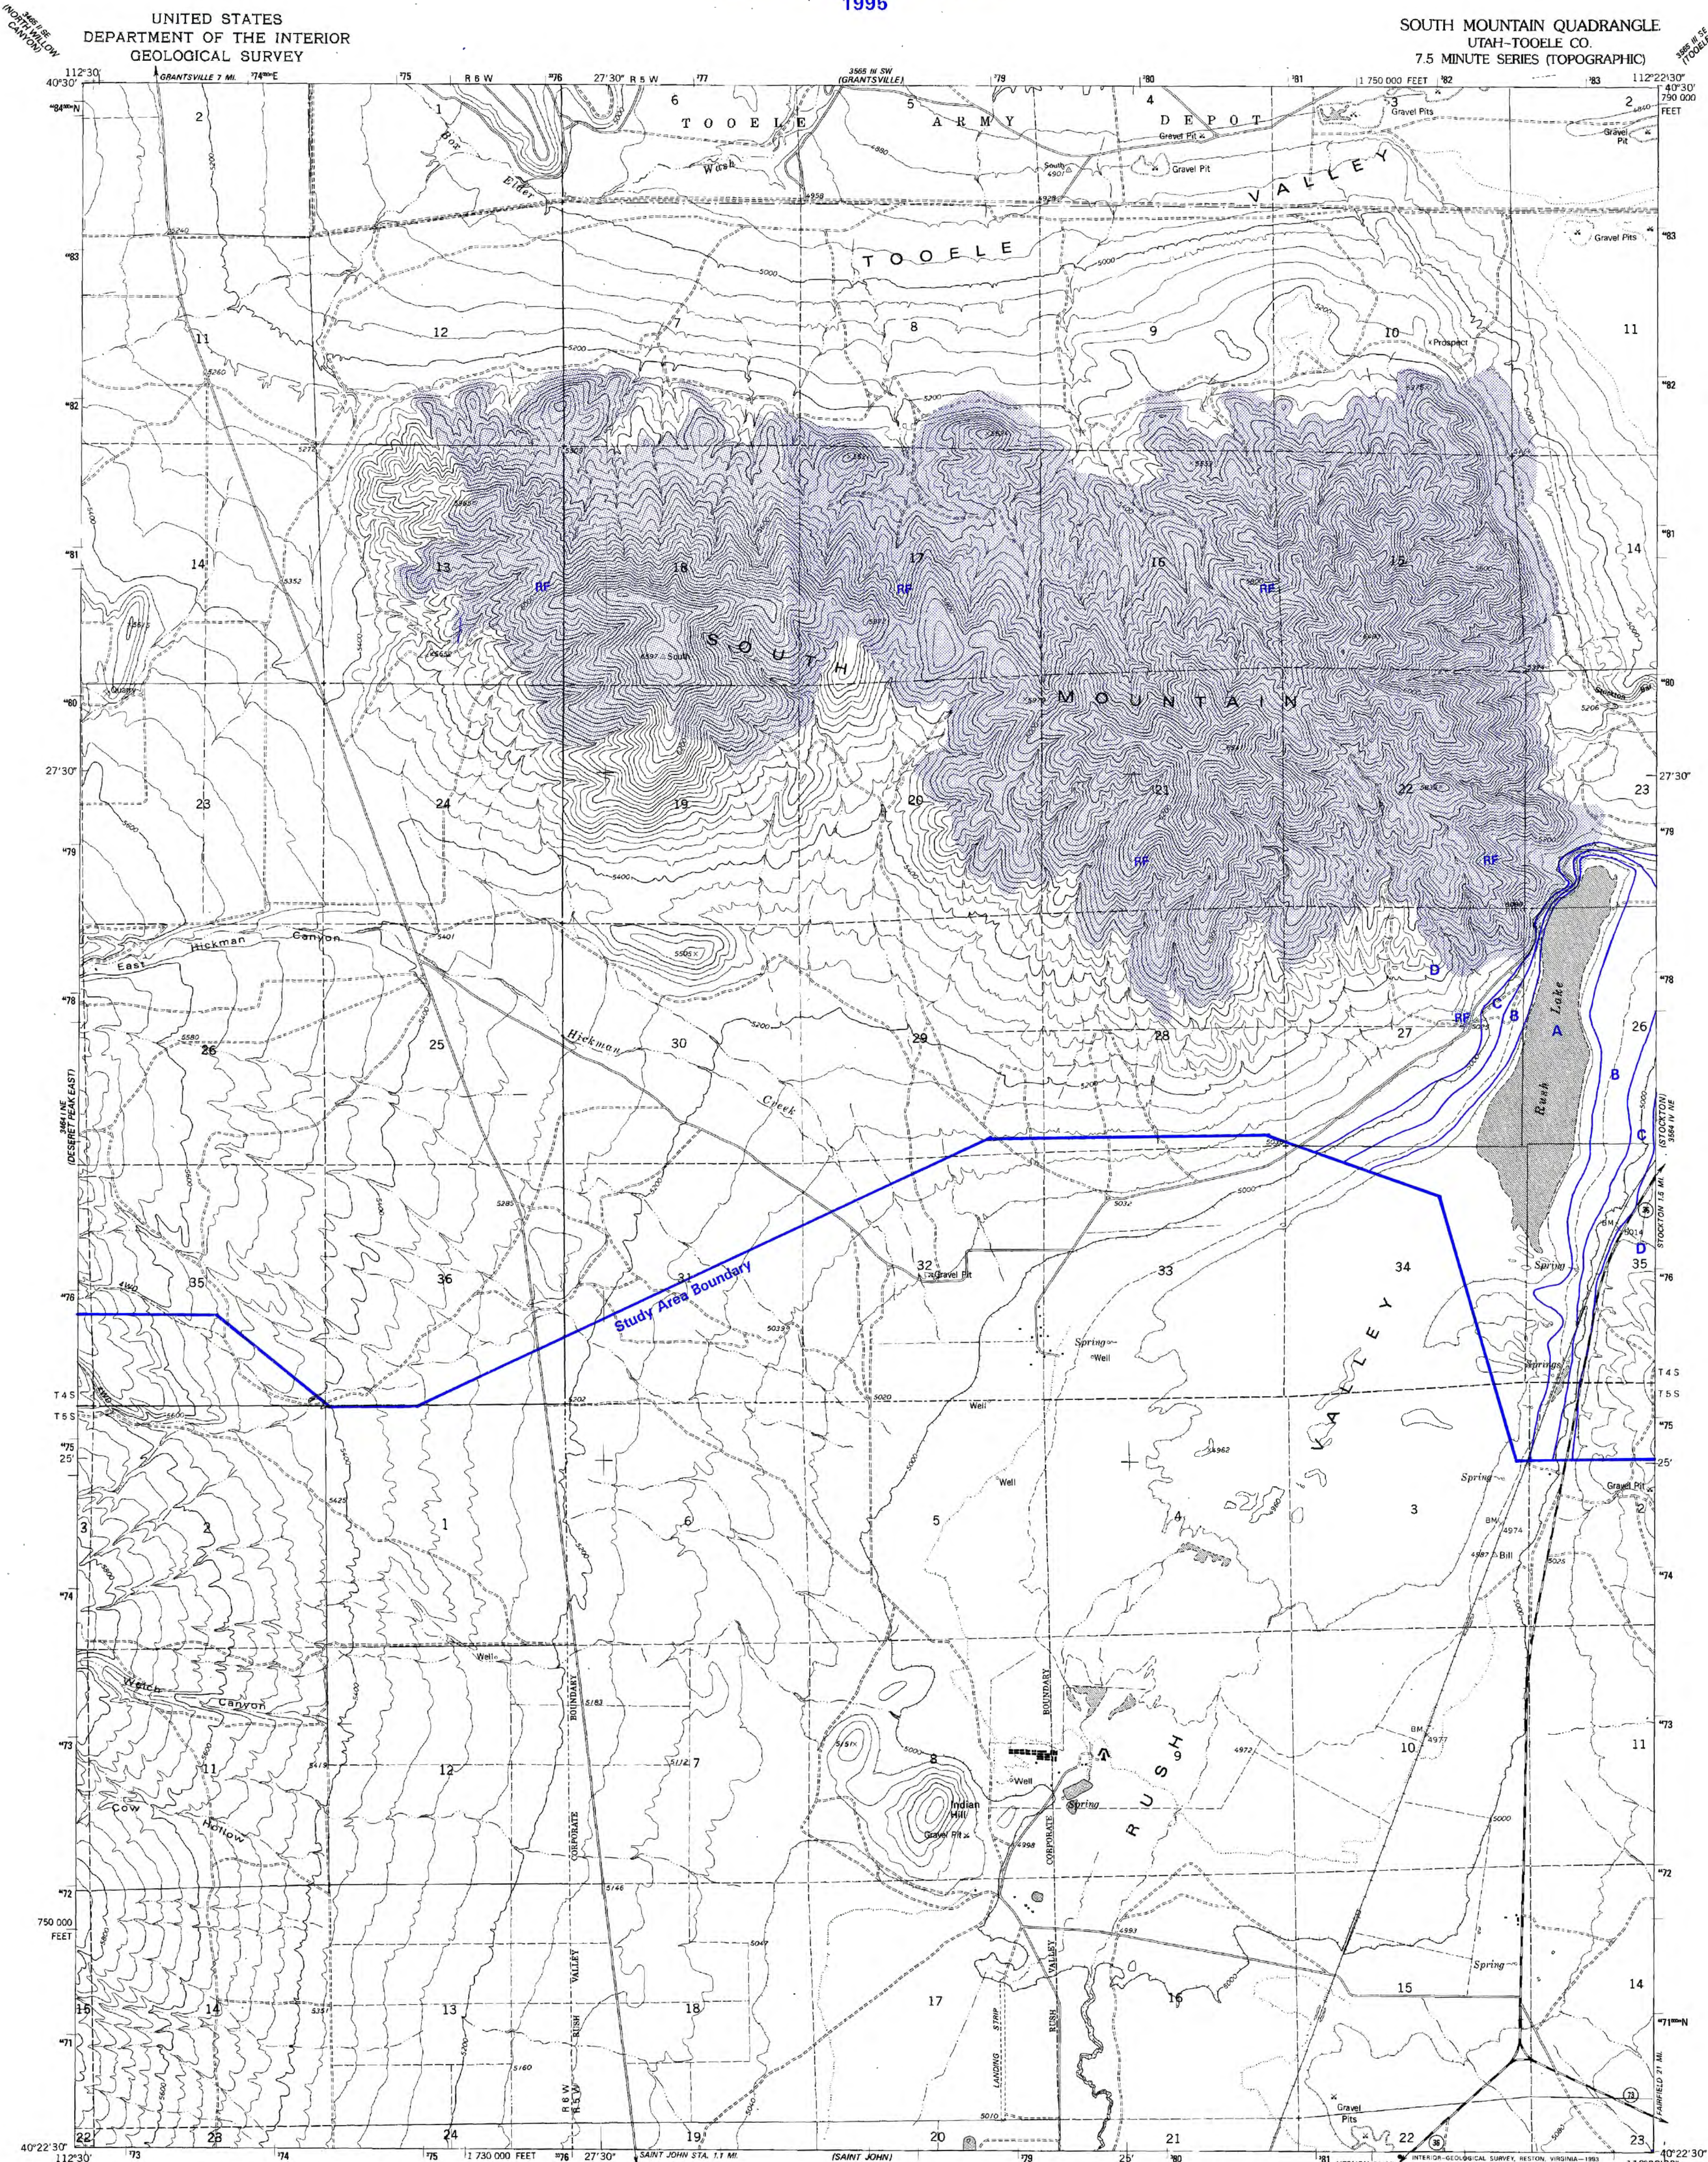
Rock-fall hazard and depth to ground water, South Mountain quadrangle, Tooele County, Utah.

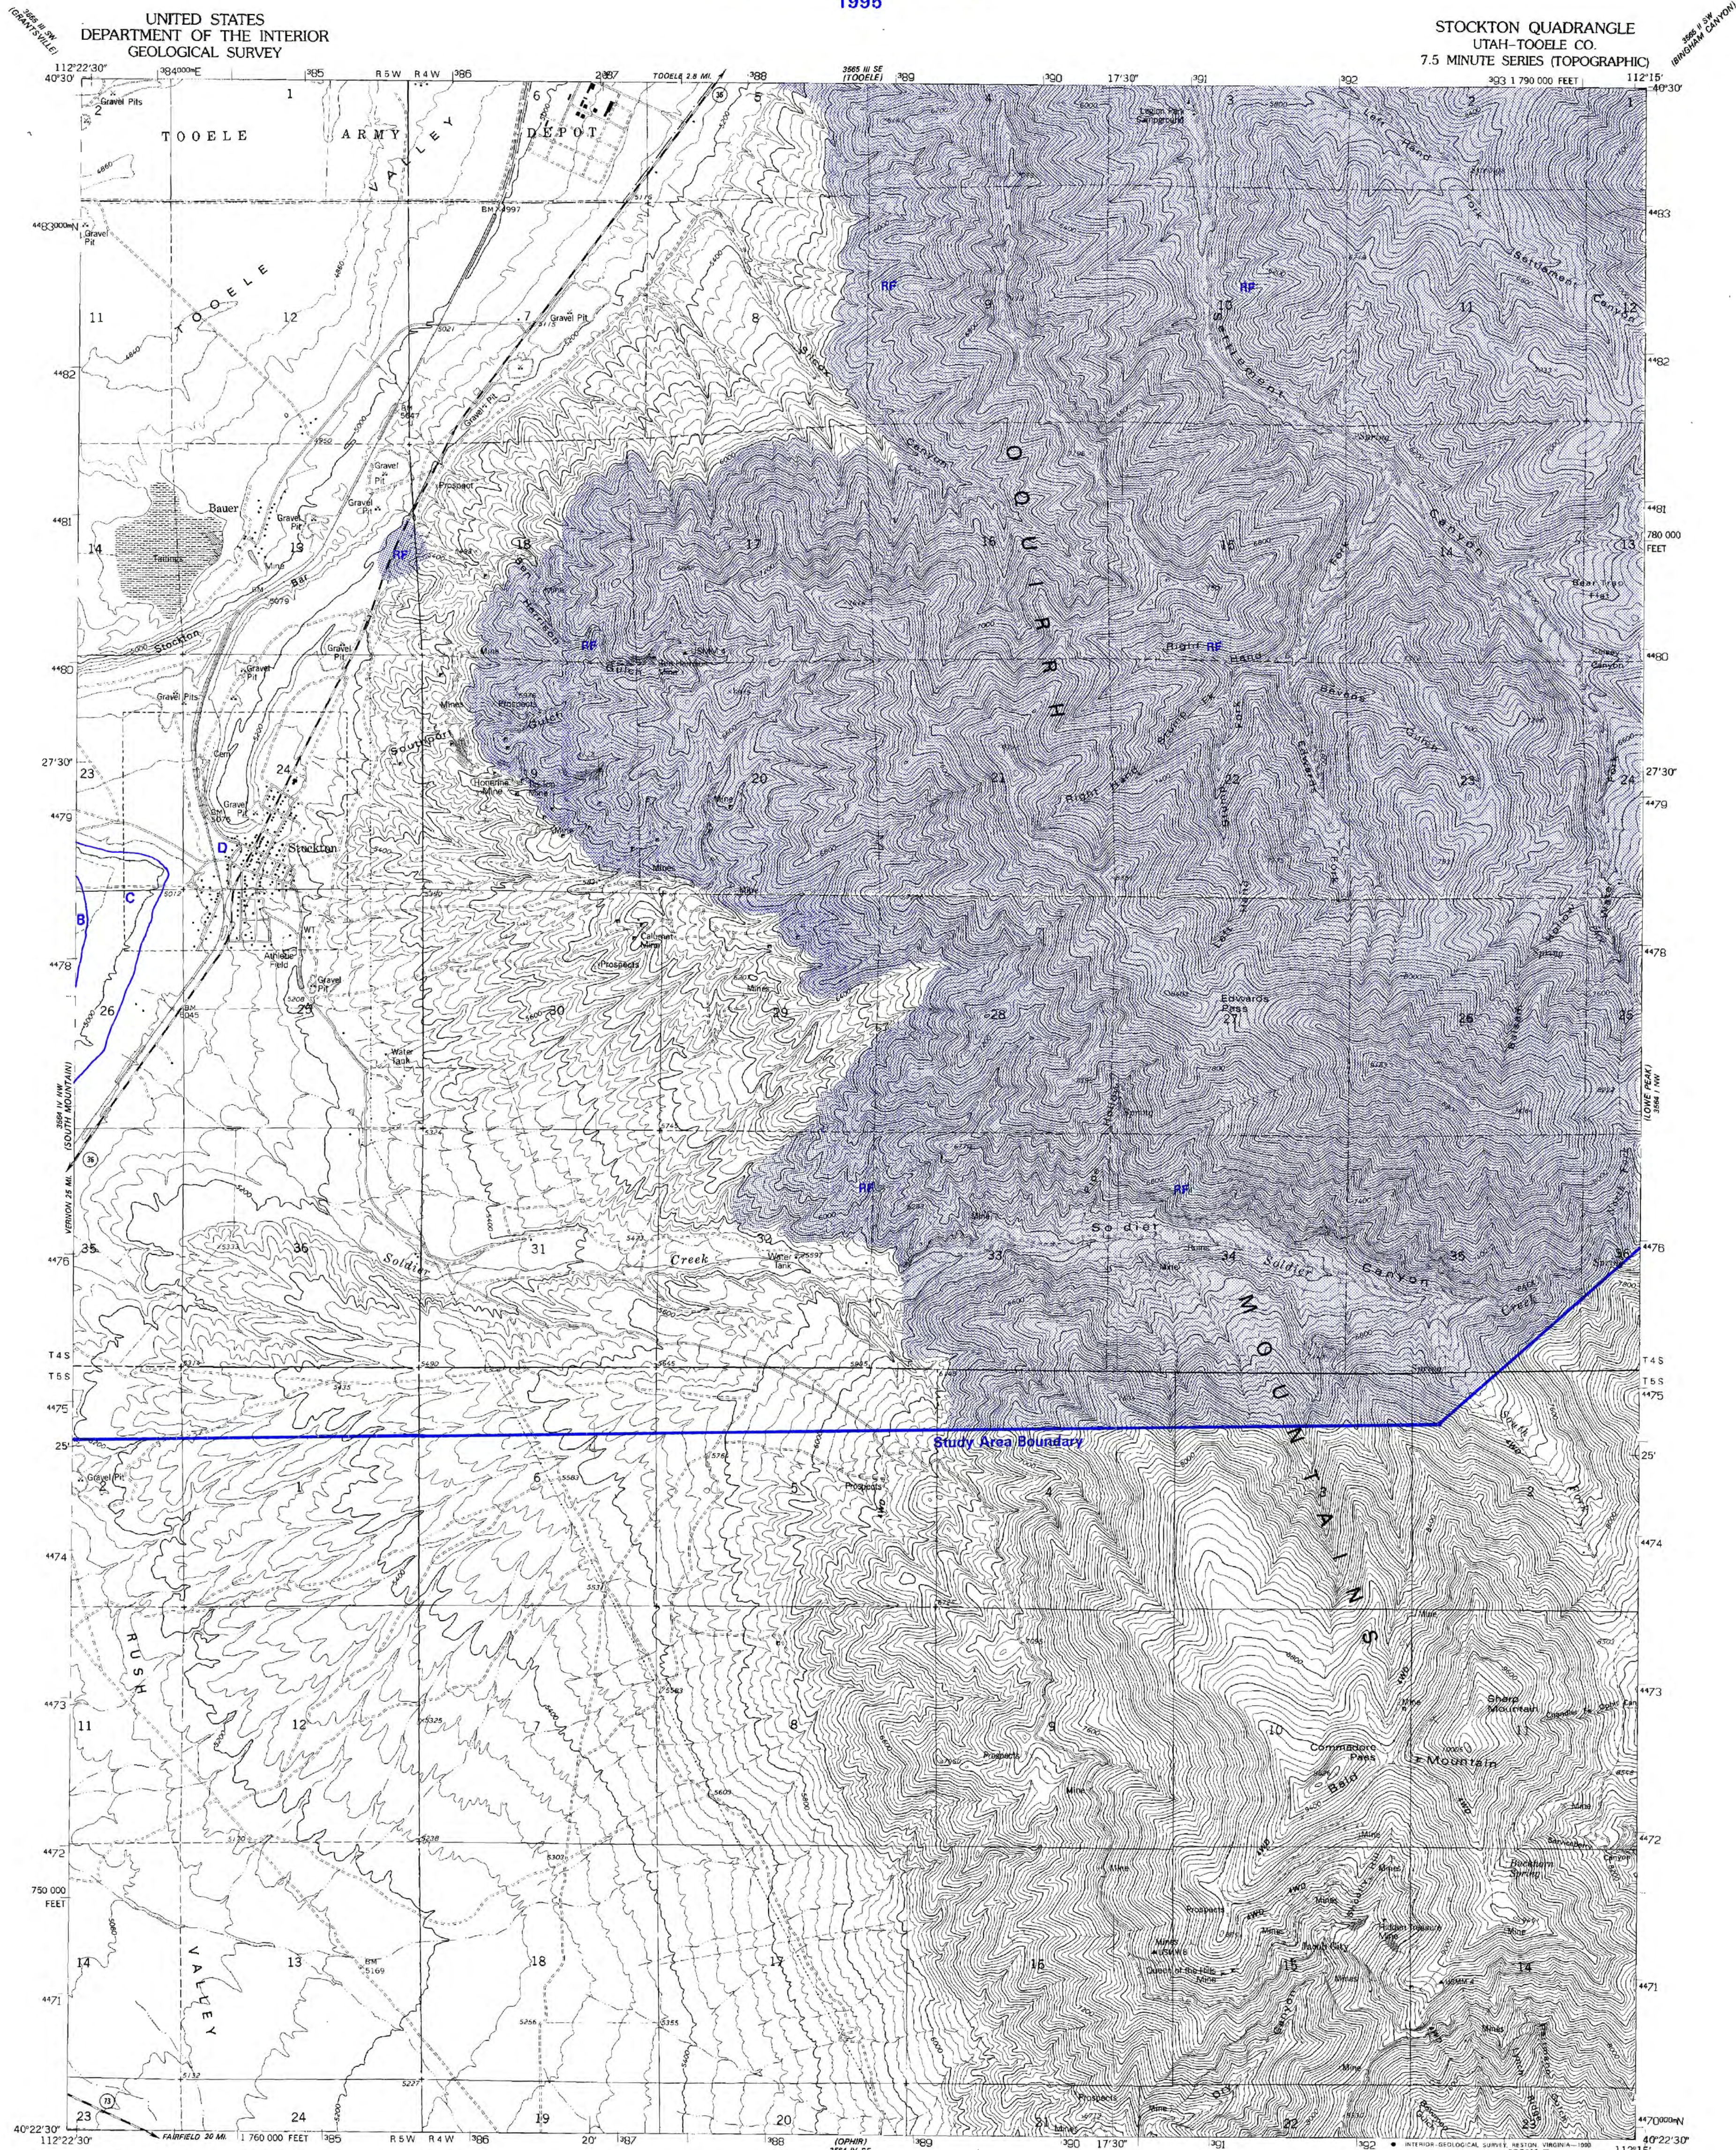
Rock-fall hazard and depth to ground water, Stockton quadrangle, Tooele County, Utah.
