GEOLOGIC HAZARDS AND LAND-USE PLANNING FOR TOOELE VALLEY AND THE WEST DESERT HAZARDOUS INDUSTRY AREA, TOOELE COUNTY, UTAH

Barry J. Solomon and Bill D. Black, editors

OPEN-FILE REPORT 318
UTAH GEOLOGICAL SURVEY
a division of
UTAH DEPARTMENT OF NATURAL RESOURCES

October 1995

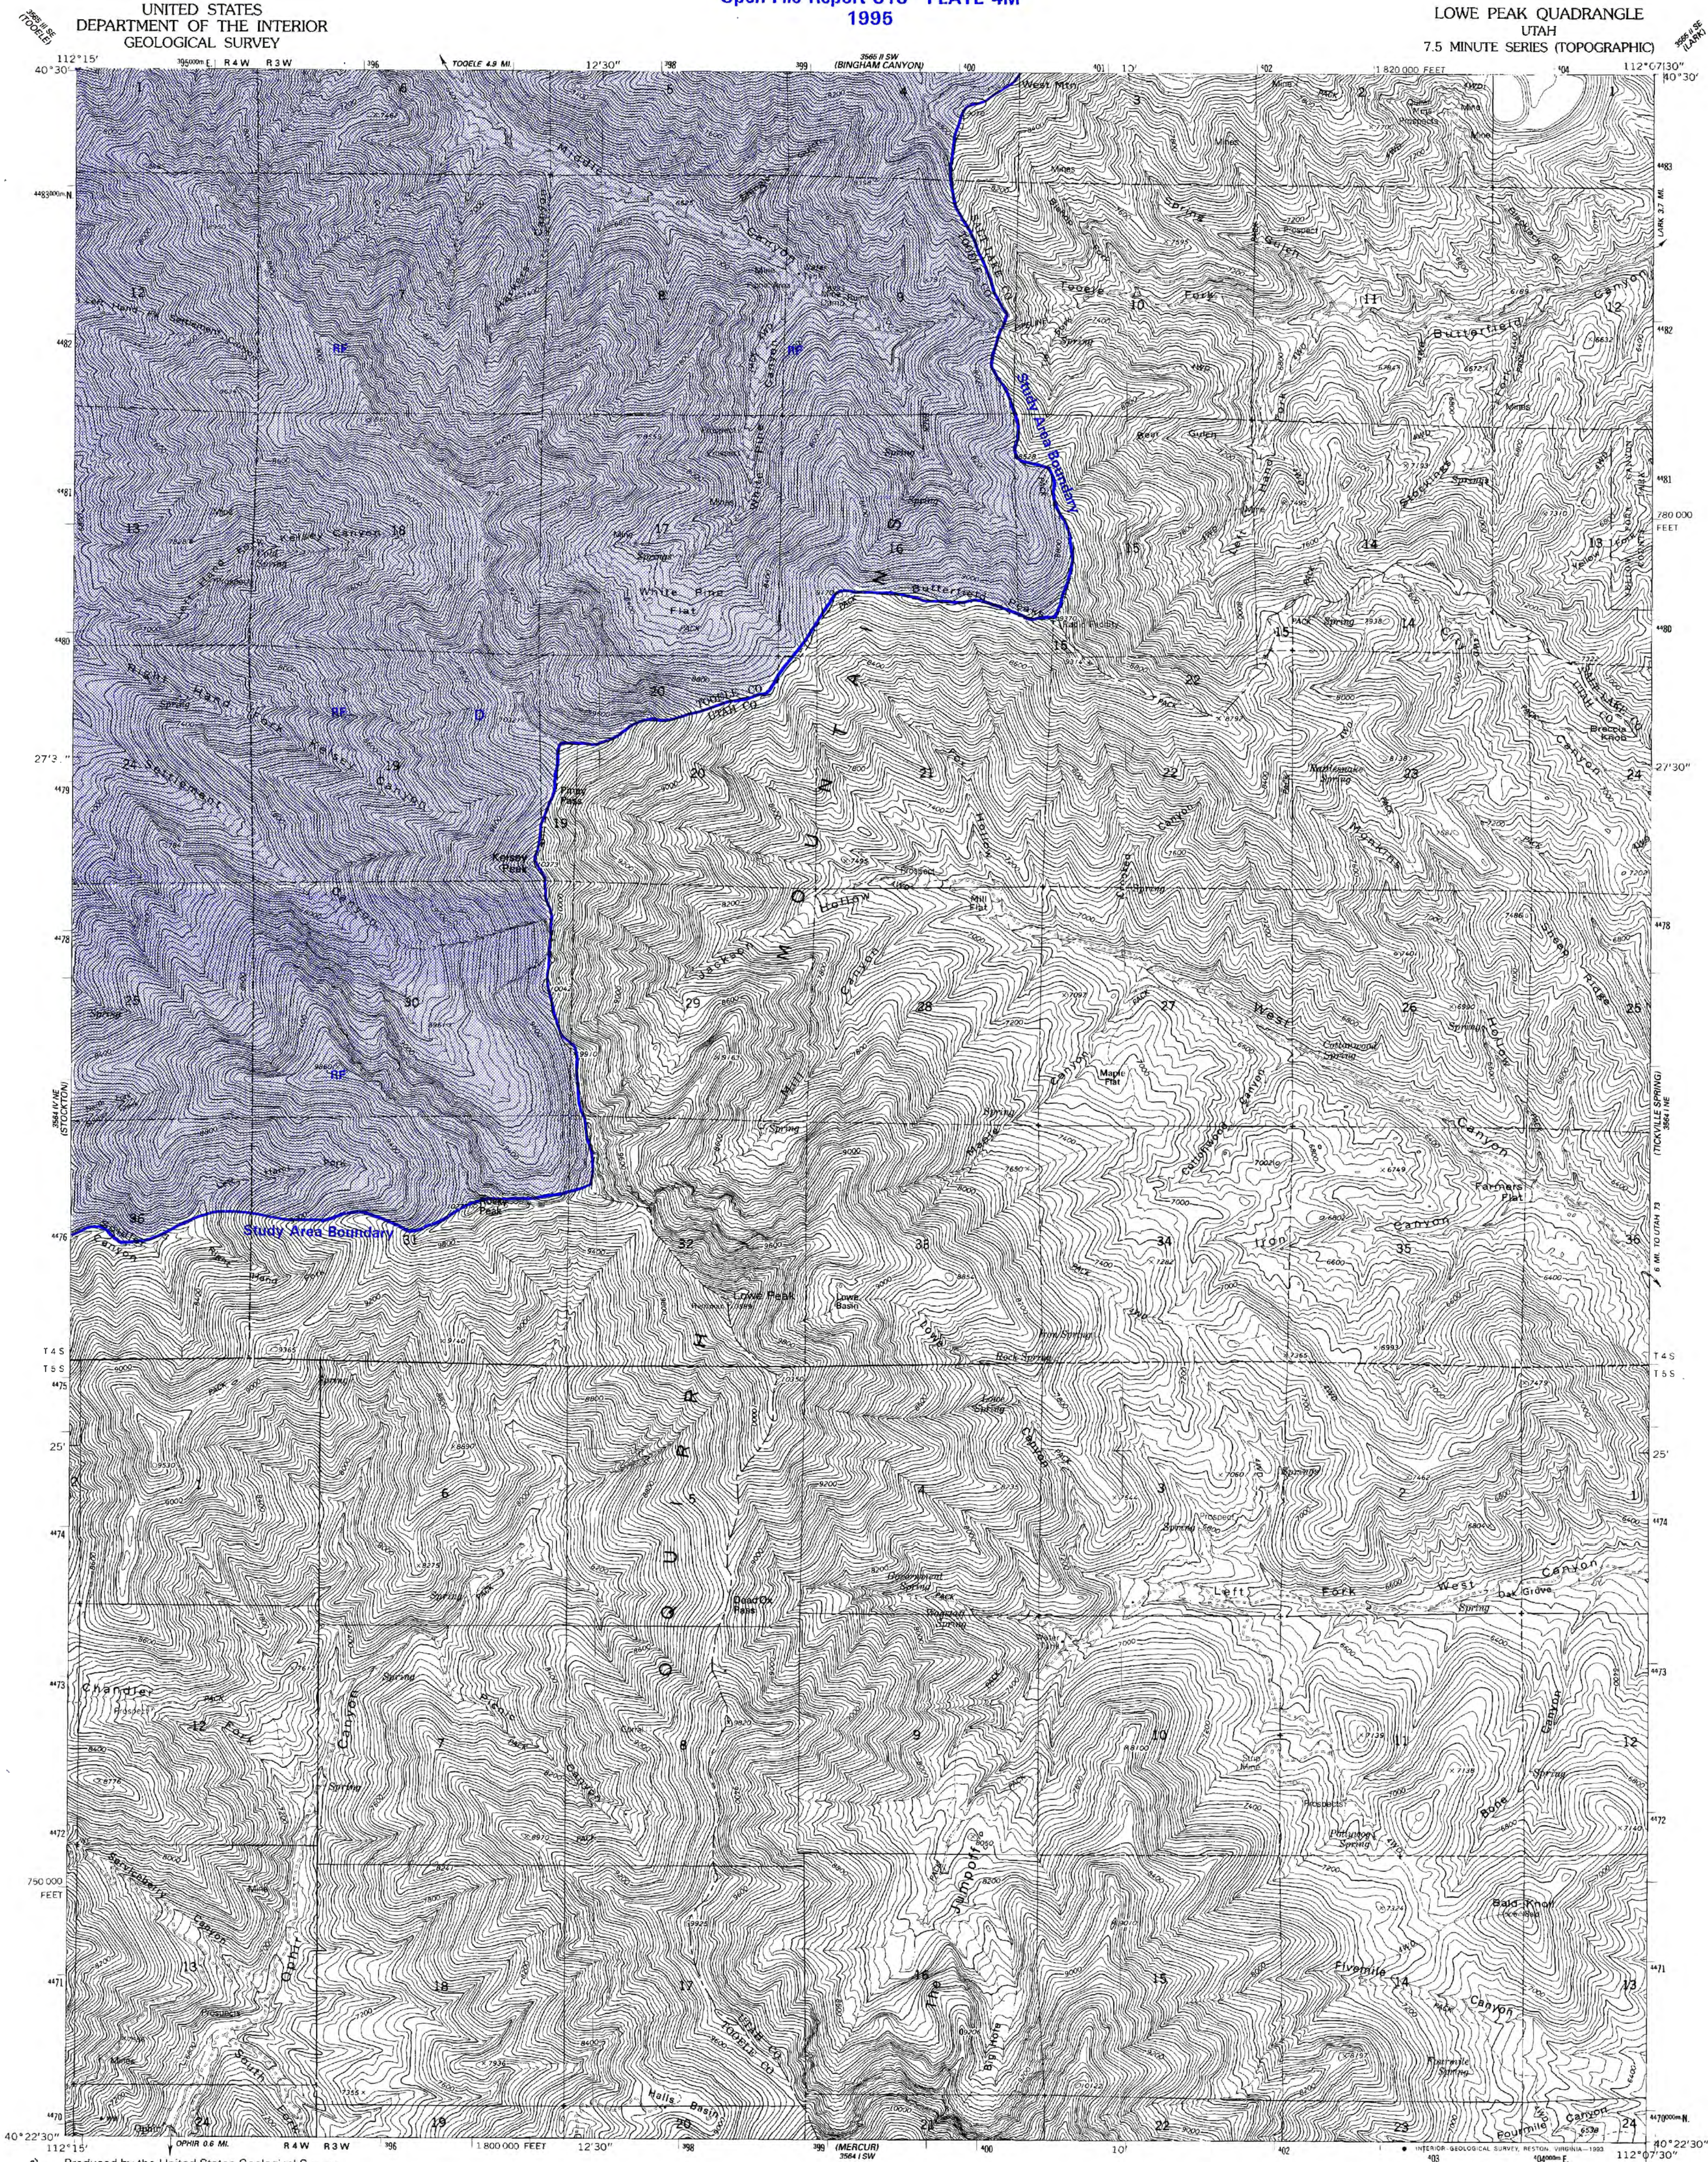
Rock-fall hazard and depth to ground water, Lowe Peak quadrangle, Tooele County, Utah.

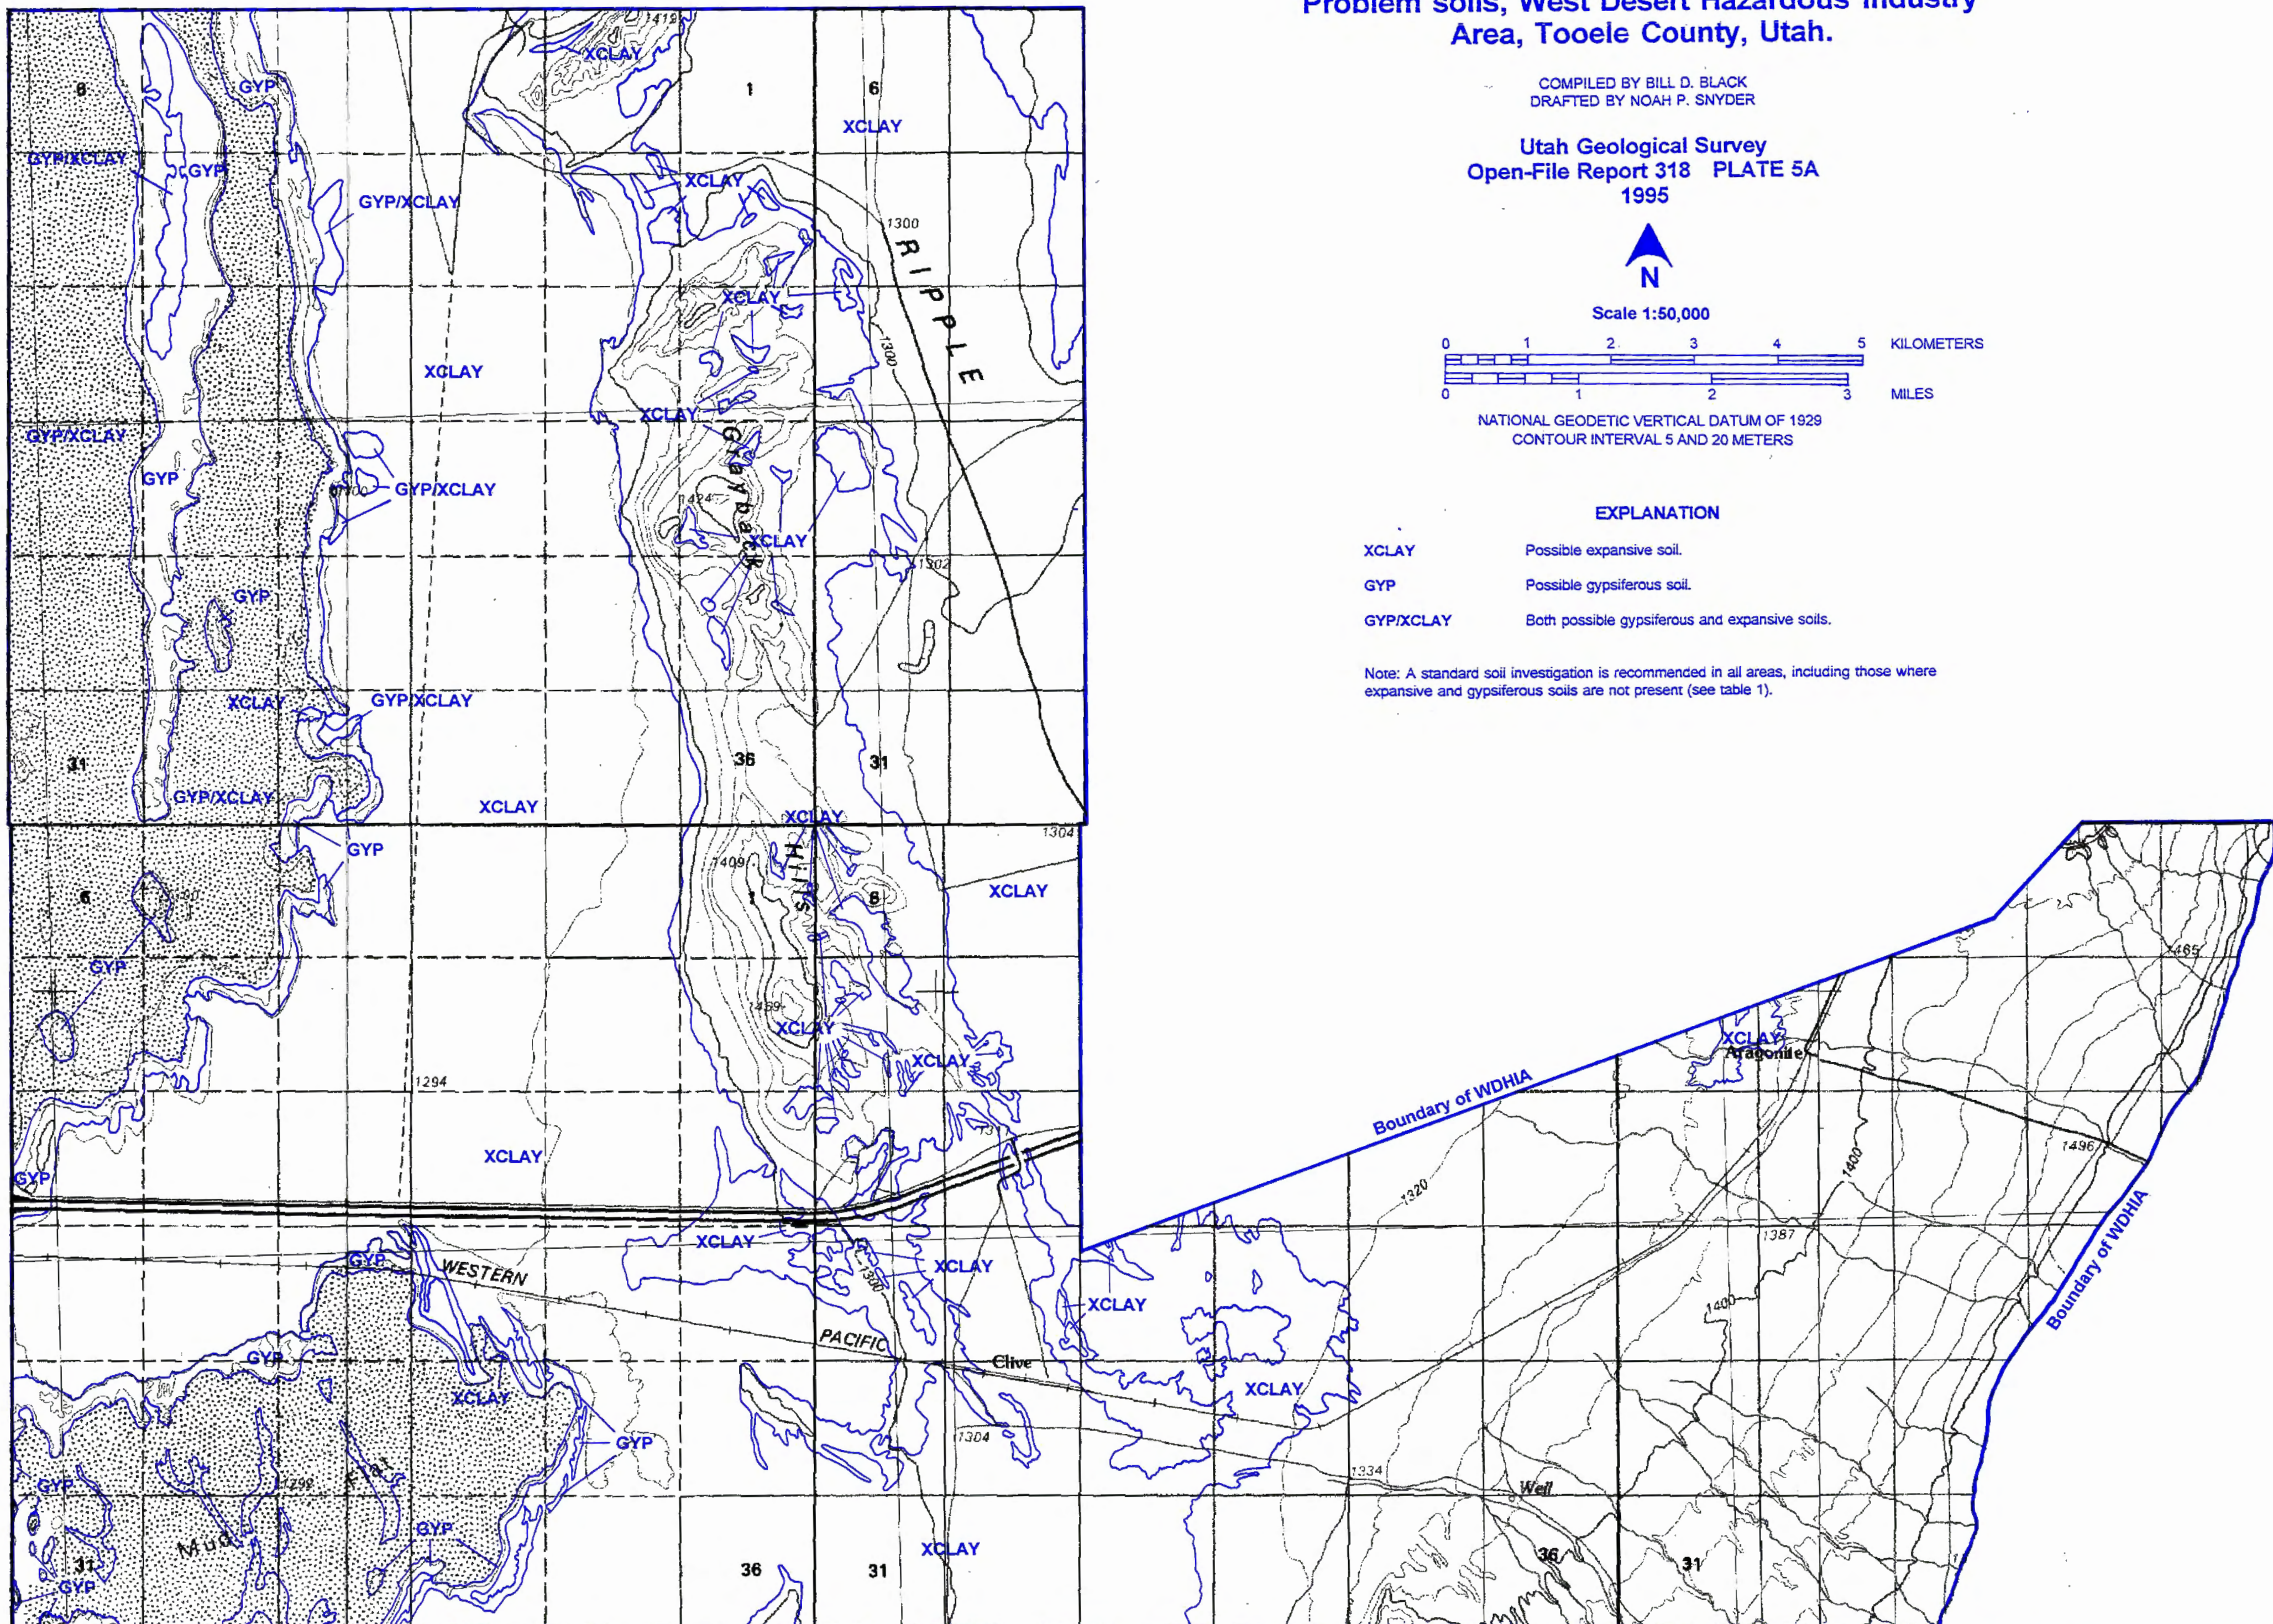
Problem soils, Flux quadrangle, Tooele County, Utah.

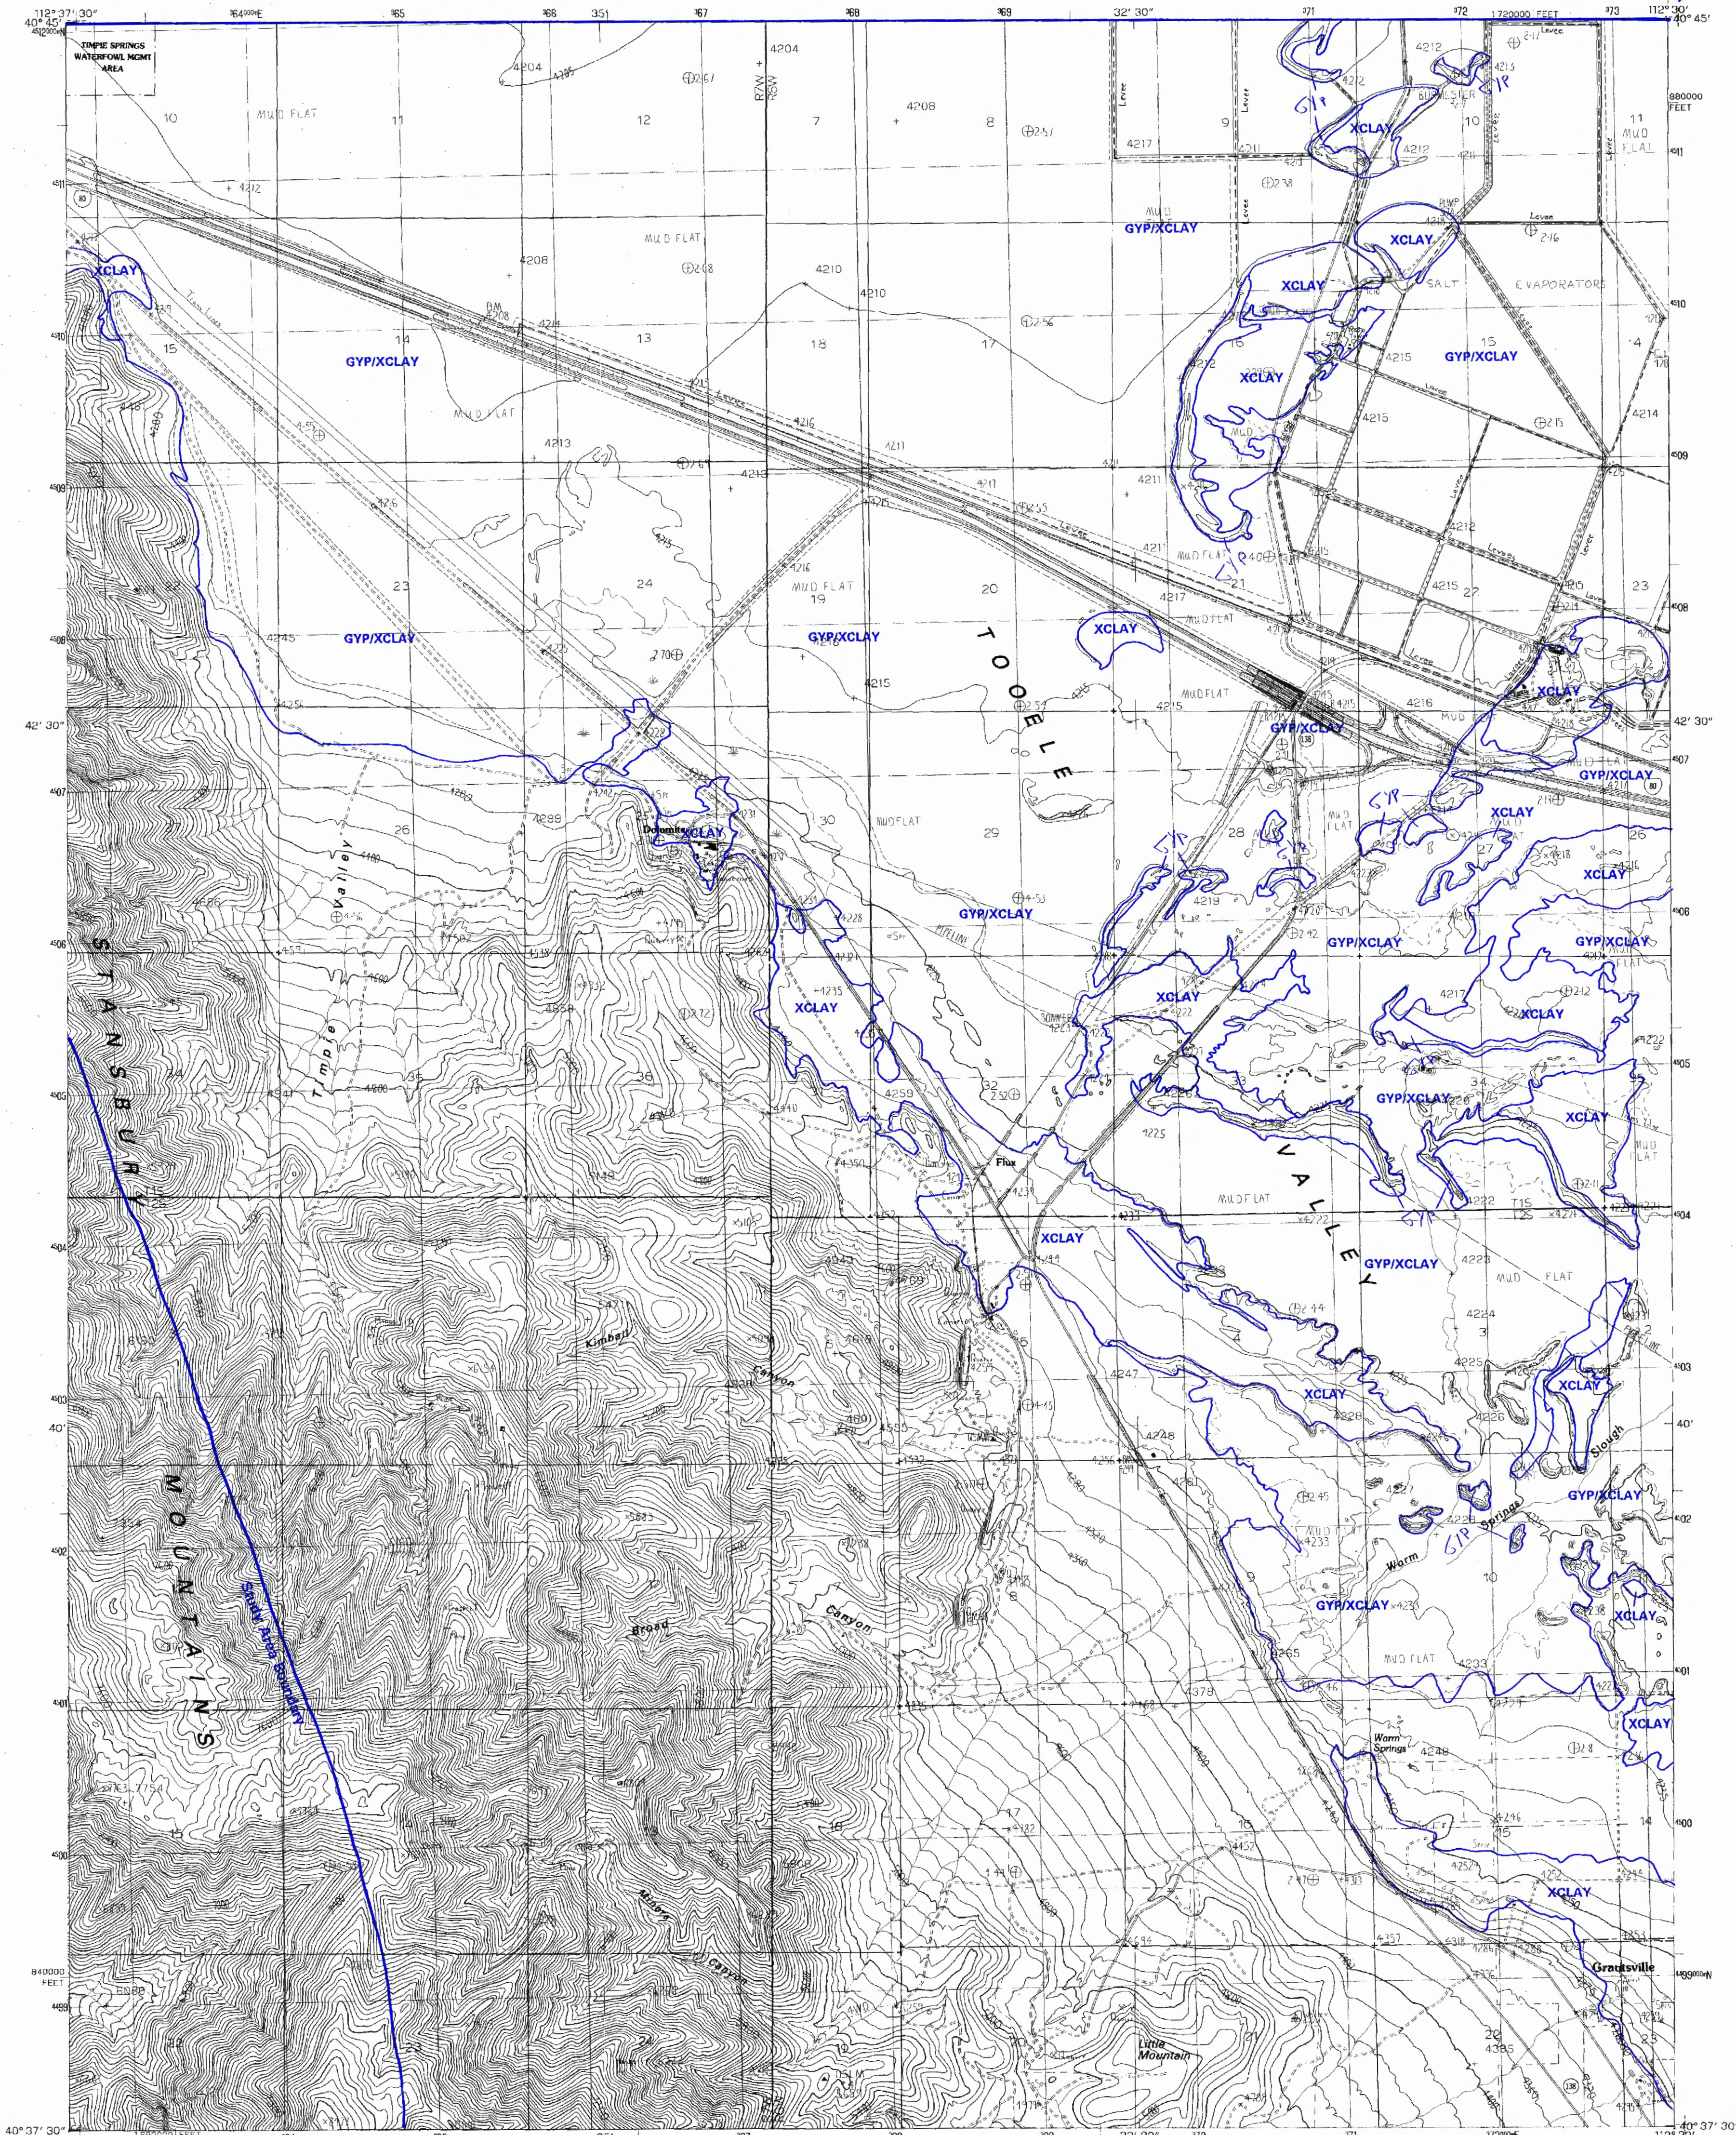
Utah Geological Survey
Open-File Report 318 PLATE 5B
1995

Note: A standard soil investigation is recommended in all areas, including those
where expansive and gypsiferous soils are not present (see table 1).

Plate 5 shows the likely extent of expansive and gypsiferous soils, based on surficial geology, in the WDHIA and Tooele Valley (figure L-5). The map is designed to highlight areas where these soils may be present and should be evaluated in standard soil-foundation investigations prior to development. In hazard areas, improperly designed roads and structures can be susceptible to damage. The maps are generalized and other localized areas may occur outside of mapped problem-soil areas. Areas where piping or mine subsidence may be found were not mapped.

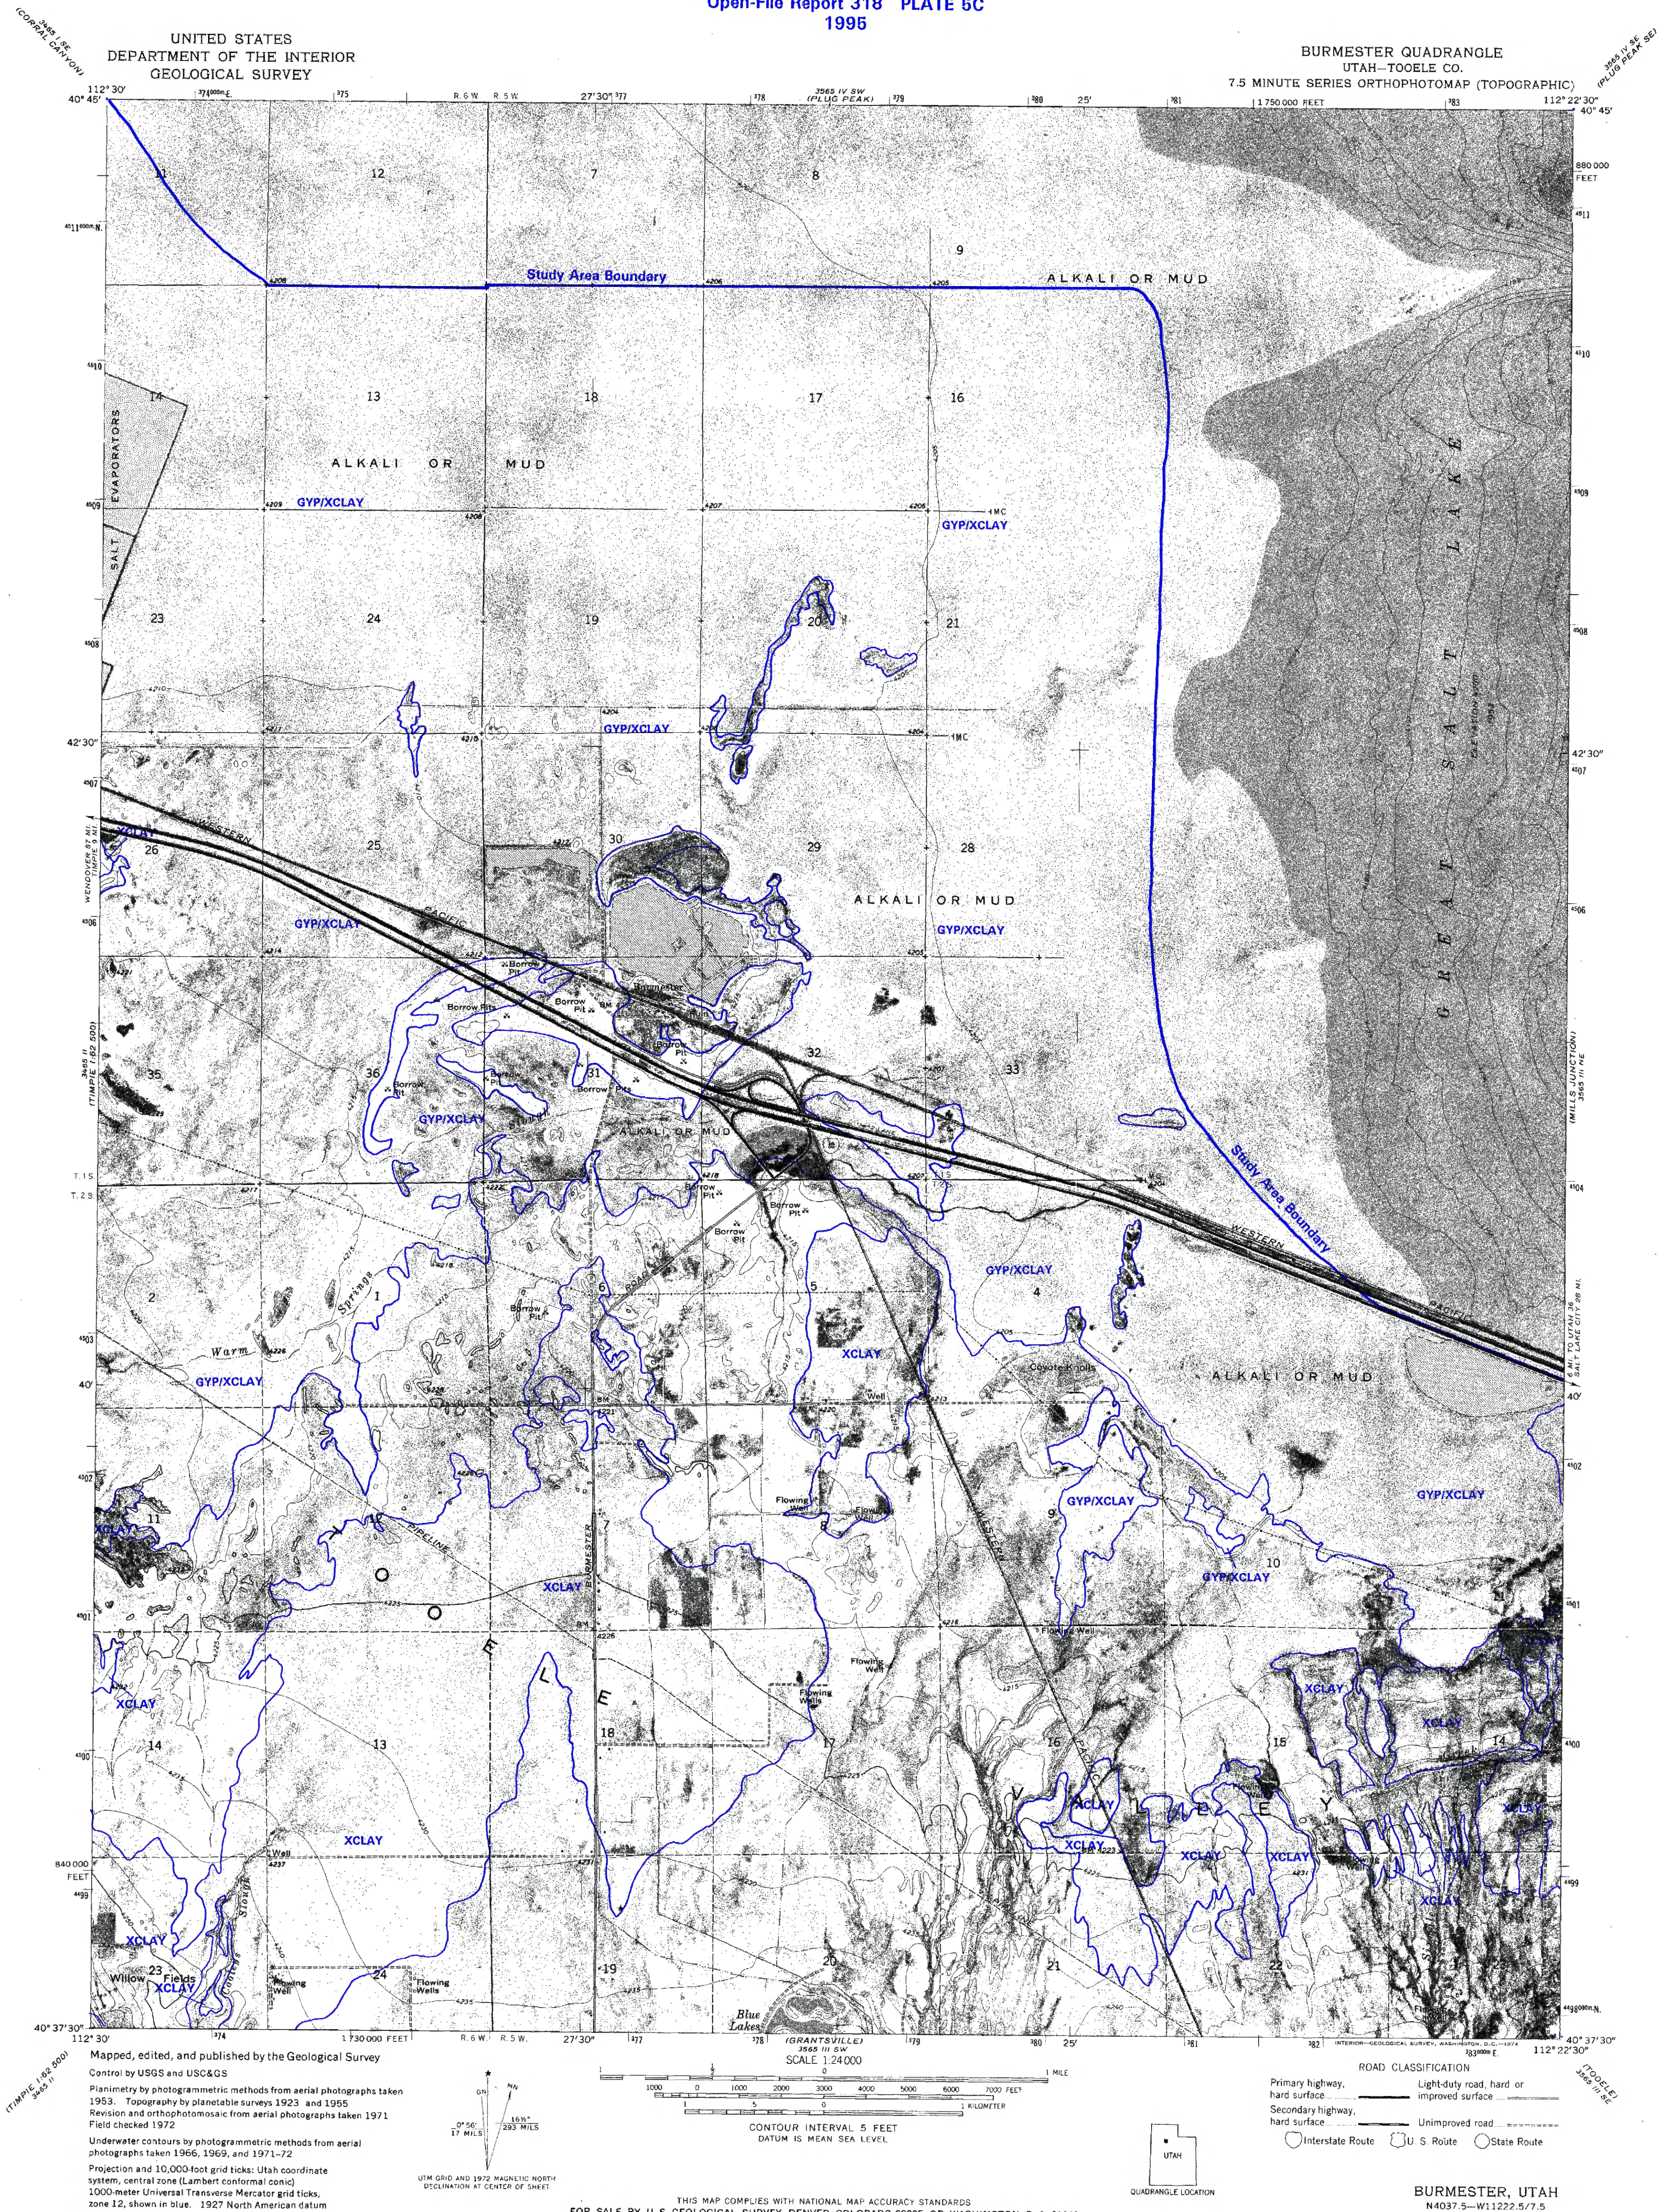
Utah Geological Survey
Open-File Report 318 PLATE 5C
1995

Problem soils, Burmester quadrangle, Tooele County, Utah.

Note: A standard soil investigation is recommended in all areas, including those where expansive and gypsiferous soils are not present (see table 1).

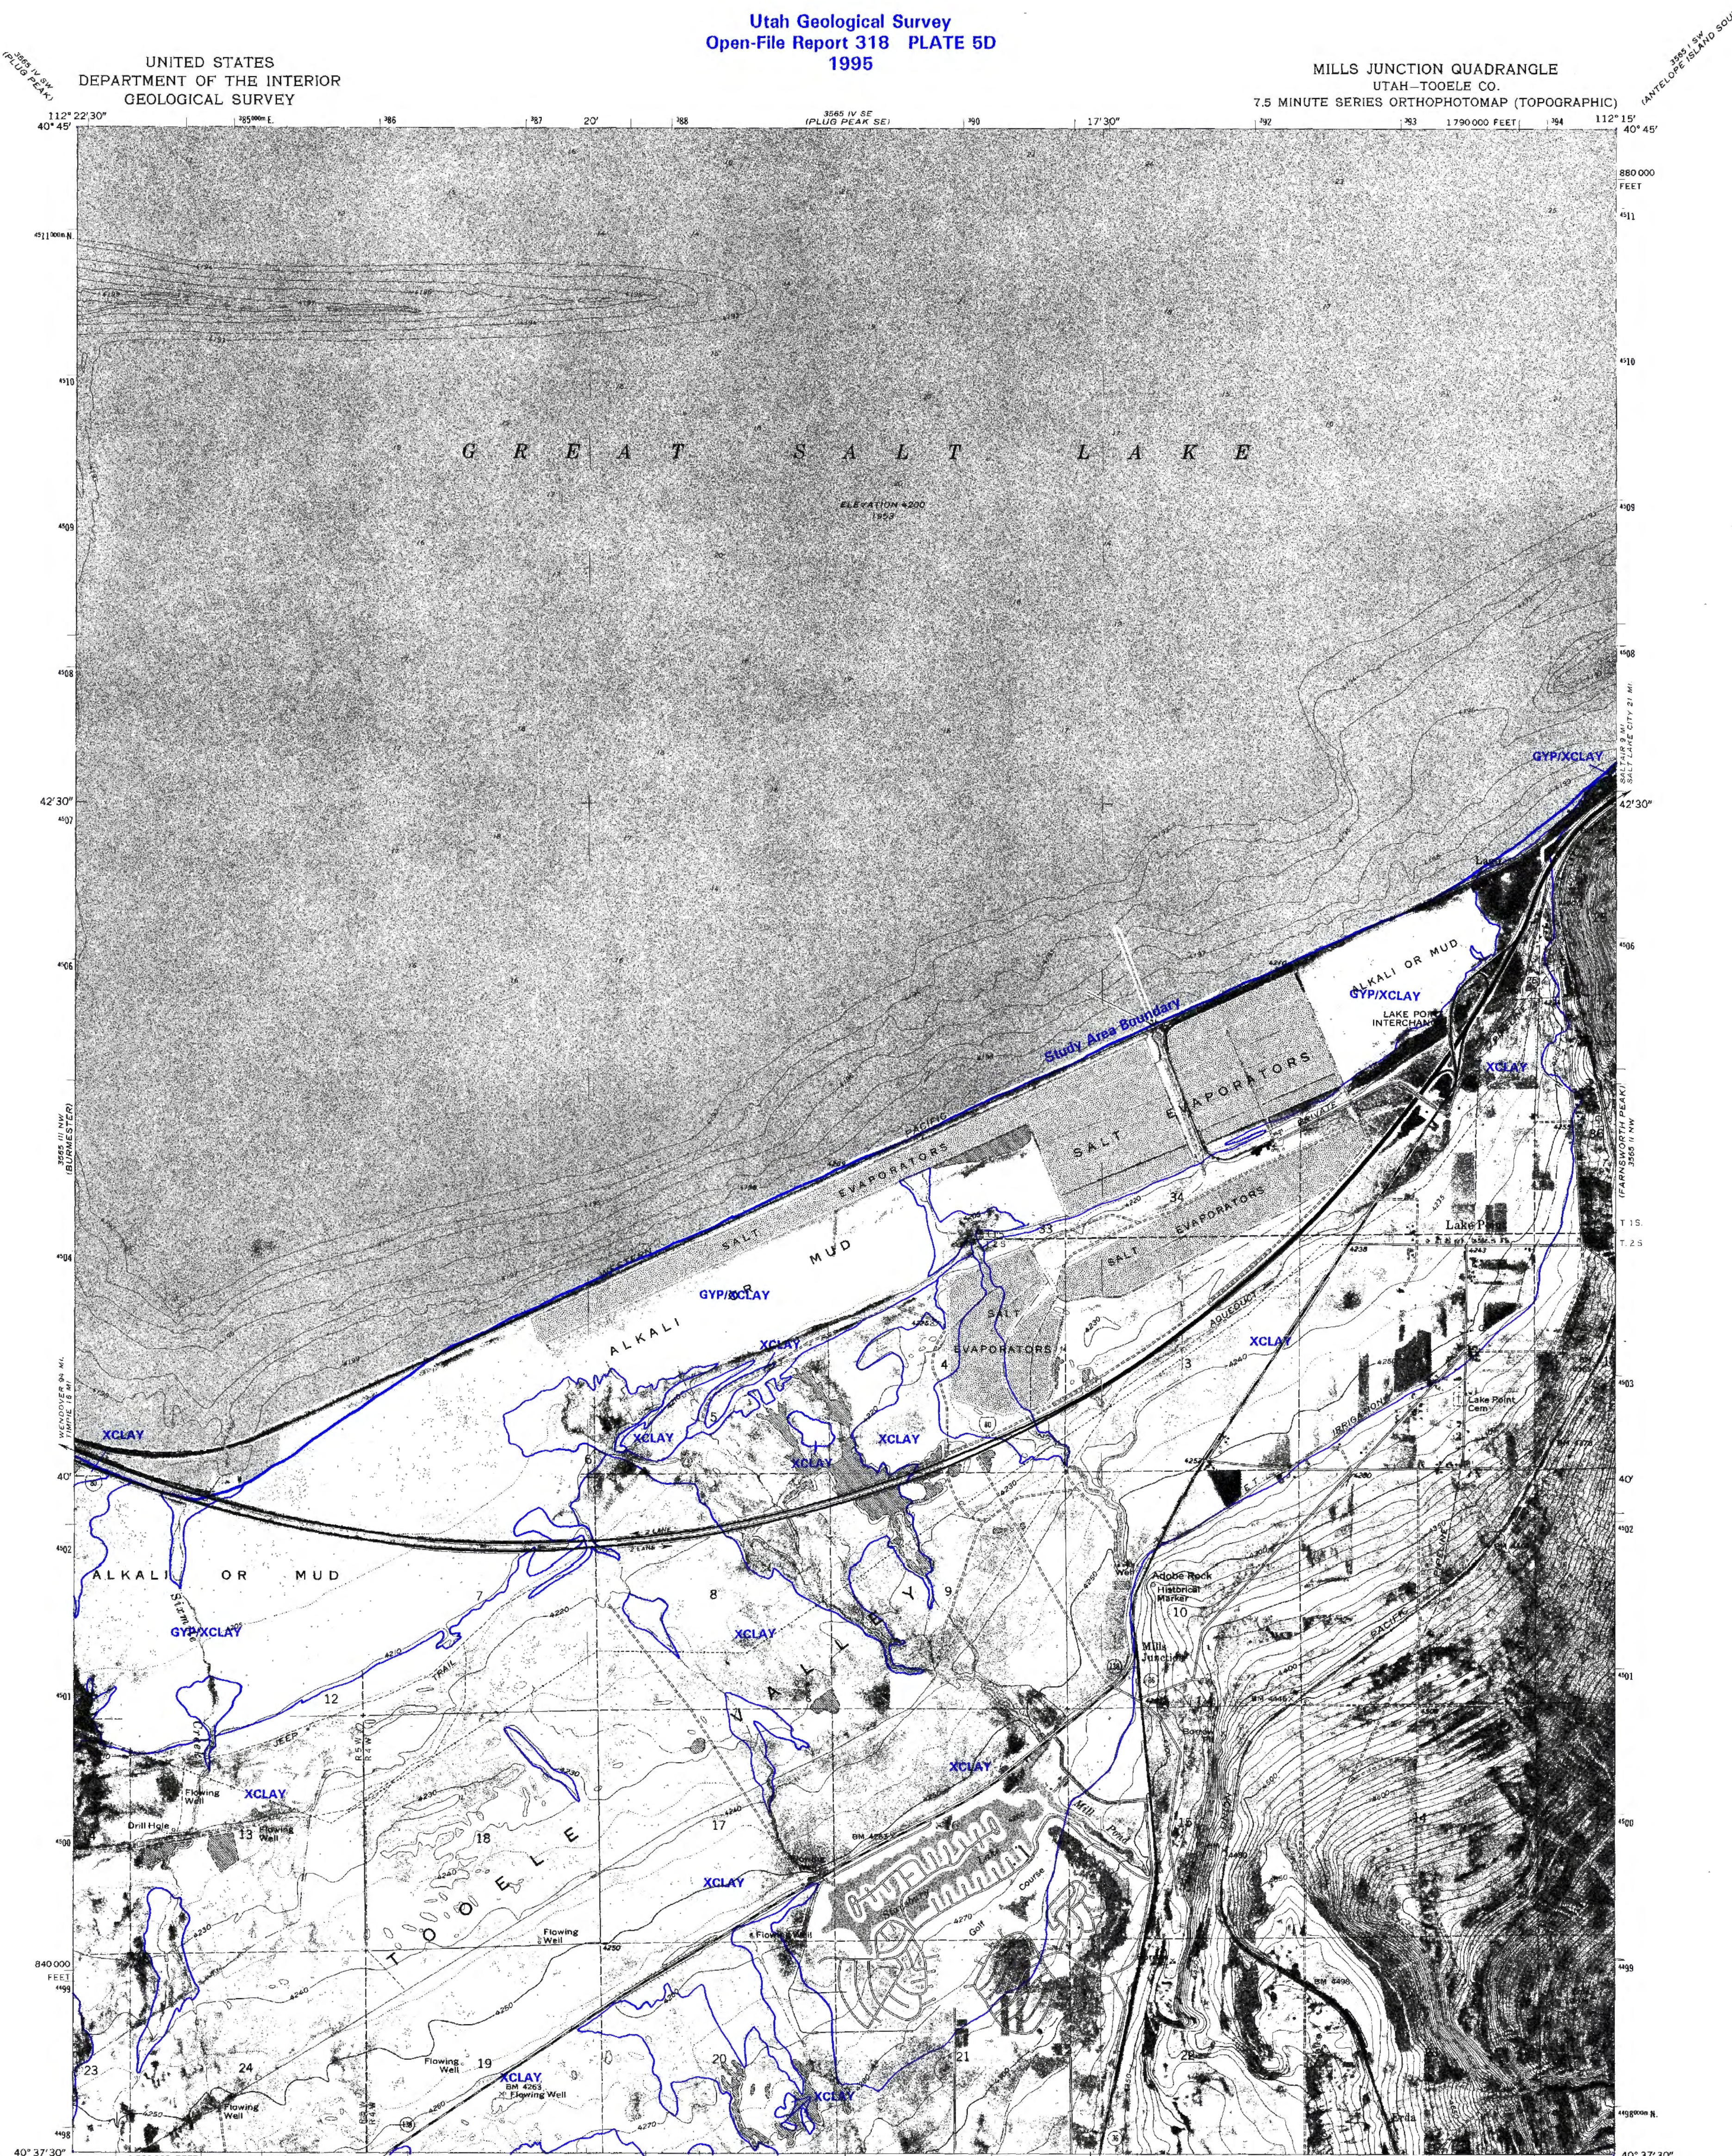
Utah Geological Survey
Open-File Report 318 PLATE 5D
1995

Problem soils, Mills Junction quadrangle, Tooele County, Utah.

Note: A standard soil investigation is recommended in all areas, including those where expansive and gypsiferous soils are not present (see table 1).

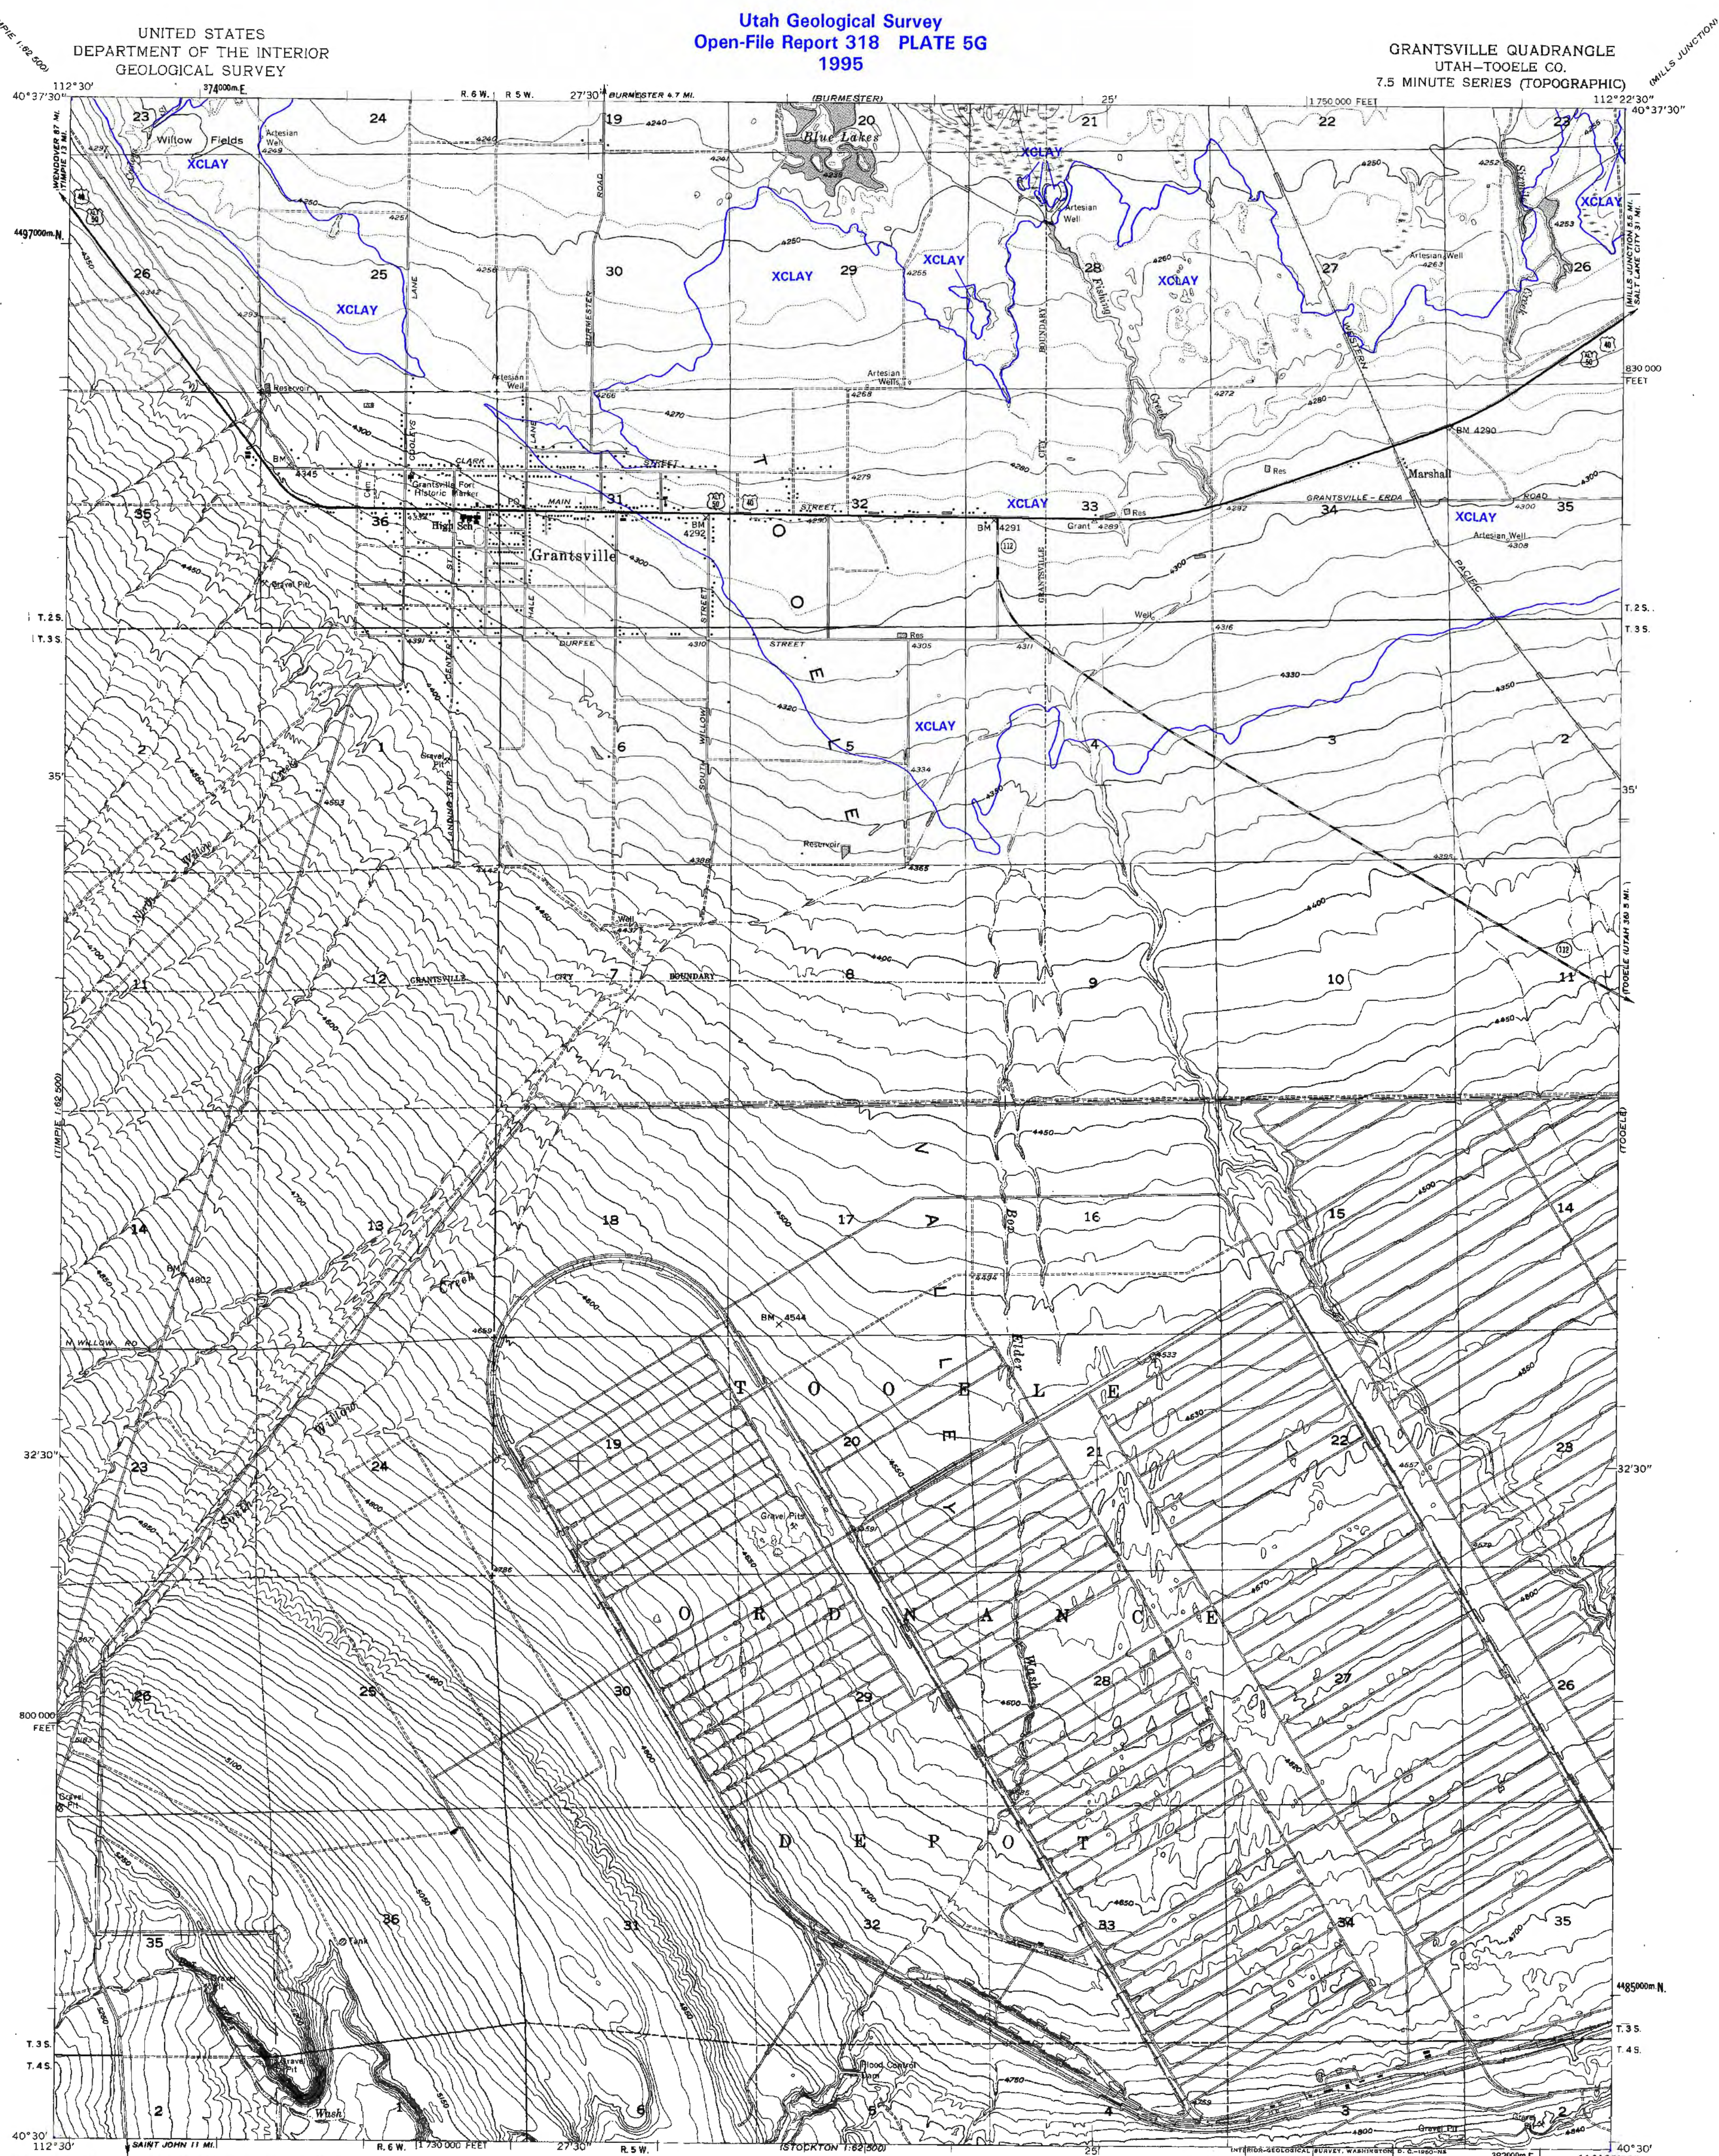
Utah Geological Survey
Open-File Report 318 PLATE 5G
1995

Note: A standard soil investigation is recommended in all areas, including those where expansive and gypsiferous soils are not present (see table 1).
